Inspection Report (On-Highway Dump Truck)

B&B Stock Number	A6804363
Year	2023
Make	Isuzu
Model	NPR HD
Serial Number	54DC4W1D1RS209203
Serial Plate

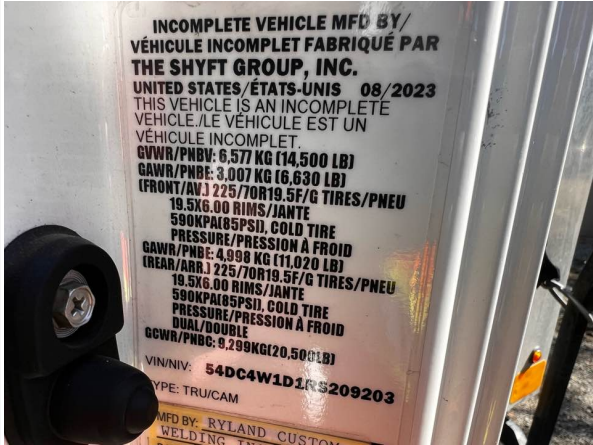
<p>INCOMPLETE VEHICLE MFD BY/ VÉHICULE INCOMPLÉT FABRIQUÉ PAR THE SHYFT GROUP, INC. UNITED STATES/ÉTATS-UNIS 08/2023 THIS VEHICLE IS AN INCOMPLETE VEHICLE./LE VÉHICULE EST UN VÉHICULE INCOMPLÉT. GVWR/PNBV: 6,577 KG (14,500 LB) GAWR/PNBE: 3,007 KG (6,630 LB) (FRONT/AV.) 225/70R19.5F/G TIRES/PNEU 19.5X6.00 RIMS/JANTE 590KPA(85PSI), COLD TIRE PRESSURE/PRESSION À FROID GAWR/PNBE: 4,998 KG (11,020 LB) (REAR/ARR.) 225/70R19.5F/G TIRES/PNEU 19.5X6.00 RIMS/JANTE 590KPA(85PSI), COLD TIRE PRESSURE/PRESSION À FROID DUAL/DOUBLE GVWR/PNBV: 8,299KG(20,500LB) VIN/NIV: 54DC4W1D1RS209203 TYPE: TRU/CAM MFD BY: RYLAND CUSTOM WELDING TRO</p>
Odometer Reading	5843
Odometer
