## Inspection Report (Trailer)

B&B Stock Number	A7956315
Year	2020
Make	P.J. Trailers
Model	40' FB Retractable
Serial Number	2726
Serial Plate Photo

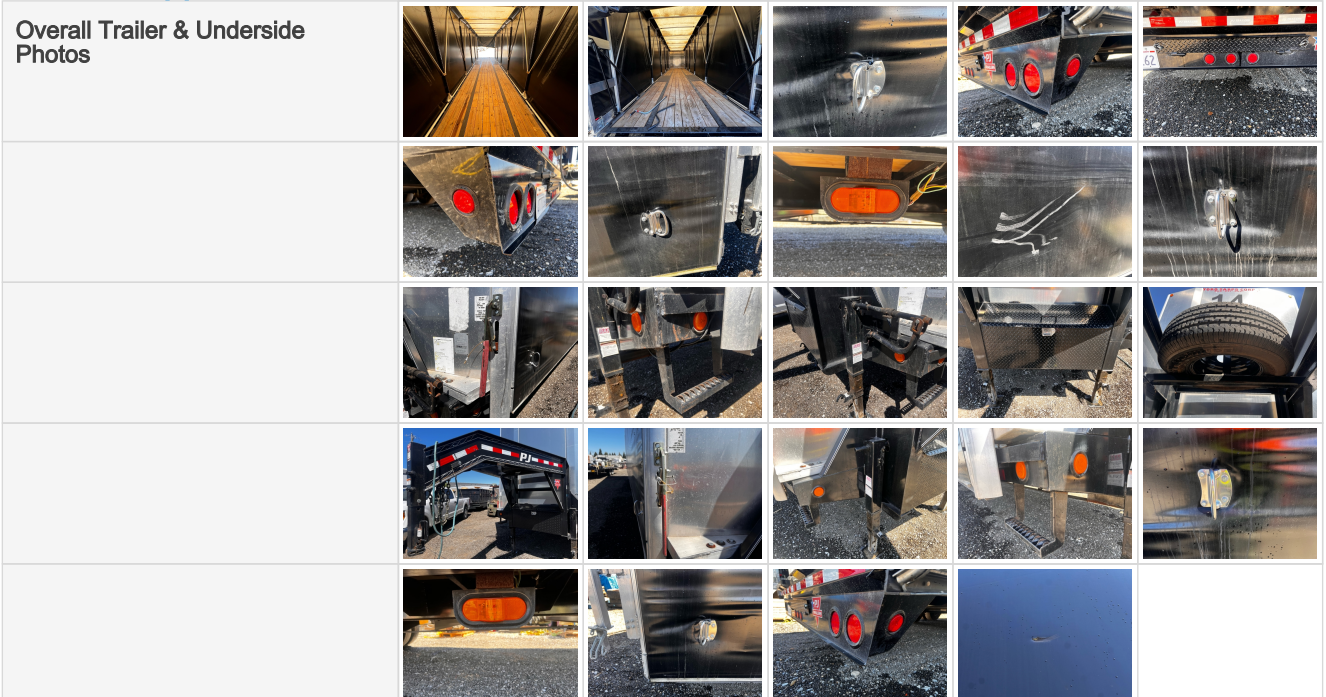
### General Appearance Photos

Frame & Deck Condition	4 - Expected Wear - Fully Operable
Trailer Lights/Wiring (Stop, Tail, Turn)	4 - Expected Wear - Fully Operable
Frame & Body Overall Rating	4 - Expected Wear - Fully Operable
