**SAN MIGUEL ELECTRIC COOPERATIVE, INC.**

**San Miguel Electric Station
Atascosa County, Texas**

CCR Impoundment Inspection Report

January 15, 2016

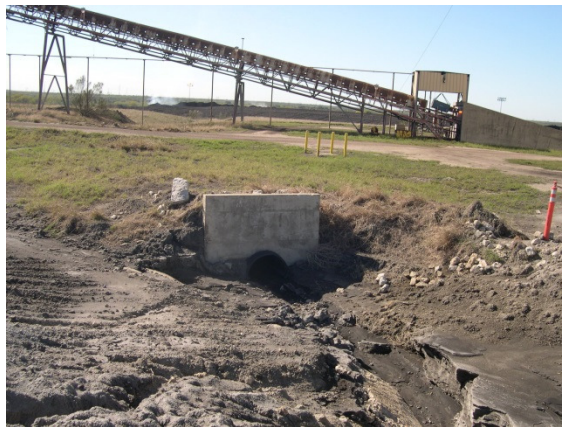
Figure 22: FGD Sludge Pile

Storm water runoff from the Pile flows to an unlined drainage channel which conveys the water to the Lignite Yard Retention Pond.
