**Maintenance and Corrective Measures
San Miguel Electric Cooperative Inc.
(as of October 2018)**

Equalization Pond

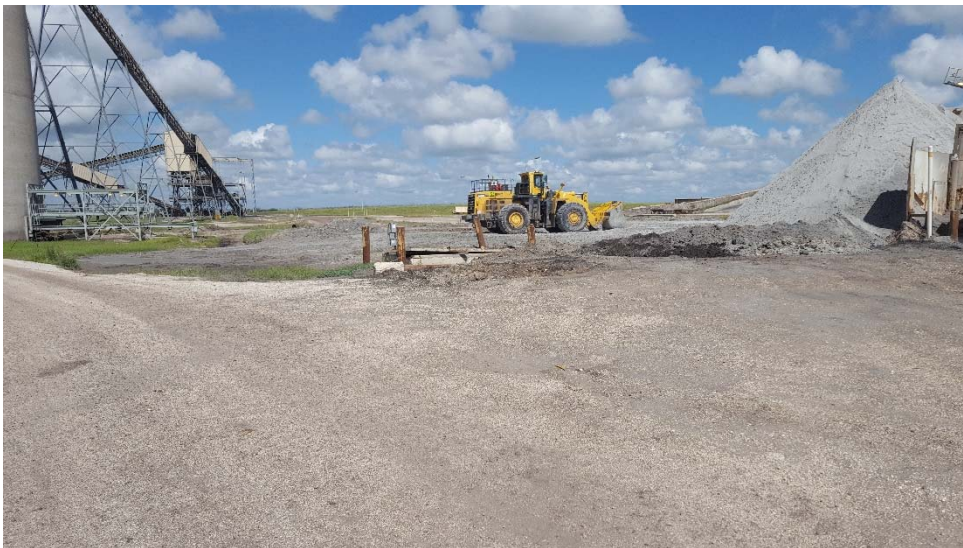
PHOTO 33:

Sludge pile is exposed resulting in minor erosion.	This is a routine maintenance matter. See Photo No. 33
Storm water runoff not draining properly. Storm water runoff ditches are present on west/north side. Run on drainage behind the concrete wall has no contact with the sludge waste.	This is a routine operations maintenance matter. SMECI excavated the ditches/drainageway as part of their routine maintenance in August 2018. See Photo No. 34
Rutting along haul roads.	This is a routine operations maintenance matter. Rutting was not observed at the time of the site visit. See Photo No. 35
Storm water structures need repair.	This is a routine operations maintenance matter. General repairs were made to storm water structures in August 2018 and are routinely maintained and repaired on an as-needed basis. See Photo No. 36

View to the southeast of the Ash Pile area. Ash is removed with a front-end loader and then placed onto large haul trucks.

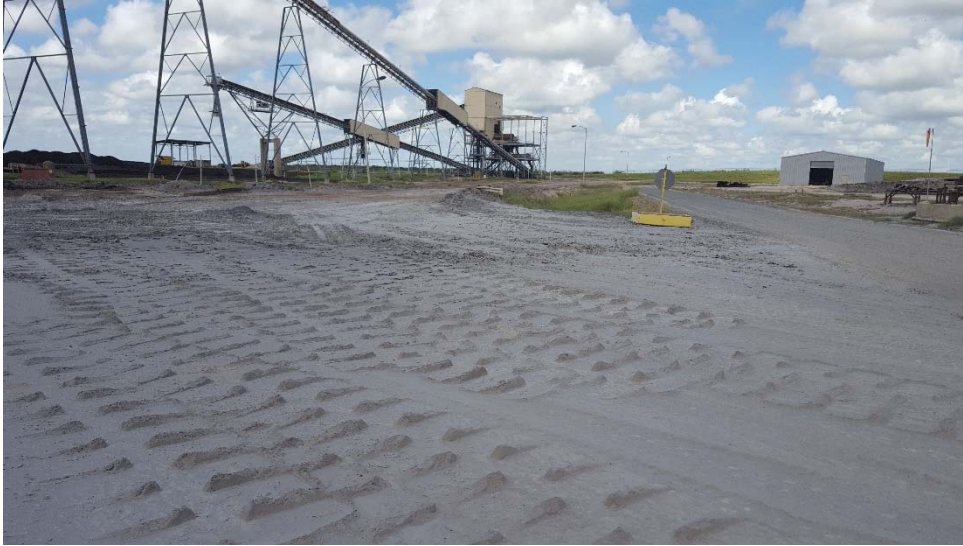
PHOTO 34:

In this area of the Ash Pile, drainage is to the west. This view is to the northeast.
