**Geotechnical Engineering Study
Ash Water Transport and Equalization Ponds
San Miguel Electric Cooperative Power Plant
Atascosa County, Texas**

Arias Job No. 2016-581

October 11, 2016

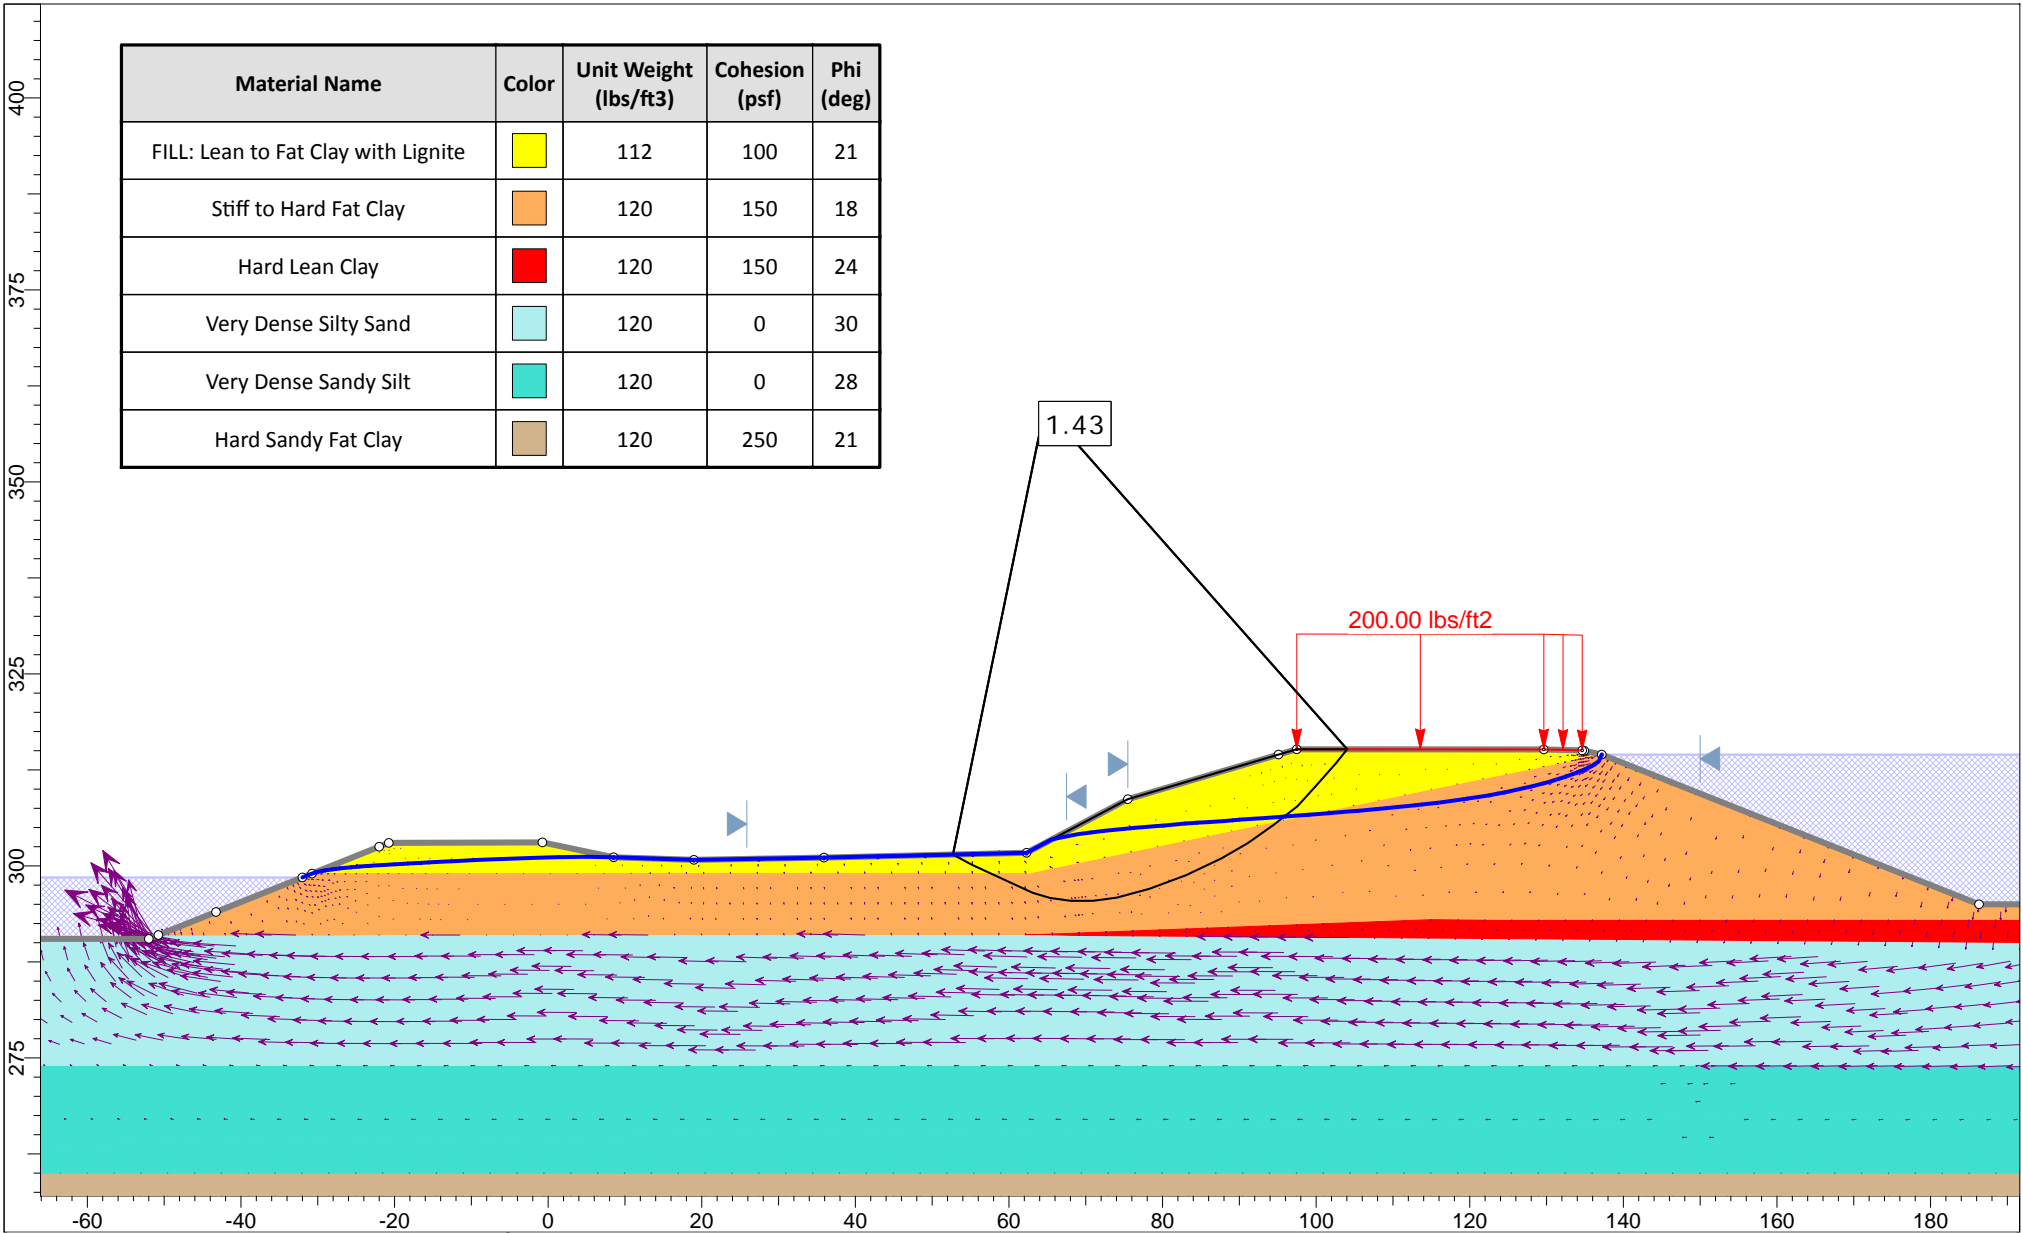
- Section 1B at West Slope - The computed factors of safety were 1.43 and 1.31, which are less than the minimum required values of 1.5 and 1.4 for the maximum storage pool and maximum surcharge pool conditions, respectively.
- Section 3 at South Slope - The computed factors of safety of 1.67 and 1.51 meet the minimum requirements of 1.5 and 1.4 for the maximum storage pool and maximum surcharge pool, respectively.
- Section 8 at South Slope - The computed factors of safety of 1.54 and 1.45 meet the minimum requirements of 1.5 and 1.4 for the maximum storage pool and maximum surcharge pool, respectively.

Project			San Miguel Electric Cooperative - Ash Pond Downstream Slope - Cross Section 1B - Maximum Storage Pool		
	Analysis Description			Long Term Drained Condition		
	Drawn By		Tim Fox, P.E.	Scale		1:300
	Date		9/29/2016, 4:07:29 PM	Company		Arias Geoprosessionals, Inc.
	File Name		Ash Pond Section 1B - Maximum Storage.slim

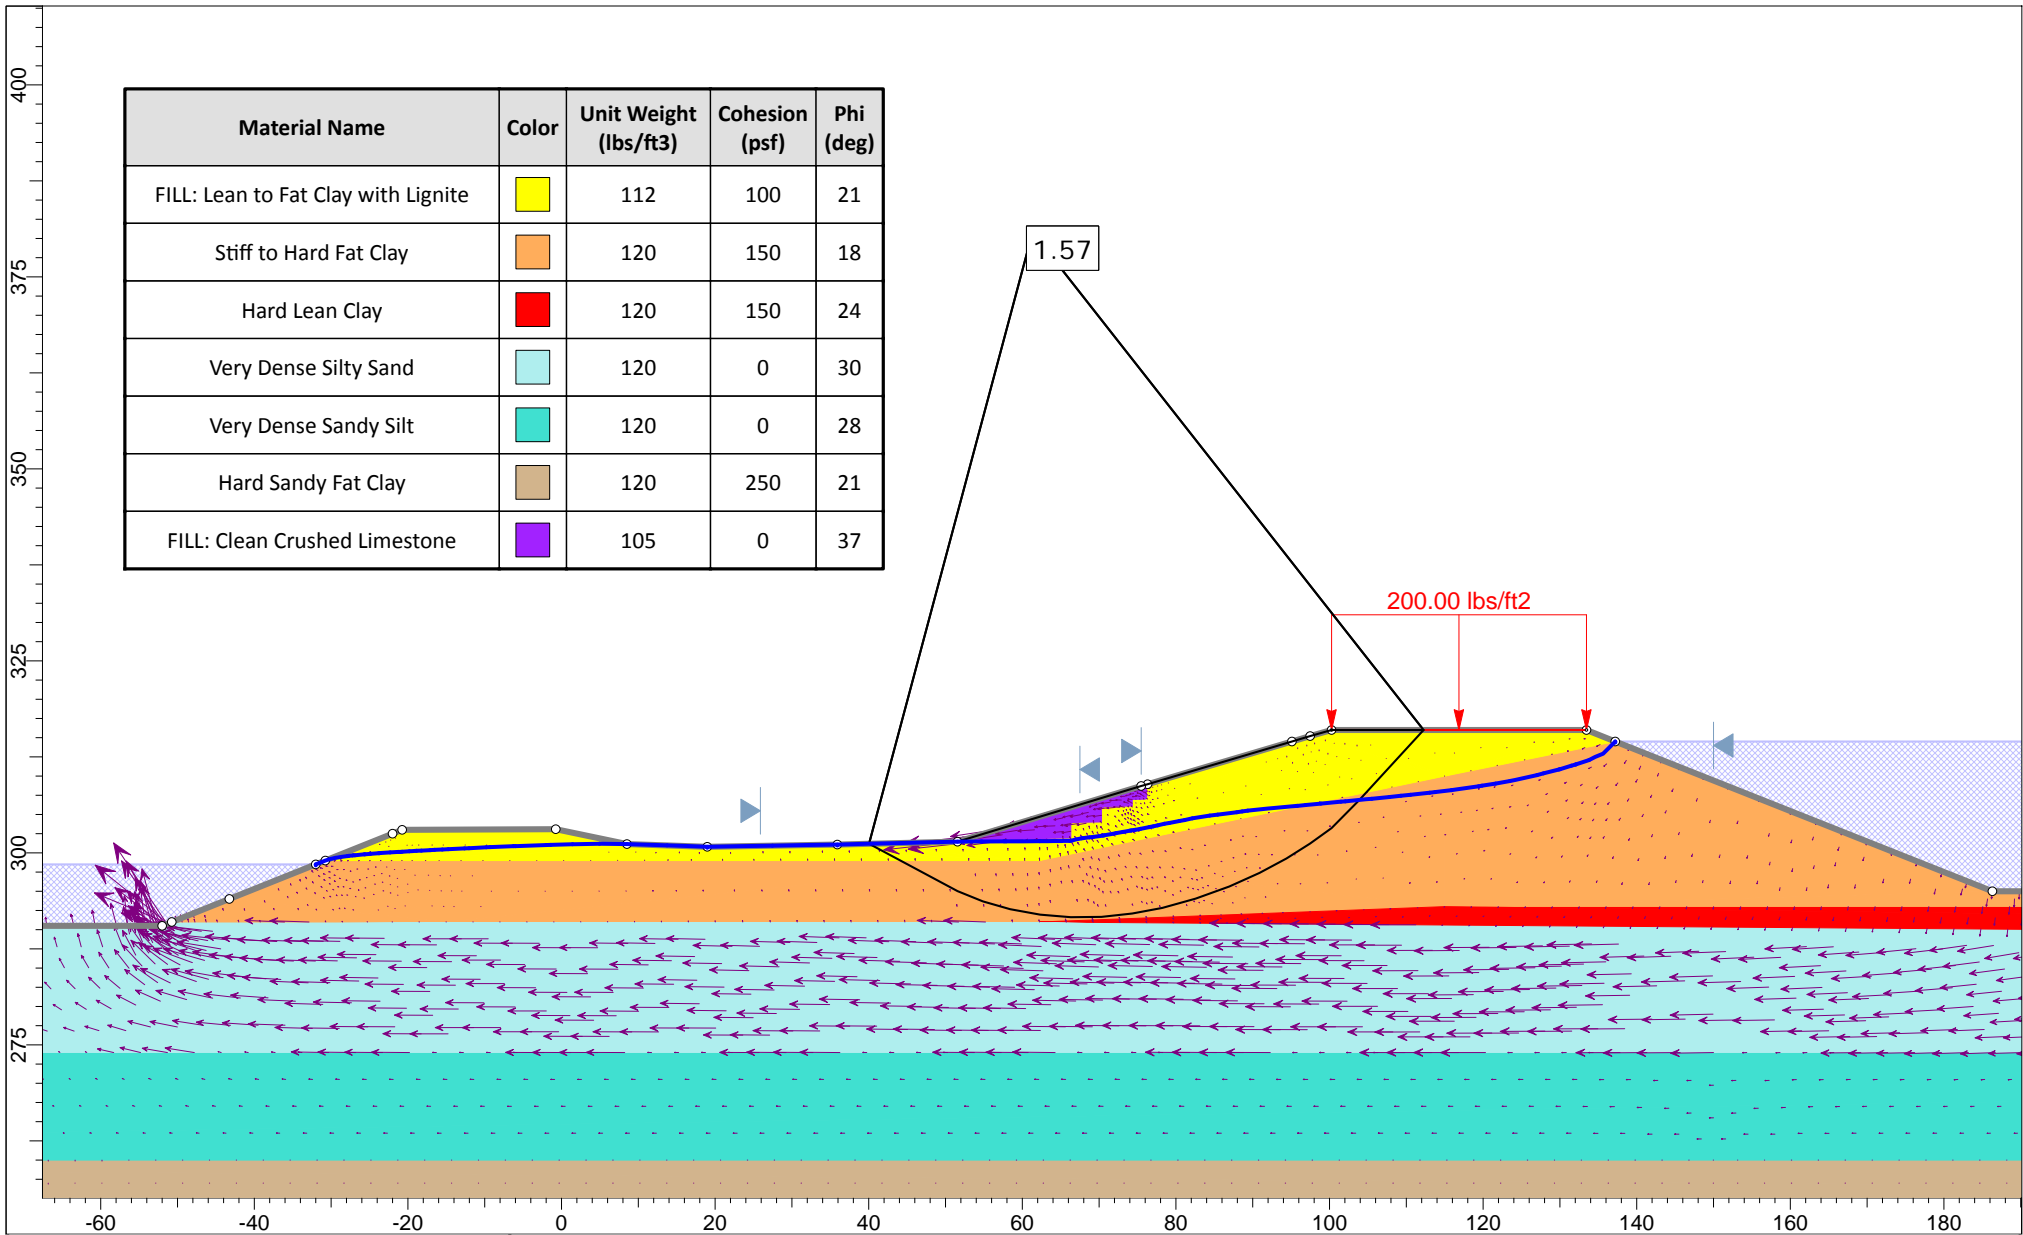
Project			
San Miguel Electric Cooperative - Ash Pond Downstream Slope - Cross Section 1B - Maximum Storage Pool			
Analysis Description			
Slope Repair - Long Term Drained Condition			
Drawn By	Tim Fox, P.E.	Scale	1:300
		Company	Arias Geoprosessionals, Inc.
Date	9/29/2016, 4:07:29 PM		File Name
		Ash Pond Section 1B - Max Storage Surcharge - Slope Repair.slim

To aid in providing stability to the Ash Water Transport Pond west downstream slope, care should be taken to properly integrate the added fill into the existing embankment by using proper “keying and benching” techniques. The remedial action should be performed where the west downstream has been steepened in the bottom portion in the area of Cross Section 1B as previously depicted in Photos 2 to 4 in Appendix B. We recommend the remedial action be performed in the sequence presented subsequently to maintain the stability of the embankment slope:

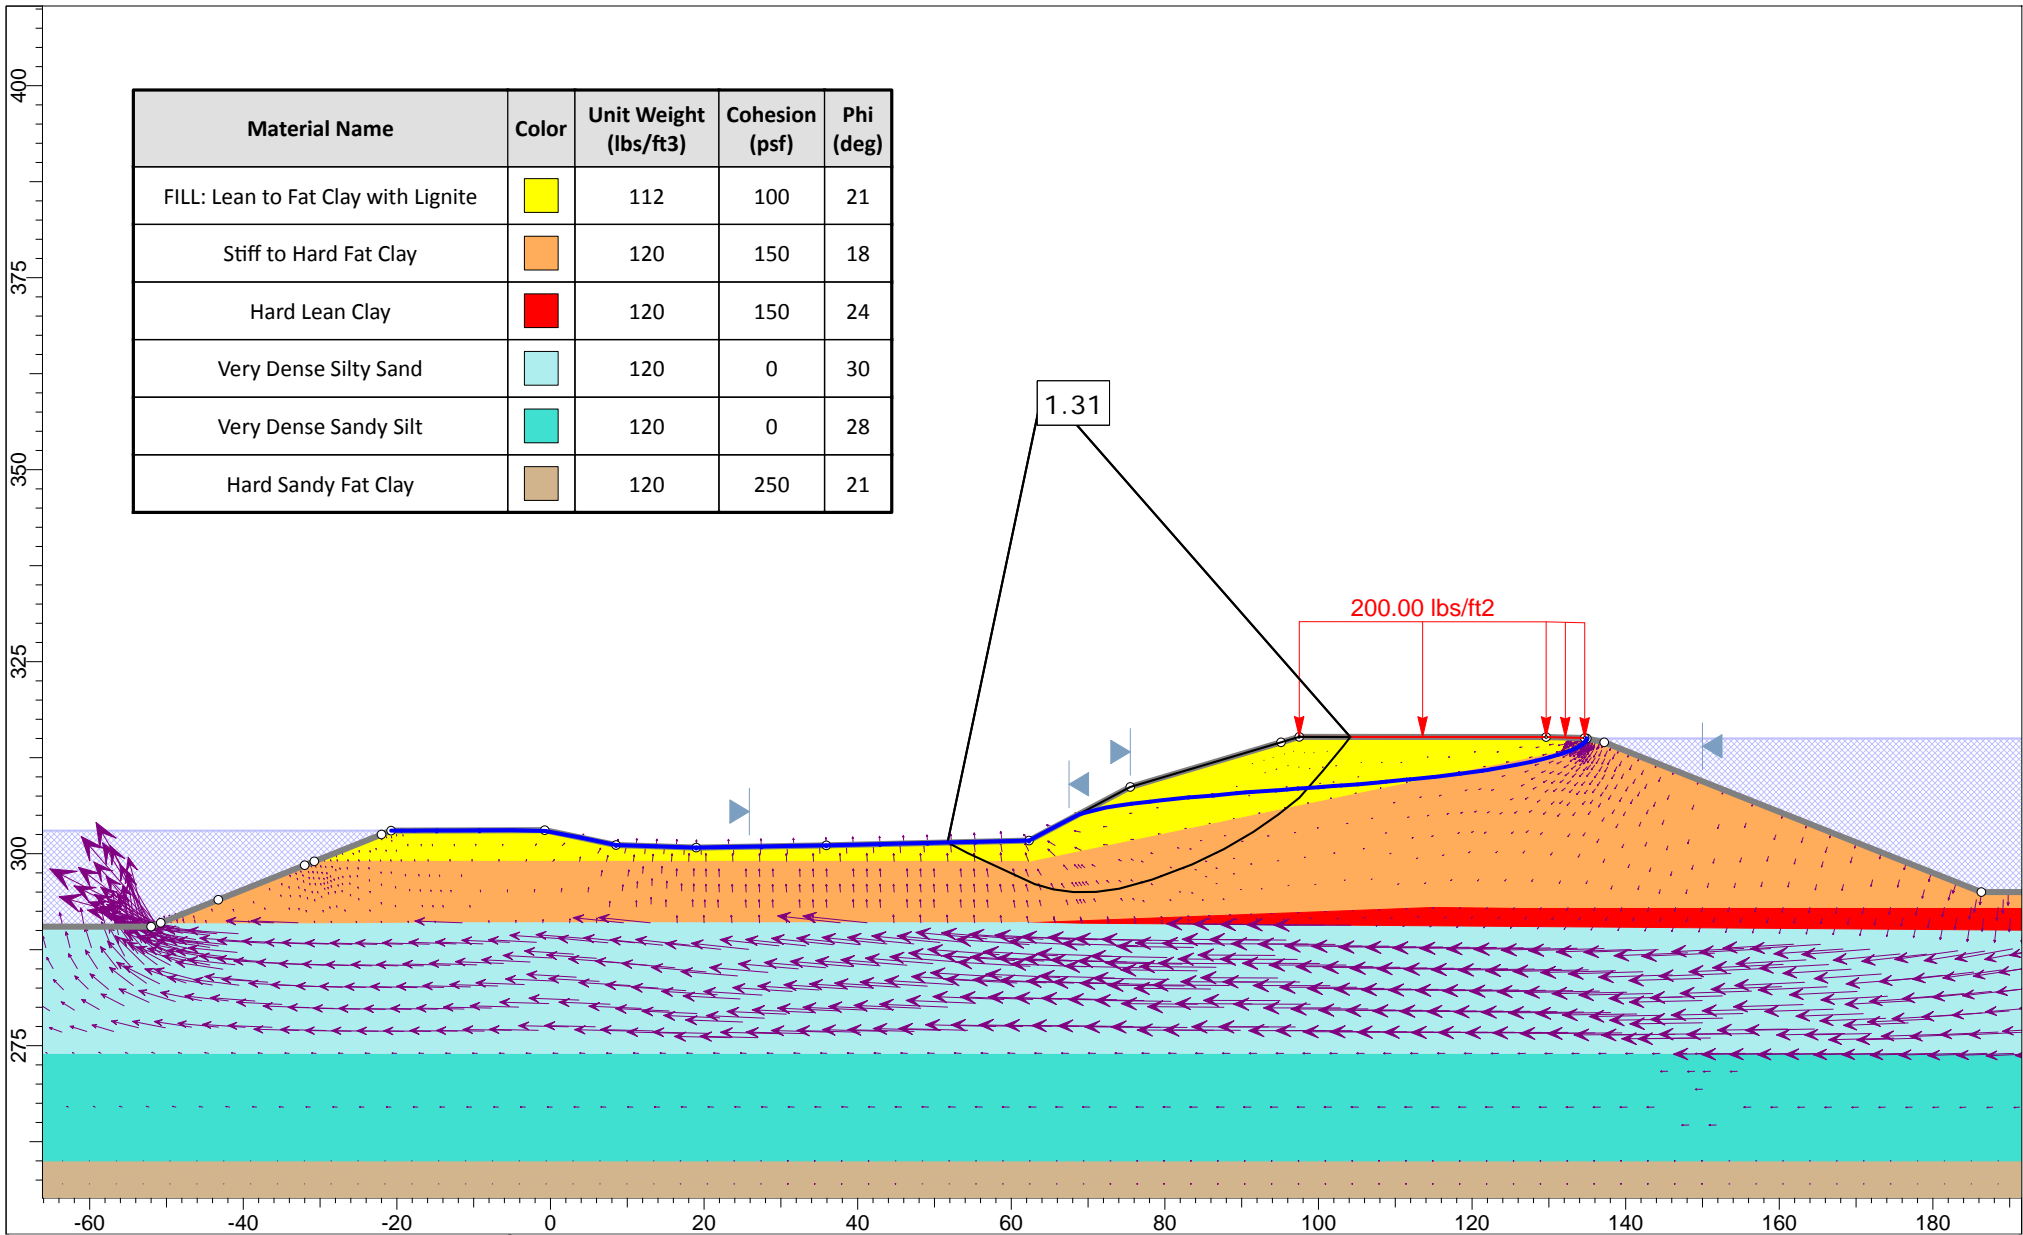
Project			
San Miguel Electric Cooperative - Ash Pond Downstream Slope - Cross Section 1B - Maximum Surcharge Pool			
Analysis Description			
Long Term Drained Condition			
Drawn By	Tim Fox, P.E.	Scale	1:300
		Company	Arias Geoprosessionals, Inc.
Date	9/29/2016, 4:07:29 PM		File Name
		Ash Pond Section 1B - Maximum Surcharge - opt.slim

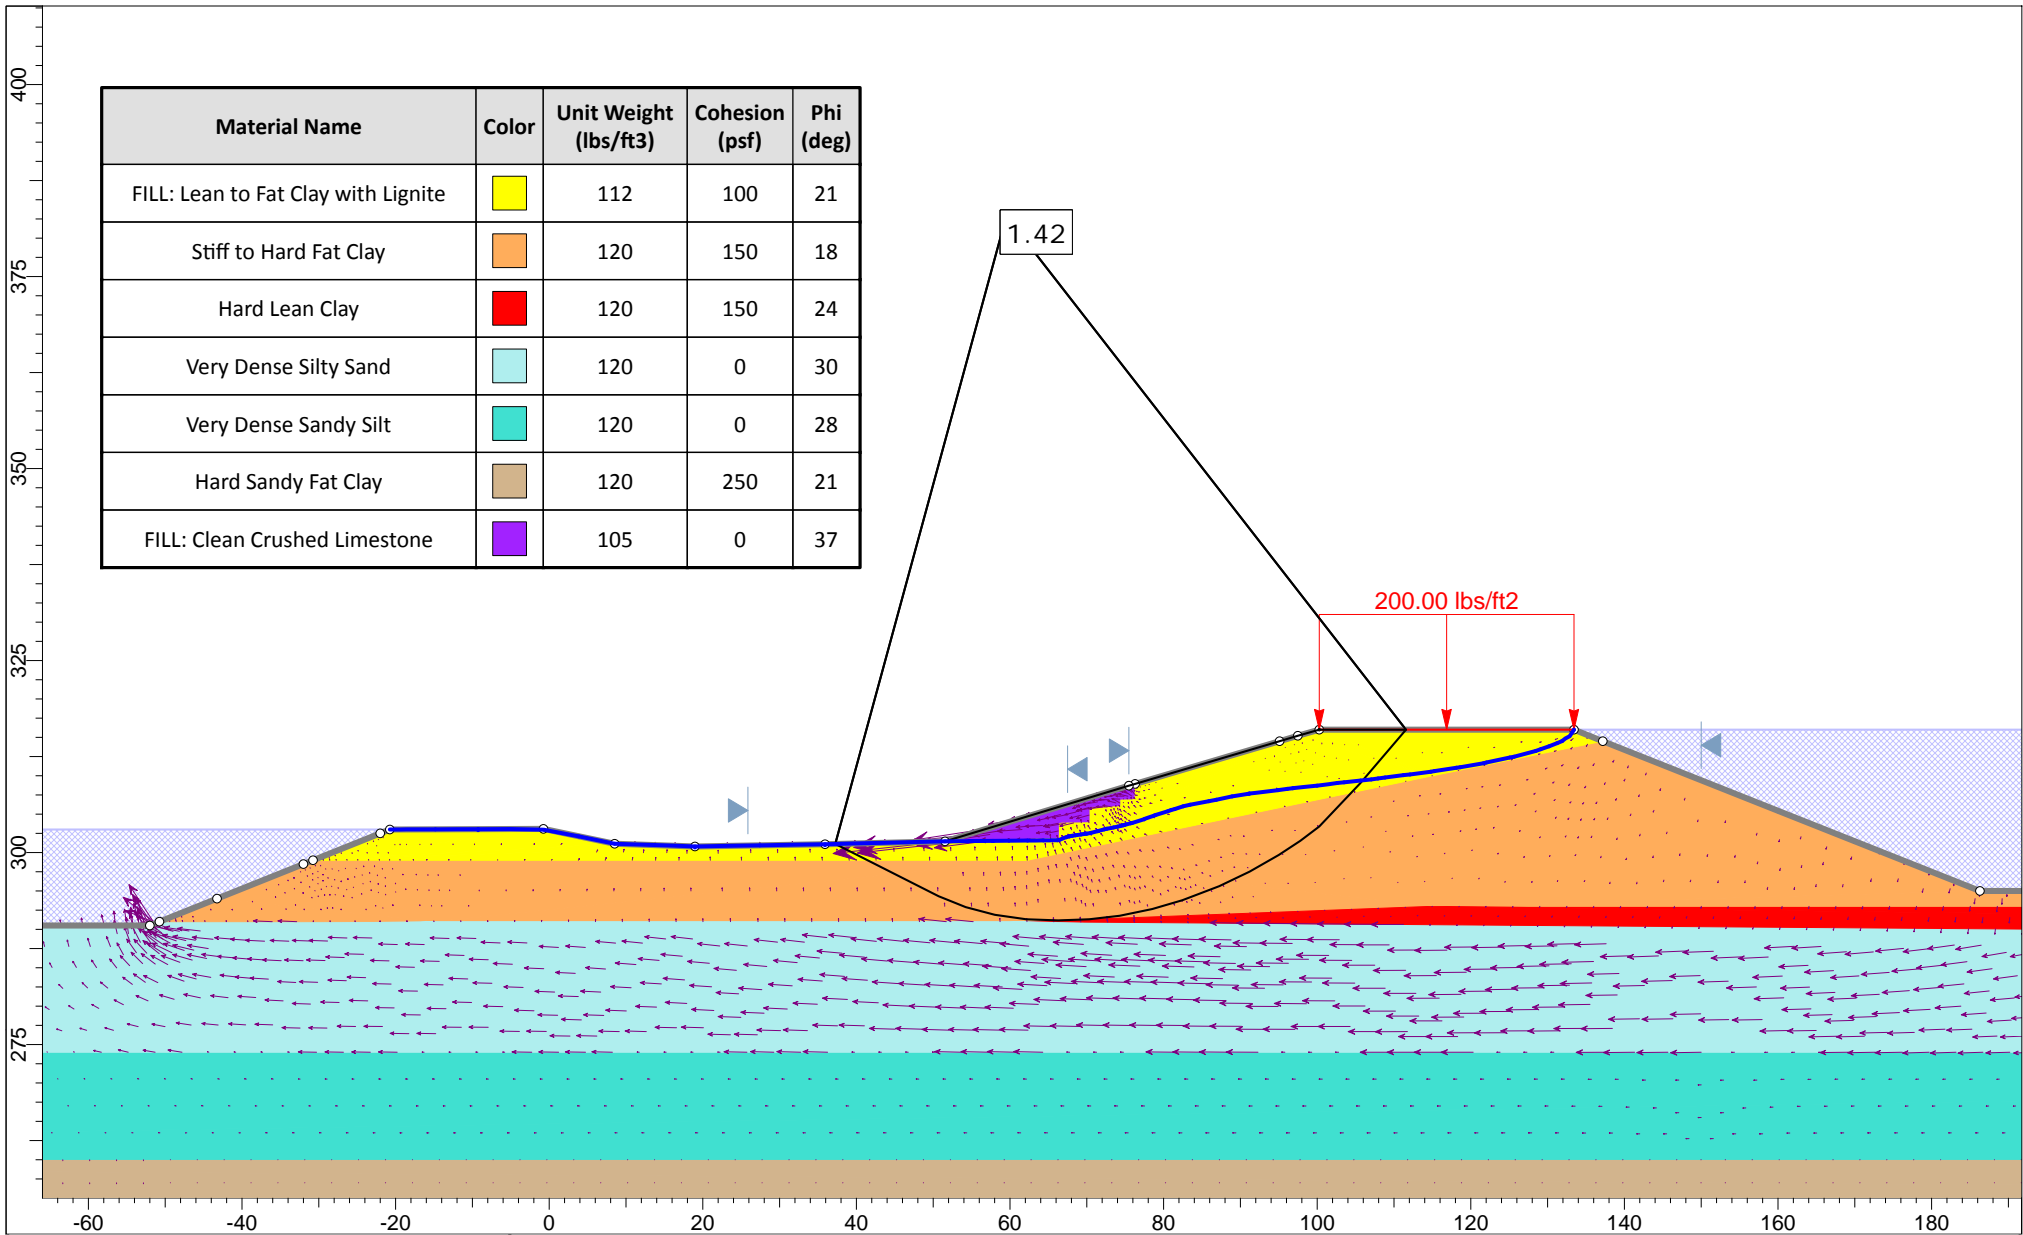
Project			
San Miguel Electric Cooperative - Ash Pond Downstream Slope - Cross Section 1B - Maximum Surcharge Pool			
Analysis Description			
Slope Repair - Long Term Drained Condition			
Drawn By	Tim Fox, P.E.	Scale	1:300
		Company	Arias Geoprosessionals, Inc.
Date	9/29/2016, 4:07:29 PM		File Name
		Ash Pond Section 1B - Maximum Surcharge - Slope Repair.slim
