**ANNUAL INSPECTION REPORT FOR COAL COMBUSTION RESIDUALS (CCR) UNITS  
SAN MIGUEL ELECTRIC COOPERATIVE POWER PLANT**

**Wood Environment & Infrastructure Solutions, Inc.**

**January 10, 2019**

**Wood Project No.: 6706160039**

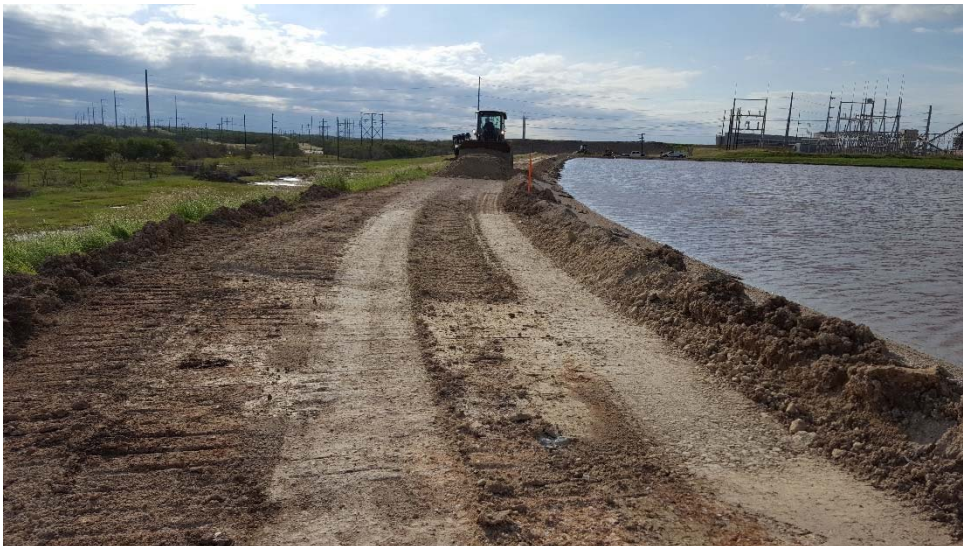
**PHOTO 2:**

Clay soils were added to the crest of the berm behind the temporary berm previously installed. Wave erosion was minimal along the shoreline and the underlying clay liner was not exposed. This view is to the west-southwest.

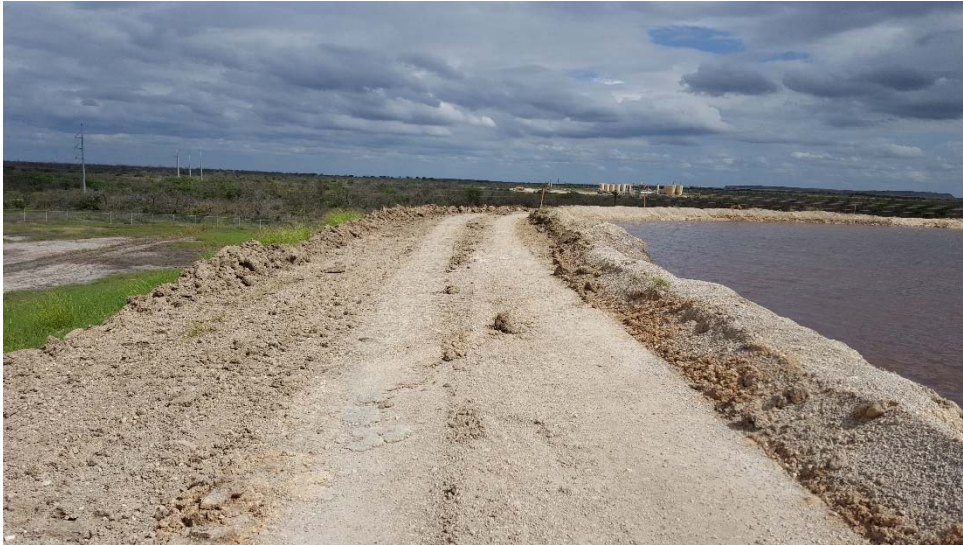
**PHOTO 3:**

Vegetation along the interior of the berm crest has been removed. This view is to the east-southeast during the installation of the first lift of clay soils on the berm crest.

Summary of Prior Deficiency/Observation*	Maintenance and Corrective Measures
The crest of the impoundment had areas with moderate rutting from vehicular traffic in localized areas around the pond.	This is a routine operations maintenance matter. Where needed, the crest of the Equalization Pond is being adjusted to an elevation of 296 feet above mean sea level and these areas are being reconditioned. See Photo No. 1
Moderate wind/wave erosion occurring at the water line of the pond.	This is a routine operations maintenance matter. The water level has been lowered and only minor erosion is present, the liner was not exposed. Maintenance and repair of the inner pond berm is performed by SMECI's Maintenance Contractor. Additionally, the inner berm is being adjusted during the heightening of the berm. See Photo No. 2
Vegetation growth in pond area along the inner face of the embankment/dike.	This is a routine operations maintenance matter. Vegetation has been removed. See Photo No. 3

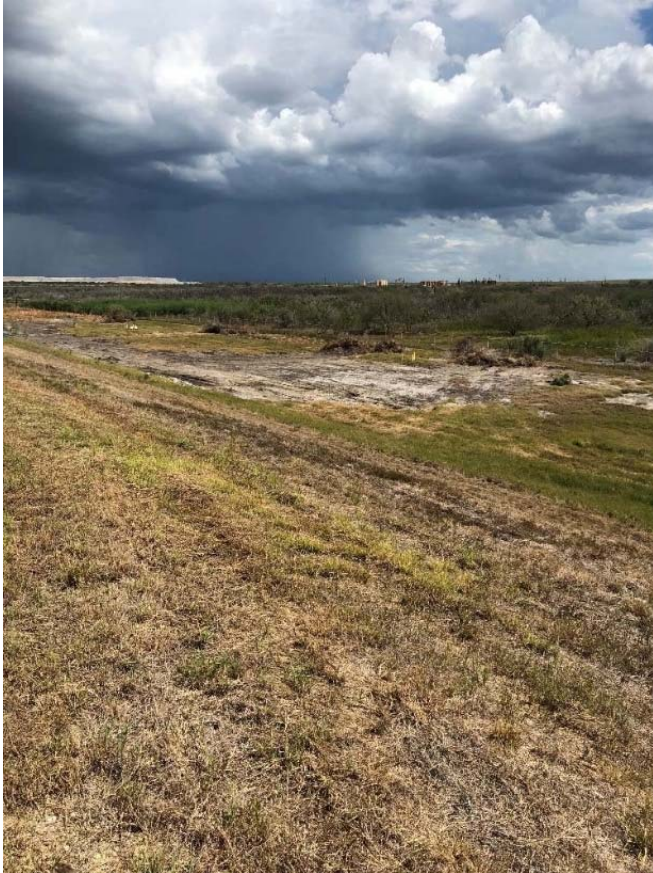
**PHOTO 5:**

Looking to the southeast from the southern crest of the Equalization Pond toward a recently disturbed area associated with brush and vegetation removal. This picture is from a drier period showing the brown vegetation. This area is a streambed that parallels the southern and eastern sides of the Equalization Pond.

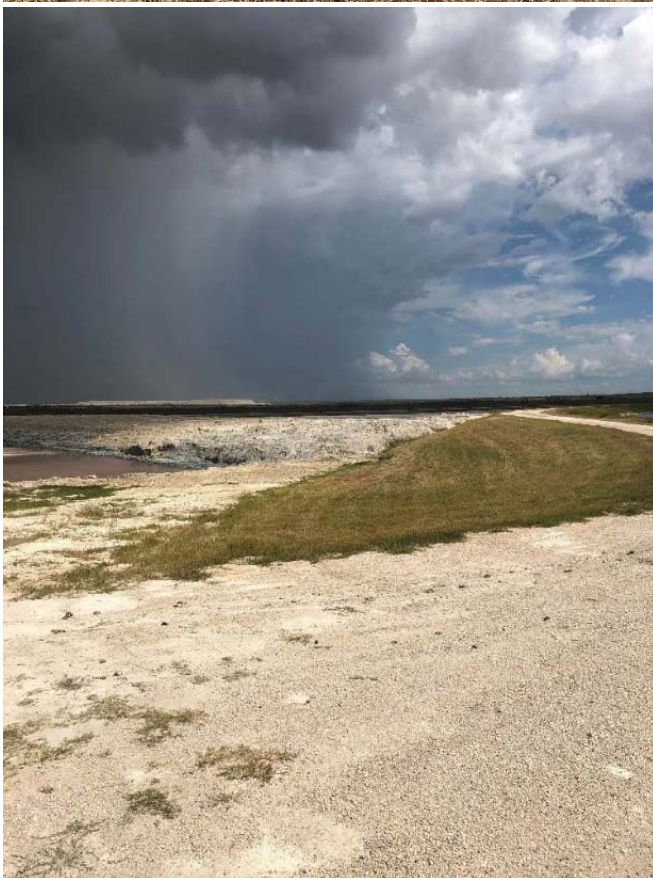
**PHOTO 6:**

Looking to the south-southeast from near the northwestern corner of the Equalization Pond. There was sparse vegetation near the shoreline. This area was disturbed by heavy equipment during the piling of ash within the pond. This area will be reseeded following the completion of the crest work at the pond.

Dense vegetation observed on the south and east sides. Ponding and moist/soft spots appear along south and east sides.	This is a routine operations maintenance matter. The berms and other areas were mowed. Soft spots were not observed. No evidence of seeps, cracks, or slope failures were observed. Mowing and vegetation clearing is performed on a routine and as-needed basis by the SMECI Maintenance Contractor. See Photo Nos. 4 (after rain) and 5 (dry period)
Sparse vegetation observed on the inner slopes on the north west side and along the downstream toe on the north east side.	This is a routine operations maintenance matter. The areas of sparse vegetation are related to recent machinery operation near the northwestern corner of the Equalization Pond. The equipment was used to stack ash within the pond for drying and eventual removal. The area along the toe of the embankment was cleared of vegetation and is scheduled for reseeding. See Photo Nos. 6 and 7

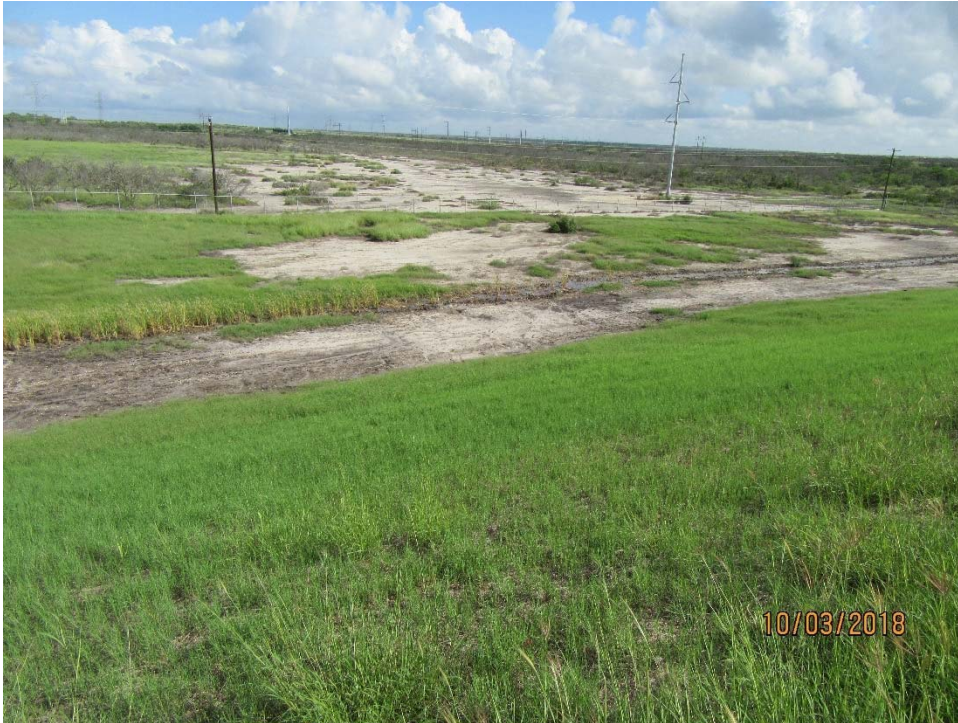
**PHOTO 7:**

This photograph is looking to the northeast down the slope of the Equalization Pond berm. The area on the southern side of the small drainageway was recently scraped and leveled near the toe of the embankment.

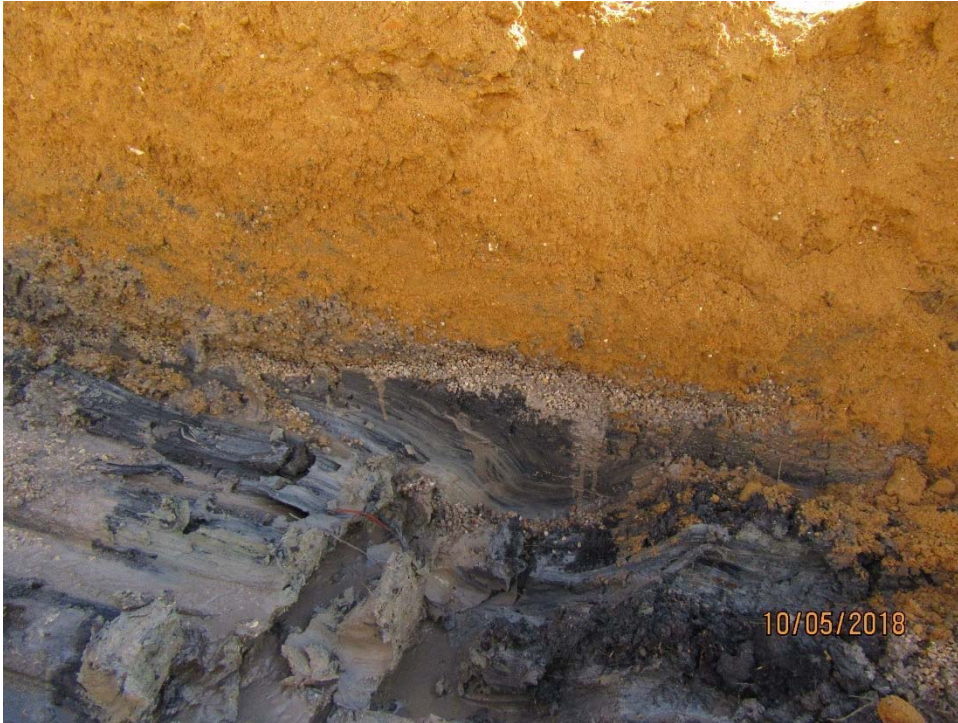
**PHOTO 27:**

View of the excavation completed at the location of the dead cattails. The excavation revealed a buried lens of small gravel. This gravel lens was holding stormwater runoff and slowly allowing it to seep to the surface. The material underlying the gravel was a fat clay. After exposing and removing the gravel lens, the excavation quickly dried up confirming there is no pond seepage.

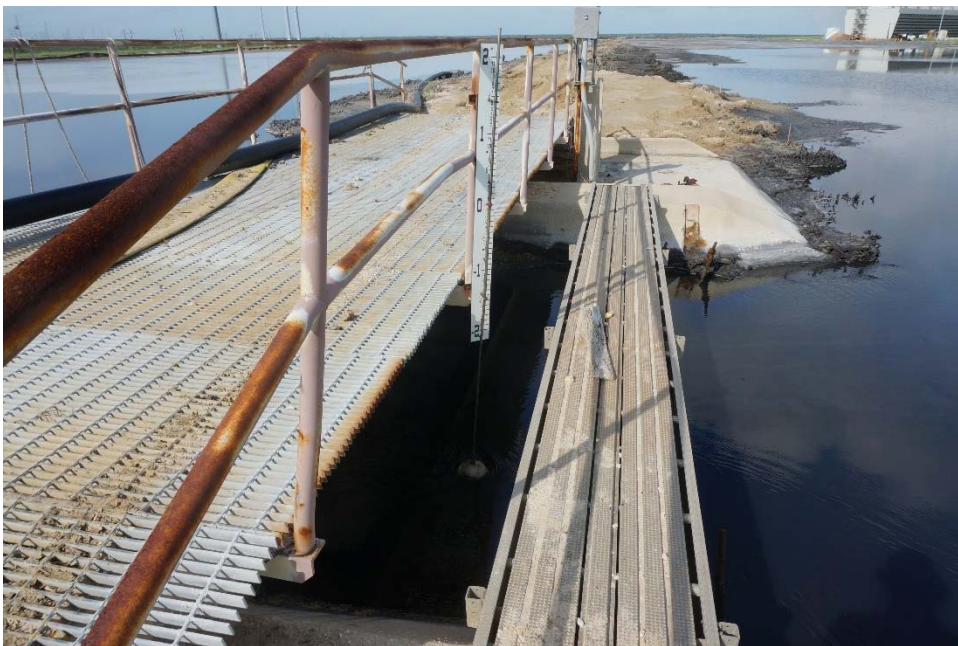
**PHOTO 28:**

The gauge located at the weir between Ash Pod A and B. New clay soils had recently been added to the berm on both side of the weir bridge.

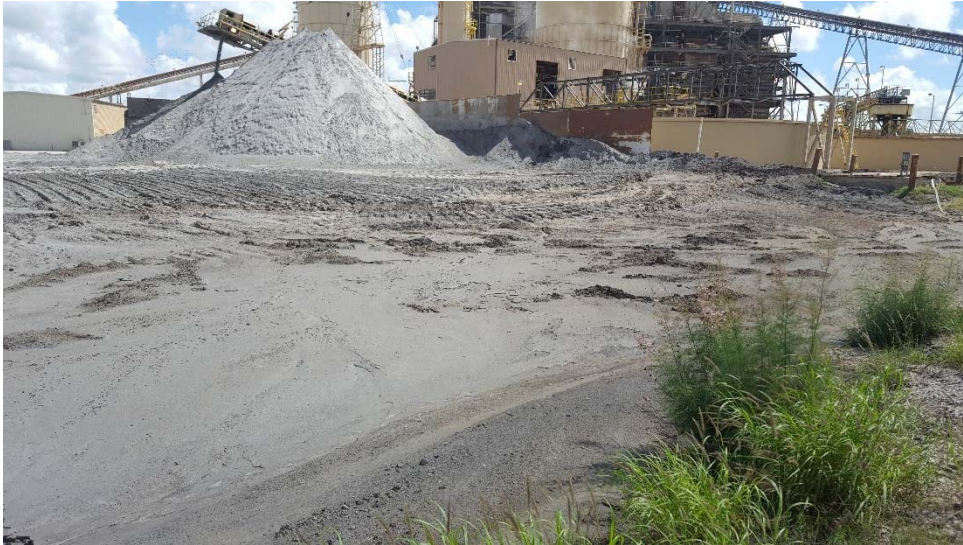
**PHOTO 33:**

View to the southeast of the Ash Pile area. Ash is removed with a front-end loader and then placed onto large haul trucks.

Sludge pile is exposed resulting in minor erosion.	This is a routine maintenance matter. See Photo No. 33
Storm water runoff not draining properly. Storm water runoff ditches are present on west/north side. Run on drainage behind the concrete wall has no contact with the sludge waste.	This is a routine operations maintenance matter. SMECI excavated the ditches/drainageway as part of their routine maintenance in August 2018. See Photo No. 34
Rutting along haul roads.	This is a routine operations maintenance matter. Rutting was not observed at the time of the site visit. See Photo No. 35
Storm water structures need repair.	This is a routine operations maintenance matter. General repairs were made to storm water structures in August 2018 and are routinely maintained and repaired on an as-needed basis. See Photo No. 36

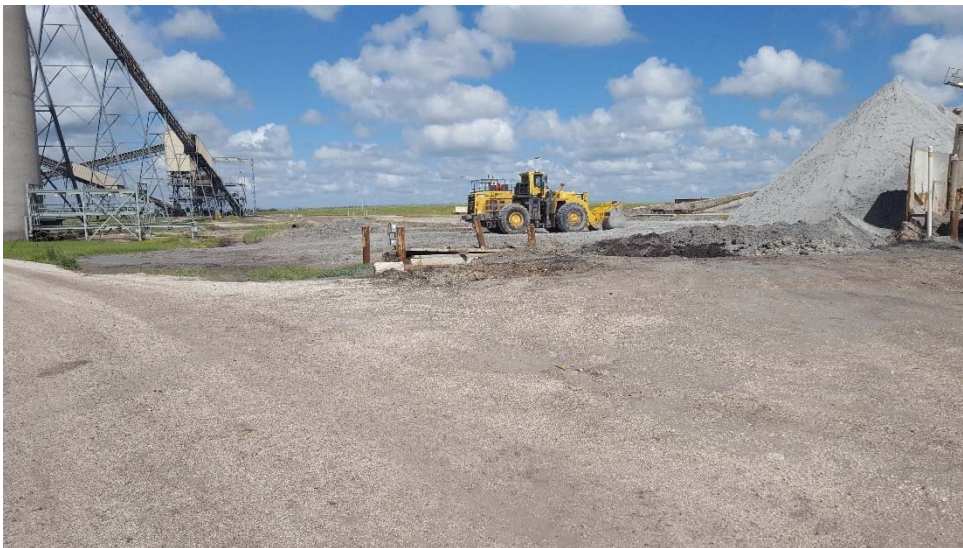
**PHOTO 34:**

In this area of the Ash Pile, drainage is to the west. This view is to the northeast.

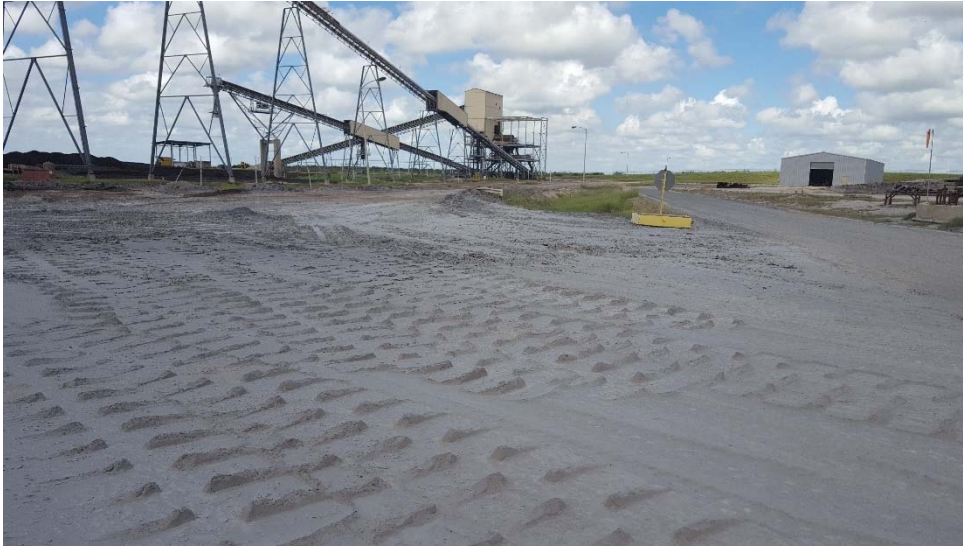
**PHOTO 35:**

This view is to the north-northwest of the northern portion of the ash loadout area. The haul road is in the background. It was not rutted at the time of the observations.

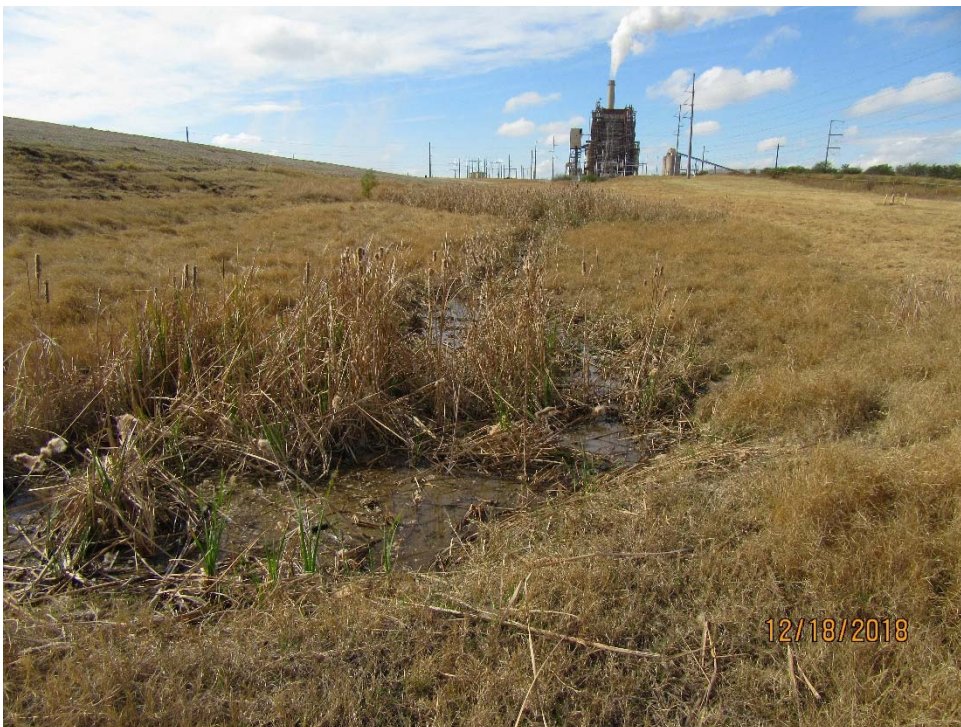
**PHOTO 1:**

Looking to the east along the northern slope of the Equalization Pond. The Equalization Pond slopes were recently mowed for the Annual Inspection. Recent December rainfall made the slopes soft in isolated areas. The December 18-19, Annual Inspection was conducted under partly cloudy conditions.

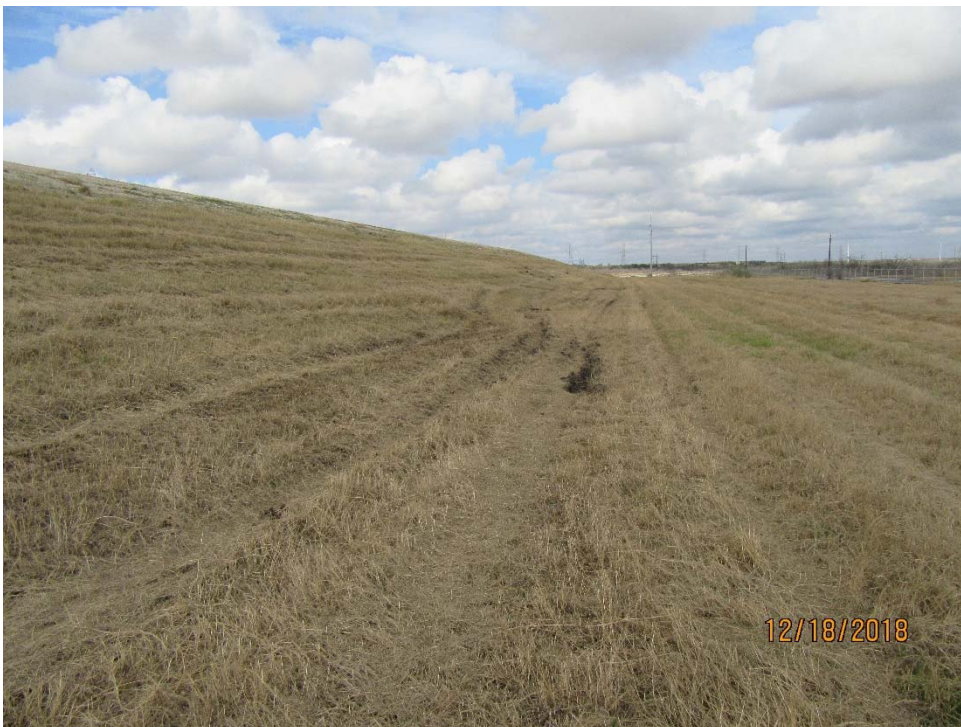
**PHOTO 3:**

The area at the northeastern corner of the Equalization Pond was slightly damp, likely from recent rainfall. This view is to the east from the northern side of the toe of the berm.

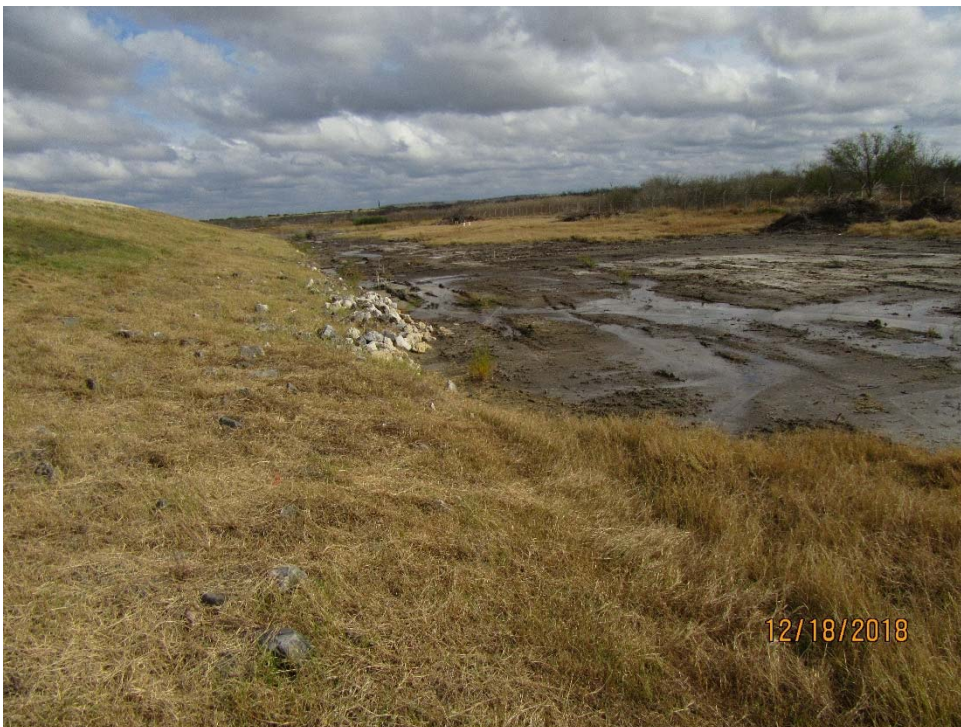
**PHOTO 7:**

Rip rap located along the toe of the Equalization Pond berm. The drainageway channel was located adjacent to the toe of the berm. Most woody vegetative grown was removed during the summer of 2018 within the channel, but some of the plants within the drainageway have begun to regrow. No woody plant growth was observed along the slope of the berm at the time of the site visit.

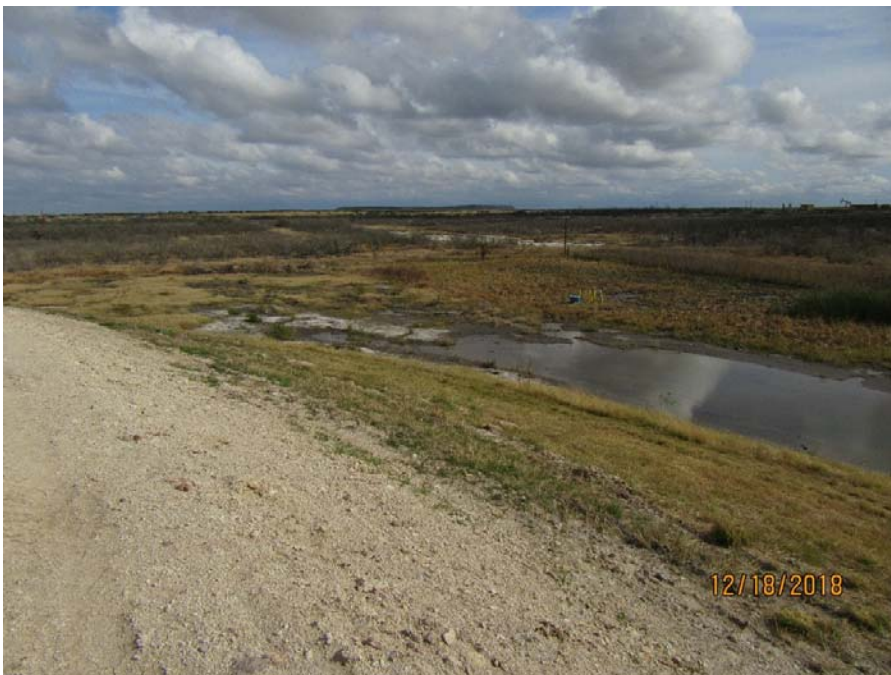
**PHOTO 11:**

Looking to the west along the crest of the berm of the Equalization Pond. The drainageway adjacent to the toe of the berm is visible within the left hand side of the photograph. No cracks or rutting was observed along the crest of the berm.

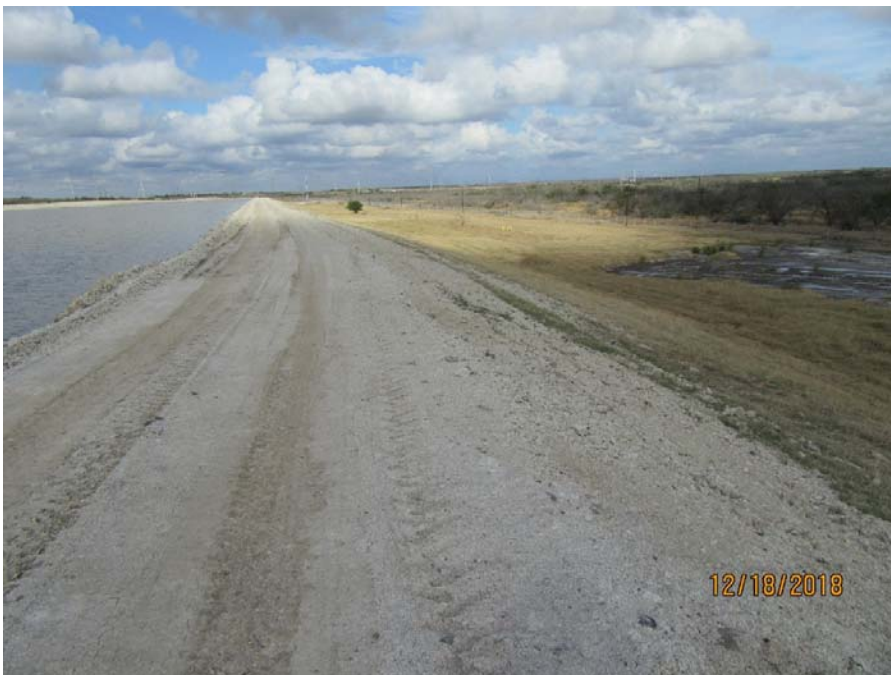
**PHOTO 13:**

View to the east-northeast along the roadway along the top of the berm. No cracking or rutting was observed along the crest. No vegetative growth was noted along the interior of the crest.

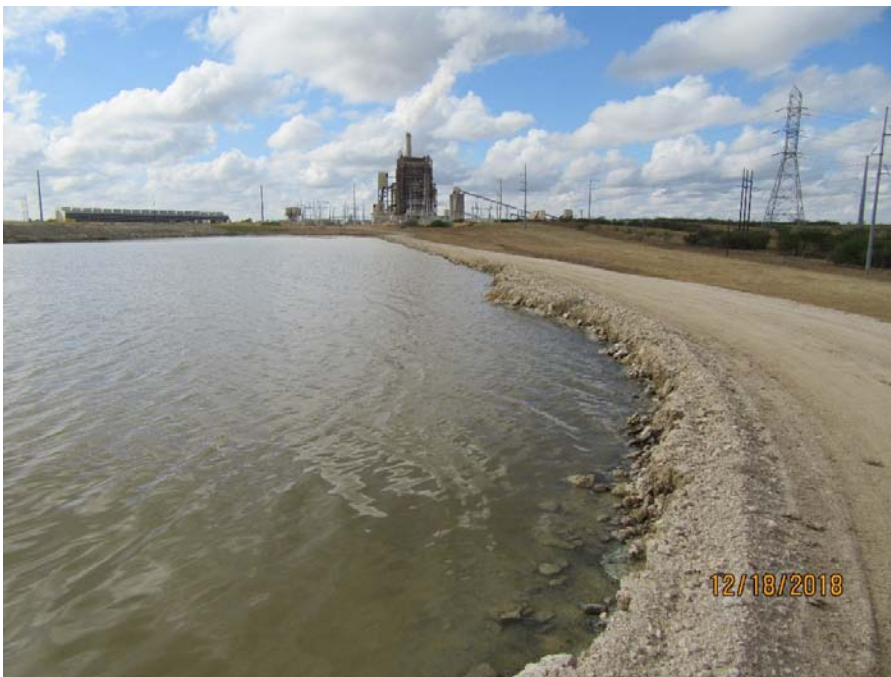
**PHOTO 15:**

Looking to the south along the crest of the berm on the eastern side of the Equalization Pond. No vegetative growth was noted along the interior of the berm.

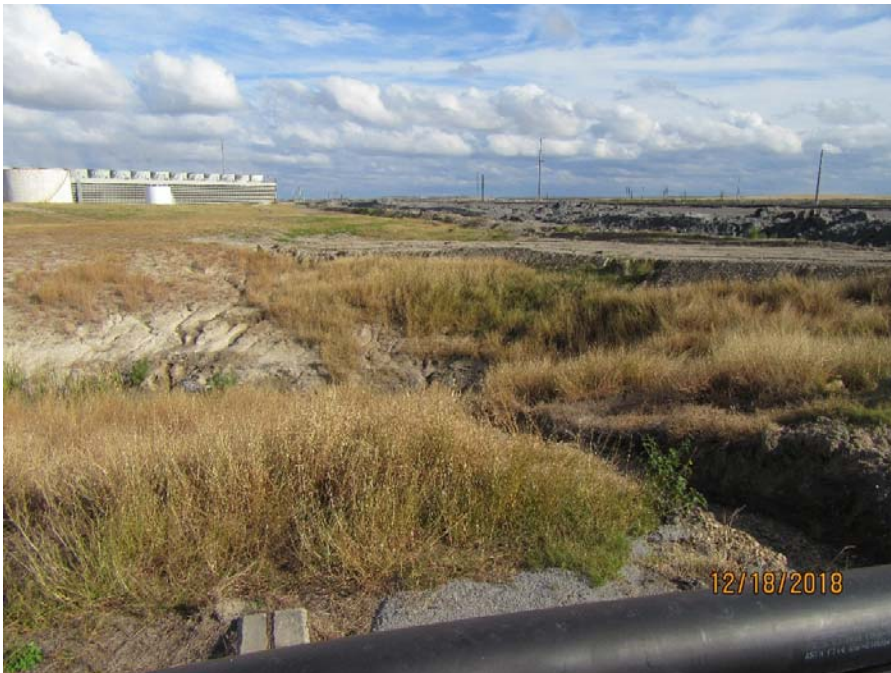
**PHOTO 2:**

The northern side of the northwestern corner of Ash Pond A looking to the southeast. Surface water now drains into a culvert approximately 75 feet north of Ash Pond A. This surface water runoff originates along the roadway that leads to the Ash Pond berms. The interior portion of the northern berm is currently covered in dredged ash.

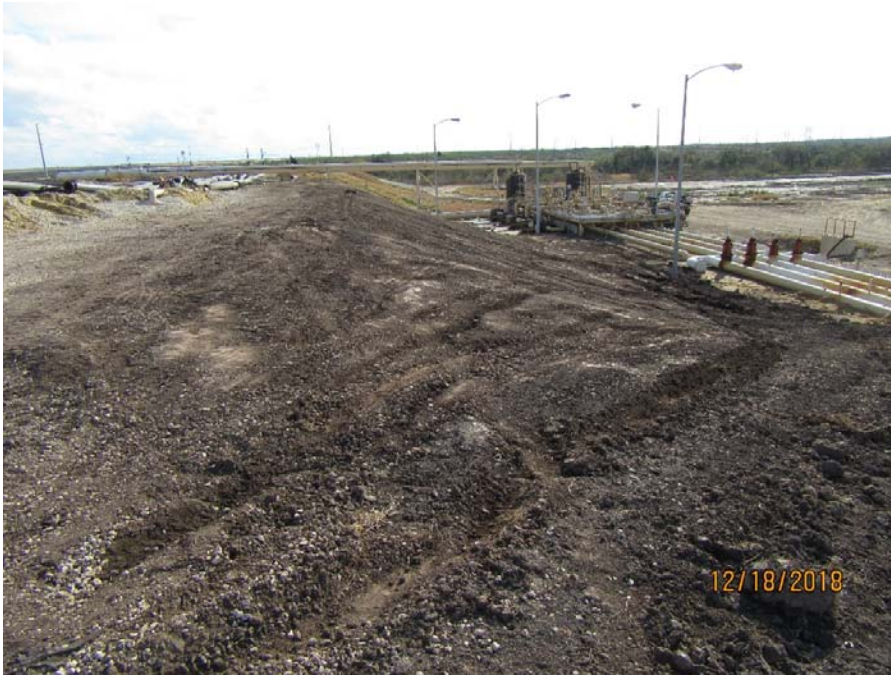
**PHOTO 3:**

This photograph is looking to the south-southwest across the recently completed toe drain located on the western side of Ash Pond A. This area had not been seeded at the time of the Annual Inspection. It will be seeded when temperatures start to warm to allow germination of the grass seed.

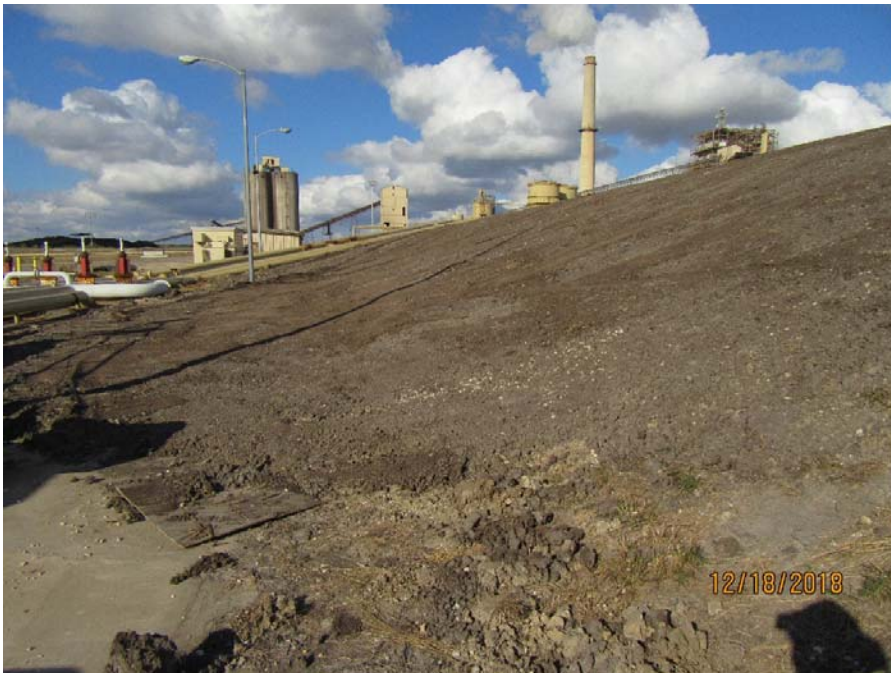
**PHOTO 4:**

Looking to the north across the slope realignment and toe drain installation. A key was excavated at the toe of the drain and then gravel was installed in a stepped pattern along the berm slope. The gravel was encapsulated within a geotextile liner.

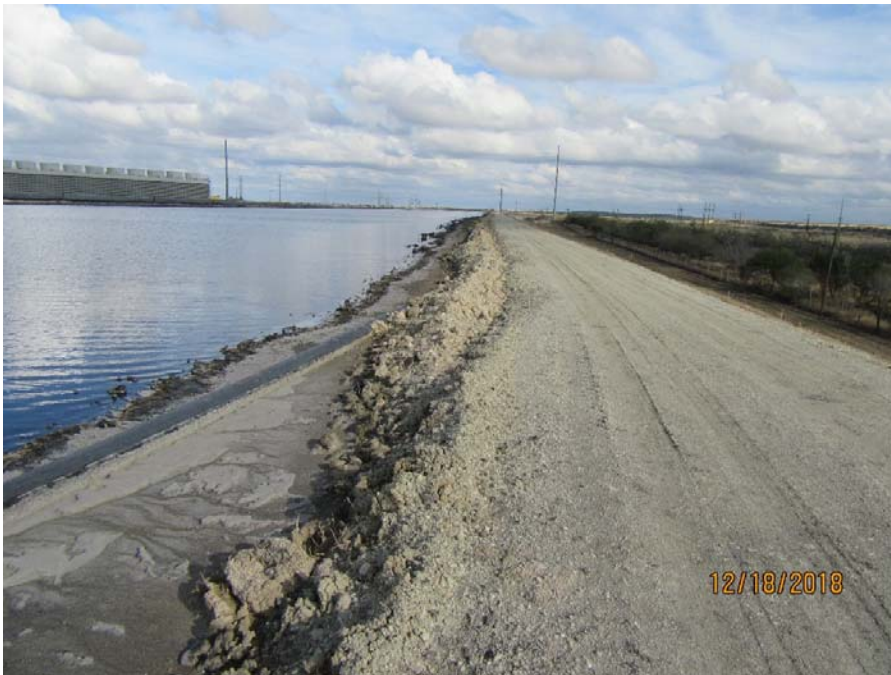
**PHOTO 8:**

The view of the interior of the berm along Ash Pond B looking to the east.

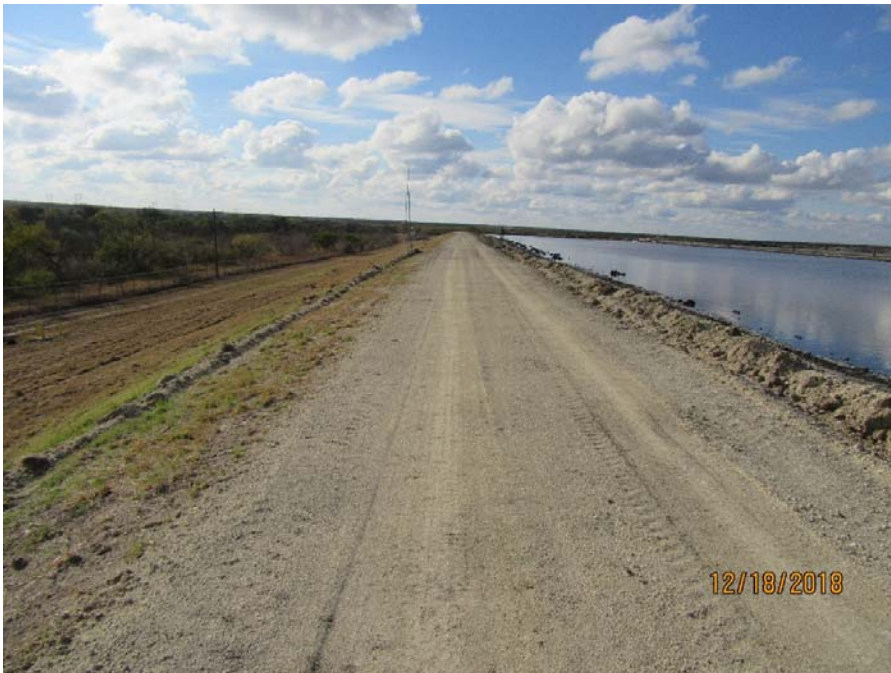
**PHOTO 10:**

Looking to the west along the southern side of the berm along the southern side of Ash Pond B. Some reshaping of the exterior of the berm was conducted at the time of the crest realignment.

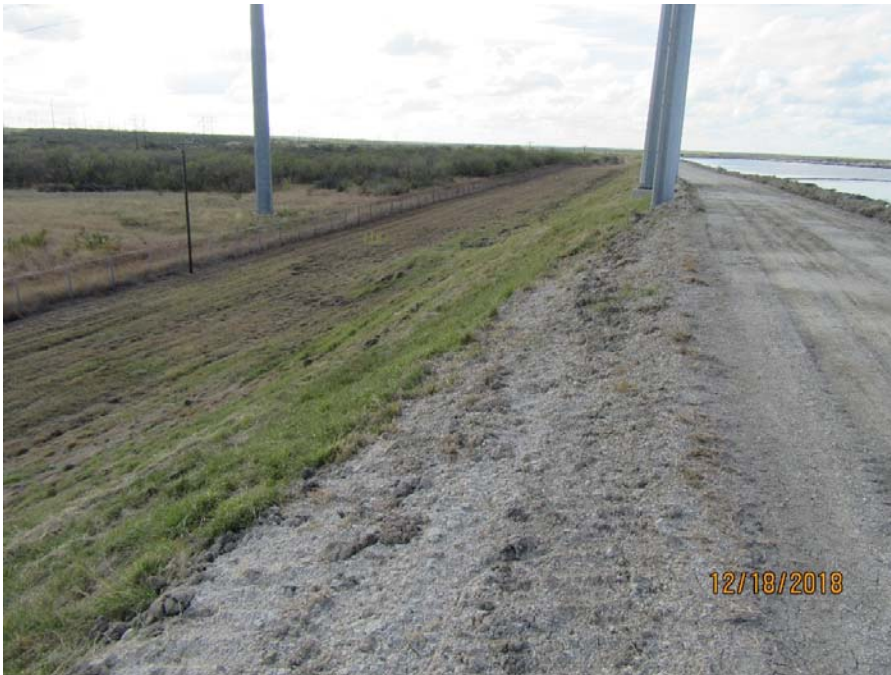
**PHOTO 12:**

Looking to the west along the southern side of the berm on the southern side of Ash Pond B. Two electrical utility poles are installed on the outside slope of the berm in this area.

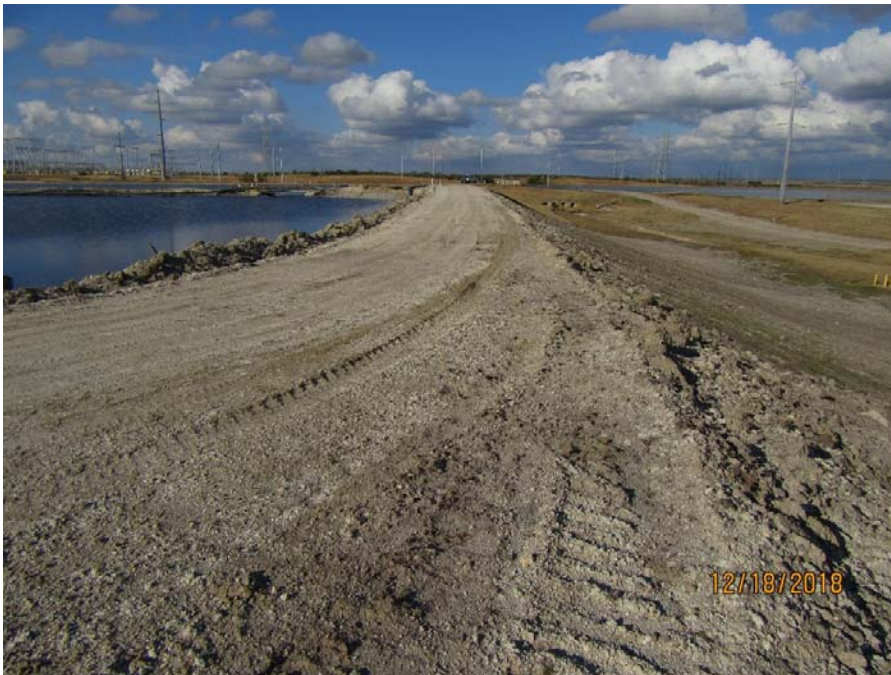
**PHOTO 14:**

Looking to the north along the reshaped crest of the berm along the east side of Ash Pond B and A. The exterior slope of the berm along the eastern side of the Ash Ponds was realigned to provide a gentler slope at a 3.5 to 1 (horizontal to vertical) incline. The slope was seeded, but has only a small amount of grass growth due to the colder winter season.

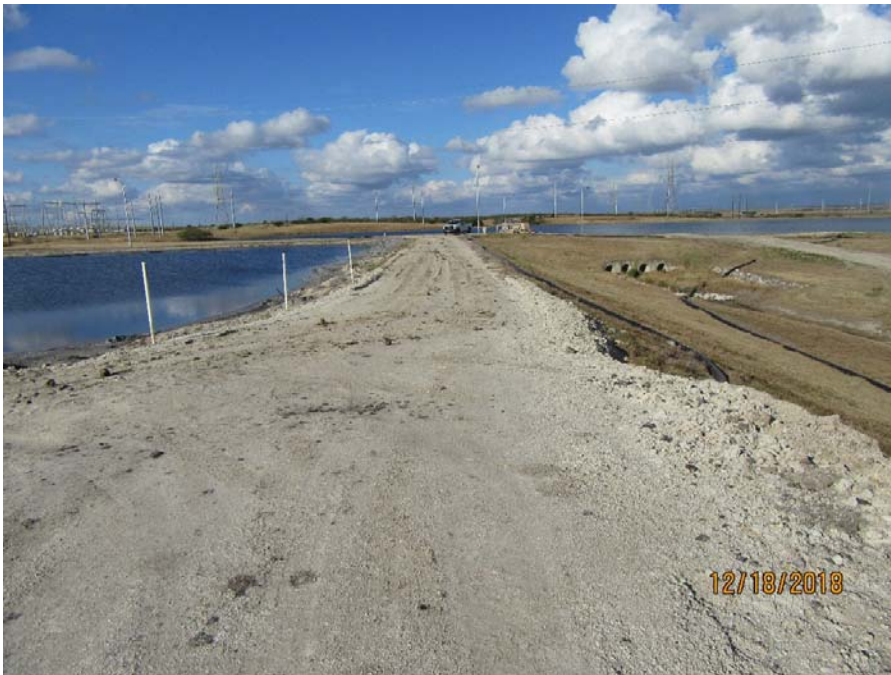
**PHOTO 16:**

The east crest of the berm along the eastern side of Ash Pond A. This area had compacted clay soils placed along the crest during the recent enhancement of the crests along the Ash Ponds.

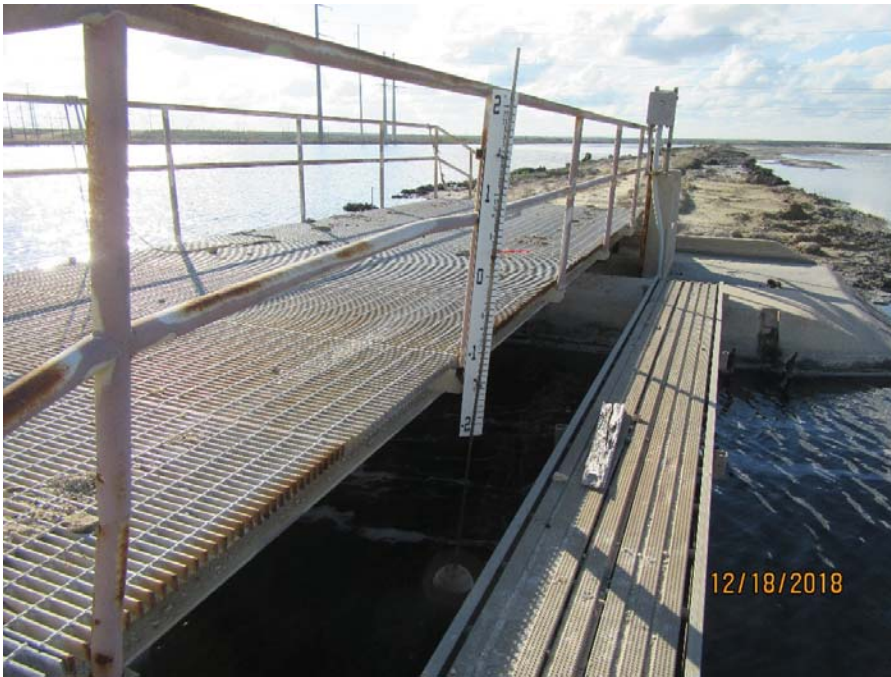
**PHOTO 17:**

The gauging device located at the weir on the eastern end of the central dike within the Ash Ponds.

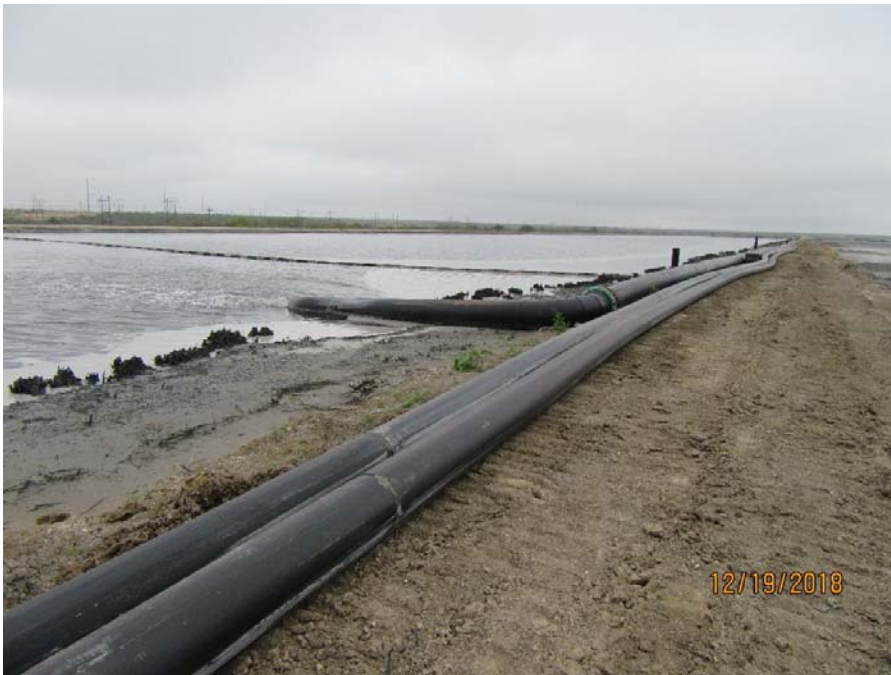
**PHOTO 18:**

The newly installed flow lines for ash and water effluent from the power plant. The flow is now directed into Ash Pond B in preparation for the dredging of Ash Pond A. This view is to the west.

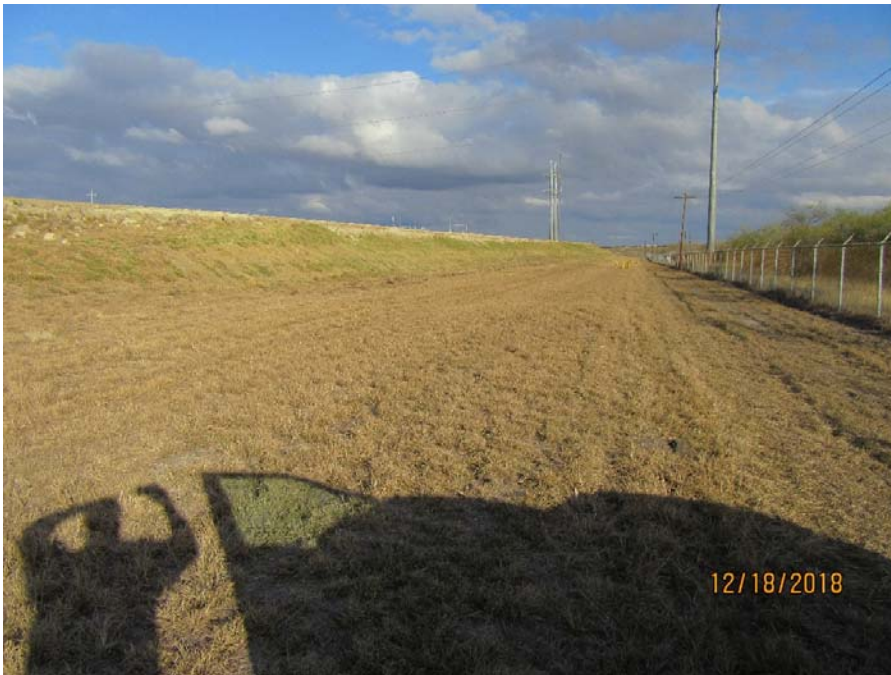
**PHOTO 20:**

This view is to the east of the base of the Ash Ponds berm from near the midpoint of the berm. The vegetative cover was good except in those areas that have been recently disturbed by construction activities. These are planned to be reseeded in the Spring.

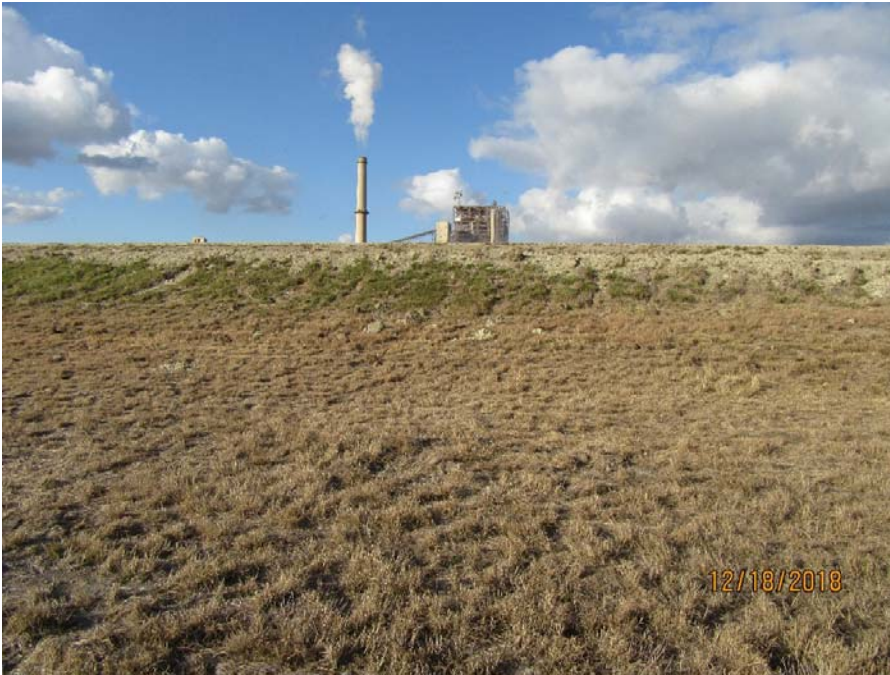
**PHOTO 21:**

Minor erosion rills located on the western side of the electrical utility poles along the southern side of the Ash Pond B berm. These are minor and can be addressed during routine maintenance activities.

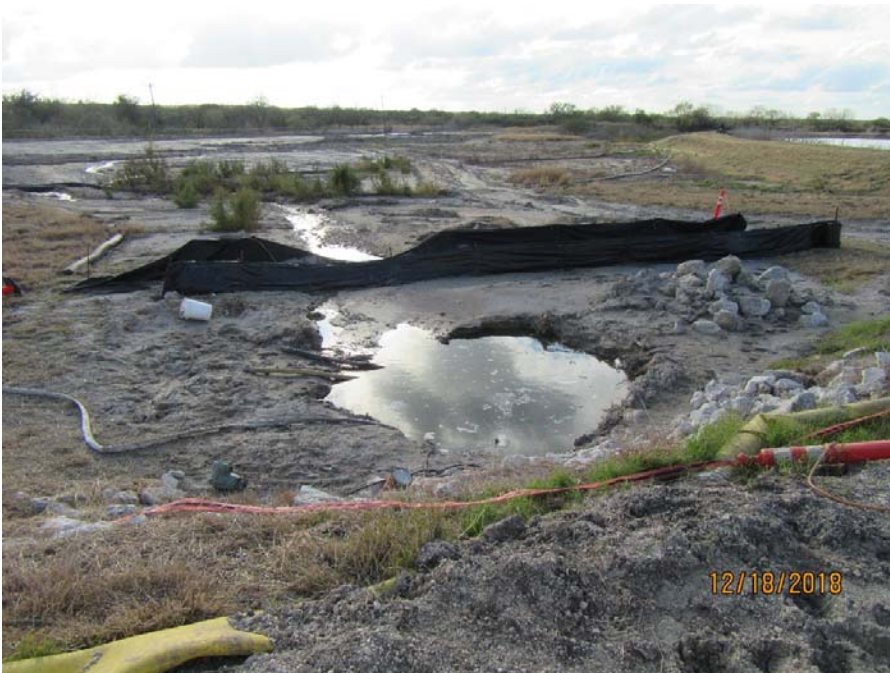
**PHOTO 22:**

A sump has been constructed below the pumping station on the western side of the Ash pond to collect rainwater runoff.

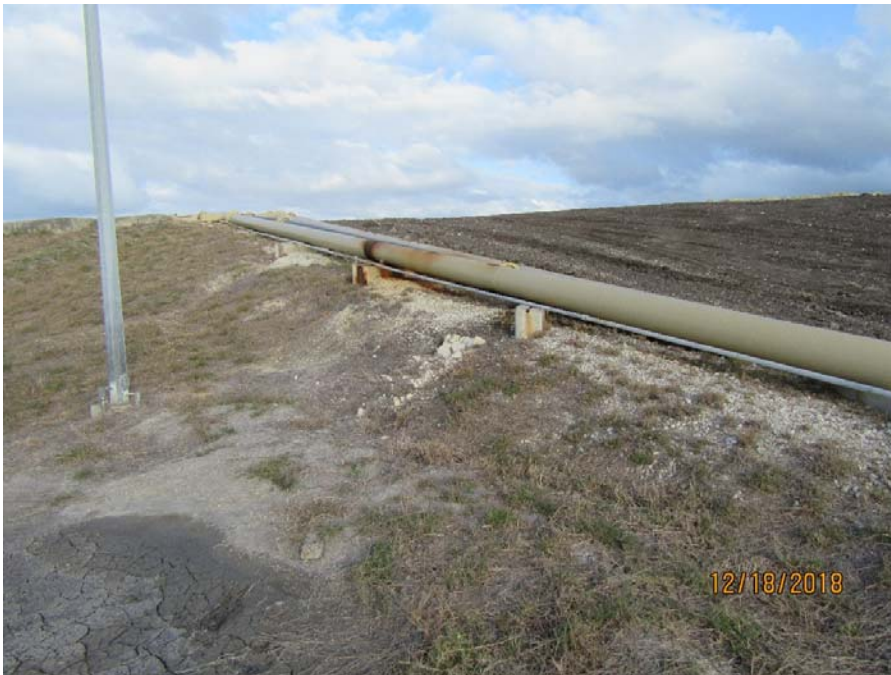
**PHOTO 23:**

Erosion is still located along the northwest side of the flow lines adjacent to the recently installed toe drain. This view is to the east.

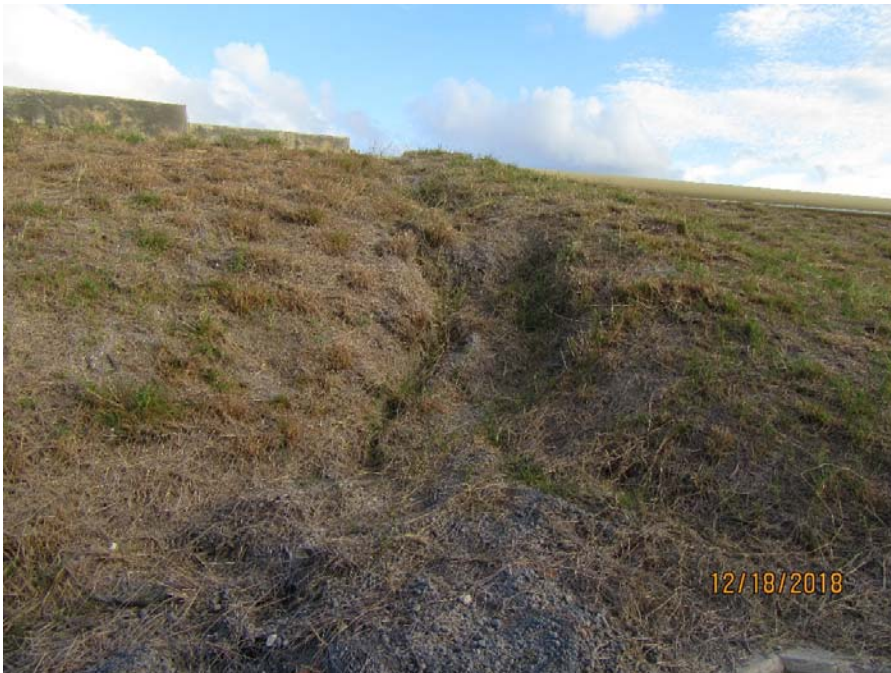
**PHOTO 24:**

Another erosional feature that was caused by runoff at the southern end of the concrete utility chase located on the top of the berm on the northwestern side of Ash Pond A. Recent construction activities have eliminated the source of this runoff. This feature can be corrected during routine maintenance of the Ash Pond berms.

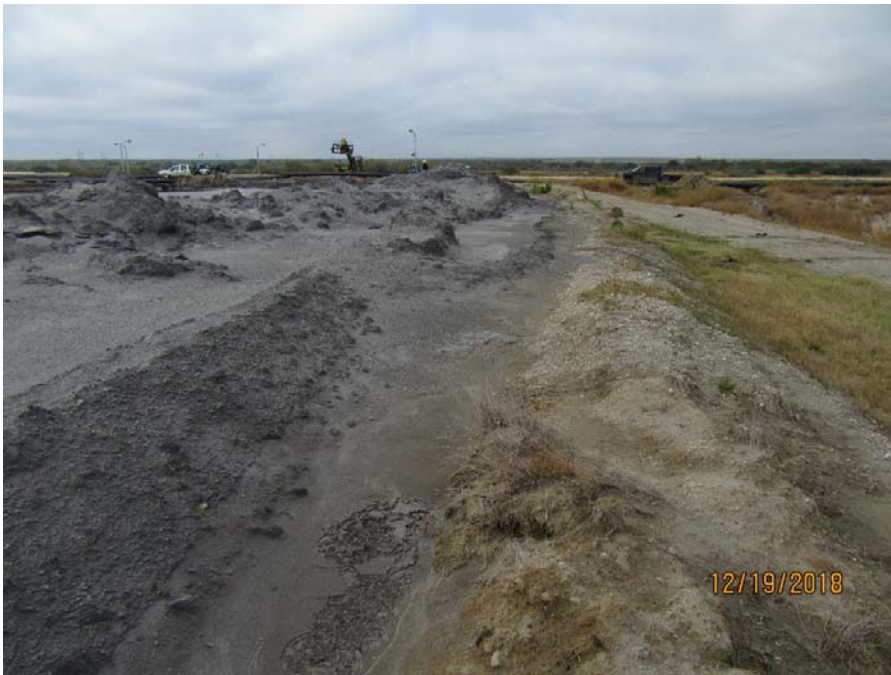
**PHOTO 26:**

The dredged ash from the northwest portion of Ash Pond A. The ash is contained within a temporary earthen berm. This are will be excavated during the dredging and removal of ash form Ash Pond A. This view is to the west.

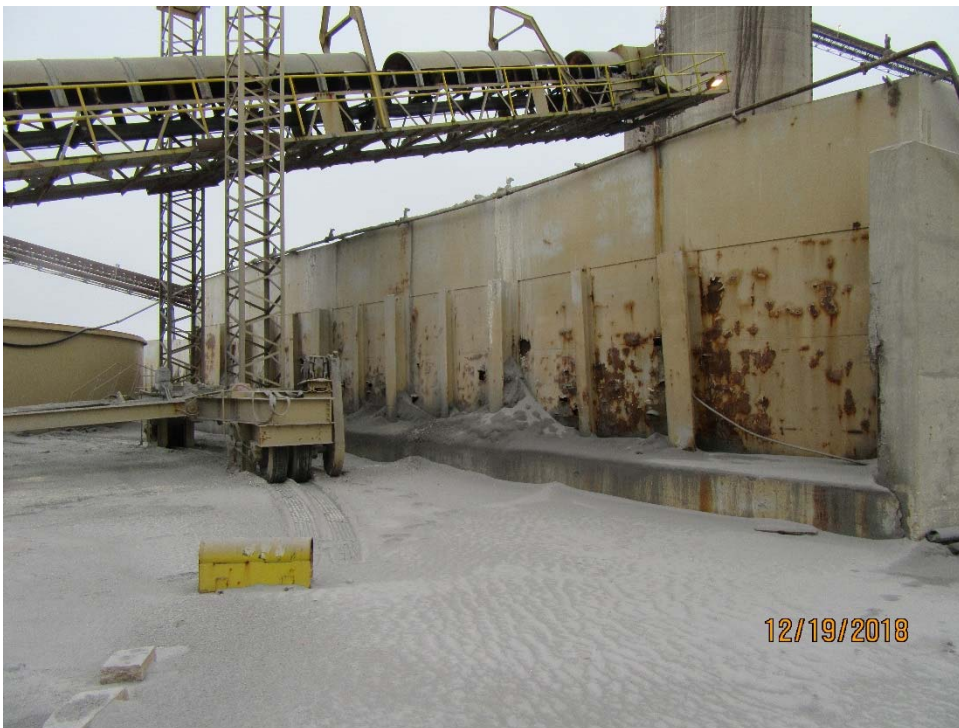
**PHOTO 2:**

The southern side of the steel portion of the containment wall. Steel plates were attached to the northern side of the wall to cover all penetrations in the wall. Windblown ash was located on the southern side of the wall. Prior to the Annual Inspection a rail storm with high winds swept through the area. This material is typically cleaned up by hand on a periodic basis according to plant personnel.
