**ANNUAL INSPECTION REPORT FOR COAL COMBUSTION RESIDUALS (CCR) UNITS  
SAN MIGUEL ELECTRIC COOPERATIVE POWER PLANT**

**Wood Environment & Infrastructure Solutions, Inc.**

**January 10, 2019**

**Wood Project No.: 6706160039**

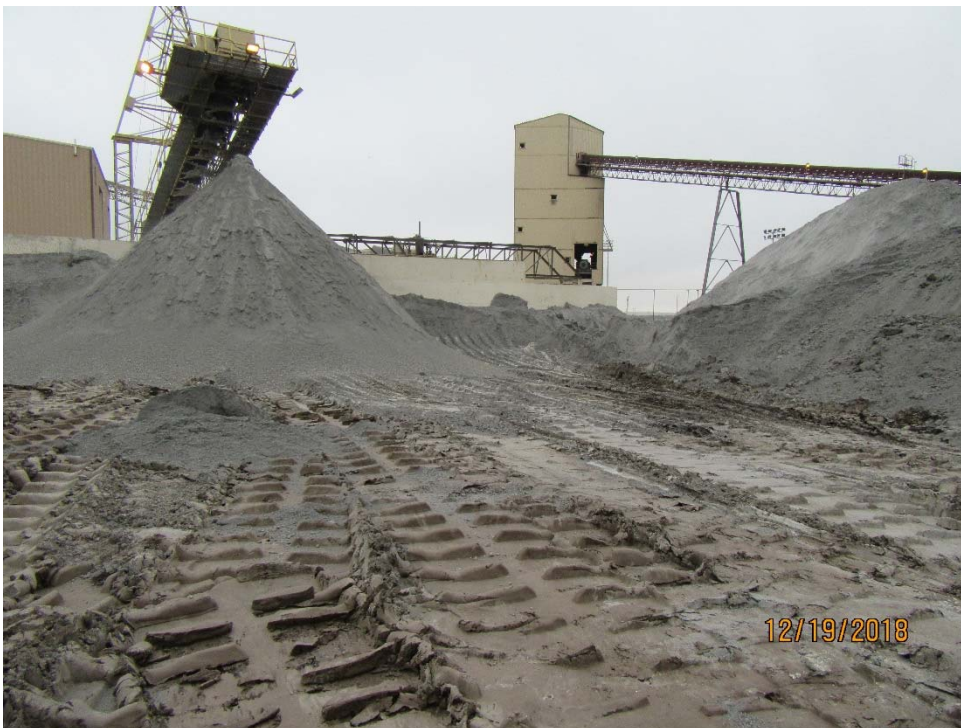
**PHOTO 4:**

The ash pile had recently been removed prior to the inspection. This view is to the south. A portion of the recently installed steel plate can be seen at the top of the southern wall.

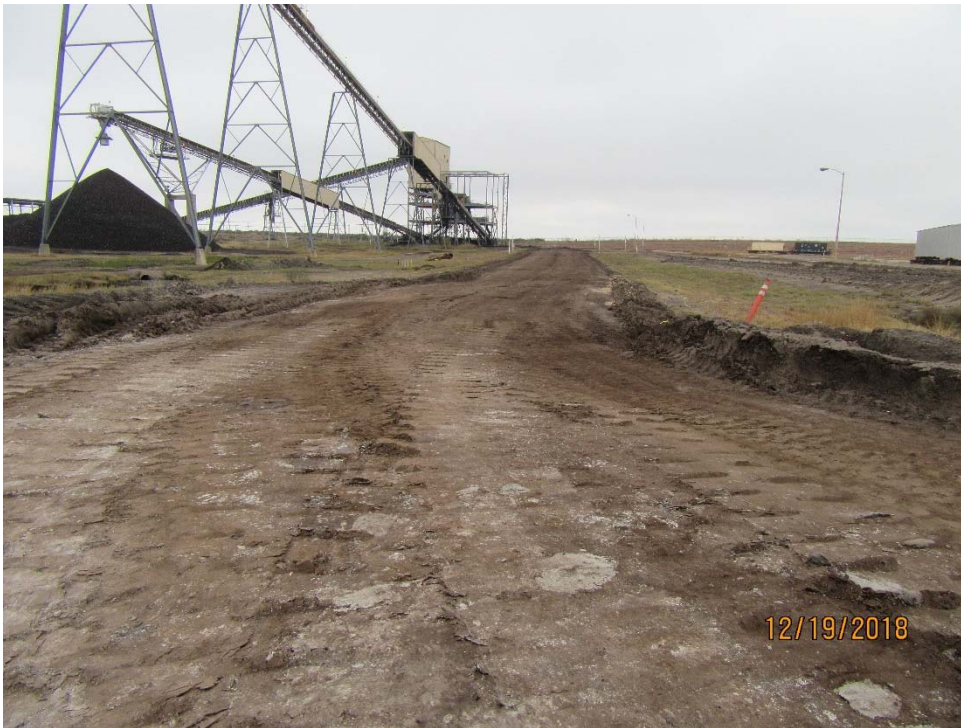
**PHOTO 5:**

The wester leg of the inbound haul road directly to the north of the Ash Pile. The view is to the north from the Ash Pile.

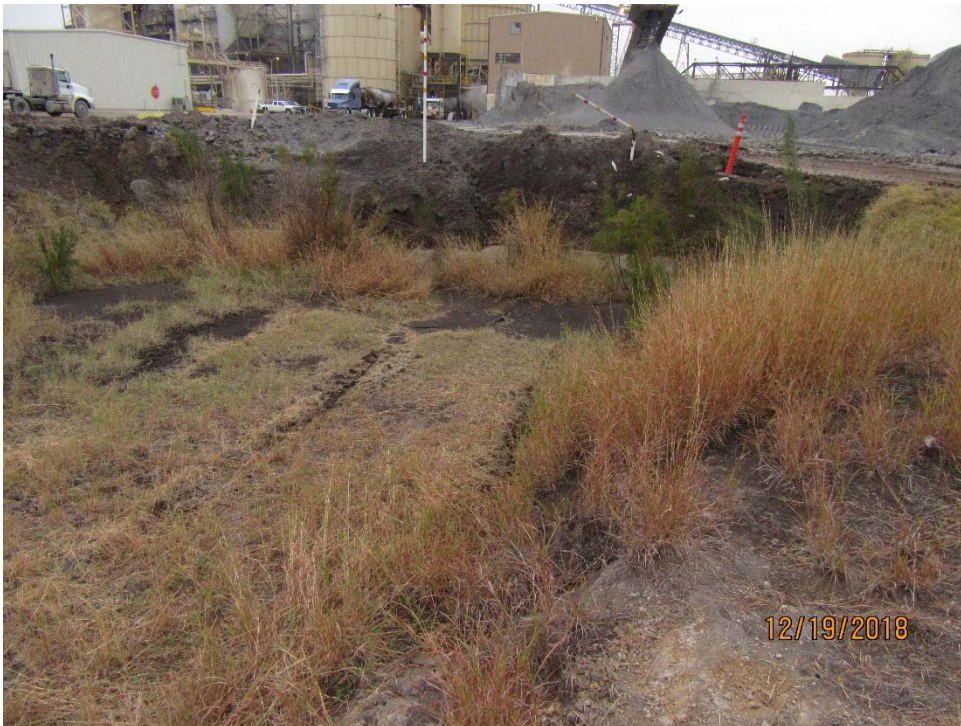
**PHOTO 6:**

The drainageway between the inbound and outbound haul roads. Sediment was above the drain culvert.

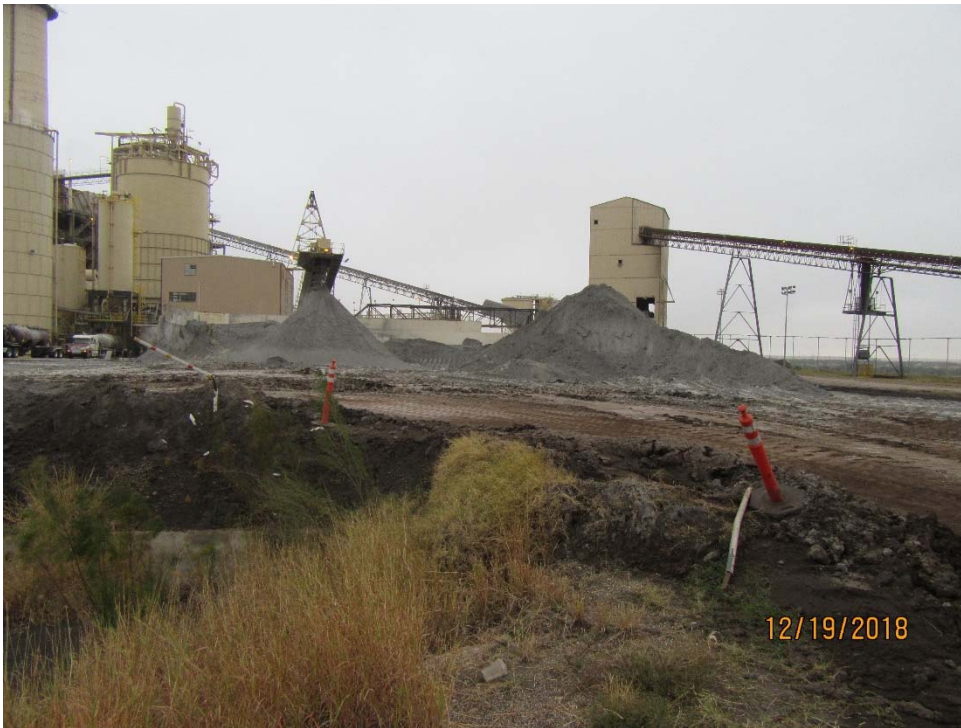
**PHOTO 7:**

Looking to the south toward the Ash Pile in the distance the inbound haul road.

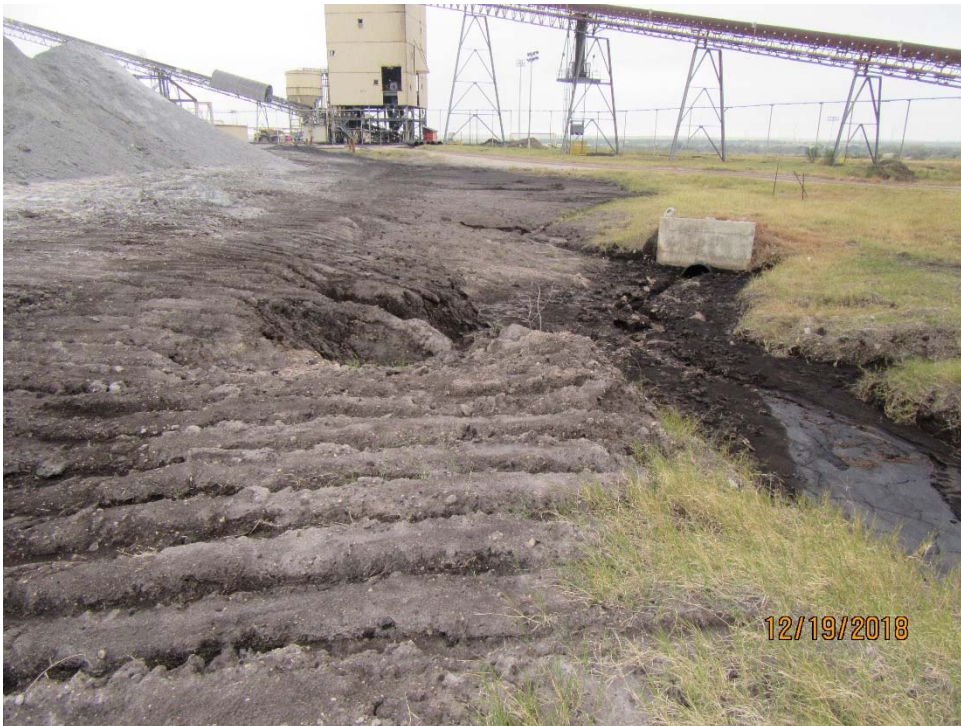
**PHOTO 8:**

Looking to the south-southwest toward the drainage culvert located on the western side of the Ash Pile. The Ash Pile area drains to this culvert.

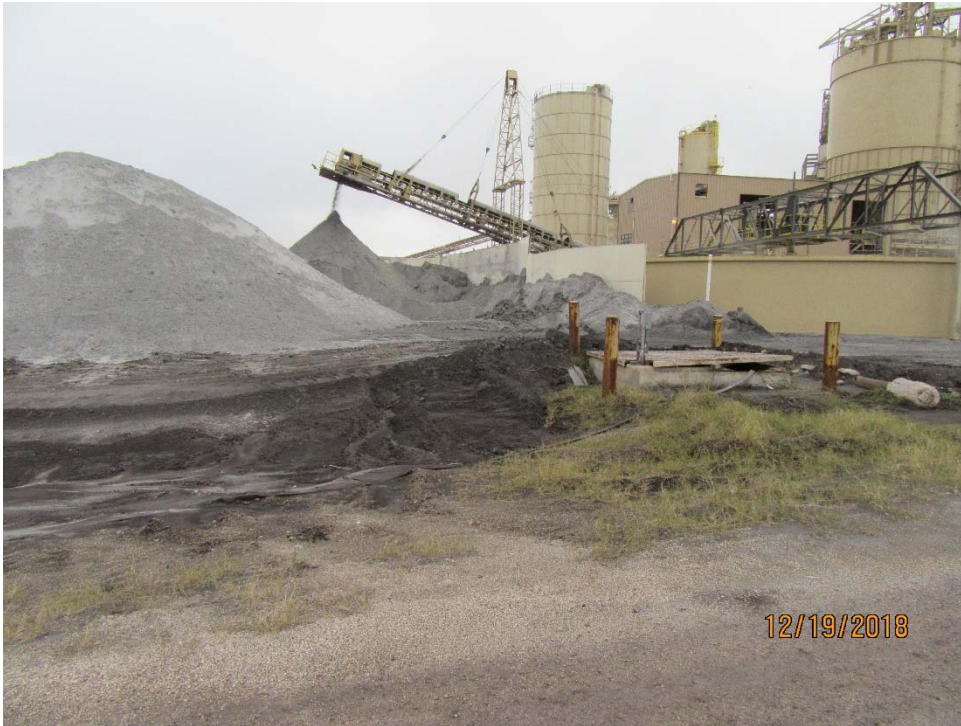
**PHOTO 9:**

Looking to the east from the western side of the Ash Pile.

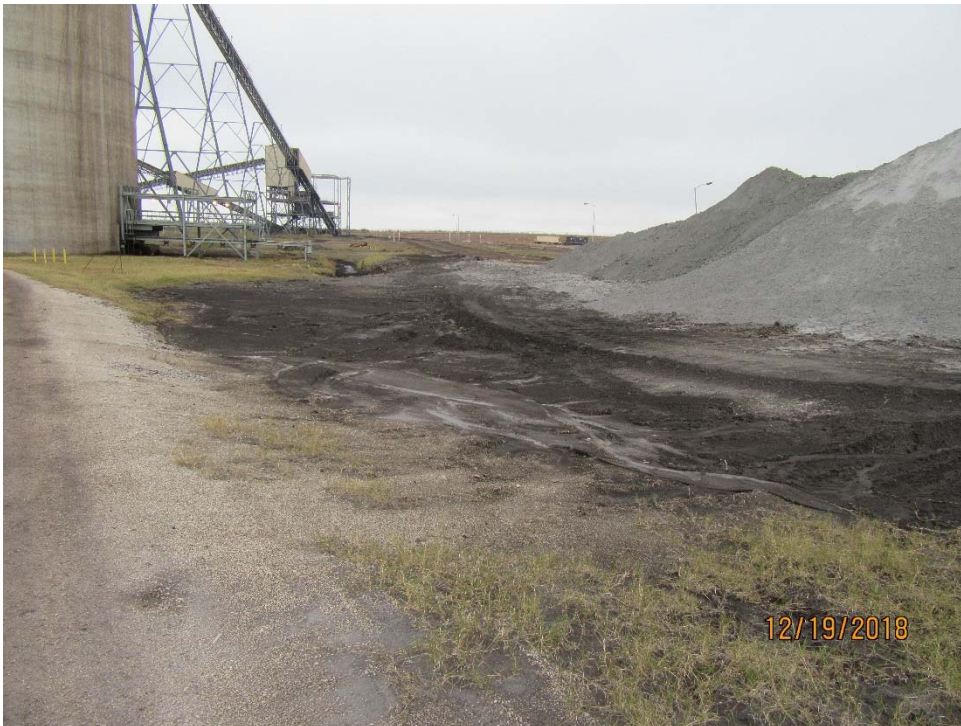
**PHOTO 10:**

Looking to the north from the southwestern edge of the Ash Pile area. All drainage is to the north toward the culvert of the western side of the Ash Pile.
