# Inspection Report

**Property Address:**  
2607- 2609 Greenmount Ave  
Baltimore MD 21218

**MDHI.com Property Inspectors**

| <b>Date:</b> 4/16/2026 | <b>Time:</b> 10:00:00 AM | <b>Report ID:</b> 041626DB1-2 |

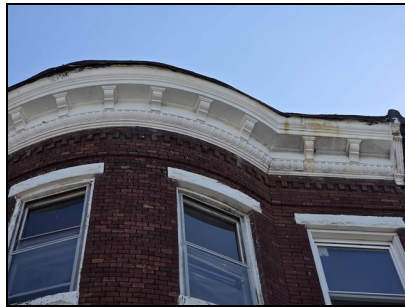
1.2 Item 2(Picture)

**1.2 (1)** There are deteriorated mortar joints in the siding. This permits moisture penetration and will cause further damage.

RECOMMENDATION: Repair the mortar joints.

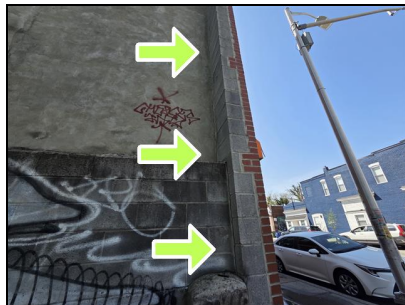
1.2 Item 5(Picture)

**1.2 (2)** There are gaps or unsealed areas side of the building and the pilasters. This will allow moisture into the structure and can lead to preventable deterioration.

Recommendation: Hire a contractor to repair the gap as needed.

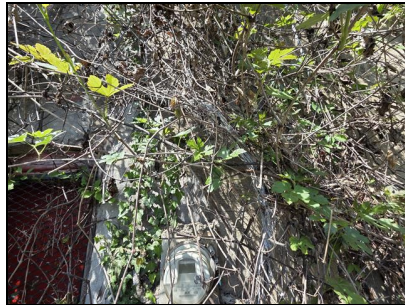
1.12 Item 2(Picture)

**1.12 Issue:** Vines and ivy are growing up the building.

**Impact:** This will draw moisture into the structure and cause deterioration. In some cases, the vegetation will grow into the home, causing mold-conducive conditions and damage.

**Recommendation:** Remove the vines/ivy and repair any damage that may be revealed.

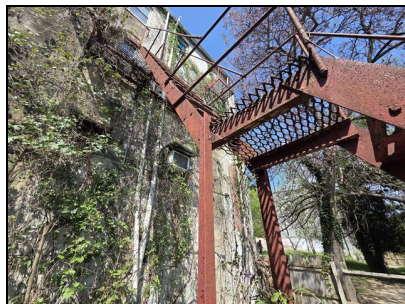
1.20 Item 2(Picture)

**1.20** Vegetation and organic growth are covering portions of the fire escape, limiting visibility and restricting a full inspection. Several welds are visibly failed or deteriorated, rendering the fire escape unsafe for use. A compromised fire escape poses a serious life-safety hazard.

**Recommendation:** Have a qualified contractor or structural steel specialist evaluate the entire fire escape system, remove obstructing growth, and perform all necessary repairs or replacements to restore safe, functional, and code-compliant emergency egress.

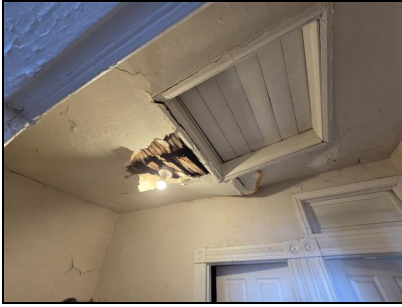
7.3 Item 10(Picture)

**7.3** The ceiling is water damaged or in need of repair.

RECOMMENDATION: Hire a contractor for an evaluation and to make repairs as needed.

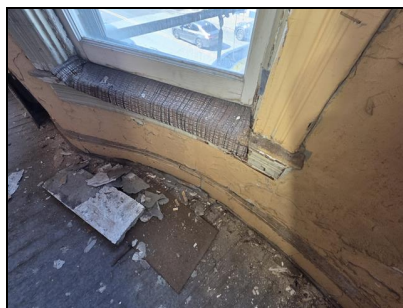
7.8 Item 2(Picture)

**7.8** The window is damaged or inoperative. This affects the proper function.

RECOMMENDATION: Repair or replace the window.

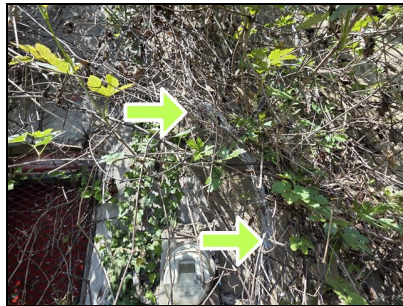
8.0 Item 2(Picture)

**8.0** There is deteriorated insulation on the service entrance cable. This is a safety hazard.

RECOMMENDATION: Hire an electrician to replace the insulation or the cable as needed.
