## Inspection Report (Bulldozer)

Year	2004
Make	Caterpillar
Model	D5N XL
Serial Number	AGG00760
Hour Meter Reading	10032

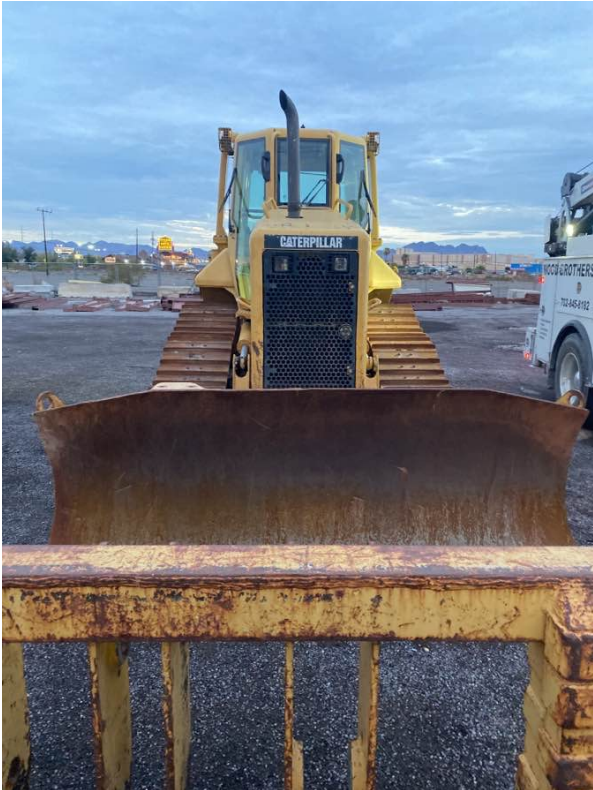
<b>Instructions</b>	<p>Evaluate the following on a 4 point scale (leave comments where an explanation is appropriate):</p> <p>4 = Like New, Recently Replaced 3 = Normal Wear &amp; Tear 2 = Above Average Wear 1 = Service Required</p> <p>Things to look for:</p> <ul style="list-style-type: none"> <li>- cosmetic damage</li> <li>- minor surface rust</li> <li>- repaint (and overspray)</li> <li>- cracked or damage glass</li> <li>- major rust (cancer)</li> <li>- cracks / visible welds</li> </ul>
<b>Front</b>	<p>3 - Normal Wear &amp; Tear</p>
<b>Comments</b>	<p>Normal wear, surface rust on blade, light scratches on front of hard nose</p>
<b>Front Photos</b>

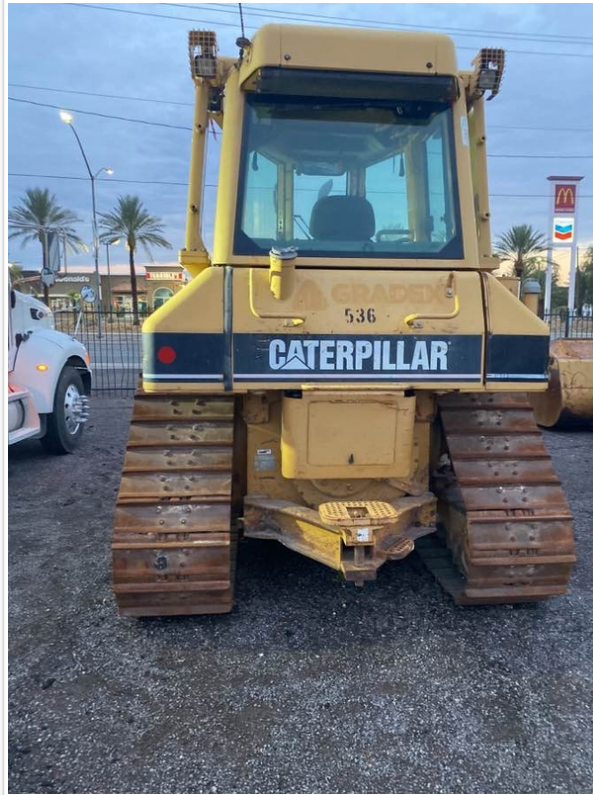
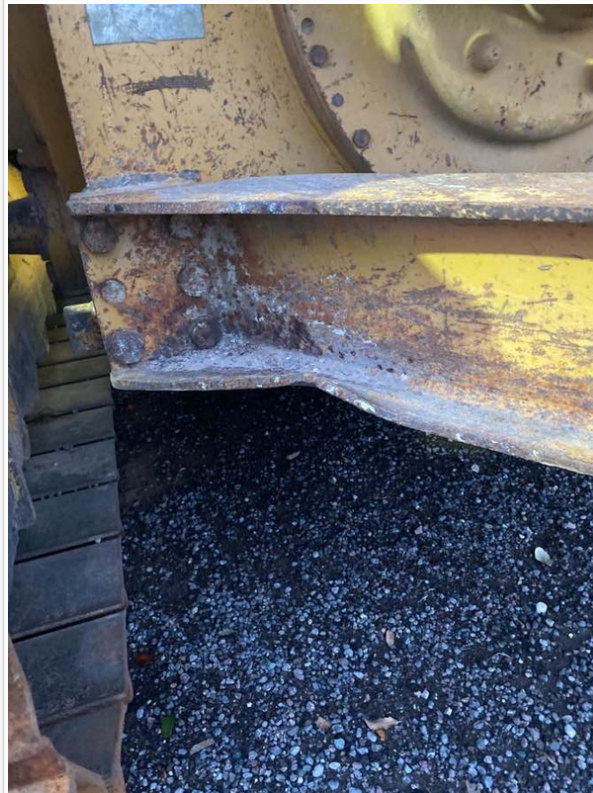
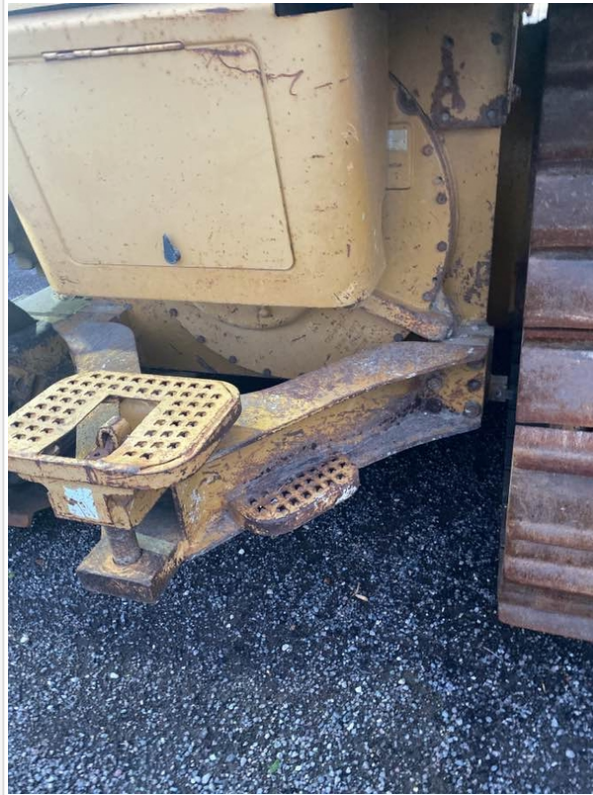
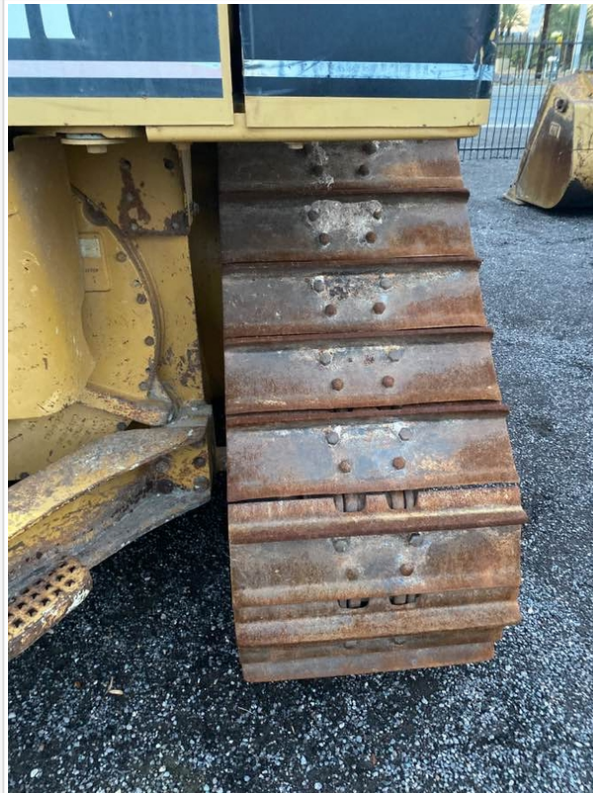
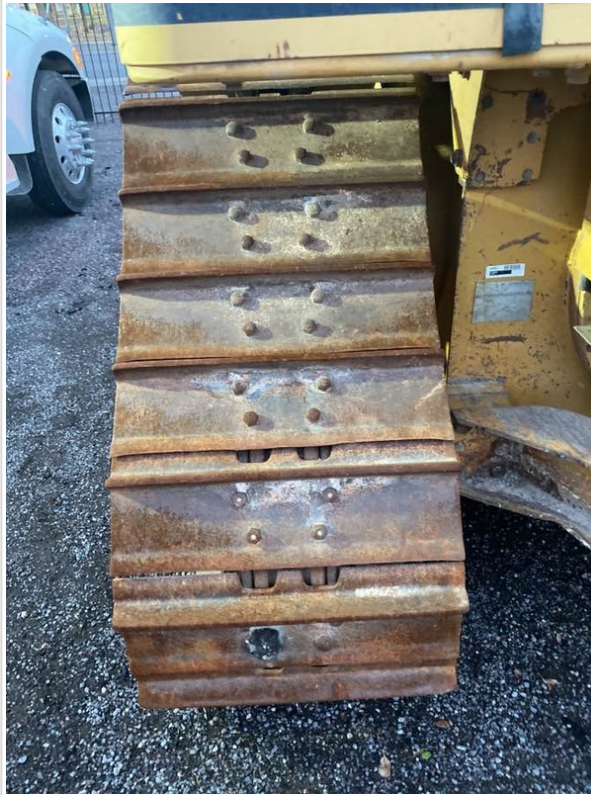
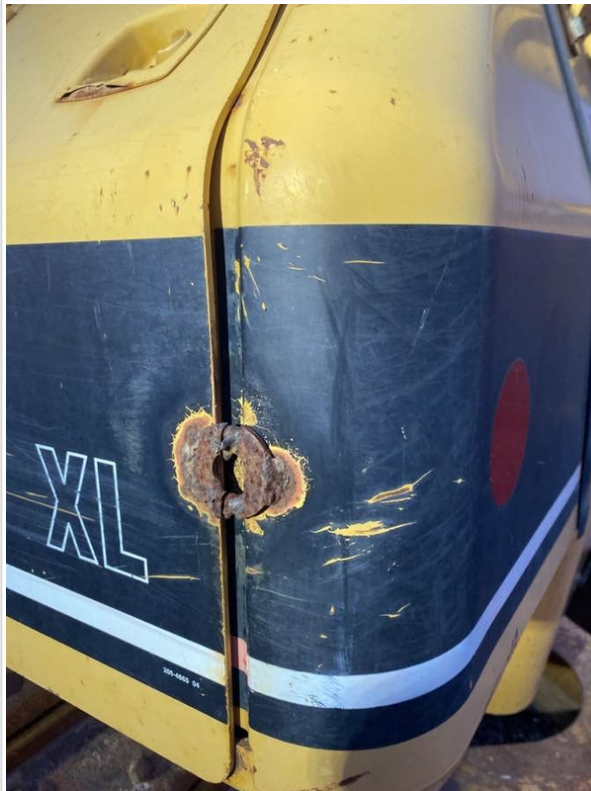
Rear Photos

Rear	3 - Normal Wear & Tear
Comments	Surface rust on tracks, minor scratches and dents

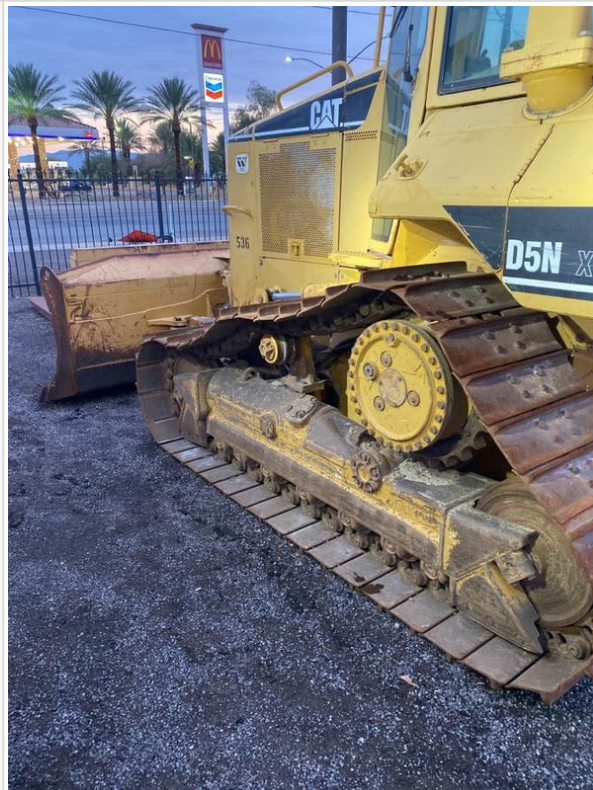
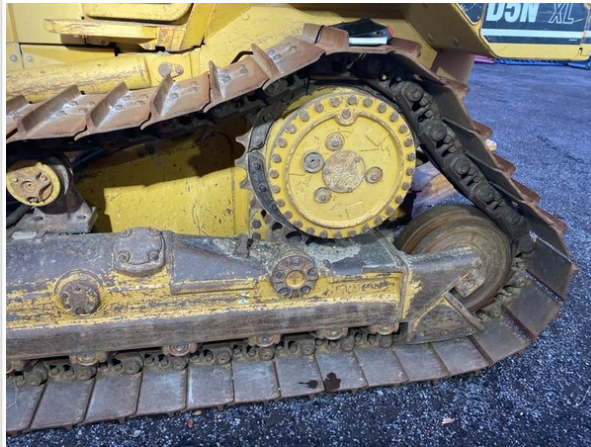
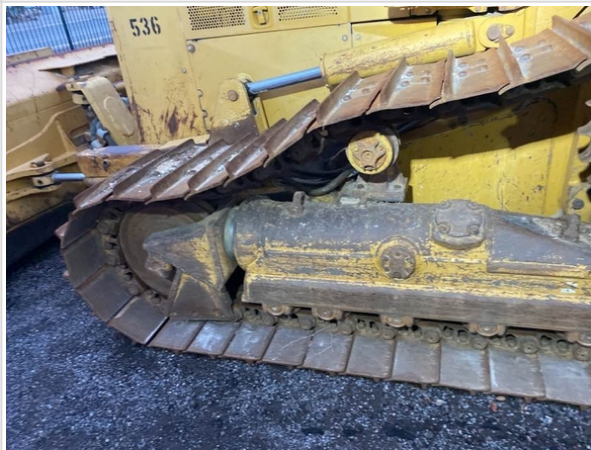
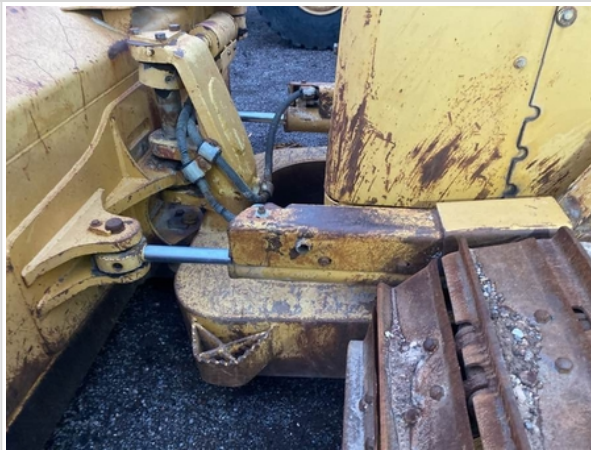
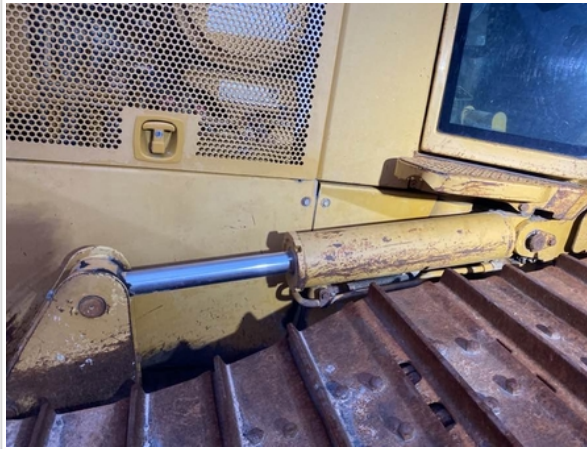
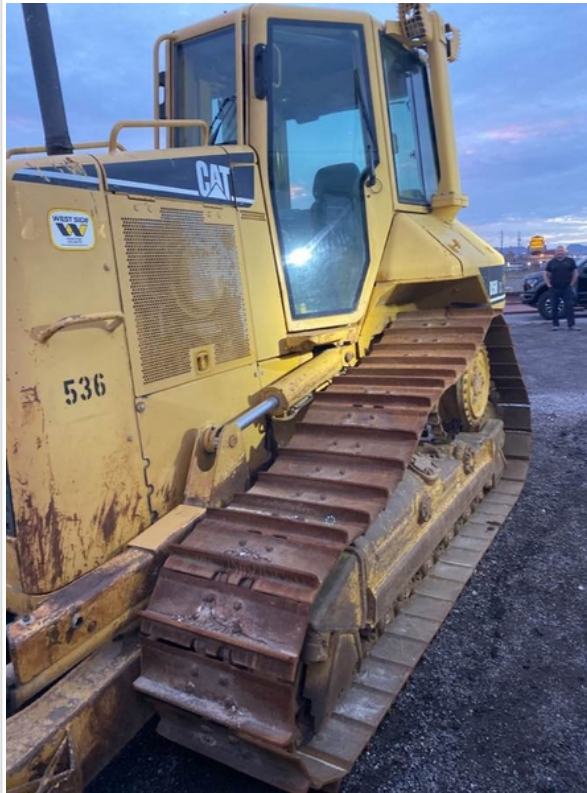
**Left Photos**

Normal wear, light scratching on paint. Tracks and track frames have surface rust

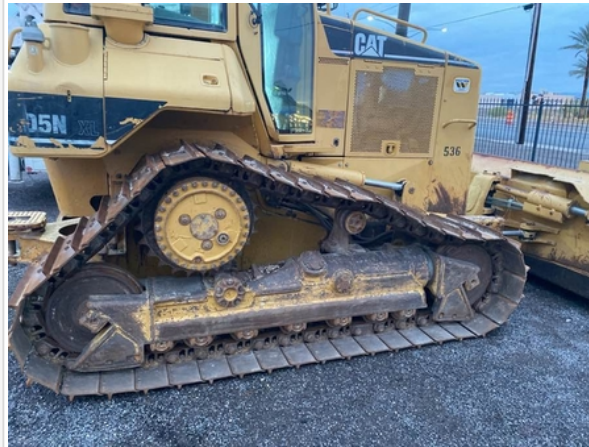
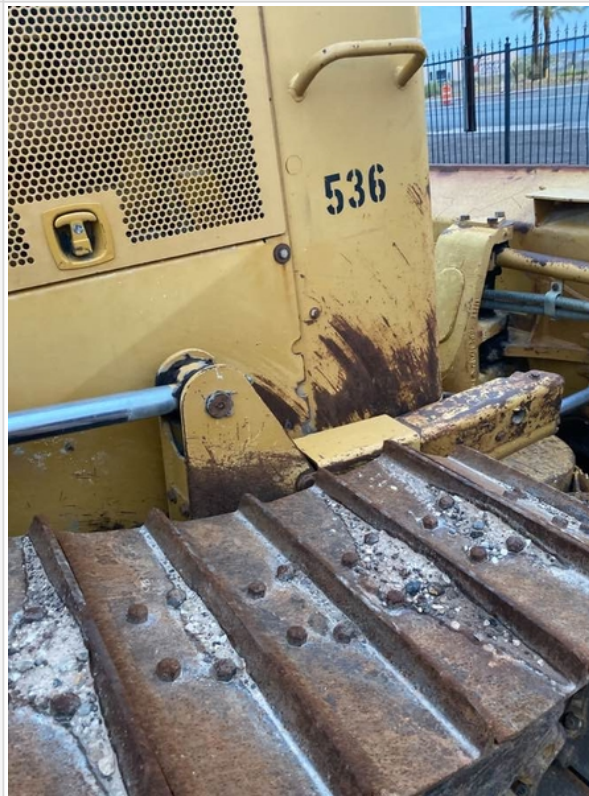
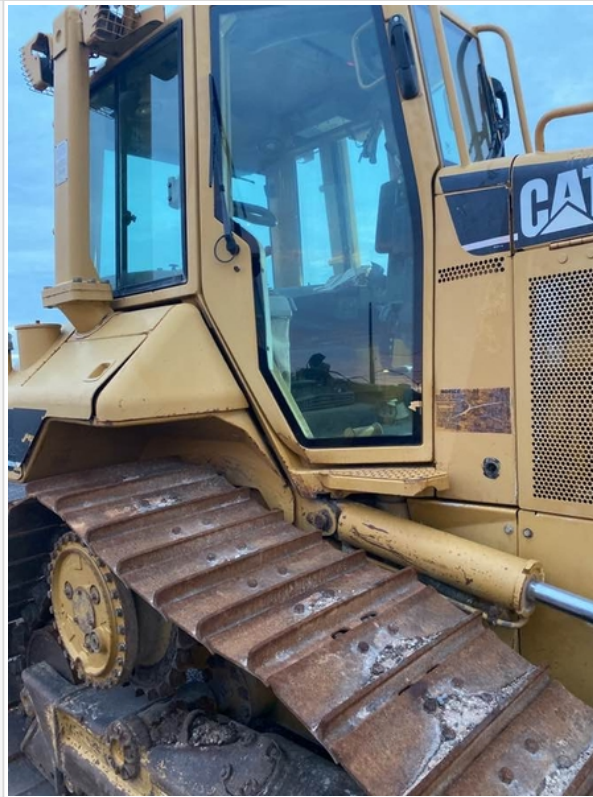
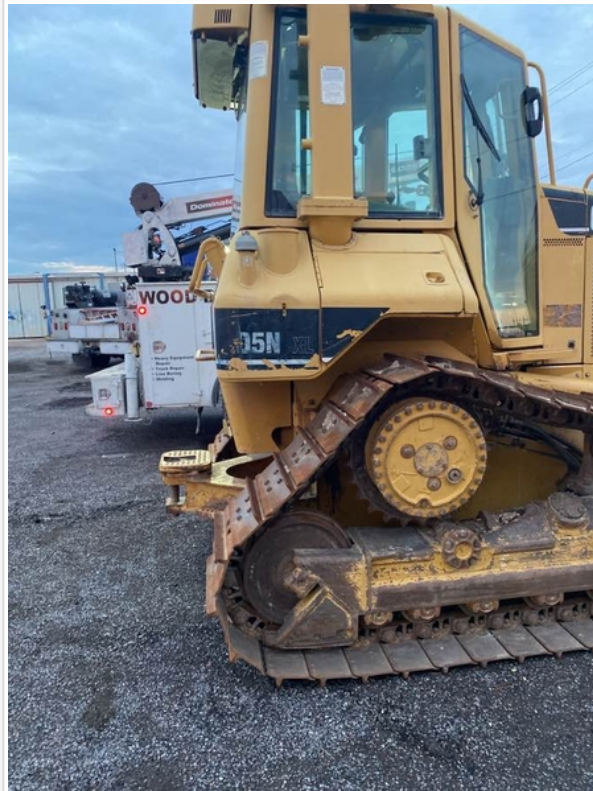
Right Photos

Right	3 - Normal Wear & Tear
Comments	Tracks and track frames have minor surface rust paint has light scratches

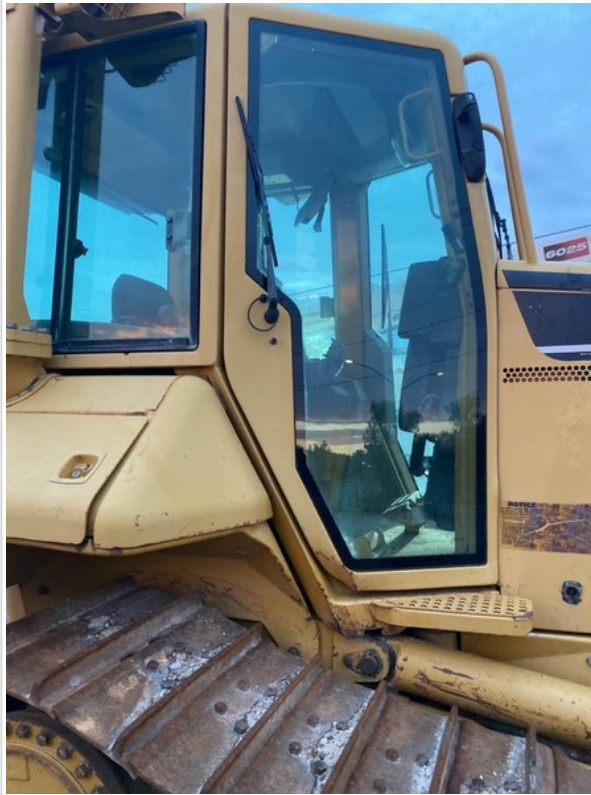
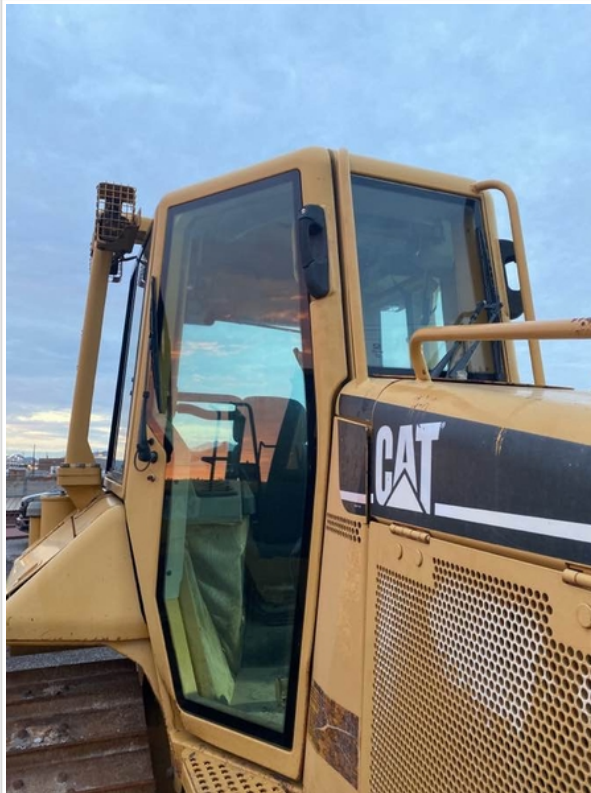
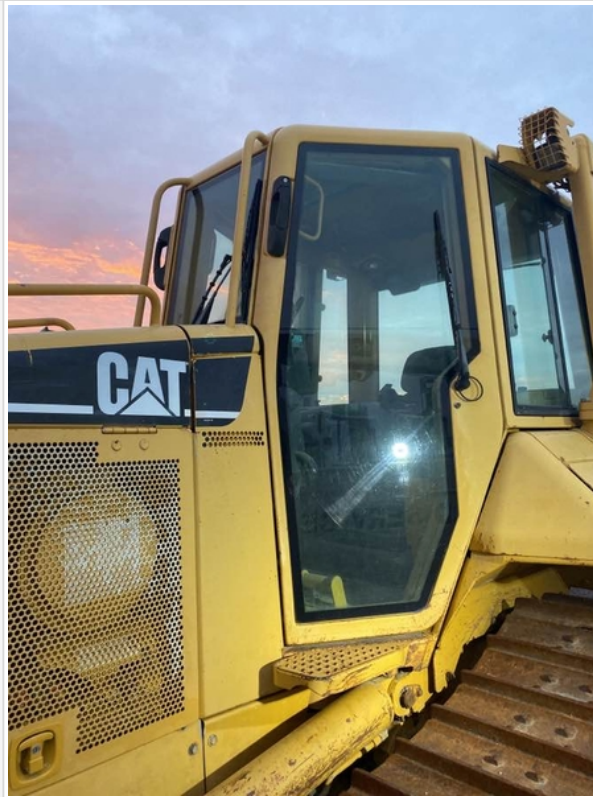
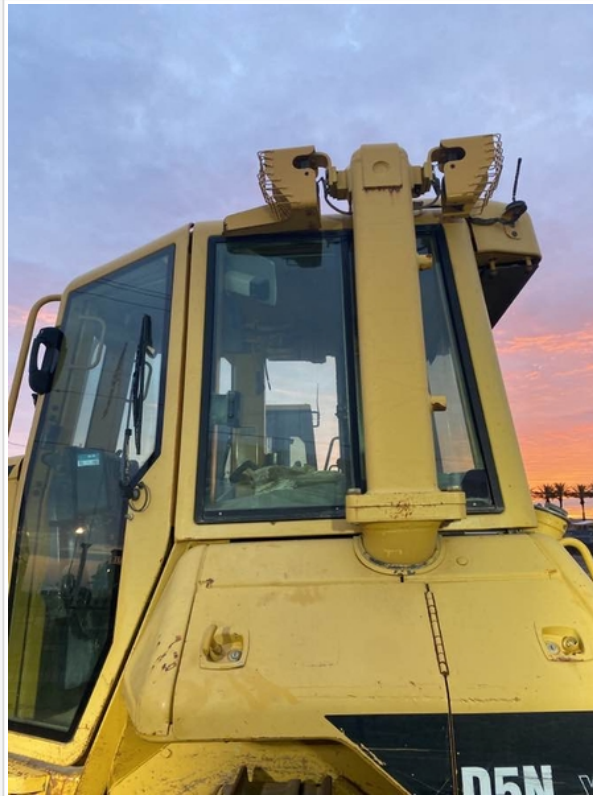
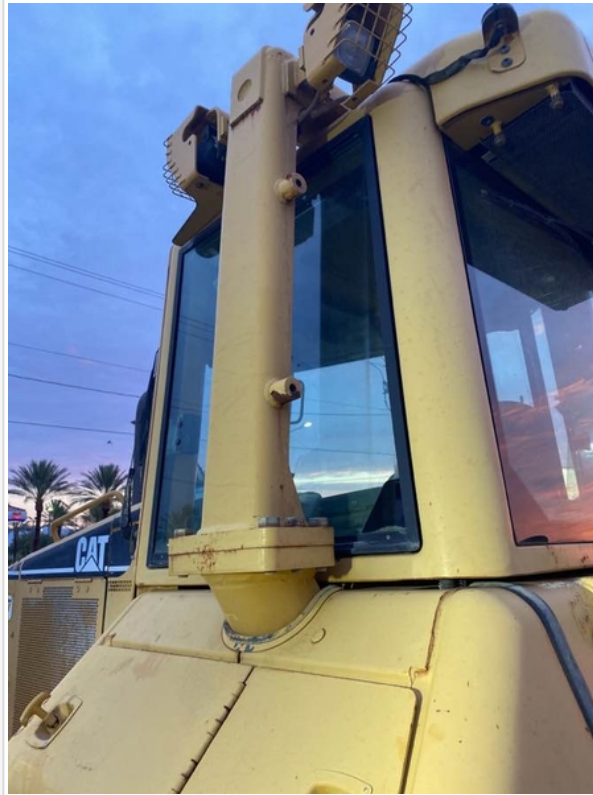
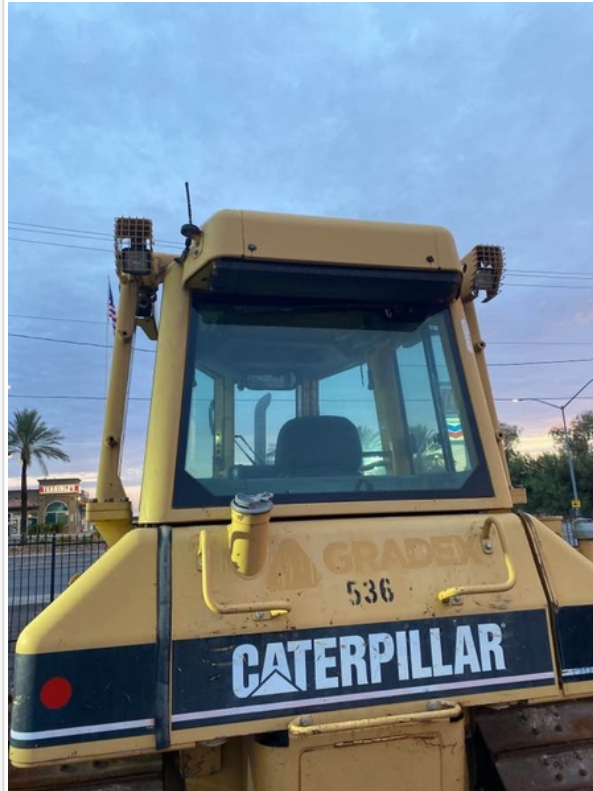
Upper	3 - Normal Wear & Tear	
Comments	Glass is good, no cracks. Wipers present. ROPS has a few spots of surface rust	
Upper Photos

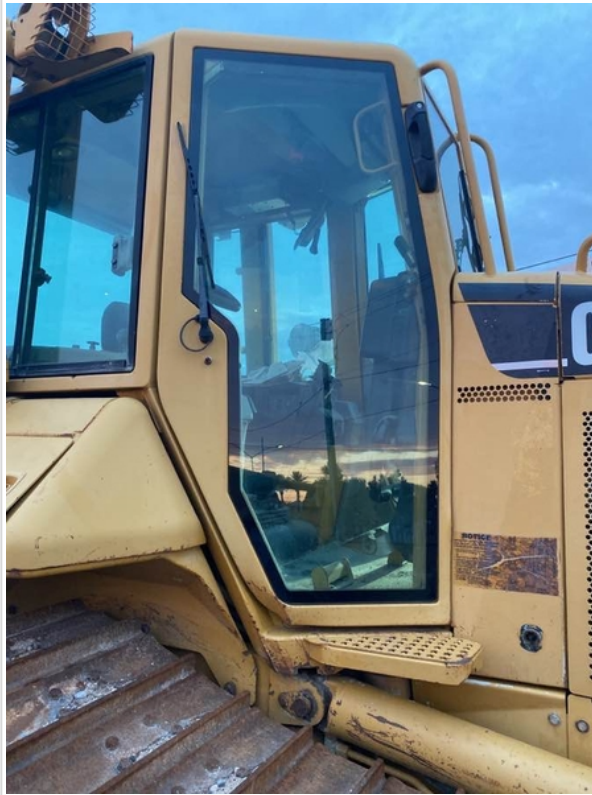
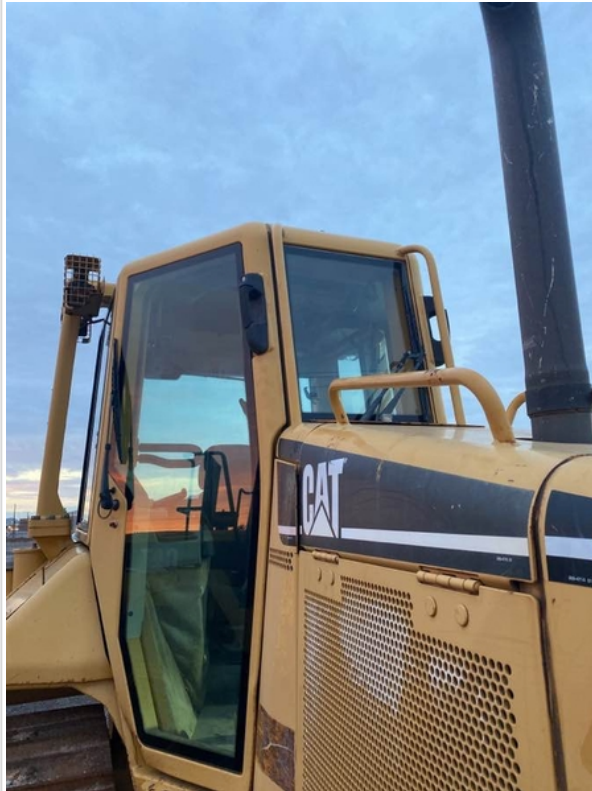
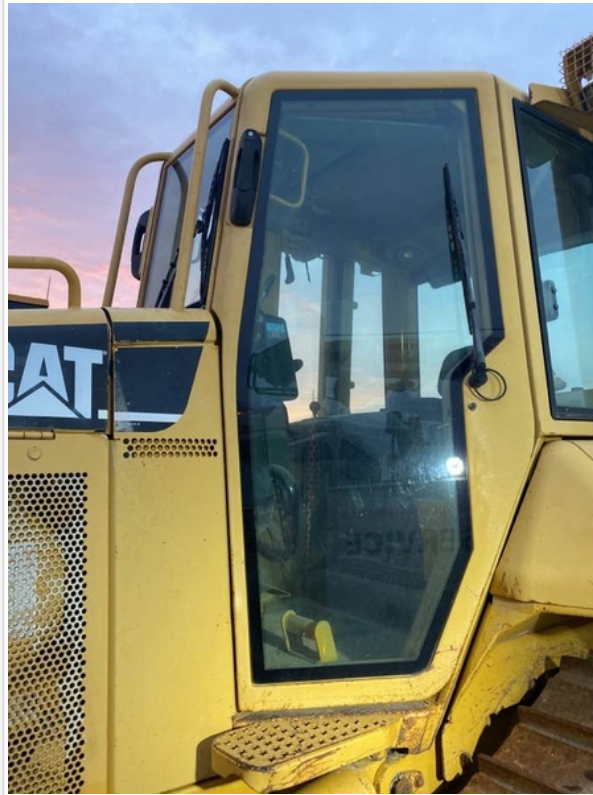
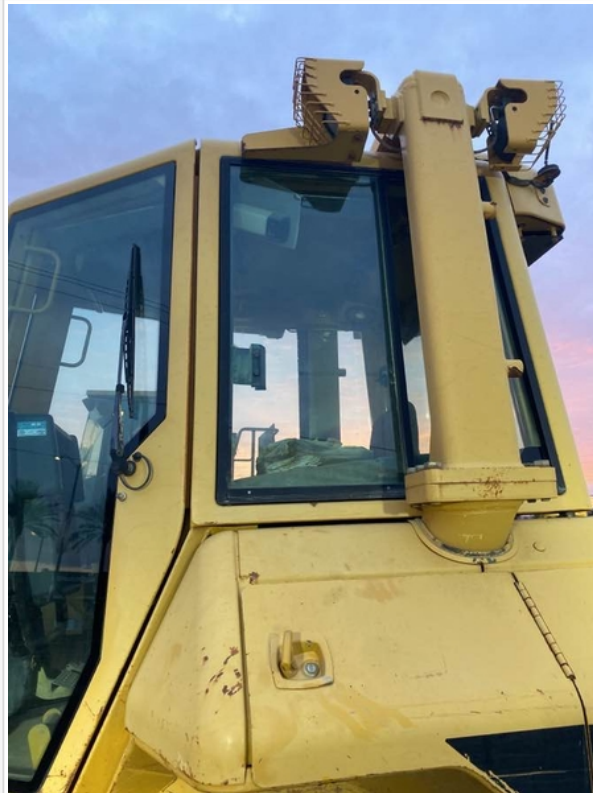
Glass Condition Photos

Glass Condition	3 - Normal Wear & Tear
Comments	Glass has no cracks.

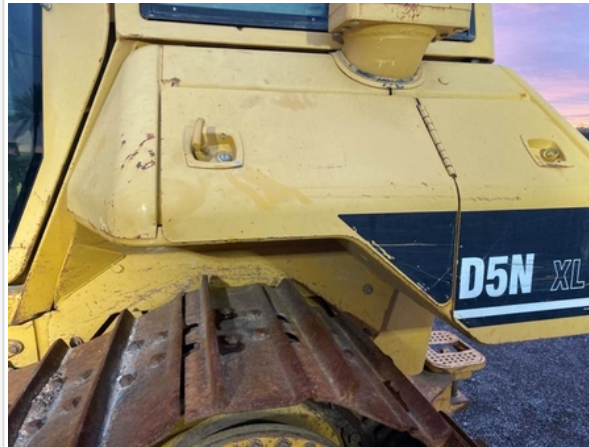
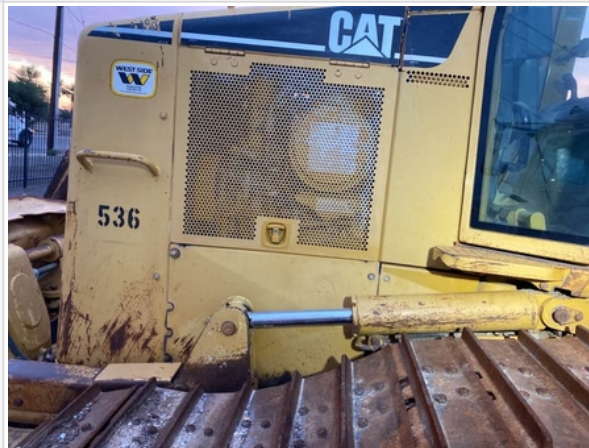
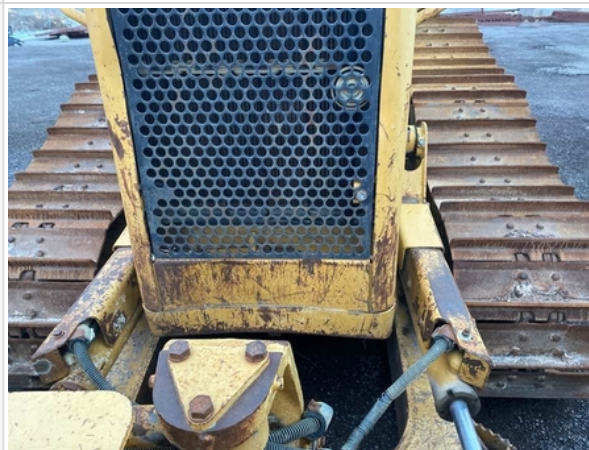
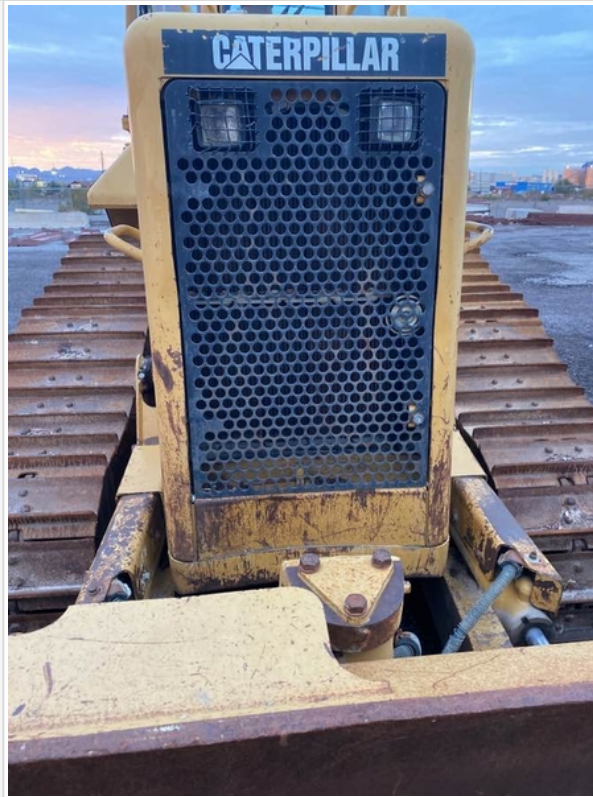
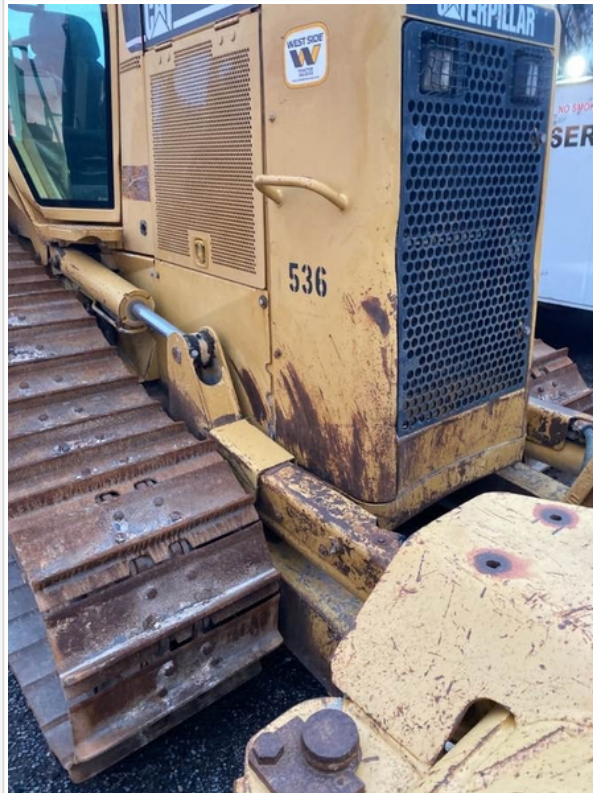
Body Panels Photos

<b>Body Panels (Any Rust Damage?)</b>	3 - Normal Wear & Tear
<b>Comments</b>	Body panels have normal wear with some light scratches and surface rust left rear corner has a washer welded on

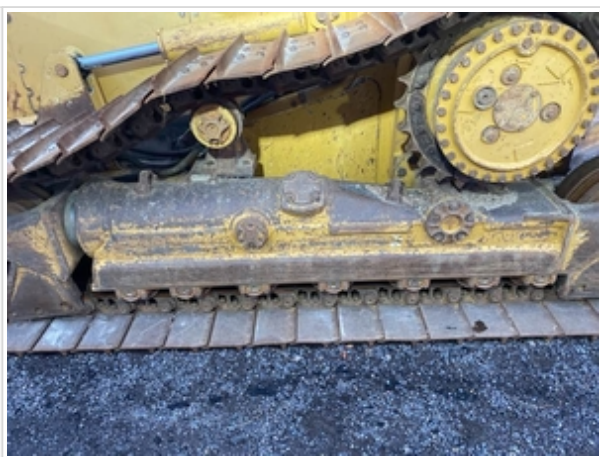
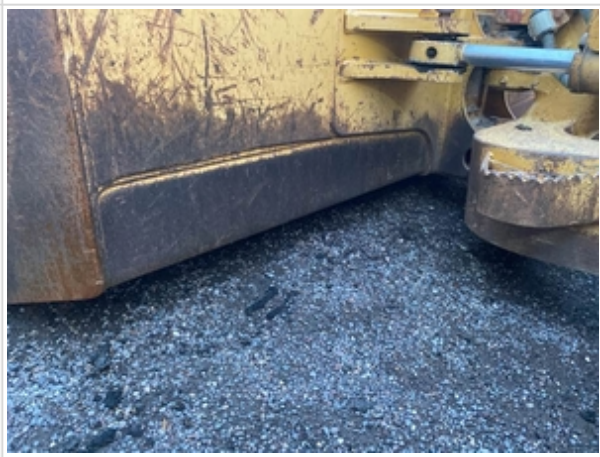
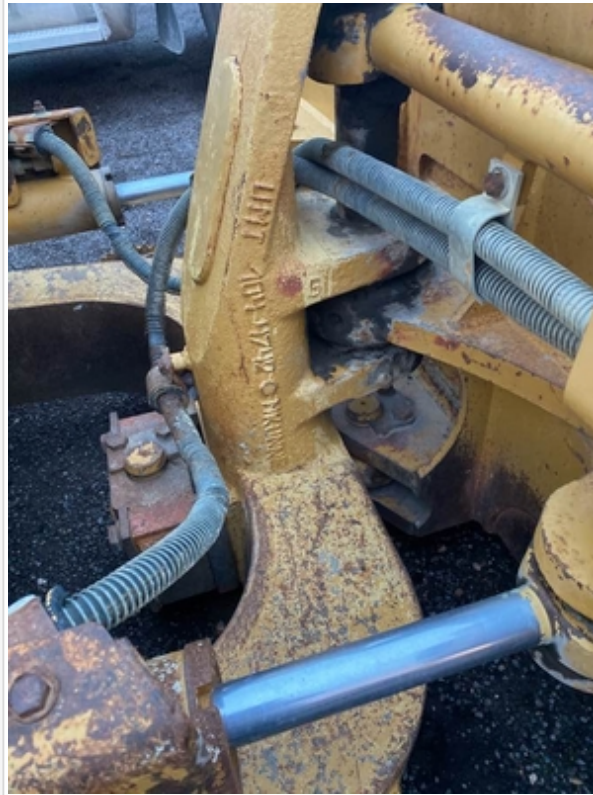
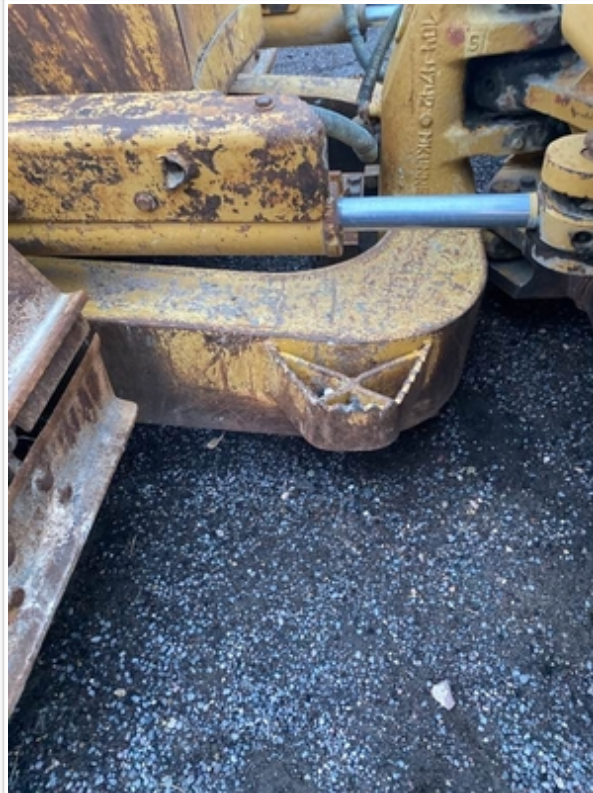
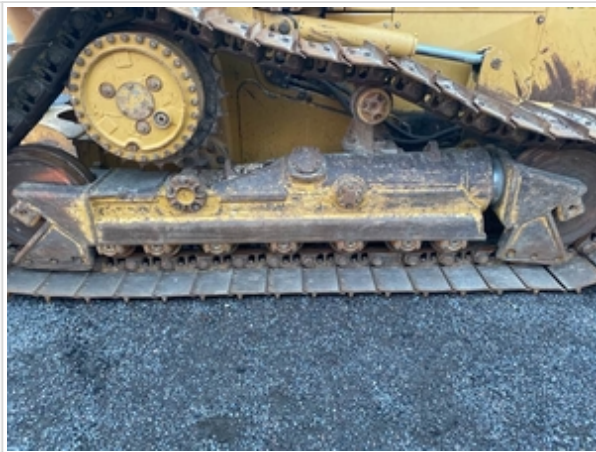
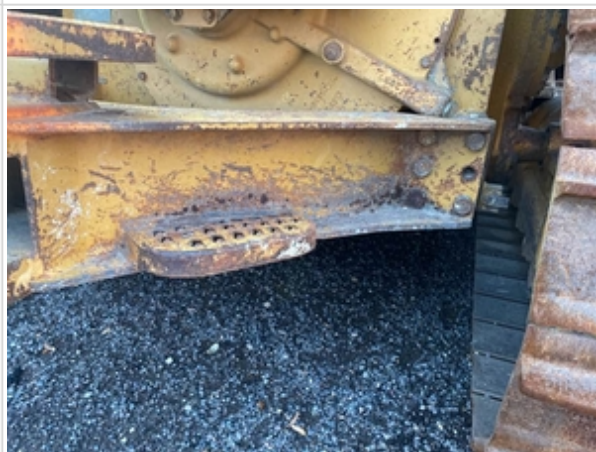
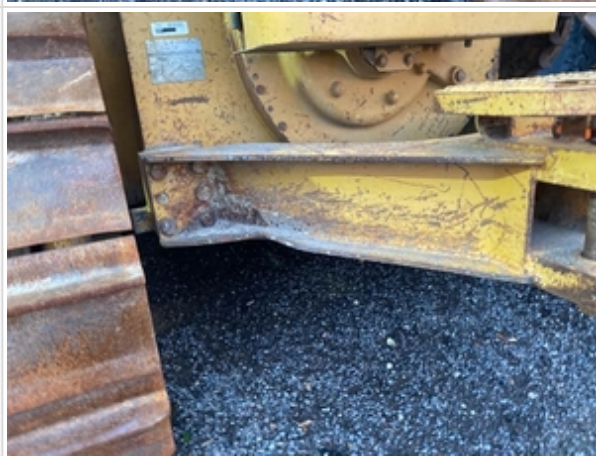
<p>Structural Condition Photos</p>

<p><b>Structural Condition (Any Visible Weld Repairs or Stress Cracks?)</b></p>	<p>3 - Normal Wear &amp; Tear</p>
<p><b>Comments</b></p>	<p>Left rear panel although not structural has a washer welded on.</p>

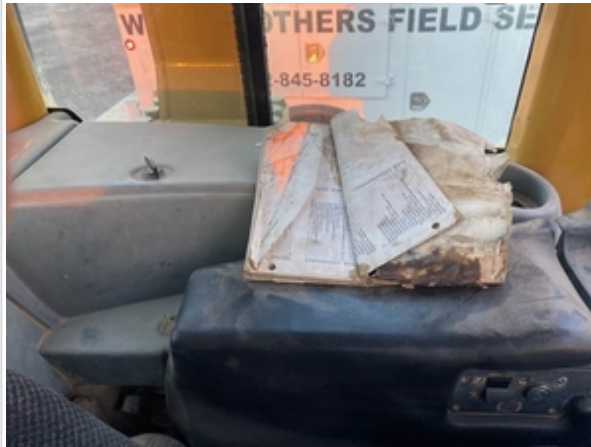
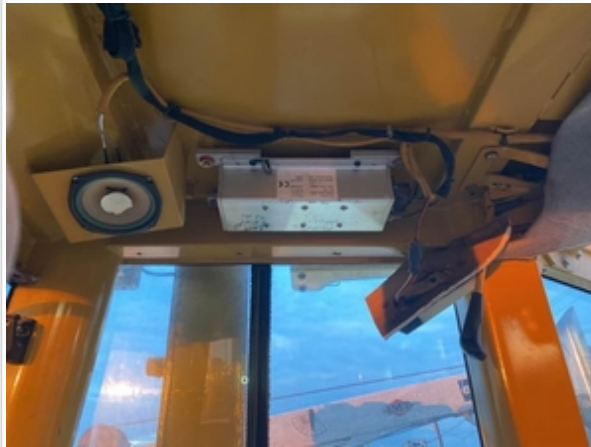
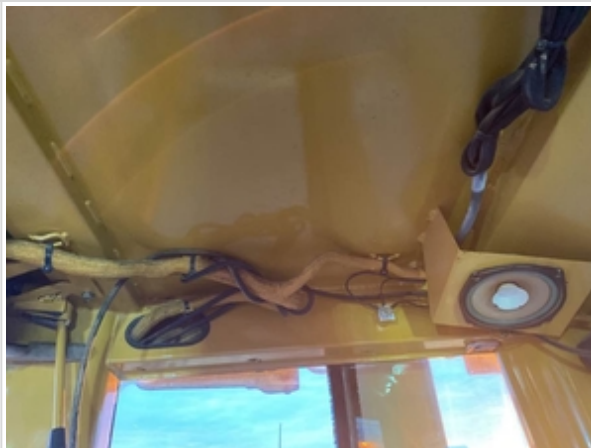
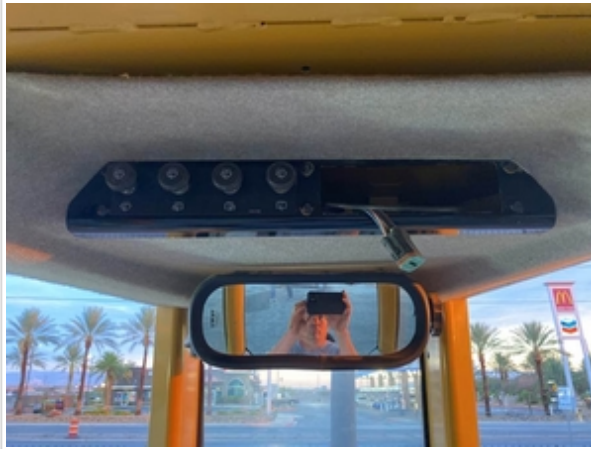
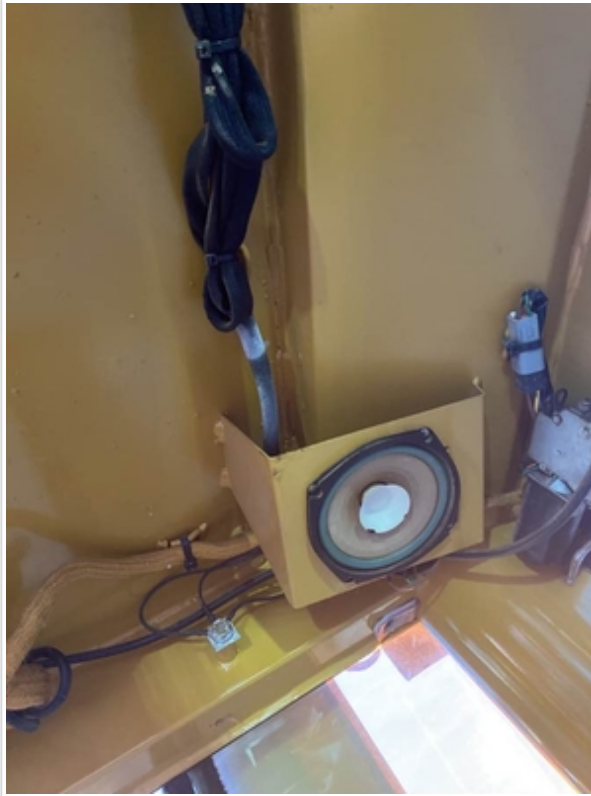
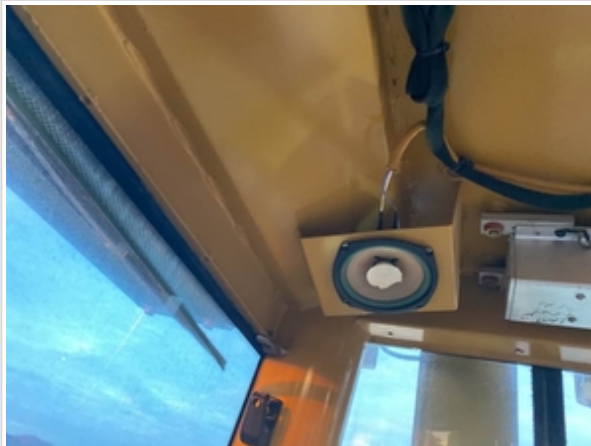
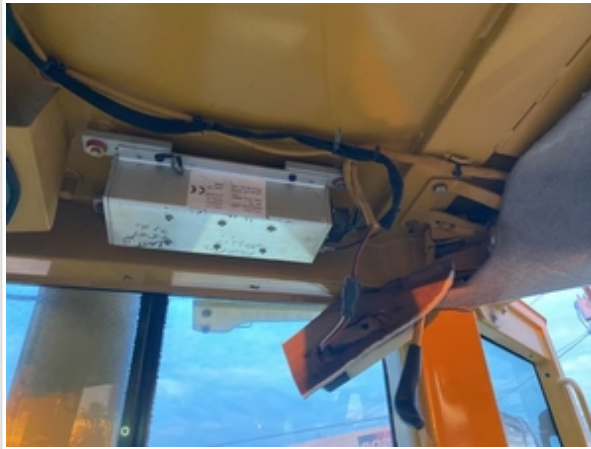
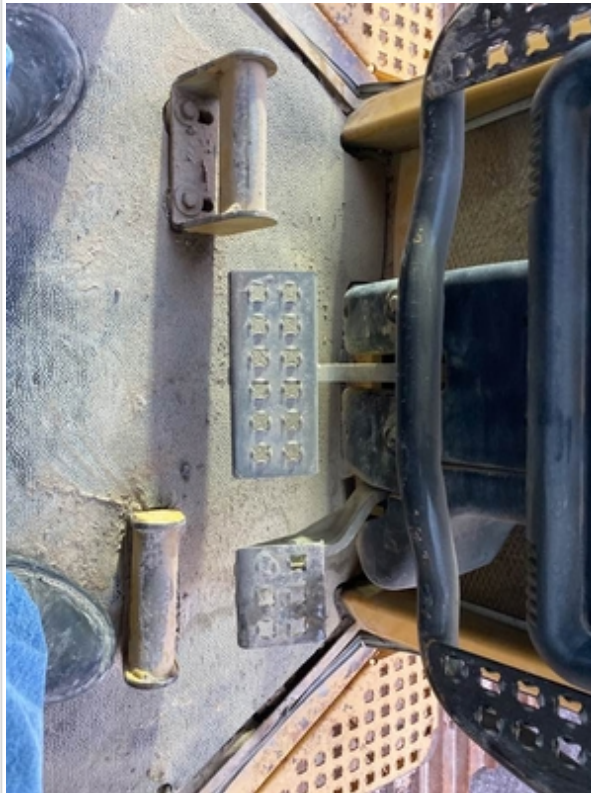
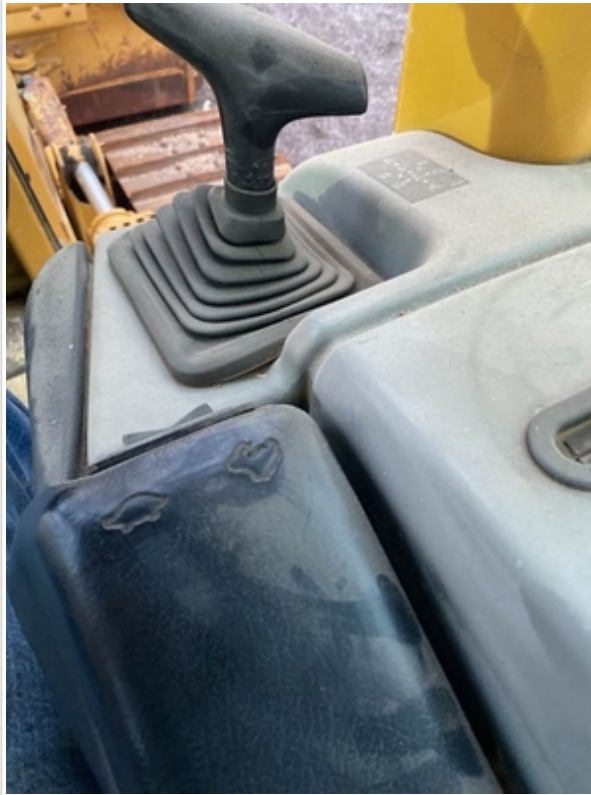
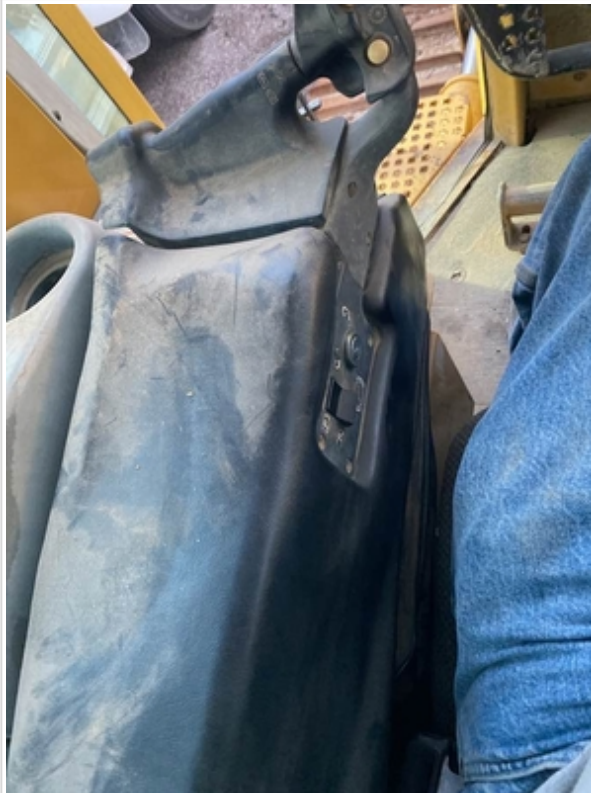
<p>Serial Number Plate Photo</p>	 
<p>Operator Cabin</p>	<p>2 - Above Average Wear</p>
<p>Comments</p>	<p>The head rest is missing. Radio is missing operator manual is present, but in rough shape.</p>
<p>Operator Cabin Photos</p>

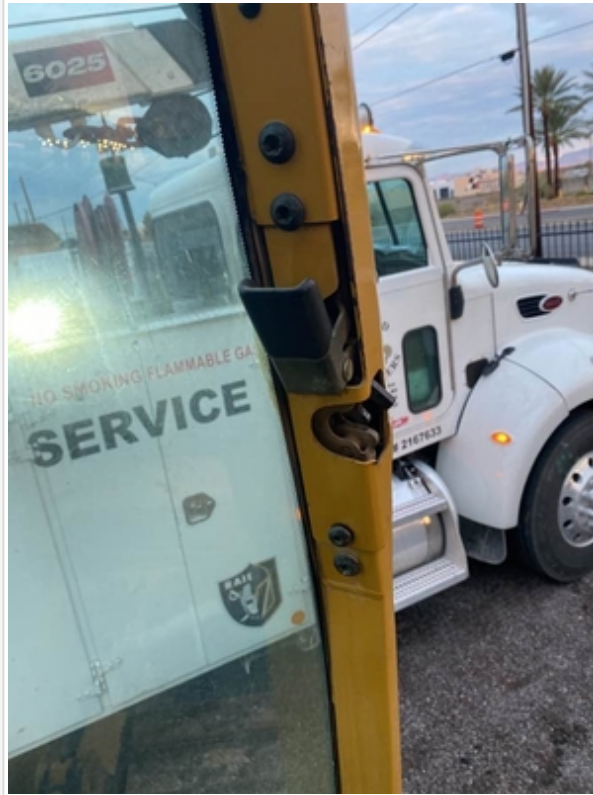
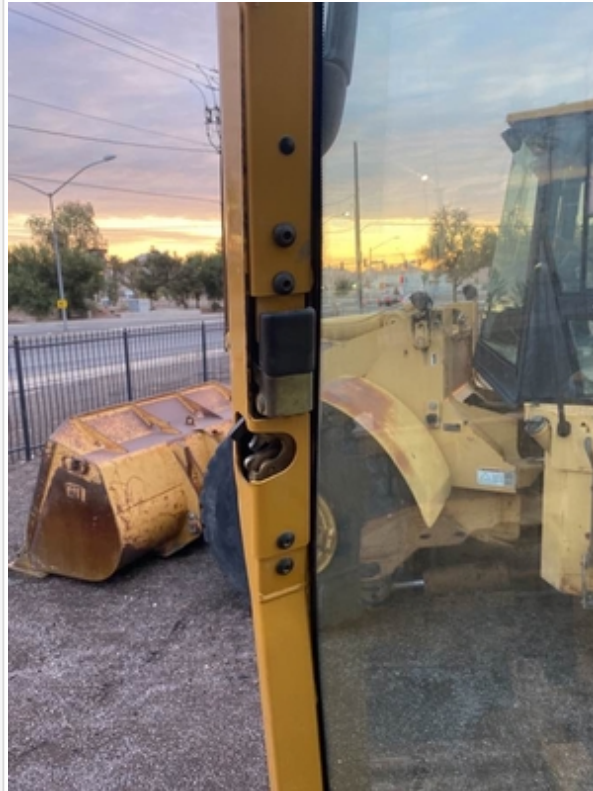
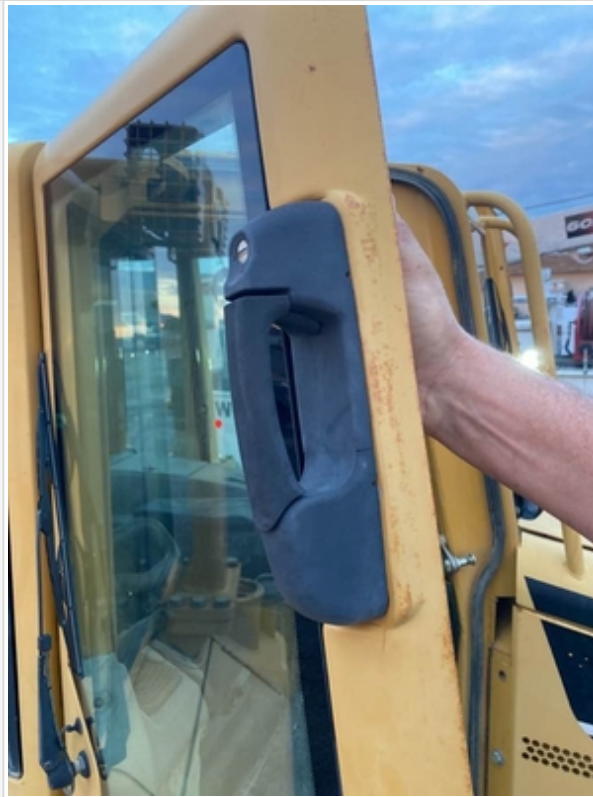
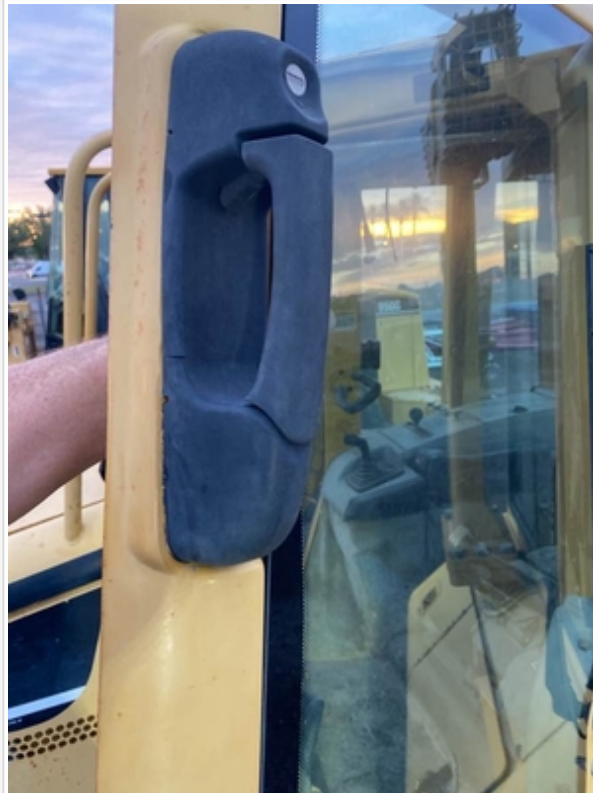
Door / Canopy Latches Photos

<b>Door / Canopy Latches</b>	3 - Normal Wear & Tear
<b>Comments</b>	Door latches on cab functional latch for left rear dood broken. Latch for right side door broken

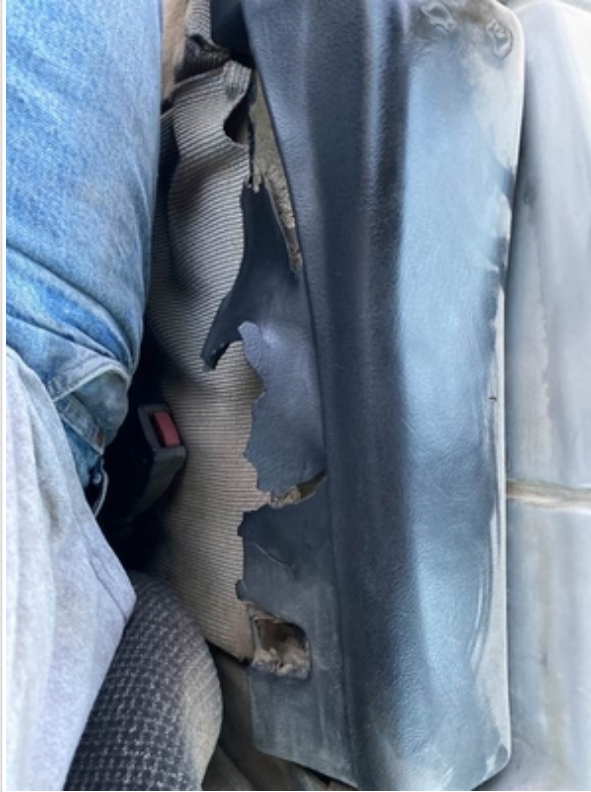
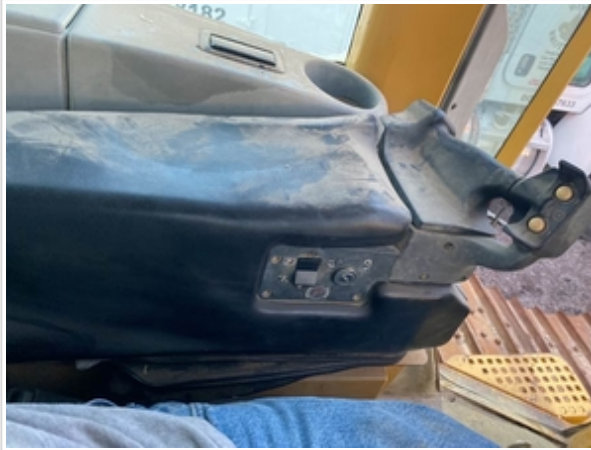
Operator's Seat & Arm Rests  
Photos

<p><b>Operator's Seat &amp; Arm Rests</b></p>	<p>3 - Normal Wear &amp; Tear</p>
<p><b>Comments</b></p>	<p>Seat and armrests were dusty but decent shape. Right arm rest has a few Knicks and tears. Seat has one small hole in upholstery</p>

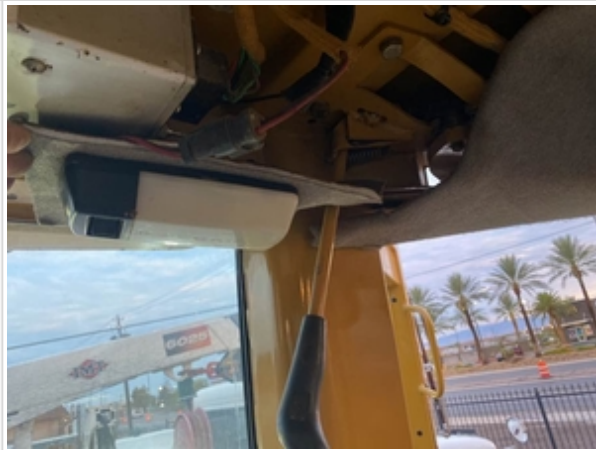
Cabin Lights Photos

<p><b>Cabin Lights</b></p>	<p>2 - Above Average Wear</p>	
<p><b>Comments</b></p>	<p>Cabin light present but hanging down from damaged headliner right front light out left upper light out</p>
