## Inspection Report (Bulldozer)

Year	2004
Make	Caterpillar
Model	D5N XL
Serial Number	AGG00760
Hour Meter Reading	10032

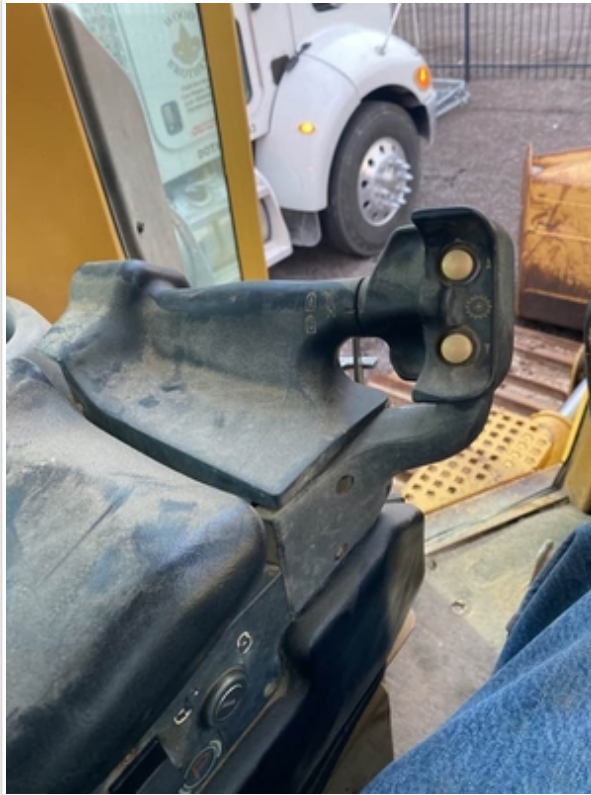
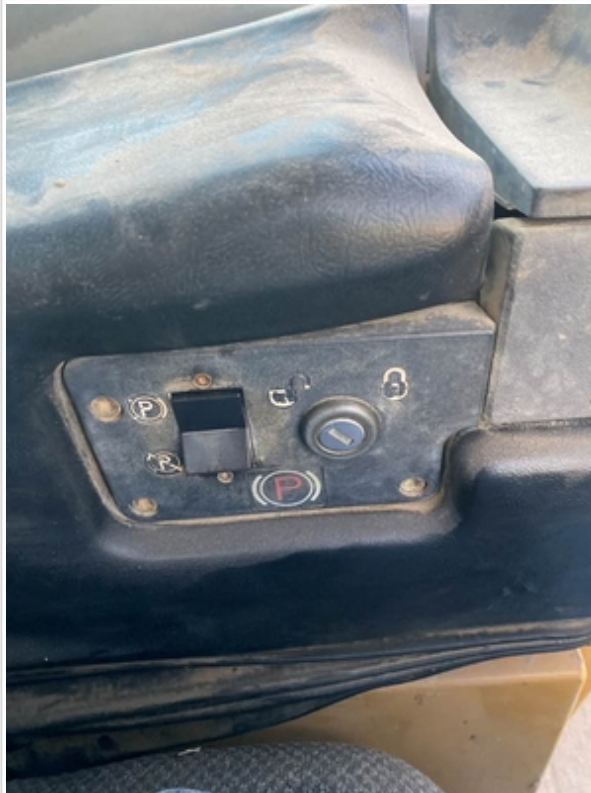
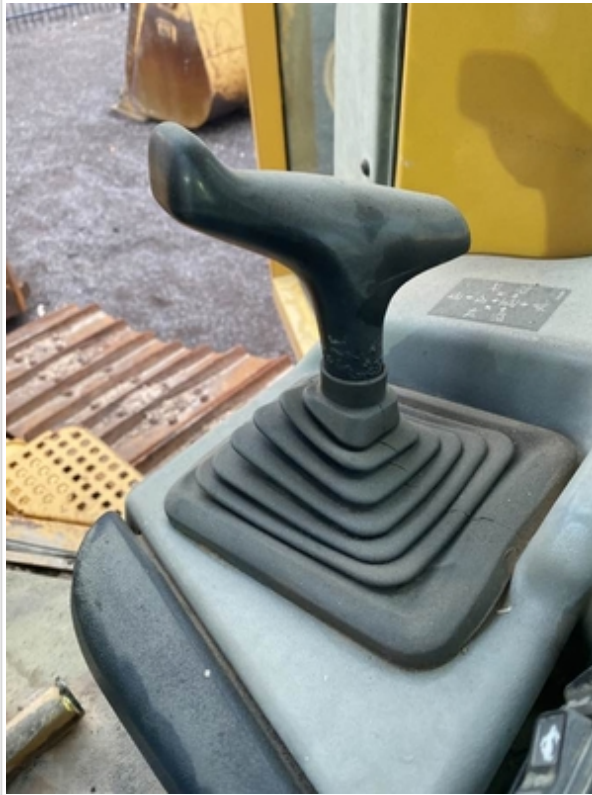
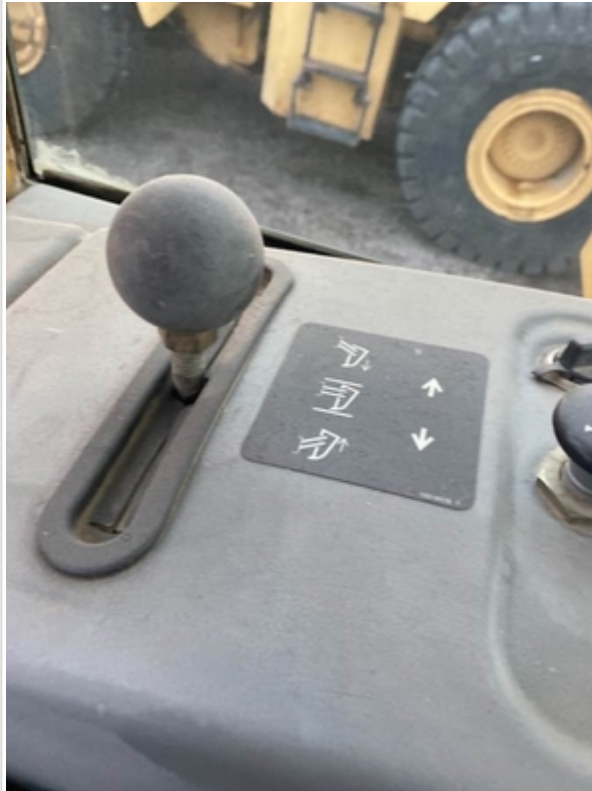
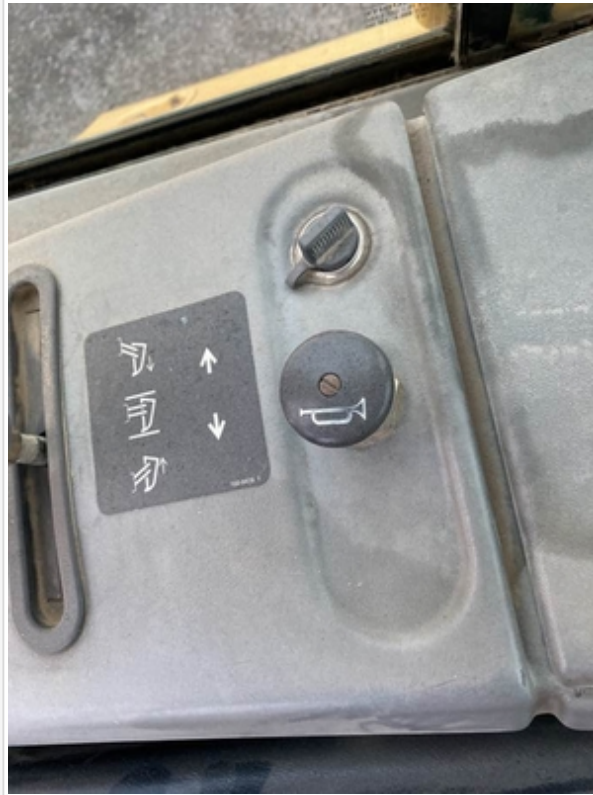
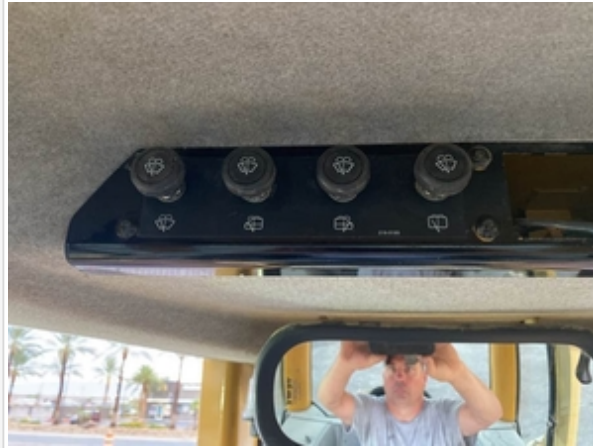
Controls & Switches	3 - Normal Wear & Tear
Comments	Controls and switches look ok. Normal wear.
Controls & Switches Photos

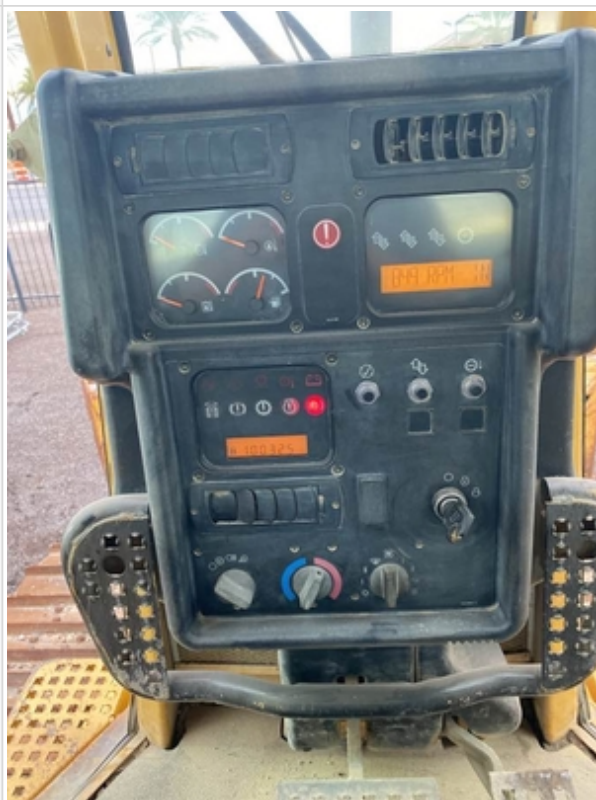
<p>Other Gauge Activity</p>	<p>3 - Normal Wear &amp; Tear</p>
<p>Comments</p>	<p>Gauges functional</p>
<p>Other Gauge Activity Photos</p>

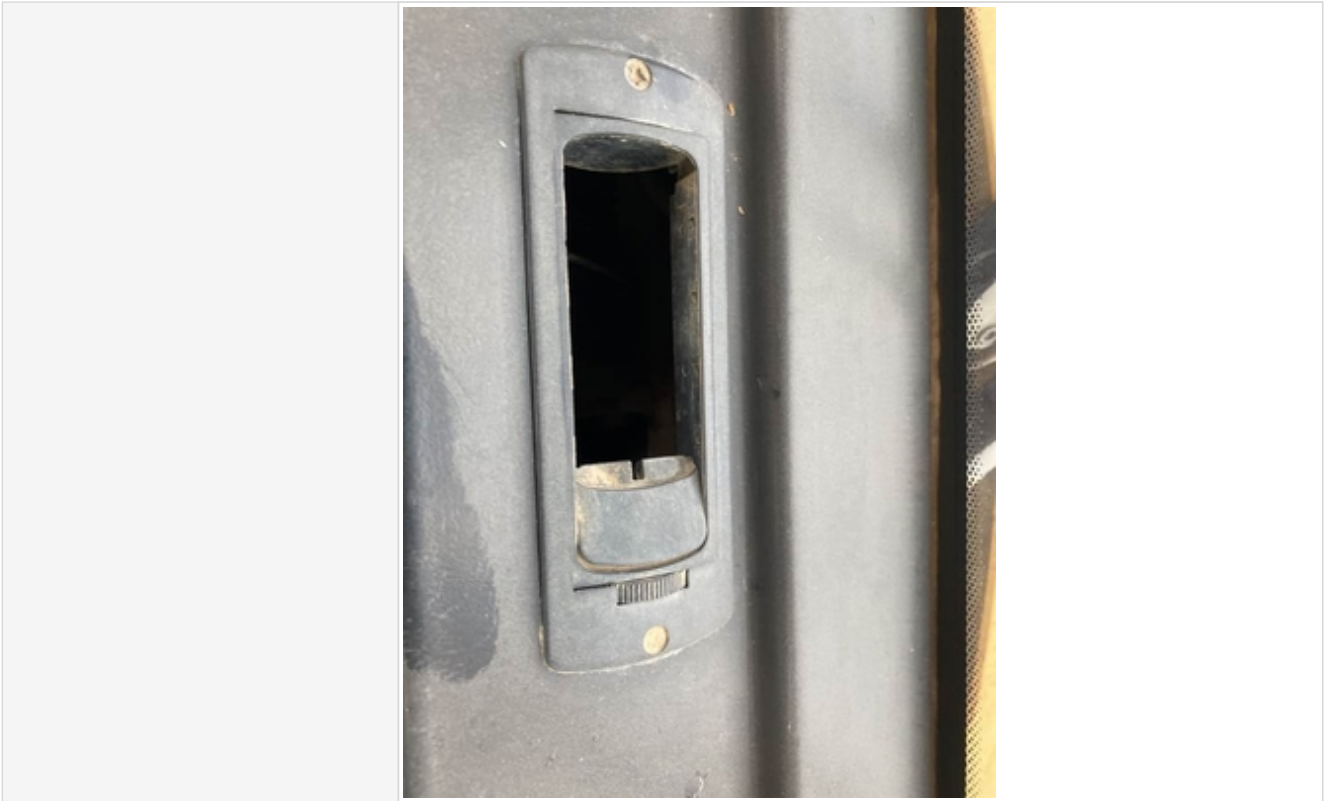
Comments	Heater blows warm air
Heater Photos	 
Air Conditioning	2 - Above Average Wear
Comments	Air conditioning blows cool but not cold.
Air Conditioning Photos	 
Fans / Vents	2 - Above Average Wear
Comments	Vents facing operator are in good shape the top/defrost vent is missing louvers
Fans / Vents Photos

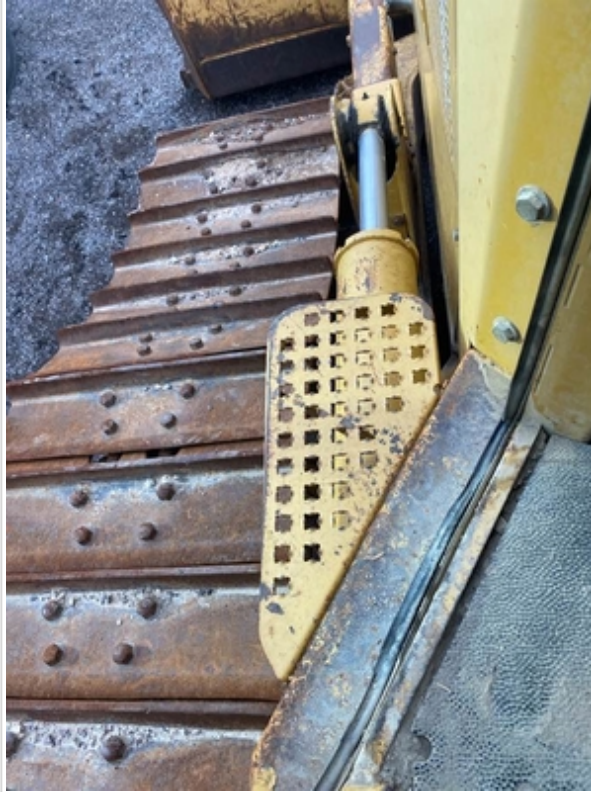
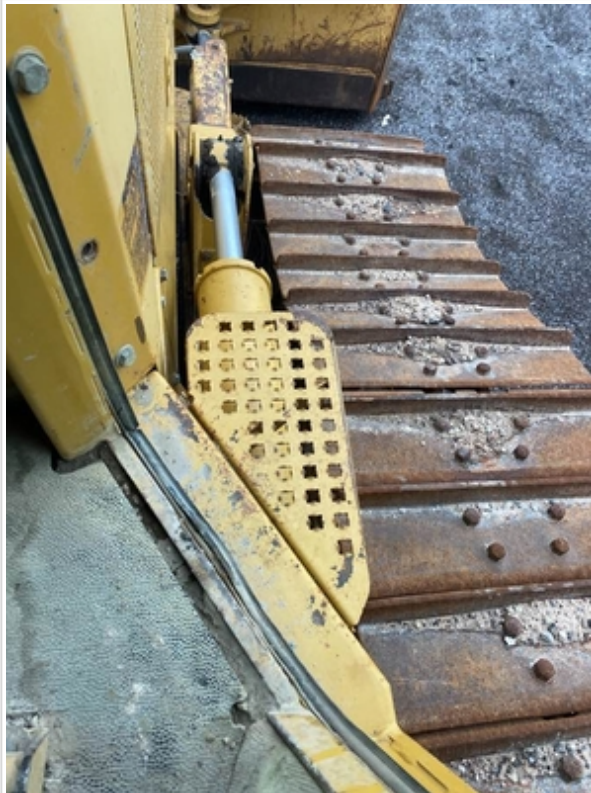
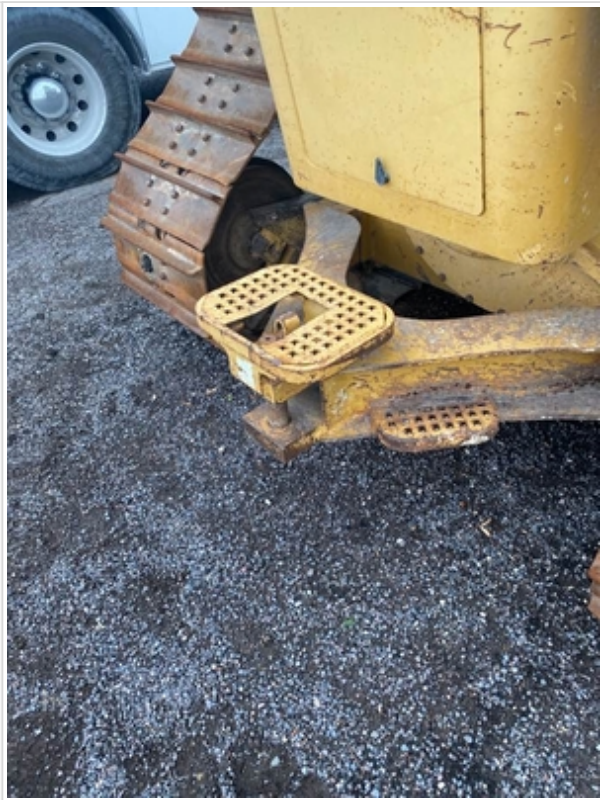
Steps / Ladders Photos

<b>Instructions</b>	<p>Evaluate the following on a 4 point scale (leave comments where an explanation is appropriate):</p> <p>4 = Like New, Recently Replaced  3 = Normal Wear &amp; Tear  2 = Above Average Wear  1 = Service Required</p> <p>Things to look for:  &lt;Samir to edit&gt;</p> <p>Take close-up photos of and leave comments.</p>
<b>Steps / Ladders</b>	3 - Normal Wear & Tear
<b>Comments</b>	Steps and ladders are in good shape. Normal wear.

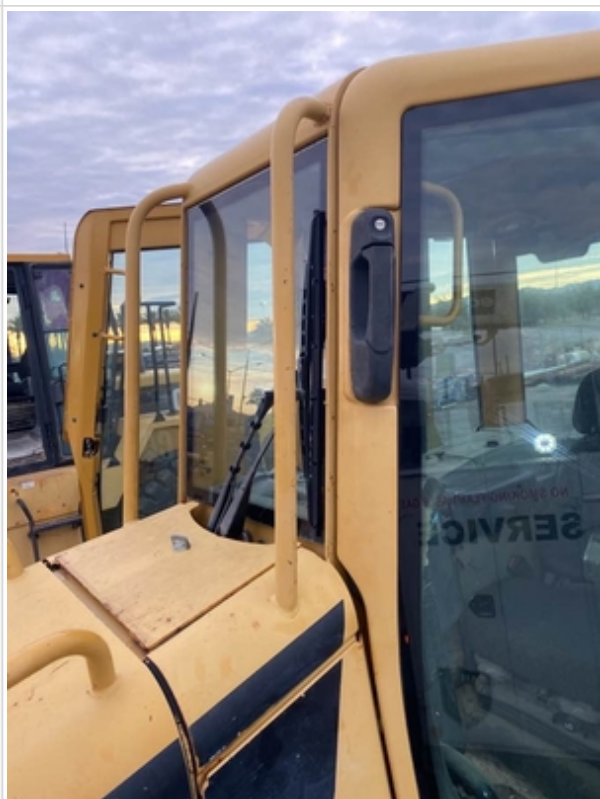
<p><b>Handrails</b></p>	<p>3 - Normal Wear &amp; Tear</p>	
<p><b>Comments</b></p>	<p>Handrails are present and serviceable</p>	
<p><b>Handrails Photos</b></p>

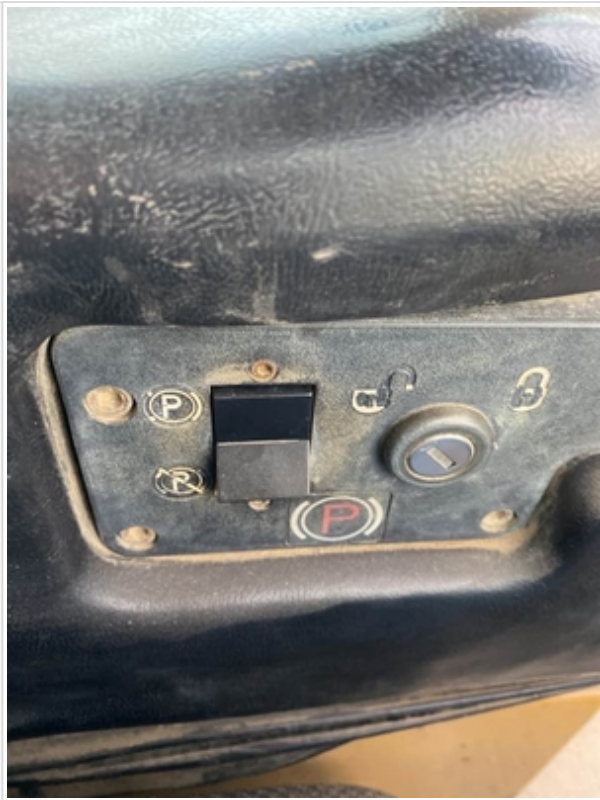
<p>Safety Lock Out / Stop Photos</p>

Safety Lock Out / Stop	3 - Normal Wear & Tear
Comments	Ok. In park won't allow shift.

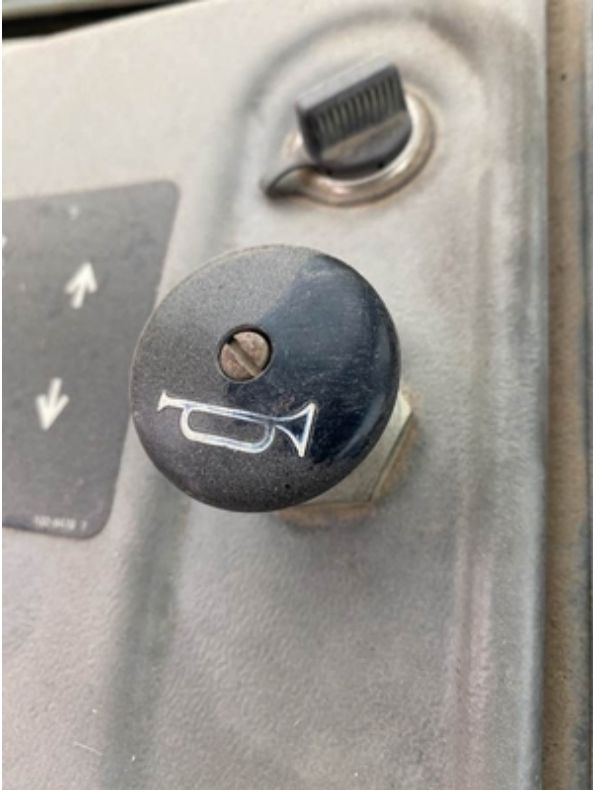
<p>Horn Photos</p>

<p>Travel Alarm</p>	<p>3 - Normal Wear &amp; Tear</p>
<p>Comments</p>	<p>Backup alarm functions</p>
<p>Horn</p>	<p>3 - Normal Wear &amp; Tear</p>
<p>Comments</p>	<p>Horn functions</p>

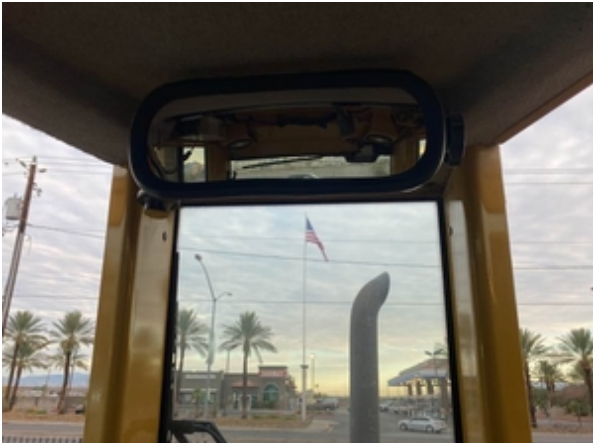
<p>Backup Camera</p>	<p>0</p>
<p>Mirrors</p>	<p>3 - Normal Wear &amp; Tear</p>
<p>Comments</p>	<p>One rear view mirror good</p>
<p>Mirrors Photos</p>

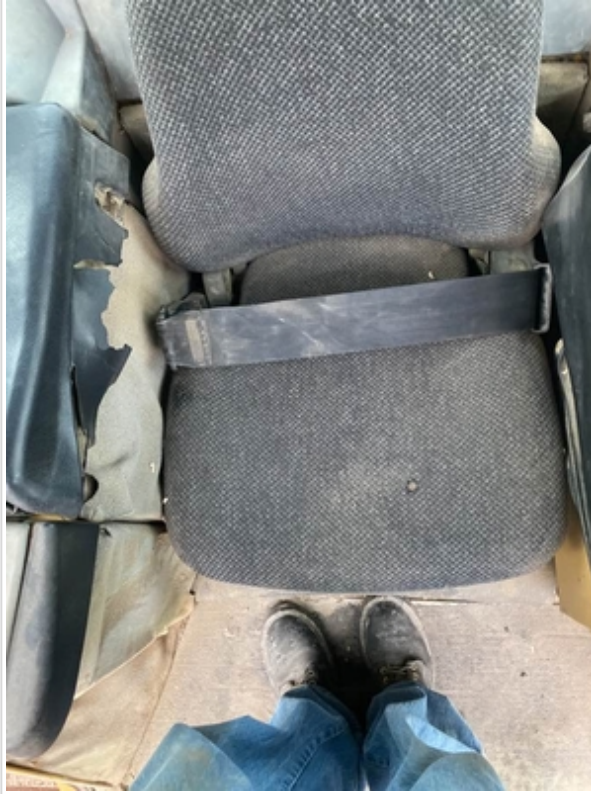
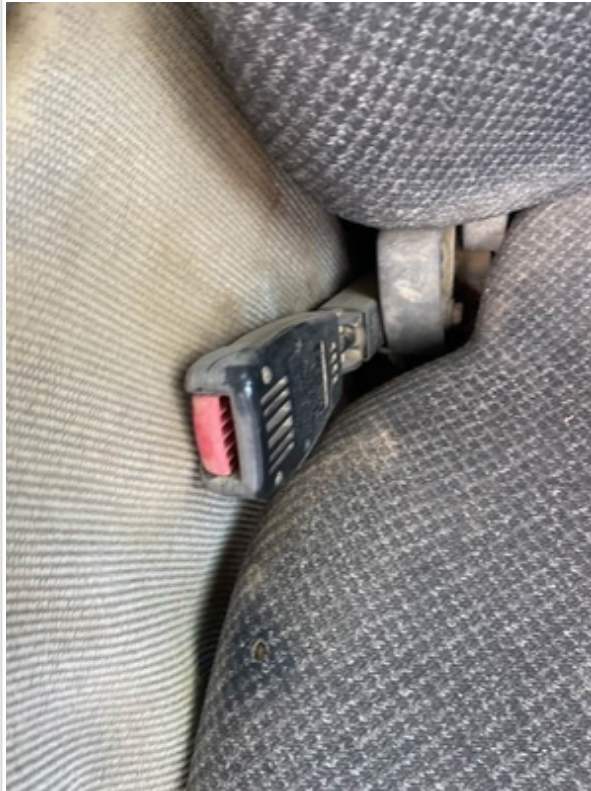
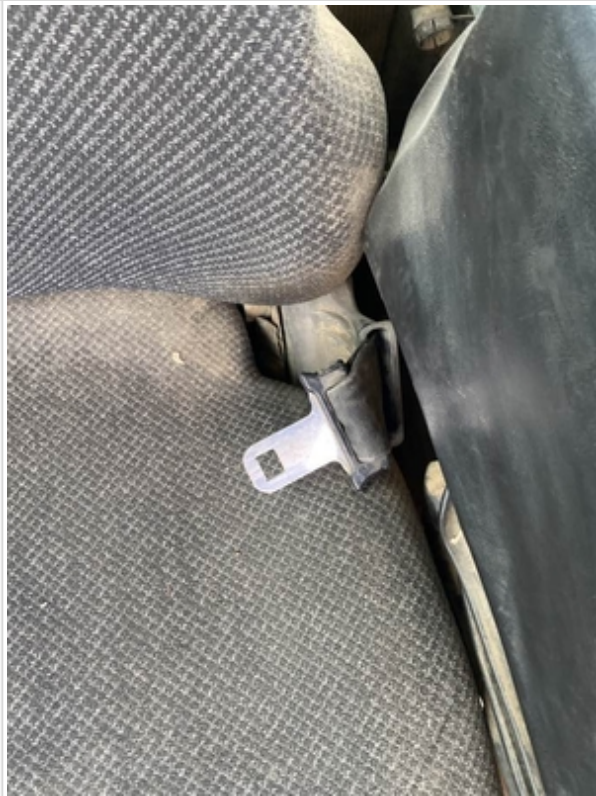
Seat Belt Photos

<p>Seat Belt</p>	<p>3 - Normal Wear &amp; Tear</p>
<p>Comments</p>	<p>Seat belt functional. No visible date on seatbelt</p>

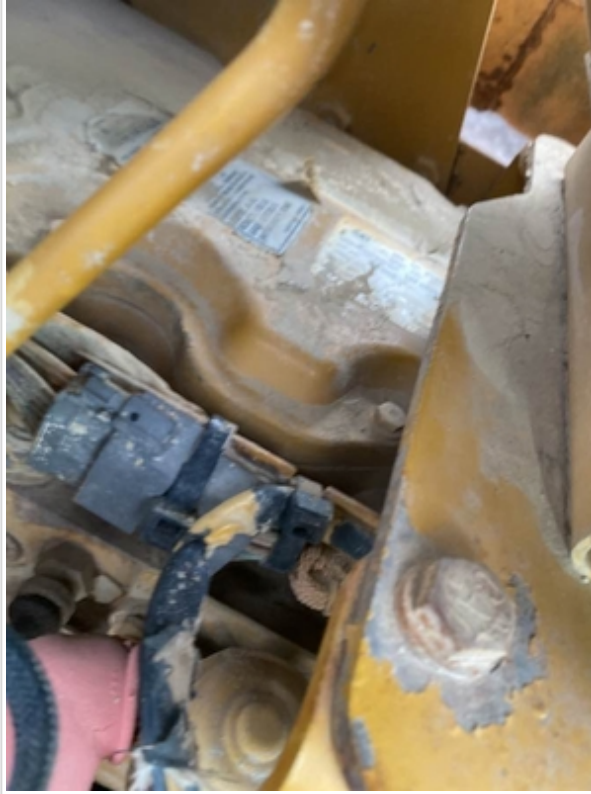
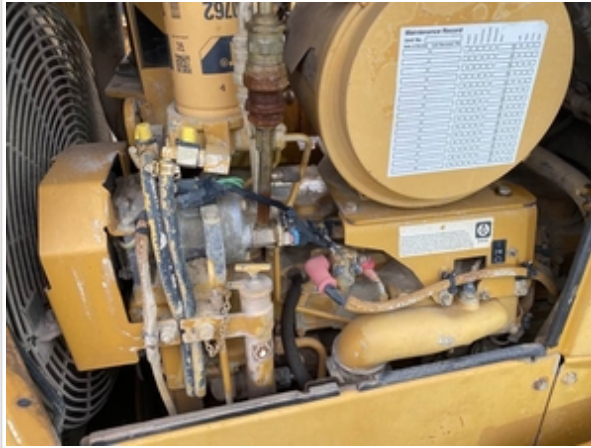
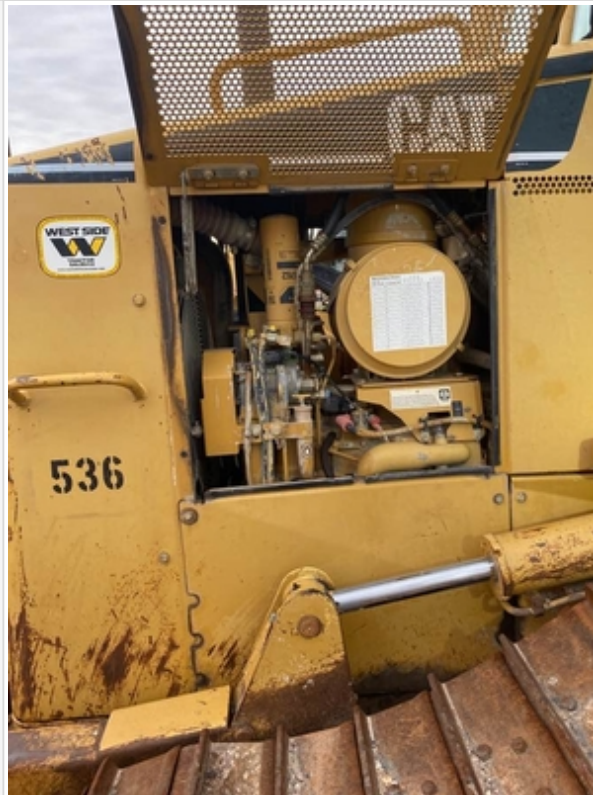
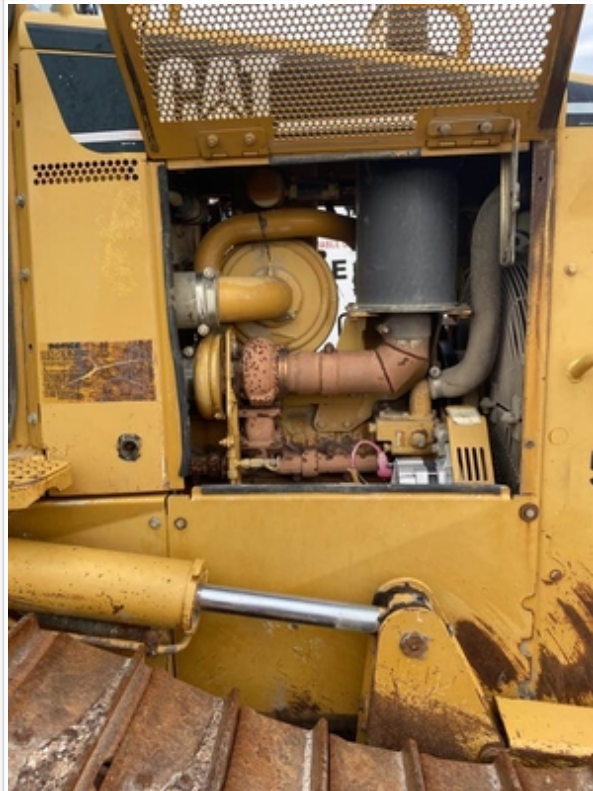
Engine Photos

Fuel Leaks	No
Cooling System Leaks	No
Overall Engine Appearance	Wet
Overall Engine Comments	Corrosion at electrical connections on relay. Oil leaks on engine. Not major. But oil present in belly pan. High pressure oil hose going to head wet. Hoses for coolant not leaking. But soft.

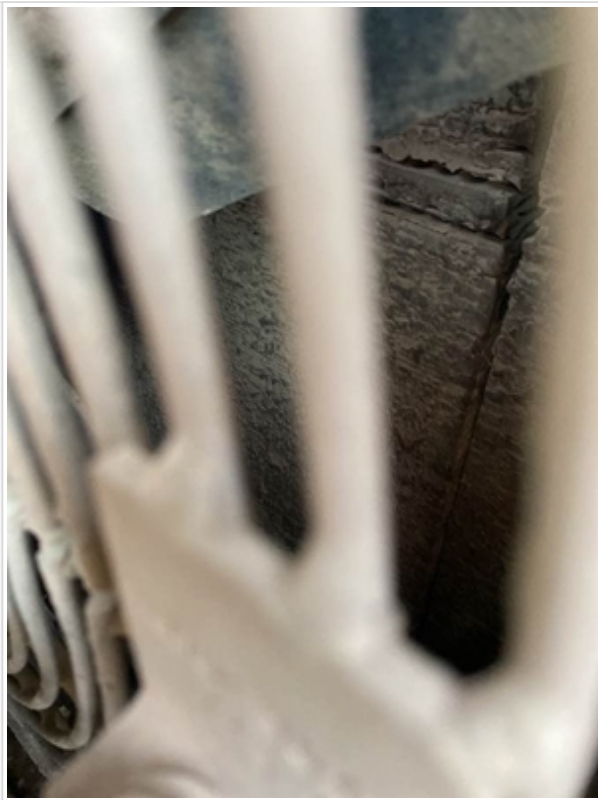
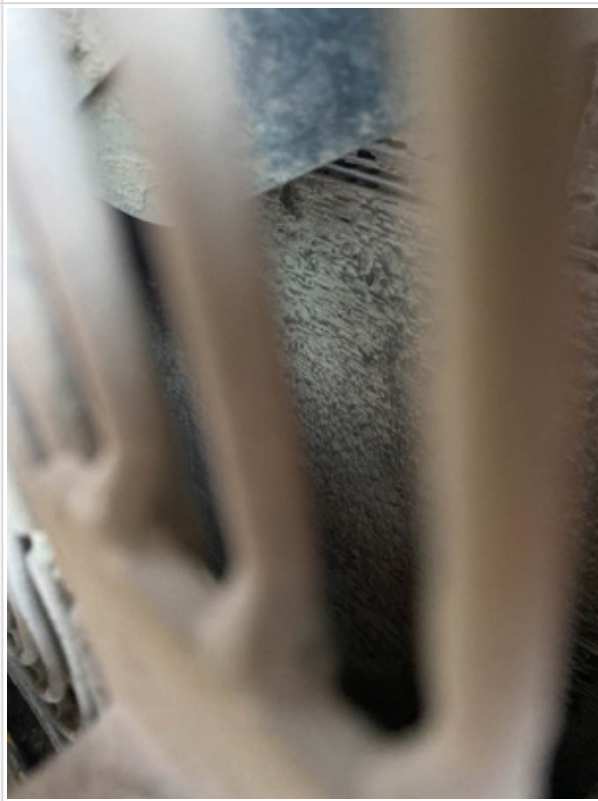
<b>Instructions</b>	Assess the condition of the engine / power unit.  For items on a 4 point scale, evaluate using the following criteria:  4 = Like New, Recently Replaced 3 = Normal Wear & Tear 2 = Above Average Wear 1 = Service Required
<b>Blow-by (Visual Observation Check)</b>	No
<b>Unusual Noises (Upon Start-up, Idle, Shutdown)</b>	No
<b>Comments</b>	Batteries were weak had to jump start.
<b>Engine Smoke (Upon Start-up, Idle, Shutdown)</b>	No
<b>Engine Exhaust Color</b>	Black
<b>Comments</b>	Slight black on start up but ran very clean
<b>Oil Color / Appearance</b>	3 - Normal Wear & Tear
<b>Comments</b>	Oil black
<b>Coolant Color / Appearance</b>	3 - Normal Wear & Tear
<b>Comments</b>	Light green
<b>Radiator</b>	1 - Service Required
<b>Comments</b>	Radiator light surface rust
<b>Radiator Photos</b>

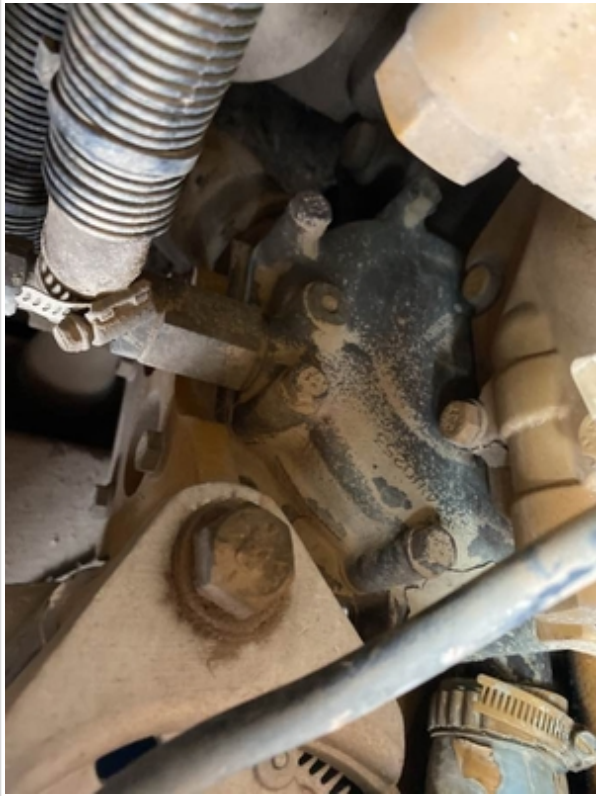
<p>Water Pump Photos</p>

<p><b>Water Pump</b></p>	<p>3 - Normal Wear &amp; Tear</p>
<p><b>Comments</b></p>	<p>Ok</p>

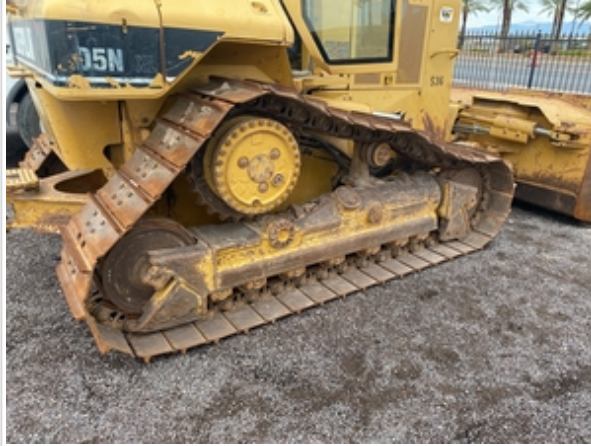
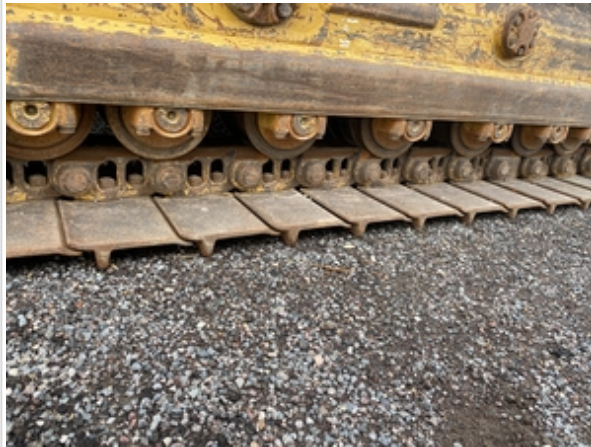
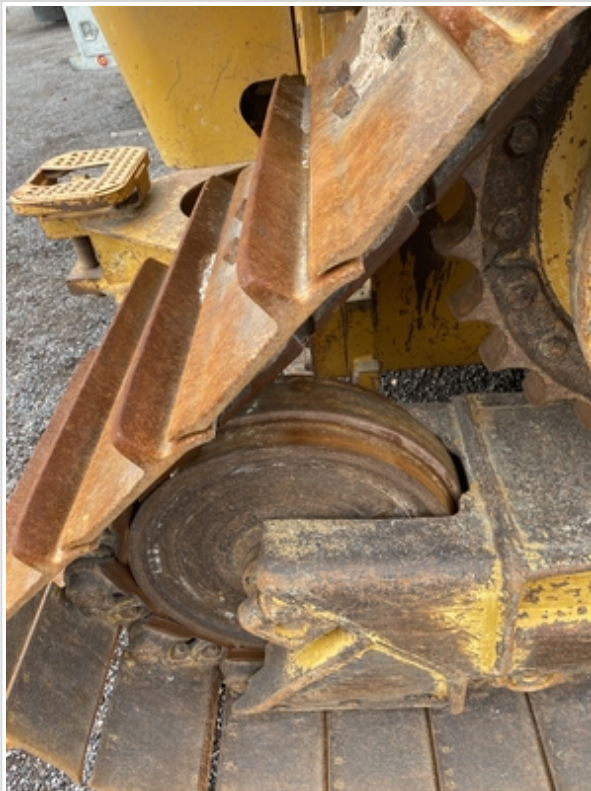
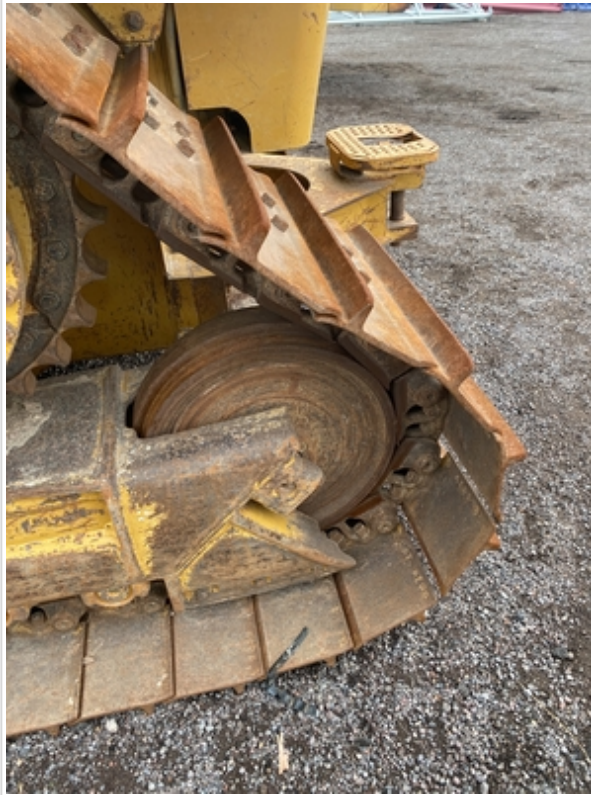
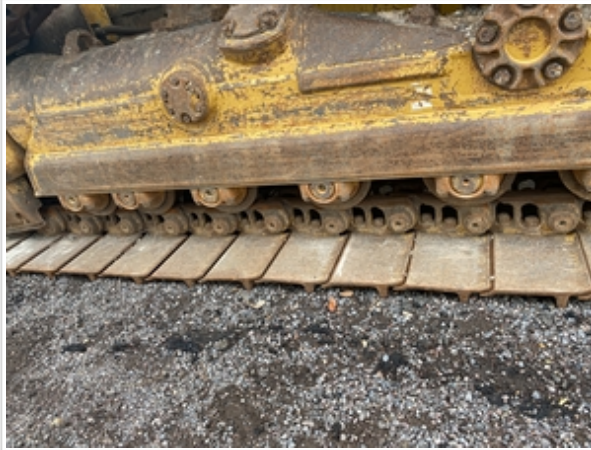
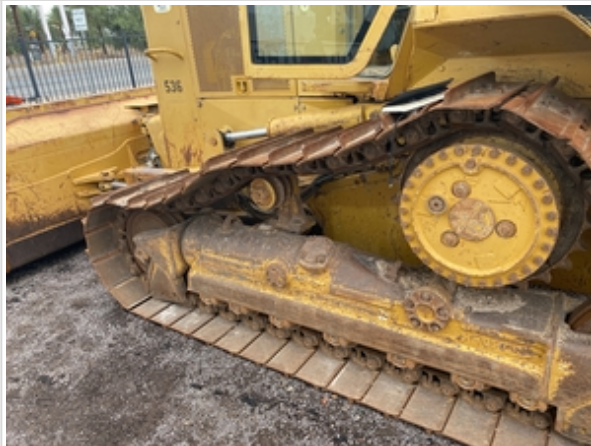
Undercarriage Overall Photos

Instructions	<p>Evaluate the following on a 4 point scale (leave comments where an explanation is appropriate):</p> <p>4 = Like New, Recently Replaced  3 = Normal Wear &amp; Tear  2 = Above Average Wear  1 = Service Required</p>
Undercarriage Overall Condition	3 - Normal Wear & Tear
Comments	Undercarriage is in decent shape. Appears to be 50%-60%

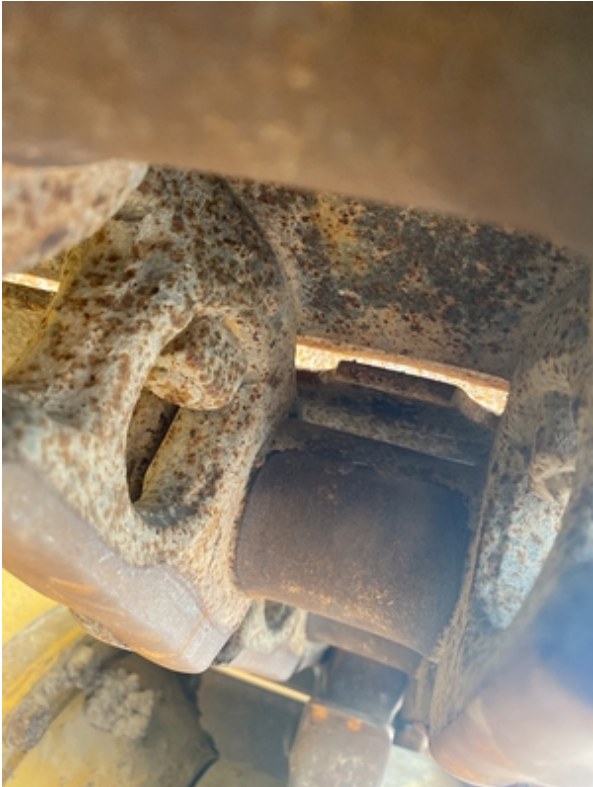
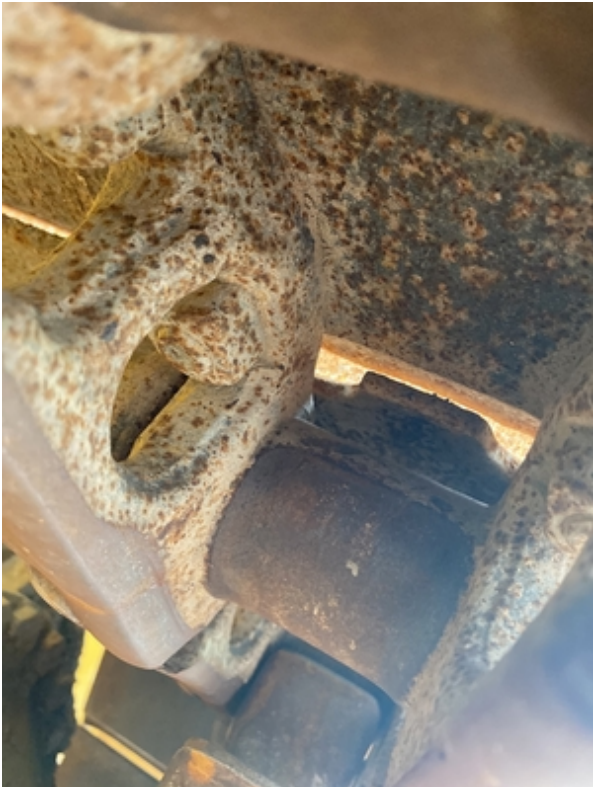
Pin & Bushings	3 - Normal Wear & Tear
Comments	Can feel west in bushings but probably 50-60% remaining life.
Pin & Bushings Photos

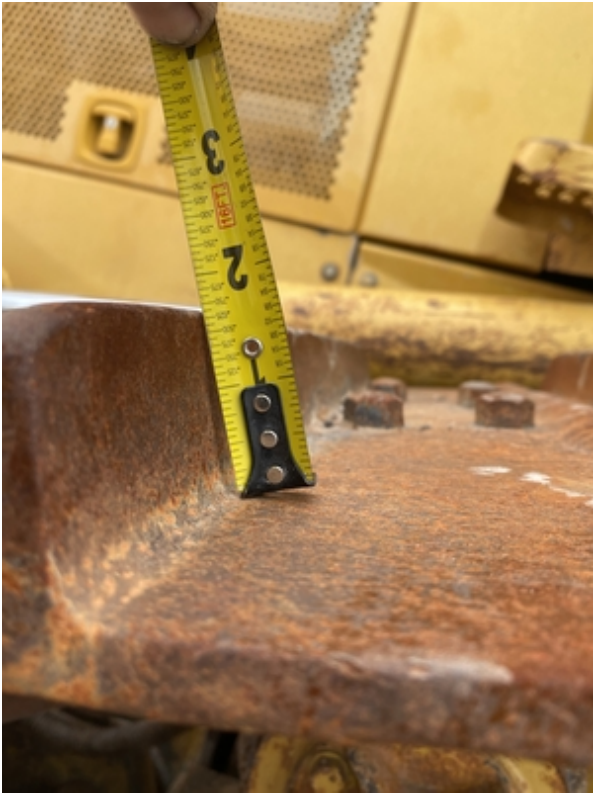
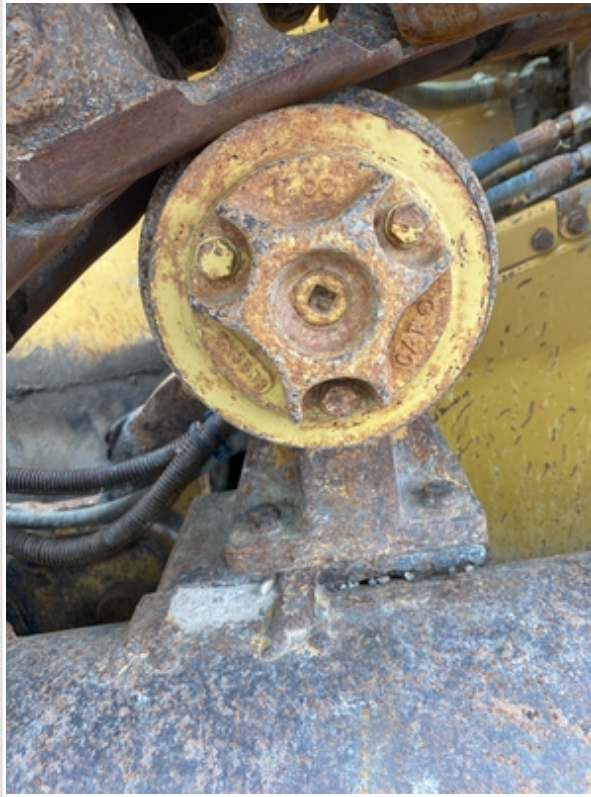
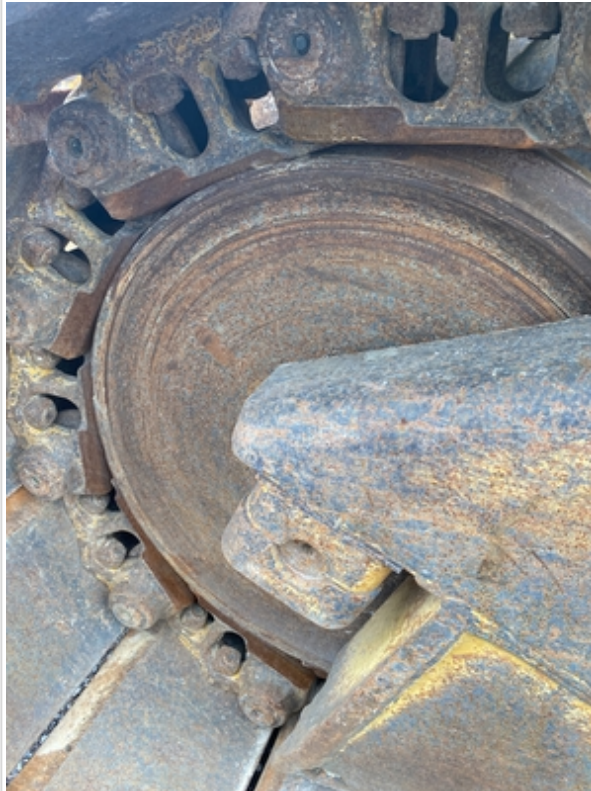
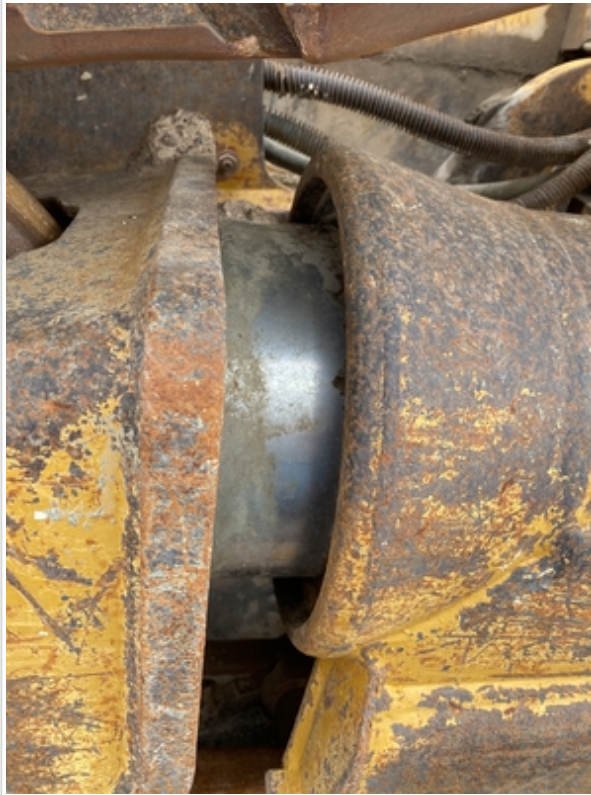
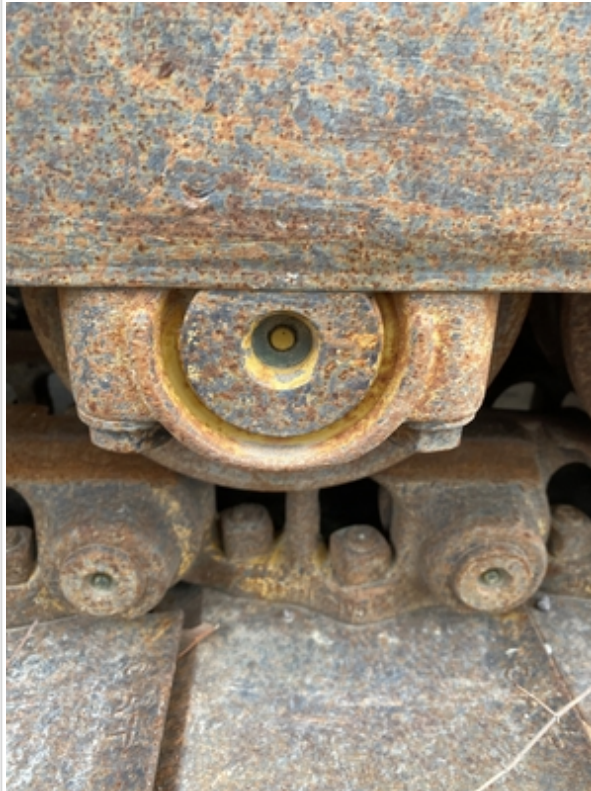
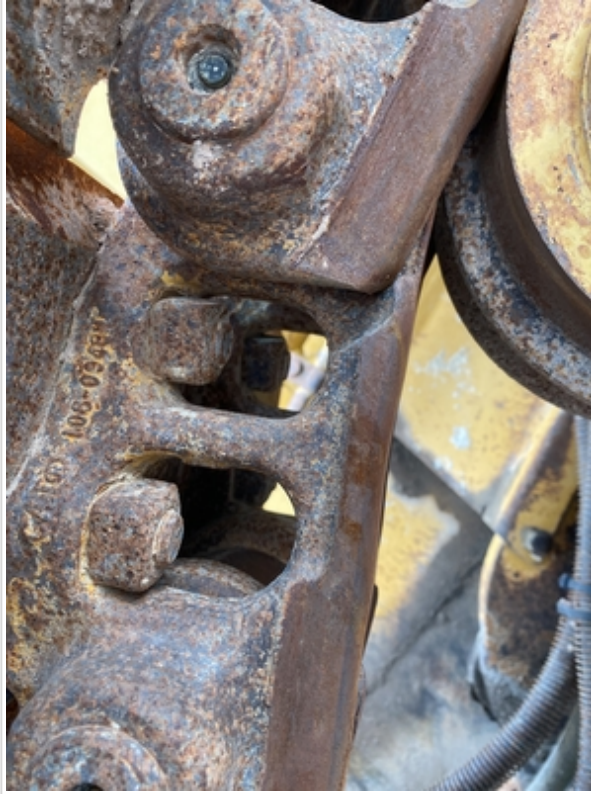
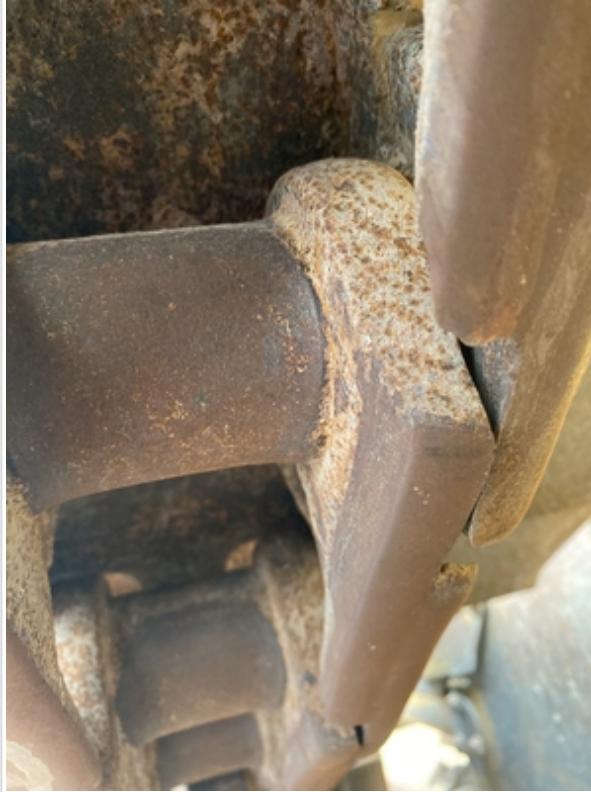
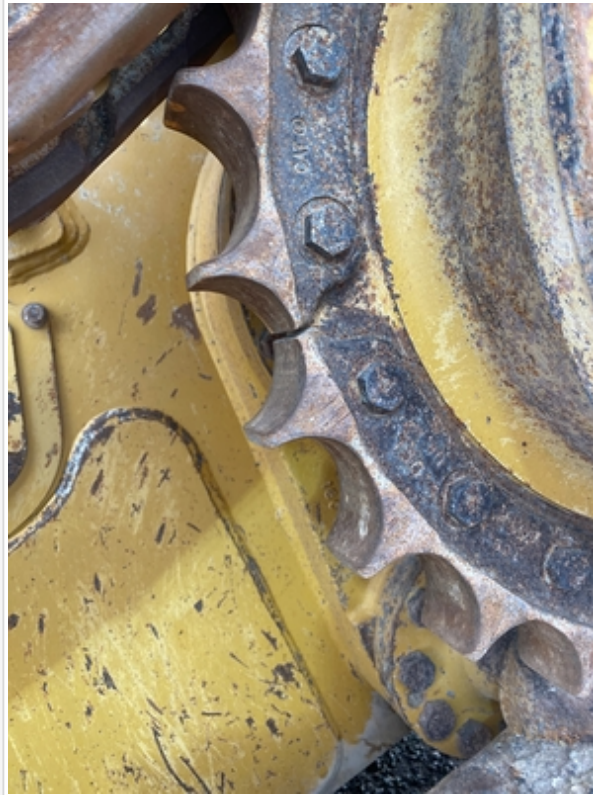
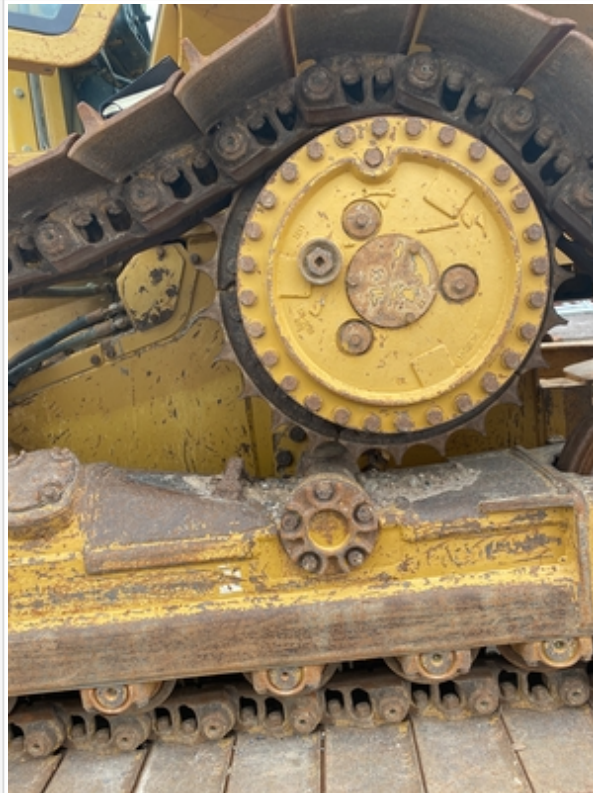
**Left Side: Link Bushings / Drive Sprocket / Shoe Condition**

3 - Normal Wear & Tear

Track Condition: Left Front	50%
Track Condition: Left Rear	50%
<b>Undercarriage Left Side Photo Instructions</b>	<p>Take photos of the undercarriage of this piece of equipment.</p> <p>Must have shots to capture:</p> <ul style="list-style-type: none"> <li>- Roller Frame (left)</li> <li>- Track Tensioner (left)</li> <li>- Track Pads (left)</li> <li>- Grouser Height (left)</li> <li>- Track Links (left)</li> <li>- Track Bushings (left)</li> <li>- Carrier Rollers (left)</li> <li>- Track Rollers (left)</li> <li>- Front Idler (left)</li> <li>- Rear Idler (left)</li> <li>- Sprocket (left)</li> </ul>
<b>Undercarriage Left Side Photos</b>

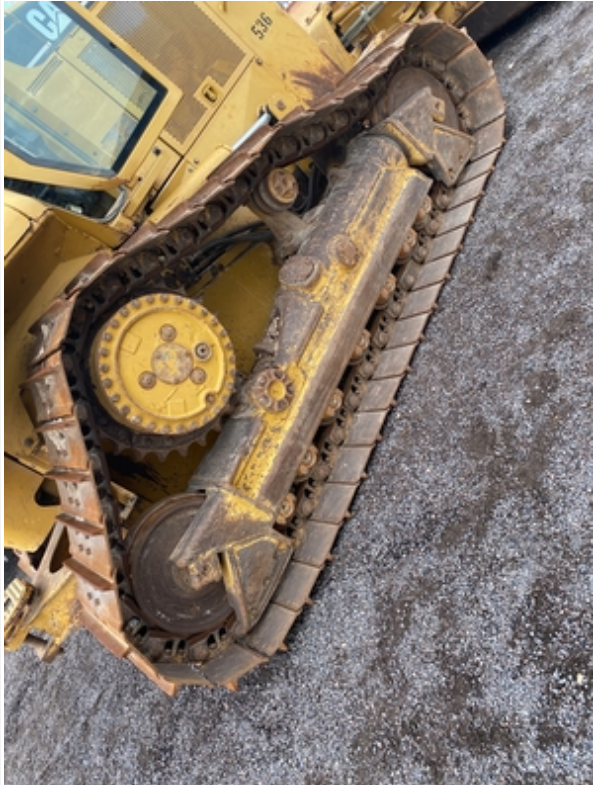
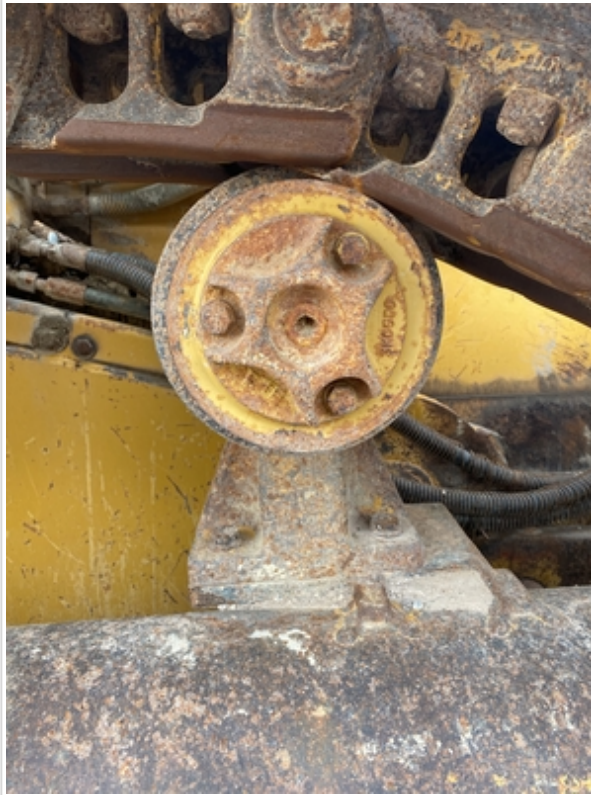
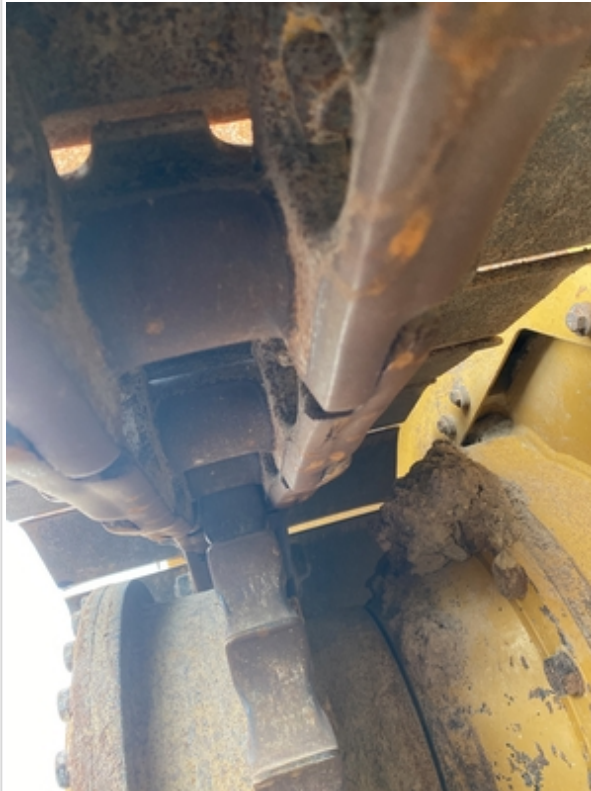
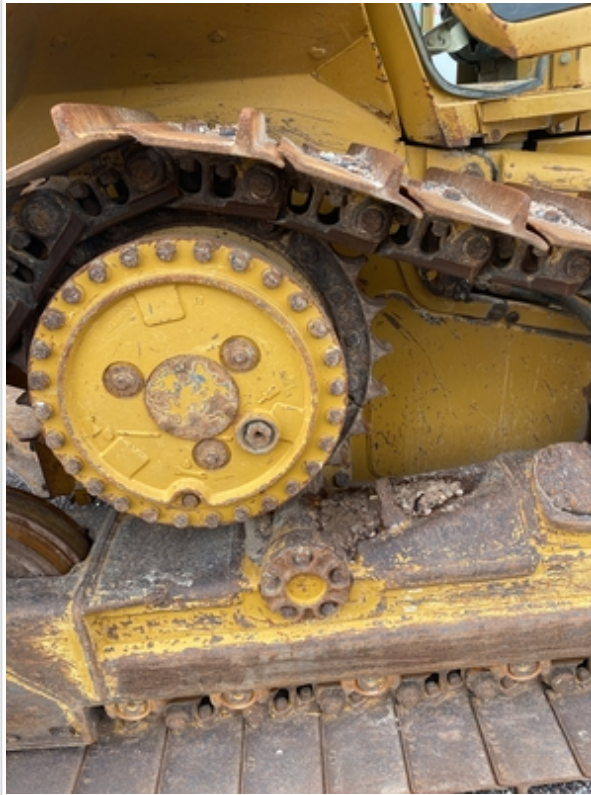
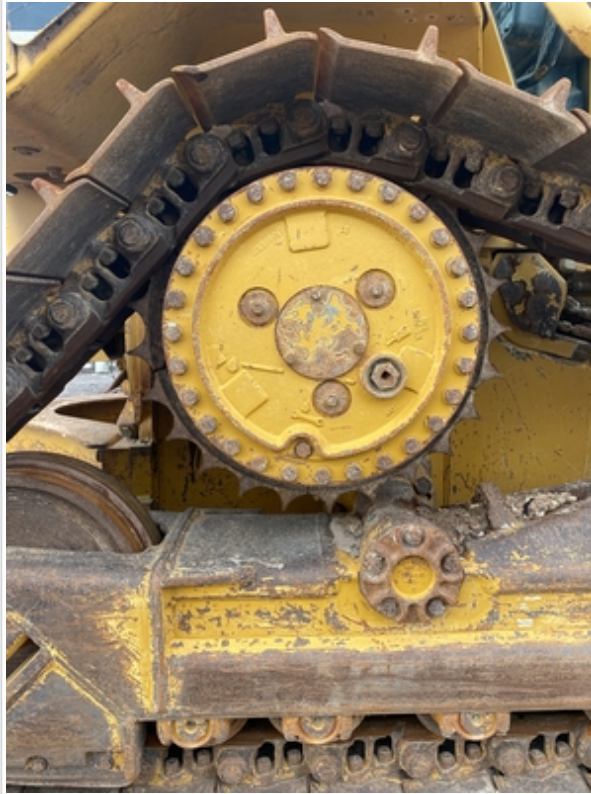
<p><b>Right Side: Link Bushings / Drive Sprocket / Shoe Condition</b></p>	<p>3 - Normal Wear &amp; Tear</p>
<p><b>Comments</b></p>	<p>Bushings can feel wear but probably 50-60% wear left.</p>

Right Side: Upper & Lower Roller / Front Idler Condition	3 - Normal Wear & Tear
Comments	Idlers ok.
Track Condition: Right Front	50%
Track Condition: Right Rear	50%
Undercarriage Right Side Photo Instructions	<p>Take photos of the undercarriage of this piece of equipment.</p> <p>Must have shots to capture:</p> <ul style="list-style-type: none"> <li>- Roller Frame (right)</li> <li>- Track Tensioner (right)</li> <li>- Track Pads (right)</li> <li>- Grouser Height (right)</li> <li>- Track Links (right)</li> <li>- Track Bushings (right)</li> <li>- Carrier Rollers (right)</li> <li>- Track Rollers (right)</li> <li>- Front Idler (right)</li> <li>- Rear Idler (right)</li> <li>- Sprocket (right)</li> </ul>
Undercarriage Right Side Photos
