## Inspection Report (Bulldozer)

Year	2004
Make	Caterpillar
Model	D5N XL
Serial Number	AGG00760
Hour Meter Reading	10032

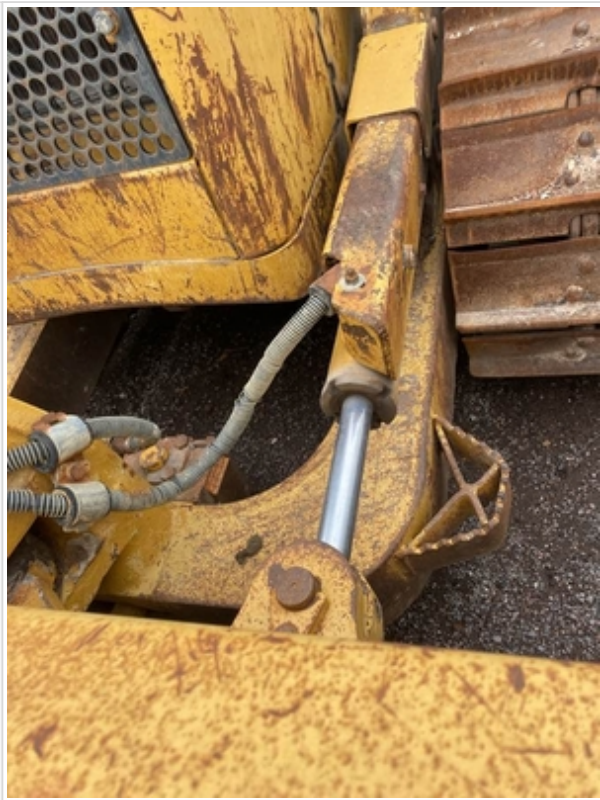
<b>Instructions</b>	<p>Evaluate the following on a 4 point scale (leave comments where an explanation is appropriate):</p> <p>4 = Like New, Recently Replaced          3 = Normal Wear &amp; Tear          2 = Above Average Wear          1 = Service Required</p>
<b>Push Arm / C-Frame Condition</b>	3 - Normal Wear & Tear
<b>Comments</b>	No visible cracks
<b>Push Arm / C-Frame Photos</b>

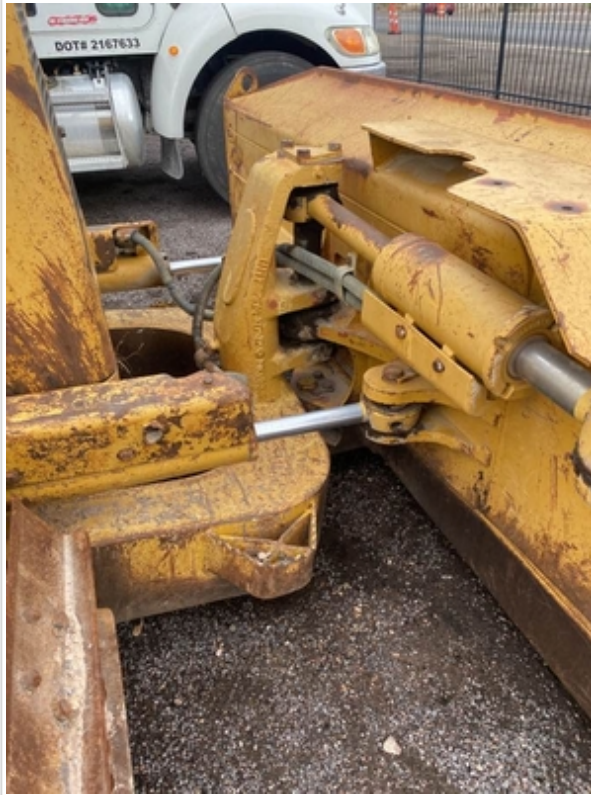
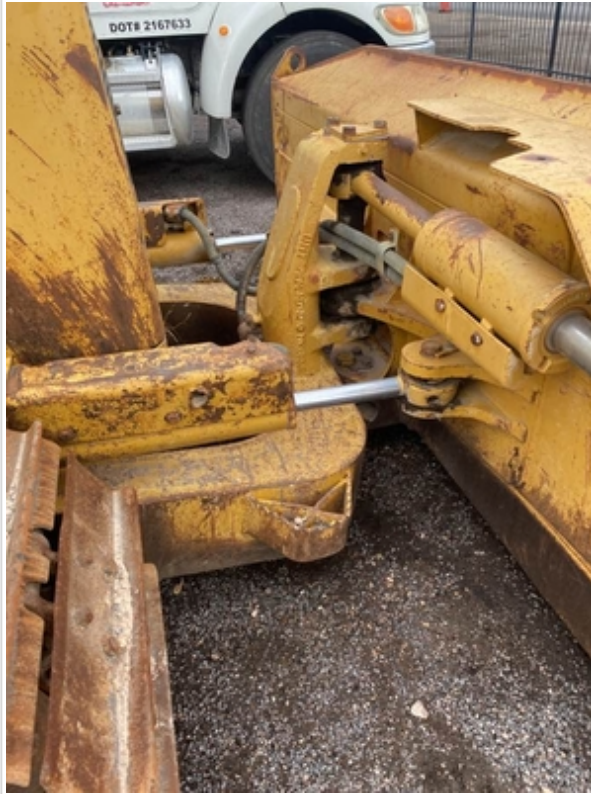
<b>Push Arm Pivot / C-Frame Trunnions Condition</b>	3 - Normal Wear & Tear	
<b>Comments</b>	No appreciable movement. Or cracks	
<b>Push Arm Pivot / C-Frame Trunnions Photos</b>

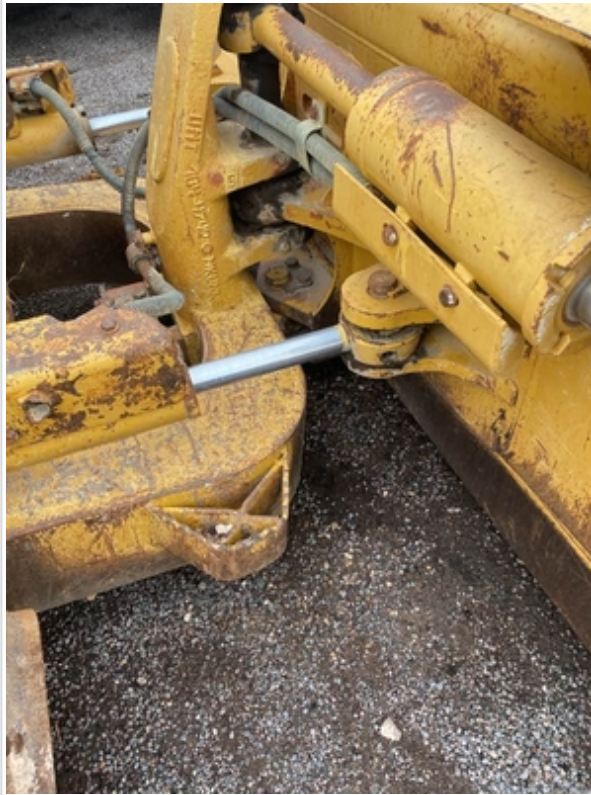
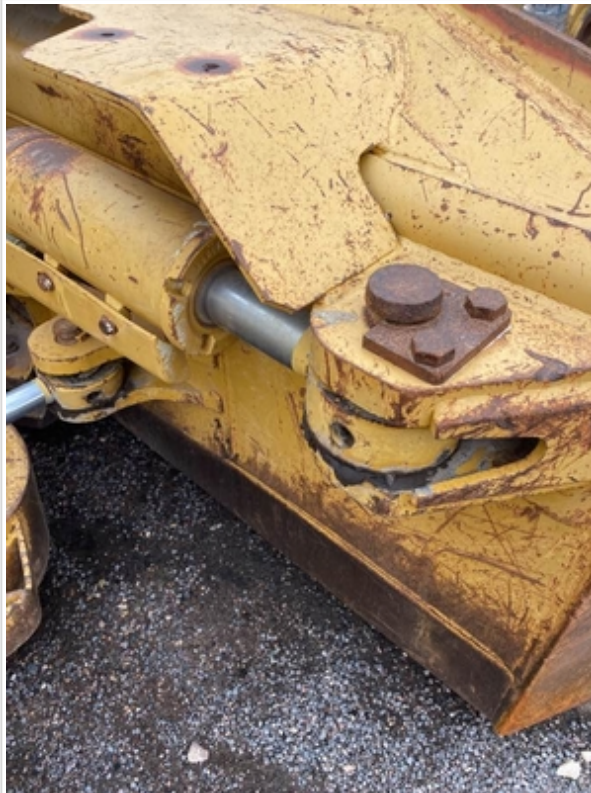
Tilt Linkage Pin & Bushings  
Photos

Tilt Linkage Pin & Bushings	3 - Normal Wear & Tear
Comments	Ok. No excessive movement

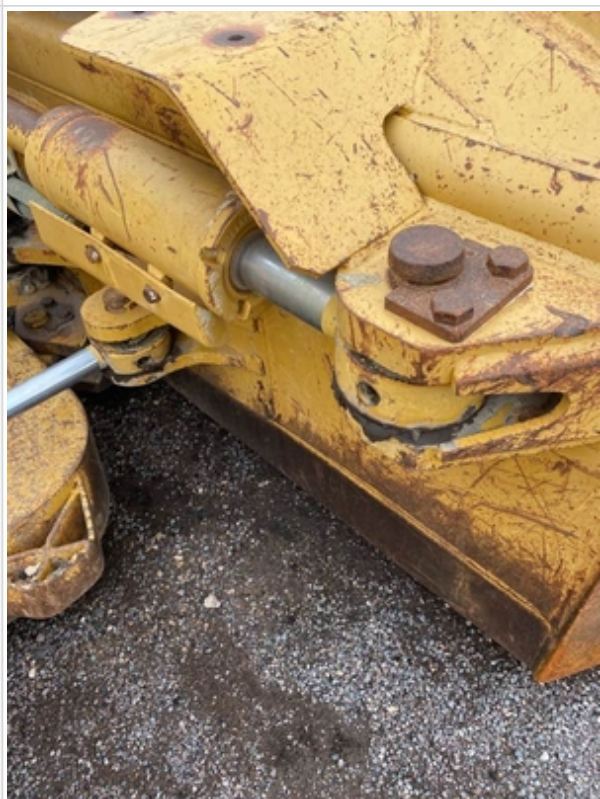
<p><b>Angle Linkage Pin &amp; Bushings</b></p>	<p>3 - Normal Wear &amp; Tear</p>	
<p><b>Comments</b></p>	<p>No excessive movement</p>	
<p><b>Angle Linkage Pin &amp; Bushings Photos</b></p>

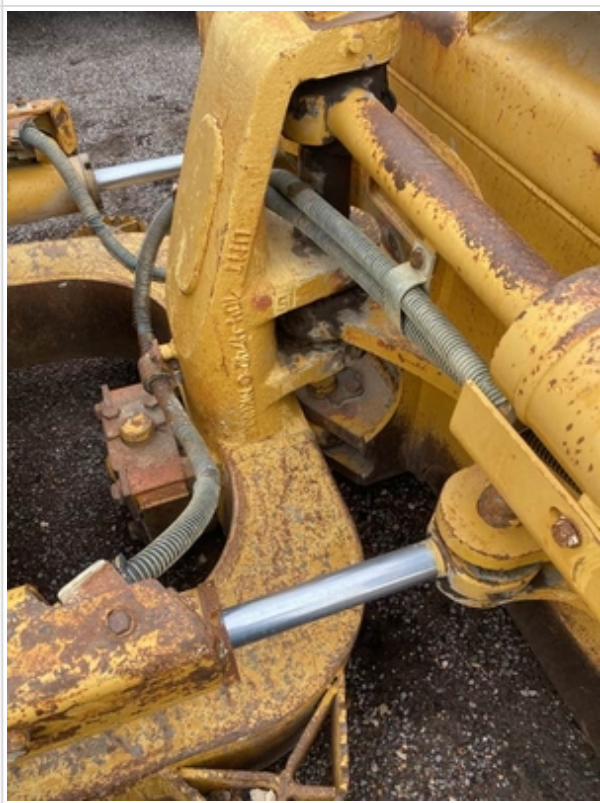
<p><b>Blade Trunnions / Bushings</b></p>	<p>3 - Normal Wear &amp; Tear</p>	
<p><b>Comments</b></p>	<p>Ok. No excessive play or movement</p>	
<p><b>Blade Trunnions / Bushings Photos</b></p>

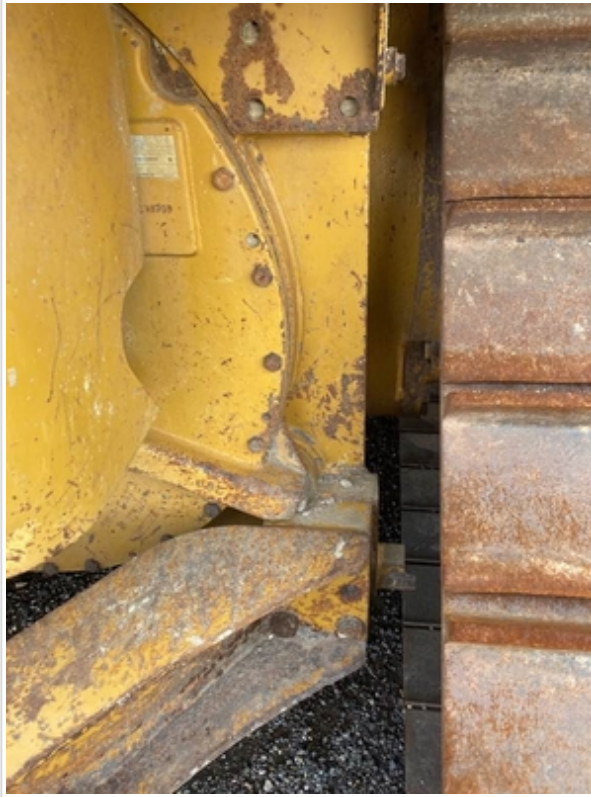
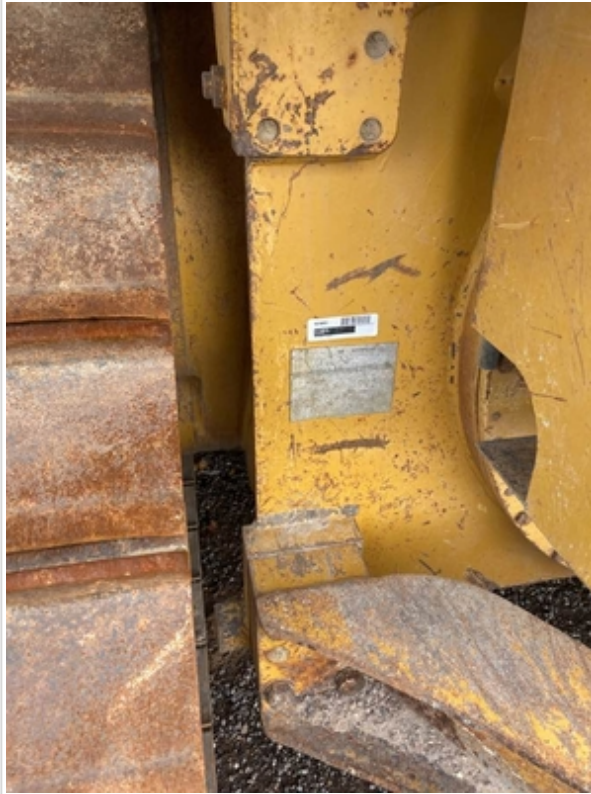
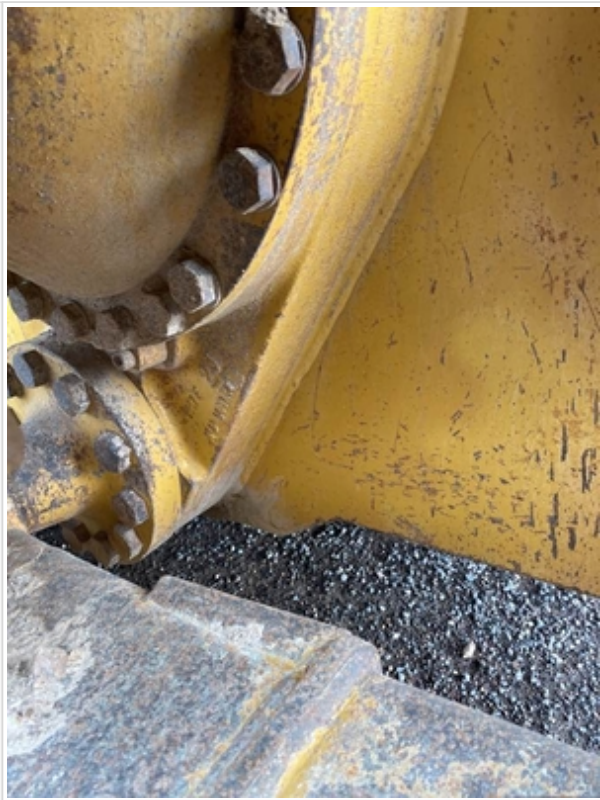
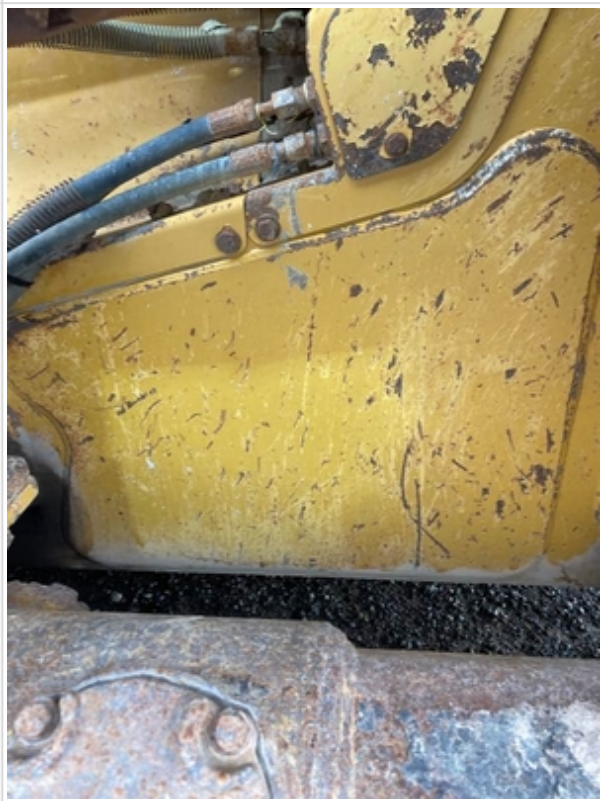
<p><b>Frame Condition</b></p>	<p>3 - Normal Wear &amp; Tear</p>

Comments	Ok. No cracks visible
Frame Photos

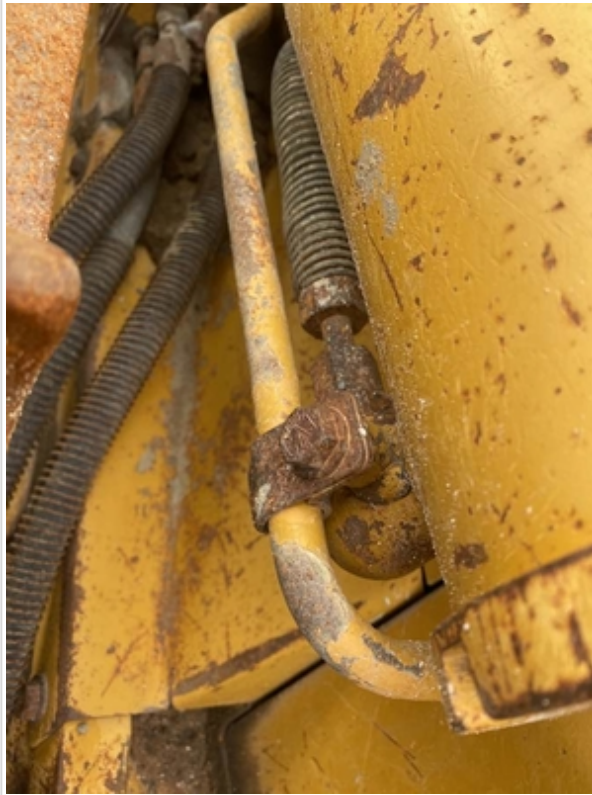
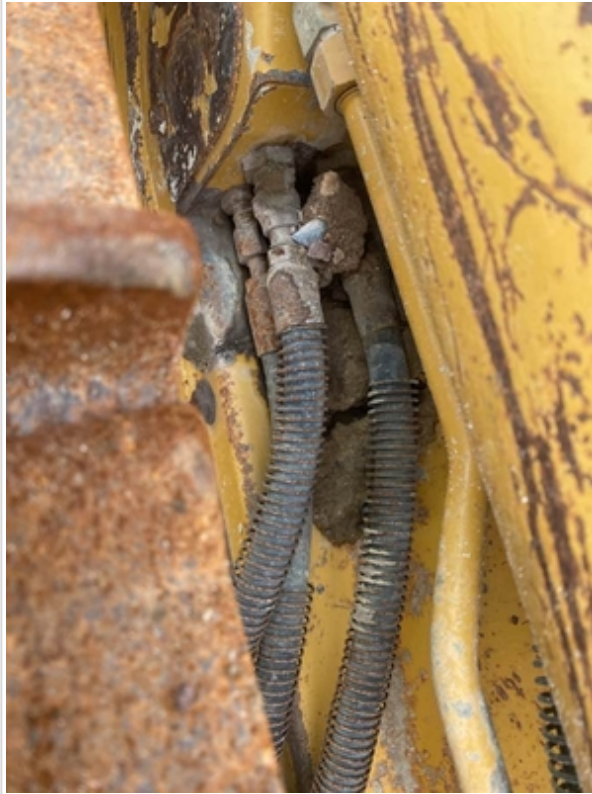
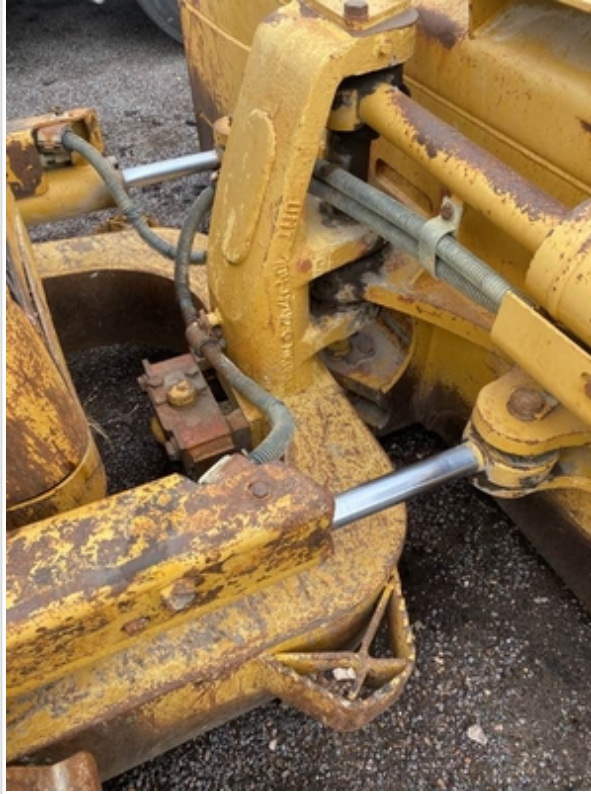
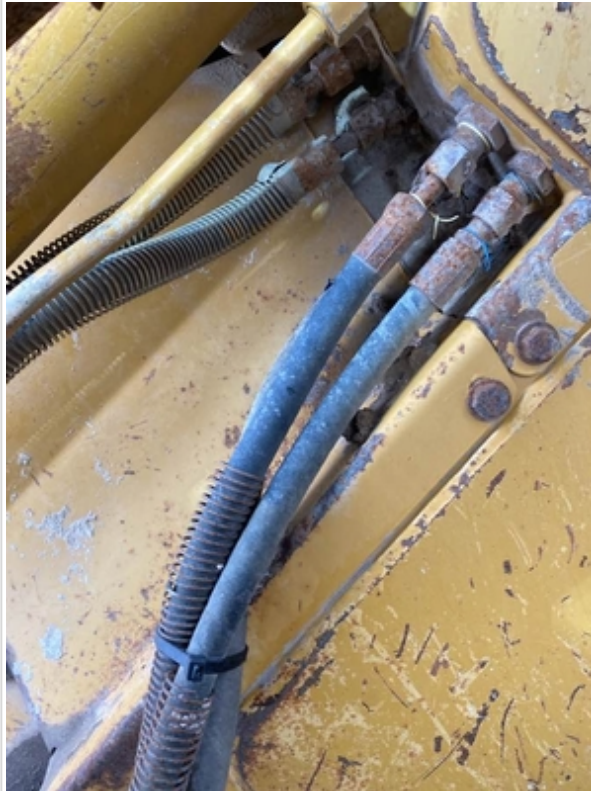
<b>Instructions</b>	<p>Evaluate the following on a 4 point scale (leave comments where an explanation is appropriate):</p> <p>4 = Like New, Recently Replaced  3 = Normal Wear &amp; Tear  2 = Above Average Wear  1 = Service Required</p> <p>Things to look for:  - All hydraulic lines  - All hydraulic cylinders  - All mounting pins  - Leaks  - Wet/damp lines</p> <p>Take close-up photos and leave comments.</p>
<b>Overall Appearance of Hydraulic Lines / Fittings</b>	<p>3</p>
<b>Comments</b>	<p>Ok. Light dust around seals on cylinders. No major leaks</p>
<b>Hydraulic Lines Photos</b>

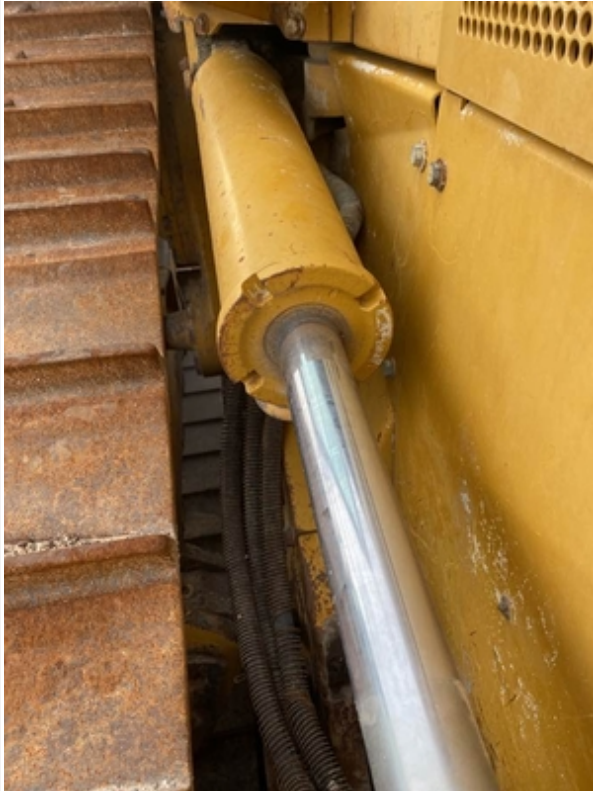
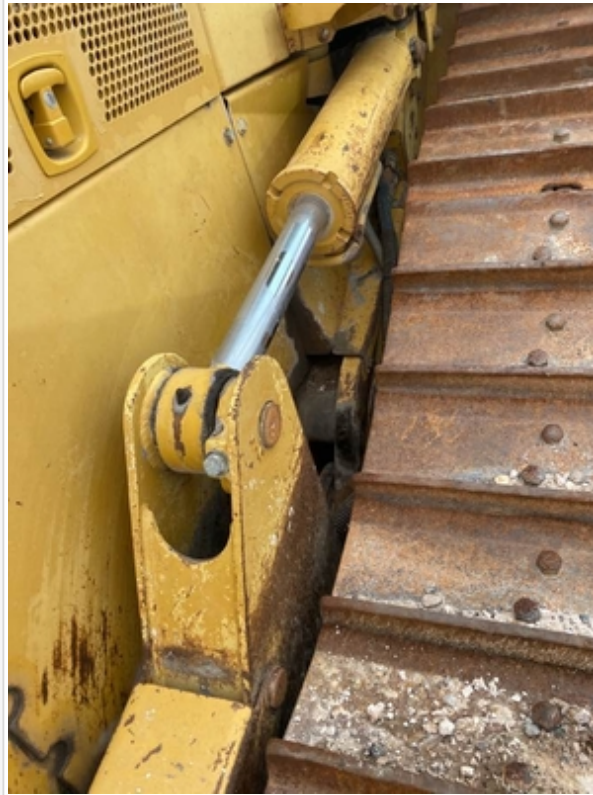
Lift Cylinder Photos

Lift Cylinder	Check the lift cylinder. Note any wear, pitting, discoloration, etc. Take photos.
Lift Cylinder: Mounting Pin	3
Lift Cylinder: Oil Leaks	No

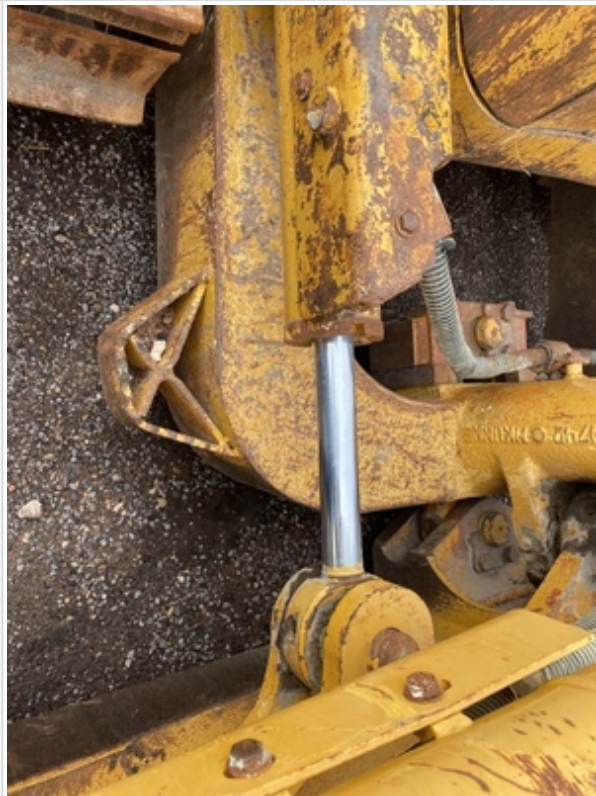
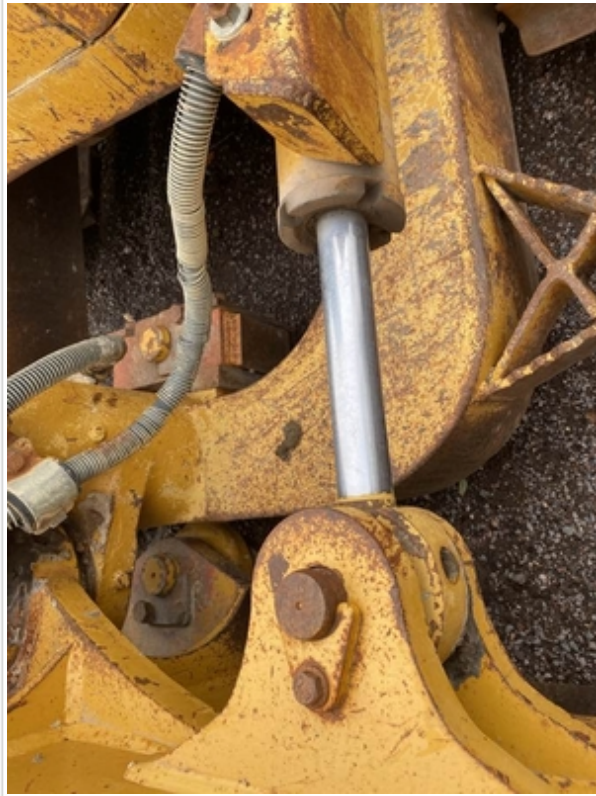
<p>Angle Cylinder Photos</p>

<p><b>Angle Cylinder</b></p>	<p>Check the angle cylinder. Note any wear, pitting, discoloration, etc. Take photos.</p>
<p><b>Angle Cylinder: Mounting Pin</b></p>	<p>3</p>
<p><b>Angle Cylinder: Oil Leaks</b></p>	<p>No</p>
<p><b>Comments</b></p>	<p>No leaks</p>

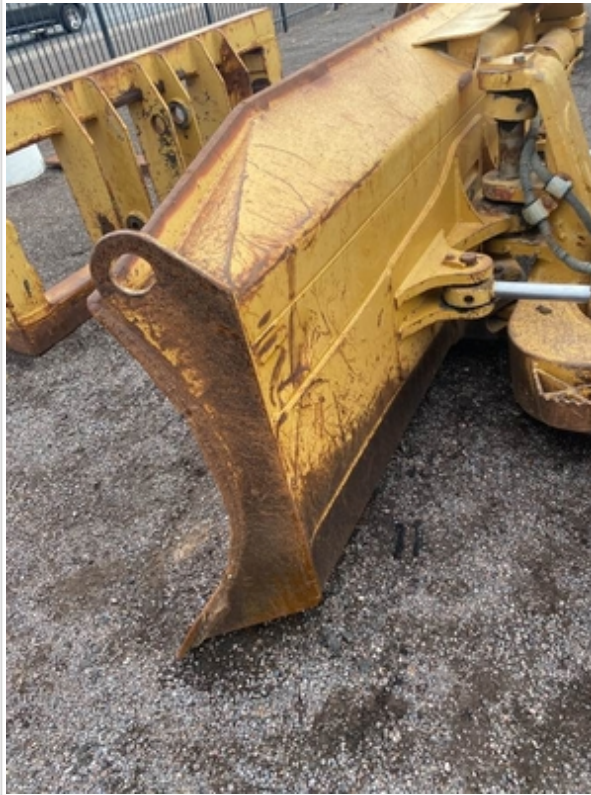
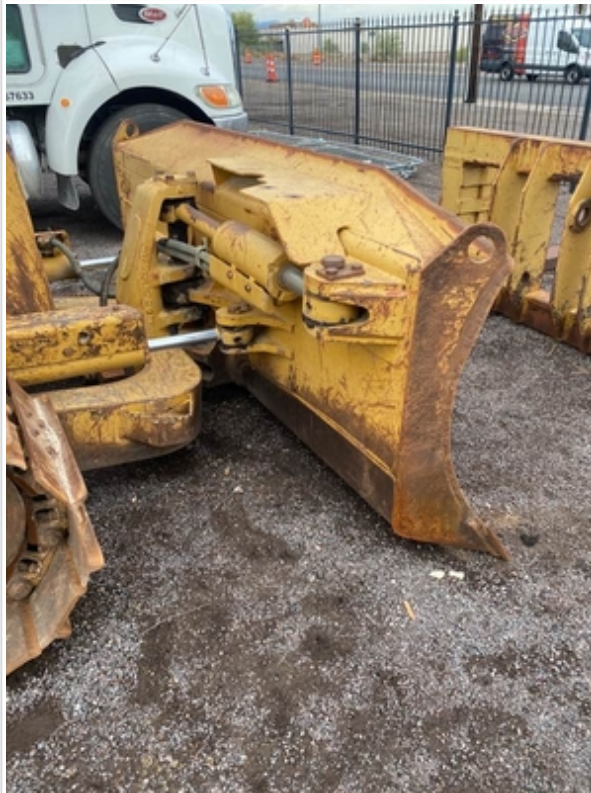
<b>Instructions</b>	<p>Evaluate the following on a 4 point scale (leave comments where an explanation is appropriate):</p> <p>4 = Like New, Recently Replaced          3 = Normal Wear &amp; Tear          2 = Above Average Wear          1 = Service Required</p>
<b>Blade Condition</b>	<p>3 - Normal Wear &amp; Tear</p>
<b>Comments</b>	<p>Normal wear.</p>
<b>Blade Photos</b>

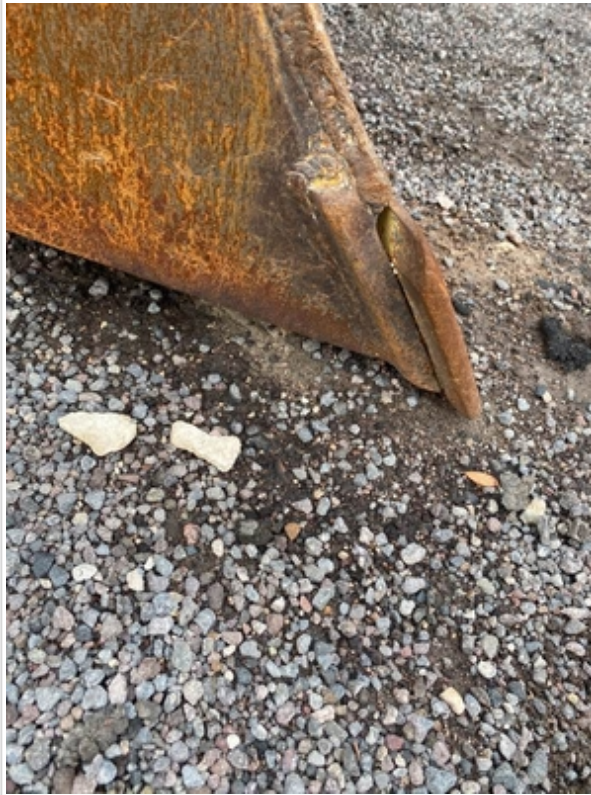
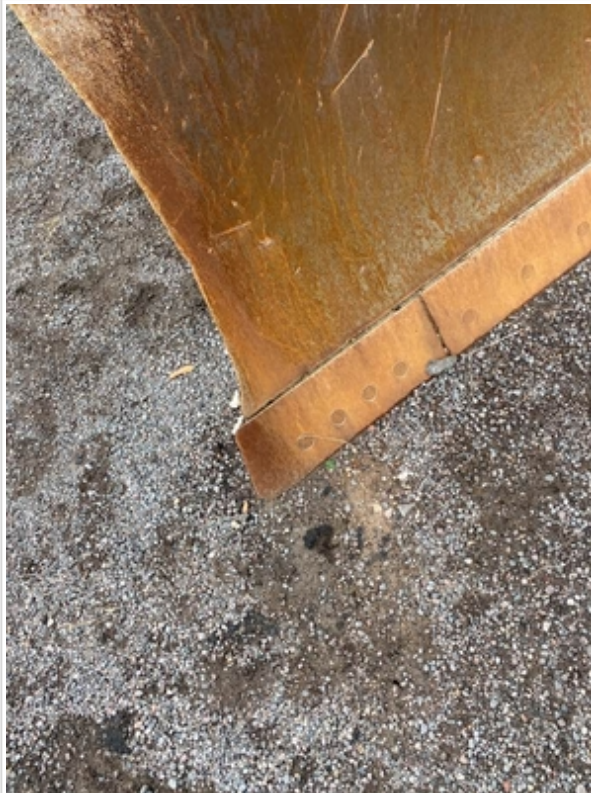
Blade Edge Photos

Blade Edge	3 - Normal Wear & Tear
Comments	Normal wear
