## Inspection Report (Excavator)

Year	2007
Make	Caterpillar
Model	320C
Serial Number	CAT0320CVPAC01289
Hour Meter Reading	7763
Previous Application (e.g., earth moving, mining, demolition, etc)	general construction

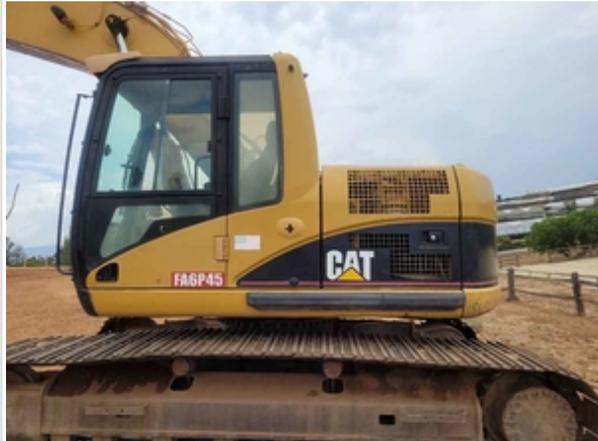
<p><b>Left</b></p>	<p>3 - Normal Wear &amp; Tear</p>
<p><b>Left Condition</b></p>	<p>No visible damage</p>
<p><b>Left Photos</b></p>

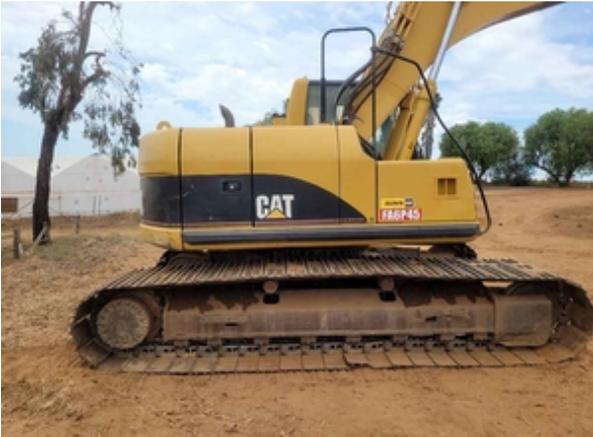
<p><b>Right</b></p>	<p>4 - Like New, Recently Replaced</p>
<p><b>Right Condition</b></p>	<p>No visible damage</p>
<p><b>Right Photos</b></p>

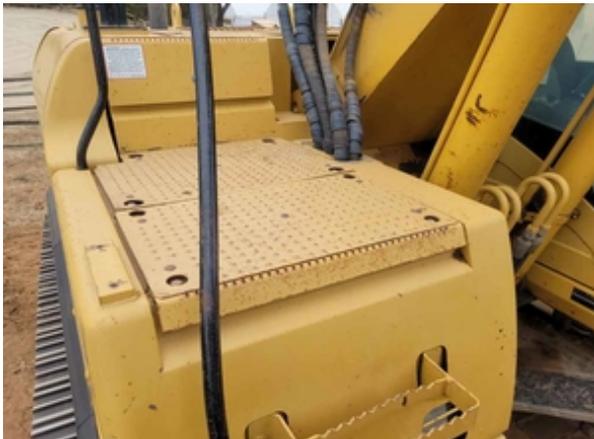
Upper	3 - Normal Wear & Tear	
Upper Condition	No visible damage, Other (see comments)	
Comments	a few seps a bit bent but okay	
Upper Photos

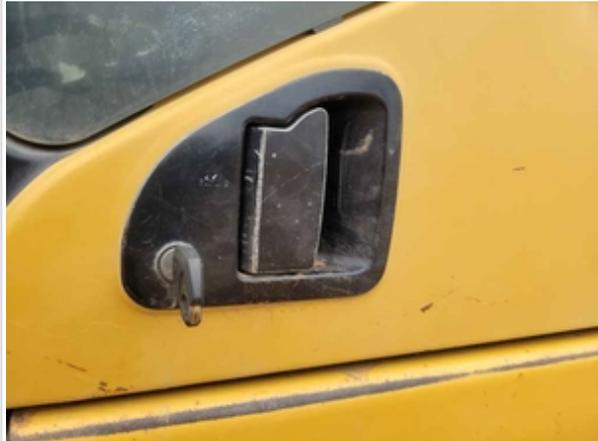
<p><b>Doors / Canopy Latches</b></p>	<p>4 - Like New, Recently Replaced</p>
<p><b>Doors / Canopy Latches Condition</b></p>	<p>No visible damage</p>
<p><b>Doors / Canopy Latches Photos</b></p>

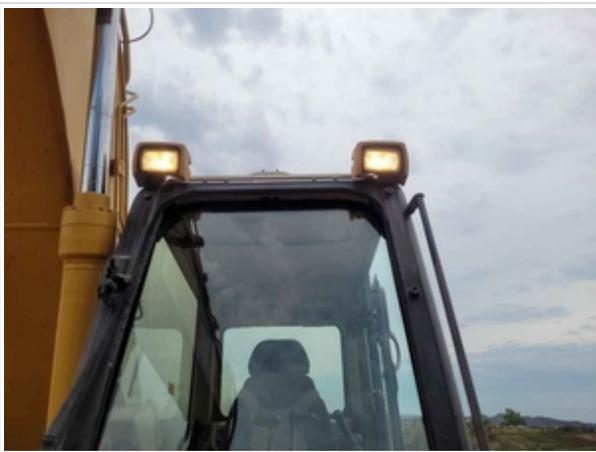
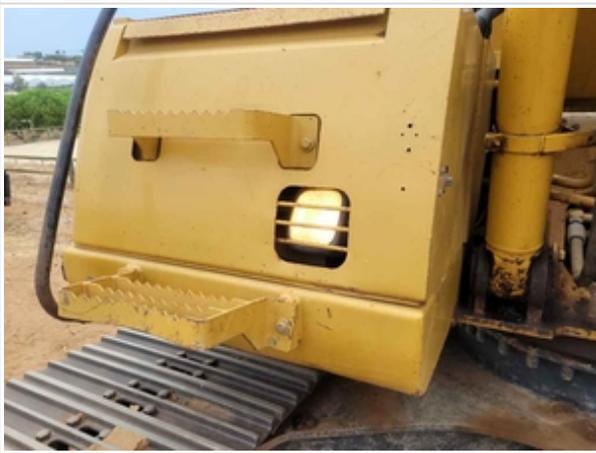
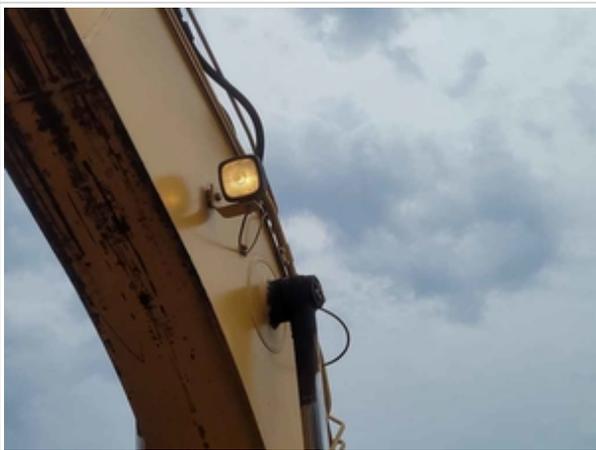
Lighting System Photos

<b>Mirrors</b>	0
<b>Lighting System</b>	3 - Normal Wear & Tear
<b>Lighting System Condition</b>	No visible damage, lighting system is operational

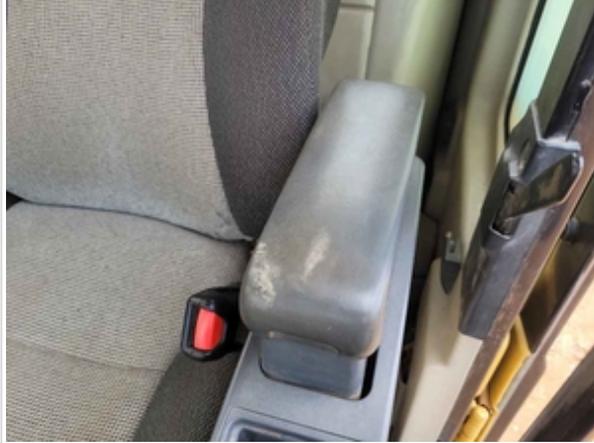
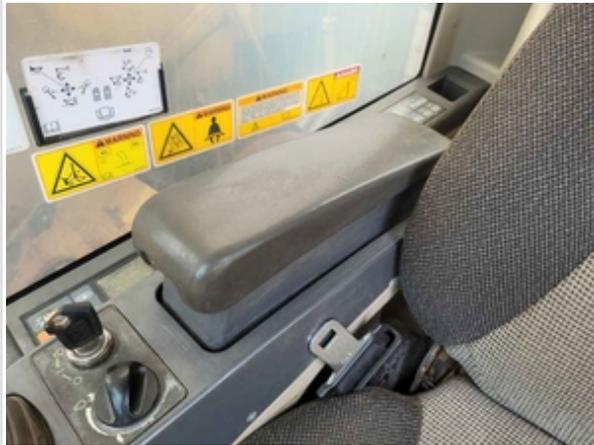
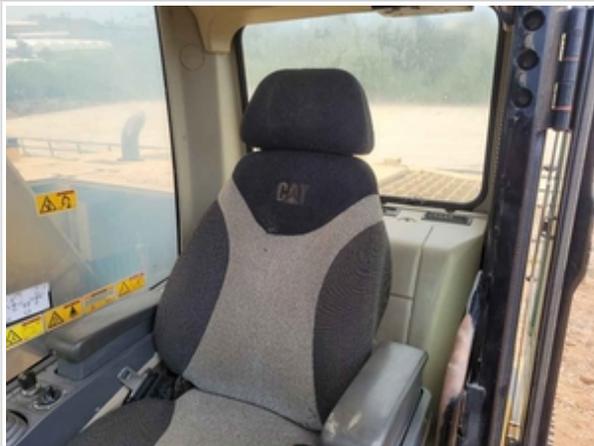
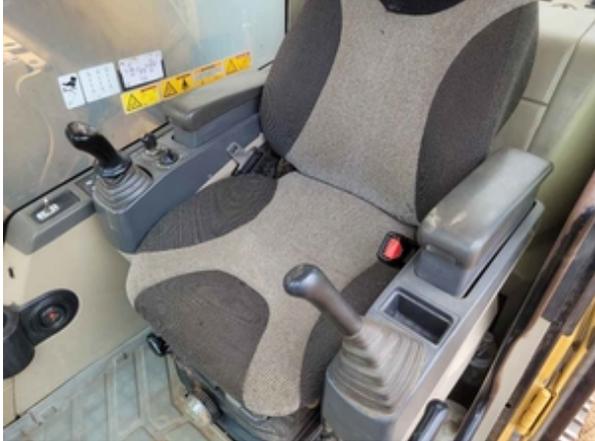
Operator's Seat & Arm Rests  
Photos

<b>Operator's Seat &amp; Arm Rests</b>	3 - Normal Wear & Tear
<b>Operator's Seat &amp; Arm Rests Condition</b>	Seat(s) have minor surface staining or small tears

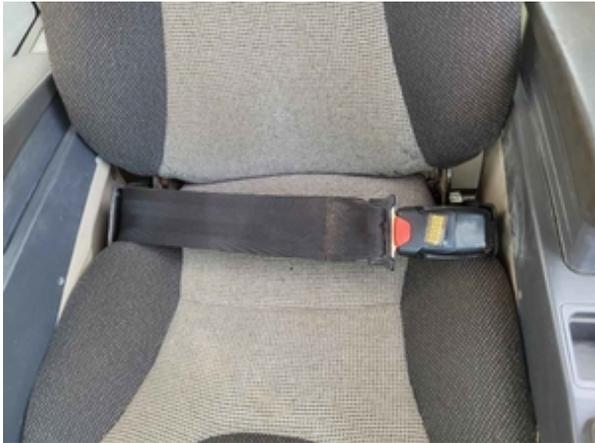
<b>Seat Belt</b>	3 - Normal Wear & Tear
<b>Seat Belt Condition</b>	Seat belt secures properly. Belt is intact and in good condition
<b>Seat Belt Photos</b>

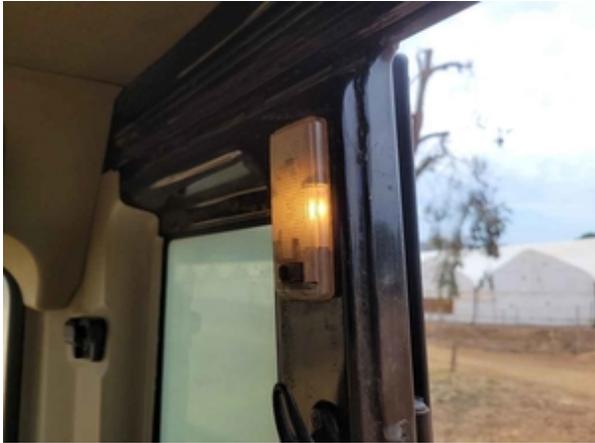
<b>Cabin Lights</b>	3 - Normal Wear & Tear
<b>Cabin Lights Condition</b>	Cabin lights are installed with all light covers in place, bulbs are installed and working properly
<b>Cabin Lights Photos</b>

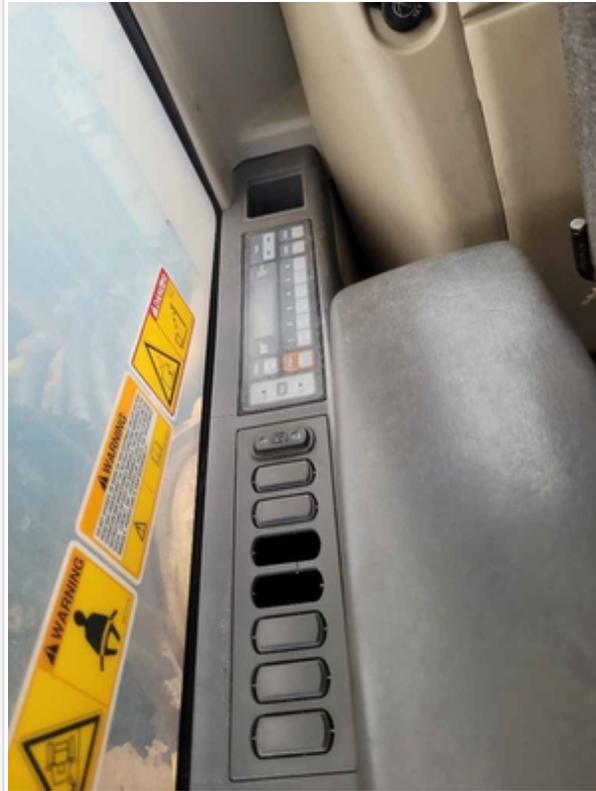
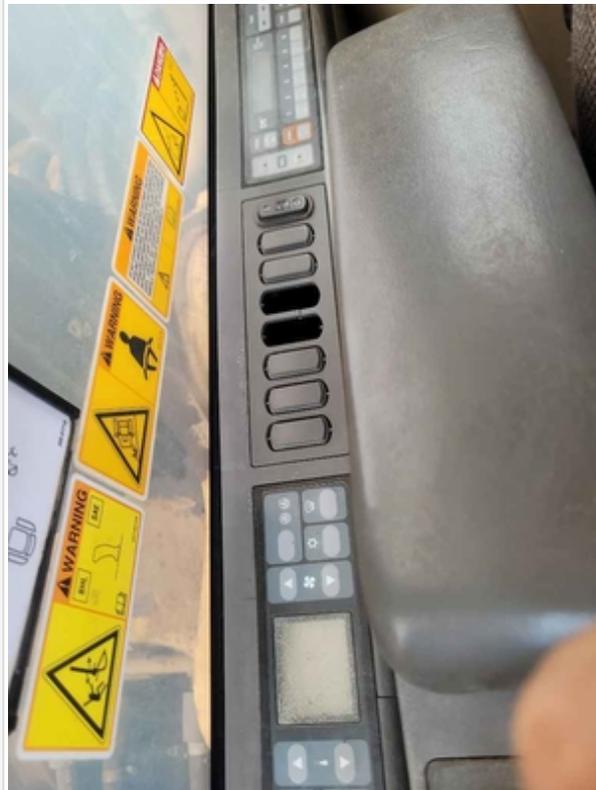
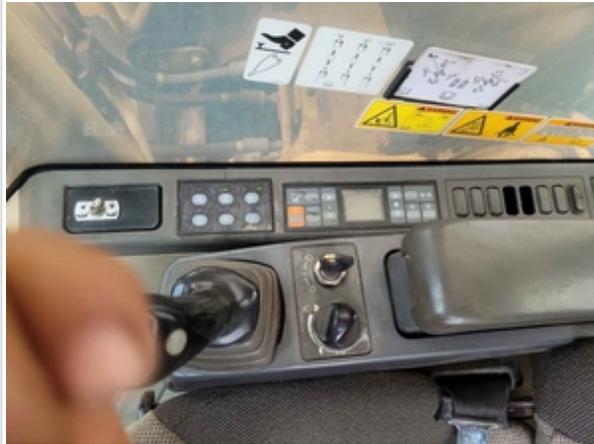
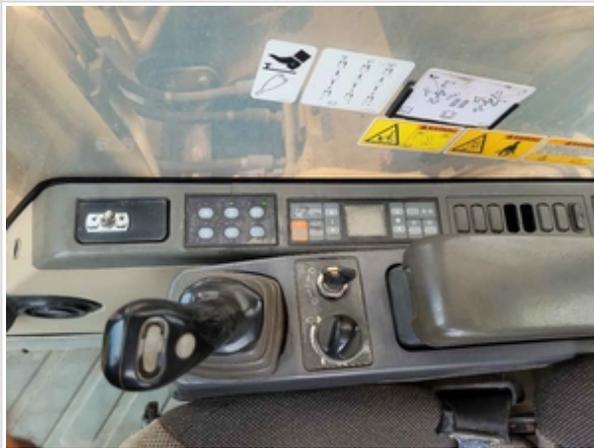
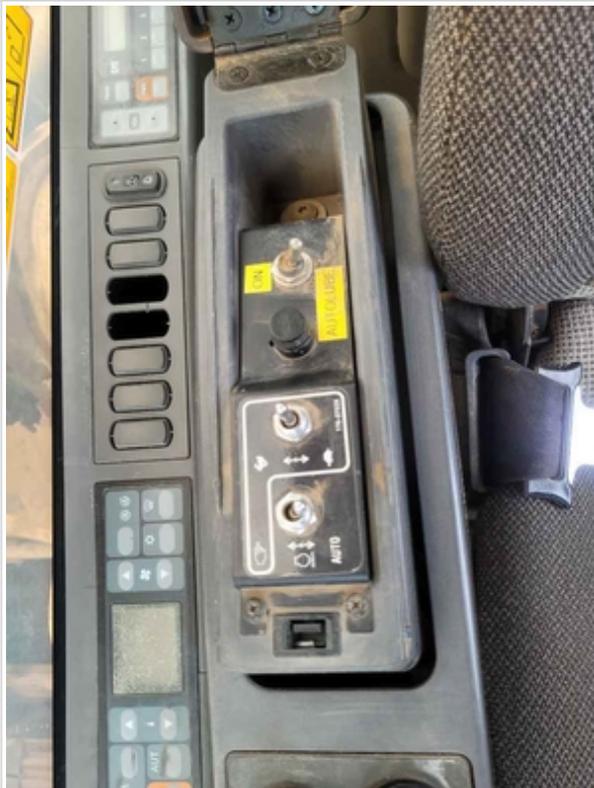
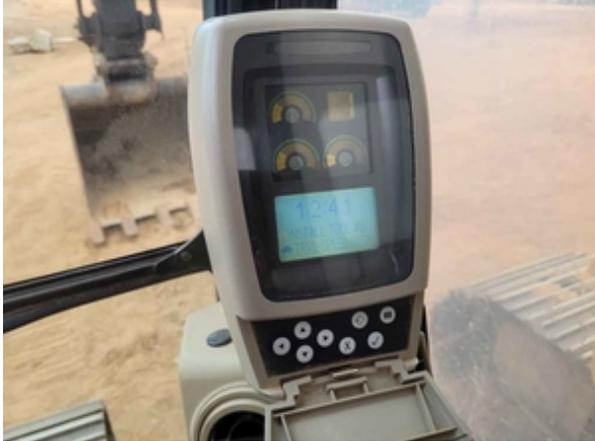
Controls & Switches Photos

<p><b>Controls &amp; Switches</b></p>	<p>4 - Like New, Recently Replaced</p>
<p><b>Controls &amp; Switches Condition</b></p>	<p>All switches are installed and functional</p>

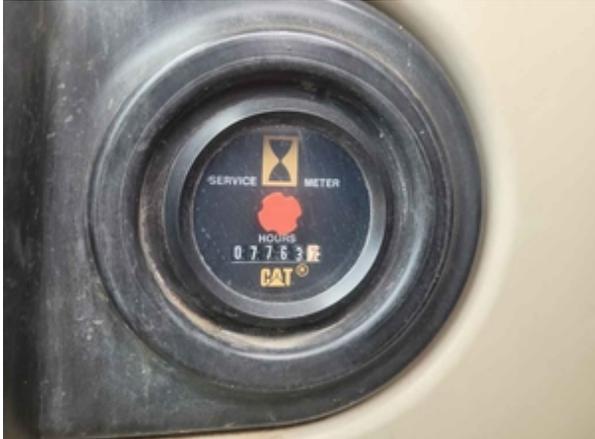
<b>Hour Meter Activity</b>	4 - Like New, Recently Replaced
<b>Hour Meter Condition</b>	Hour meter is functional and in good condition
<b>Hour Meter Activity Photos</b>

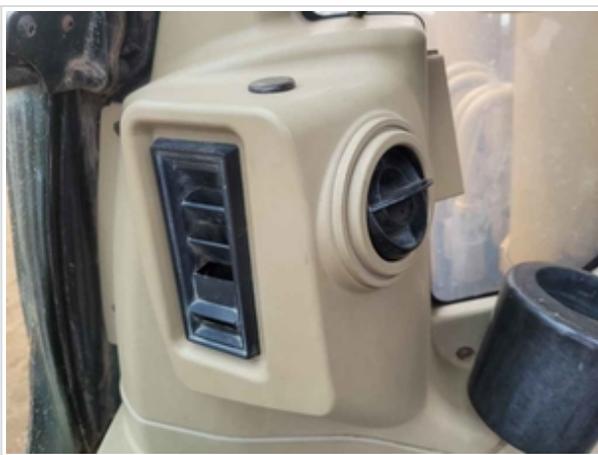
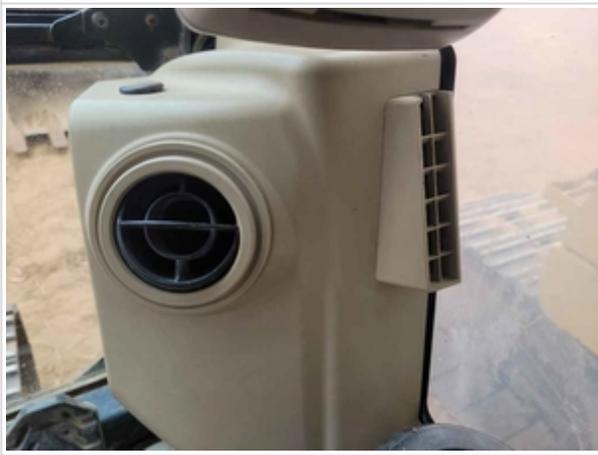
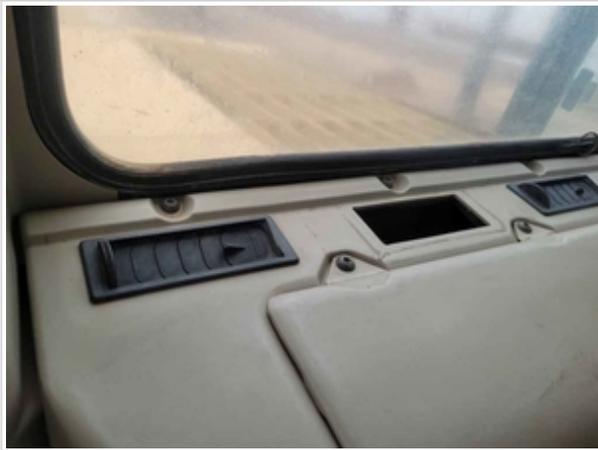
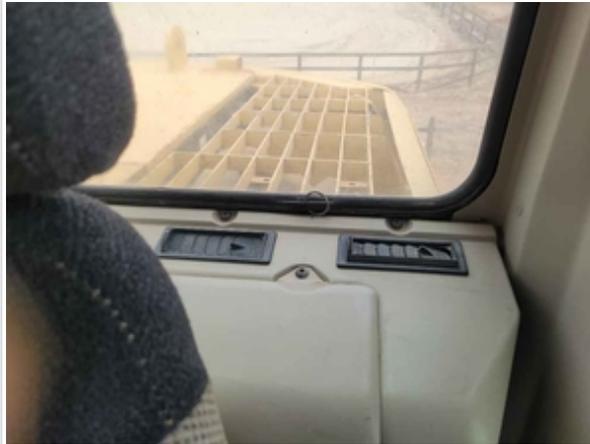
<p>Fans / Vents Photos</p>

<b>Other Gauge Activity</b>	4 - Like New, Recently Replaced
<b>Other Gauge Condition</b>	All cockpit gauges are functional and in good condition
<b>Heater &amp; A/C</b>	3 - Normal Wear & Tear
<b>Heater &amp; A/C Condition</b>	Other (see comments)
<b>Comments</b>	heater ok, ac working but not at full potential
<b>Fans / Vents</b>	3 - Normal Wear & Tear
<b>Fans / Vents Condition</b>	Fan vents are functional, in good condition, and move through a full adjustable range of motion

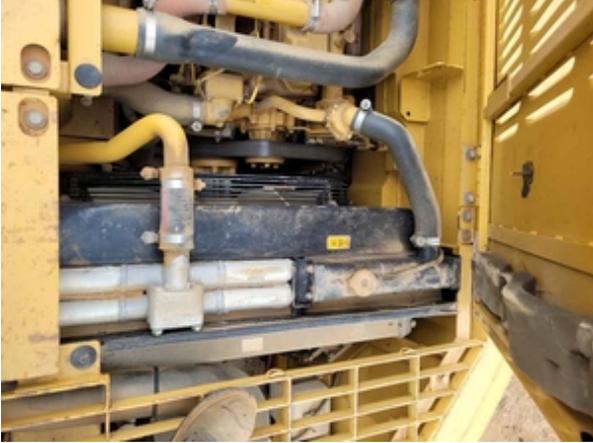
<b>Radiator Photos</b>

<b>Blow-by (Visual Observation Check)</b>	No	
<b>Unusual Noises (Upon Start-up, Idle, Shutdown)</b>	No	
<b>Unusual Noise Notes</b>	No unusual noises heard	
<b>Engine Smoke (Upon Start-up, Idle, Shutdown)</b>	No	
<b>Engine Smoke Notes</b>	No engine smoke issues observed	
<b>Engine Exhaust Color</b>	Clear	
<b>Battery</b>	3 - Normal Wear & Tear	
<b>Battery Condition</b>	Clean & dry appearance, tight connections, Other (see comments)	
<b>Comments</b>	machine started right up after sitting for a week	
<b>Radiator</b>	3 - Normal Wear & Tear	
<b>Radiator Condition</b>	Radiator fins & components appear to be in good working order, no signs of damage or leaks

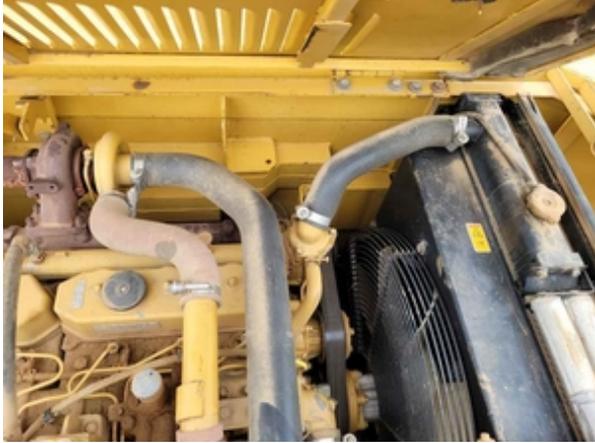
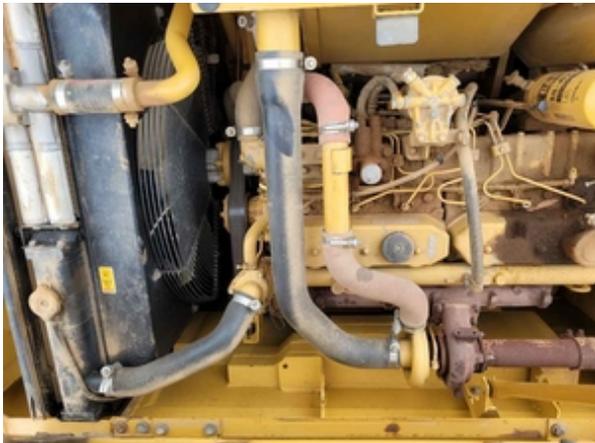
Hose Photos

<b>Hoses</b>	3 - Normal Wear & Tear
<b>Hose Condition</b>	Firm, pliant hoses with no signs of wear or leaks

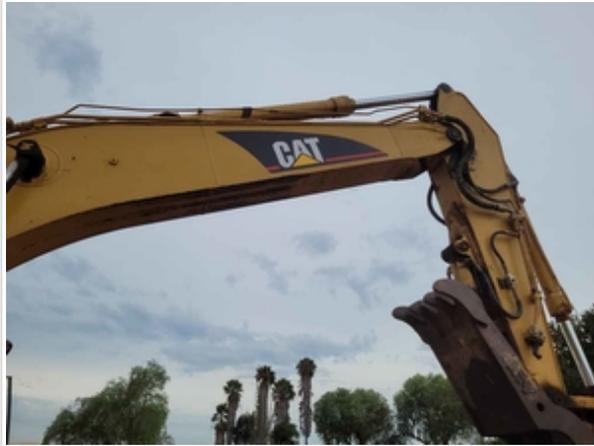
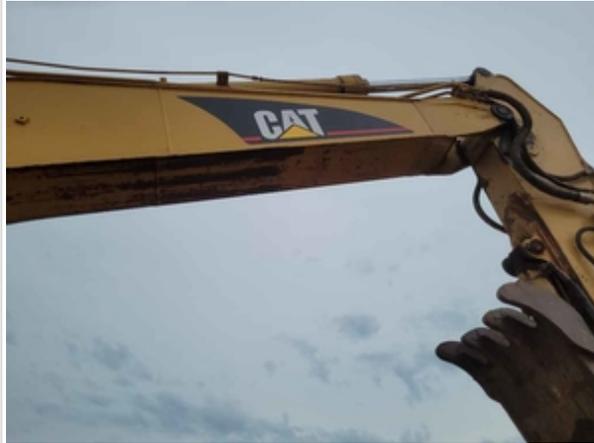
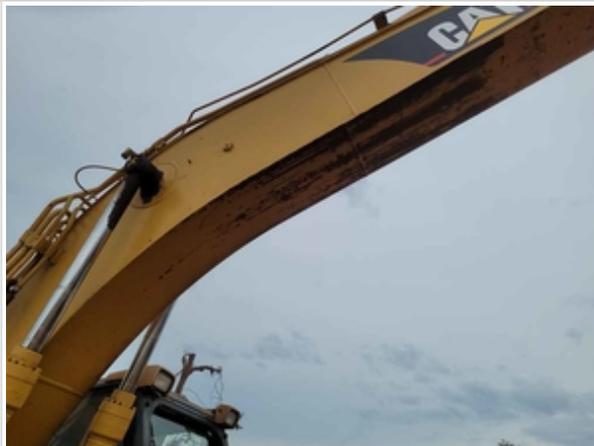
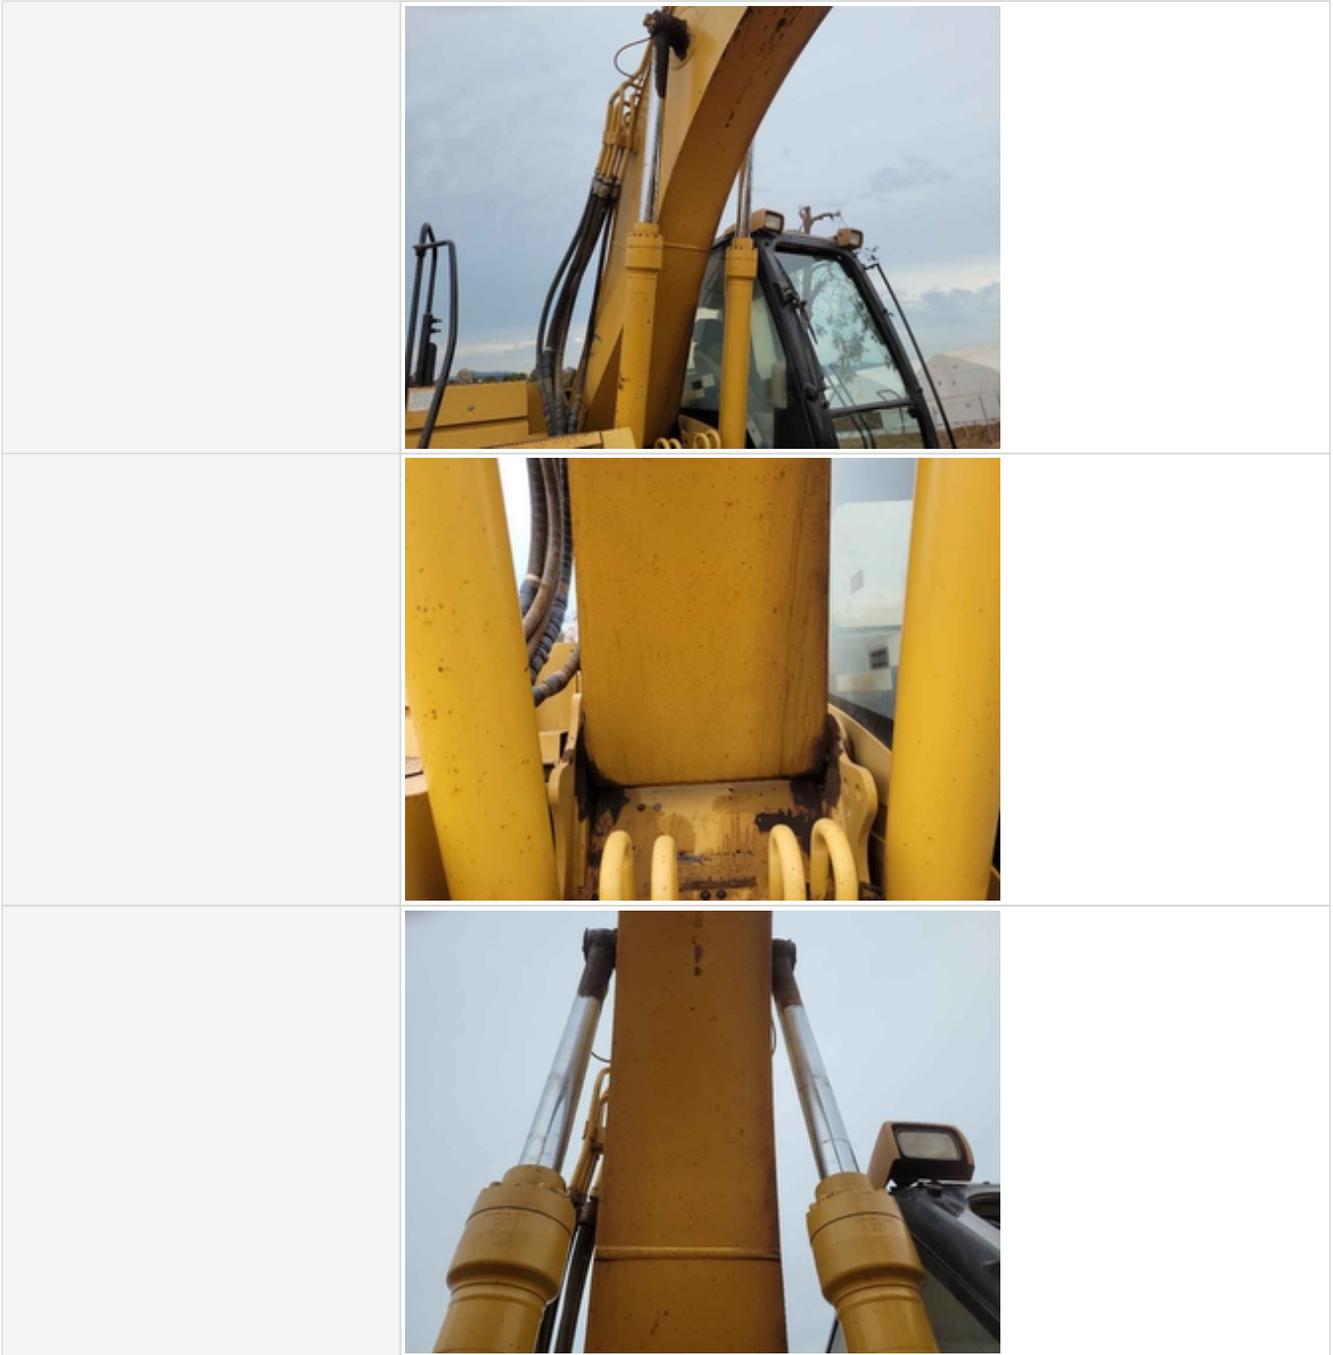
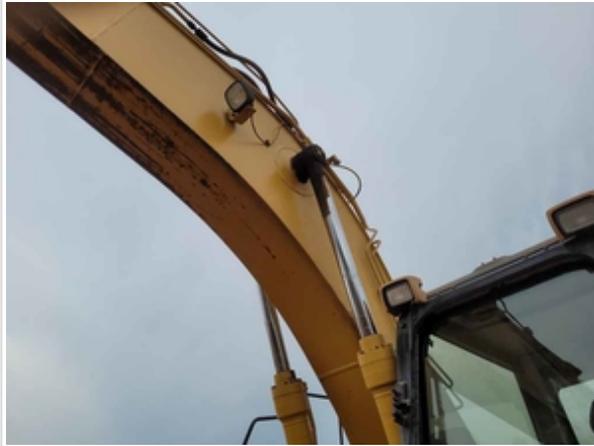
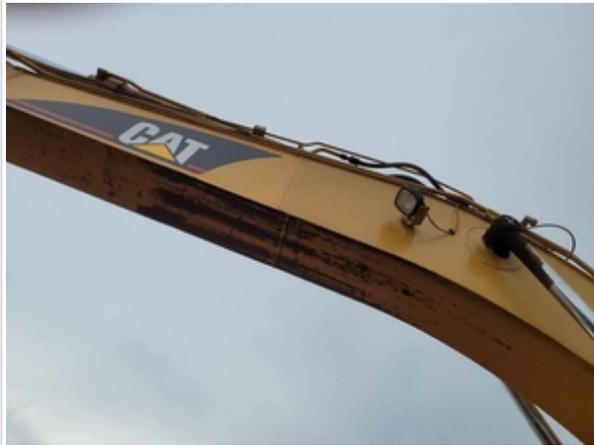
Instructions	<p>Evaluate the following on a 4 point scale (leave comments where an explanation is appropriate):</p> <p>4 = Like New, Recently Replaced  3 = Normal Wear &amp; Tear  2 = Above Average Wear  1 = Service Required</p>
Boom Condition	4 - Like New, Recently Replaced
Boom Photos

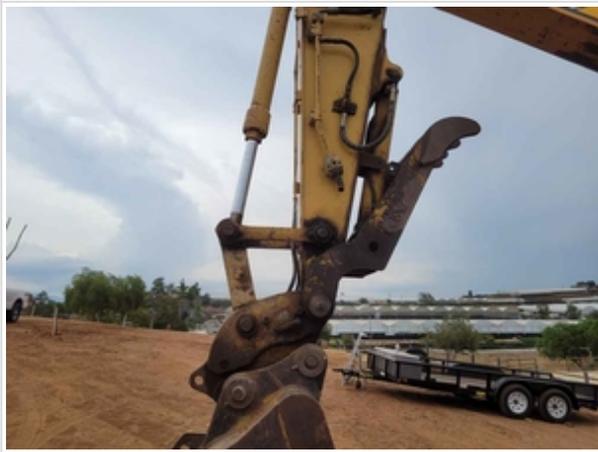
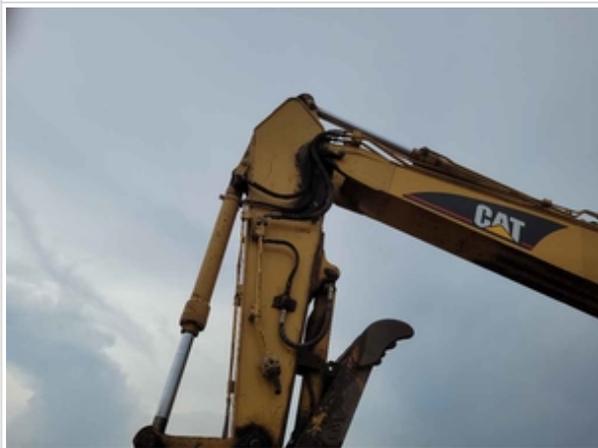
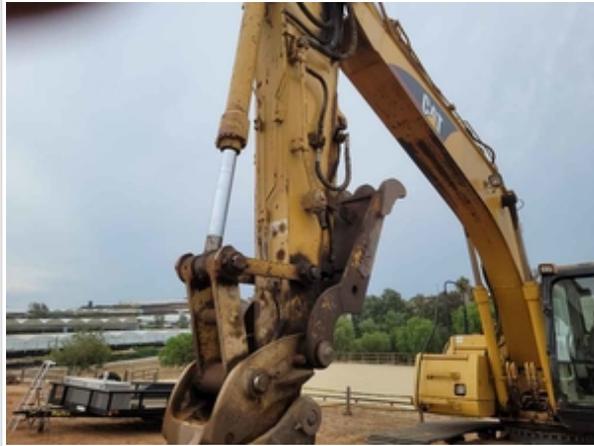
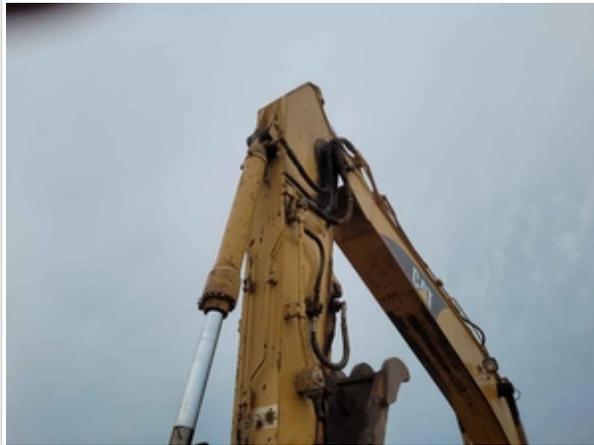
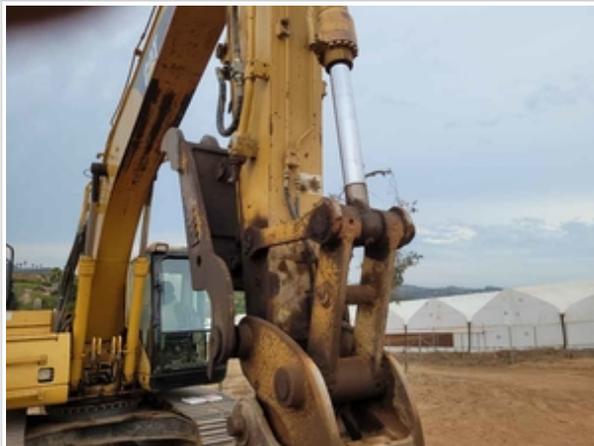
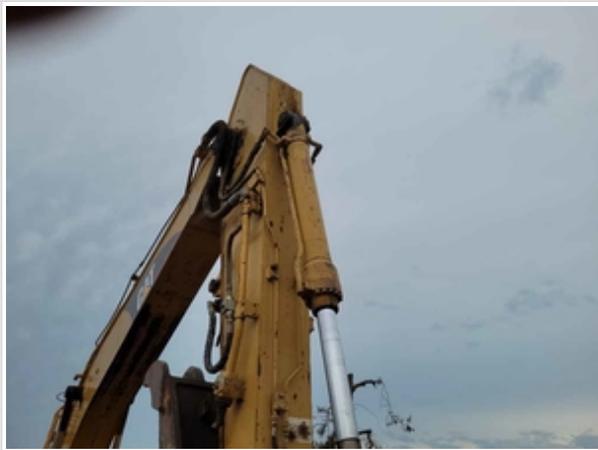
<b>Stick Condition</b>	4 - Like New, Recently Replaced	
<b>Stick Photos</b>

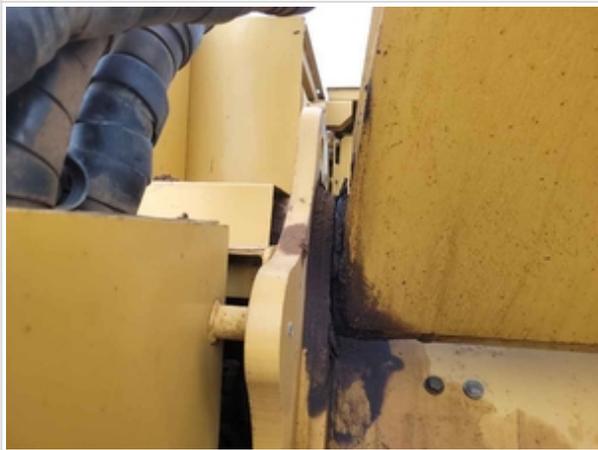
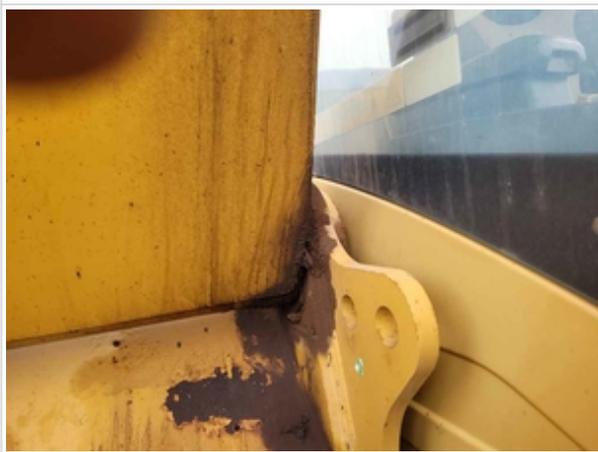
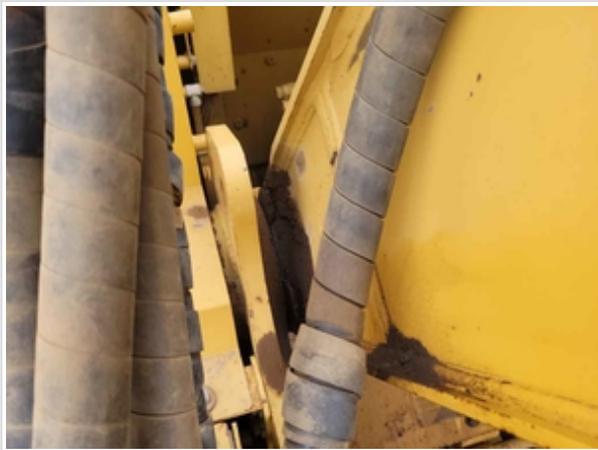
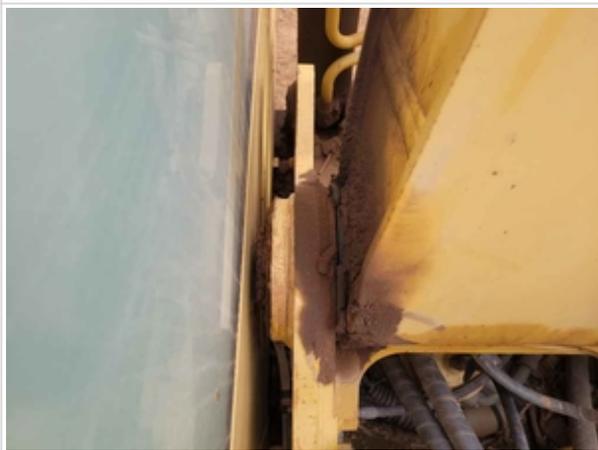
<p><b>Boom Base Pin &amp; Bushings</b></p>	<p>3 - Normal Wear &amp; Tear</p>
<p><b>Boom Base Pin &amp; Bushings Photos</b></p>

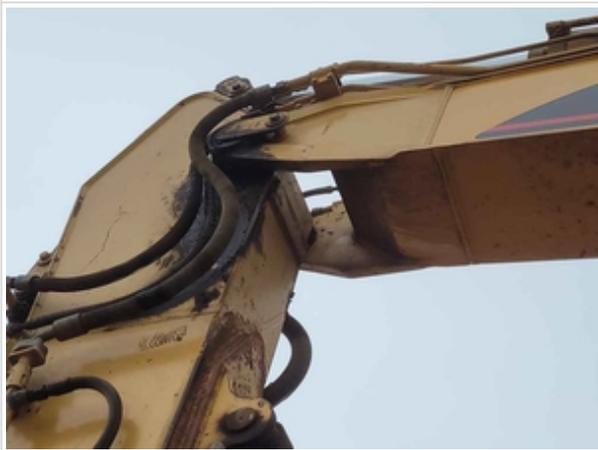
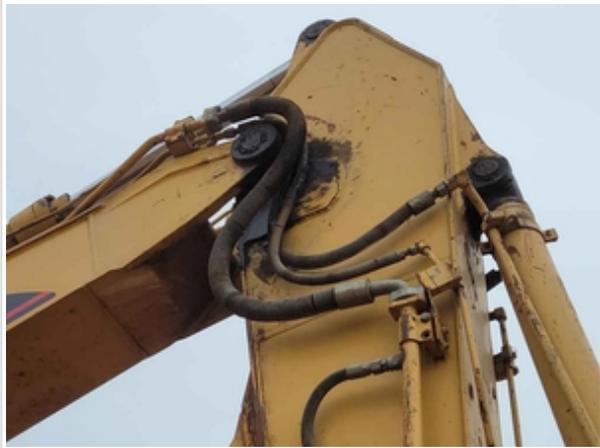
<p><b>Boom to Stick Pin &amp; Bushings</b></p>	<p>3 - Normal Wear &amp; Tear</p>	
<p><b>Boom to Stick Pin &amp; Bushings Photos</b></p>

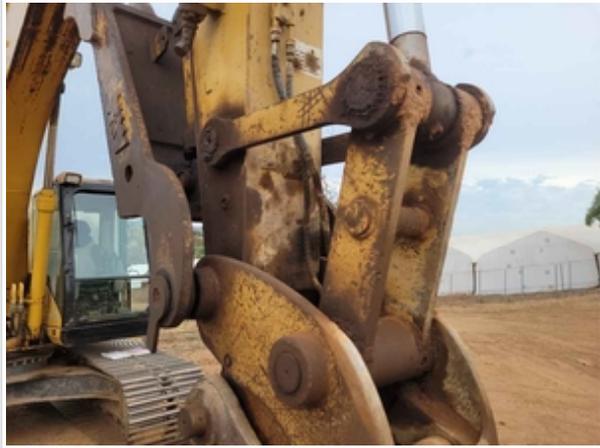
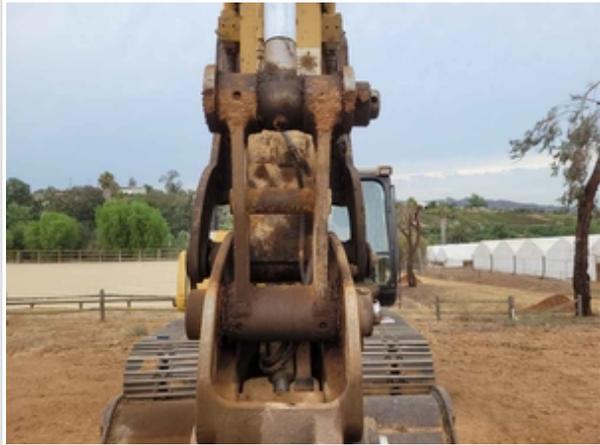
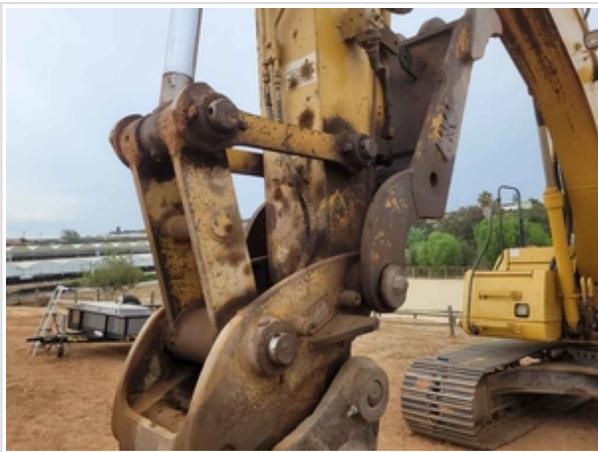
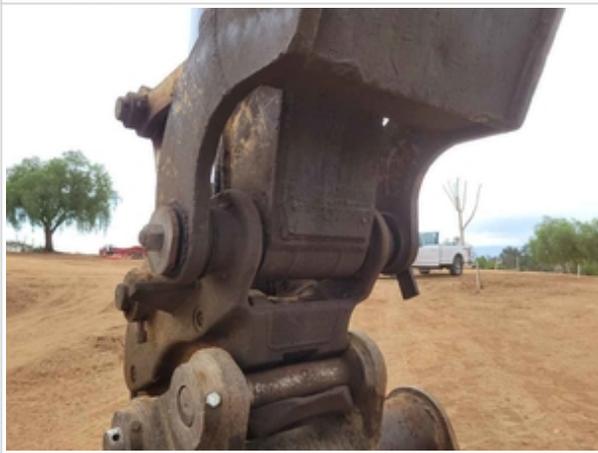
<p>Stick to Bucket Pin &amp; Bushings</p>	<p>3 - Normal Wear &amp; Tear</p>	
<p>Stick to Bucket Pin &amp; Bushings Photos</p>

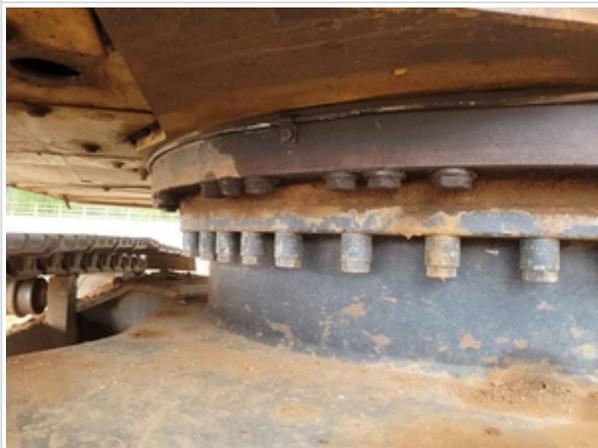
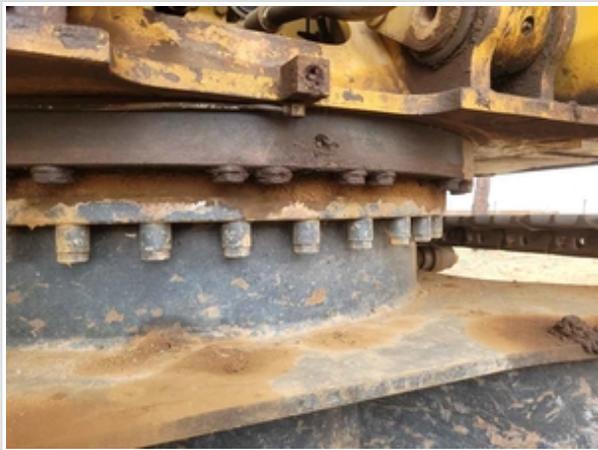
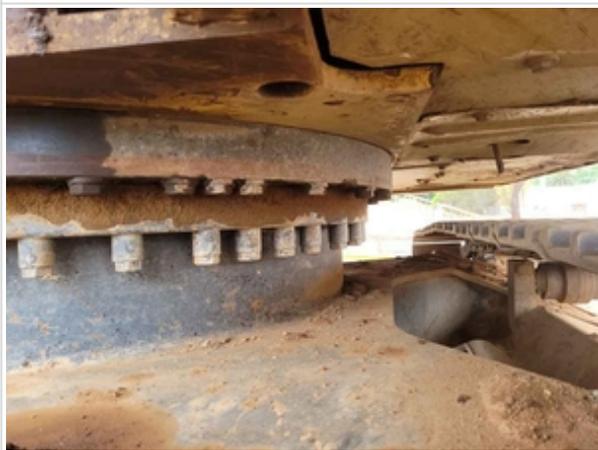
<p><b>Turntable Bearing</b></p>	<p>3 - Normal Wear &amp; Tear</p>
<p><b>Turntable Bearing Photos</b></p>

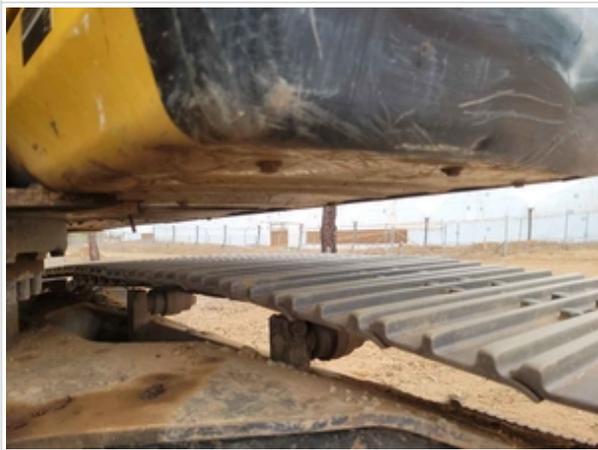
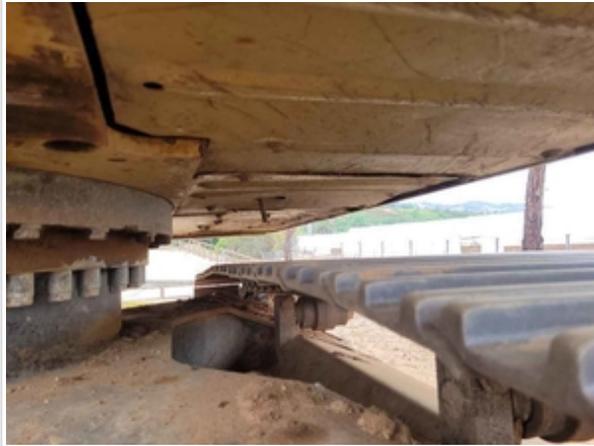
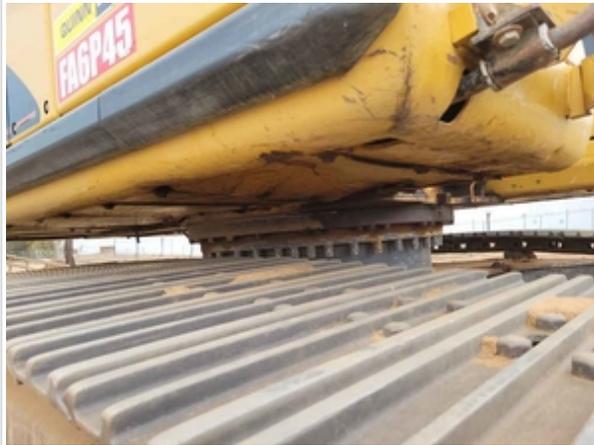
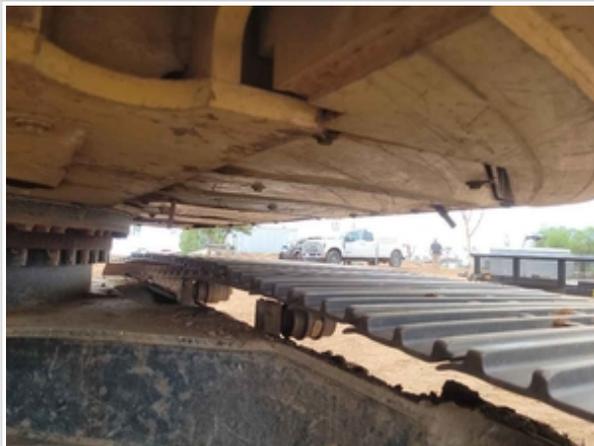
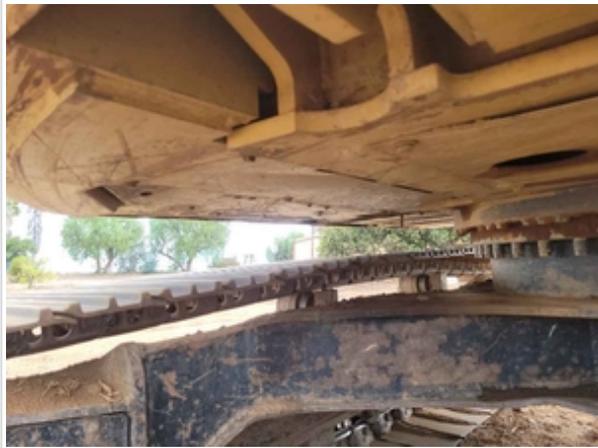
<p><b>Bottom Covers</b></p>	<p>3 - Normal Wear &amp; Tear</p>	
<p><b>Bottom Covers Photos</b></p>
