## Inspection Report (Excavator)

Year	2007
Make	Caterpillar
Model	320C
Serial Number	CAT0320CVPAC01289
Hour Meter Reading	7763
Previous Application (e.g., earth moving, mining, demolition, etc)	general construction

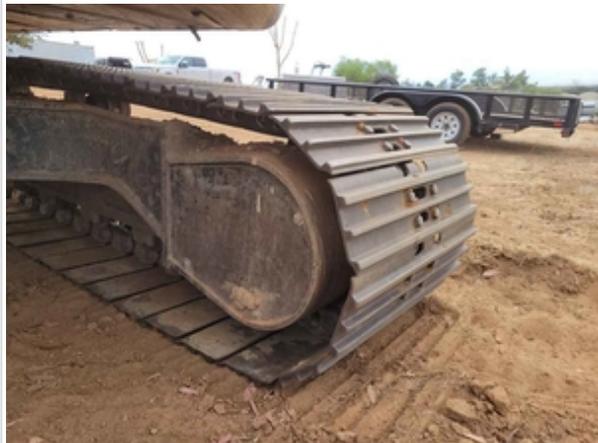
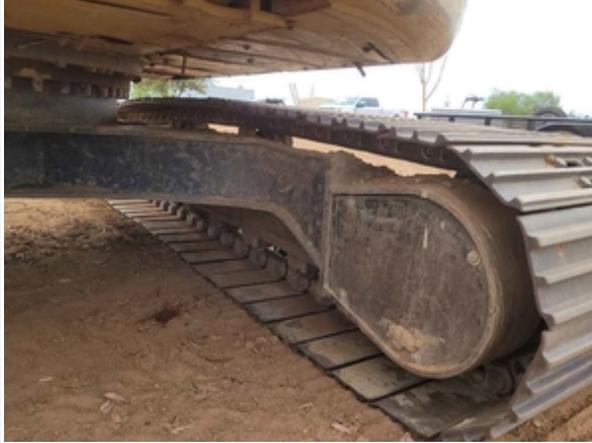
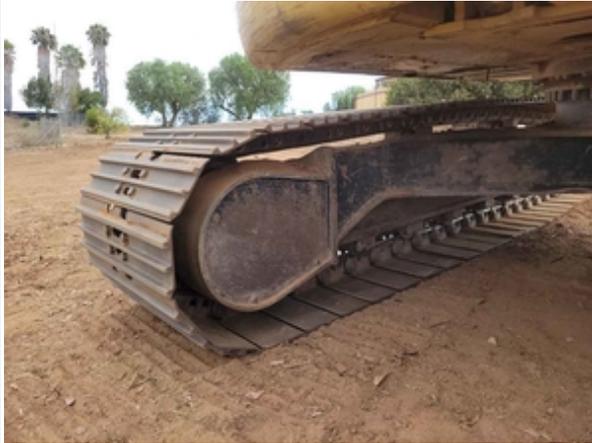
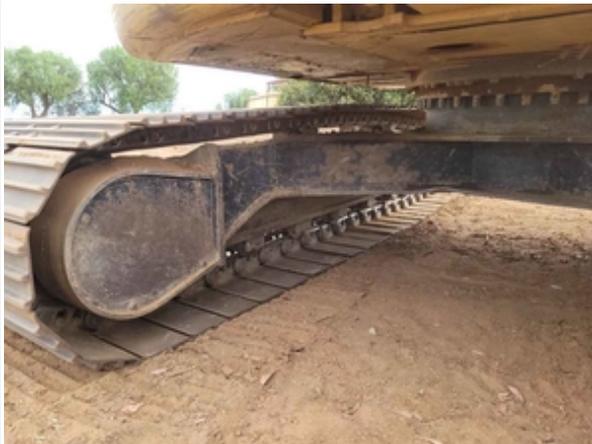
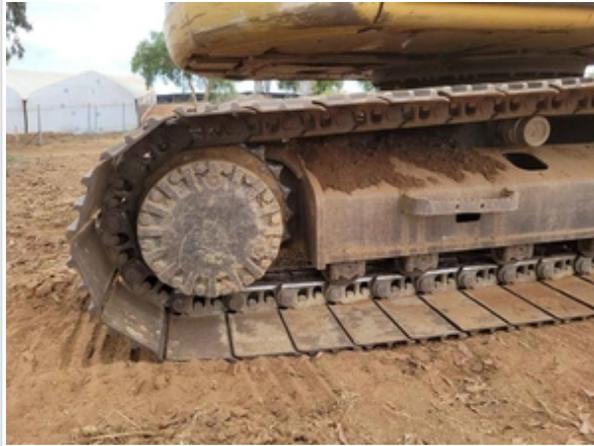
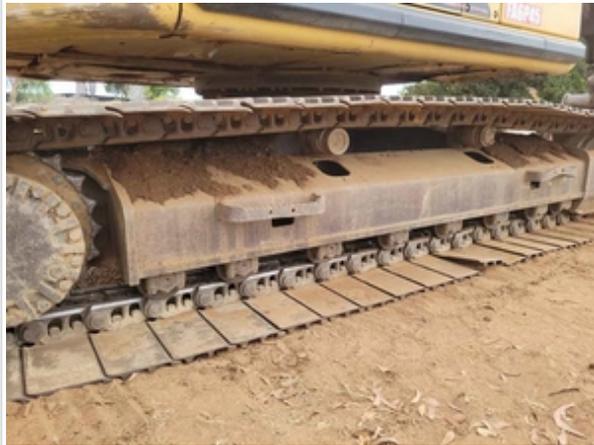
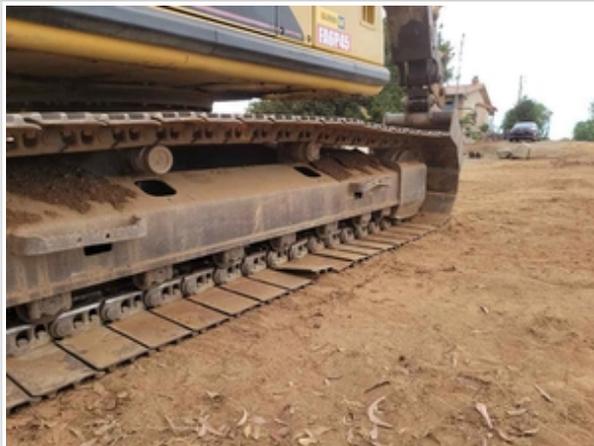
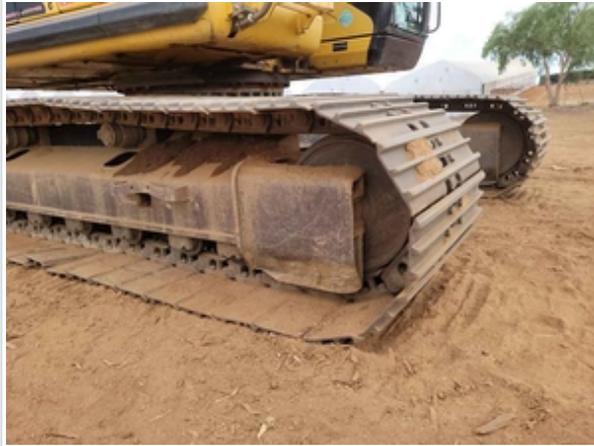
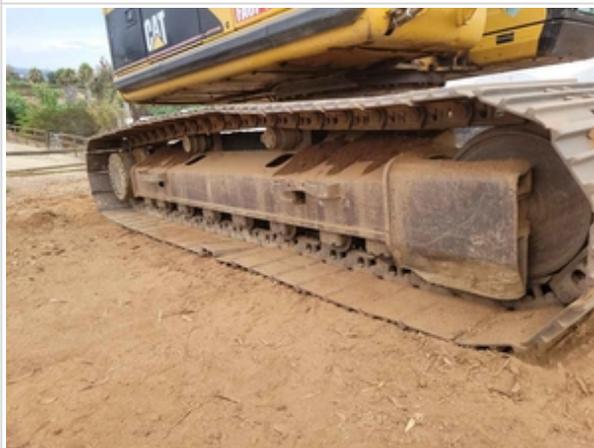
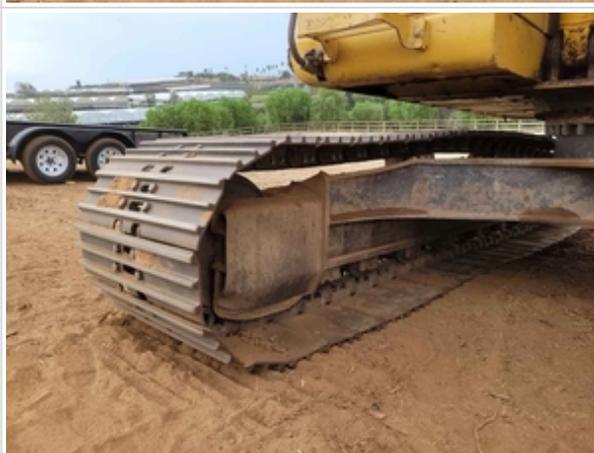
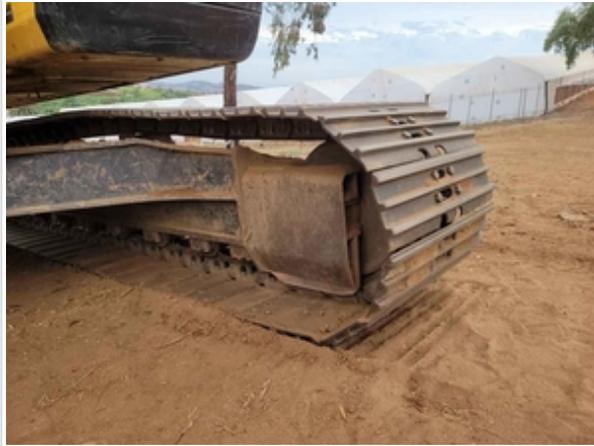
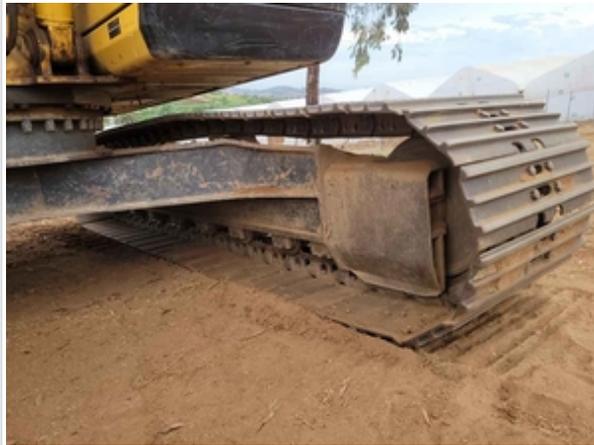
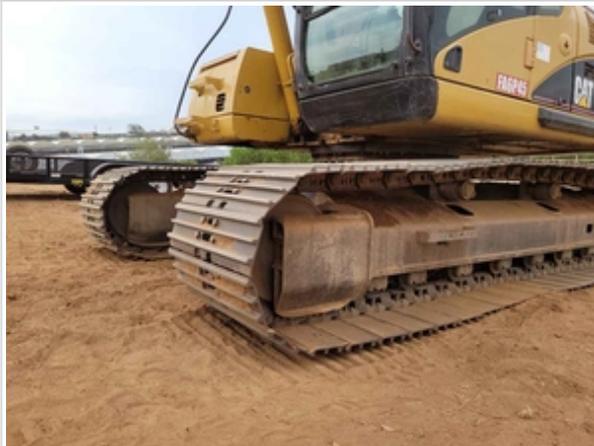
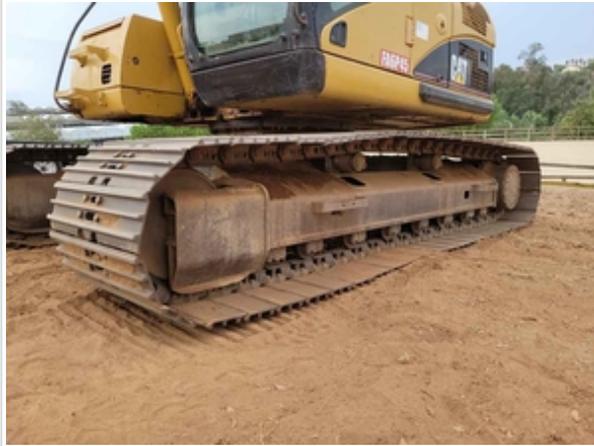
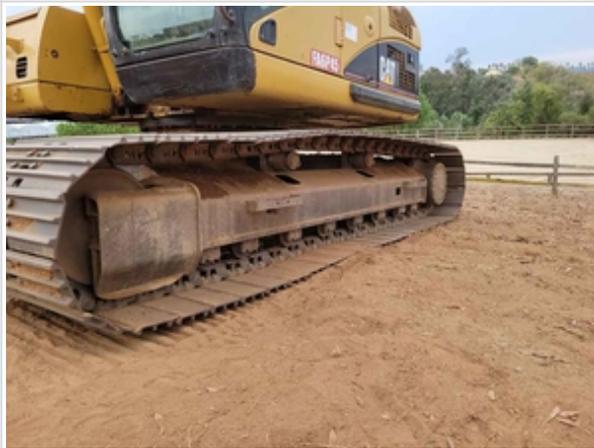
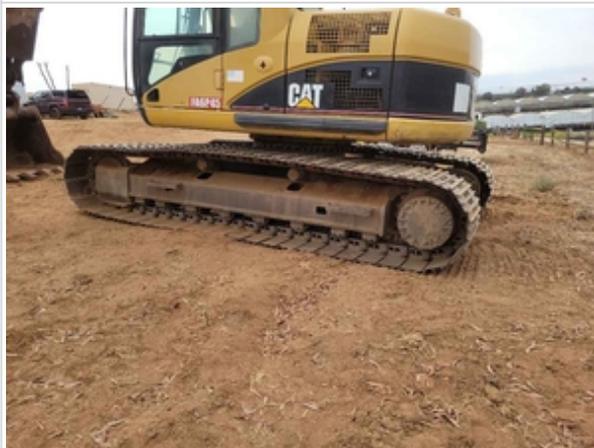
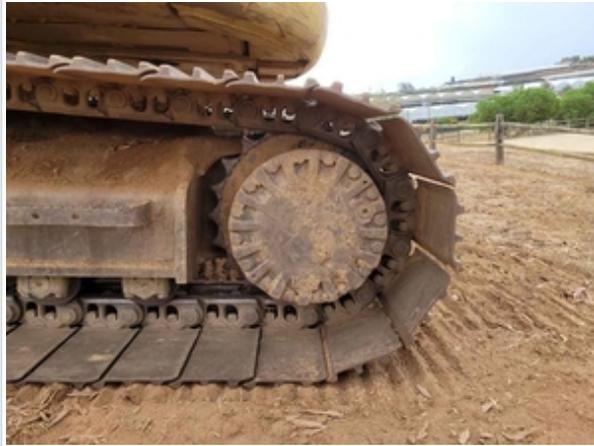
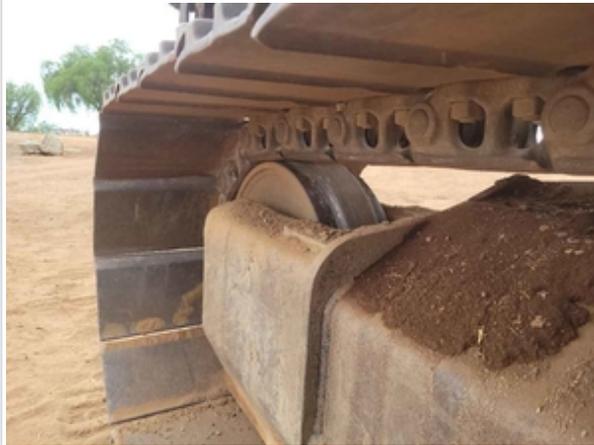
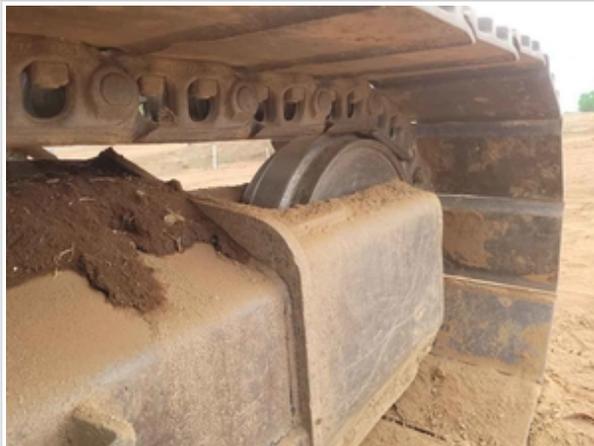
Instructions	<p>Evaluate the following on a 4 point scale (leave comments where an explanation is appropriate):</p> <p>4 = Like New, Recently Replaced          3 = Normal Wear &amp; Tear          2 = Above Average Wear          1 = Service Required</p>	
Undercarriage Overall Condition	3 - Normal Wear & Tear	
Comments	1 r/s track pad bent rest is okay	
Undercarriage Overall Photos

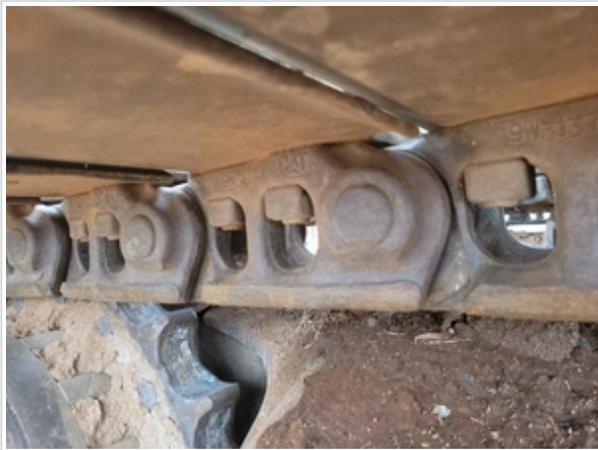
Pin & Bushings

3 - Normal Wear & Tear

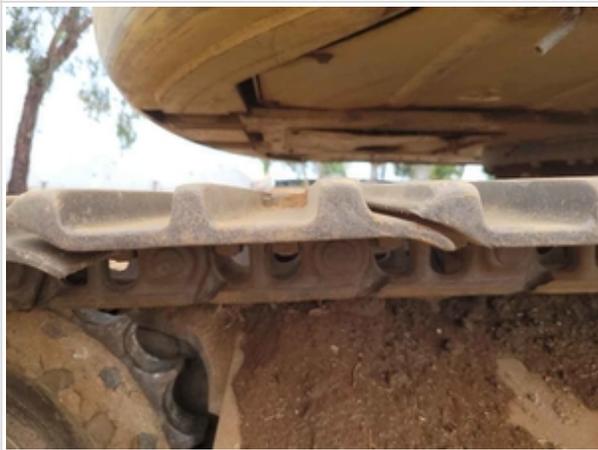
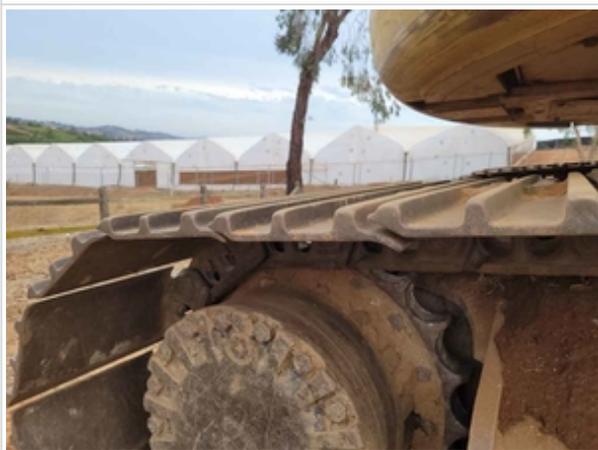
<p>Tracks</p>	<p>3 - Normal Wear &amp; Tear</p>	
<p>Tracks Photos</p>

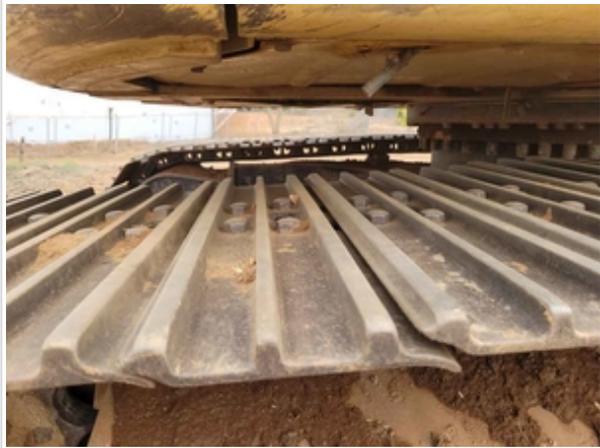
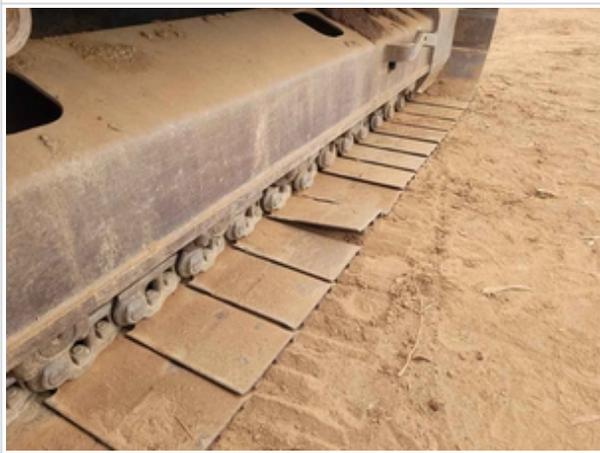
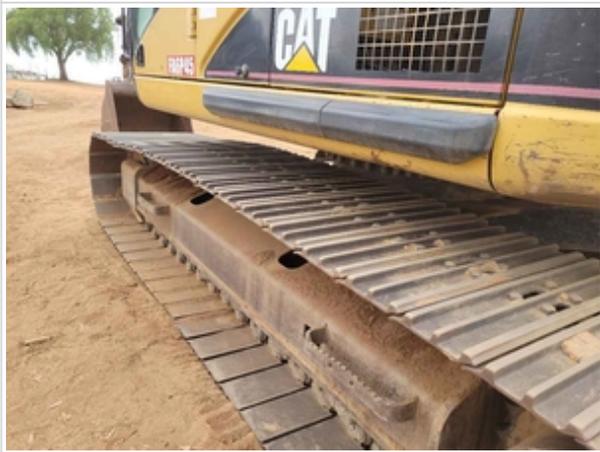
<b>Left Side: Link Bushings / Drive Sprocket / Shoe Condition</b>	3 - Normal Wear & Tear	
<b>Left Side: Upper &amp; Lower Roller / Front Idler Condition</b>	3 - Normal Wear & Tear	
<b>Track Condition: Left Front</b>	50%	
<b>Track Condition: Left Rear</b>	50%

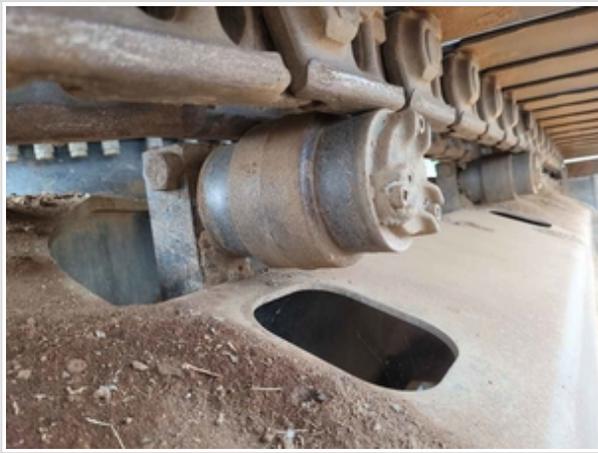
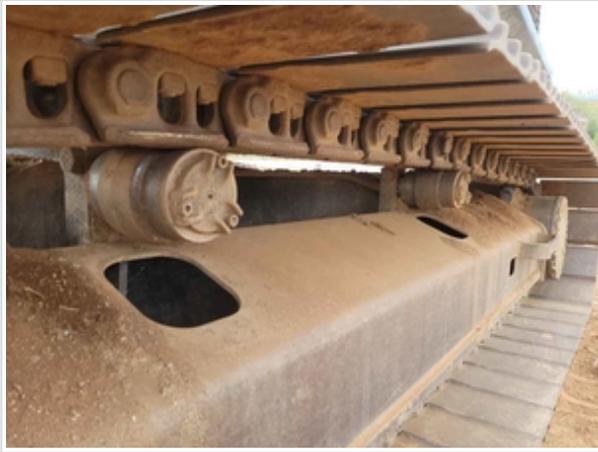
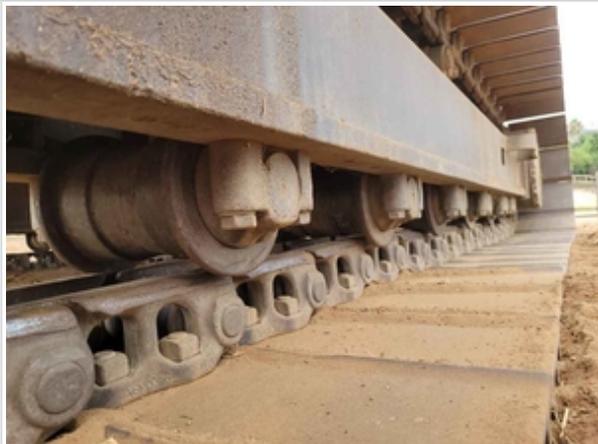
Right Side: Link Bushings / Drive Sprocket / Shoe Condition	3 - Normal Wear & Tear
Right Side: Upper & Lower Roller / Front Idler Condition	3 - Normal Wear & Tear
Track Condition: Right Front	50%
Track Condition: Right Rear	50%
Undercarriage Right Side Photo Instructions	<p>Take photos of the undercarriage of this piece of equipment.</p> <p>Must have shots to capture:</p> <ul style="list-style-type: none"> <li>- Roller Frame (right)</li> <li>- Track Tensioner (right)</li> <li>- Track Pads (right)</li> <li>- Grouser Height (right)</li> <li>- Track Links (right)</li> <li>- Track Bushings (right)</li> <li>- Carrier Rollers (right)</li> <li>- Track Rollers (right)</li> <li>- Idler (right)</li> <li>- Sprocket (right)</li> </ul>
Undercarriage Right Side Photos

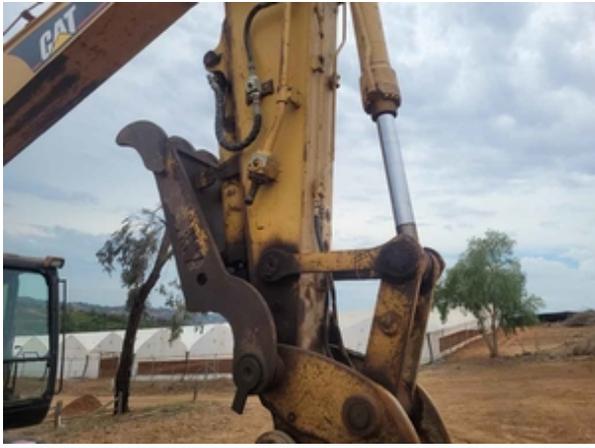
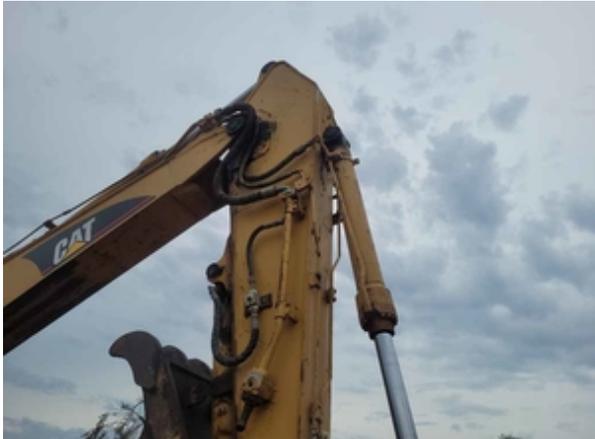
Wet or Damp Hydraulic Lines / Fittings	No
Appearance of Hydraulic Lines / Fittings	3
Hydraulic Lines / Fittings Condition	Hydraulic lines & fittings are clean and in good condition
Appearance of Hydraulic Lines / Fittings Photos

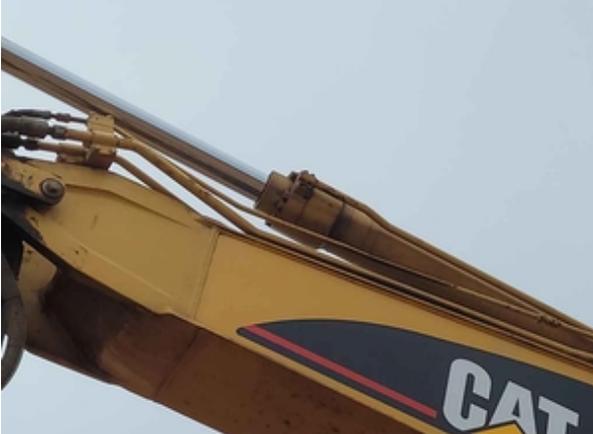
Stick Cylinder Photos

<p><b>Stick Cylinder</b></p>	<p>Check the stick cylinder. Note any wear, pitting, discoloration, etc. Take photos.</p>
<p><b>Stick Cylinder: Mounting Pin</b></p>	<p>3</p>
<p><b>Stick Cylinder: Oil Leaks</b></p>	<p>No</p>
<p><b>Comments</b></p>	<p>possible seepage no major leaks</p>

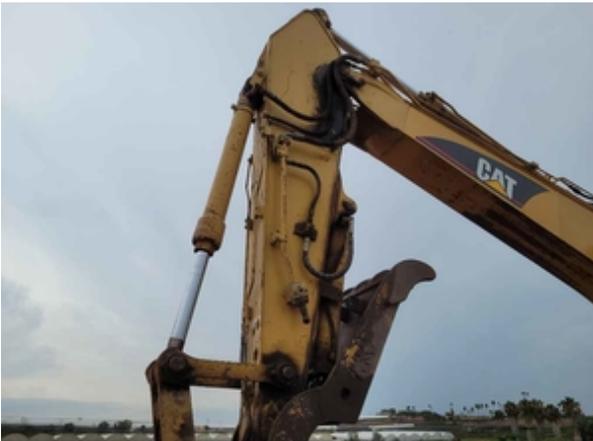
Bucket Cylinder	Check the bucket cylinder. Note any wear, pitting, discoloration, etc. Take photos.
Bucket Cylinder: Mounting Pin	3
Bucket Cylinder: Oil Leaks	No
Bucket Cylinder Photos

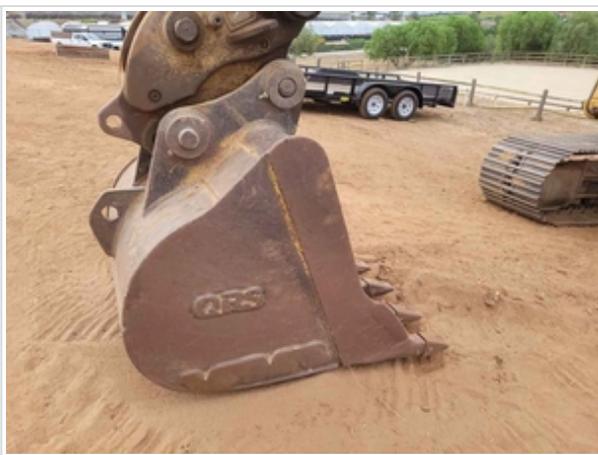
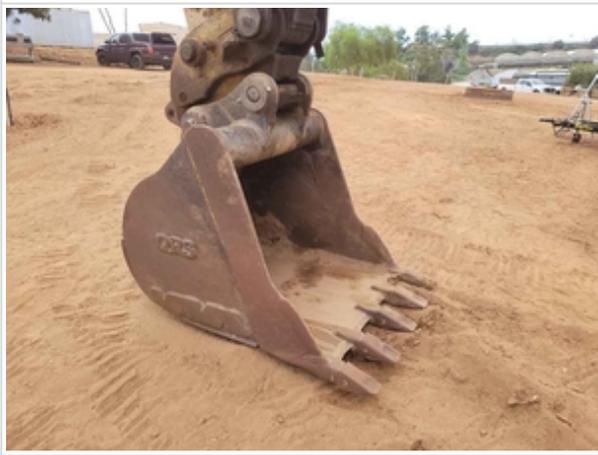
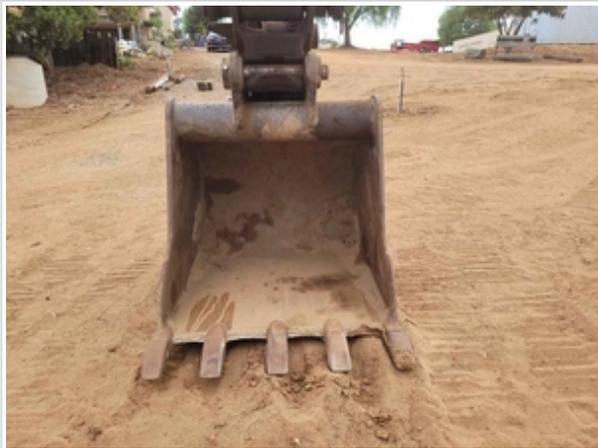
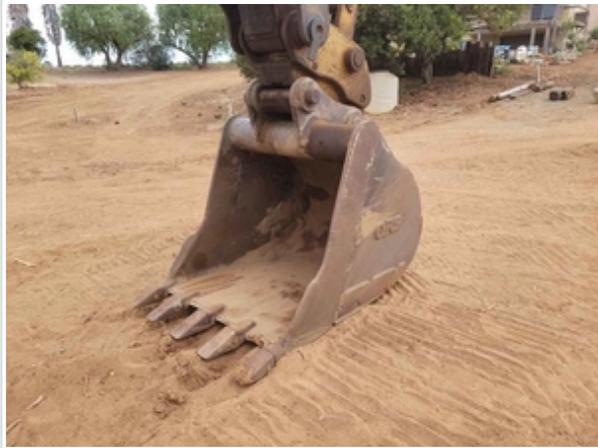
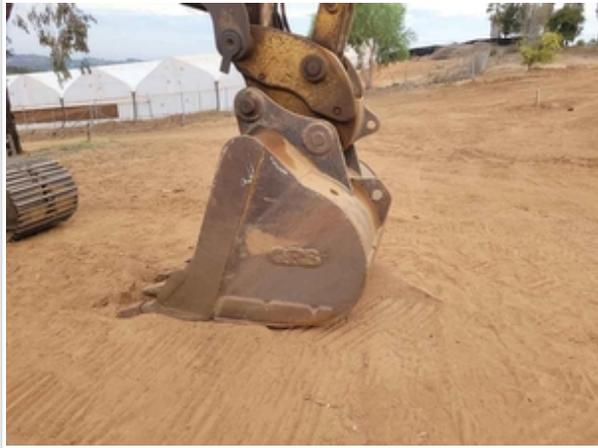
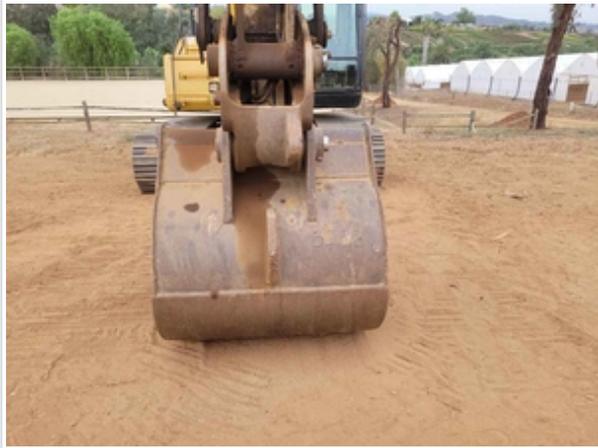
<p>Bucket Photos</p>

Instructions	<p>Evaluate the following on a 4 point scale (leave comments where an explanation is appropriate):</p> <p>4 = Like New, Recently Replaced  3 = Normal Wear &amp; Tear  2 = Above Average Wear  1 = Service Required</p>
Bucket Condition	3 - Normal Wear & Tear
