Inspection Report (Excavator)

Year	2014
Make	Takeuchi
Model	TB240
Serial Number	124000138
Hour Meter Reading	2519.7
Previous Application (e.g., earth moving, mining, demolition, etc)	Demolition

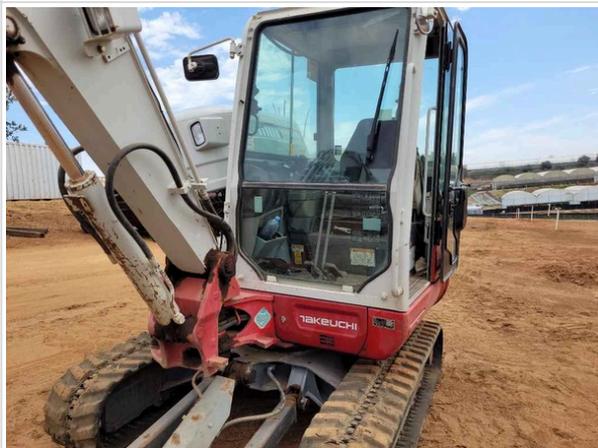
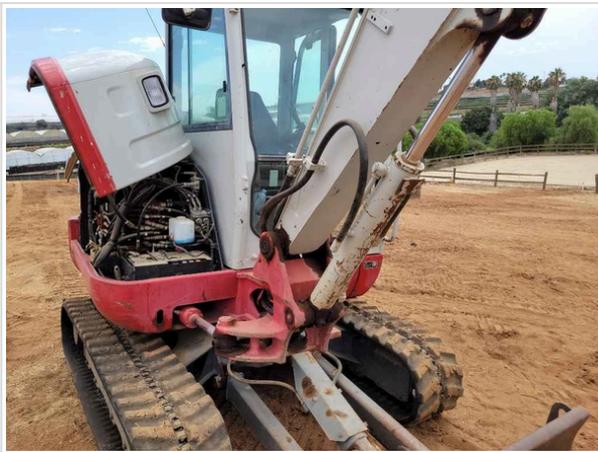
Front	3 - Normal Wear & Tear
Front Photos

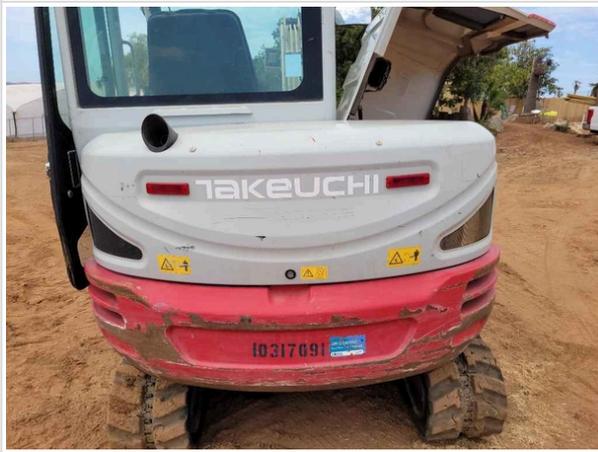
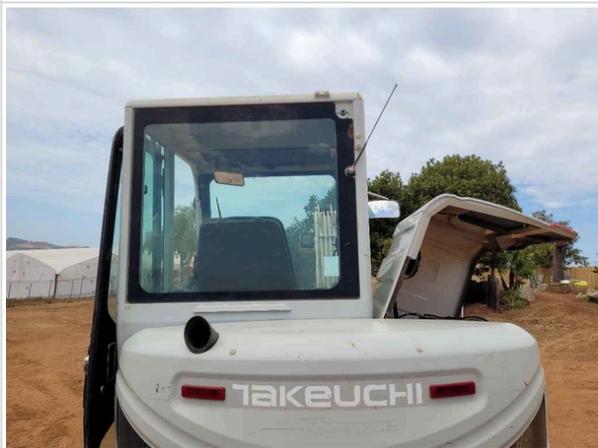
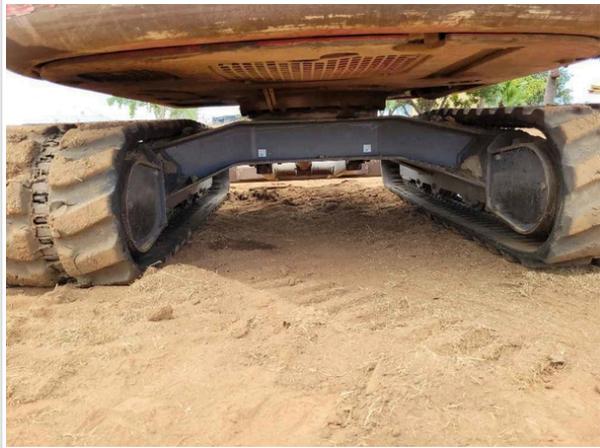
<p>Rear</p>	<p>3 - Normal Wear & Tear</p>	
<p>Rear Photos</p>

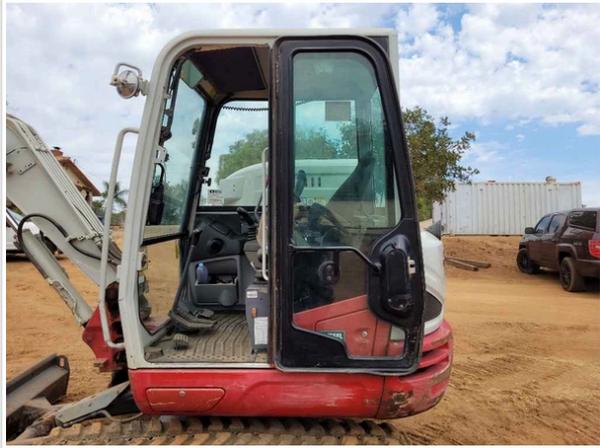
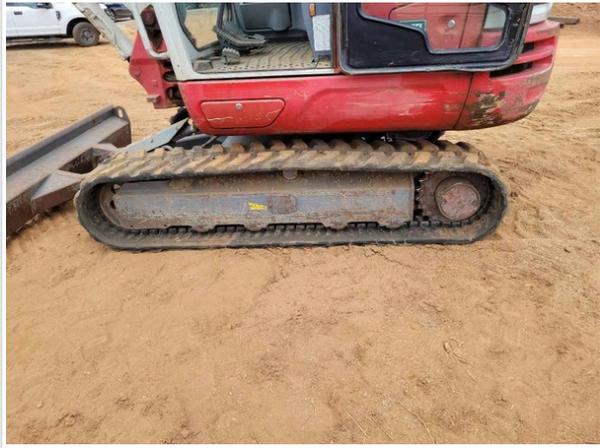
<p>Left</p>	<p>3 - Normal Wear & Tear</p>	
<p>Left Photos</p>

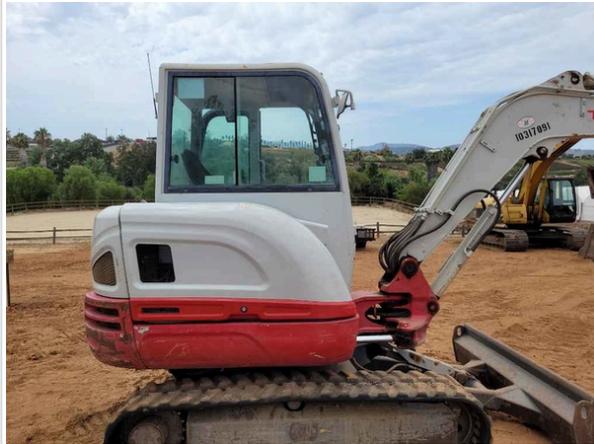
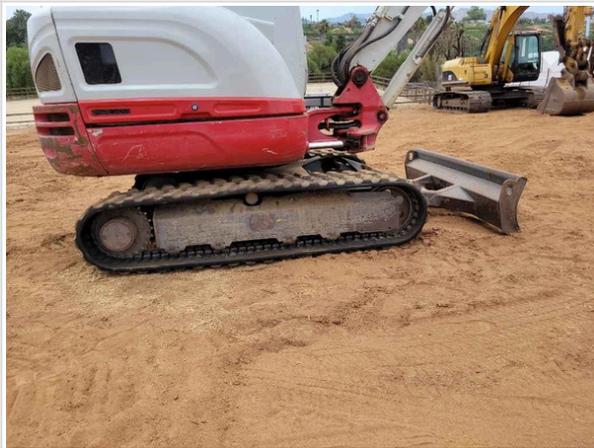
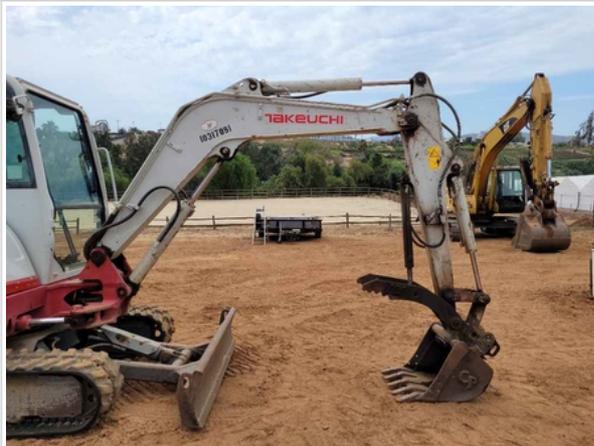
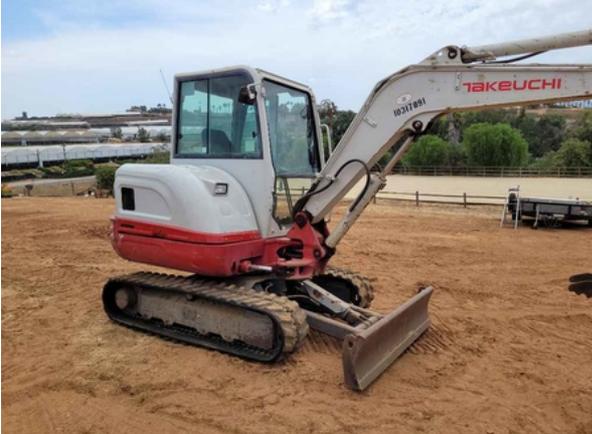
Right Photos

<p>Right</p>	<p>3 - Normal Wear & Tear</p>

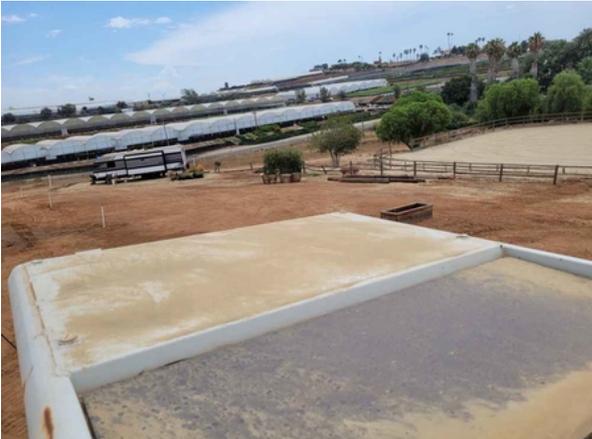
Upper	3 - Normal Wear & Tear	
Upper Photos

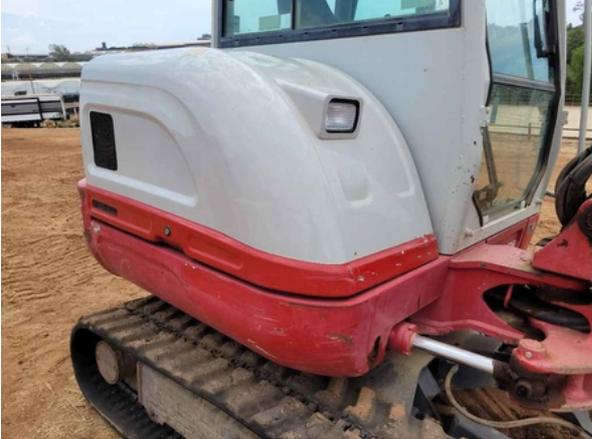
Body Panels (Any Rust Damage?)	3 - Normal Wear & Tear	
Body Panel Condition	No visible damage, good paint condition and panel fitment, Other (see comments)	
Comments	minor scuff marks all the way around	
Body Panels Photos

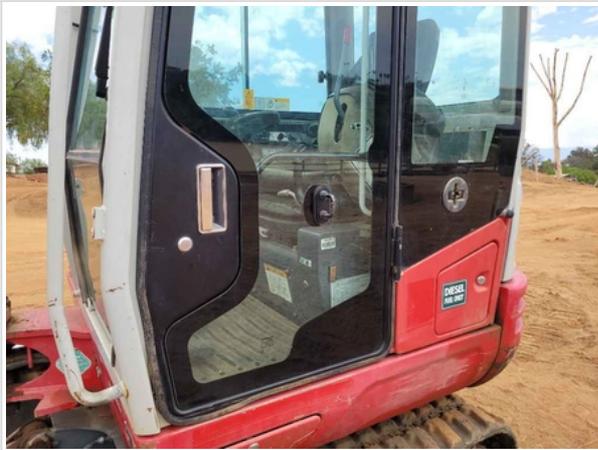
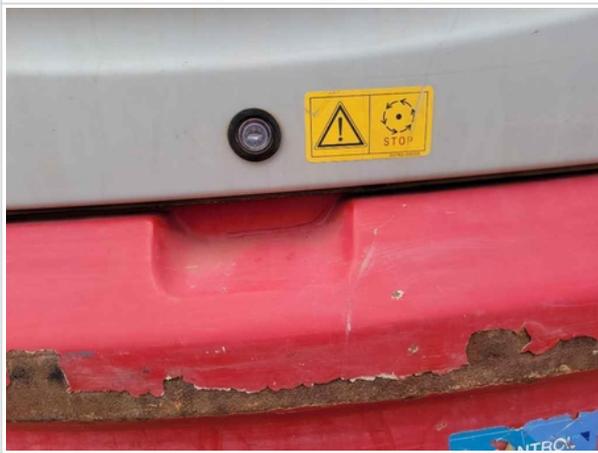
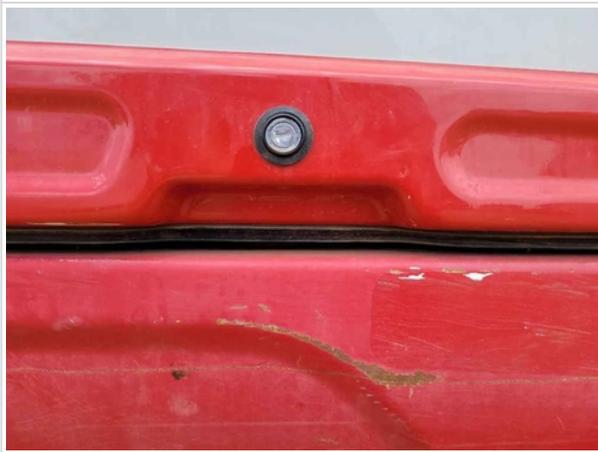
<p>Doors / Canopy Latches Photos</p>

3 - Normal Wear & Tear

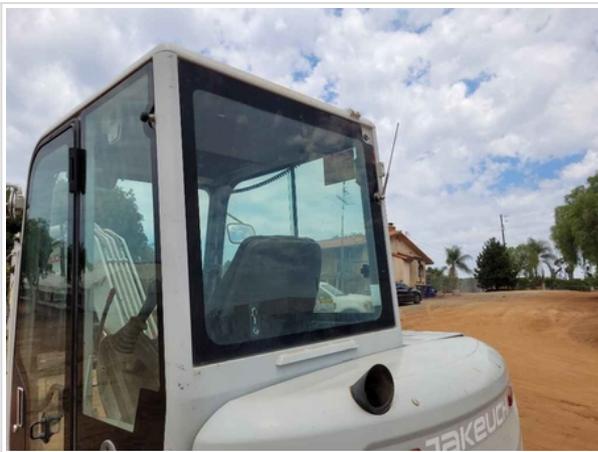
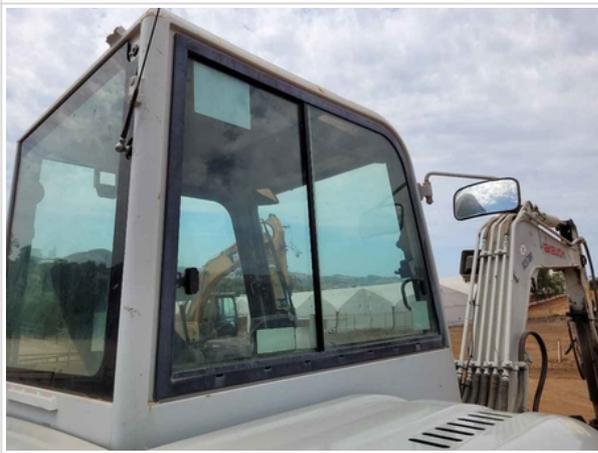
Glass Condition Photos

<p>Glass Condition</p>	<p>3 - Normal Wear & Tear</p>
<p>Glass Condition Notes</p>	<p>Glass intact, no visible damage, Other (see comments)</p>
<p>Comments</p>	<p>small scratches</p>

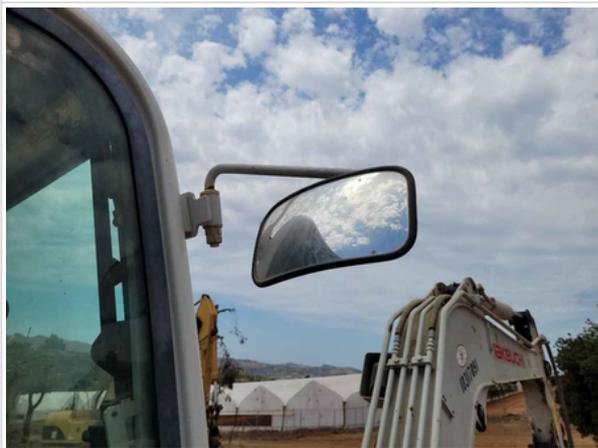
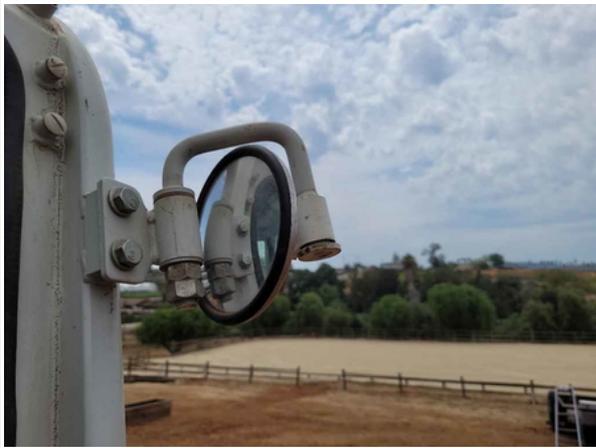
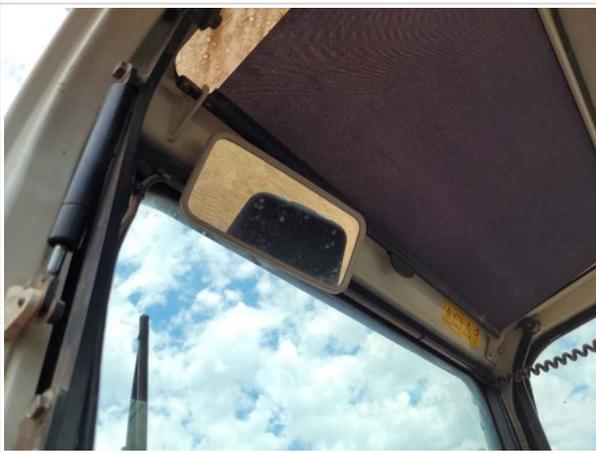
<p>Mirrors</p>	<p>3 - Normal Wear & Tear</p>	
<p>Mirrors Photos</p>

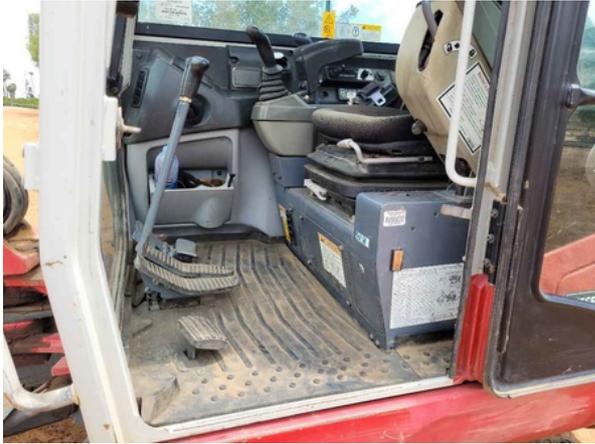
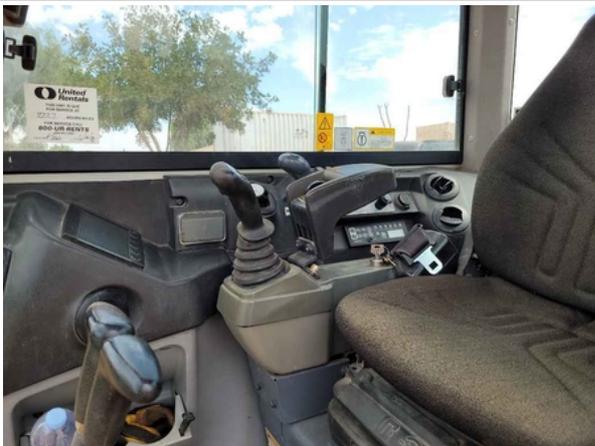
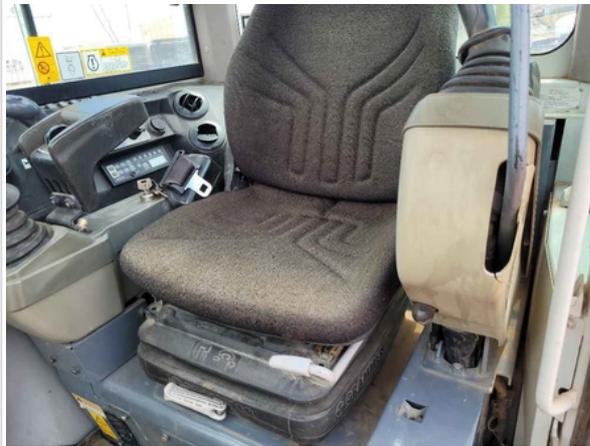
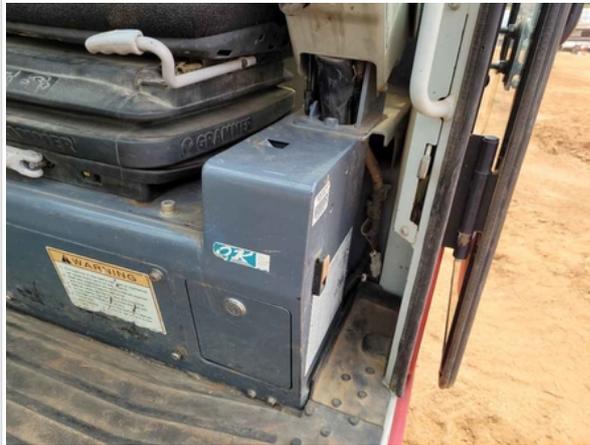
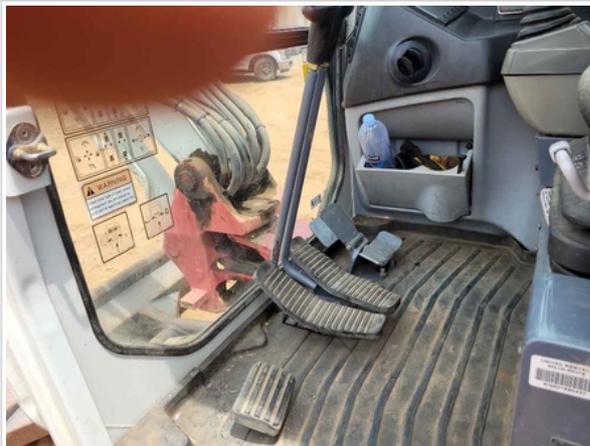
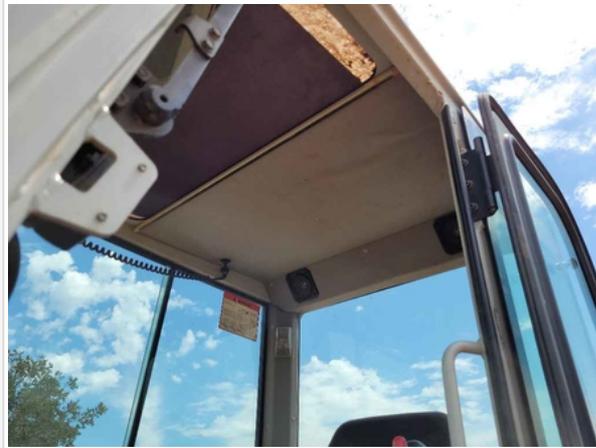
Operator Cabin Overall	3 - Normal Wear & Tear
Operator Cabin Photos

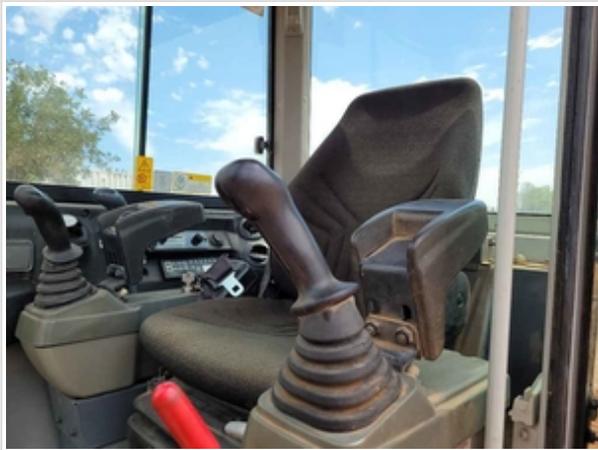
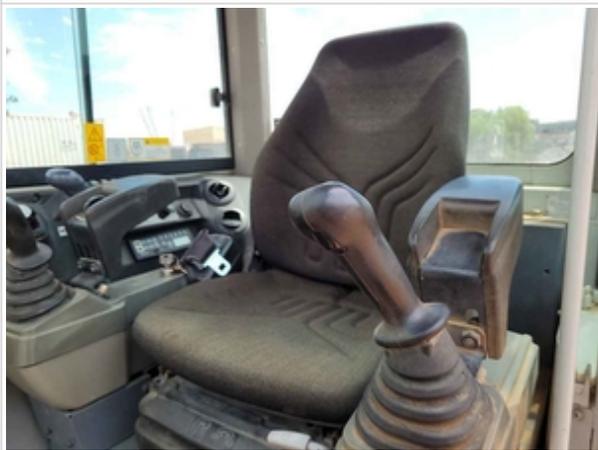
<p>Operator's Seat & Arm Rests Photos</p>

Operator's Seat & Arm Rests	3 - Normal Wear & Tear
Operator's Seat & Arm Rests Condition	Seat(s) in good condition, no stains or tears in upholstery

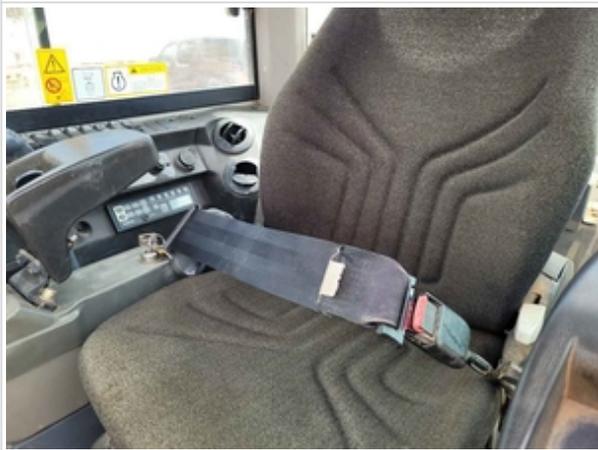
<p>Seat Belt</p>	<p>3 - Normal Wear & Tear</p>
<p>Seat Belt Photos</p>

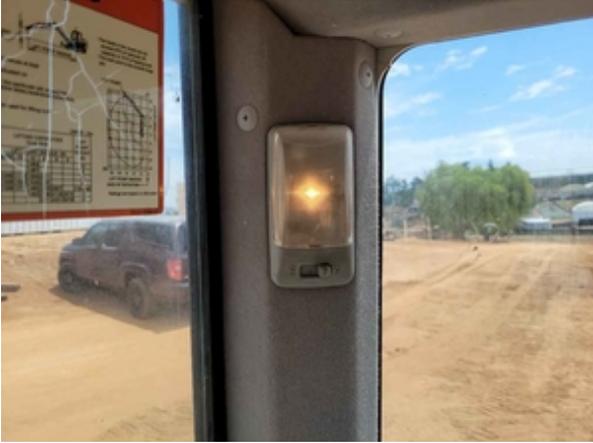
Cabin Lights Photos

<p>Cabin Lights</p>	<p>4 - Like New, Recently Replaced</p>
<p>Cabin Lights Condition</p>	<p>Cabin lights are installed with all light covers in place, bulbs are installed and working properly</p>

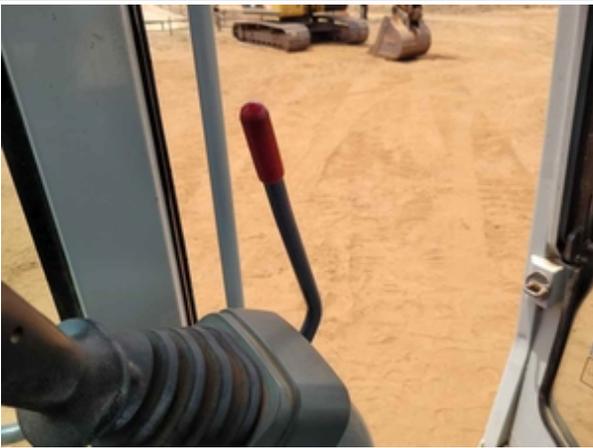
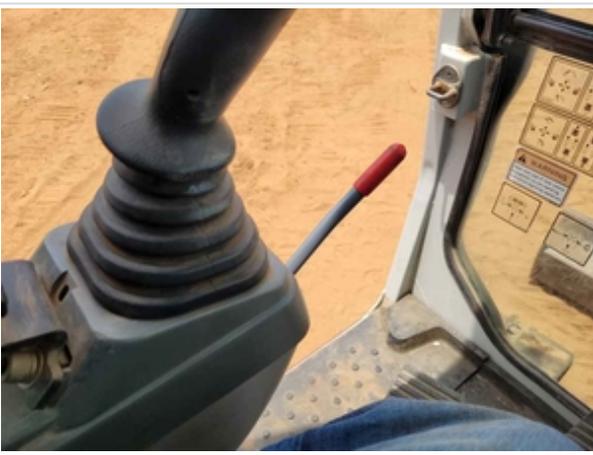
Safety Lock Out / Stop	4 - Like New, Recently Replaced
Safety Lock Out / Stop Condition	Safety lock out device is present, in good condition, and functional
Safety Lock Out / Stop Photos

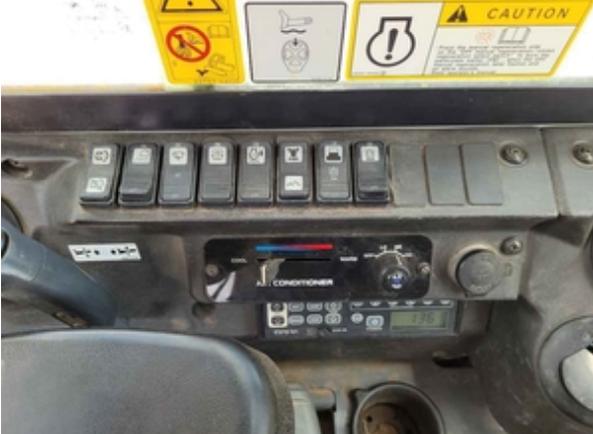
Controls & Switches Photos

Controls & Switches	4 - Like New, Recently Replaced
Controls & Switches Condition	All switches are installed and functional

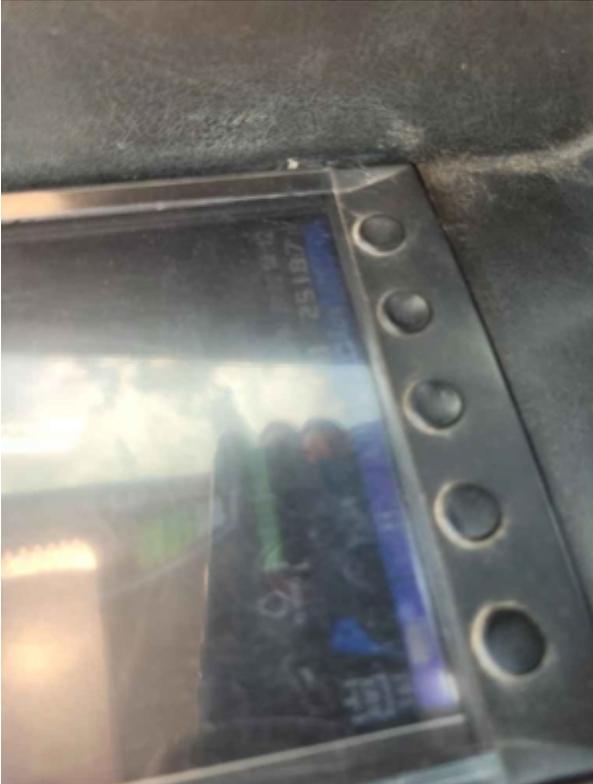
Hour Meter Activity	4 - Like New, Recently Replaced
Hour Meter Condition	Hour meter is functional and in good condition
Hour Meter Activity Photos

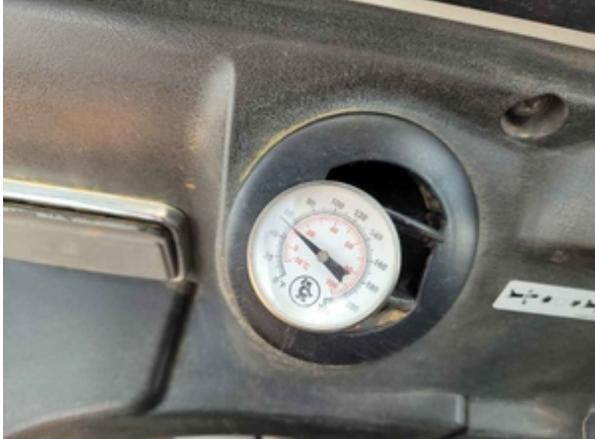
Heater & A/C Photos

Other Gauge Activity	4 - Like New, Recently Replaced
Other Gauge Condition	All cockpit gauges are functional and in good condition
Heater & A/C	4 - Like New, Recently Replaced

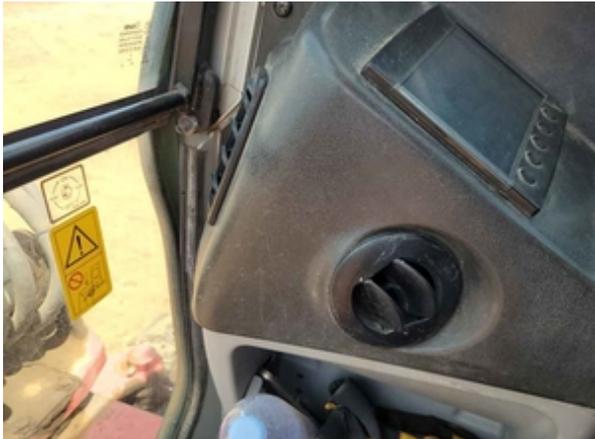
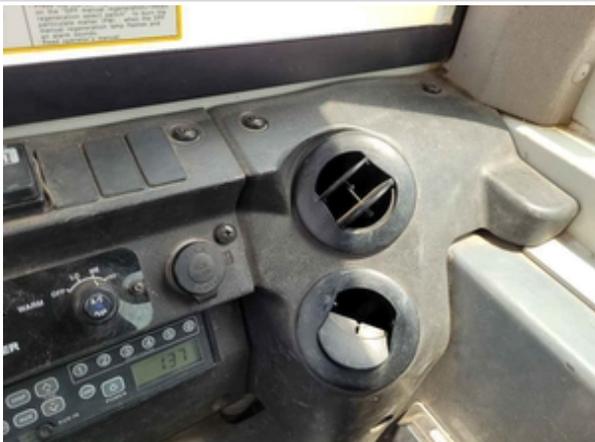
Fans / Vents	4 - Like New, Recently Replaced	
Fans / Vents Condition	Fan vents are functional, in good condition, and move through a full adjustable range of motion	
Fans / Vents Photos

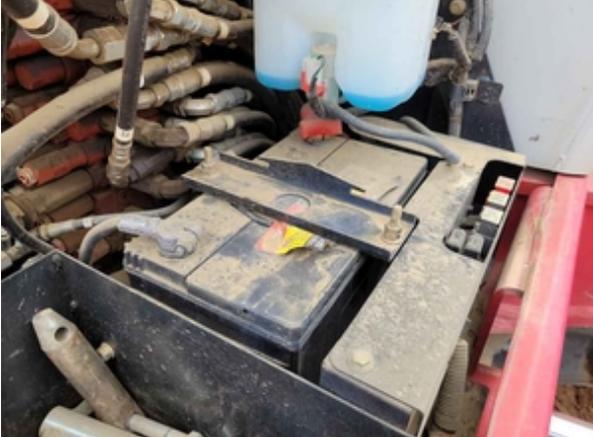
Battery Condition Photos

Blow-by (Visual Observation Check)	No
Unusual Noises (Upon Start-up, Idle, Shutdown)	No
Unusual Noise Notes	No unusual noises heard
Engine Smoke (Upon Start-up, Idle, Shutdown)	No
Engine Smoke Notes	No engine smoke issues observed
Engine Exhaust Color	Clear
Battery	3 - Normal Wear & Tear
Battery Condition	Clean & dry appearance, tight connections

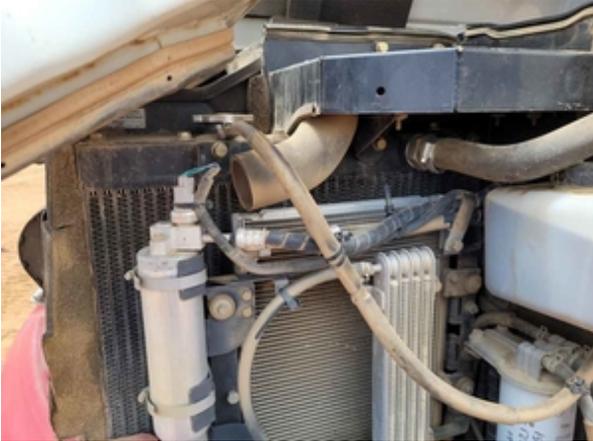
Radiator	4 - Like New, Recently Replaced
Radiator Condition	Radiator fins & components appear to be in good working order, no signs of damage or leaks
Radiator Photos

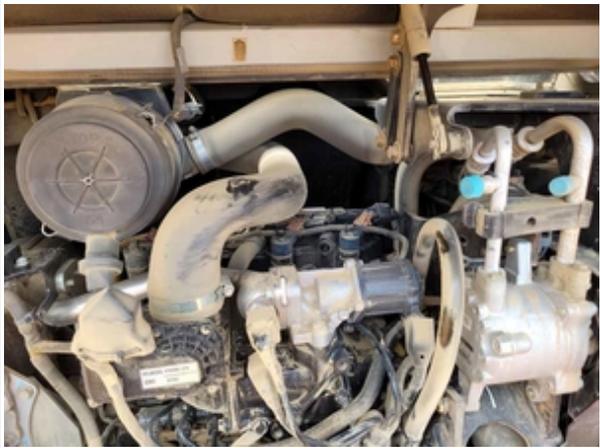
Hose Photos

Hoses	4 - Like New, Recently Replaced
Hose Condition	Firm, pliant hoses with no signs of wear or leaks

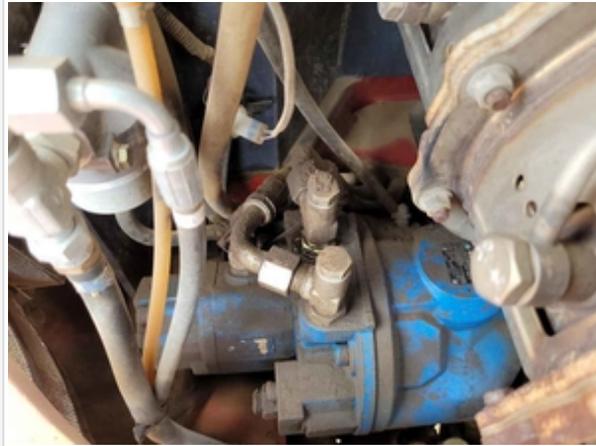
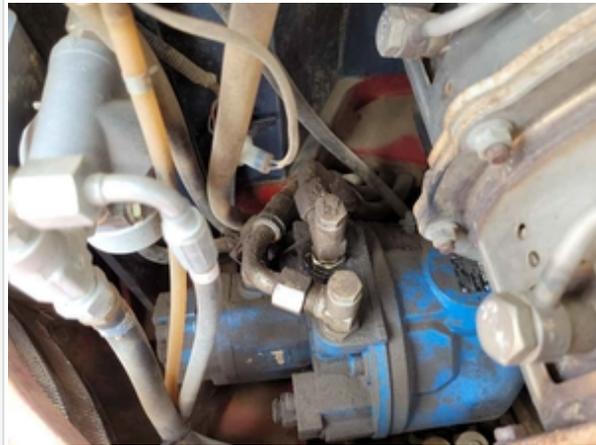
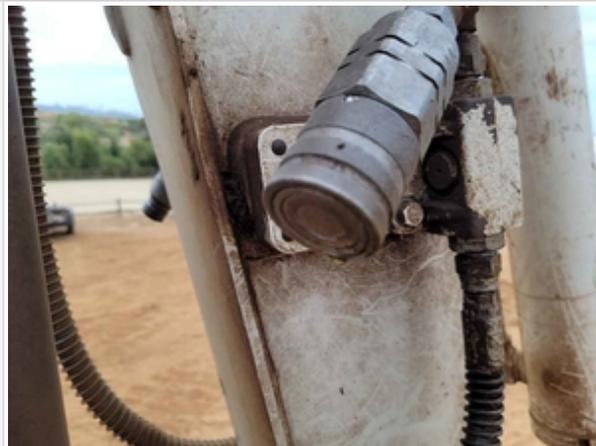
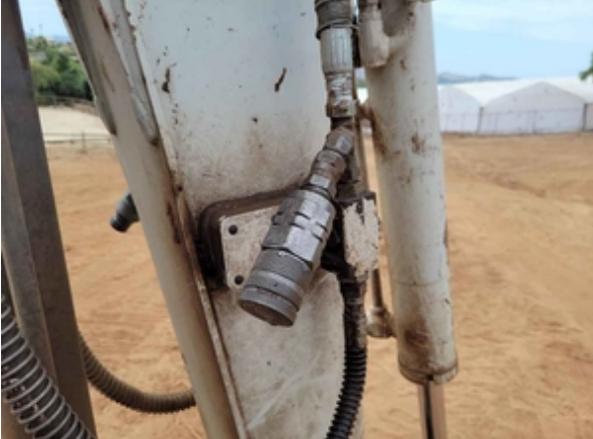
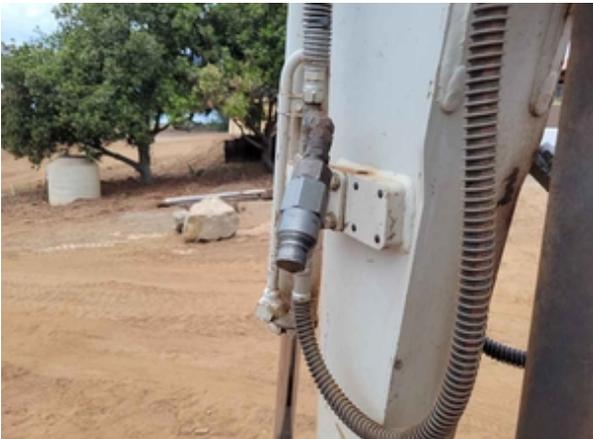
Water Pump	4 - Like New, Recently Replaced	
Water Pump Condition	No unusual pump noises heard	
Cooling System Leaks	No	
Coolant Color / Appearance	3 - Normal Wear & Tear	
Coolant Color/Appearance Notes	Normal Translucent appearance, no visual signs of contamination	
Oil Leaks	Yes	
Oil Leak Notes	No oil leaks seen, Other (see comments)	
Comments	no engine oil leaks present, oil leaks are present on hyd. pump that connects to engine	
Oil Leak Photos

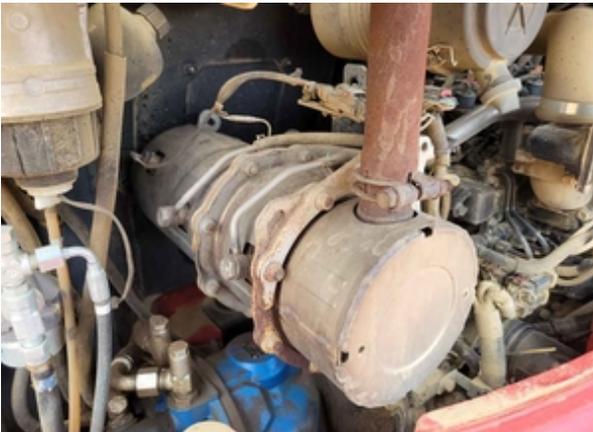
Oil Color / Appearance	3 - Normal Wear & Tear
Oil Color / Appearance Notes	Clean oil appearance, no signs of cross contamination
Fuel Leaks	No
Equipped with DPF (Diesel Particulate Filter)	Yes
DPF Condition	3 - Normal Wear & Tear
DPF Condition Notes	Filter housing is intact with no signs of damage or malfunction, DPF indicator is not illuminated
DPF Photos

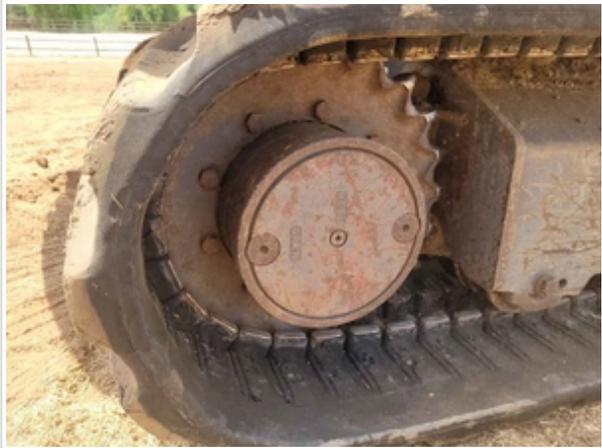
Overall Drivetrain Comments	Hydraulic motors work and sound normal

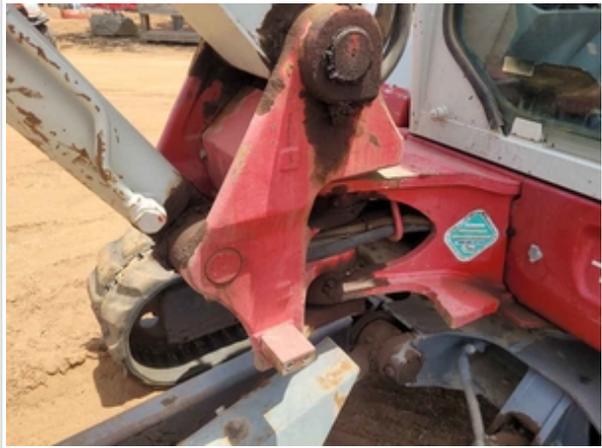
Instructions	<p>Evaluate the following on a 4 point scale (leave comments where an explanation is appropriate):</p> <p>4 = Like New, Recently Replaced 3 = Normal Wear & Tear 2 = Above Average Wear 1 = Service Required</p>	
Boom Condition	3 - Normal Wear & Tear	
Comments	Boom in great shape with no damages	
Stick Condition	3 - Normal Wear & Tear	
Comments	stick in good shape	
Boom Base Pin & Bushings	3 - Normal Wear & Tear	
Boom Base Pin & Bushings Photos

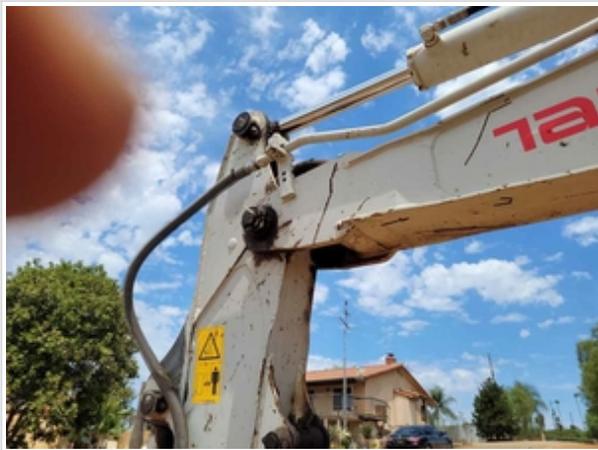
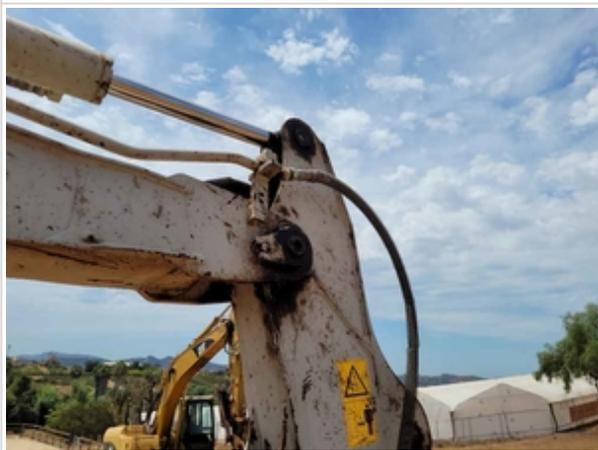
<p>Stick to Bucket Pin & Bushings Photos</p>

Boom to Stick Pin & Bushings	4 - Like New, Recently Replaced	
Stick to Bucket Pin & Bushings	4 - Like New, Recently Replaced

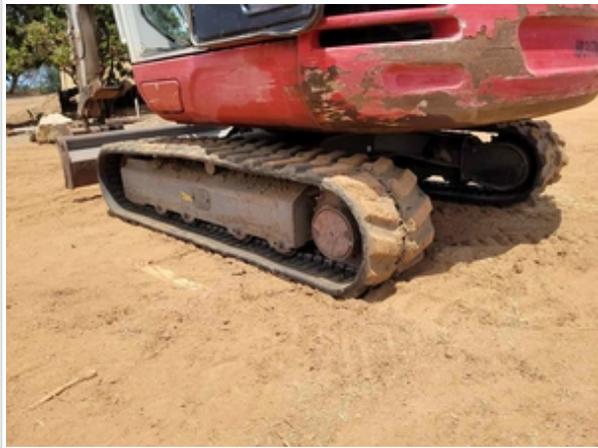
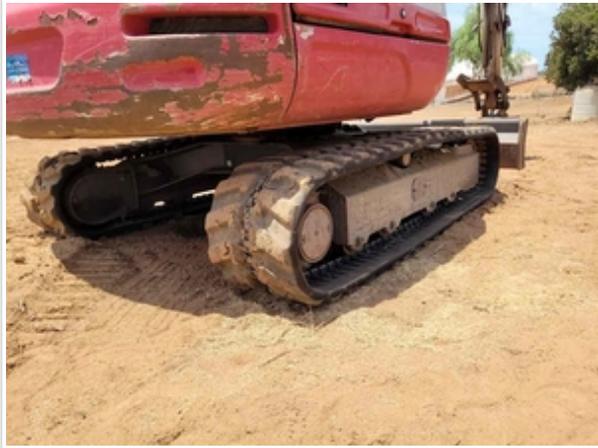
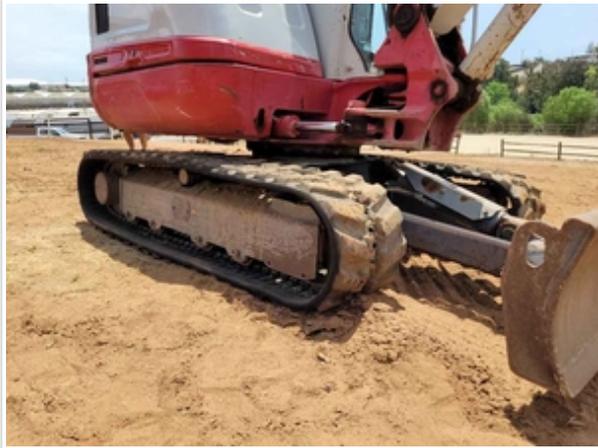
Instructions	<p>Evaluate the following on a 4 point scale (leave comments where an explanation is appropriate):</p> <p>4 = Like New, Recently Replaced 3 = Normal Wear & Tear 2 = Above Average Wear 1 = Service Required</p>
Undercarriage Overall Condition	3 - Normal Wear & Tear
Comments	l/s track on backwards possibly
Undercarriage Overall Photos

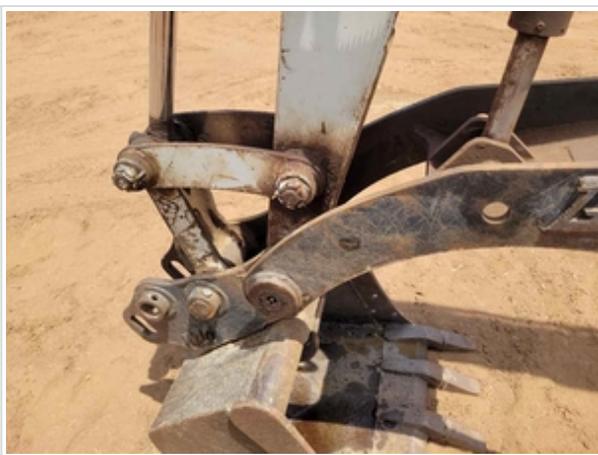
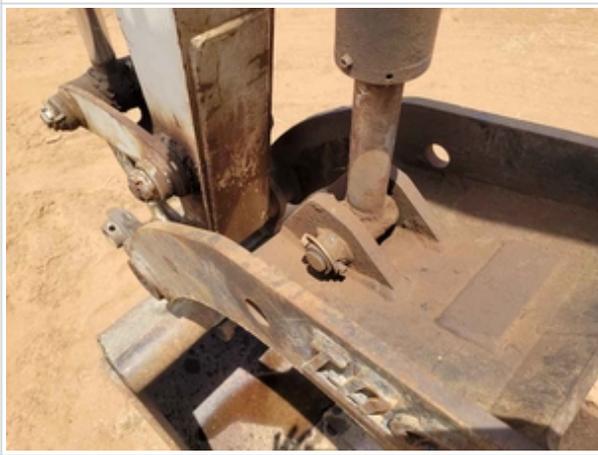
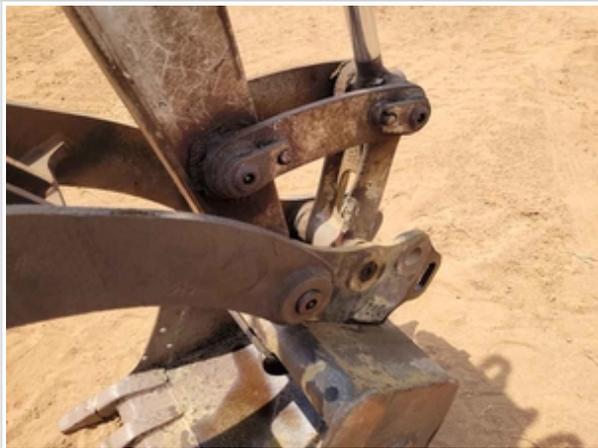
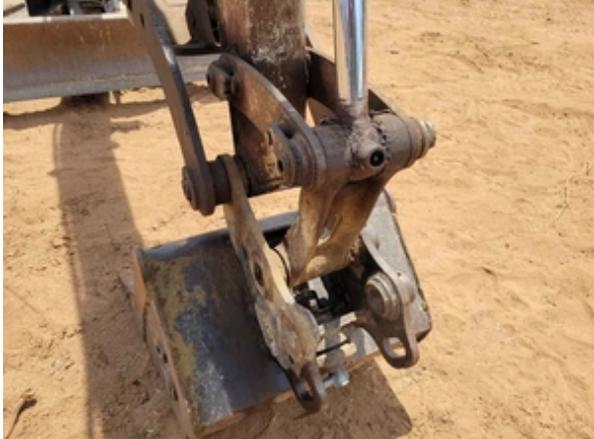
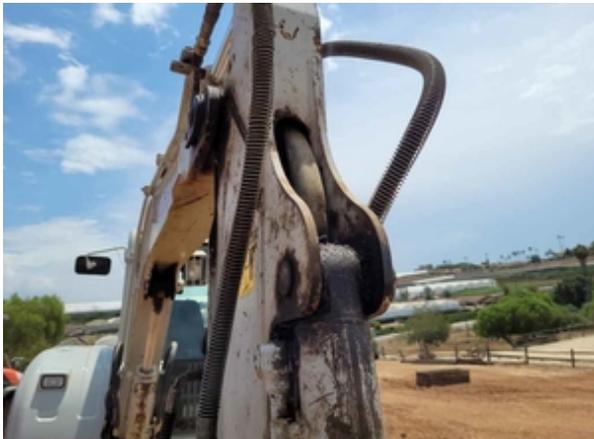
<p>Pin & Bushings Photos</p>

<p>Pin & Bushings</p>	<p>4 - Like New, Recently Replaced</p>
<p>Comments</p>	<p>all in good shape</p>

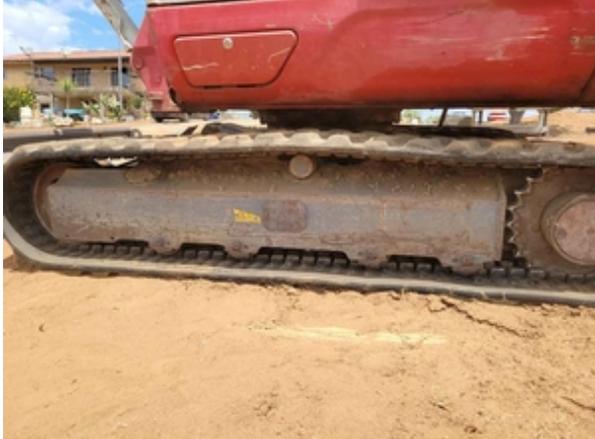
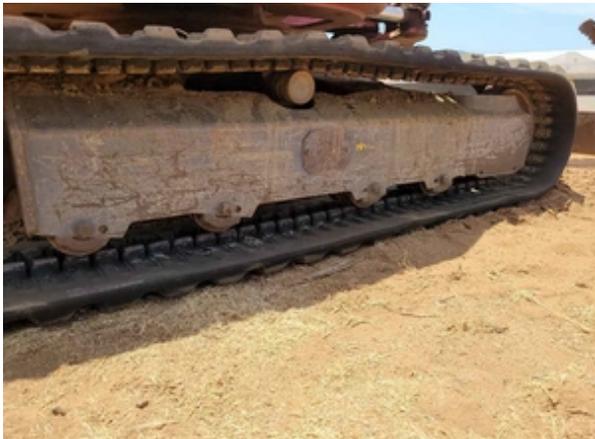
Undercarriage Left Side Photos

Tracks	3 - Normal Wear & Tear	
Left Side: Link Bushings / Drive Sprocket / Shoe Condition	3 - Normal Wear & Tear	
Comments	sprockets okay	
Left Side: Upper & Lower Roller / Front Idler Condition	3 - Normal Wear & Tear	
Track Condition: Left Front	70%	
Track Condition: Left Rear	70%	
Undercarriage Left Side Photo Instructions	<p>Take photos of the undercarriage of this piece of equipment.</p> <p>Must have shots to capture:</p> <ul style="list-style-type: none"> - Roller Frame (left) - Track Tensioner (left) - Track Pads (left) - Grouser Height (left) - Track Links (left) - Track Bushings (left) - Carrier Rollers (left) - Track Rollers (left) - Idler (left) - Sprocket (left)

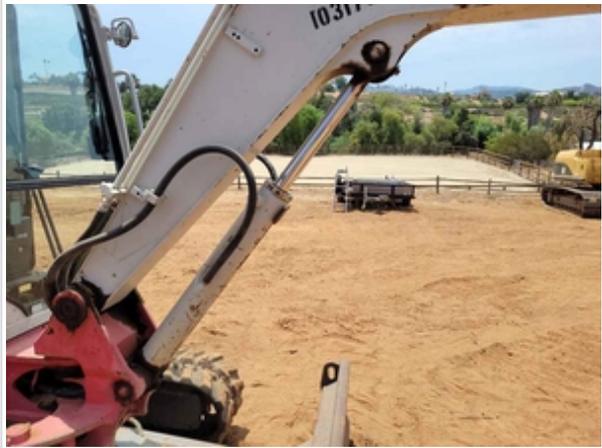
<p>Boom Cylinder Photos</p>

Boom Cylinder	Check the boom cylinder. Note any wear, pitting, discoloration, etc. Take photos.
Boom Cylinder: Mounting Pin	3
Boom Cylinder: Oil Leaks	No

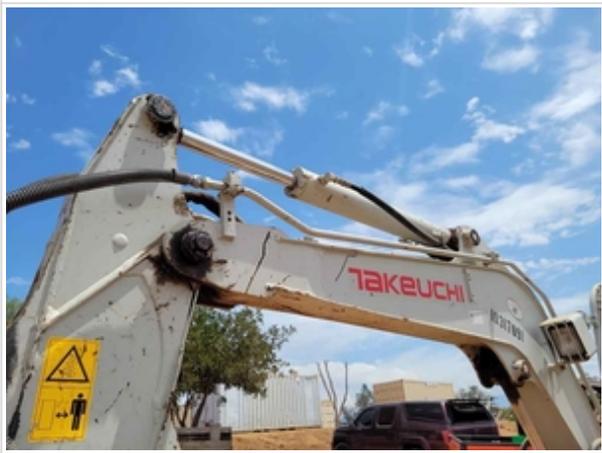
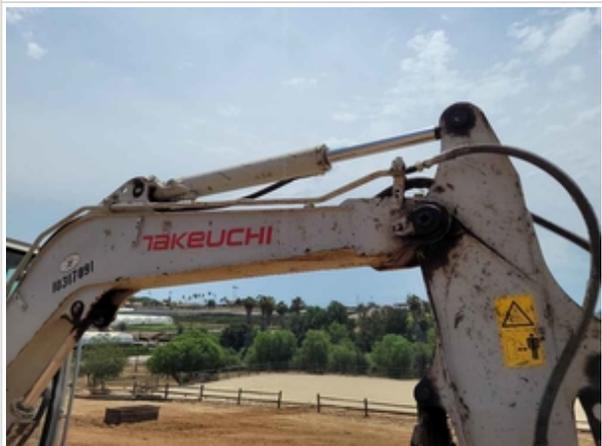
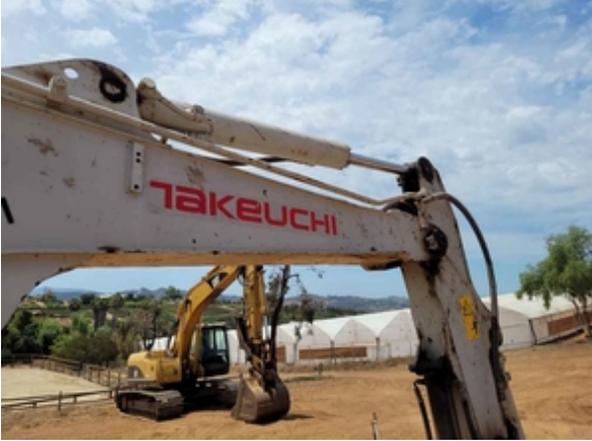
<p>Stick Cylinder</p>	<p>Check the stick cylinder. Note any wear, pitting, discoloration, etc. Take photos.</p>	
<p>Stick Cylinder: Mounting Pin</p>	<p>3</p>	
<p>Stick Cylinder: Oil Leaks</p>	<p>No</p>	
<p>Stick Cylinder Photos</p>

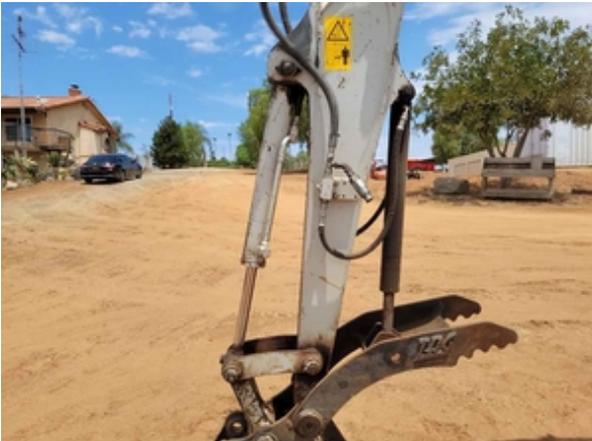
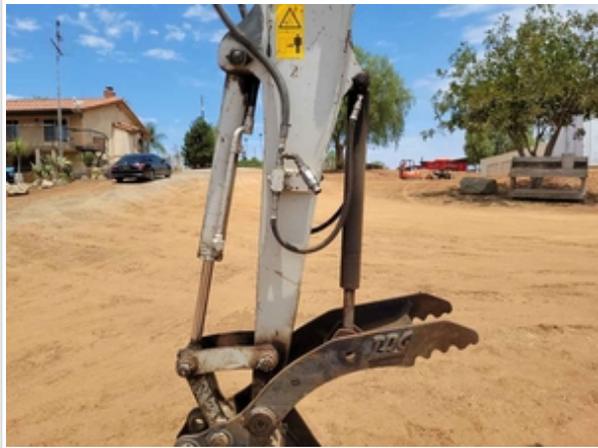
Bucket Cylinder	Check the bucket cylinder. Note any wear, pitting, discoloration, etc. Take photos.	
Bucket Cylinder: Mounting Pin	3	
Bucket Cylinder: Oil Leaks	No	
Comments	bucket cylinder in good condition	
Bucket Cylinder Photos

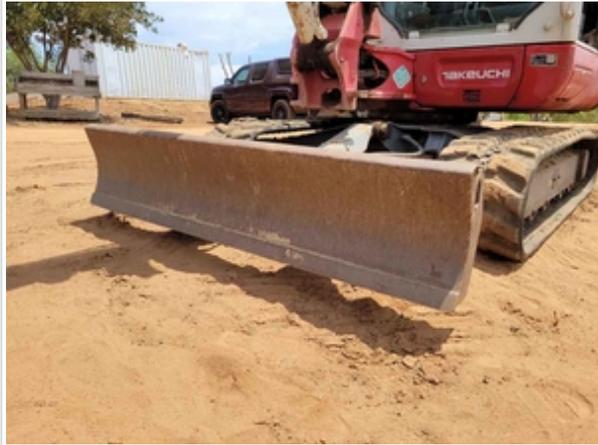
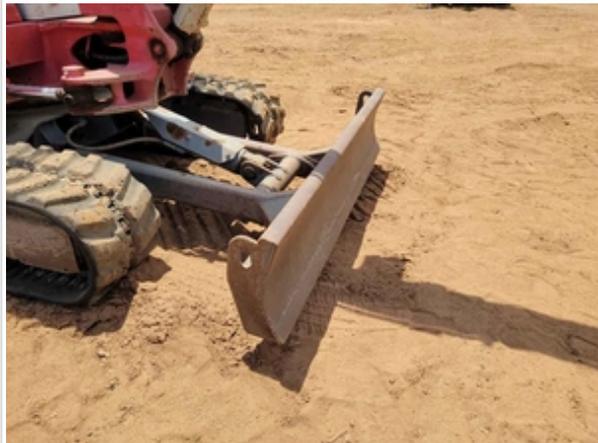
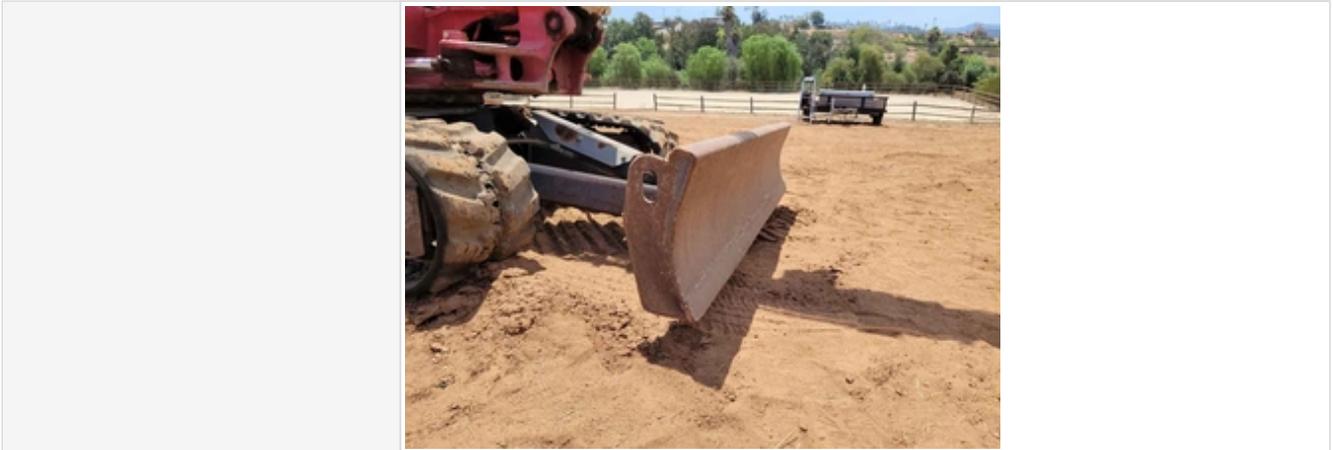
<p>Blade</p>	<p>Check the blade. Note any wear, pitting, discoloration, etc. Take photos.</p>
<p>Blade</p>	<p>3</p>
<p>Blade Photos</p>

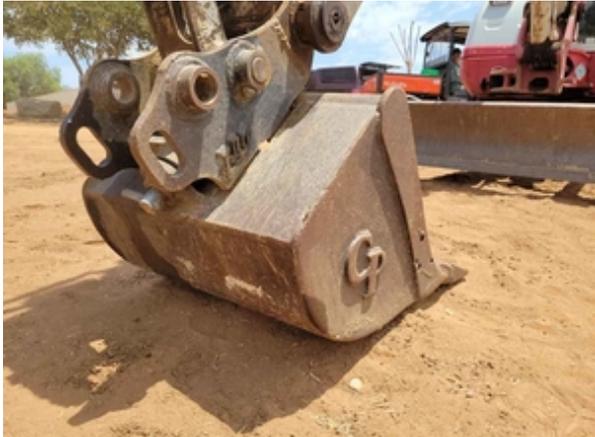
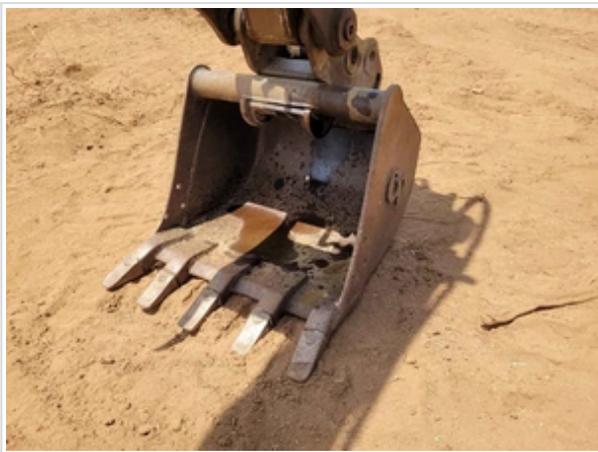
Instructions	<p>Evaluate the following on a 4 point scale (leave comments where an explanation is appropriate):</p> <p>4 = Like New, Recently Replaced 3 = Normal Wear & Tear 2 = Above Average Wear 1 = Service Required</p>
Bucket Condition	<p>3 - Normal Wear & Tear</p>
Comments	<p>24" bucket currently on machine with thumb attachment</p>
Bucket Photos

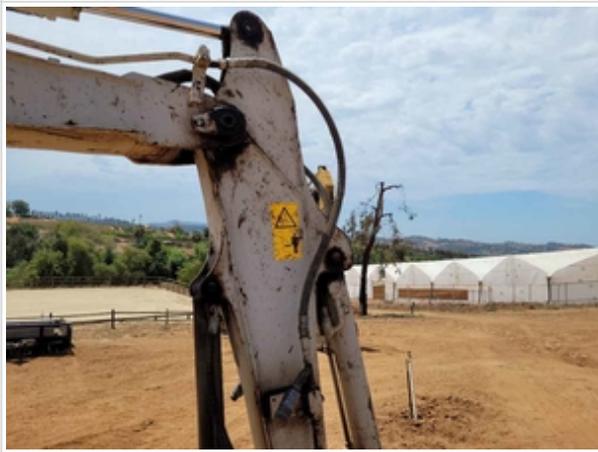
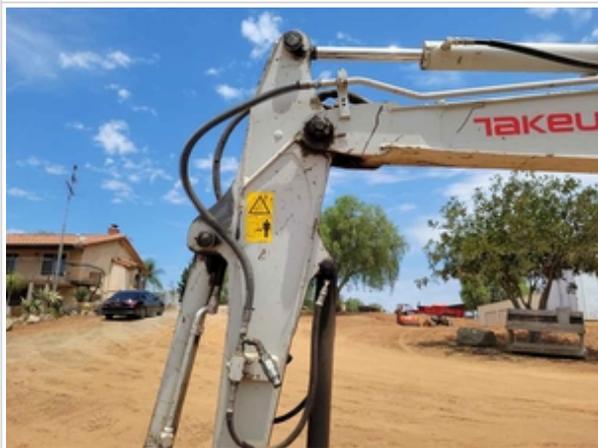
Bucket Hose & Fittings	3 - Normal Wear & Tear	
Bucket Hose & Fittings Photos

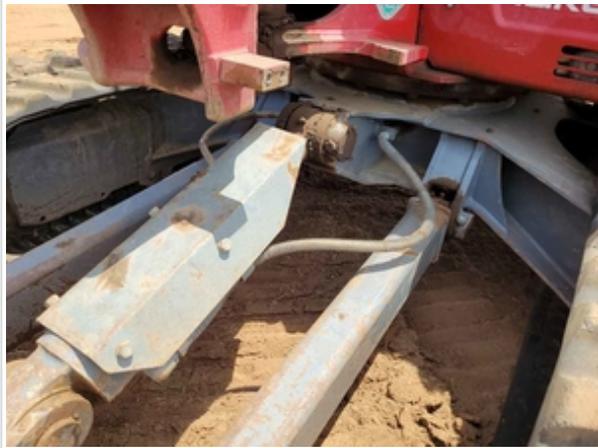
Blade Hose & Fittings Photos

Blade Condition	3 - Normal Wear & Tear
Comments	Normal wear and tear in good shape
Blade Edge	3 - Normal Wear & Tear
Blade Hose & Fittings	3 - Normal Wear & Tear

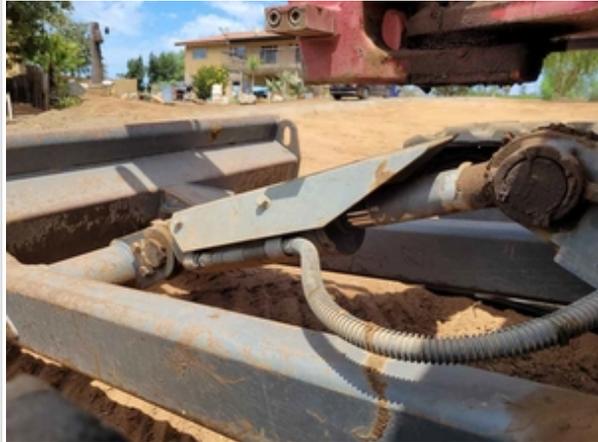
Blade Cylinder	3 - Normal Wear & Tear
Blade Cylinder Photos
