Inspection Report (Excavator)

Year	2014
Make	Takeuchi
Model	TB240
Serial Number	124000138
Hour Meter Reading	2519.7
Previous Application (e.g., earth moving, mining, demolition, etc)	Demolition

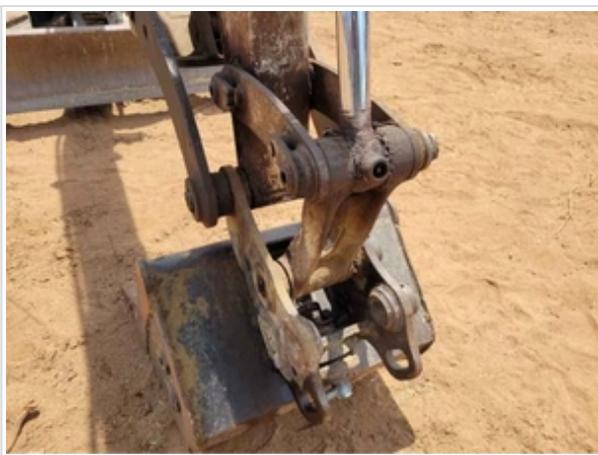
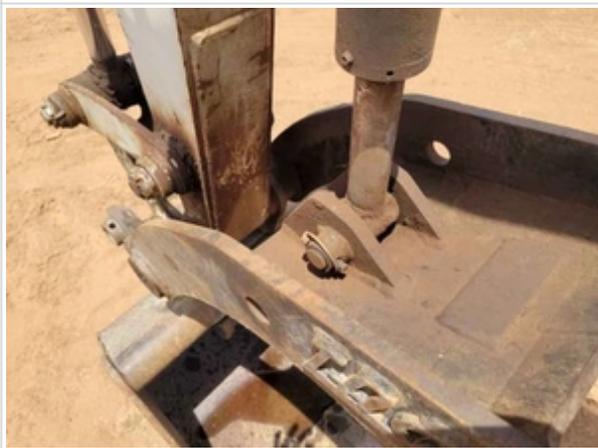
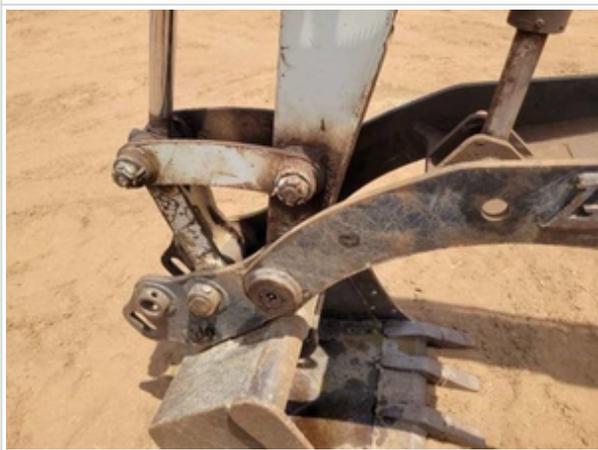
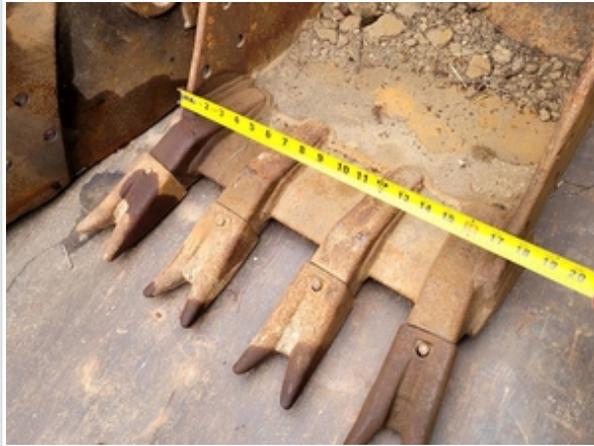
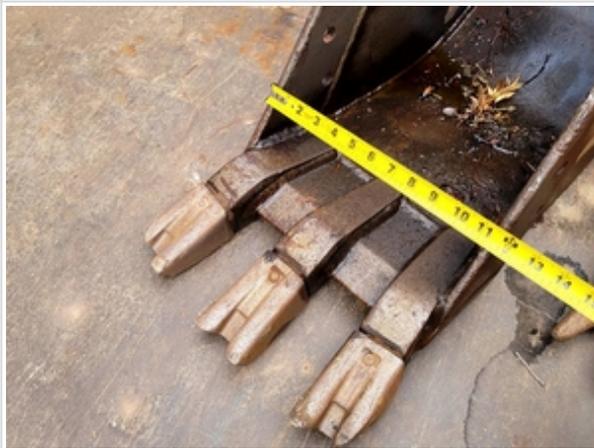
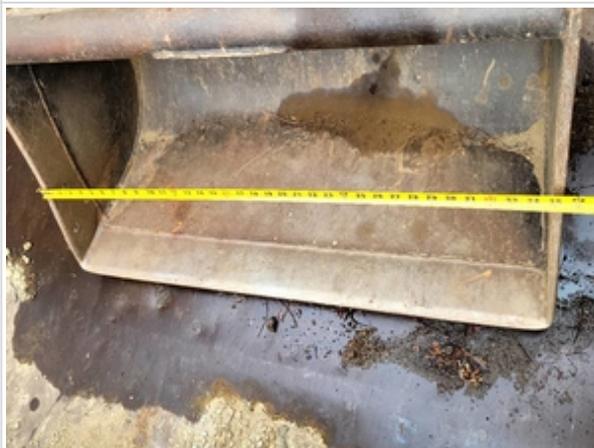
<p>Attachment Photos</p>

Attachment Type	hydraulic thumb
Attachment Size / Specs	12",18",24" and 36" buckets are included also a hydraulic breaker and a compaction wheel
Attachment Condition	3 - Normal Wear & Tear
Comments	thumb attachment functions properly, extra buckets included, compaction wheel and breaker included
