## Inspection Report (Telehandler)

Year	2022
Make	JLG/Skytrak
Model	10054
Serial Number	0160111934
Hour Meter Reading	25.0 Hours
Previous Application (e.g., earth moving, mining, demolition, etc)	Warehouse/Yard Material Handling

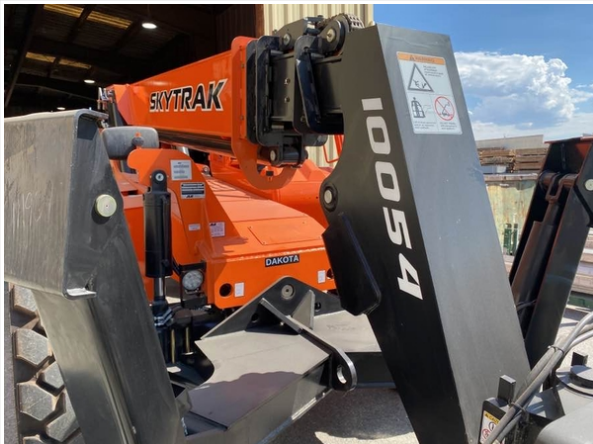
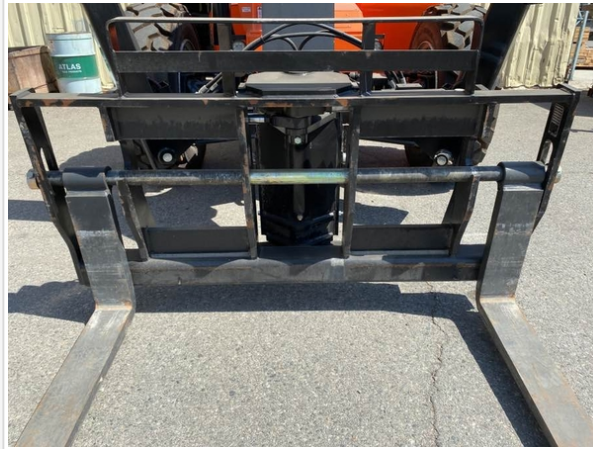
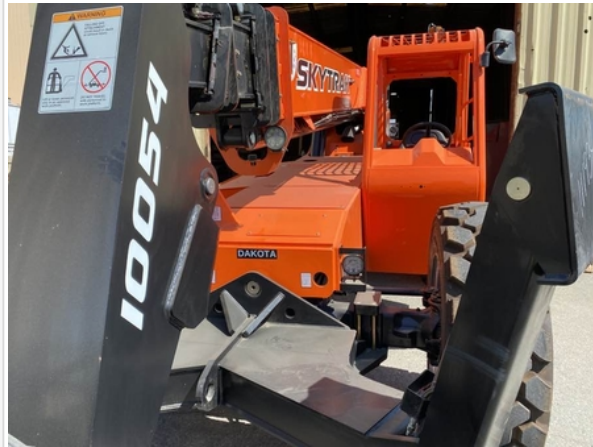
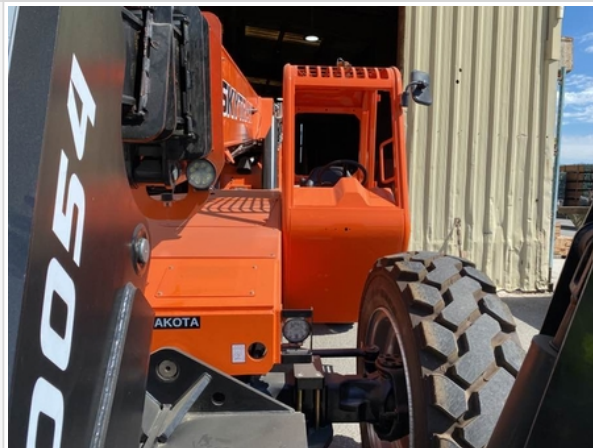
Front	4 - Like New, Recently Replaced
Front Condition	No visible damage
Front Photos

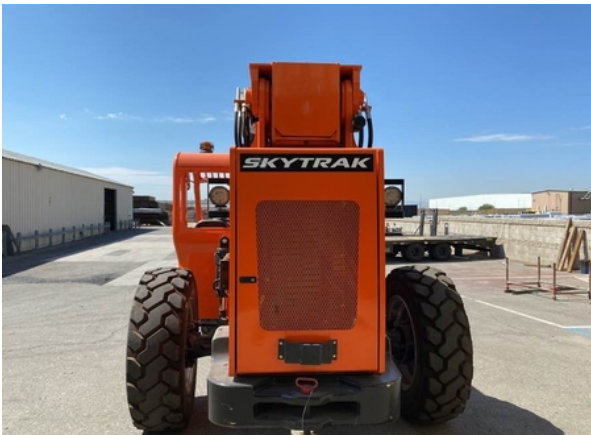
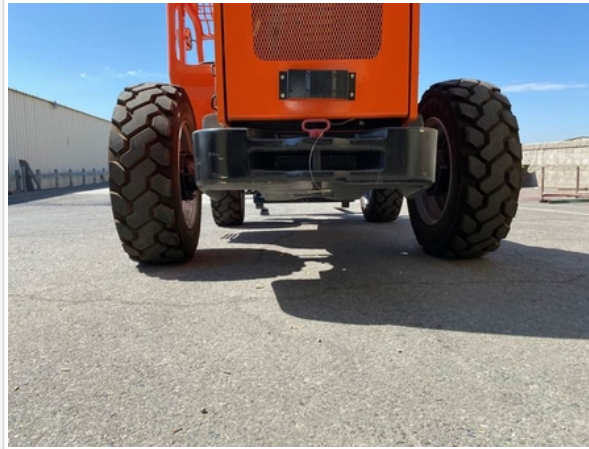
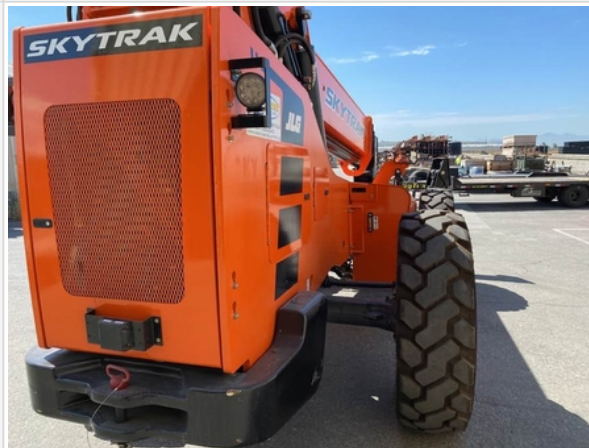
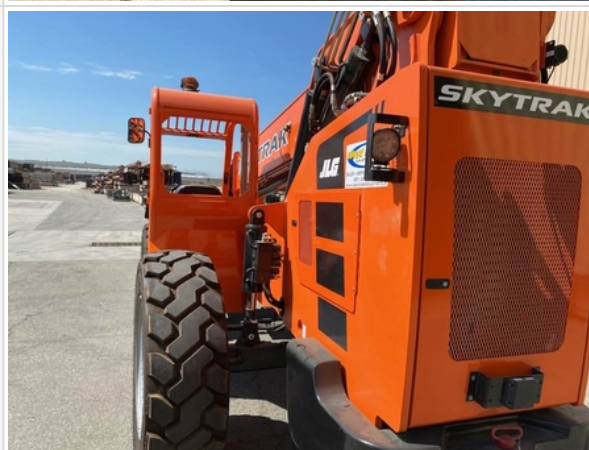
<b>Rear</b>	4 - Like New, Recently Replaced
<b>Rear Condition</b>	No visible damage, Other (see comments)
<b>Comments</b>	Very minor scuff marks on counter weight/bumper
<b>Rear Photos</b>

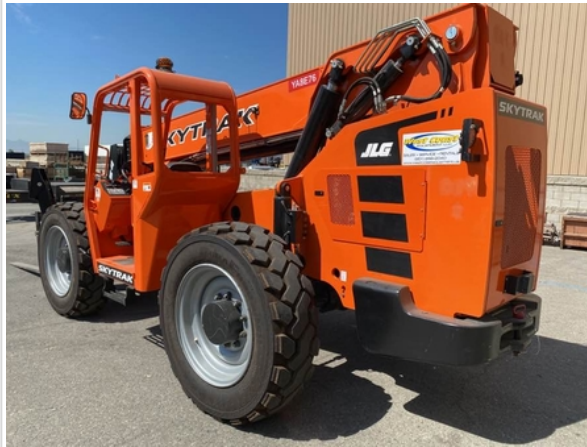
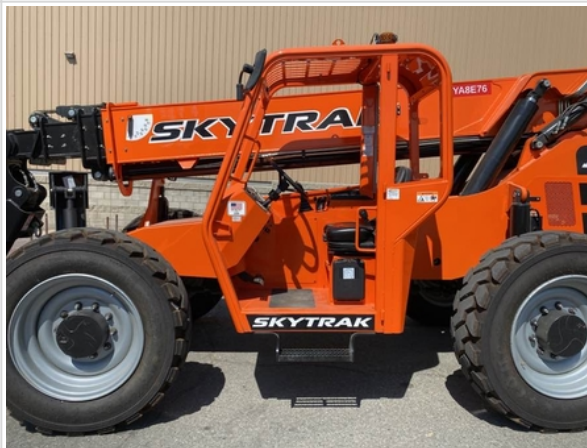
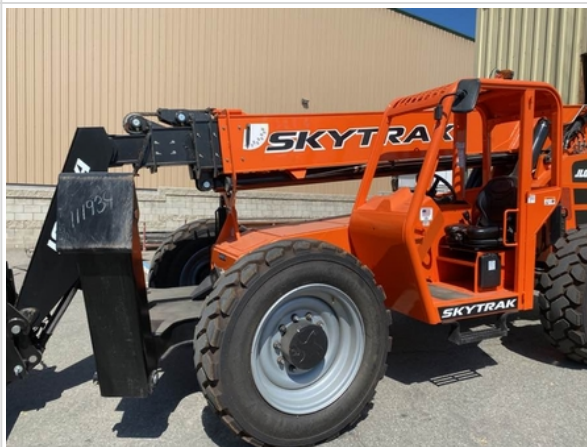
Left Photos

<p>Left</p>	<p>4 - Like New, Recently Replaced</p>

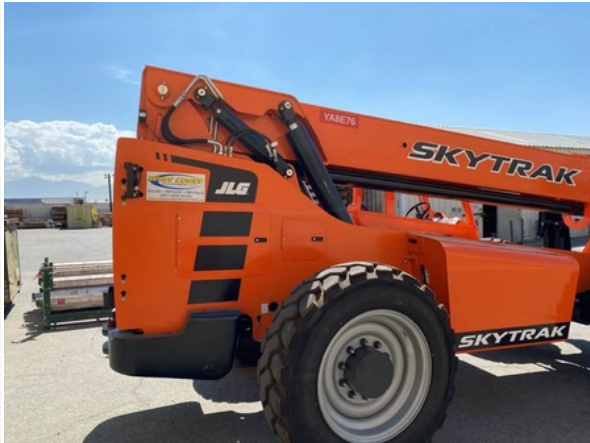
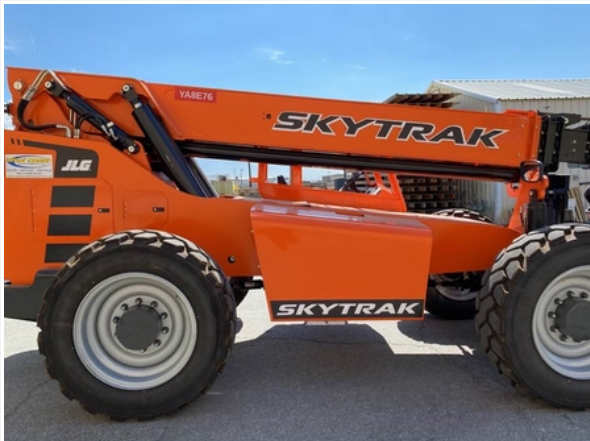
<b>Right</b>	4 - Like New, Recently Replaced	
<b>Right Condition</b>	No visible damage	
<b>Right Photos</b>

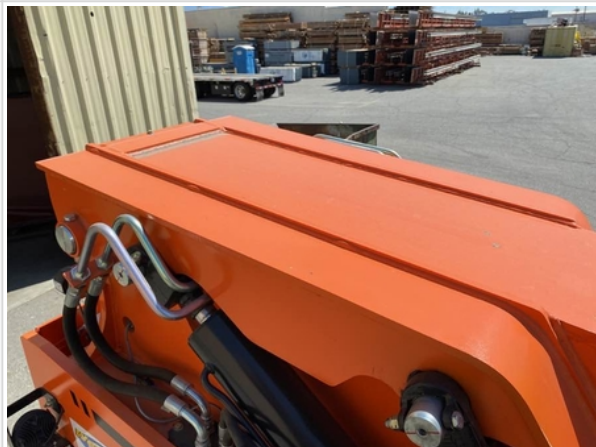
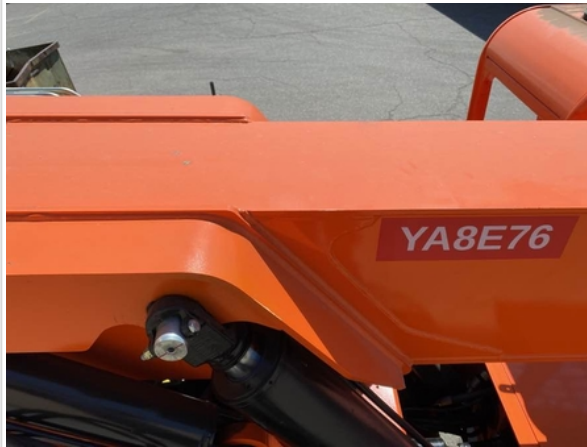
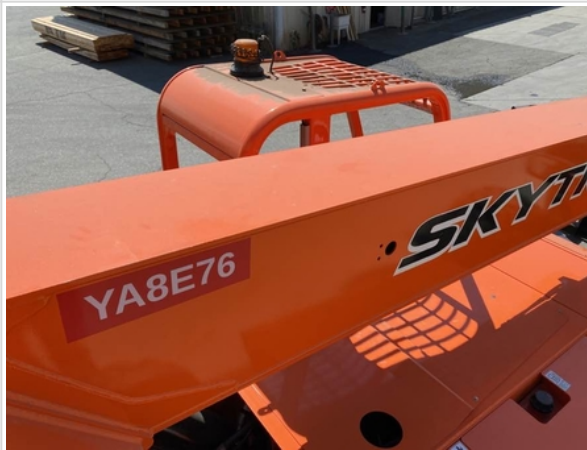
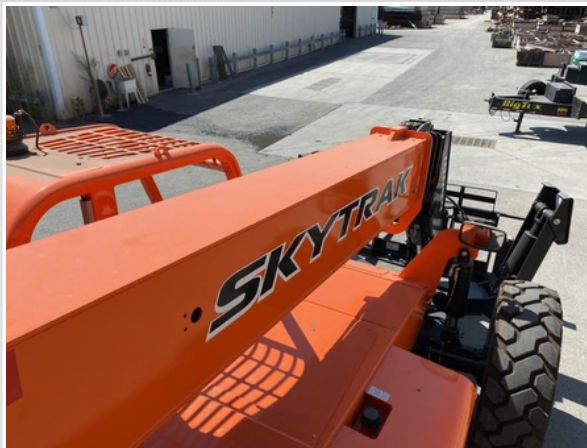
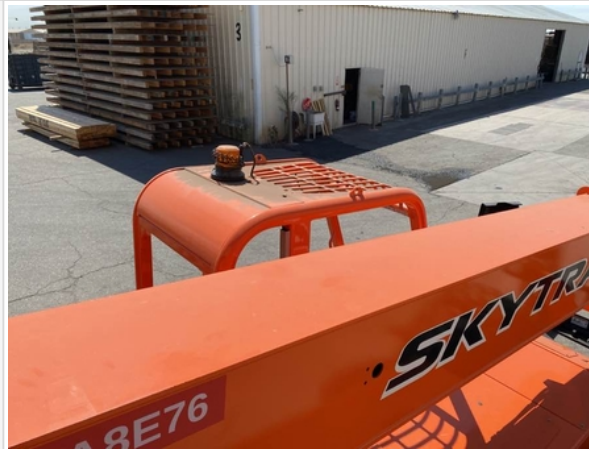
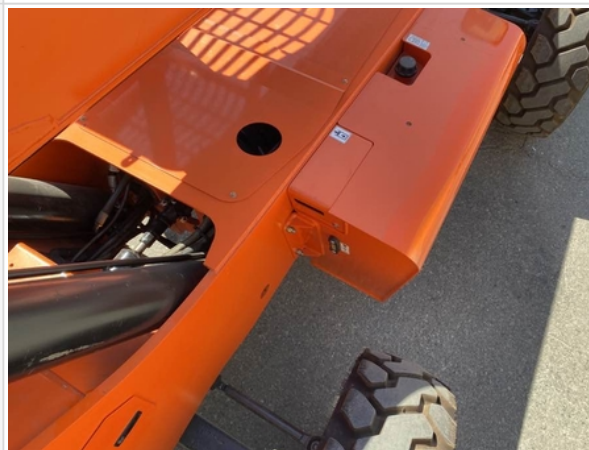
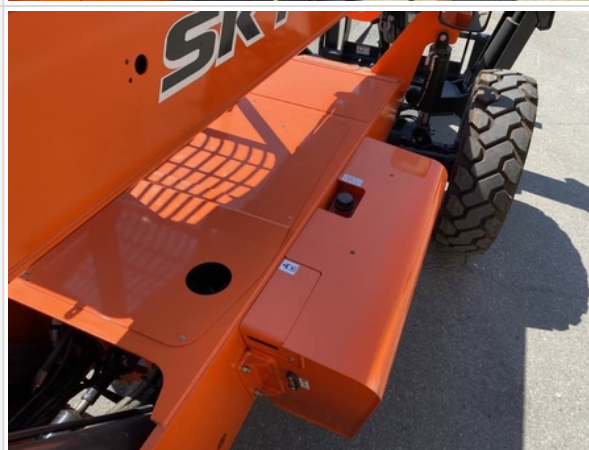
<b>Upper</b>	4 - Like New, Recently Replaced	
<b>Upper Condition</b>	No visible damage	
<b>Upper Photos</b>

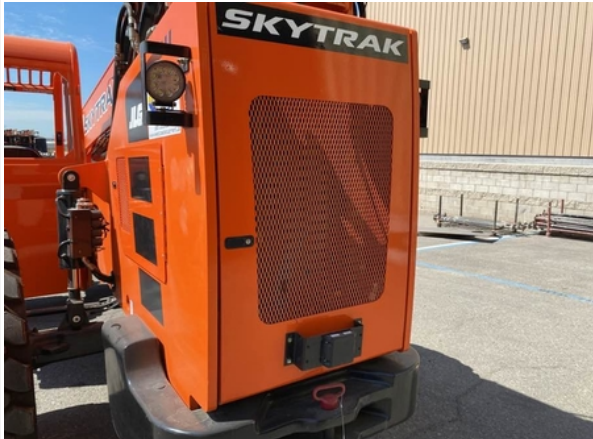
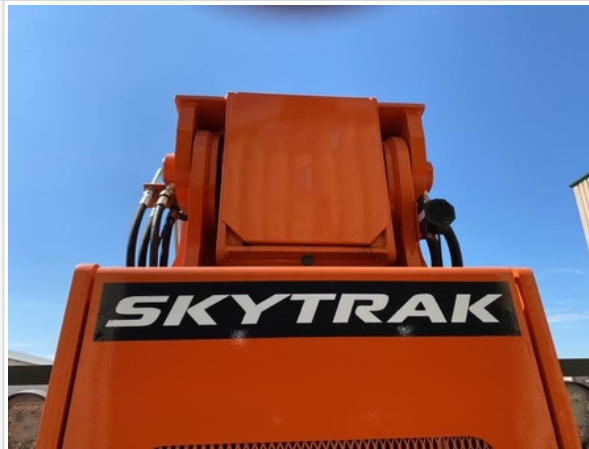
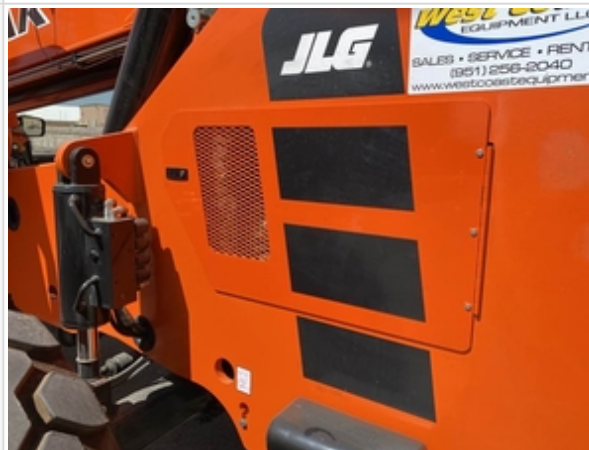
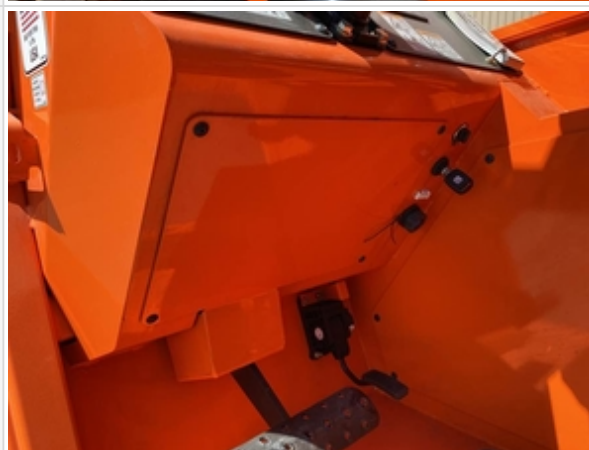
<b>Body Panels (Any Rust Damage?)</b>	4 - Like New, Recently Replaced
<b>Body Panel Condition</b>	No visible damage, good paint condition and panel fitment
<b>Body Panels Photos</b>

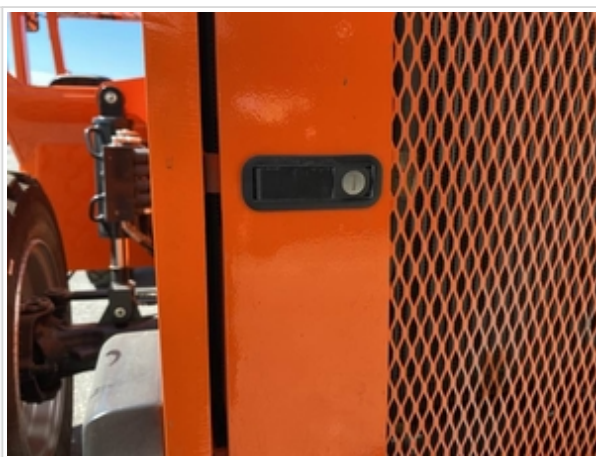
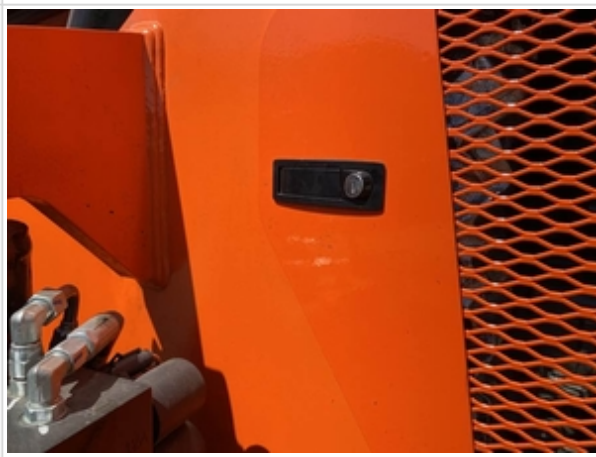
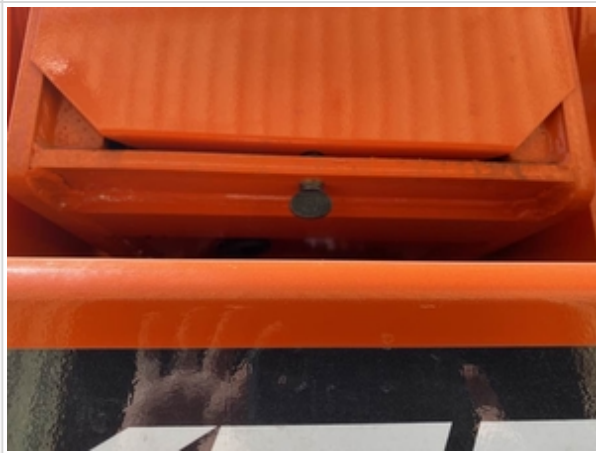
<p>Doors / Canopy Latches Photos</p>

<b>Doors / Canopy Latches</b>	4 - Like New, Recently Replaced	
<b>Doors / Canopy Latches Condition</b>	No visible damage

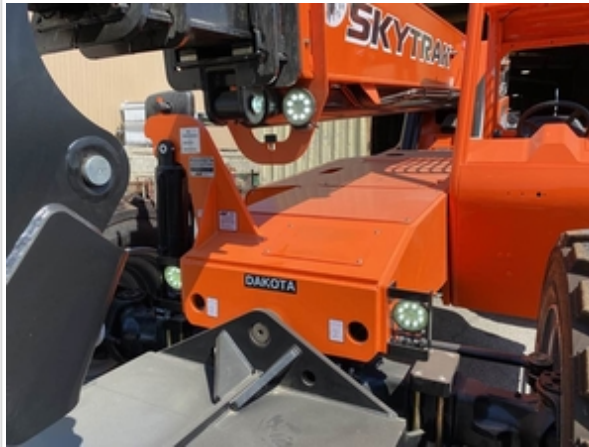
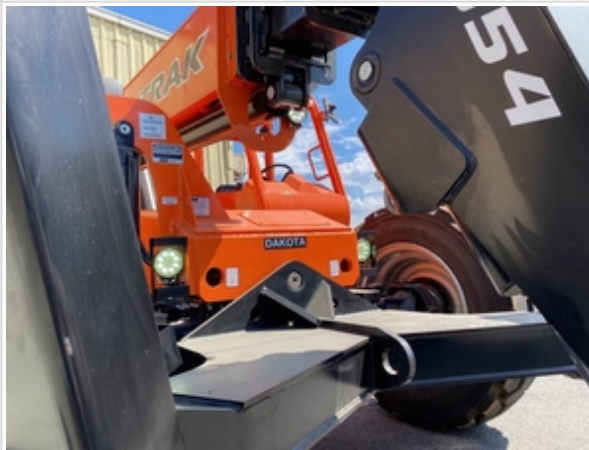
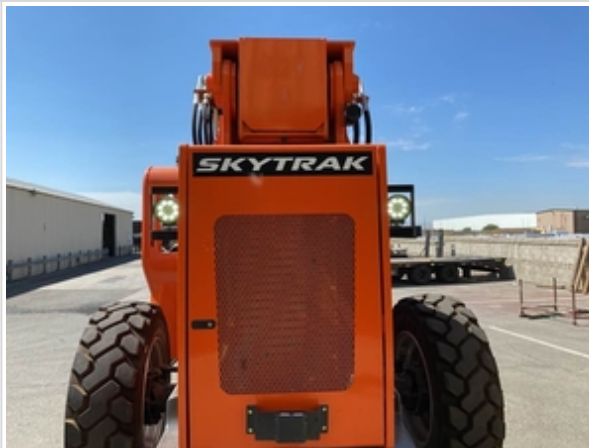
Lighting System Photos

<b>Lighting System</b>	4 - Like New, Recently Replaced	
<b>Lighting System Condition</b>	No visible damage, lighting system is operational

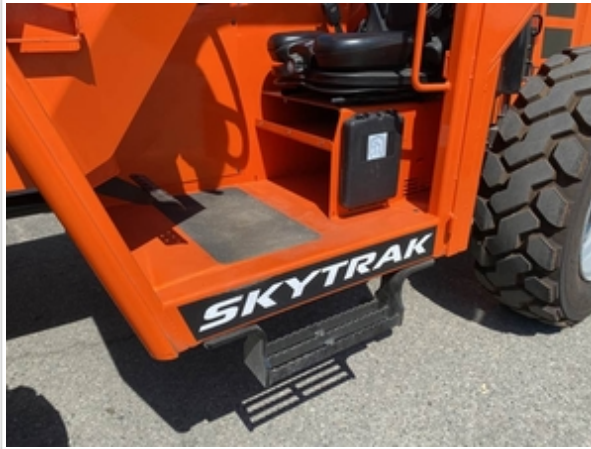
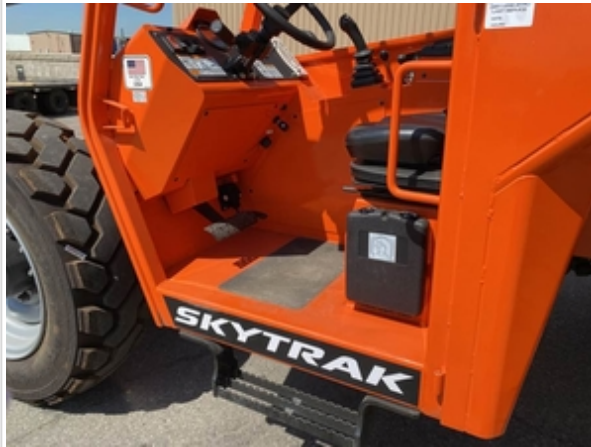
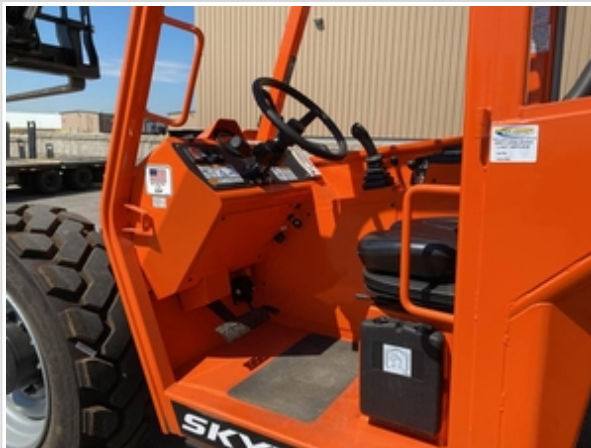
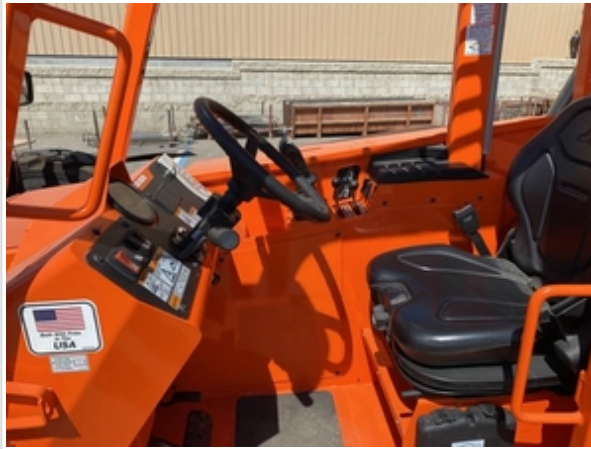
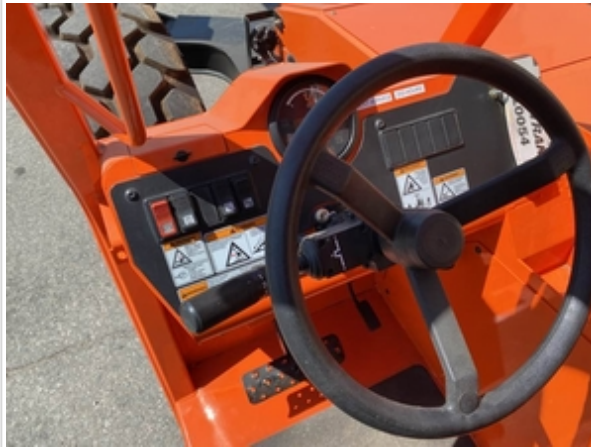
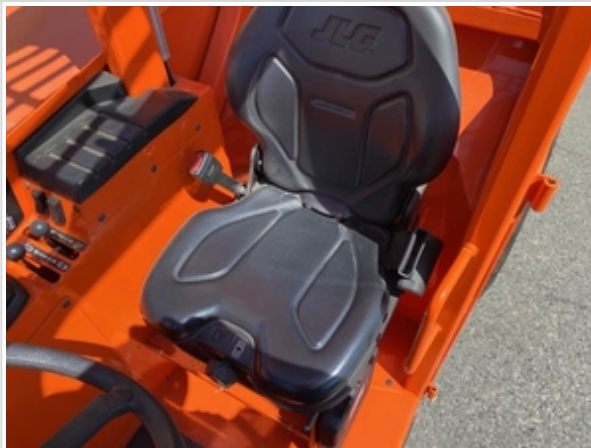
Operator Cabin Overall	4 - Like New, Recently Replaced
Operator Cabin Overall Condition	Good cabin appearance, solid floors, panels, and ceiling
Operator Cabin Photos

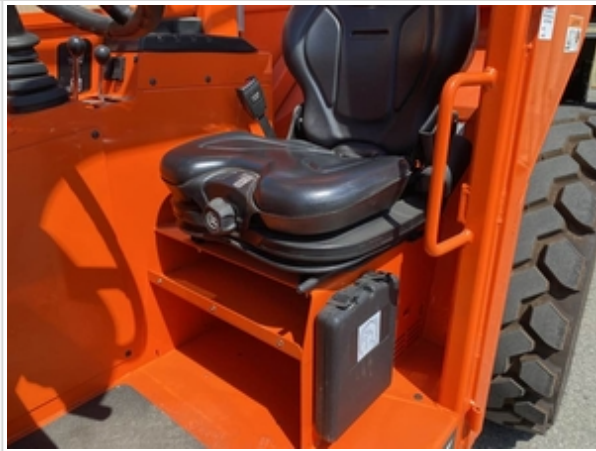
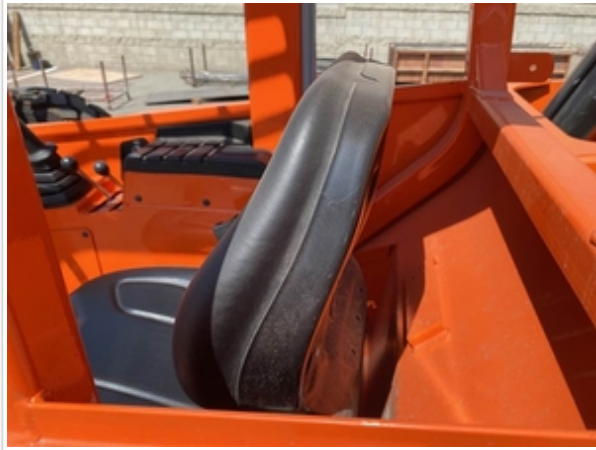
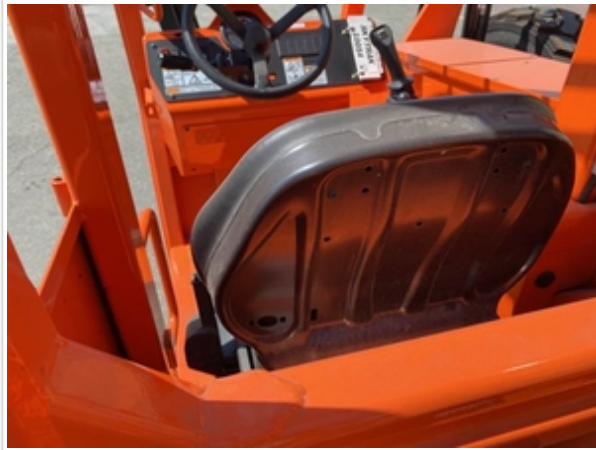
<b>Operator's Seat &amp; Arm Rests</b>	4 - Like New, Recently Replaced	
<b>Operator's Seat &amp; Arm Rests Condition</b>	Seat(s) in good condition, no stains or tears in upholstery	
<b>Operator's Seat &amp; Arm Rests Photos</b>

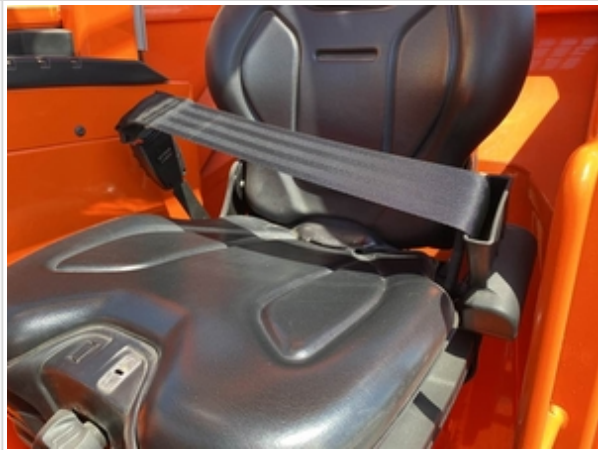
<b>Seat Belt Photos</b>

<b>Seat Belt</b>	4 - Like New, Recently Replaced
<b>Seat Belt Condition</b>	Seat belt secures properly. Belt is intact and in good condition

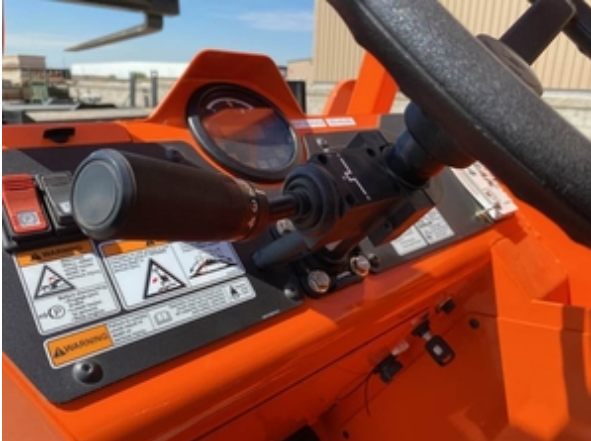
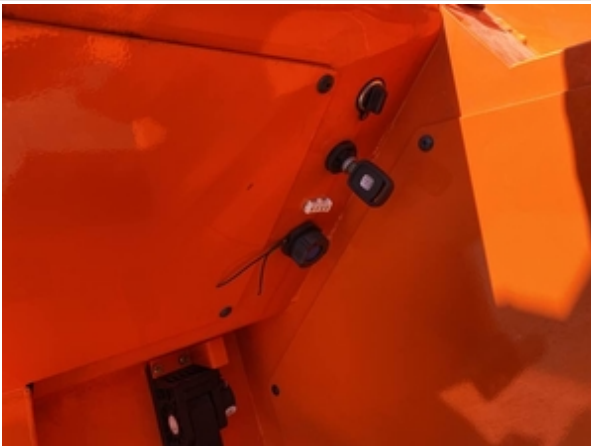
<b>Cabin Lights</b>	0	
<b>Safety Lock Out / Stop</b>	0	
<b>Controls &amp; Switches</b>	4 - Like New, Recently Replaced	
<b>Controls &amp; Switches Condition</b>	All switches are installed and functional	
<b>Controls &amp; Switches Photos</b>

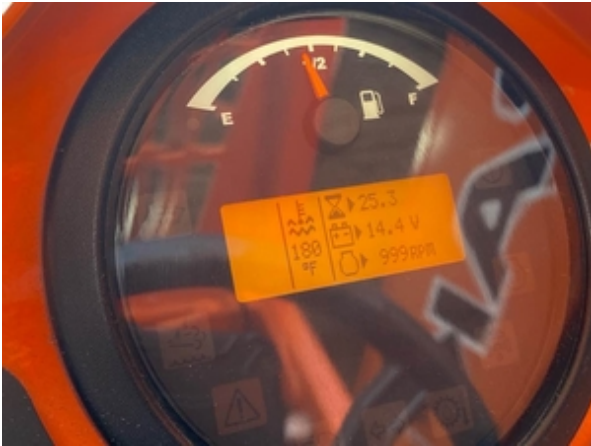
<b>Hour Meter Activity</b>	4 - Like New, Recently Replaced
<b>Hour Meter Condition</b>	Hour meter is functional and in good condition
<b>Hour Meter Activity Photos</b>

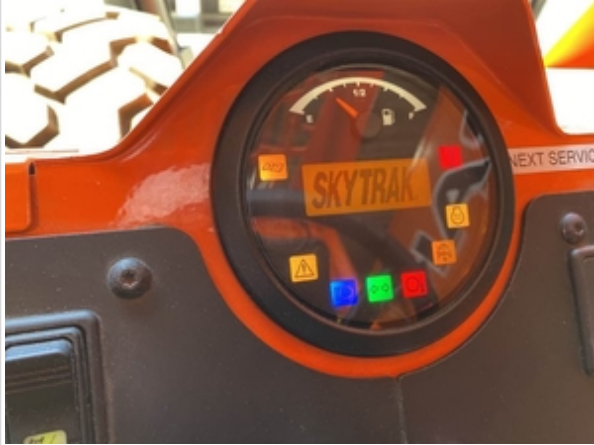
Other Gauge Activity Photos

<b>Other Gauge Activity</b>	4 - Like New, Recently Replaced
<b>Other Gauge Condition</b>	All cockpit gauges are functional and in good condition

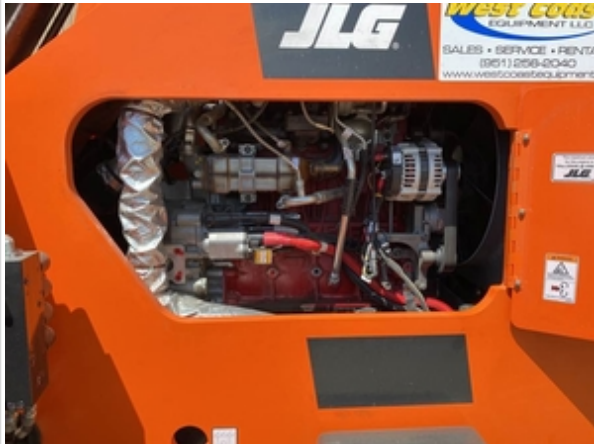
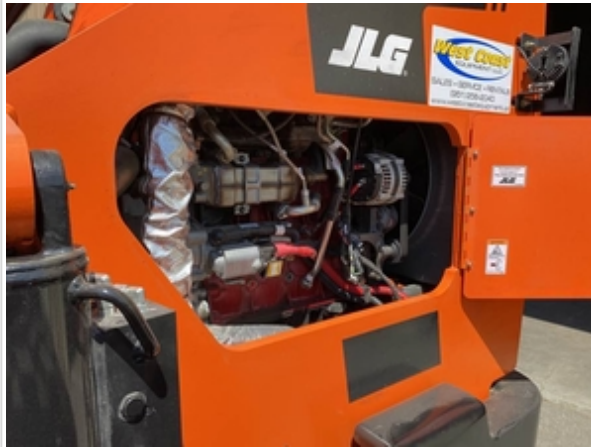
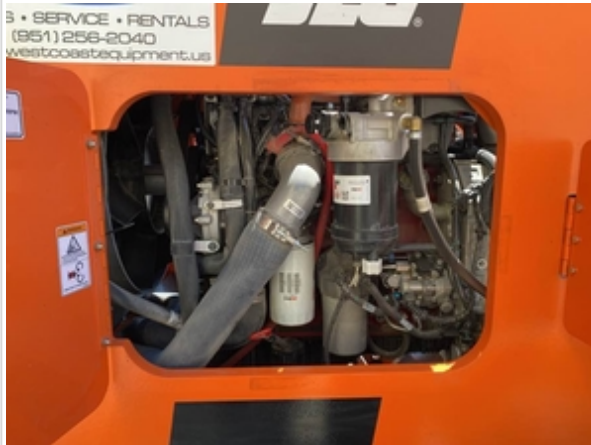
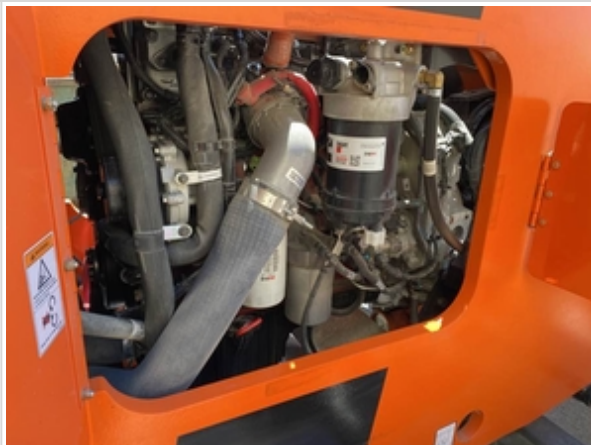
Engine Type (Make, Model, Cylinders, Hp)	Cummins - QSF 3.8 L - 4Cyl. - 74HP.
Engine Serial Number	77215265
Engine Fuel Type	Diesel
Engine Photos

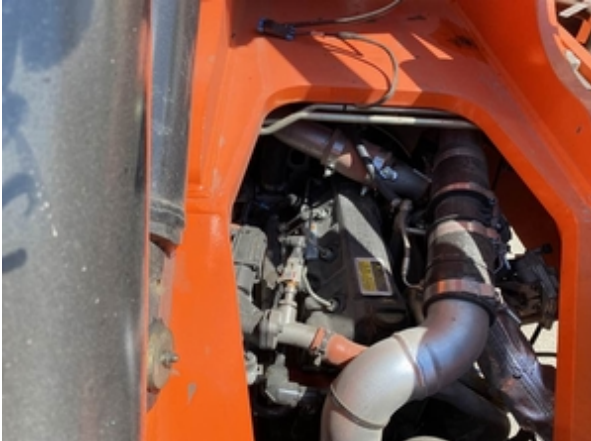
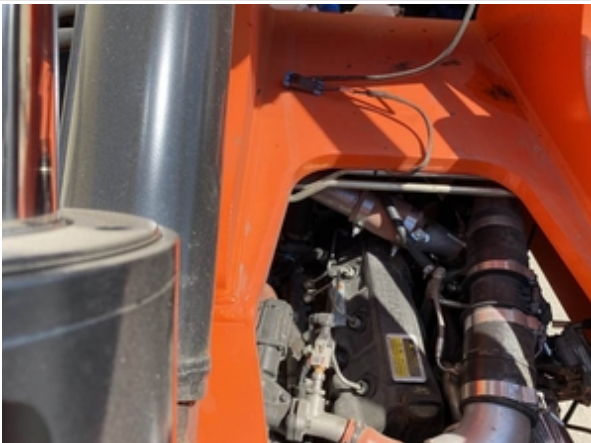
<b>Blow-by (Visual Observation Check)</b>	No
<b>Unusual Noises (Upon Start-up, Idle, Shutdown)</b>	No
<b>Unusual Noise Notes</b>	No unusual noises heard
<b>Engine Smoke (Upon Start-up, Idle, Shutdown)</b>	No
<b>Engine Smoke Notes</b>	No engine smoke issues observed
<b>Engine Exhaust Color</b>	Clear
<b>Battery</b>	4 - Like New, Recently Replaced
<b>Battery Condition</b>	Like new, recently replaced

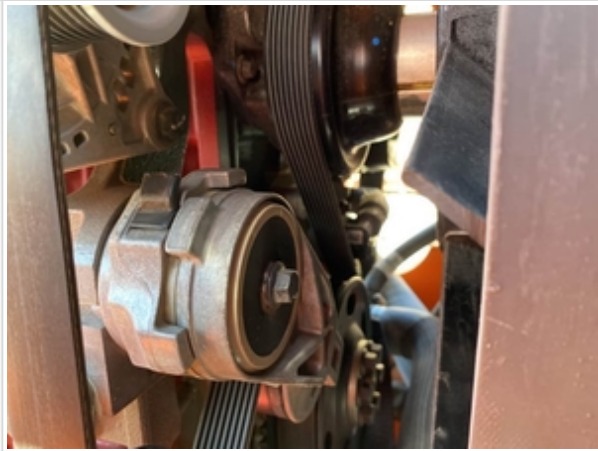
<b>Belts</b>	4 - Like New, Recently Replaced	
<b>Belt Condition</b>	Belts appear in good condition & alignment with proper tension	
<b>Belt Photos</b>

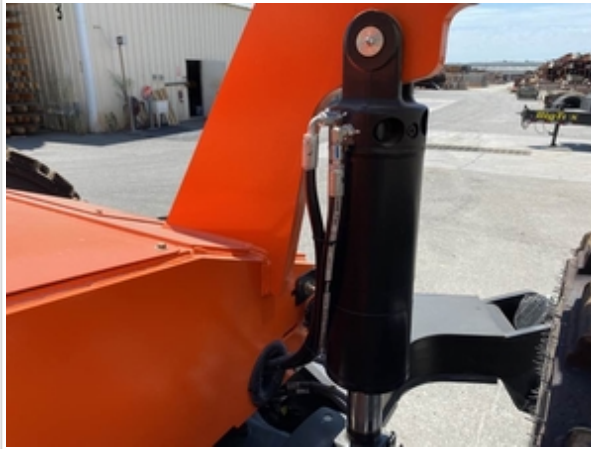
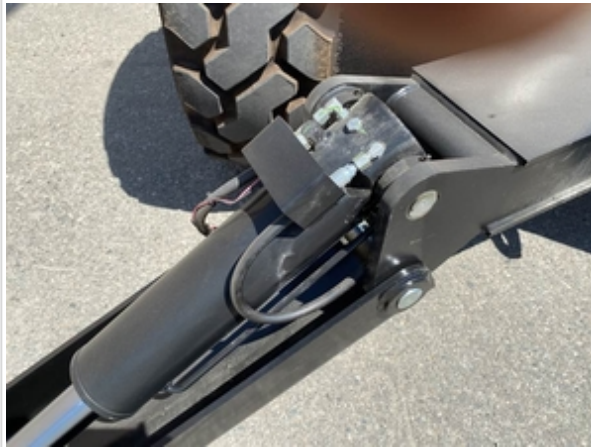
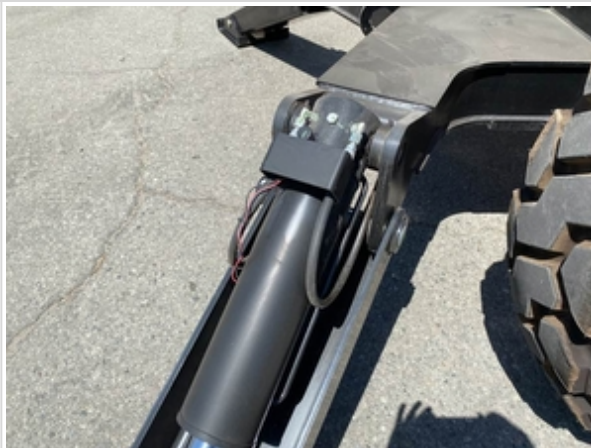
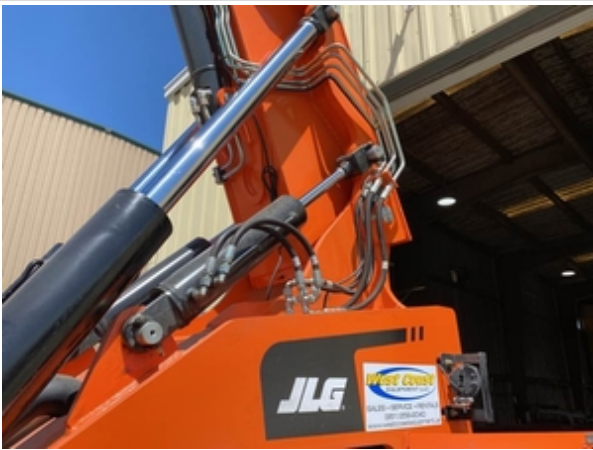
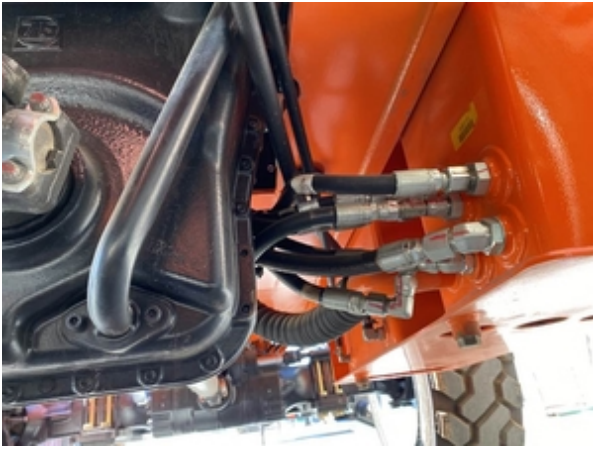
<b>Hoses</b>	4 - Like New, Recently Replaced	
<b>Hose Condition</b>	Firm, pliant hoses with no signs of wear or leaks	
<b>Hose Photos</b>

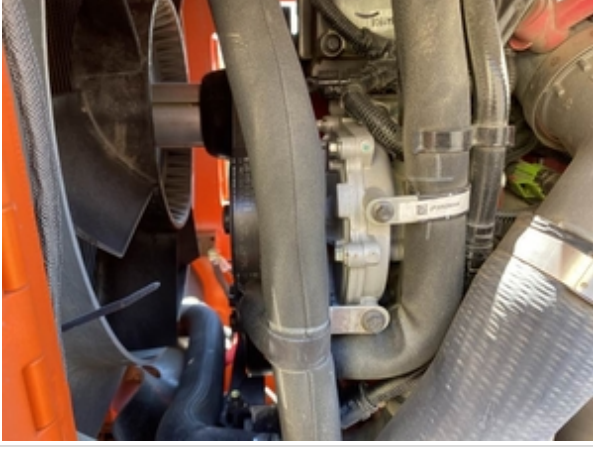
<b>Water Pump</b>	4 - Like New, Recently Replaced	
<b>Water Pump Condition</b>	No unusual pump noises heard	
<b>Water Pump Photos</b>

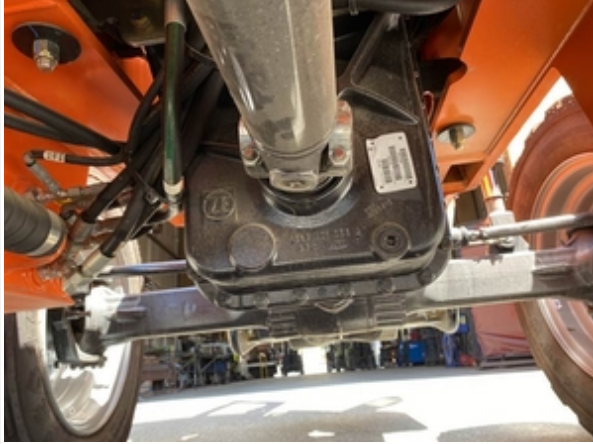
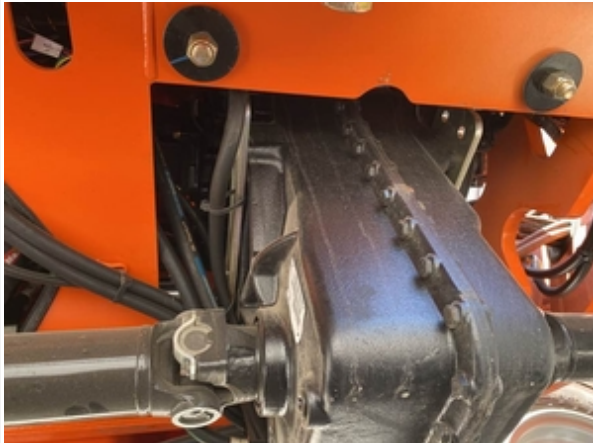
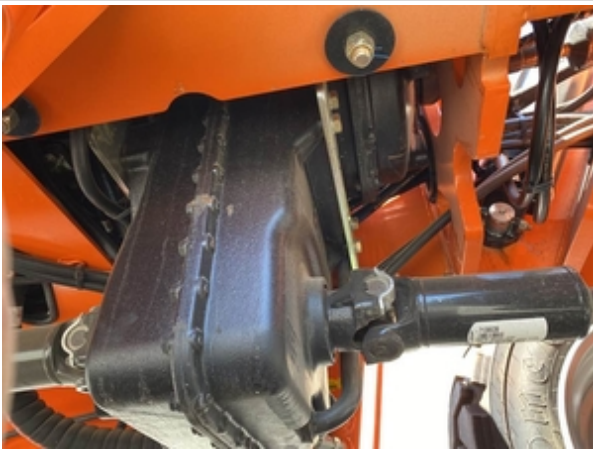
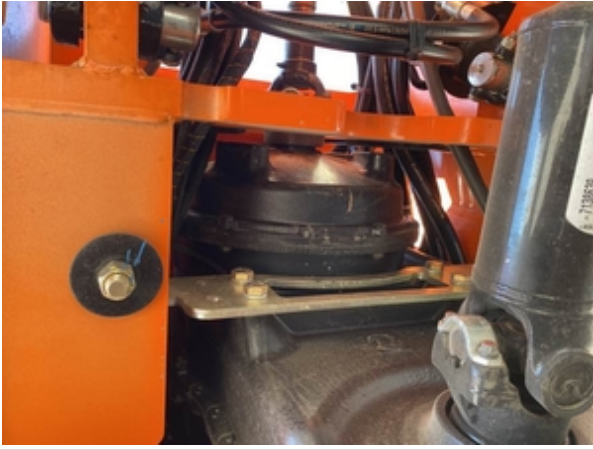
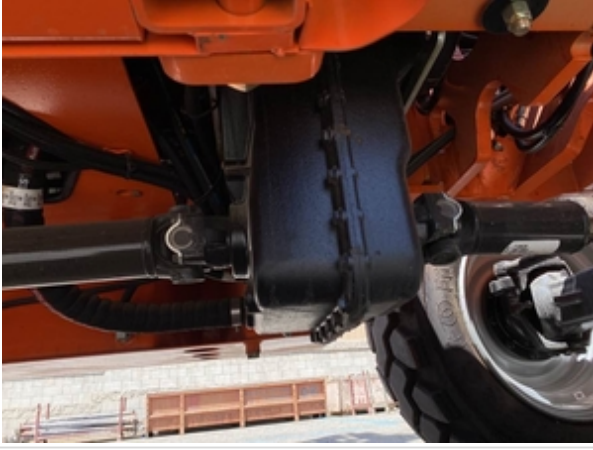
Transmission Info	4 speed, F.N.R., ZF power shift transmission
Transmission	4 - Like New, Recently Replaced
Transmission Condition	No unusual noises or vibrations
Transmission Photos

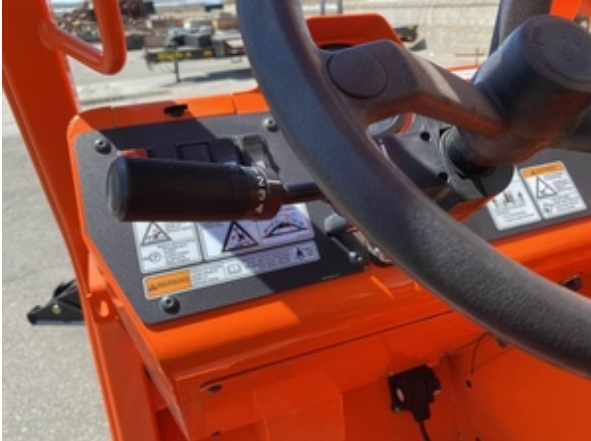
Shift Level Photos

<b>Clutch</b>	0	
<b>Shift Lever</b>	4 - Like New, Recently Replaced	
<b>Shift Lever Condition</b>	Good forward and reverse function

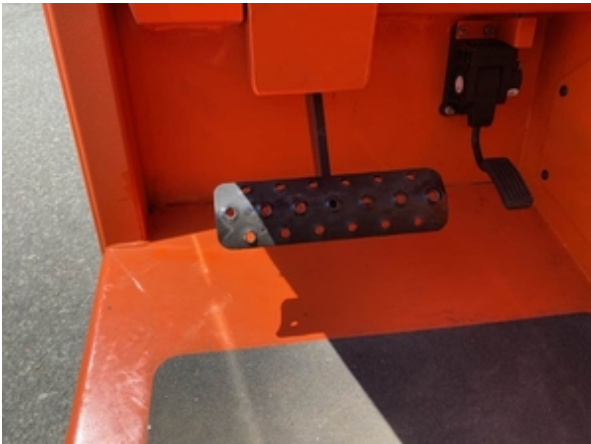
Foot Brake	4 - Like New, Recently Replaced
Foot Brake Condition	Good brake function
Foot Brake Photos

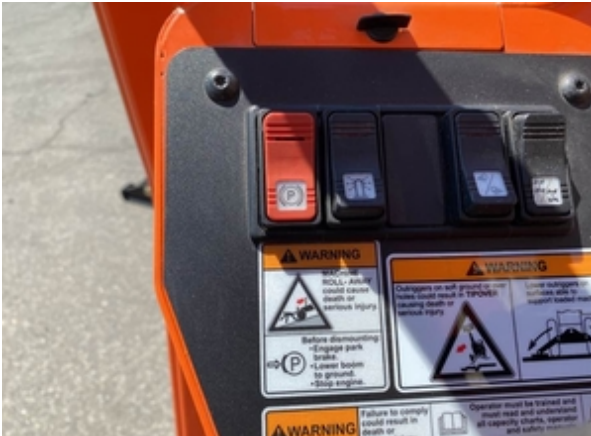
Inching Brake	0
Parking Brake	4 - Like New, Recently Replaced
Parking Brake Condition	Good brake function
Parking Brake Photos

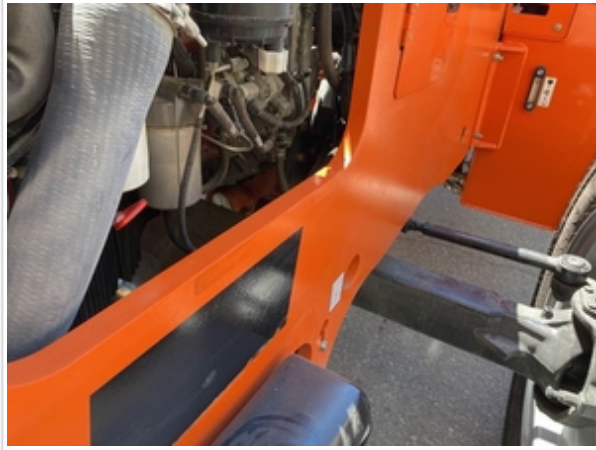
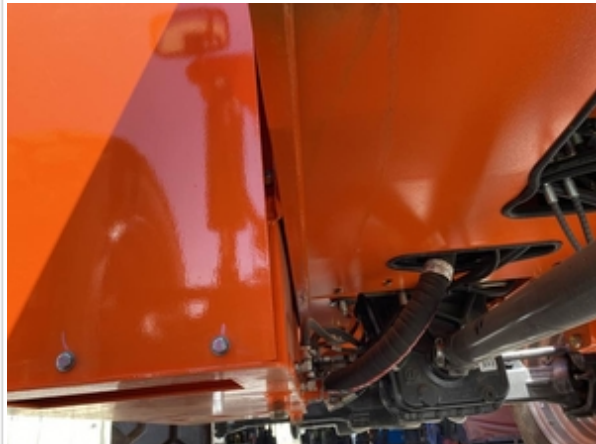
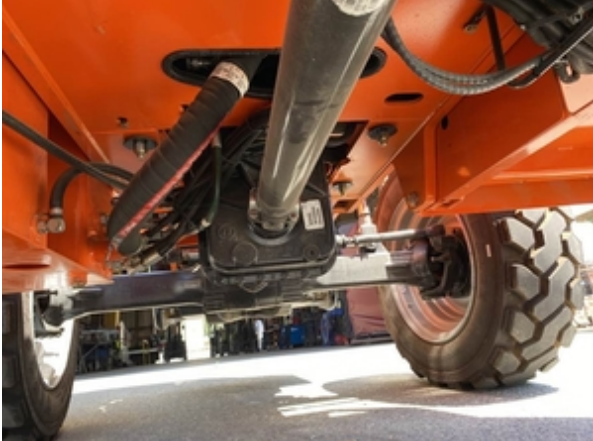
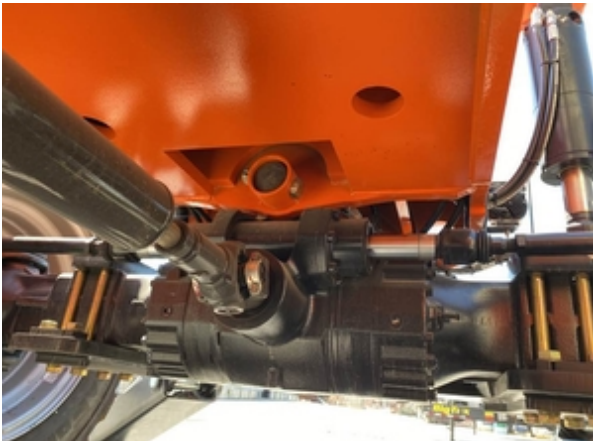
<b>Instructions</b>	Evaluate the following on a 4 point scale (leave comments where an explanation is appropriate):  4 = Like New, Recently Replaced 3 = Normal Wear & Tear 2 = Above Average Wear 1 = Service Required
<b>Frame</b>	4 - Like New, Recently Replaced
<b>Frame Photos</b>

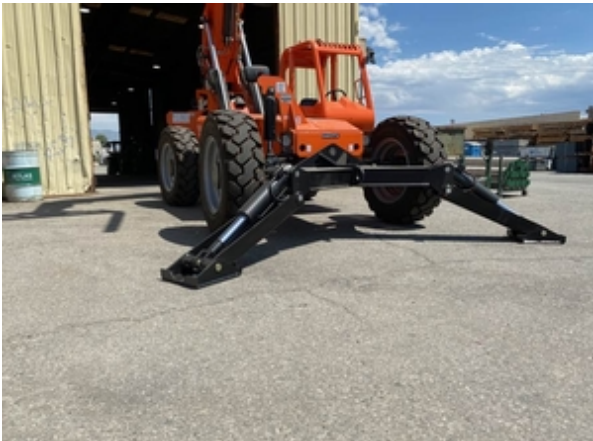
<b>Stance</b>	4 - Like New, Recently Replaced
<b>Stance Photos</b>

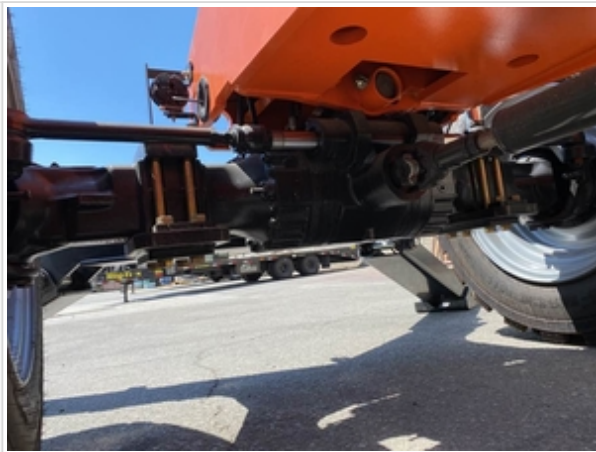
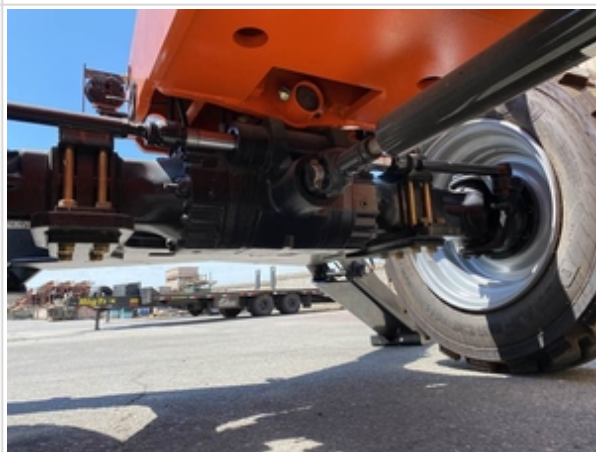
Front Axle Appearance Photos

<b>Front Axle Appearance</b>	4 - Like New, Recently Replaced

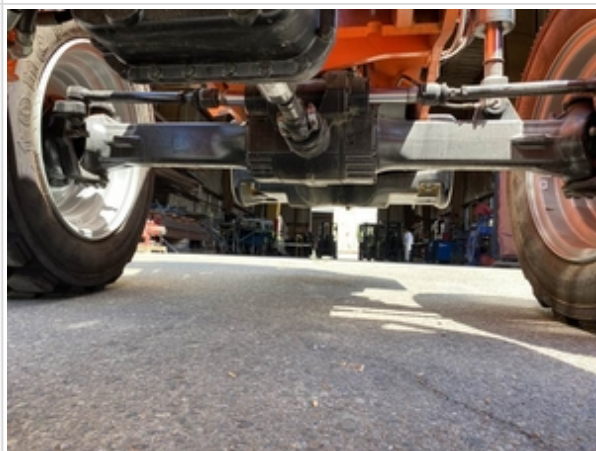
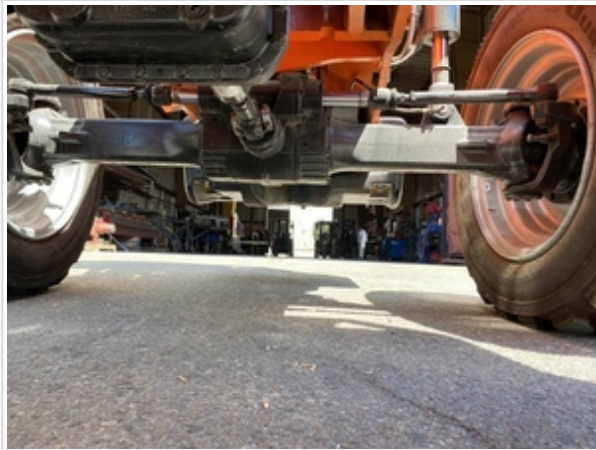
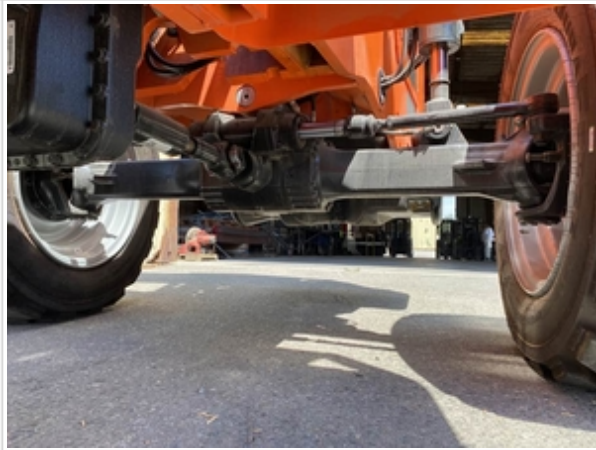
Rear Axle Appearance	4 - Like New, Recently Replaced	
Rear Axle Appearance Photos

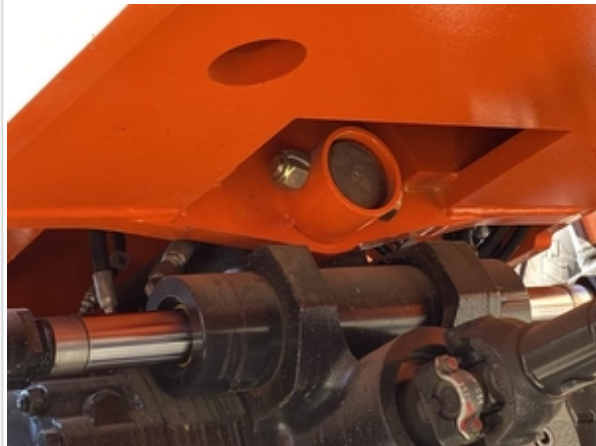
<p><b>Oscillating Pin Appearance</b></p>	<p>4 - Like New, Recently Replaced</p>	
<p><b>Oscillating Pin Appearance Photos</b></p>

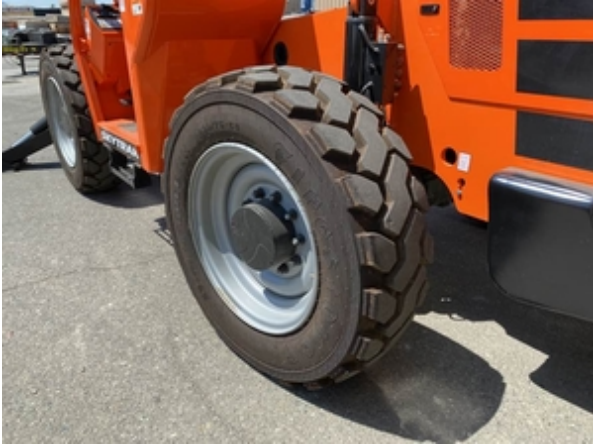
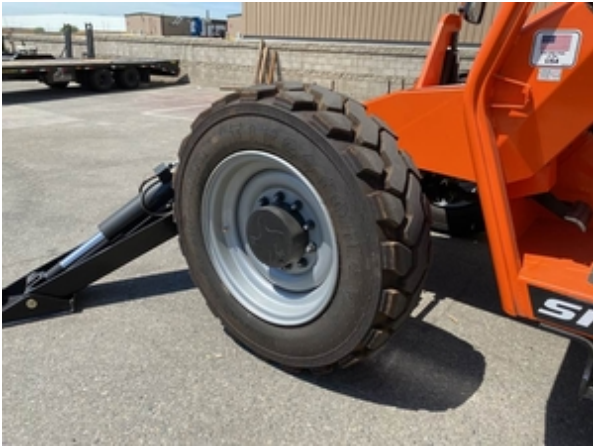
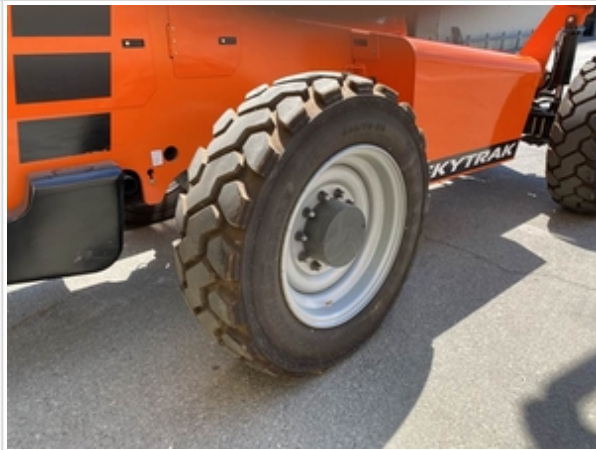
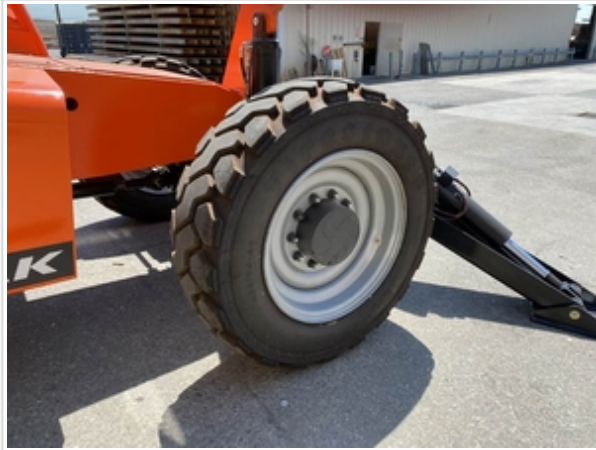
<b>Wheels &amp; Tires</b>	4 - Like New, Recently Replaced	
<b>Comments</b>	New	
<b>Wheels &amp; Tires Photos</b>

<b>Tire Brand</b>	Firestone Duraforce MH
<b>Tire Size</b>	400/75 -28
<b>Front Left Tire - Ratio Remaining</b>	90%
<b>Rear Left Tire - Ratio Remaining</b>	90%
<b>Front Right Tire - Ratio Remaining</b>	90%
<b>Rear Right Tire - Ratio Remaining</b>	90%
<b>Boom Condition</b>	4 - Like New, Recently Replaced
<b>Comments</b>	Tires above 90%
