## Inspection Report (Telehandler)

Year	2022
Make	JLG/Skytrak
Model	10054
Serial Number	0160111934
Hour Meter Reading	25.0 Hours
Previous Application (e.g., earth moving, mining, demolition, etc)	Warehouse/Yard Material Handling

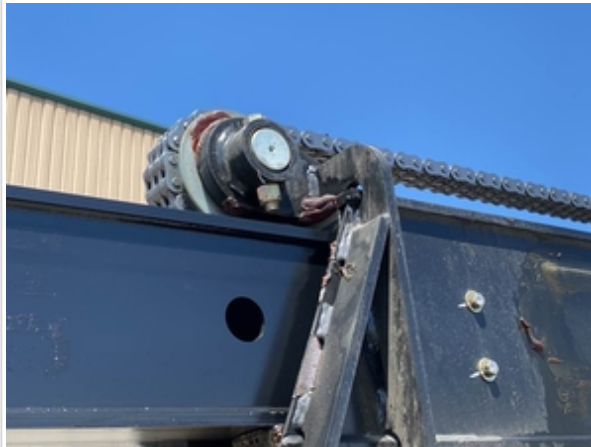
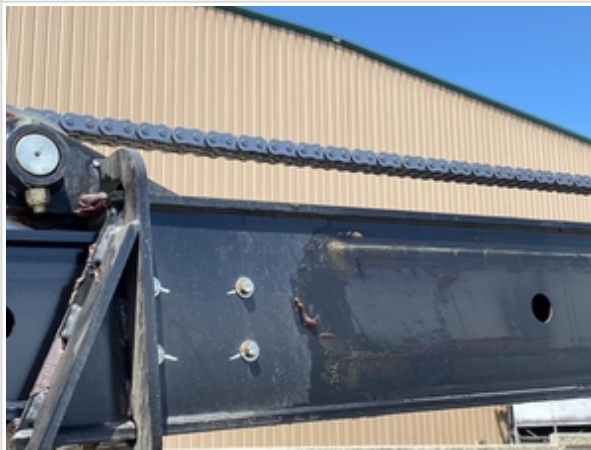
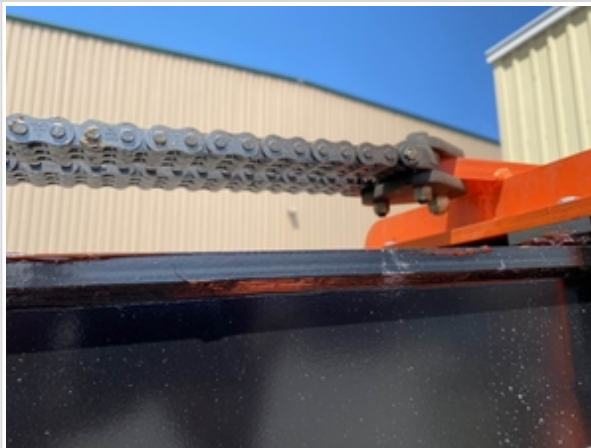
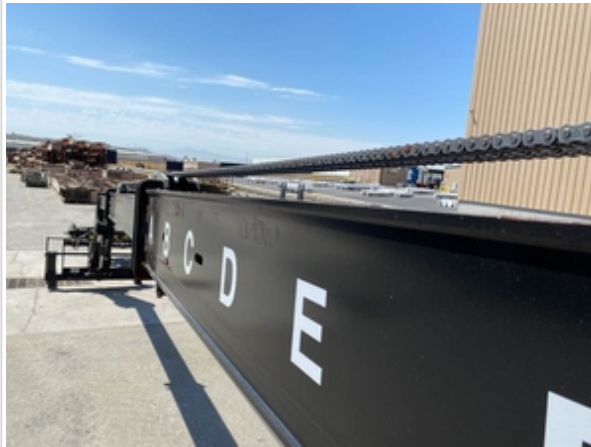
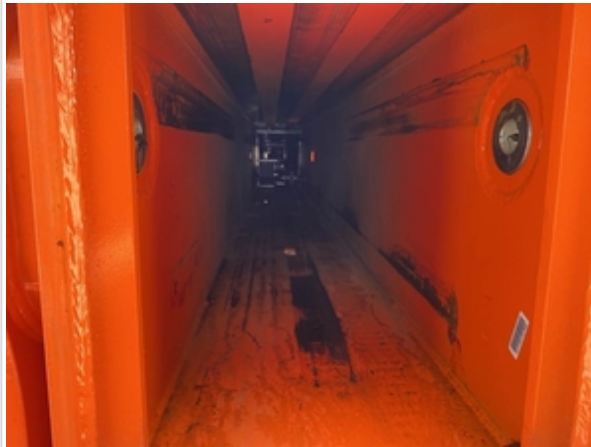
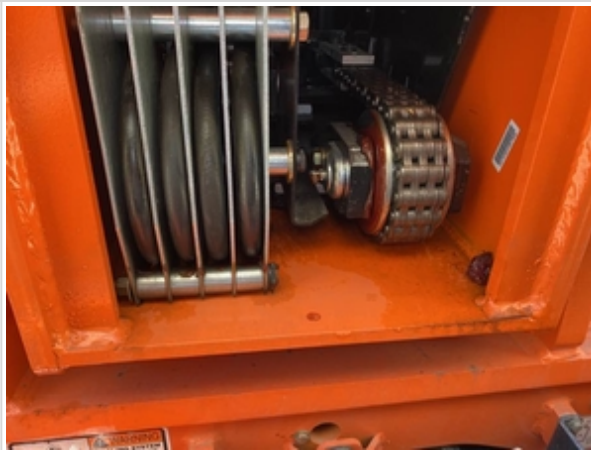
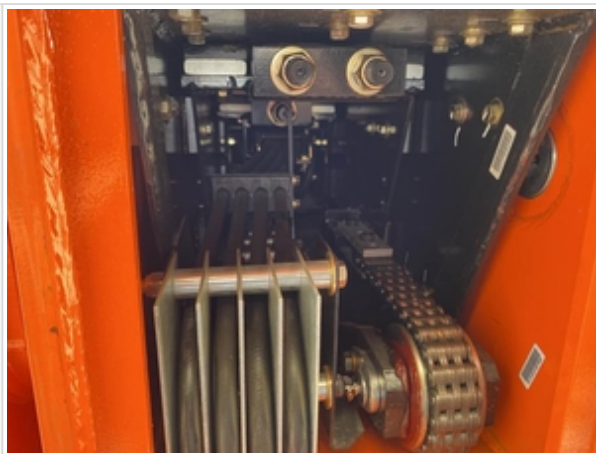
Chain / Tensioners Photos

<p><b>Chain / Tensioners</b></p>	<p>4 - Like New, Recently Replaced</p>

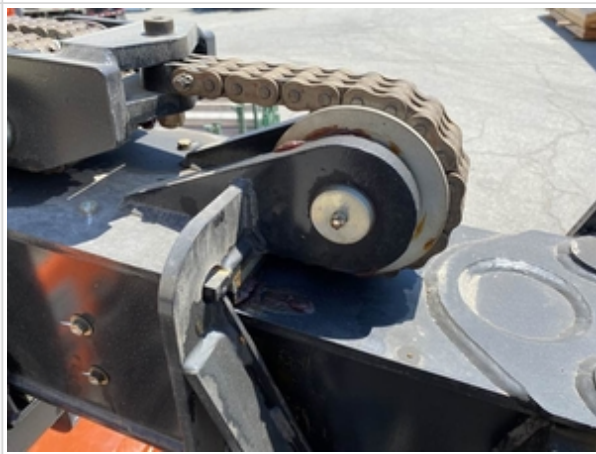
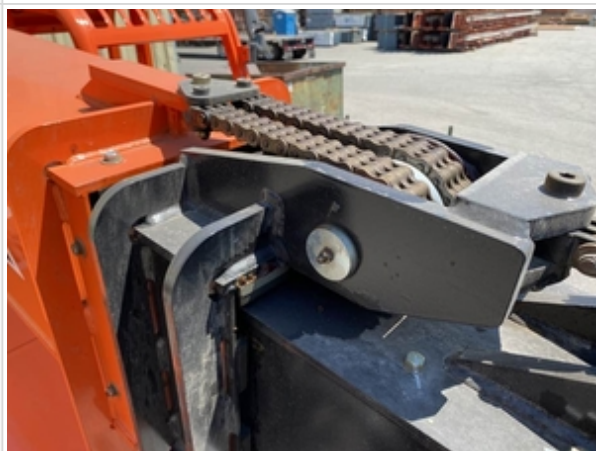
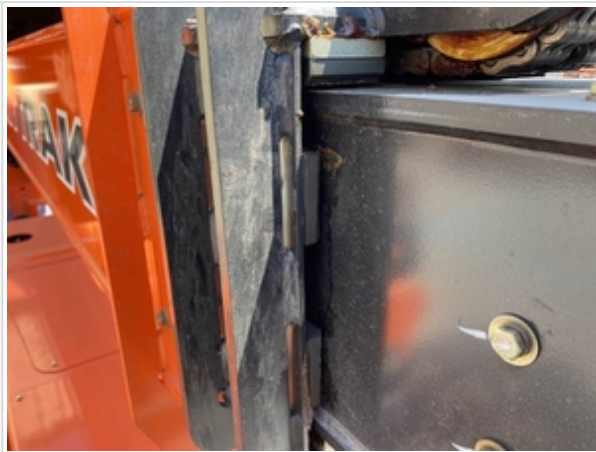
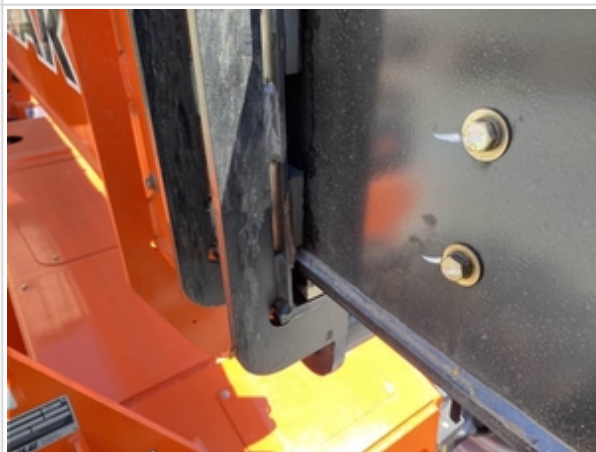
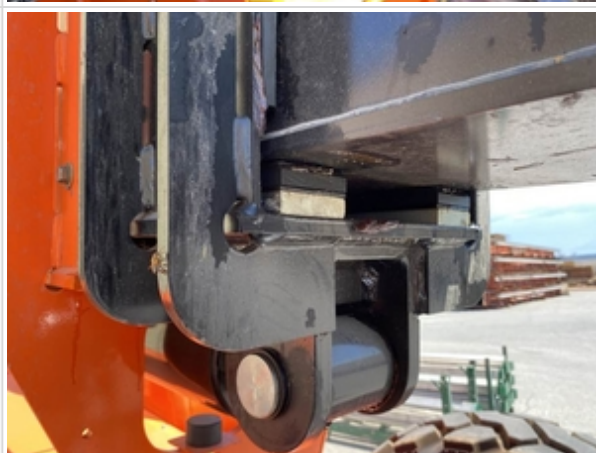
<p><b>Rollers &amp; Guides</b></p>	<p>4 - Like New, Recently Replaced</p>	
<p><b>Rollers &amp; Guides Photos</b></p>

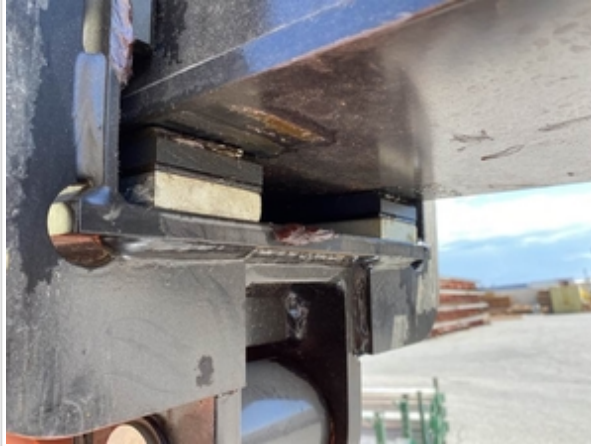
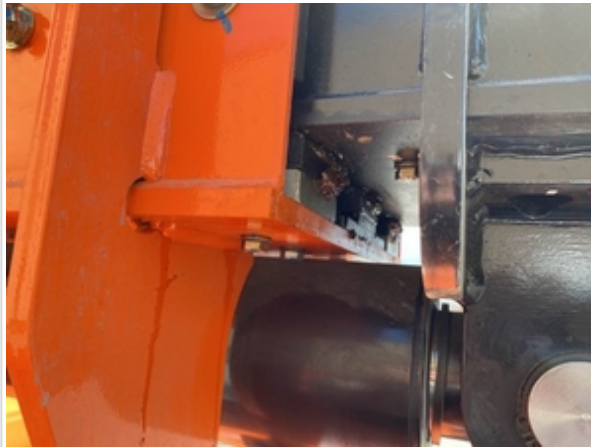
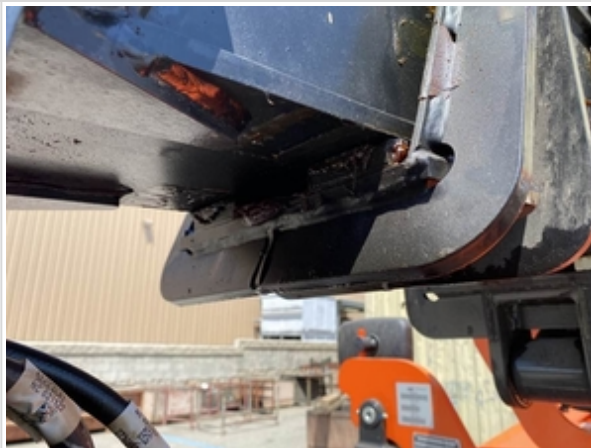
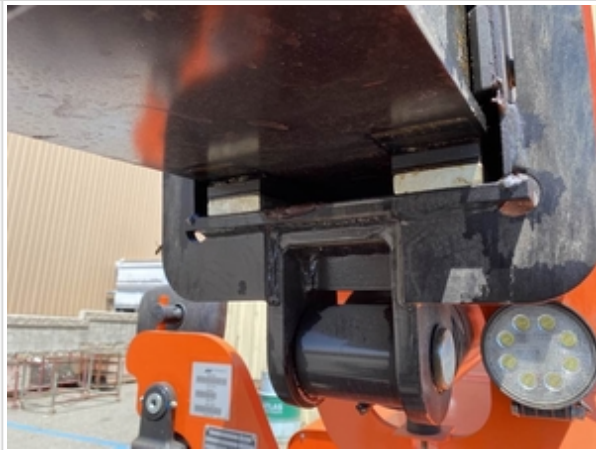
Boom Wear Guides Photos

<p><b>Boom Wear Guides</b></p>	<p>4 - Like New, Recently Replaced</p>

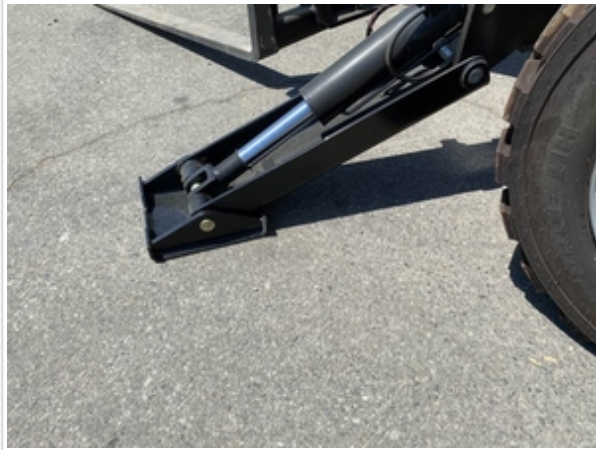
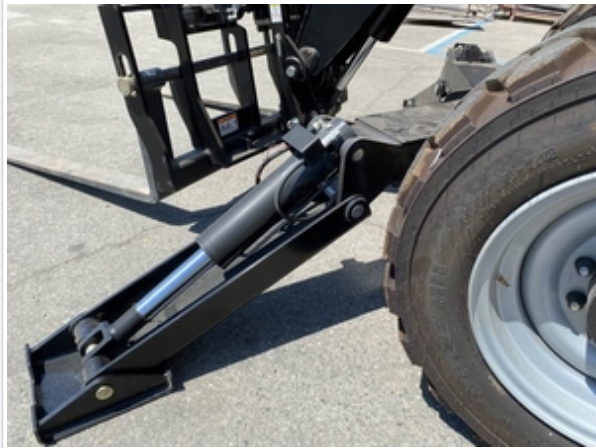
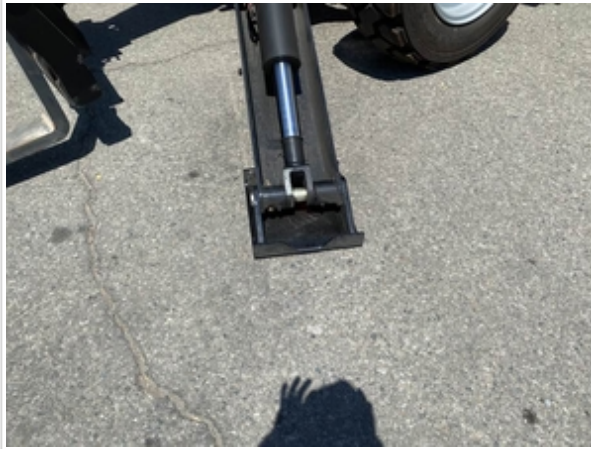
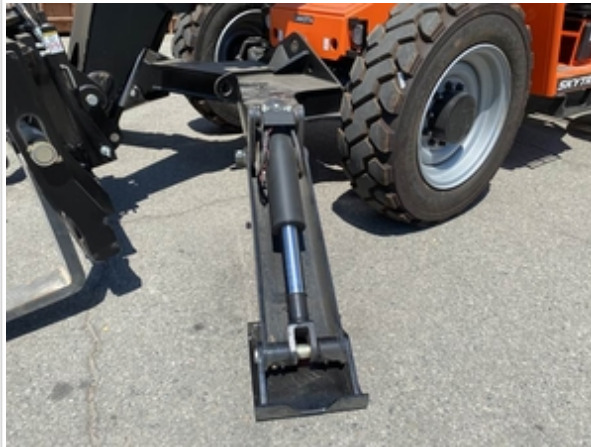
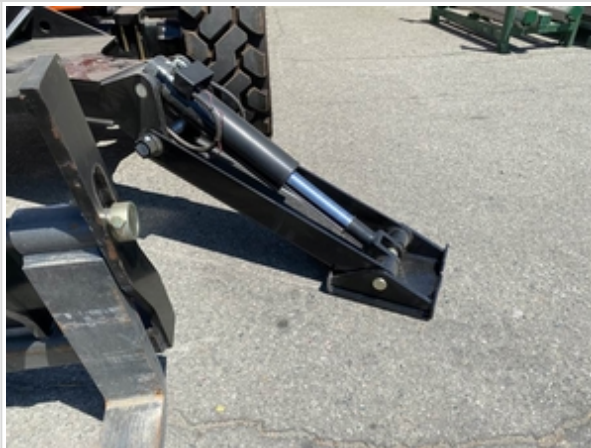
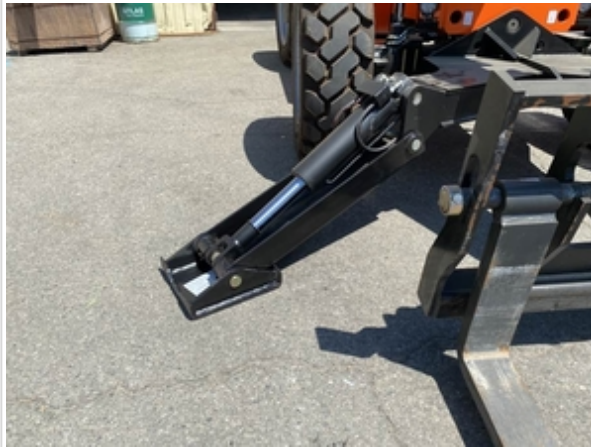
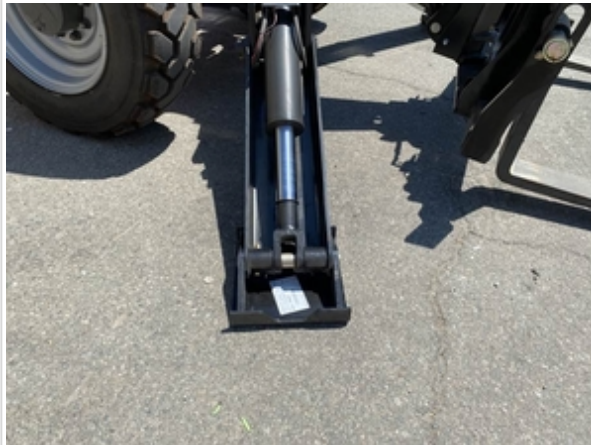
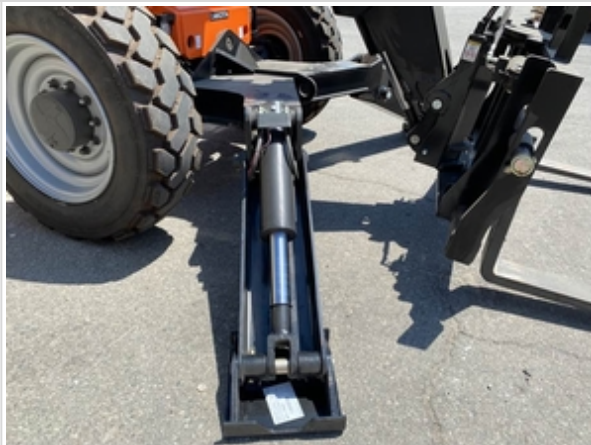
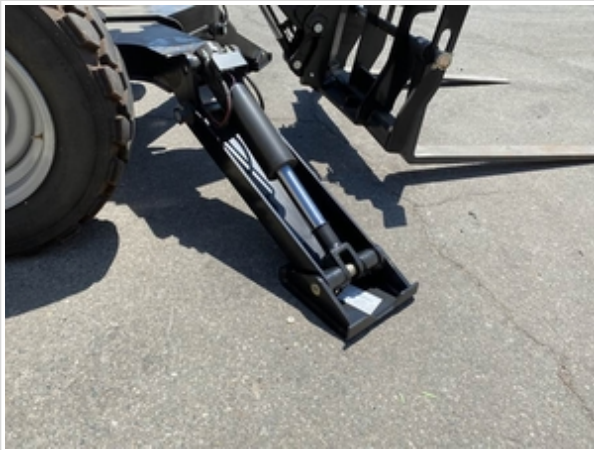
<p><b>Outriggers</b></p>	<p>4 - Like New, Recently Replaced</p>
<p><b>Outriggers Photos</b></p>

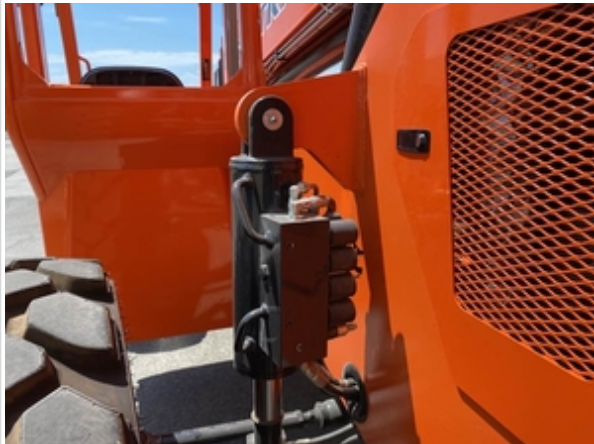
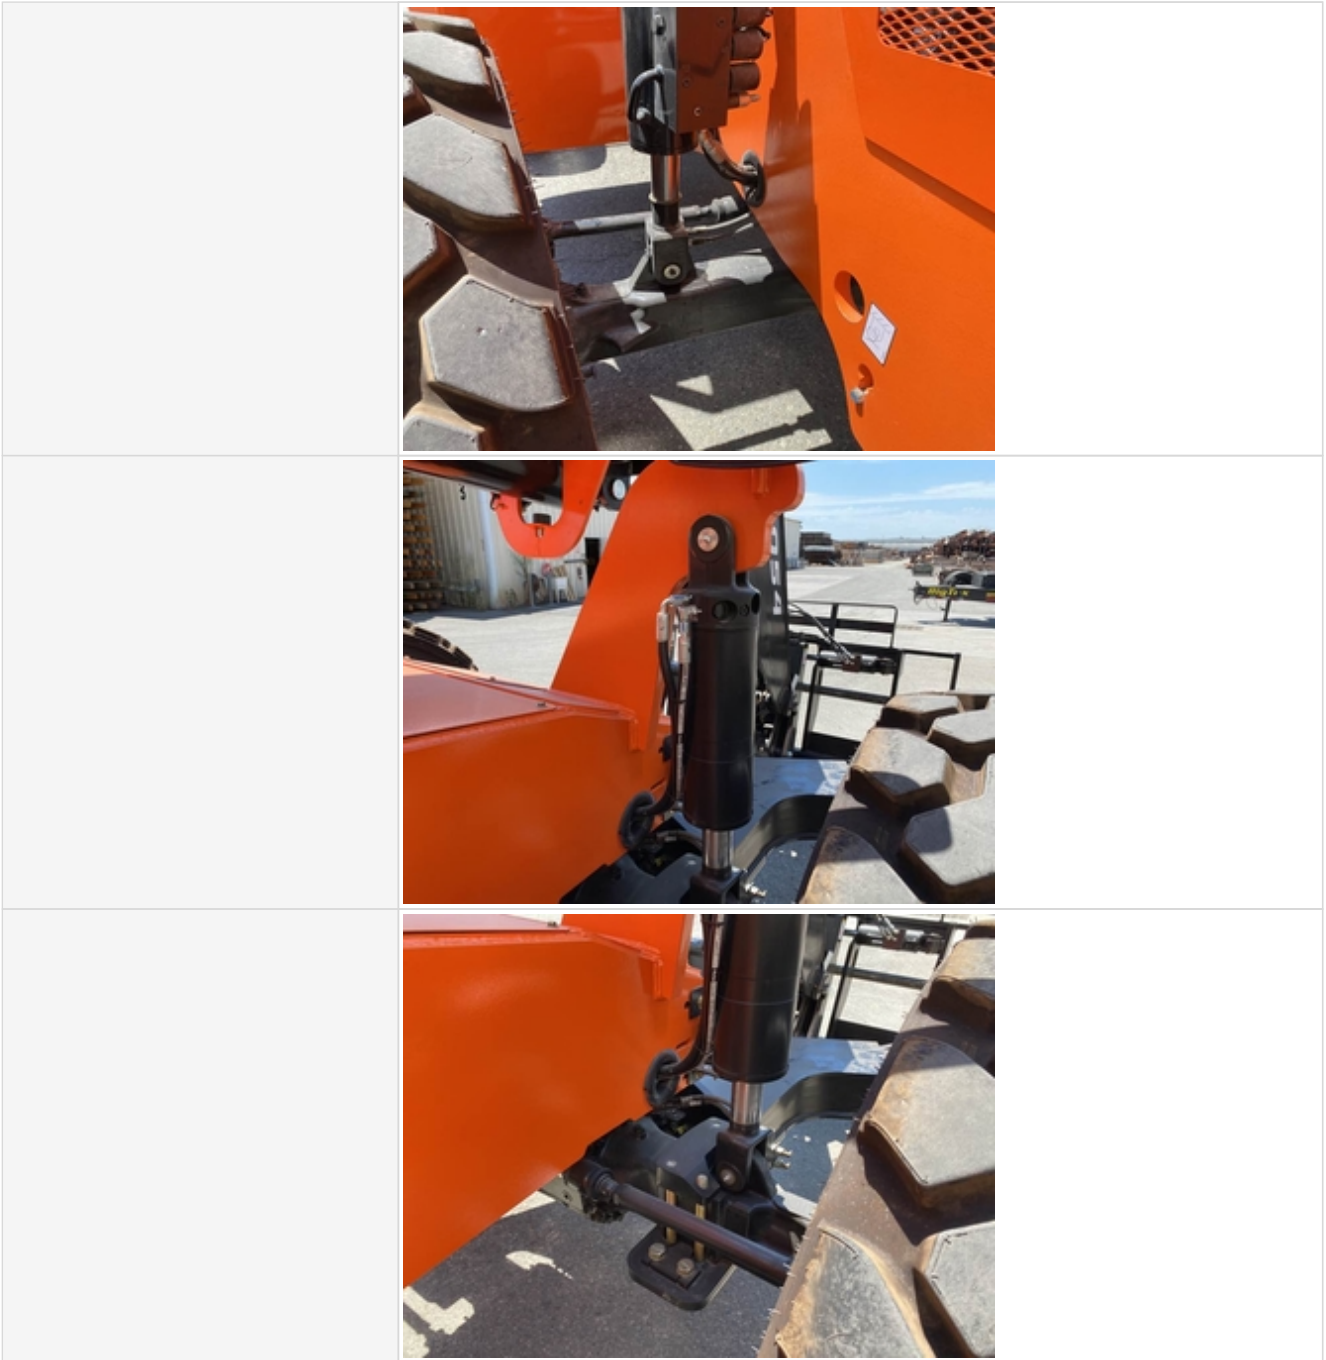
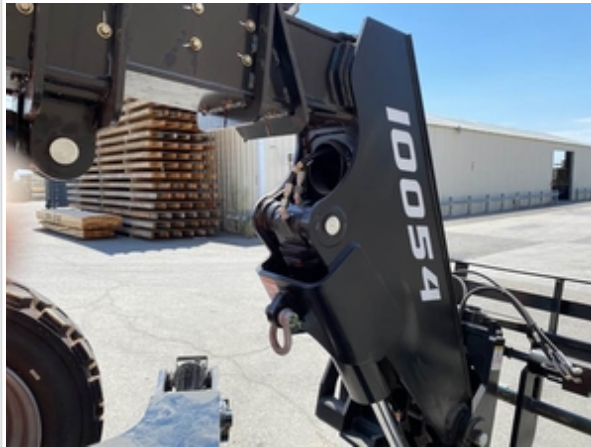
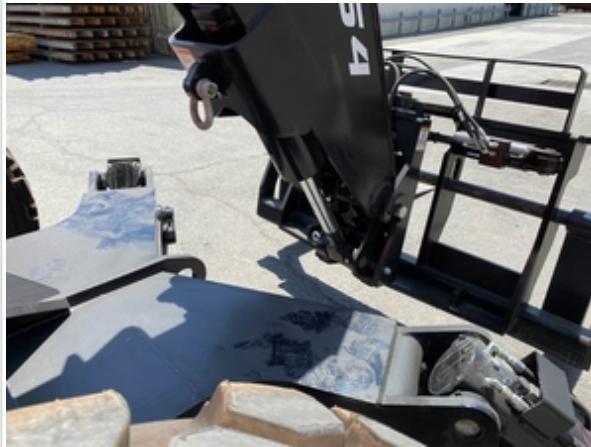
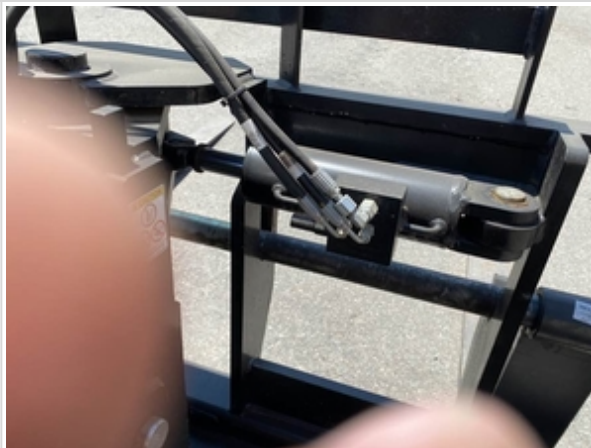
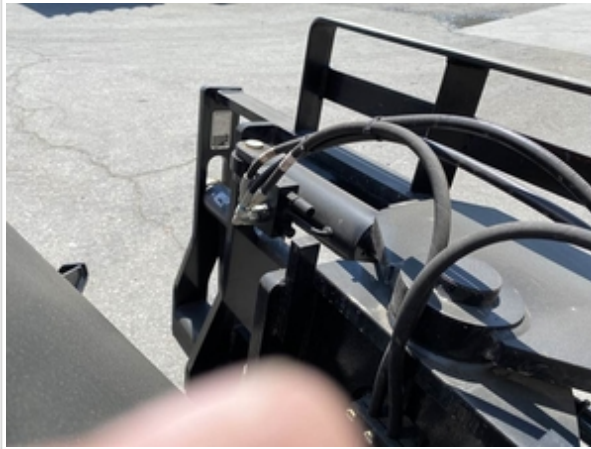
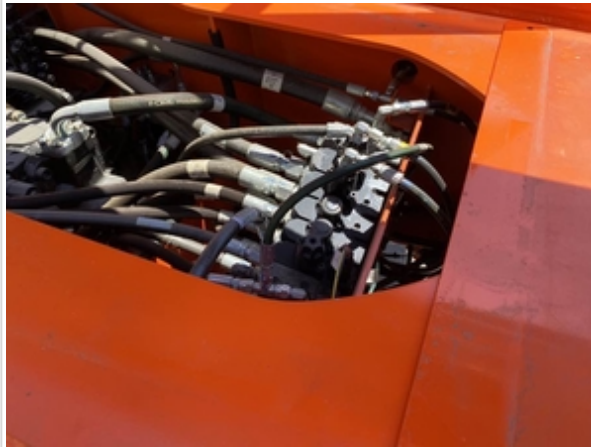
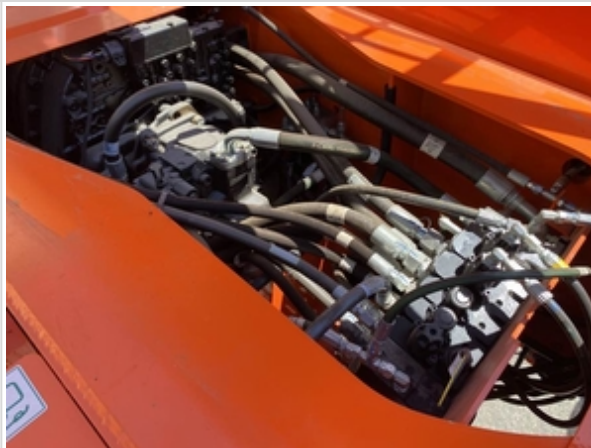
<b>Wet or Damp Hydraulic Lines / Fittings</b>	No	
<b>Appearance of Hydraulic Lines / Fittings</b>	4	
<b>Hydraulic Lines / Fittings Condition</b>	Hydraulic lines & fittings are clean and in good condition	
<b>Appearance of Hydraulic Lines / Fittings Photos</b>

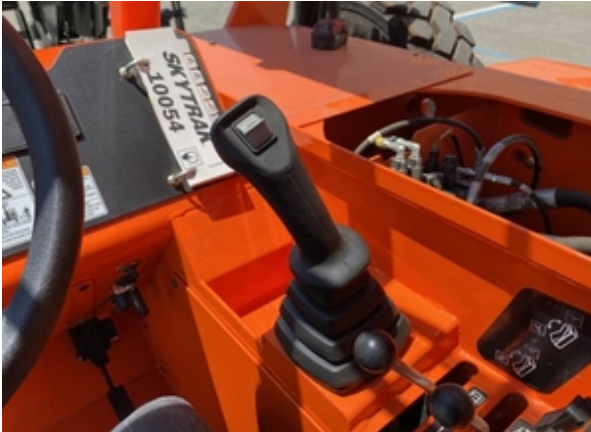
<b>Unusual Noises (Hydraulic Pump)</b>	No	
<b>Hydraulic Pump Notes</b>	No unusual noises heard during operation	
<b>External Controls / Levers</b>	4	
<b>External Controls / Levers Condition</b>	Good function & condition of hydraulic controls	
<b>External Controls / Levers Photos</b>

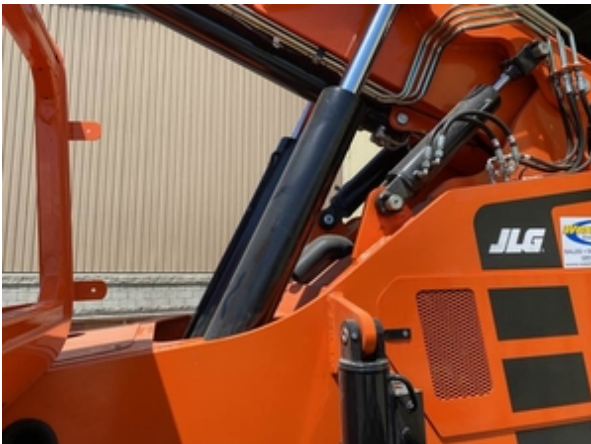
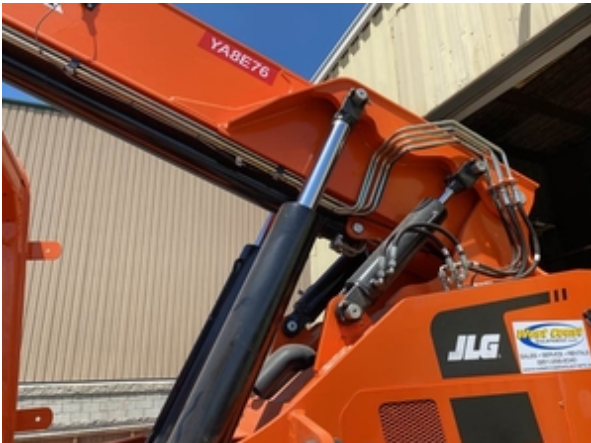
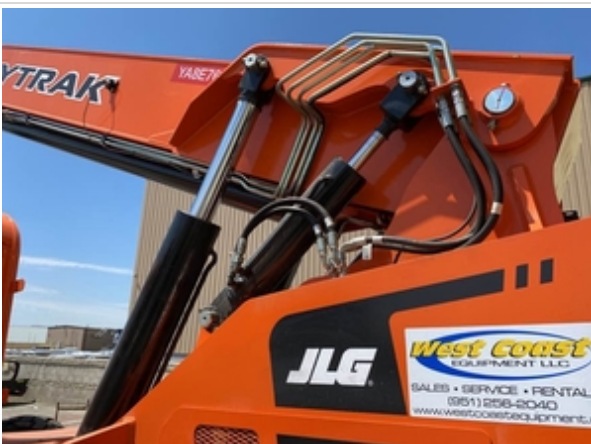
<b>Boom Lift Cylinders</b>	Check the boom lift cylinders. Note any wear, pitting, discoloration, etc. Take photos.
<b>Boom Lift Cylinders: Mounting Pin</b>	4
<b>Boom Lift Cylinders: Oil Leaks</b>	No
<b>Boom Lift Cylinders Photos</b>

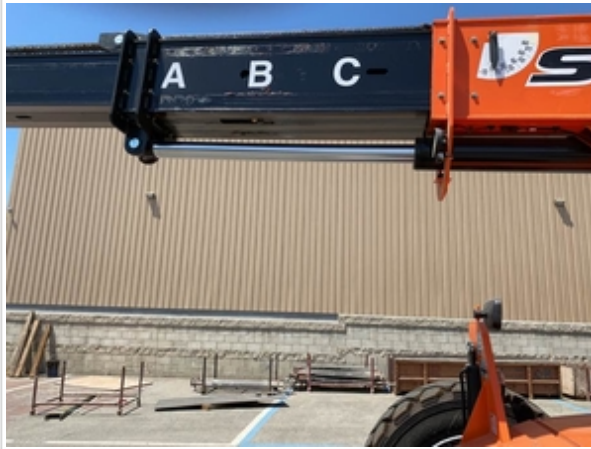
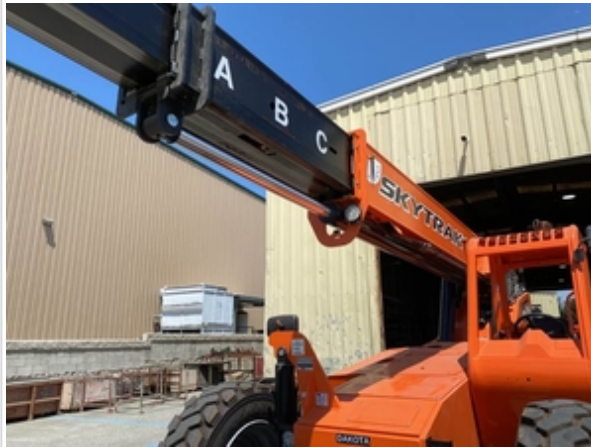
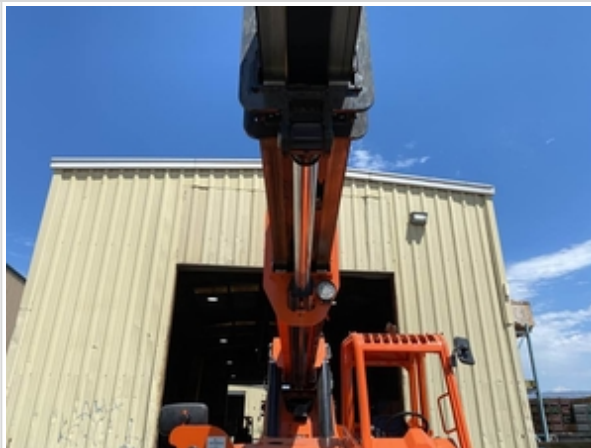
Telescopic Boom Cylinders  
Photos

<b>Telescopic Boom Cylinders</b>	Check the telescopic boom cylinders. Note any wear, pitting, discoloration, etc. Take photos.	
<b>Telescopic Boom Cylinders: Mounting Pin</b>	4	
<b>Telescopic Boom Cylinders: Oil Leaks</b>	No

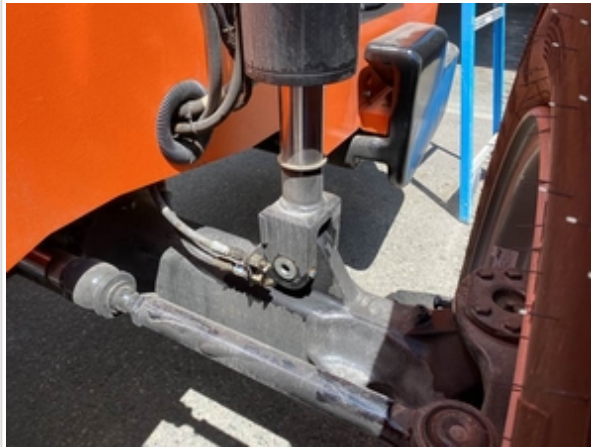
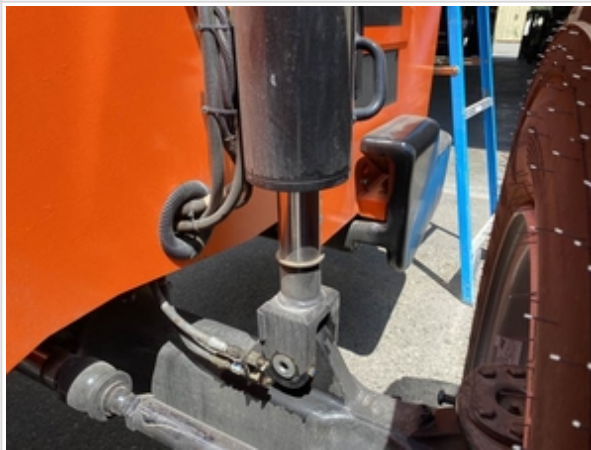
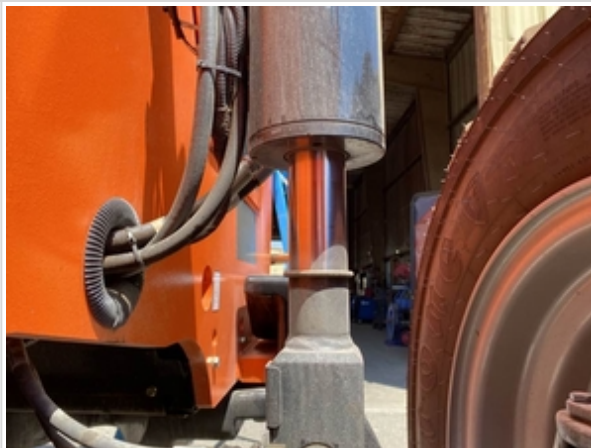
Frame Leveling Cylinders Photos

<b>Frame Leveling Cylinders</b>	Check the frame leveling cylinders. Note any wear, pitting, discoloration, etc. Take photos.
<b>Frame Leveling Cylinders: Mounting Pin</b>	4
<b>Frame Leveling Cylinders: Oil Leaks</b>	No

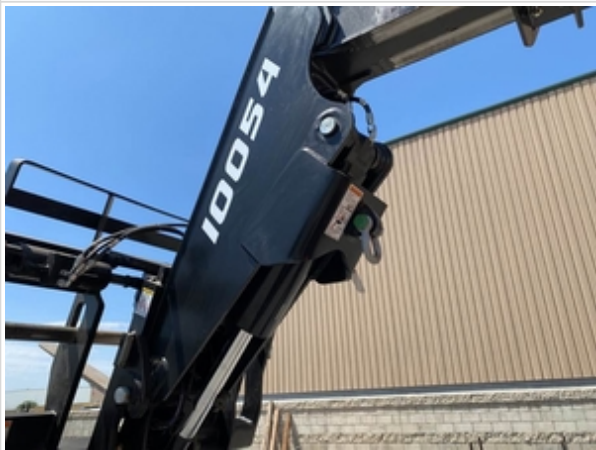
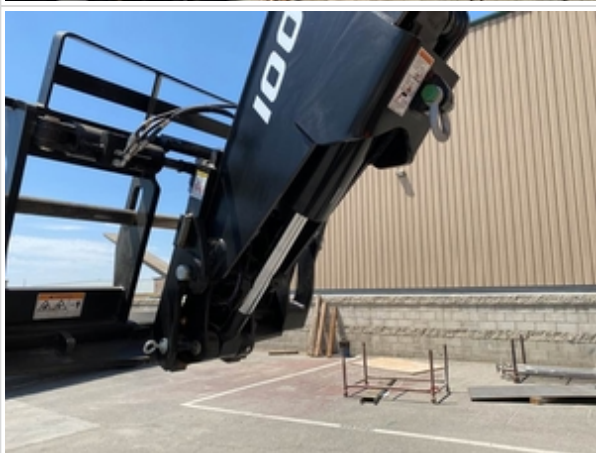
<b>Carriage Tilt Cylinder</b>	Check the carriage tilt cylinders. Note any wear, pitting, discoloration, etc. Take photos.	
<b>Carriage Tilt Cylinder: Mounting Pin</b>	4	
<b>Carriage Tilt Cylinder: Oil Leaks</b>	No	
<b>Carriage Tilt Cylinder Photos</b>

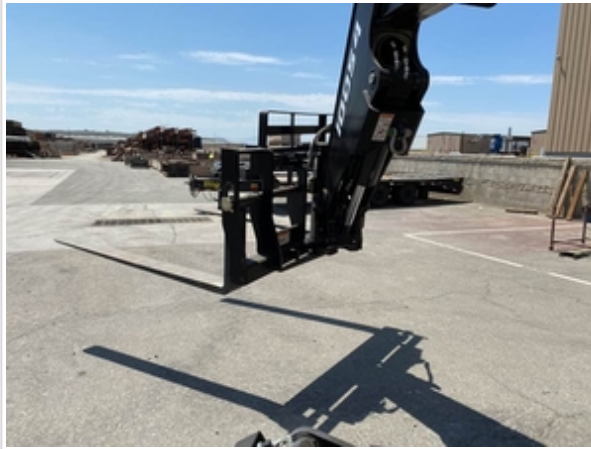
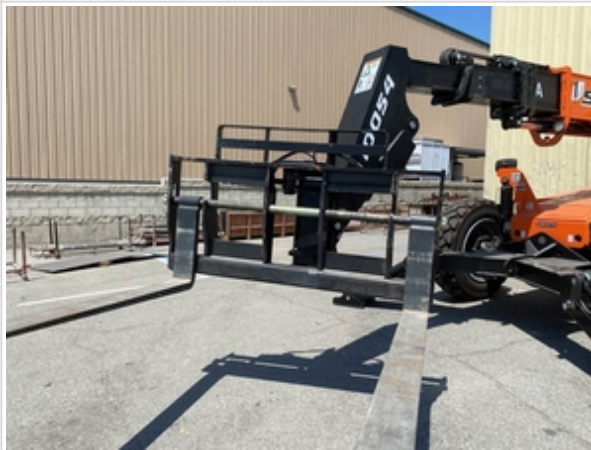
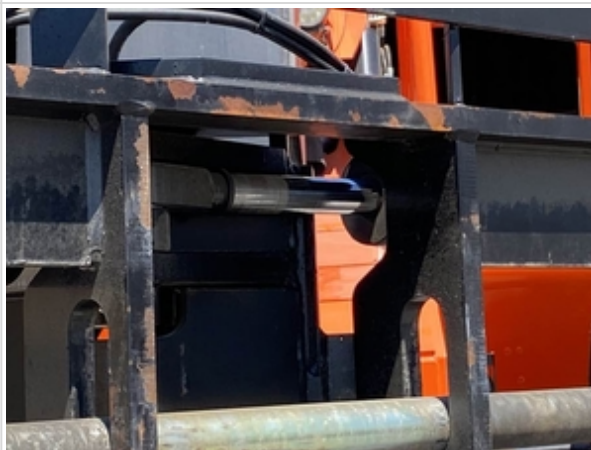
Side Shift Cylinder Photos

<b>Side Shift Cylinder</b>	Check the side shift cylinder. Note any wear, pitting, discoloration, etc. Take photos.
<b>Side Shift Cylinder: Mounting Pin</b>	4
<b>Side Shift Cylinder: Oil Leaks</b>	No

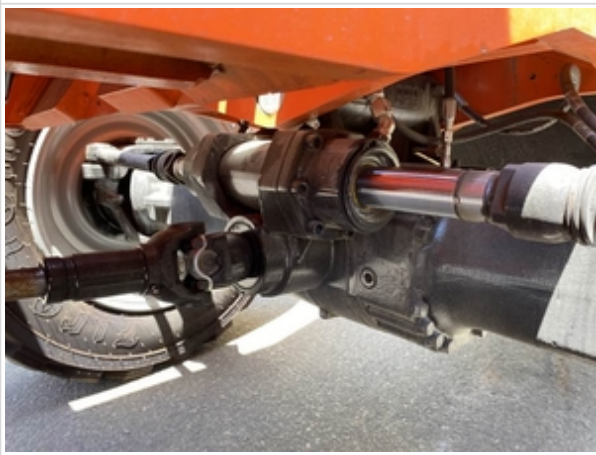
<b>Steering Cylinders</b>	Check the steering cylinders. Note any wear, pitting, discoloration, etc. Take photos.	
<b>Steering Cylinders: Mounting Pin</b>	4	
<b>Steering Cylinders: Oil Leaks</b>	No	
<b>Steering Cylinders Photos</b>

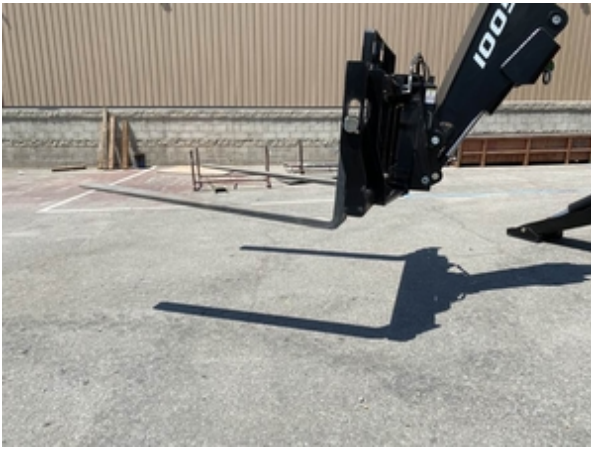
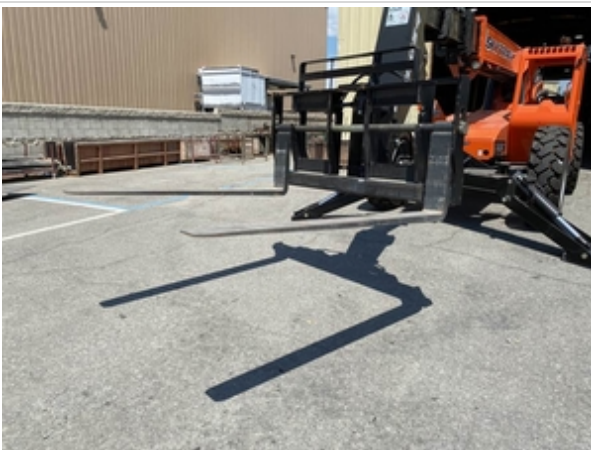
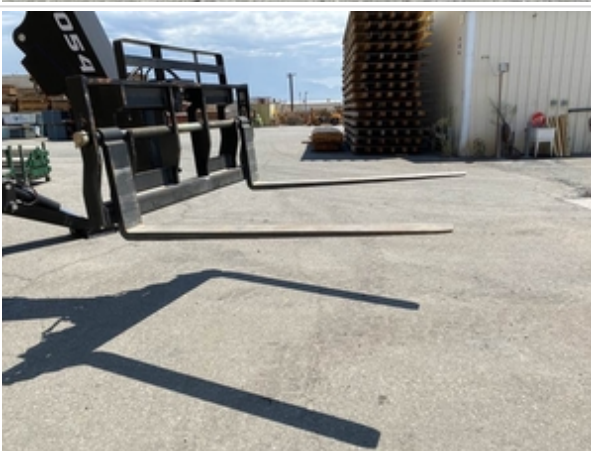
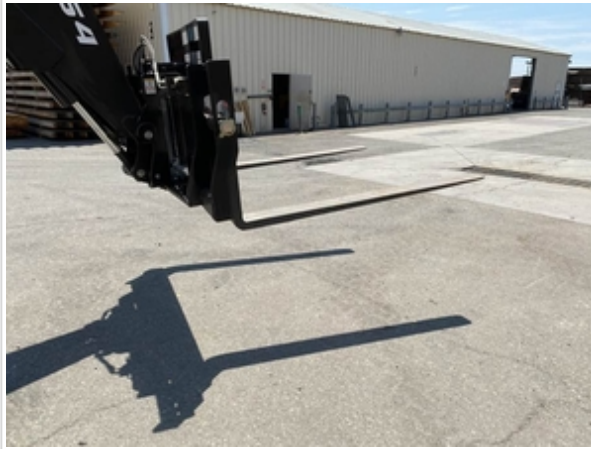
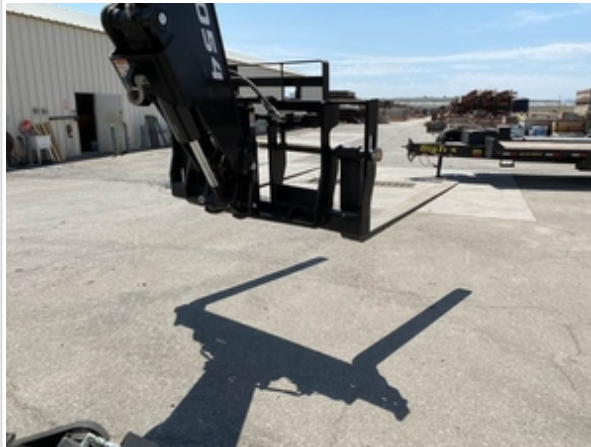
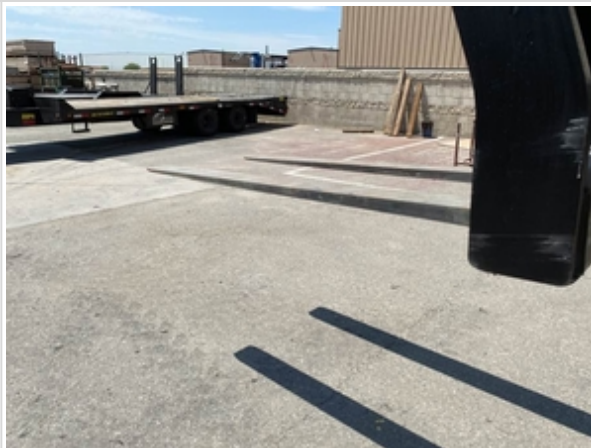
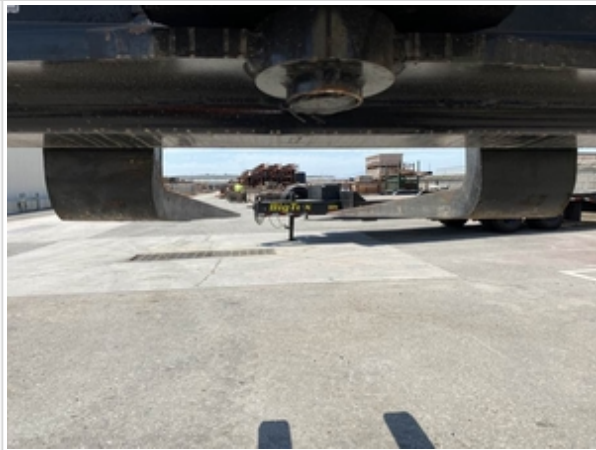
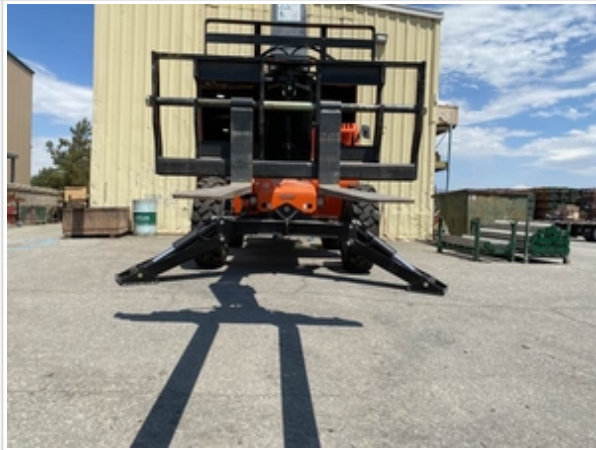
<b>Instructions</b>	<p>Evaluate the following on a 4 point scale (leave comments where an explanation is appropriate):</p> <p>4 = Like New, Recently Replaced          3 = Normal Wear &amp; Tear          2 = Above Average Wear          1 = Service Required</p>
<b>Forks / Work Tool Condition</b>	4 - Like New, Recently Replaced
<b>Forks / Work Tool Photos</b>

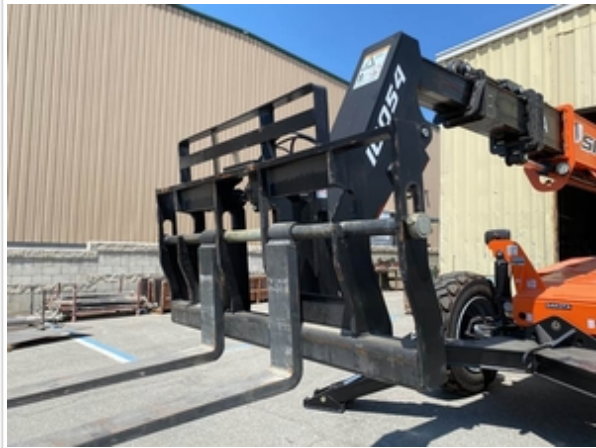
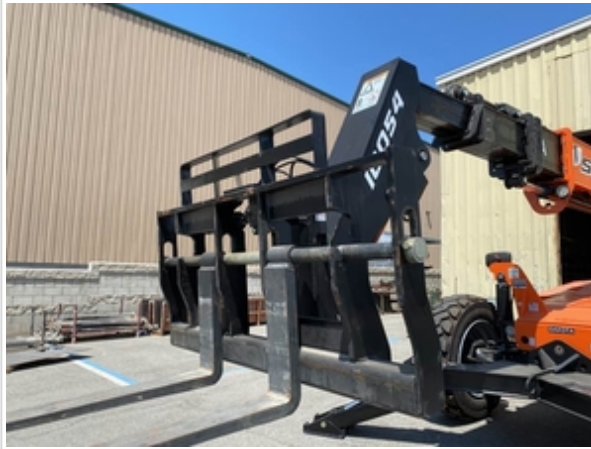
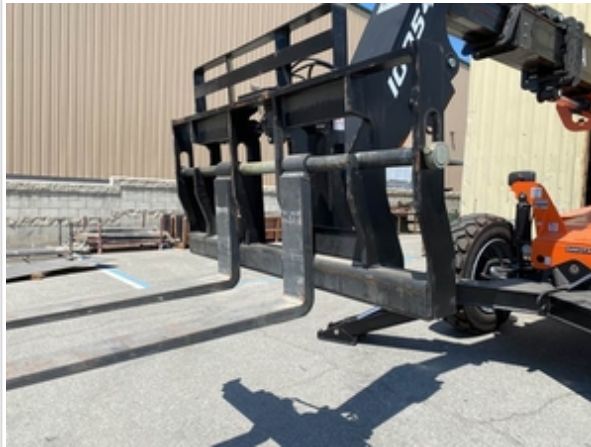
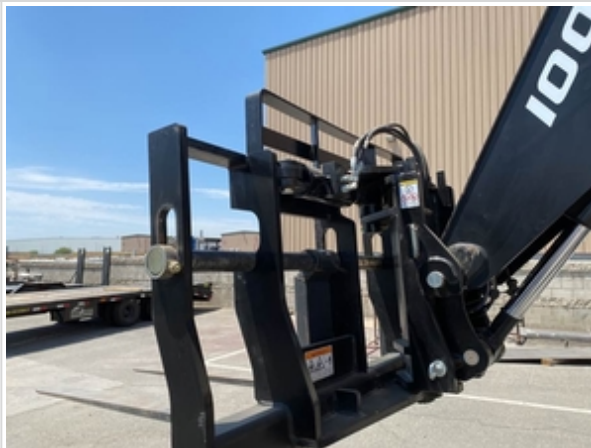
<p><b>Back Rest Condition</b></p>	<p>4 - Like New, Recently Replaced</p>
<p><b>Back Rest Photos</b></p>
