Inspection Report (Boom Lift)

Year	2015
Make	JLG
Model	660sj
Serial Number	0300197865
Hour Meter Reading	2804
Previous Application (e.g., earth moving, mining, demolition, etc)	General Construction Rentals

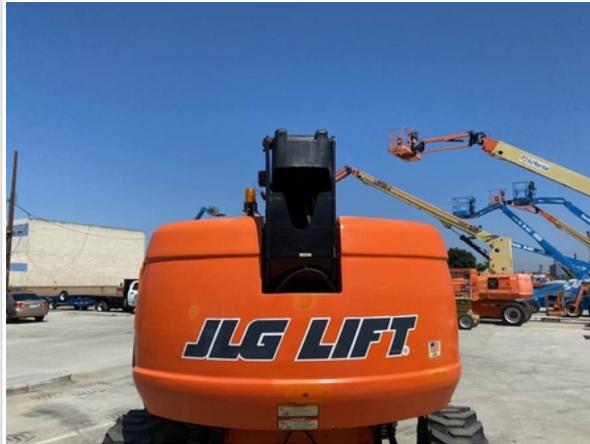
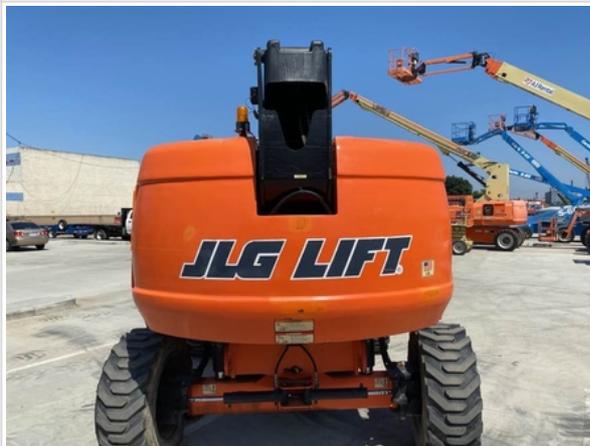
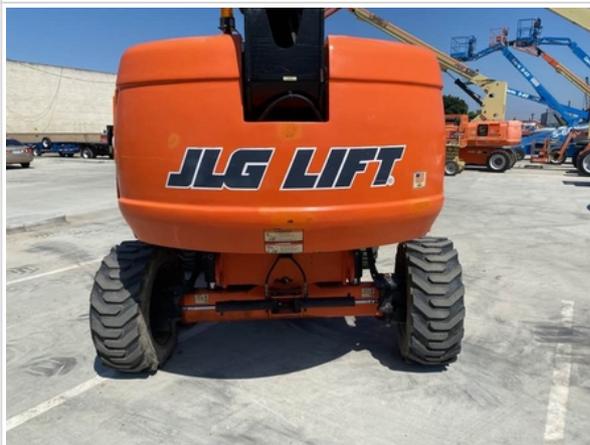
Rear Photos

Rear	4 - Like New, Recently Replaced
Comments	Minor scuff marks with touch up paint

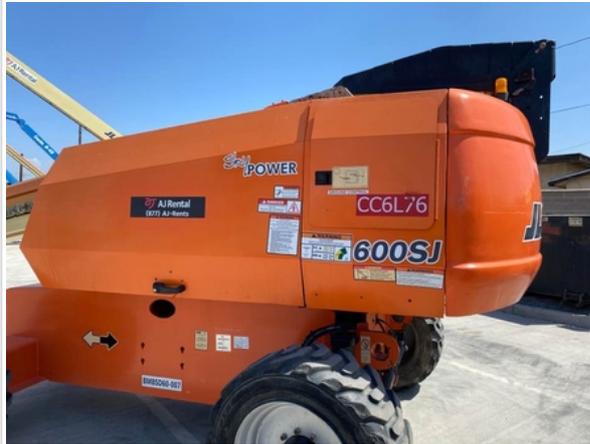
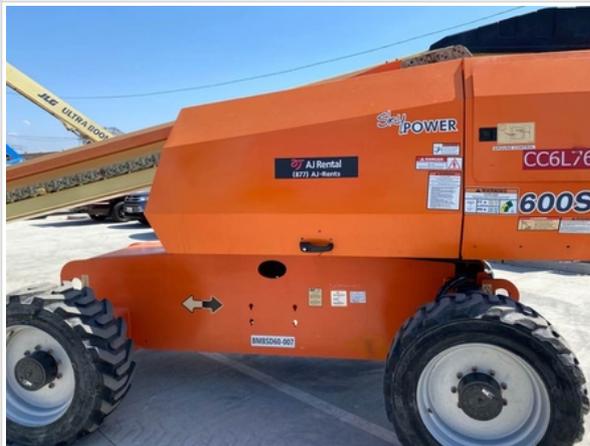
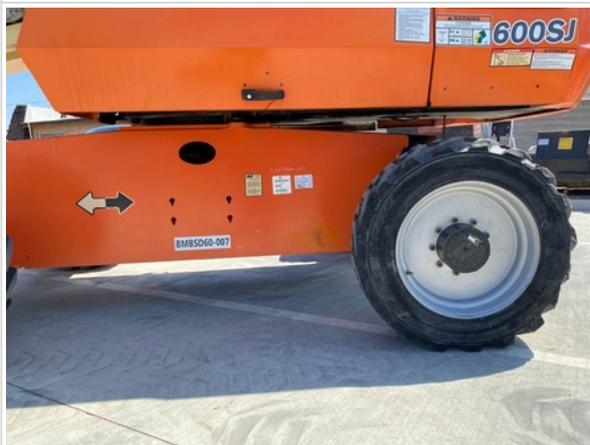
Left Photos

Left

3 - Normal Wear & Tear

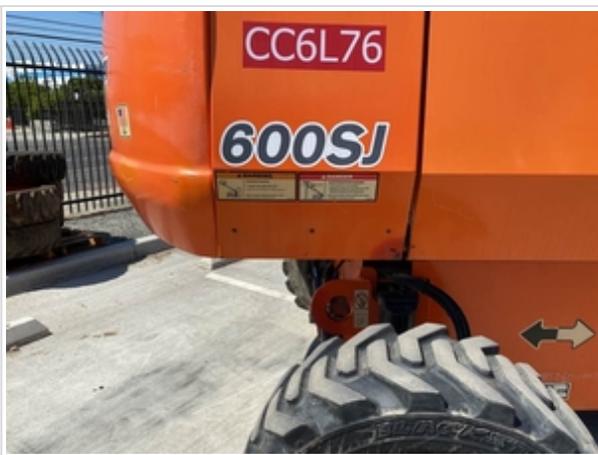
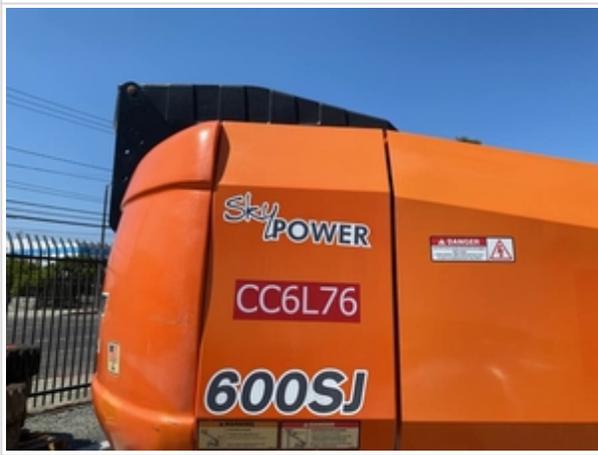
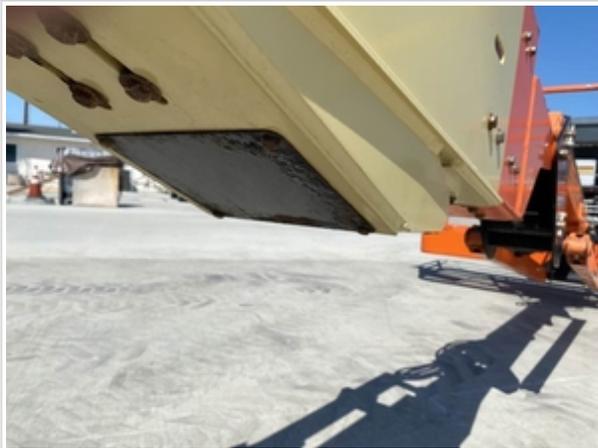
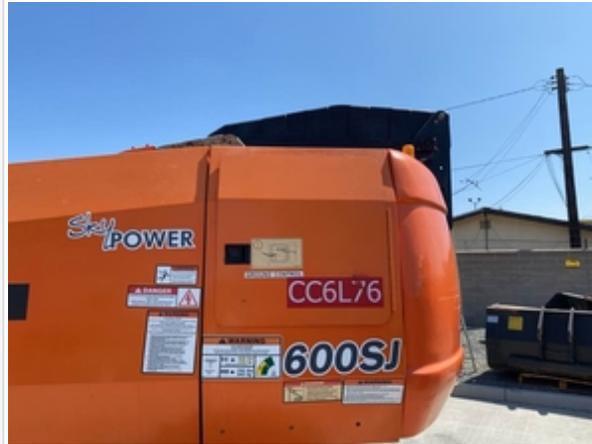
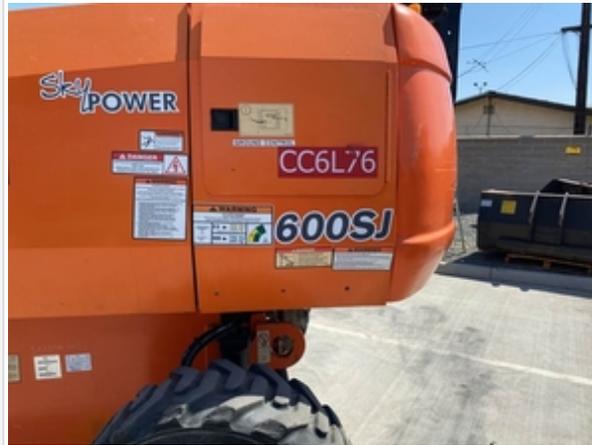
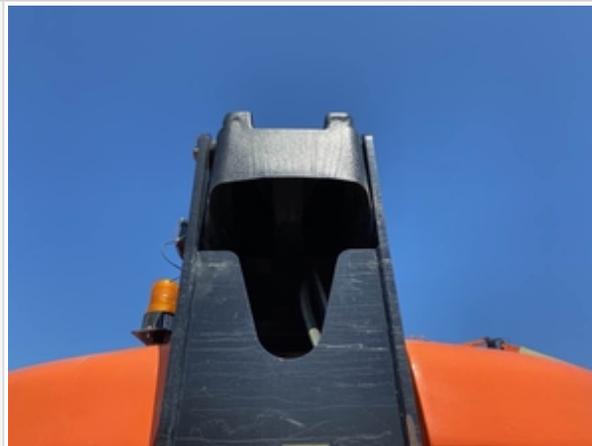
<p>Body Panels Photos</p>

<p>Body Panels (Any Damage?)</p>	<p>3 - Normal Wear & Tear</p>

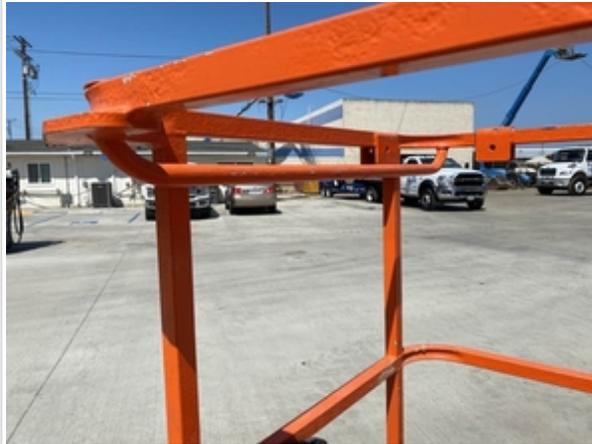
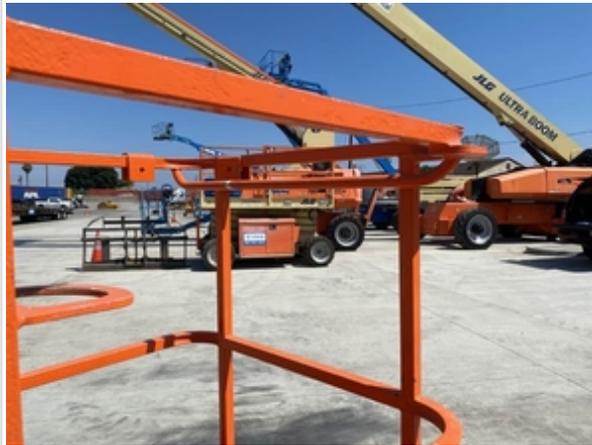
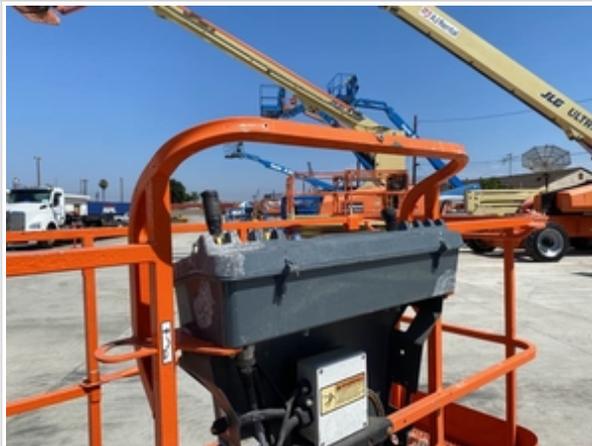
Hand Rails Photos

Hand Rails

3 - Normal Wear & Tear

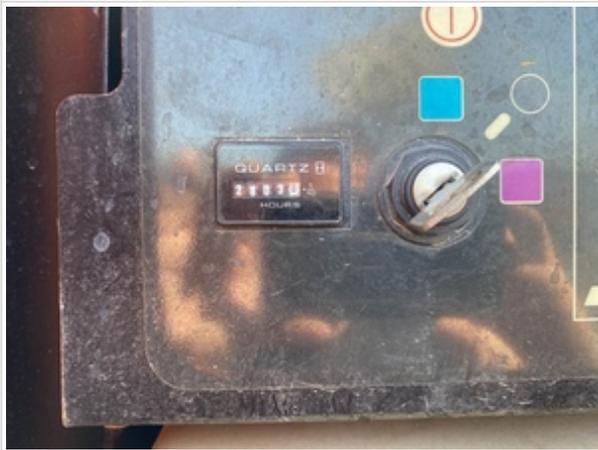
Hour Meter Activity	3 - Normal Wear & Tear
Hour Meter Activity Photos

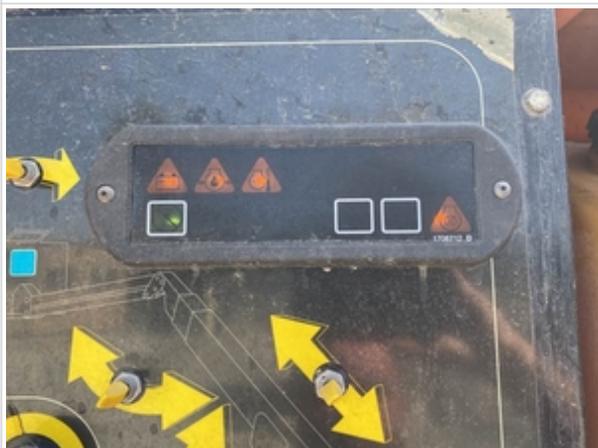
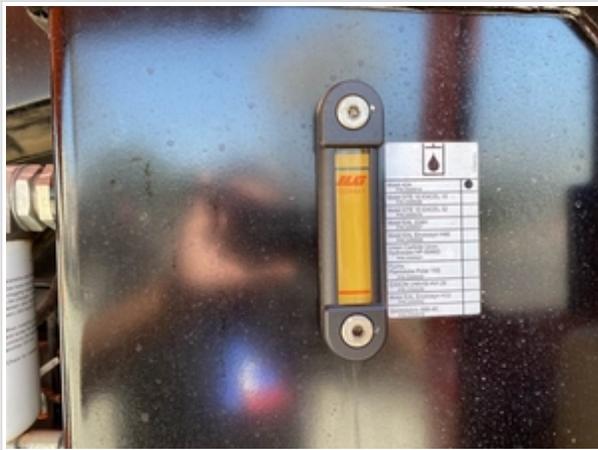
Other Gauge Activity	3 - Normal Wear & Tear
Other Gauge Activity Photos

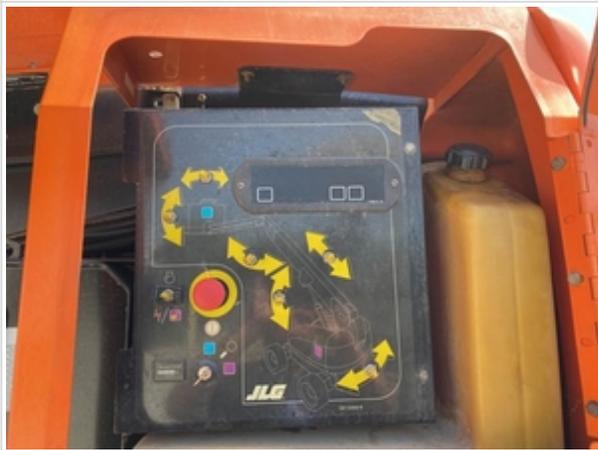
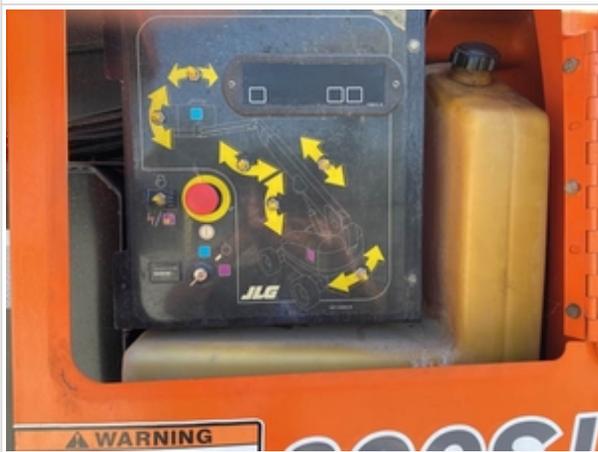
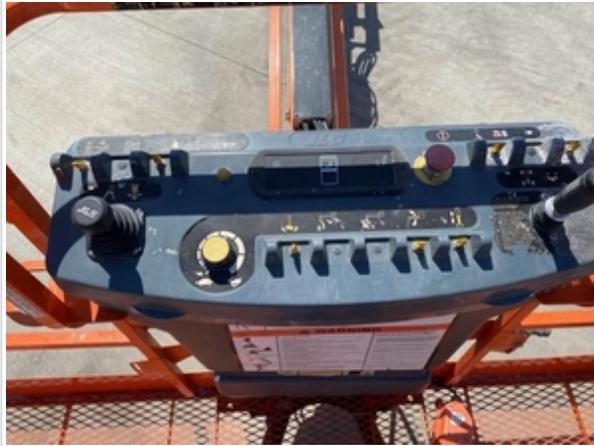
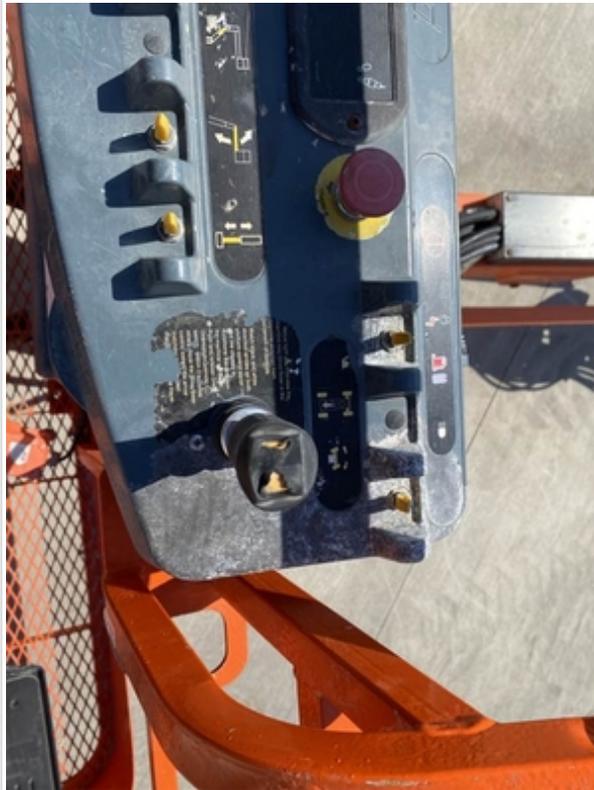
<p>Controls & Switches</p>	<p>4 - Like New, Recently Replaced</p>
<p>Controls & Switches Photos</p>

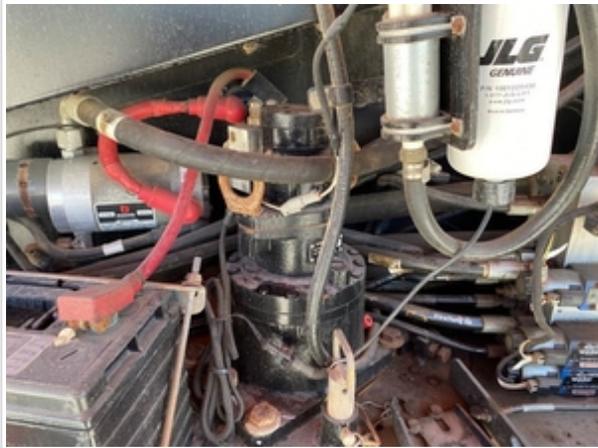
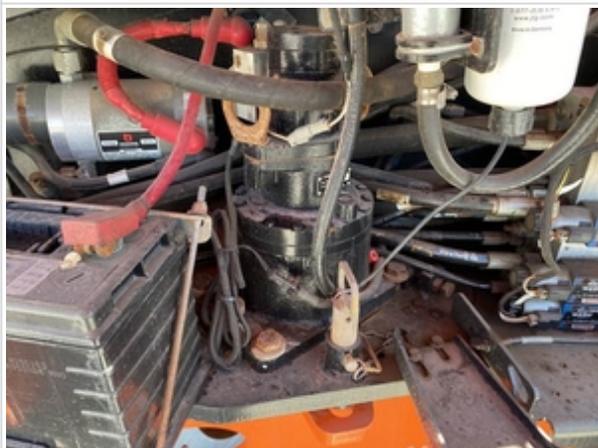
<p>Swing Break Photos</p>

Horn	4 - Like New, Recently Replaced	
Travel Alarm	4 - Like New, Recently Replaced	
Swing Brake	4 - Like New, Recently Replaced

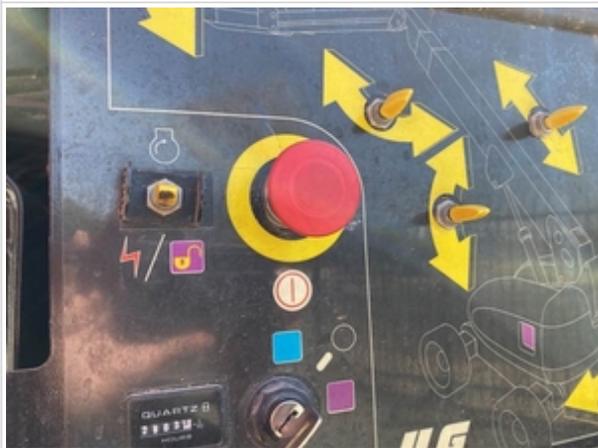
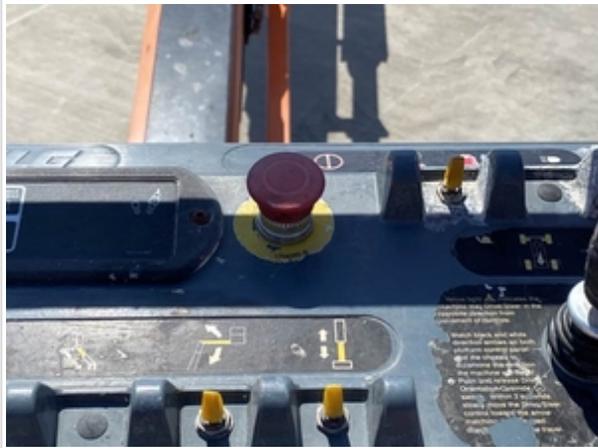
<p>Safety Lock Out / Stop</p>	<p>4 - Like New, Recently Replaced</p>
<p>Safety Lock Out / Stop Photos</p>

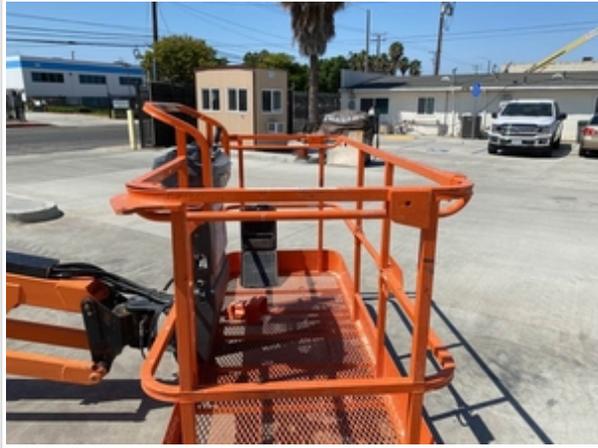
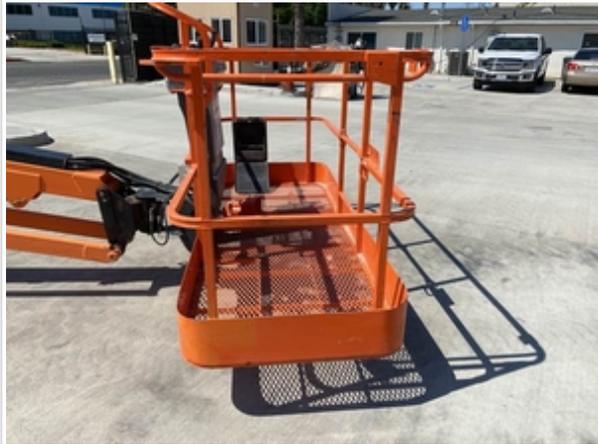
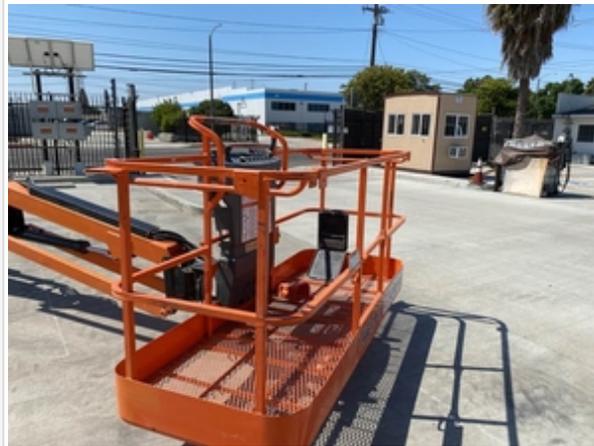
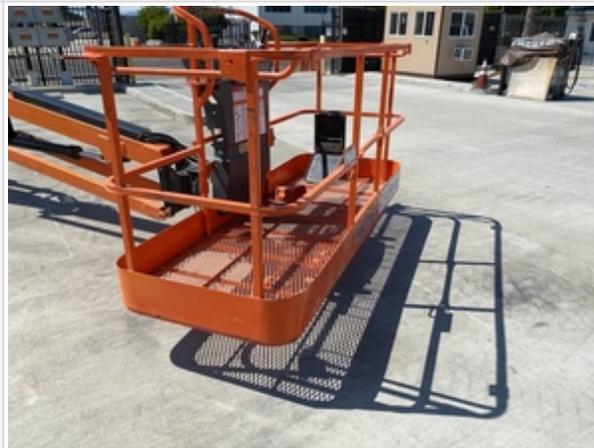
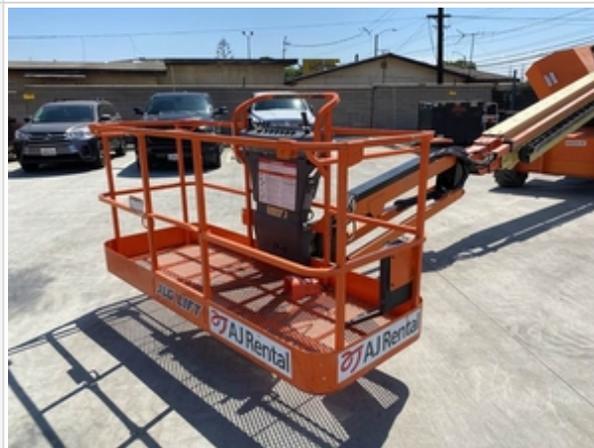
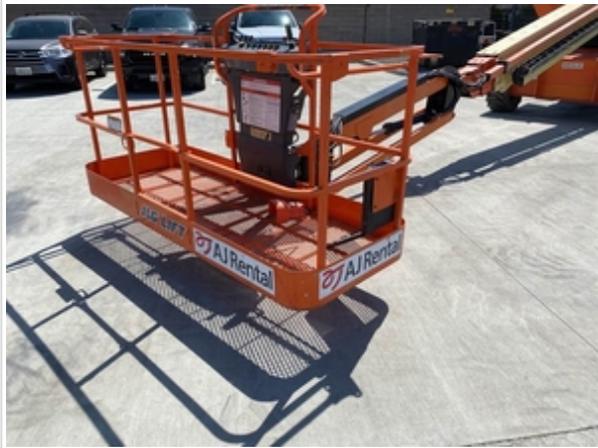
Platform Safety Rails & Appearance	4 - Like New, Recently Replaced	
Platform Safety Rails & Appearance Photos

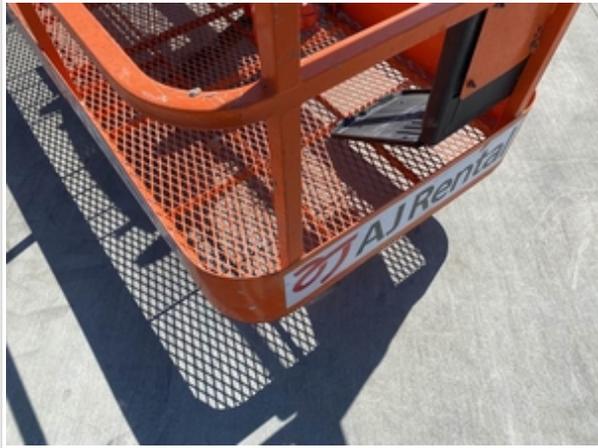
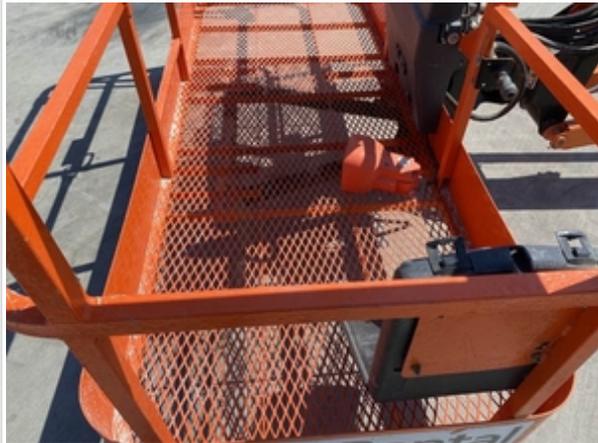
A photograph of an orange aerial lift platform on a concrete surface. The platform has a metal mesh floor and safety railings. The "AJ Rental" logo is visible on the side of the platform.
<p>Platform Floor</p>	<p>4 - Like New, Recently Replaced</p>
<p>Platform Floor Photos</p>

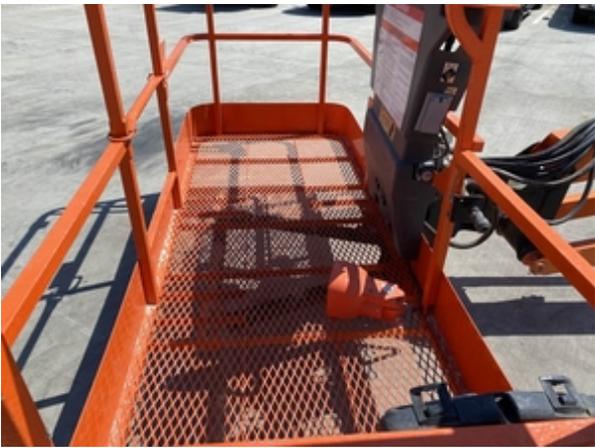
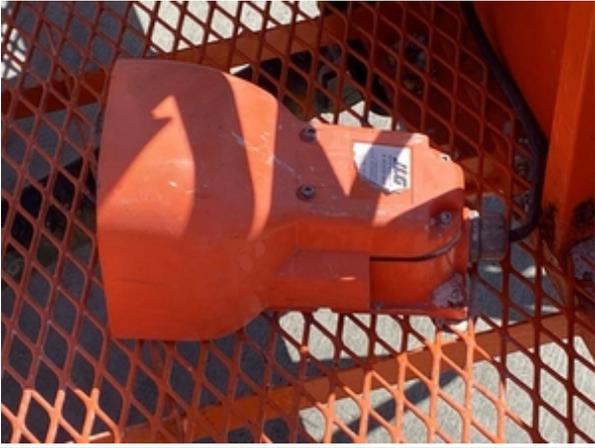
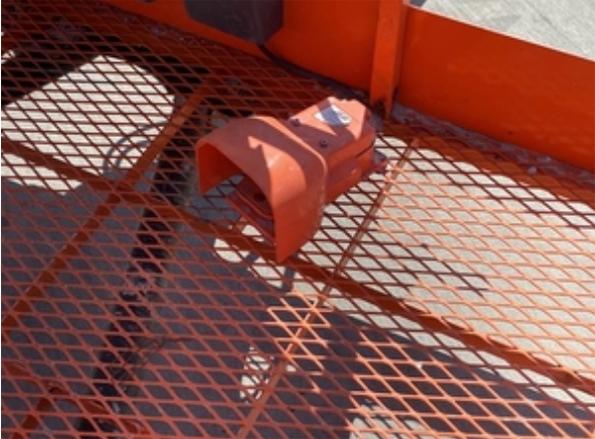
Platform Controls	4 - Like New, Recently Replaced	
Platform Controls Photos

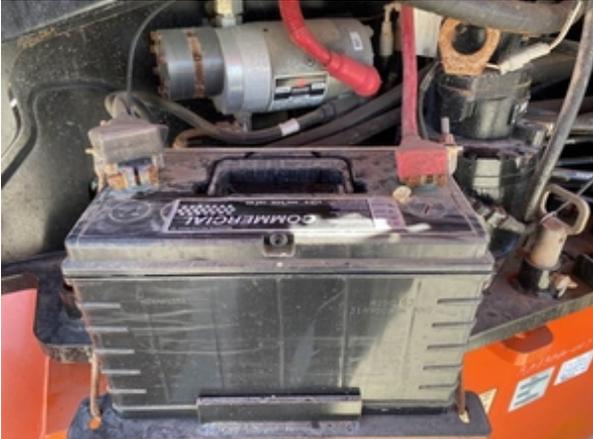
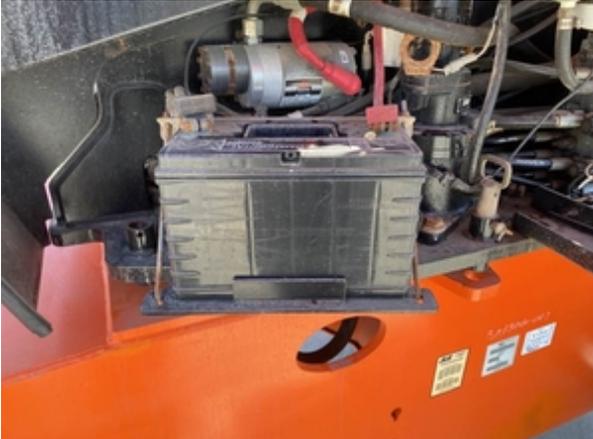
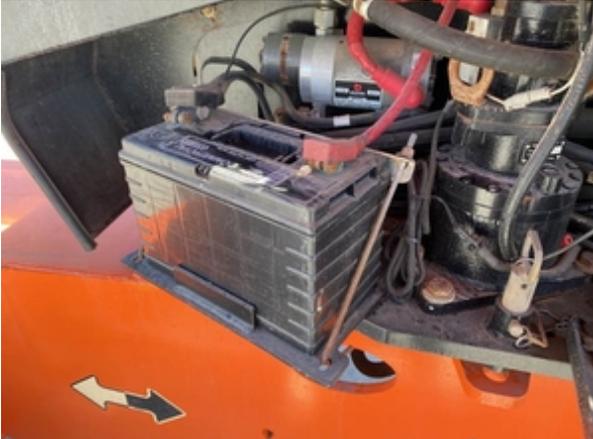
Battery	4 - Like New, Recently Replaced
Battery Condition	Like new, recently replaced, Clean & dry appearance, tight connections
Battery Condition Photos

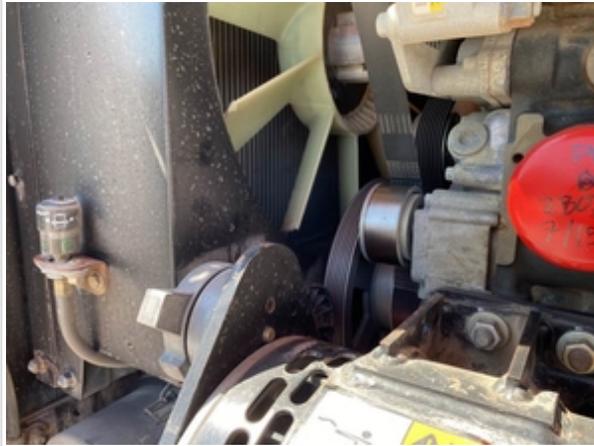
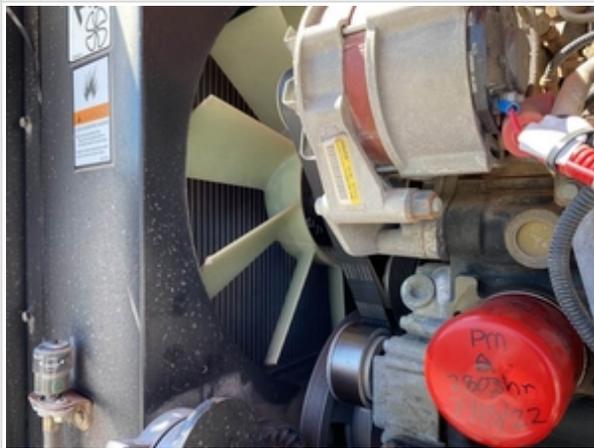
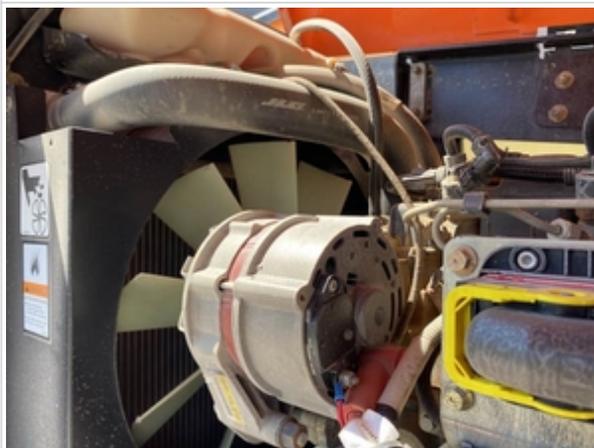
Radiator Photos

Radiator	4 - Like New, Recently Replaced
Radiator Condition	Radiator fins & components appear to be in good working order, no signs of damage or leaks

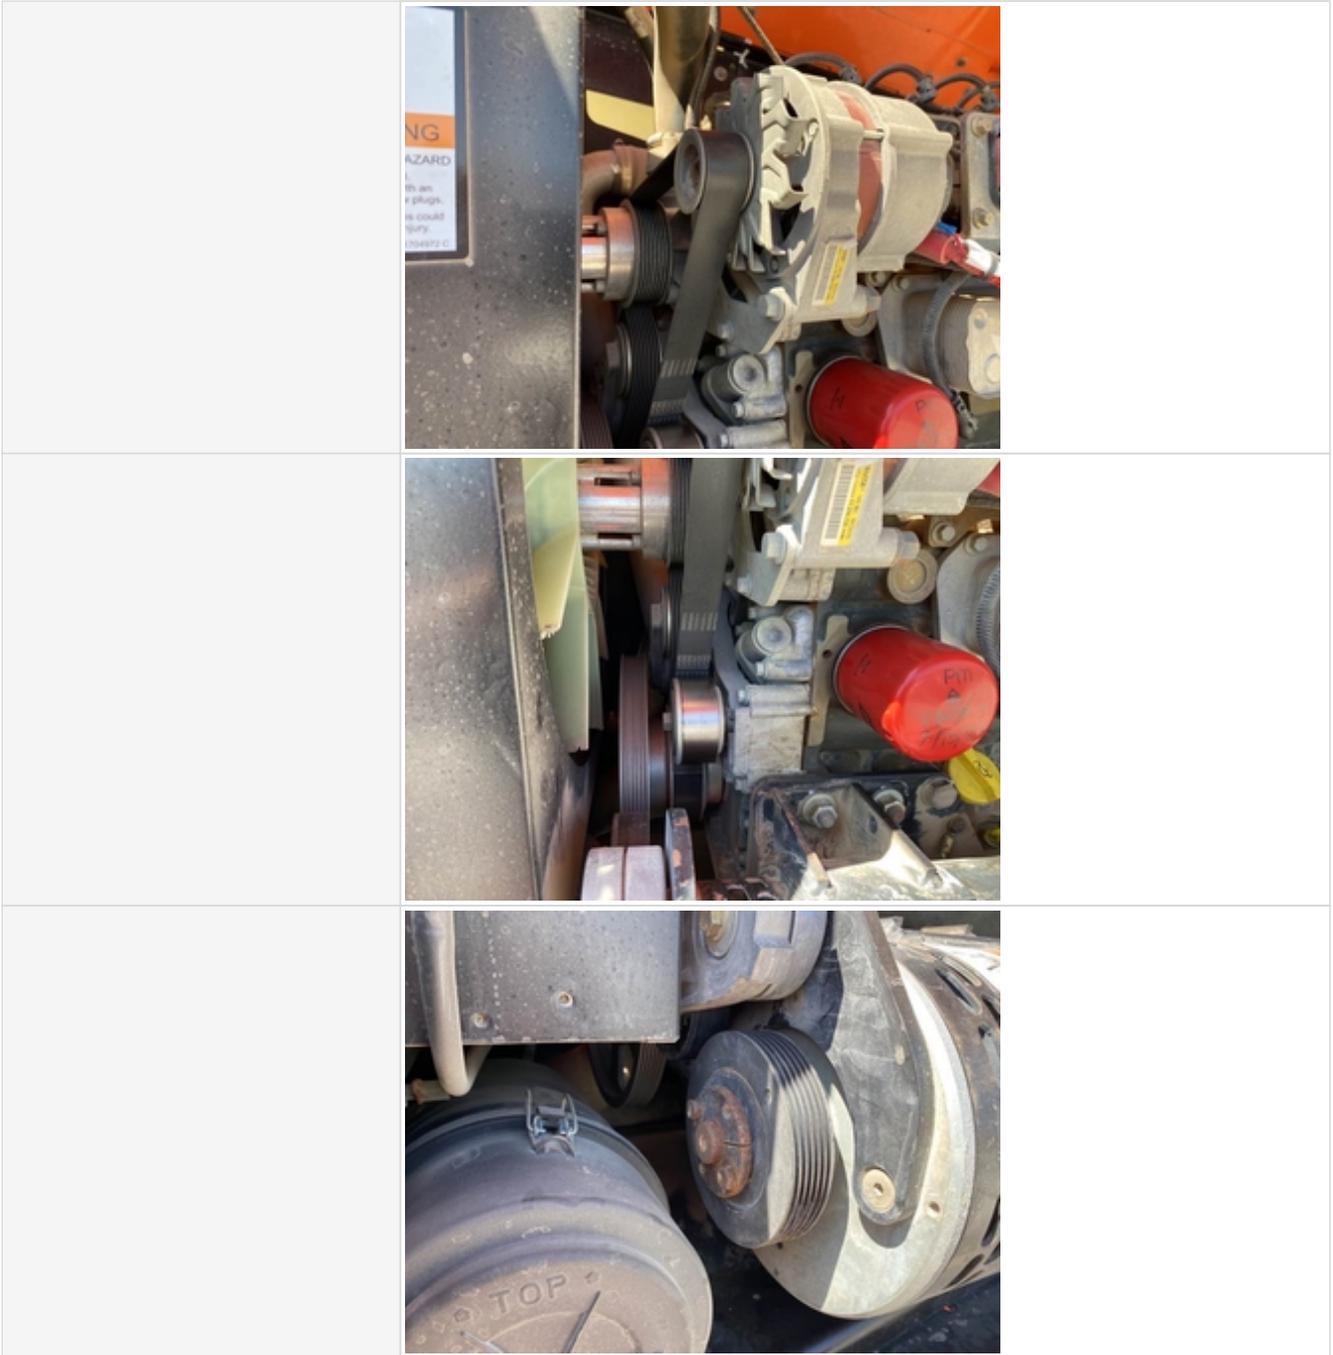
Belts	4 - Like New, Recently Replaced	
Belt Condition	Belts appear in good condition & alignment with proper tension, Other (see comments)	
Comments	Engine belt to platform generator missing	
Belt Photos

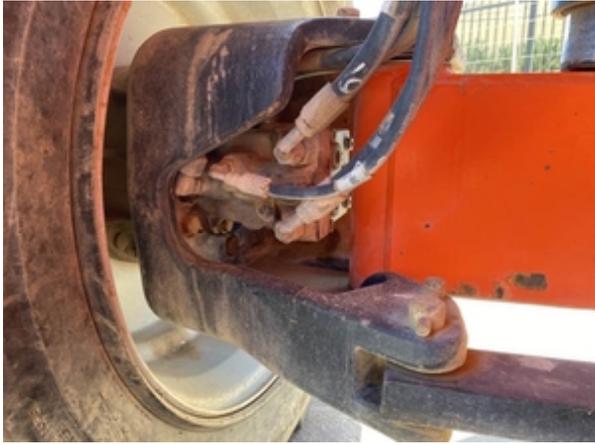
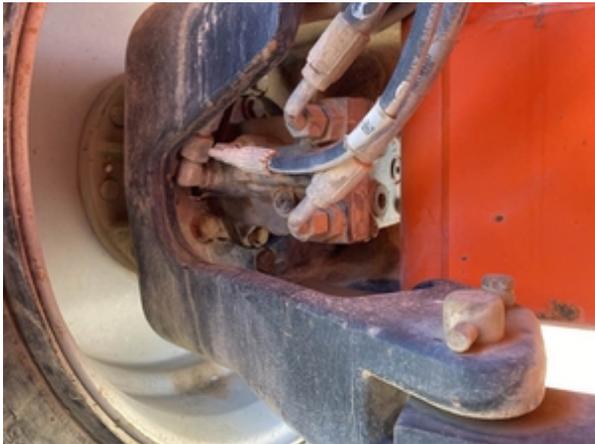
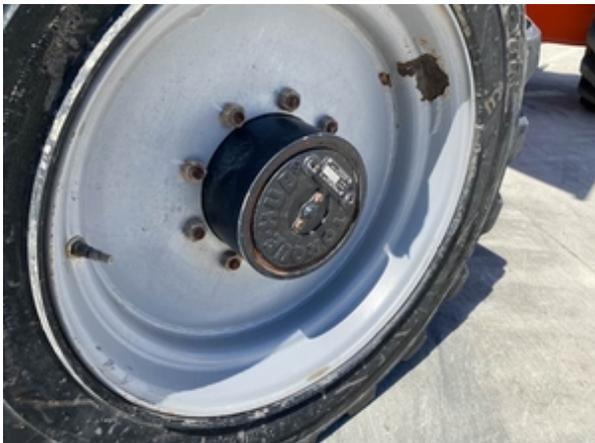
Foot Brake	0
Inching Brake	0
Parking Brake	4 - Like New, Recently Replaced
Parking Brake Condition	Good brake function
Parking Brake Photos

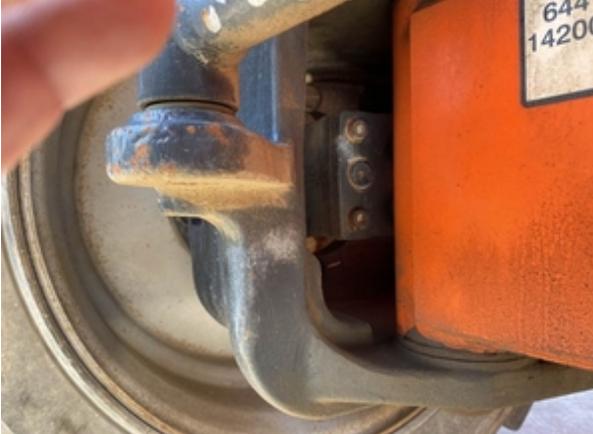
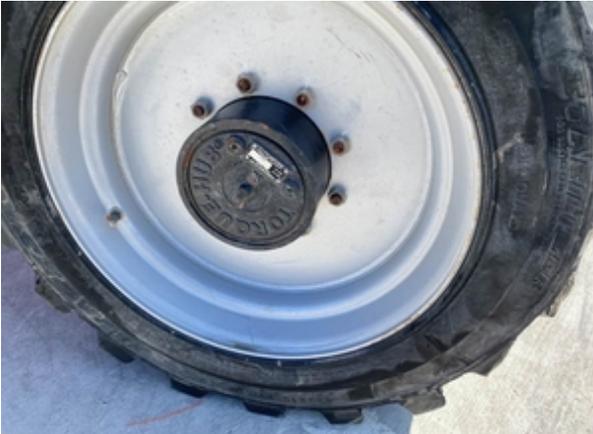
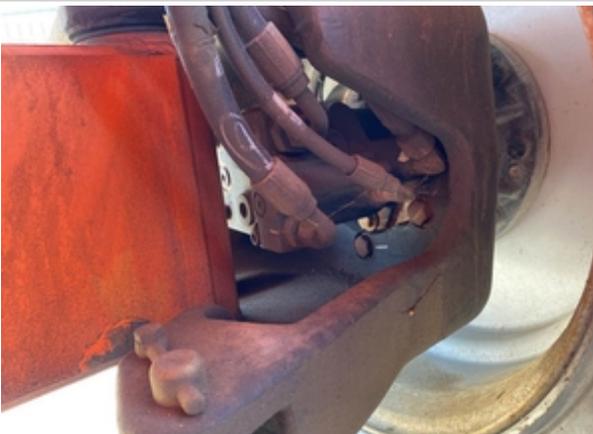
Overall Drivetrain Comments	All 4 spindles in great condition, 4x2 drive motors function properly. No obvious visual problems found with drivetrain components.

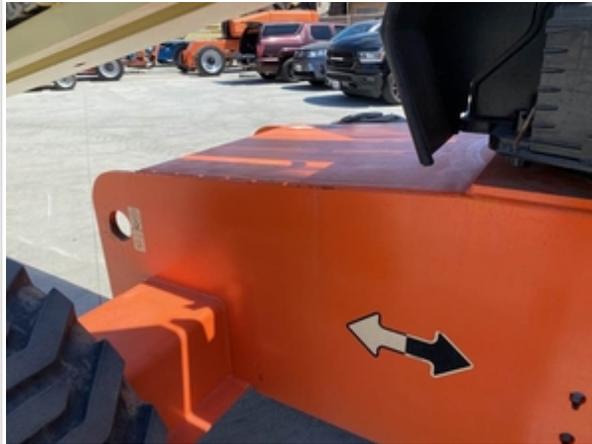
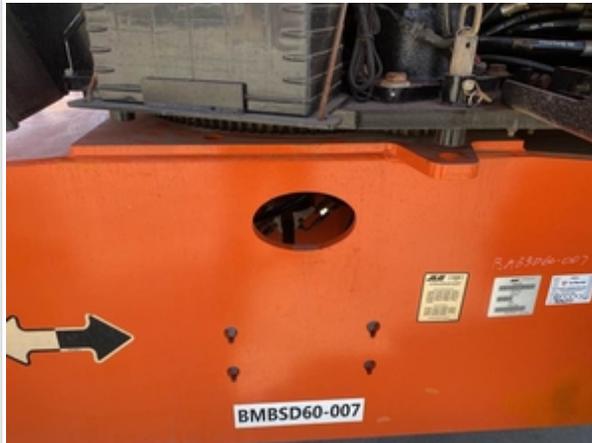
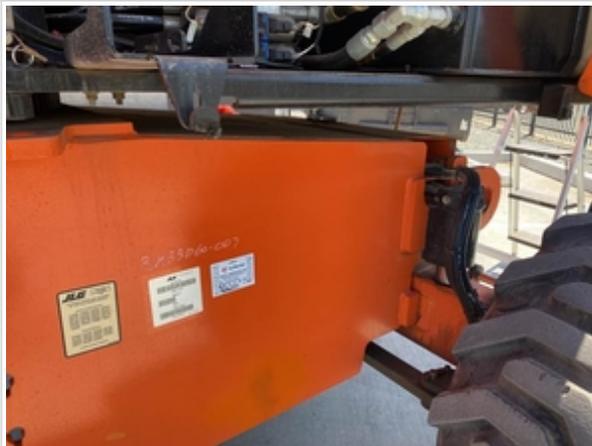
Frame Photos

Instructions	Evaluate the following on a 4 point scale (leave comments where an explanation is appropriate): 4 = Like New, Recently Replaced 3 = Normal Wear & Tear 2 = Above Average Wear 1 = Service Required
Frame	4 - Like New, Recently Replaced

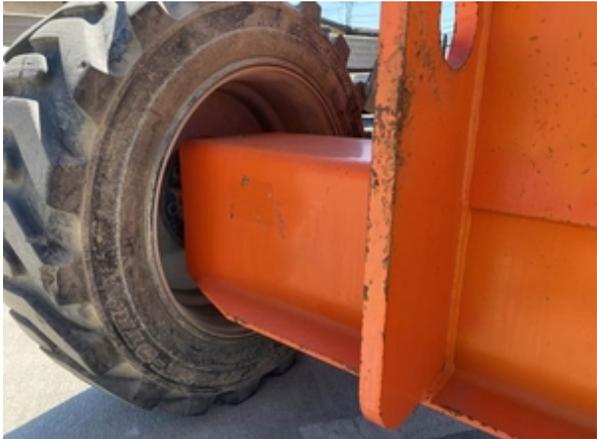
Stance	4 - Like New, Recently Replaced	
Front Axle Appearance	4 - Like New, Recently Replaced	
Front Axle Appearance Photos

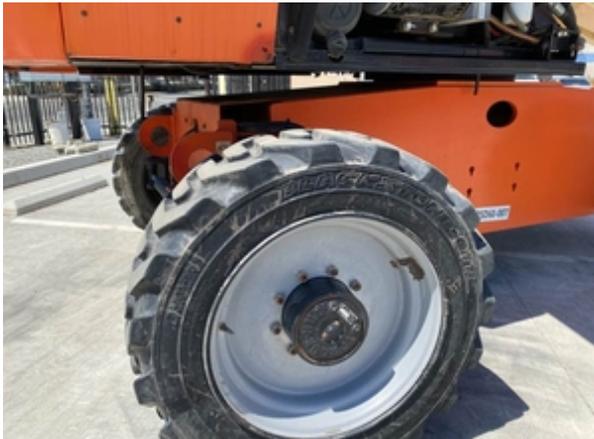
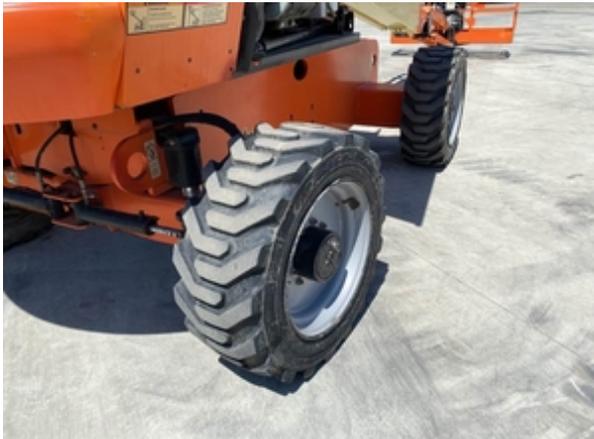
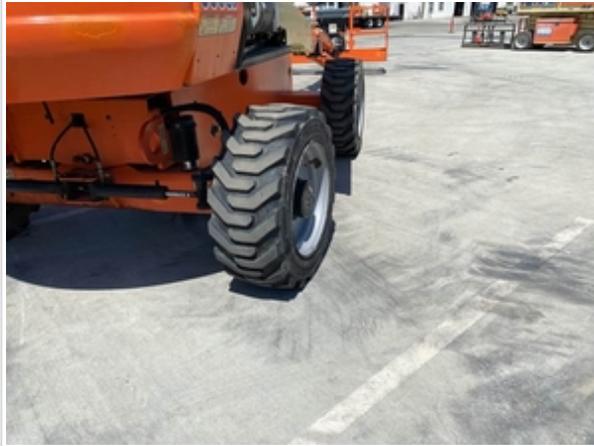
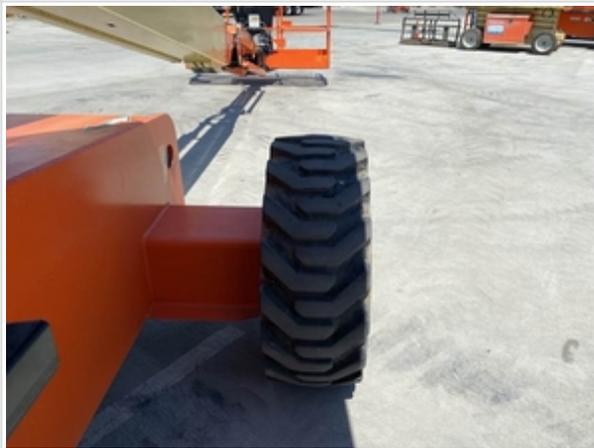
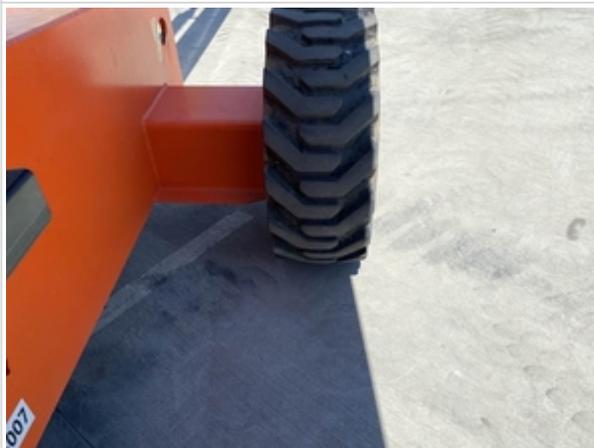
Wheels & Tires	4 - Like New, Recently Replaced	
Comments	Rear left tire has side treads cut off from impact. No major damage mostly cosmetic since top surface area is mostly relevant to machine grounds. Downgraded to 70% due to this	
Wheels & Tires Photos

Tire Brand	OTR blackstone	
Tire Size	39 x 15-22.5	
Front Left Tire - Ratio Remaining	90%	
Rear Left Tire - Ratio Remaining	70%	
Front Right Tire - Ratio Remaining	90%	
Rear Right Tire - Ratio Remaining	90%	
Swivel Bearing	4 - Like New, Recently Replaced	
Swivel Bearing Photos

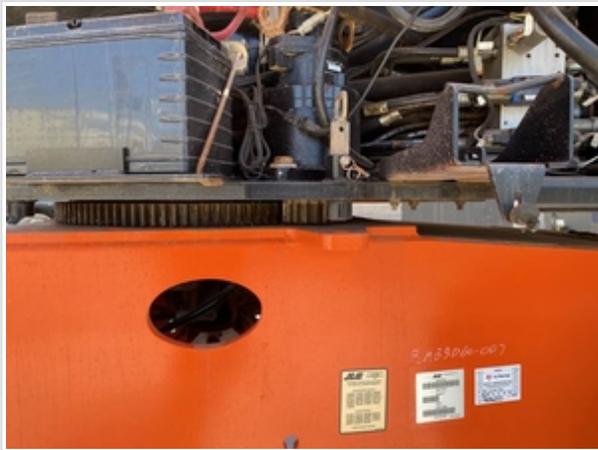
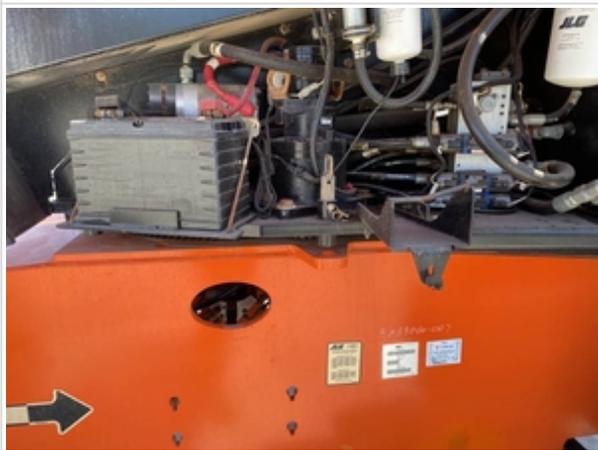
<p>Swivel Bearing Photos</p>

<p>Swivel Motor</p>	<p>4 - Like New, Recently Replaced</p>

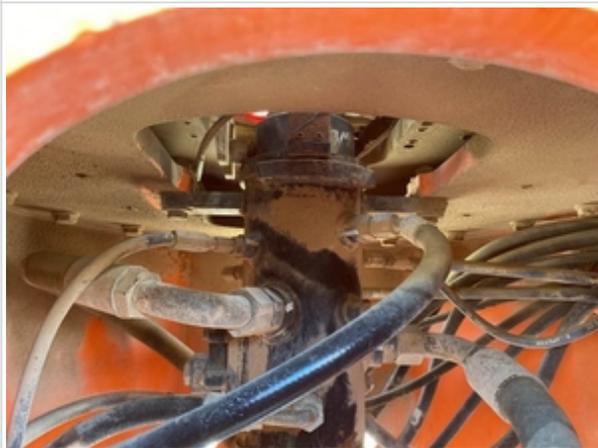
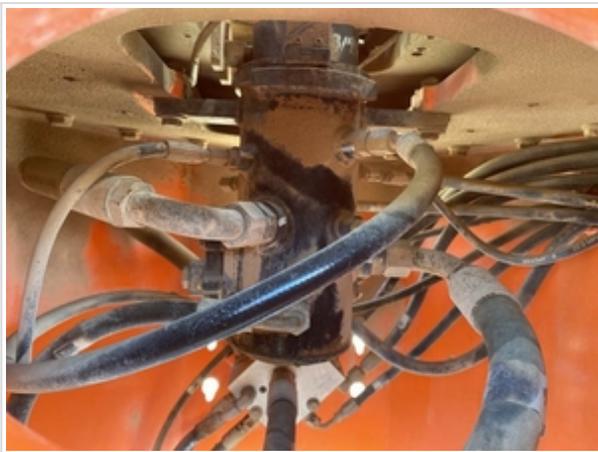
<p>Swivel Joint</p>	<p>4 - Like New, Recently Replaced</p>
<p>Swivel Joint Photos</p>

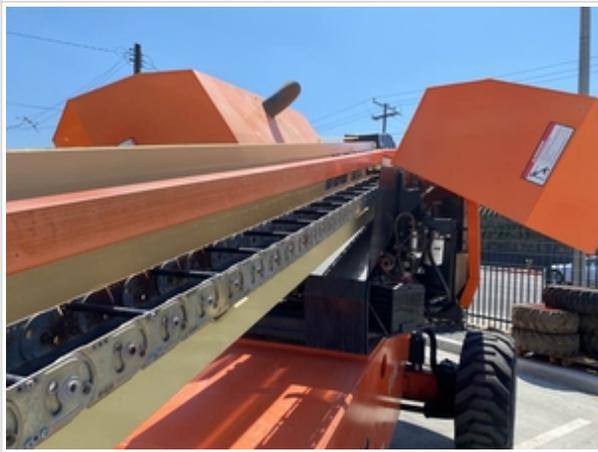
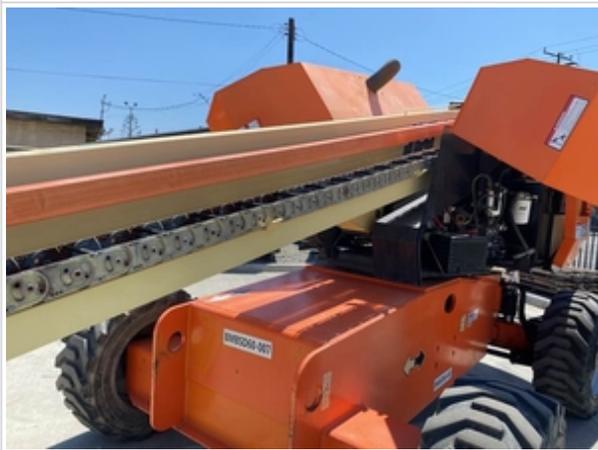
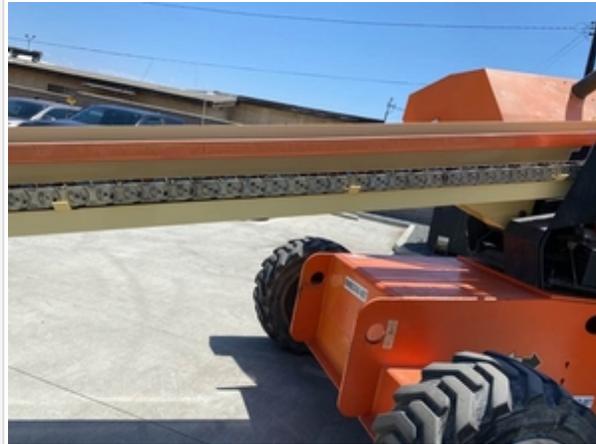
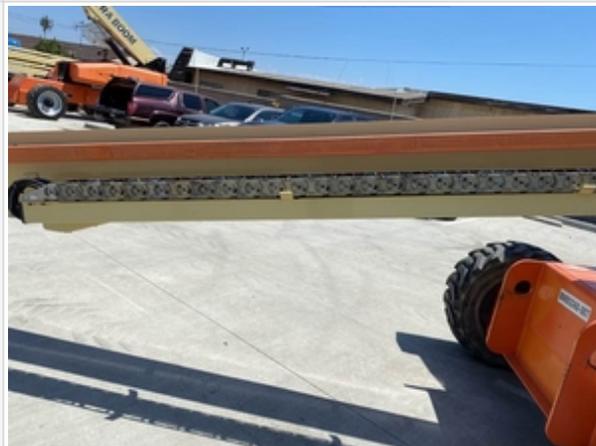
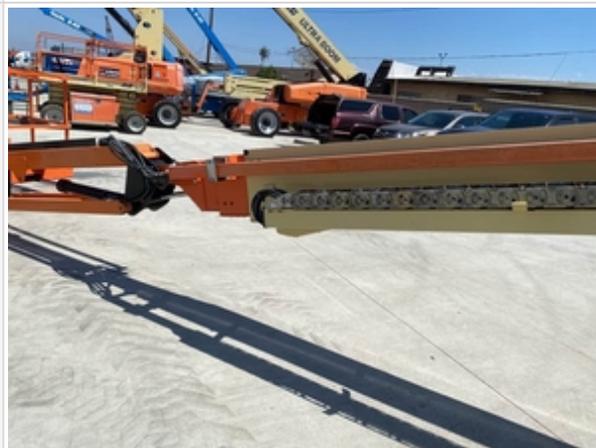
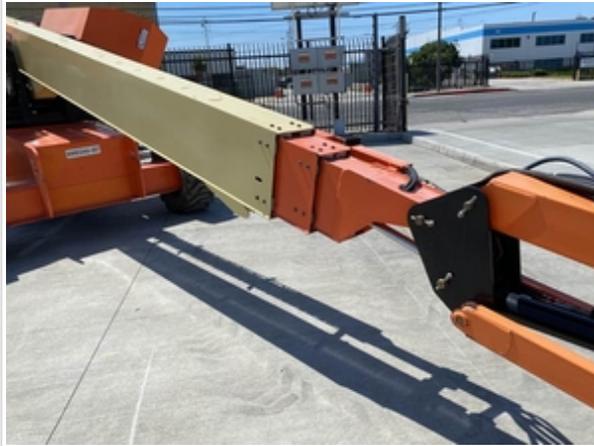
<p>Boom Condition</p>	<p>4 - Like New, Recently Replaced</p>	
<p>Boom Condition Photos</p>

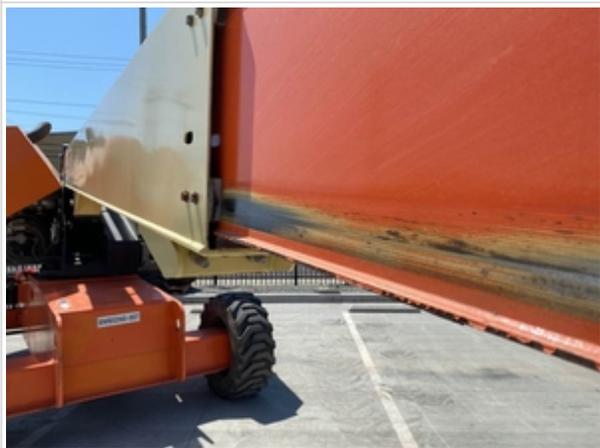
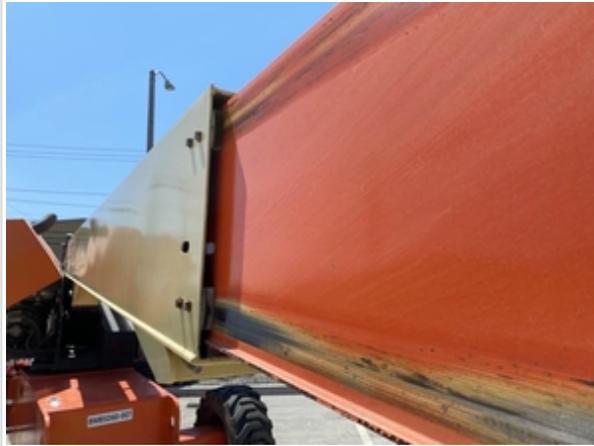
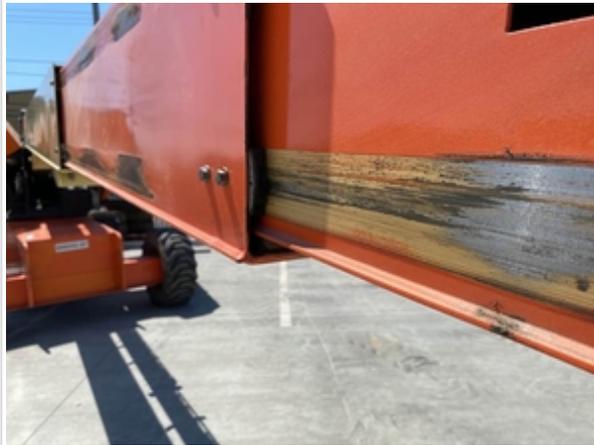
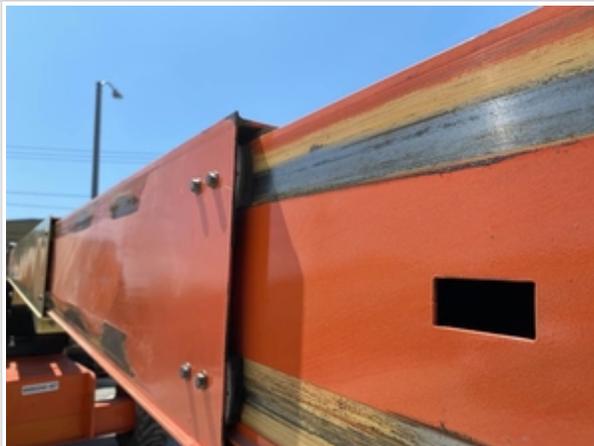
<p>Boom Wear Guides</p>	<p>4 - Like New, Recently Replaced</p>	
<p>Boom Wear Guides Photos</p>

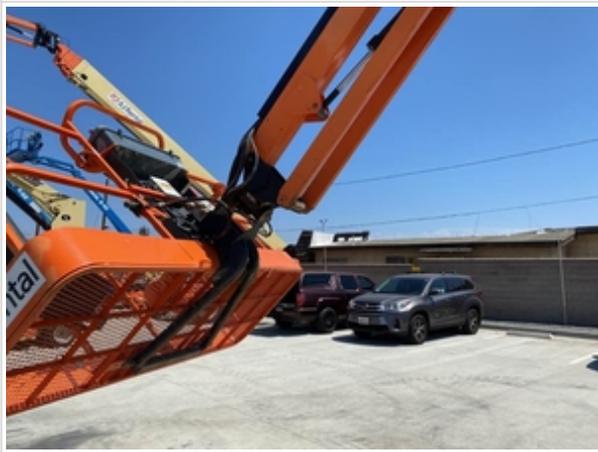
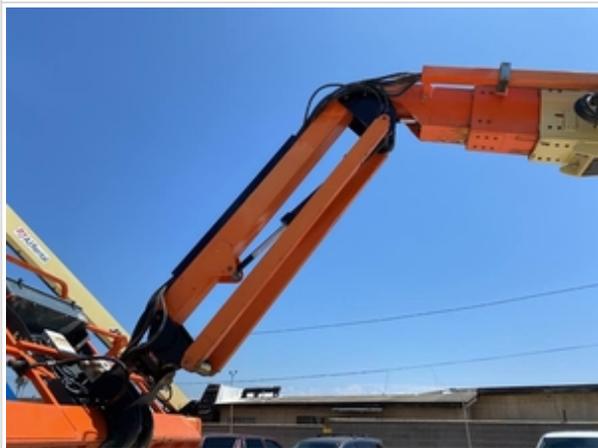
<p>Jib Condition</p>	<p>4 - Like New, Recently Replaced</p>	
<p>Jib Condition Photos</p>
