Inspection Report (Boom Lift)

Year	2015
Make	JLG
Model	660sj
Serial Number	0300197865
Hour Meter Reading	2804
Previous Application (e.g., earth moving, mining, demolition, etc)	General Construction Rentals

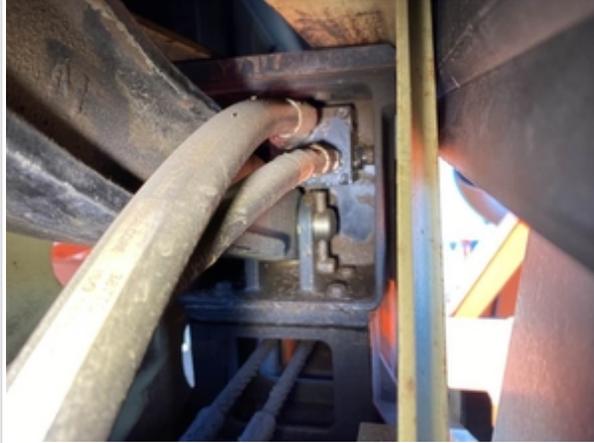
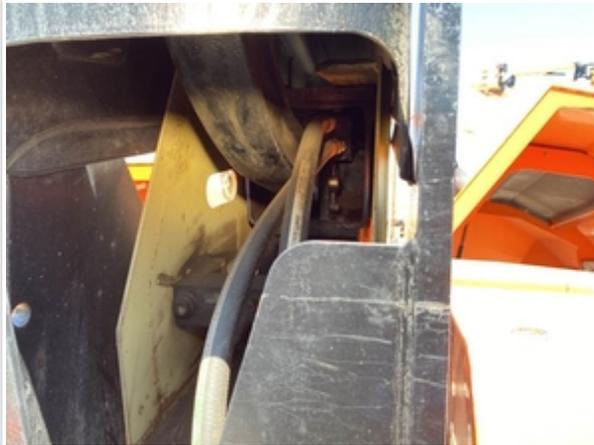
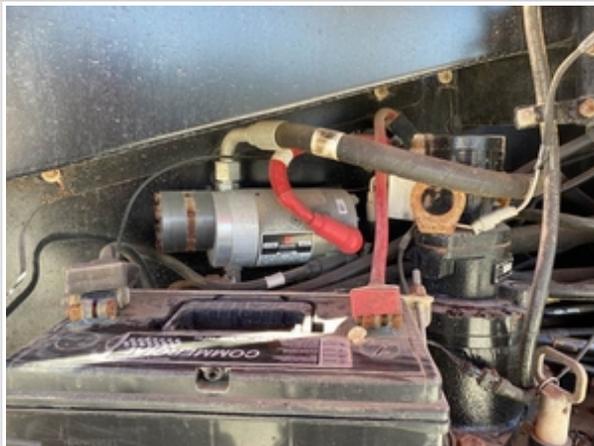
Appearance of Hydraulic Lines /
Fittings Photos

Wet or Damp Hydraulic Lines / Fittings	Yes	
Appearance of Hydraulic Lines / Fittings	4	
Hydraulic Lines / Fittings Condition	Hydraulic lines & fittings are clean and in good condition, Active leaks in hoses or fittings observed, Other (see comments)	
Comments	Only found 1 small rear hose leak at telescope cylinder valve the rest of the machine is leak free

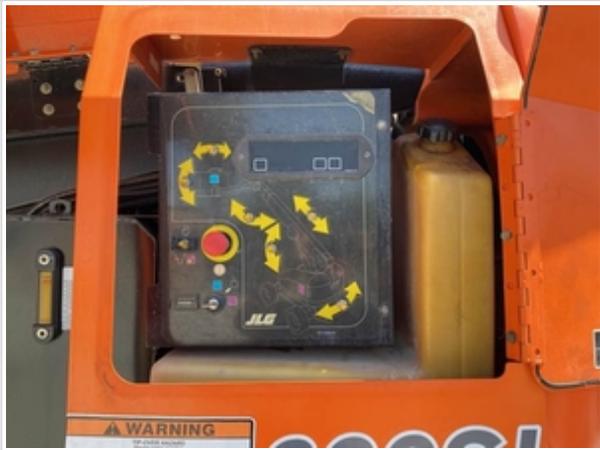
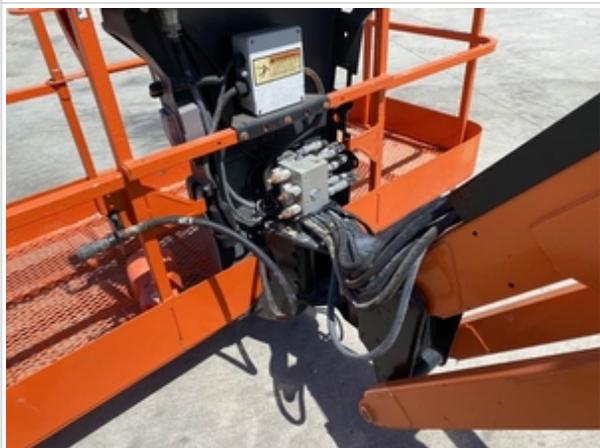
Unusual Noises (Hydraulic Pump)	No	
Hydraulic Pump Notes	No unusual noises heard during operation	
External Controls / Levers	4	
External Controls / Levers Condition	Good function & condition of hydraulic controls	
External Controls / Levers Photos

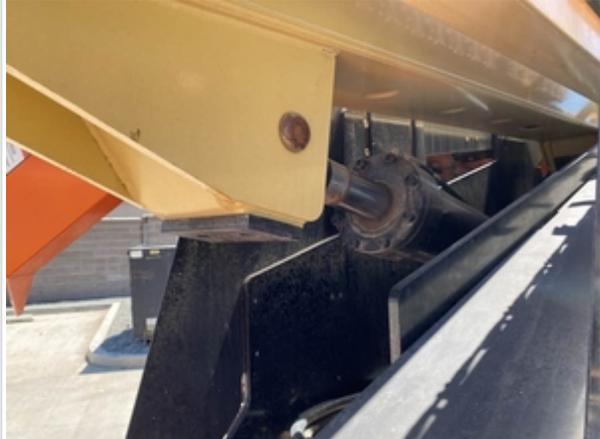
Boom Lift Cylinders	Check the boom lift cylinders. Note any wear, pitting, discoloration, etc. Take photos.
Boom Lift Cylinders: Mounting Pin	4
Boom Lift Cylinders: Oil Leaks	No
Boom Lift Cylinders Photos

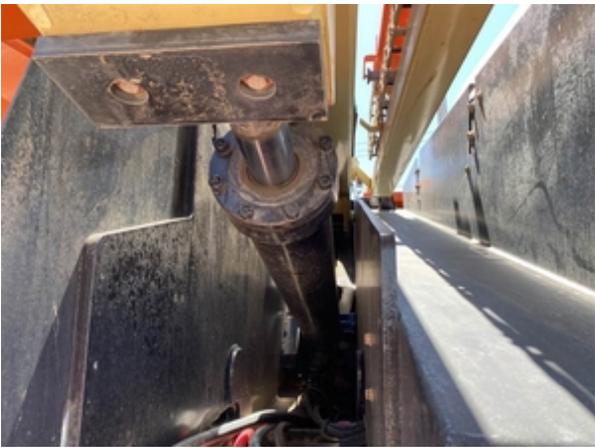
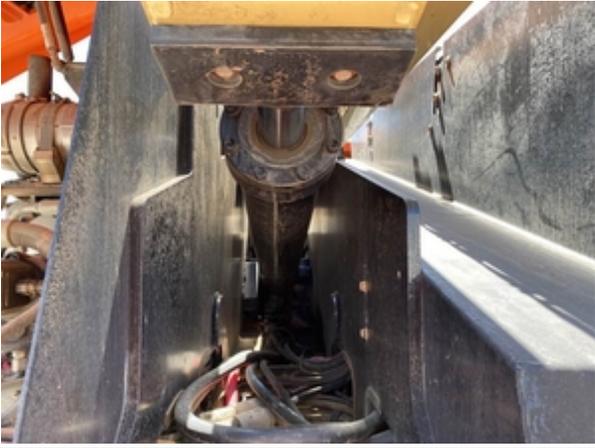
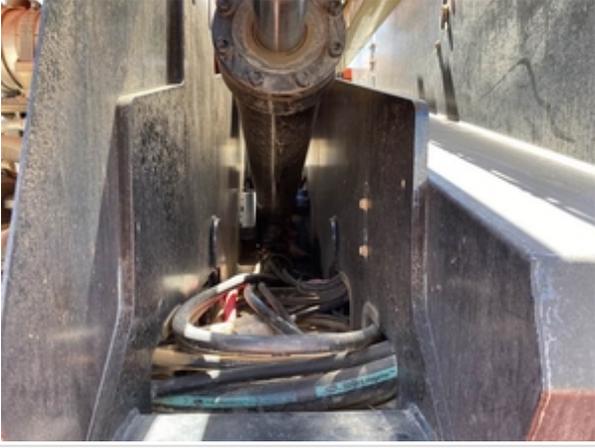
Boom Extension Cylinder	Check the boom extension cylinder. Note any wear, pitting, discoloration, etc. Take photos.	
Boom Extension Cylinder: Mounting Pin	4	
Boom Extension Cylinder: Oil Leaks	No	
Comments	Small oil leak at rear telescope cylinder hose only

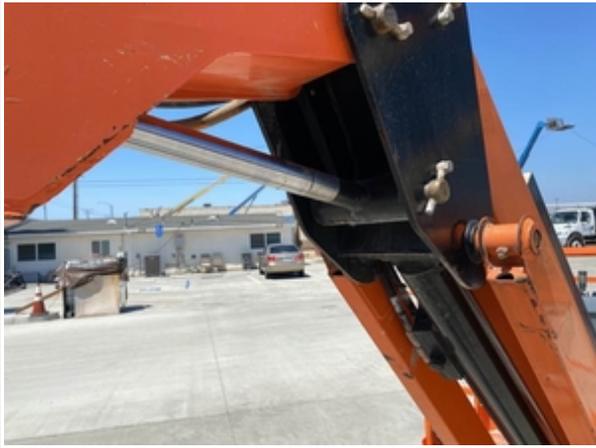
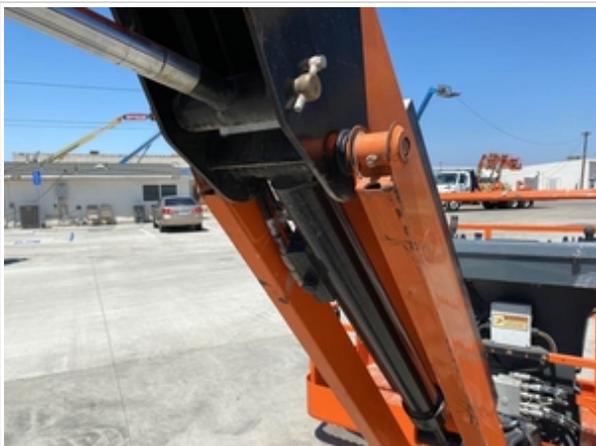
Jib Cylinder	Check the jib cylinder. Note any wear, pitting, discoloration, etc. Take photos.
Jib Cylinder: Oil Leaks	No
Jib Cylinder: Mounting Pin	4
Jib Cylinder Photos

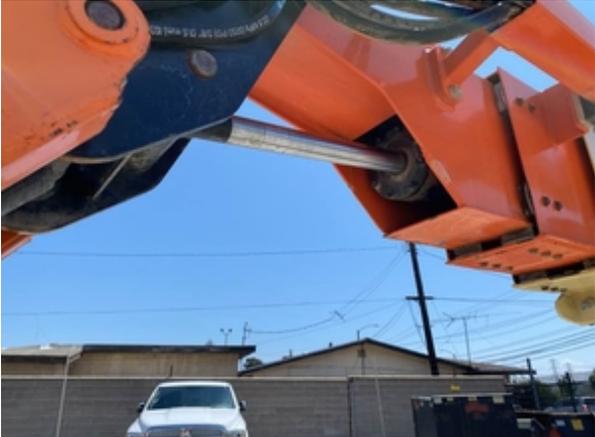
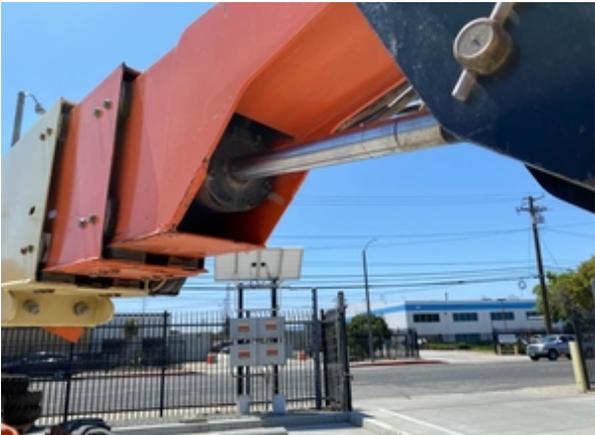
Basket Tilt Cylinder	Check the basket tilt cylinders. Note any wear, pitting, discoloration, etc. Take photos.
Basket Tilt Cylinder: Mounting Pin	4
Basket Tilt Cylinder: Oil Leaks	No
Basket Tilt Cylinder Photos

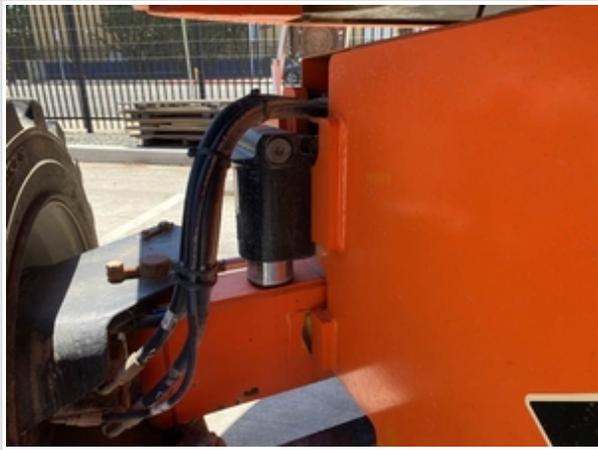
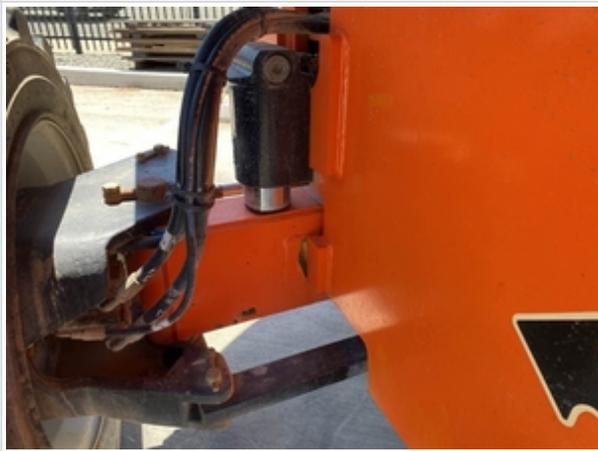
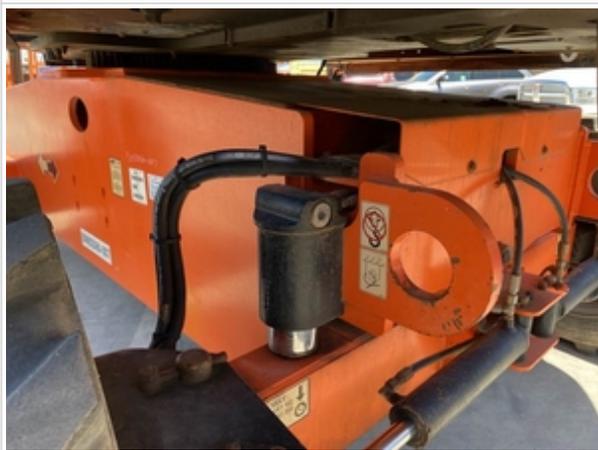
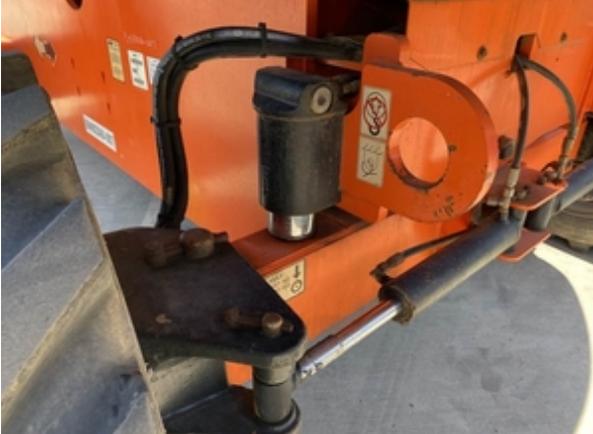
Frame Leveling Cylinders	Check the frame leveling cylinders. Note any wear, pitting, discoloration, etc. Take photos.
Frame Leveling Cylinders: Mounting Pin	4

<p>Frame Leveling Cylinders: Oil Leaks</p>	<p>No</p>
<p>Frame Leveling Cylinders Photos</p>

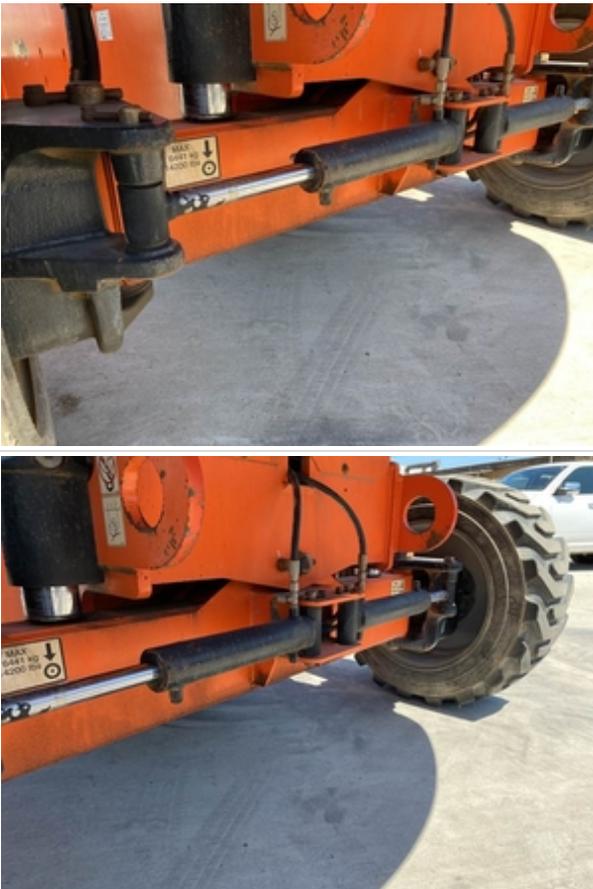
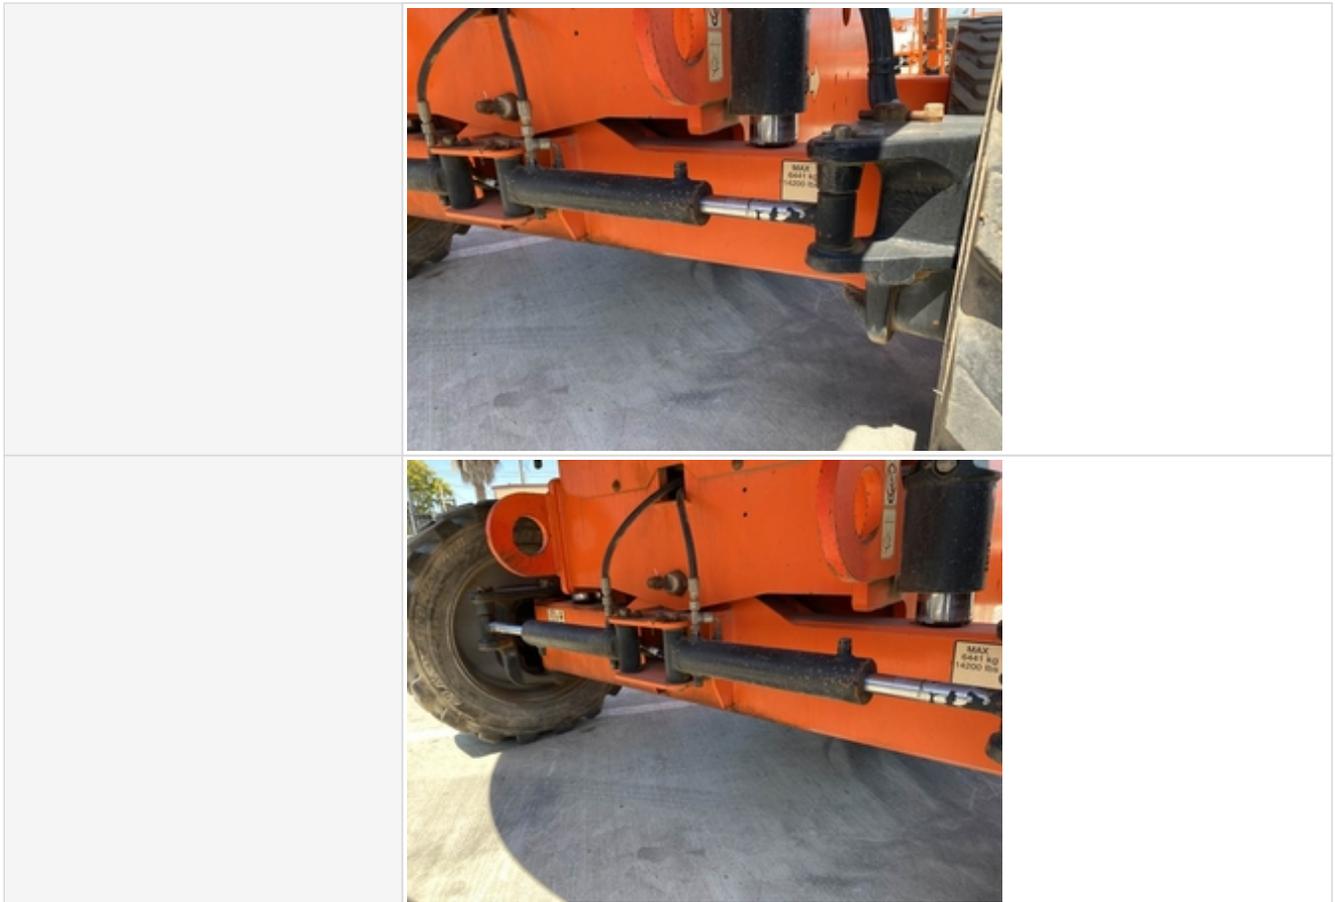
Outrigger Cylinders	Check the outrigger cylinders. Note any wear, pitting, discoloration, etc. Take photos.
Steering Cylinders	Check the steering cylinders. Note any wear, pitting, discoloration, etc. Take photos.
Steering Cylinders: Mounting Pin	4
Steering Cylinders: Oil Leaks	No
Steering Cylinders Photos
