Inspection Report (Backhoe Loader)

Year	2001
Make	Case
Model	580 Super M
Serial Number	JJG0377074
Hour Meter Reading	3452
Previous Application (e.g., earth moving, mining, demolition, etc)	Demo and general construction

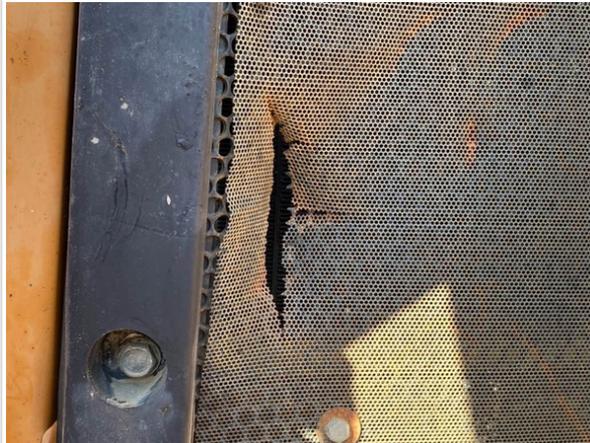
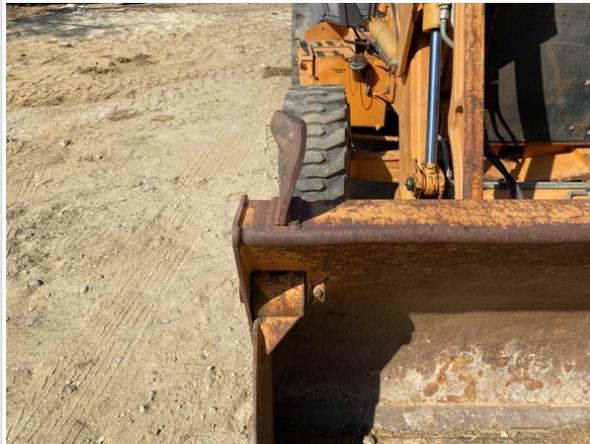
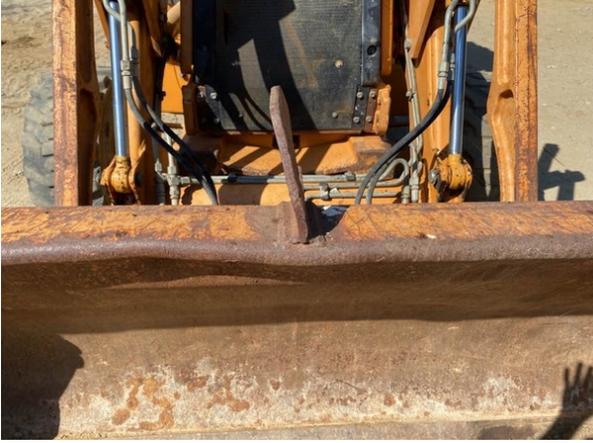
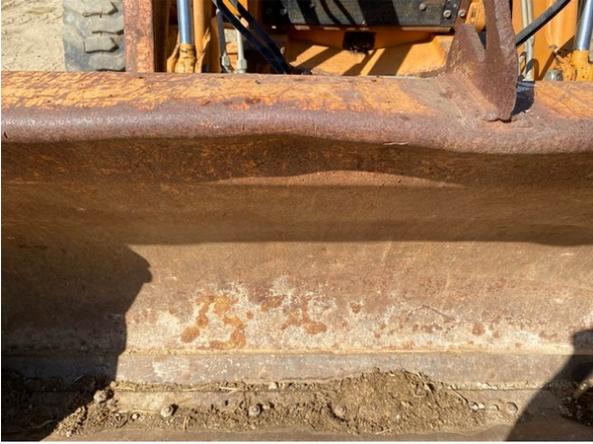
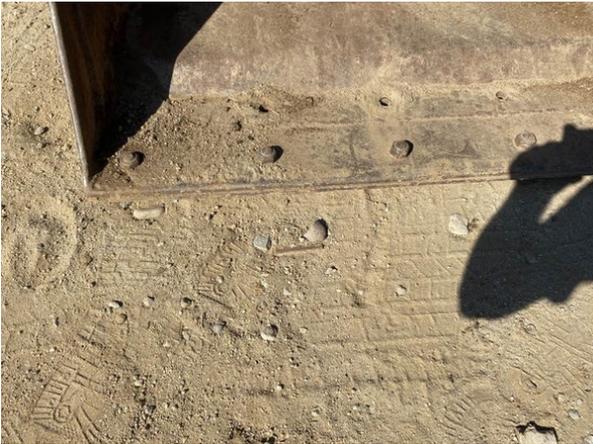
Front	3 - Normal Wear & Tear
Front Condition	Visible chipped paint or dents, Large dents or cracks, Other (see comments)
Comments	Cracked front grill, bent loader bucket hooks, cutting edge low,
Front Photos

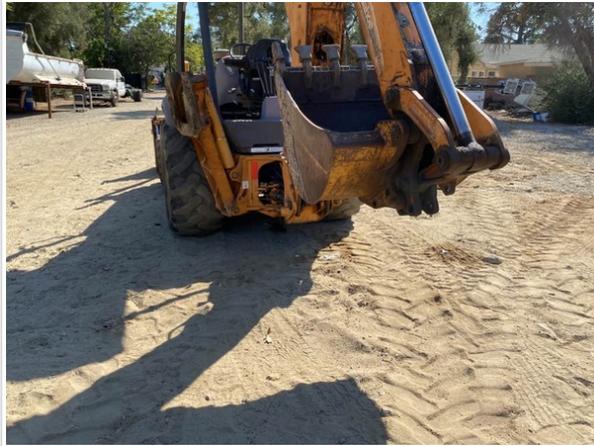
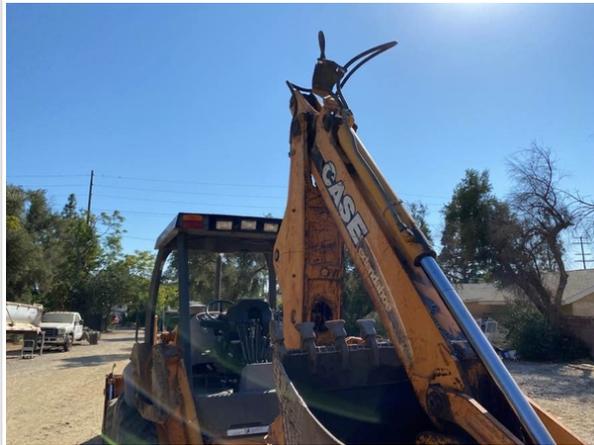
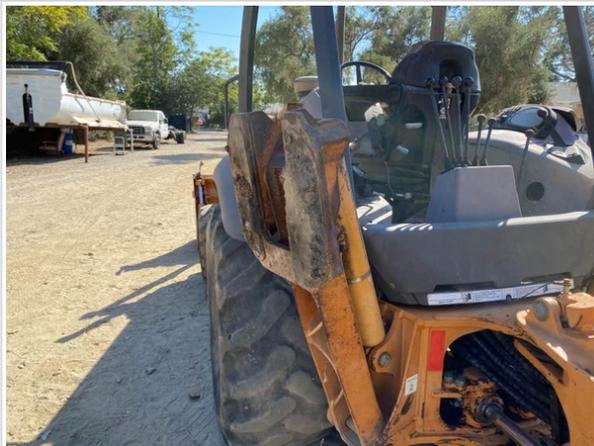
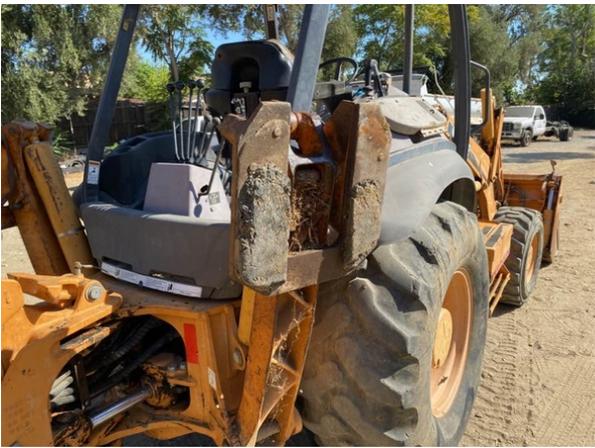
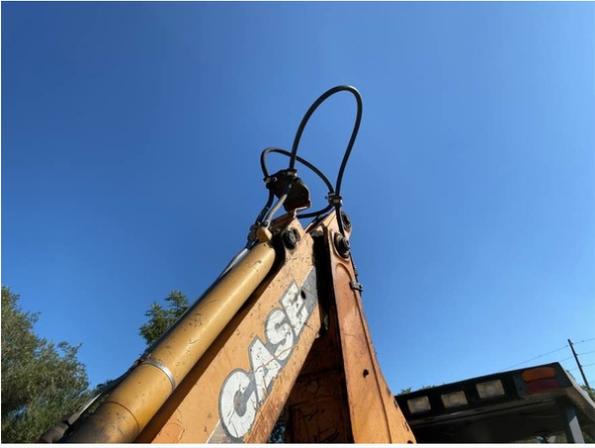
Rear Photos

Rear	3 - Normal Wear & Tear
Rear Condition	Other (see comments)
Comments	Normal wear and tear, outrigger pads worn

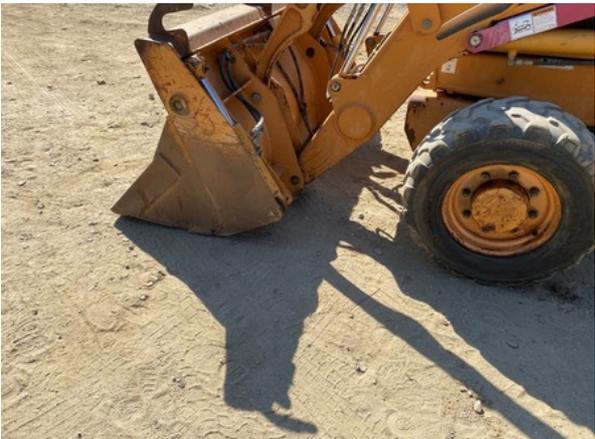
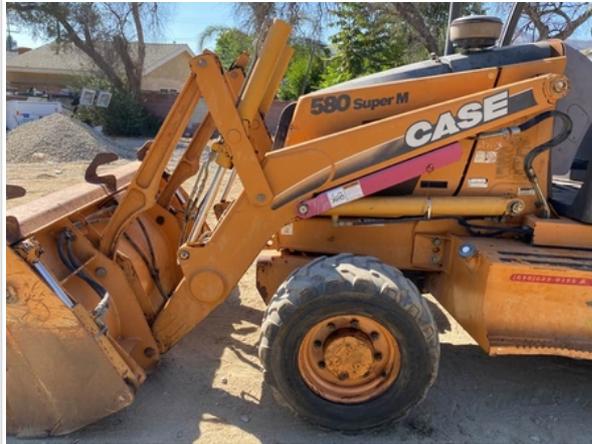
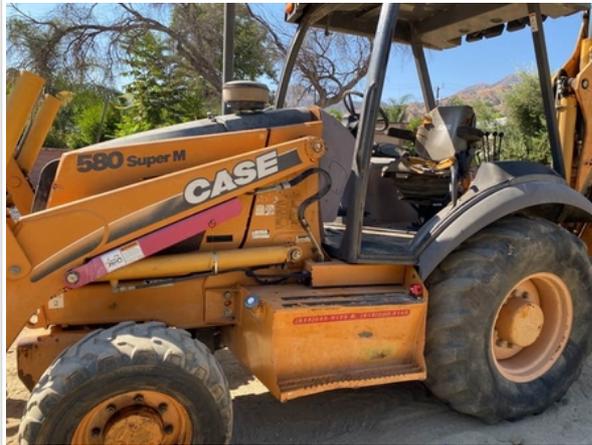
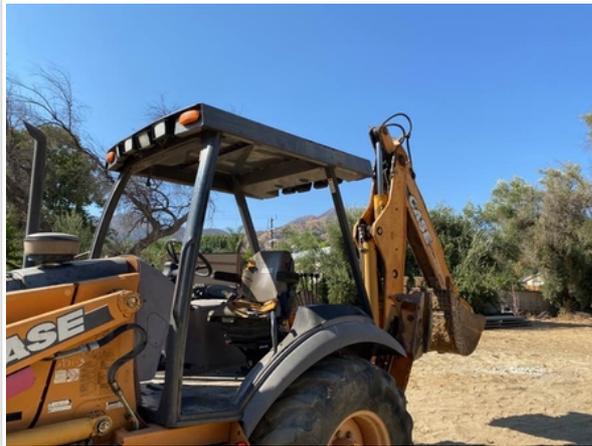
Left	3 - Normal Wear & Tear	
Left Condition	Visible chipped paint or dents, Other (see comments)	
Comments	Lest side step bent, rest of left side looks good	
Left Photos

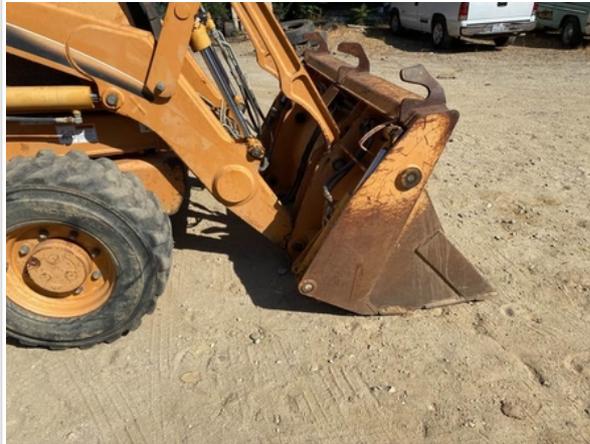
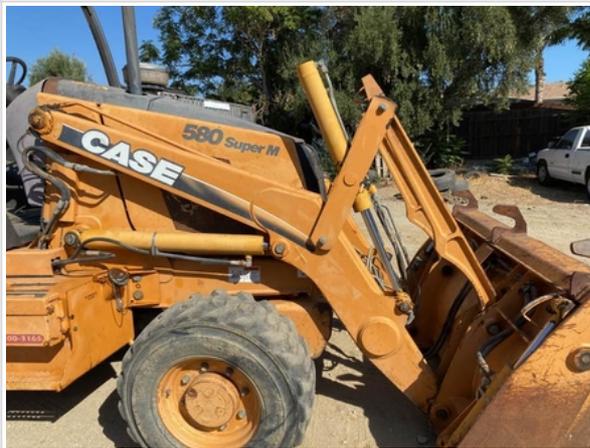
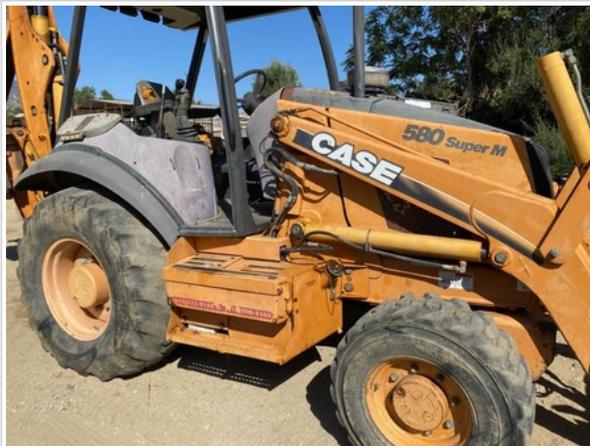
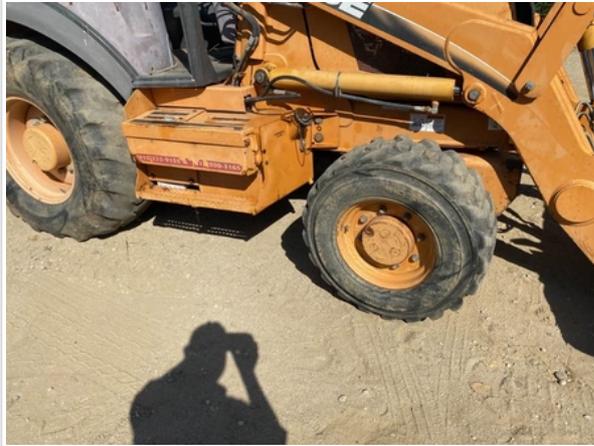
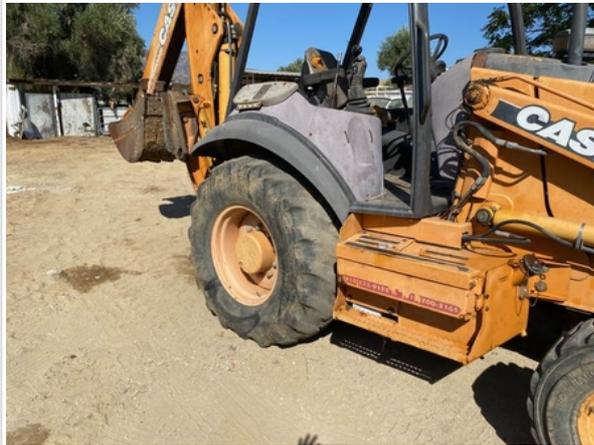
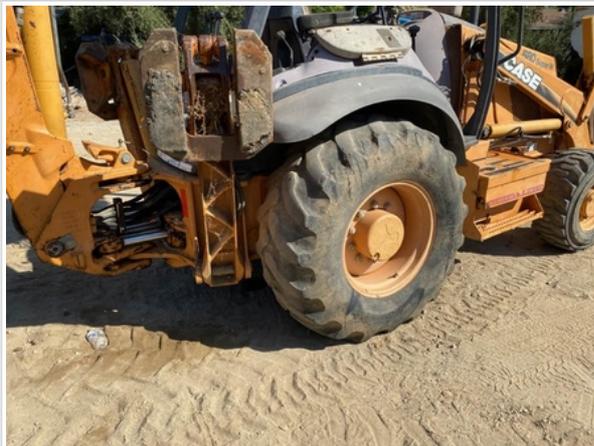
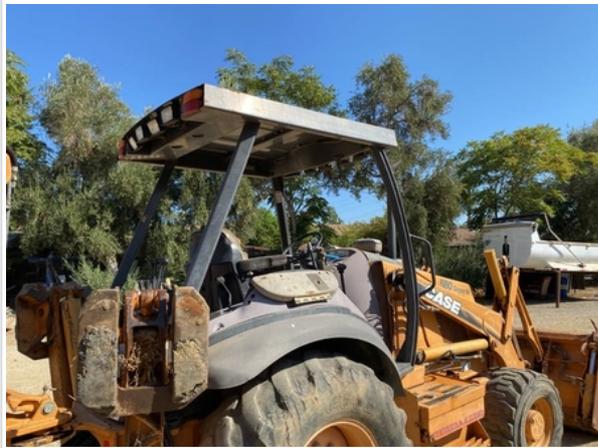
Right Photos

Right	3 - Normal Wear & Tear
Right Condition	No visible damage

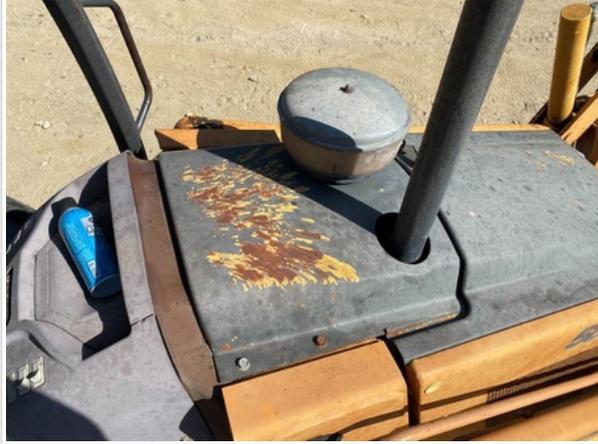
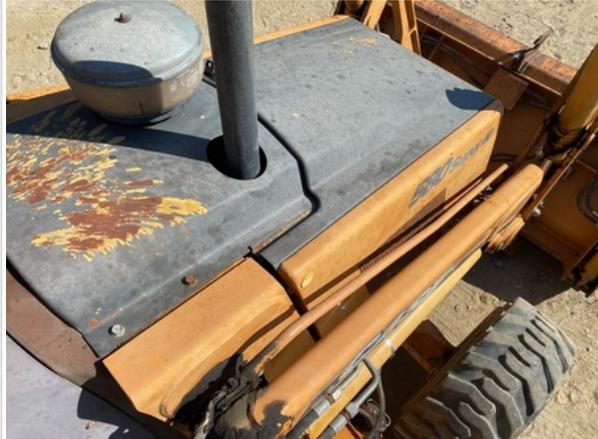
Upper	3 - Normal Wear & Tear	
Upper Condition	Areas of surface rust observed, Other (see comments)	
Comments	Normal wear and tear	
Upper Photos

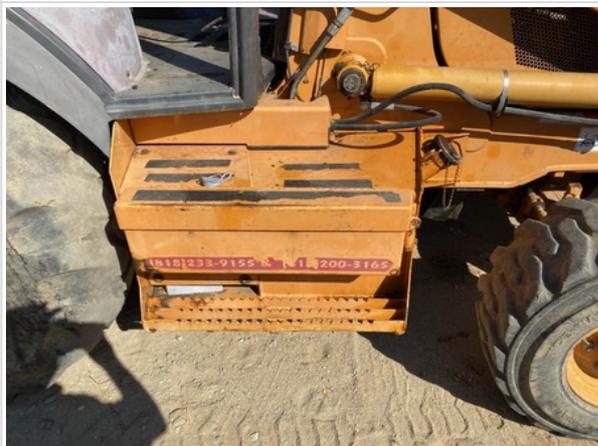
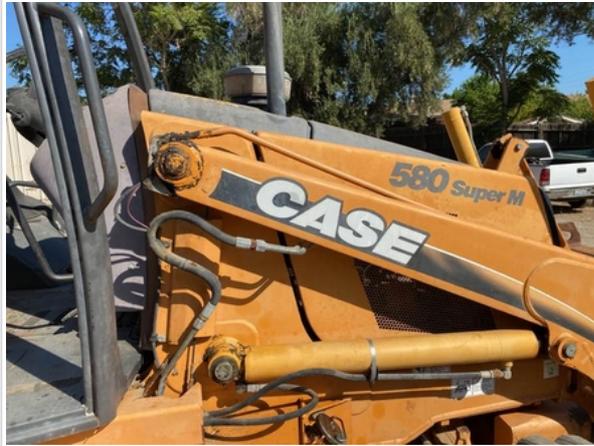
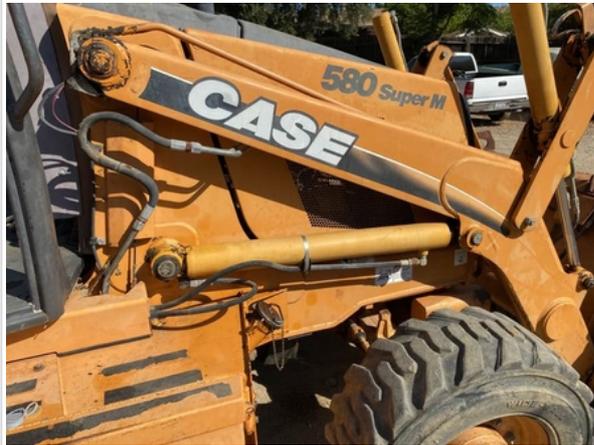
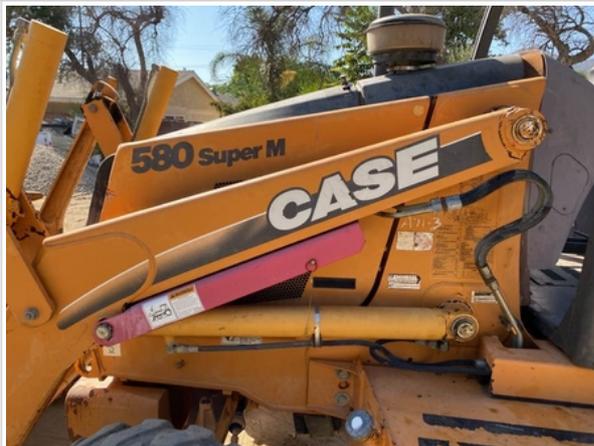
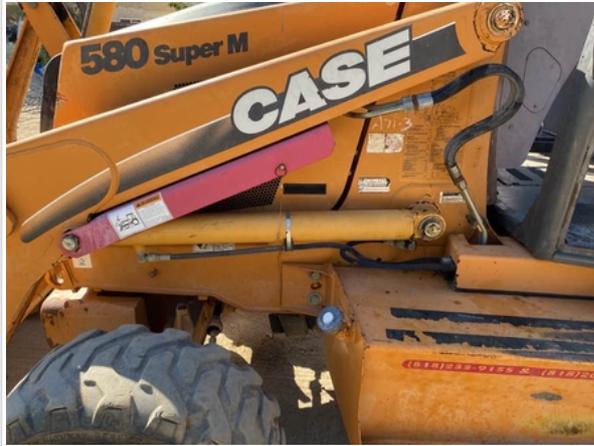
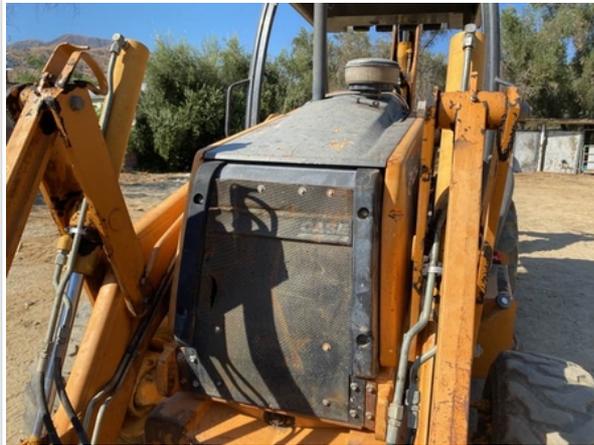
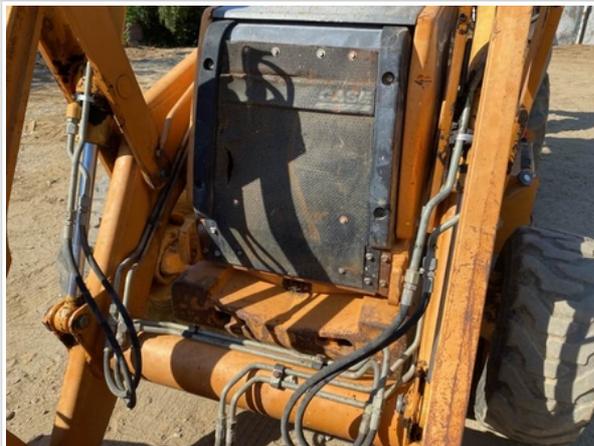
Body Panels (Any Rust Damage?)	3 - Normal Wear & Tear	
Body Panel Condition	Other (see comments)	
Comments	Front grill only panel damaged	
Body Panels Photos

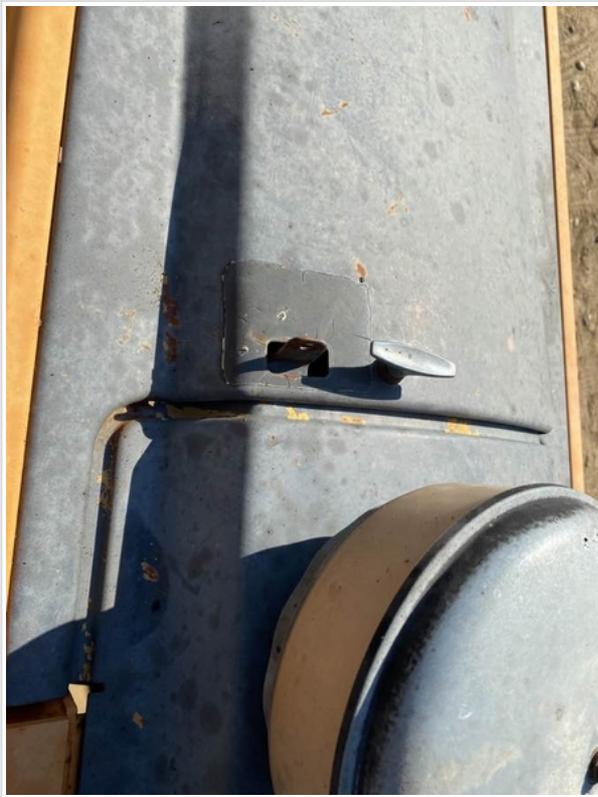
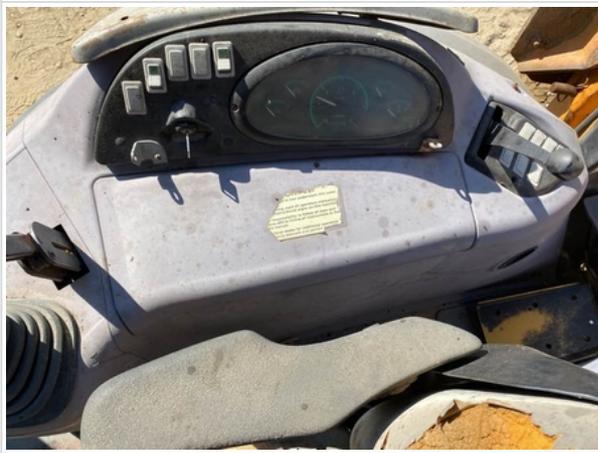
Doors / Canopy Latches Photos

Doors / Canopy Latches	3 - Normal Wear & Tear
Doors / Canopy Latches Condition	No visible damage

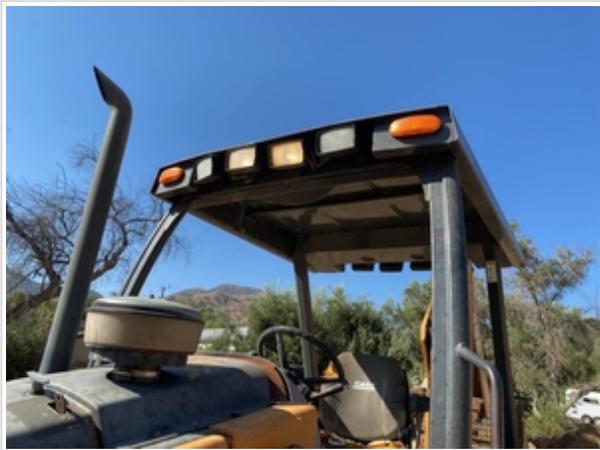
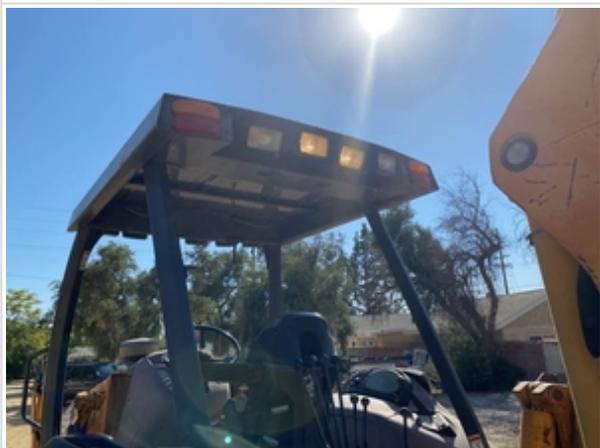
Lighting System Photos

Glass Condition	0
Mirrors	0
Lighting System	3 - Normal Wear & Tear
Lighting System Condition	One or more exterior lights are non-operational

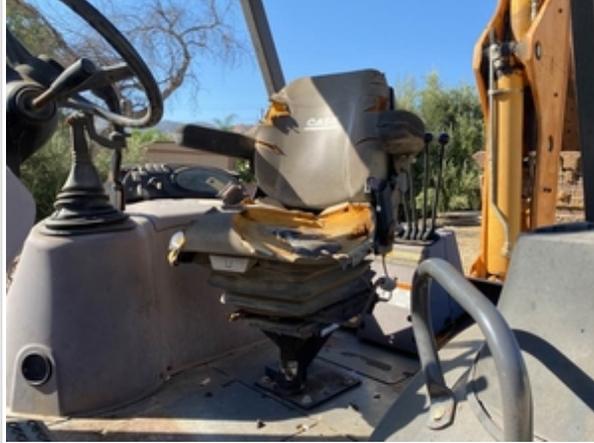
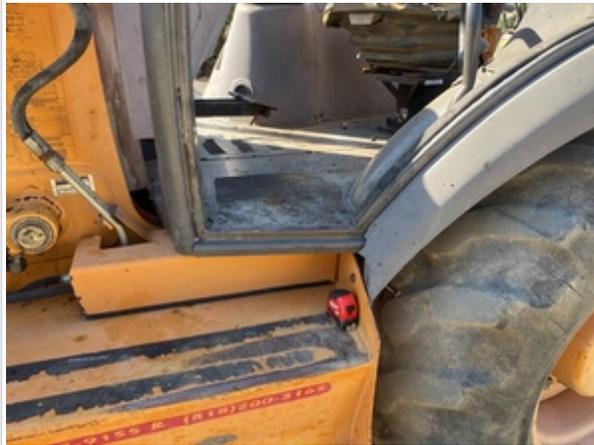
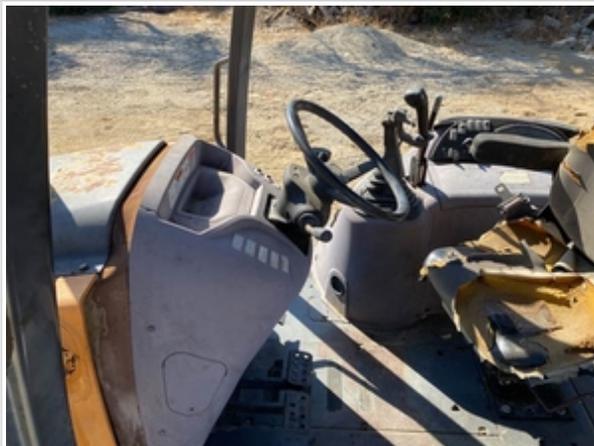
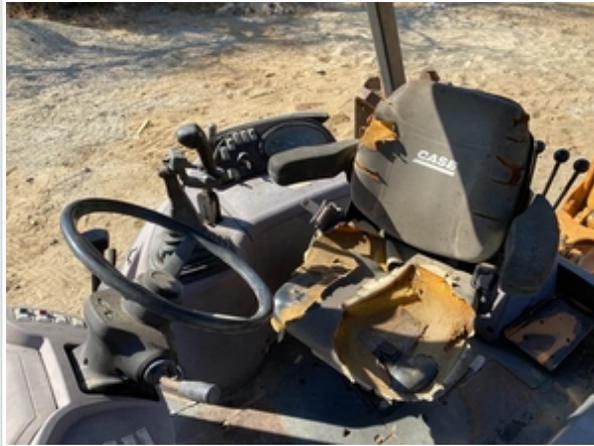
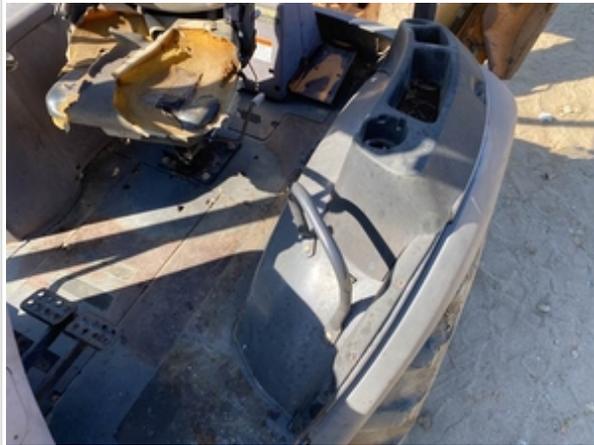
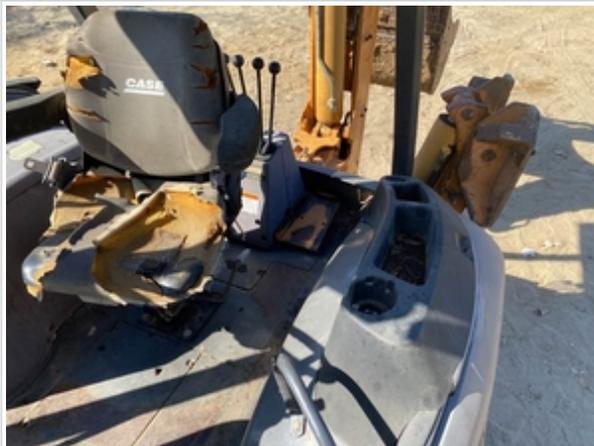
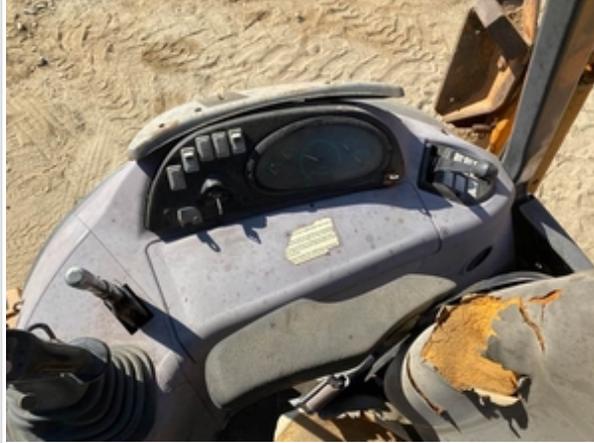
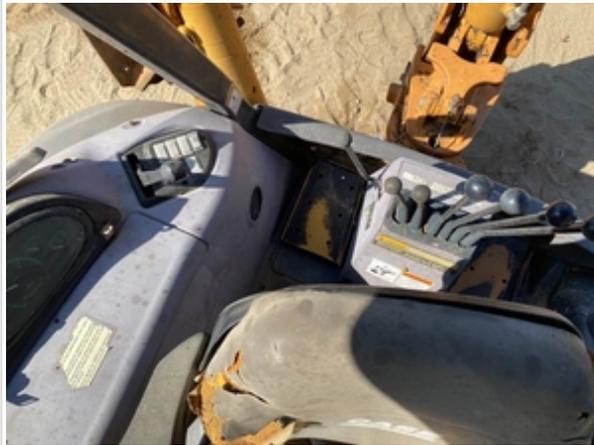
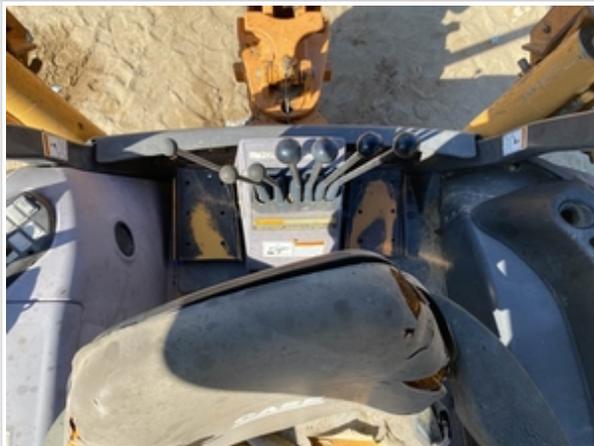
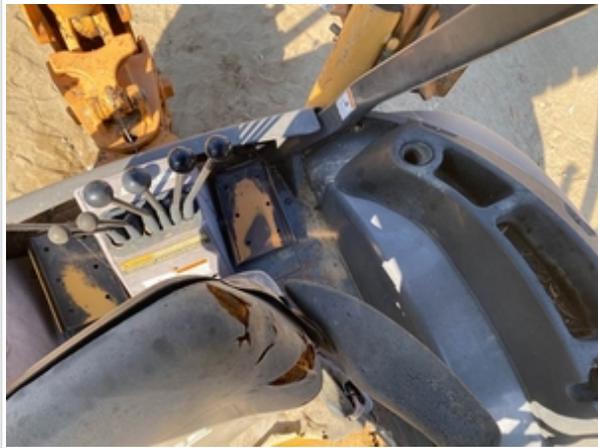
Operator Cabin Photos

Operator Cabin Overall	3 - Normal Wear & Tear	
Operator Cabin Overall Condition	Minor cosmetic wear to cabin surfaces, floors, panels, and ceiling. Other (see comments)	
Comments	Seat cushion damaged, operator control labels worn

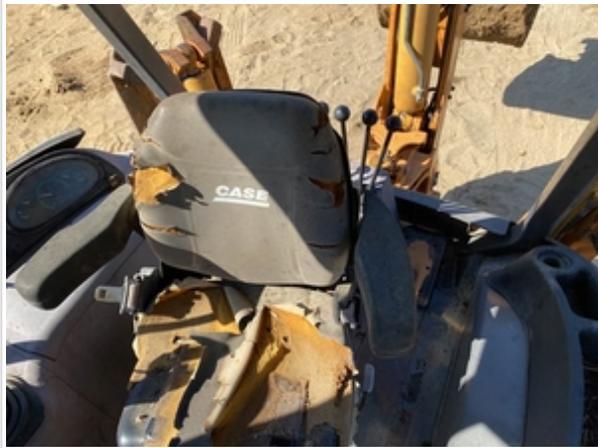
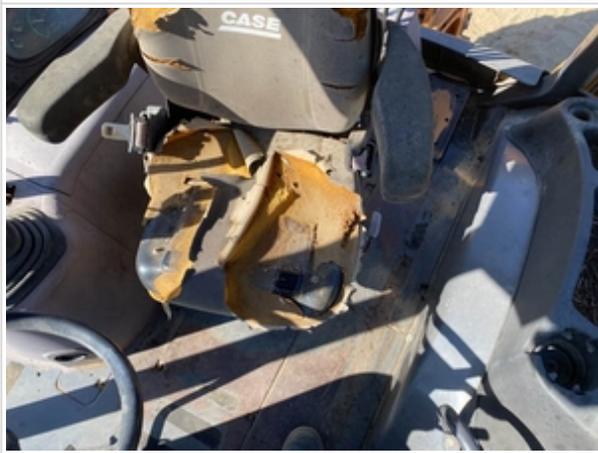
Operator's Seat & Arm Rests	1 - Service Required
Operator's Seat & Arm Rests Condition	Seat(s) is damaged due to sun exposure; fading, cracking observed, Seat(s) has major surface staining or tears
Operator's Seat & Arm Rests Photos

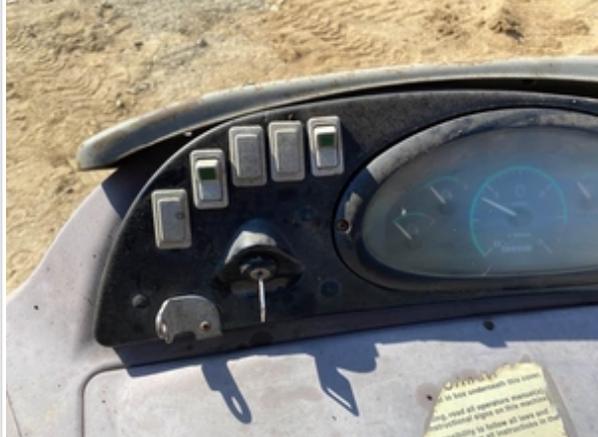
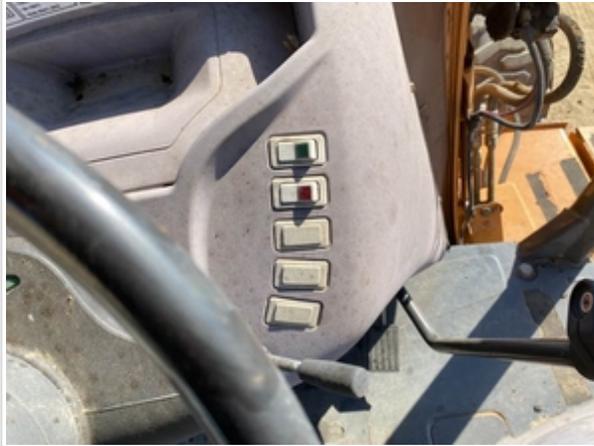
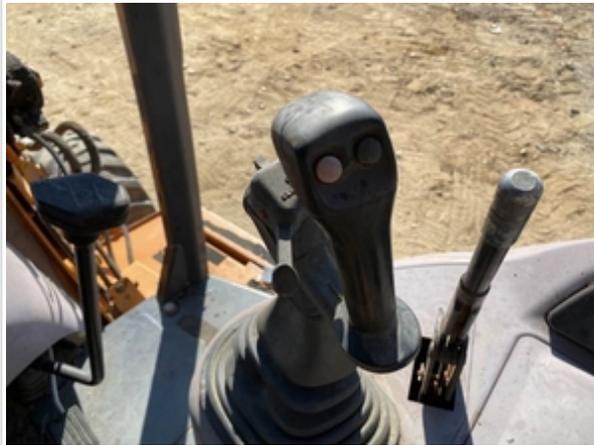
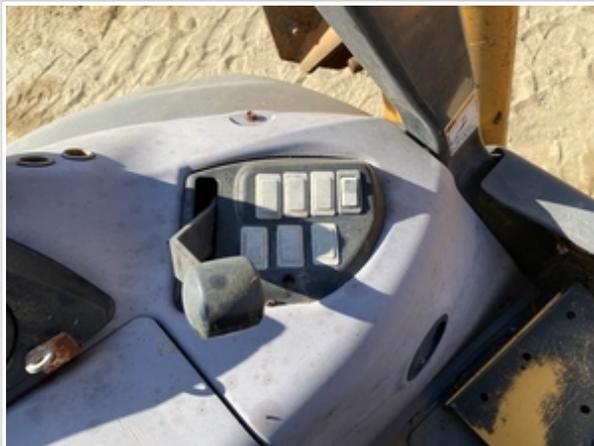
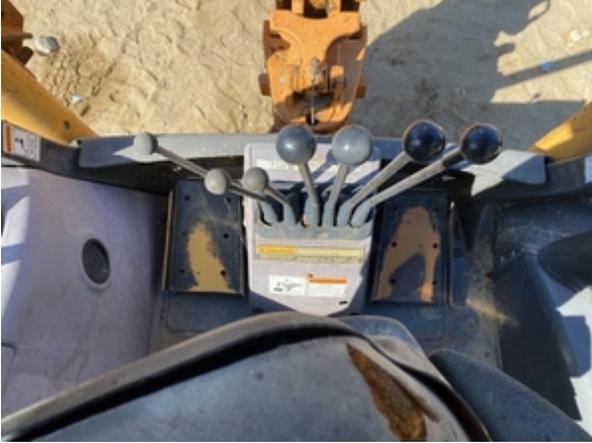
Cabin Lights	0
Safety Lock Out / Stop	0
Controls & Switches	2 - Above Average Wear
Controls & Switches Condition	Other (see comments)
Comments	Switch labels worn (unable to read)
Controls & Switches Photos

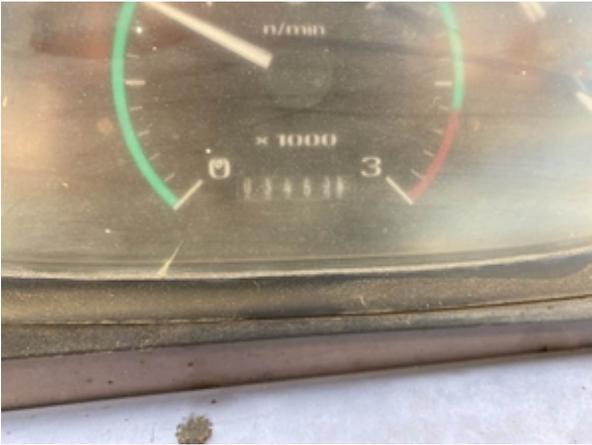
Hour Meter Activity	3 - Normal Wear & Tear	
Hour Meter Condition	Hour meter is functional and in good condition	
Hour Meter Activity Photos

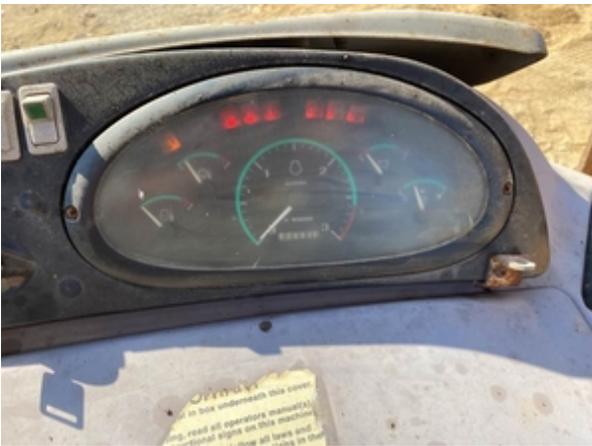
Other Gauge Activity	3 - Normal Wear & Tear	
Other Gauge Condition	All cockpit gauges are functional and in good condition, Gauges are functional, with some wear and/or cosmetic damage	
Other Gauge Activity Photos

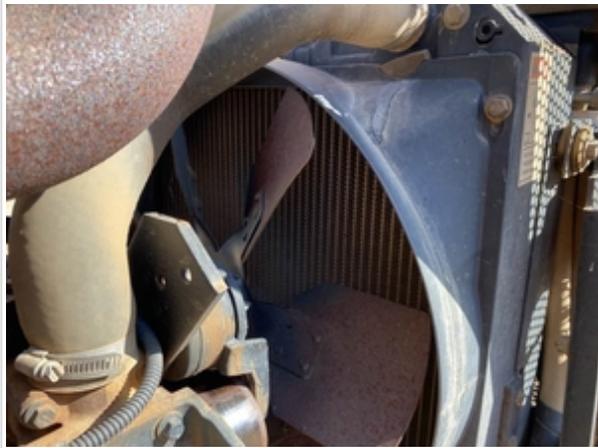
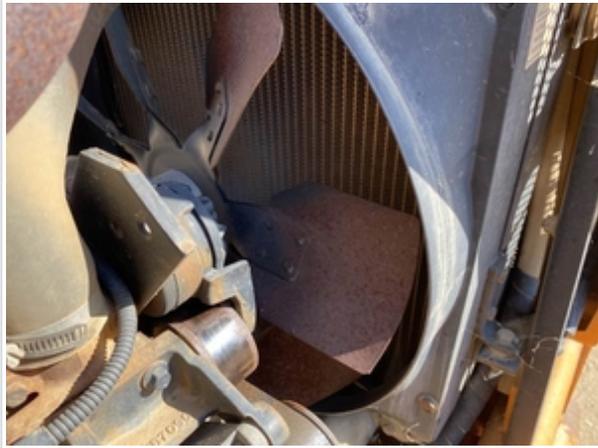
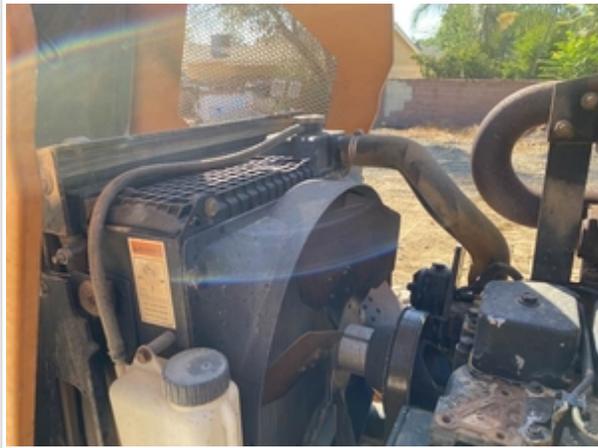
Radiator Photos

Blow-by (Visual Observation Check)	No
Unusual Noises (Upon Start-up, Idle, Shutdown)	No
Unusual Noise Notes	No unusual noises heard
Engine Smoke (Upon Start-up, Idle, Shutdown)	Yes
Engine Smoke Notes	Engine smoke observed upon start up, Other (see comments)
Comments	Normal smoke at startup
Engine Exhaust Color	Black
Battery	3 - Normal Wear & Tear
Battery Condition	Dusty & dirty appearance, Other (see comments)
Comments	Holds power, starts engine right up
Radiator	3 - Normal Wear & Tear
Radiator Condition	Radiator fins & components appear to be in good working order, no signs of damage or leaks

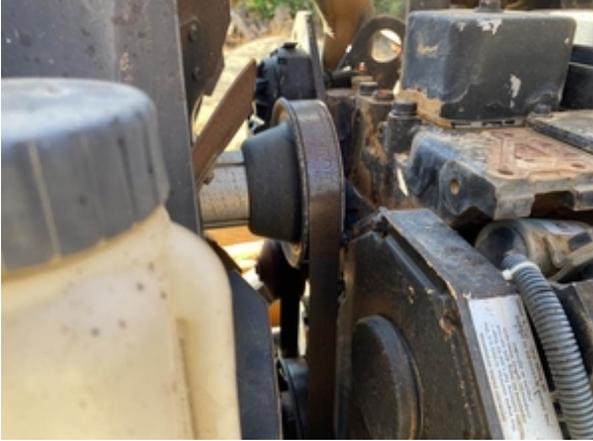
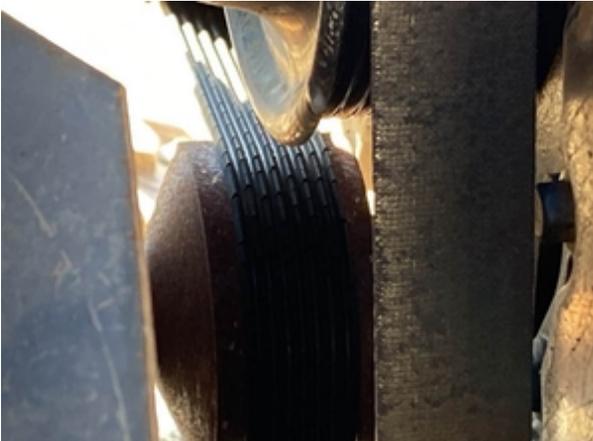
Belt Photos

Belts	2 - Above Average Wear
Belt Condition	Cracks, missing grooves, or separating layers on one or more belts, Other (see comments)
Comments	Serpentine belt should be replaced soon

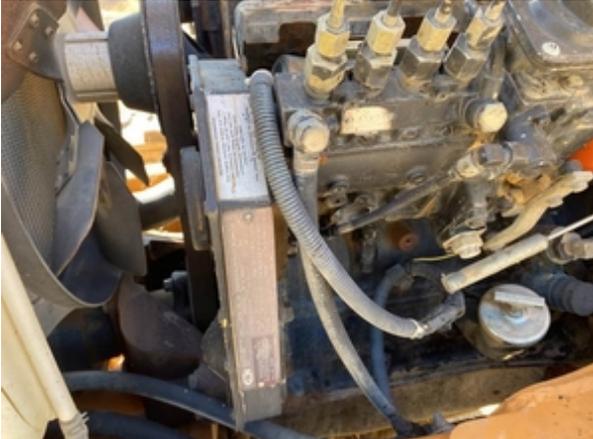
Hoses	3 - Normal Wear & Tear
Hose Condition	Firm, pliant hoses with no signs of wear or leaks
Hose Photos

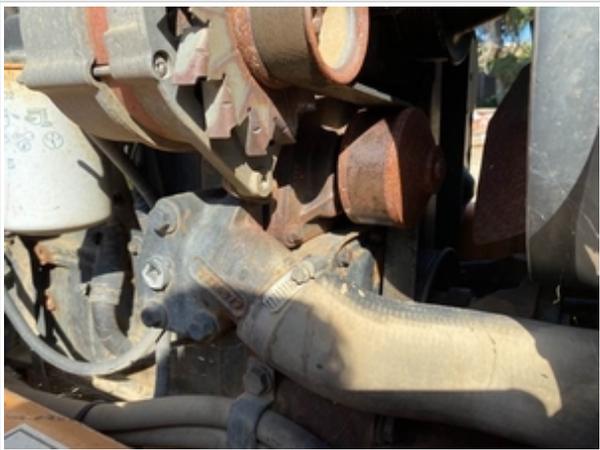
Water Pump	3 - Normal Wear & Tear	
Water Pump Condition	No unusual pump noises heard	
Water Pump Photos

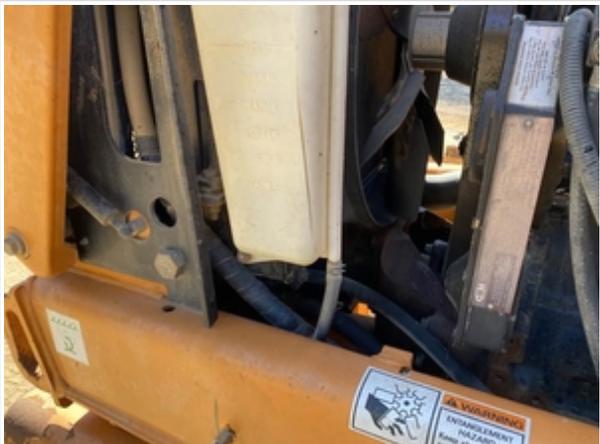
Cooling System Leaks	Yes	
Cooling System Condition	Other (see comments)	
Comments	Coolant reservoir cracked and unable to contain coolant, radiator full	
Cooling System Leaks Photos

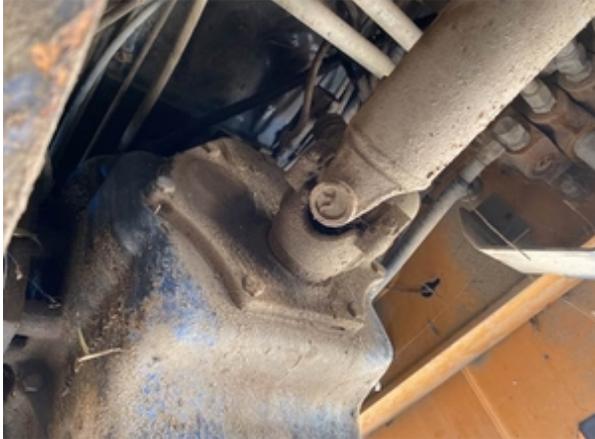
Transmission	3 - Normal Wear & Tear
Transmission Condition	No unusual noises or vibrations
Transmission Photos

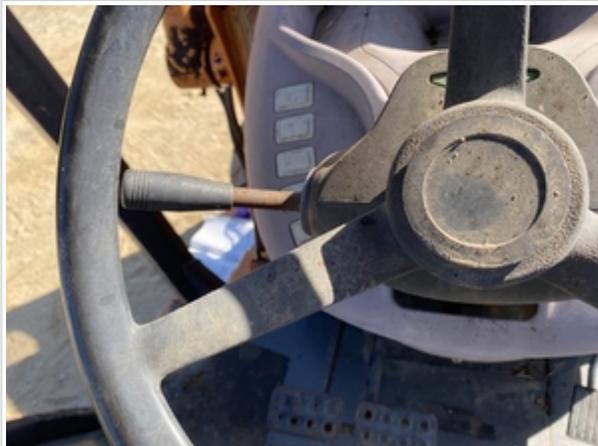
Clutch	0	
Shift Lever	3 - Normal Wear & Tear	
Shift Lever Condition	Good forward and reverse function	
Shift Level Photos

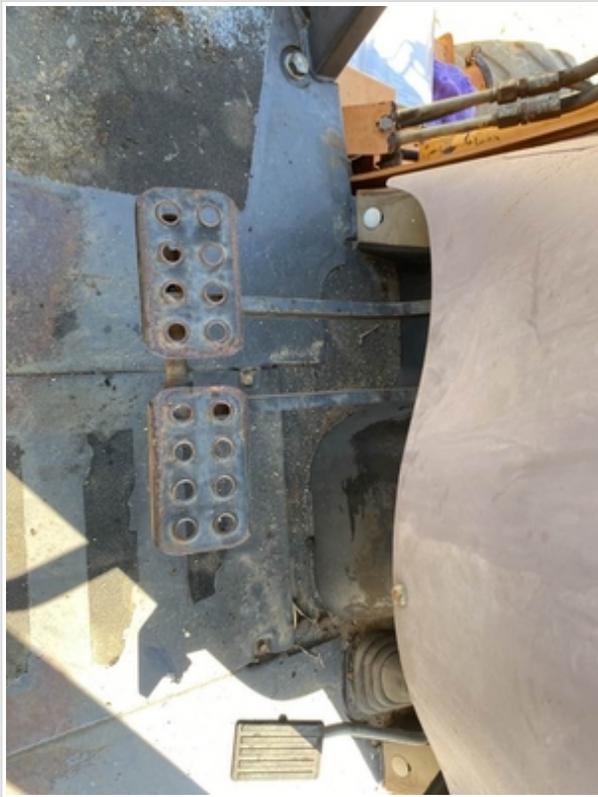
Foot Brake Photos

Foot Brake	3 - Normal Wear & Tear	
Foot Brake Condition	Good brake function

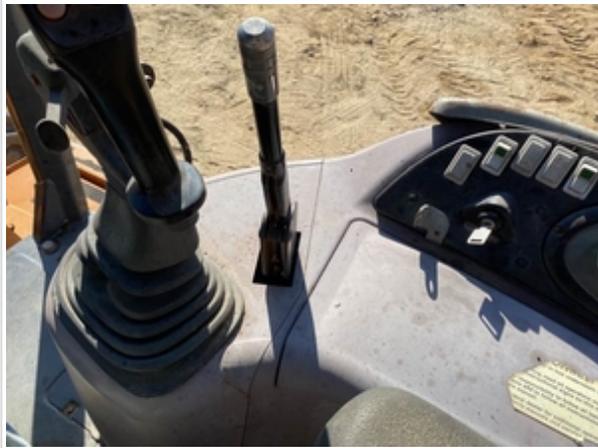
Inching Brake	0
Parking Brake	1 - Service Required
Parking Brake Condition	Poor performance; brake won't hold
Comments	May just need an adjustment
Parking Brake Photos

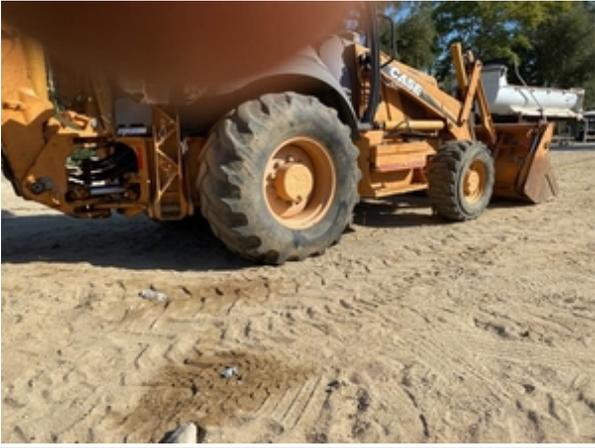
Stance	3 - Normal Wear & Tear	
Stance Photos

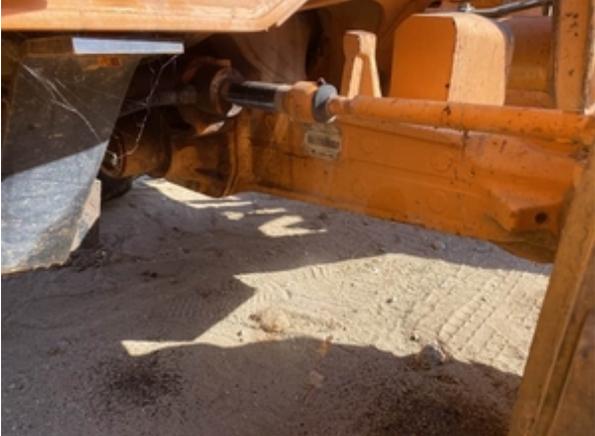
Front Axle Appearance	3 - Normal Wear & Tear	
Front Axle Appearance Photos

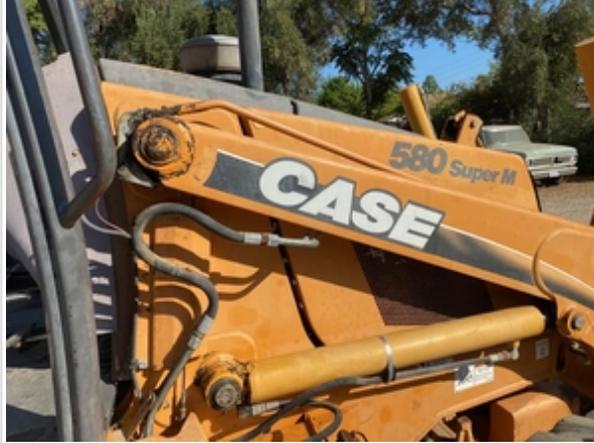
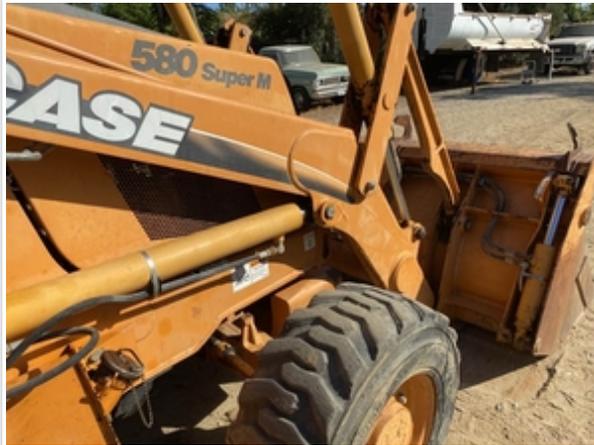
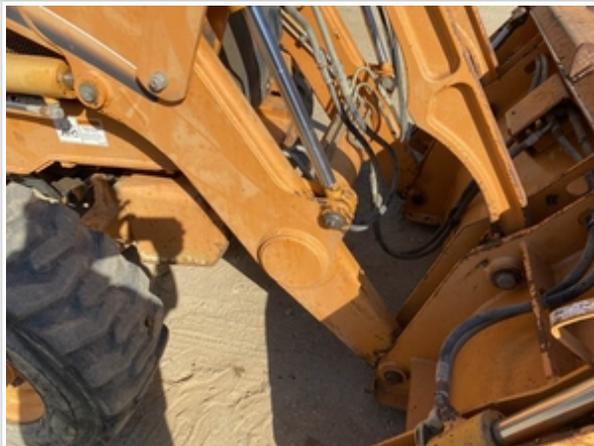
Lift Arm Photos

Oscillating Pin Appearance	0	
Wheels & Tires	3 - Normal Wear & Tear	
Comments	Normal wear on all 4 tires with sidewalk cracks appearing	
Tire Brand	Goodyear rear Firestone front	
Tire Size	19.5L -24 front 12. -16.5 front	
Front Left Tire - Ratio Remaining	50%	
Rear Left Tire - Ratio Remaining	30%	
Front Right Tire - Ratio Remaining	30%	
Rear Right Tire - Ratio Remaining	70%	
Lift Arm	3 - Normal Wear & Tear

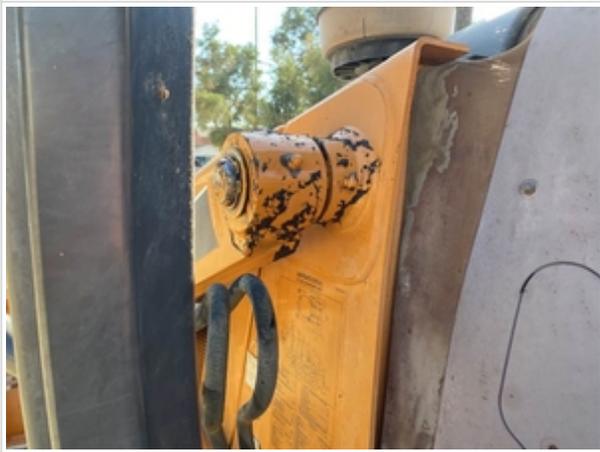
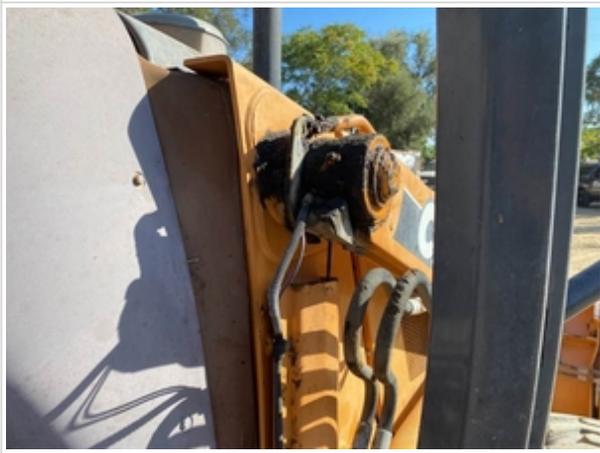
<p>Chassis to Arm Pins</p>	<p>3 - Normal Wear & Tear</p>	
<p>Chassis to Arm Pins Photos</p>

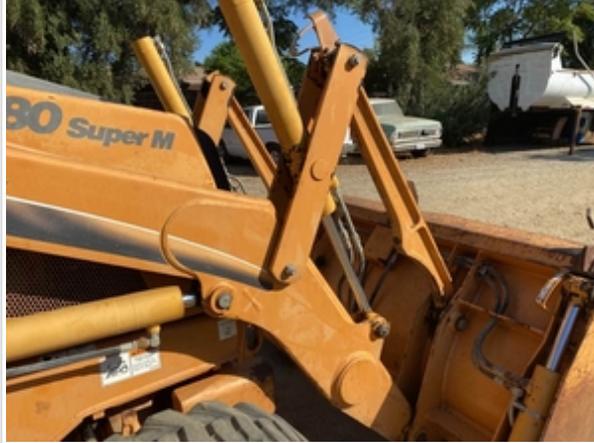
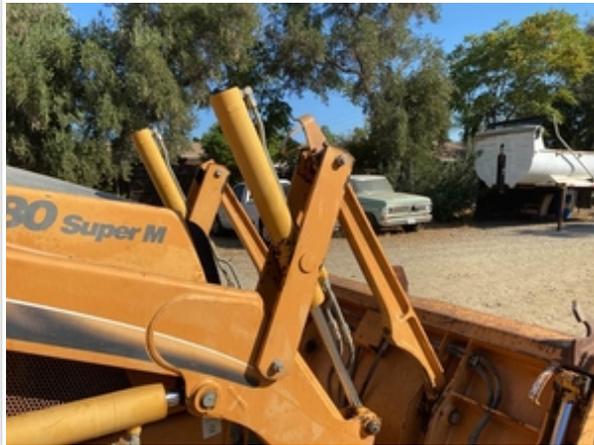
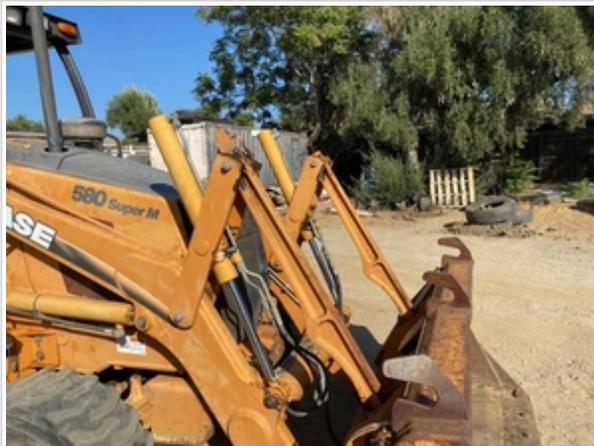
Tilt Linkage Photos

<p>Tilt Linkage</p>	<p>3 - Normal Wear & Tear</p>

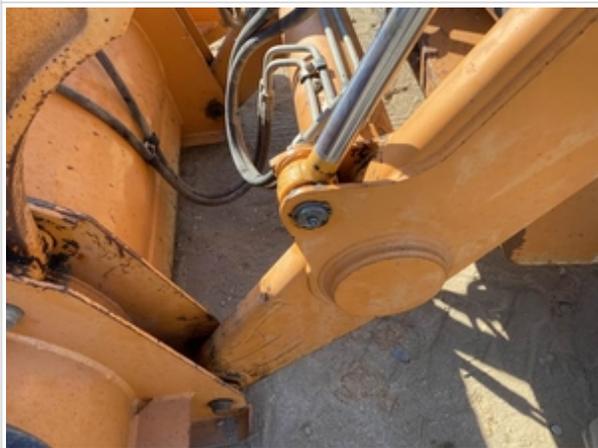
<p>Tilt Linkage Pins & Bushings</p>	<p>3 - Normal Wear & Tear</p>
<p>Tilt Linkage Pins & Bushings Photos</p>

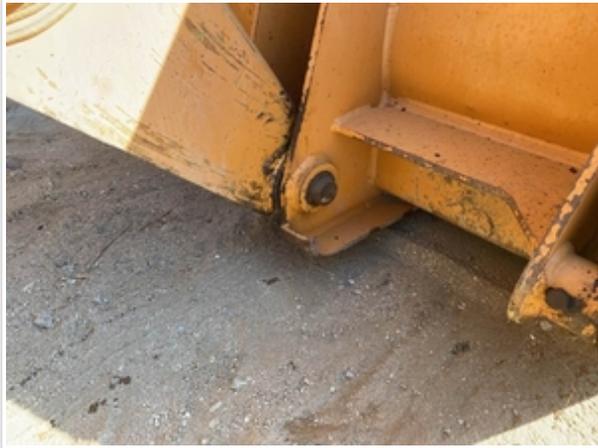
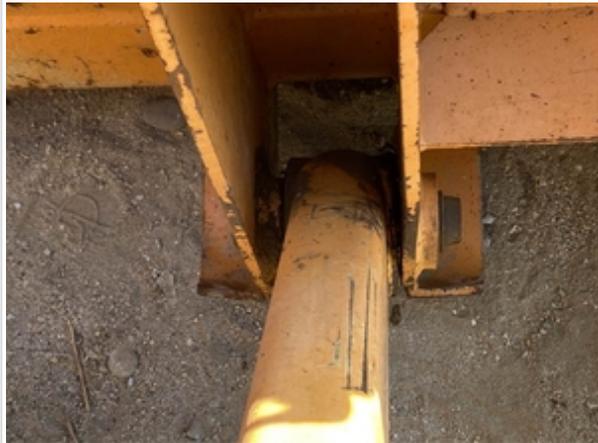
Bucket to Arm Pins	3 - Normal Wear & Tear
Bucket to Arm Pins Photos
