Inspection Report (Backhoe Loader)

Year	2001
Make	Case
Model	580 Super M
Serial Number	JJG0377074
Hour Meter Reading	3452
Previous Application (e.g., earth moving, mining, demolition, etc)	Demo and general construction

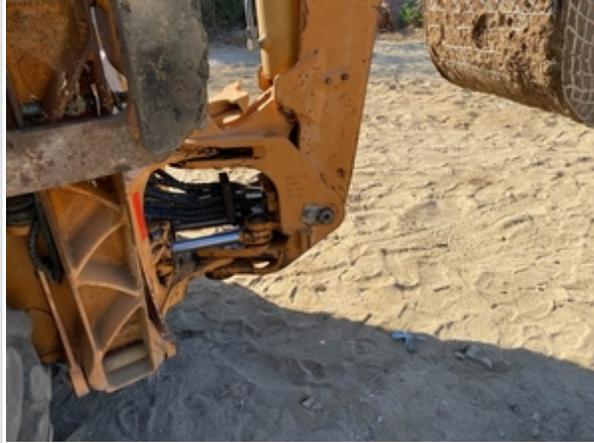
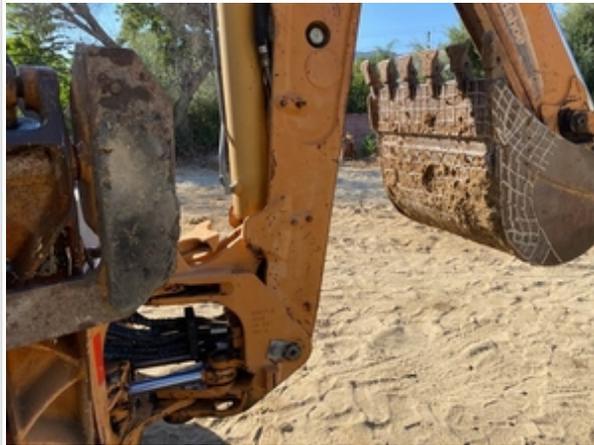
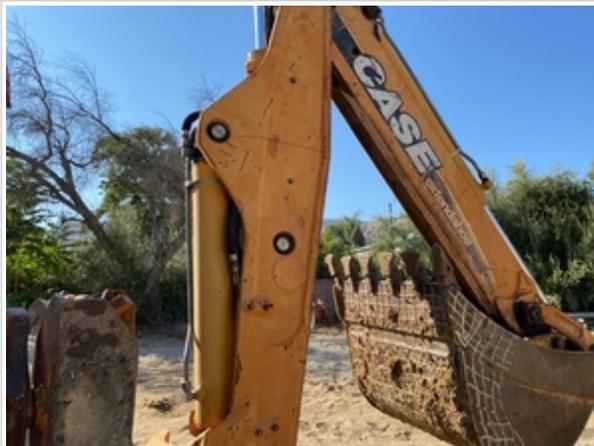
Boom Condition Photos

<p>Boom Condition</p>	<p>3 - Normal Wear & Tear</p>

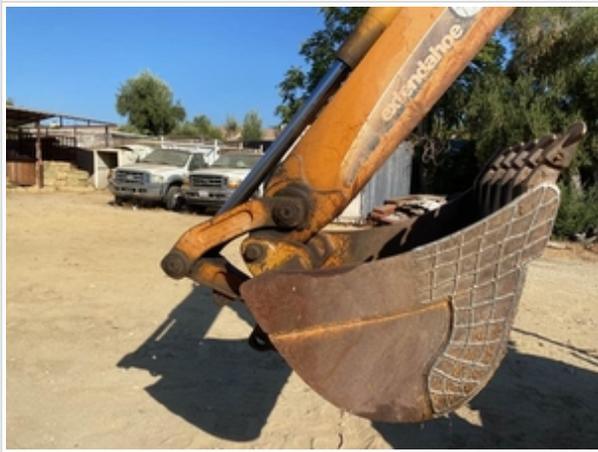
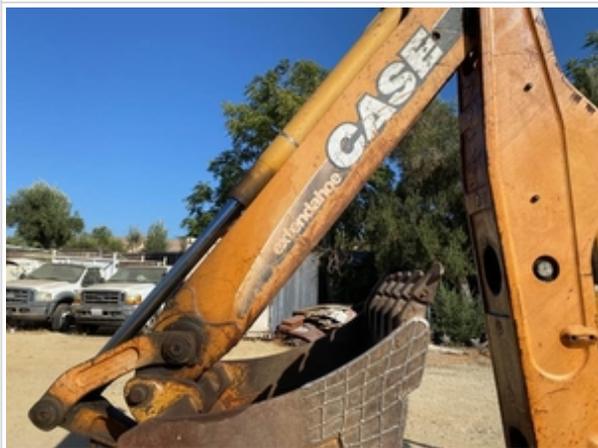
<p>Stick Condition</p>	<p>3 - Normal Wear & Tear</p>	
<p>Stick Condition Photos</p>

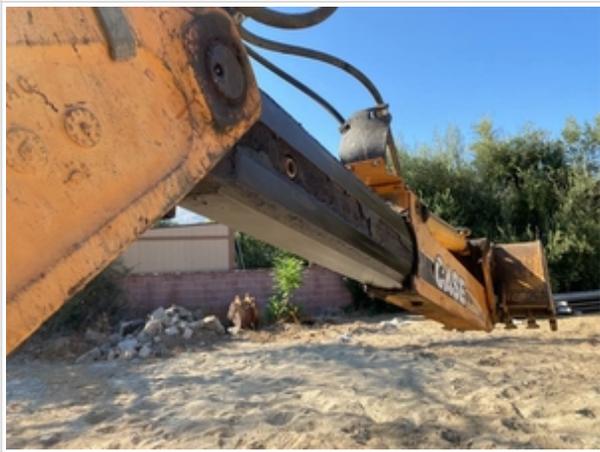
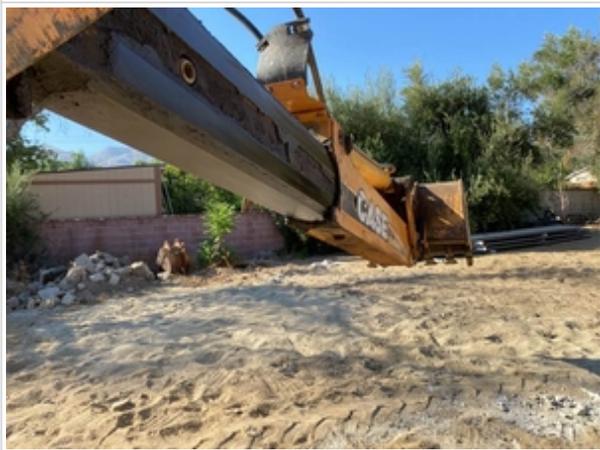
<p>Stick Extension Wear Guides</p>	<p>3 - Normal Wear & Tear</p>	
<p>Stick Extension Wear Guides Photos</p>

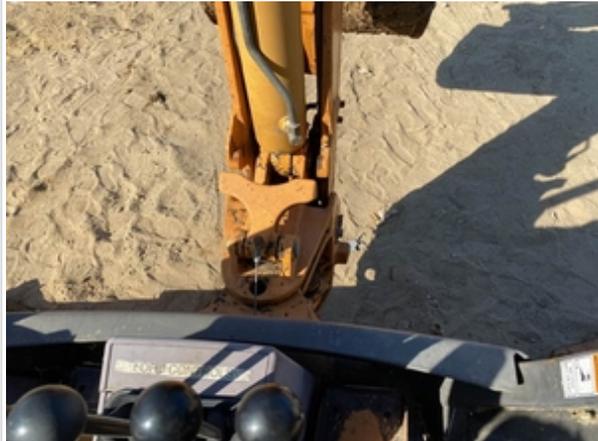
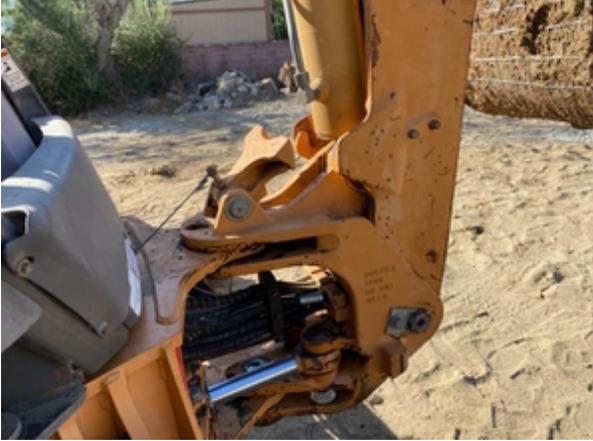
Boom Lock	2 - Above Average Wear
Comments	Boom lock will not go into place with ease
Boom Lock Photos

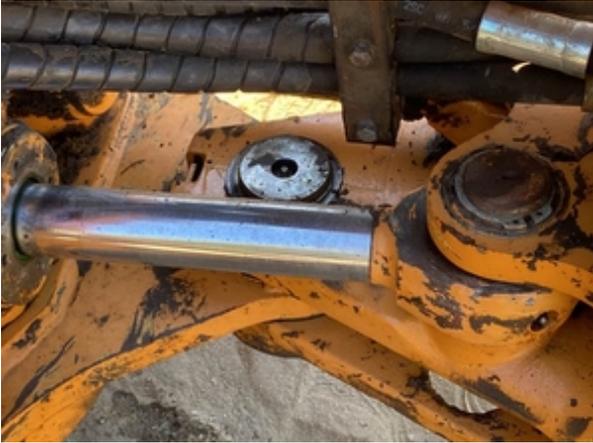
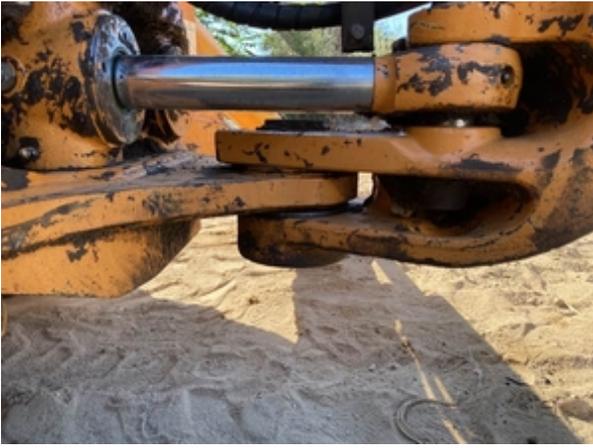
Swing Tower Pivot	0
Boom Base Pin & Bushings	3 - Normal Wear & Tear
Boom Base Pin & Bushings Photos

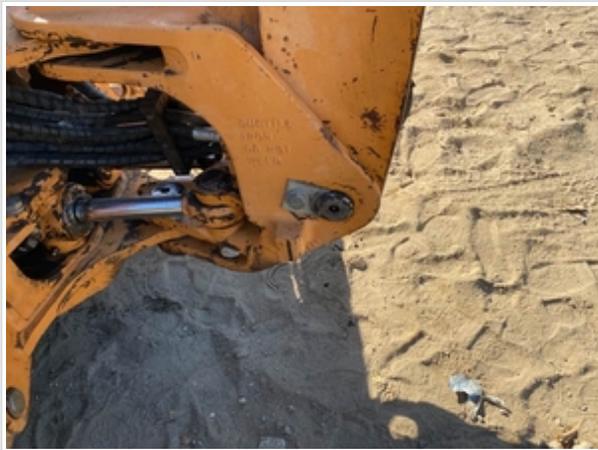
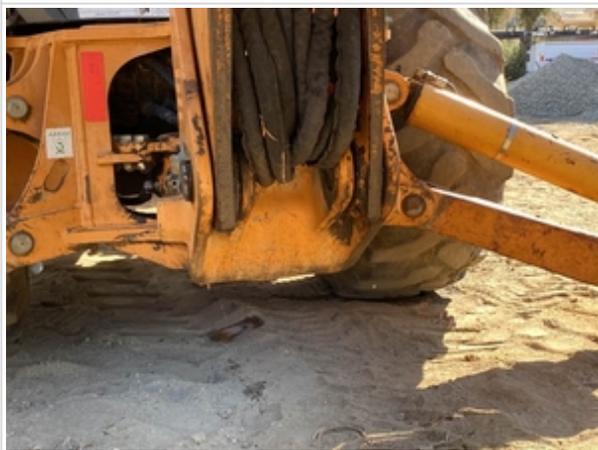
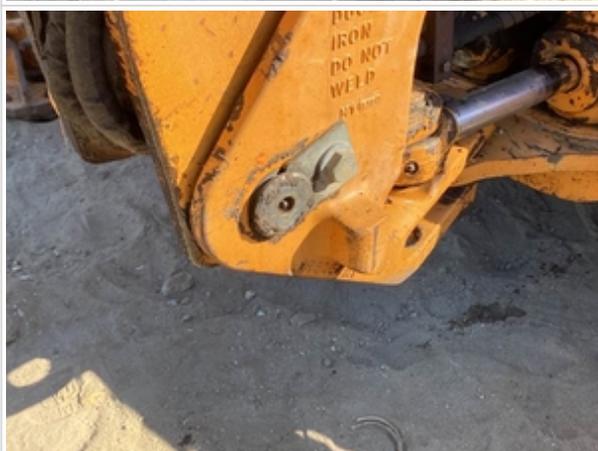
<p>Boom to Stick Pin & Bushings Photos</p>

Boom to Stick Pin & Bushings	3 - Normal Wear & Tear

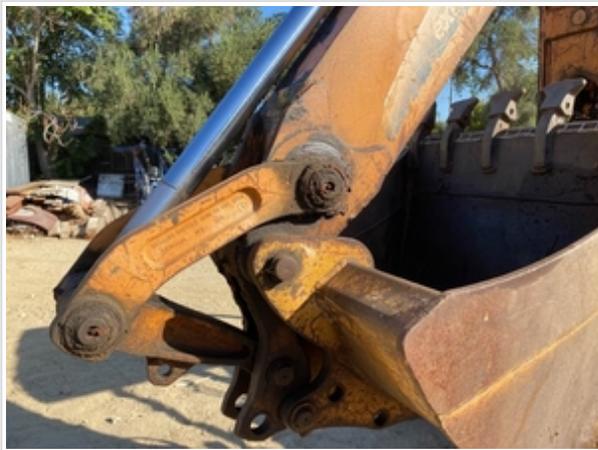
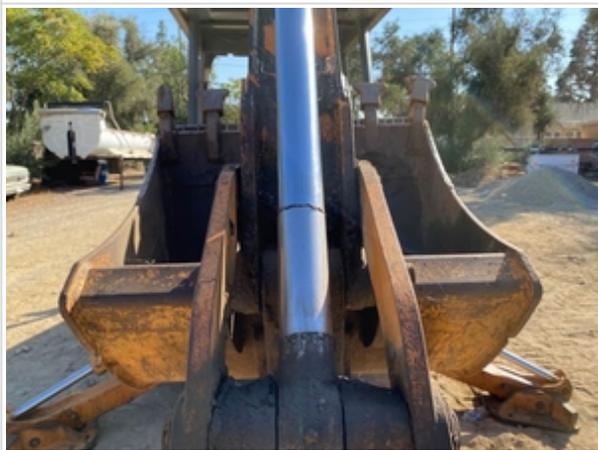
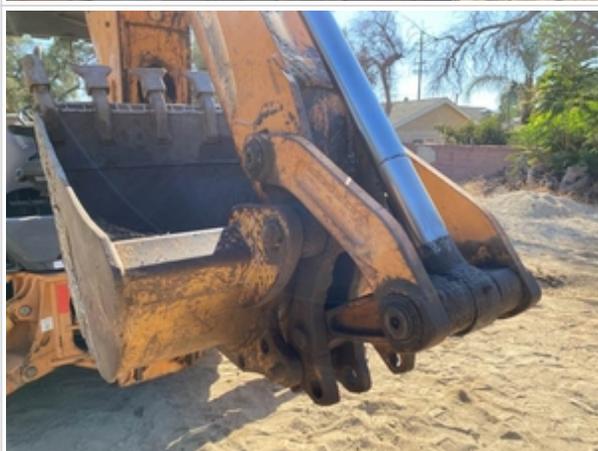
<p>Stick to Bucket Pin & Bushings Photos</p>

<p>Stick to Bucket Pin & Bushings</p>	<p>3 - Normal Wear & Tear</p>

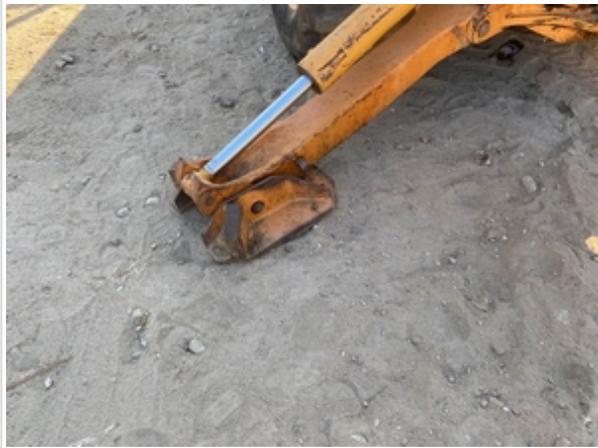
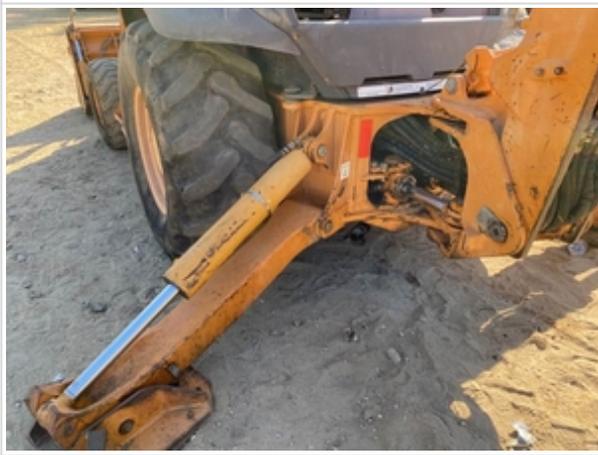
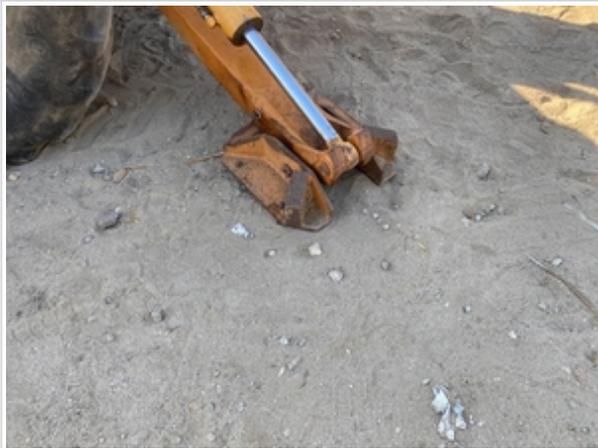
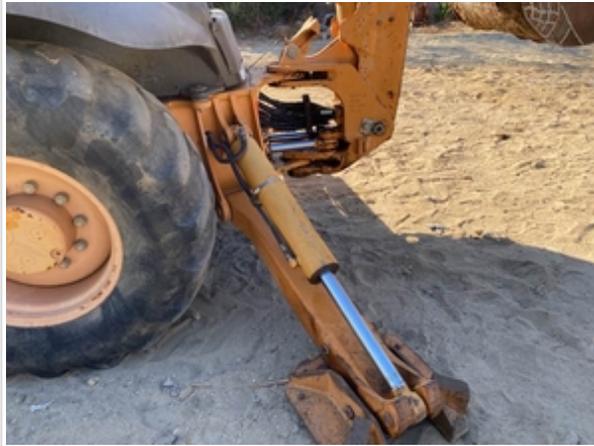
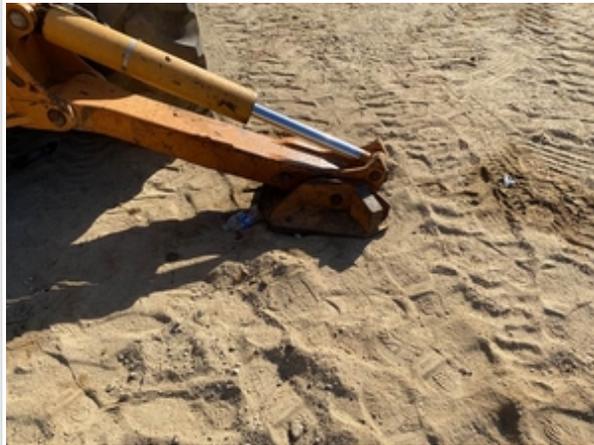
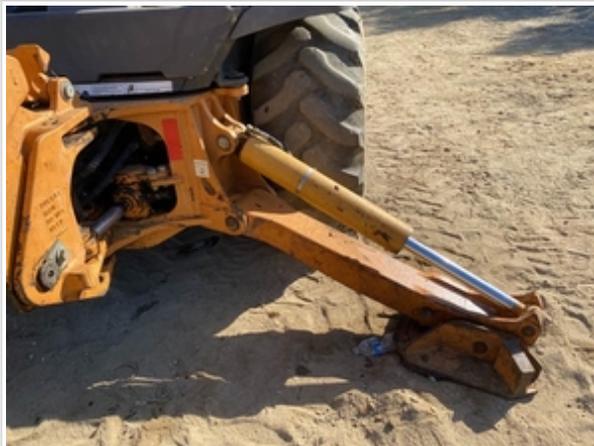
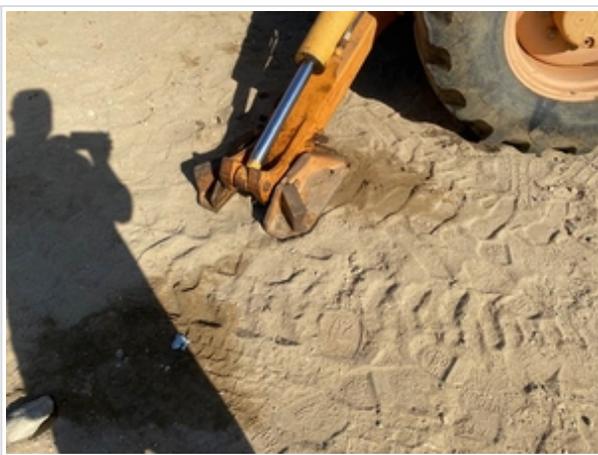
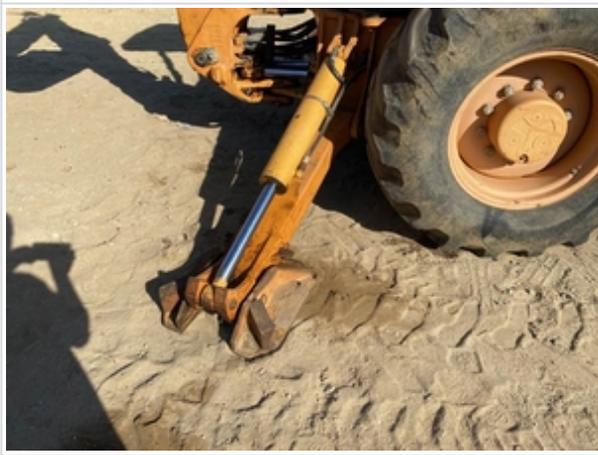
<p>Outriggers Photos</p>

<p>Outriggers</p>	<p>3 - Normal Wear & Tear</p>
<p>Comments</p>	<p>R/s outrigger cylinder leaking</p>

Outrigger Cylinders	Check the outrigger cylinders. Note any wear, pitting, discoloration, etc. Take photos.
Outrigger Cylinders: Mounting Pin	3
Outrigger Cylinders: Oil Leaks	Yes
Comments	Right side outrigger cylinder leaking at rod seal
Outrigger Cylinders Photos

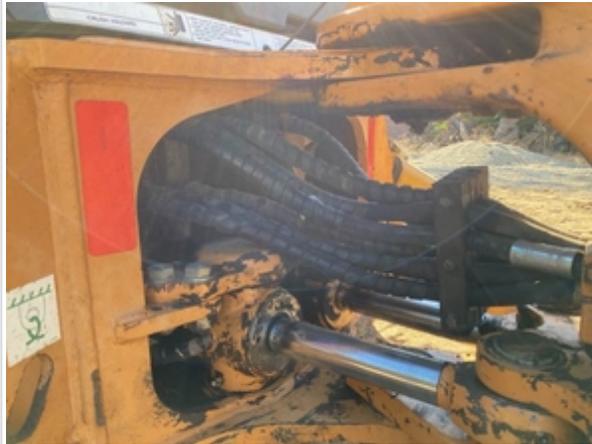
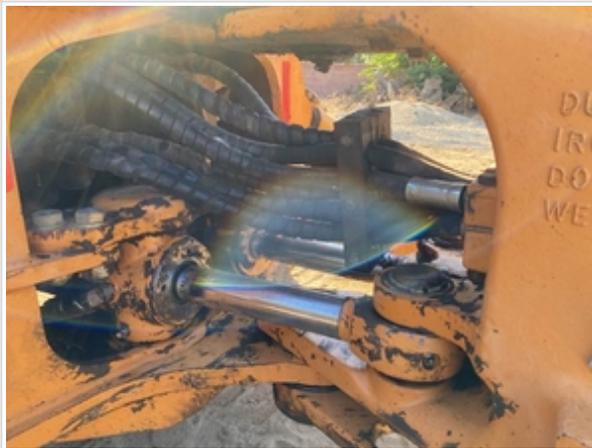
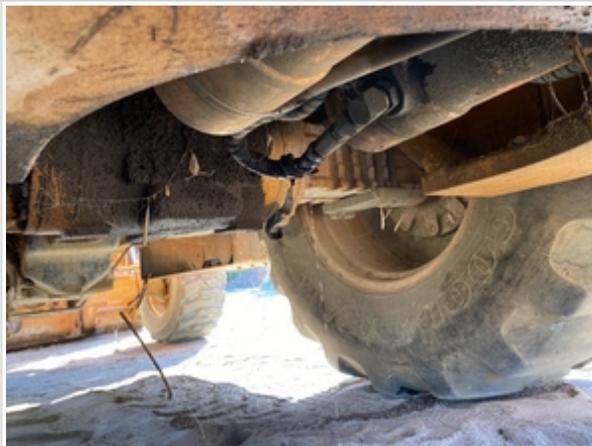
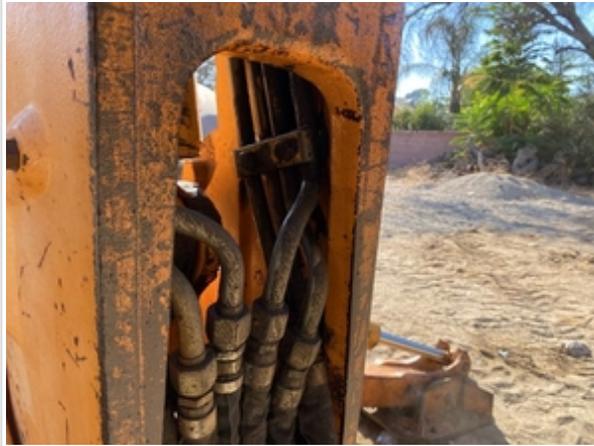
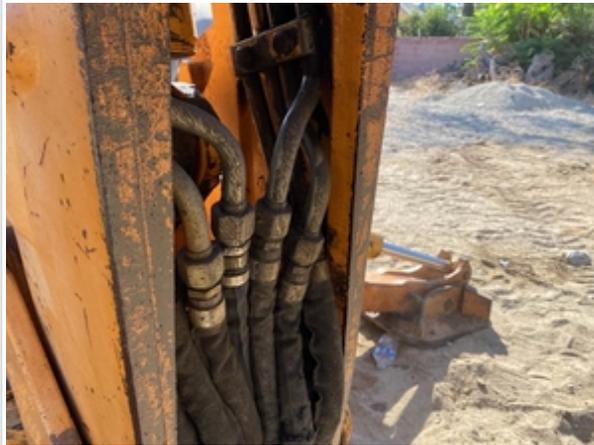
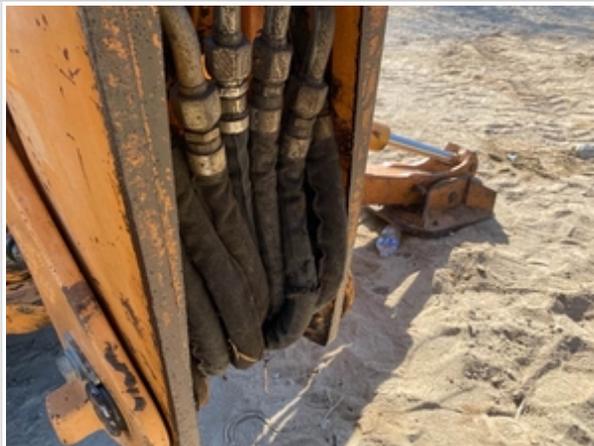
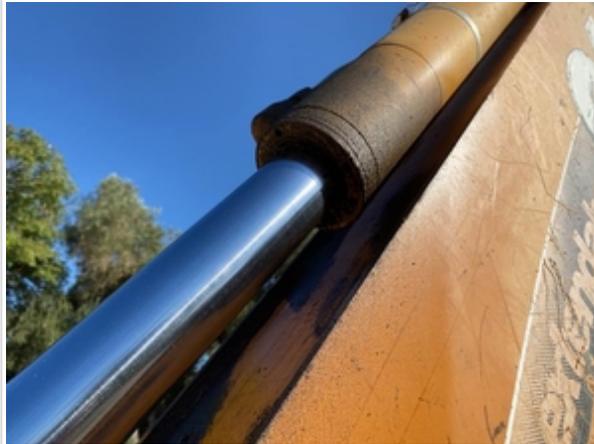
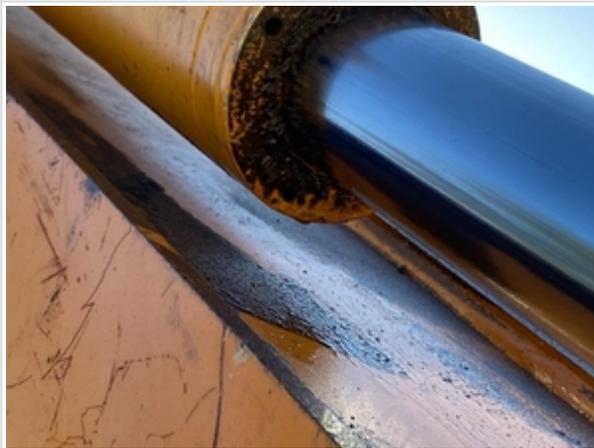
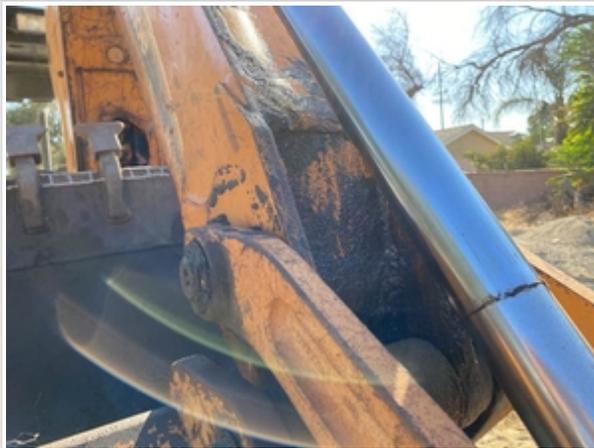
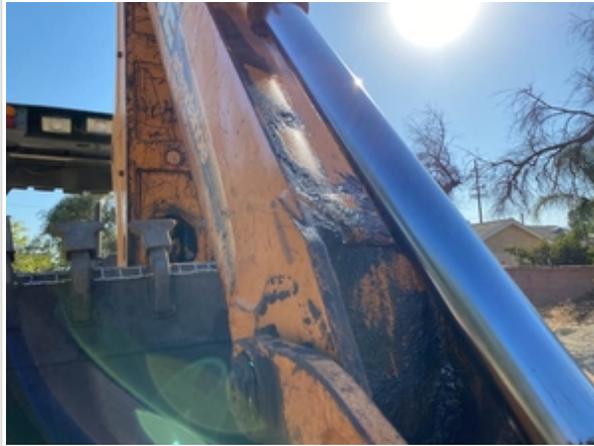
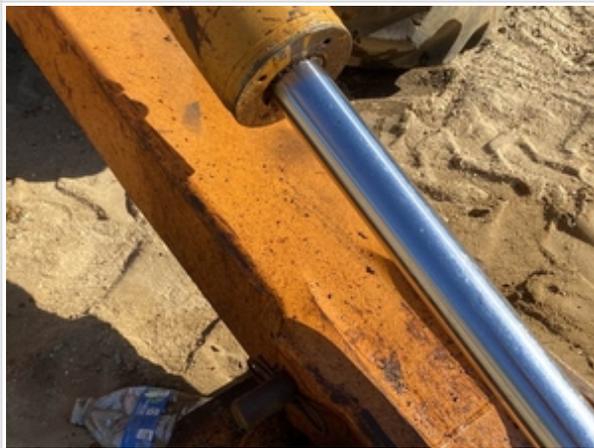
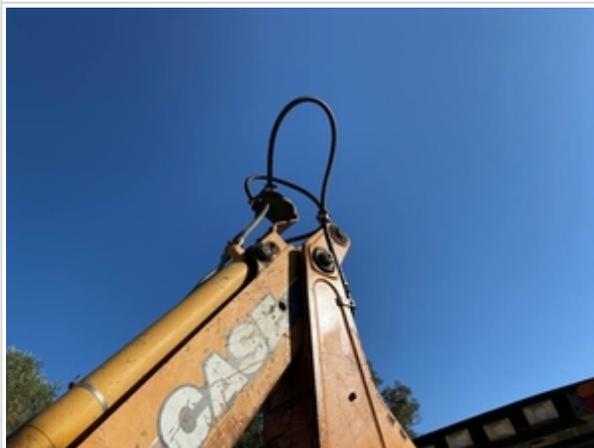
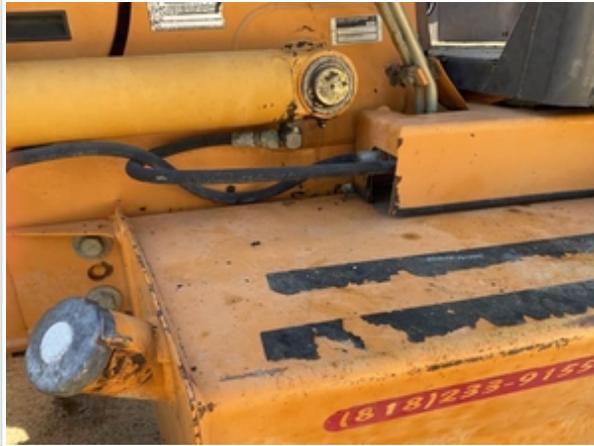
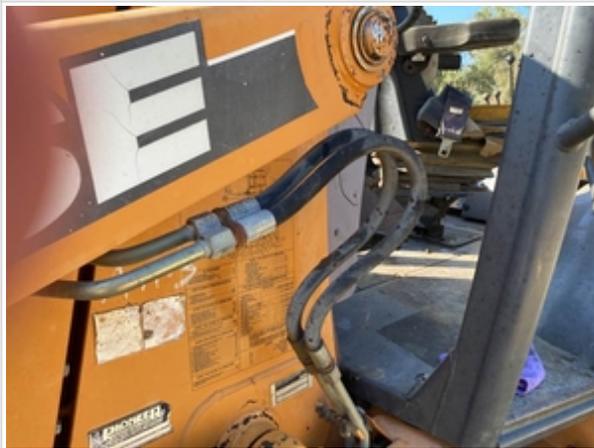
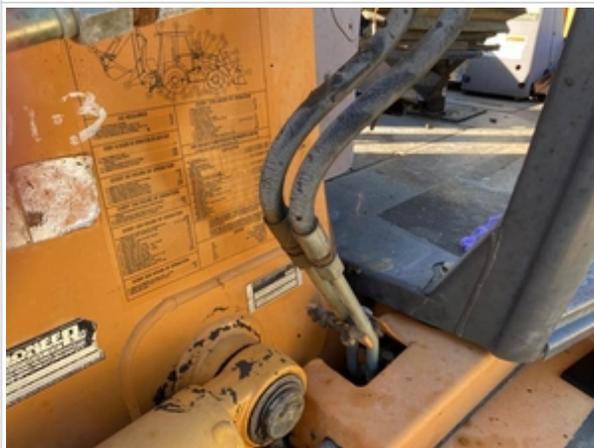
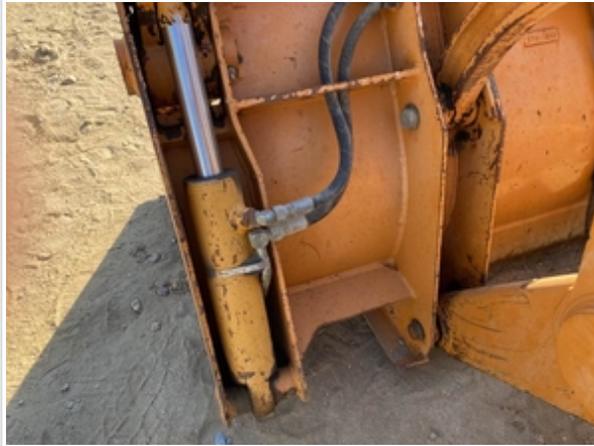
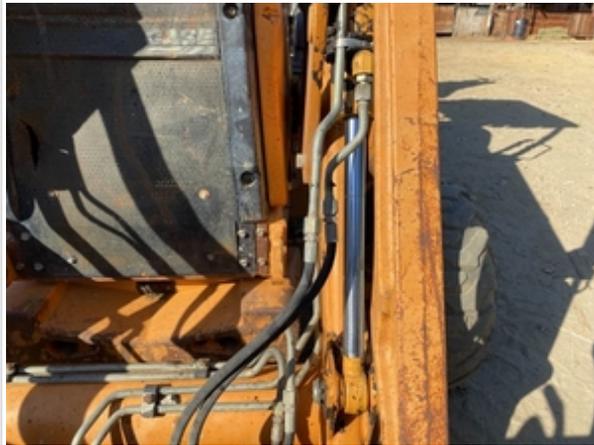
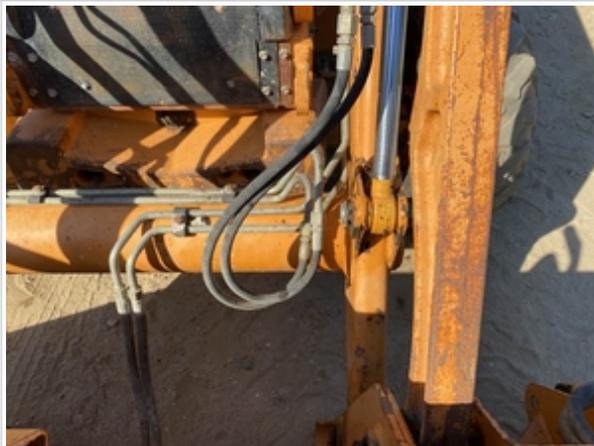
Appearance of Hydraulic Lines /
Fittings Photos

Wet or Damp Hydraulic Lines / Fittings	Yes
Appearance of Hydraulic Lines / Fittings	3
Hydraulic Lines / Fittings Condition	Active leaks in hoses or fittings observed, Cracking, stiff, or charred hydraulic hoses, Other (see comments)
Comments	2 hoses actively leaking, 1 at swing cylinders, 1 at steer cylinders, others hoses weather cracked, others need to be replaced soon

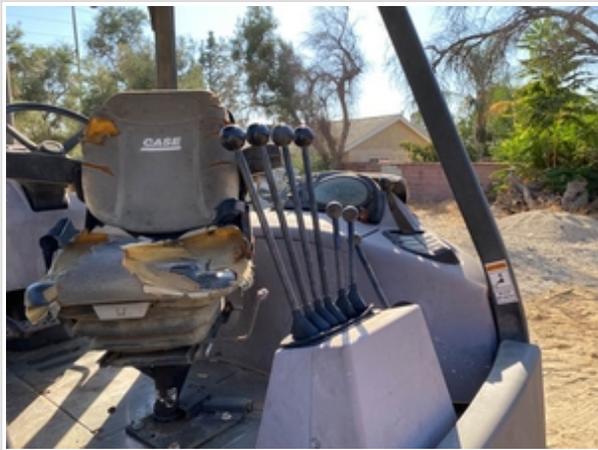
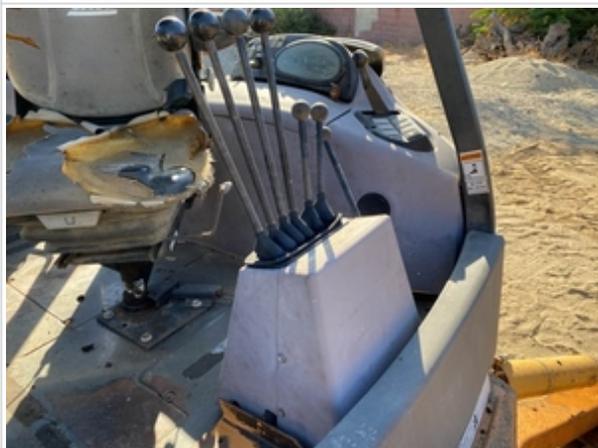
External Controls / Levers Photos

Unusual Noises (Hydraulic Pump)	No
Hydraulic Pump Notes	No unusual noises heard during operation
External Controls / Levers	3
External Controls / Levers Condition	Good function & condition of hydraulic controls, Other (see comments)
Comments	Ford controls

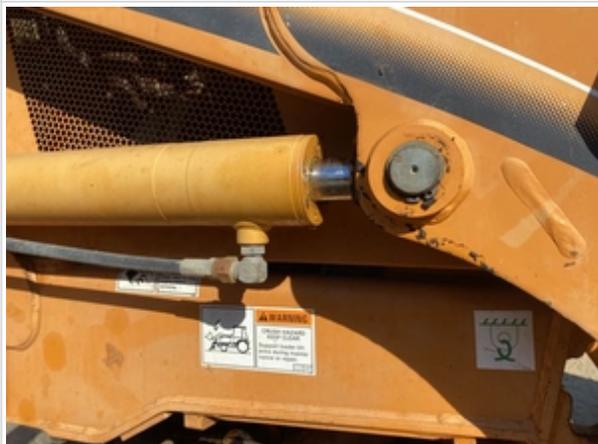
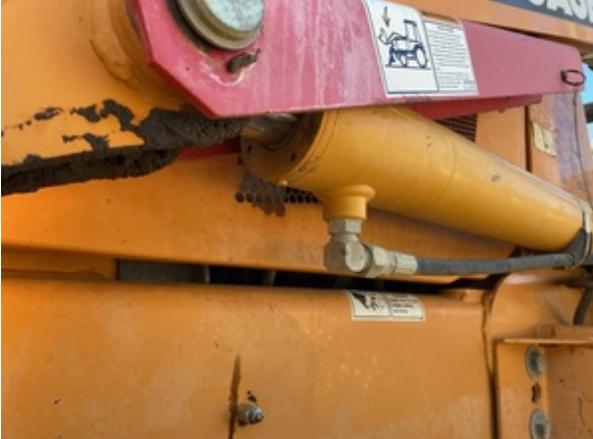
Loader Lift / Tilt Cylinders	Check the lift and tilt cylinders. Note any wear, pitting, discoloration, etc. Take photos.
Loader Lift / Tilt Cylinders: Mounting Pin	3
Loader Lift / Tilt Cylinders: Oil Leaks	No
Comments	Loader and tilt cylinders dry and in good condition
Loader Lift / Tilt Cylinders Photos

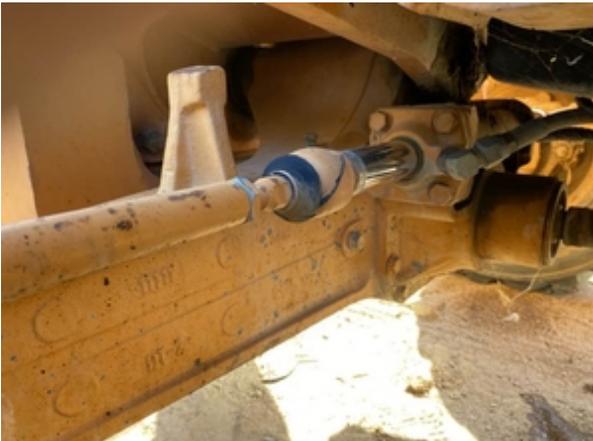
Steering Cylinder	Check the steering cylinder. Note any wear, pitting, discoloration, etc. Take photos.
Steering Cylinder: Mounting Pin	3
Steering Cylinder: Oil Leaks	No
Steering Cylinder Photos

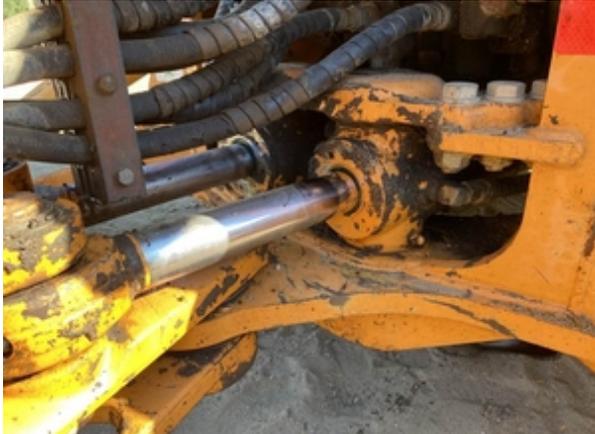
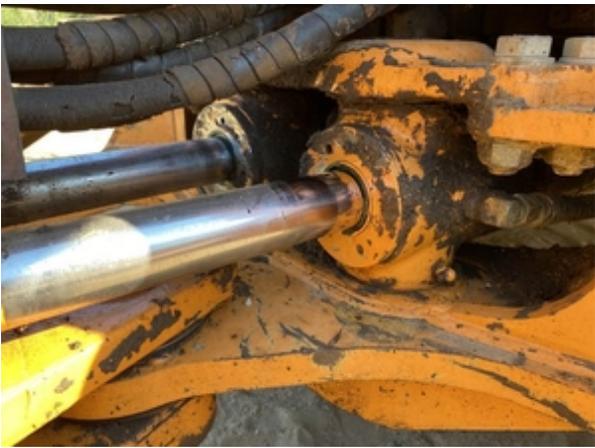
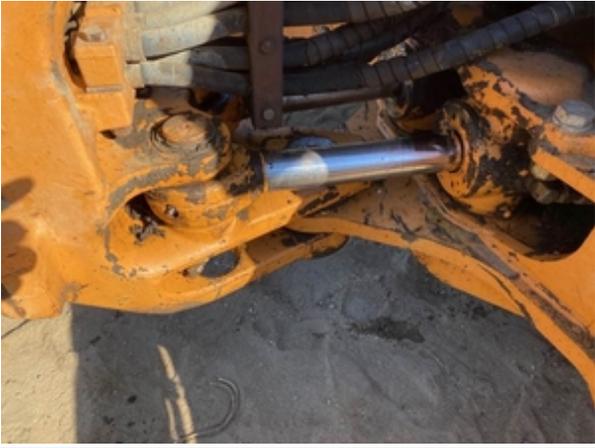
Boom Swing / Lift Cylinders	Check the boom swing and lift cylinders. Note any wear, pitting, discoloration, etc. Take photos.
Boom Swing / Lift Cylinders: Mounting Pin	3
Boom Swing / Lift Cylinders: Oil Leaks	No
Comments	Hoses to cylinders leaking not cylinder themselves
Boom Swing / Lift Cylinders Photos

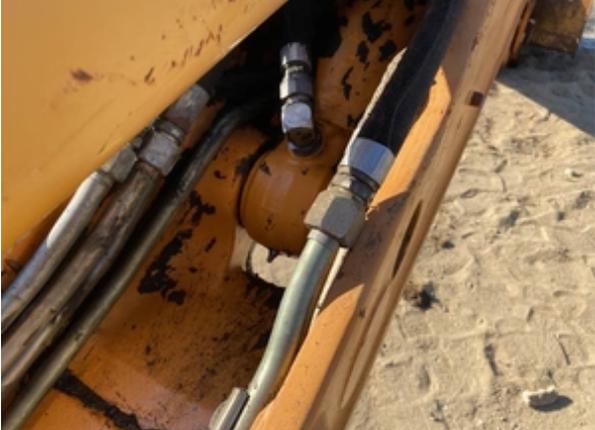
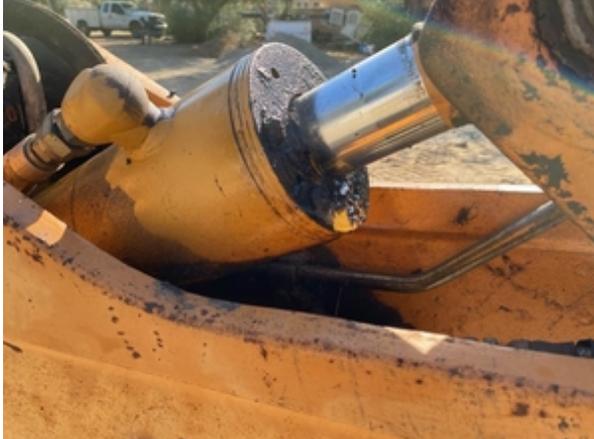
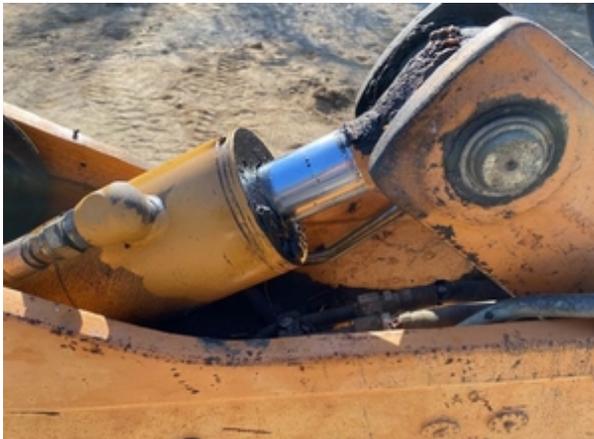
Stick Cylinder	Check the stick cylinder. Note any wear, pitting, discoloration, etc. Take photos.	
Stick Cylinder: Mounting Pin	3	
Stick Cylinder: Oil Leaks	Yes	
Comments	Stick cylinder leaking at rod seal	
Stick Cylinder Photos

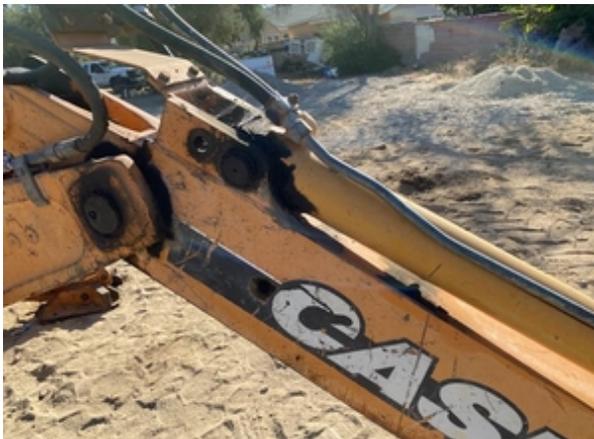
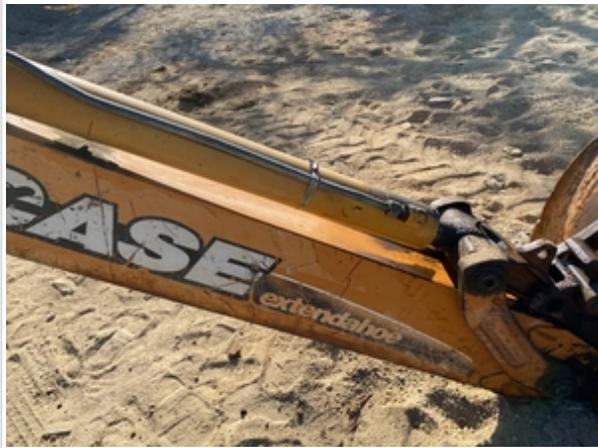
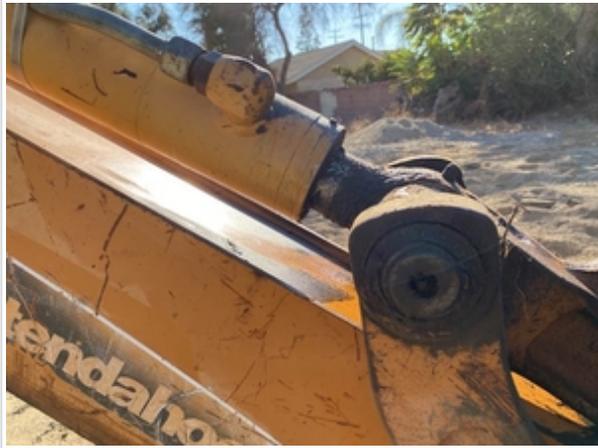
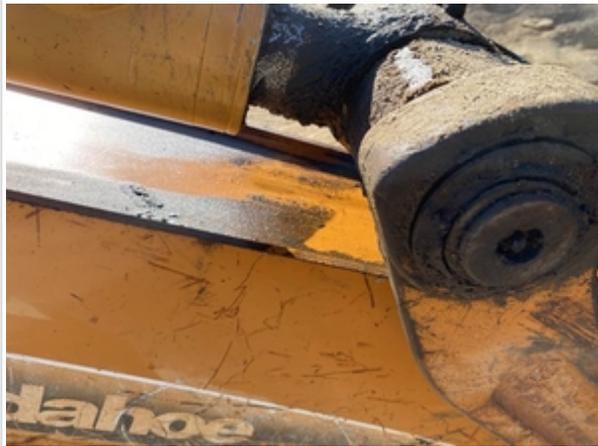
Bucket Cylinder	Check the bucket cylinder. Note any wear, pitting, discoloration, etc. Take photos.	
Bucket Cylinder: Mounting Pin	3	
Bucket Cylinder: Oil Leaks	Yes	
Comments	Bucket cylinder leaking at rod seal	
Bucket Cylinder Photos

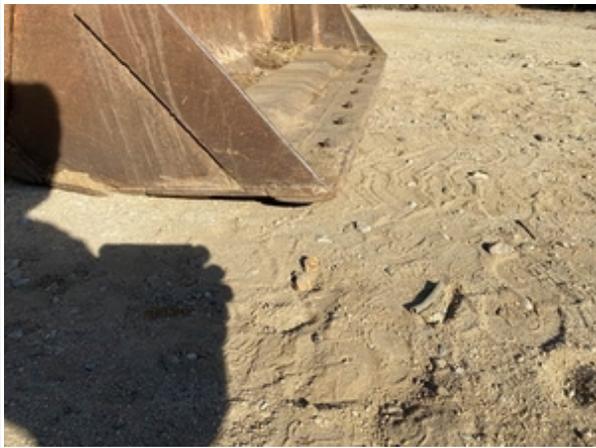
<p>Loader Bucket Edge / Deflectors Photos</p>

<p>Loader Bucket Edge / Deflectors</p>	<p>2 - Above Average Wear</p>
<p>Comments</p>	<p>Bucket cutting edge worn on both sides</p>

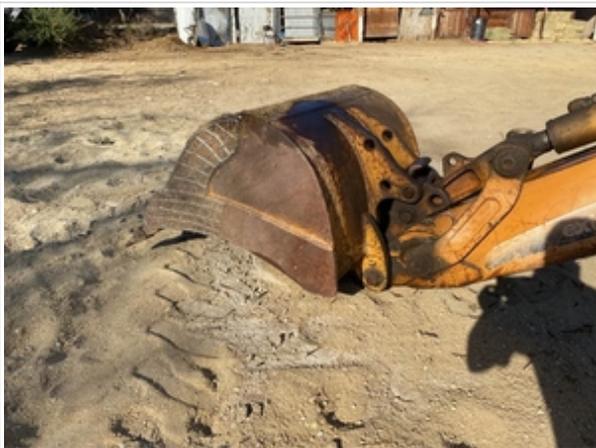
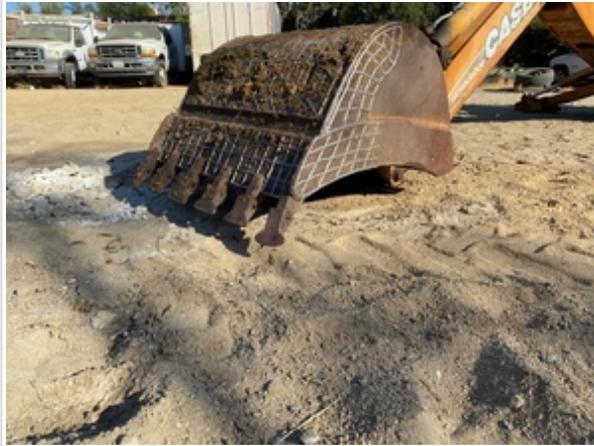
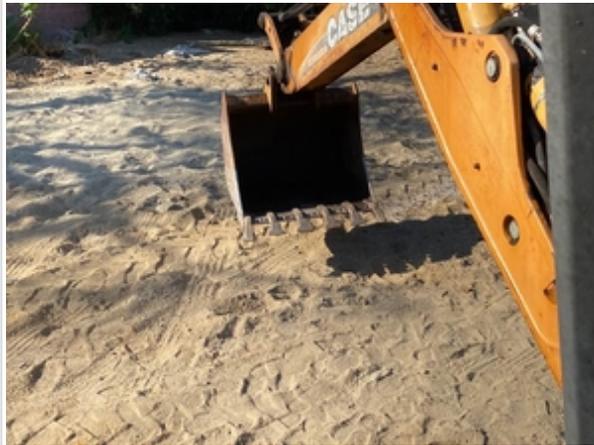
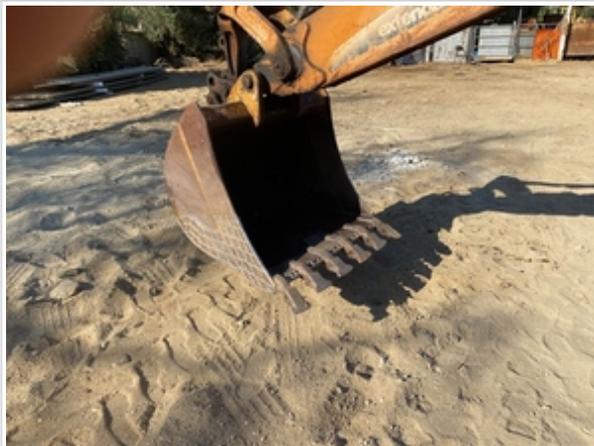
<p>Backhoe Bucket</p>	<p>3 - Normal Wear & Tear</p>
<p>Backhoe Bucket Photos</p>

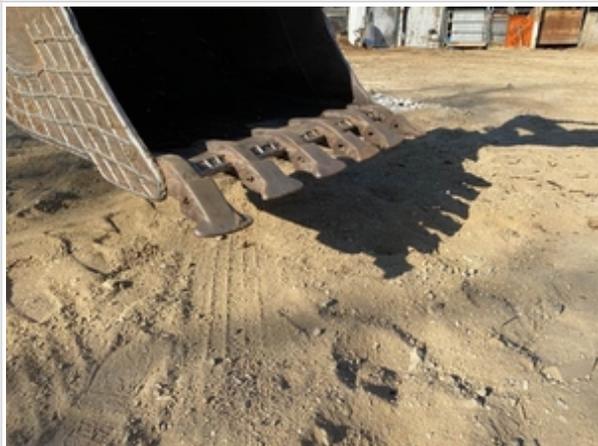
Backhoe Bucket Edge / Deflectors	3 - Normal Wear & Tear	
Comments	Bucket teeth worn and need to be replaced soon	
Backhoe Bucket Edge / Deflectors Photos
