Inspection Report (Wheel Loader)

Year	2010
Make	Kubota
Model	L39
Serial Number	12552 - 12434
Hour Meter Reading	2039.5
Previous Application (e.g., earth moving, mining, demolition, etc)	General Construction, Commercial Plumbing Contractor

Quality Rating	3
Functionality Rating	3
Overall Rating	3
What's Great About the Machine	This machine is well kept and has a great bundle of attachments like : 5' fork attachment : skip loader Gannon type attachment (for rear) : 6' front loader gp bucket for wet dirt or mixing concrete applications : hitch receiver style from center front bucket attachments and 6' extension for lifting objects into place
What Needs Work	A few rear hydraulic hoses for backhoe attachment need to be replaced. Service brakes need to be adjusted or repaired for a more firm brake application
Any Additional Info from the Seller?	Original owner of this machine
Inspector's Name	Mario Ramirez
Date/Time	08-25-2022

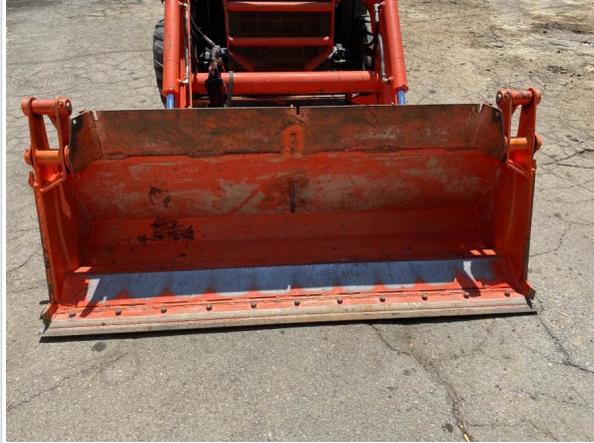
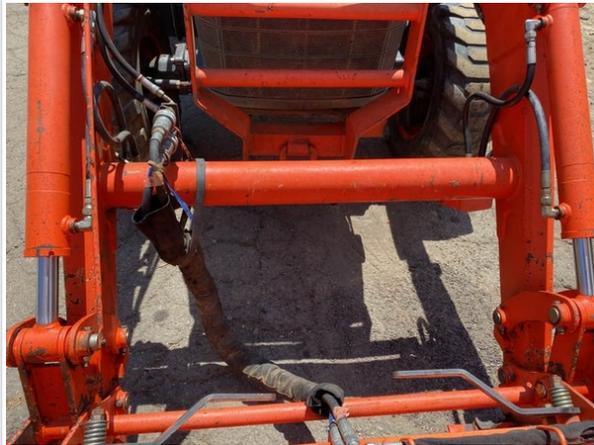
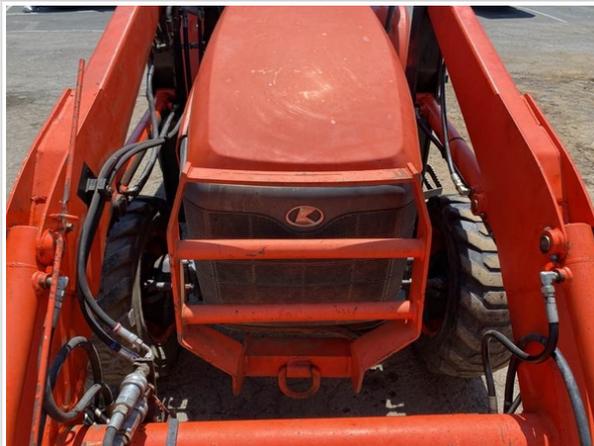
Front Photos

Front	3 - Normal Wear & Tear
Front Condition	No visible damage, Other (see comments)
Comments	Normal wear

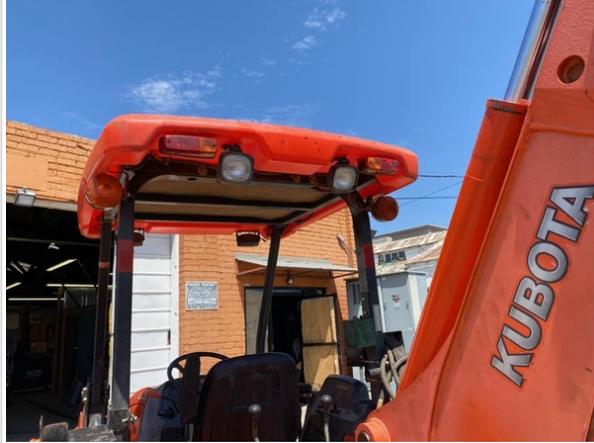
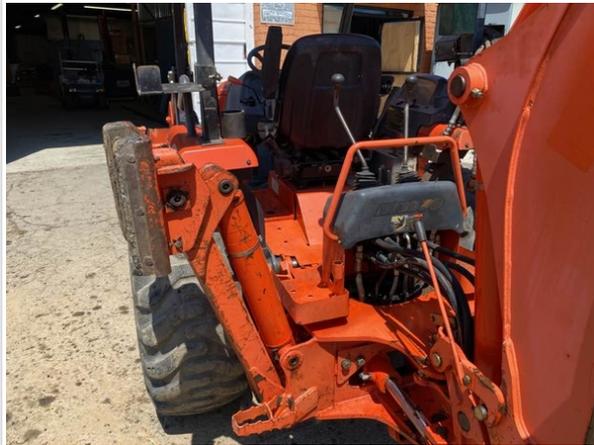
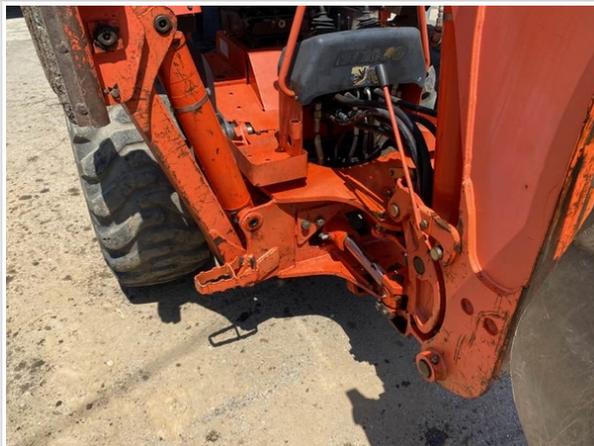
Rear Photos

Rear	3 - Normal Wear & Tear
Rear Condition	No visible damage

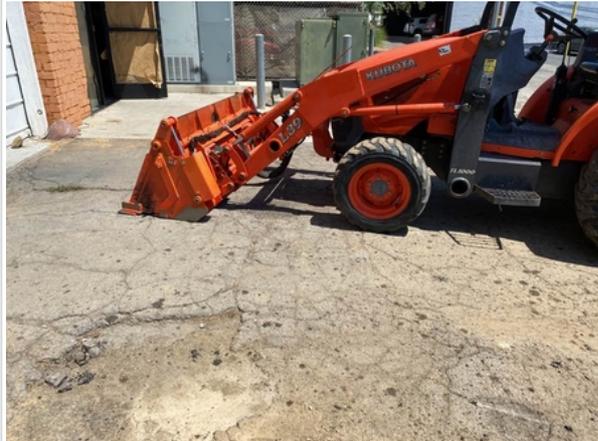
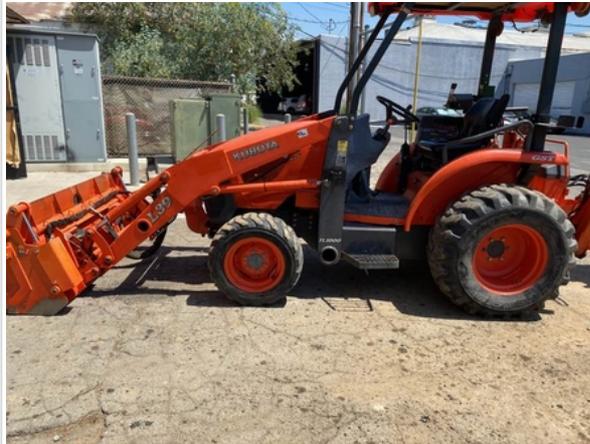
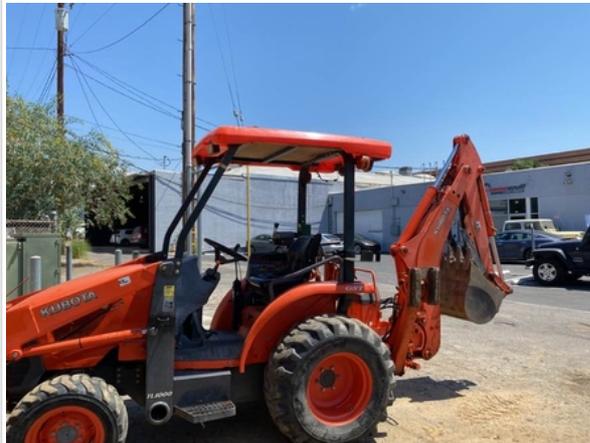
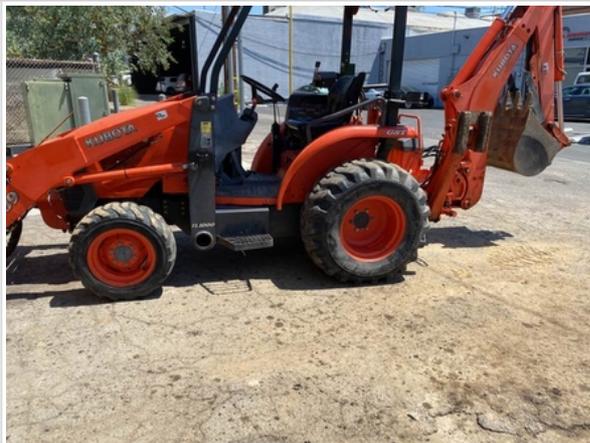
<p>Left</p>	<p>3 - Normal Wear & Tear</p>
<p>Left Condition</p>	<p>No visible damage</p>
<p>Left Photos</p>

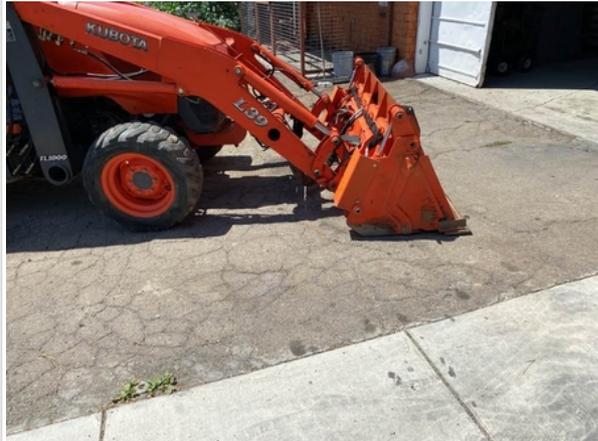
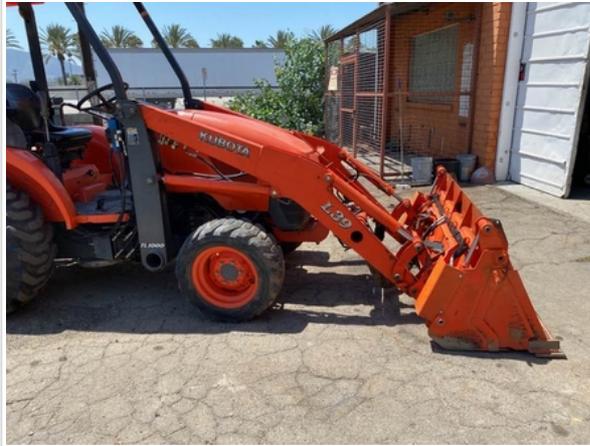
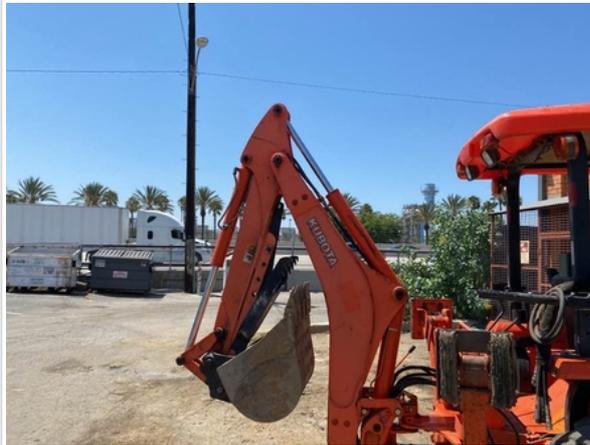
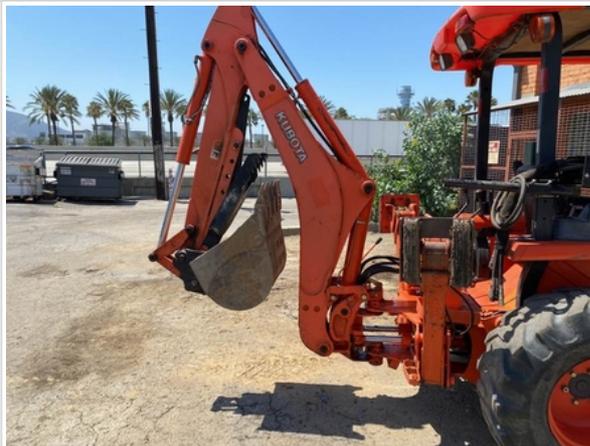
<p>Right</p>	<p>3 - Normal Wear & Tear</p>
<p>Right Condition</p>	<p>No visible damage</p>
<p>Right Photos</p>

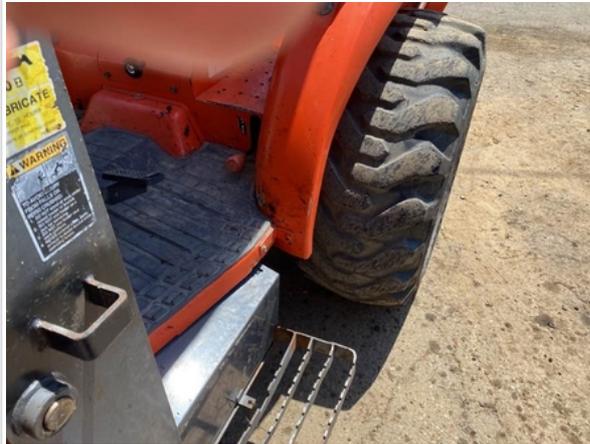
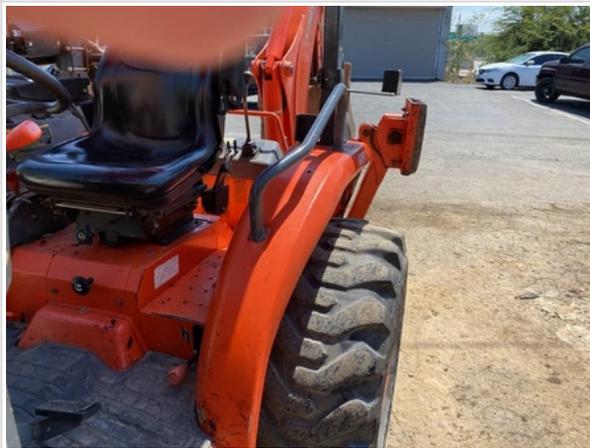
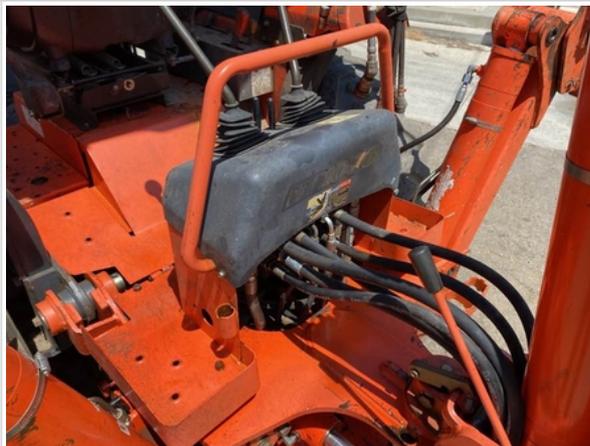
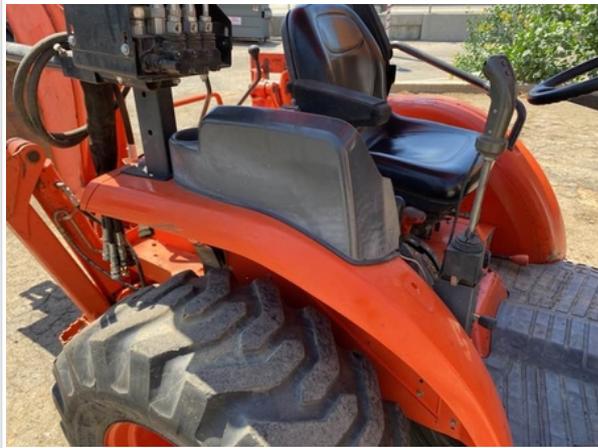
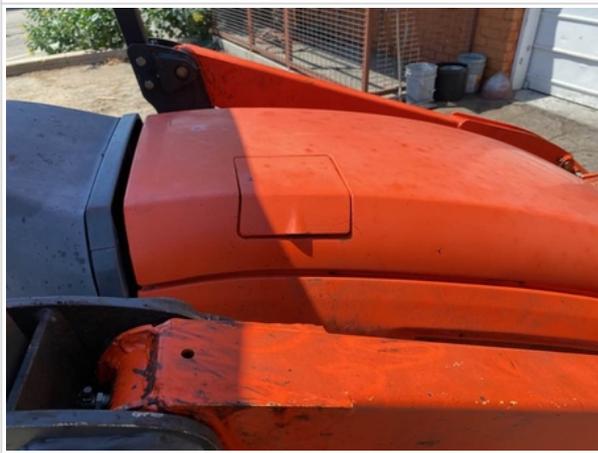
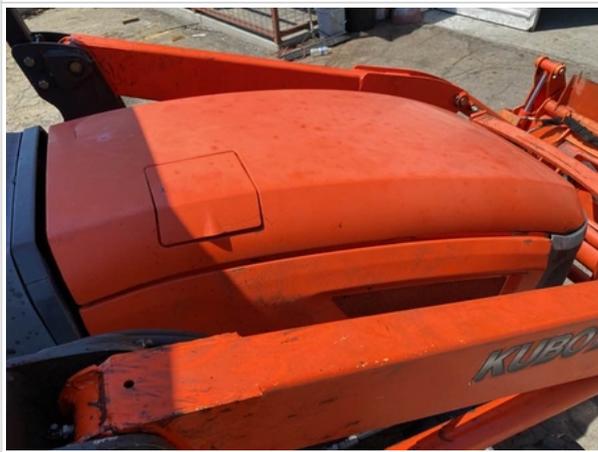
Body Panels (Any Rust Damage?)	3 - Normal Wear & Tear
Body Panel Condition	No visible damage, good paint condition and panel fitment
Body Panels Photos

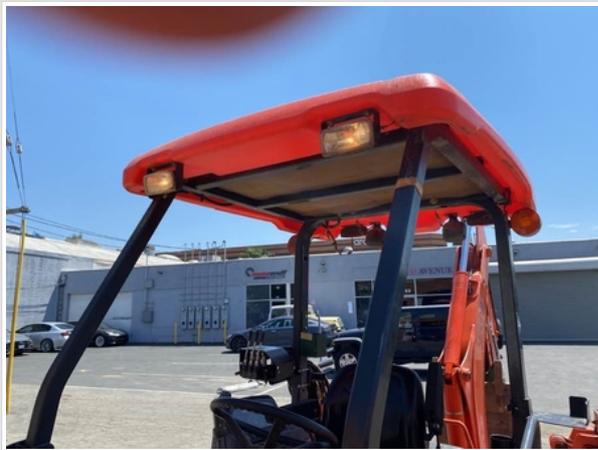
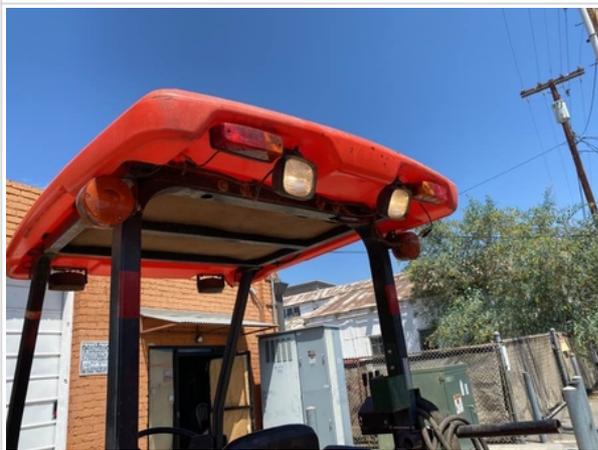
Lighting System Photos

Doors / Canopy Latches	0	
Glass Condition	0	
Mirrors	0	
Lighting System	3 - Normal Wear & Tear	
Lighting System Condition	No visible damage, lighting system is operational

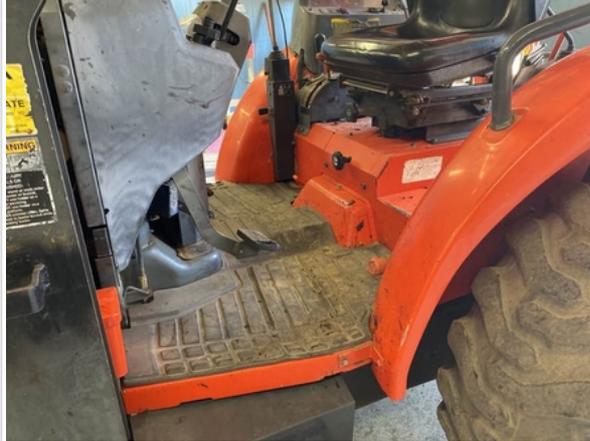
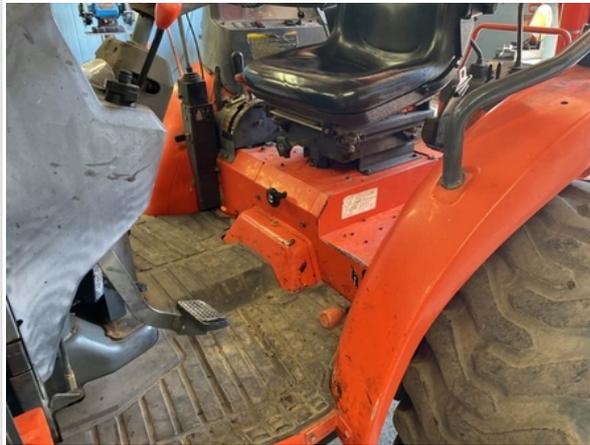
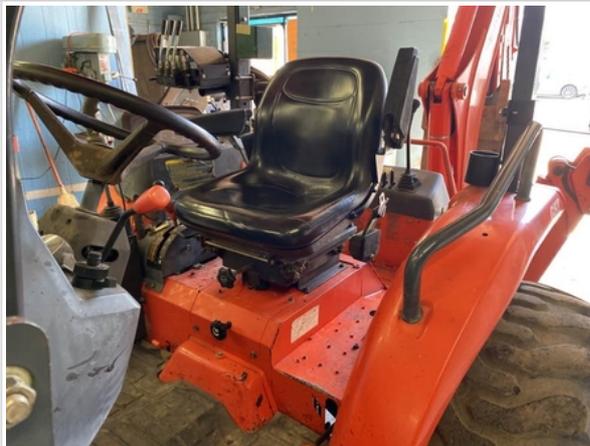
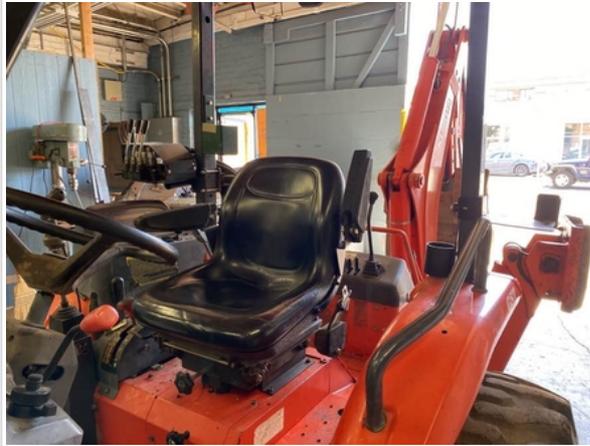
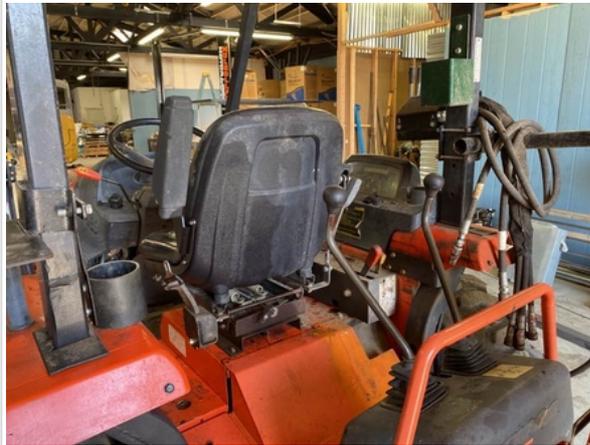
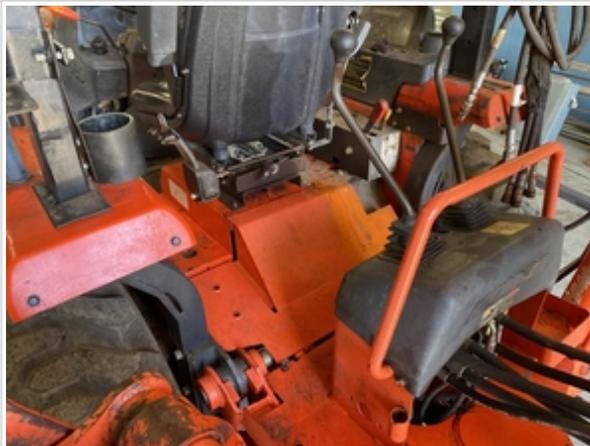
Operator Cabin Photos

Operator Cabin Overall	3 - Normal Wear & Tear
Operator Cabin Overall Condition	Good cabin appearance, solid floors, panels, and ceiling

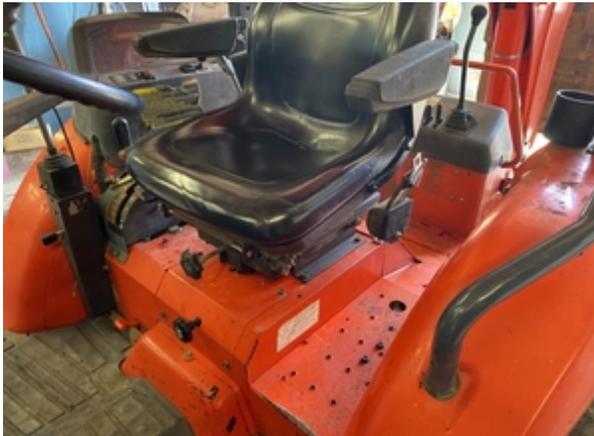
Operator's Seat & Arm Rests	3 - Normal Wear & Tear	
Operator's Seat & Arm Rests Condition	Seat(s) in good condition, no stains or tears in upholstery, Seat(s) have minor surface staining or small tears	
Operator's Seat & Arm Rests Photos

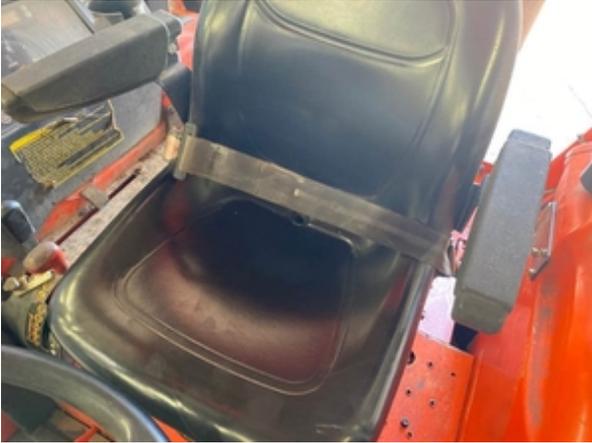
Seat Belt	3 - Normal Wear & Tear	
Seat Belt Condition	Seat belt secures properly. Belt is intact and in good condition	
Seat Belt Photos

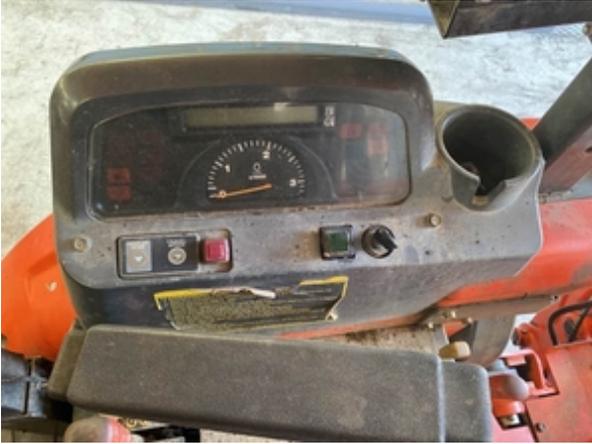
Cabin Lights	0	
Safety Lock Out / Stop	0	
Controls & Switches	3 - Normal Wear & Tear	
Controls & Switches Condition	All switches are installed and functional	
Controls & Switches Photos

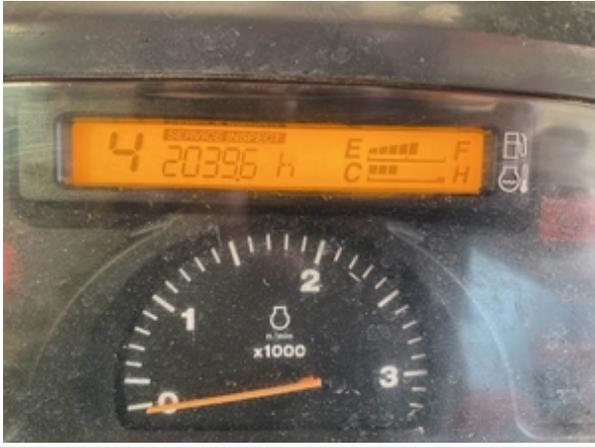
Hour Meter Activity	3 - Normal Wear & Tear

Hour Meter Condition	Hour meter is functional and in good condition
Hour Meter Activity Photos

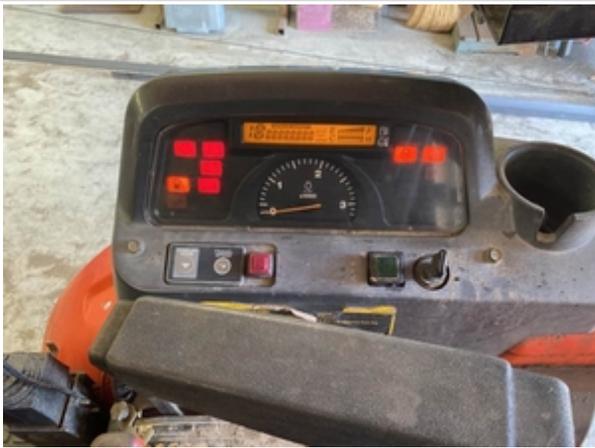
Other Gauge Activity	3 - Normal Wear & Tear
Other Gauge Condition	All cockpit gauges are functional and in good condition
Other Gauge Activity Photos

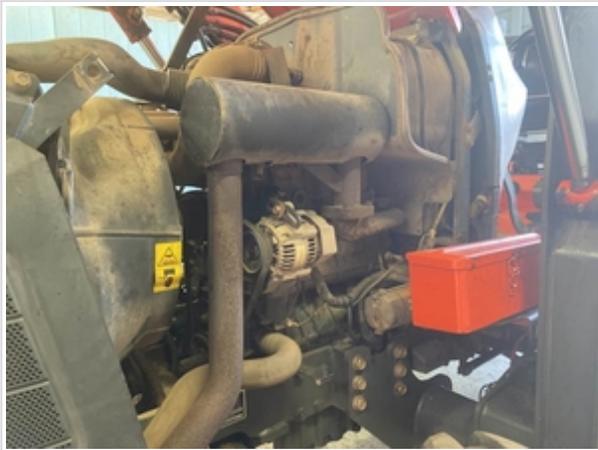
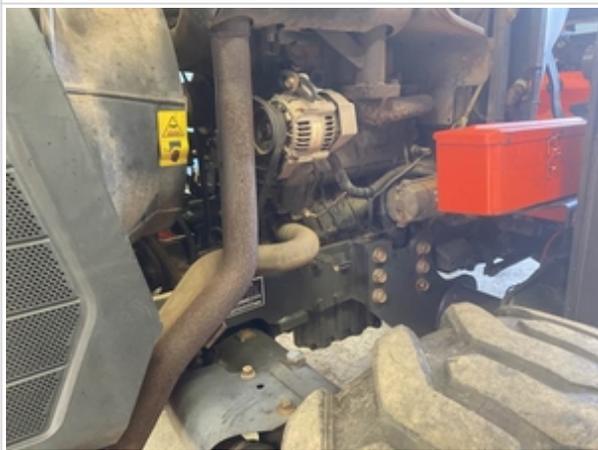
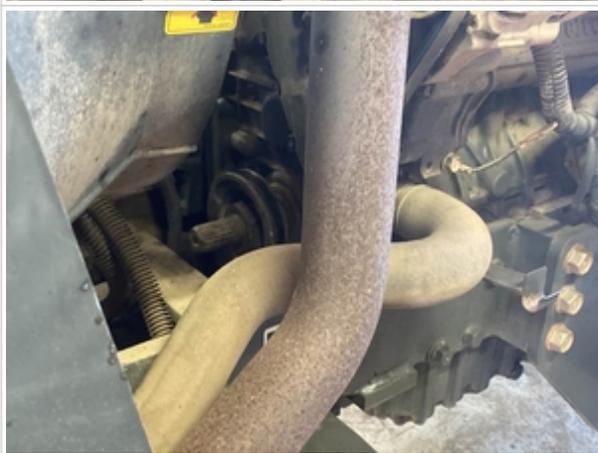
Engine Photos

Comments	No oil leaks found. Dry residual oil behind injection pump. (Possible oil spilled from filling engine)
Fuel Leaks	No
Equipped with DPF (Diesel Particulate Filter)	No
Requires DEF (Diesel Exhaust Fluid)	No
Overall Engine Appearance	Clean & dry
Overall Engine Comments	Overall engine looks well maintained with no obvious major repairs needed.

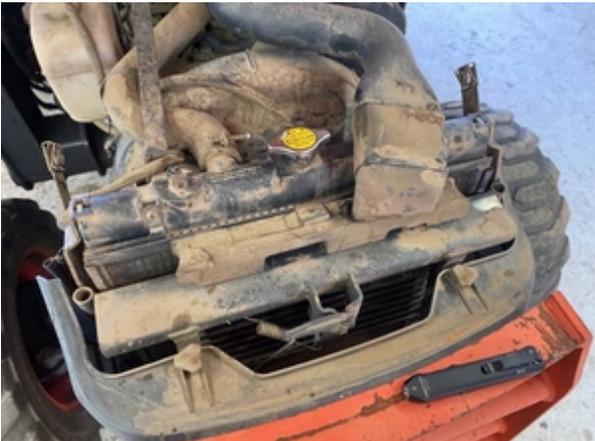
Radiator	3 - Normal Wear & Tear	
Radiator Condition	Radiator fins & components appear to be in good working order, no signs of damage or leaks	
Radiator Photos

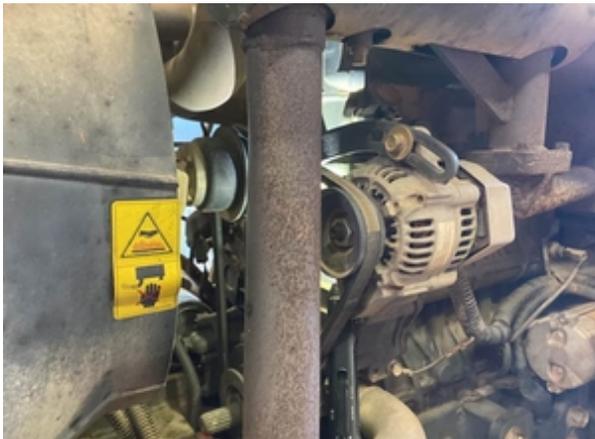
Belts	3 - Normal Wear & Tear
Belt Condition	Other (see comments)
Comments	Normal wear, belt needs to be adjusted
Belt Photos

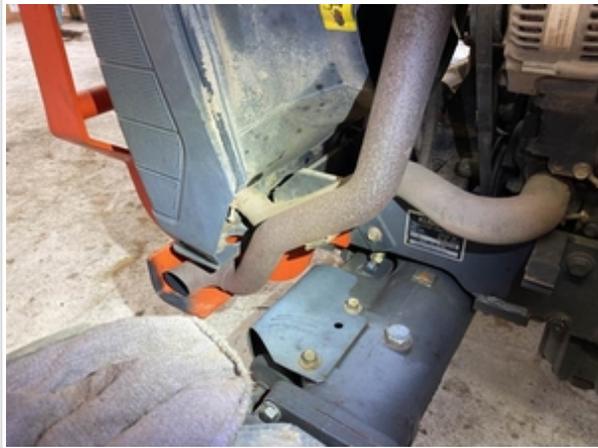
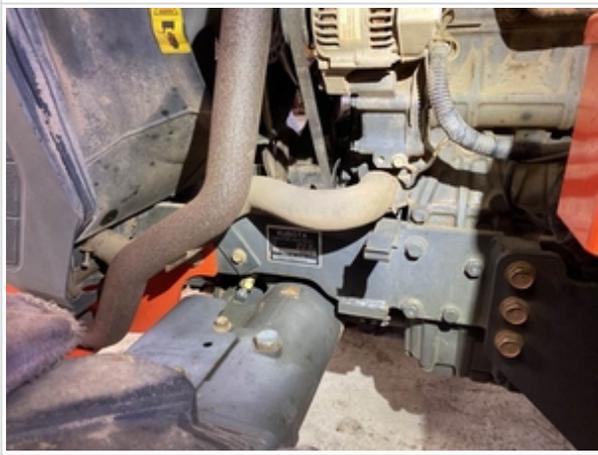
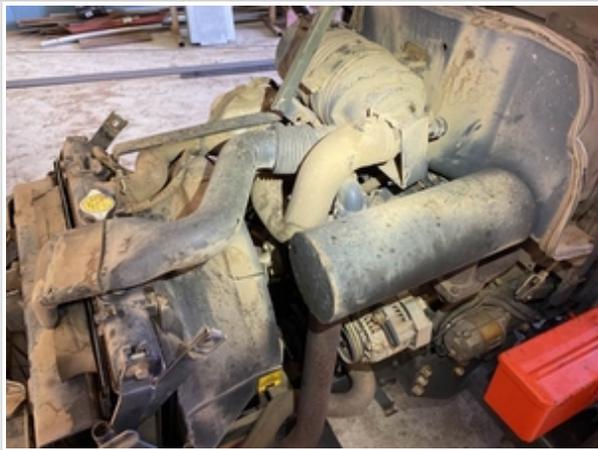
<p>Hose Photos</p>

Hoses	3 - Normal Wear & Tear
Hose Condition	Firm, pliant hoses with no signs of wear or leaks

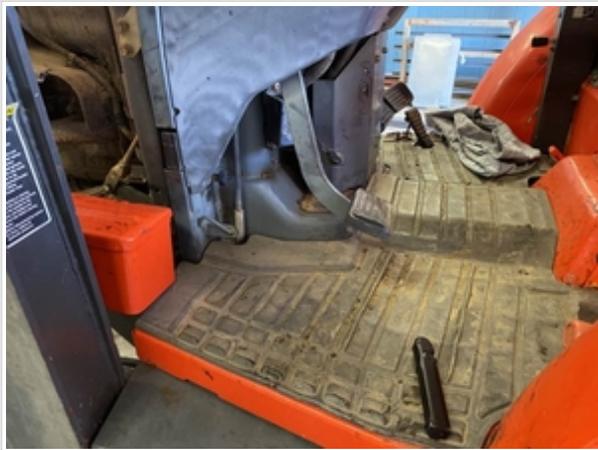
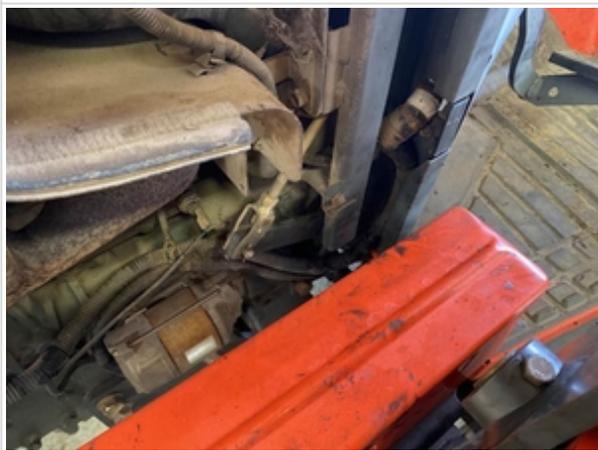
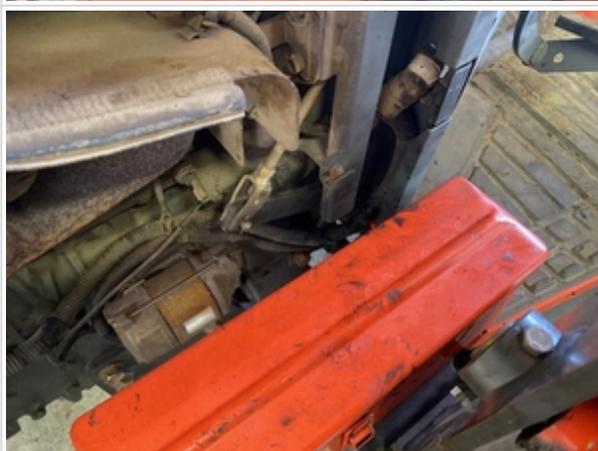
Clutch Photos

Clutch	3 - Normal Wear & Tear	
Clutch Condition	Clutch is functioning as expected

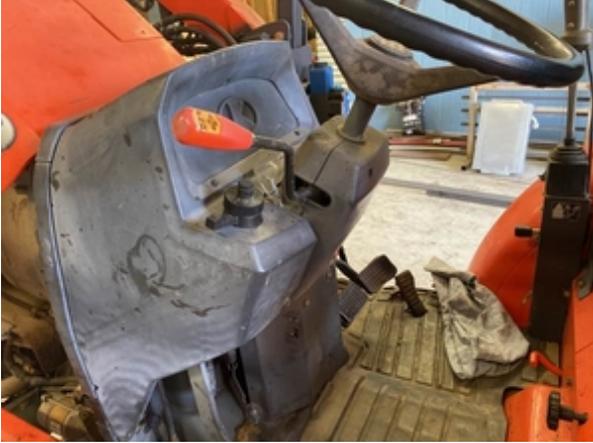
Shift Level Photos

Shift Lever	3 - Normal Wear & Tear
Shift Lever Condition	Good forward and reverse function

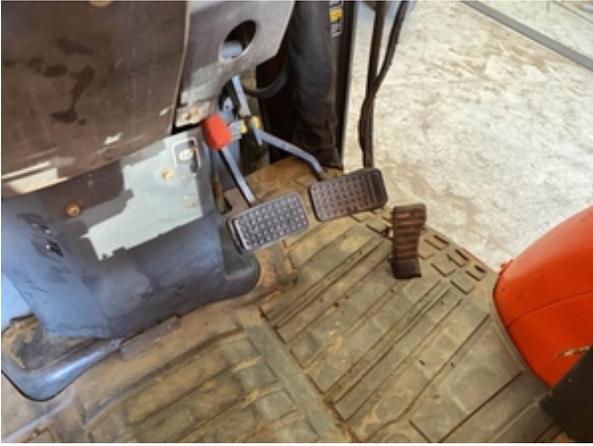
Foot Brake	2 - Above Average Wear
Foot Brake Condition	Poor braking performance, Other (see comments)
Comments	Brakes work but may need to be serviced
Foot Brake Photos

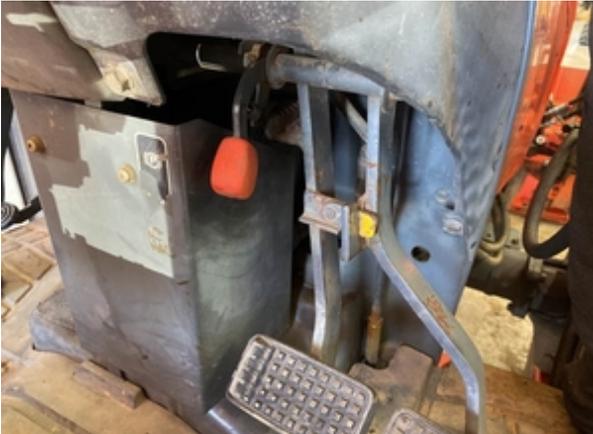
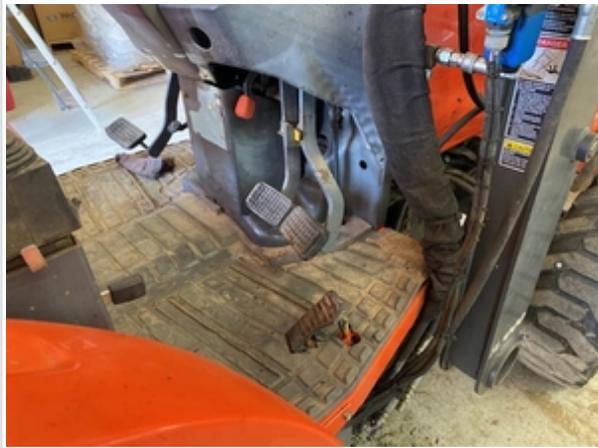
Inching Brake	0
Parking Brake	3 - Normal Wear & Tear
Parking Brake Condition	Poor performance; brake won't hold, Other (see comments)
Comments	Parking brakes basically hold service brake pedals engaged so fixing service brakes will fix parking brake too
Parking Brake Photos

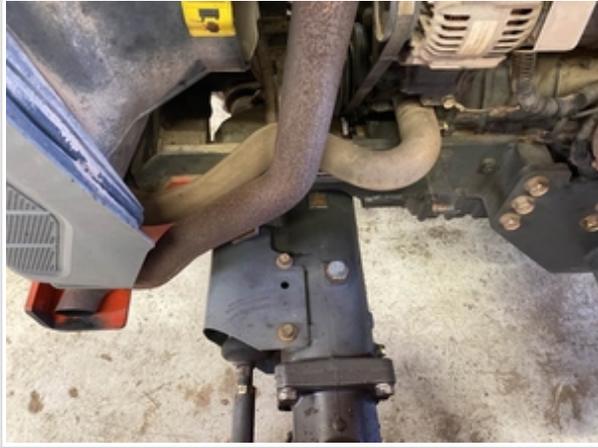
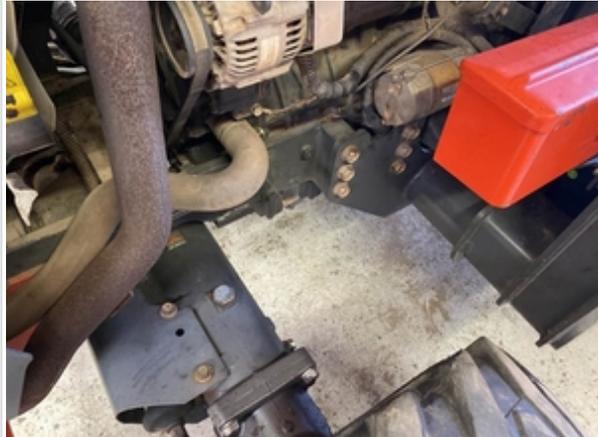
Instructions	<p>Evaluate the following on a 4 point scale (leave comments where an explanation is appropriate):</p> <p>4 = Like New, Recently Replaced 3 = Normal Wear & Tear 2 = Above Average Wear 1 = Service Required</p>
Frame	3 - Normal Wear & Tear
Frame Photos

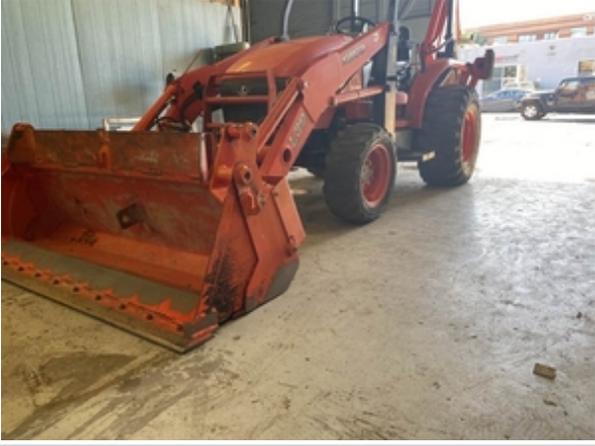
Stance	3 - Normal Wear & Tear	
Stance Photos

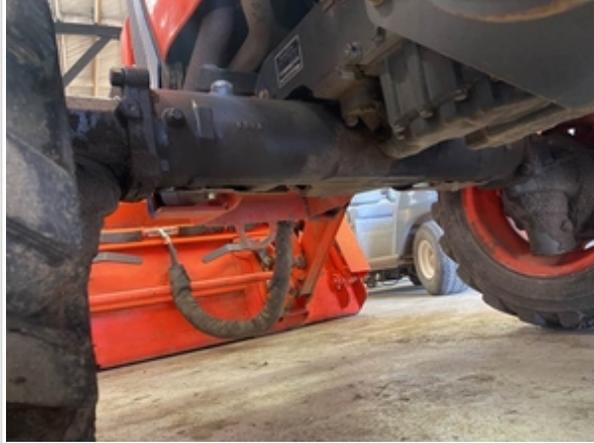
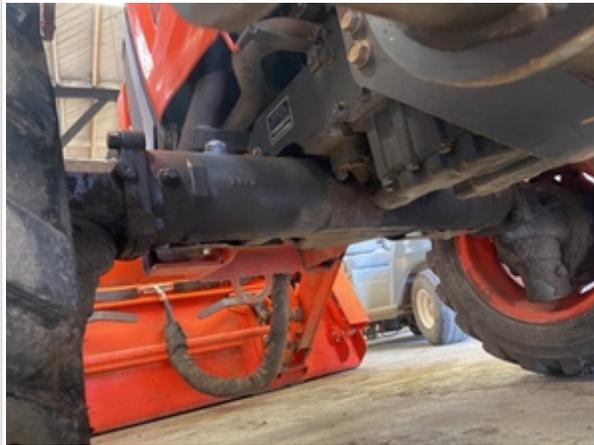
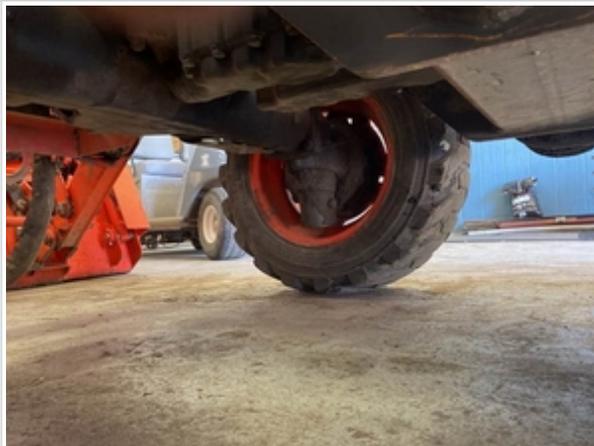
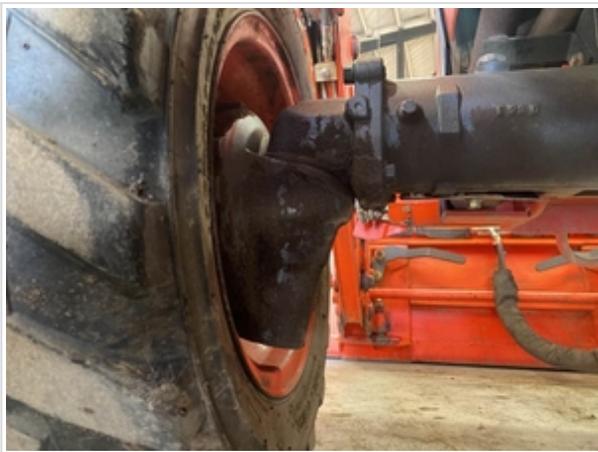
Front Axle Appearance Photos

Front Axle Appearance	3 - Normal Wear & Tear

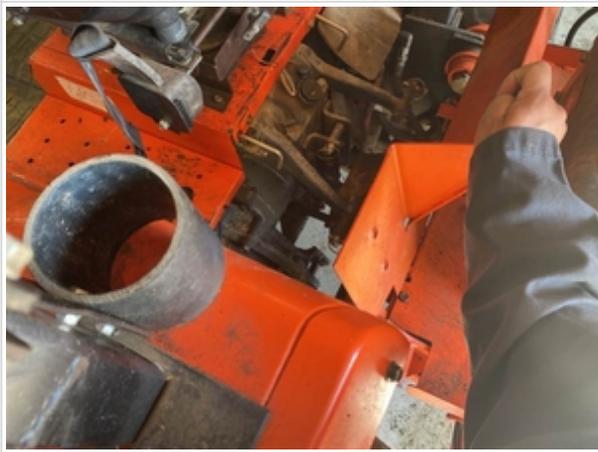
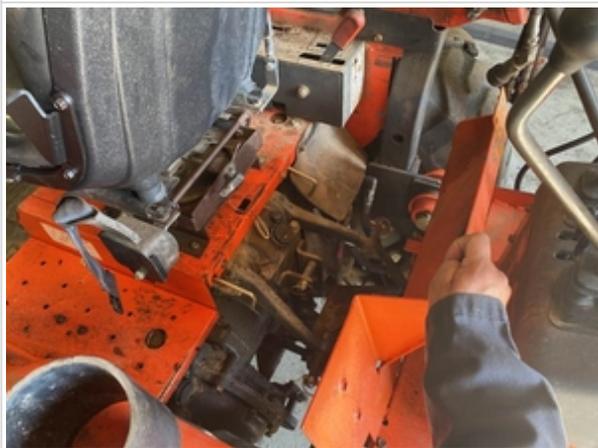
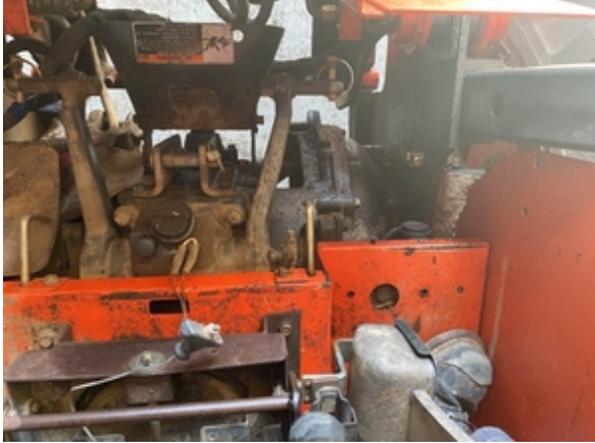
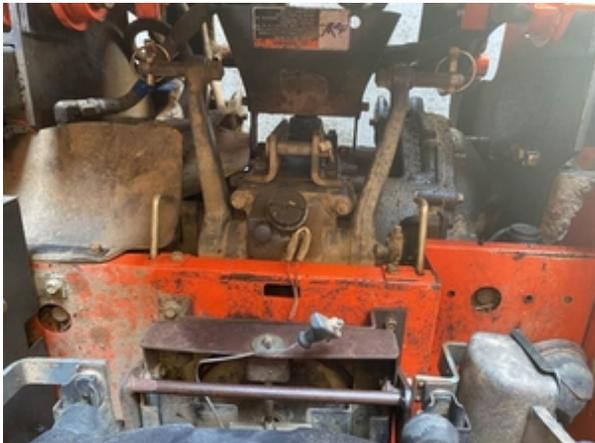
<p>Rear Axle Appearance</p>	<p>3 - Normal Wear & Tear</p>
<p>Rear Axle Appearance Photos</p>

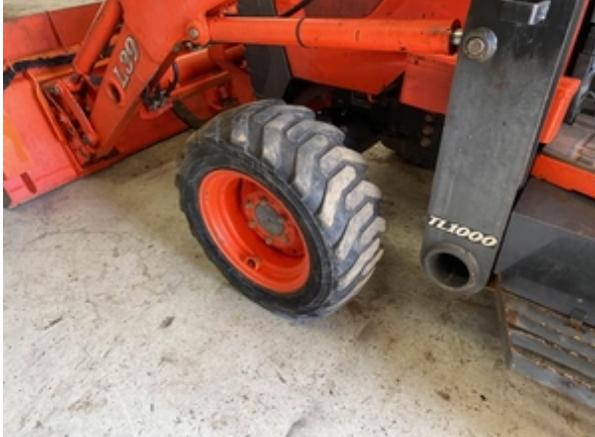
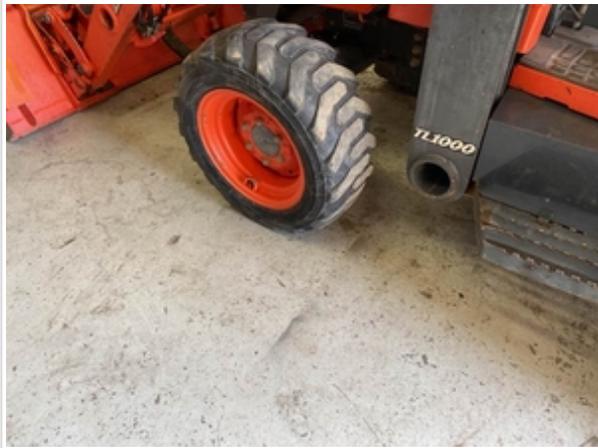
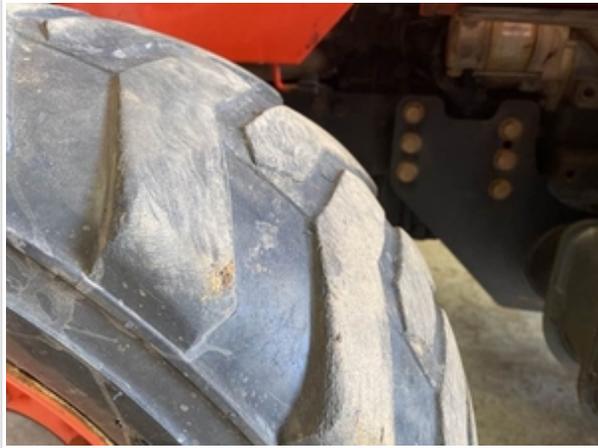
Articulating Center Pin Appearance	0
Tire Brand	Lande (front) Titan & Firestone (rear)
Tire Size	27 x 10.5 front and 15 x 19.5 rear
Front Left Tire - Ratio Remaining	30%
Front Left Tire Photos

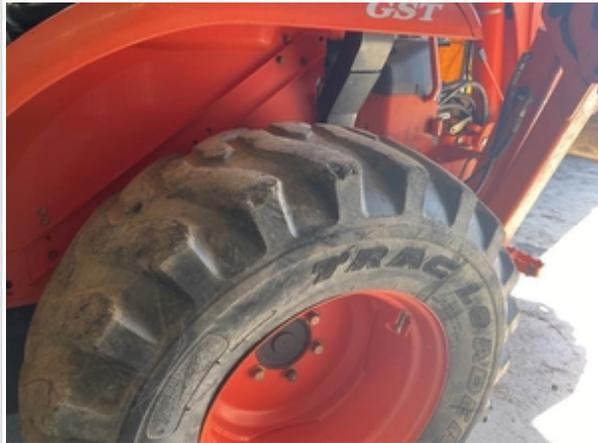
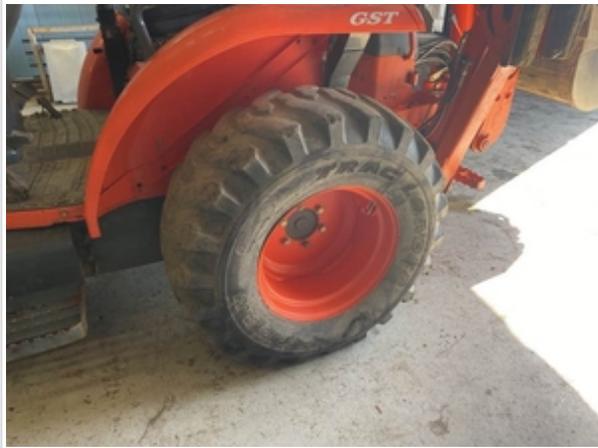
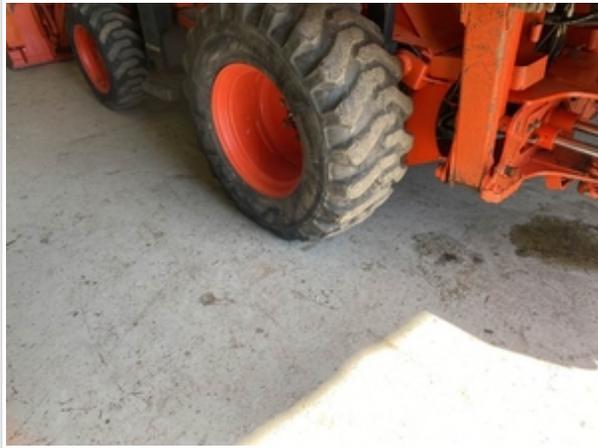
<p>Rear Left Tire - Ratio Remaining</p>	<p>50%</p>
<p>Rear Left Tire Photos</p>

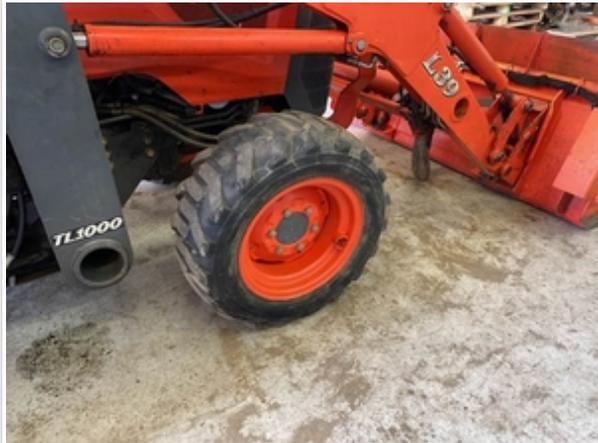
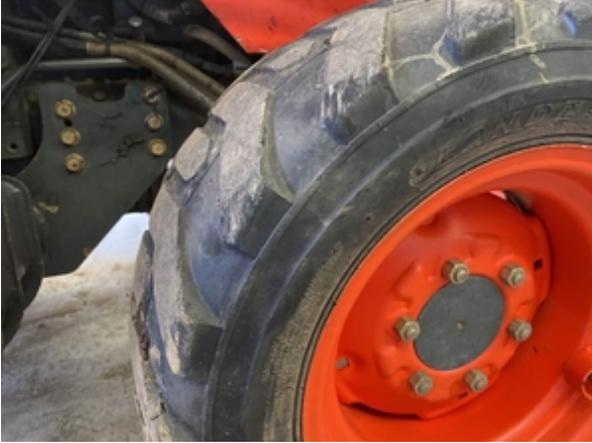
<p>Front Right Tire - Ratio Remaining</p>	<p>10%</p>
<p>Front Right Tire Photos</p>

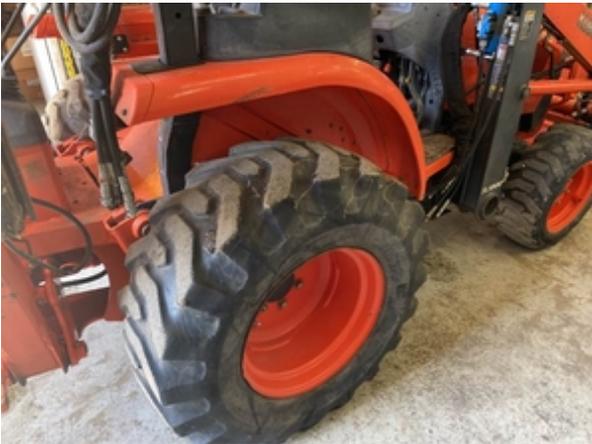
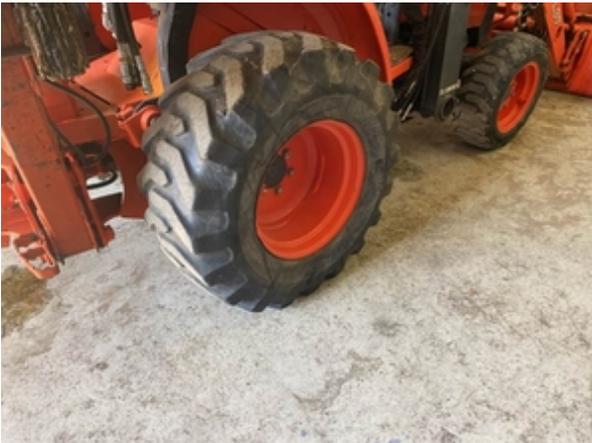
Rear Right Tire - Ratio Remaining	70%	
Rear Right Tire Photos

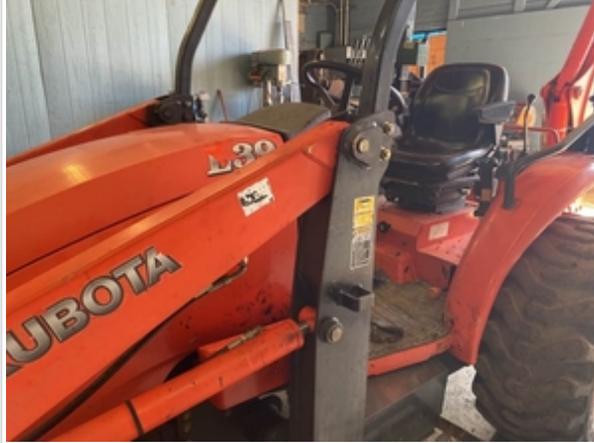
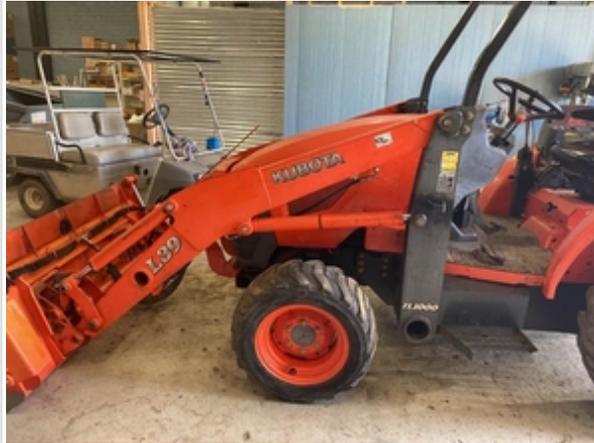
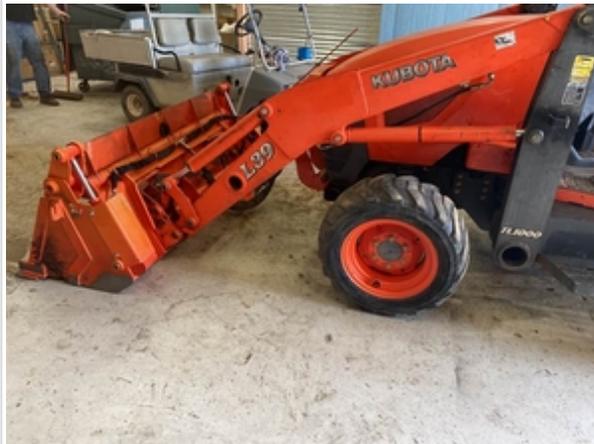
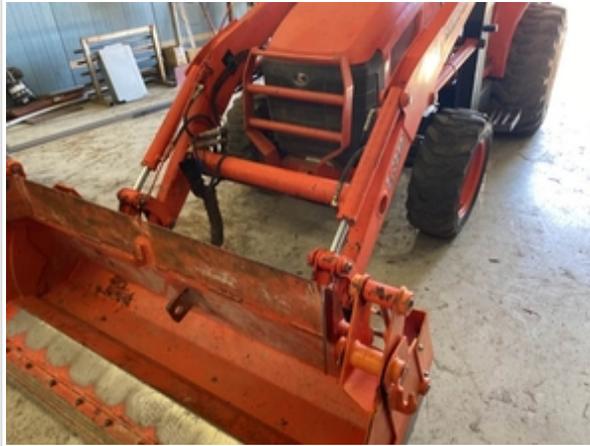
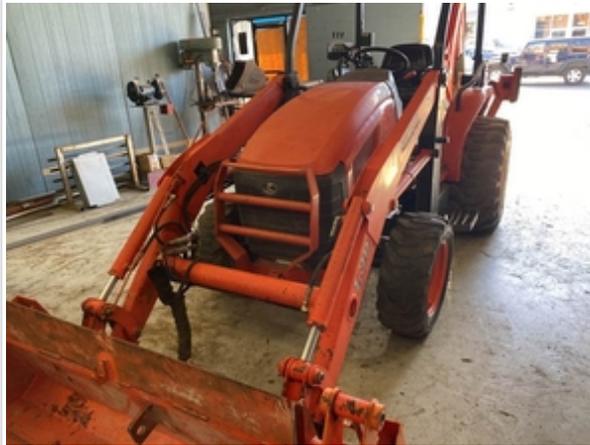
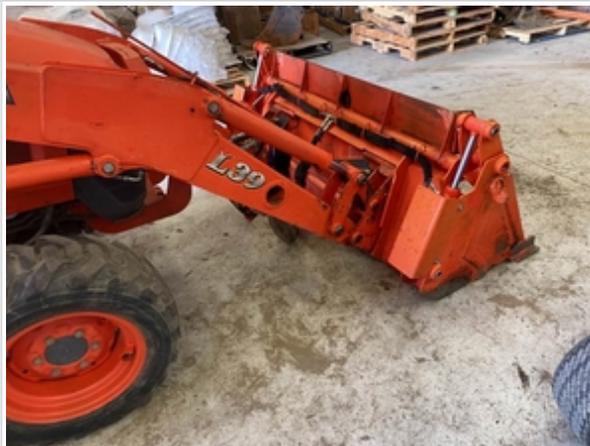
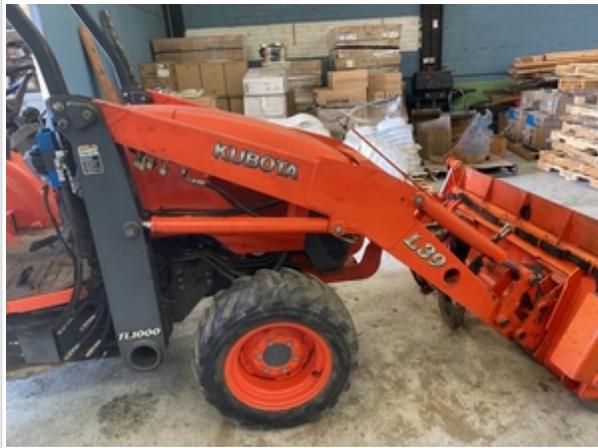
Lift Arm Photos

Lift Arm	3 - Normal Wear & Tear

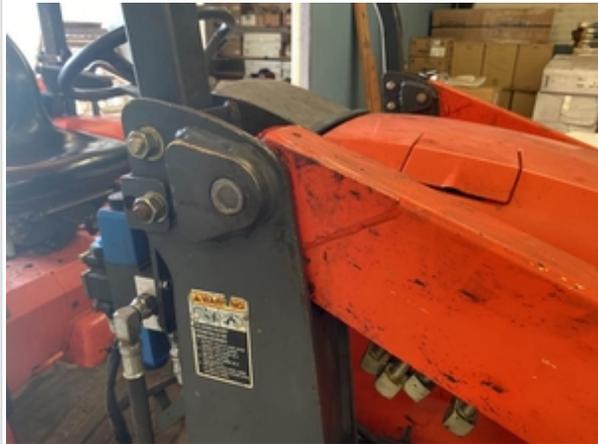
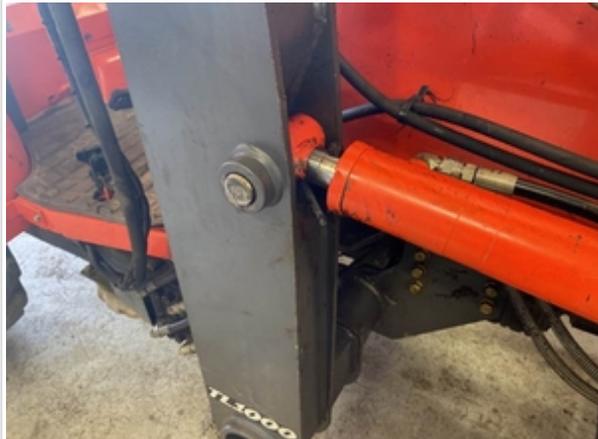
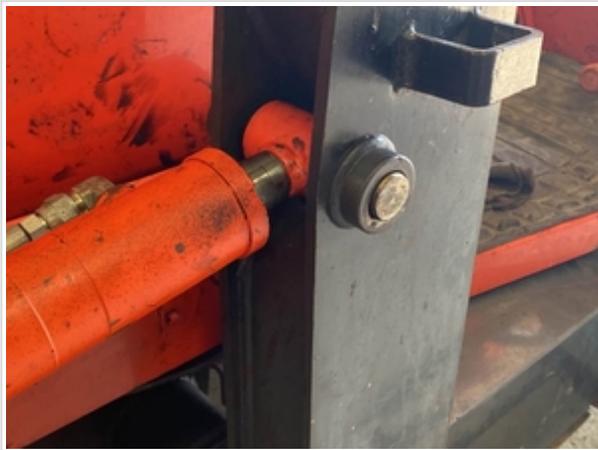
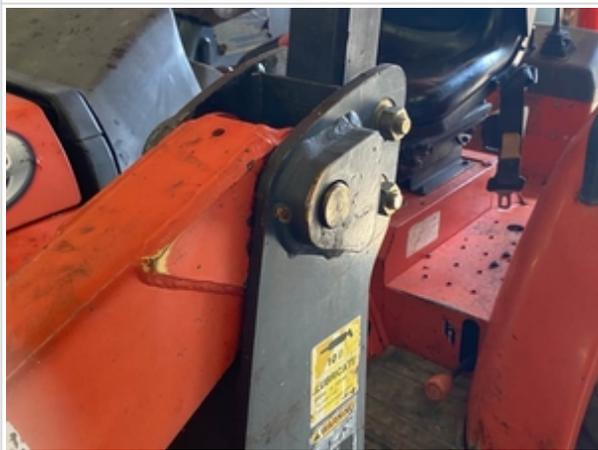
<p>Chassis to Arm Pins</p>	<p>3 - Normal Wear & Tear</p>	
<p>Chassis to Arm Pins Photos</p>

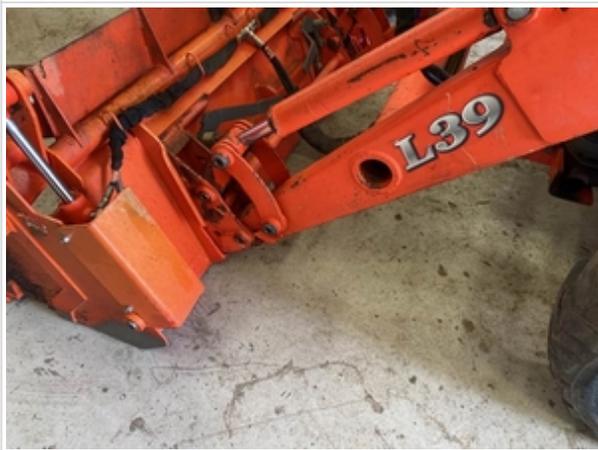
<p>Tilt Linkage</p>	<p>3 - Normal Wear & Tear</p>
<p>Tilt Linkage Photos</p>
