Inspection Report (Wheel Loader)

Year	2010
Make	Kubota
Model	L39
Serial Number	12552 - 12434
Hour Meter Reading	2039.5
Previous Application (e.g., earth moving, mining, demolition, etc)	General Construction, Commercial Plumbing Contractor

Quality Rating	3
Functionality Rating	3
Overall Rating	3
What's Great About the Machine	This machine is well kept and has a great bundle of attachments like : 5' fork attachment : skip loader Gannon type attachment (for rear) : 6' front loader gp bucket for wet dirt or mixing concrete applications : hitch receiver style from center front bucket attachments and 6' extension for lifting objects into place
What Needs Work	A few rear hydraulic hoses for backhoe attachment need to be replaced. Service brakes need to be adjusted or repaired for a more firm brake application
Any Additional Info from the Seller?	Original owner of this machine
Inspector's Name	Mario Ramirez
Date/Time	08-25-2022

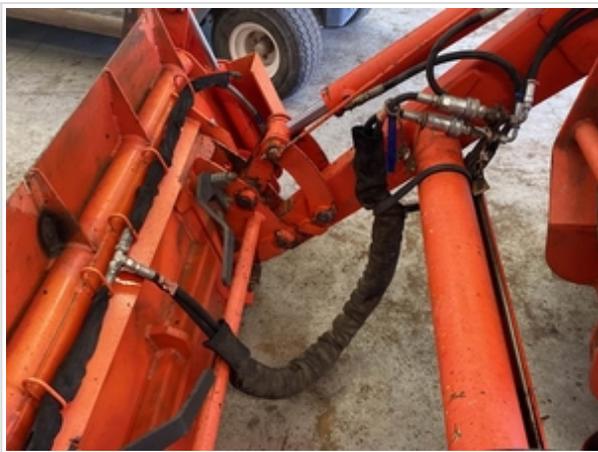
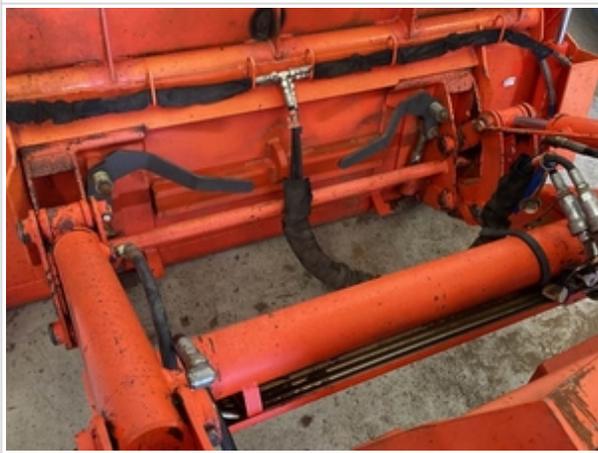
<p>Tilt Linkage</p>	<p>3 - Normal Wear & Tear</p>
<p>Tilt Linkage Photos</p>

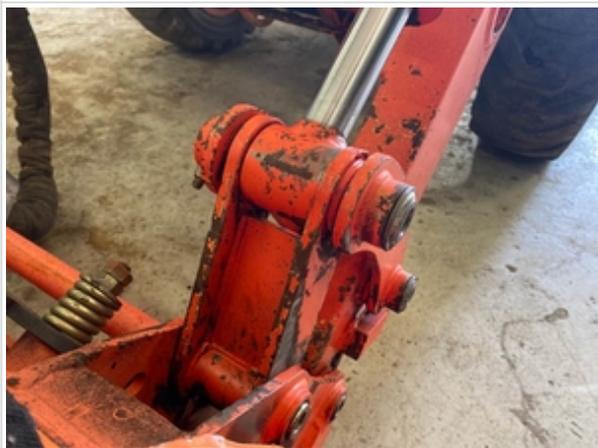
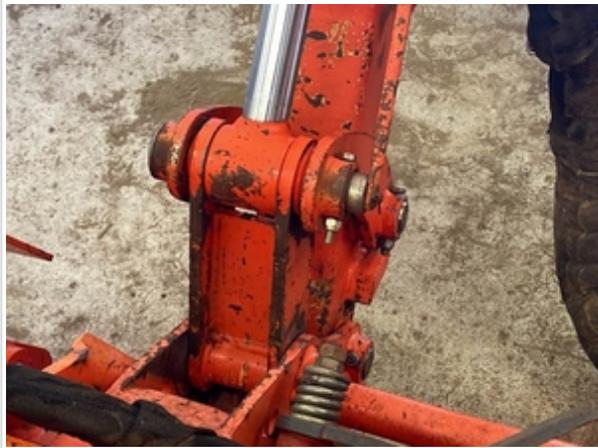
<p>Tilt Linkage Pins and Bushings</p>	<p>3 - Normal Wear & Tear</p>	
<p>Tilt Linkage Pins and Bushings Photos</p>

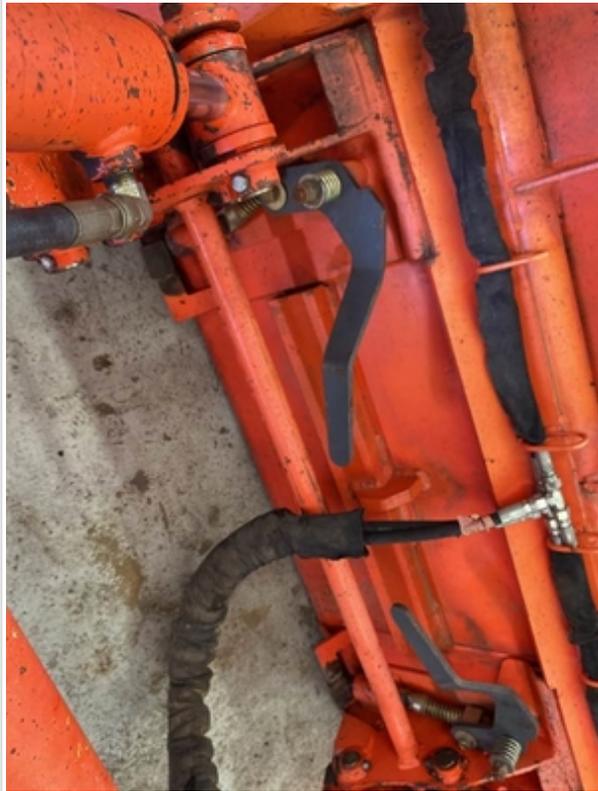
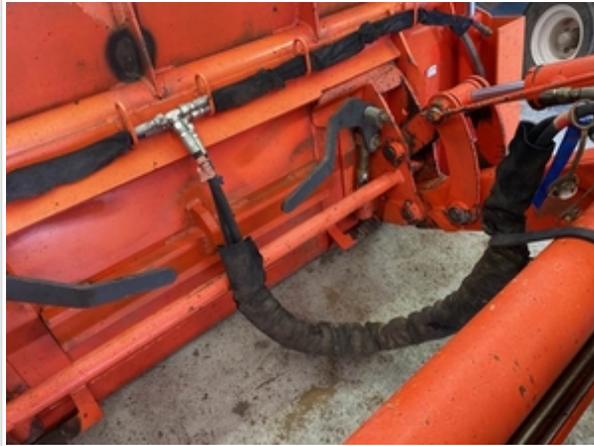
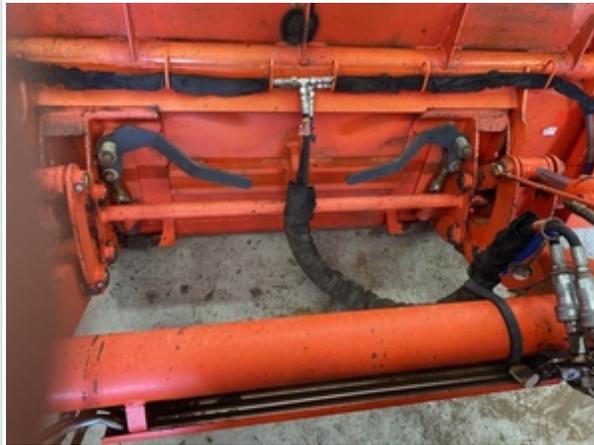
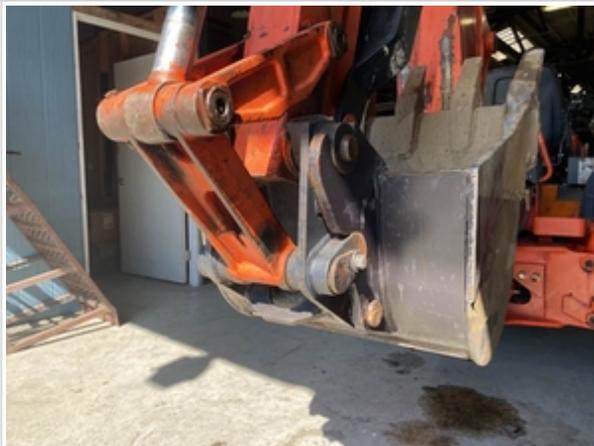
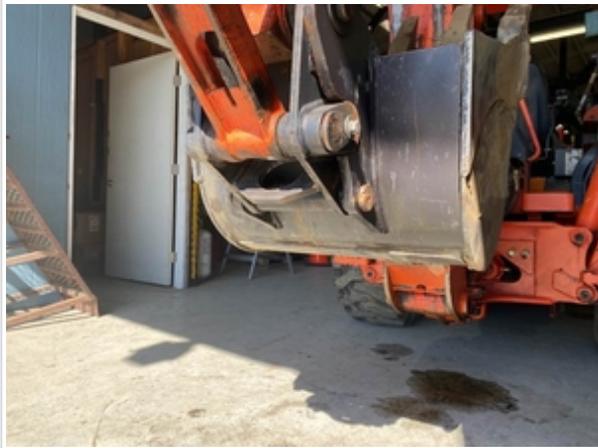
Quick Coupler	3 - Normal Wear & Tear
Quick Coupler Photos

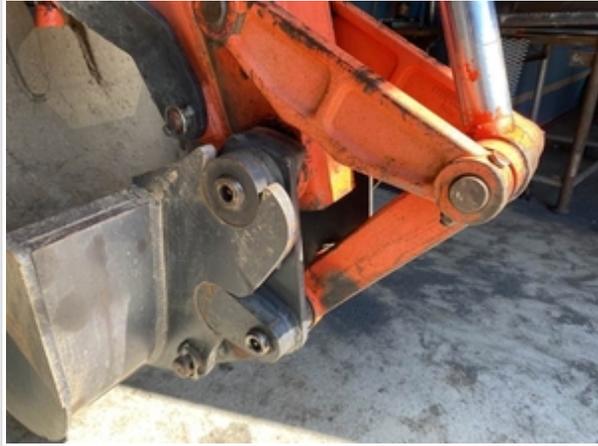
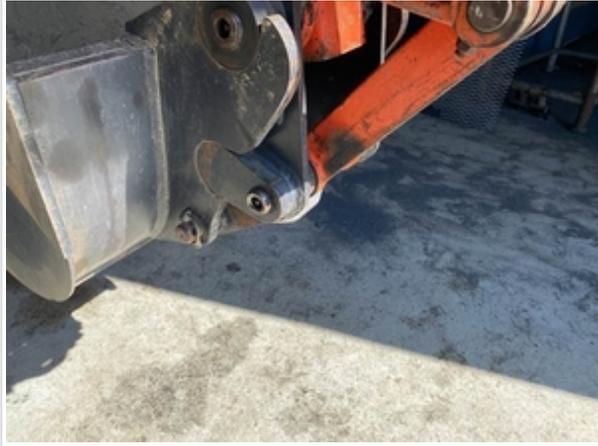
Quick Coupler to Arms Pins	3 - Normal Wear & Tear	
Quick Coupler to Arms Pins Photos

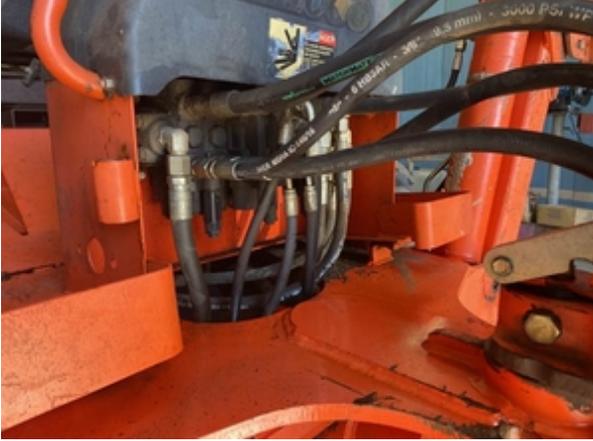
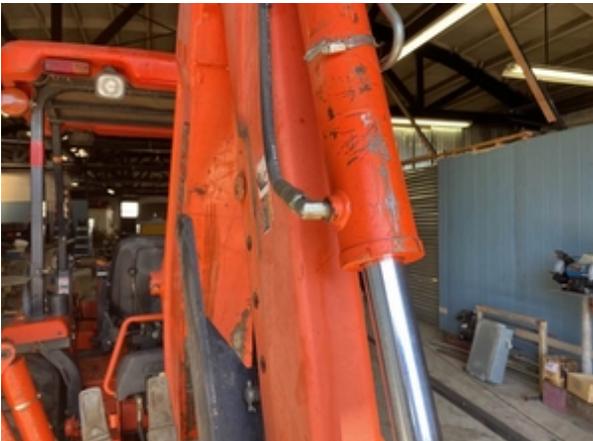
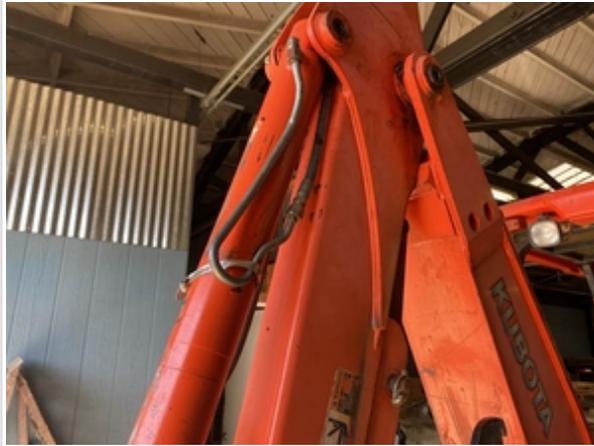
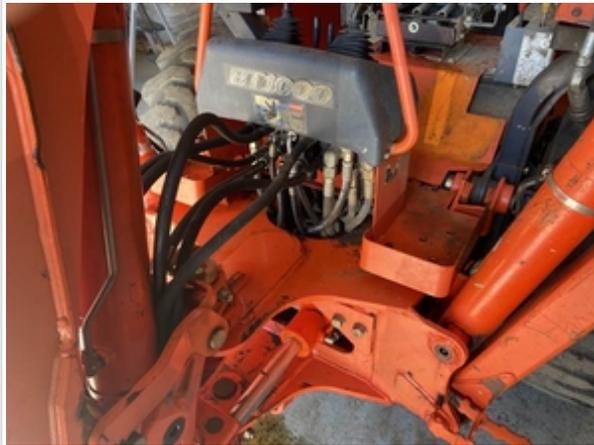
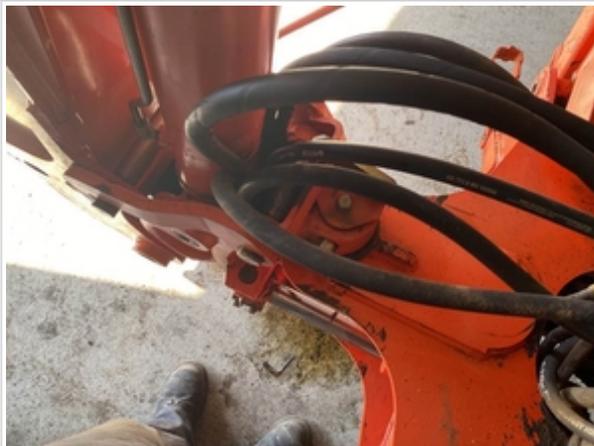
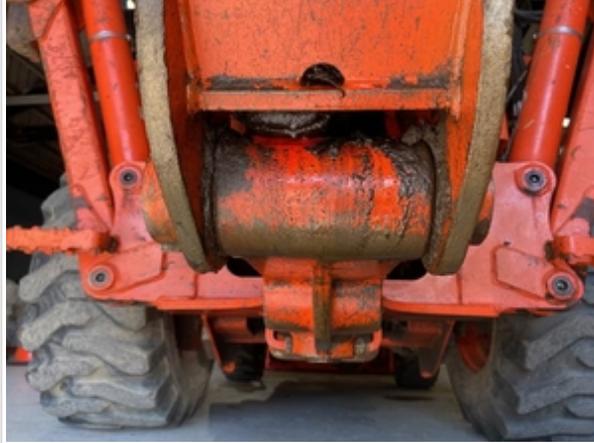
Appearance of Hydraulic Lines / Fittings	3
Hydraulic Lines / Fittings Condition	Hydraulic lines & fittings are clean and in good condition, Worn, cut, or damaged hose covering, Active leaks in hoses or fittings observed, Other (see comments)
Comments	Most hydraulic hoses good condition, 1 active seepage leak at hyd. Hose that goes down backhoe boom area
Appearance of Hydraulic Lines / Fittings Photos

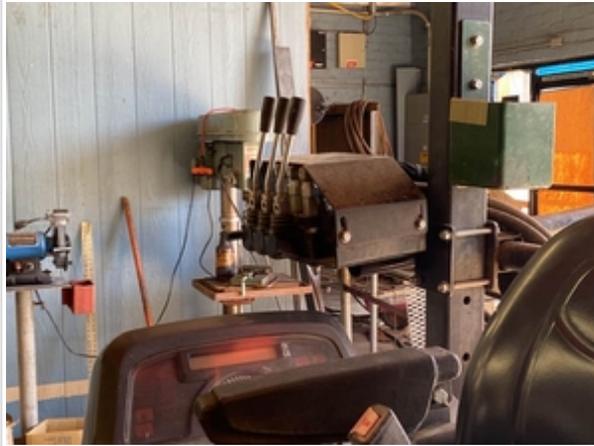
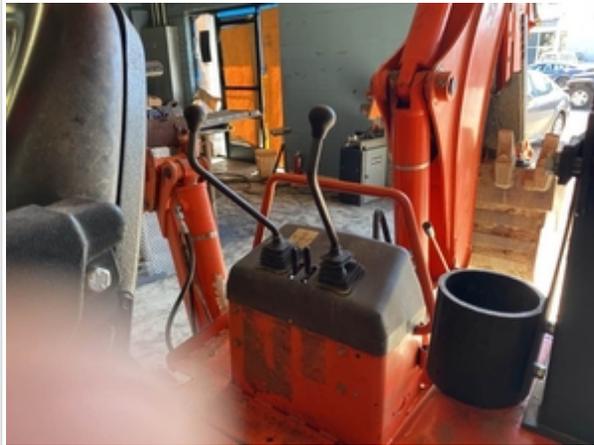
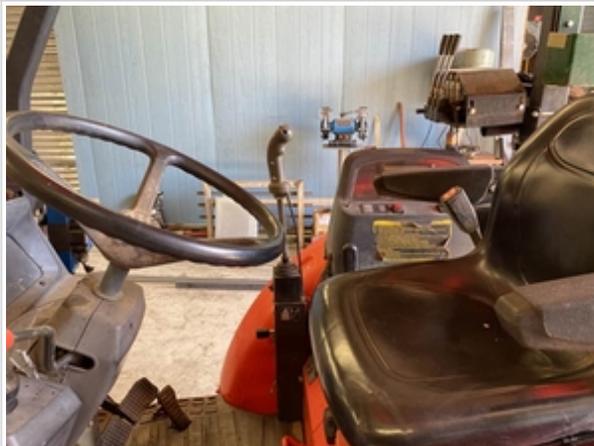
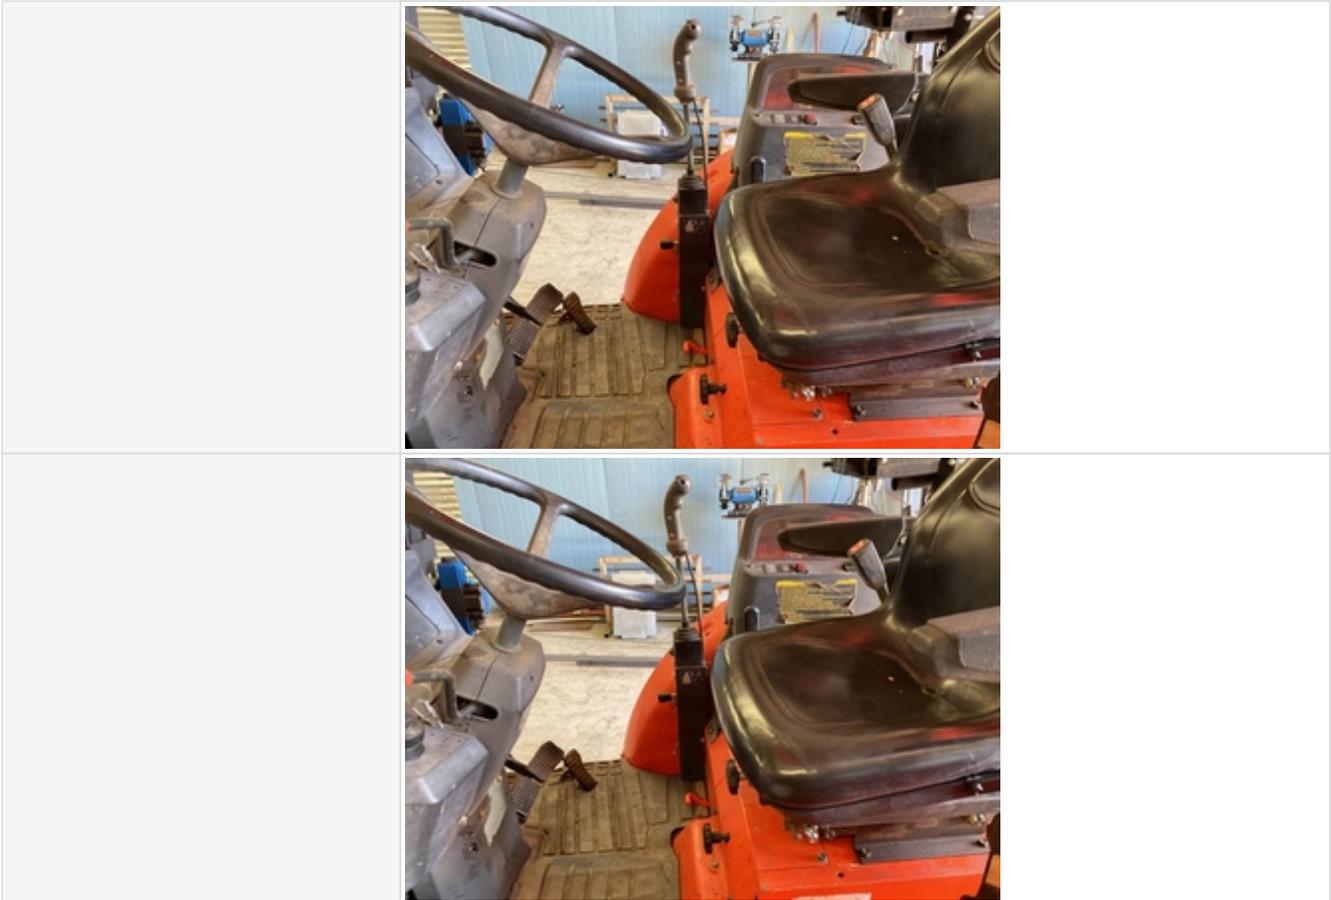
Unusual Noises (Hydraulic Pump)	No
Hydraulic Pump Notes	No unusual noises heard during operation
External Controls / Levers	3
External Controls / Levers Condition	Good function & condition of hydraulic controls

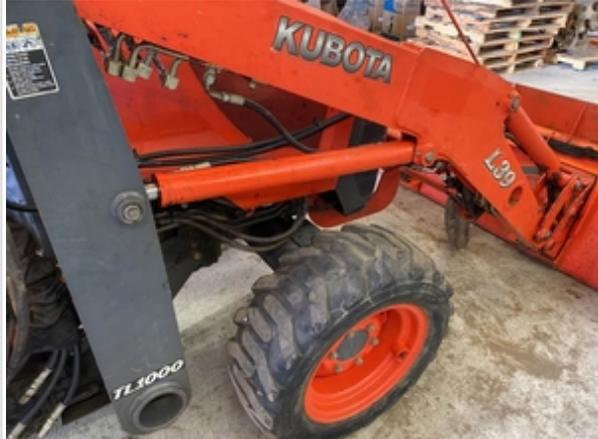
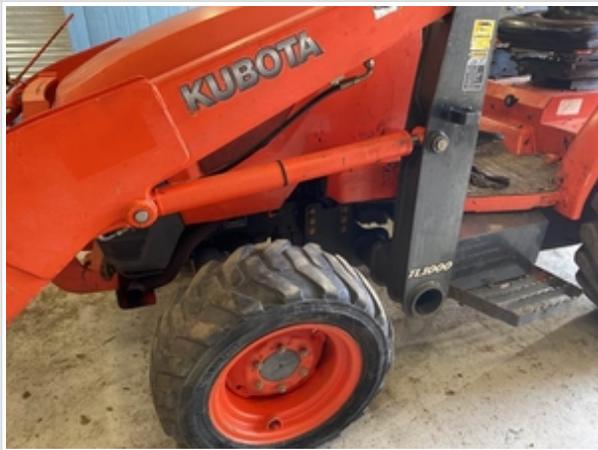
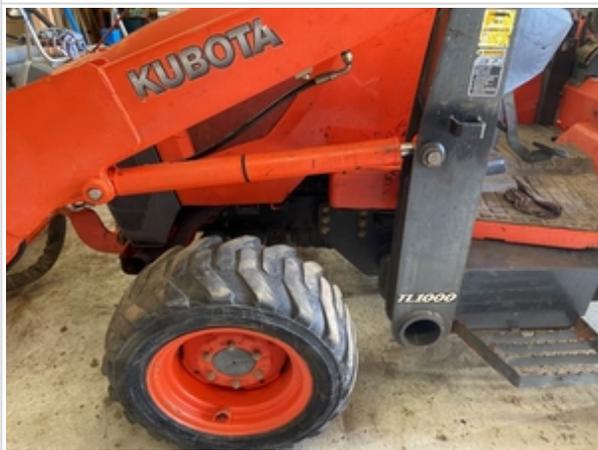
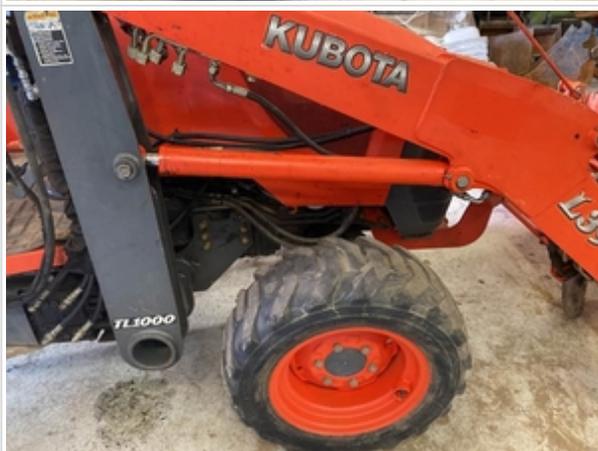
Lift Cylinder	Check the lift cylinder. Note any wear, pitting, discoloration, etc. Take photos.
Lift Cylinder: Mounting Pin	3
Lift Cylinder: Oil Leaks	No
Lift Cylinder Photos

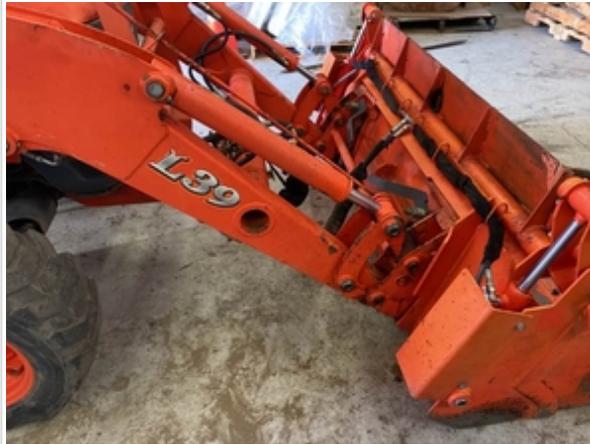
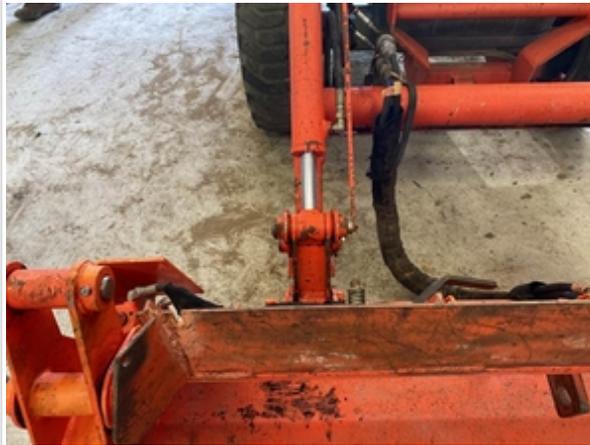
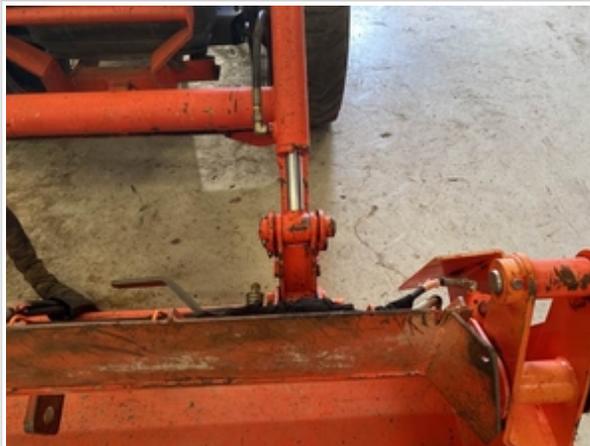
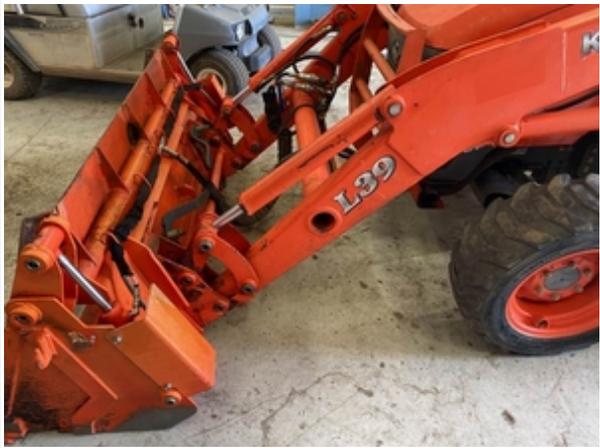
Bucket Cylinder	Check the bucket cylinder. Note any wear, pitting, discoloration, etc. Take photos.
Bucket Cylinder: Mounting Pin	3
Bucket Cylinder: Oil Leaks	No

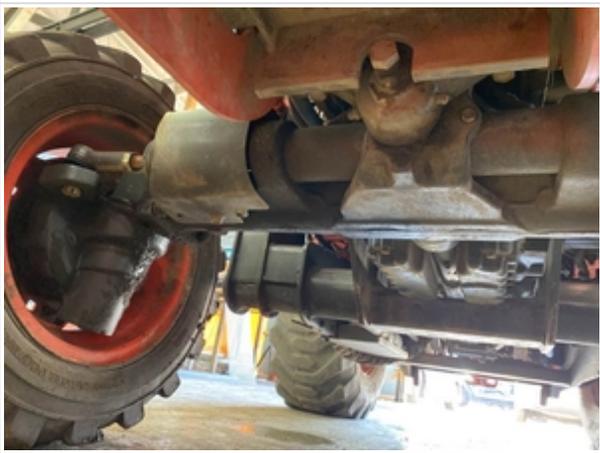
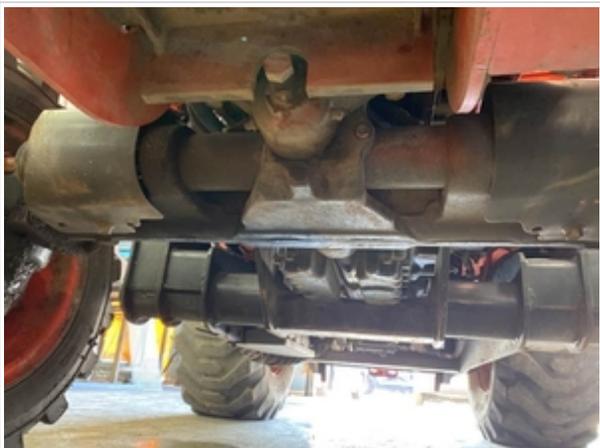
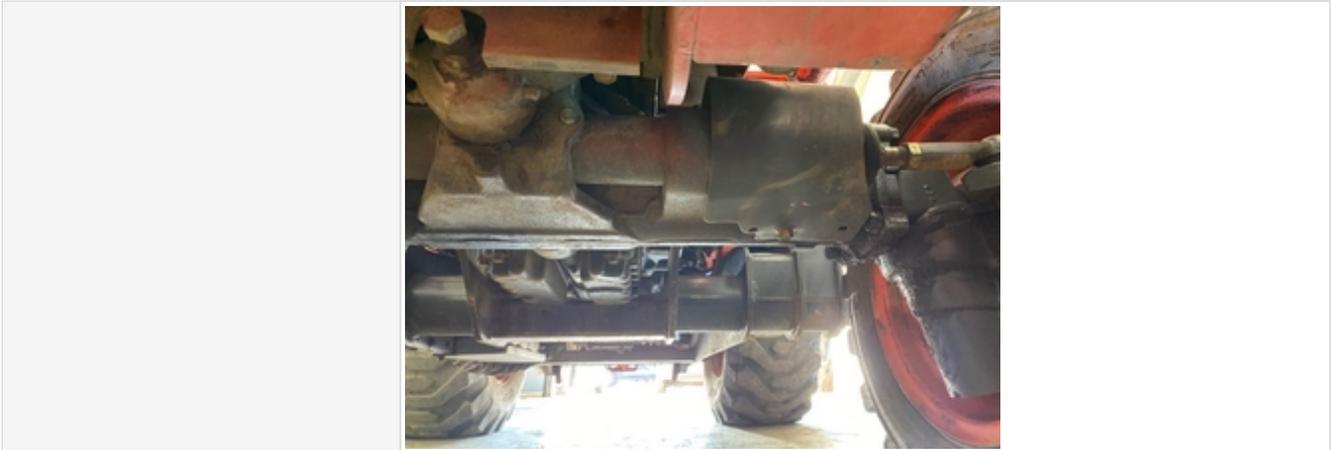
Steering Cylinder	Check the steering cylinder. Note any wear, pitting, discoloration, etc. Take photos.	
Steering Cylinder: Mounting Pin	3	
Steering Cylinder: Oil Leaks	No	
Steering Cylinder Photos

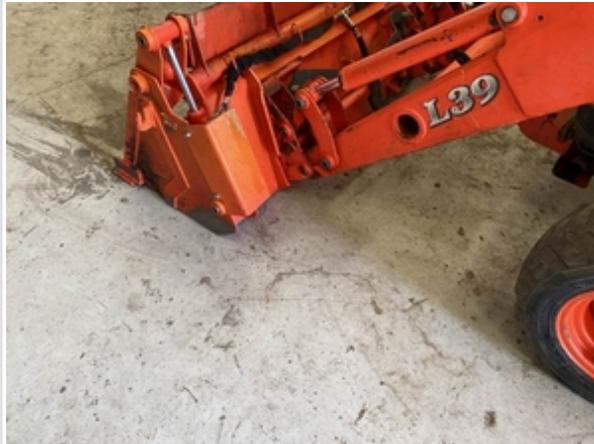
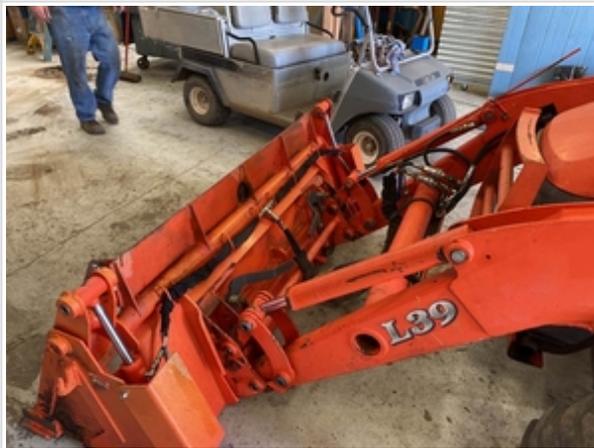
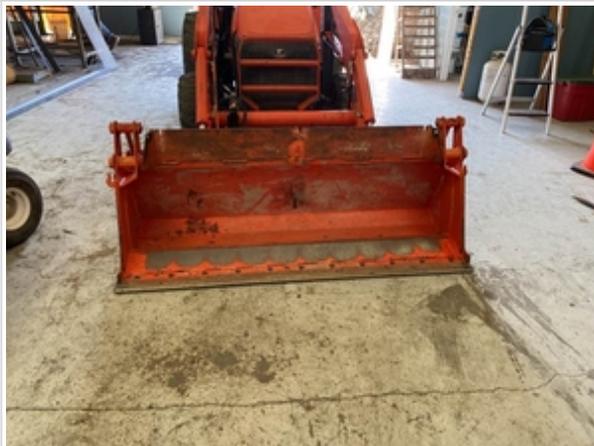
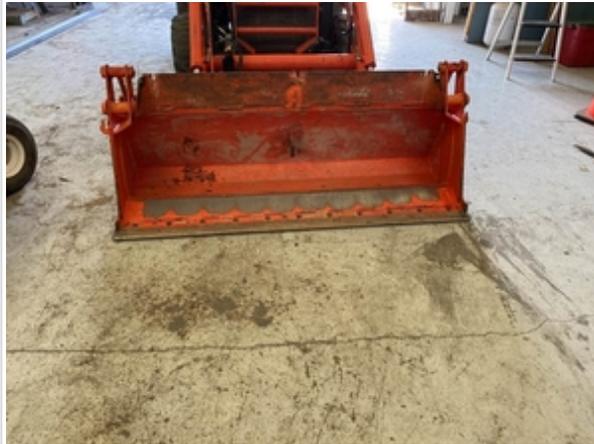
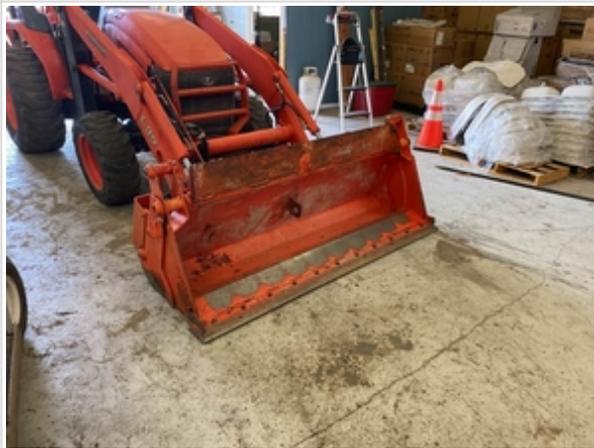
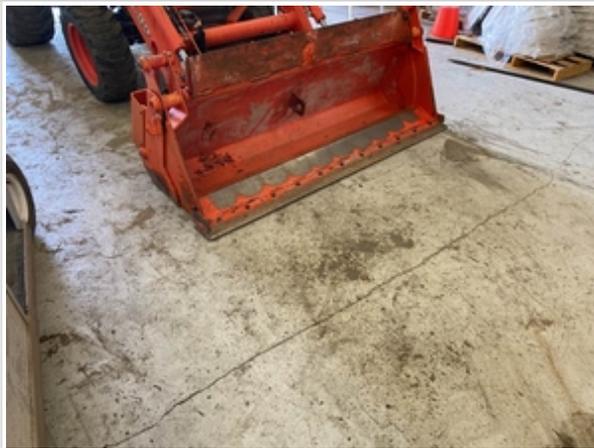
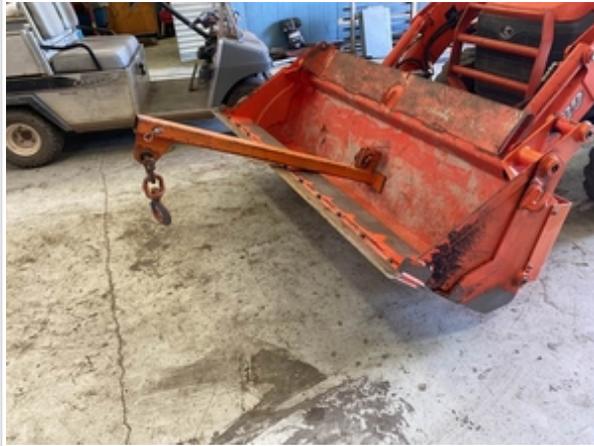
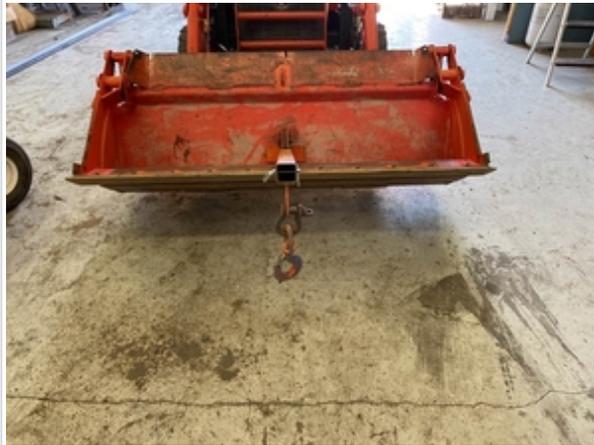
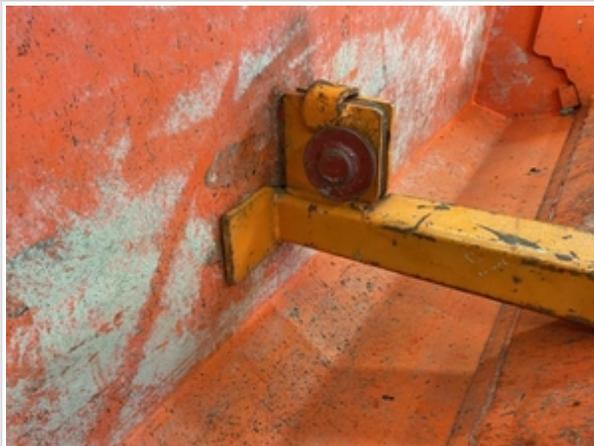
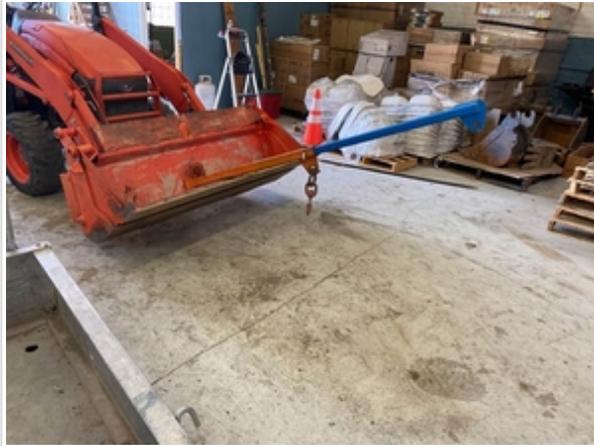
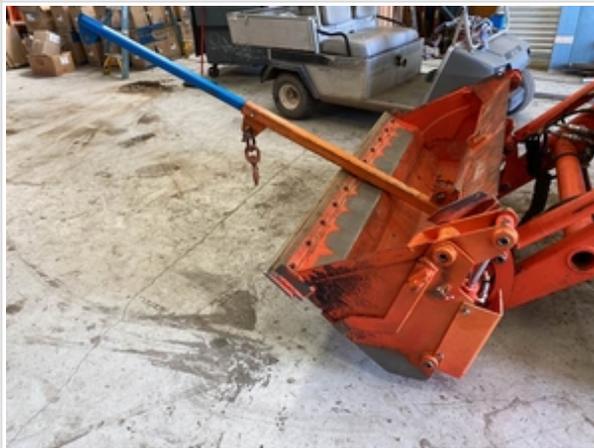
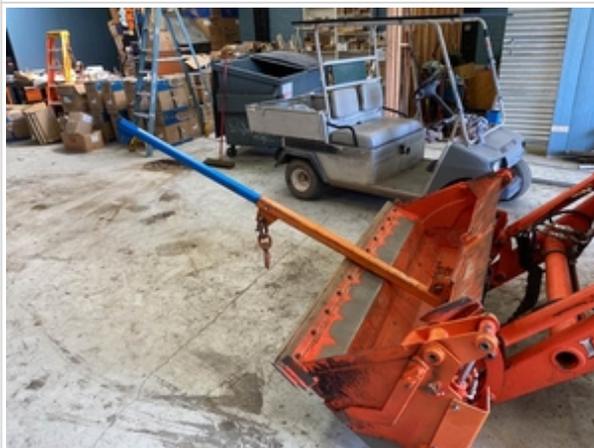
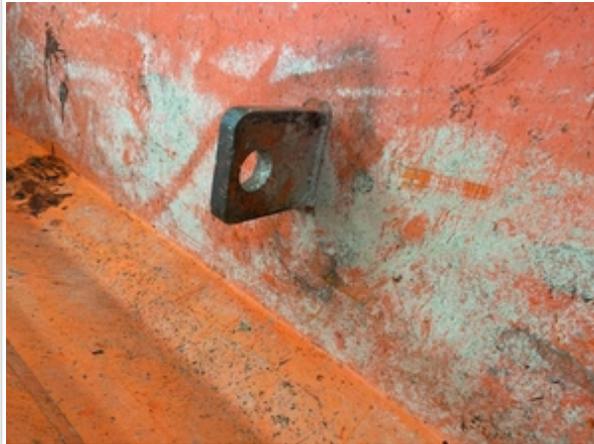
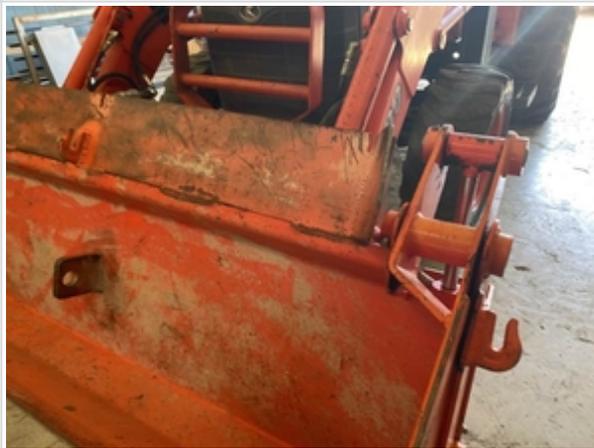
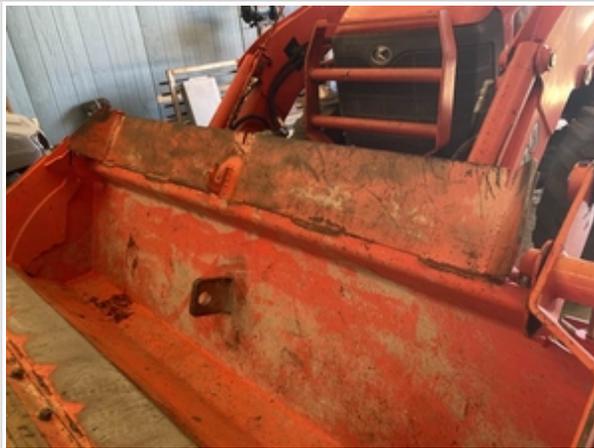
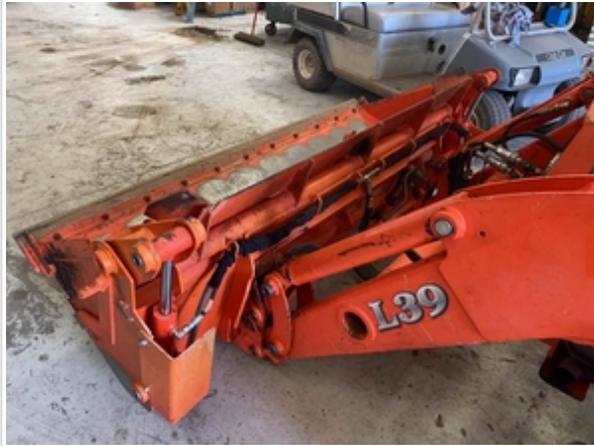
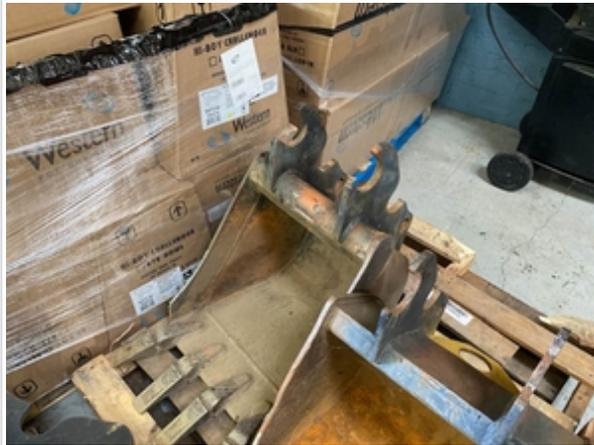
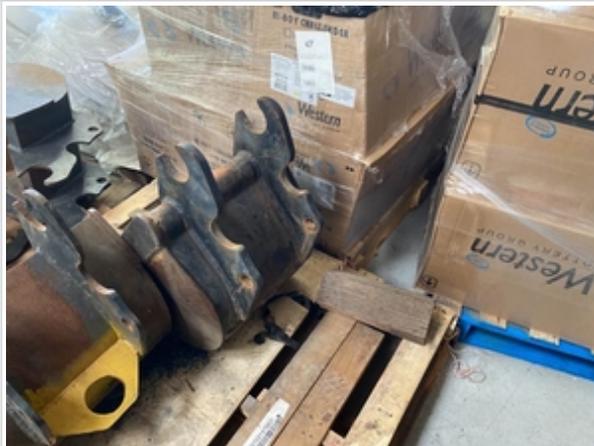
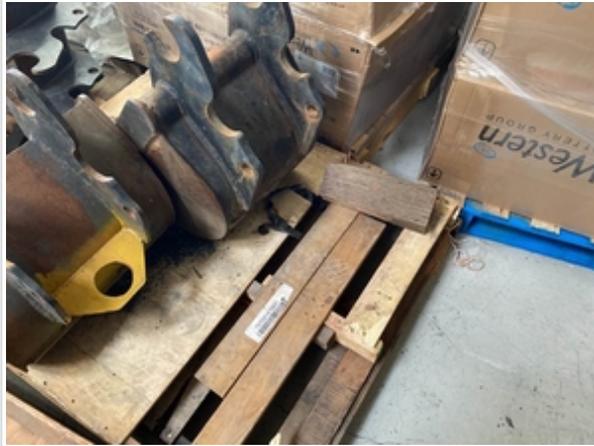
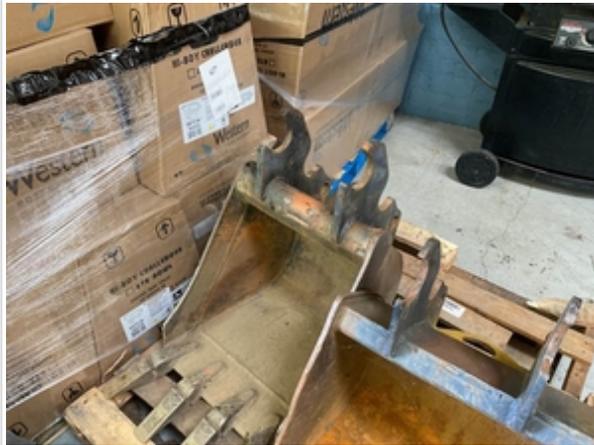
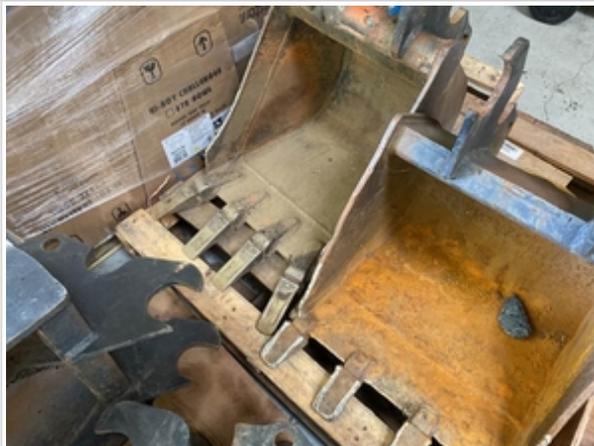
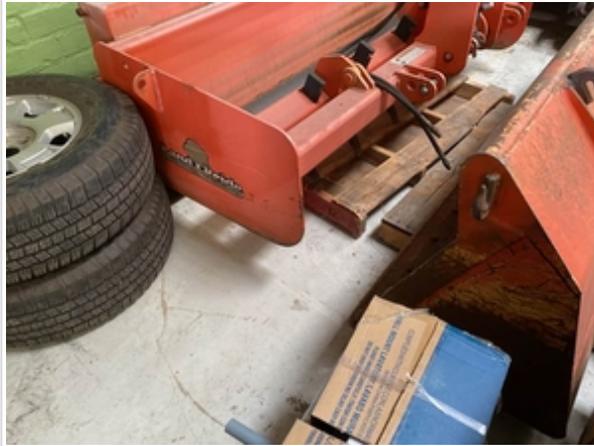
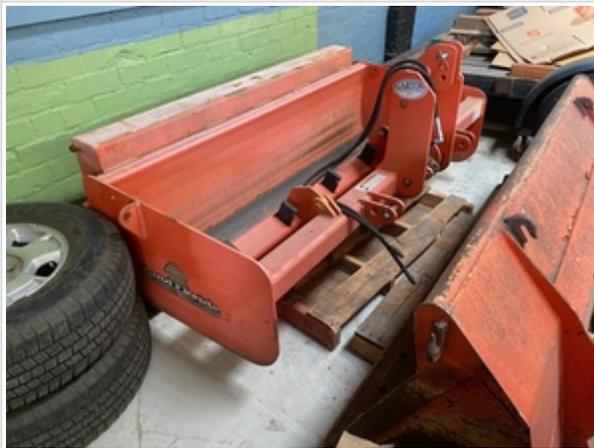
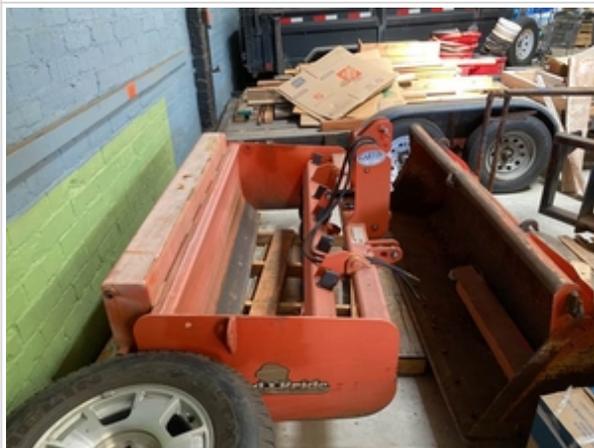
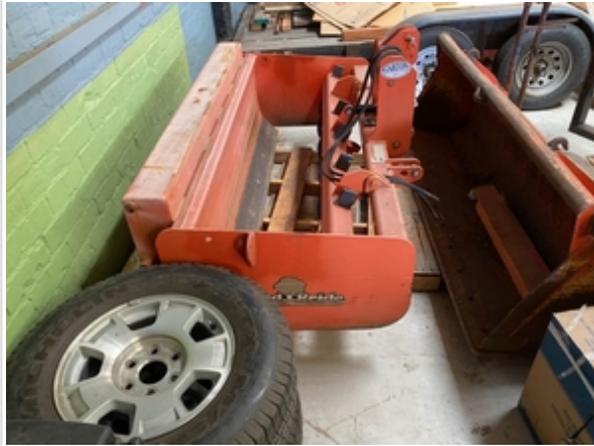
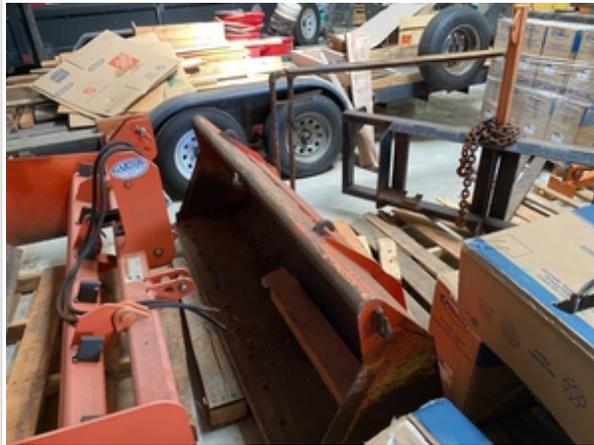
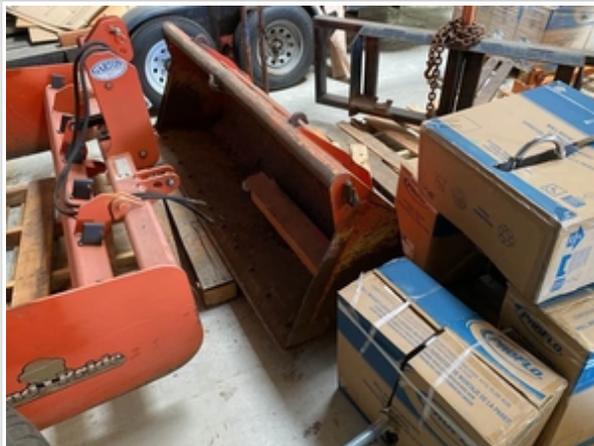
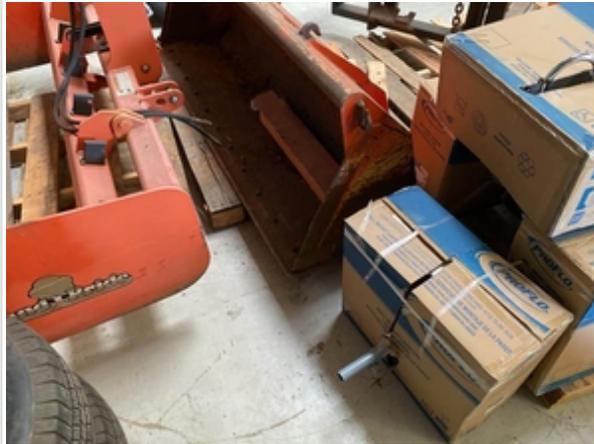
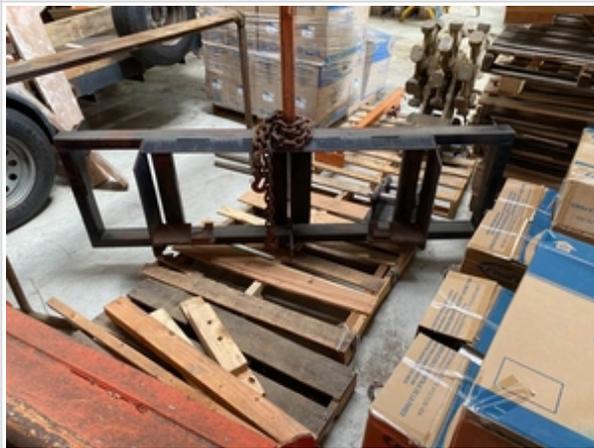
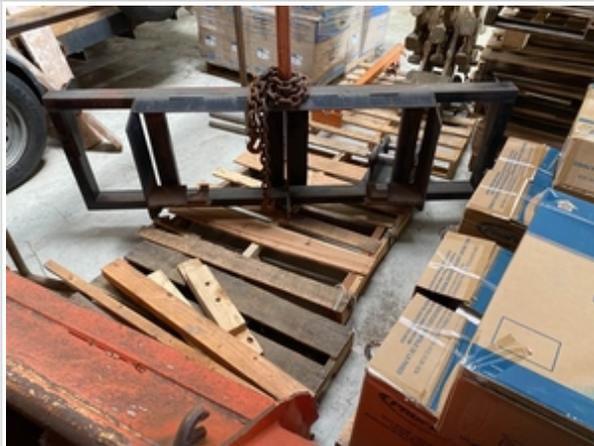
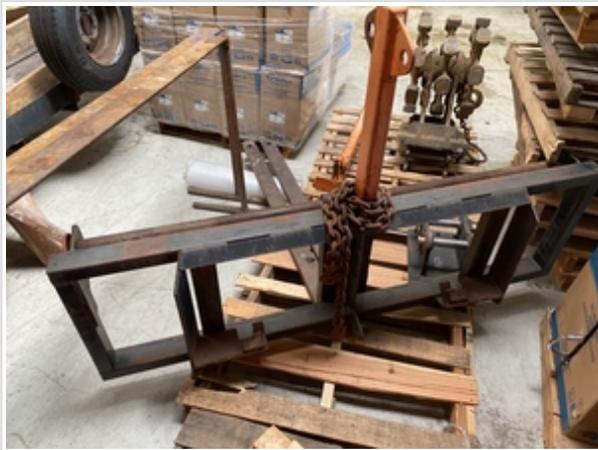
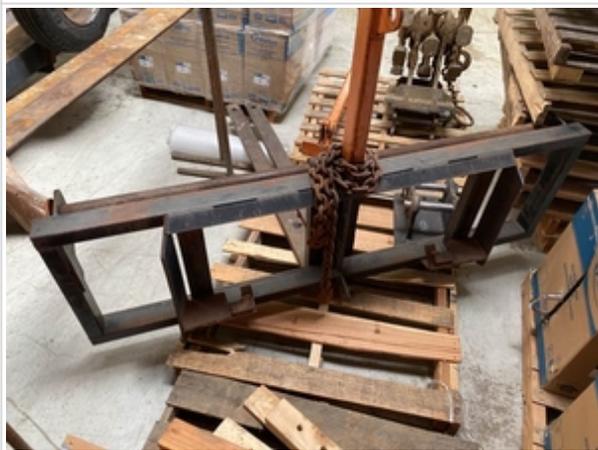
Instructions	<p>Evaluate the following on a 4 point scale (leave comments where an explanation is appropriate):</p> <p>4 = Like New, Recently Replaced 3 = Normal Wear & Tear 2 = Above Average Wear 1 = Service Required</p>
Bucket	<p>3 - Normal Wear & Tear</p>
Comments	<p>Certified welder fabricated 7" top shield to 4 to 1 bucket, fab. Center hold bracket inside bucket, and 8', 2" square extension for cherry picking and attaching hitch receiver for moving small tow behind equipment around job site!</p>
Bucket Photos

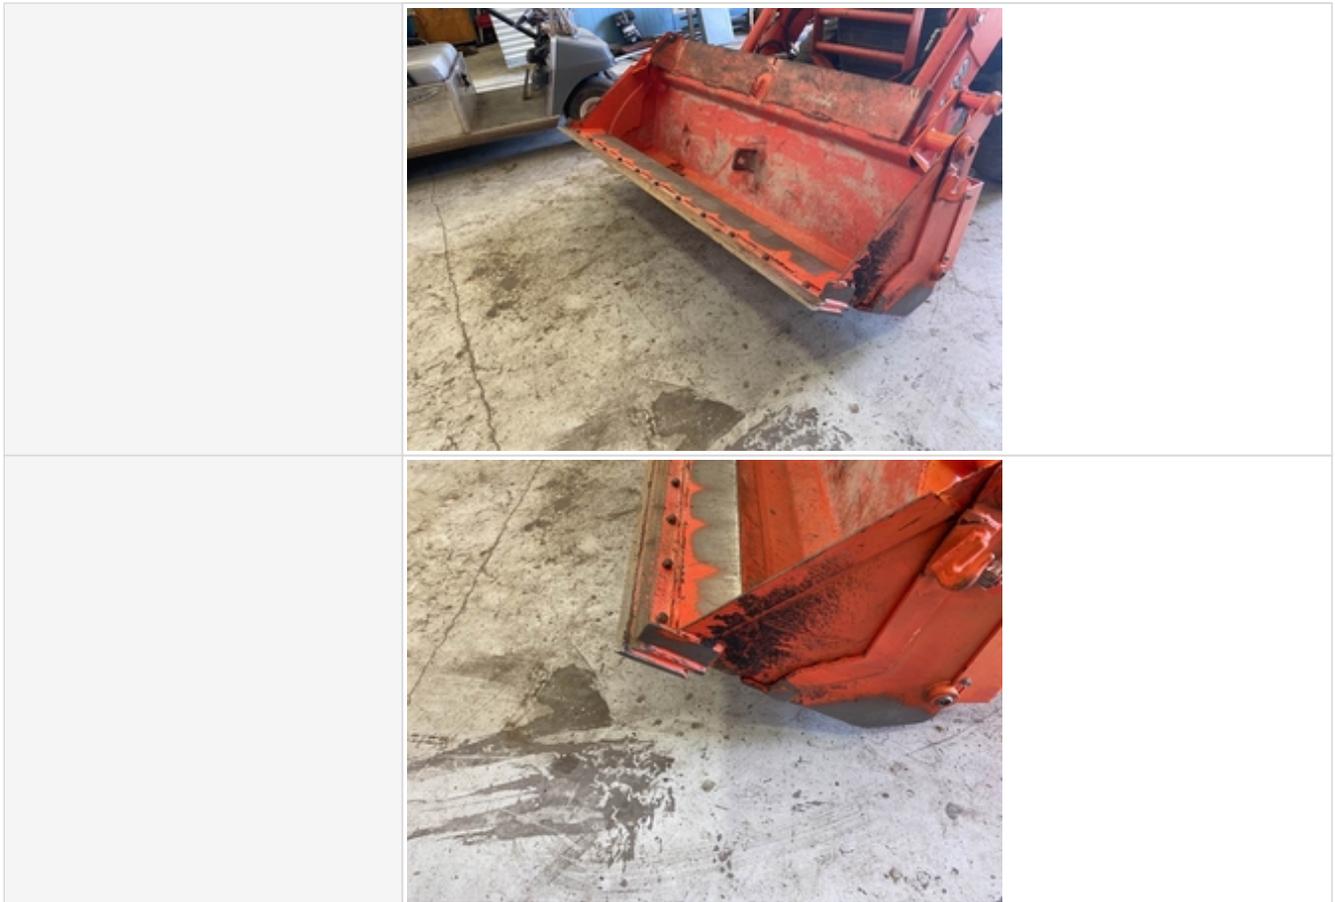
Bucket Edge/Shanks/Teeth	3 - Normal Wear & Tear	
Comments	Only 1 backhoe bucket to this machine 16"	
Bucket Edge/Shanks/Teeth Photos
