Inspection Report (On-Highway Dump Truck)

Year	2011
Make	Peterbilt
Model	367
Serial Number	1NPTLU0X4BD127976
Truck Odometer Reading	425,002 miles
Current Inspection / State Cert / DOT	90 day b.i.t. Inspection performed 6/20/22 @424,994
Previous Application (e.g., earth moving, mining, demolition, etc)	asphalt road work

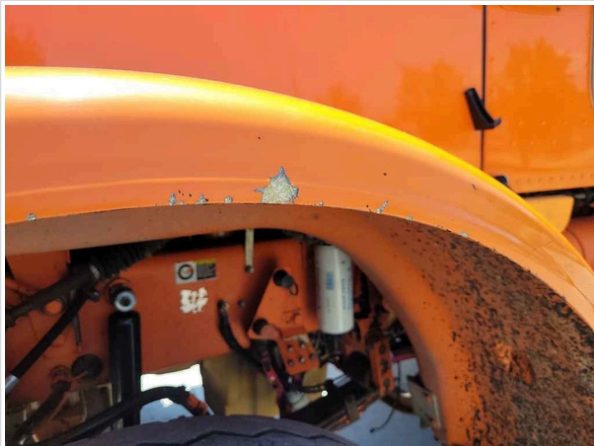
Front	3 - Normal Wear & Tear
Front Condition	No visible damage, Other (see comments)
Comments	minor fiberglass chips off fenders and clear coat peeling
Front Photos

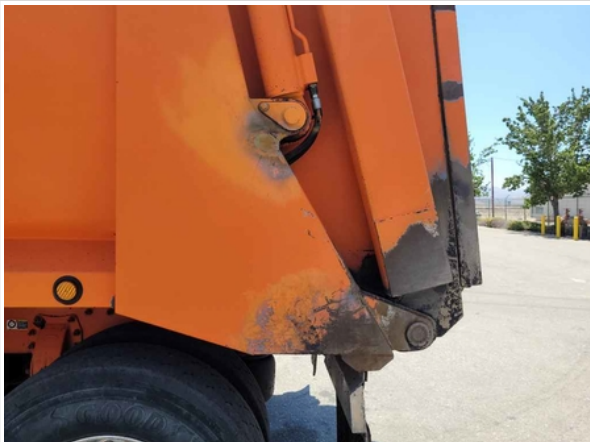
Left	3 - Normal Wear & Tear	
Left Condition	Other (see comments), No visible damage	
Comments	front left behind fender cover cracked (cosmetic) and rear left side discoloration from weld repairs	
Left Photos

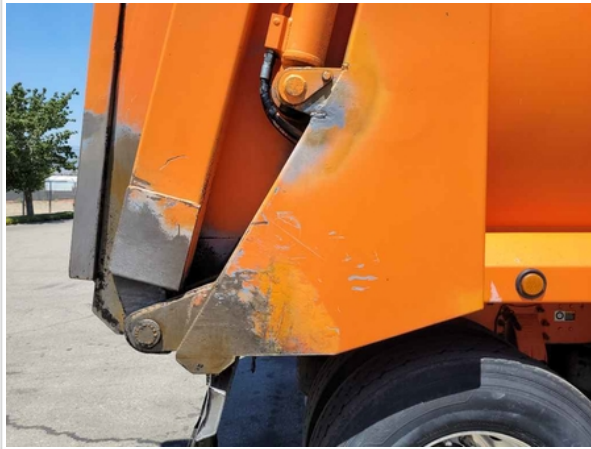
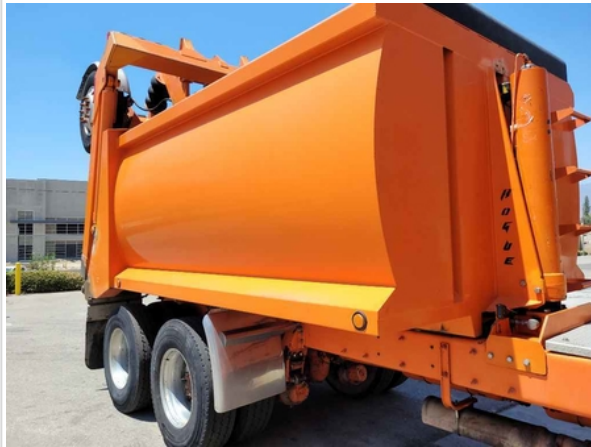
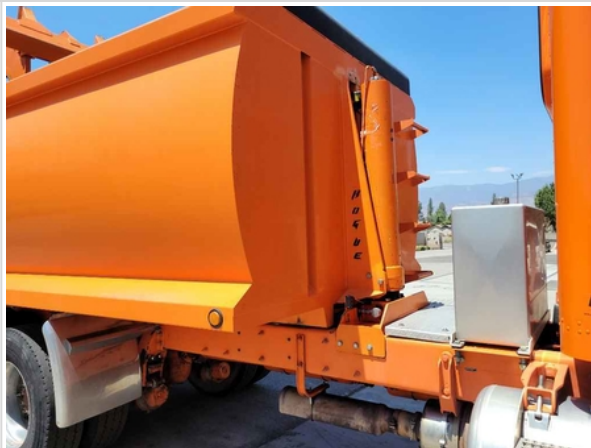
Right Photos

Right	3 - Normal Wear & Tear	
Right Condition	No visible damage, Other (see comments)	
Comments	discoloration from weld repairs

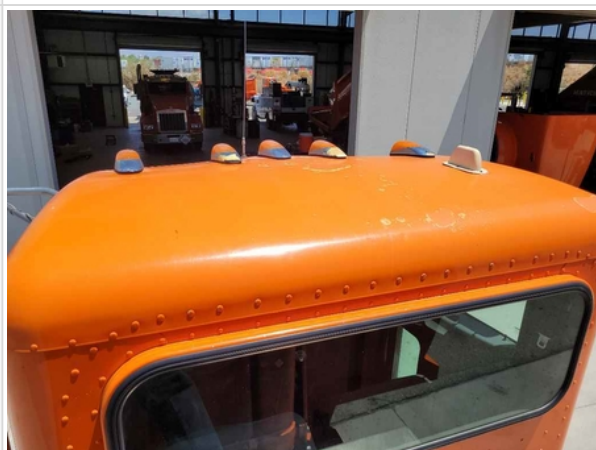
Upper	3 - Normal Wear & Tear	
Upper Condition	No visible damage, Other (see comments)	
Comments	clear coat peeling	
Upper Photos

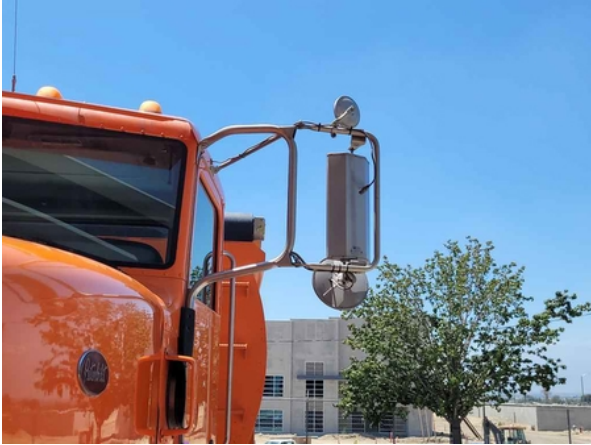
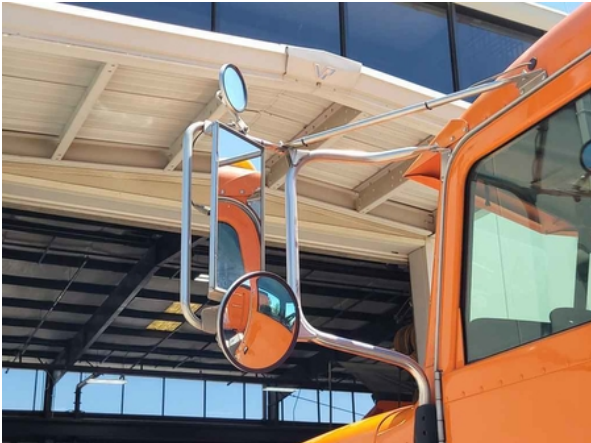
Mirrors	4 - Like New, Recently Replaced	
Mirror Condition Notes	Mirrors present and intact, no visible damage	
Mirrors Photos

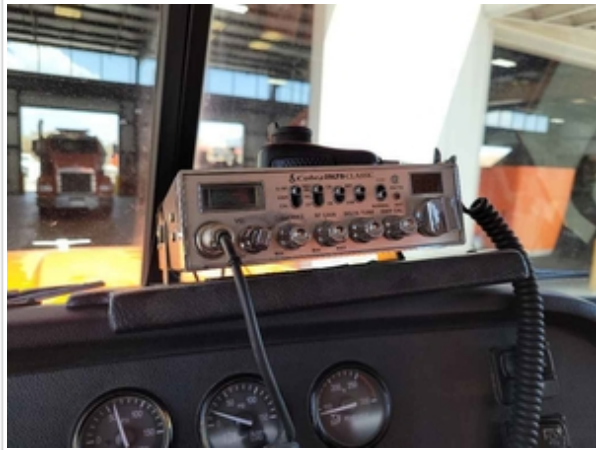
Horn	4 - Like New, Recently Replaced	
Reverse Alarm / Backup Signal	7	
Backup Camera	0	
Other Electronic Devices	4	
Comments	no sound?

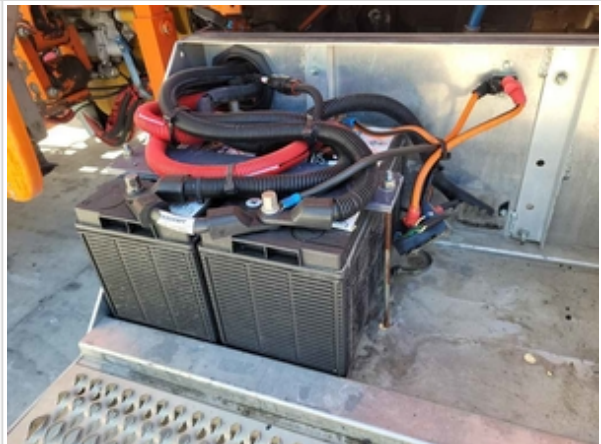
Blow-by (Visual Observation Check)	No	
Unusual Noises (Upon Start-up, Idle, Shutdown)	No	
Unusual Noise Notes	No unusual noises heard	
Engine Smoke (Upon Start-up, Idle, Shutdown)	No	
Engine Smoke Notes	No engine smoke issues observed	
Engine Exhaust Color	Clear	
Battery	4 - Like New, Recently Replaced	
Battery Condition	Like new, recently replaced	
Battery Condition Photos

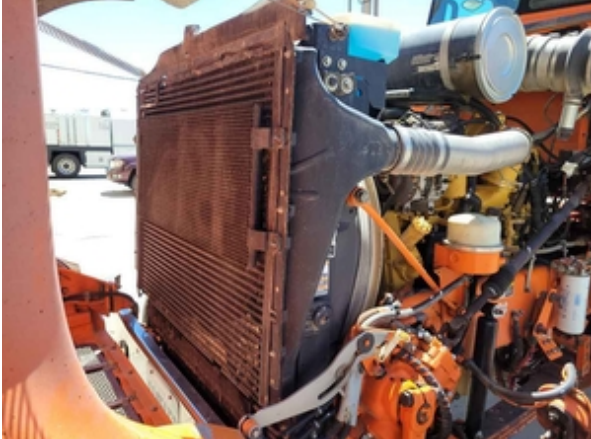
Radiator	3 - Normal Wear & Tear
Radiator Condition	Radiator fins & components appear to be in good working order, no signs of damage or leaks
Radiator Photos

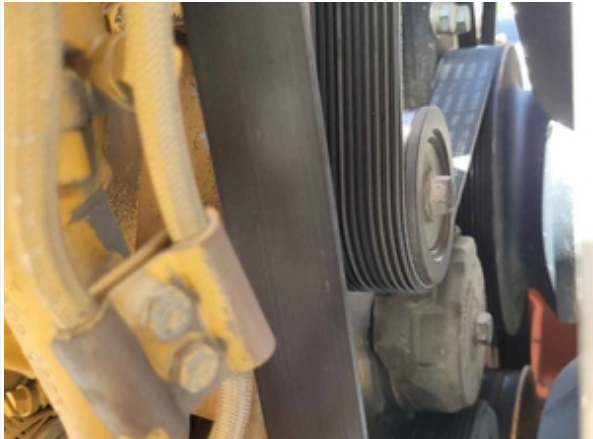
Belts	4 - Like New, Recently Replaced	
Belt Condition	Belts appear in good condition & alignment with proper tension	
Belt Photos

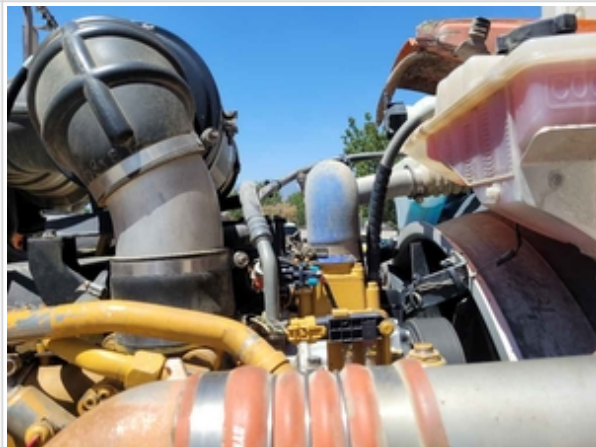
Hoses	3 - Normal Wear & Tear
Hose Condition	Firm, pliant hoses with no signs of wear or leaks
Hose Photos

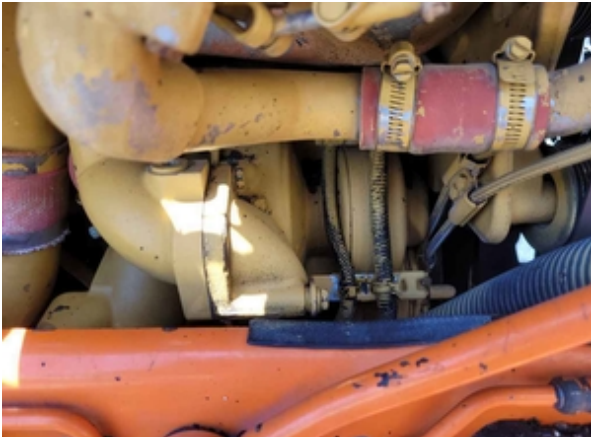
Water Pump	3 - Normal Wear & Tear
Water Pump Condition	No unusual pump noises heard
Water Pump Photos

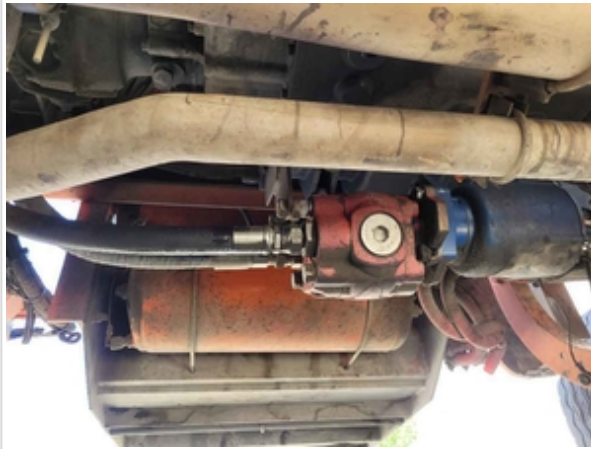
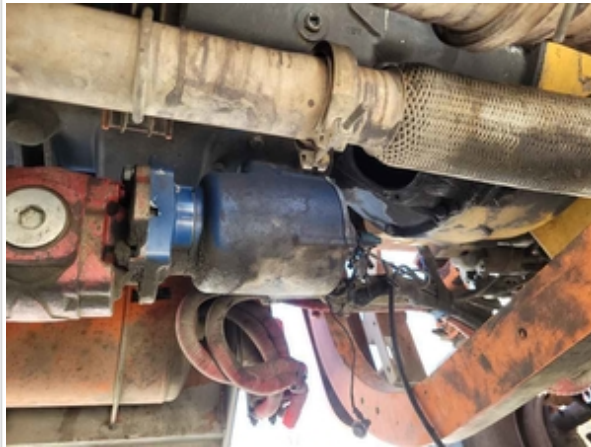
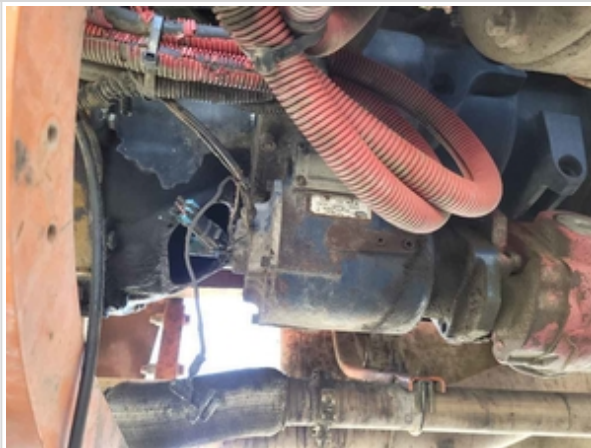
Transmission Info (Make/Model)	Eaton Fuller 13 speed
Drive Type	4X2
Overdrive	N/A
Transmission	3 - Normal Wear & Tear
Transmission Condition	No unusual noises or vibrations
Transmission Condition Photos

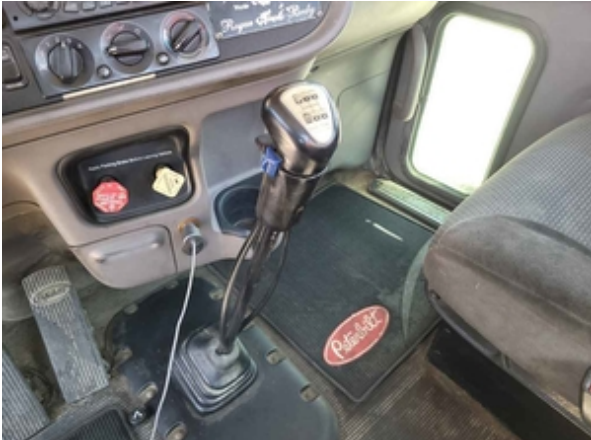
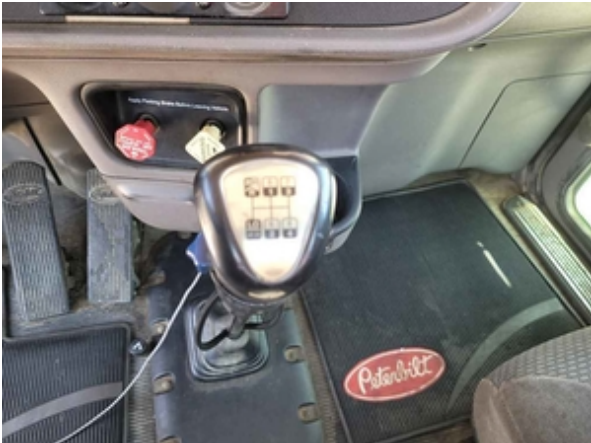
Shift Lever	3 - Normal Wear & Tear
Shift Lever Condition	Good forward and reverse function, Shifting delays observed
Shift Lever Photos

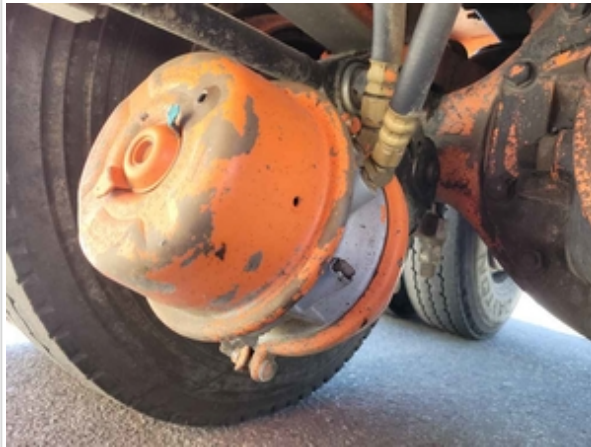
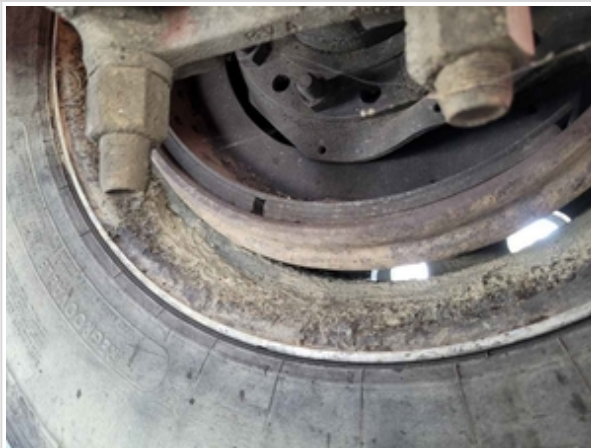
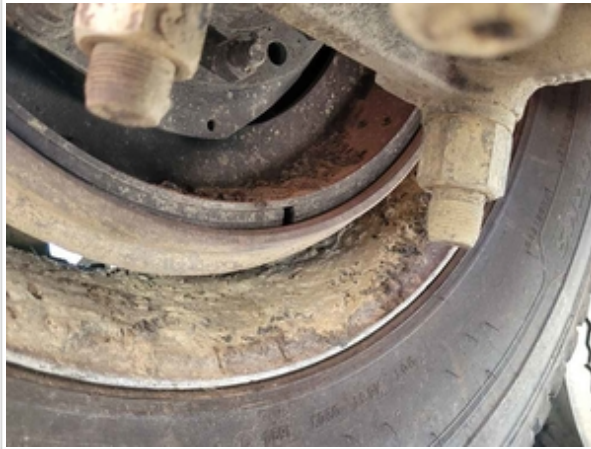
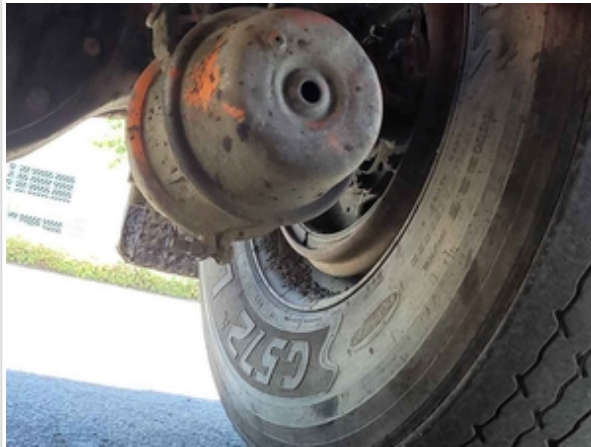
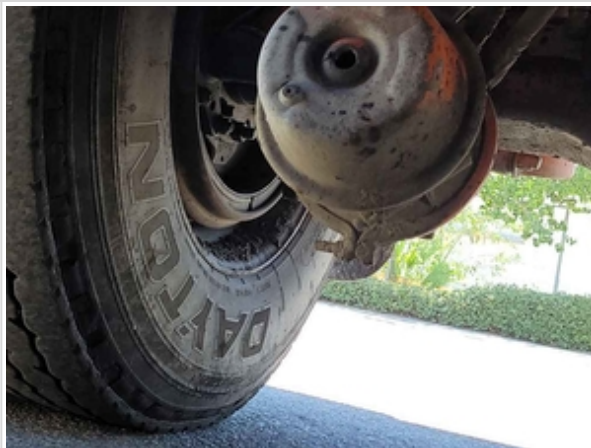
Parking Brake Photos

Front Differential	0
Brake System Type	Air Brakes
Air Brake System	3 - Normal Wear & Tear
Comments	air brake system working well
Foot Brake	3 - Normal Wear & Tear
Foot Brake Condition	Good brake function
Engine Brake Configuration	1 Position
Engine Brake	3 - Normal Wear & Tear
Parking Brake	4 - Like New, Recently Replaced
Parking Brake Condition	Good brake function

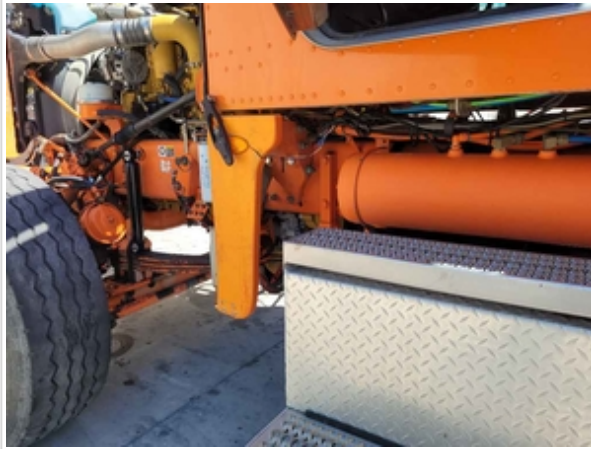
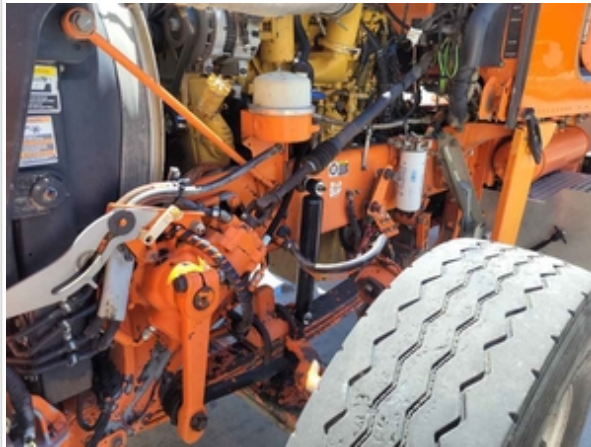
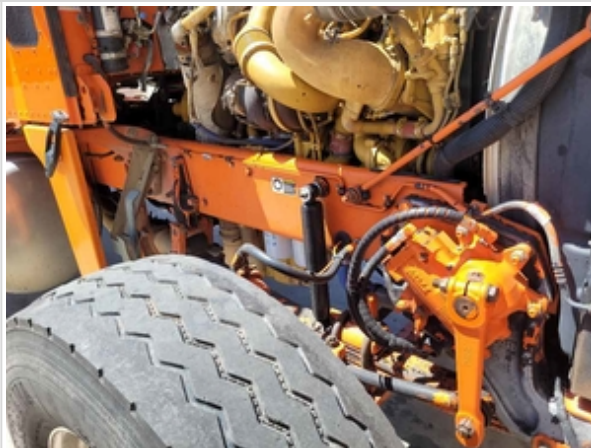
<p>Frame Photos</p>

Frame	4 - Like New, Recently Replaced
Comments	Frame in great condition

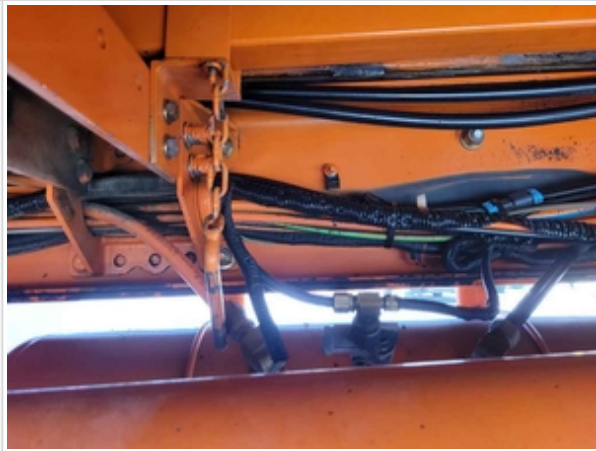
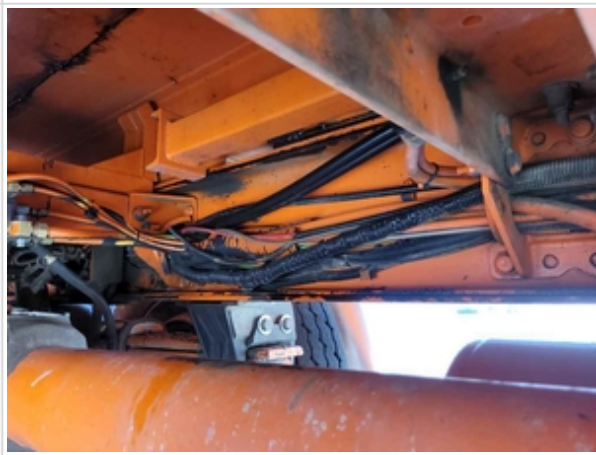
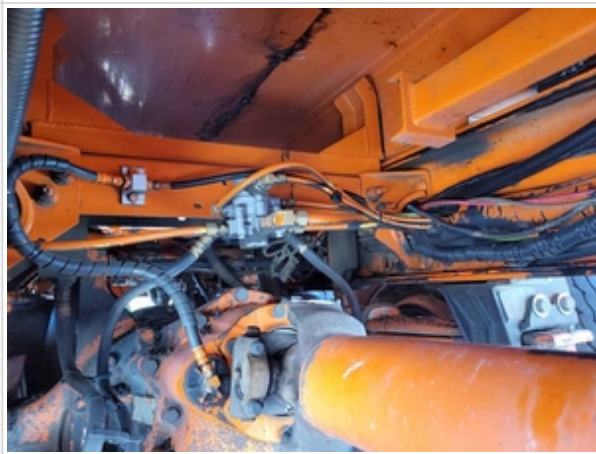
Suspension	3 - Normal Wear & Tear	
Comments	suspension may need work done, front tires showing signs of uneven tread wear

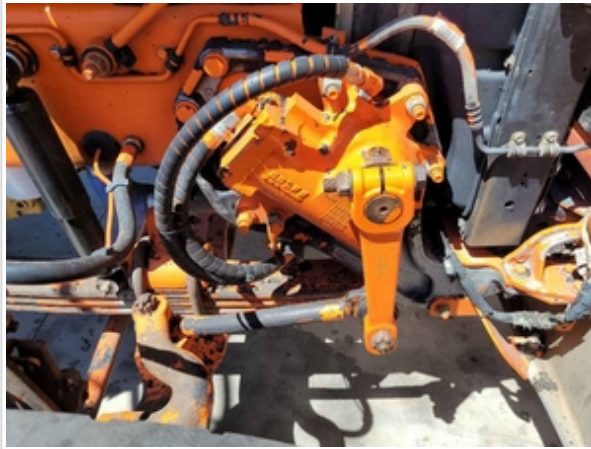
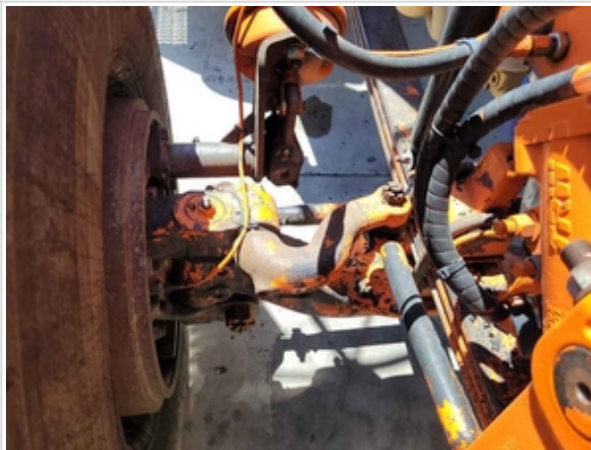
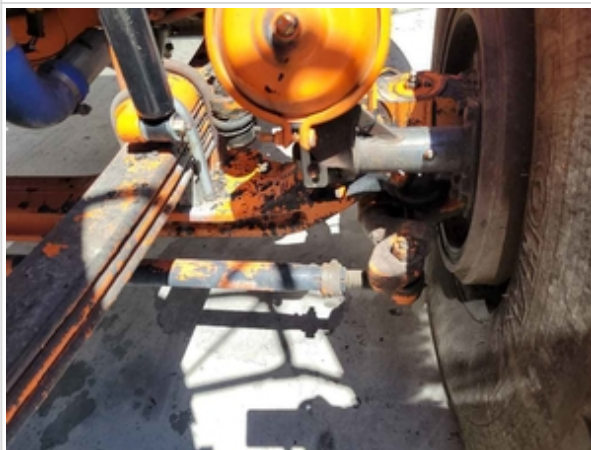
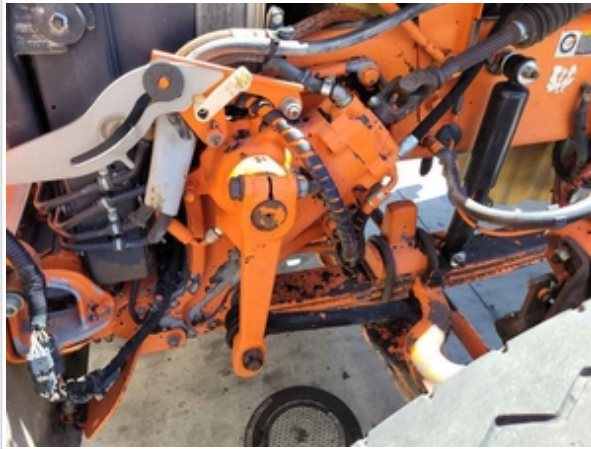
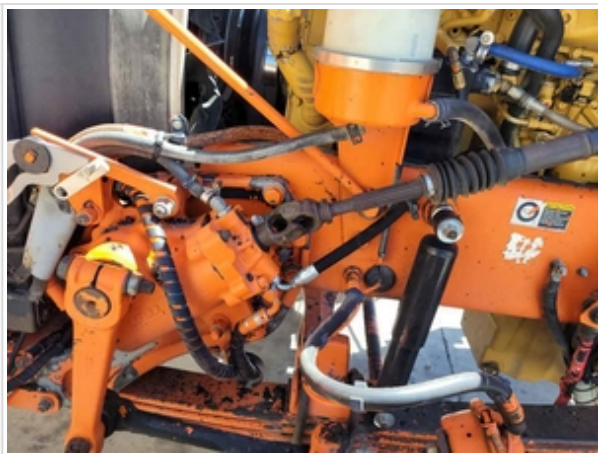
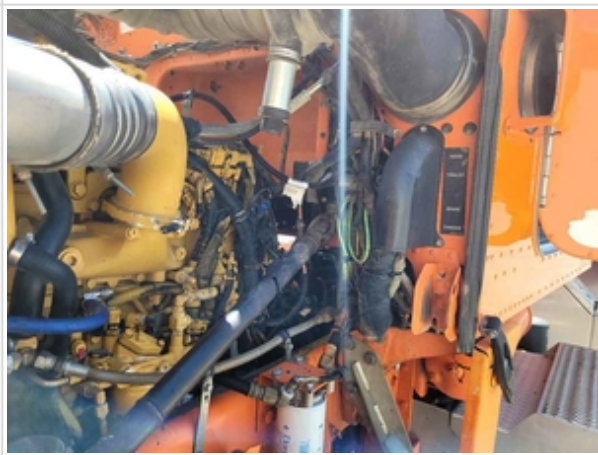
Steering Components Photos

Steering Components	3 - Normal Wear & Tear	
Comments	Front tires showing signs of uneven wear, may be related to worn steering components and/or alignment

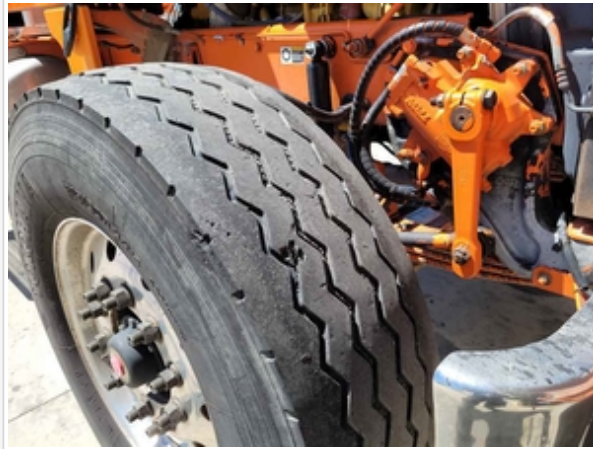
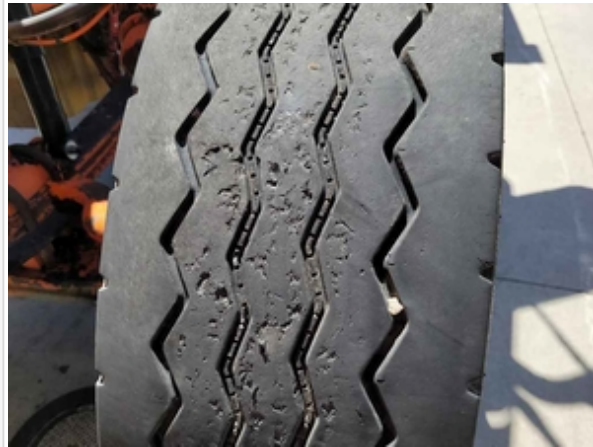
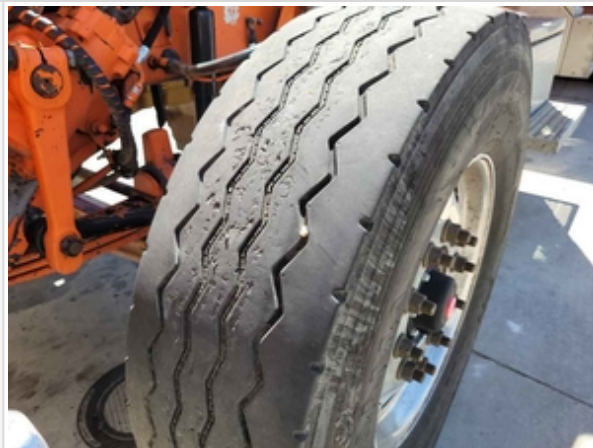
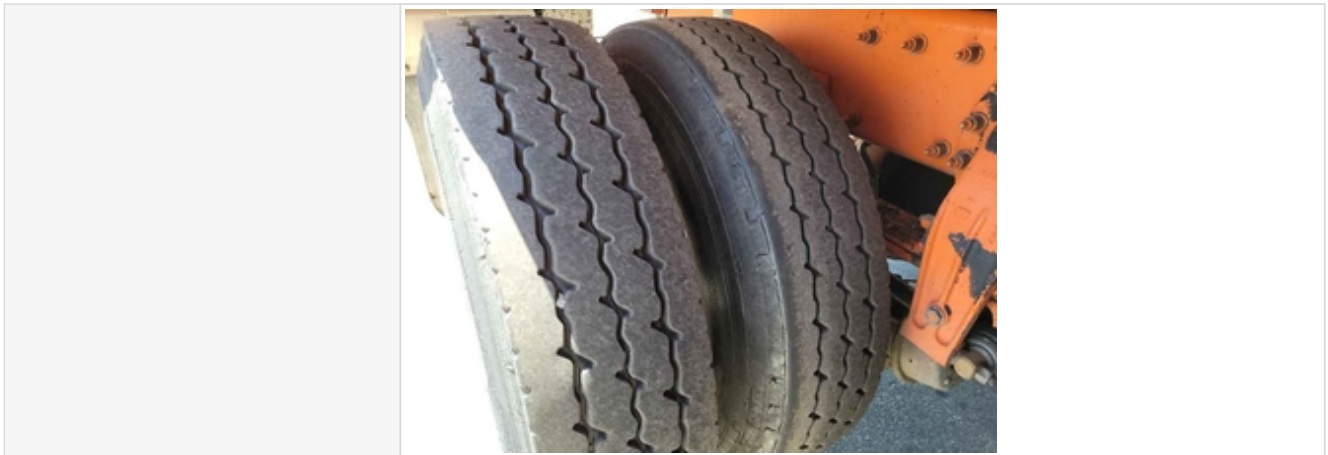
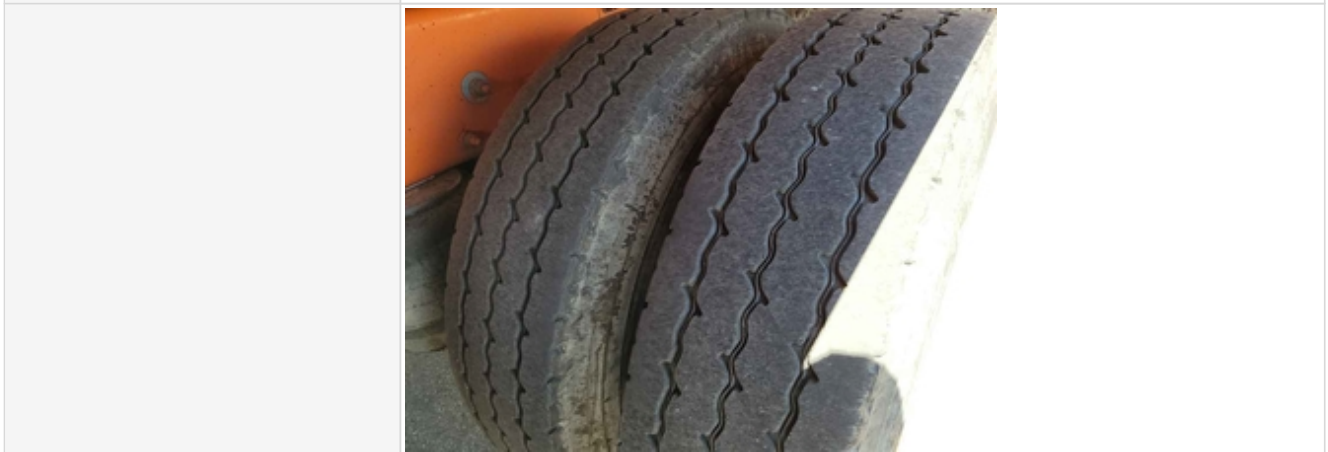
Wheels & Tires	2 - Above Average Wear	
Comments	front tires worn	
Wheels & Tires Photos

Tire Brand	Yokohama
Tire Size	315/80R/22.5 Front 11R/22.5 Rear
Front Left Tire - Ratio Remaining	10%
Front Right Tire - Ratio Remaining	10%
Rear Right Tire - Ratio Remaining	30%
Rear Left Tire - Ratio Remaining	30%

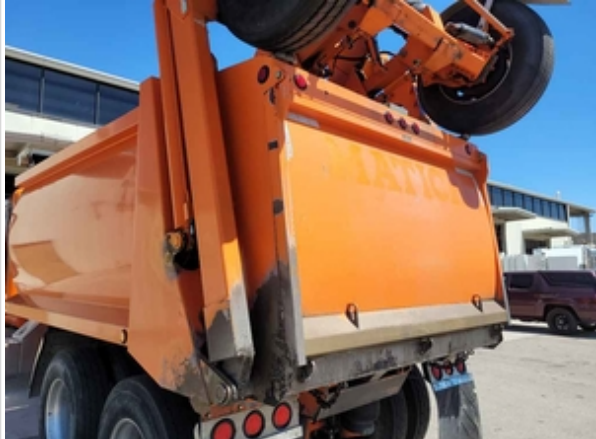
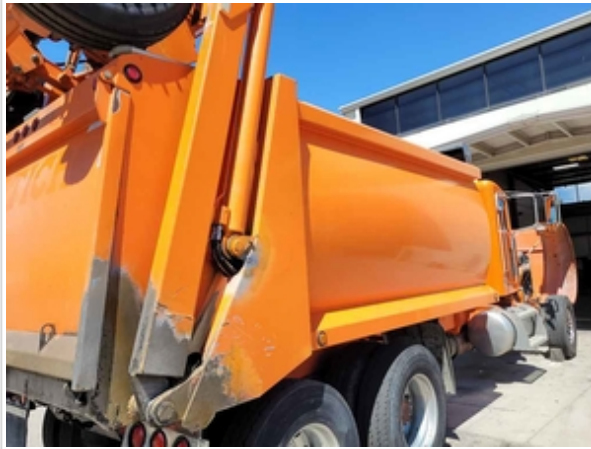
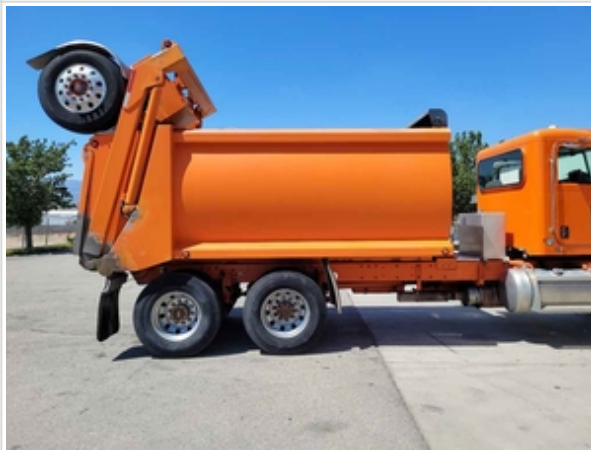
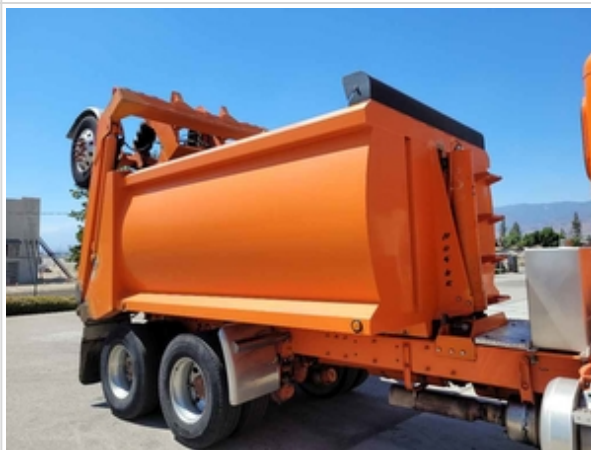
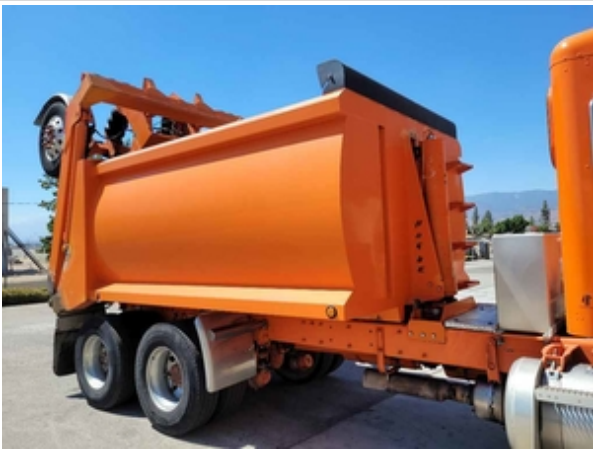
Dump Body, Tailgate, Support & Trap	Check the condition of the dump body, tailgate, support & tarp. Note any damage or wear. Take photos.	
Dump Body Make & Material	Rogue	
Dump Body Length (ft and inches)	14'	
Dump Body Height (ft and inches)	5'	
Bed Body	3	
Comments	dump body in good shape	
Bed Body Photos

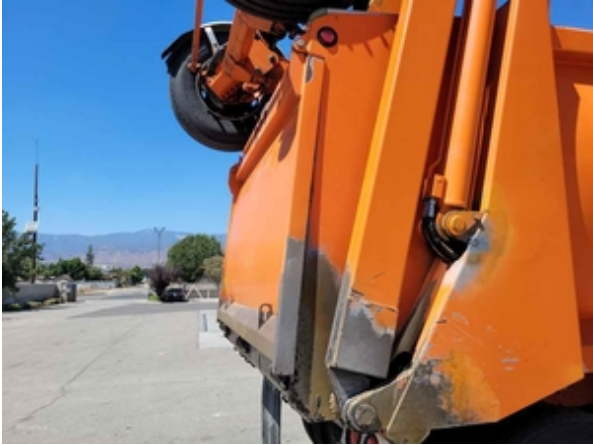
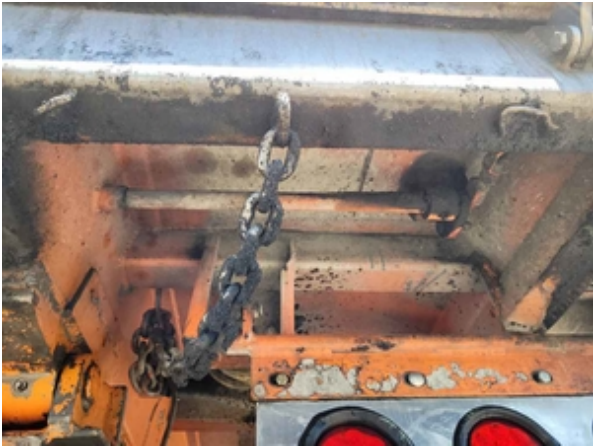
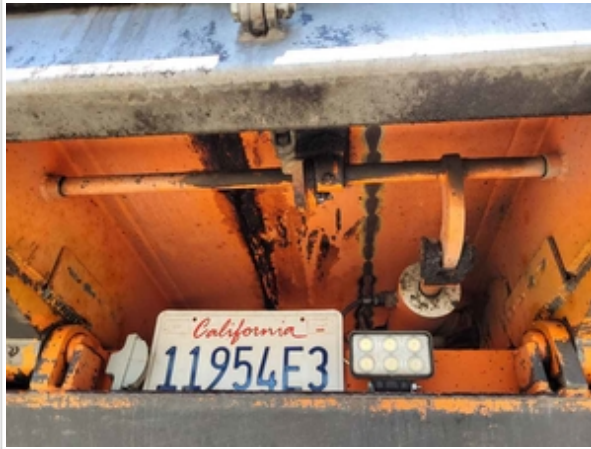
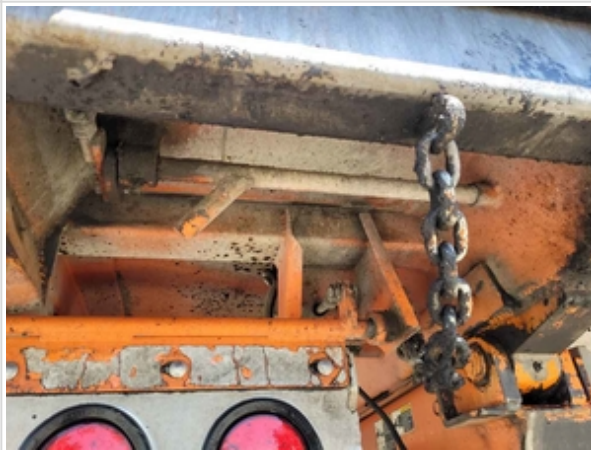
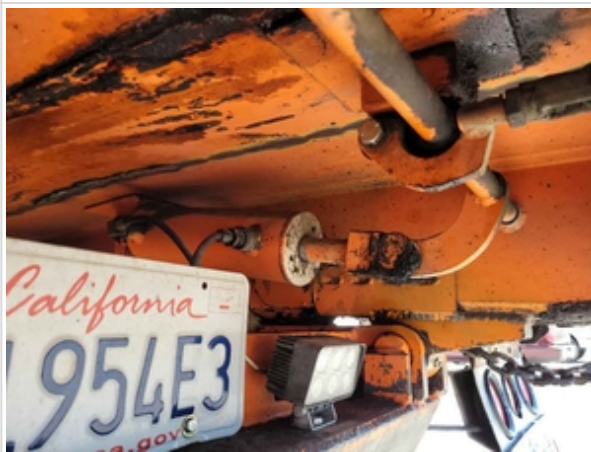
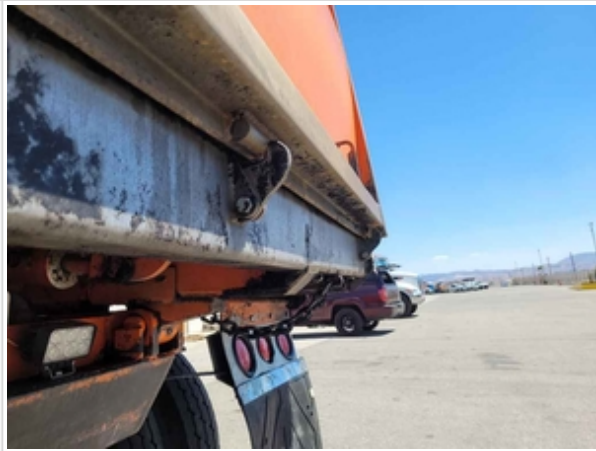
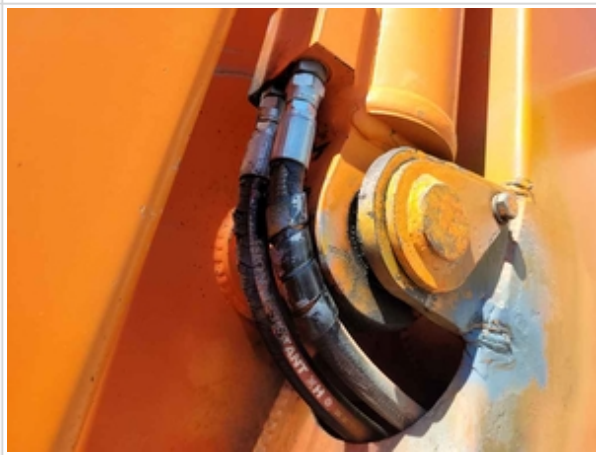
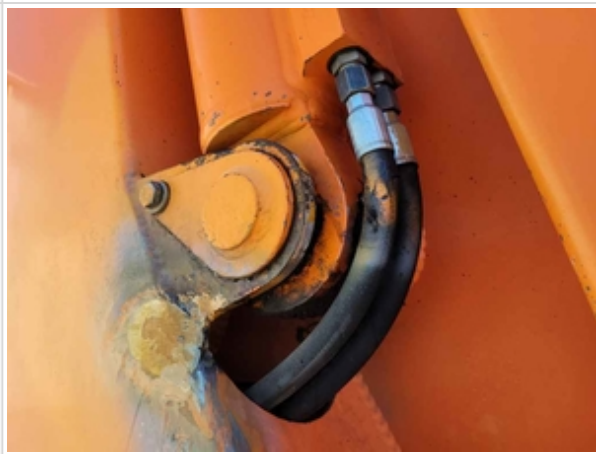
Tailgate	3	
Comments	tailgate in good shape	
Tailgate Photos

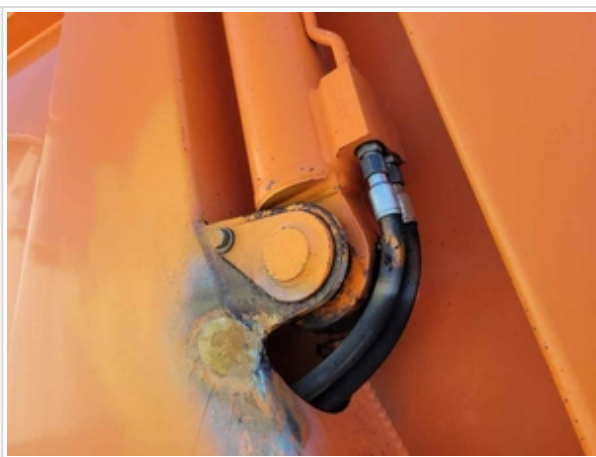
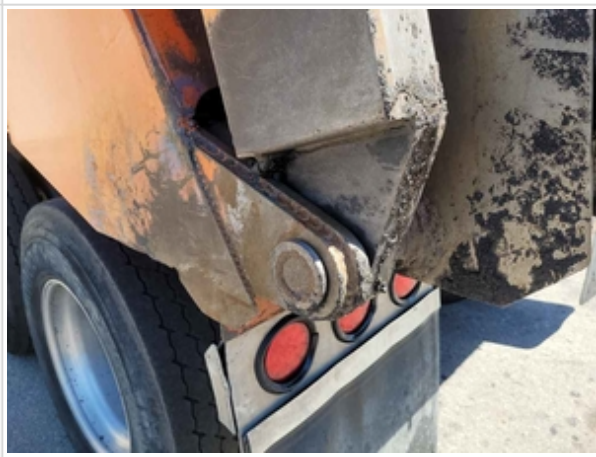
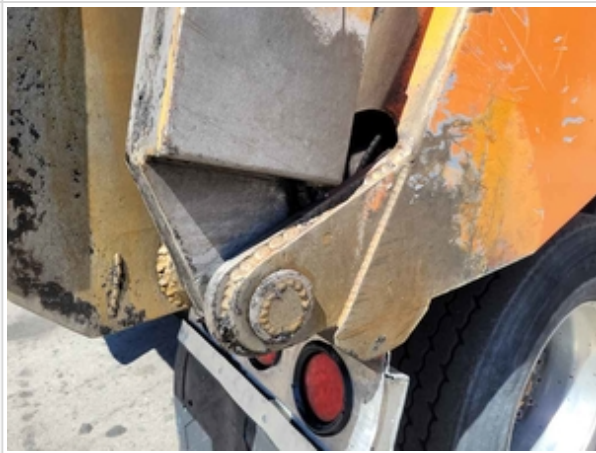
<p>Support Frame Photos</p>

Tailgate Latch	3	
Support Frame	3

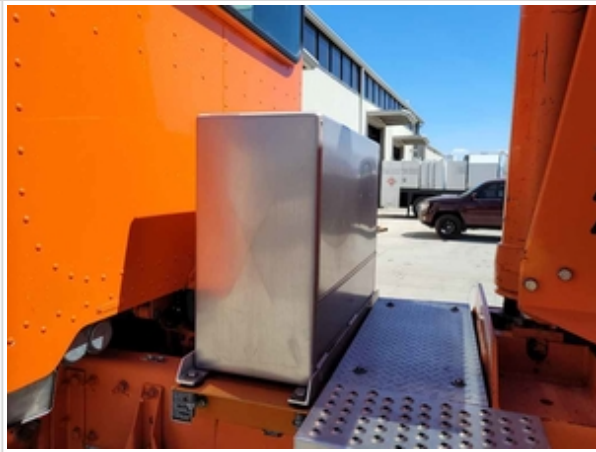
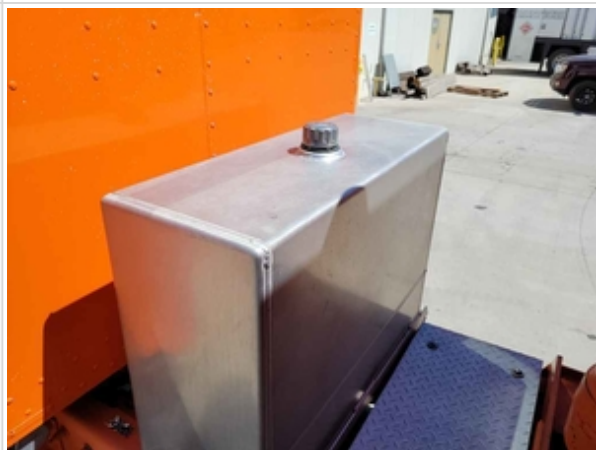
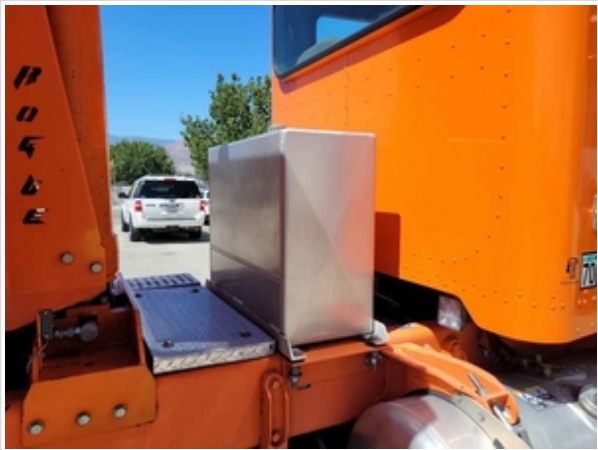
Hydraulics	Check the condition of the hydraulics. Check lines, hoses, fittings, leaks, function, etc. Note any damage or wear. Take photos.	
Hydraulic Tank	4	
Comments	have not tested tarp, tailgate, strong arm axle and dump bed actuation	
Hydraulic Tank Photos
