Inspection Report (On-Highway Flatbed Truck)

Year	2012
Make	Kenworth
Model	T800
Serial Number	1XKDDP9X6CJ300188
Truck Odometer Reading	362,335 Miles 22,953 Hours
Current Inspection / State Cert / DOT	Annual Inspection Performed 12/2021 per 49CFR-396
Previous Application (e.g., earth moving, mining, demolition, etc)	Rental Equipment Transportation

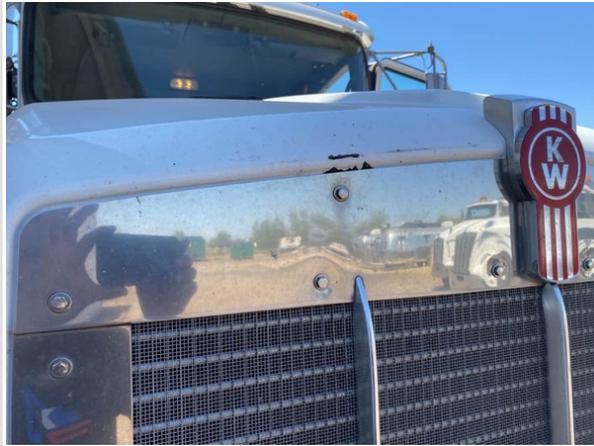
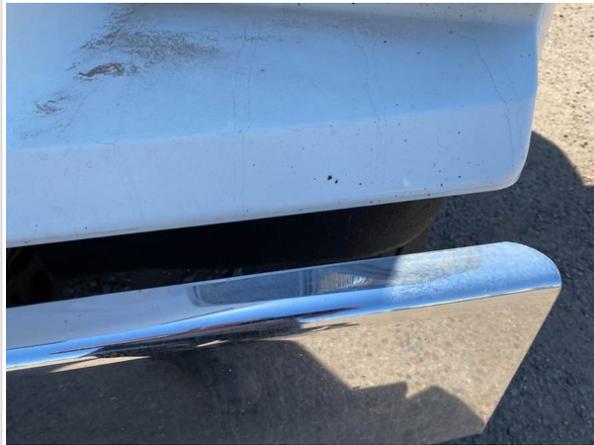
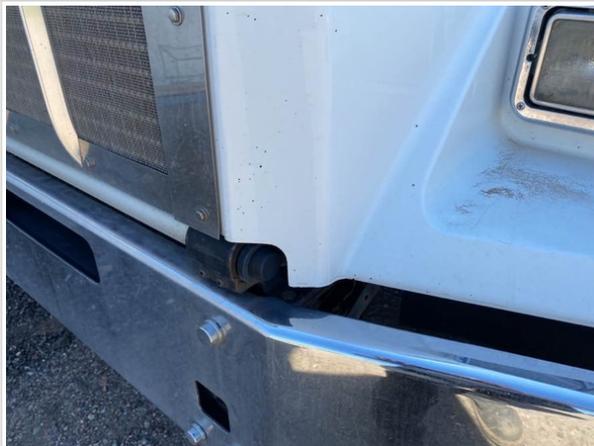
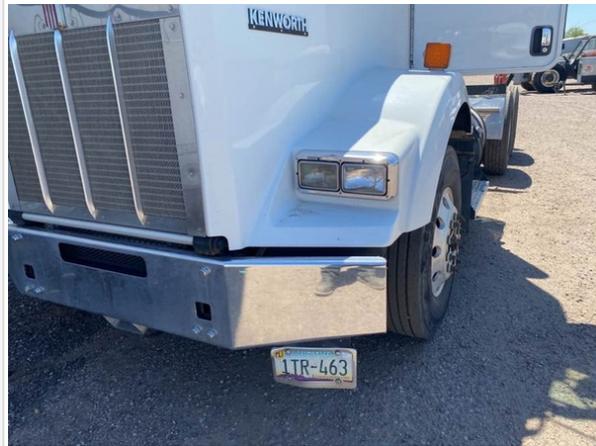
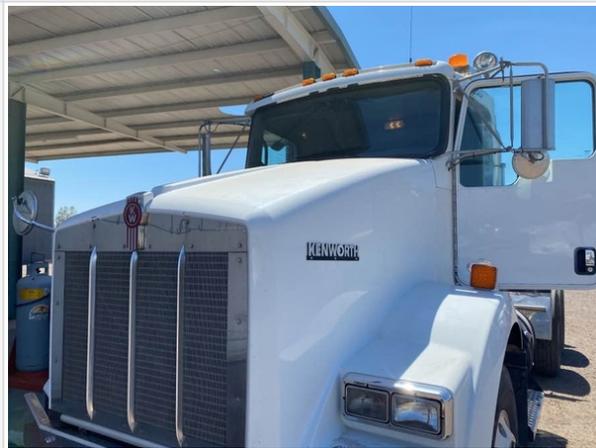
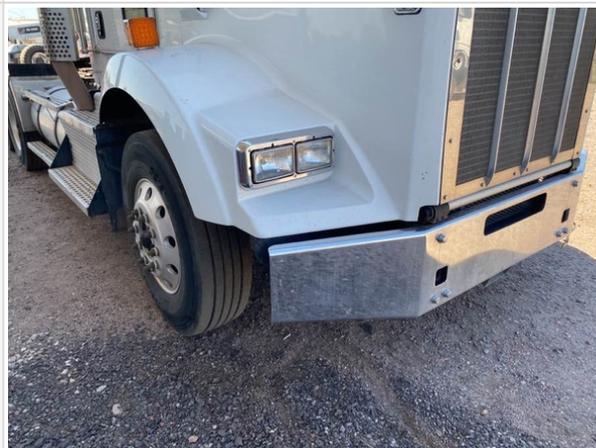
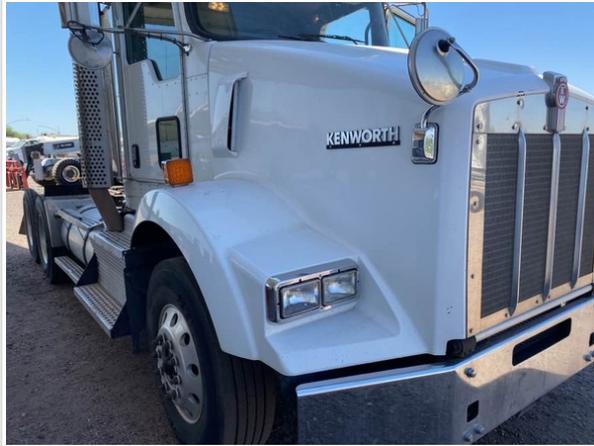
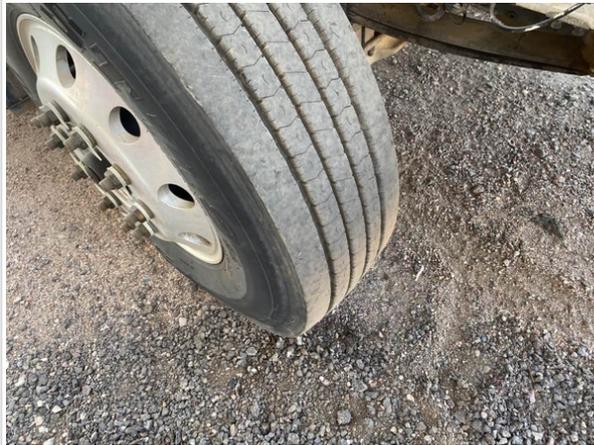
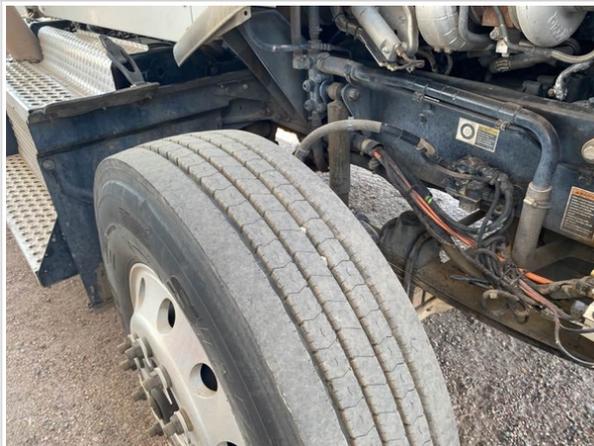
Front	3 - Normal Wear & Tear
Front Condition	No visible damage, Visible chipped paint or dents
Comments	Front tires 11r22.5 70 to 80% to 90% of tread life left

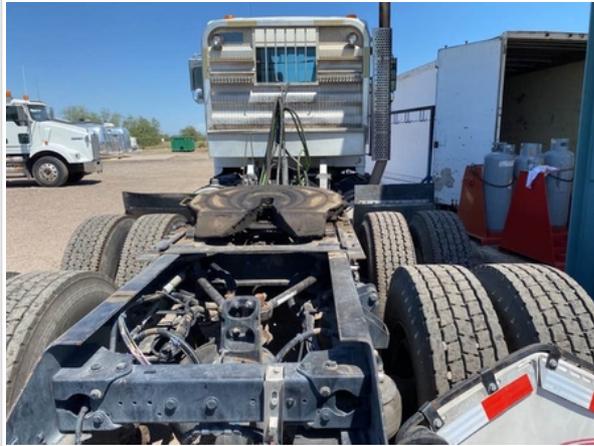
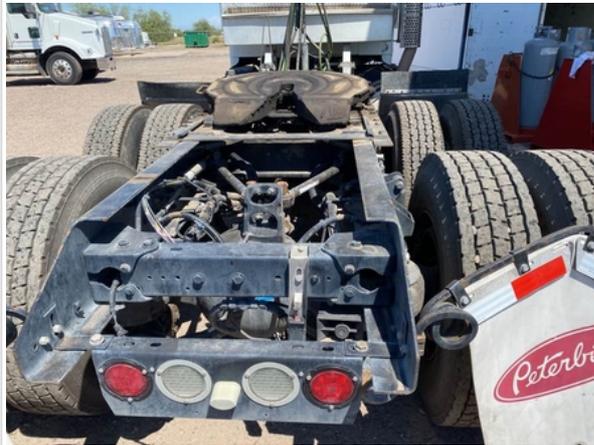
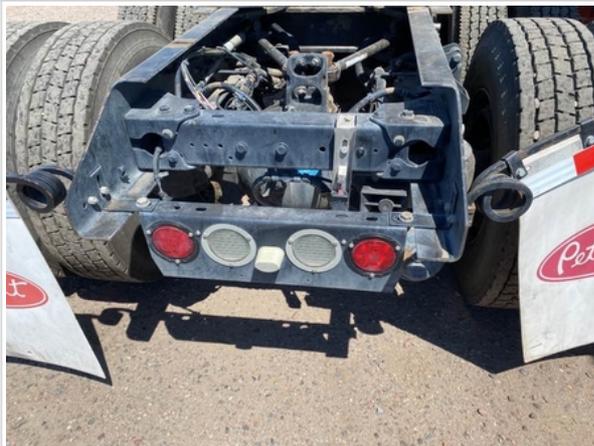
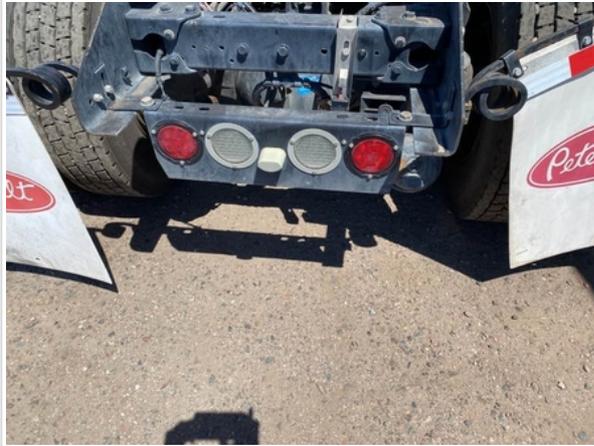
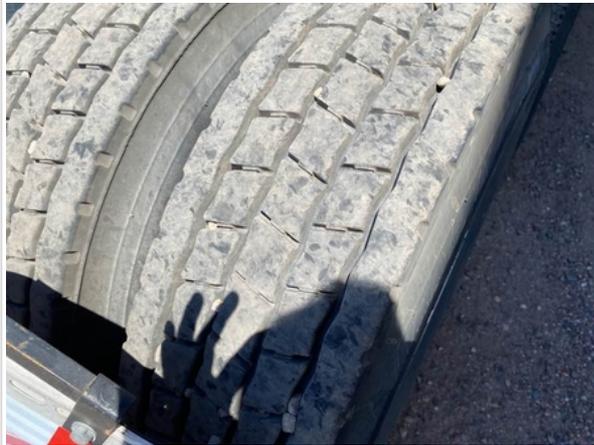
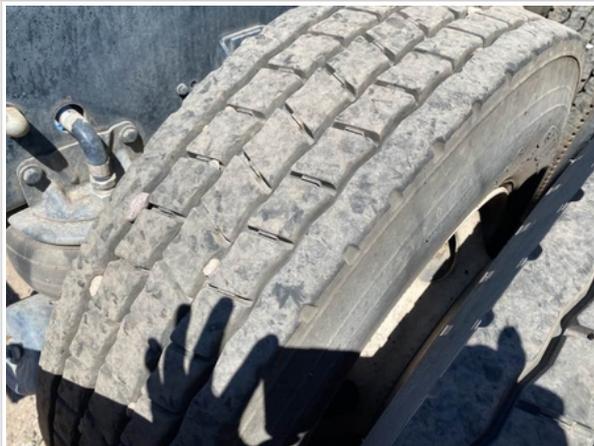
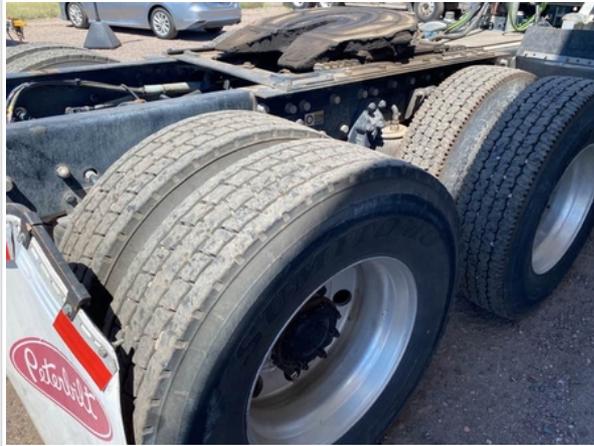
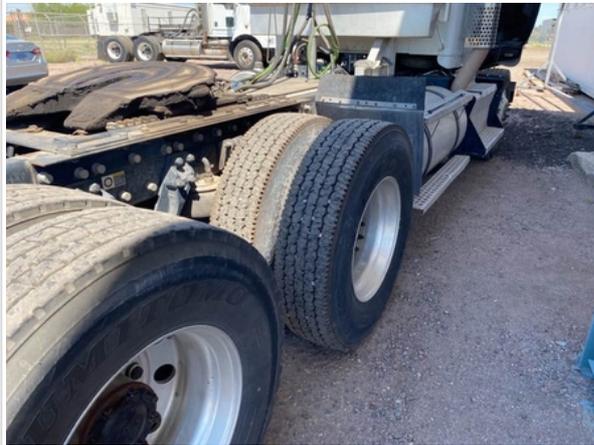
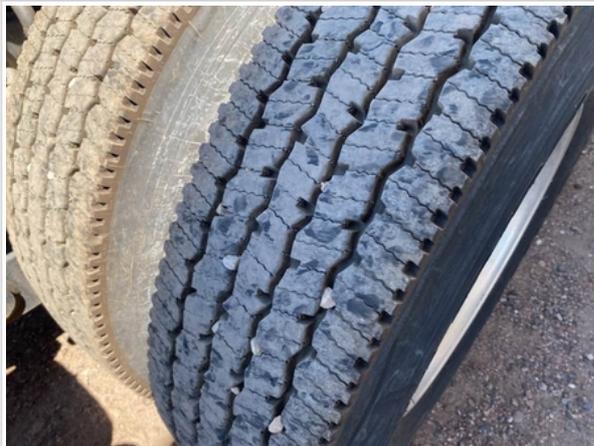
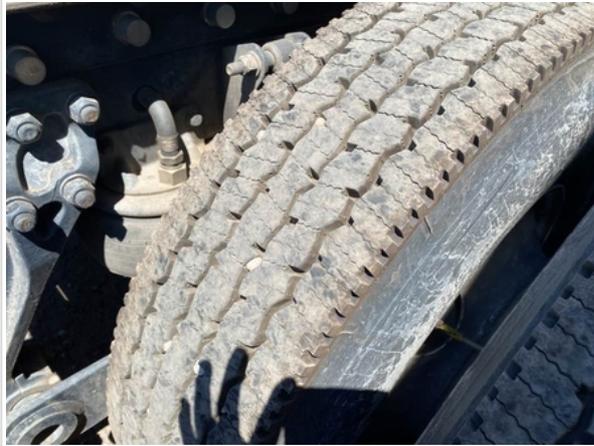
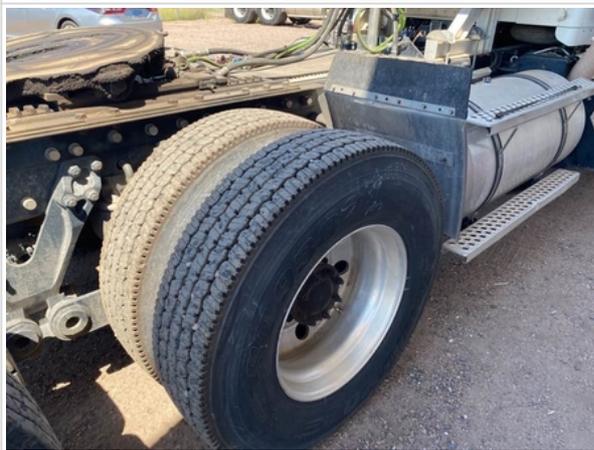
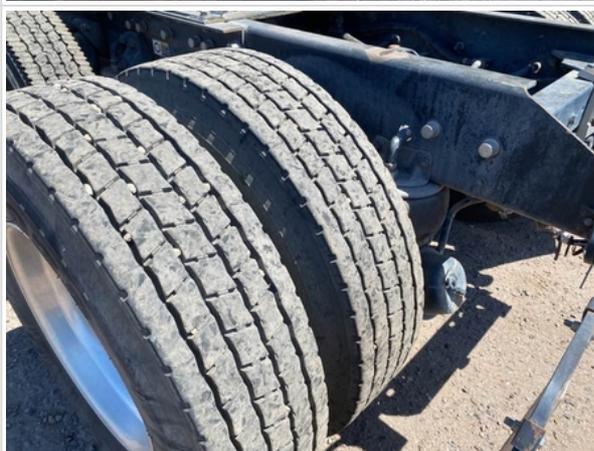
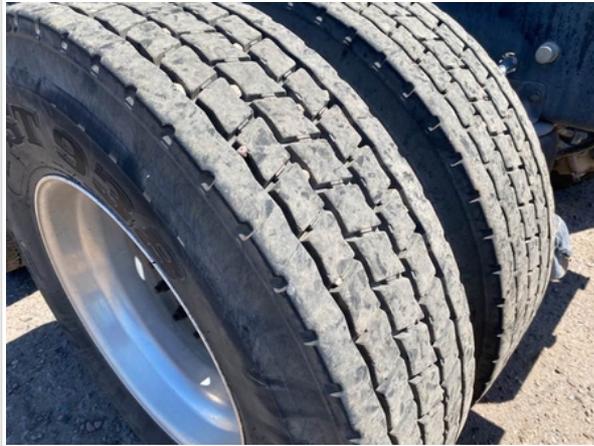
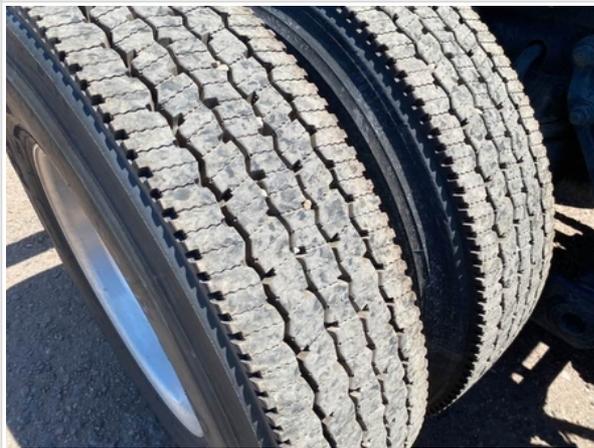
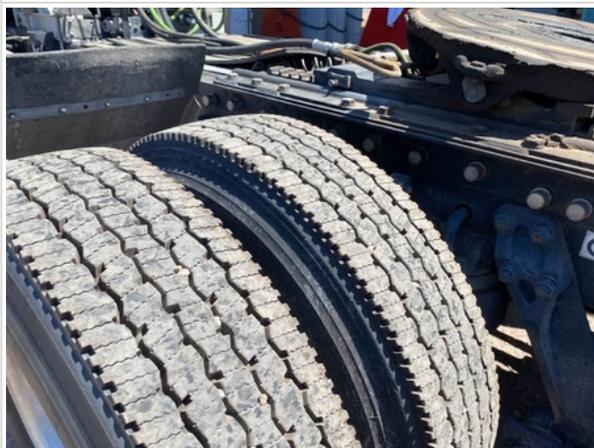
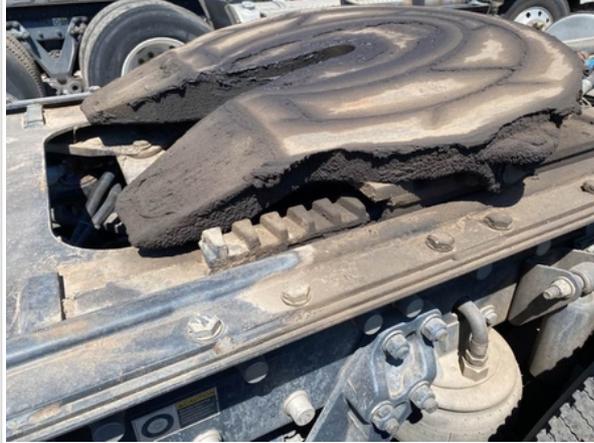
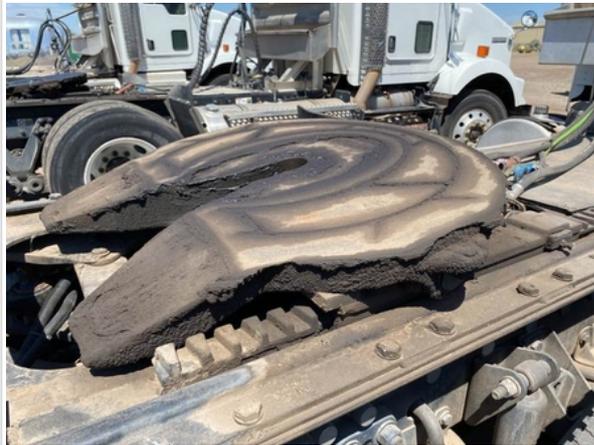
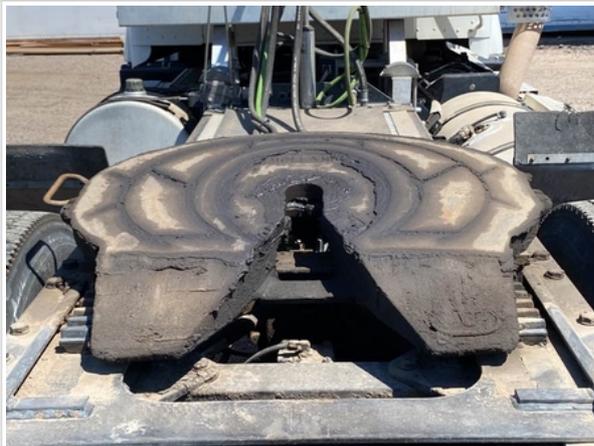
Rear	3 - Normal Wear & Tear	
Rear Condition	No visible damage, Other (see comments)	
Comments	Rear tires 11r22.5 80% to 90% of tread life left on all 8 tires	
Rear Photos

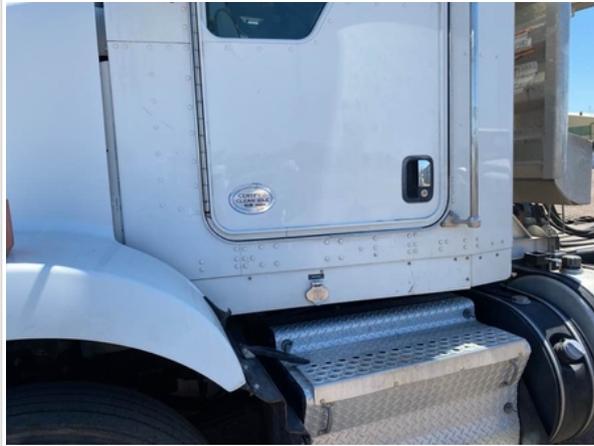
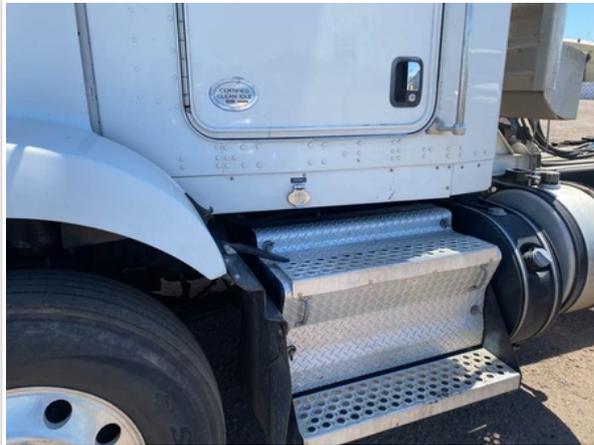
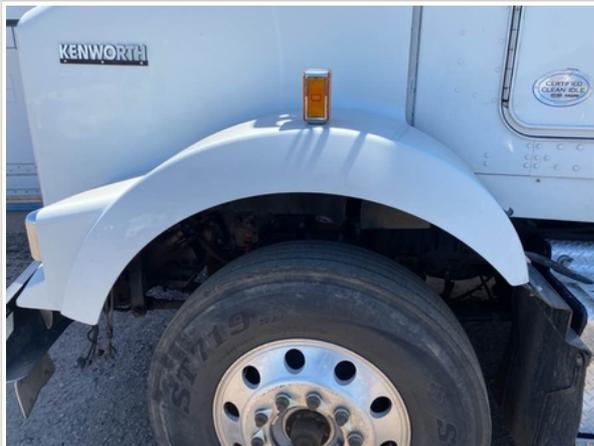
Left	3 - Normal Wear & Tear
Left Condition	No visible damage
Left Photos

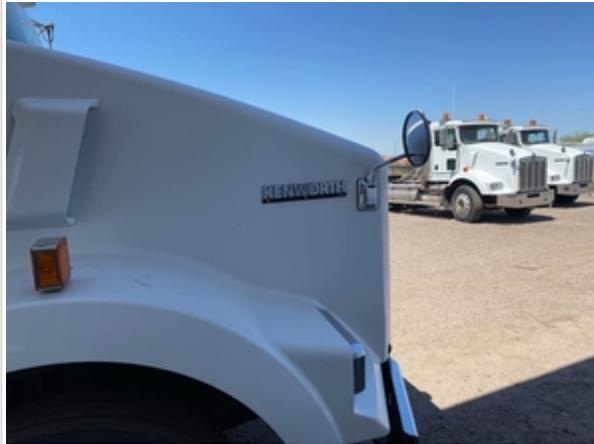
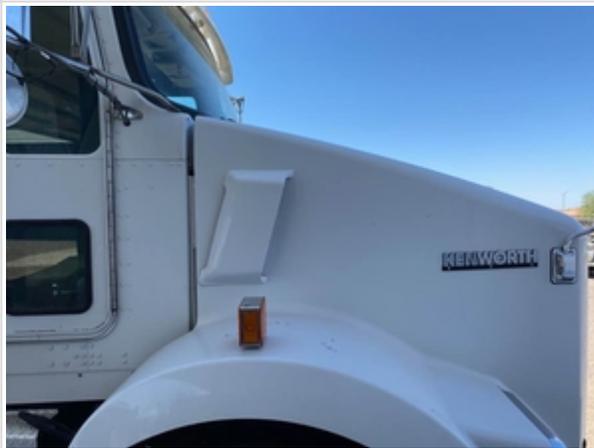
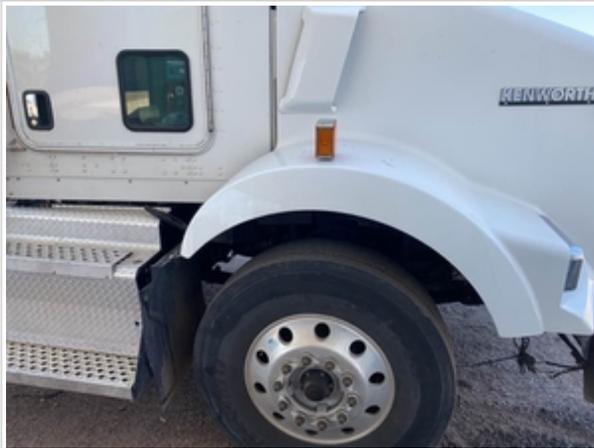
Right	3 - Normal Wear & Tear
Right Condition	No visible damage
Right Photos

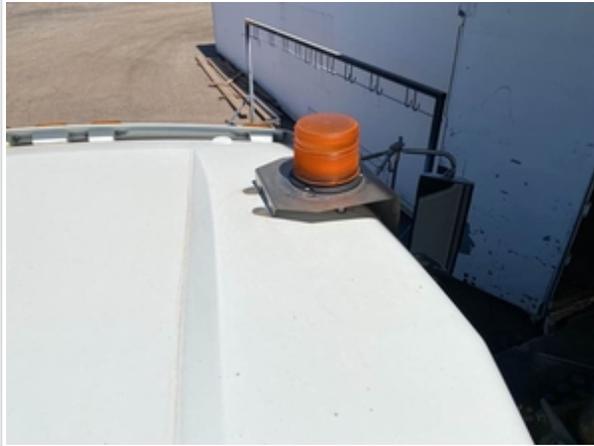
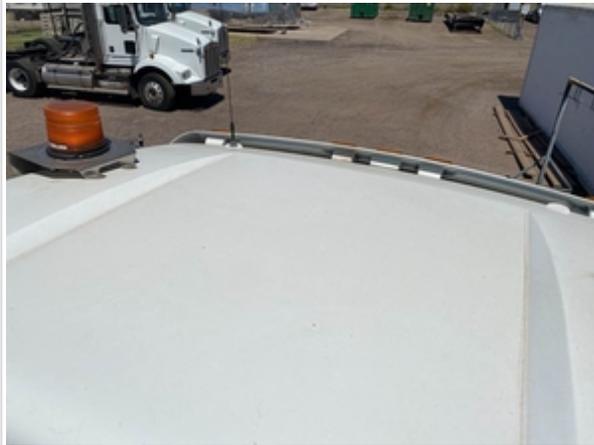
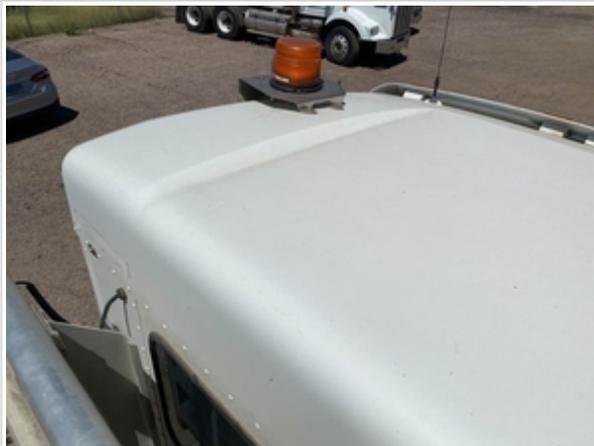
Upper Photos

Upper	3 - Normal Wear & Tear
Upper Condition	No visible damage

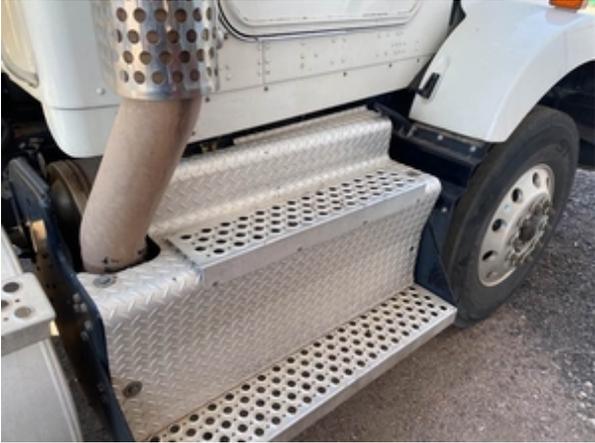
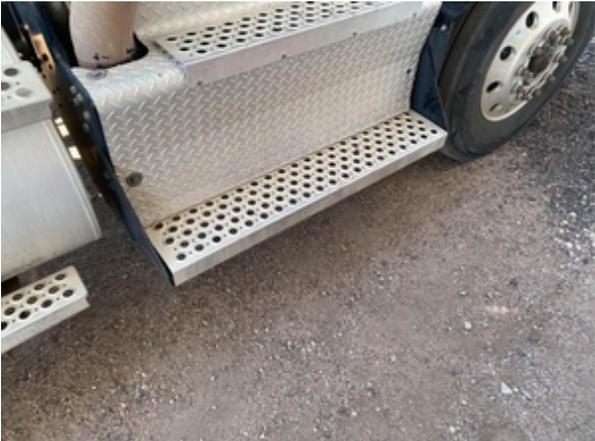
Body Panels (Any Rust Damage?)	3 - Normal Wear & Tear	
Body Panel Condition	No visible damage, good paint condition and panel fitment	
Body Panels Photos

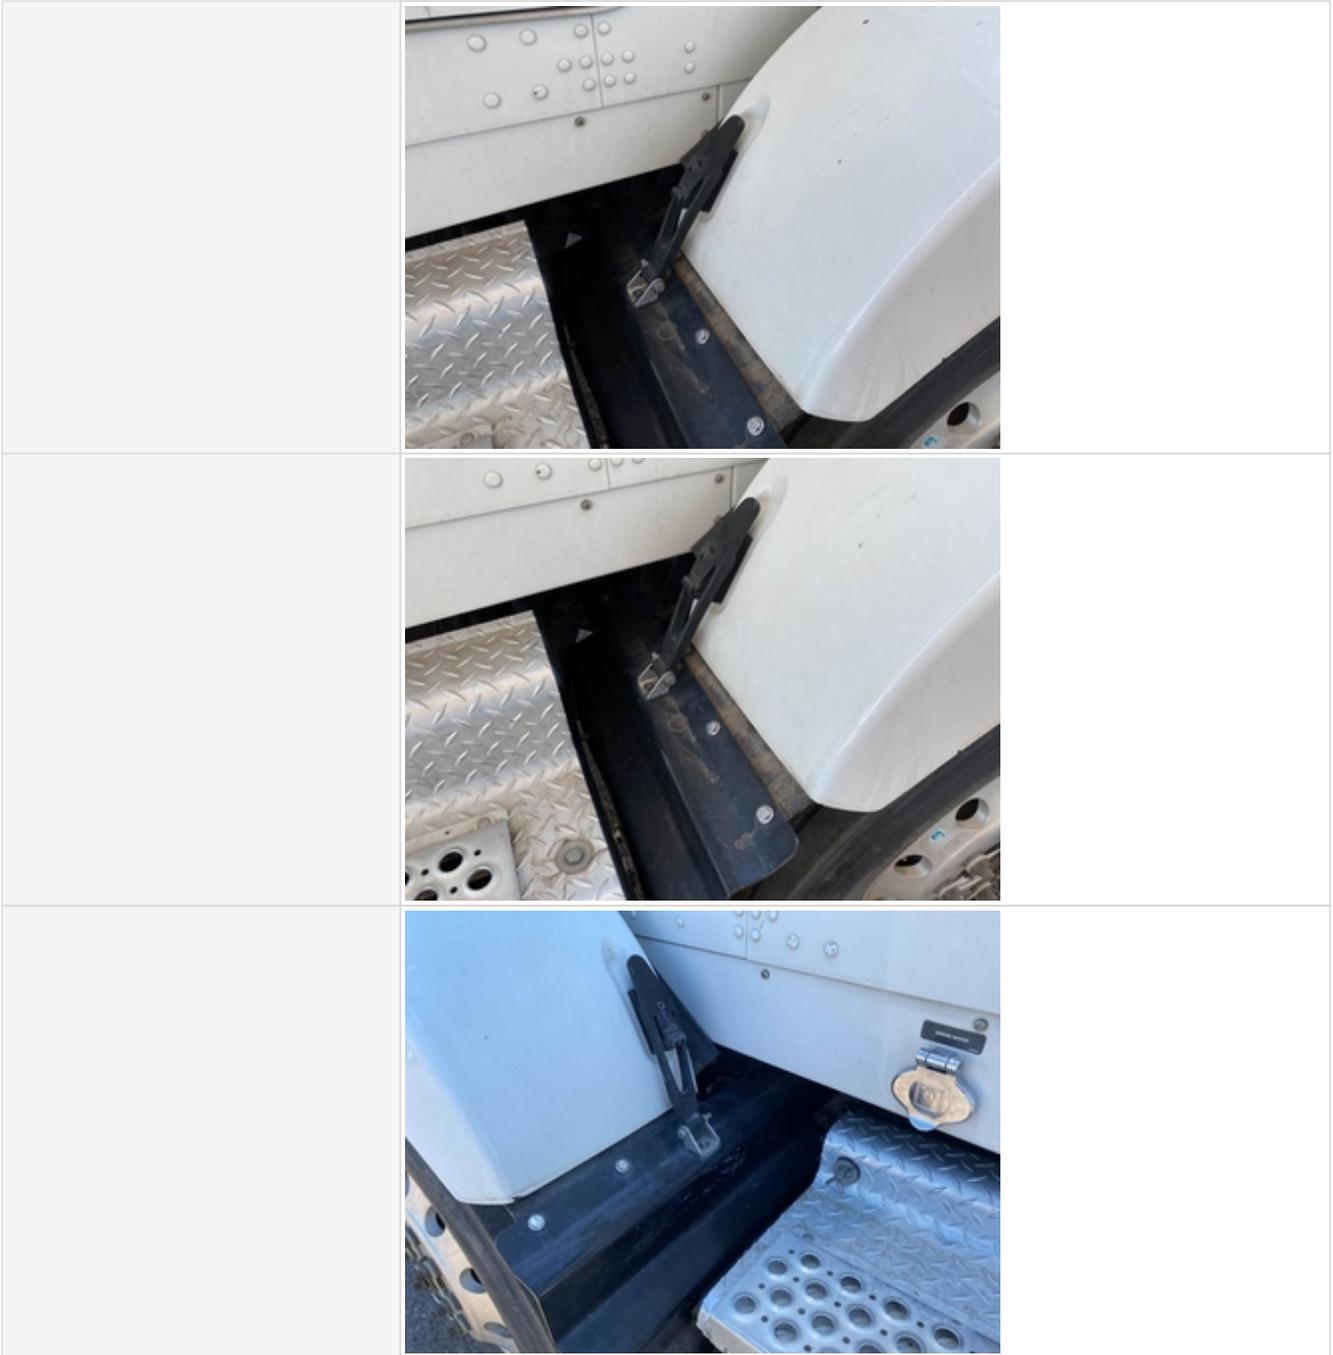
Doors / Canopy Latches	3 - Normal Wear & Tear	
Doors / Canopy Latches Condition	No visible damage	
Doors / Canopy Latches Photos

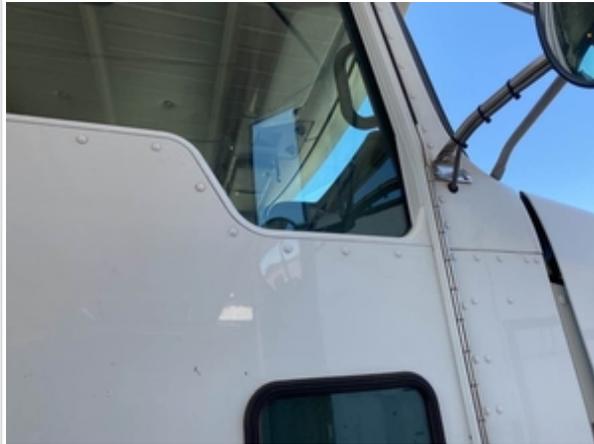
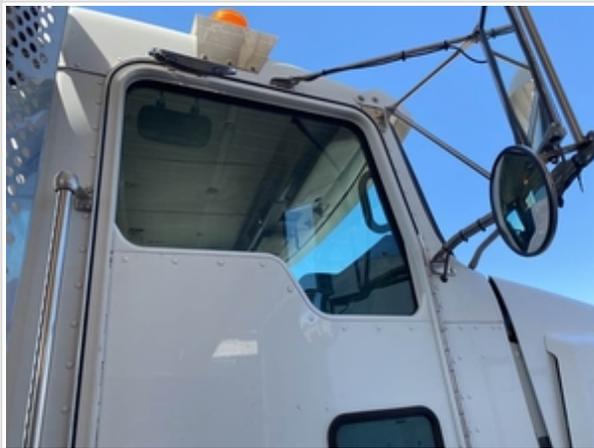
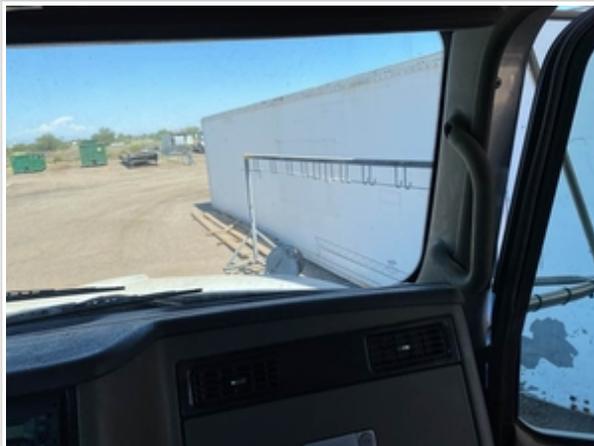
Glass Condition	3 - Normal Wear & Tear	
Glass Condition Notes	Glass intact, no visible damage, Minor chips or cracks observed	
Glass Condition Photos

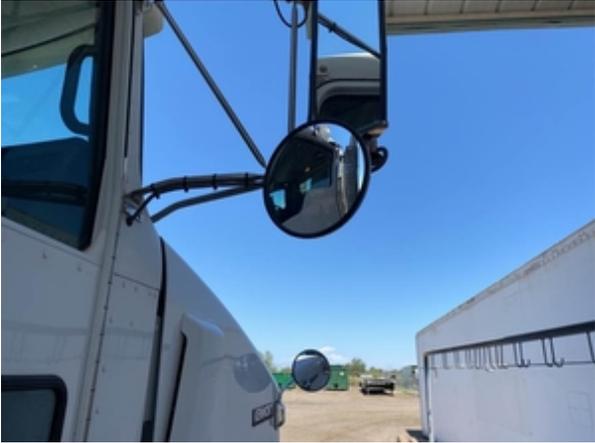
Mirrors	3 - Normal Wear & Tear	
Mirror Condition Notes	Mirrors present and intact, no visible damage	
Mirrors Photos

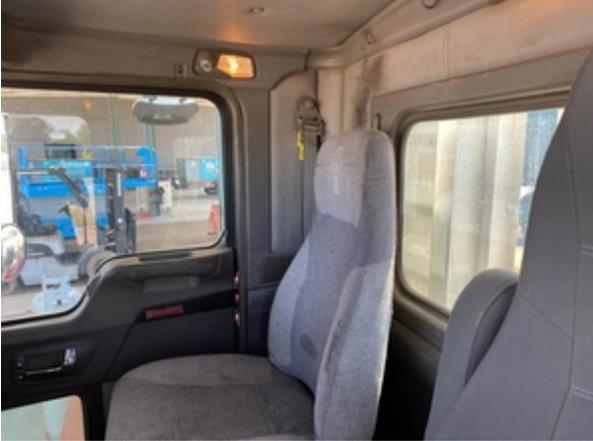
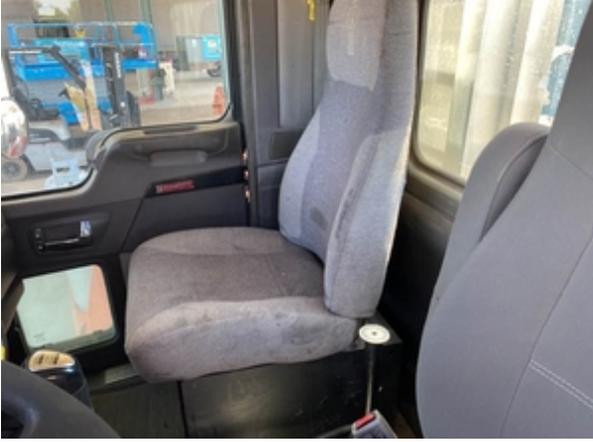
Operator Cabin	3 - Normal Wear & Tear
Operator Cabin Photos

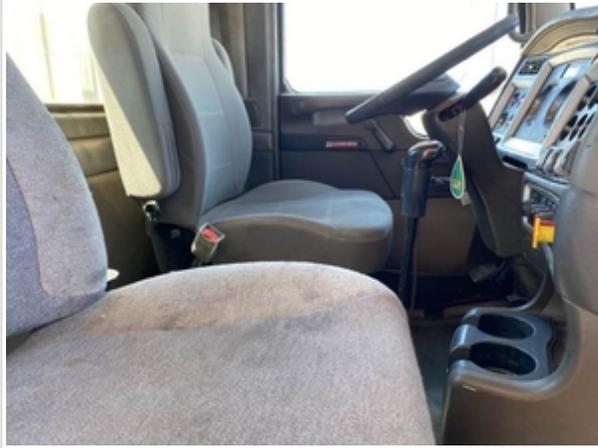
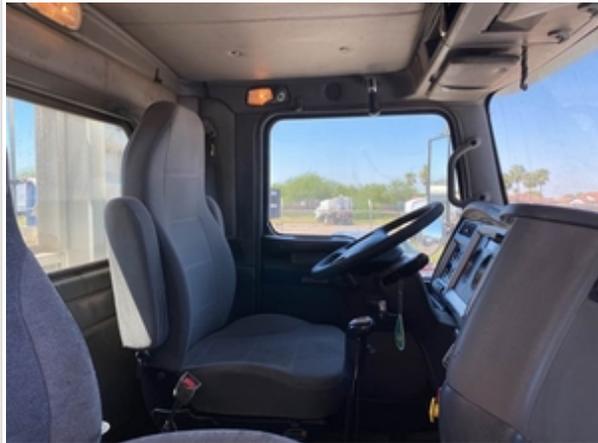
<p>Operator's Seat & Arm Rests</p>	<p>3 - Normal Wear & Tear</p>
<p>Operator's Seat & Arm Rests Photos</p>

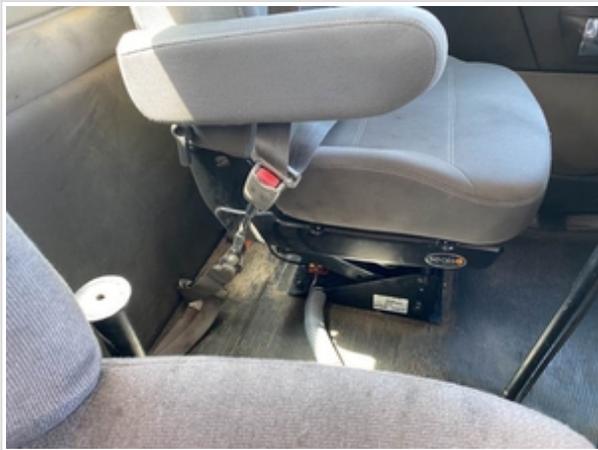
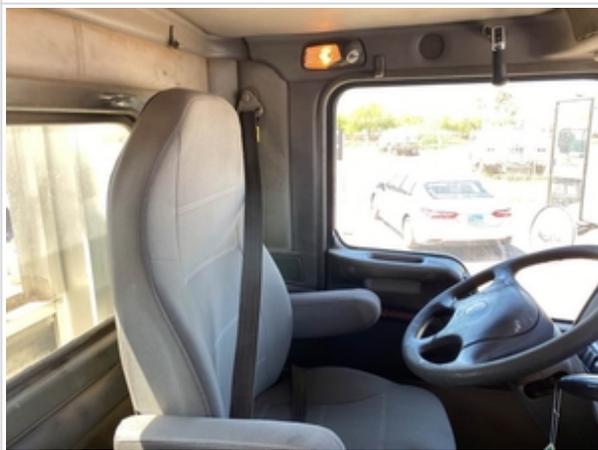
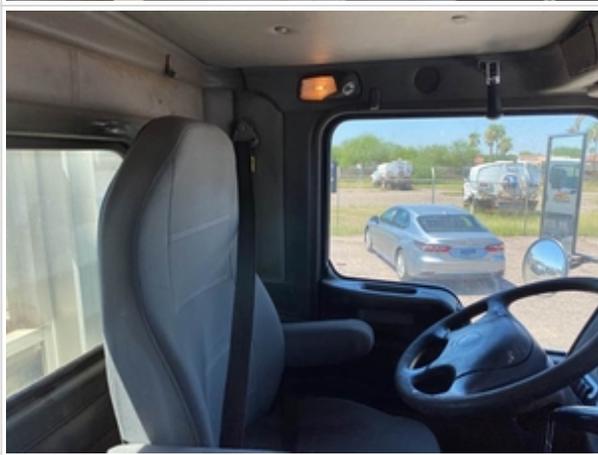
<p>Seat Belt Photos</p>

Seat Belt

3 - Normal Wear & Tear

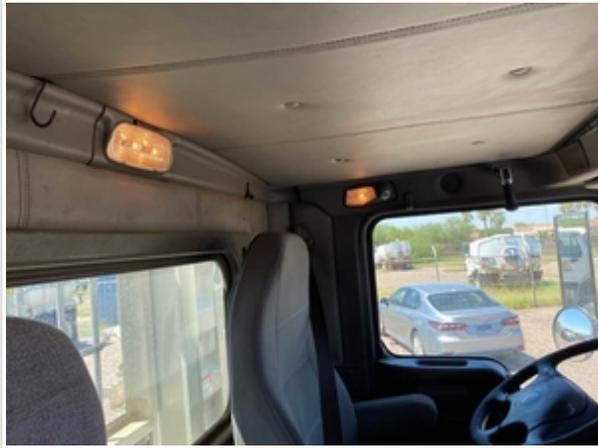
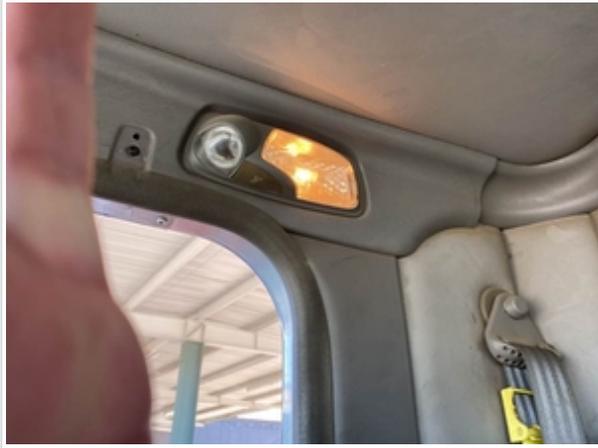
Cabin Lights	3 - Normal Wear & Tear	
Cabin Lights Photos

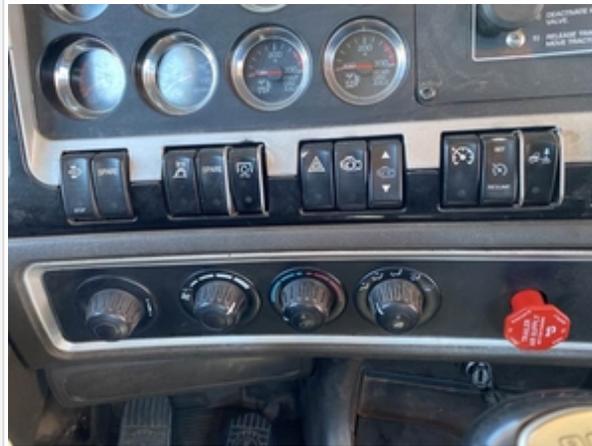
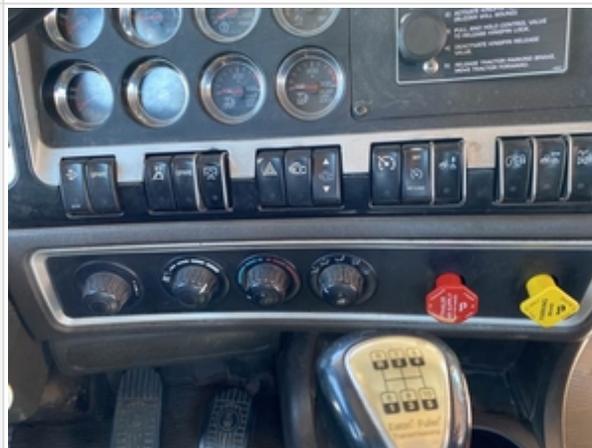
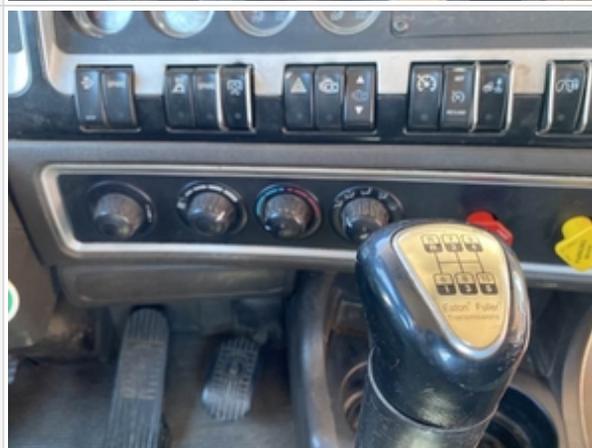
Controls & Switches Photos

Controls & Switches	3 - Normal Wear & Tear

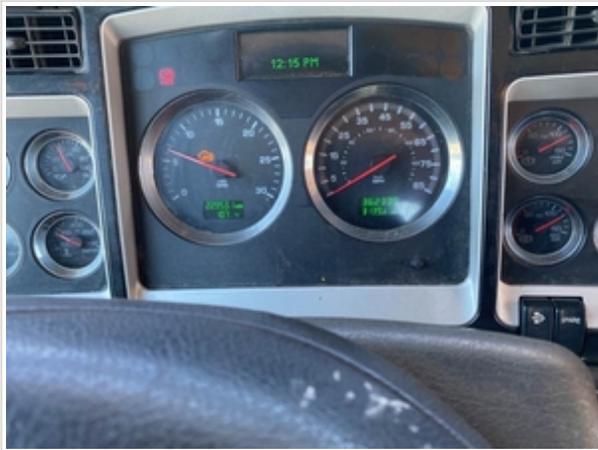
<p>Odometer Activity Photos</p>

<p>Odometer Activity</p>	<p>3 - Normal Wear & Tear</p>

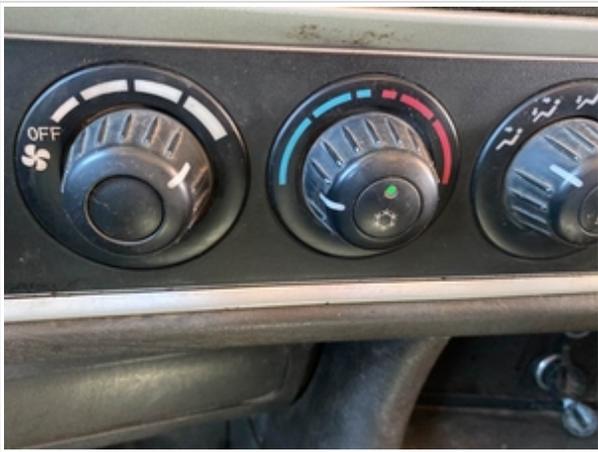
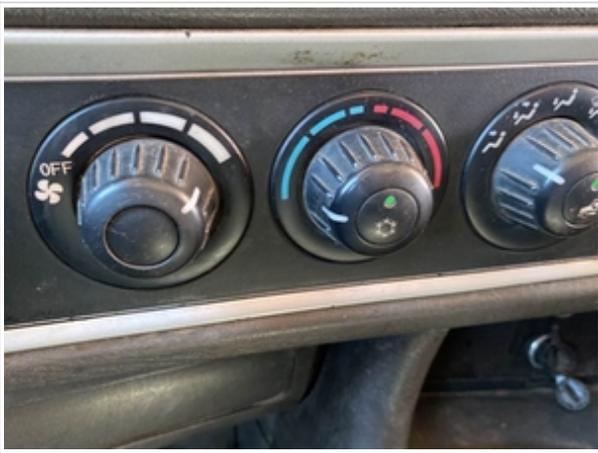
Heater & A/C	3 - Normal Wear & Tear	
Heater & A/C Photos

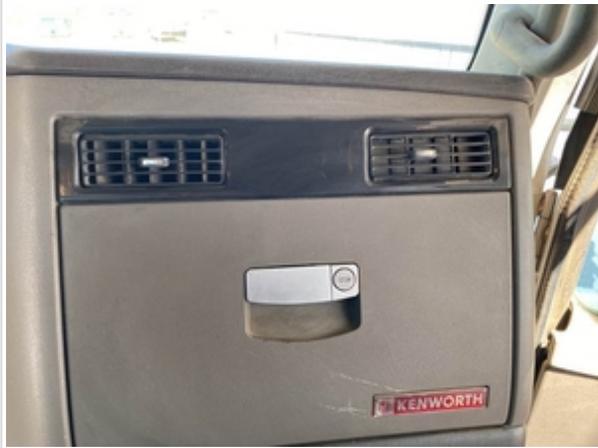
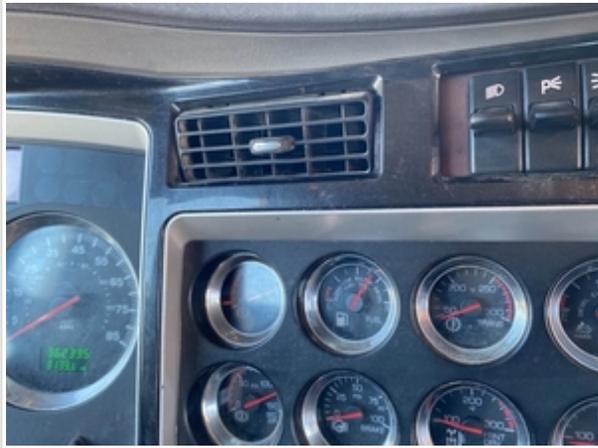
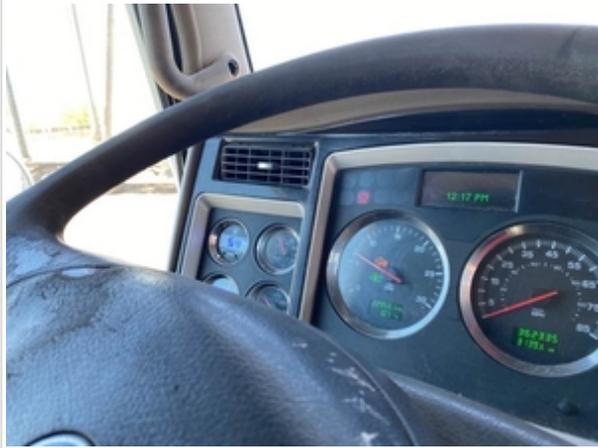
Fans / Vents Photos

Fans / Vents	3 - Normal Wear & Tear

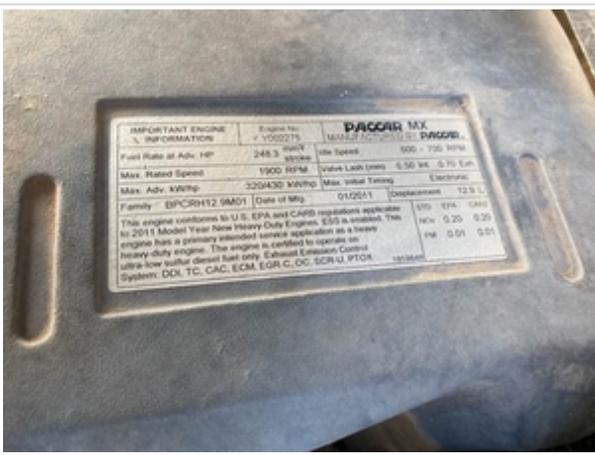
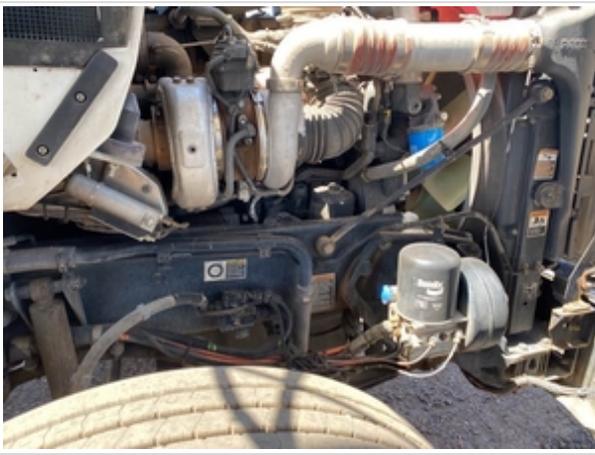
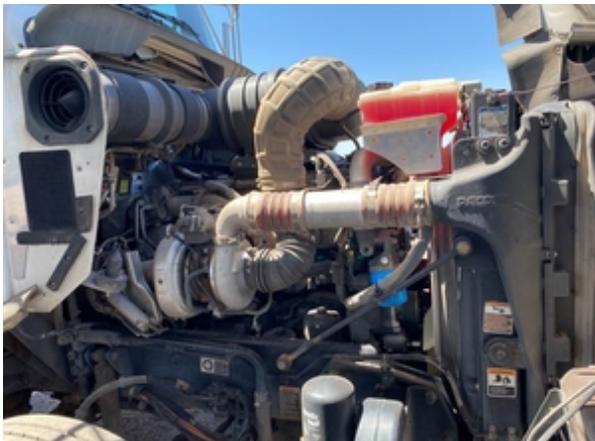
Engine Type (Make, Model, Cylinders, Hp)	PACCAR MX-13 - 6 CYL. - 12.9L - 430 HP																								
Engine Serial Number	Y002275																								
Engine Fuel Type	Diesel																								
Engine Photos

Overall Engine Appearance	Clean & dry
Overall Engine Comments	Engine looks well serviced and unkept. Signs of various components replaced to keep the engine running strong and healthy. No fluid leaks or obvious, major repairs needed from a visual standpoint.

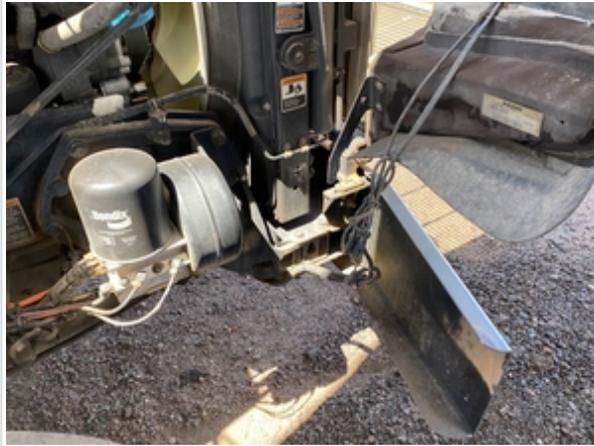
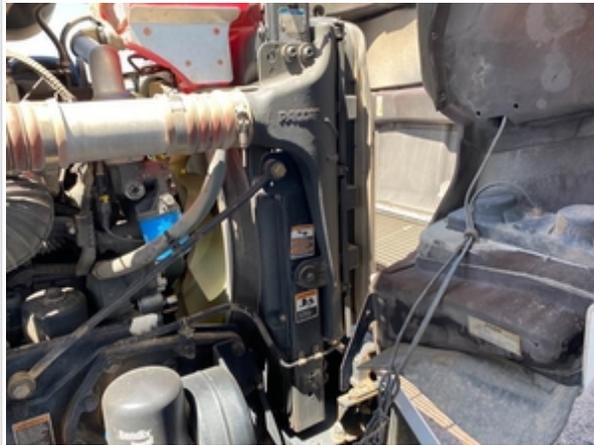
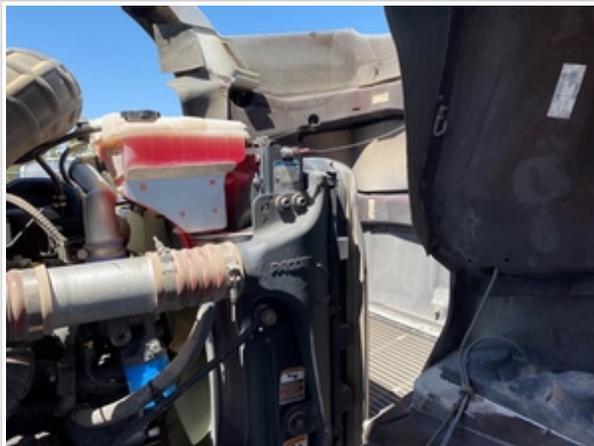
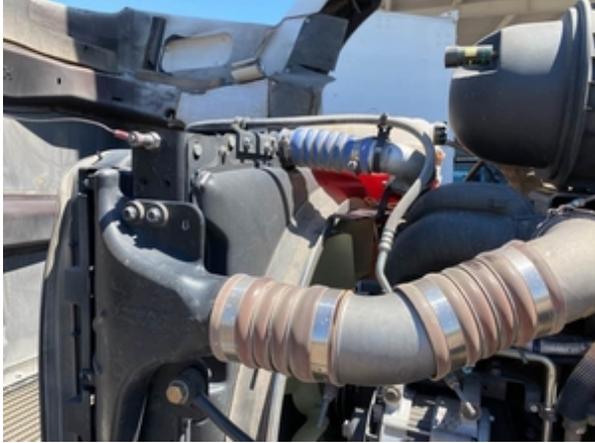
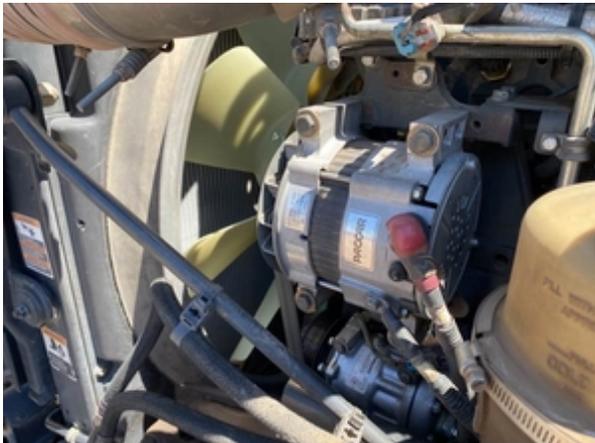
Radiator	3 - Normal Wear & Tear
Radiator Condition	Radiator fins & components appear to be in good working order, no signs of damage or leaks
Radiator Photos

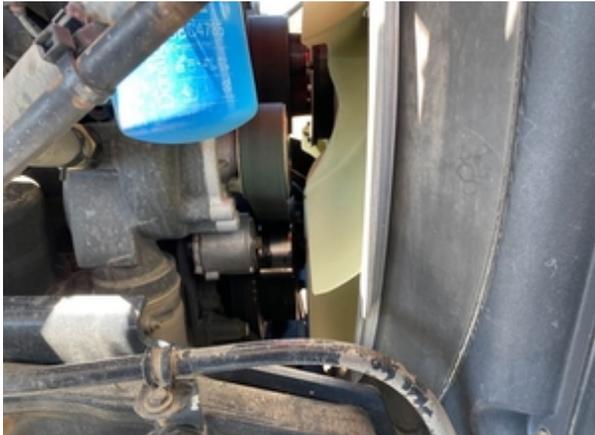
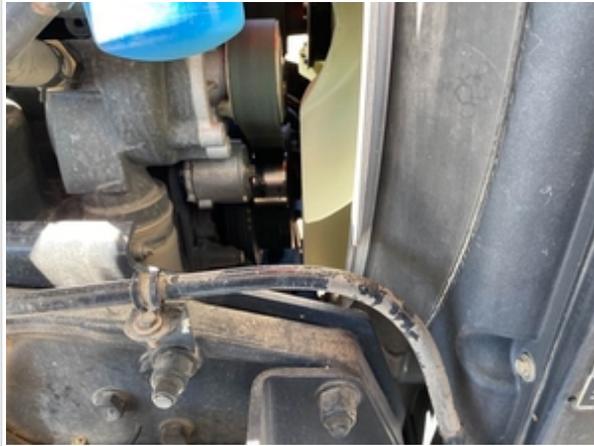
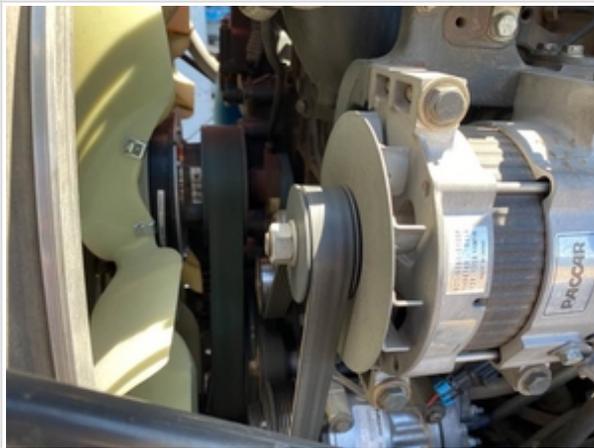
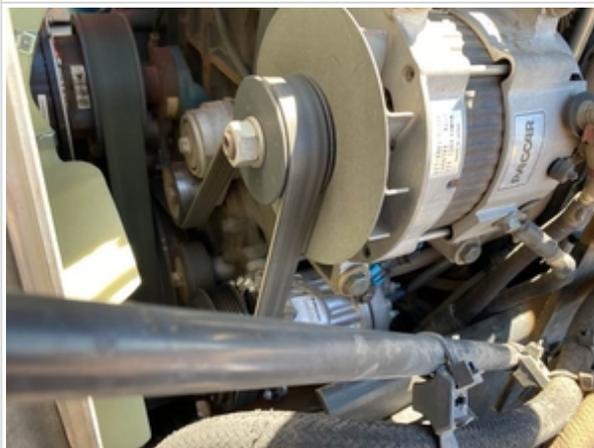
Belts	3 - Normal Wear & Tear
Belt Condition	Belts appear in good condition & alignment with proper tension
Belt Photos

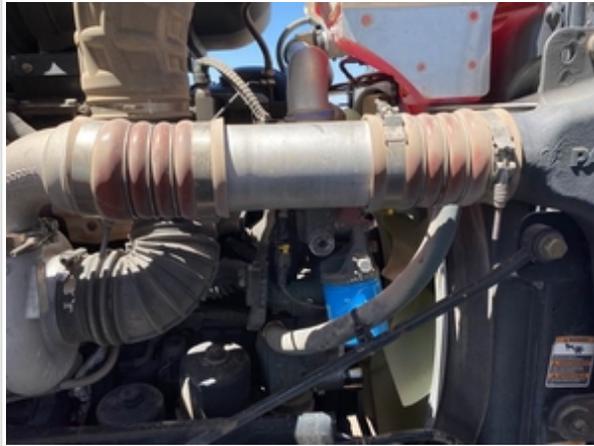
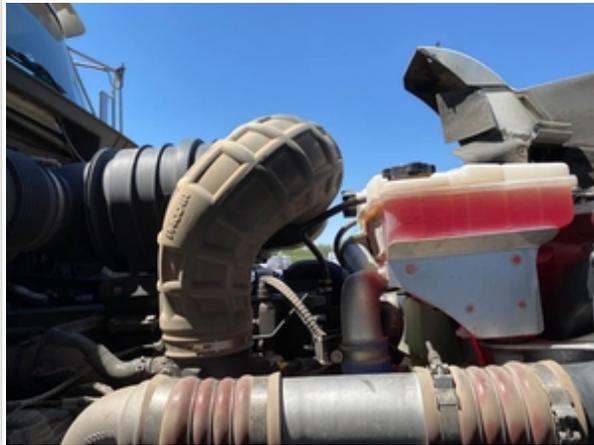
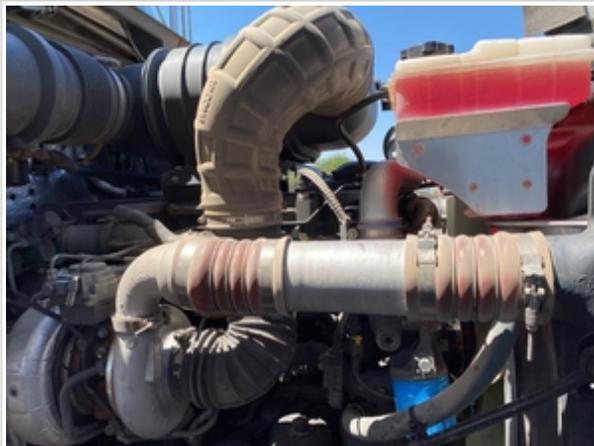
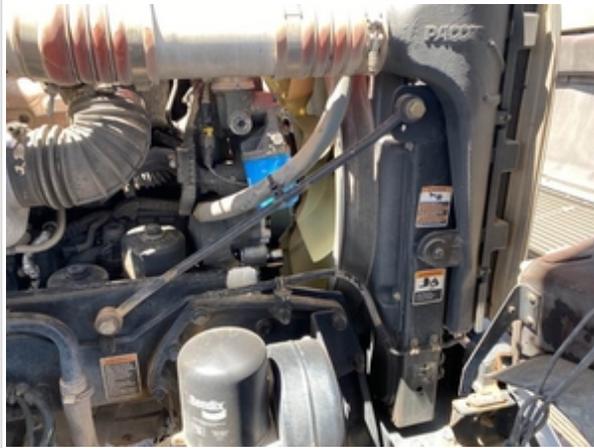
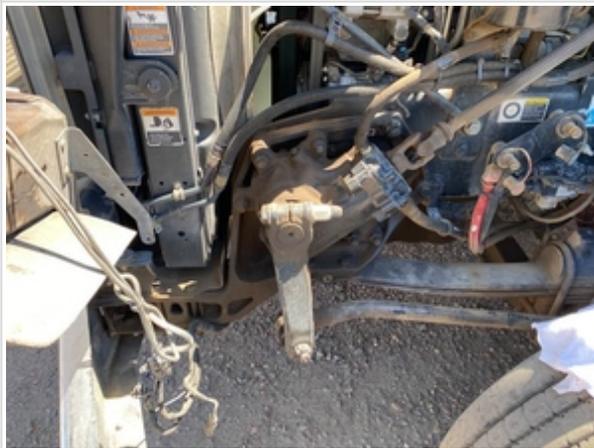
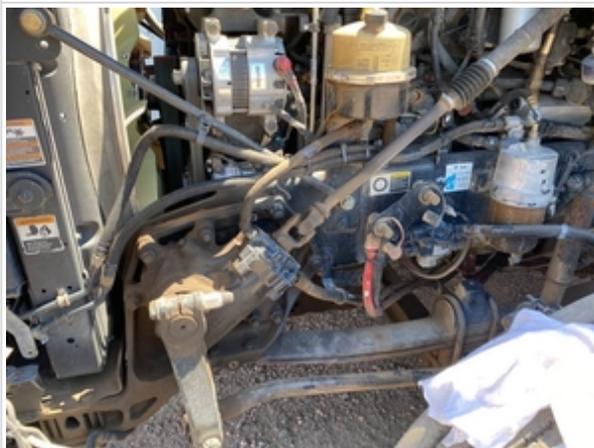
Hoses	3 - Normal Wear & Tear	
Hose Condition	Firm, pliant hoses with no signs of wear or leaks	
Hose Photos
