Inspection Report (On-Highway Flatbed Truck)

Year	2012
Make	Kenworth
Model	T800
Serial Number	1XKDDP9X6CJ300188
Truck Odometer Reading	362,335 Miles 22,953 Hours
Current Inspection / State Cert / DOT	Annual Inspection Performed 12/2021 per 49CFR-396
Previous Application (e.g., earth moving, mining, demolition, etc)	Rental Equipment Transportation

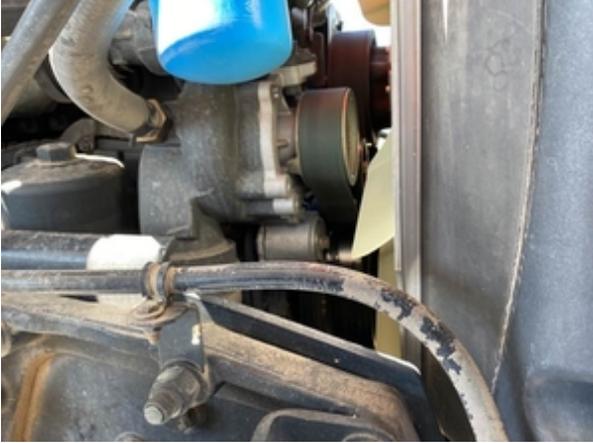
Water Pump Photos

Water Pump	3 - Normal Wear & Tear	
Water Pump Condition	No unusual pump noises heard, Other (see comments)	
Comments	Recently replaced

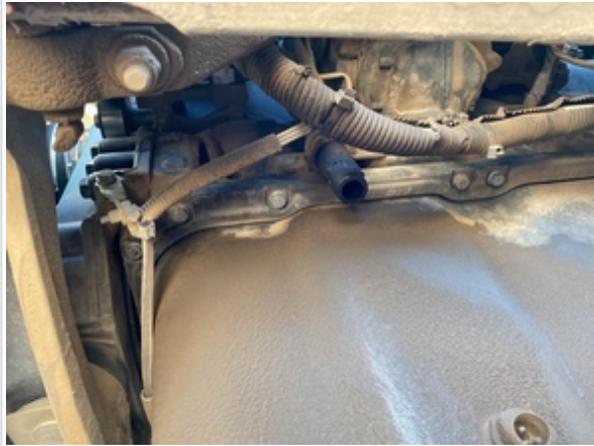
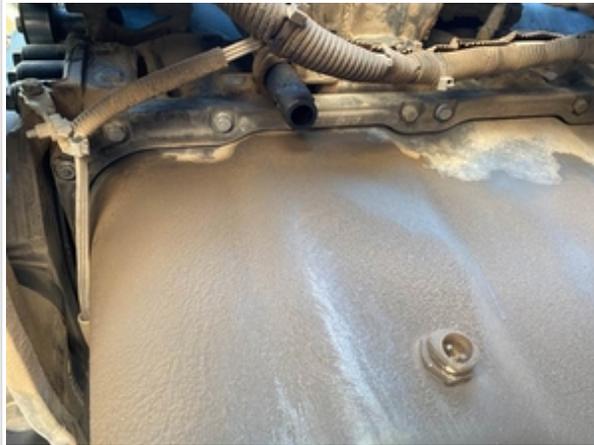
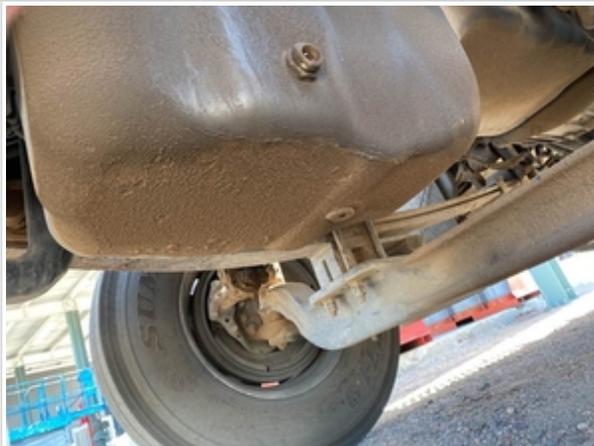
Cooling System Leaks	No
Coolant Color / Appearance	3 - Normal Wear & Tear
Coolant Color/Appearance Notes	Normal Translucent appearance, no visual signs of contamination
Oil Leaks	Yes
Oil Leak Notes	No oil leaks seen, Dried oil seepages seen
Oil Leak Photos

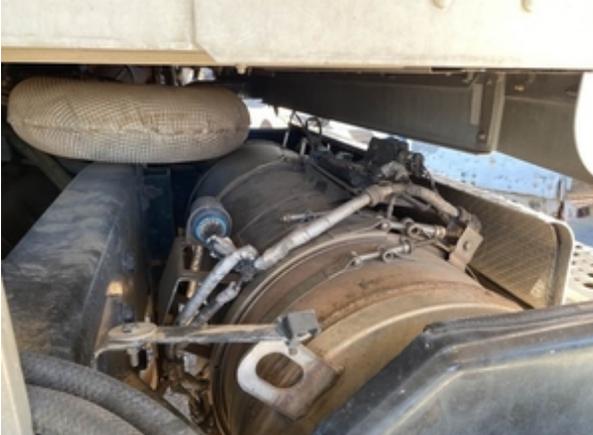
Oil Color / Appearance	3 - Normal Wear & Tear
Oil Color / Appearance Notes	Clean oil appearance, no signs of cross contamination, Appropriate oil level
Fuel Leaks	No
Equipped with DPF (Diesel Particulate Filter)	Yes
DPF Condition	3 - Normal Wear & Tear
DPF Condition Notes	Filter housing is intact with no signs of damage or malfunction, DPF indicator is not illuminated
DPF Photos

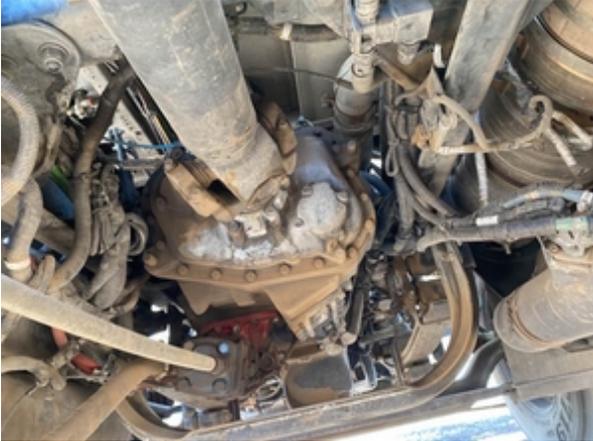
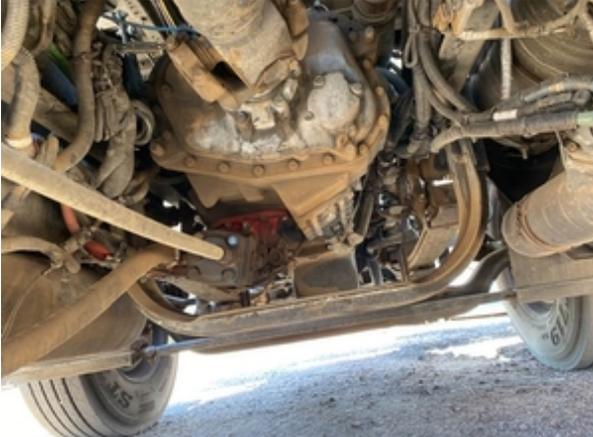
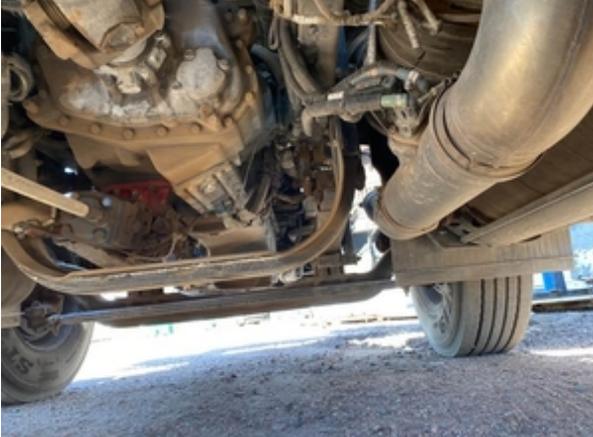
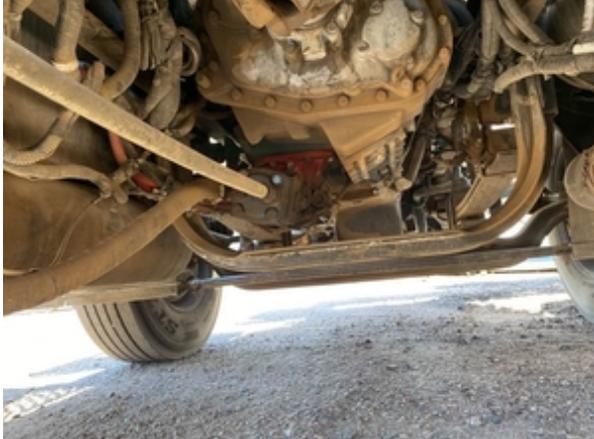
Overdrive	No
Transmission	3 - Normal Wear & Tear
Transmission Condition	No unusual noises or vibrations
Transmission Condition Photos

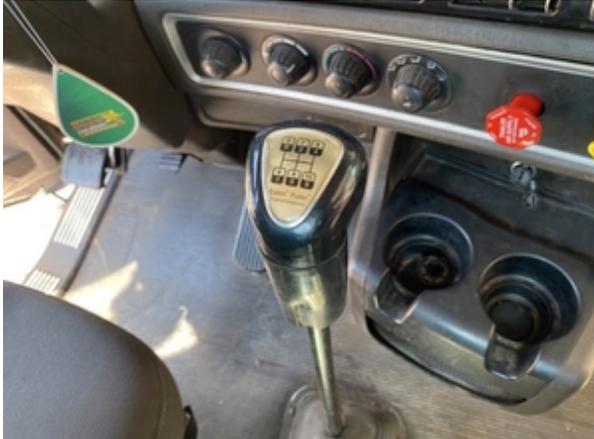
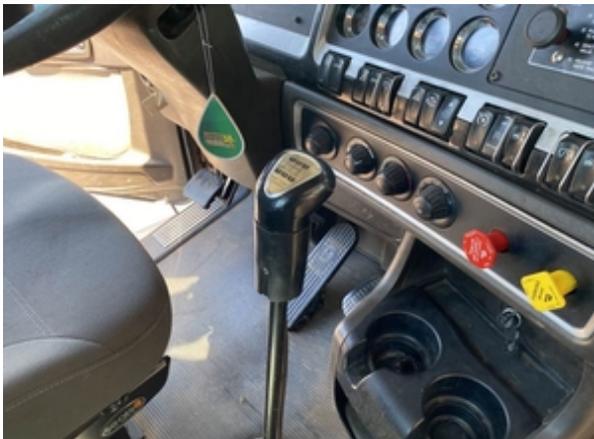
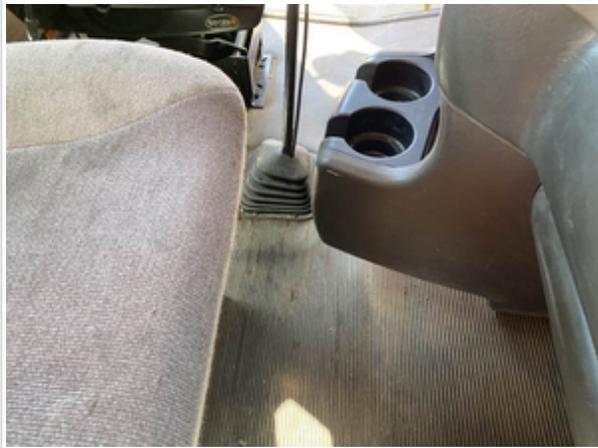
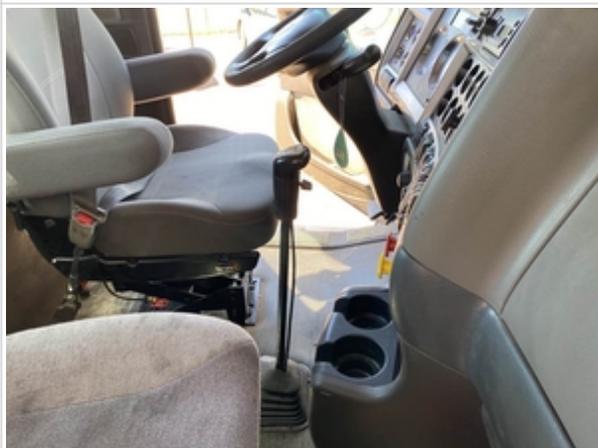
Clutch	3 - Normal Wear & Tear	
Clutch Condition	Clutch is functioning as expected	
Shift Lever	3 - Normal Wear & Tear	
Shift Lever Condition	Good forward and reverse function	
Shift Lever Photos

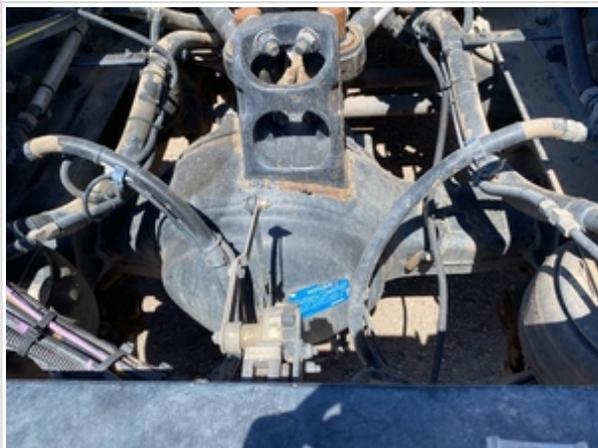
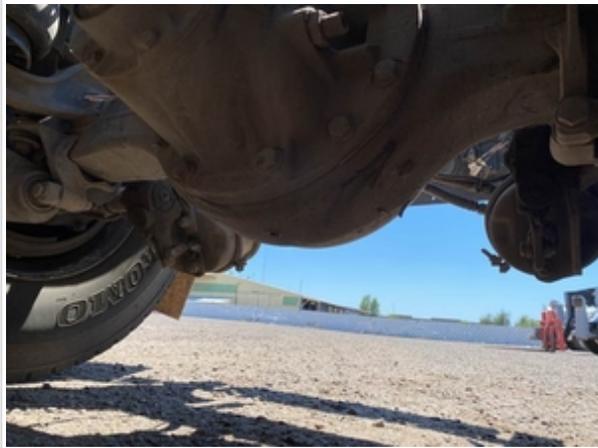
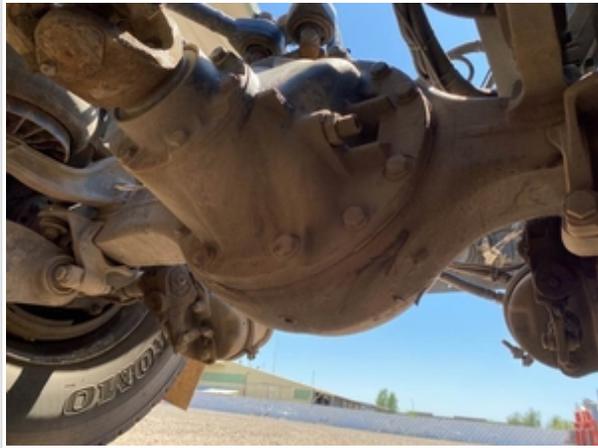
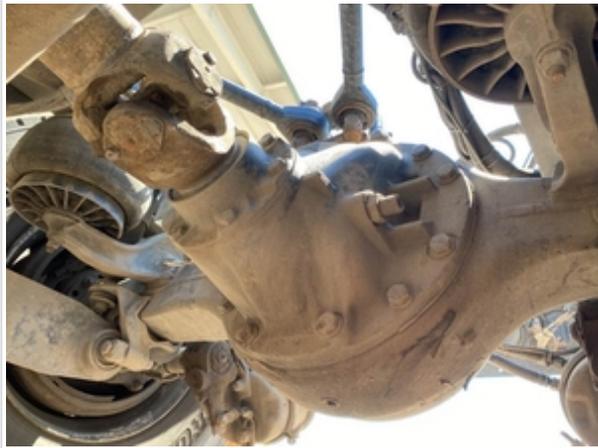
Differential	Check condition of the differential(s). Take photos and notes as relevant.	
Rear Differential	3 - Normal Wear & Tear	
Rear Differential Condition	Dry housing appearance, no unusual noises heard during operation	
Rear Differential Photos

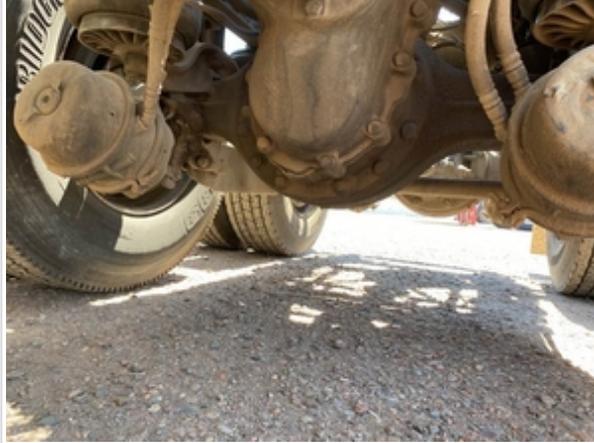
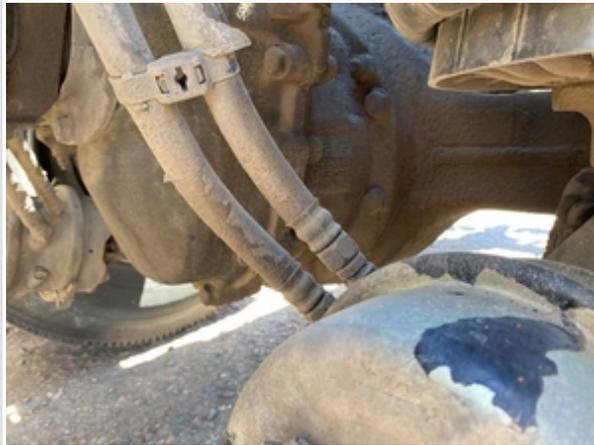
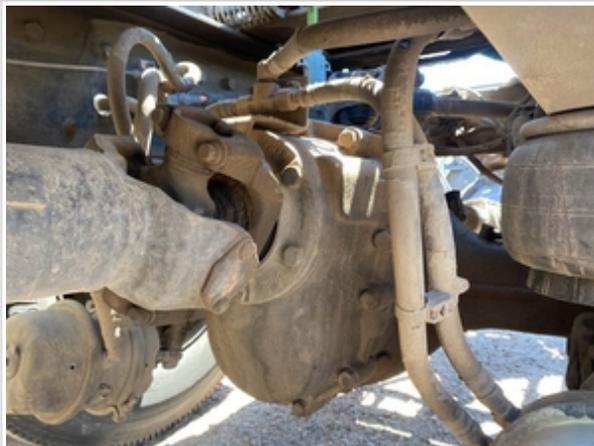
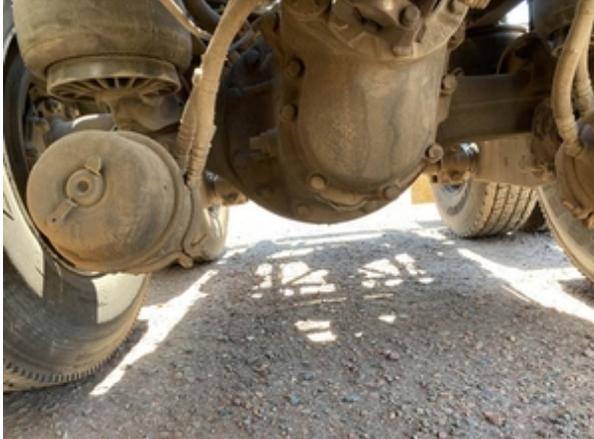
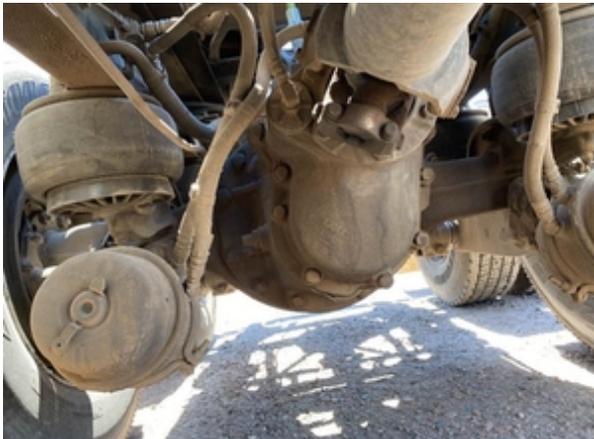
Front Differential	3 - Normal Wear & Tear
Front Differential Condition	Dry housing appearance, no unusual noises heard during operation

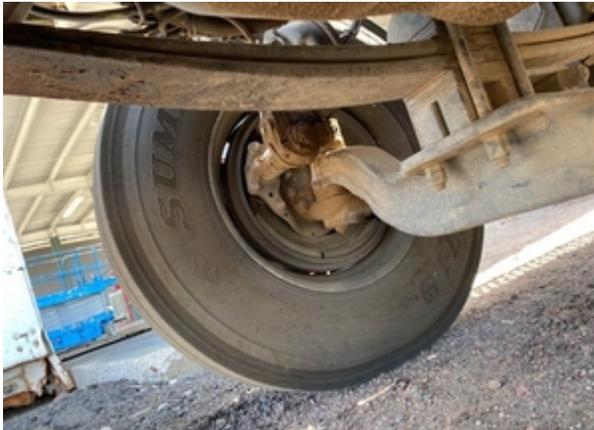
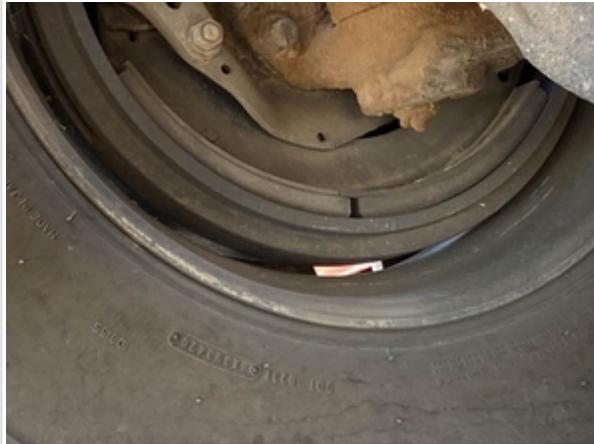
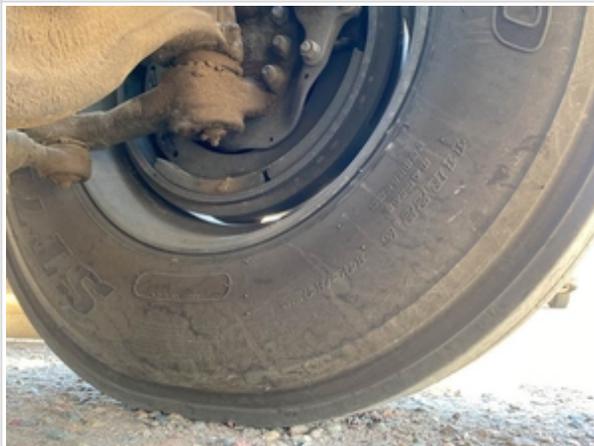
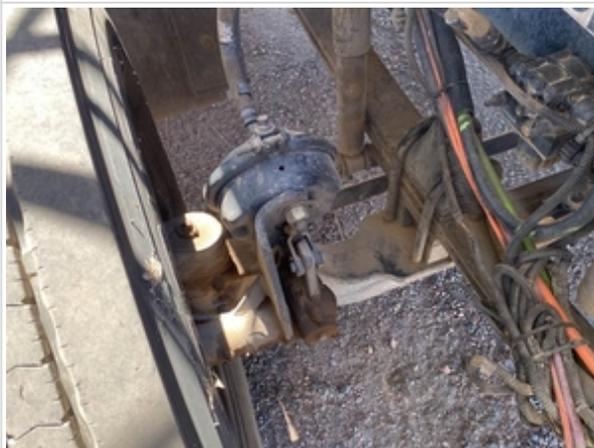
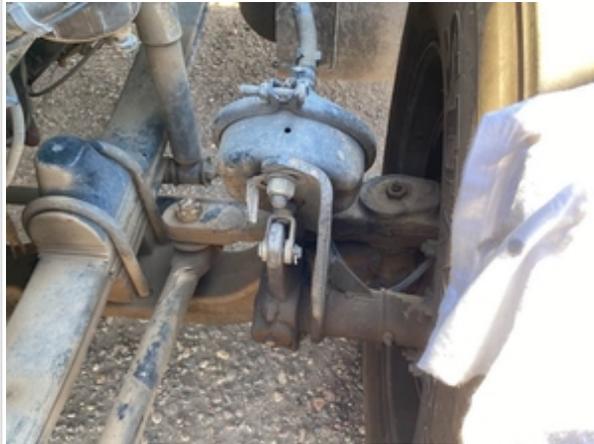
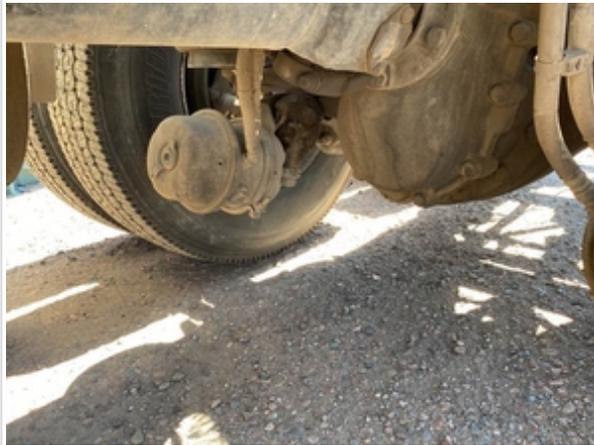
Brake System Type	Air Brakes	
Air Brakes Build Correct Pressure	Yes	
Air Brake System Leaks	Yes	
Comments	Small air leak behind dash	
Air Brake Hose Condition	3 - Normal Wear & Tear	
Comments	Rear brakes shoes less than 50% life left, front between 50 and 60% life left	
Air Brake System Photos

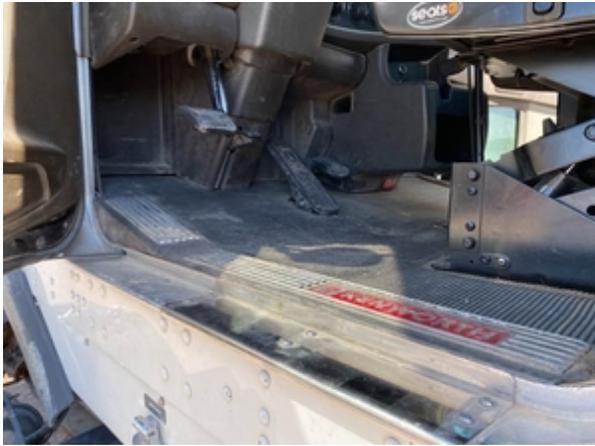
Foot Brake	3 - Normal Wear & Tear
Foot Brake Condition	Good brake function

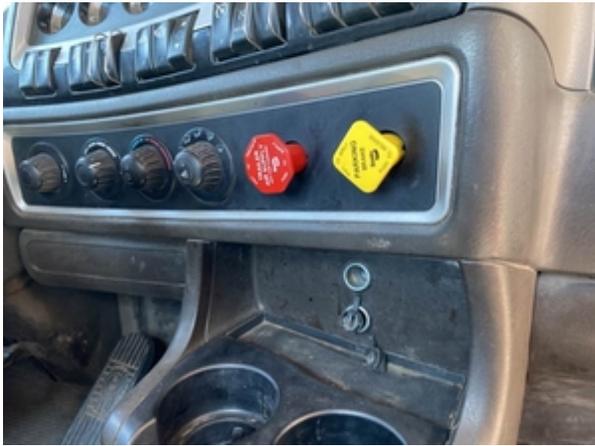
Engine Brake Configuration	2 Position
Engine Brake	3 - Normal Wear & Tear
Parking Brake	3 - Normal Wear & Tear
Parking Brake Condition	Good brake function
Parking Brake Photos
