Inspection Report (On-Highway Flatbed Truck)

Year	2012
Make	Kenworth
Model	T800
Serial Number	1XKDDP9X1CJ300194
Truck Odometer Reading	333,395Miles and 9227.5 hours
Current Inspection / State Cert / DOT	Annual Inspection Performed 02/2022 per 49CFR-396
Previous Application (e.g., earth moving, mining, demolition, etc)	Equipment rental machinery transport

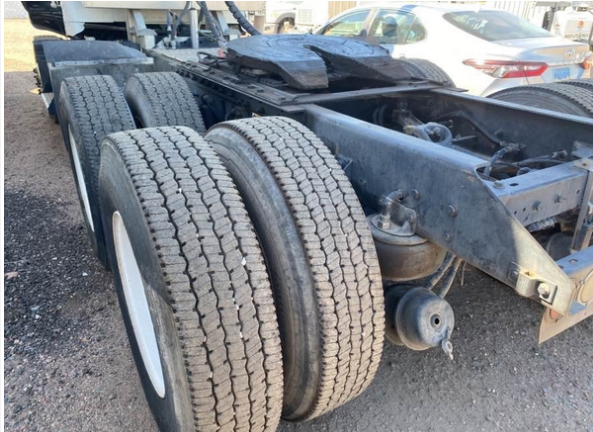
Rear	3 - Normal Wear & Tear
Rear Condition	No visible damage, Other (see comments)
Comments	2nd axle 11r22.5 have 30 to 40 % tread life left 3rd axle has 60 to 70%
Rear Photos

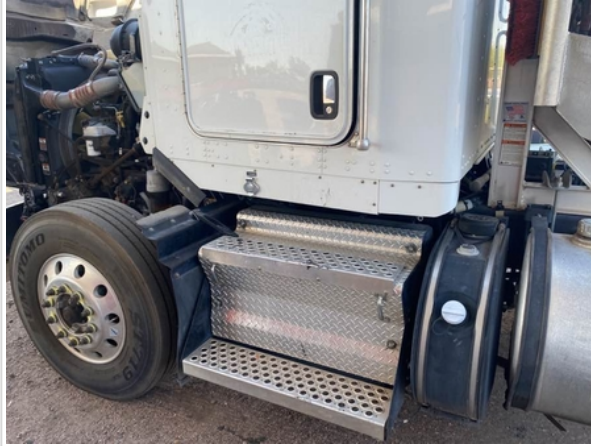
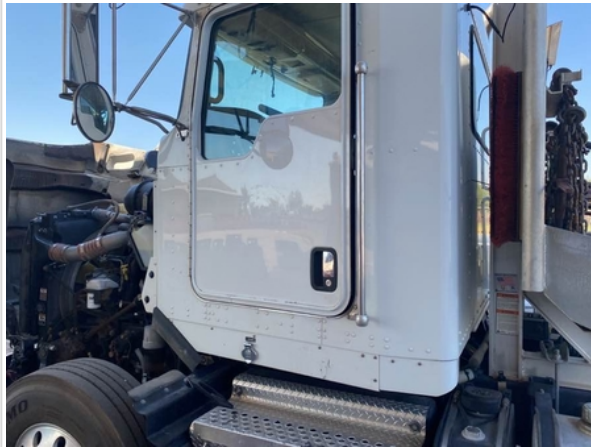
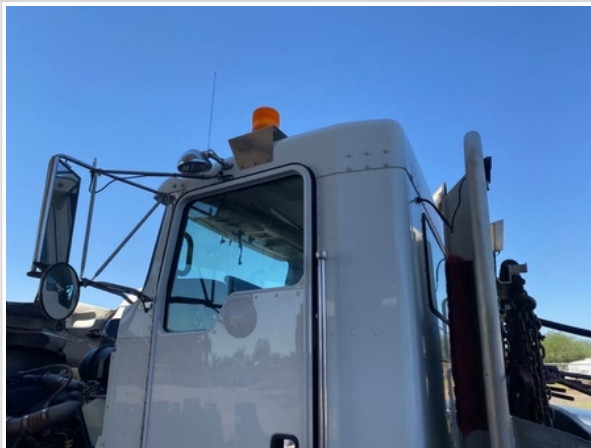
Left Photos

Left	3 - Normal Wear & Tear
Left Condition	No visible damage, Other (see comments)
Comments	Missing chain storage box and rear left side mudflap

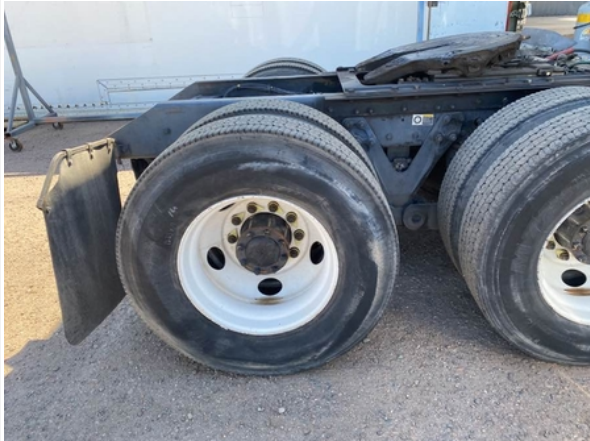
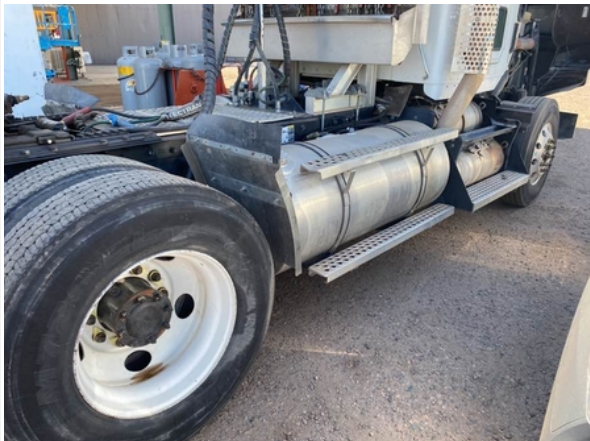
Right	3 - Normal Wear & Tear	
Right Condition	No visible damage, Other (see comments)	
Comments	Missing right side dpf panels on side steps	
Right Photos

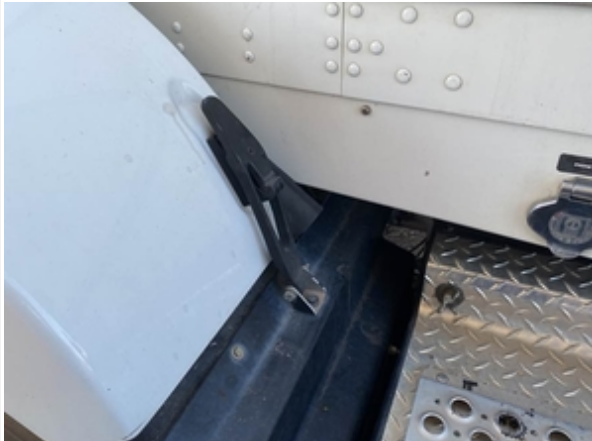
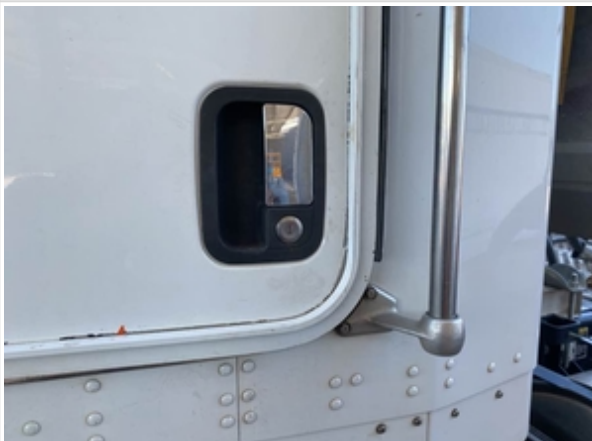
Doors / Canopy Latches	3 - Normal Wear & Tear	
Doors / Canopy Latches Condition	No visible damage	
Doors / Canopy Latches Photos

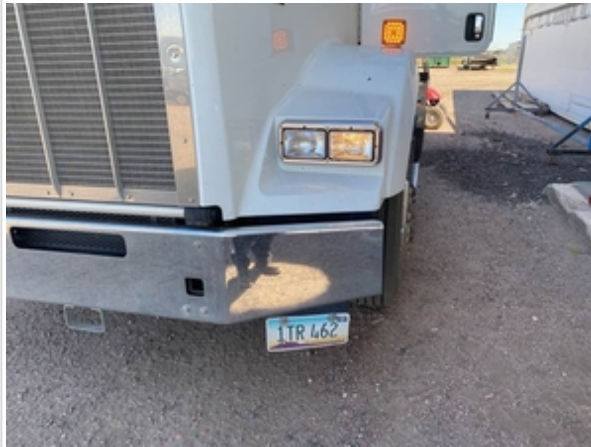
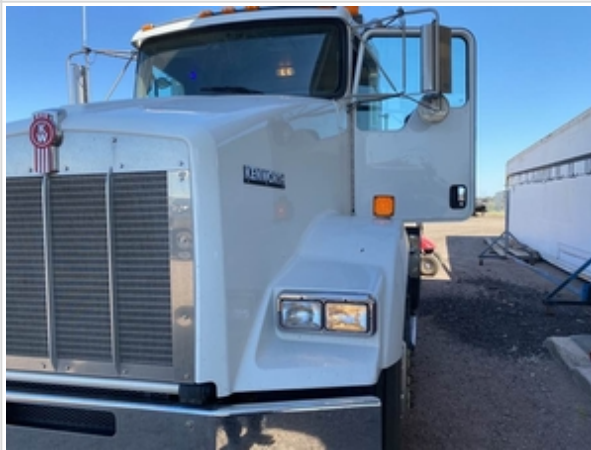
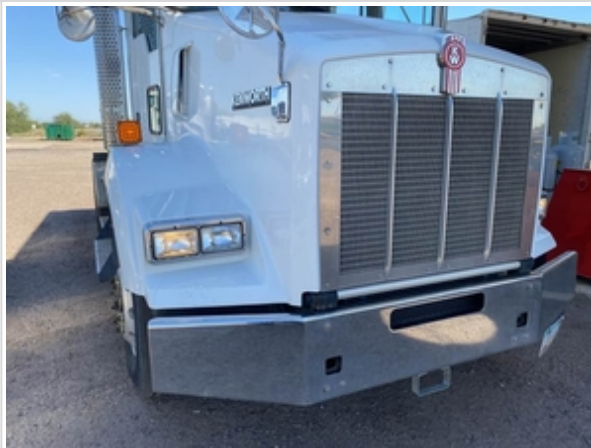
Lighting System Photos

Lighting System	3 - Normal Wear & Tear
Lighting System Condition	No visible damage, lighting system is operational

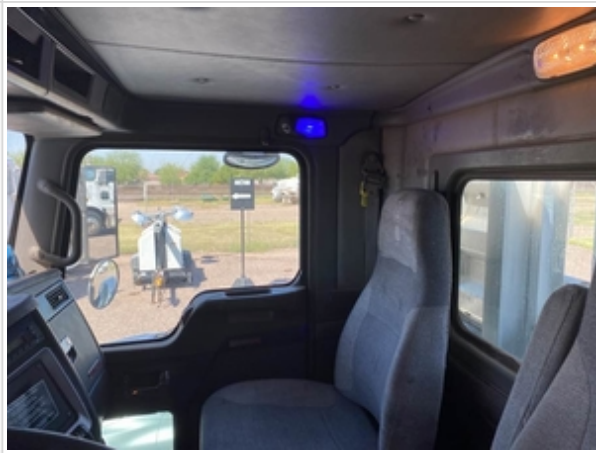
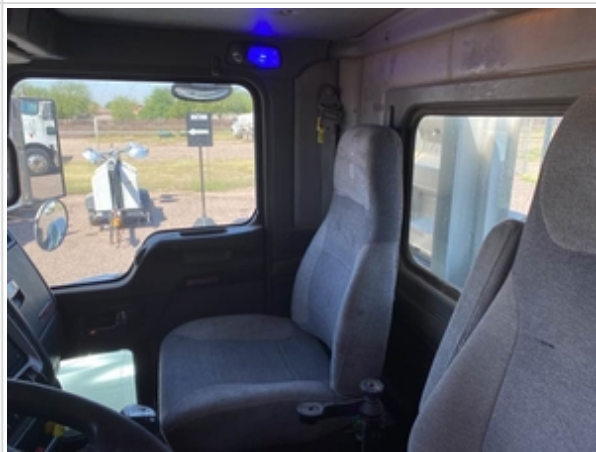
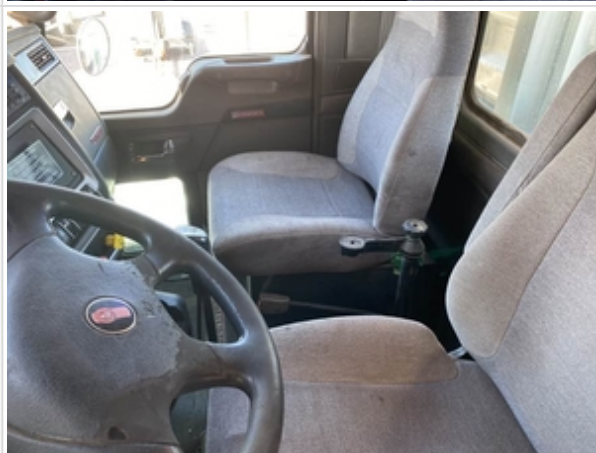
Operator Cabin	3 - Normal Wear & Tear
Operator Cabin Photos

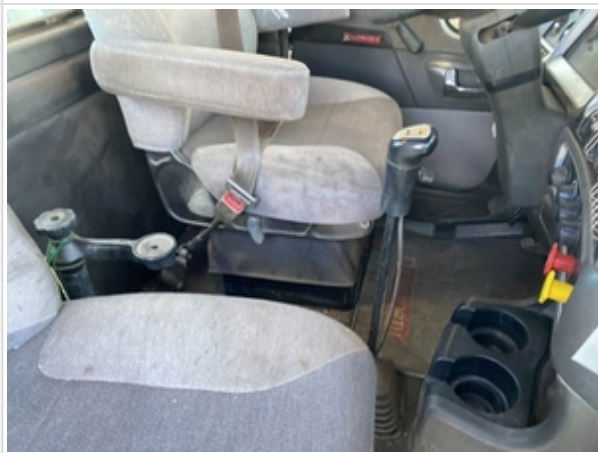
<p>Operator's Seat & Arm Rests</p>	<p>3 - Normal Wear & Tear</p>	
<p>Operator's Seat & Arm Rests Photos</p>

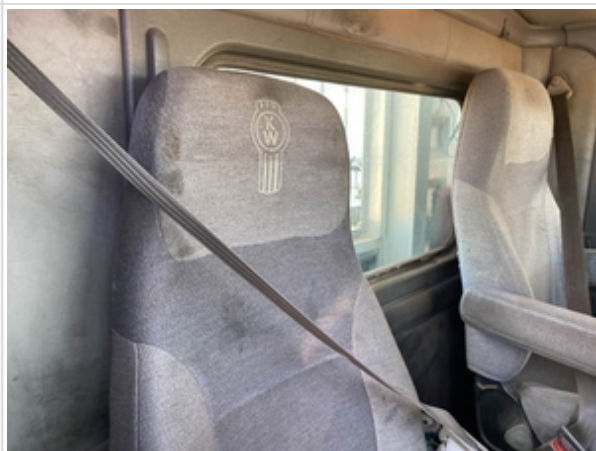
<p>Seat Belt</p>	<p>3 - Normal Wear & Tear</p>	
<p>Seat Belt Photos</p>

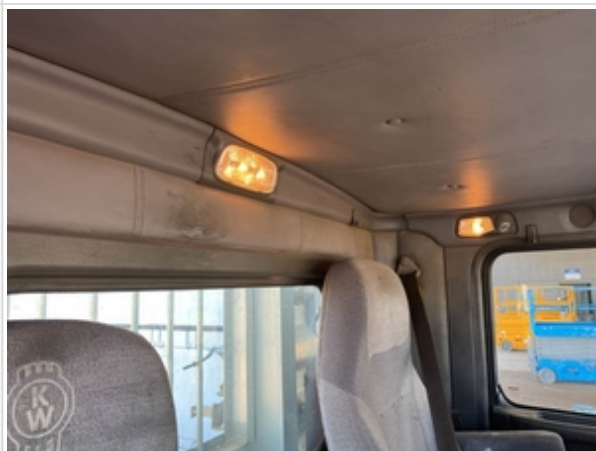
<p>Cabin Lights</p>	<p>3 - Normal Wear & Tear</p>	
<p>Cabin Lights Photos</p>

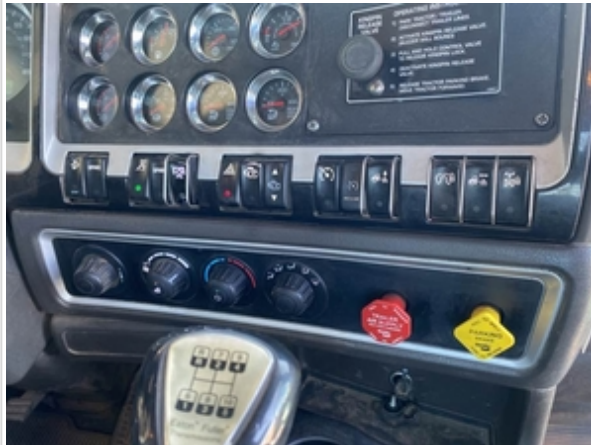
Controls & Switches Photos

Controls & Switches

3 - Normal Wear & Tear

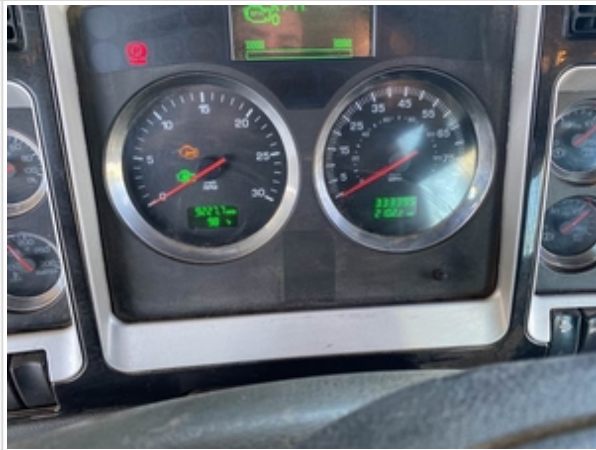
Odometer Activity Photos

<p>Odometer Activity</p>	<p>3 - Normal Wear & Tear</p>

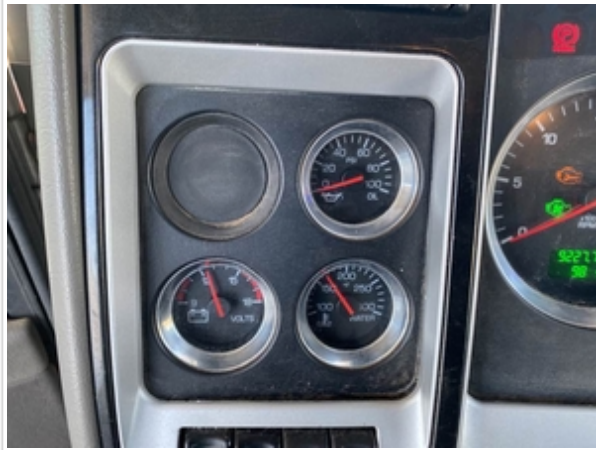
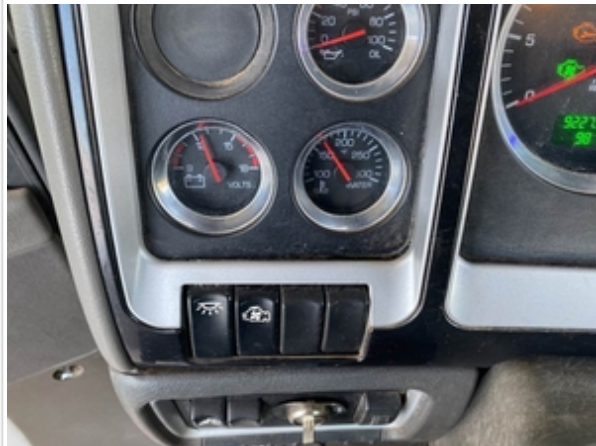
Other Gauge Activity	3 - Normal Wear & Tear
Other Gauge Activity Photos

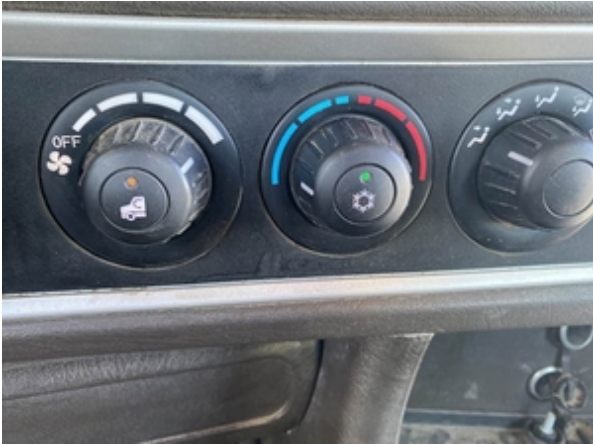
Heater & A/C	3 - Normal Wear & Tear
Heater & A/C Photos

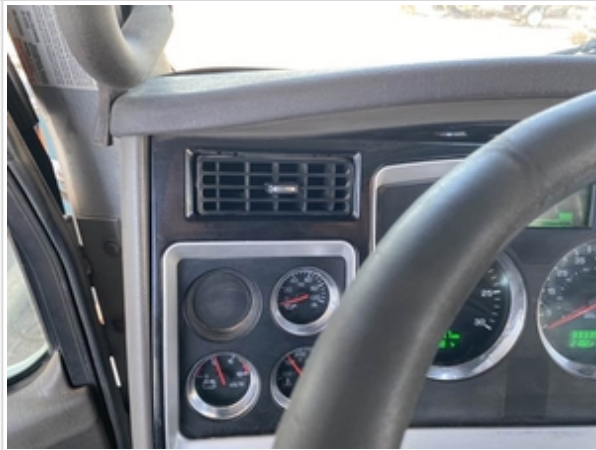
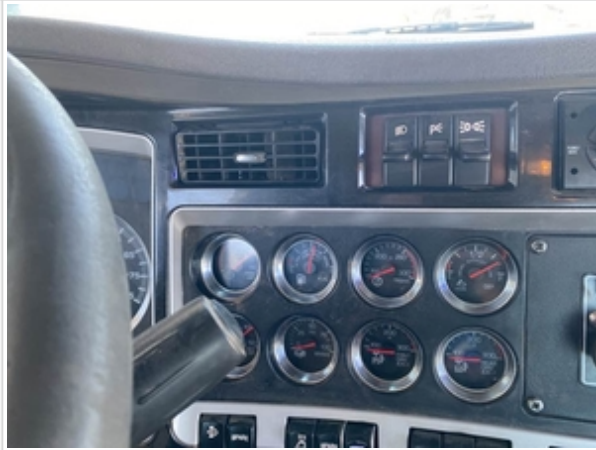
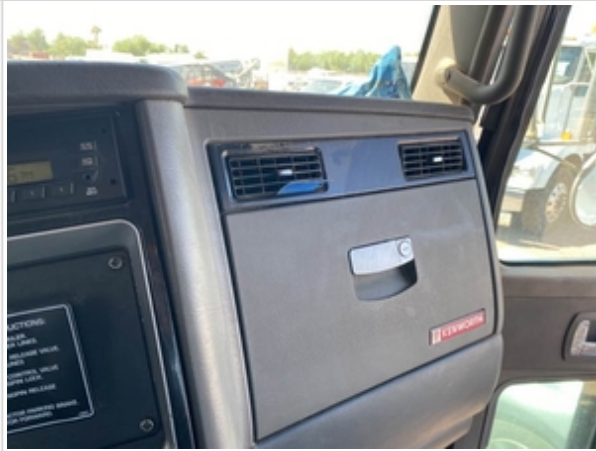
Fans / Vents Photos

Fans / Vents	3 - Normal Wear & Tear

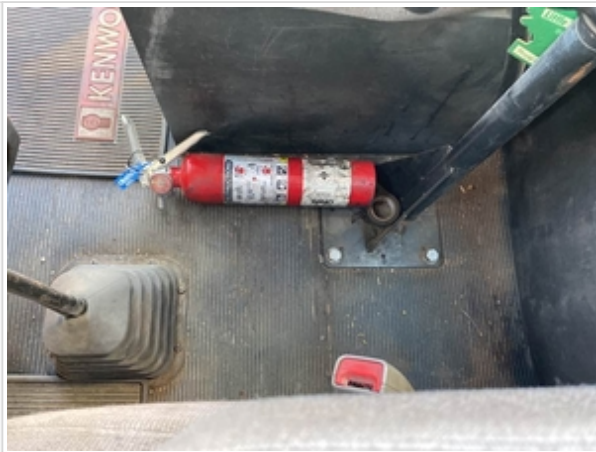
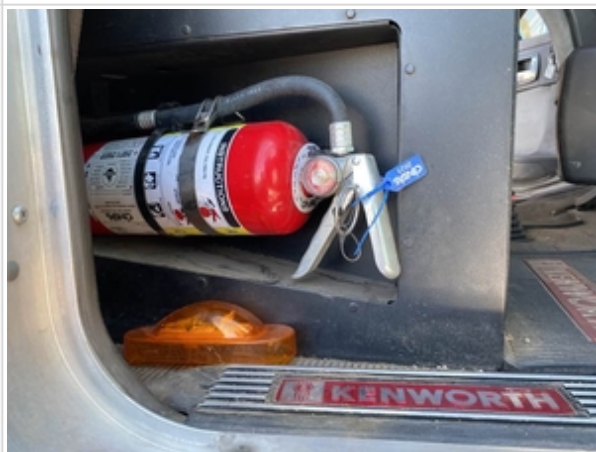
Fire Extinguisher Photos

Horn	4 - Like New, Recently Replaced
Reverse Alarm / Backup Signal	7
Backup Camera	0
Other Electronic Devices	0
Fire Extinguisher	3 - Normal Wear & Tear

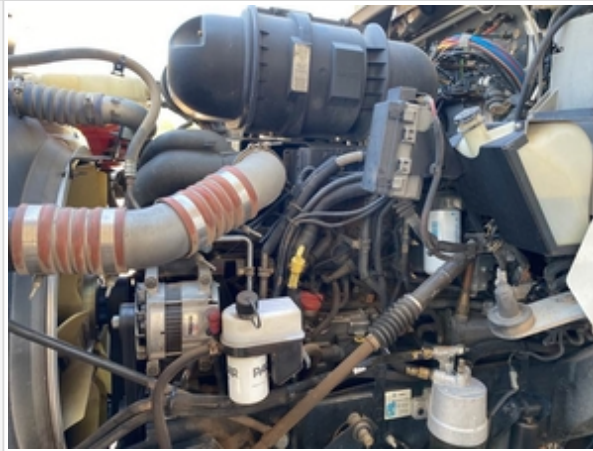
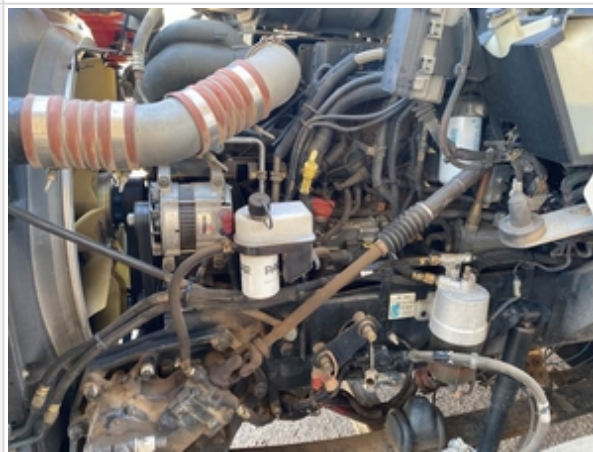
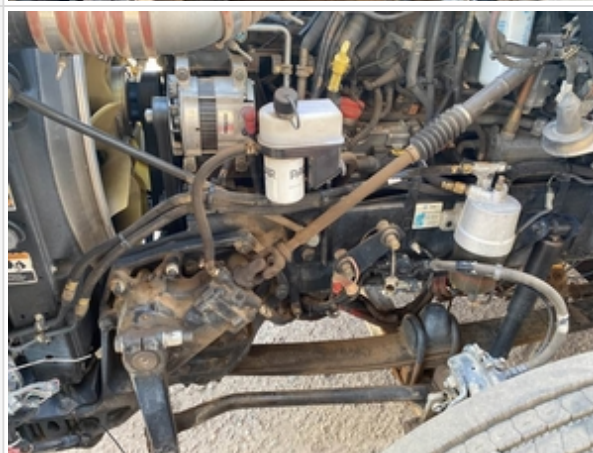
Engine Type (Make, Model, Cylinders, Hp)	PACCAR MX-13 - 6 CYL. - 12.9L - 430 HP
Engine Serial Number	Y002514
Engine Fuel Type	Diesel
Engine Photos

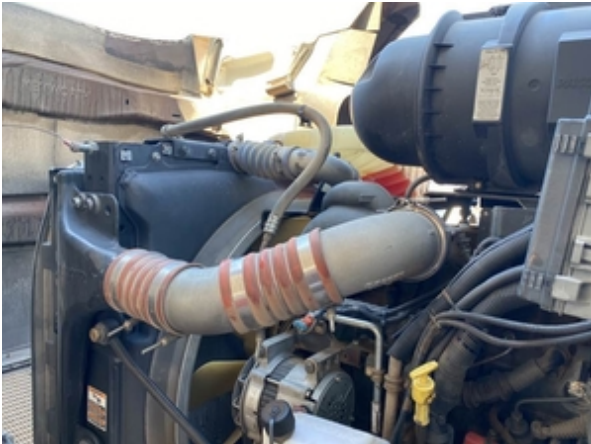
Radiator	3 - Normal Wear & Tear
Radiator Condition	Radiator fins & components appear to be in good working order, no signs of damage or leaks
Radiator Photos

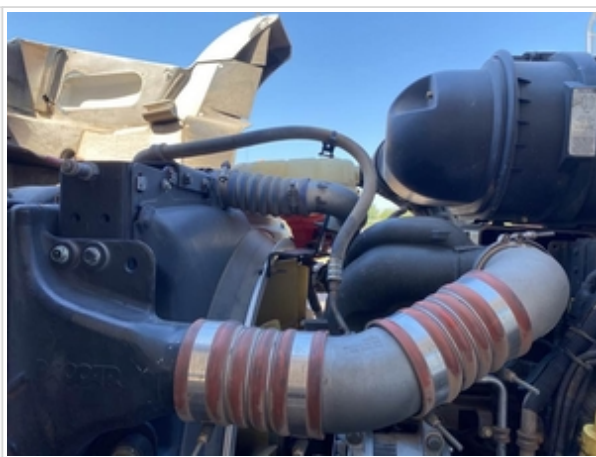
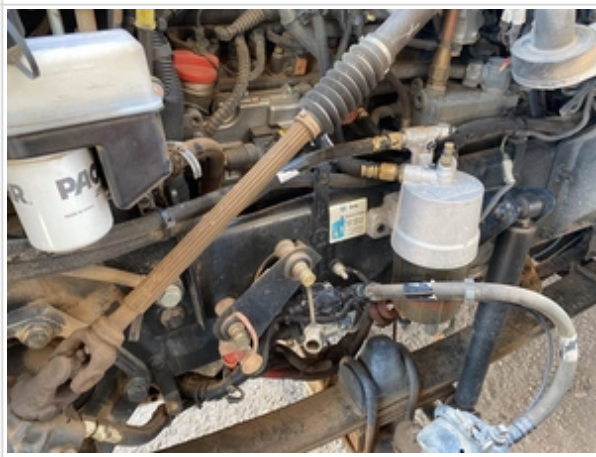
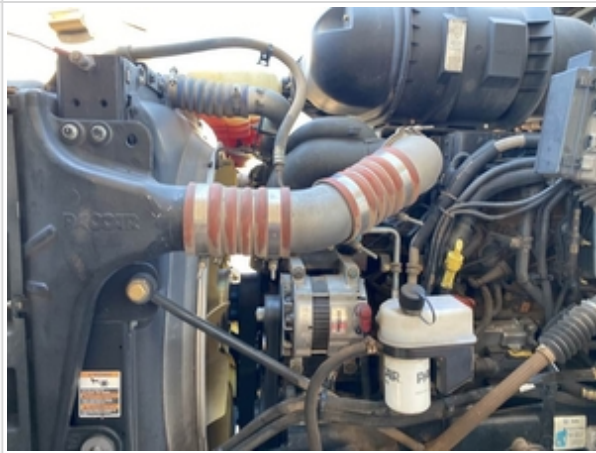
<p>Hose Photos</p>

Hoses	3 - Normal Wear & Tear
Hose Condition	Firm, pliant hoses with no signs of wear or leaks

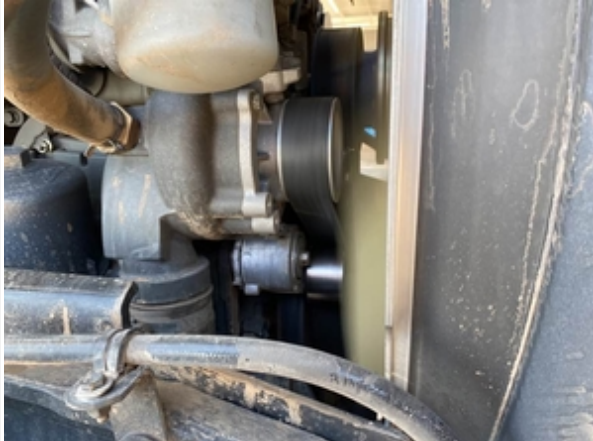
Water Pump Photos

Water Pump	3 - Normal Wear & Tear
Water Pump Condition	No unusual pump noises heard, Other (see comments)

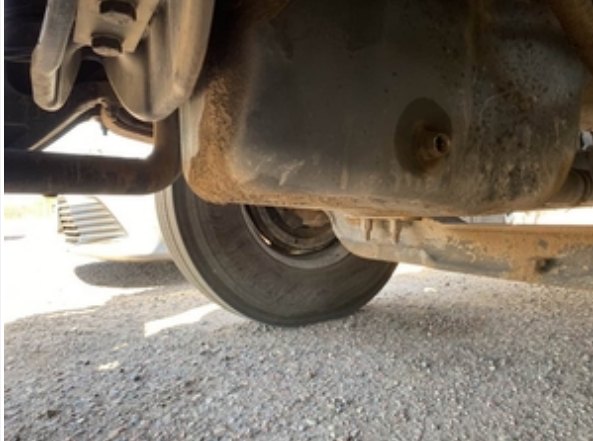
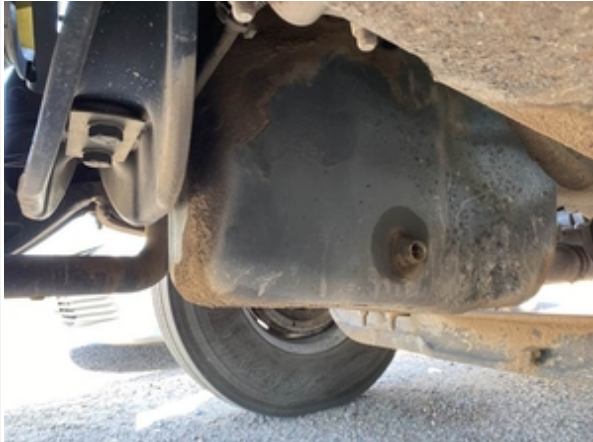
Cooling System Leaks	No
Coolant Color / Appearance	3 - Normal Wear & Tear
Coolant Color/Appearance Notes	Normal Translucent appearance, no visual signs of contamination
Oil Leaks	Yes
Oil Leak Notes	No oil leaks seen, Dried oil seepages seen, Other (see comments)
Comments	From around front crank pulley/damper
Oil Leak Photos

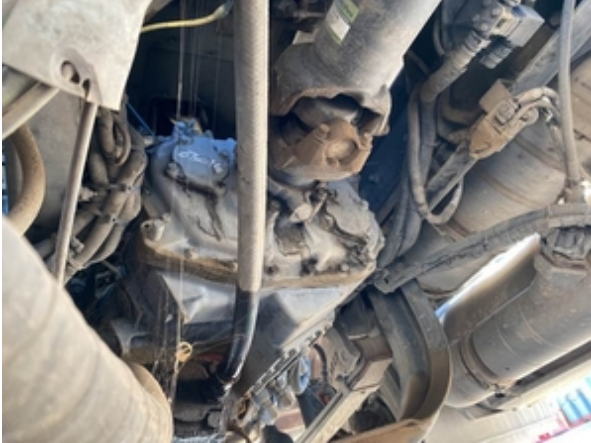
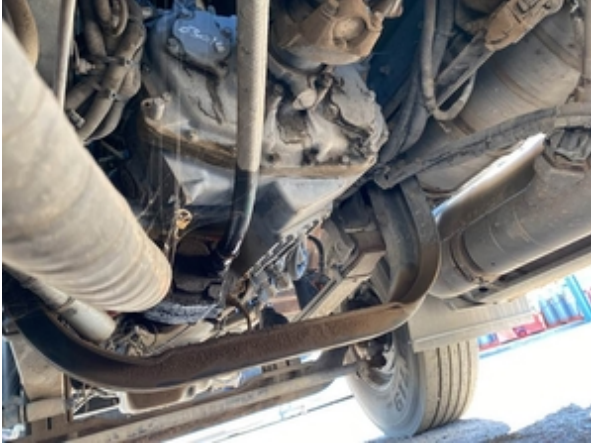
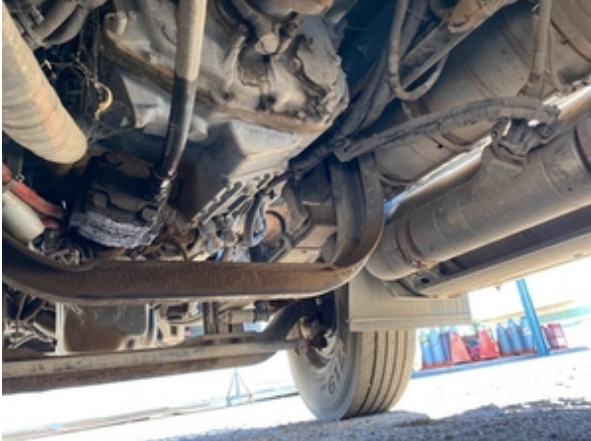
Overdrive	No
Transmission	3 - Normal Wear & Tear
Transmission Condition	No unusual noises or vibrations
Transmission Condition Photos

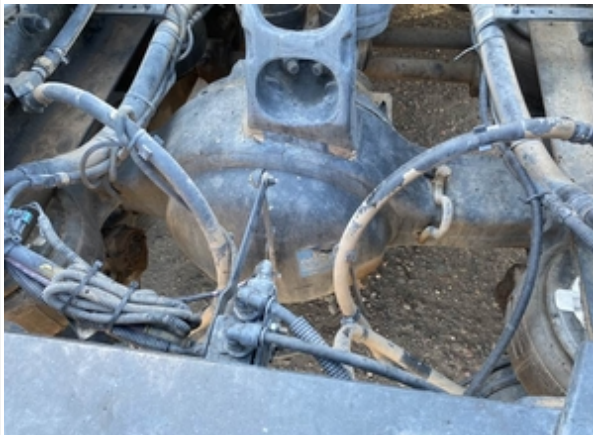
Differential	Check condition of the differential(s). Take photos and notes as relevant.
Rear Differential	3 - Normal Wear & Tear
Rear Differential Condition	Dry housing appearance, no unusual noises heard during operation
Rear Differential Photos

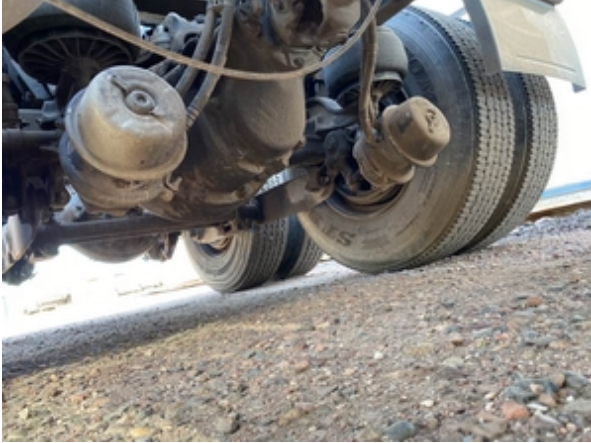
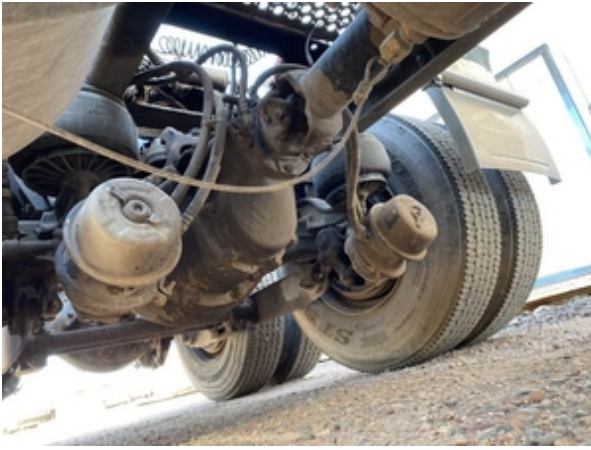
Front Differential Photos

Front Differential	3 - Normal Wear & Tear
Front Differential Condition	Dry housing appearance, no unusual noises heard during operation

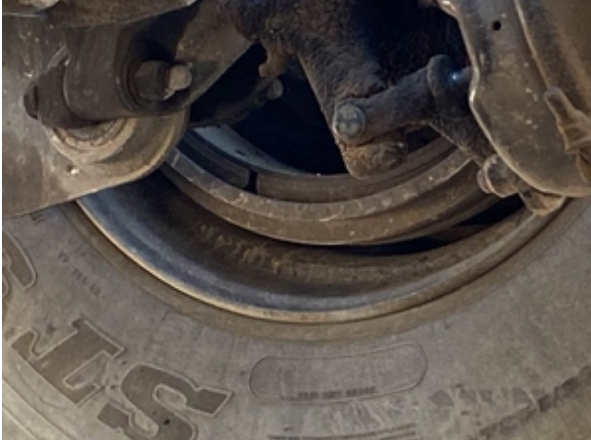
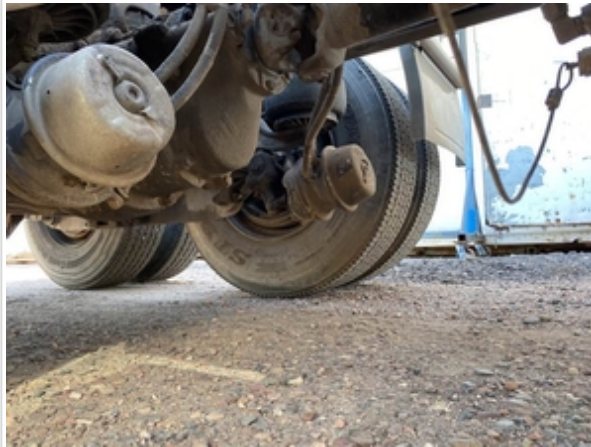
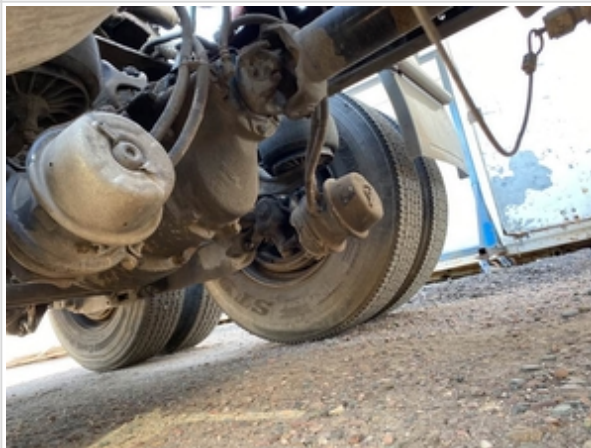
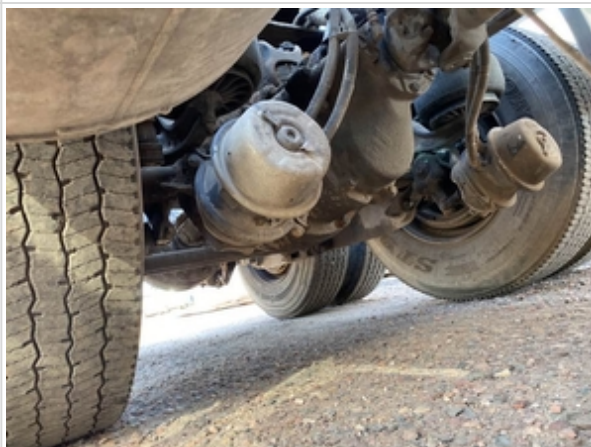
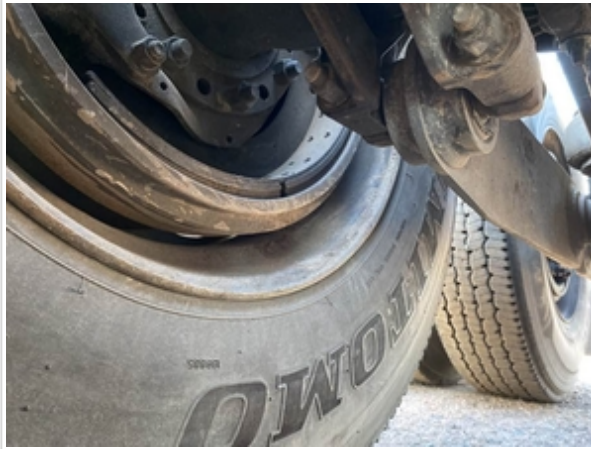
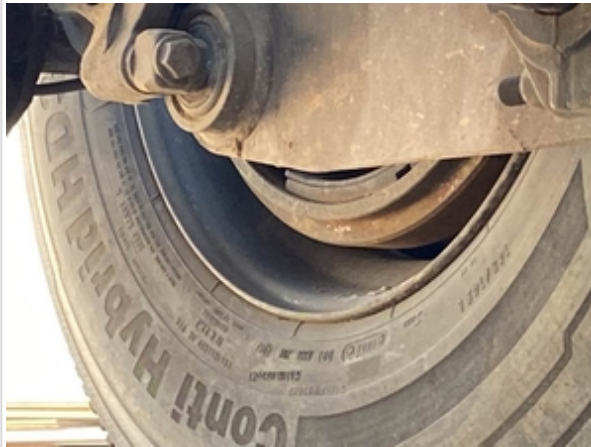
Brake System Type	Air Brakes
Air Brakes Build Correct Pressure	Yes
Air Brake System Leaks	No
Comments	2nd axle r/s brake shows below 50% of life left. The rest between 60% to 70% all the way around
Air Brake Hose Condition	3 - Normal Wear & Tear
Air Brake System Photos

Parking Brake Photos	 
Overall Drivetrain Comments	Overall 2nd axle tires getting low and will need to be replaced soon. Also 2nd axle right side brake shoes getting low and will need to be replaced soon.

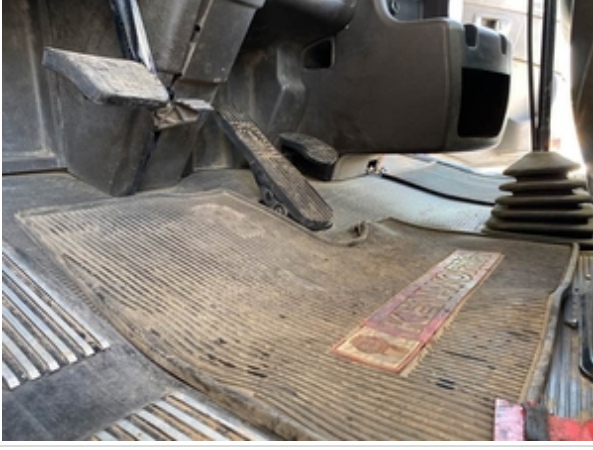
Foot Brake	3 - Normal Wear & Tear	
Foot Brake Condition	Good brake function	
Foot Brake Photos
