Inspection Report (Skip Loader)

Year	2016
Make	John Deere
Model	210K
Serial Number	1T8210EKTFG892310
Hour Meter Reading	4,159.3
Previous Application (e.g., earth moving, mining, demolition, etc)	Asphalt Paving

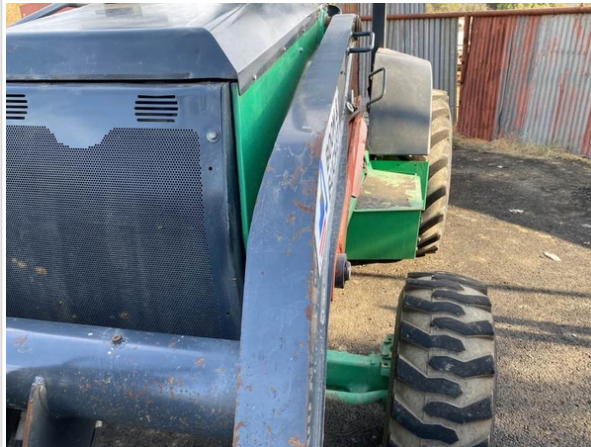
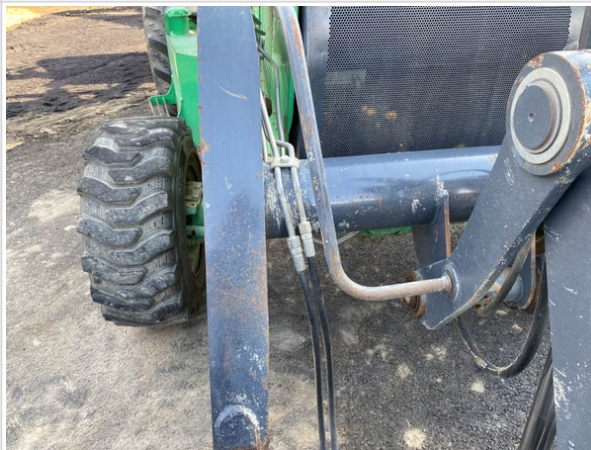
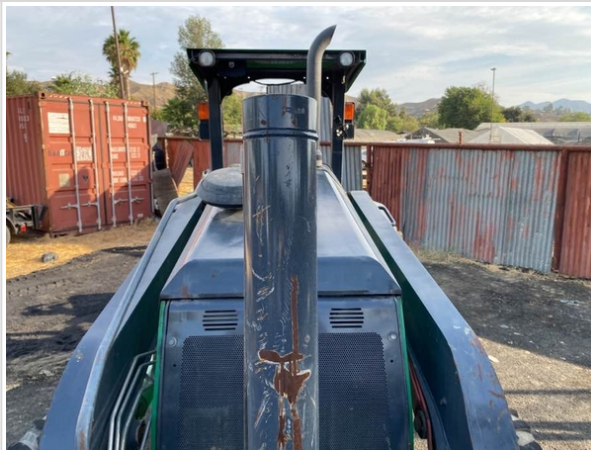
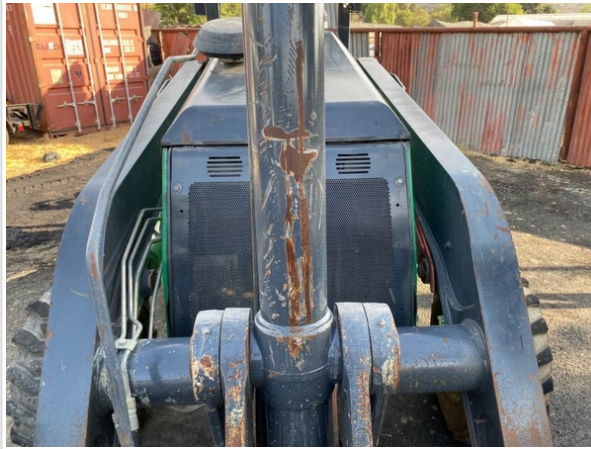
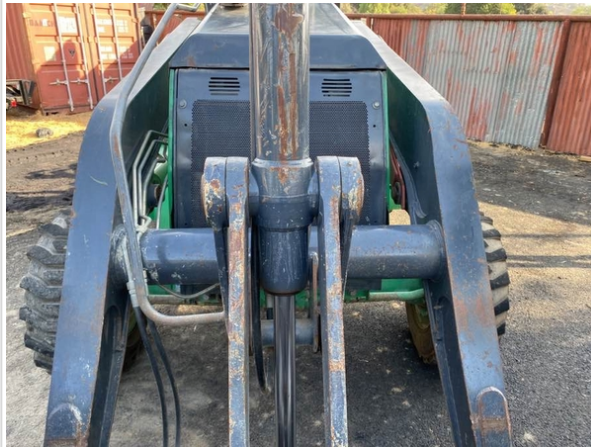
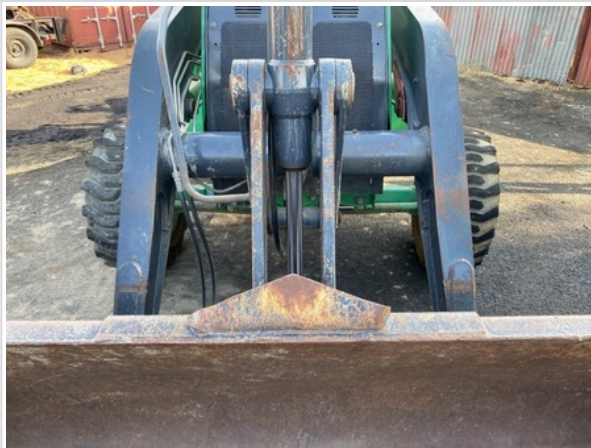
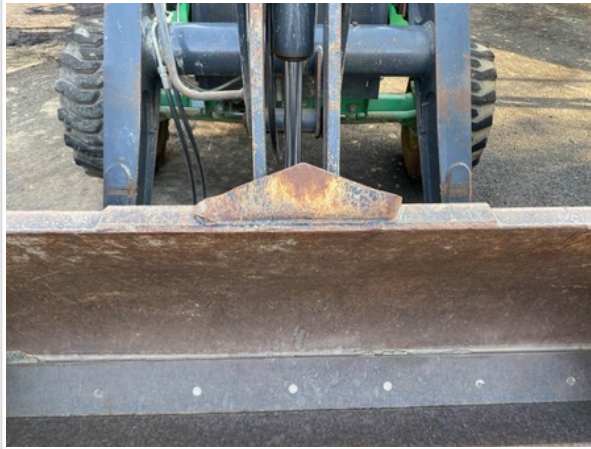
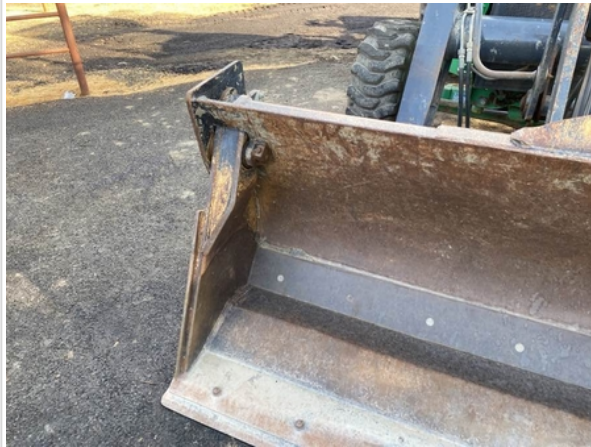
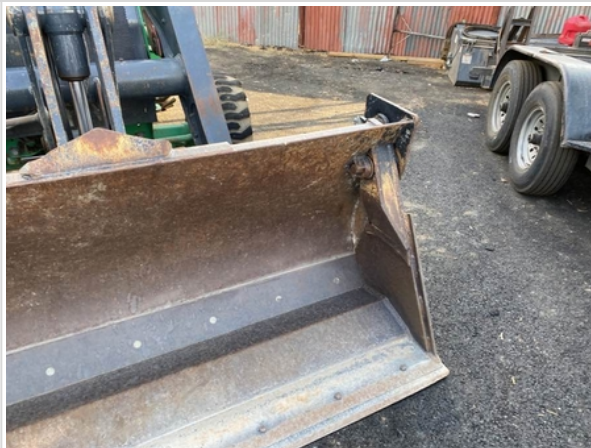
Front	3 - Normal Wear & Tear
Front Condition	Visible chipped paint or dents, Areas of surface rust observed, Other (see comments)
Comments	Normal wear and tear
Front Photos

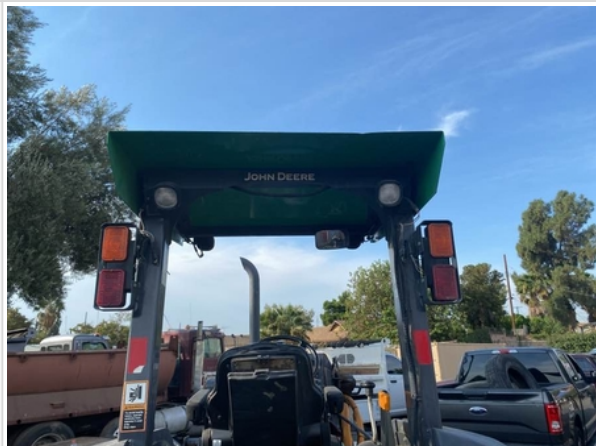
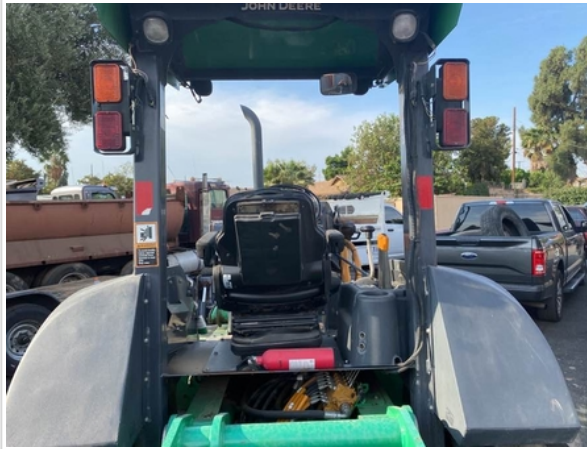
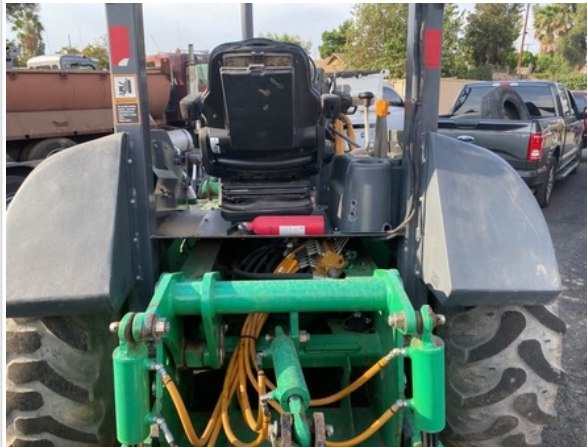
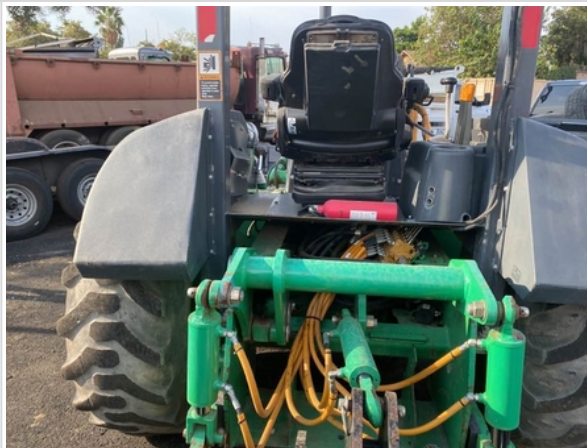
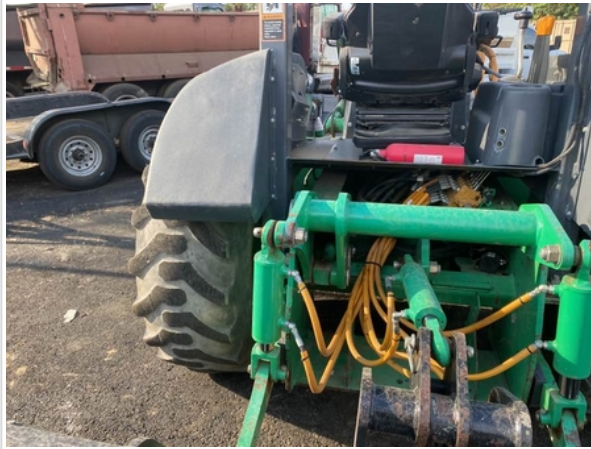
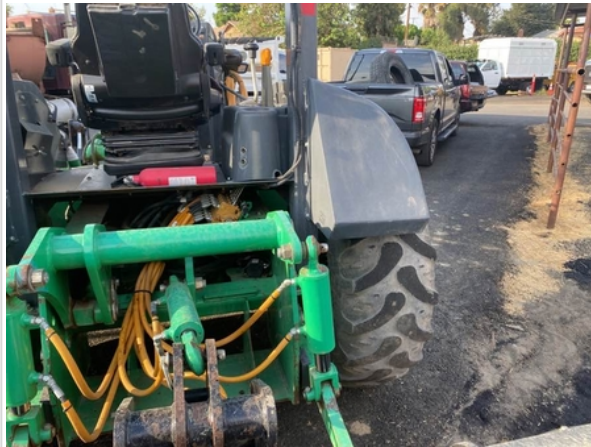
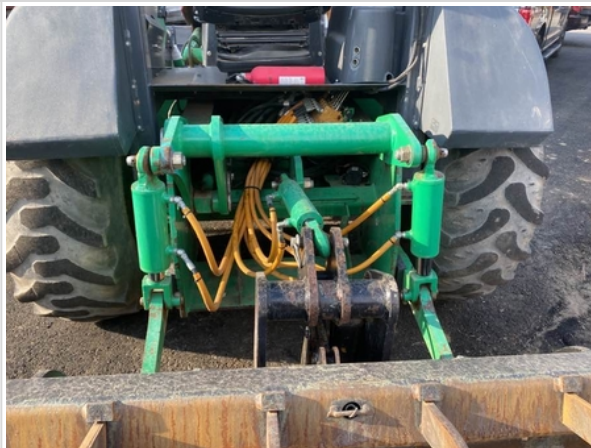
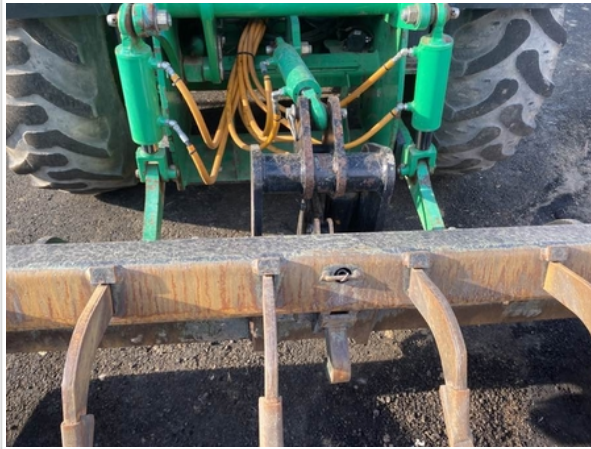
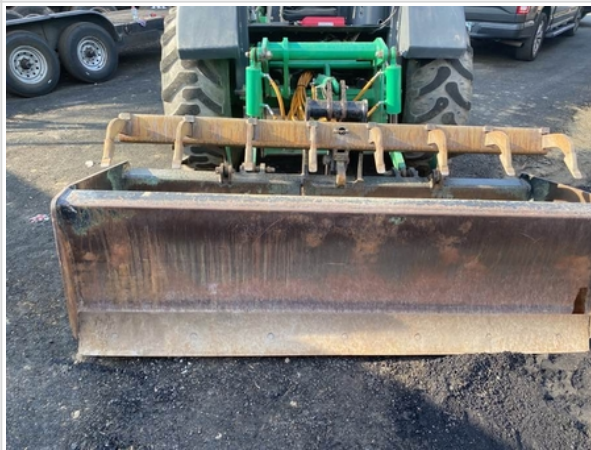
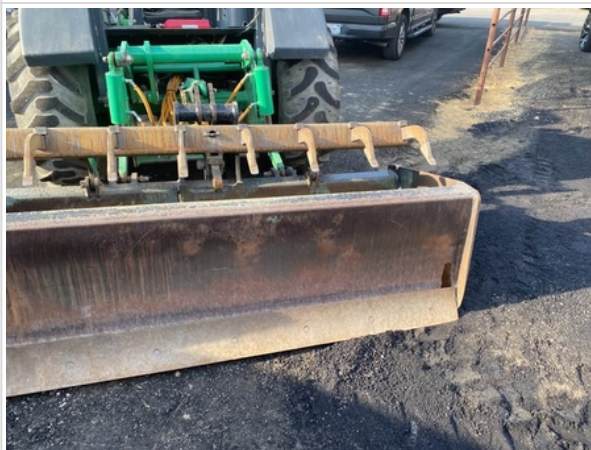
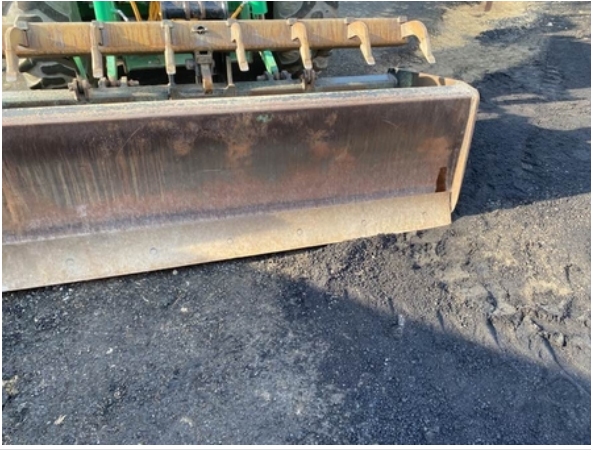
Rear	3 - Normal Wear & Tear
Rear Condition	No visible damage, Other (see comments)
Comments	Normal wear and tear on gannons
Rear Photos

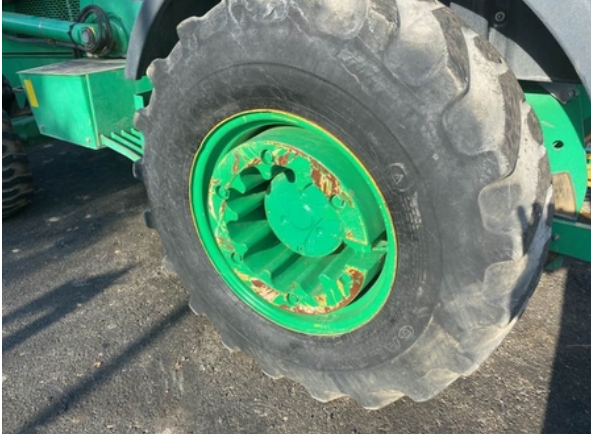
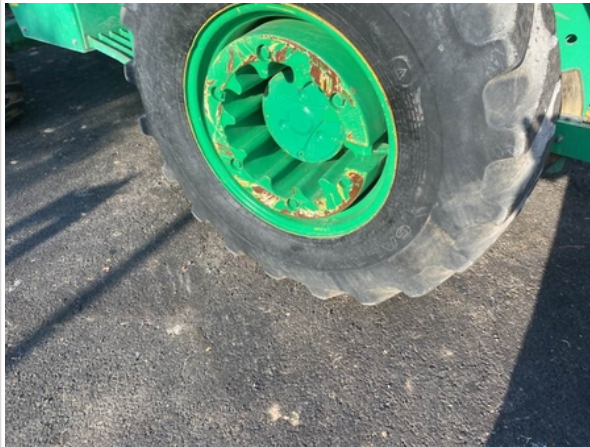
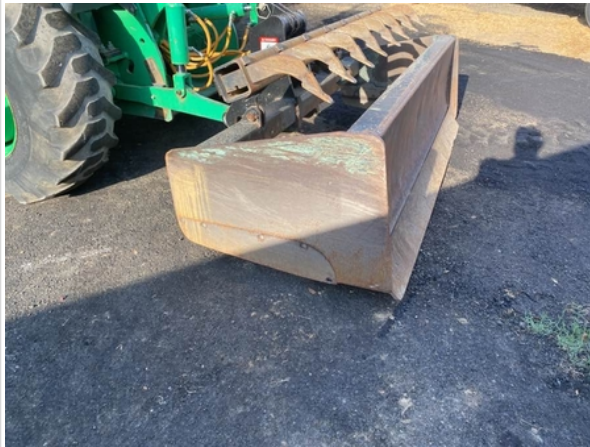
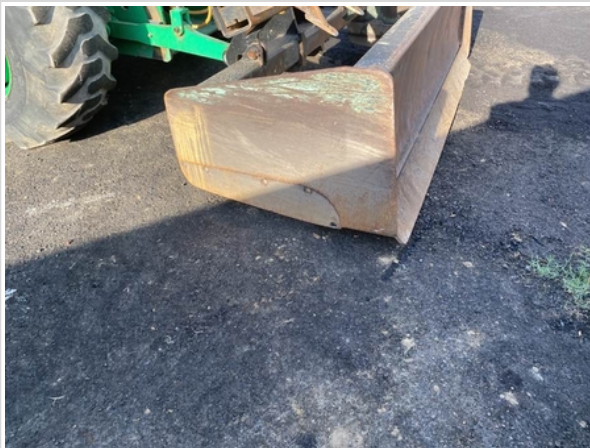
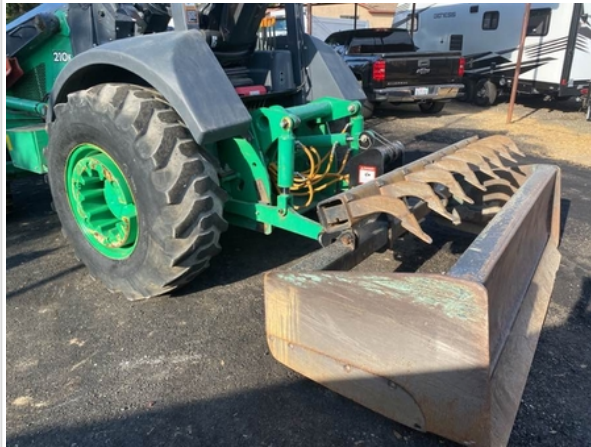
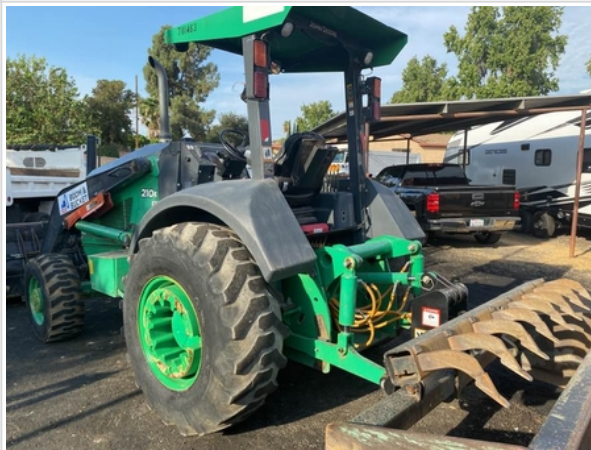
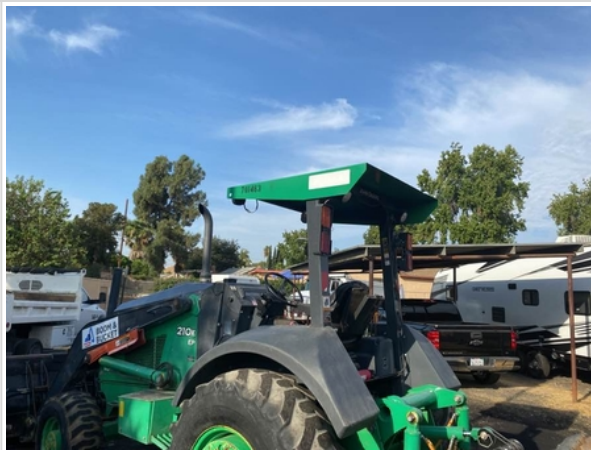
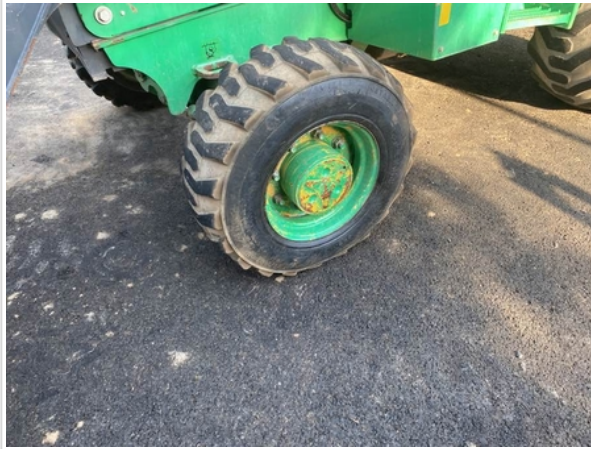
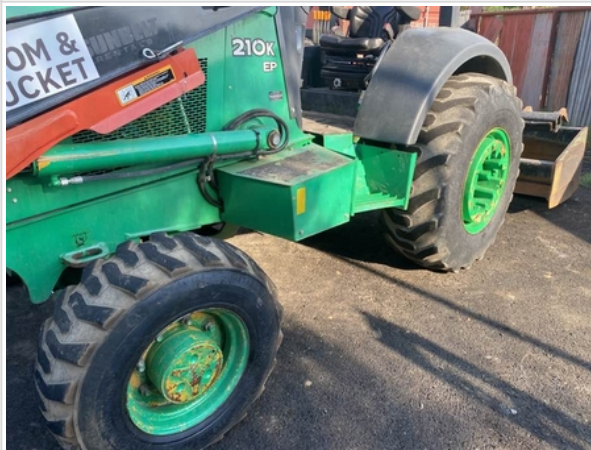
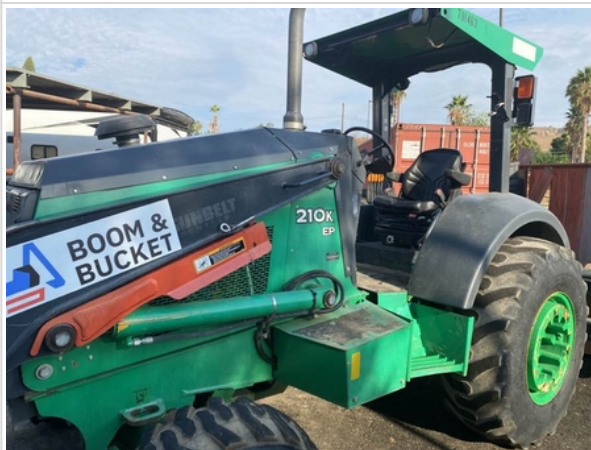
Left	3 - Normal Wear & Tear	
Left Condition	No visible damage, Other (see comments)	
Comments	Rear wheel scuff marks	
Left Photos

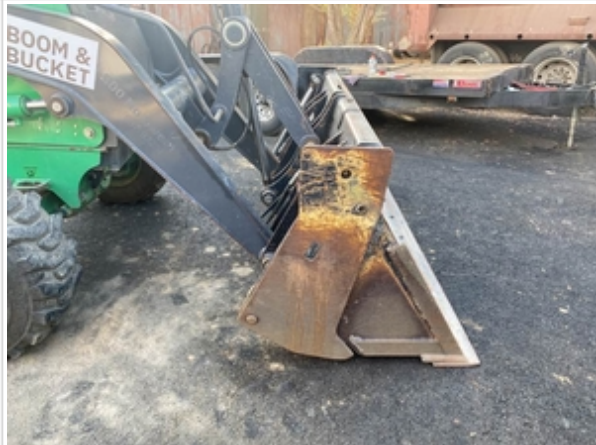
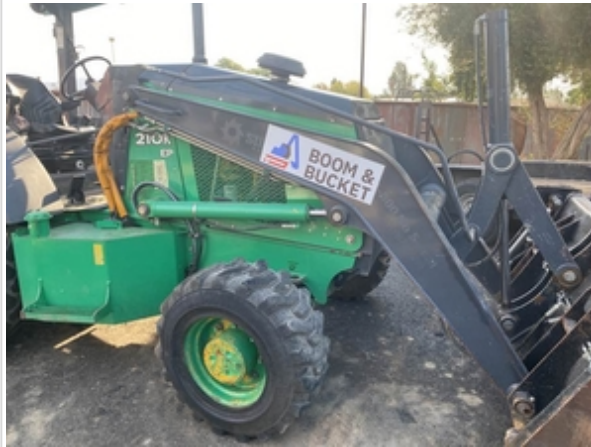
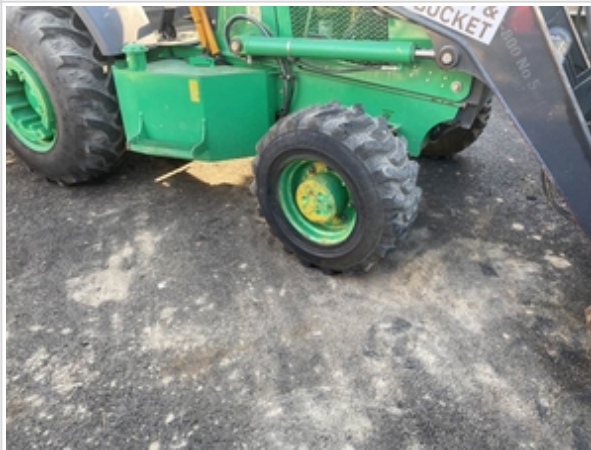
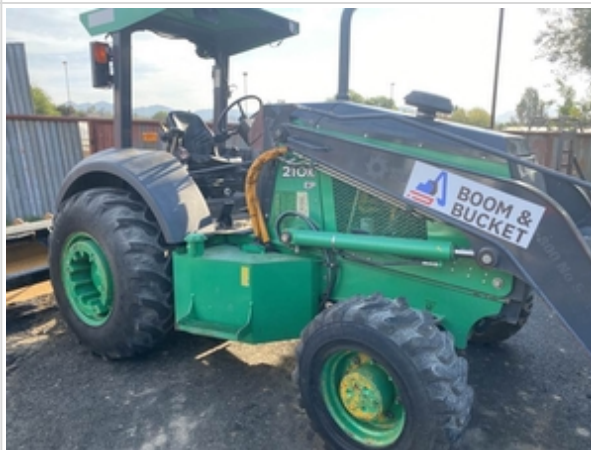
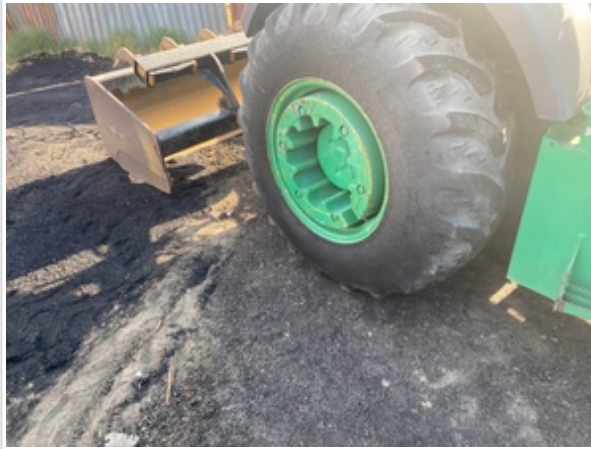
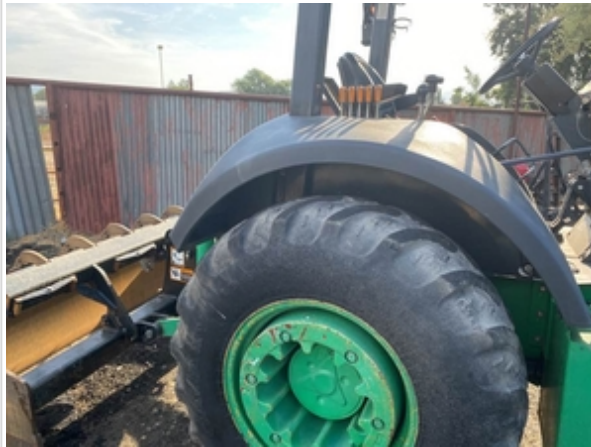
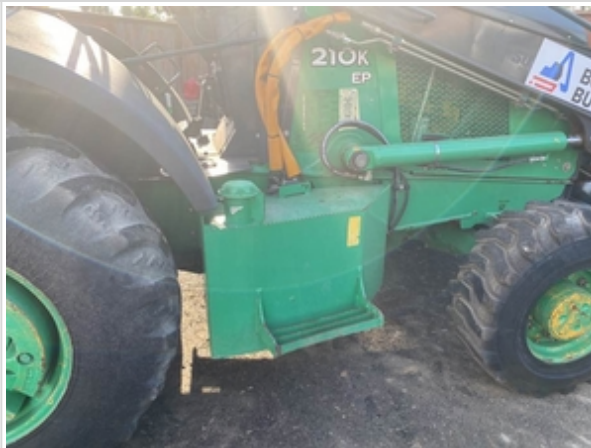
Right	3 - Normal Wear & Tear
Right Condition	No visible damage
Right Photos

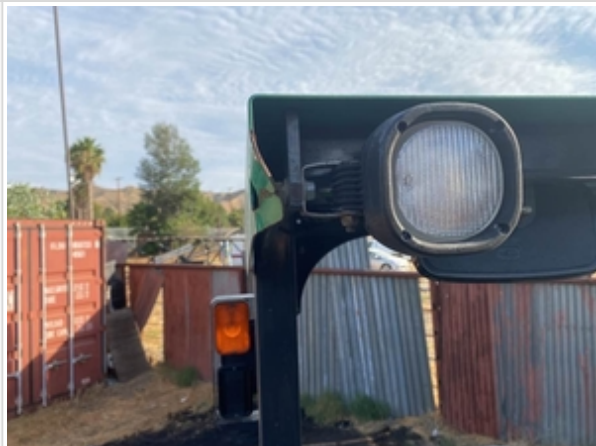
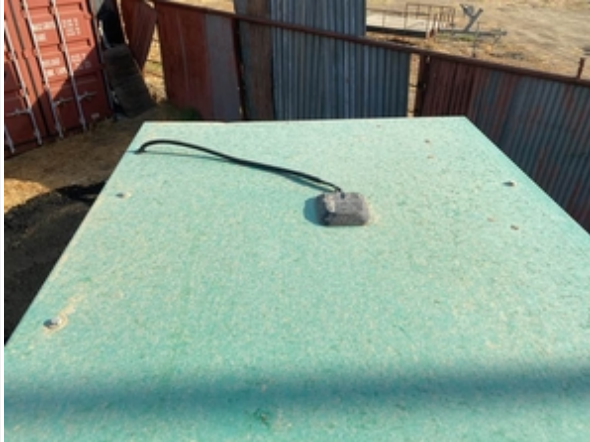
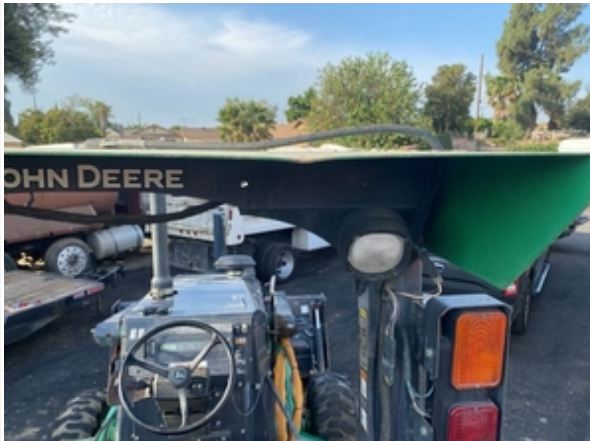
Upper	3 - Normal Wear & Tear
Upper Condition	Visible chipped paint or dents, Other (see comments)
Comments	Small dents on corner and rear
Upper Photos

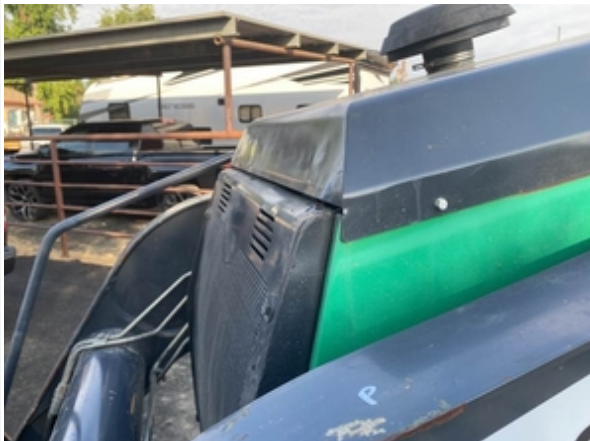
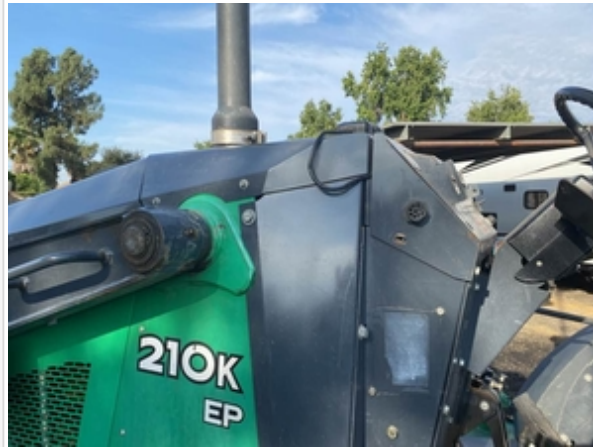
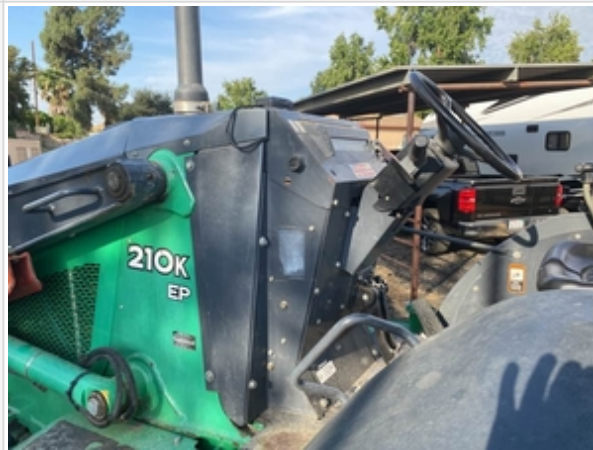
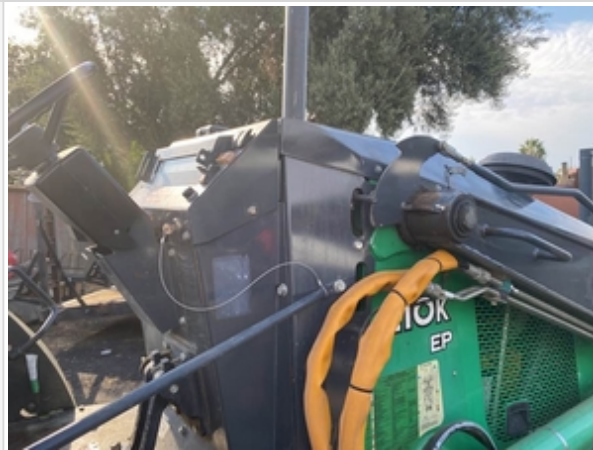
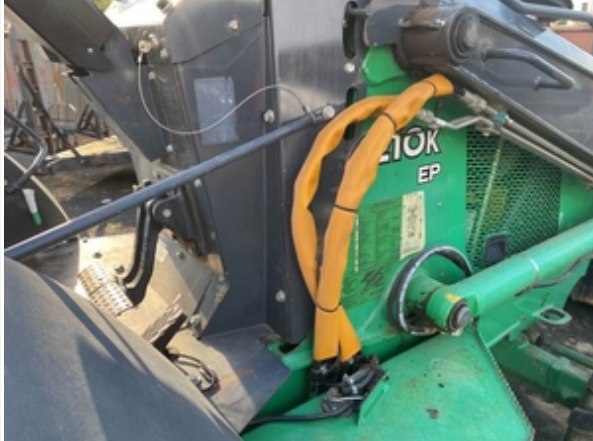
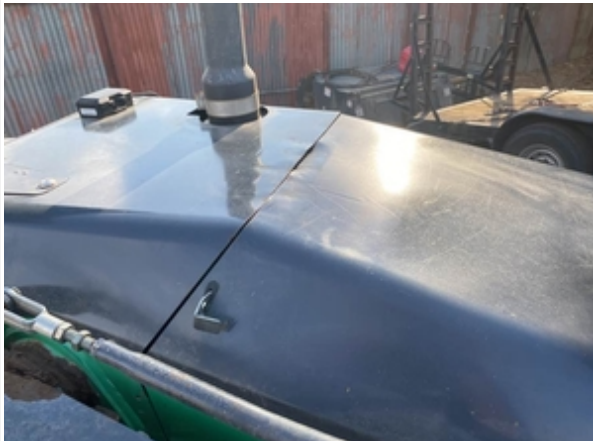
Body Panels (Any Rust Damage?)	3 - Normal Wear & Tear	
Body Panel Condition	No visible damage, good paint condition and panel fitment, Other (see comments)	
Comments	Small dents	
Body Panels Photos

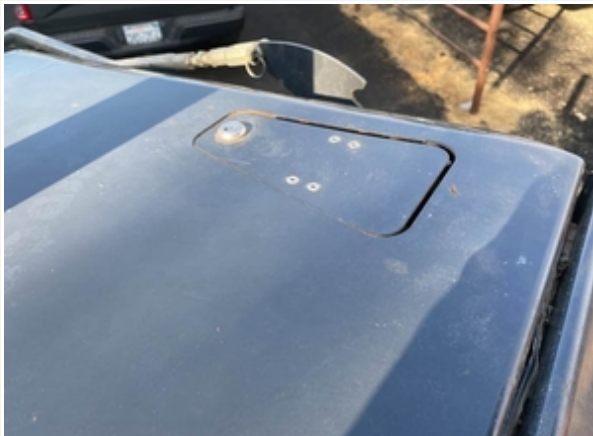
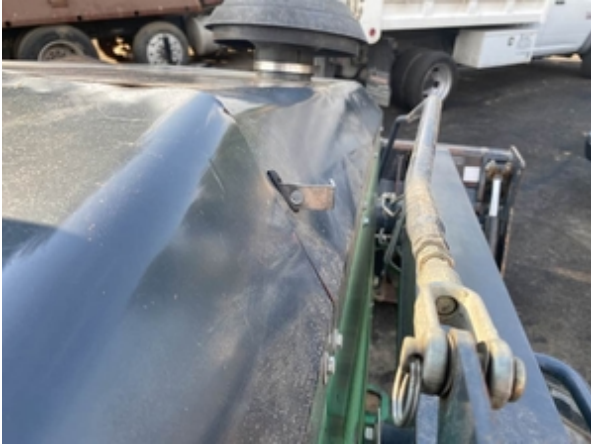
Doors / Canopy Latches	3 - Normal Wear & Tear
Doors / Canopy Latches Condition	No visible damage
Doors / Canopy Latches Photos

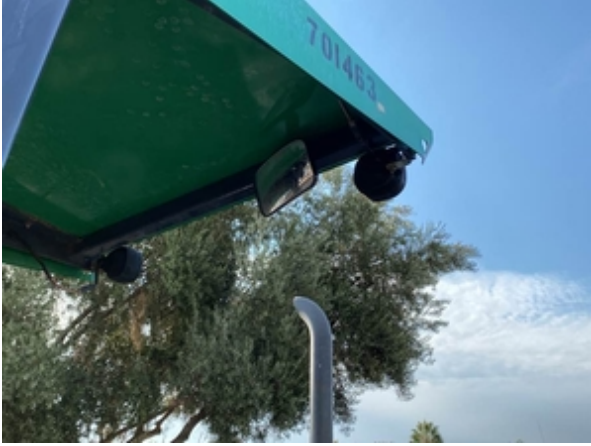
Glass Condition	0
Mirrors	3 - Normal Wear & Tear
Mirror Condition Notes	Mirrors present and intact, no visible damage
Mirrors Photos

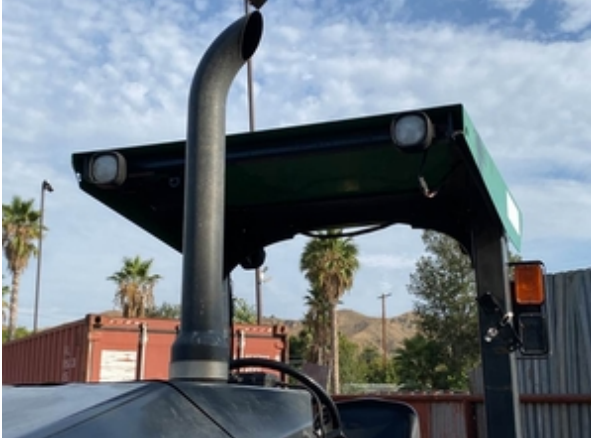
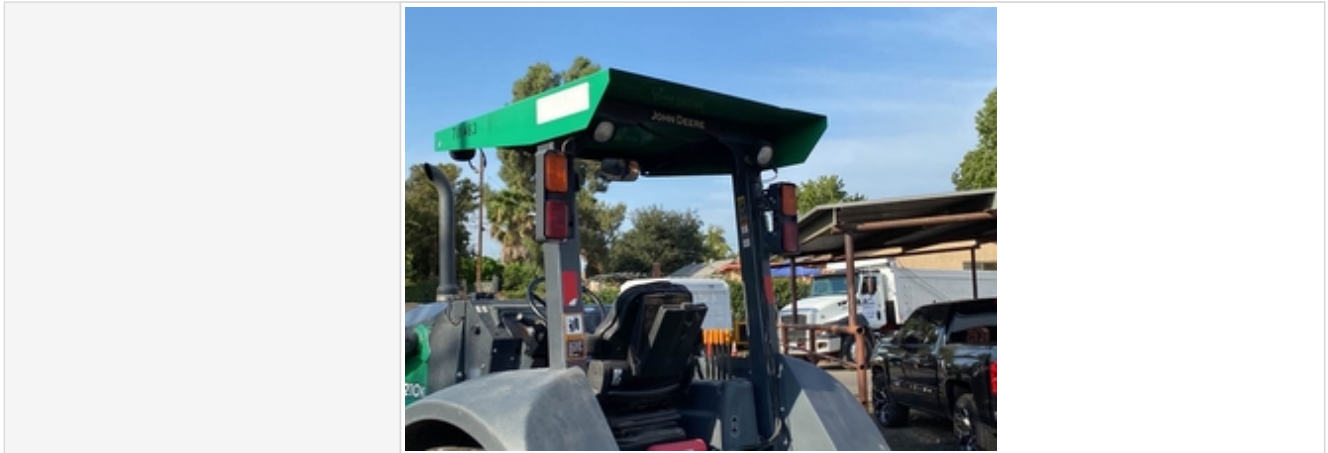
Lighting System	2 - Above Average Wear
Lighting System Condition	Overall lighting system is non-operational, Other (see comments)
Lighting System Photos

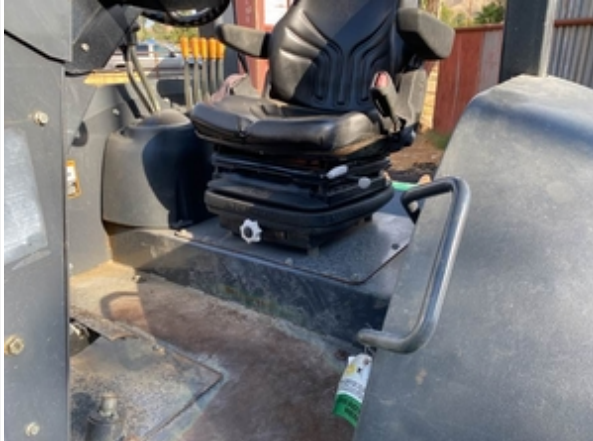
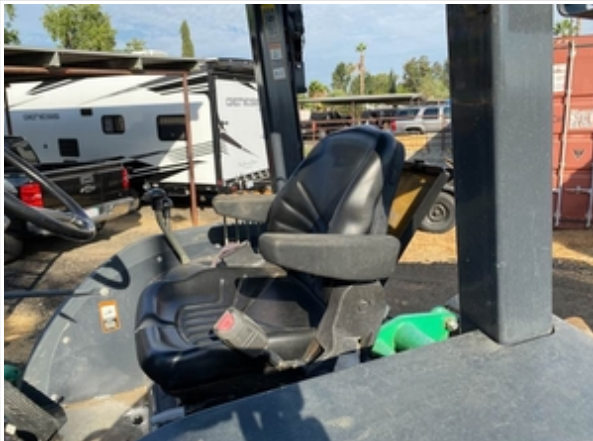
Operator's Seat & Arm Rests	3 - Normal Wear & Tear	
Operator's Seat & Arm Rests Condition	Seat(s) in good condition, no stains or tears in upholstery	
Operator's Seat & Arm Rests Photos

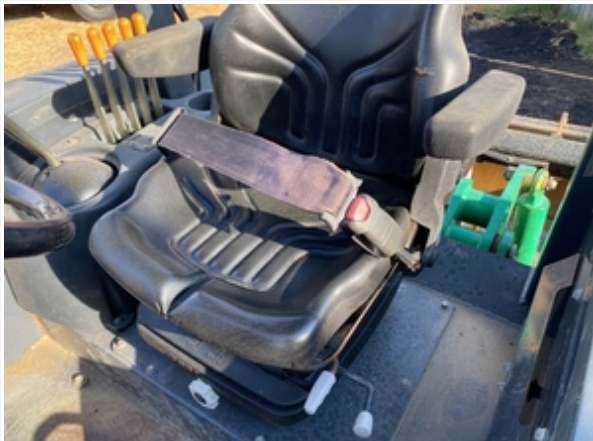
Seat Belt	3 - Normal Wear & Tear
Seat Belt Condition	Seat belt secures properly. Belt is intact and in good condition
Seat Belt Photos

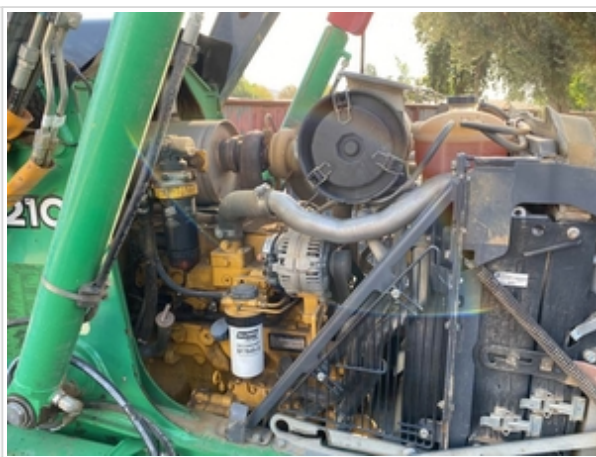
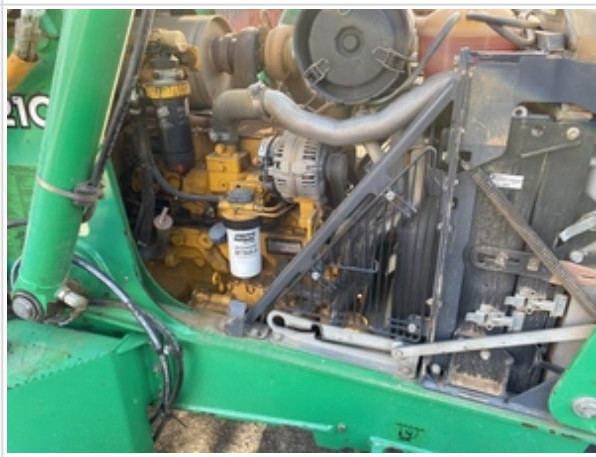
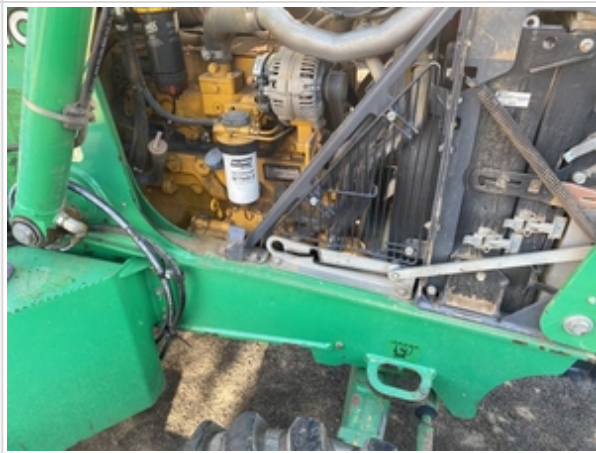
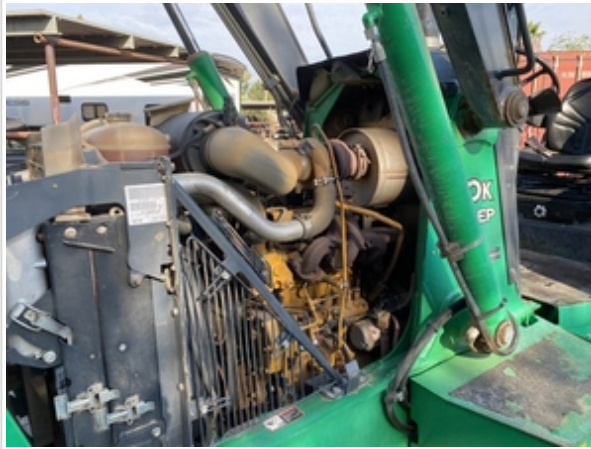
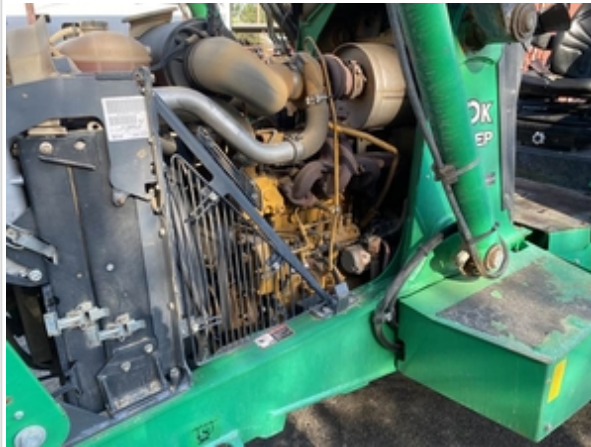
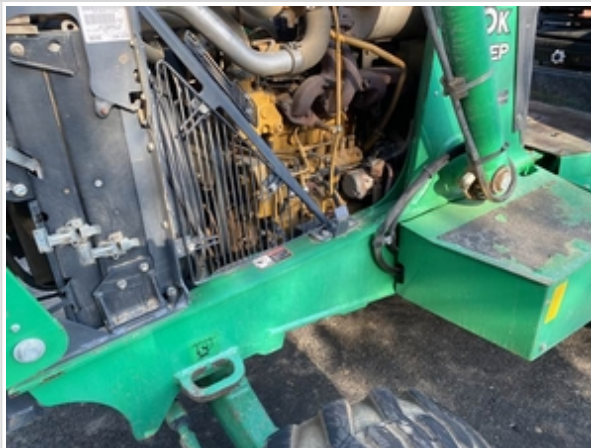
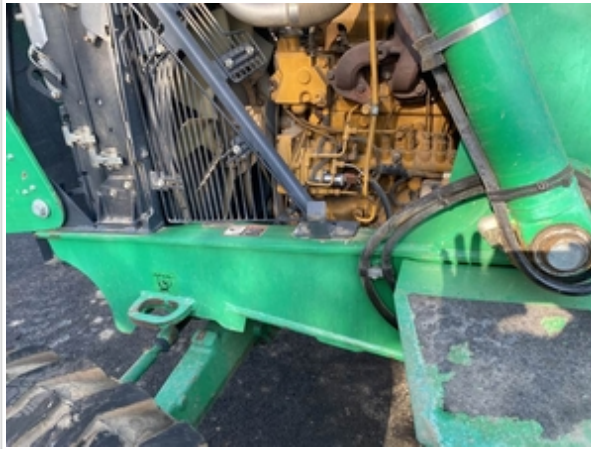
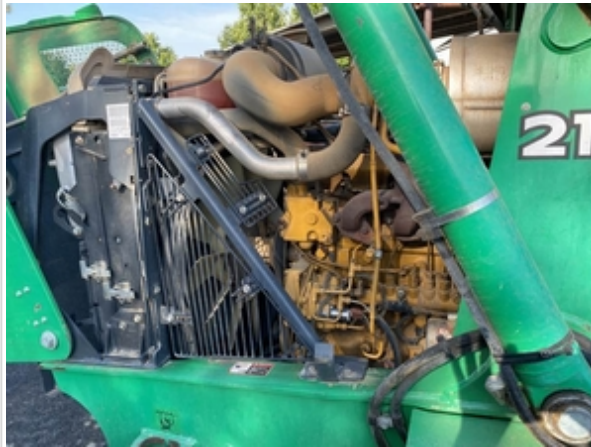
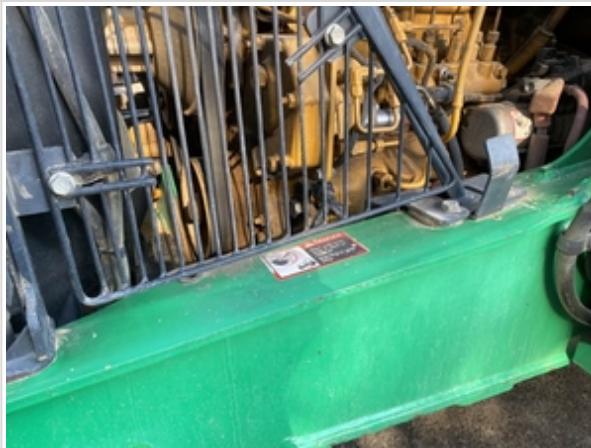
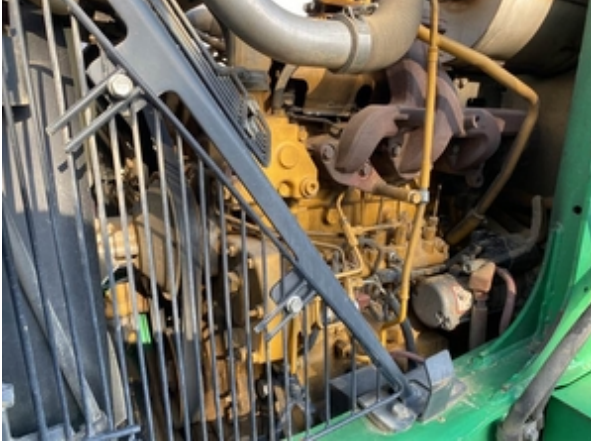
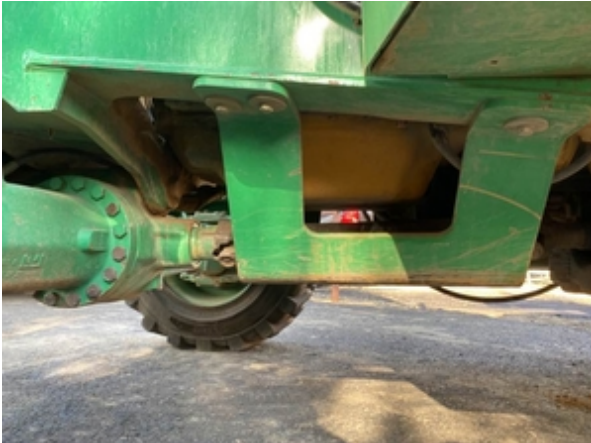
<p>Engine Photos</p>

Blow-by (Visual Observation Check)	No
Unusual Noises (Upon Start-up, Idle, Shutdown)	No
Unusual Noise Notes	No unusual noises heard
Engine Smoke (Upon Start-up, Idle, Shutdown)	No
Engine Smoke Notes	Engine smoke observed upon start up, Continuous engine smoke observed during operation
Comments	Engine smoke consistent from start up to being put under load. Not heavy smoke but visible
Engine Exhaust Color	Black
Battery	3 - Normal Wear & Tear

Comments	Dried oil seepage seen from valve cover area
Oil Color / Appearance	3 - Normal Wear & Tear
Oil Color / Appearance Notes	Clean oil appearance, no signs of cross contamination, Appropriate oil level
Fuel Leaks	No
Equipped with DPF (Diesel Particulate Filter)	No
Requires DEF (Diesel Exhaust Fluid)	No
Overall Engine Appearance	Dusty & dry
Overall Engine Comments	Engine looks healthy with no active leaks found. Air filter should be replaced soon. A service is recommended. Slight engine smoke under load.

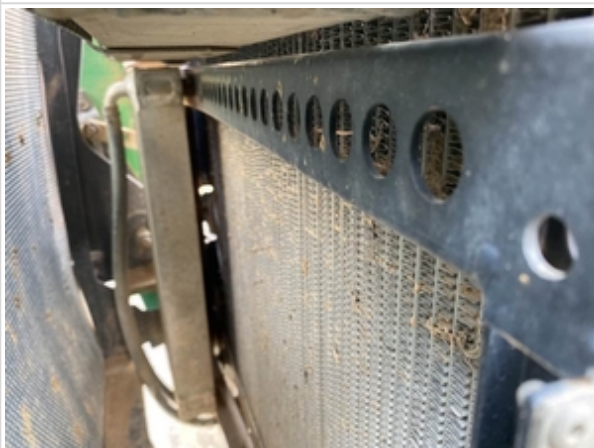
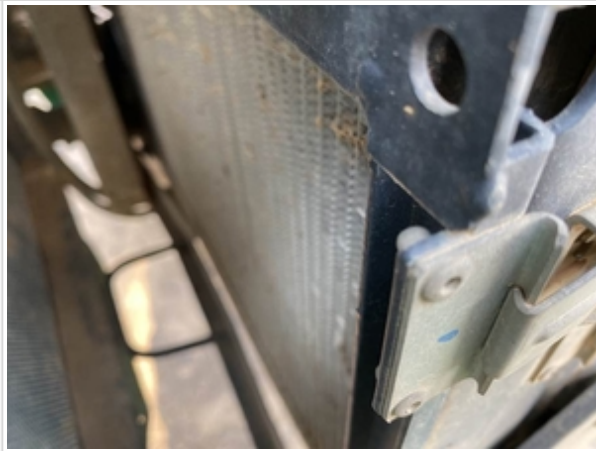
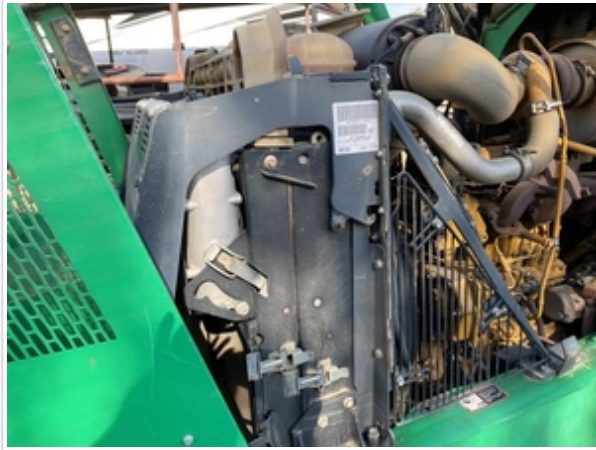
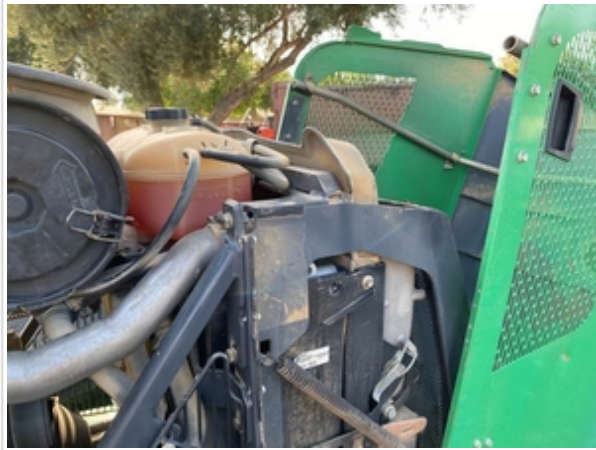
Radiator	3 - Normal Wear & Tear
Radiator Condition	Radiator fins & components appear to be in good working order, no signs of damage or leaks
Radiator Photos

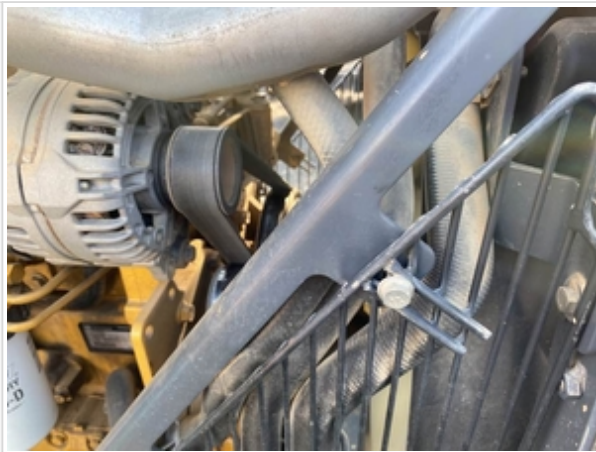
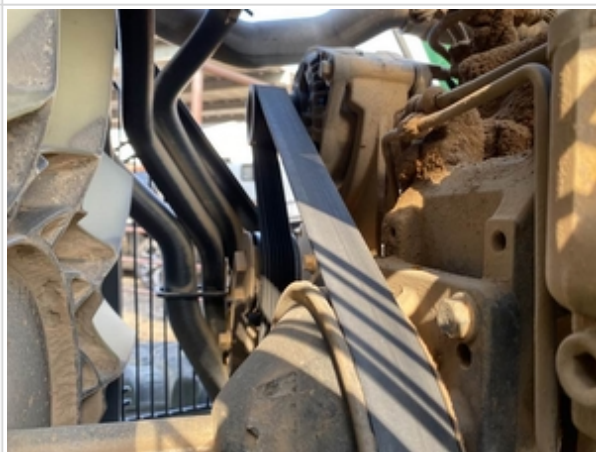
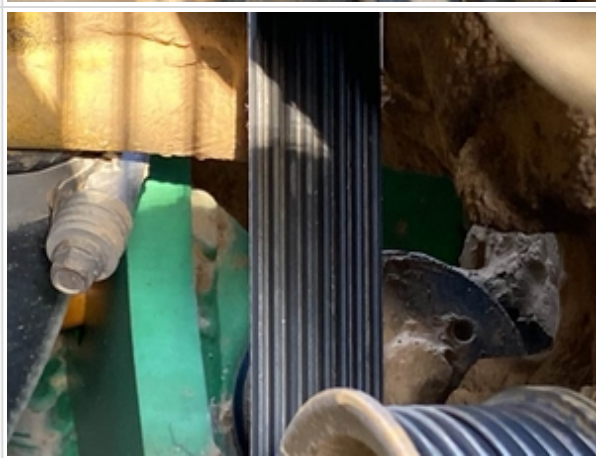
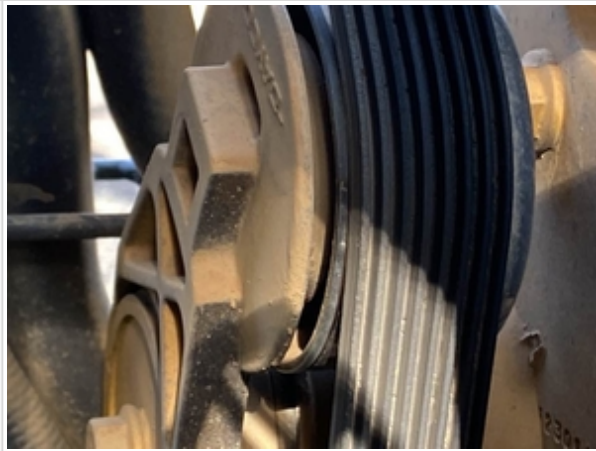
<p>Belt Photos</p>

Belts	3 - Normal Wear & Tear
Belt Condition	Belts appear in good condition & alignment with proper tension

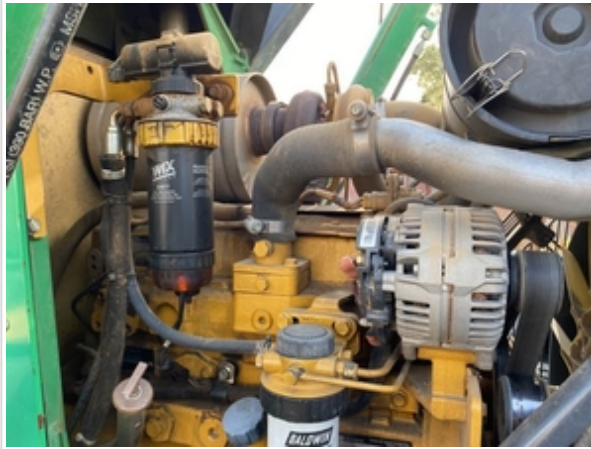
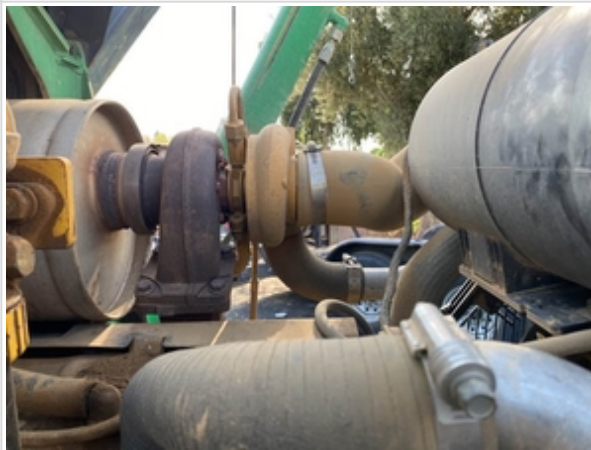
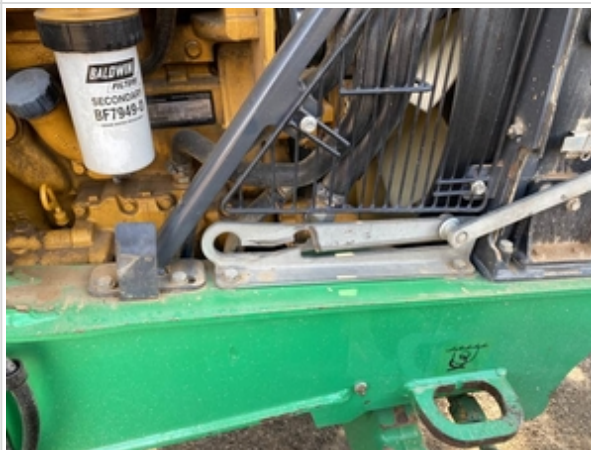
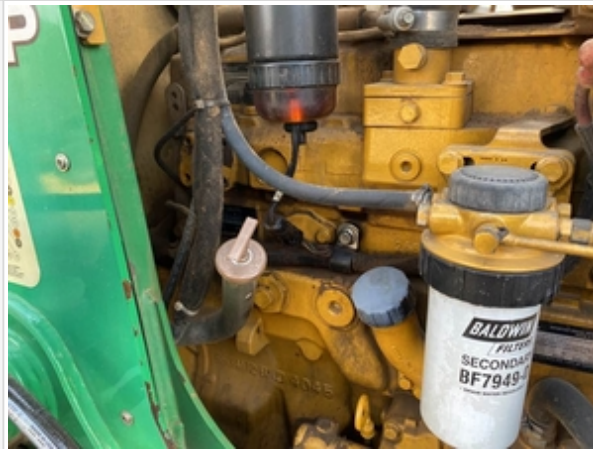
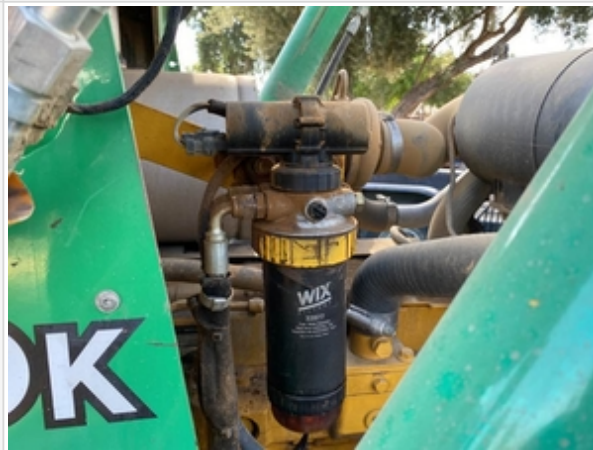
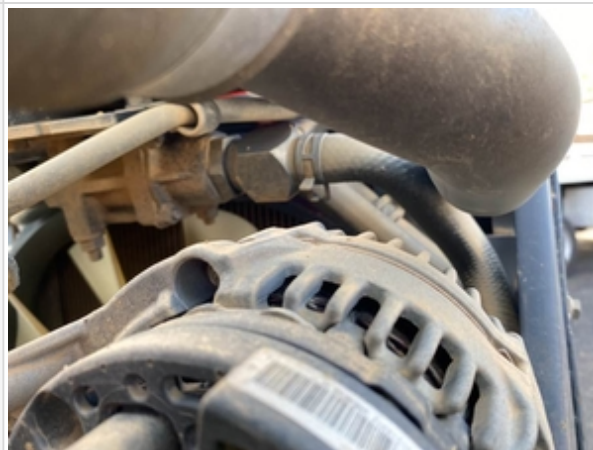
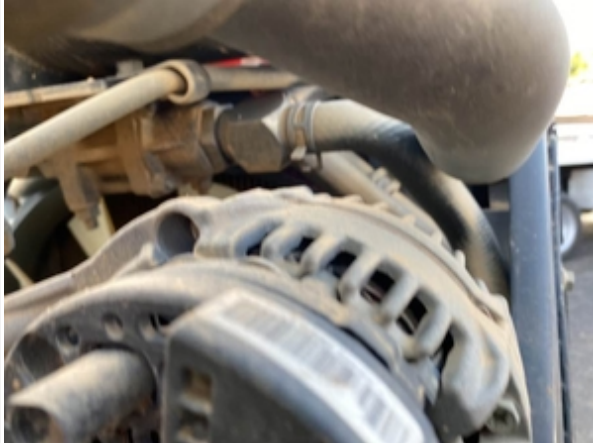
Hoses	3 - Normal Wear & Tear	
Hose Condition	Firm, pliant hoses with no signs of wear or leaks	
Hose Photos

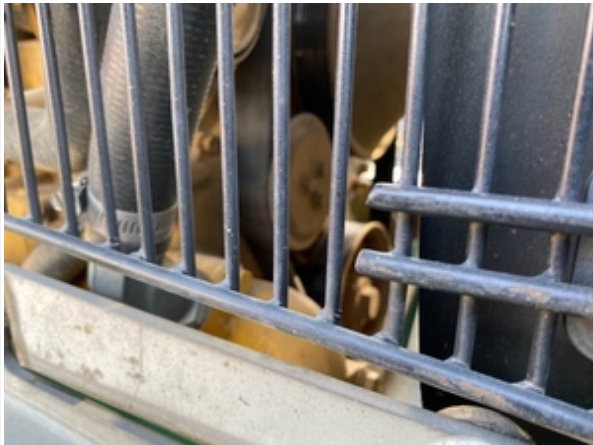
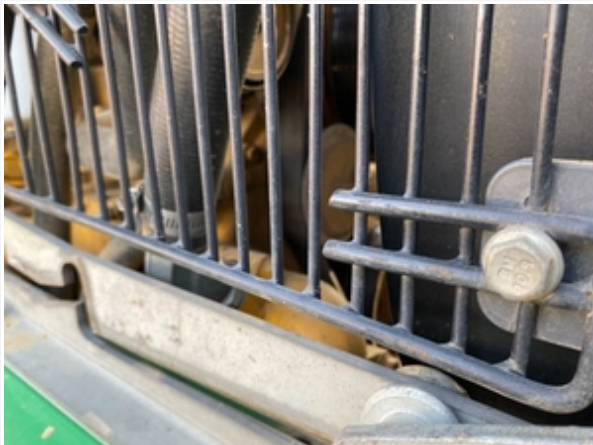
Water Pump	3 - Normal Wear & Tear
Water Pump Condition	No unusual pump noises heard
Water Pump Photos
