Inspection Report (Skip Loader)

Year	2016
Make	John Deere
Model	210K
Serial Number	1T8210EKTFG892310
Hour Meter Reading	4,159.3
Previous Application (e.g., earth moving, mining, demolition, etc)	Asphalt Paving

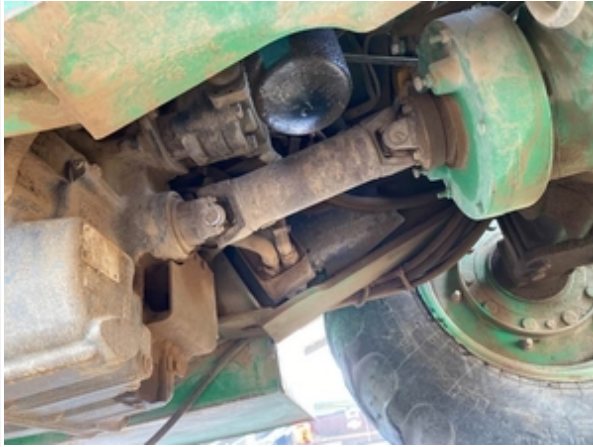
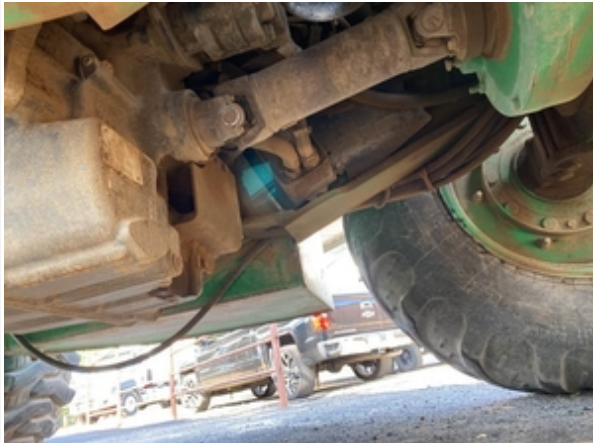
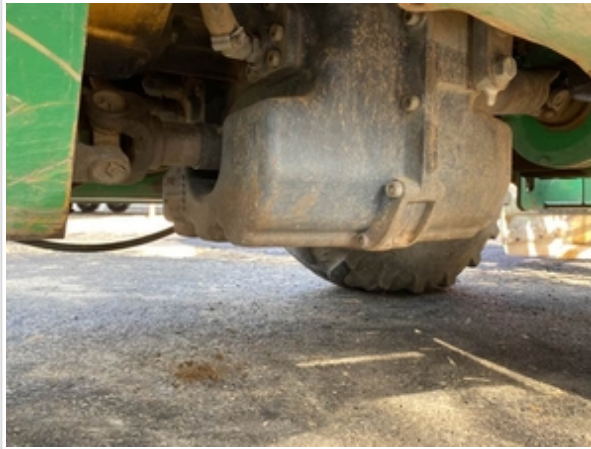
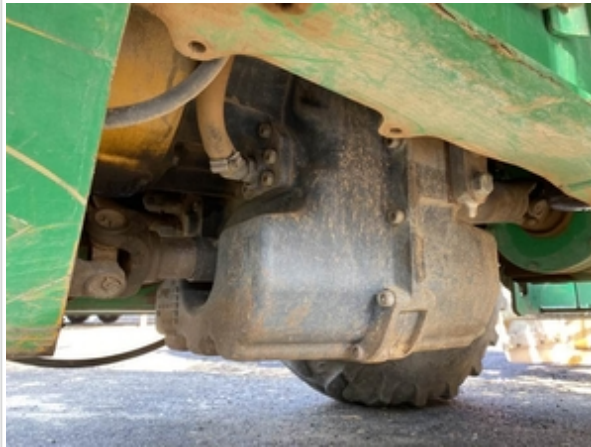
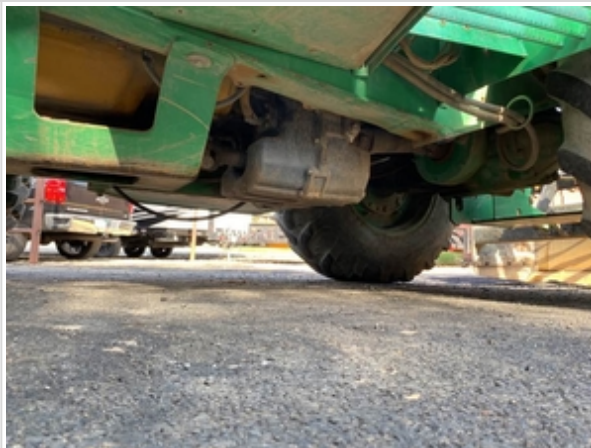
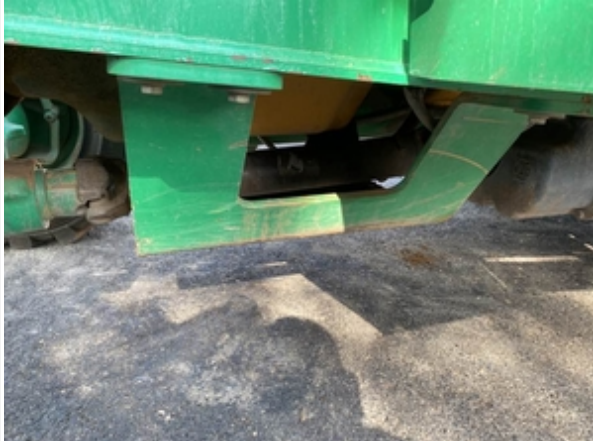
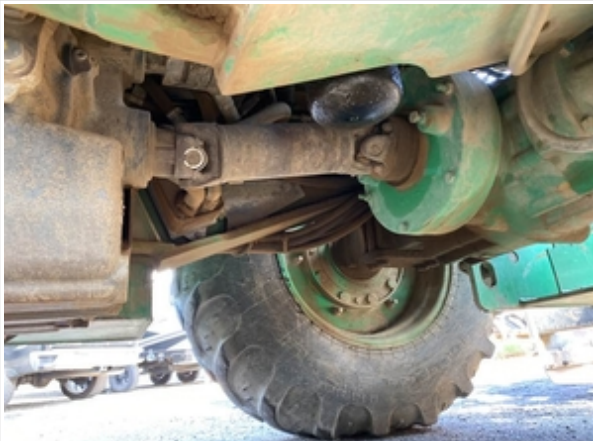
Transmission Info	4 x 4
Transmission	3 - Normal Wear & Tear
Transmission Condition	No unusual noises or vibrations
Transmission Photos

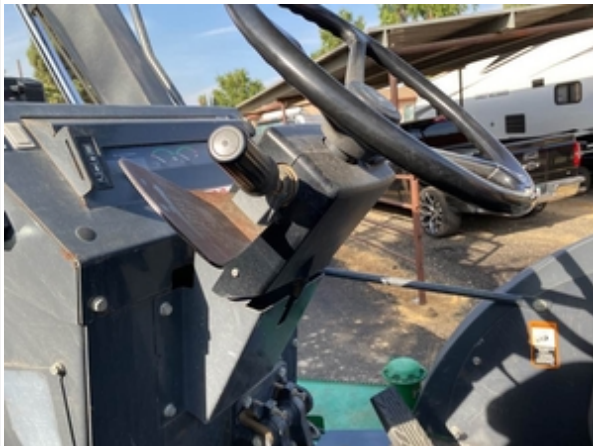
Clutch	0	
Shift Lever	3 - Normal Wear & Tear	
Shift Lever Condition	Good forward and reverse function	
Shift Level Photos

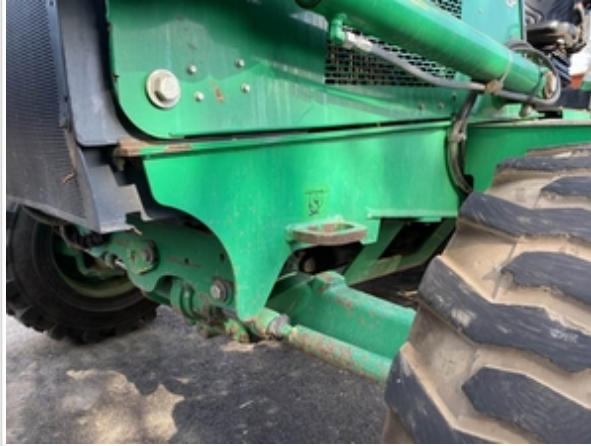
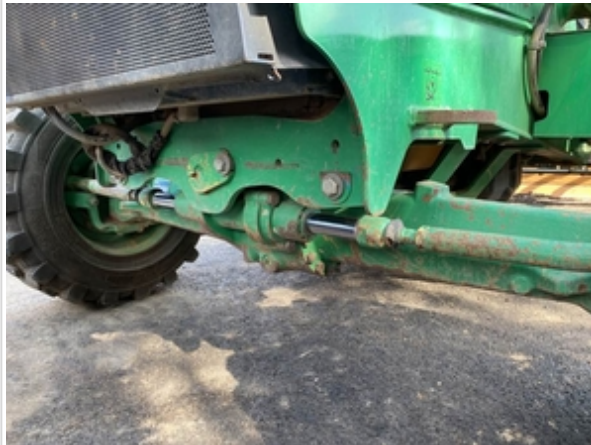
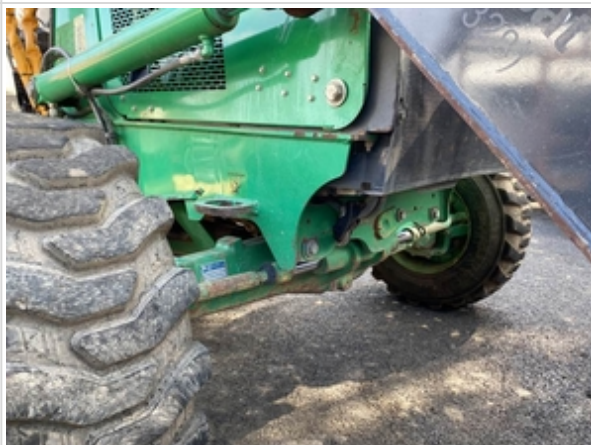
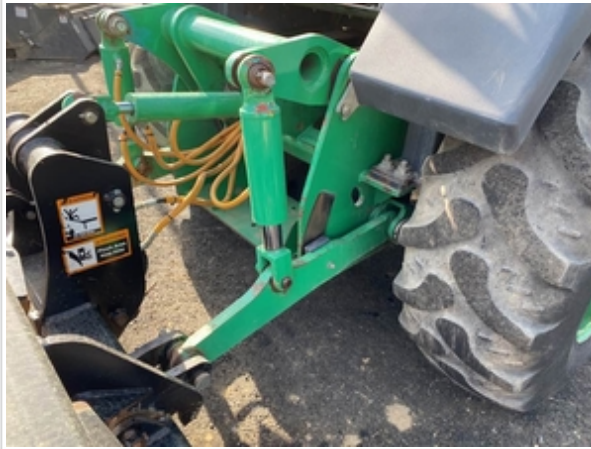
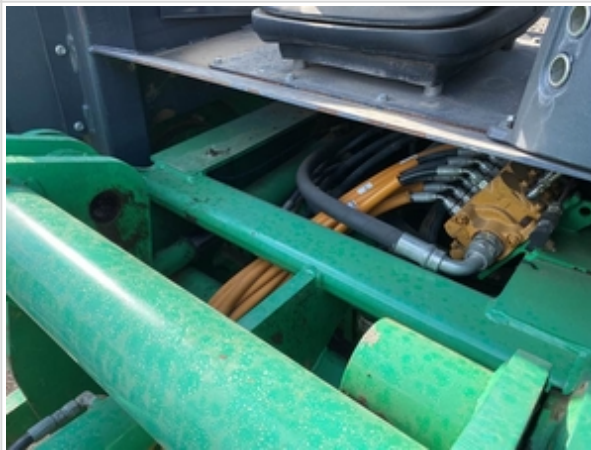
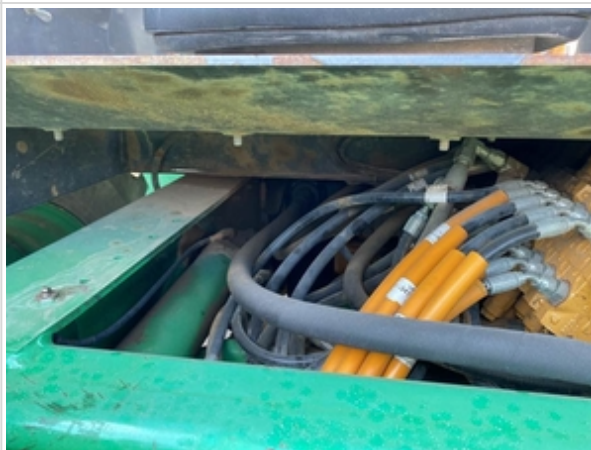
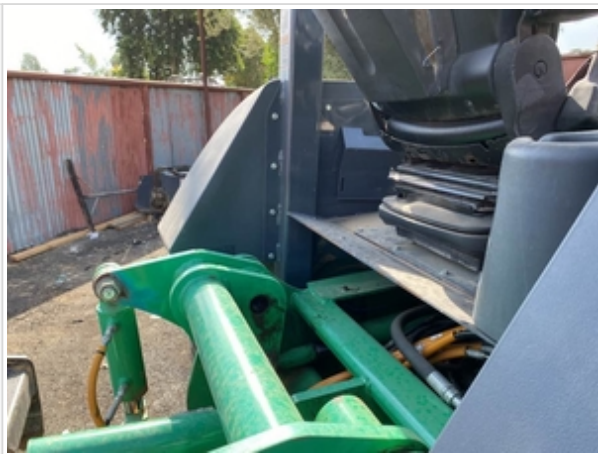
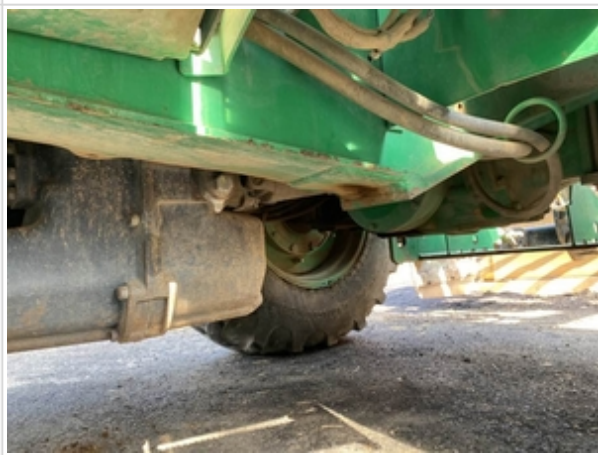
Frame Photos

Instructions	<p>Evaluate the following on a 4 point scale (leave comments where an explanation is appropriate):</p> <p>4 = Like New, Recently Replaced 3 = Normal Wear & Tear 2 = Above Average Wear 1 = Service Required</p>
Frame	3 - Normal Wear & Tear

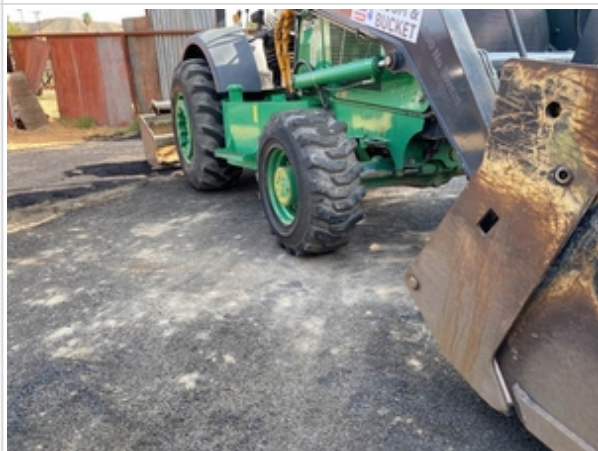
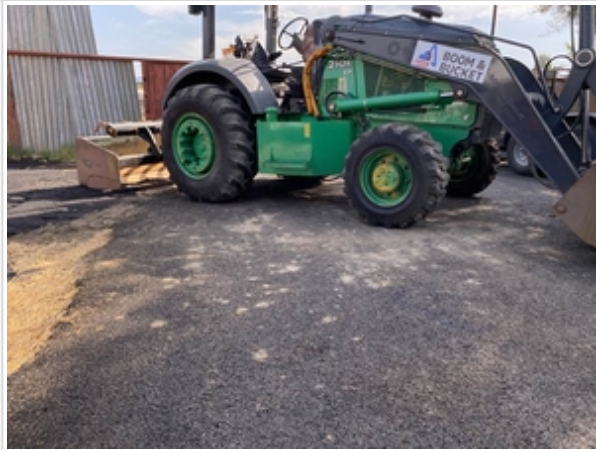
<p>Stance</p>	<p>3 - Normal Wear & Tear</p>	
<p>Stance Photos</p>

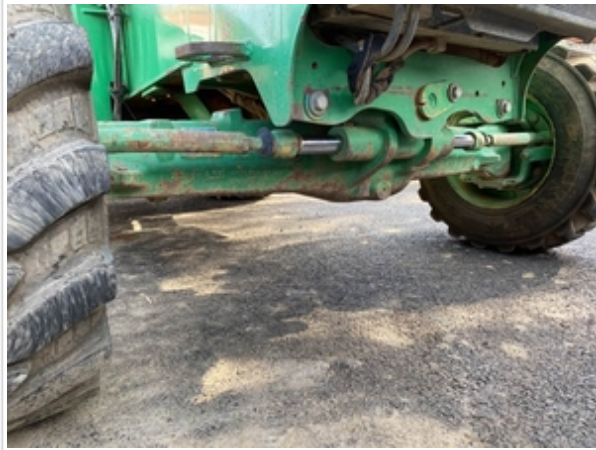
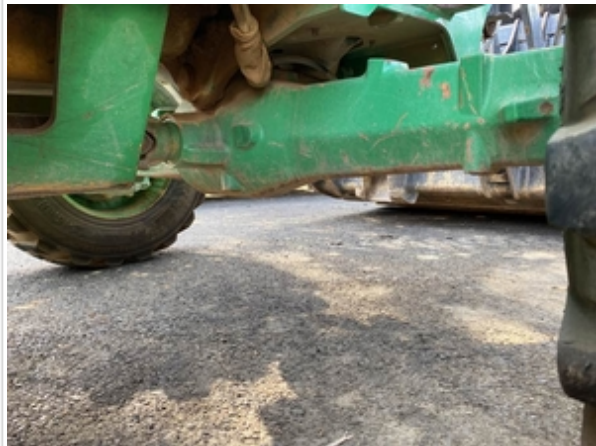
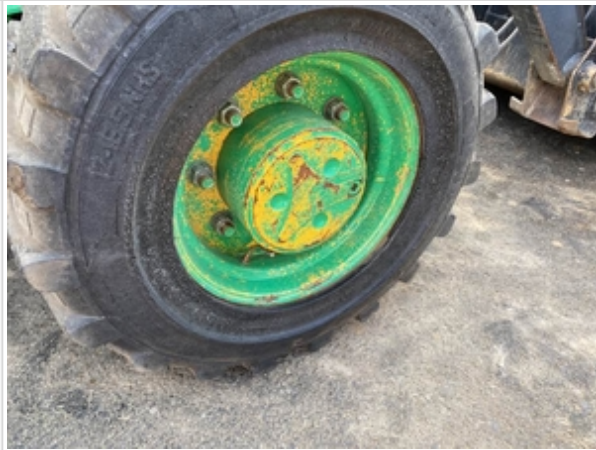
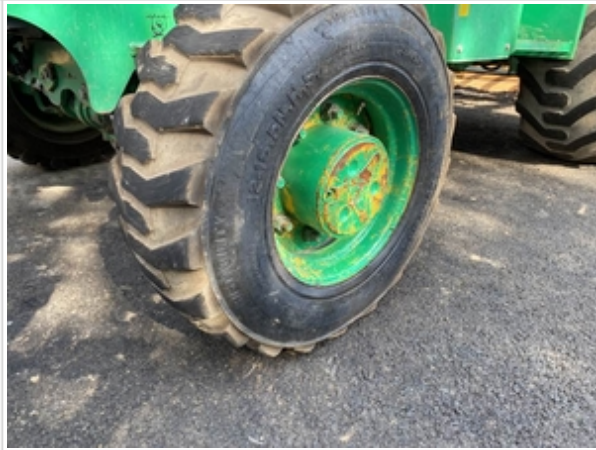
<p>Front Axle Appearance</p>	<p>3 - Normal Wear & Tear</p>
<p>Front Axle Appearance Photos</p>

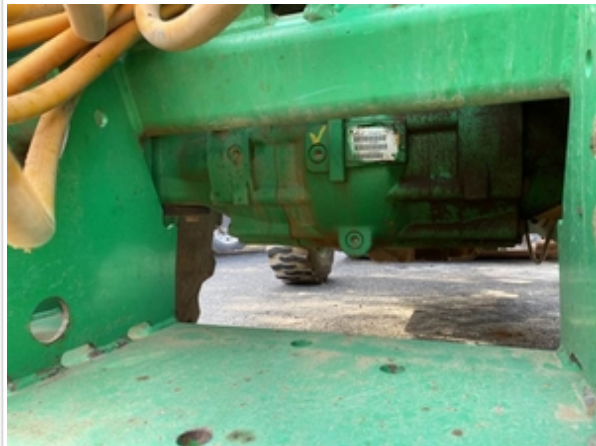
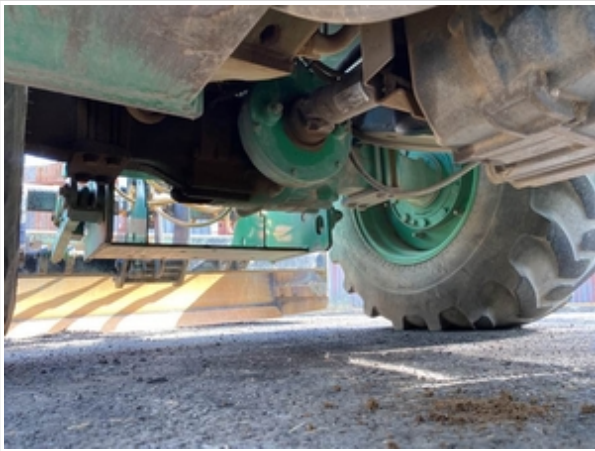
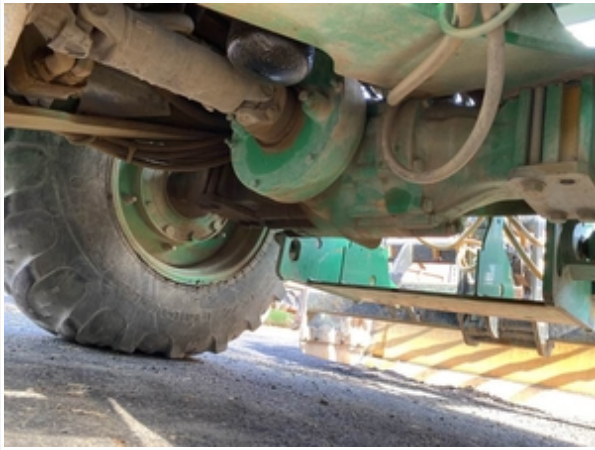
<p>Rear Axle Appearance</p>	<p>3 - Normal Wear & Tear</p>
<p>Rear Axle Appearance Photos</p>

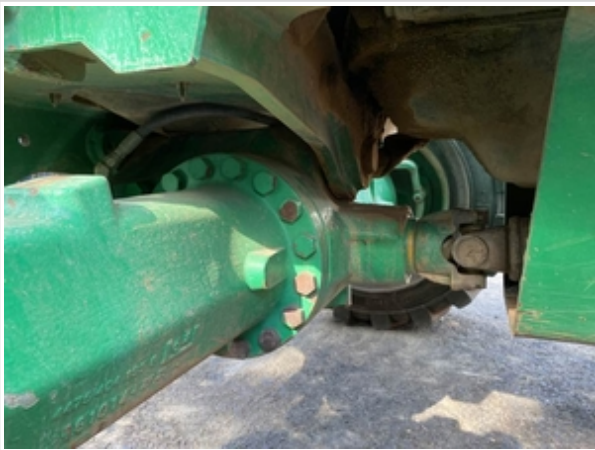
Oscillating Pin Appearance	3 - Normal Wear & Tear	
Oscillating Pin Appearance Photos

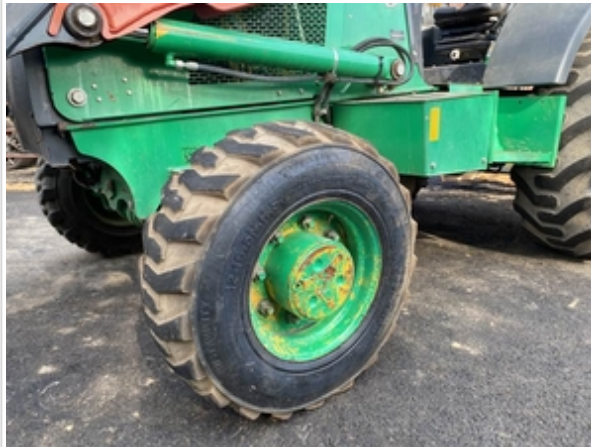
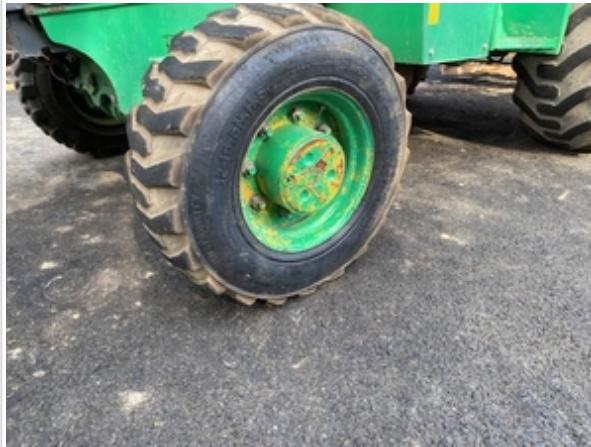
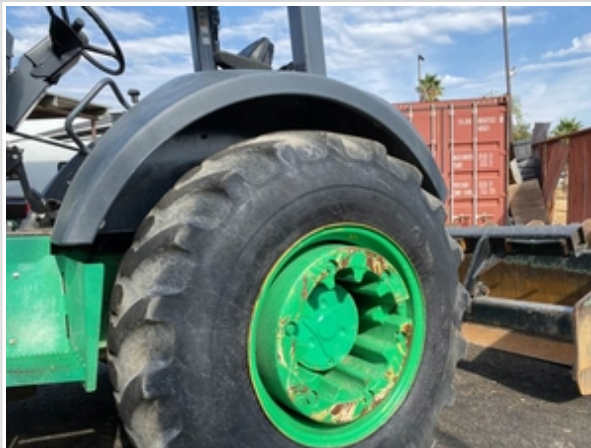
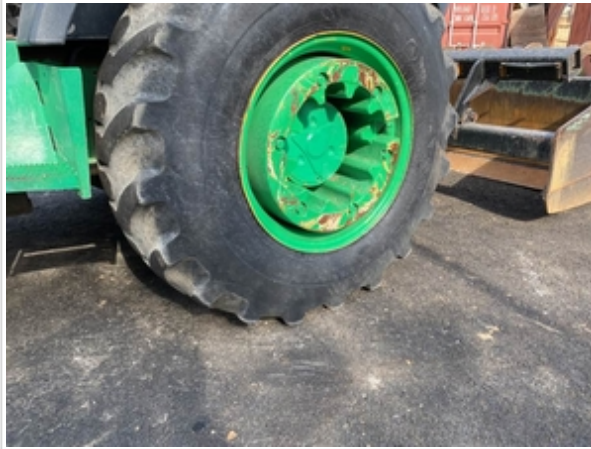
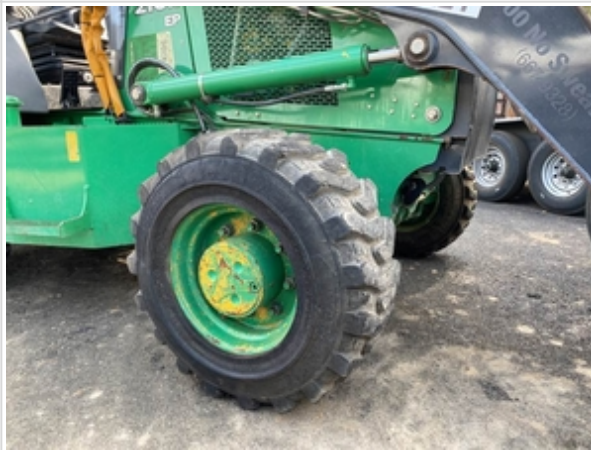
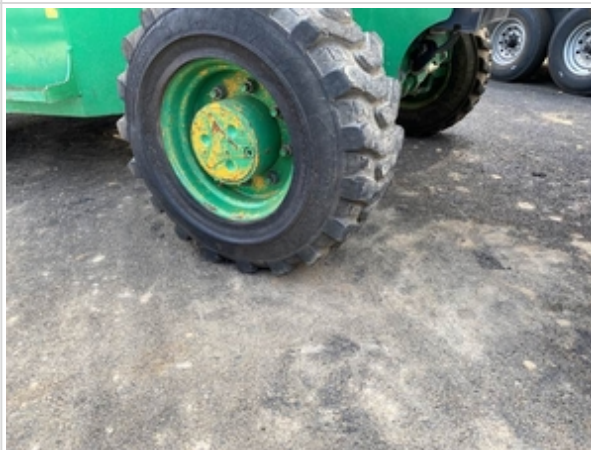
Wheels & Tires Photos

Wheels & Tires	3 - Normal Wear & Tear

Tire Brand	Front Camso rear Galaxy
Tire Size	Front 12 -16.5 Rear 16.9 -24
Front Left Tire - Ratio Remaining	30%
Rear Left Tire - Ratio Remaining	10%
Front Right Tire - Ratio Remaining	90%
Rear Right Tire - Ratio Remaining	10%
Lift Arm	3 - Normal Wear & Tear
Lift Arm Photos

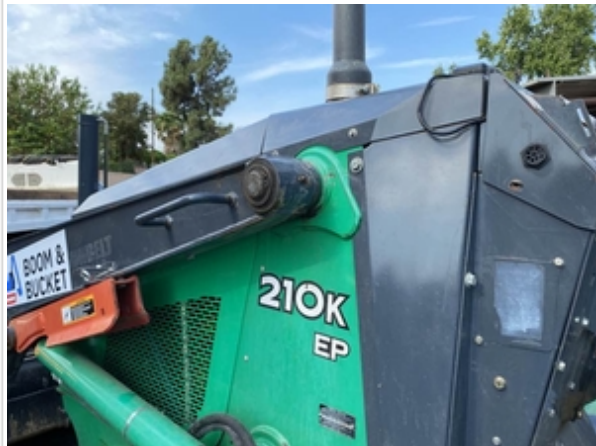
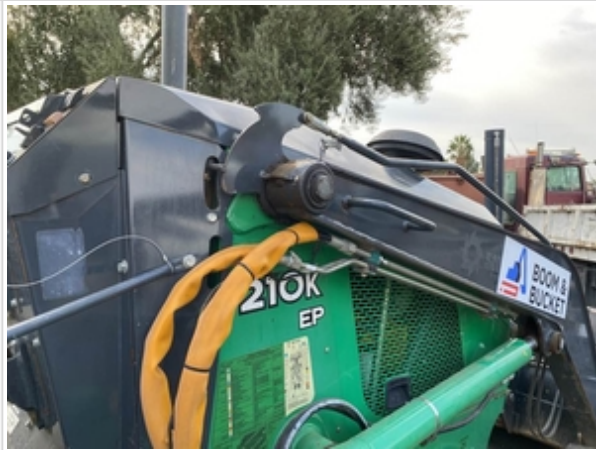
<p>Chassis to Arm Pins</p>	<p>3 - Normal Wear & Tear</p>
<p>Chassis to Arm Pins Photos</p>

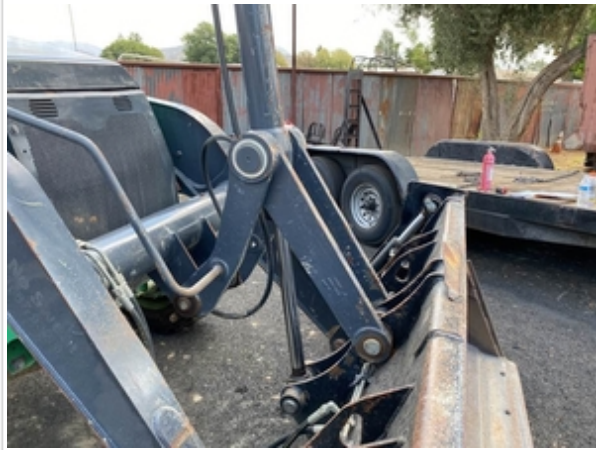
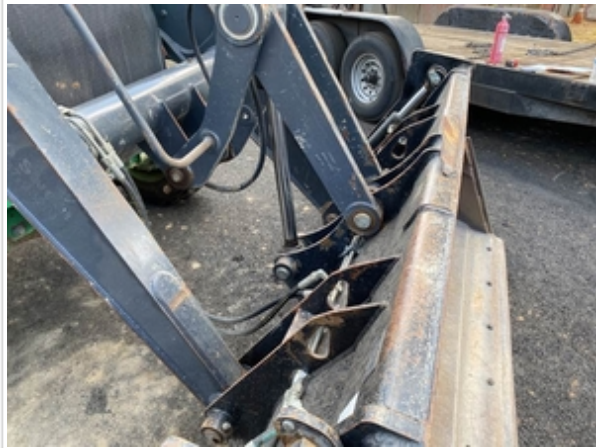
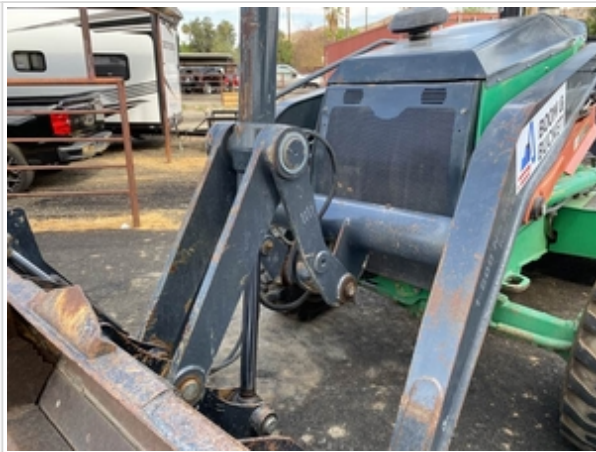
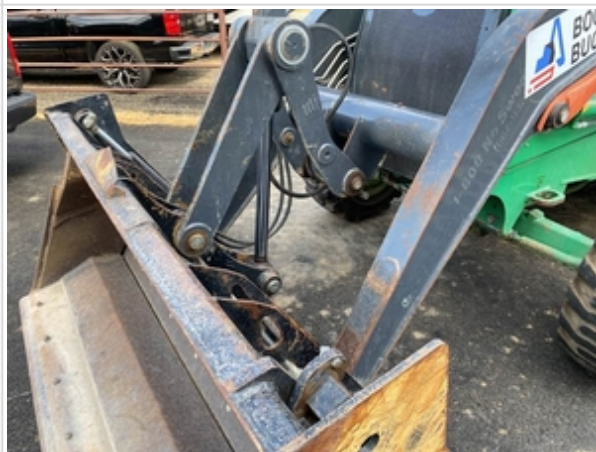
<p>Tilt Linkage</p>	<p>3 - Normal Wear & Tear</p>
<p>Tilt Linkage Photos</p>

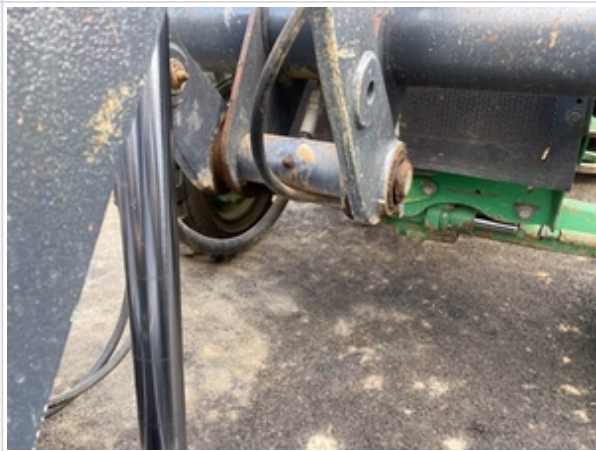
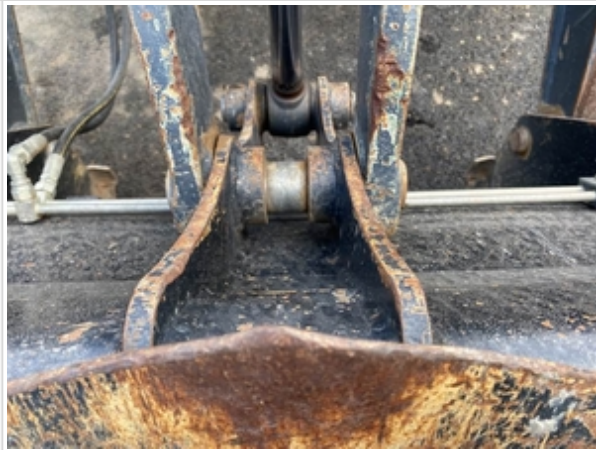
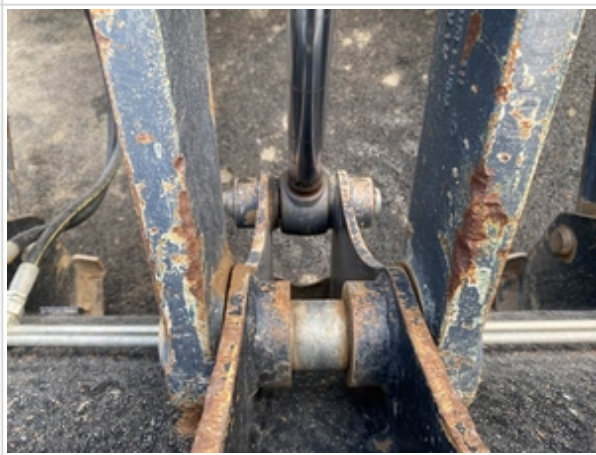
<p>Tilt Linkage Pins & Bushings</p>	<p>3 - Normal Wear & Tear</p>
<p>Tilt Linkage Pins & Bushings Photos</p>

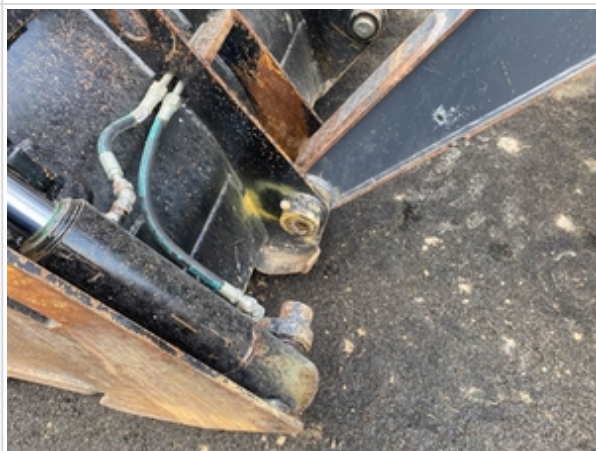
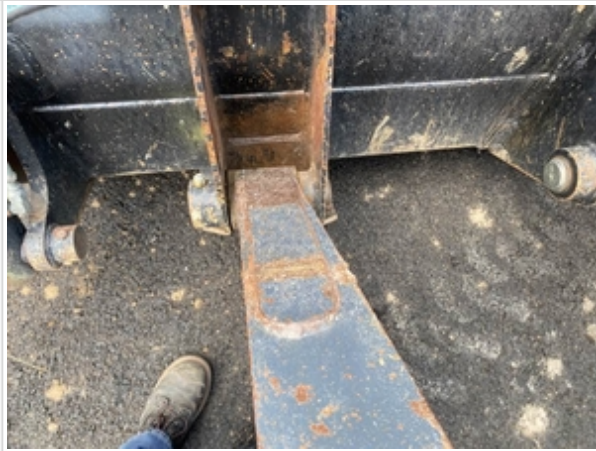
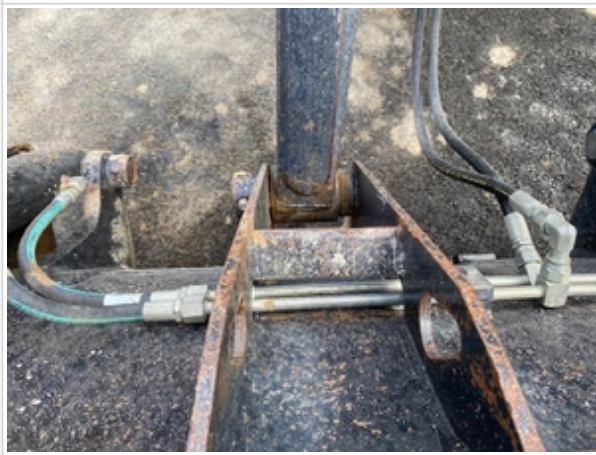
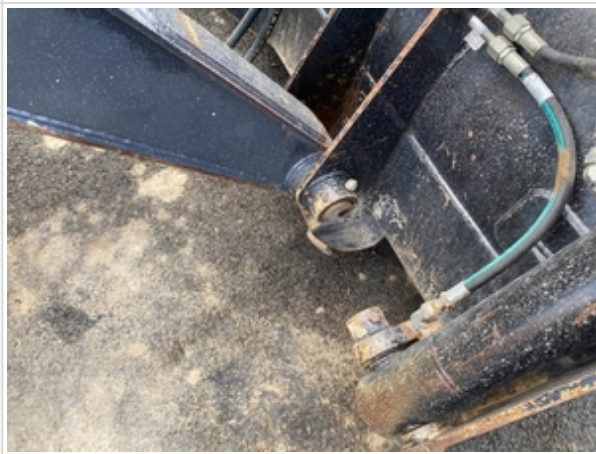
<p>Bucket to Arm Pins</p>	<p>3 - Normal Wear & Tear</p>	
<p>Bucket to Arm Pins Photos</p>

Overall Chassis	3 - Normal Wear & Tear	
Overall Chassis Comments	Overall the machines frame and chassis is in great condition. No issues found.

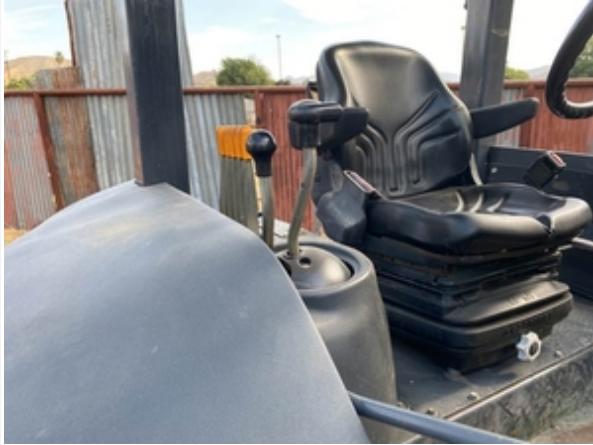
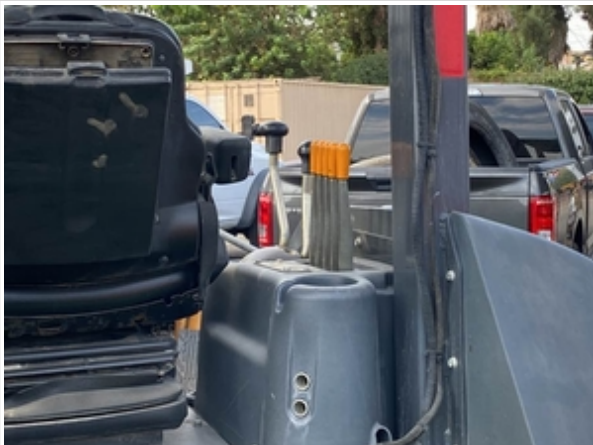
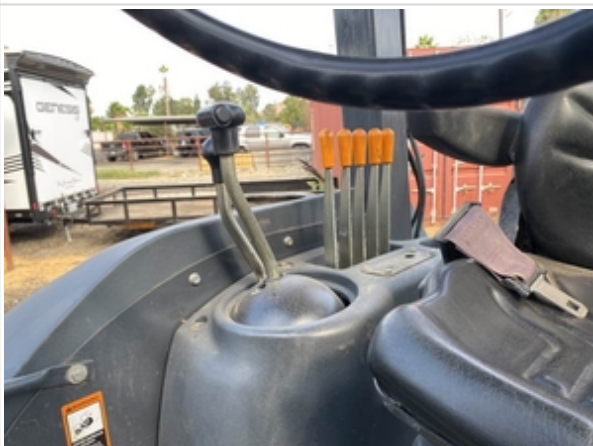
Hydraulic Lines / Fittings Condition	Hydraulic lines & fittings are clean and in good condition, Twisted, kinked, or flattened hydraulic hoses, Other (see comments)
Comments	Front hardlines for front bucket tilt cylinder slightly bent but functions well
Unusual Noises (Hydraulic Pump)	No
External Controls / Levers	3
External Controls / Levers Condition	Good function & condition of hydraulic controls
External Controls / Levers Photos

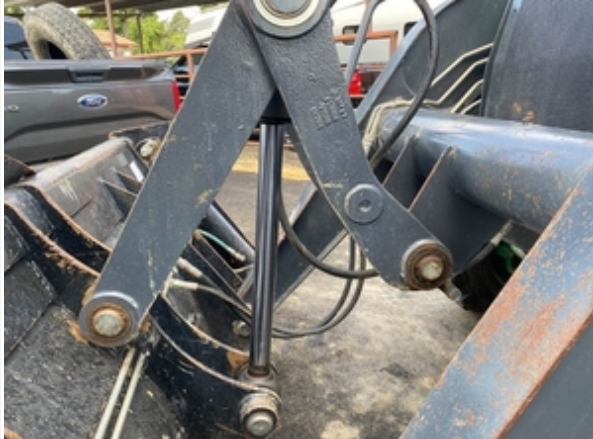
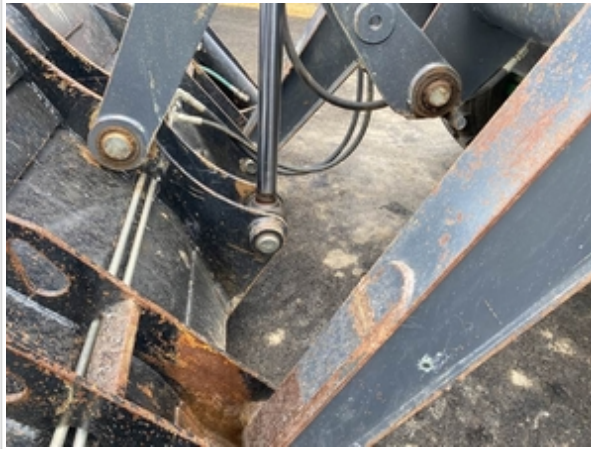
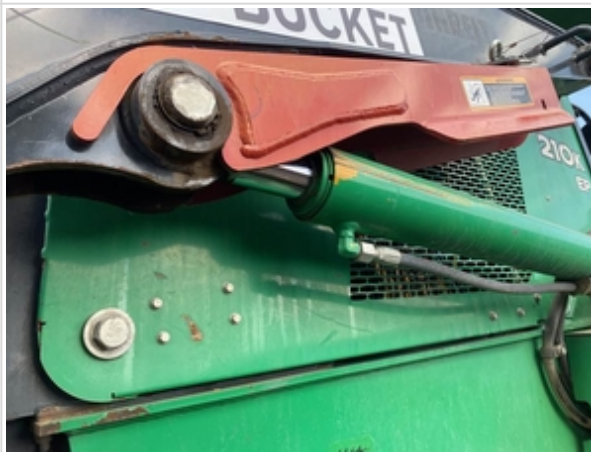
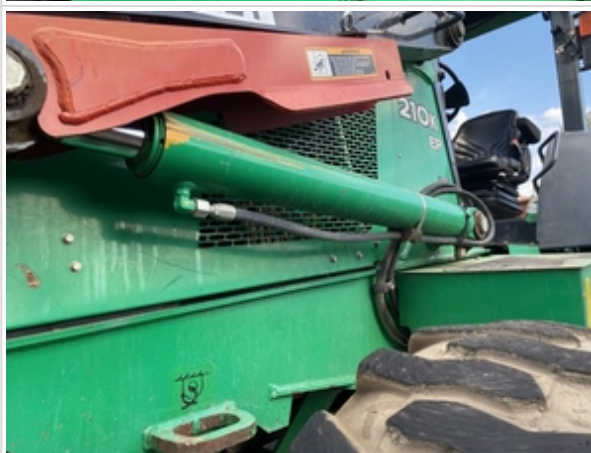
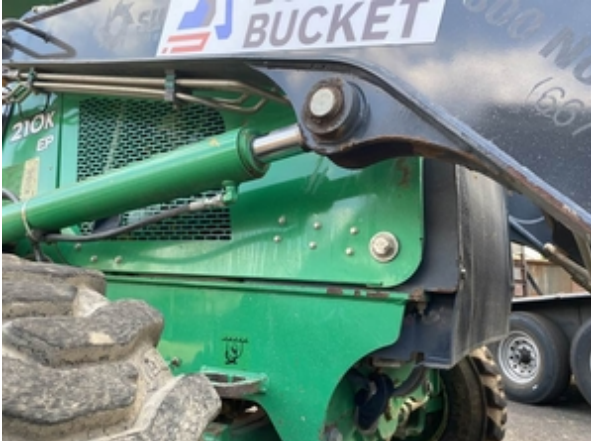
Bucket Lift / Tilt Cylinders	Check the bucket lift and tilt cylinders. Note any wear, pitting, discoloration, etc. Take photos.
Bucket Lift / Tilt Cylinders: Mounting Pin	3
Bucket Lift / Tilt Cylinders: Oil Leaks	No
Comments	Front tilt cylinder starting to seep oil out of rod seal
Bucket Lift / Tilt Cylinders Photos

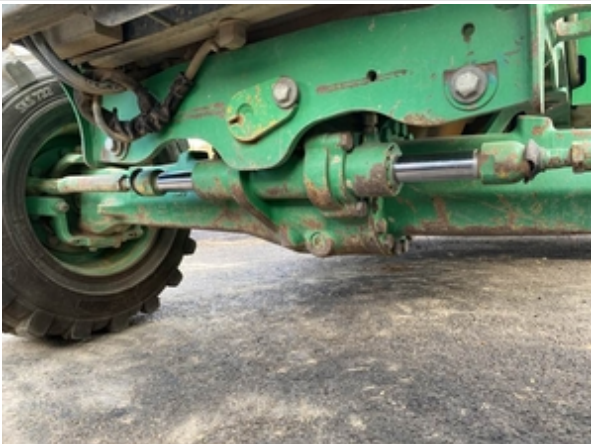
Steering Cylinder	Check the steering cylinder. Note any wear, pitting, discoloration, etc. Take photos.
Steering Cylinder: Mounting Pin	3
Steering Cylinder: Oil Leaks	No
Steering Cylinder Photos

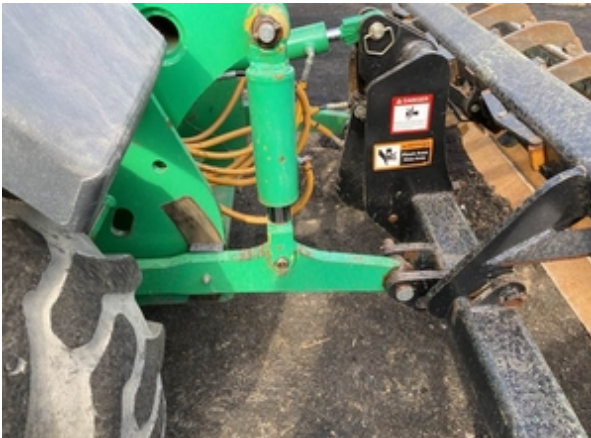
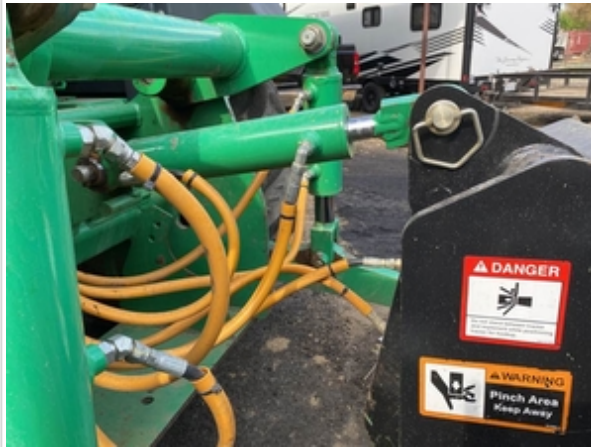
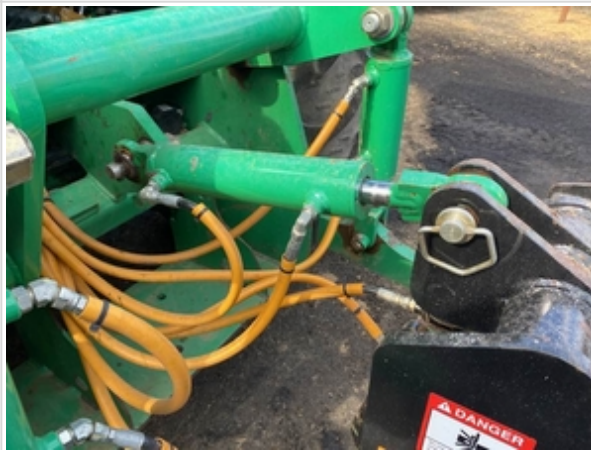
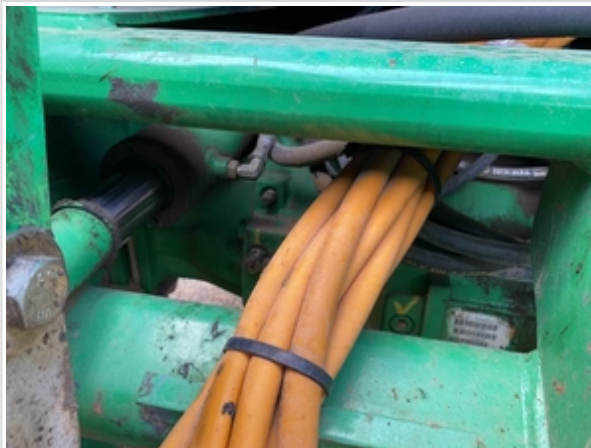
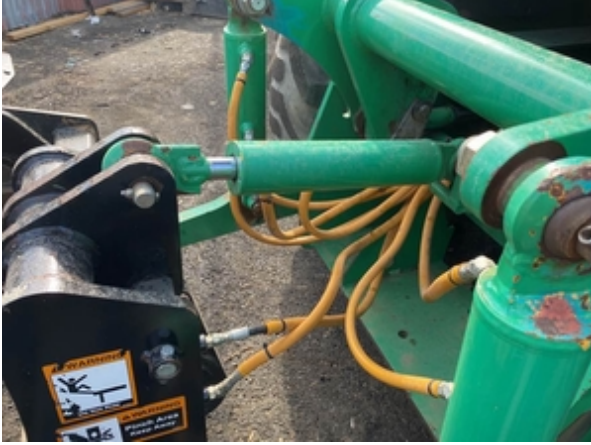
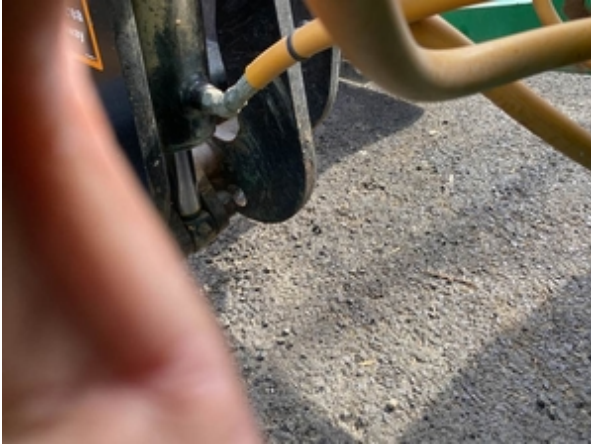
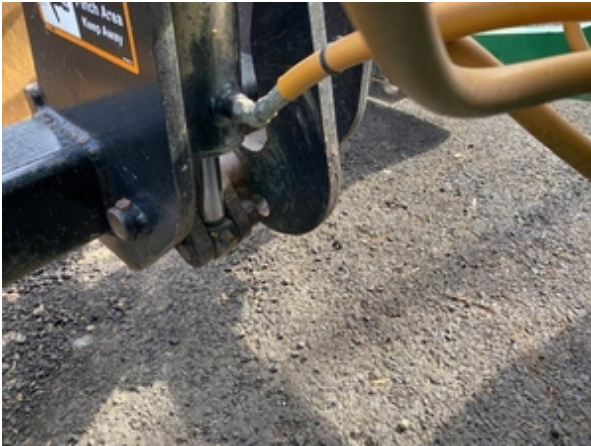
Box Cylinders	Check the box blade cylinders. Note any wear, pitting, discoloration, etc. Take photos.
Box Cylinders: Mounting Pin	3
Box Cylinders: Oil Leaks	No
Box Cylinders Photos

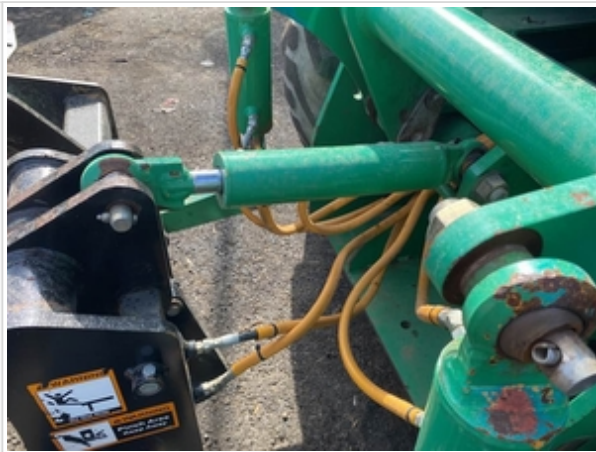
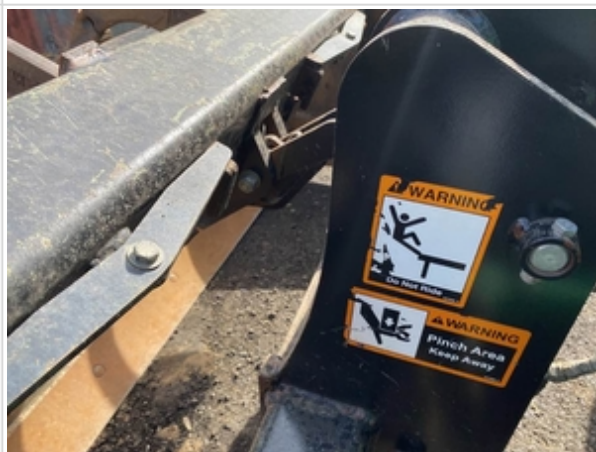
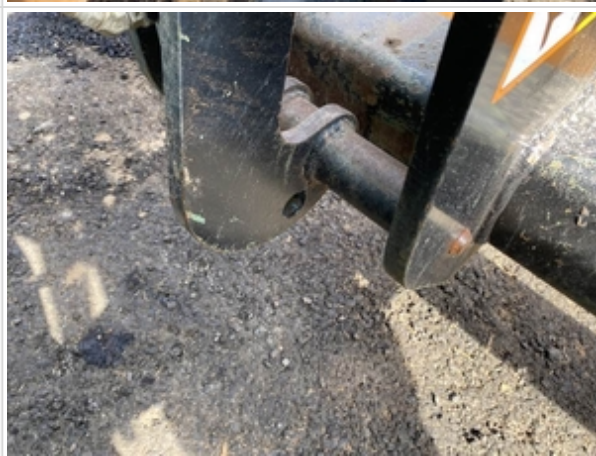
Scarifier / Ripper Cylinder Photos

Scarifier / Ripper Cylinder	Check the scarifier / ripper cylinder. Note any wear, pitting, discoloration, etc. Take photos.
Scarifier / Ripper Cylinder: Mounting Pin	3
Scarifier / Ripper Cylinder: Oil Leaks	No

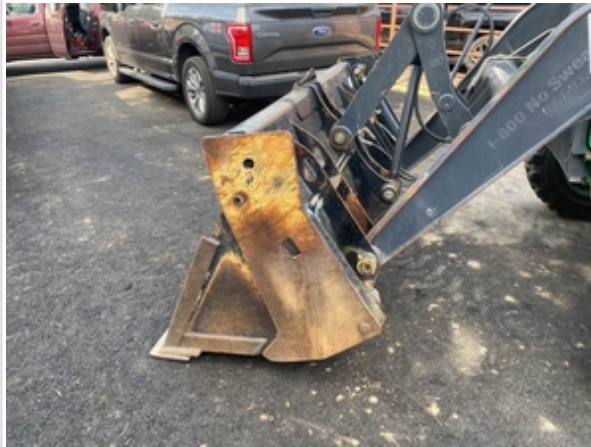
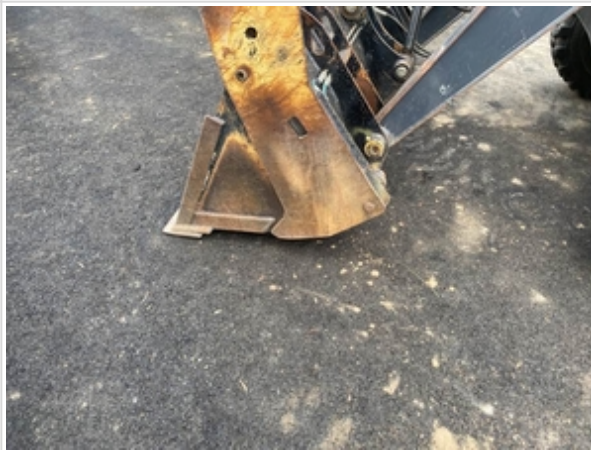
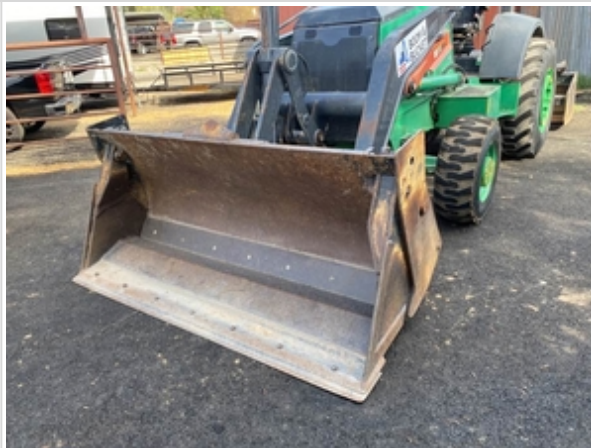
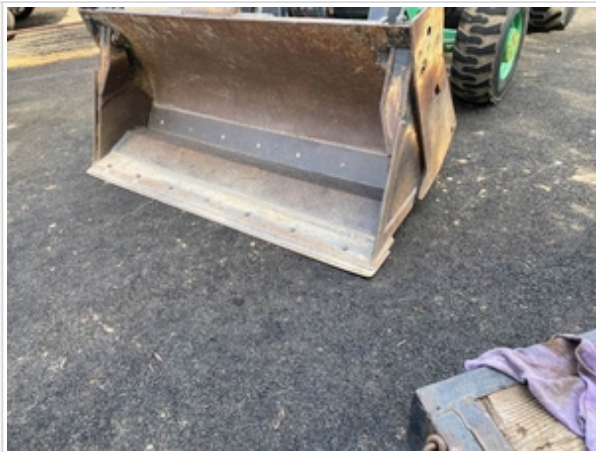
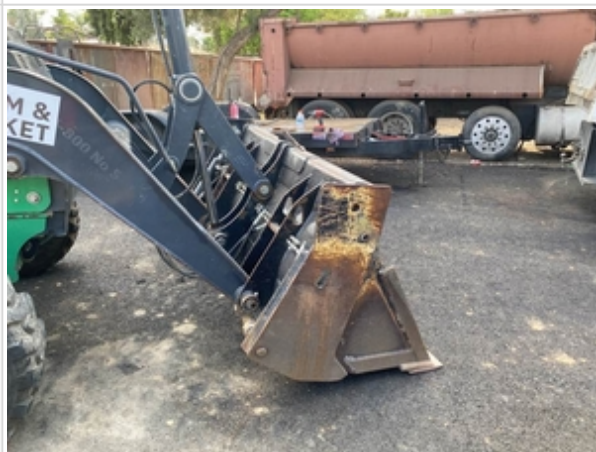
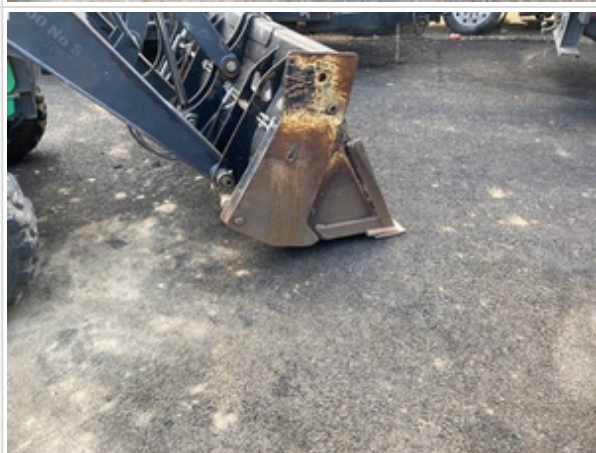
Bucket Photos

Instructions	Evaluate the following on a 4 point scale (leave comments where an explanation is appropriate): 4 = Like New, Recently Replaced 3 = Normal Wear & Tear 2 = Above Average Wear 1 = Service Required
Bucket	3 - Normal Wear & Tear

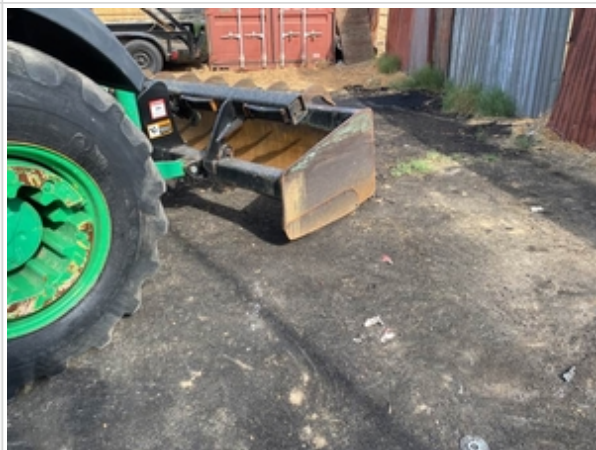
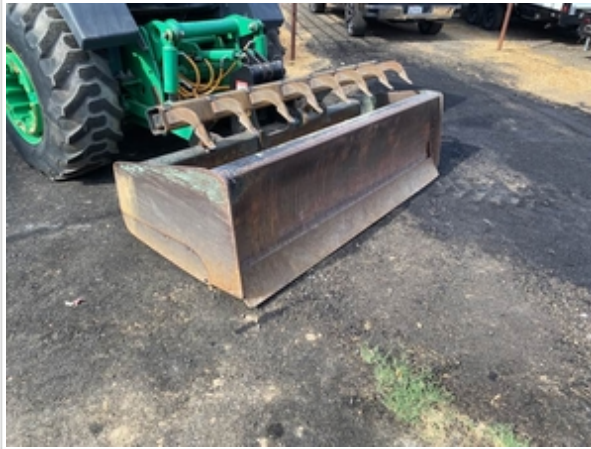
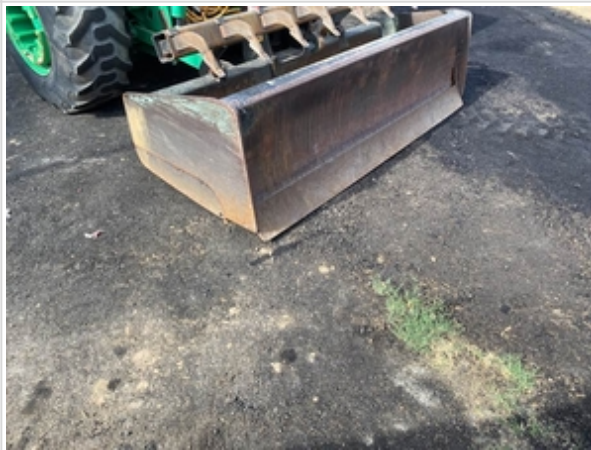
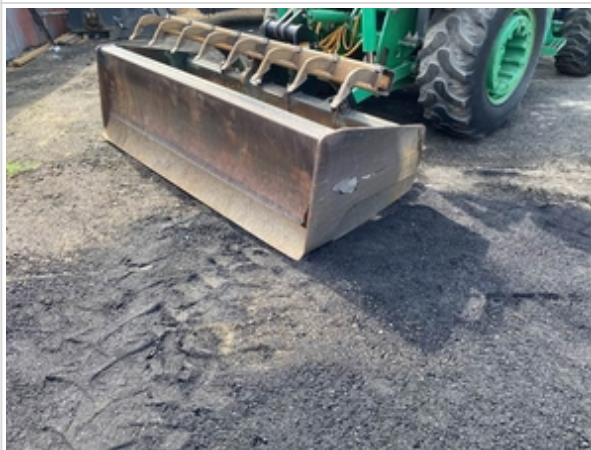
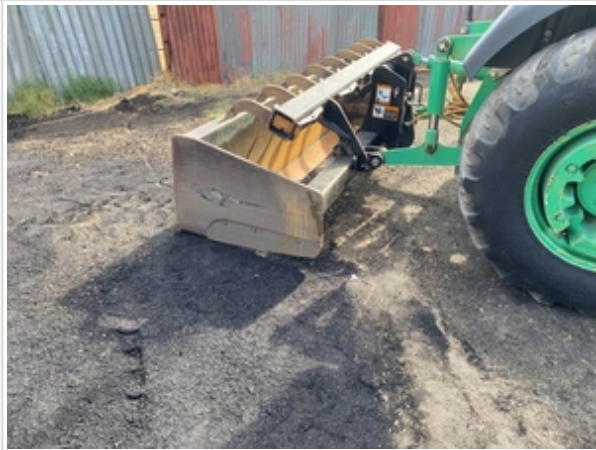
Box	3 - Normal Wear & Tear
Box Photos

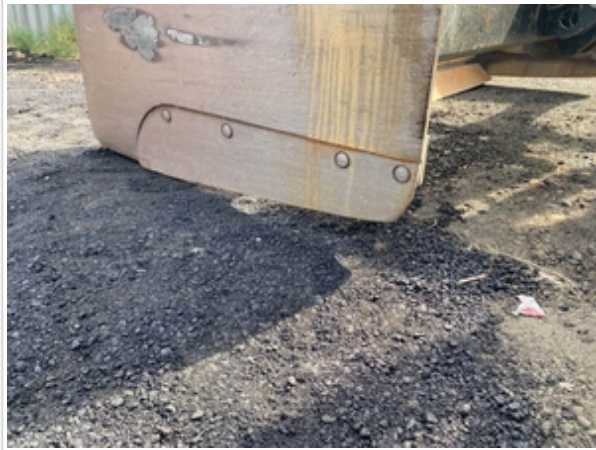
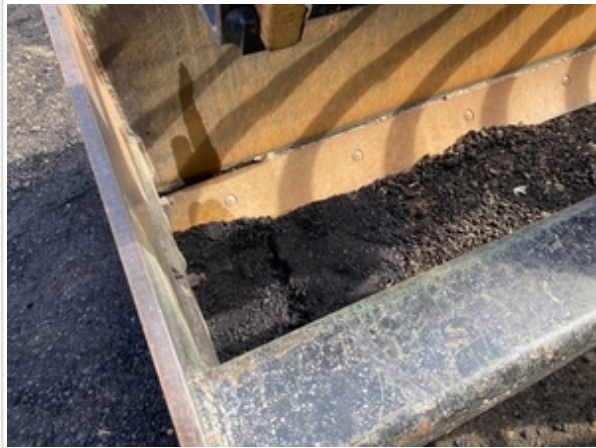
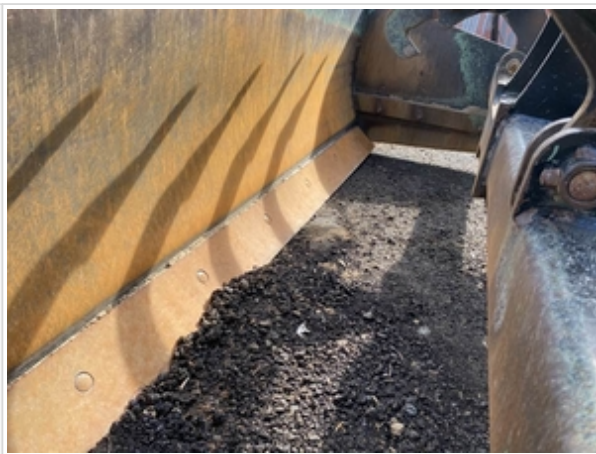
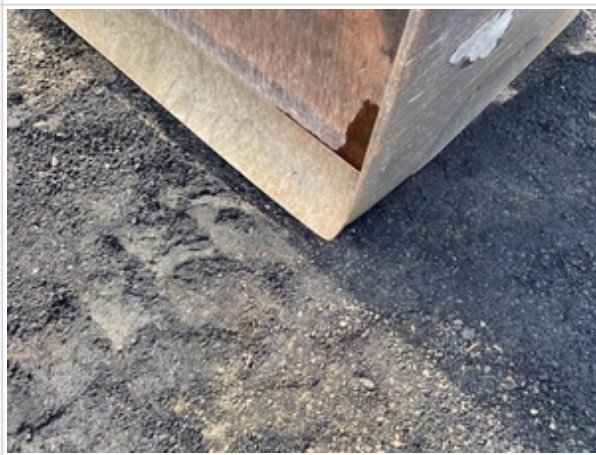
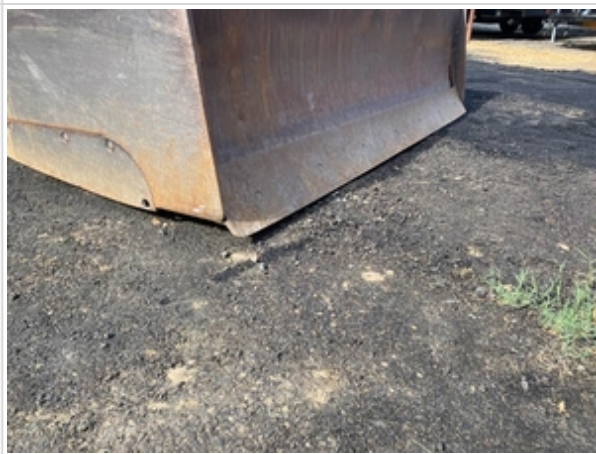
<p>Blade</p>	<p>3 - Normal Wear & Tear</p>
<p>Blade Photos</p>

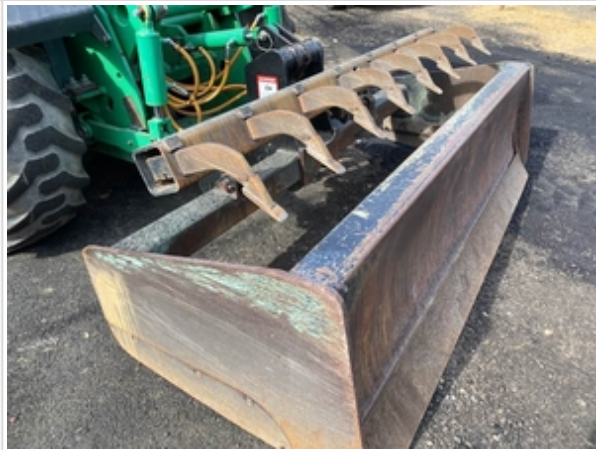
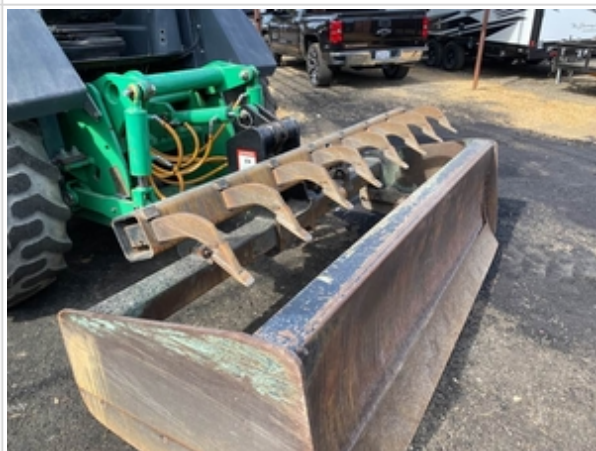
Scarifier Photos

<p>Scarifier</p>	<p>3 - Normal Wear & Tear</p>
