## Inspection Report (Vibratory Compactor)

Year	2016
Make	HAMM
Model	HD 12 VV
Serial Number	H2300767
Hour Meter Reading	881.2
Previous Application (e.g., earth moving, mining, demolition, etc)	Equipment Rental

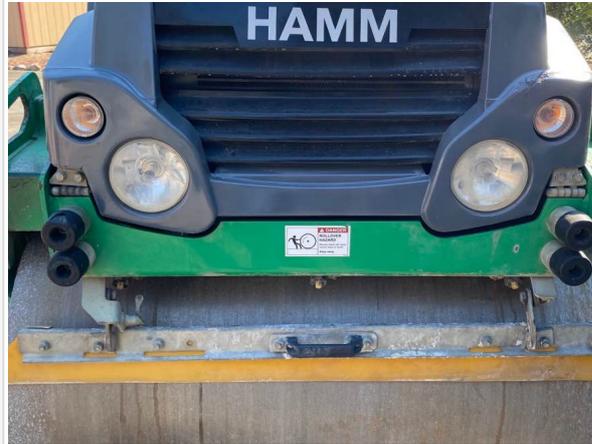
Front Photos

Front	3 - Normal Wear & Tear
Front Condition	No visible damage, Visible chipped paint or dents, Other (see comments)
Comments	Normal wear and tear no major damage

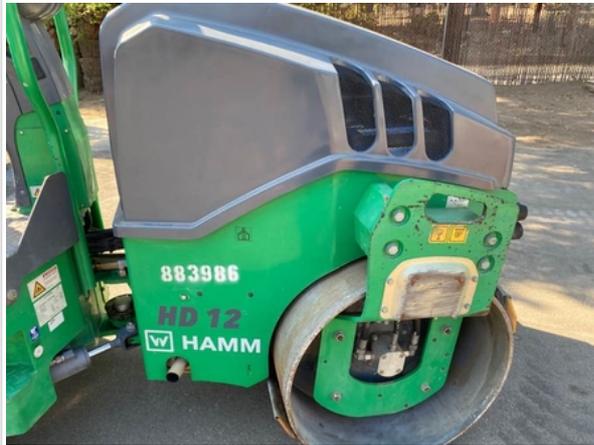
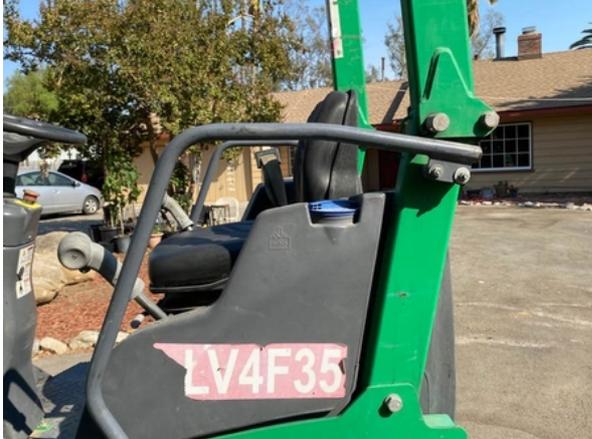
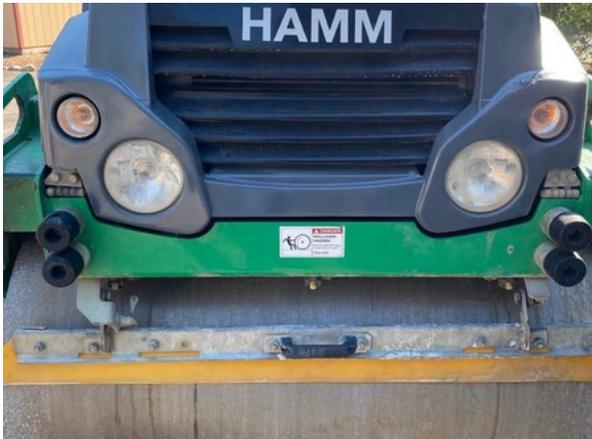
<b>Body Panels (Any Rust Damage?)</b>	3 - Normal Wear & Tear
<b>Body Panel Condition</b>	No visible damage, good paint condition and panel fitment, Other (see comments)
<b>Comments</b>	Small crack on front left side of hood and scuff marks on some panels but most minor scratches
<b>Body Panels Photos</b>

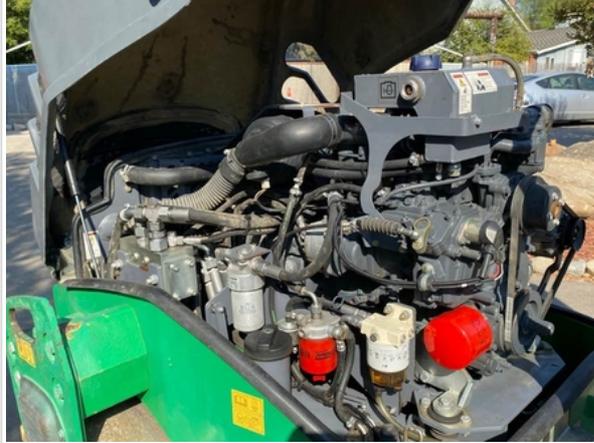
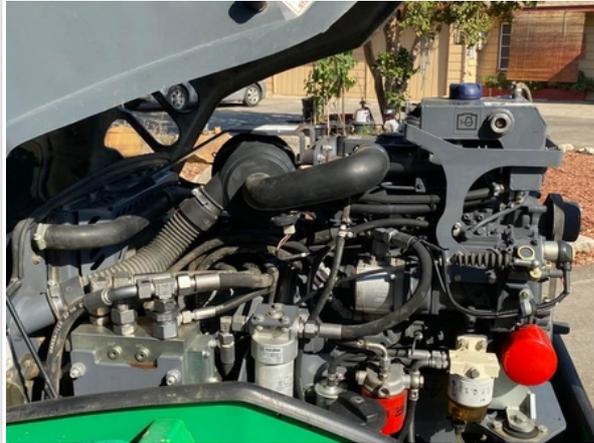
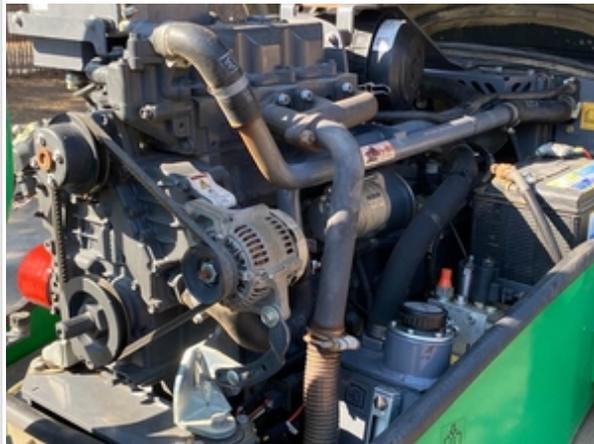
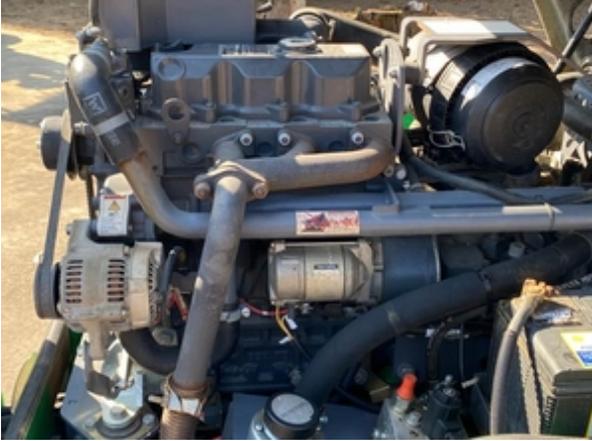
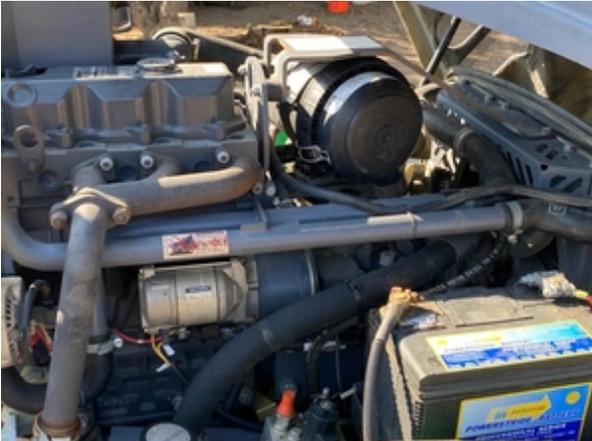
Engine Photos

<b>Blow-by (Visual Observation Check)</b>	No	
<b>Unusual Noises (Upon Start-up, Idle, Shutdown)</b>	No	
<b>Unusual Noise Notes</b>	No unusual noises heard	
<b>Engine Smoke (Upon Start-up, Idle, Shutdown)</b>	No	
<b>Engine Smoke Notes</b>	No engine smoke issues observed	
<b>Engine Exhaust Color</b>	Clear	
<b>Battery</b>	3 - Normal Wear & Tear	
<b>Battery Condition</b>	Like new, recently replaced

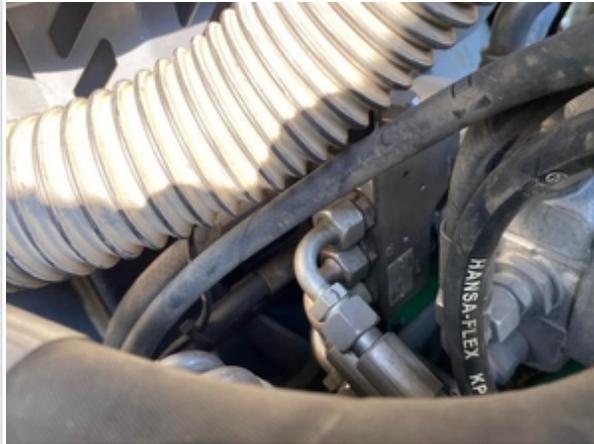
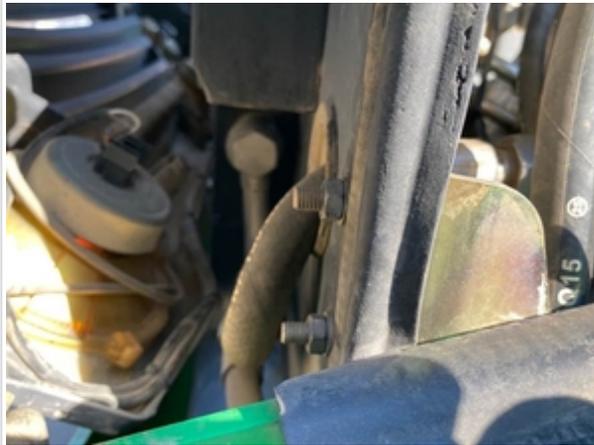
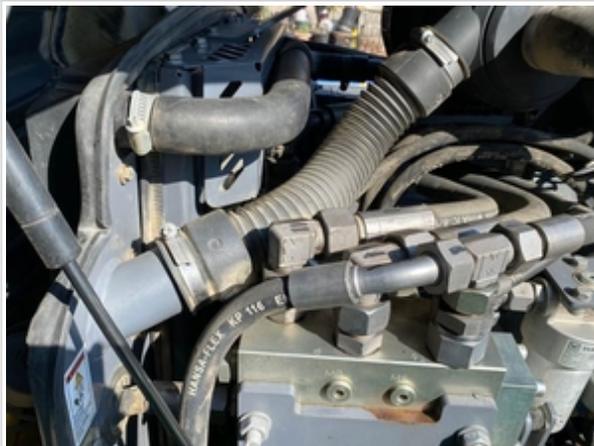
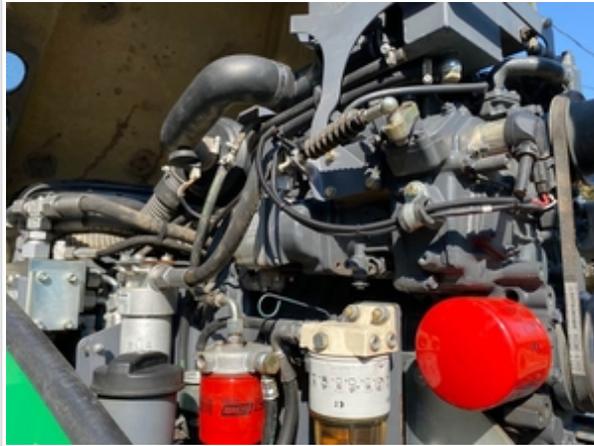
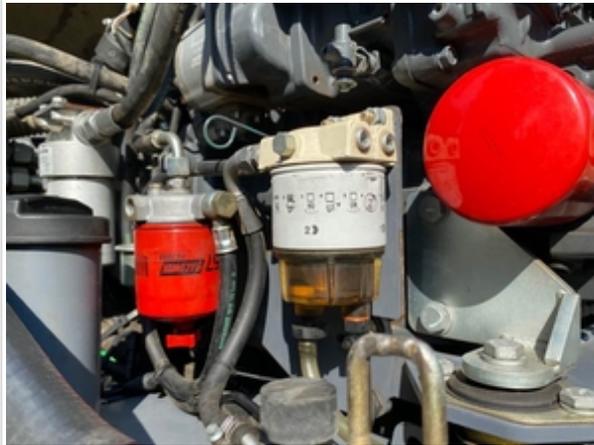
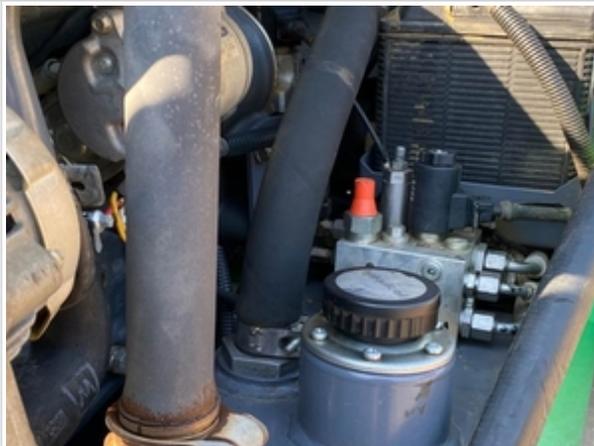
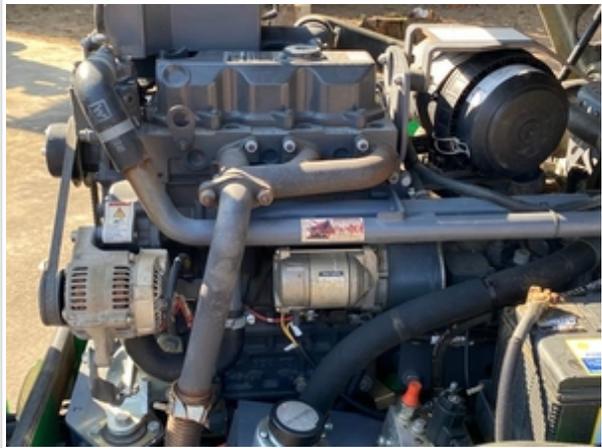
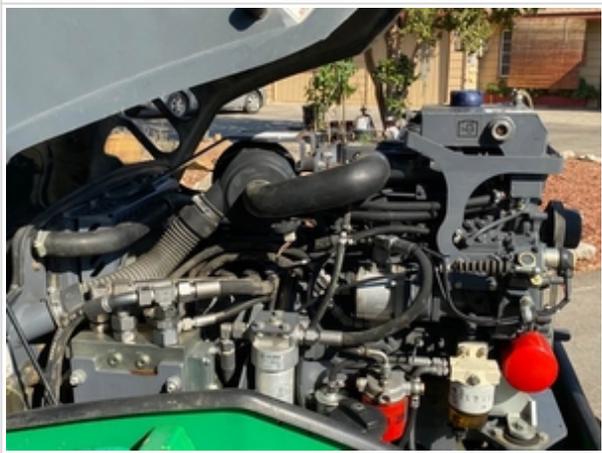
<b>Hoses</b>	3 - Normal Wear & Tear
<b>Hose Condition</b>	Firm, pliant hoses with no signs of wear or leaks
<b>Hose Photos</b>

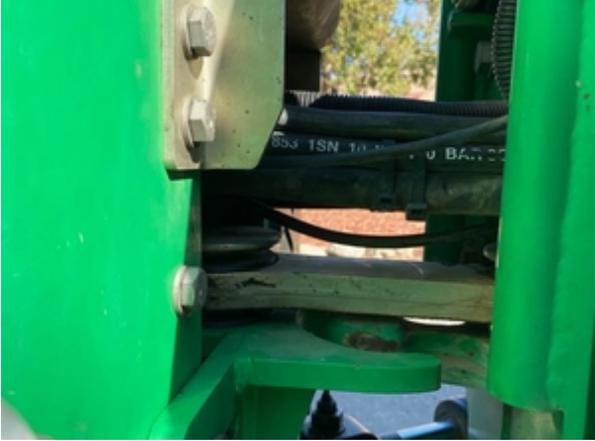
Frame	3 - Normal Wear & Tear
Comments	No issues found with frame

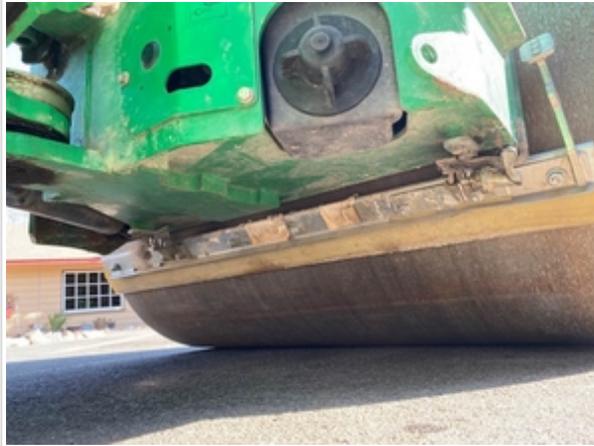
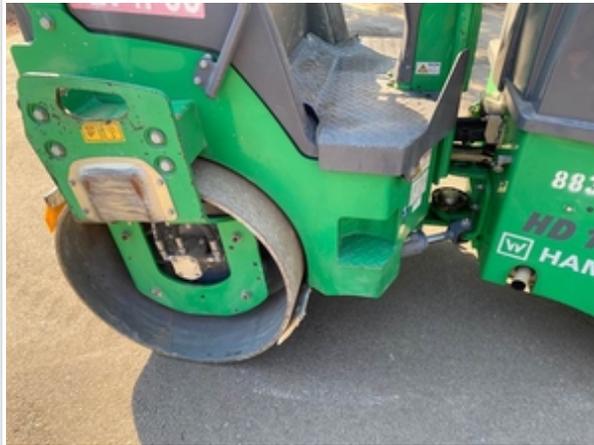
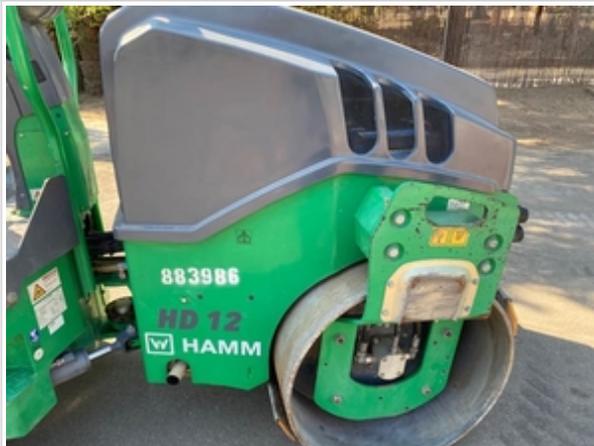
<b>Drum(s) Condition</b>	3 - Normal Wear & Tear	
<b>Comments</b>	Drums in great condition	
<b>Drum(s) Photos</b>

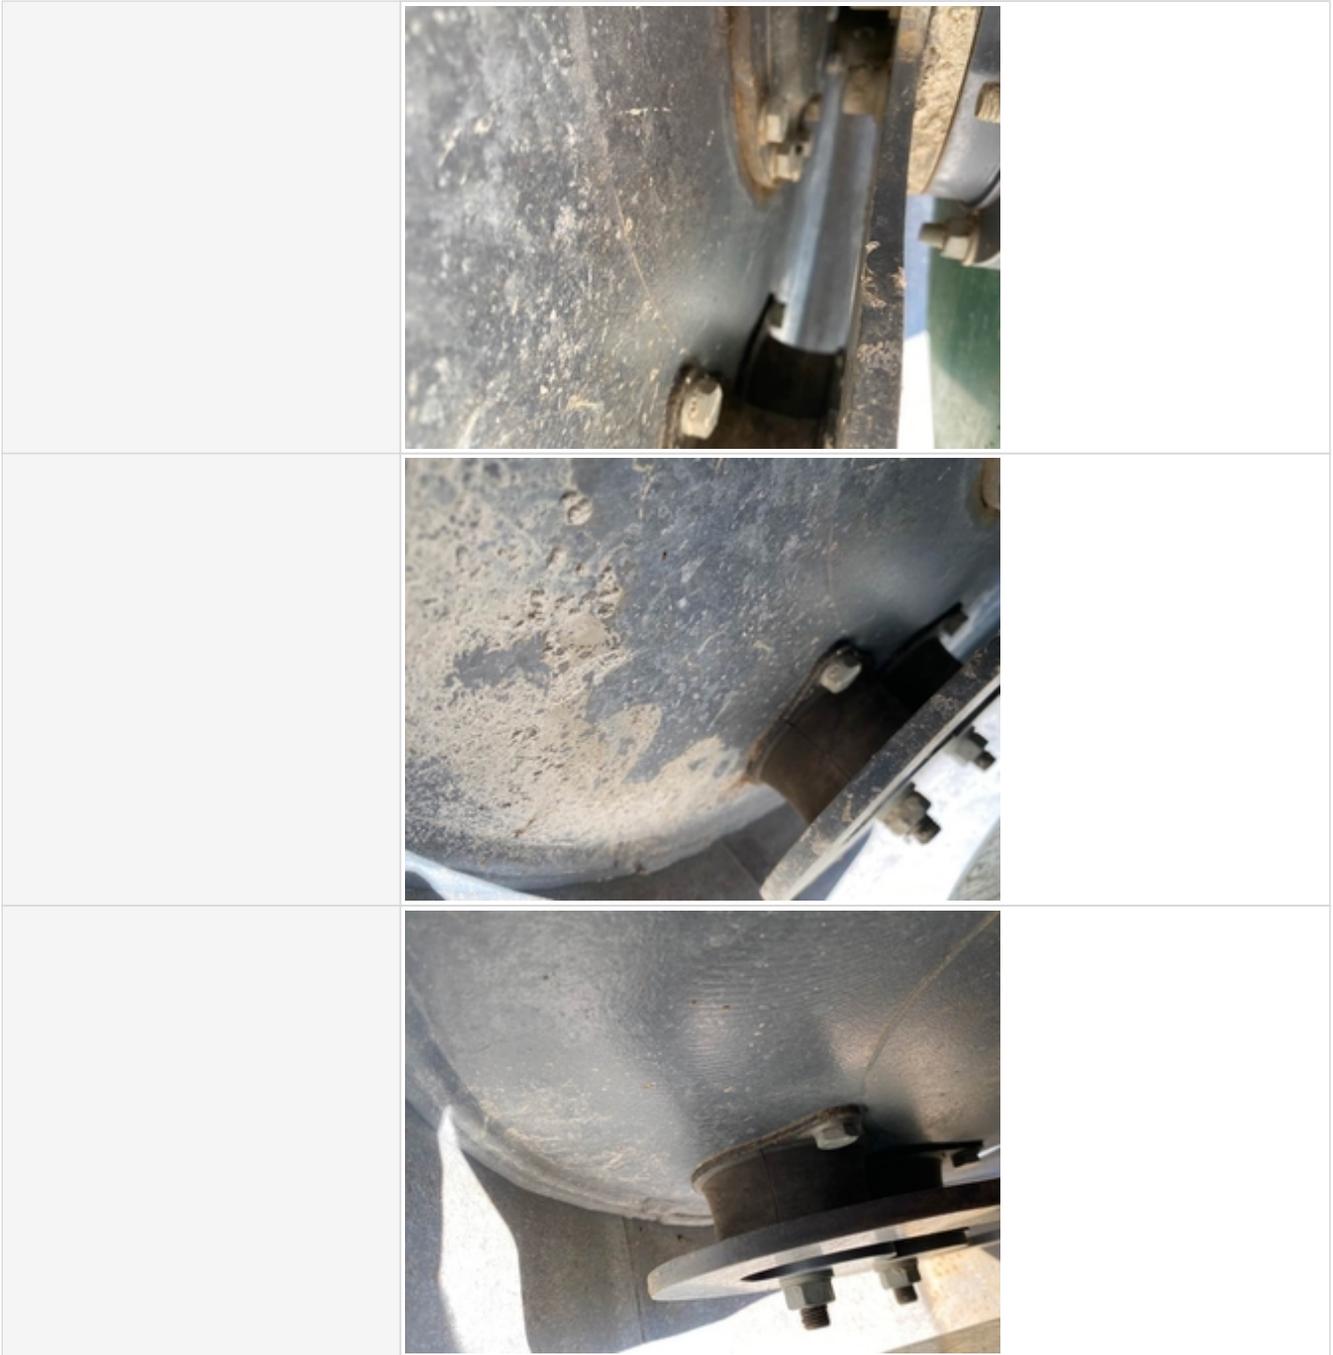
<p>Vibratory Rubber Mounts (Front &amp; Rear)</p>	<p>3 - Normal Wear &amp; Tear</p>	
<p>Vibratory Rubber Mounts (Front &amp; Rear) Photos</p>

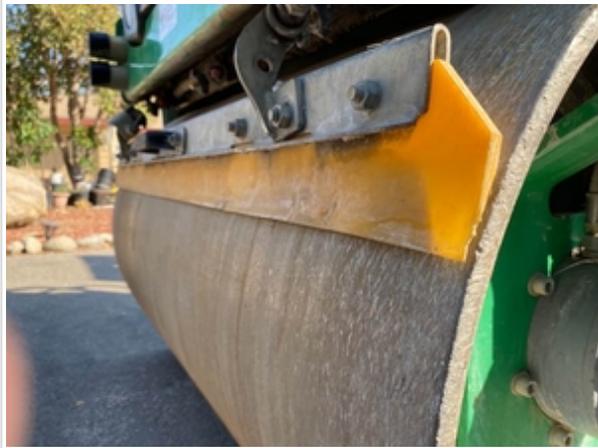
<p>Drum Scraper</p>	<p>3 - Normal Wear &amp; Tear</p>	
<p>Drum Scraper Photos</p>

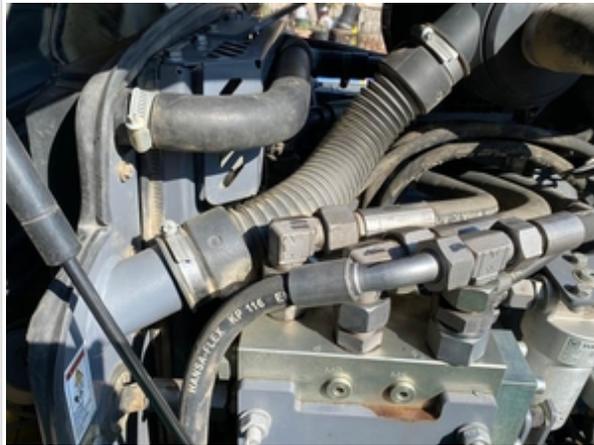
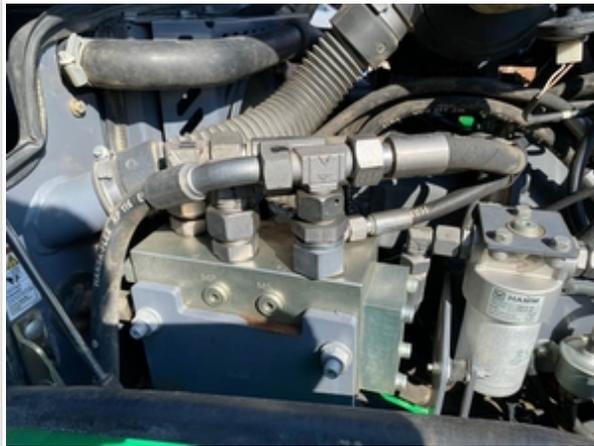
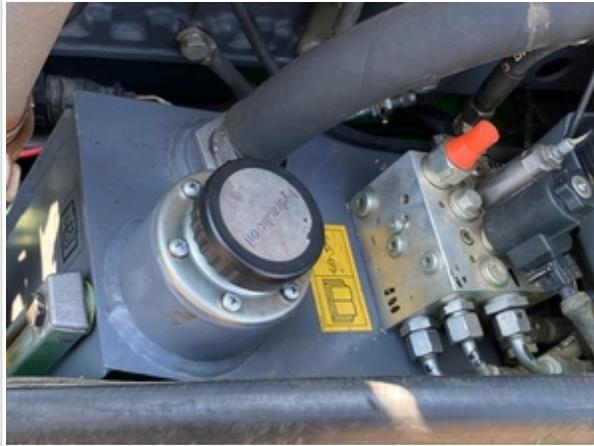
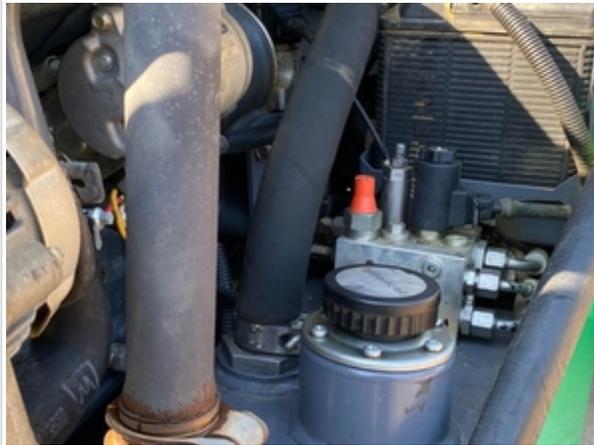
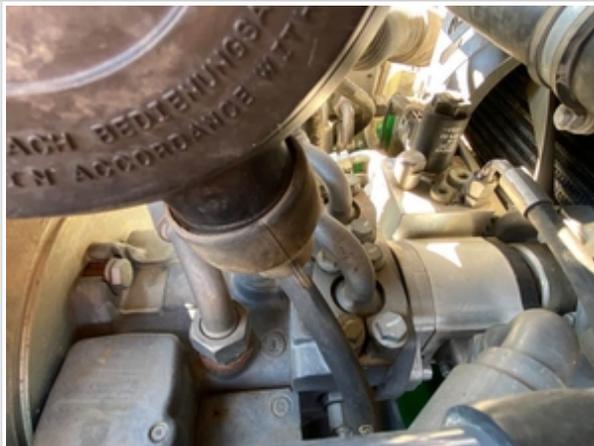
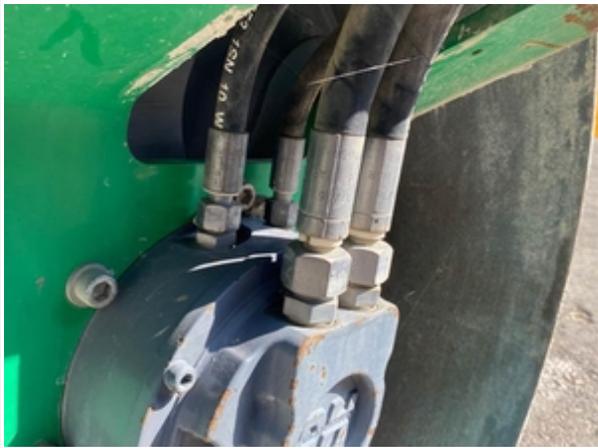
<b>Wet or Damp Hydraulic Lines / Fittings</b>	No
<b>Appearance of Hydraulic Lines / Fittings</b>	3
<b>Hydraulic Lines / Fittings Condition</b>	Hydraulic lines & fittings are clean and in good condition
<b>Appearance of Hydraulic Lines / Fittings Photos</b>

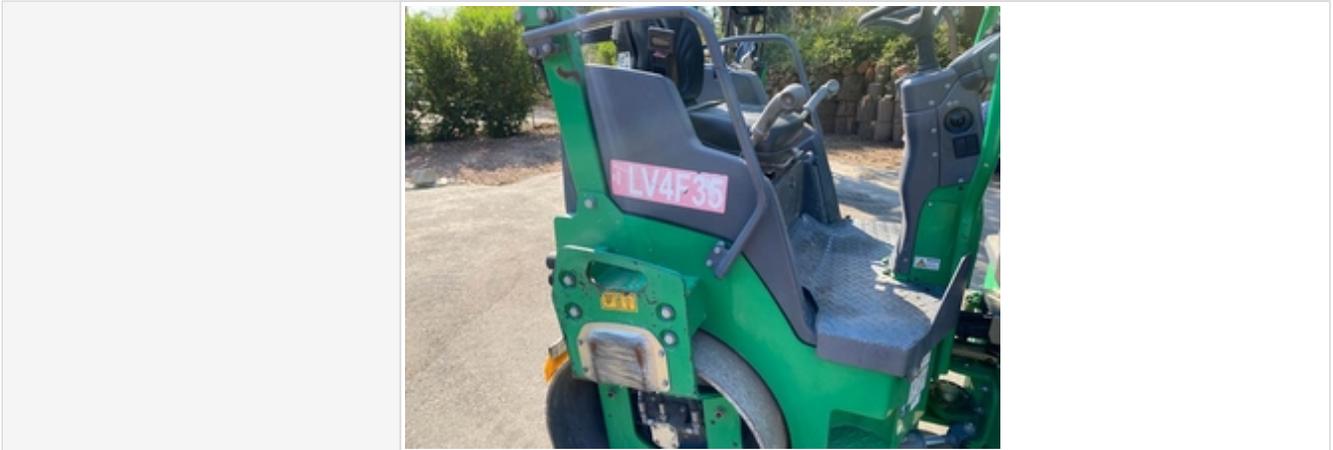
<b>Unusual Noises (Hydraulic Pump)</b>	No	
<b>Hydraulic Pump Notes</b>	No unusual noises heard during operation	
<b>External Controls / Levers</b>	3	
<b>External Controls / Levers Condition</b>	Good function & condition of hydraulic controls	
<b>External Controls / Levers Photos</b>
