Inspection Report (Vibratory Compactor)

Year	2008
Make	Volvo
Model	SD 116DX
Serial Number	198742
Hour Meter Reading	1,688
Previous Application (e.g., earth moving, mining, demolition, etc)	Paving General Contractor

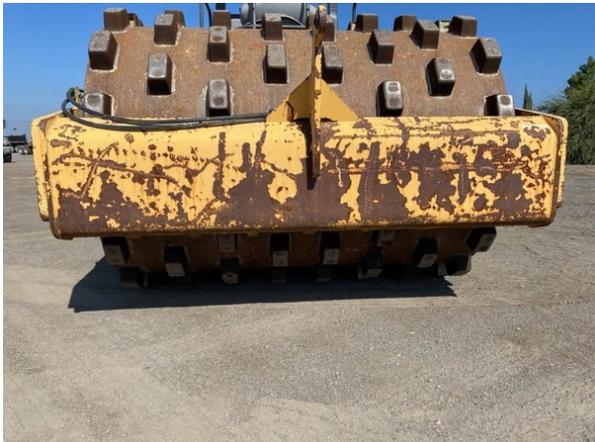
Front	3 - Normal Wear & Tear
Front Condition	No visible damage, Visible chipped paint or dents, Other (see comments)
Comments	No damage just cosmetic scuff marks
Front Photos

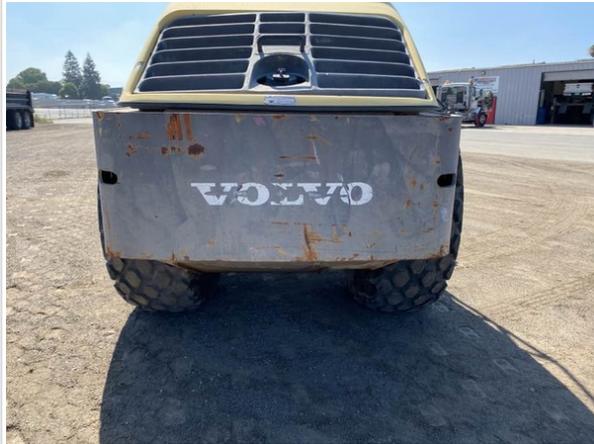
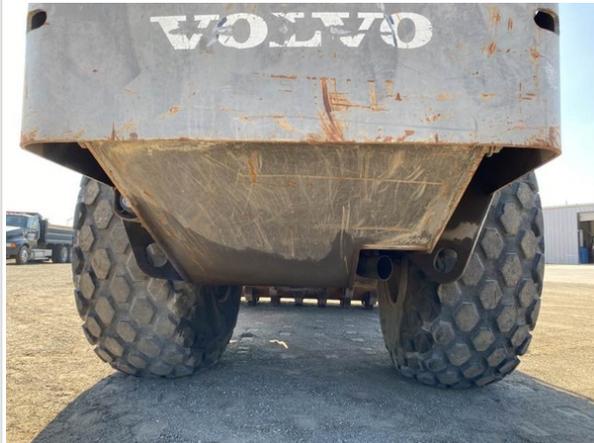
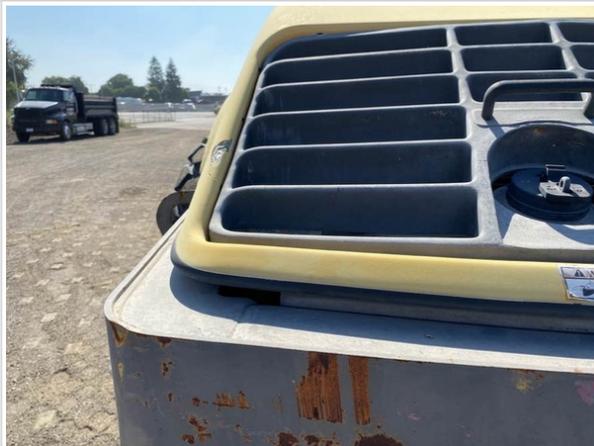
Rear Photos

Rear	3 - Normal Wear & Tear
Rear Condition	No visible damage, Visible chipped paint or dents, Other (see comments)
Comments	No damage just cosmetic scuff marks and minor cracks in fiberglass hood

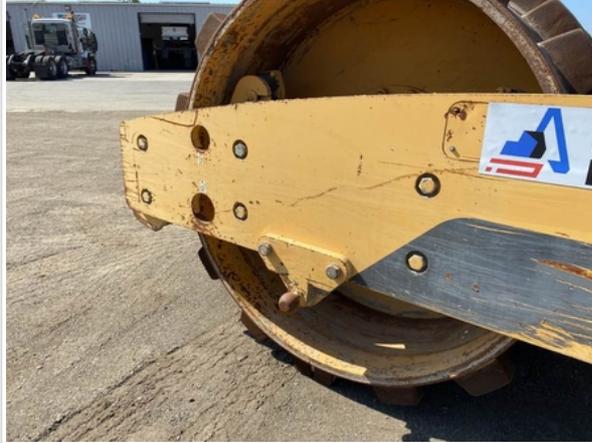
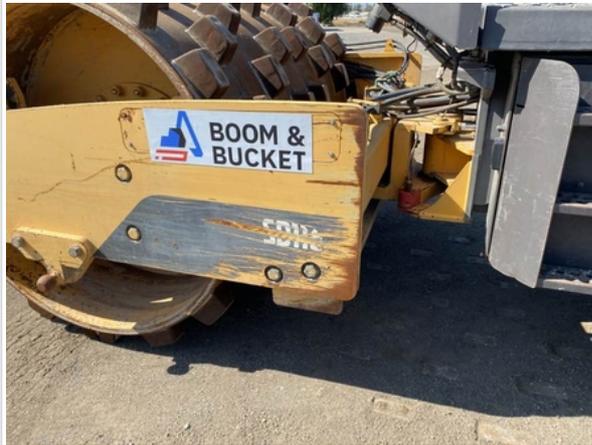
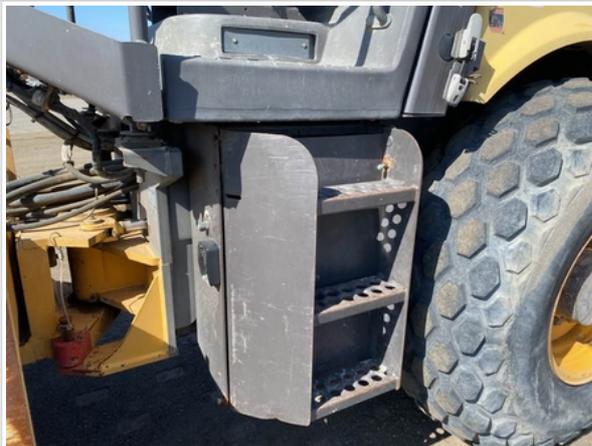
Left Photos

Left	3 - Normal Wear & Tear
Left Condition	No visible damage, Visible chipped paint or dents, Other (see comments)
Comments	No damage just cosmetic scuff marks

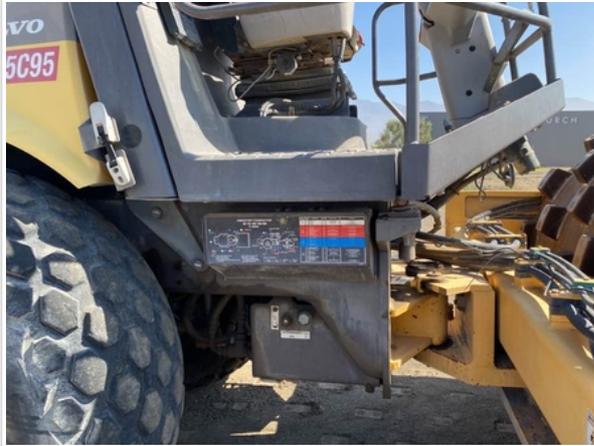
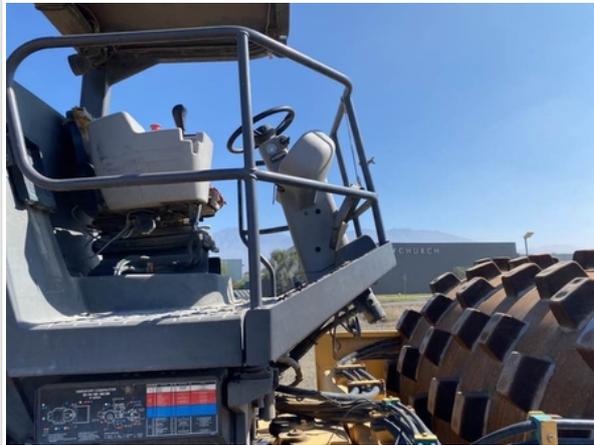
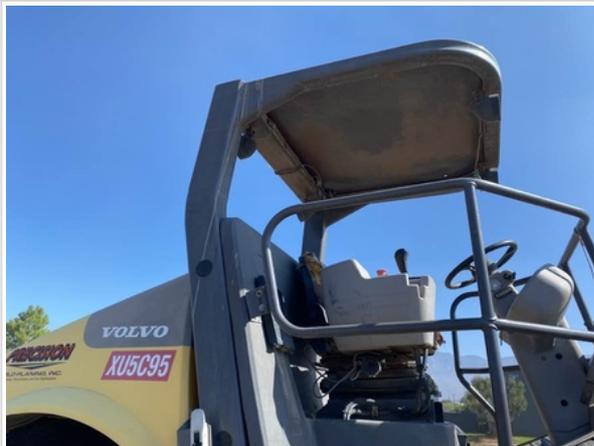
Right	3 - Normal Wear & Tear	
Right Condition	No visible damage, Visible chipped paint or dents, Other (see comments)	
Comments	Slight damage to rear right side tie down hook (bent) and scuff marks	
Right Photos

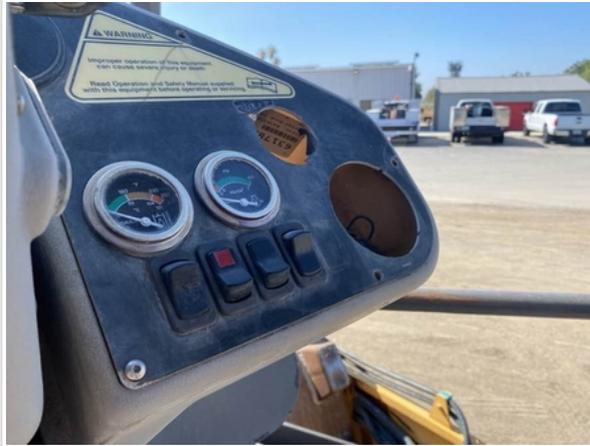
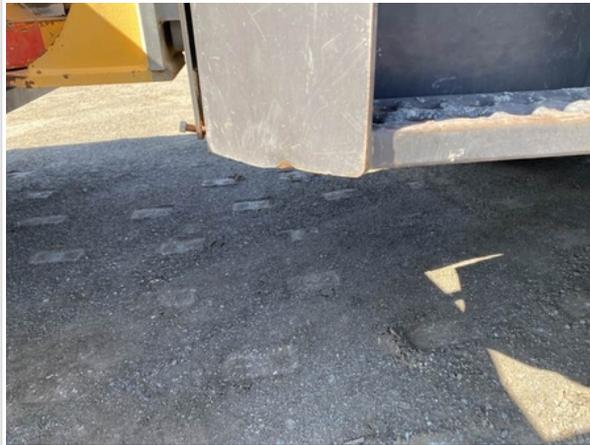
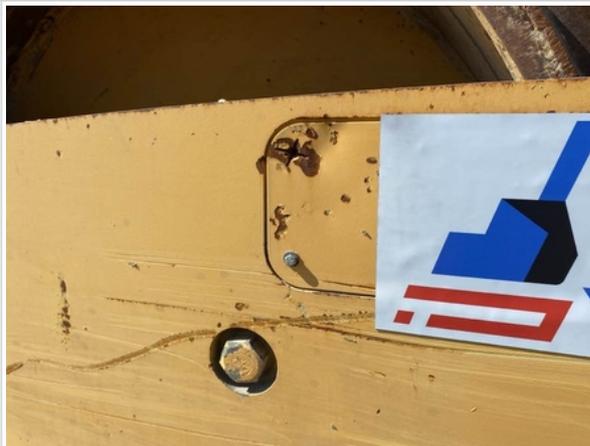
Body Panels (Any Rust Damage?)	3 - Normal Wear & Tear
Body Panel Condition	No visible damage, good paint condition and panel fitment, Other (see comments)
Comments	Operator control panel missing some covers(cosmetic)
Body Panels Photos

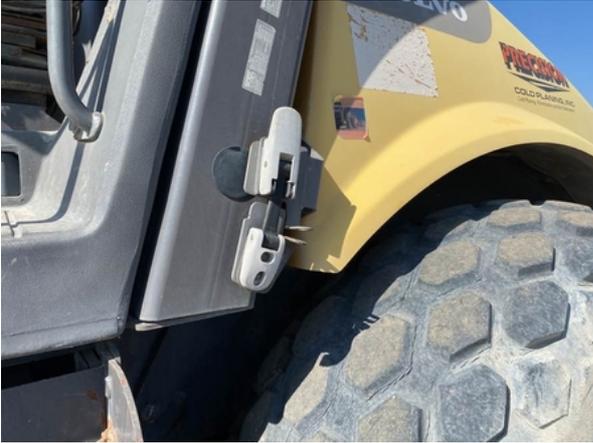
Doors / Canopy Latches	3 - Normal Wear & Tear	
Doors / Canopy Latches Condition	No visible damage	
Doors / Canopy Latches Photos

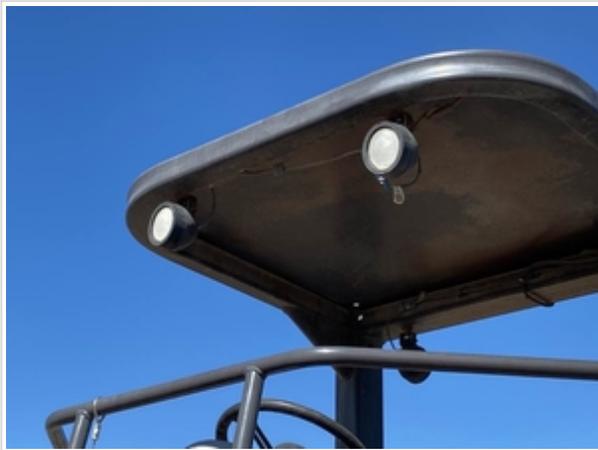
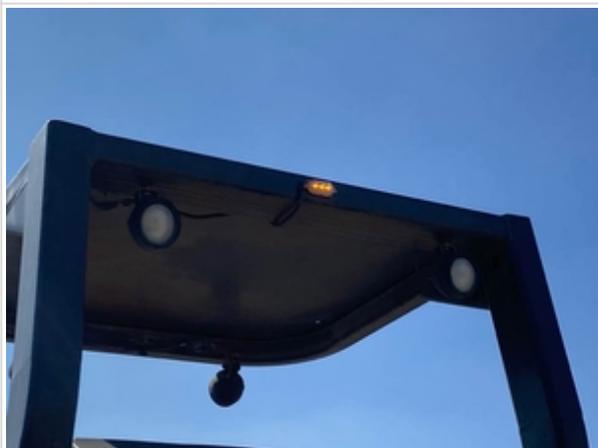
Lighting System Photos

Glass Condition	0	
Mirrors	0	
Lighting System	2 - Above Average Wear	
Lighting System Condition	No visible damage, lighting system is operational, Other (see comments)	
Comments	Factory lights on machine inop. Aftermarket rear strobe light okay

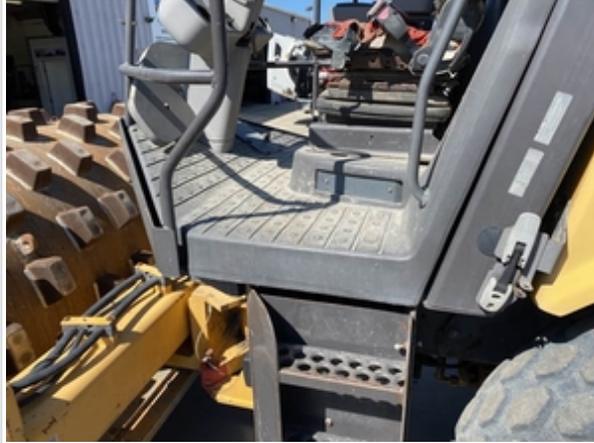
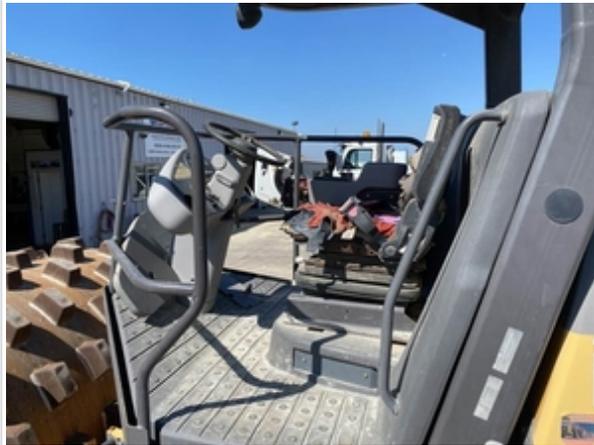
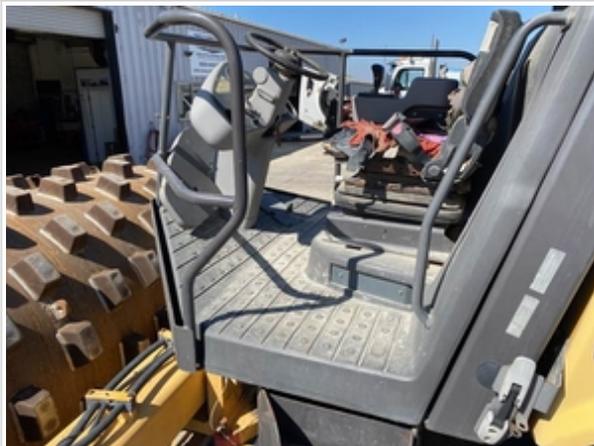
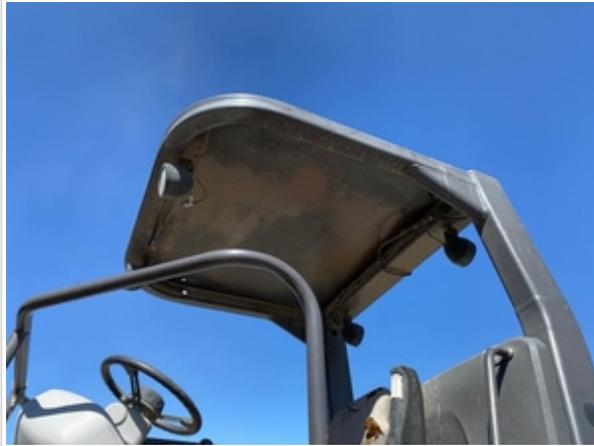
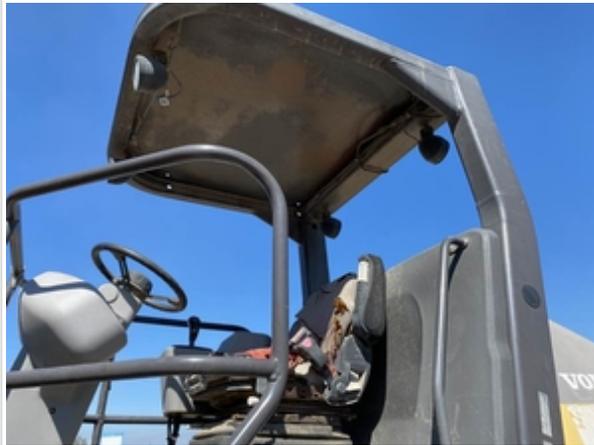
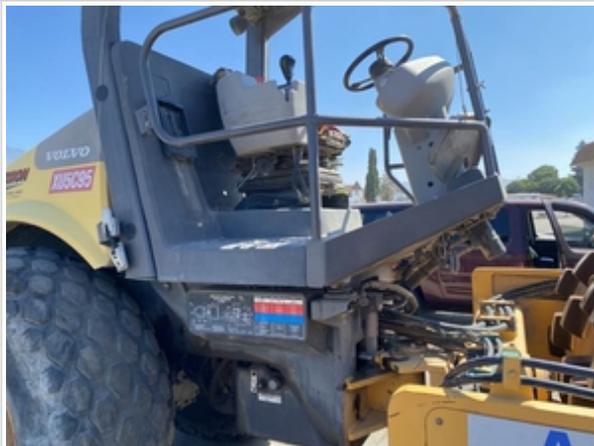
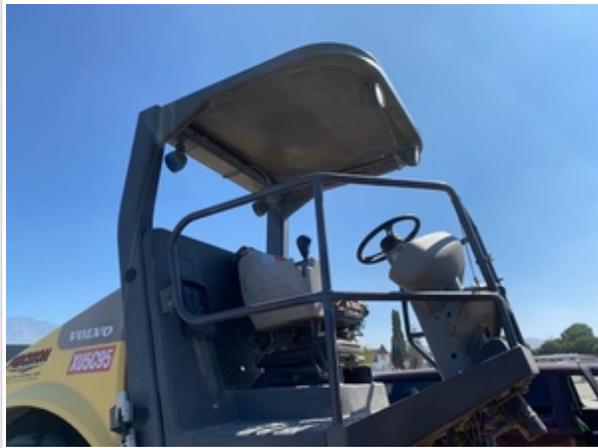
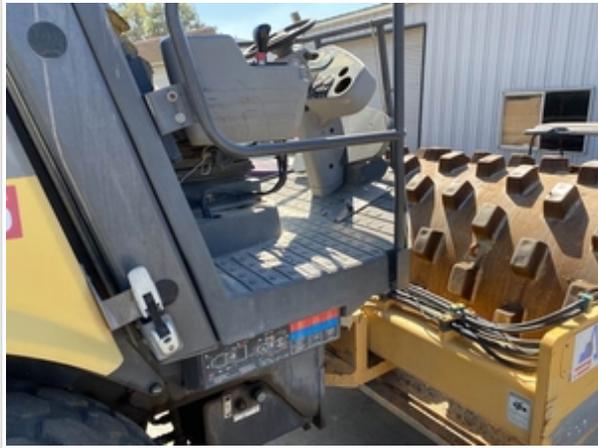
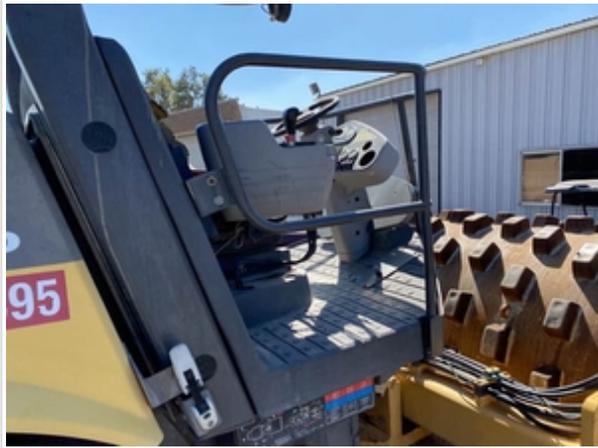
Operator Cabin Photos

Operator Cabin Overall	3 - Normal Wear & Tear	
Operator Cabin Overall Condition	Good cabin appearance, solid floors, panels, and ceiling, Other (see comments)	
Comments	Besides the seat the rest of the cabin in good condition

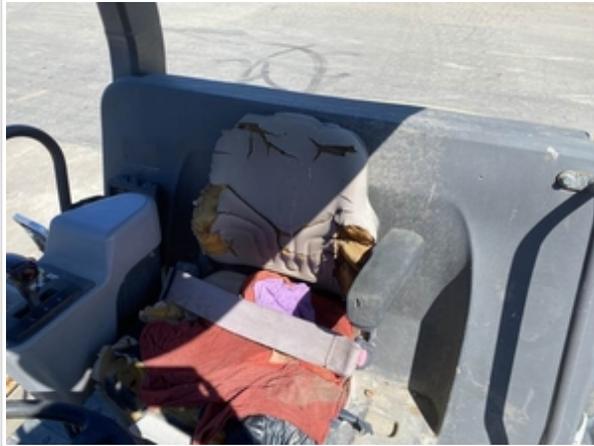
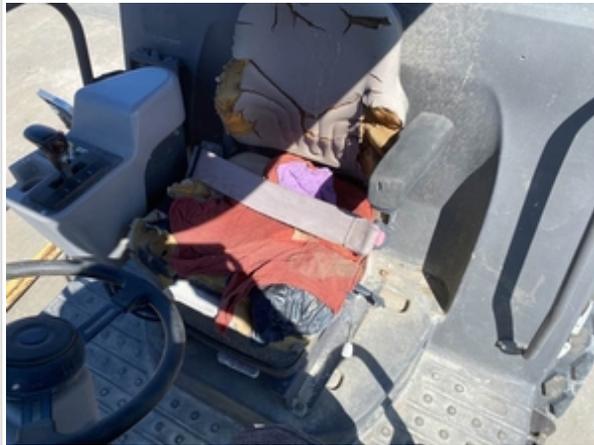
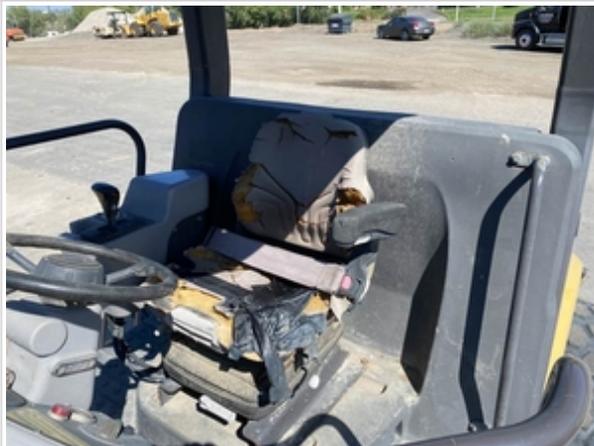
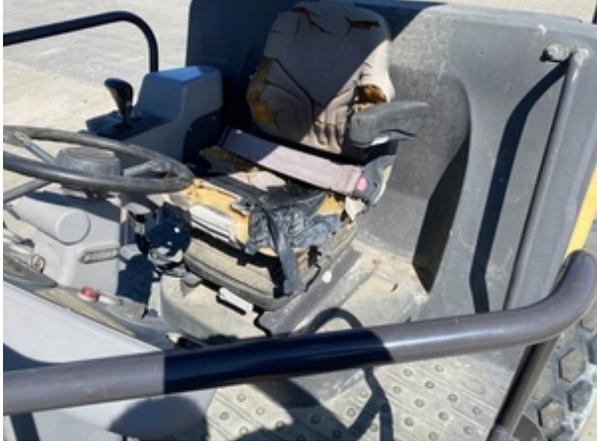
Operator's Seat & Arm Rests
Photos

Operator's Seat & Arm Rests	2 - Above Average Wear
Operator's Seat & Arm Rests Condition	Seat(s) is damaged due to sun exposure; fading, cracking observed, Seat(s) has major surface staining or tears

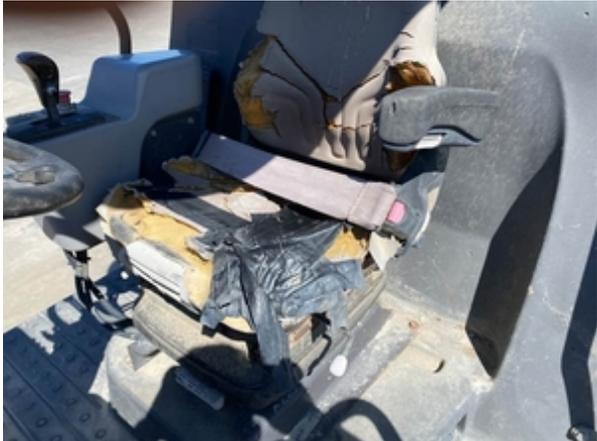
Seat Belt	3 - Normal Wear & Tear
Seat Belt Condition	Other (see comments)
Comments	Seat belt locks but not smooth
Seat Belt Photos

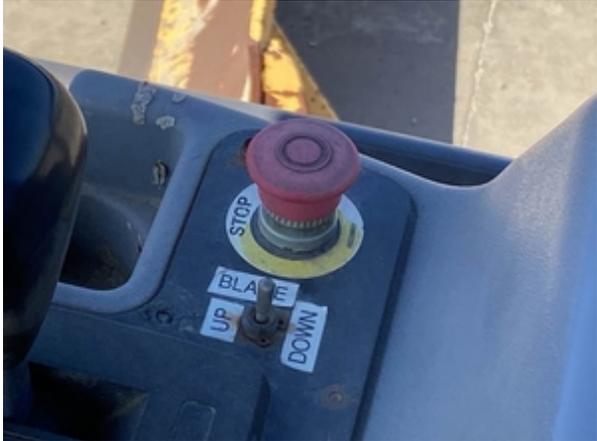
Cabin Lights	0
Safety Lock Out / Stop	3 - Normal Wear & Tear
Safety Lock Out / Stop Condition	Safety lock out device is present, in good condition, and functional
Safety Lock Out / Stop Photos

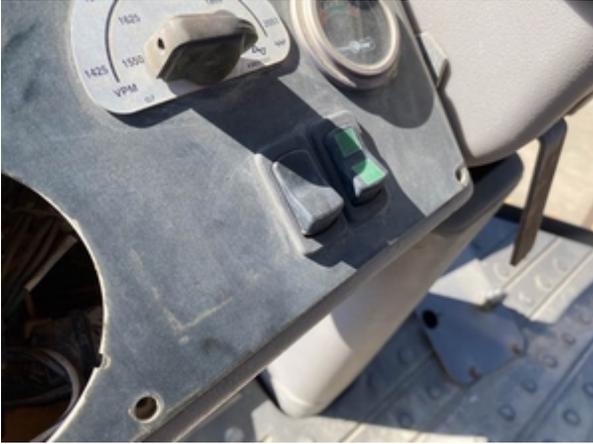
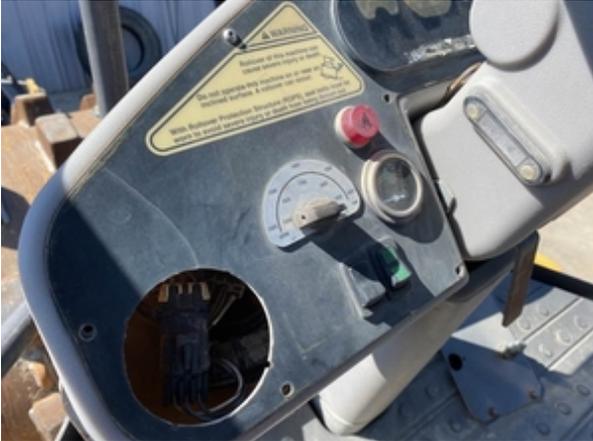
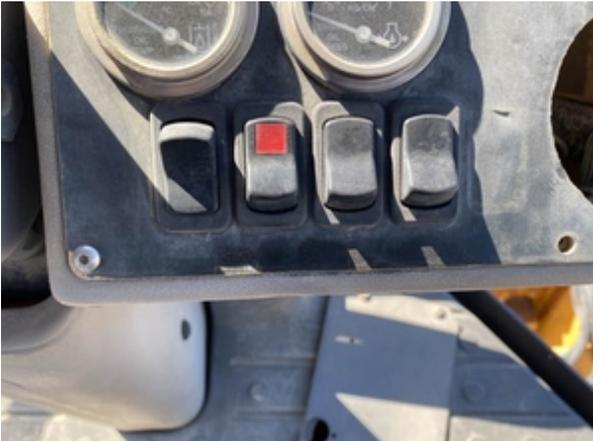
Controls & Switches Condition	All switches are installed and functional, Other (see comments)
Comments	Unable to read front control panel switches (decals worn off)
Controls & Switches Photos

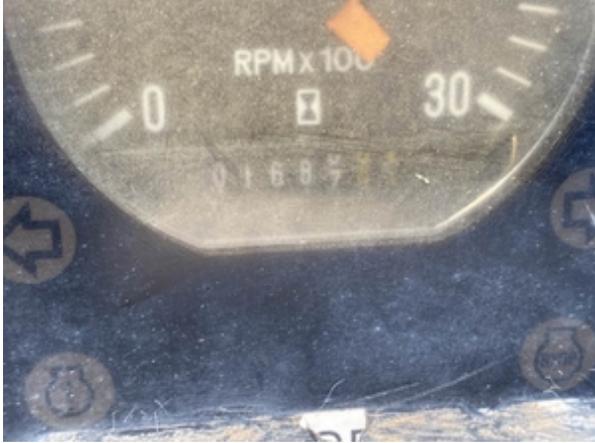
<p>Hour Meter Activity Photos</p>

Hour Meter Activity	3 - Normal Wear & Tear
Hour Meter Condition	Hour meter is functional and in good condition

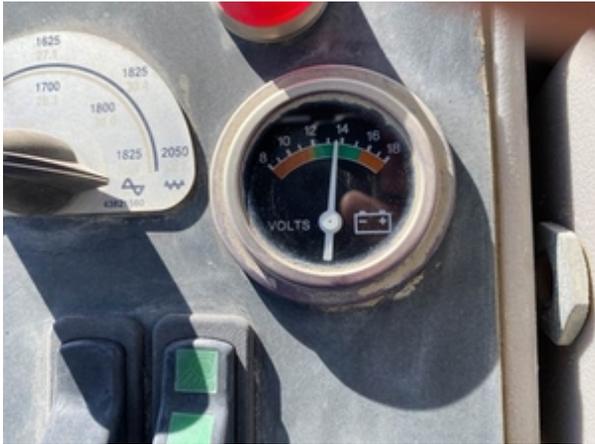
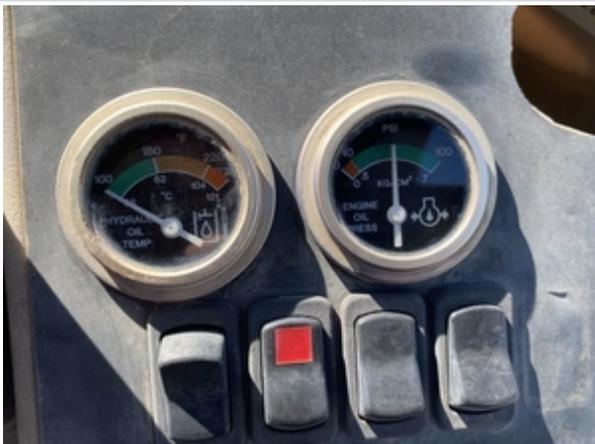
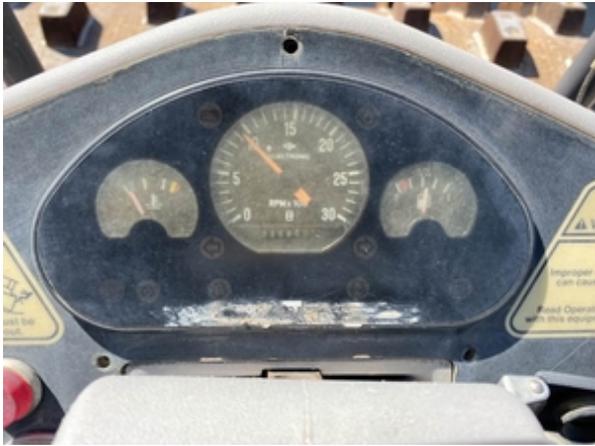
<p>Other Gauge Activity</p>	<p>3 - Normal Wear & Tear</p>
<p>Other Gauge Condition</p>	<p>All cockpit gauges are functional and in good condition, Gauges are functional, with some wear and/or cosmetic damage</p>
<p>Other Gauge Activity Photos</p>

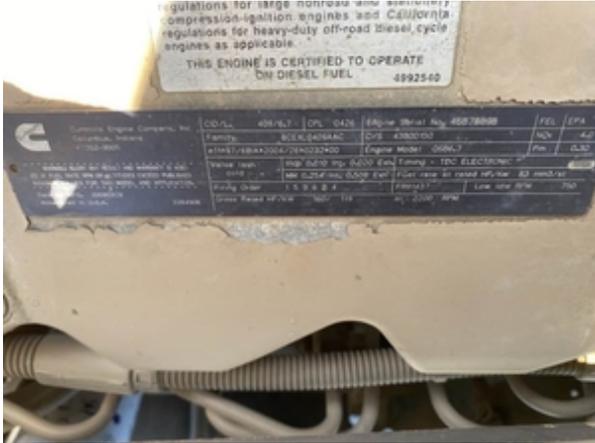
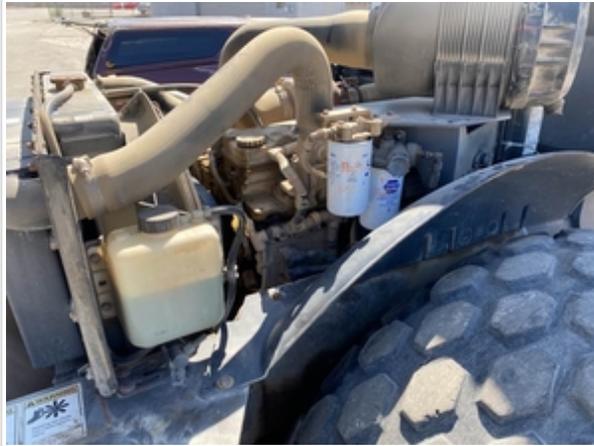
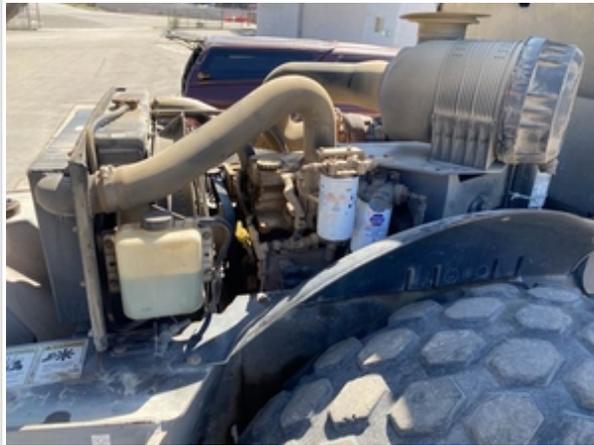
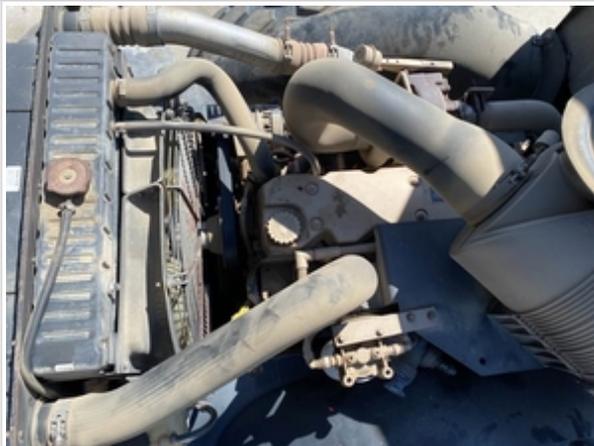
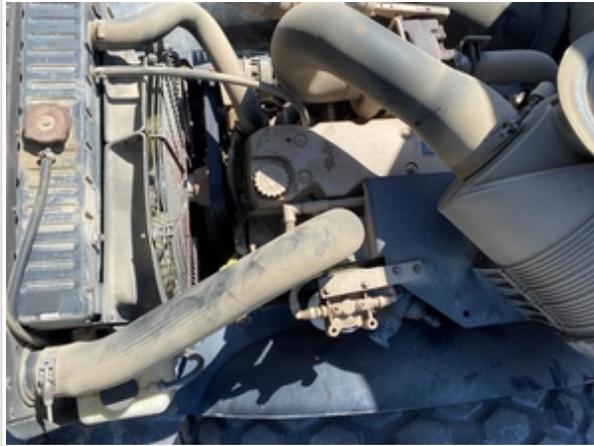
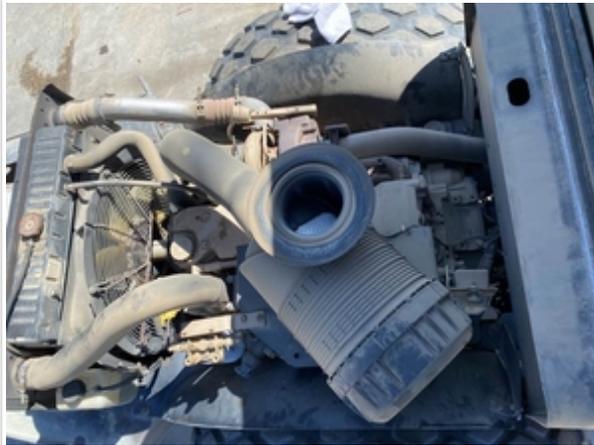
Blow-by (Visual Observation Check)	No	
Unusual Noises (Upon Start-up, Idle, Shutdown)	No	
Unusual Noise Notes	No unusual noises heard, Other (see comments)	
Comments	Exhaust piping to muffler broken so it sounds like open exhaust loud	
Engine Smoke (Upon Start-up, Idle, Shutdown)	No	
Engine Exhaust Color	Clear	
Battery	2 - Above Average Wear	
Battery Condition	Dusty & dirty appearance, Other (see comments)	
Comments	Battery hold down missing

Equipped with DPF (Diesel Particulate Filter)	No
Requires DEF (Diesel Exhaust Fluid)	No
Overall Engine Appearance	Dusty & dry
Overall Engine Comments	Could use a psi wash. No active leaks found from engine. Exhaust broken before muffler. Fuel leaking from fuel tank.

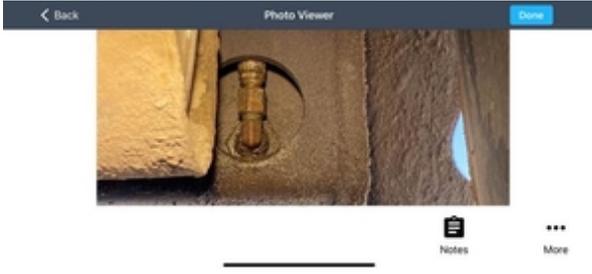
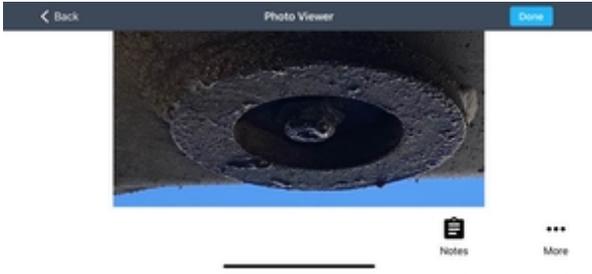
Oil Color / Appearance Notes	Clean oil appearance, no signs of cross contamination, Appropriate oil level
Fuel Leaks	Yes
Fuel Leak Notes	Wet spots & streaking on fuel lines indicate an active leak, Other (see comments)
Comments	Fuel leak coming from rear fuel tank area, possible hose
Fuel Leaks Photos

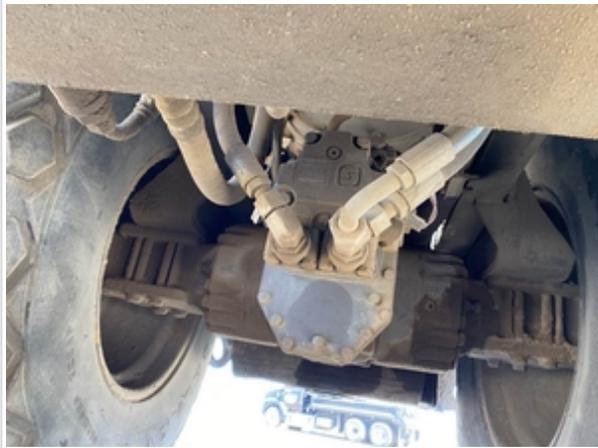
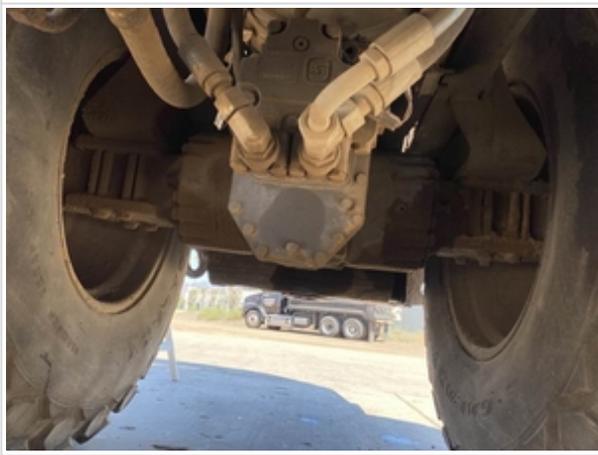
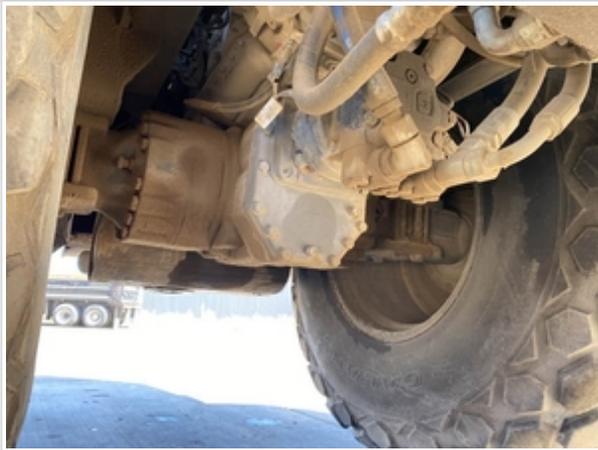
<p>Drive Motor Photos</p>

Drivetrain	
Hydrostatic Transmission?	Yes
2 Speed?	Yes
Hydrostatic Drive Configuration	Other (see comments)
Comments	Drive motor to a rear axle propelled
Drive Motors	2 - Above Average Wear
Comments	Drive motor also on front drum

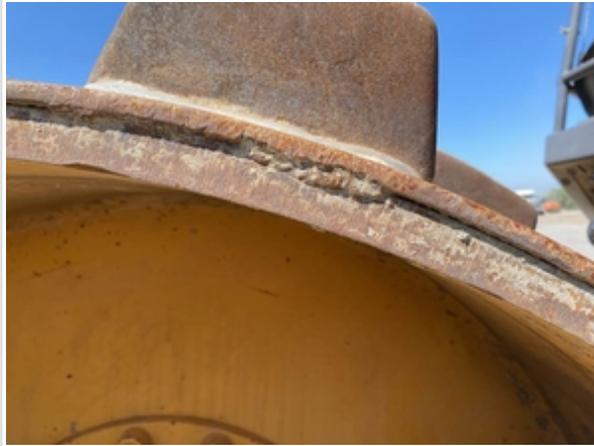
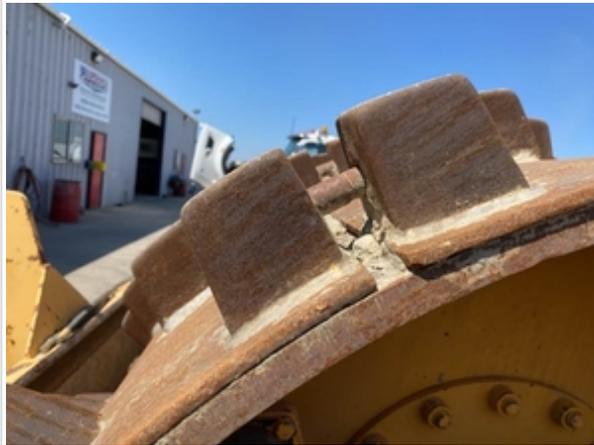
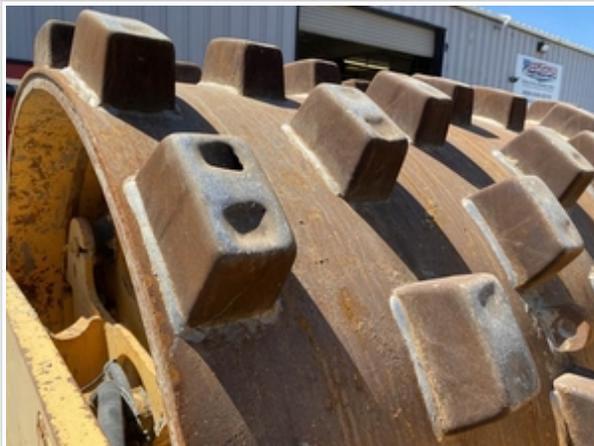
Drum(s) Condition	3 - Normal Wear & Tear	
Comments	Sheepfoot stich welded to smooth drum	
Drum(s) Photos

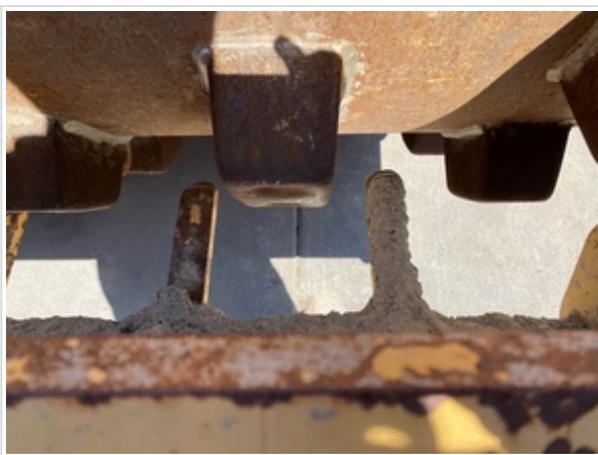
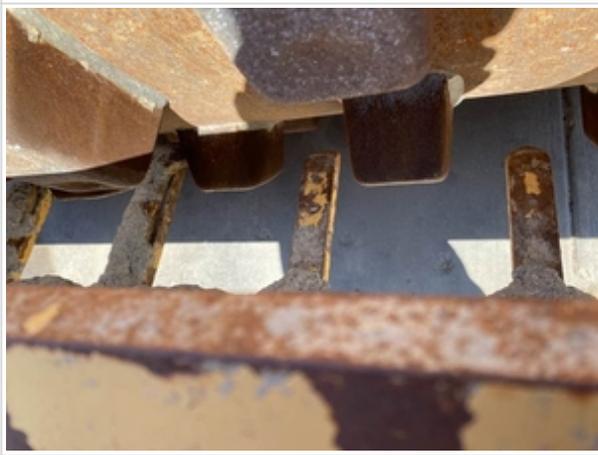
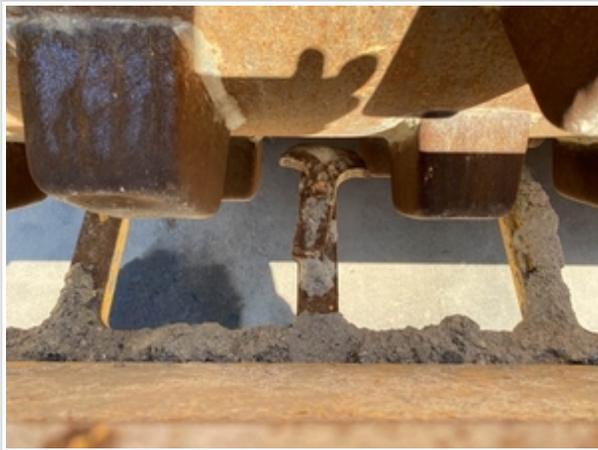
<p>Drum Scraper Photos</p>

Drum Scraper	2 - Above Average Wear	
Comments	Scraper frames in place, the scrapers that bolt to these are mostly missing

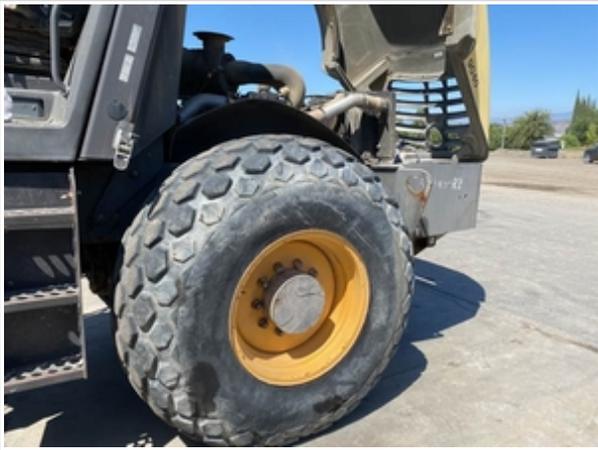
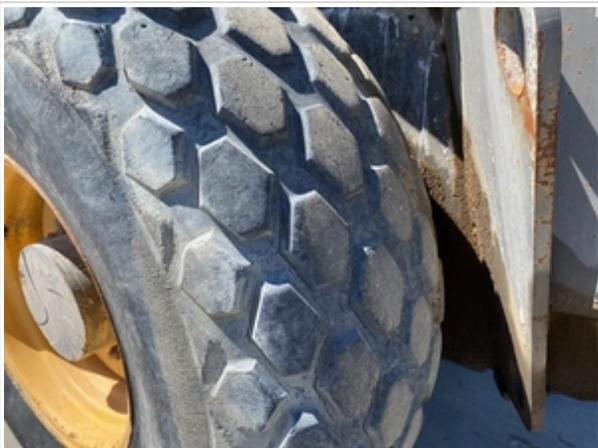
Tire Brand	Galaxy	
Tire Size	23.1 -26	
Left Tire - Ratio Remaining	30%	
Left Tire Photos

Overall Chassis	3 - Normal Wear & Tear
Overall Chassis Comments	Overall chasis holding together just fine. Tires getting old and have surface cracks.

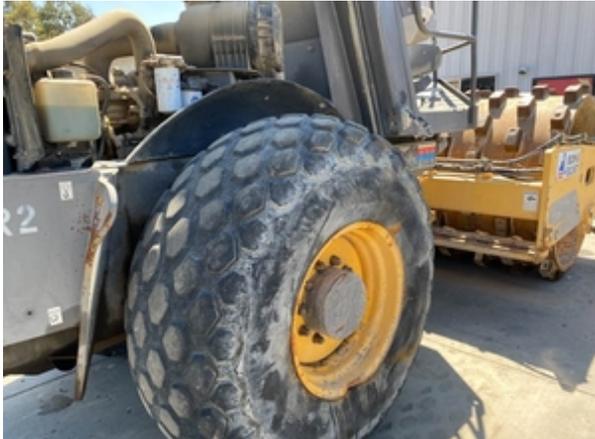
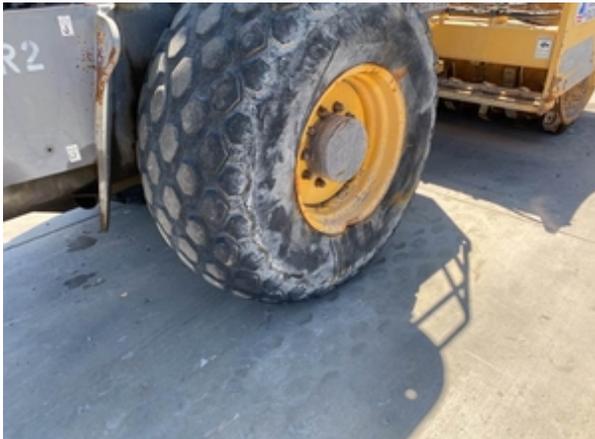
Right Tire - Ratio Remaining	30%	
Right Tire Photos

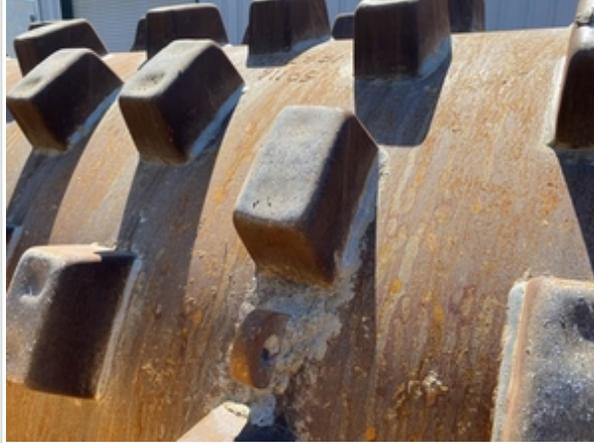
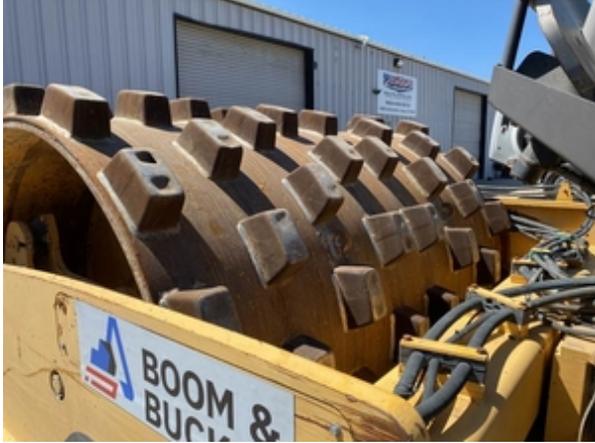
Padfoot Feet Condition Photos

Padfoot Feet Condition	3 - Normal Wear & Tear	
Comments	Some are in great condition others worn through surface. Most okay

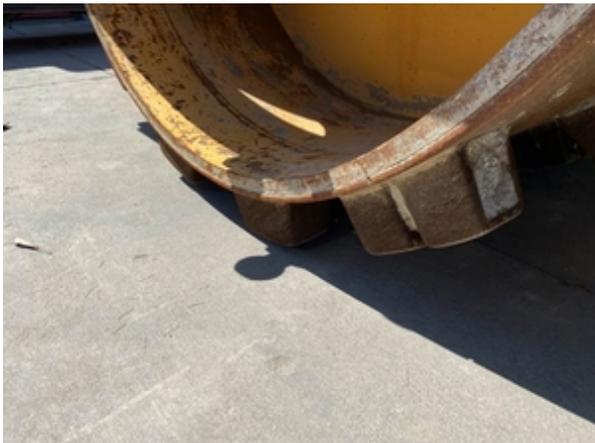
Padfoot Fitment	3 - Normal Wear & Tear	
Comments	Solid to smooth drum not loose	
Padfoot Fitment Photos

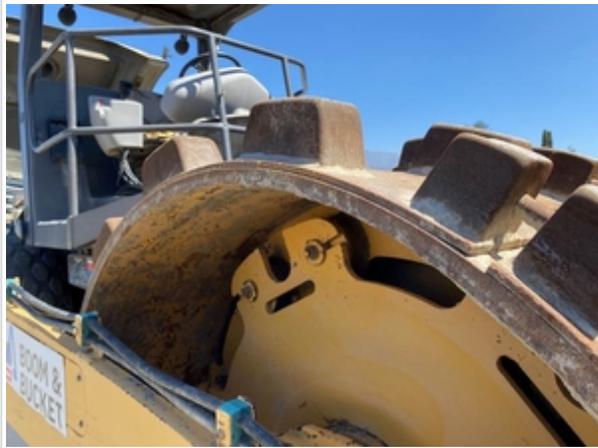
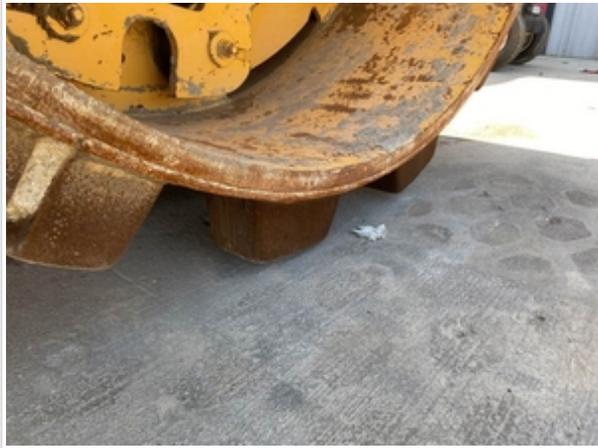
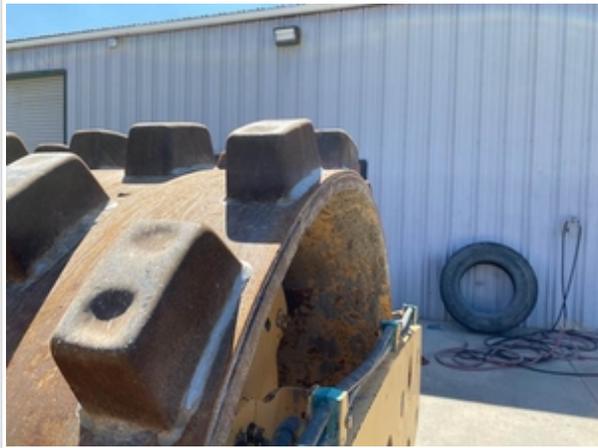
Padfoot Hardware	3 - Normal Wear & Tear
Comments	All intact plus welded on edges

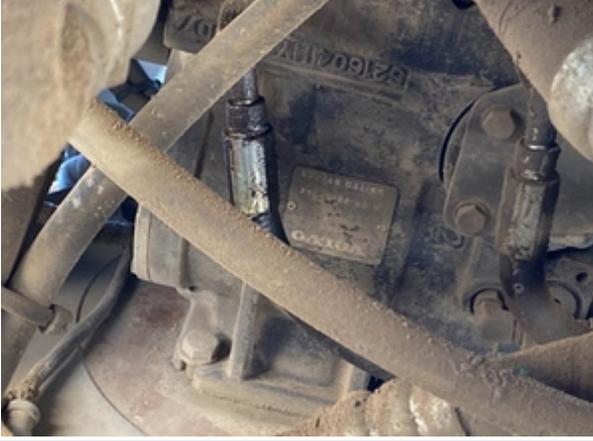
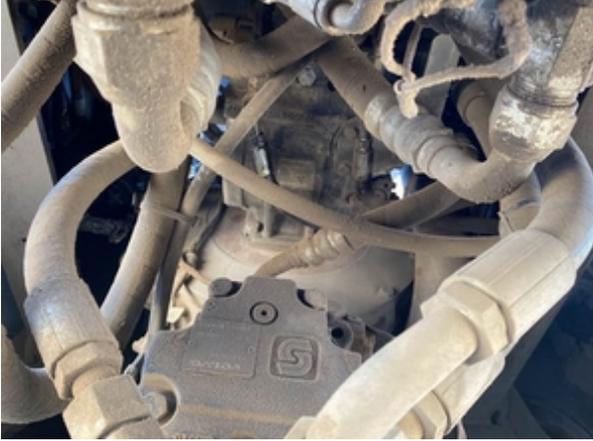
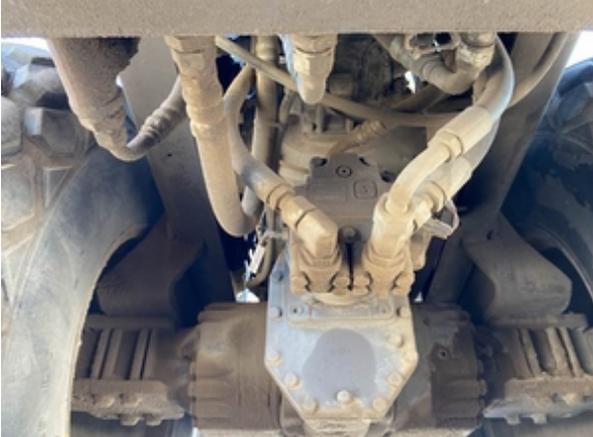
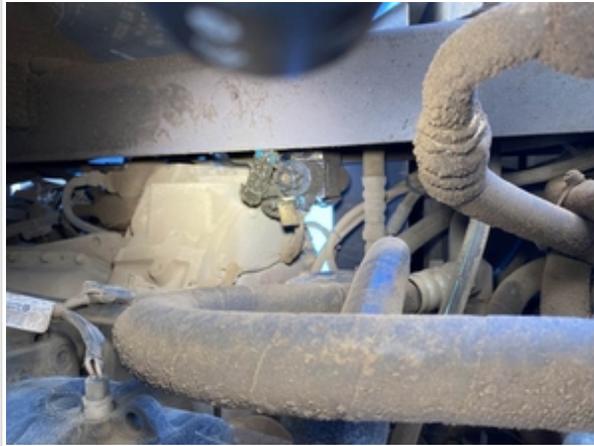
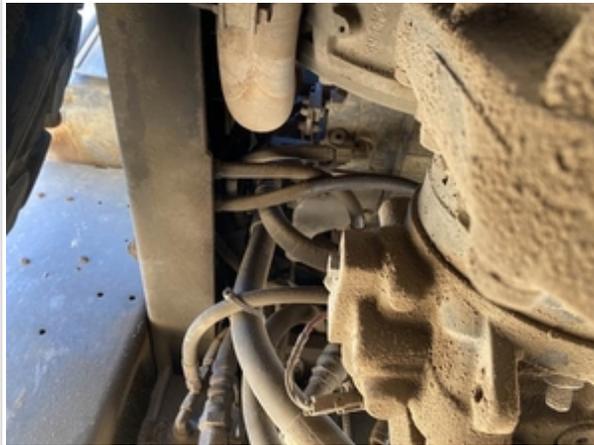
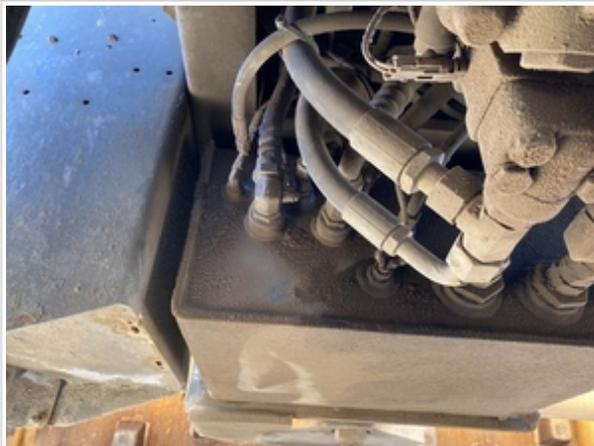
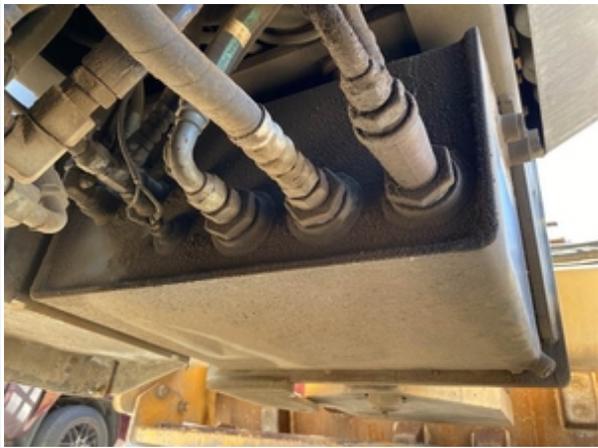
Hydraulic Lines / Fittings Condition	Hydraulic lines & fittings are clean and in good condition, Dried seepages observed, Active leaks in hoses or fittings observed, Other (see comments)
Comments	Few hydraulic leaks found
Appearance of Hydraulic Lines / Fittings Photos

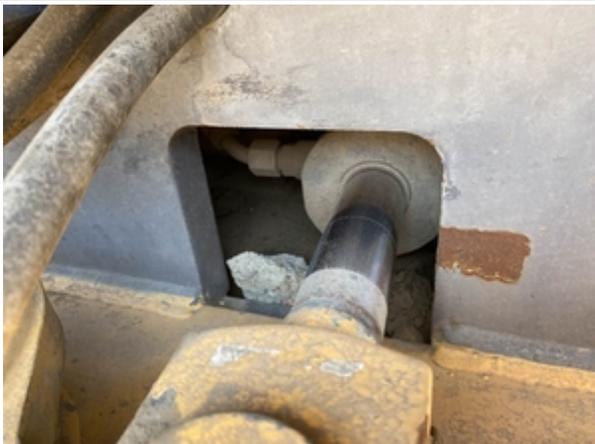
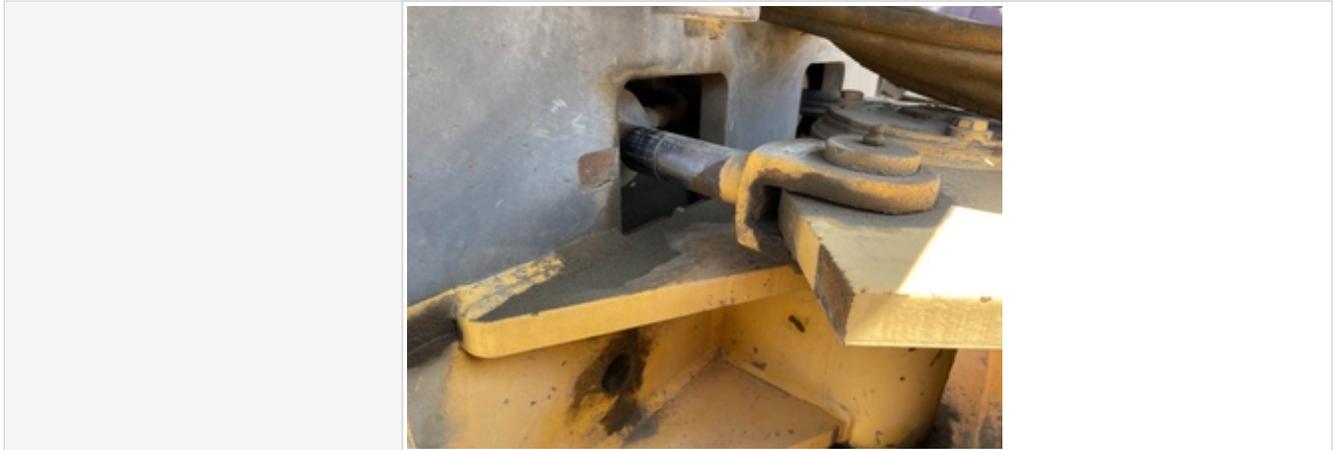
Steering Cylinders: Mounting Pin	3
Steering Cylinders: Oil Leaks	No
Steering Cylinders Photos
