## Inspection Report (Telehandler)

Year	2014
Make	JLG
Model	10054
Serial Number	0160060545
Hour Meter Reading	4,230
Previous Application (e.g., earth moving, mining, demolition, etc)	Equipment Rentals

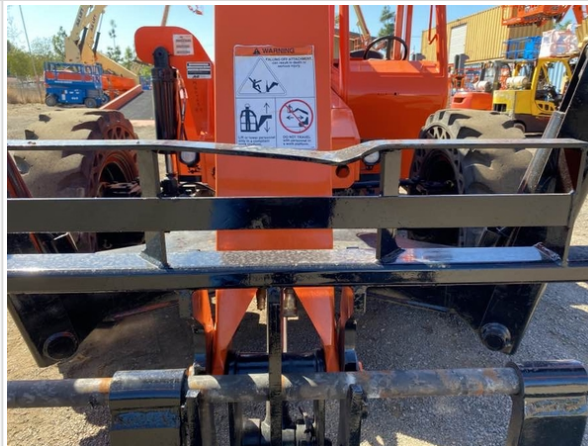
Front	3 - Normal Wear & Tear
Front Condition	No visible damage, Other (see comments)
Comments	Small dent to topside of front fork backrest
Front Photos

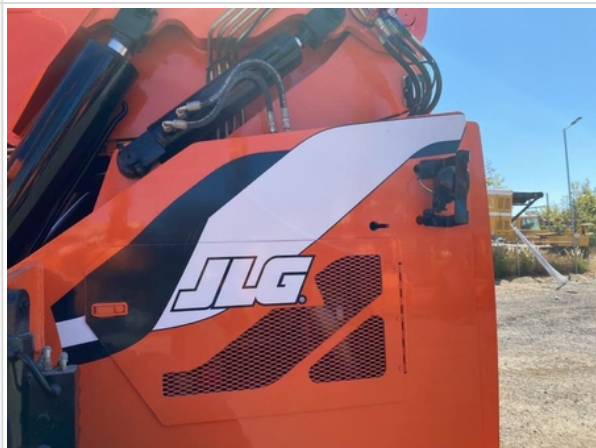
<b>Left</b>	3 - Normal Wear & Tear	
<b>Left Condition</b>	No visible damage, Other (see comments)	
<b>Comments</b>	Small dent on bottom left side of side step	
<b>Left Photos</b>

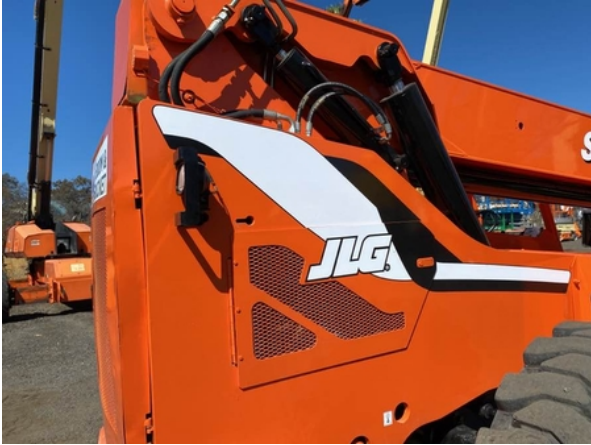
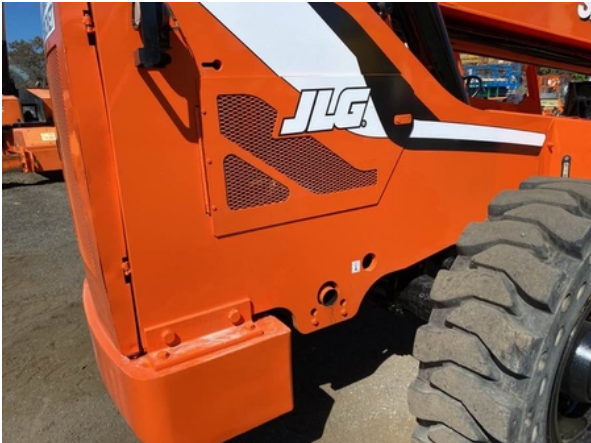
<b>Right</b>	3 - Normal Wear & Tear	
<b>Right Condition</b>	No visible damage, Other (see comments)	
<b>Right Photos</b>

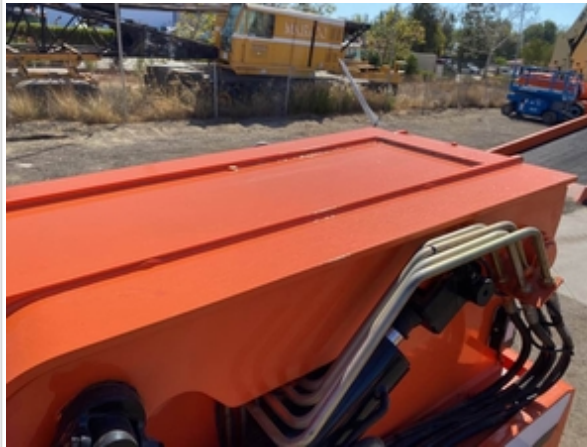
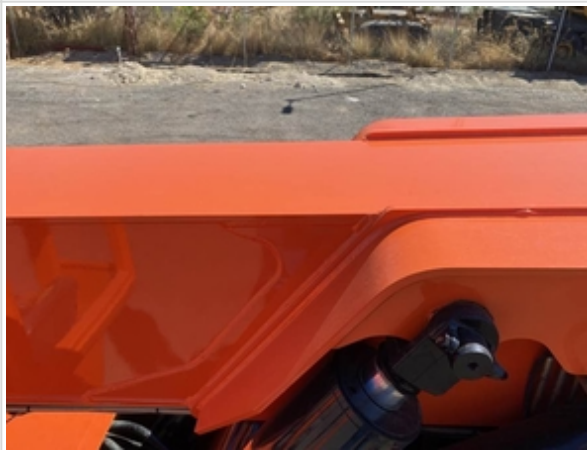
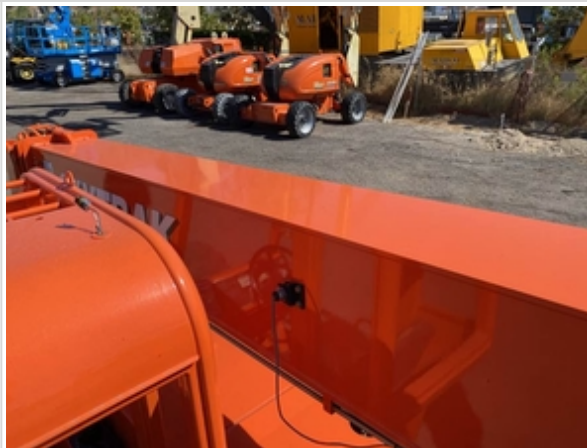
Upper Photos

<p>Upper</p>	<p>3 - Normal Wear &amp; Tear</p>	
<p>Upper Condition</p>	<p>No visible damage</p>

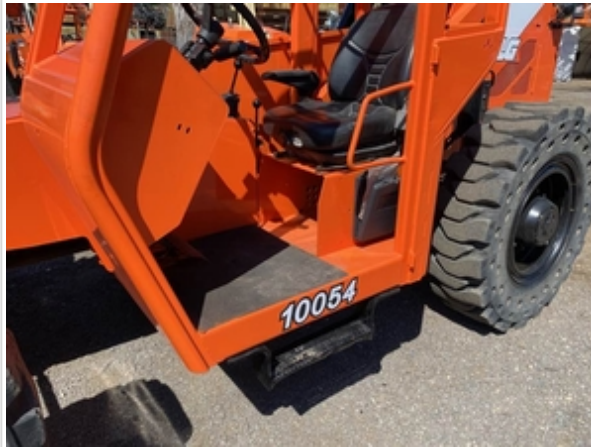
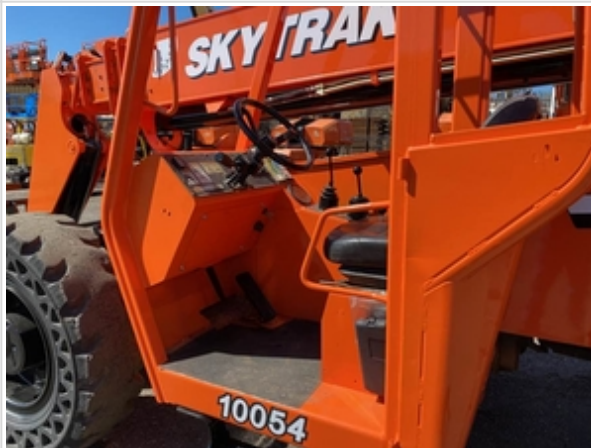
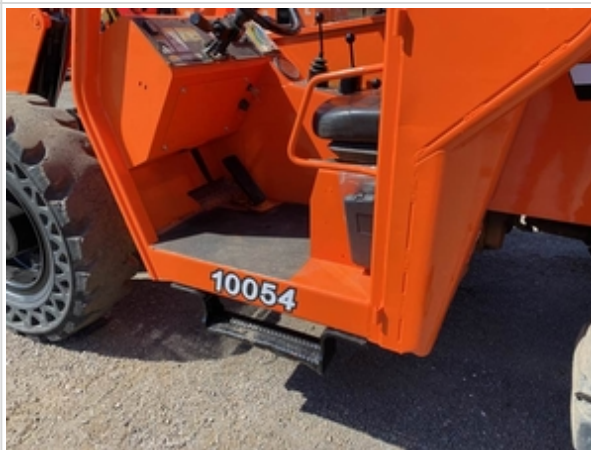
Operator Cabin Overall	3 - Normal Wear & Tear
Operator Cabin Overall Condition	Good cabin appearance, solid floors, panels, and ceiling
Operator Cabin Photos

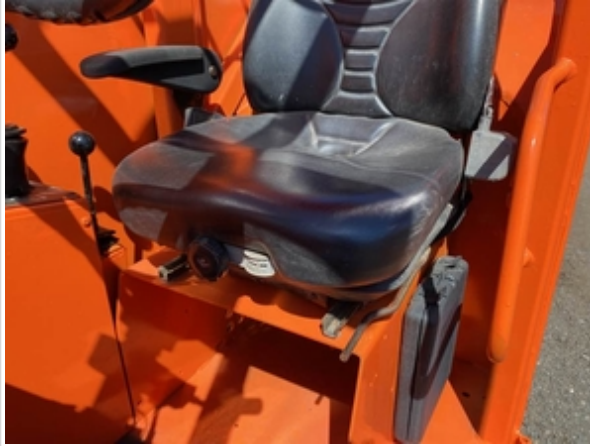
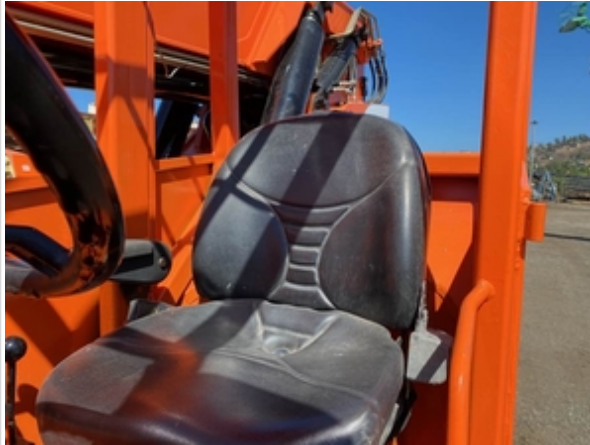
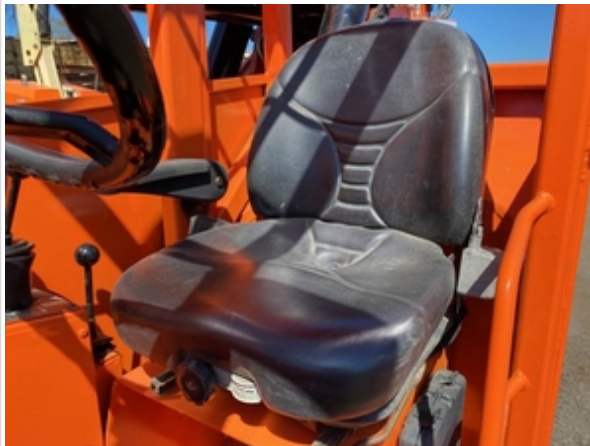
Operator's Seat & Arm Rests  
Photos

<b>Operator's Seat &amp; Arm Rests</b>	3 - Normal Wear & Tear	
<b>Operator's Seat &amp; Arm Rests Condition</b>	Seat(s) in good condition, no stains or tears in upholstery, Seat(s) have minor surface staining or small tears, Other (see comments)	
<b>Comments</b>	Seat in good shape just a small tear on top of seat

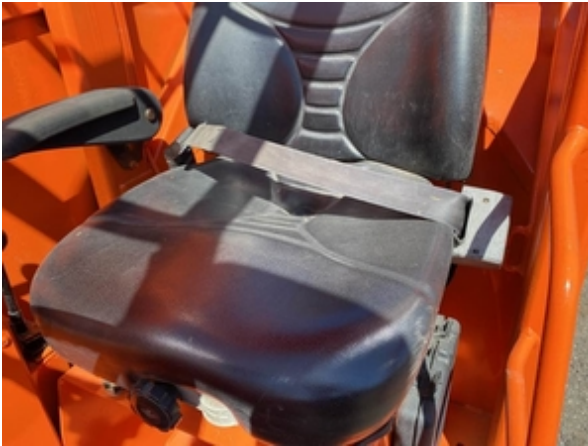
<b>Seat Belt</b>	3 - Normal Wear & Tear	
<b>Seat Belt Condition</b>	Seat belt secures properly. Belt is intact and in good condition	
<b>Seat Belt Photos</b>

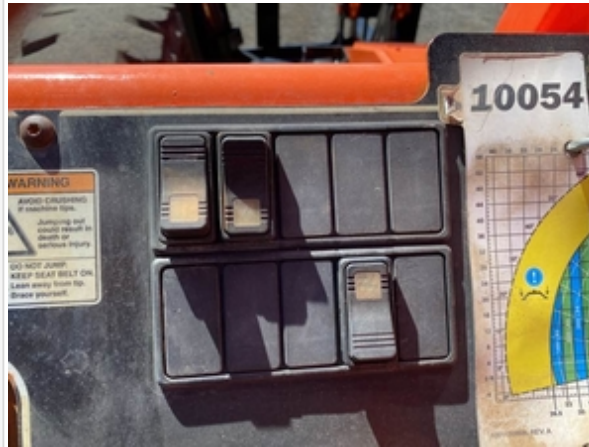
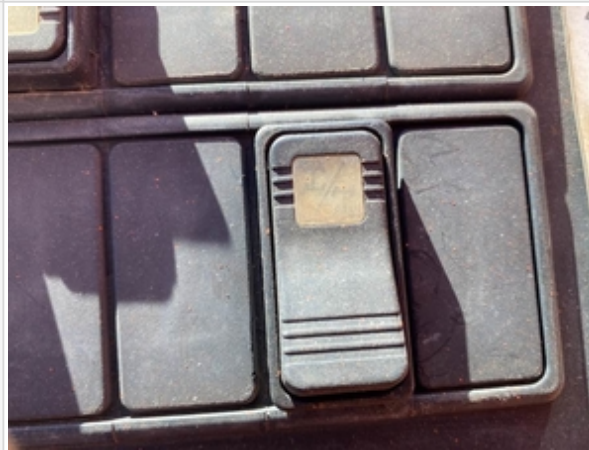
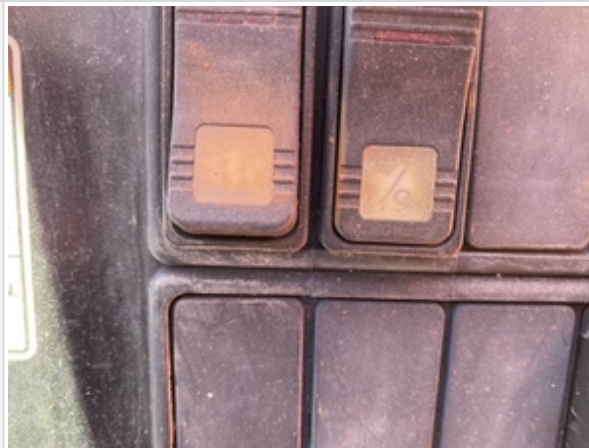
Controls & Switches Photos

<b>Cabin Lights</b>	0	
<b>Safety Lock Out / Stop</b>	0	
<b>Controls &amp; Switches</b>	3 - Normal Wear & Tear	
<b>Controls &amp; Switches Condition</b>	All switches are installed and functional

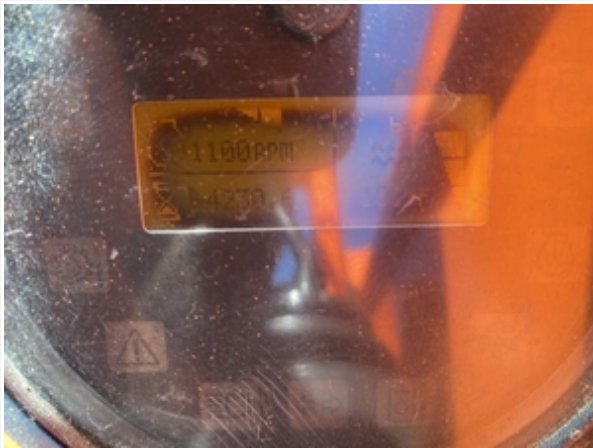
<b>Hour Meter Activity</b>	3 - Normal Wear & Tear
<b>Hour Meter Condition</b>	Hour meter is functional and in good condition
<b>Hour Meter Activity Photos</b>

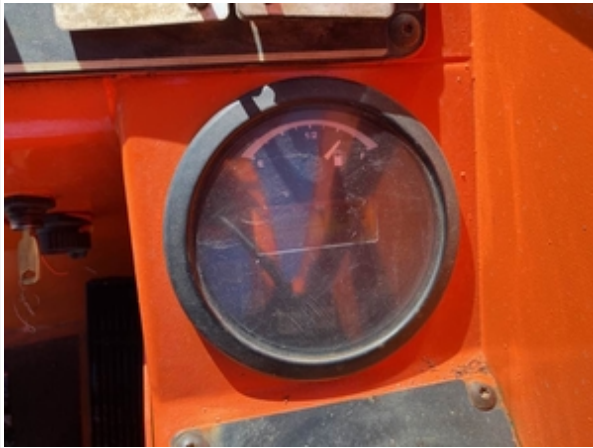
Other Gauge Activity Photos

<b>Other Gauge Activity</b>	3 - Normal Wear & Tear
<b>Other Gauge Condition</b>	All cockpit gauges are functional and in good condition

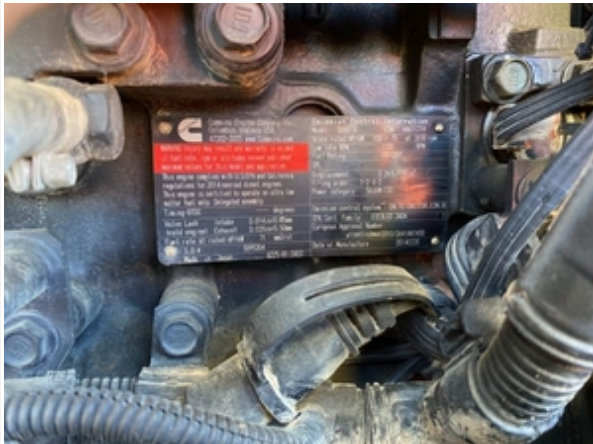
Engine Type (Make, Model, Cylinders, Hp)	Cummins QSB3.3 - 4cyl. - 75HP - 3.3L
Engine Serial Number	68611719
Engine Fuel Type	Diesel
Engine Photos

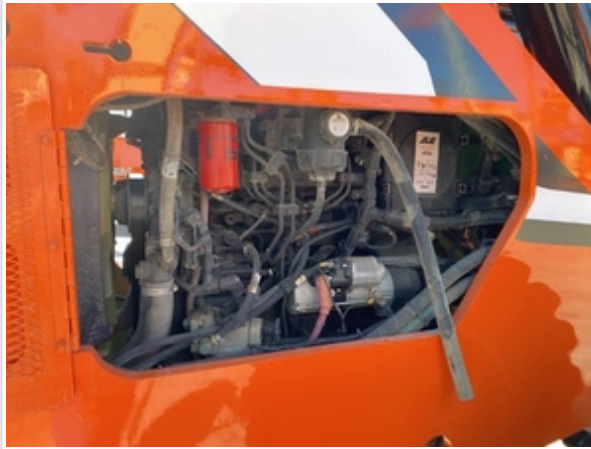
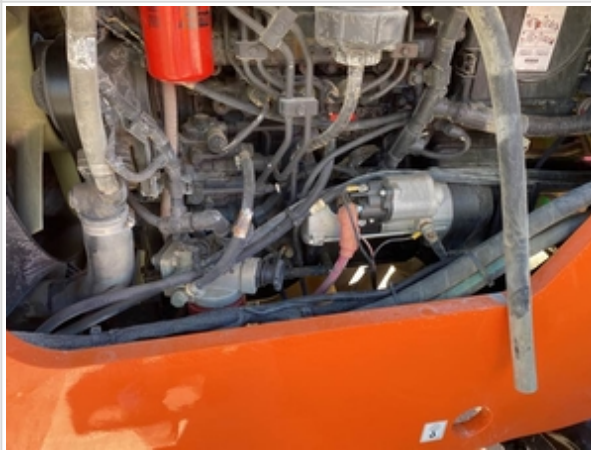
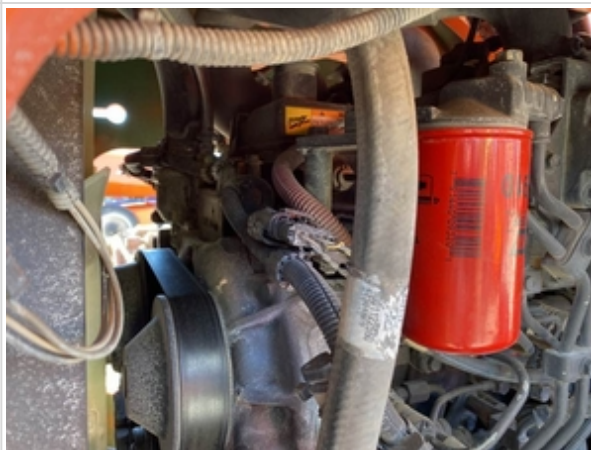
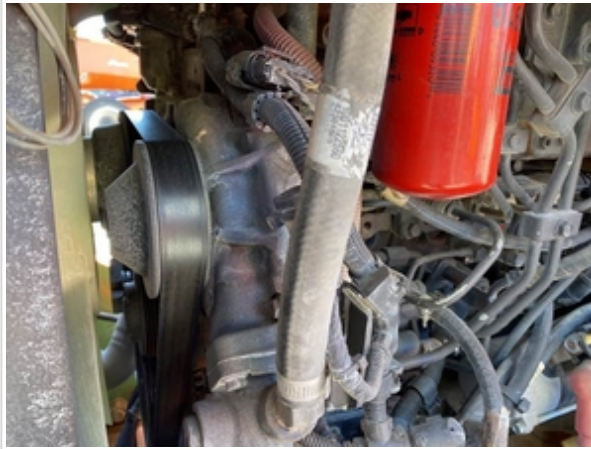
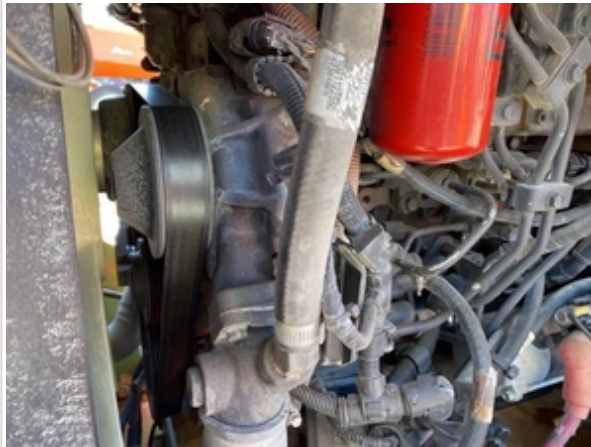
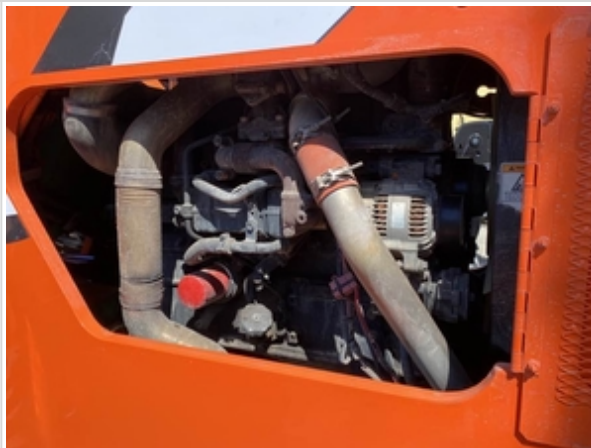
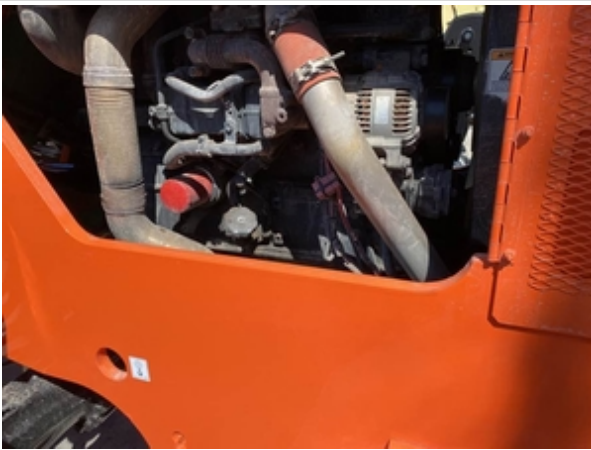
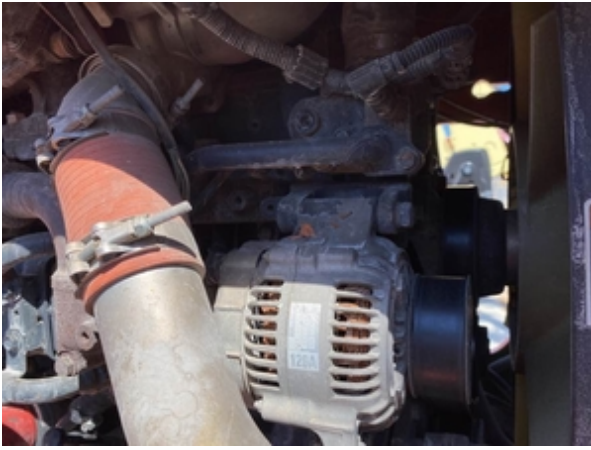
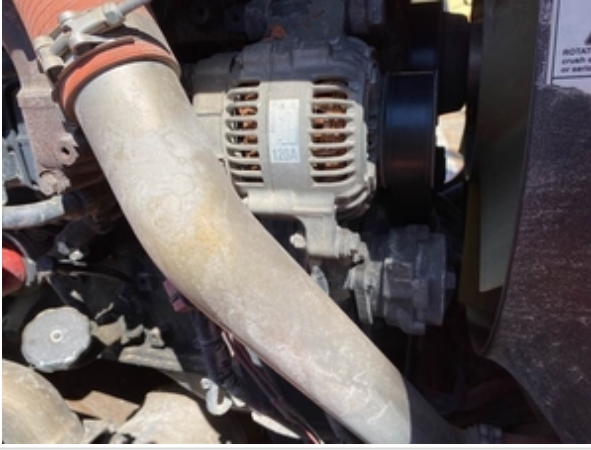
<b>Blow-by (Visual Observation Check)</b>	No	
<b>Unusual Noises (Upon Start-up, Idle, Shutdown)</b>	No	
<b>Unusual Noise Notes</b>	No unusual noises heard	
<b>Engine Smoke (Upon Start-up, Idle, Shutdown)</b>	No	
<b>Engine Smoke Notes</b>	No engine smoke issues observed	
<b>Engine Exhaust Color</b>	Clear

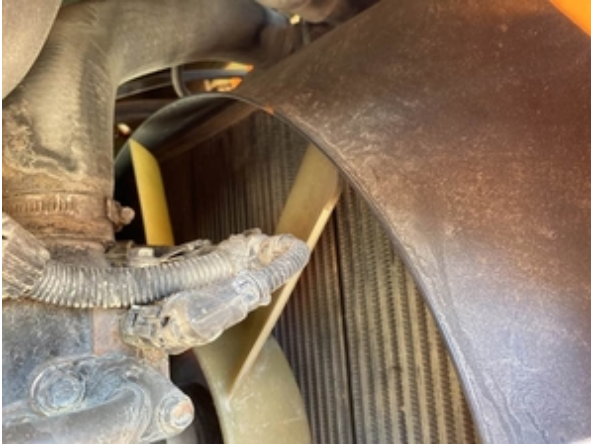
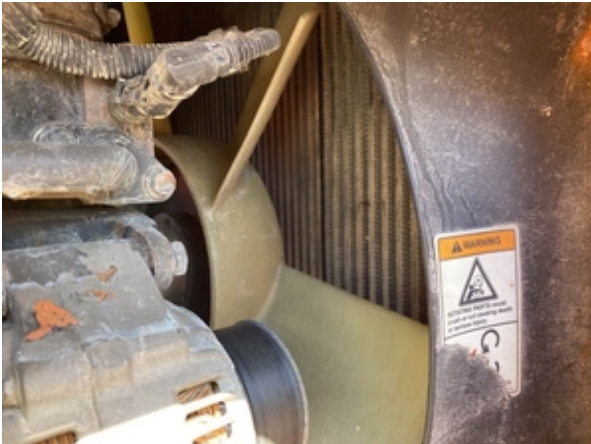
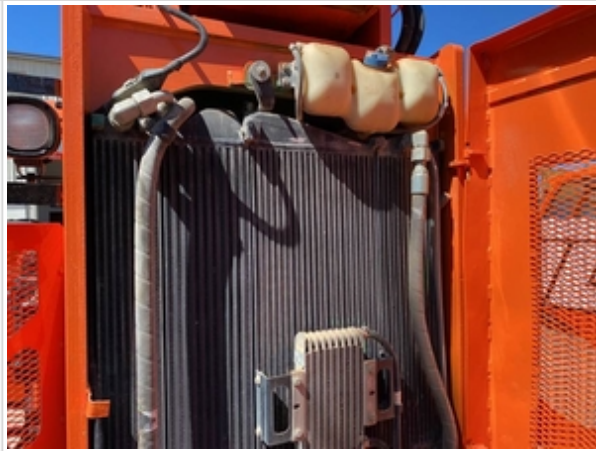
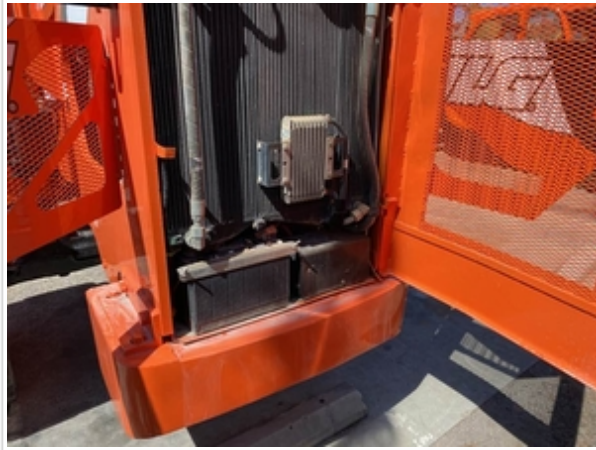
Radiator	3 - Normal Wear & Tear
Radiator Condition	Radiator fins & components appear to be in good working order, no signs of damage or leaks
Radiator Photos

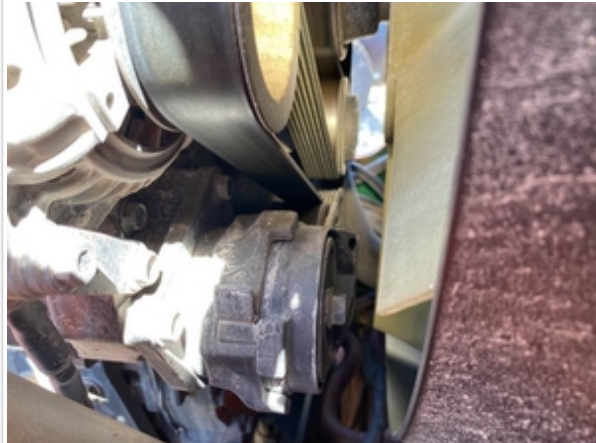
<b>Belts</b>	3 - Normal Wear & Tear
<b>Belt Condition</b>	Belts appear in good condition & alignment with proper tension
<b>Belt Photos</b>

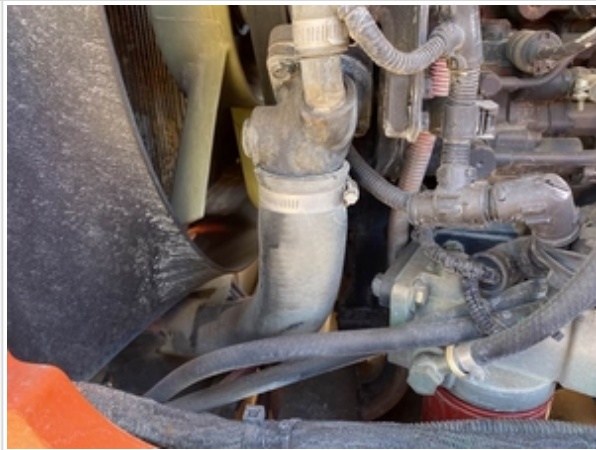
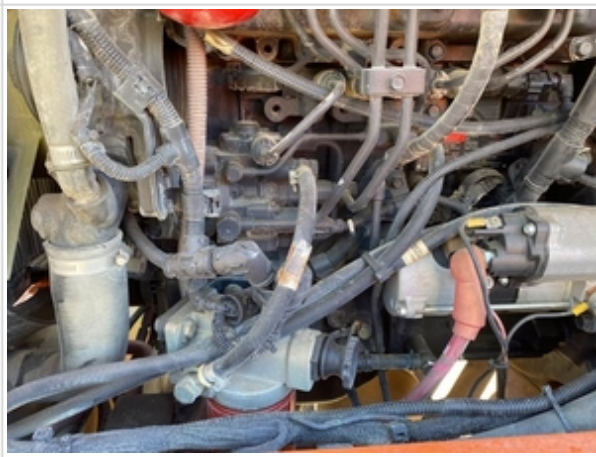
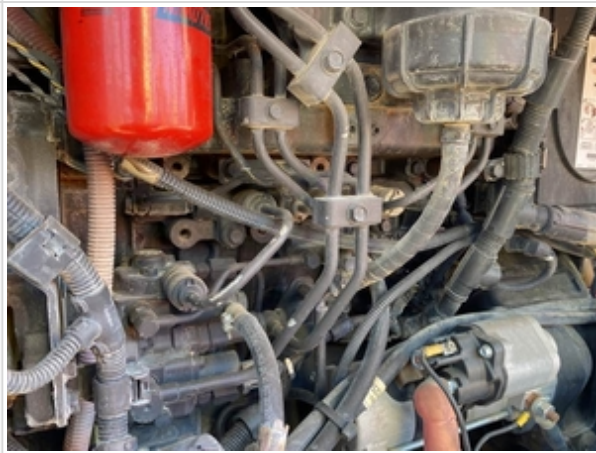
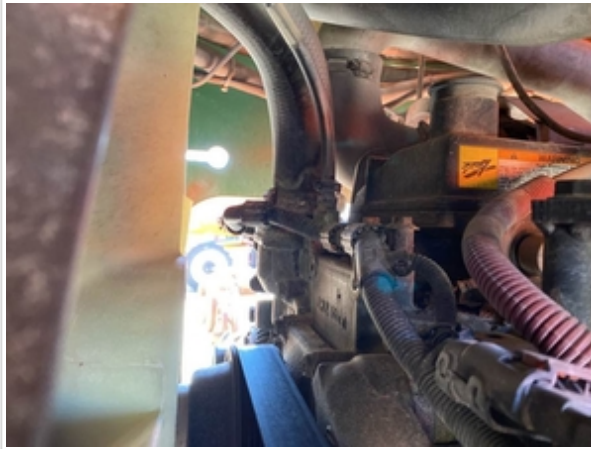
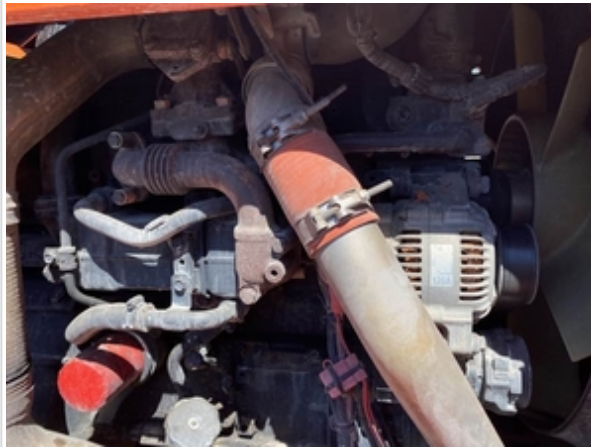
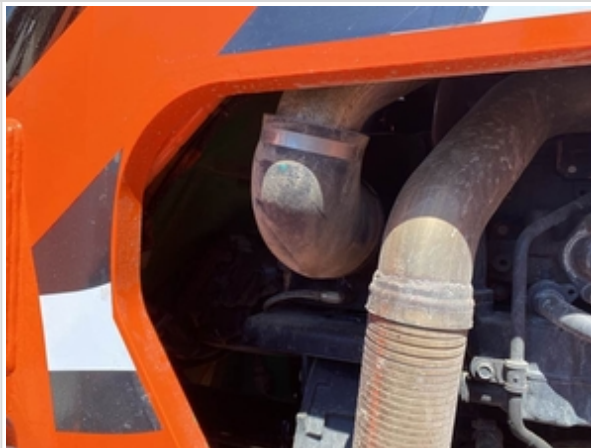
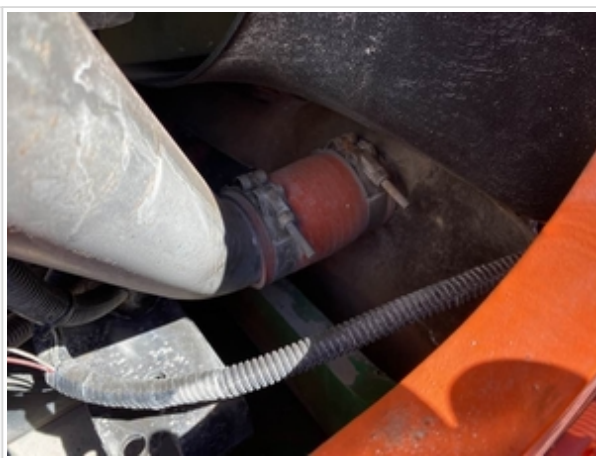
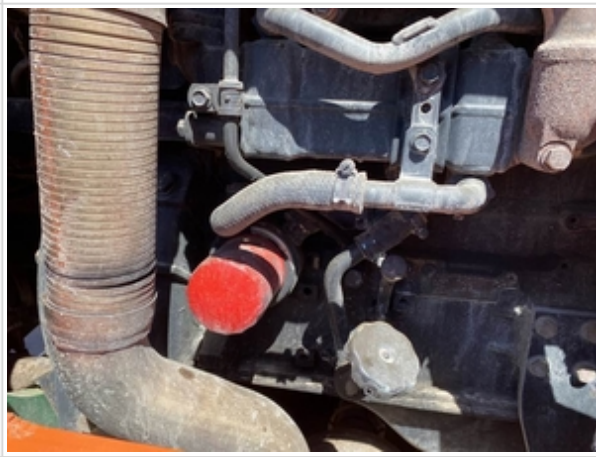
<p>Hose Photos</p>

<b>Hoses</b>	3 - Normal Wear & Tear
<b>Hose Condition</b>	Firm, pliant hoses with no signs of wear or leaks

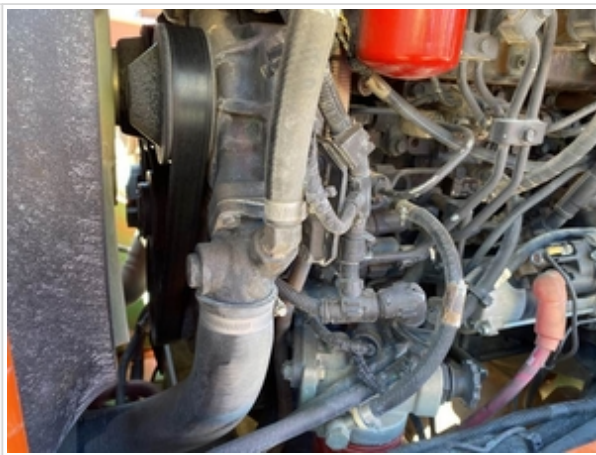
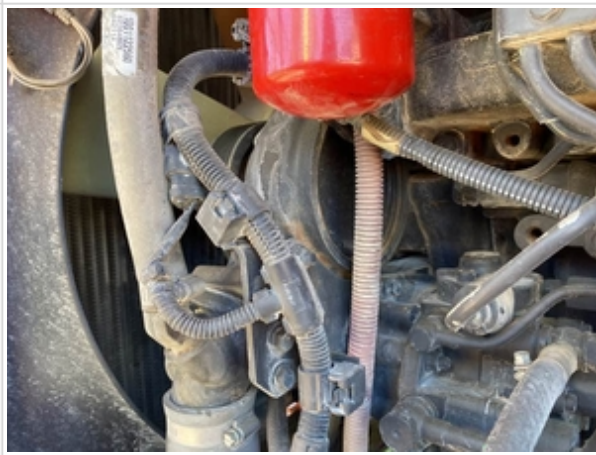
<b>Water Pump</b>	3 - Normal Wear & Tear	
<b>Water Pump Condition</b>	No unusual pump noises heard	
<b>Water Pump Photos</b>

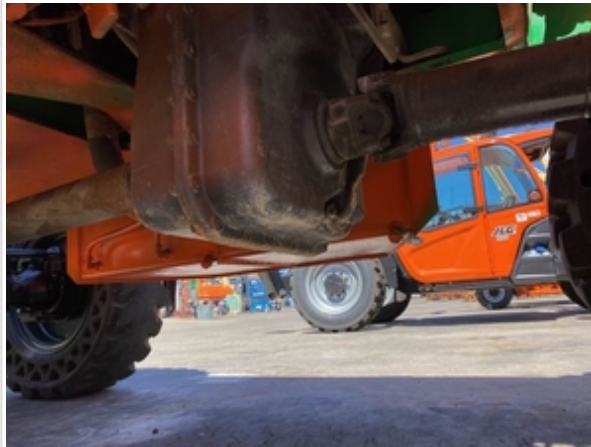
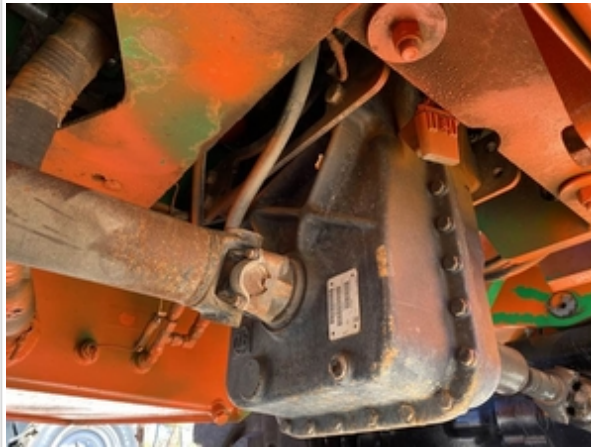
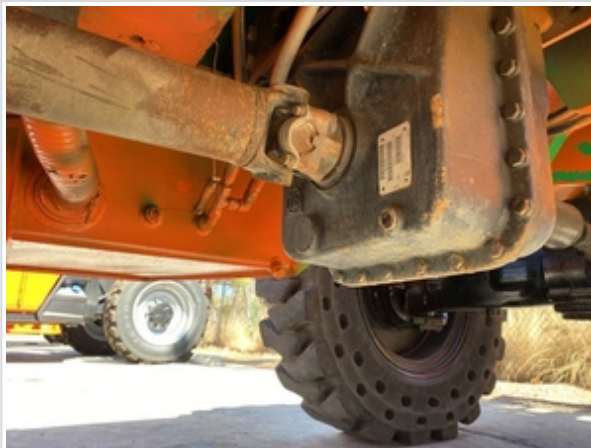
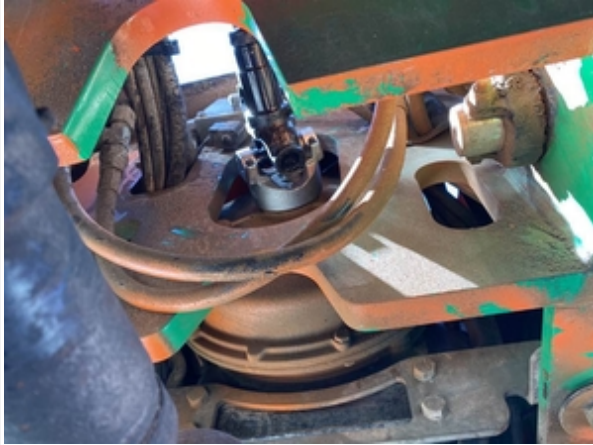
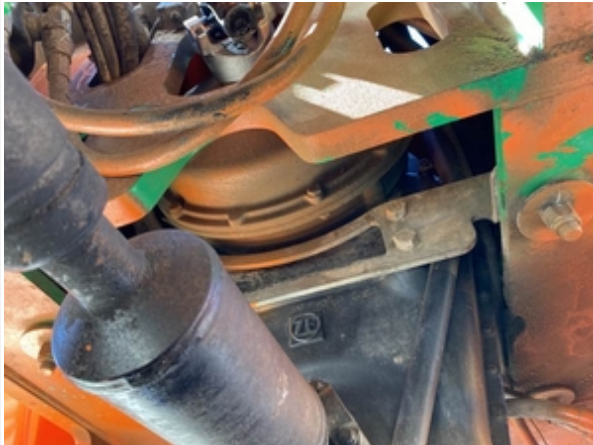
Transmission Info	ZF Power shift 4 speed transmission
Transmission	3 - Normal Wear & Tear

Transmission Condition	No unusual noises or vibrations
Transmission Photos

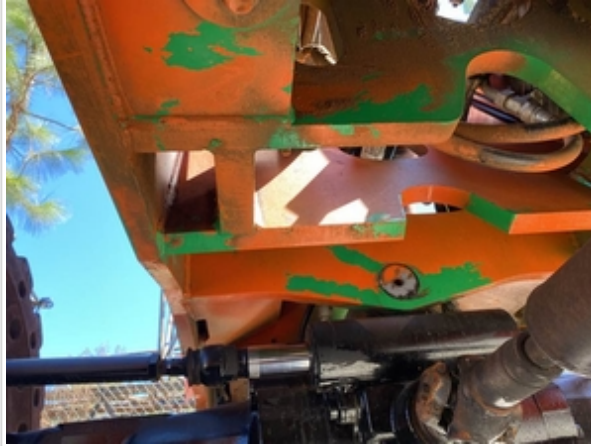
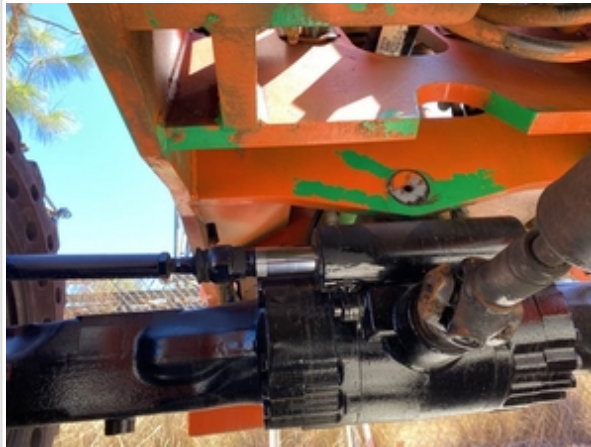
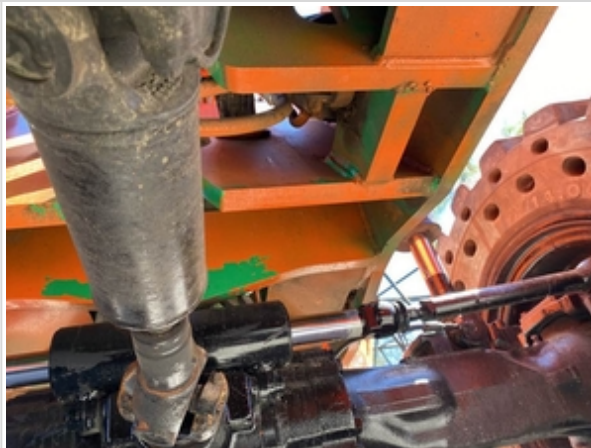
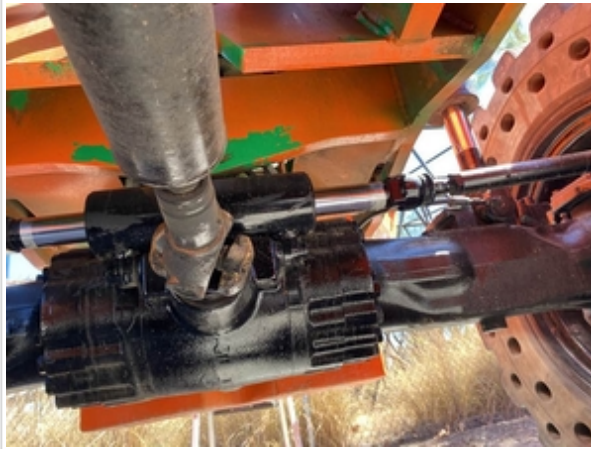
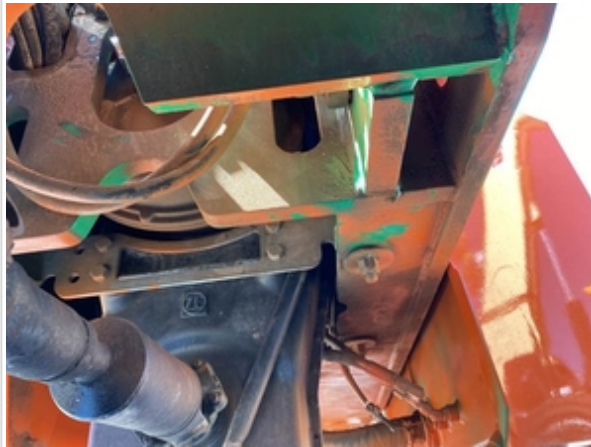
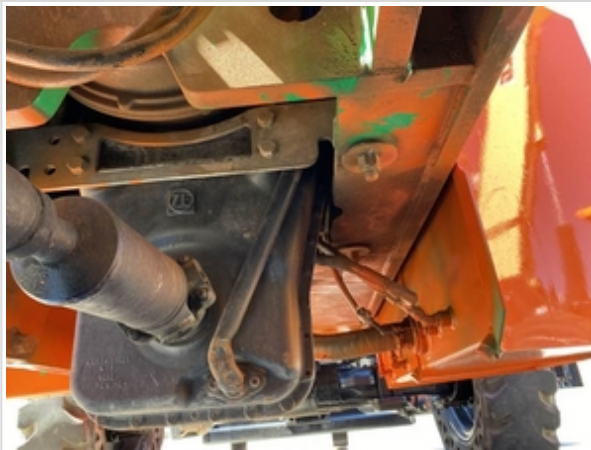
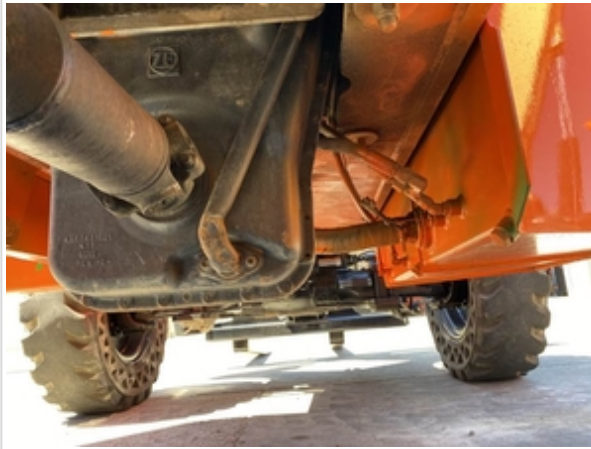
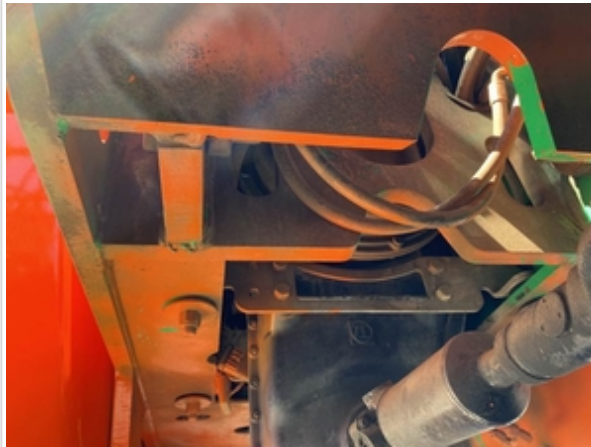
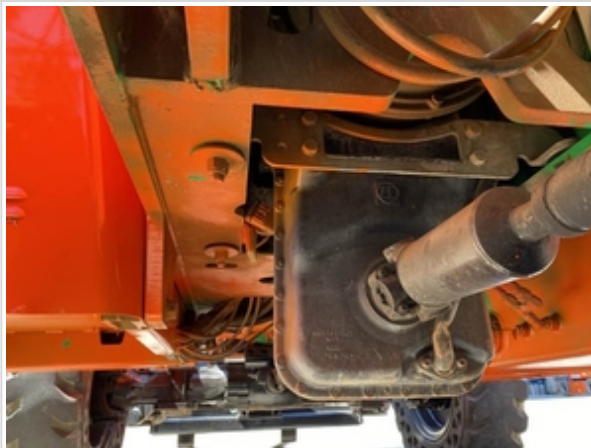
Frame Photos

Instructions	<p>Evaluate the following on a 4 point scale (leave comments where an explanation is appropriate):</p> <p>4 = Like New, Recently Replaced          3 = Normal Wear &amp; Tear          2 = Above Average Wear          1 = Service Required</p>
Frame	3 - Normal Wear & Tear

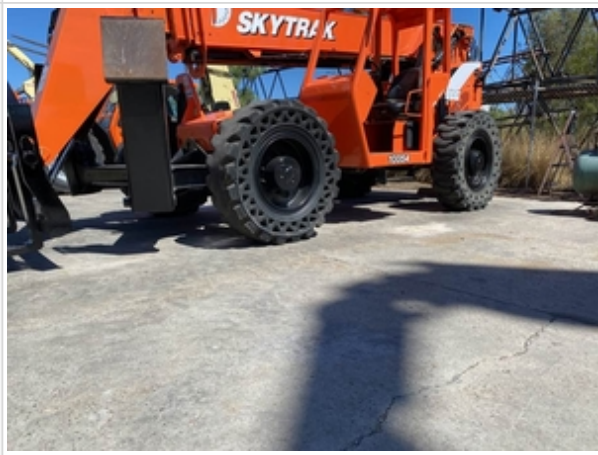
<b>Stance</b>	3 - Normal Wear & Tear	
<b>Stance Photos</b>

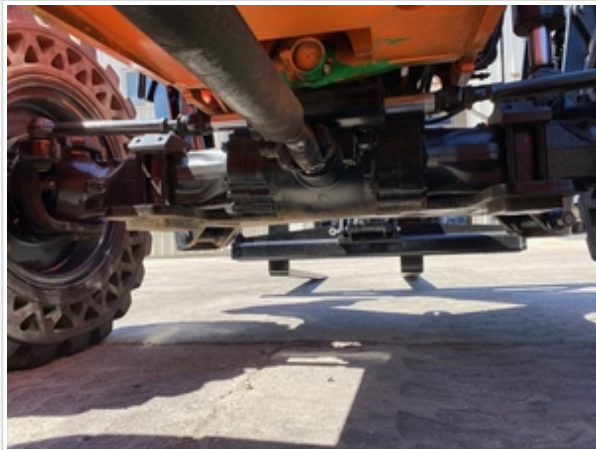
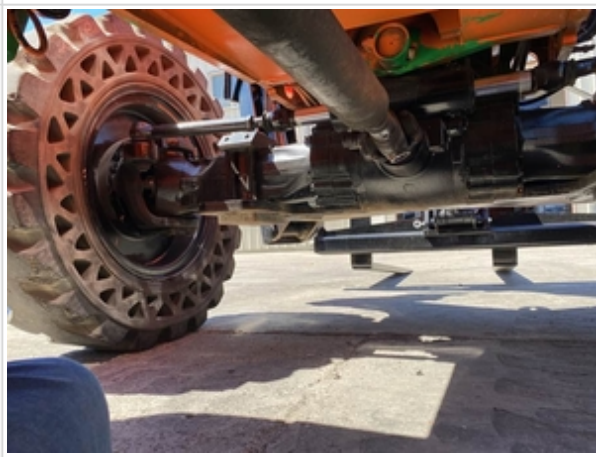
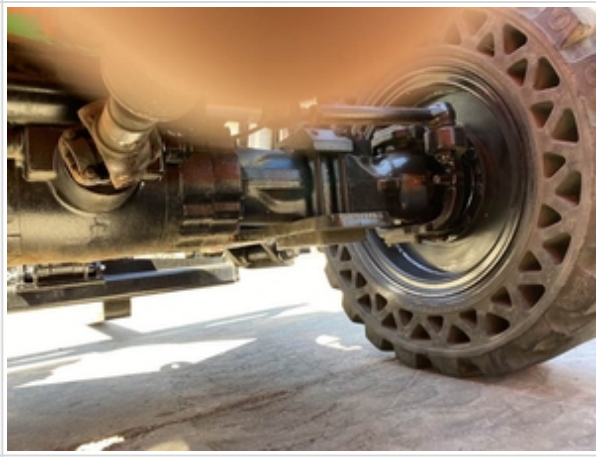
<p>Front Axle Appearance Photos</p>

<b>Front Axle Appearance</b>	3 - Normal Wear & Tear

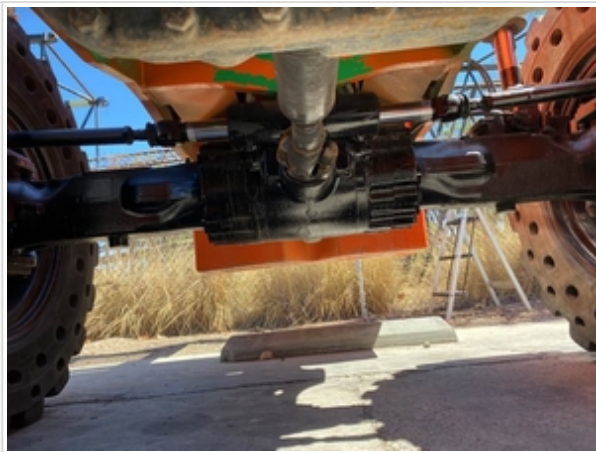
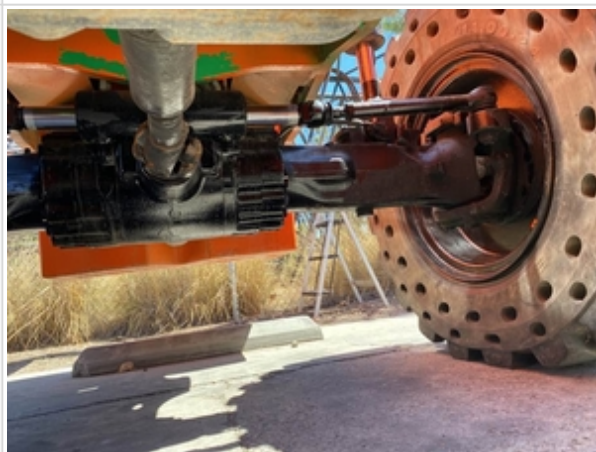
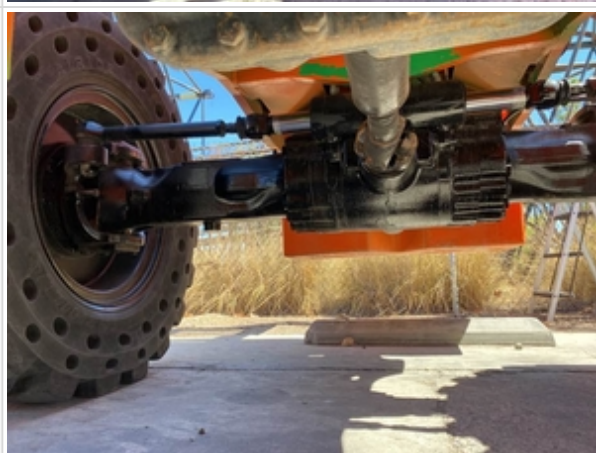
<p>Rear Axle Appearance Photos</p>

<p>Rear Axle Appearance</p>	<p>3 - Normal Wear &amp; Tear</p>

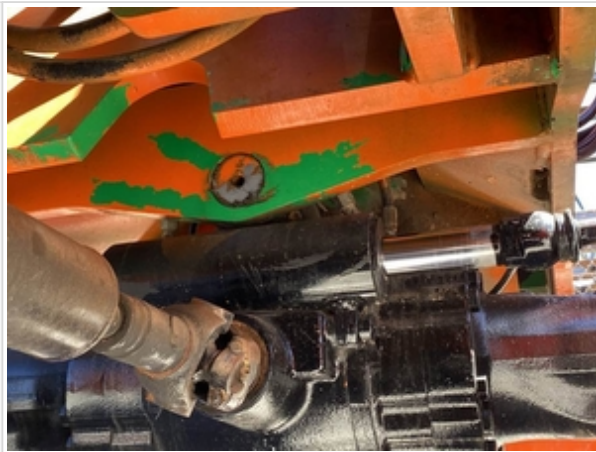
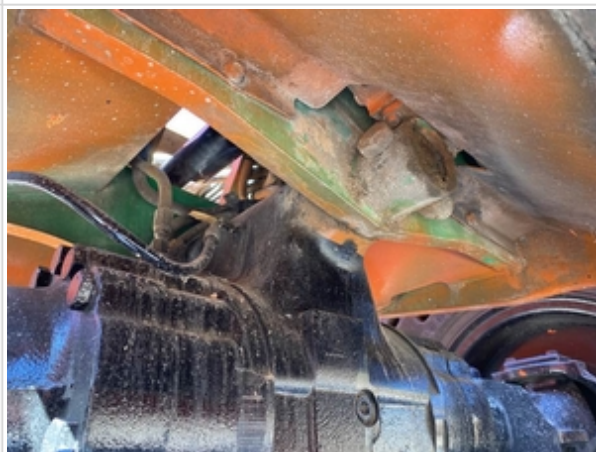
Oscillating Pin Appearance Photos

<p>Oscillating Pin Appearance</p>	<p>3 - Normal Wear &amp; Tear</p>

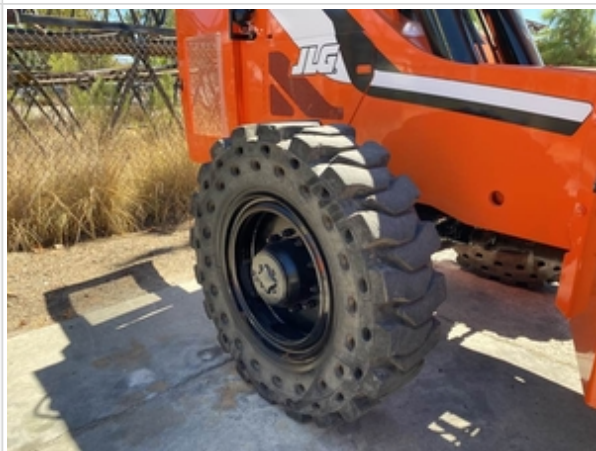
Wheels & Tires	3 - Normal Wear & Tear
Wheels & Tires Photos

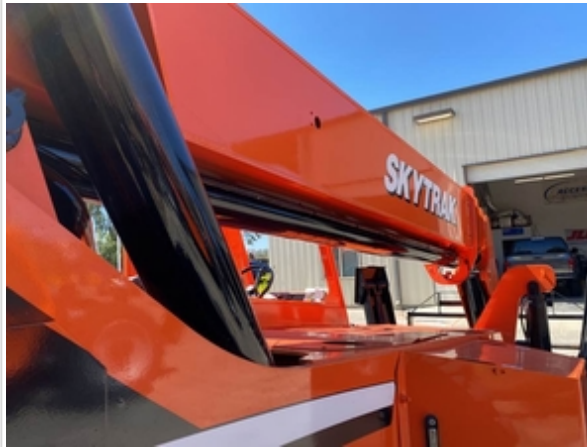
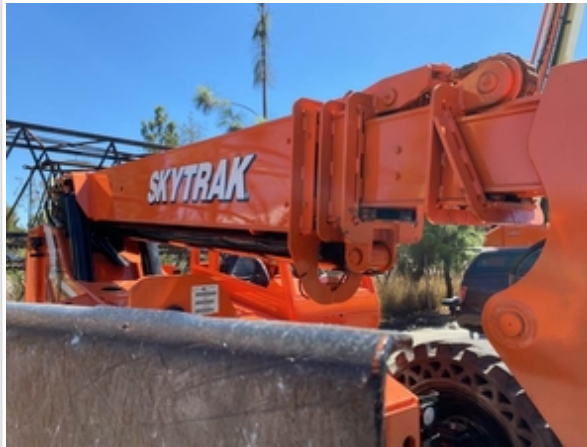
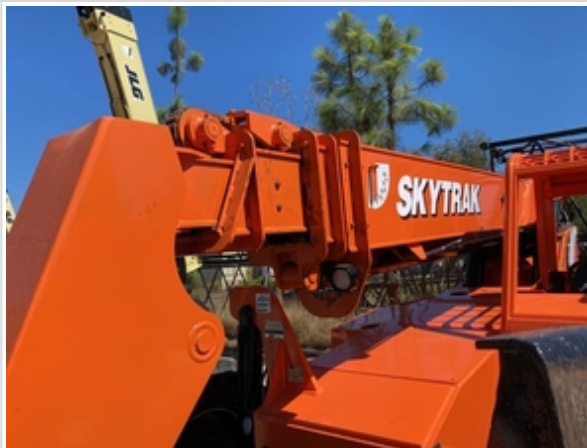
Boom Condition Photos

Tire Brand	Airide
Tire Size	14.00 -24
Front Left Tire - Ratio Remaining	30%
Rear Left Tire - Ratio Remaining	90%
Front Right Tire - Ratio Remaining	30%
Rear Right Tire - Ratio Remaining	90%
Boom Condition	3 - Normal Wear & Tear

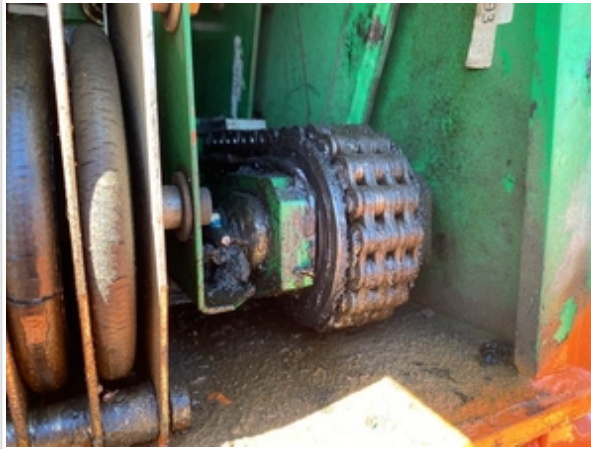
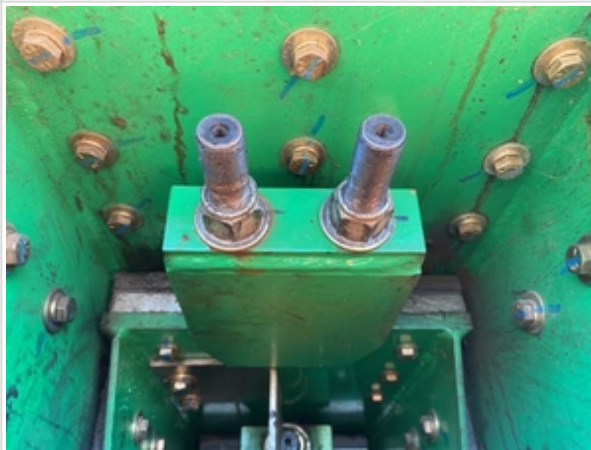
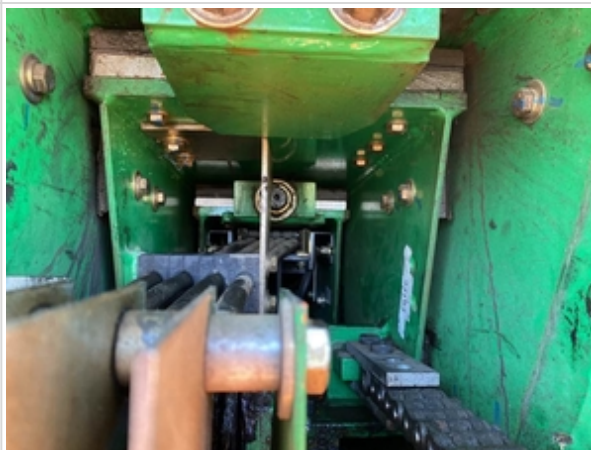
Chain / Tensioners Photos

**Chain / Tensioners**

3 - Normal Wear & Tear

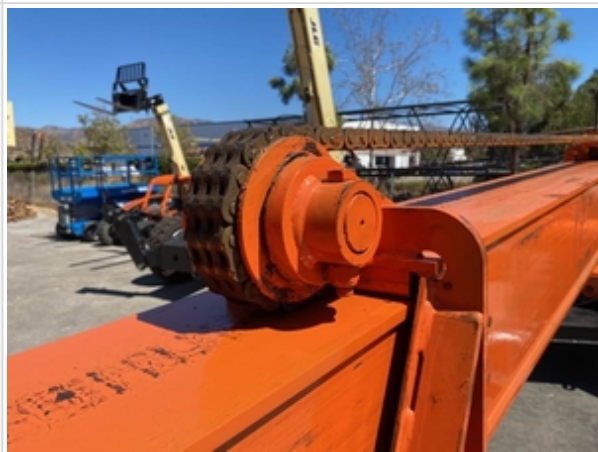
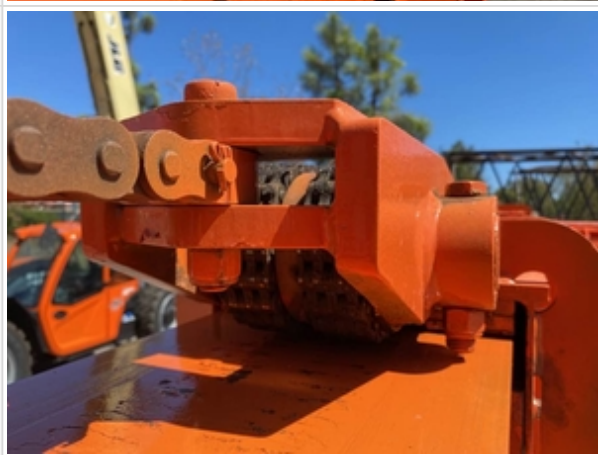
<p><b>Rollers &amp; Guides</b></p>	<p>3 - Normal Wear &amp; Tear</p>	
<p><b>Rollers &amp; Guides Photos</b></p>

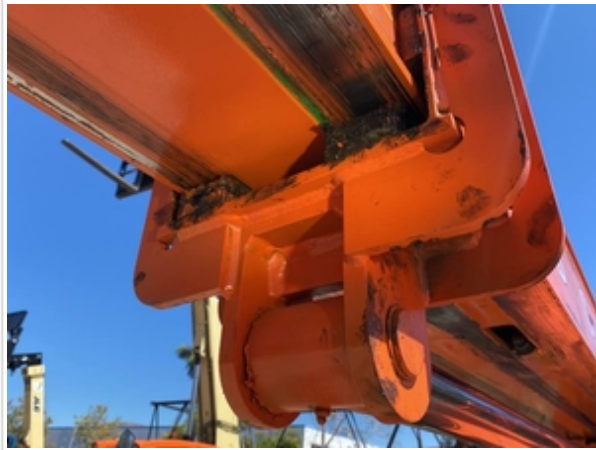
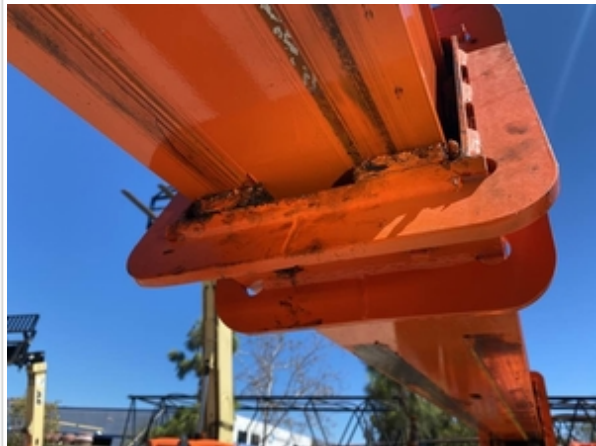
<b>Boom Wear Guides</b>	3 - Normal Wear & Tear
<b>Boom Wear Guides Photos</b>

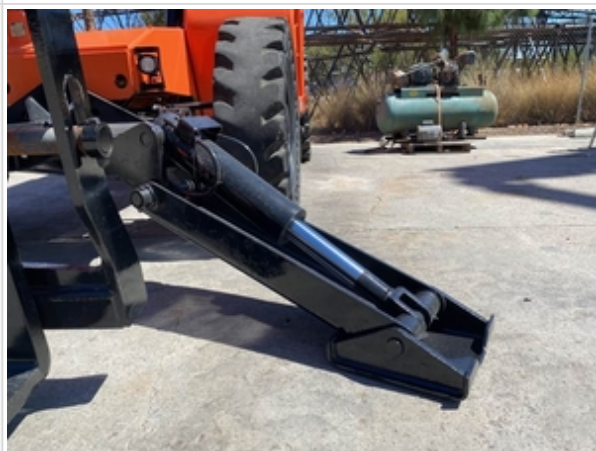
<p><b>Outriggers</b></p>	<p>3 - Normal Wear &amp; Tear</p>	
<p><b>Outriggers Photos</b></p>

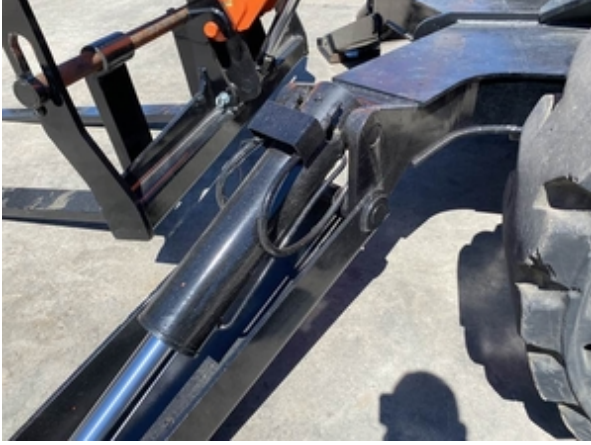
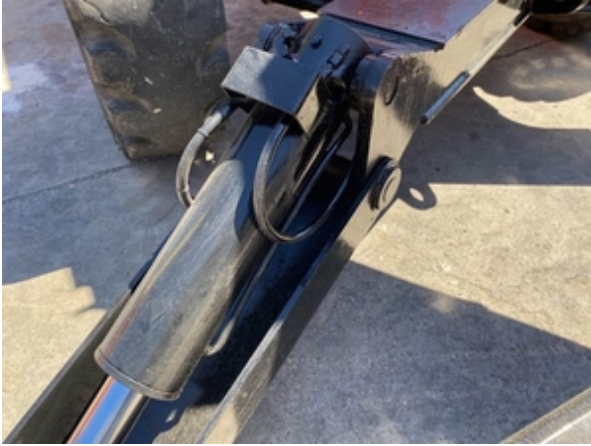
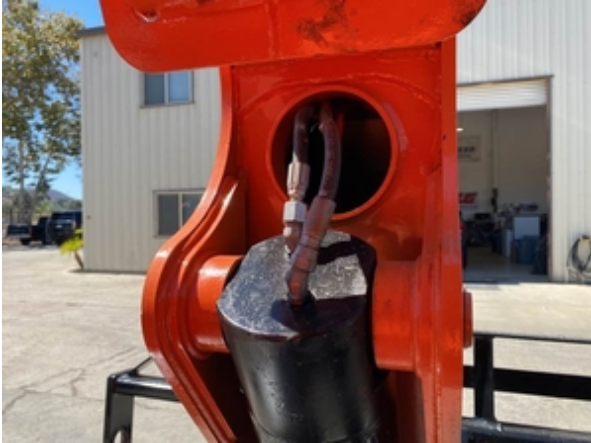
<b>Hydraulic Lines / Fittings Condition</b>	Hydraulic lines & fittings are clean and in good condition, Cracking, stiff, or charred hydraulic hoses, Other (see comments)
<b>Appearance of Hydraulic Lines / Fittings Photos</b>
