## Inspection Report (Telehandler)

Year	2014
Make	JLG
Model	10054
Serial Number	0160060545
Hour Meter Reading	4,230
Previous Application (e.g., earth moving, mining, demolition, etc)	Equipment Rentals

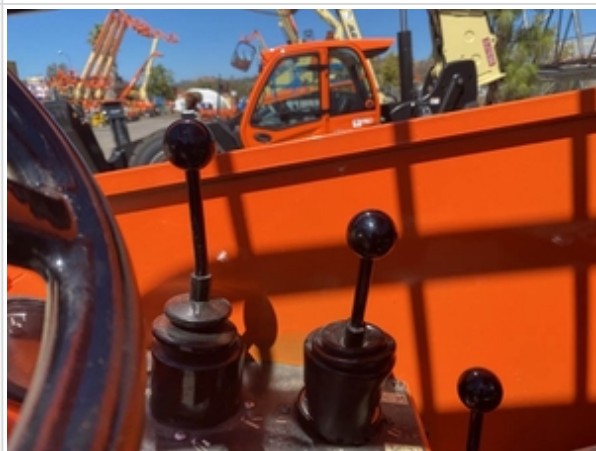
<b>Unusual Noises (Hydraulic Pump)</b>	No	
<b>Hydraulic Pump Notes</b>	No unusual noises heard during operation	
<b>External Controls / Levers</b>	3	
<b>External Controls / Levers Condition</b>	Good function & condition of hydraulic controls	
<b>External Controls / Levers Photos</b>

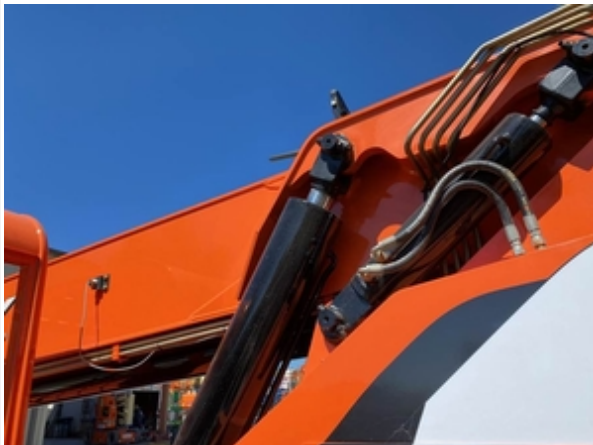
Boom Lift Cylinders	Check the boom lift cylinders. Note any wear, pitting, discoloration, etc. Take photos.
Boom Lift Cylinders: Mounting Pin	3
Boom Lift Cylinders: Oil Leaks	No
Boom Lift Cylinders Photos

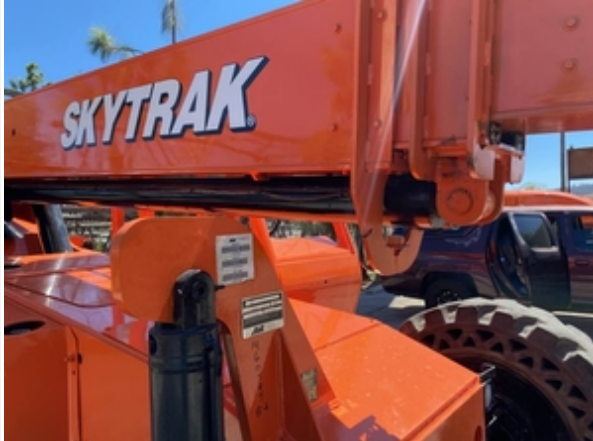
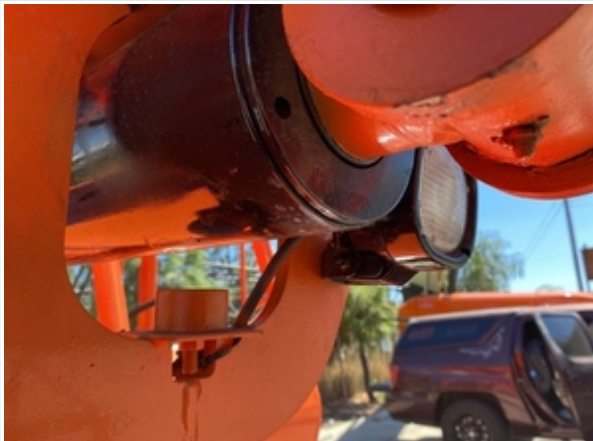
<b>Telescopic Boom Cylinders Photos</b>

<b>Telescopic Boom Cylinders</b>	Check the telescopic boom cylinders. Note any wear, pitting, discoloration, etc. Take photos.
<b>Telescopic Boom Cylinders: Mounting Pin</b>	3
<b>Telescopic Boom Cylinders: Oil Leaks</b>	No

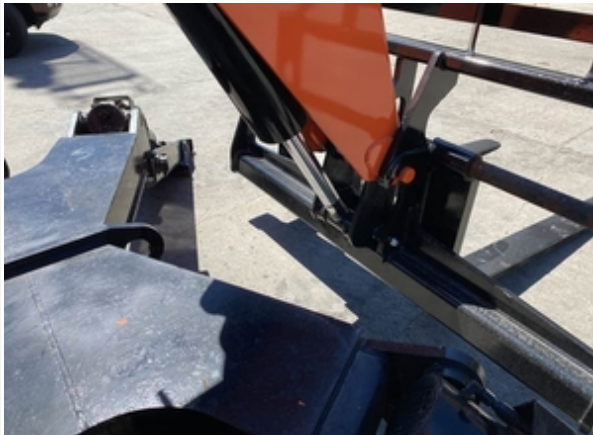
<b>Frame Leveling Cylinders</b>	Check the frame leveling cylinders. Note any wear, pitting, discoloration, etc. Take photos.	
<b>Carriage Tilt Cylinder</b>	Check the carriage tilt cylinders. Note any wear, pitting, discoloration, etc. Take photos.	
<b>Carriage Tilt Cylinder: Mounting Pin</b>	3	
<b>Carriage Tilt Cylinder: Oil Leaks</b>	No	
<b>Carriage Tilt Cylinder Photos</b>

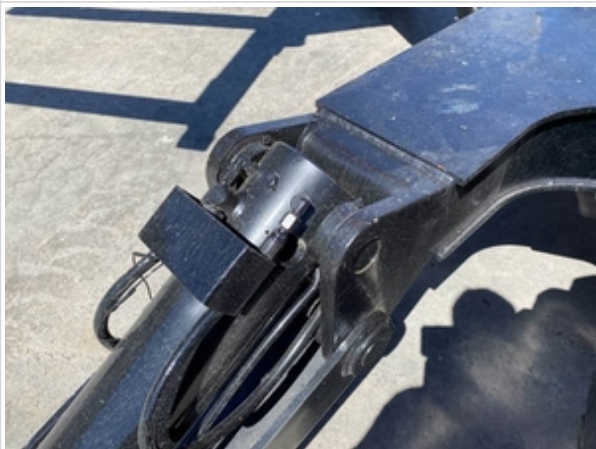
<b>Side Shift Cylinder</b>	Check the side shift cylinder. Note any wear, pitting, discoloration, etc. Take photos.	
<b>Outrigger Cylinders</b>	Check the outrigger cylinders. Note any wear, pitting, discoloration, etc. Take photos.	
<b>Outrigger Cylinders: Mounting Pin</b>	3	
<b>Outrigger Cylinders: Oil Leaks</b>	No	
<b>Outrigger Cylinders Photos</b>

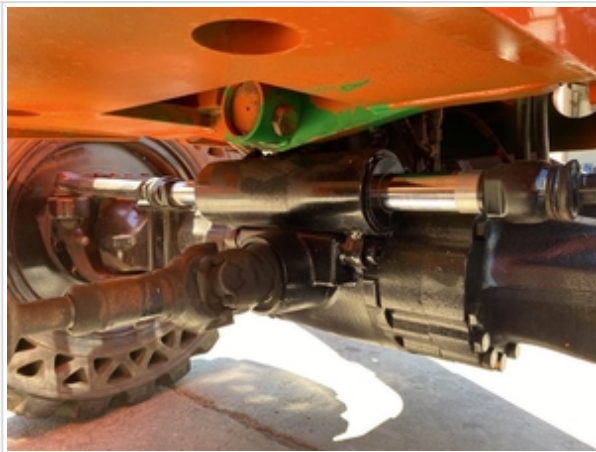
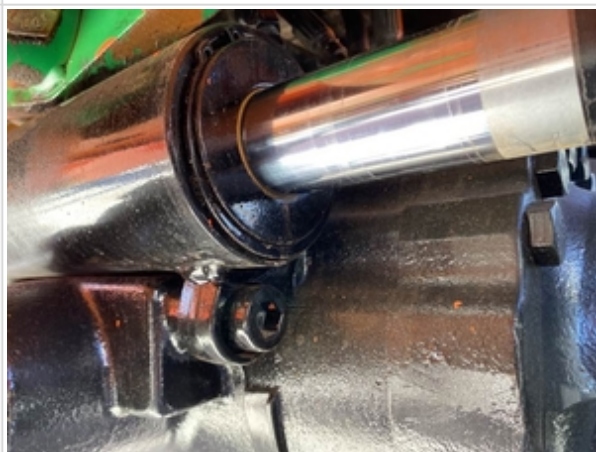
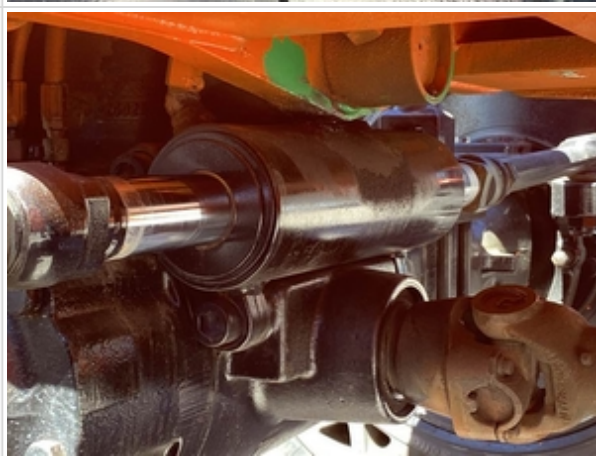
Steering Cylinders Photos

<b>Steering Cylinders</b>	Check the steering cylinders. Note any wear, pitting, discoloration, etc. Take photos.
<b>Steering Cylinders: Mounting Pin</b>	3
<b>Steering Cylinders: Oil Leaks</b>	No

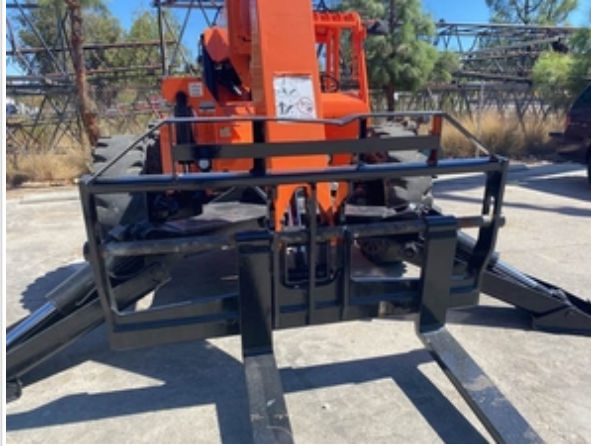
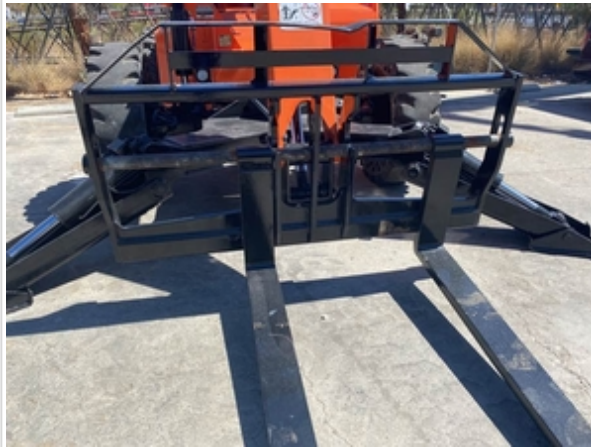
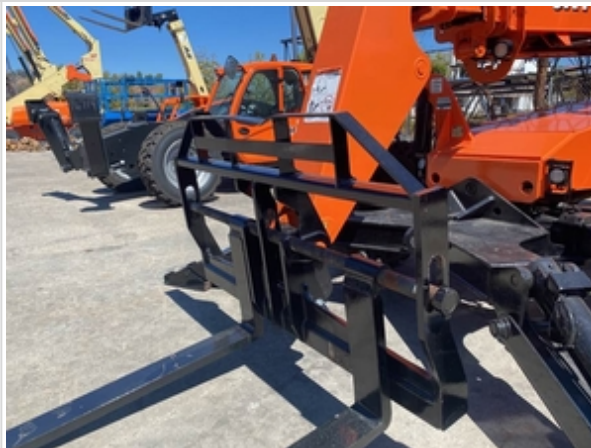
Back Rest Photos

<b>Back Rest Condition</b>	3 - Normal Wear & Tear
<b>Comments</b>	Smal dent on top center
