Inspection Report (Wheel Loader)

Year	1998
Make	Komatsu
Model	WA380-3L
Serial Number	A50435
Hour Meter Reading	7,589
Previous Application (e.g., earth moving, mining, demolition, etc)	General Construction

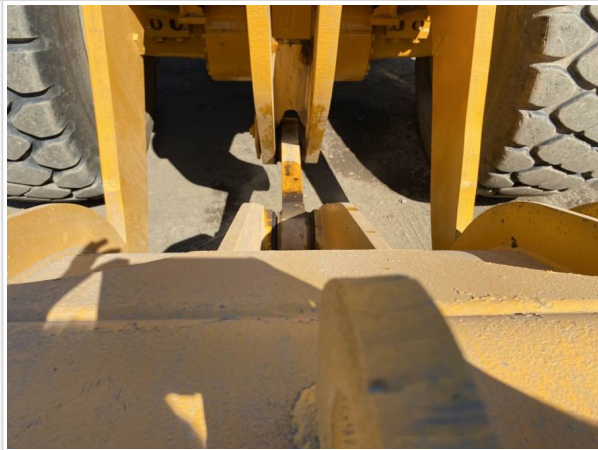
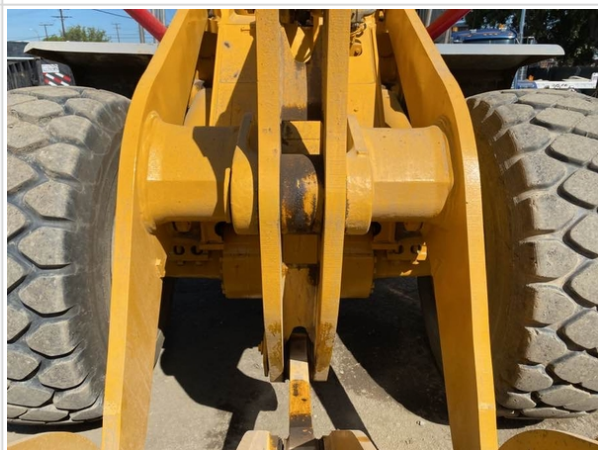
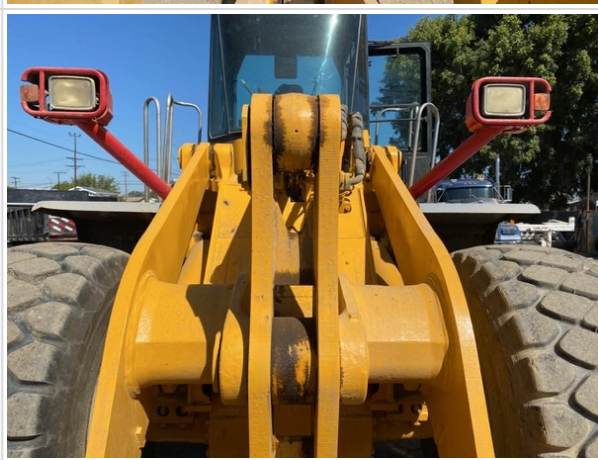
<p>Front Photos</p>

Front	3 - Normal Wear & Tear
Front Condition	No visible damage

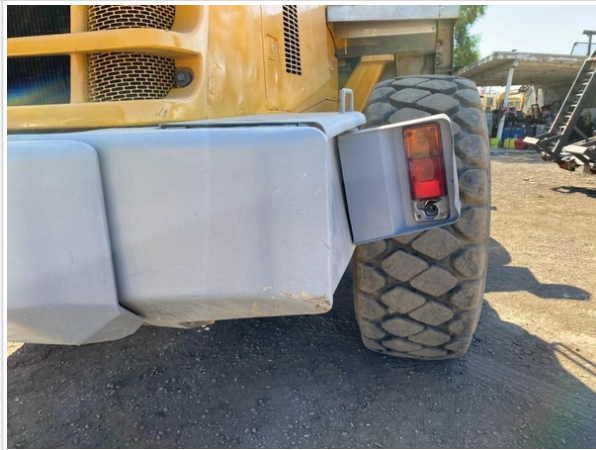
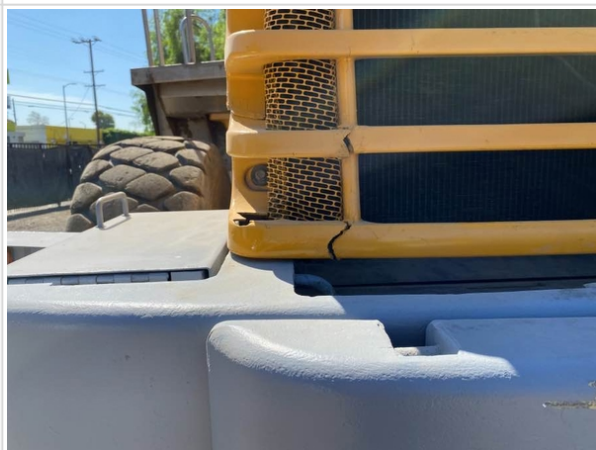
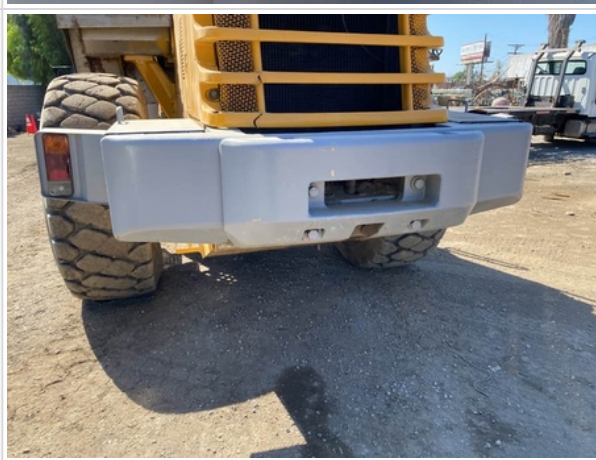
<p>Rear Photos</p>

Rear	2 - Above Average Wear
Rear Condition	Large dents or cracks, Other (see comments)
Comments	Rear hood cracked, right side batter box/light bent

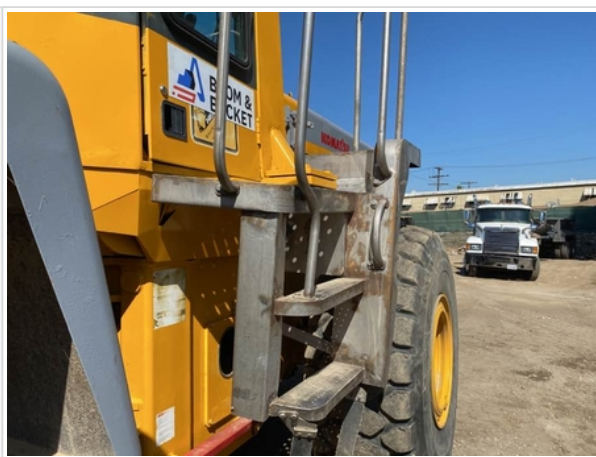
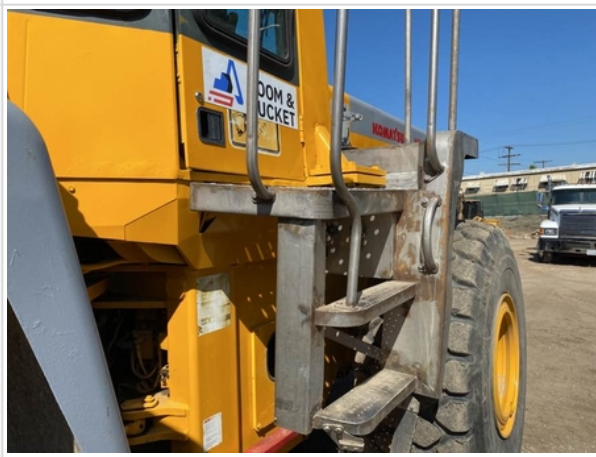
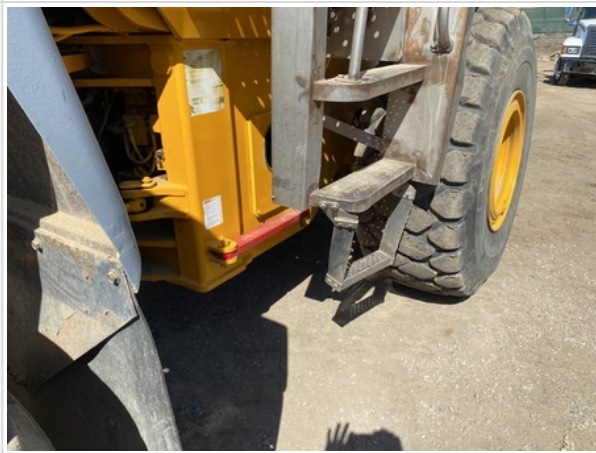
<p>Left Photos</p>

Left	3 - Normal Wear & Tear
Left Condition	Other (see comments)
Comments	Left side operator step ladder bent in, small dent on top side of cab

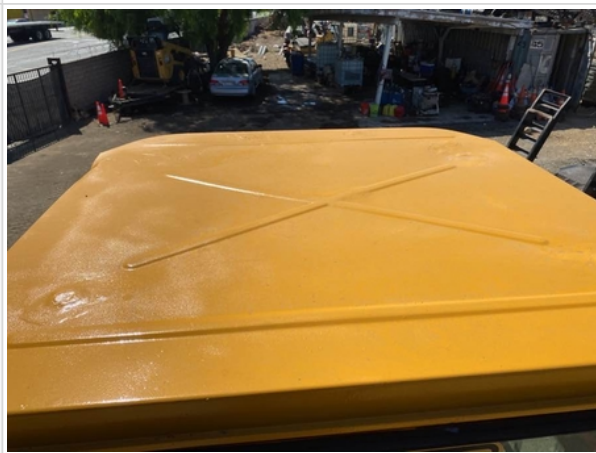
<p>Upper</p>	<p>3 - Normal Wear & Tear</p>	
<p>Upper Photos</p>

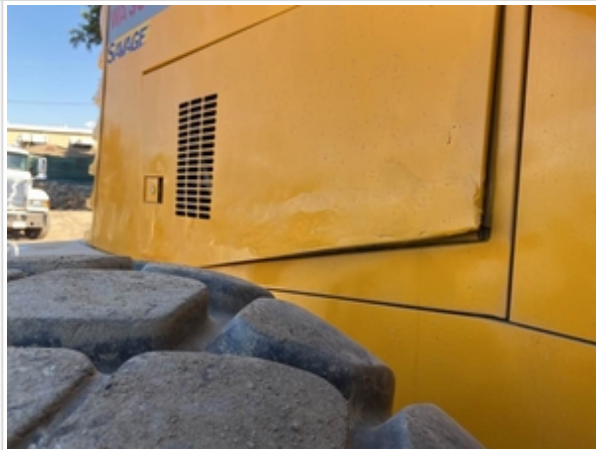
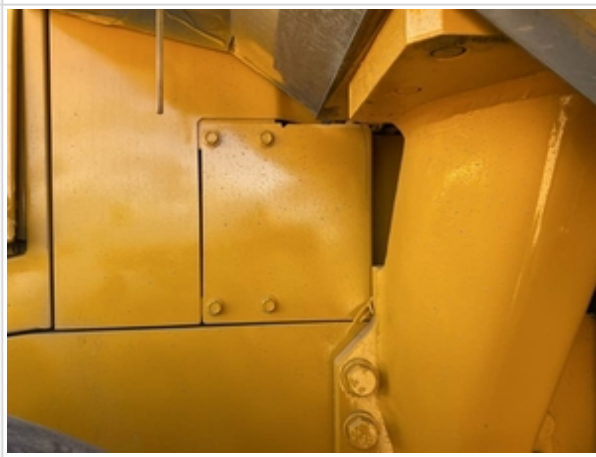
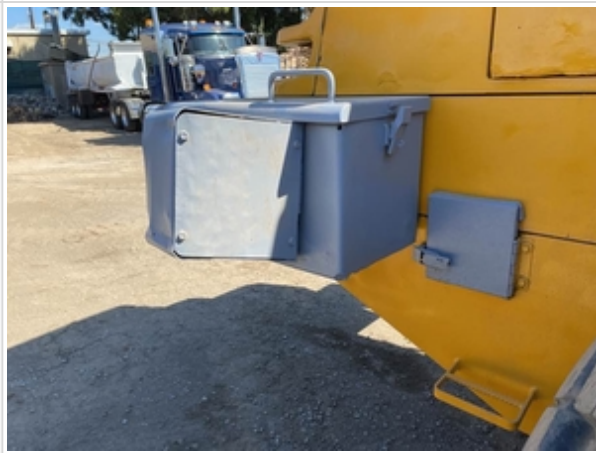
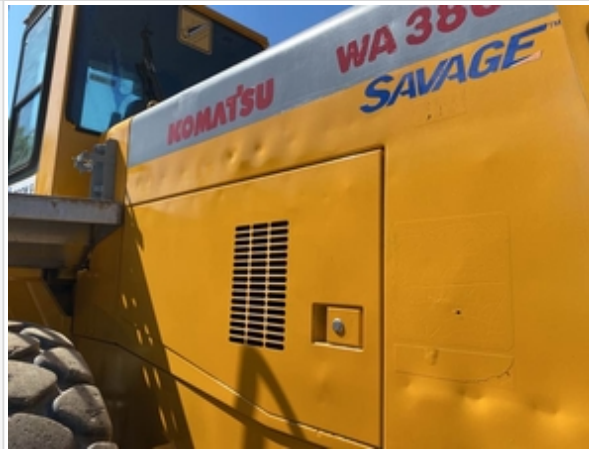
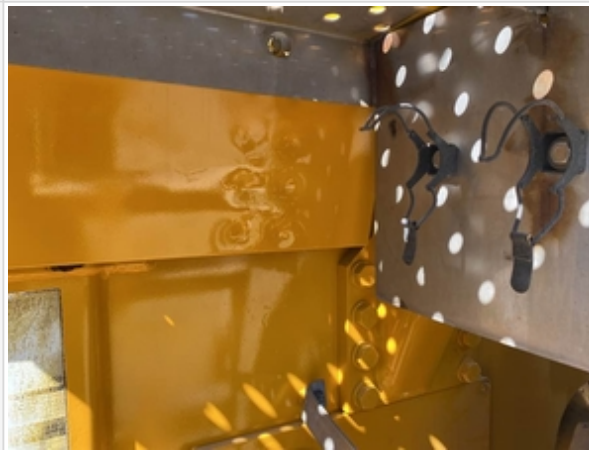
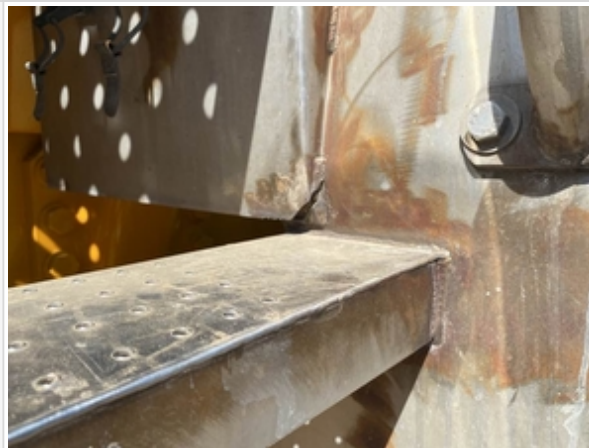
<p>Body Panels Photos</p>

Body Panels (Any Rust Damage?)	3 - Normal Wear & Tear
Body Panel Condition	Some panel misalignment observed, Other (see comments)
Comments	Body repaired areas visible

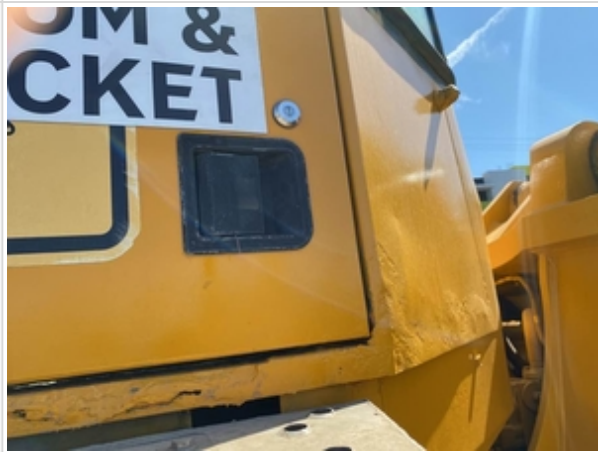
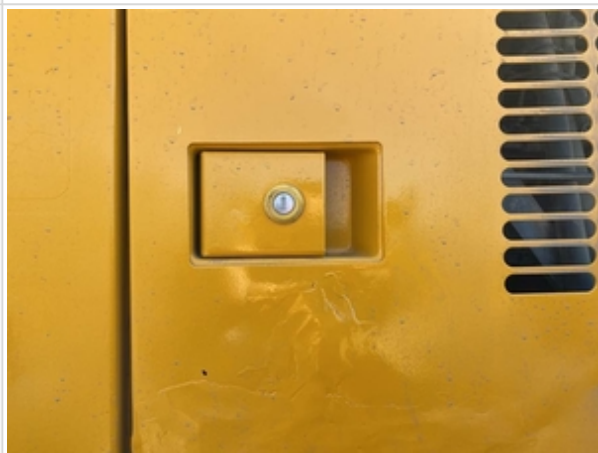
Doors / Canopy Latches	3 - Normal Wear & Tear	
Doors / Canopy Latches Condition	No visible damage	
Doors / Canopy Latches Photos

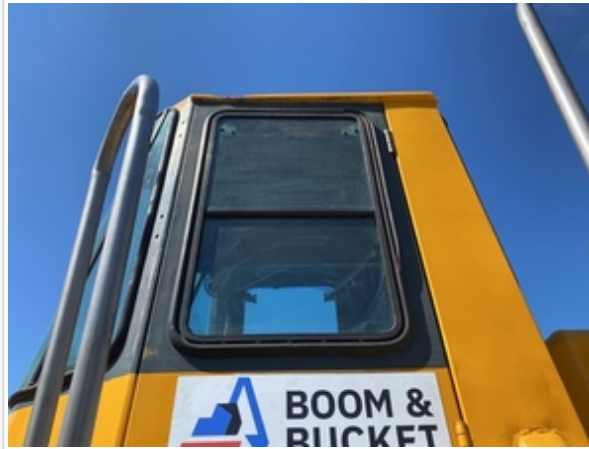
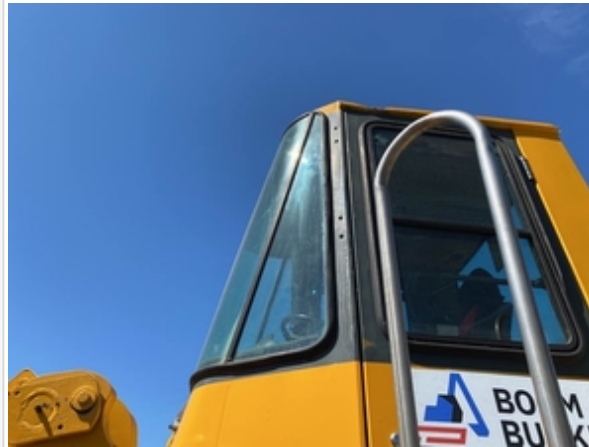
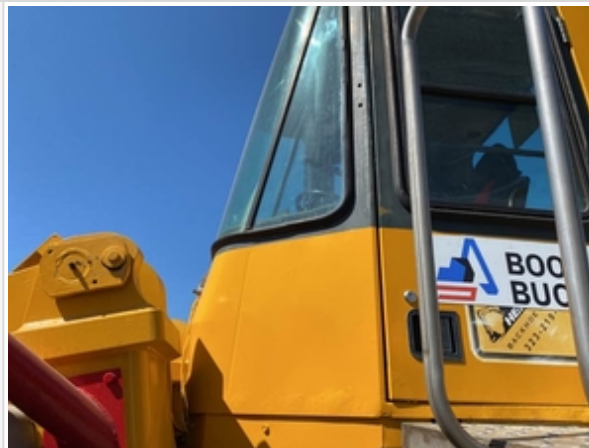
Glass Condition Photos

Glass Condition	3 - Normal Wear & Tear
Glass Condition Notes	Glass intact, no visible damage

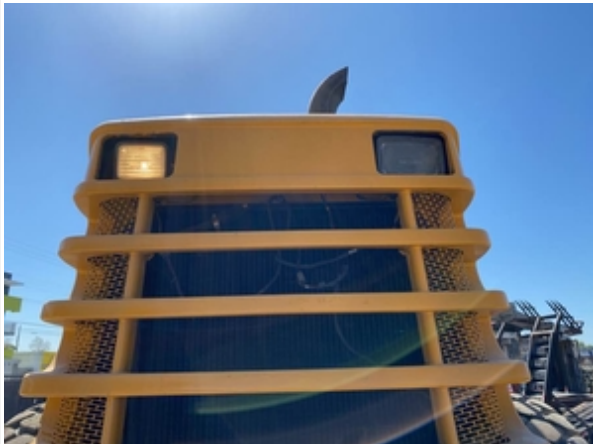
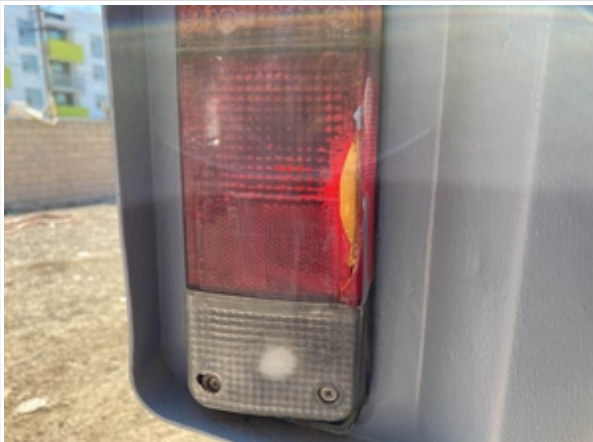
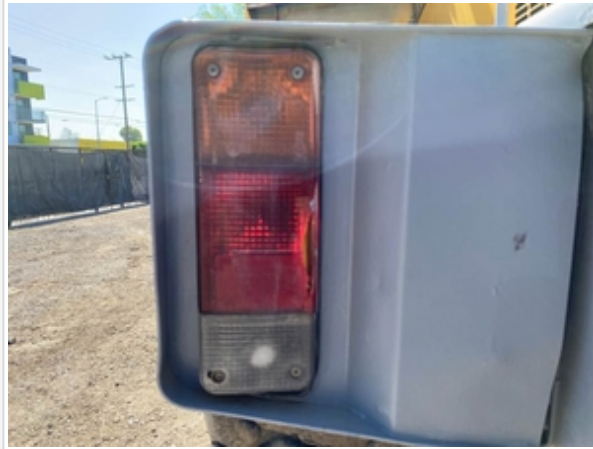
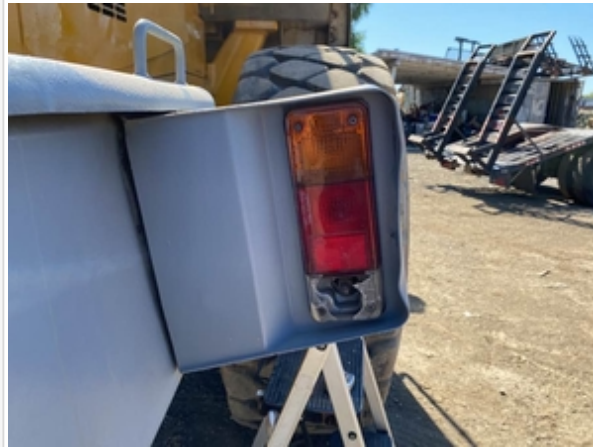
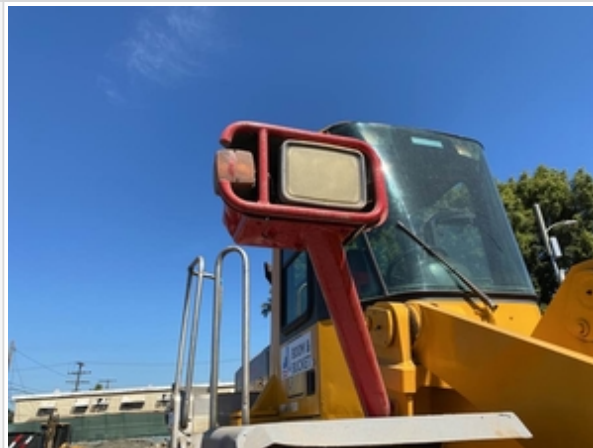
Mirrors	0	
Lighting System	2 - Above Average Wear	
Lighting System Condition	One or more exterior lights are non-operational, Other (see comments)	
Comments	Headlights above fenders inop, front r/s turn signal inop, r/s rear work lights inop.	
Lighting System Photos

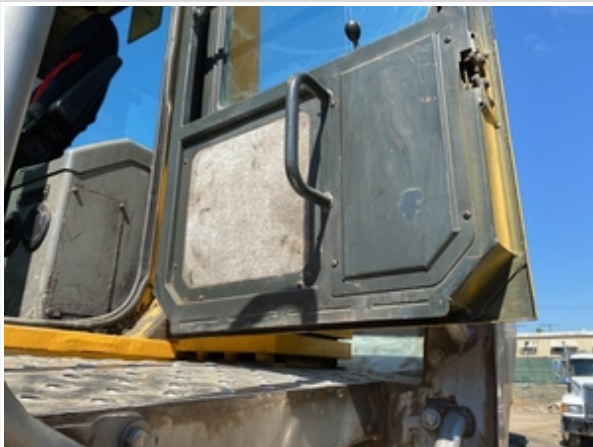
Operator Cabin Overall	2 - Above Average Wear
Operator Cabin Overall Condition	Minor cosmetic wear to cabin surfaces, floors, panels, and ceiling, Other (see comments)
Comments	Seat cover on, seat upholstery worn underneath
Operator Cabin Photos

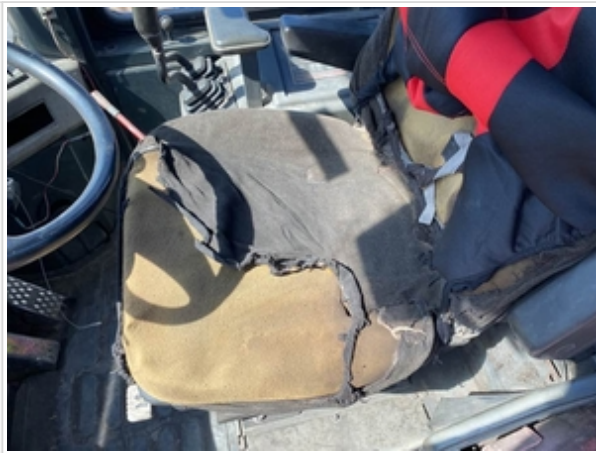
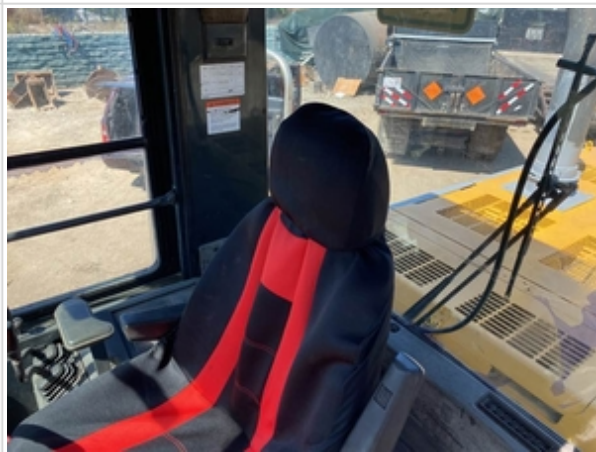
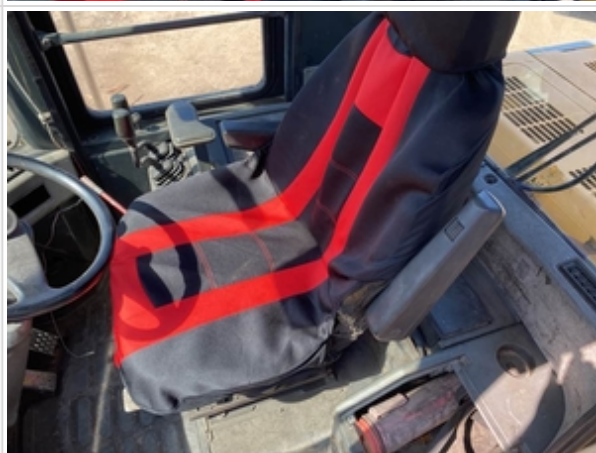
Operator's Seat & Arm Rests	3 - Normal Wear & Tear
Operator's Seat & Arm Rests Condition	Seat(s) has major surface staining or tears, Other (see comments)

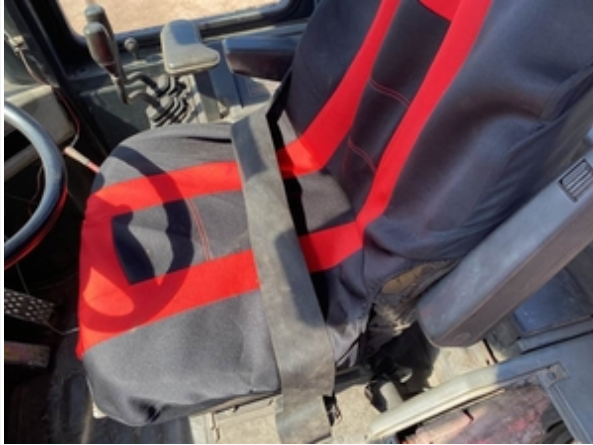
<p>Seat Belt</p>	<p>1 - Service Required</p>
<p>Seat Belt Condition</p>	<p>Seat belt is inoperative or not installed, Other (see comments)</p>
<p>Comments</p>	<p>Seat belt inop due to missing left side</p>

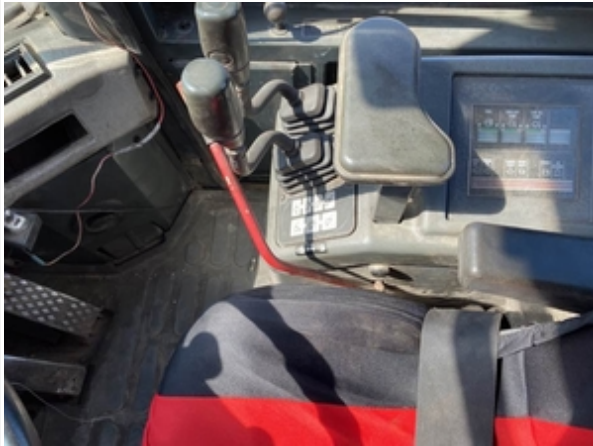
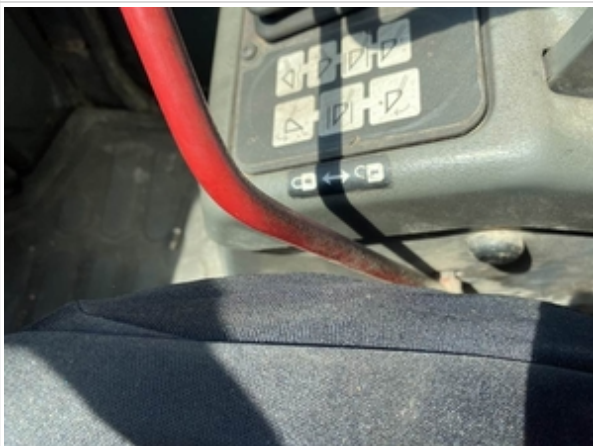
Cabin Lights	0
Safety Lock Out / Stop	2 - Above Average Wear
Safety Lock Out / Stop Condition	Improper/insufficient safety lock out device is supplied for the machine, Other (see comments)
Comments	Safety lock for front bucket controls inop.
Safety Lock Out / Stop Photos

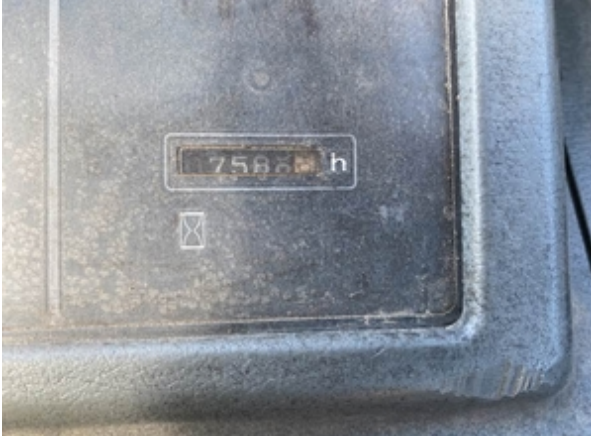
<p>Hour Meter Activity</p>	<p>3 - Normal Wear & Tear</p>
<p>Hour Meter Condition</p>	<p>Hour meter is functional and in good condition</p>

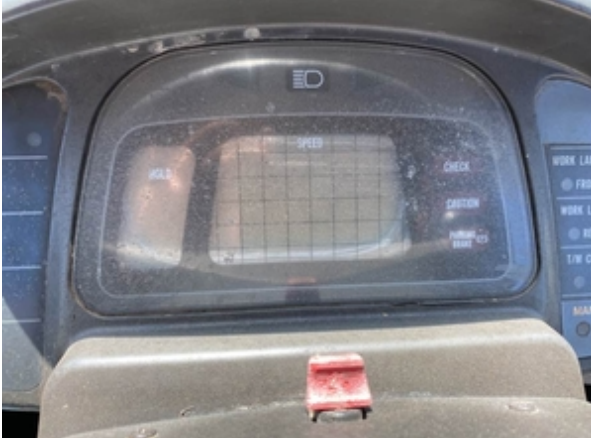
Other Gauge Activity	1 - Service Required
Other Gauge Condition	One or more gauges are unreadable or not functioning (specify in comments), Other (see comments)
Comments	Main operator front cluster inop, r/s machine operating gauges inop
Other Gauge Activity Photos

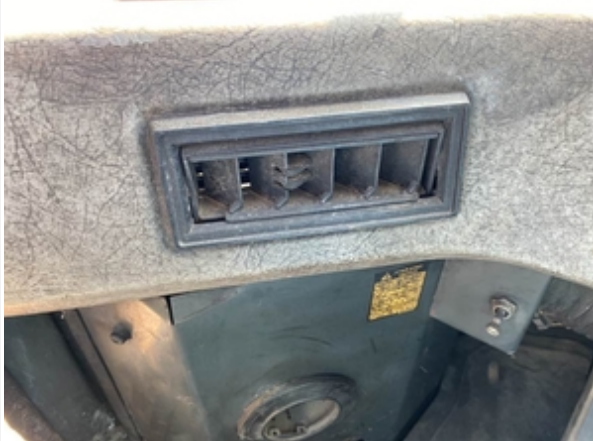
Fans / Vents Condition	Fan vents are not blowing air, Other (see comments)
Comments	Some vents missing
Fans / Vents Photos

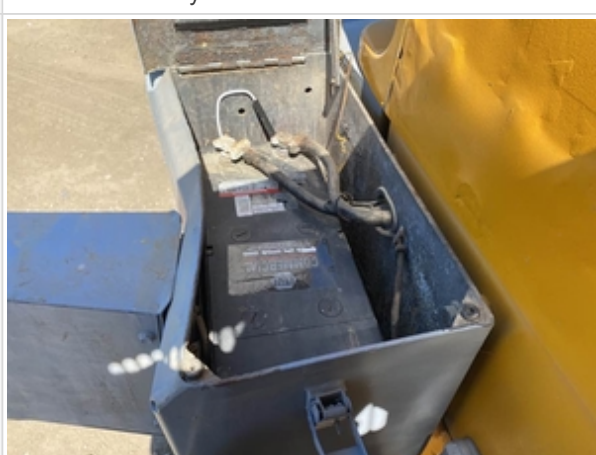
Blow-by (Visual Observation Check)	Yes	
Comments	Minor blow by	
Unusual Noises (Upon Start-up, Idle, Shutdown)	No	
Unusual Noise Notes	No unusual noises heard	
Engine Smoke (Upon Start-up, Idle, Shutdown)	Yes	
Engine Smoke Notes	Engine smoke observed upon start up, Other (see comments)	
Comments	Engine smoke observed under initial load then dissipates.	
Engine Exhaust Color	Black, Heavy black smoke at start up, Other (see comments)	
Comments	Minor consistent black smoke under load	
Battery	2 - Above Average Wear	
Battery Condition	Like new, recently replaced, Stains & signs of corrosion seen, Other (see comments)	
Comments	Batteries missing hold downs brackets, R/S has minor corrosion buildup, batteries look less than a year old	
Battery Condition Photos

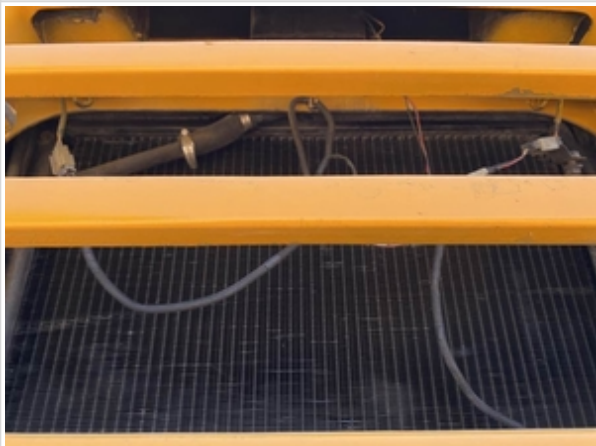
<p>Radiator</p>	<p>3 - Normal Wear & Tear</p>	
<p>Radiator Condition</p>	<p>Radiator fins & components appear to be in good working order, no signs of damage or leaks</p>	
<p>Radiator Photos</p>

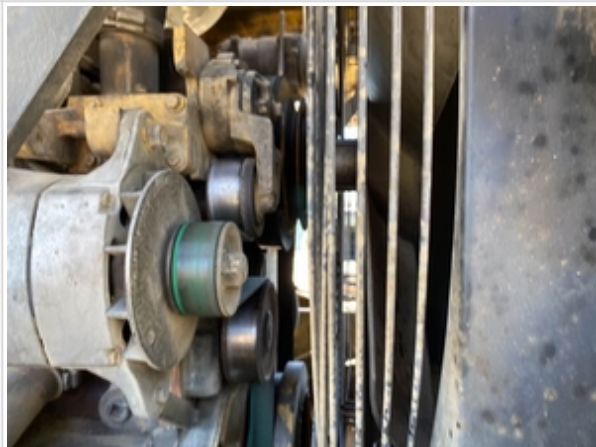
<p>Belts</p>	<p>3 - Normal Wear & Tear</p>
<p>Belt Condition</p>	<p>Belts appear in good condition & alignment with proper tension</p>
<p>Belt Photos</p>

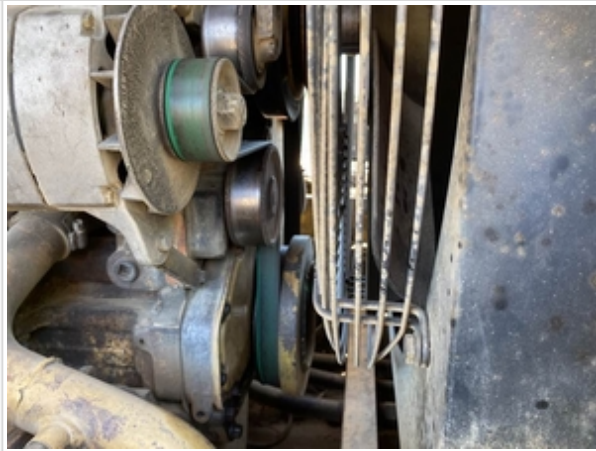
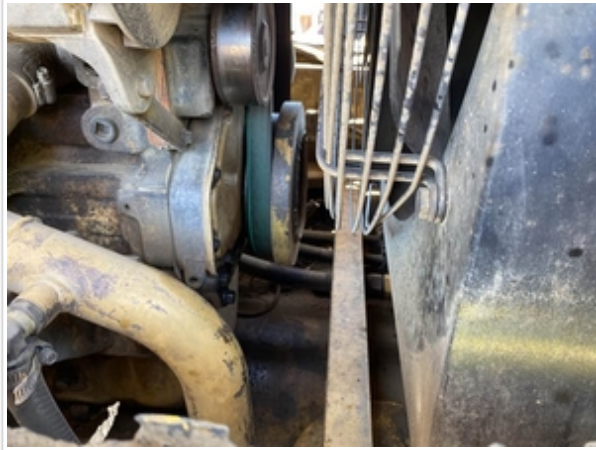
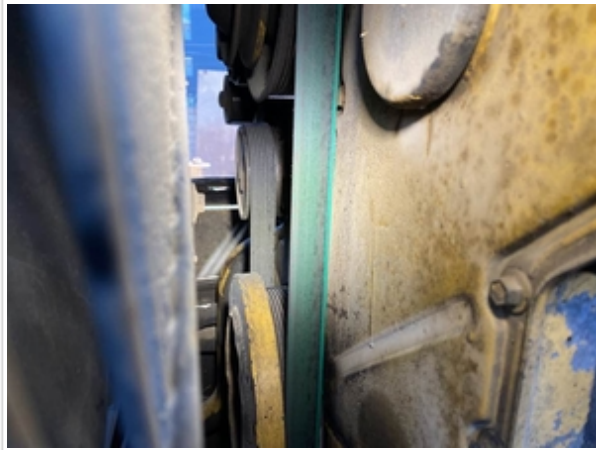
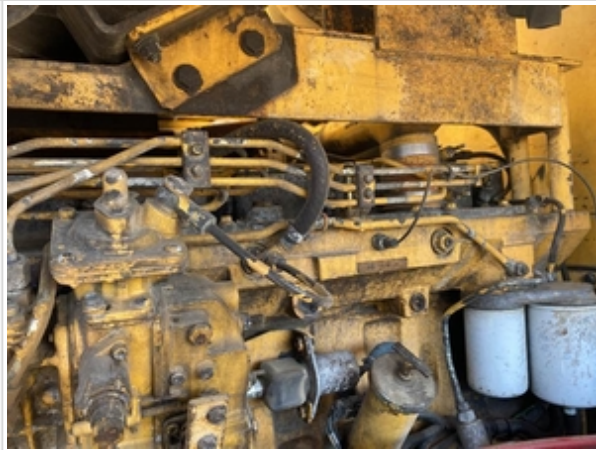
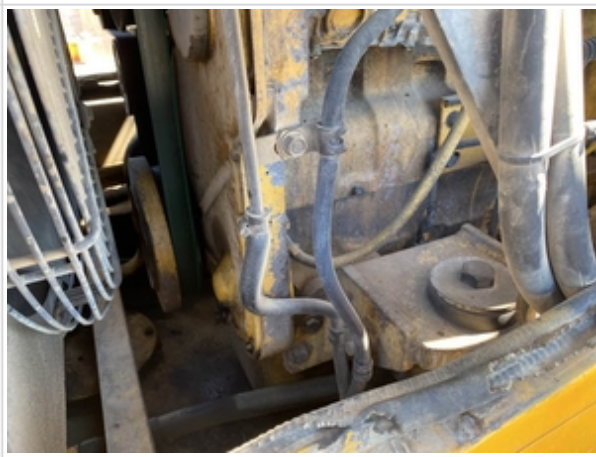
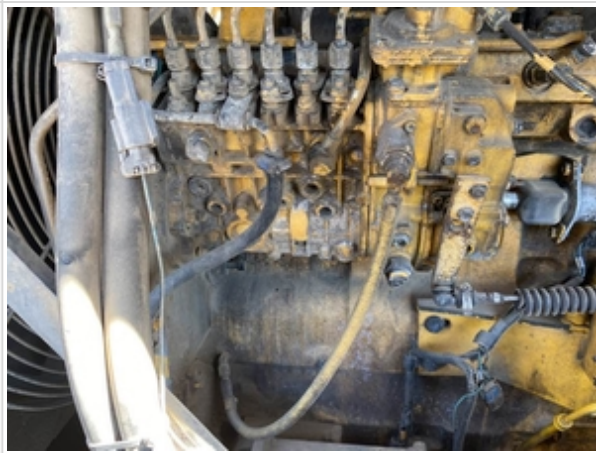
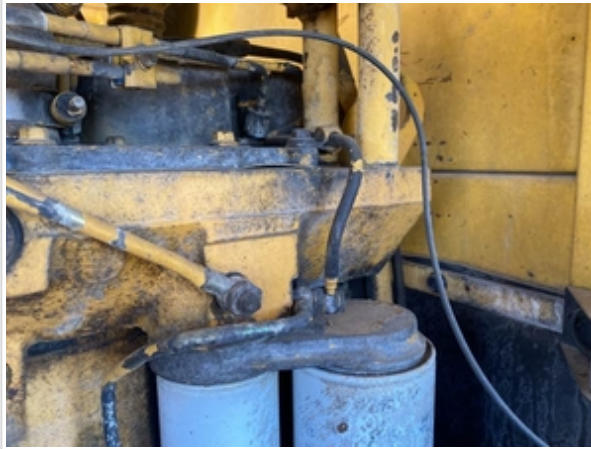
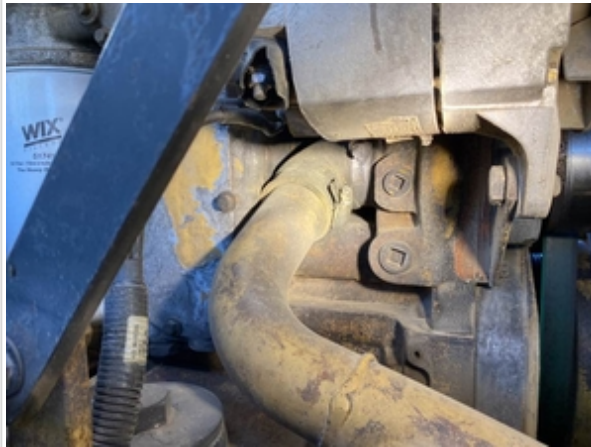
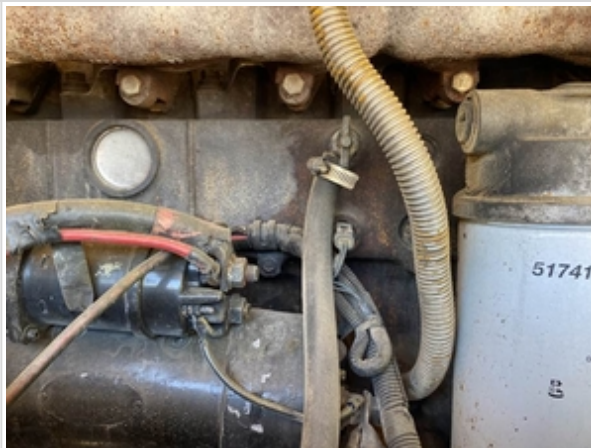
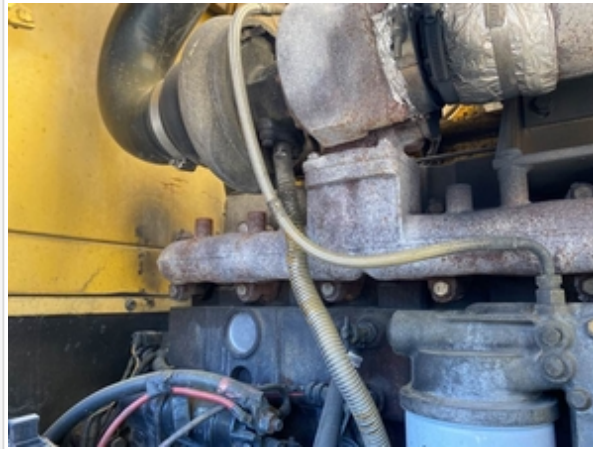
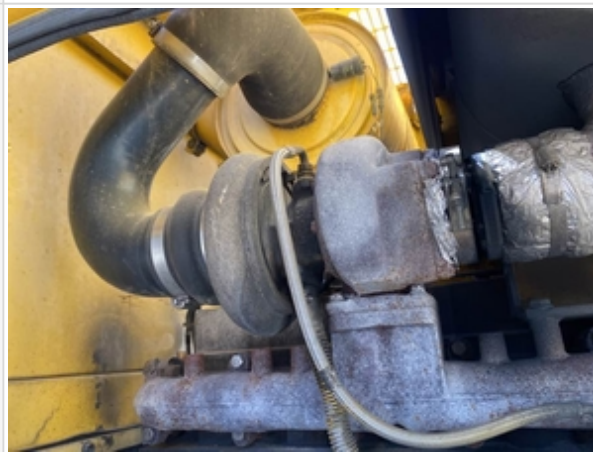
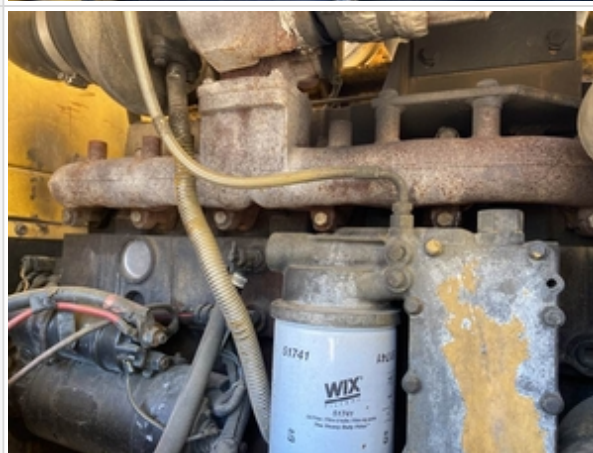
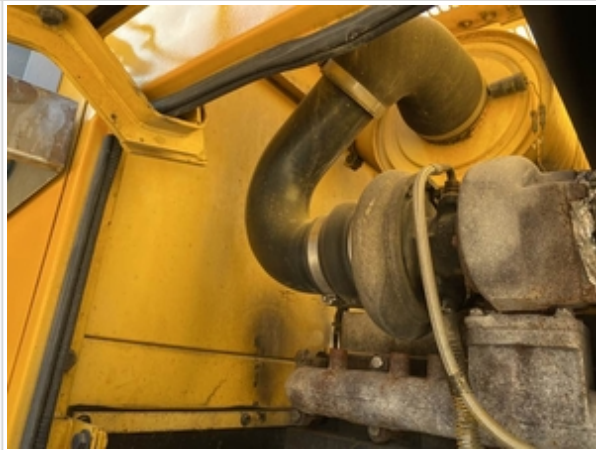
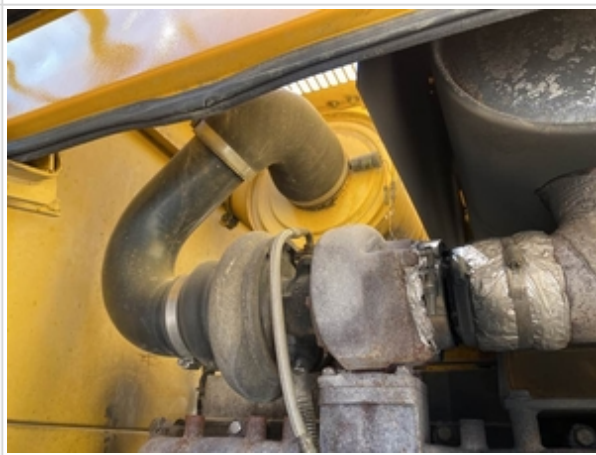
<p>Hose Photos</p>

Hoses	3 - Normal Wear & Tear
Hose Condition	Firm, pliant hoses with no signs of wear or leaks, Other (See commentss

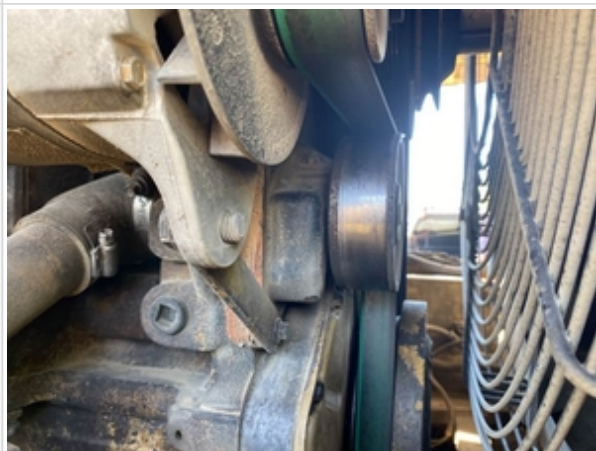
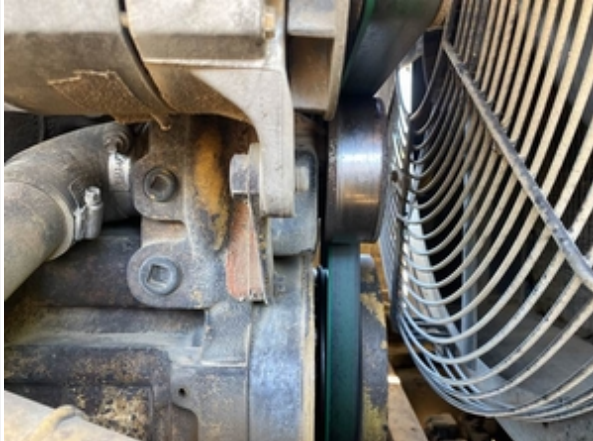
<p>Water Pump</p>	<p>3 - Normal Wear & Tear</p>	
<p>Water Pump Photos</p>

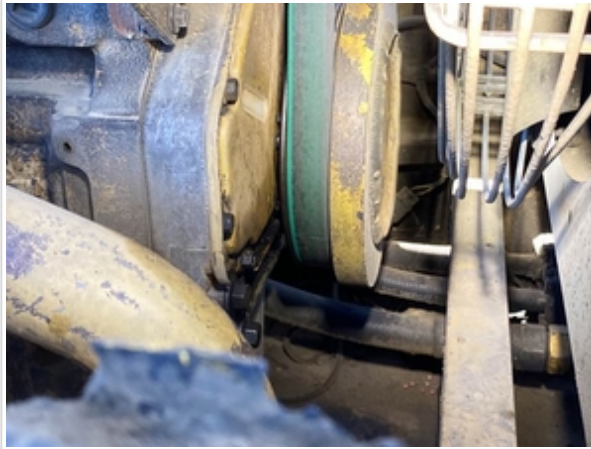
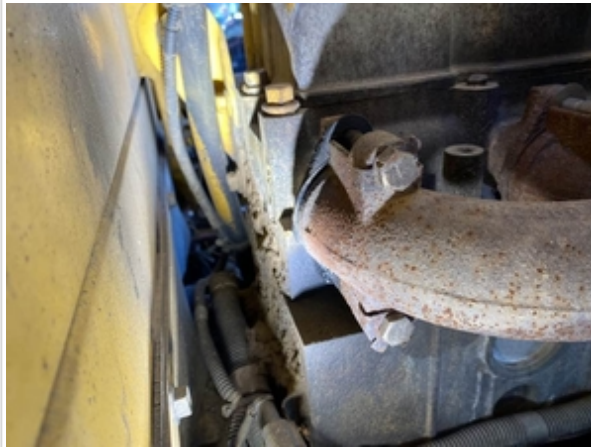
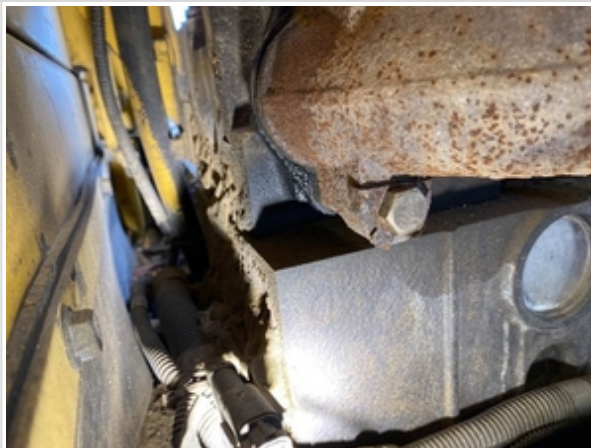
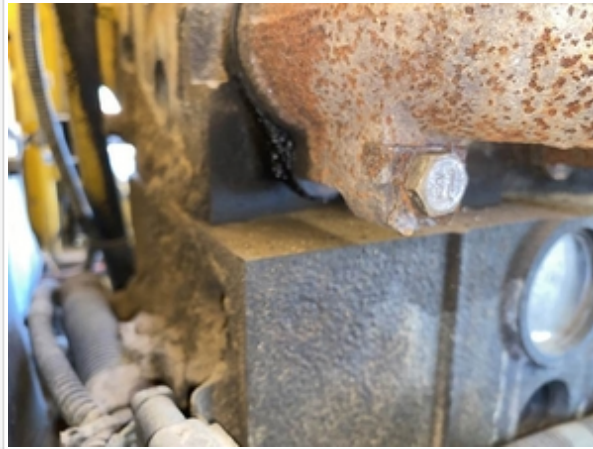
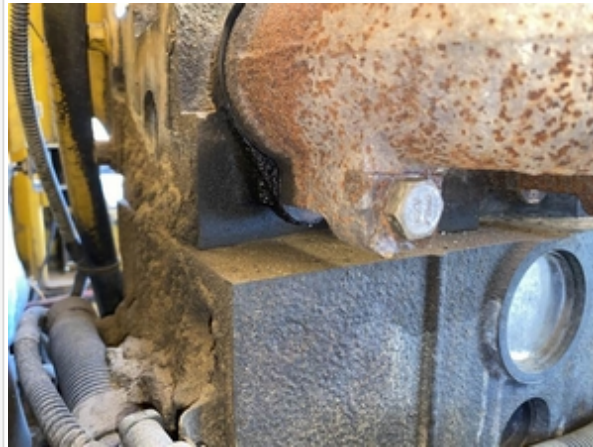
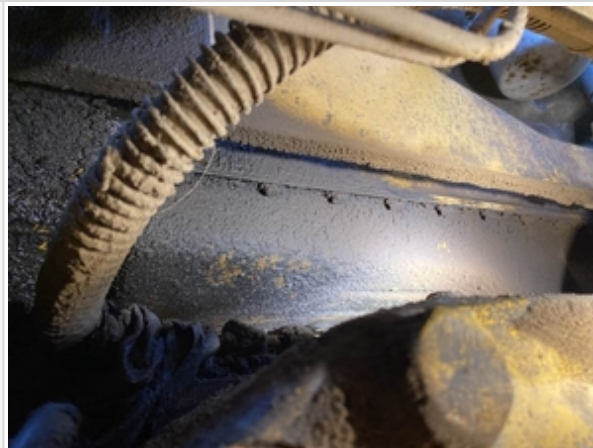
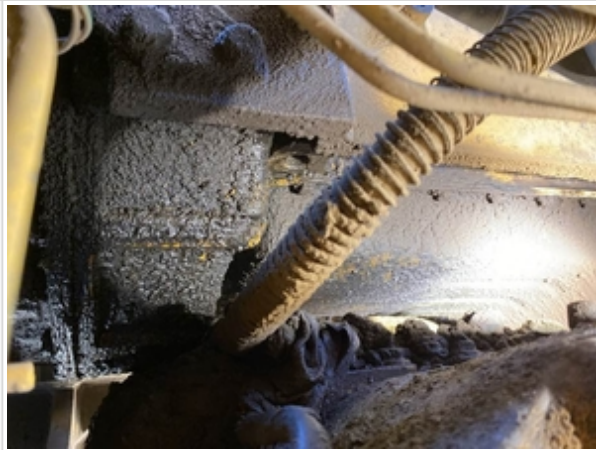
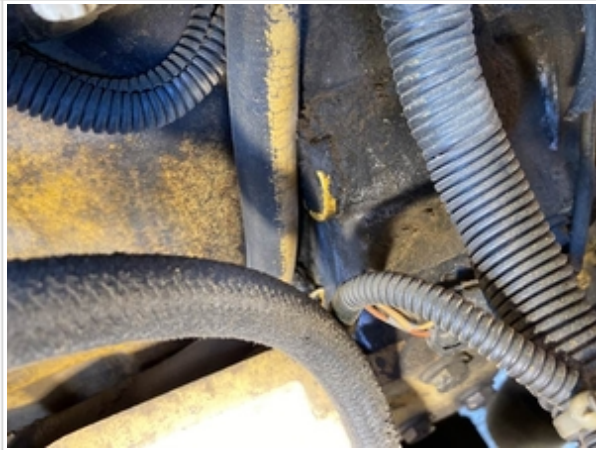
Cooling System Leaks	No	
Coolant Color / Appearance	3 - Normal Wear & Tear	
Coolant Color/Appearance Notes	Normal Translucent appearance, no visual signs of contamination	
Oil Leaks	Yes	
Oil Leak Notes	Wetness & discoloration observed, Other (see comments)	
Comments	Possible blowby cylinder #6, Seepage from front main seal, leak from starter area, possible seepage from oil pan gasket, small leak r/s engine next to breather hose	
Oil Leak Photos

Oil Color / Appearance	3 - Normal Wear & Tear
Oil Color / Appearance Notes	Clean oil appearance, no signs of cross contamination, Appropriate oil level
Fuel Leaks	No
Equipped with DPF (Diesel Particulate Filter)	No
Requires DEF (Diesel Exhaust Fluid)	No
Overall Engine Appearance	Areas of dried seepage seen on engine hoses & components, Dusty & dry
Overall Engine Comments	Exhaust pipe broken from hot side of turbo. I advise checking health condition of Cyl. #6 due to oil or soot buildup around exhaust manifold connection to head. Oil seepage coming from r/s block cover. Seepage leak from Front main seal and oil pan.

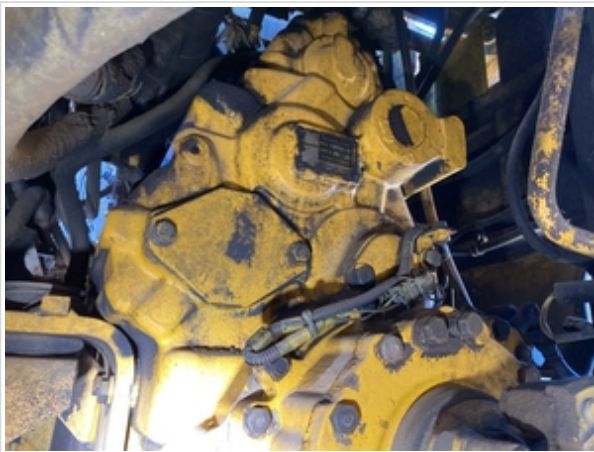
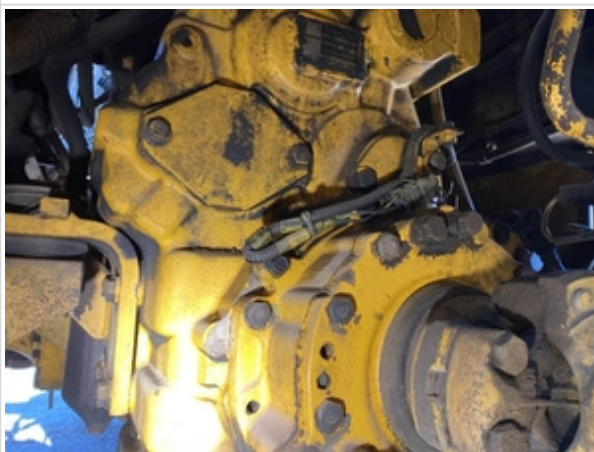
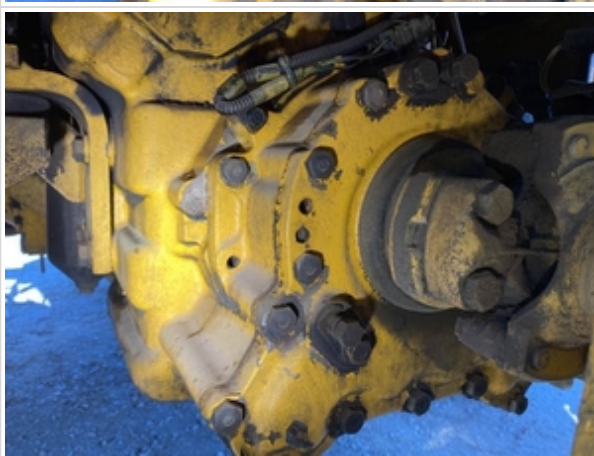
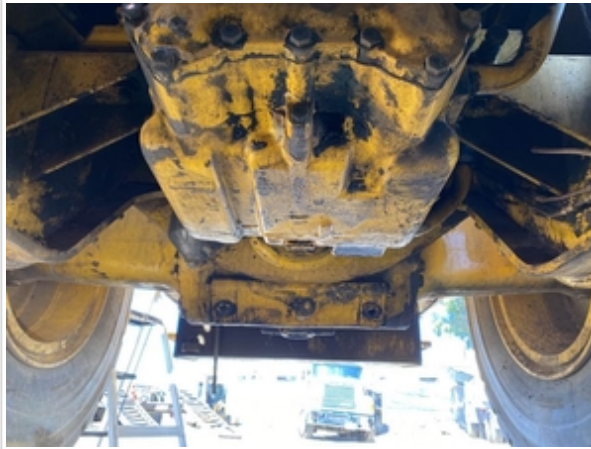
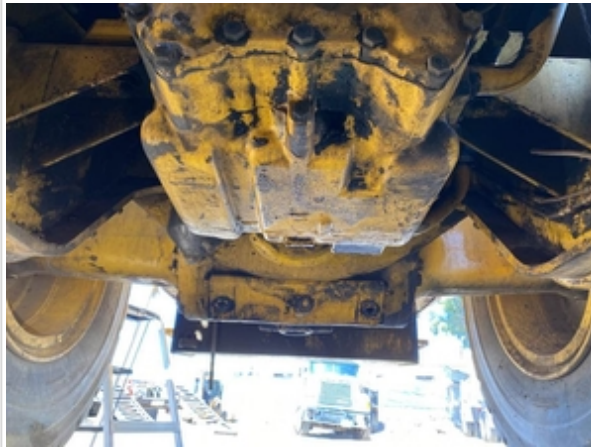
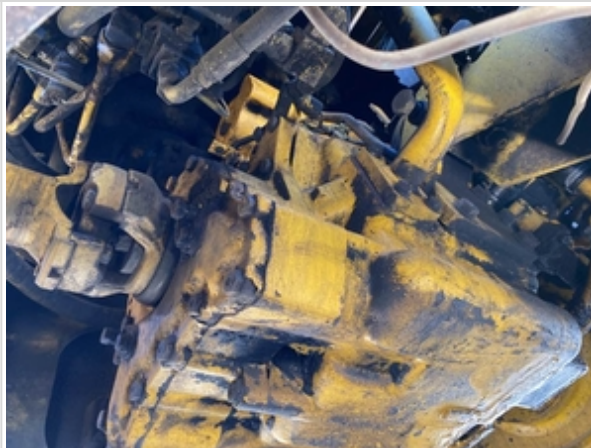
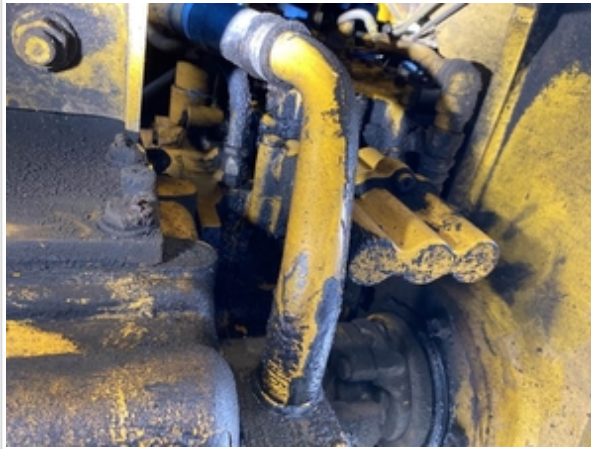
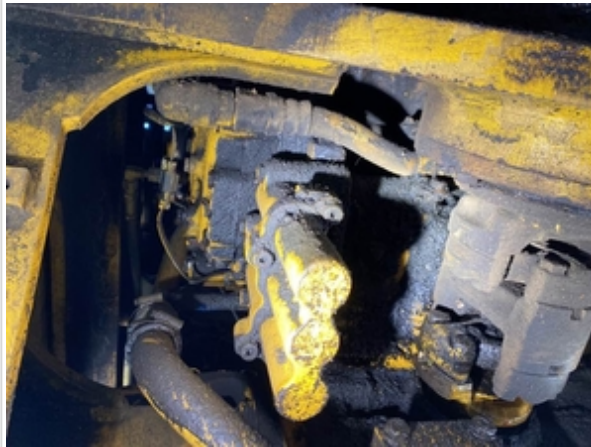
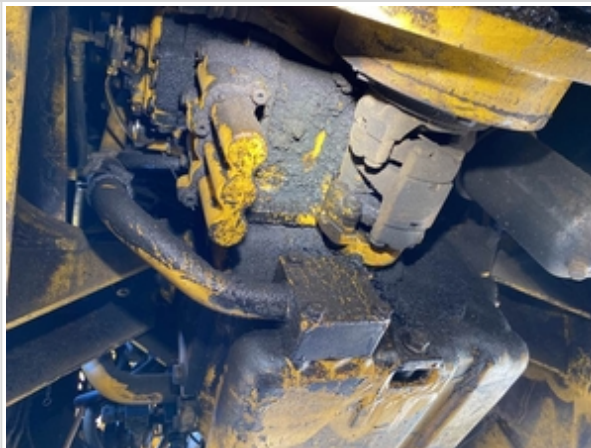
Transmission Photos

Transmission Info	Powershift 4 speed trans
Transmission	3 - Normal Wear & Tear
Transmission Condition	No unusual noises or vibrations, Leaking transmission fluid observed, Other (see comments)
Comments	Leaks observed from output shaft seal

Inching Brake	3 - Normal Wear & Tear	
Inching Brake Condition	Good brake function	
Inching Brake Photos	 	
Parking Brake	3 - Normal Wear & Tear	
Parking Brake Condition	Good brake function	
Parking Brake Photos	 	
Overall Drivetrain Comments	Overall transmission runs good. Multiple leaks from rear side of trans

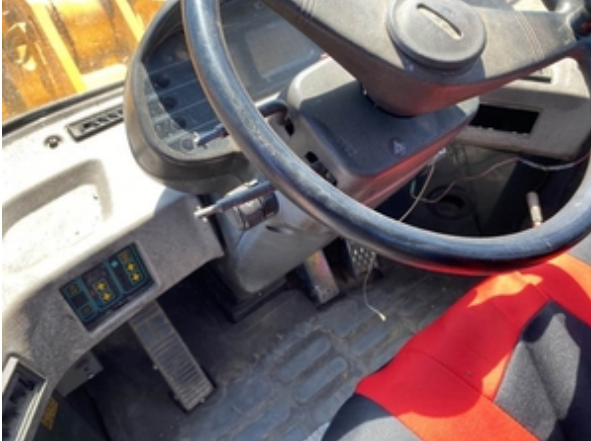
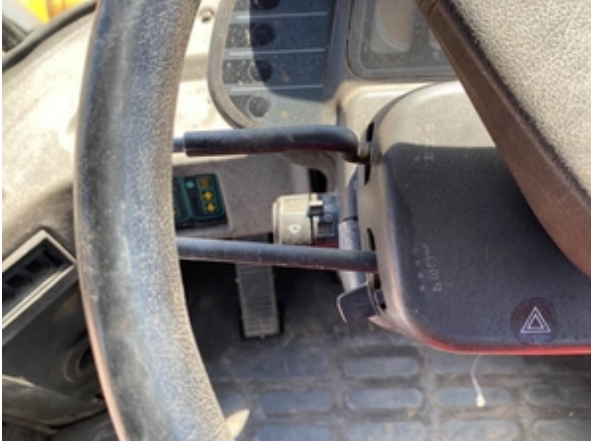
Clutch	0
Shift Lever	2 - Above Average Wear
Shift Lever Condition	Good forward and reverse function, Other Comments

Comments	Transmission shifts smooth, gear selection 1 & 2 okay
Shift Level Photos

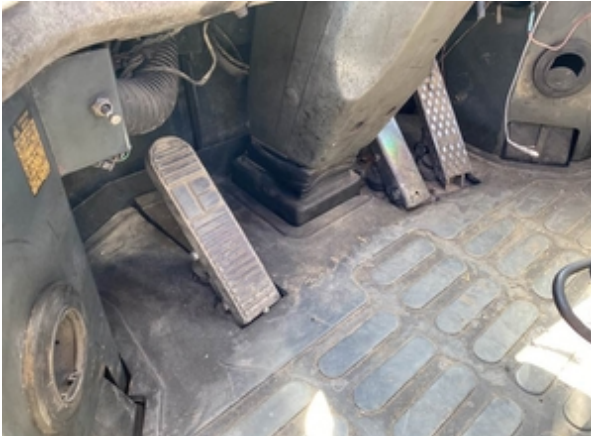
Foot Brake	3 - Normal Wear & Tear
Foot Brake Condition	Good brake function
Foot Brake Photos

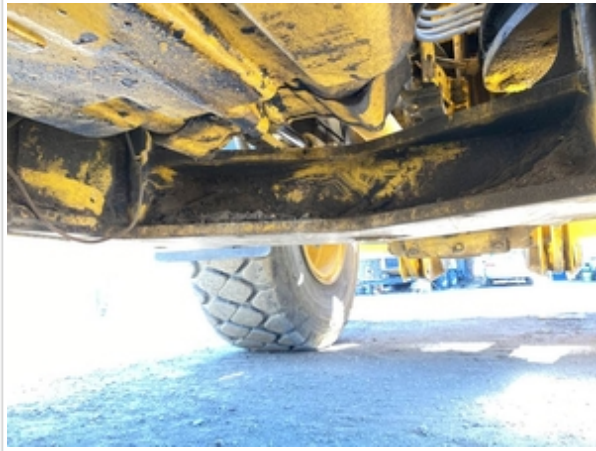
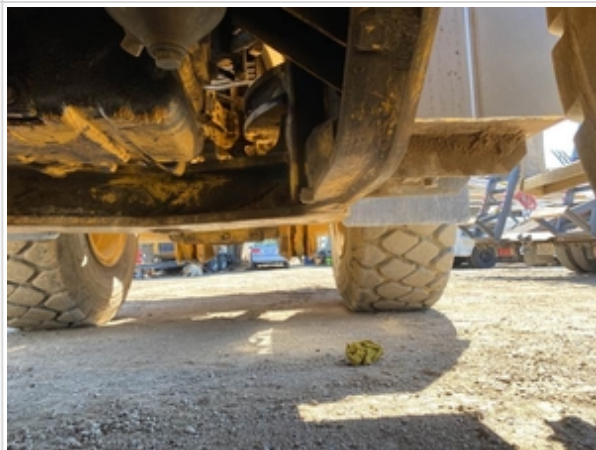
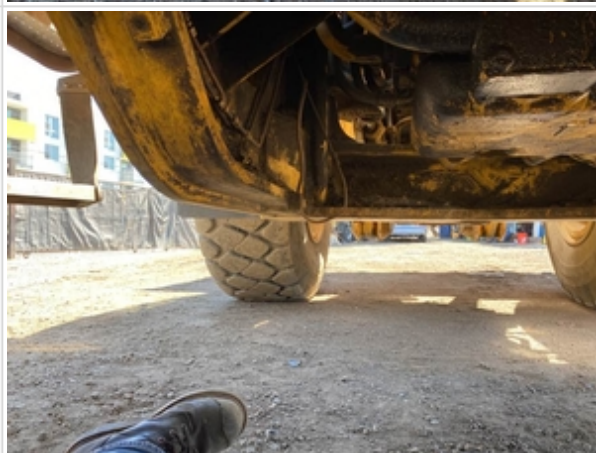
Instructions	<p>Evaluate the following on a 4 point scale (leave comments where an explanation is appropriate):</p> <p>4 = Like New, Recently Replaced 3 = Normal Wear & Tear 2 = Above Average Wear 1 = Service Required</p>
Frame	<p>3 - Normal Wear & Tear</p>
Frame Photos
