Inspection Report (Wheel Loader)

Year	1998
Make	Komatsu
Model	WA380-3L
Serial Number	A50435
Hour Meter Reading	7,589
Previous Application (e.g., earth moving, mining, demolition, etc)	General Construction

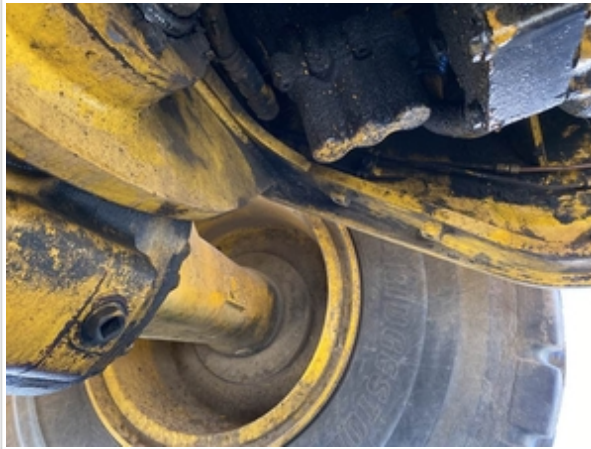
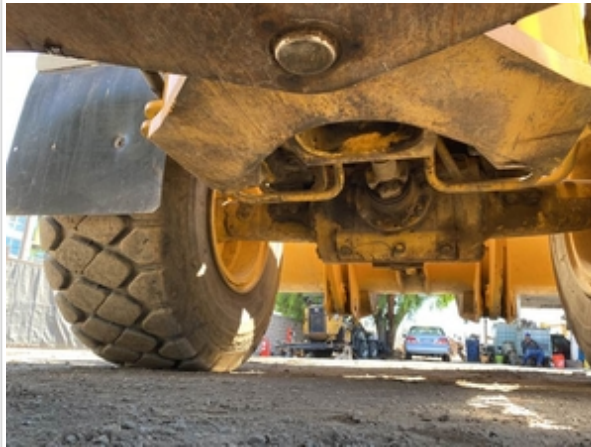
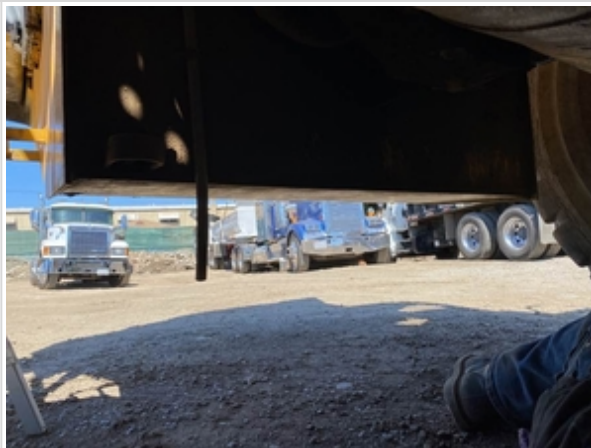
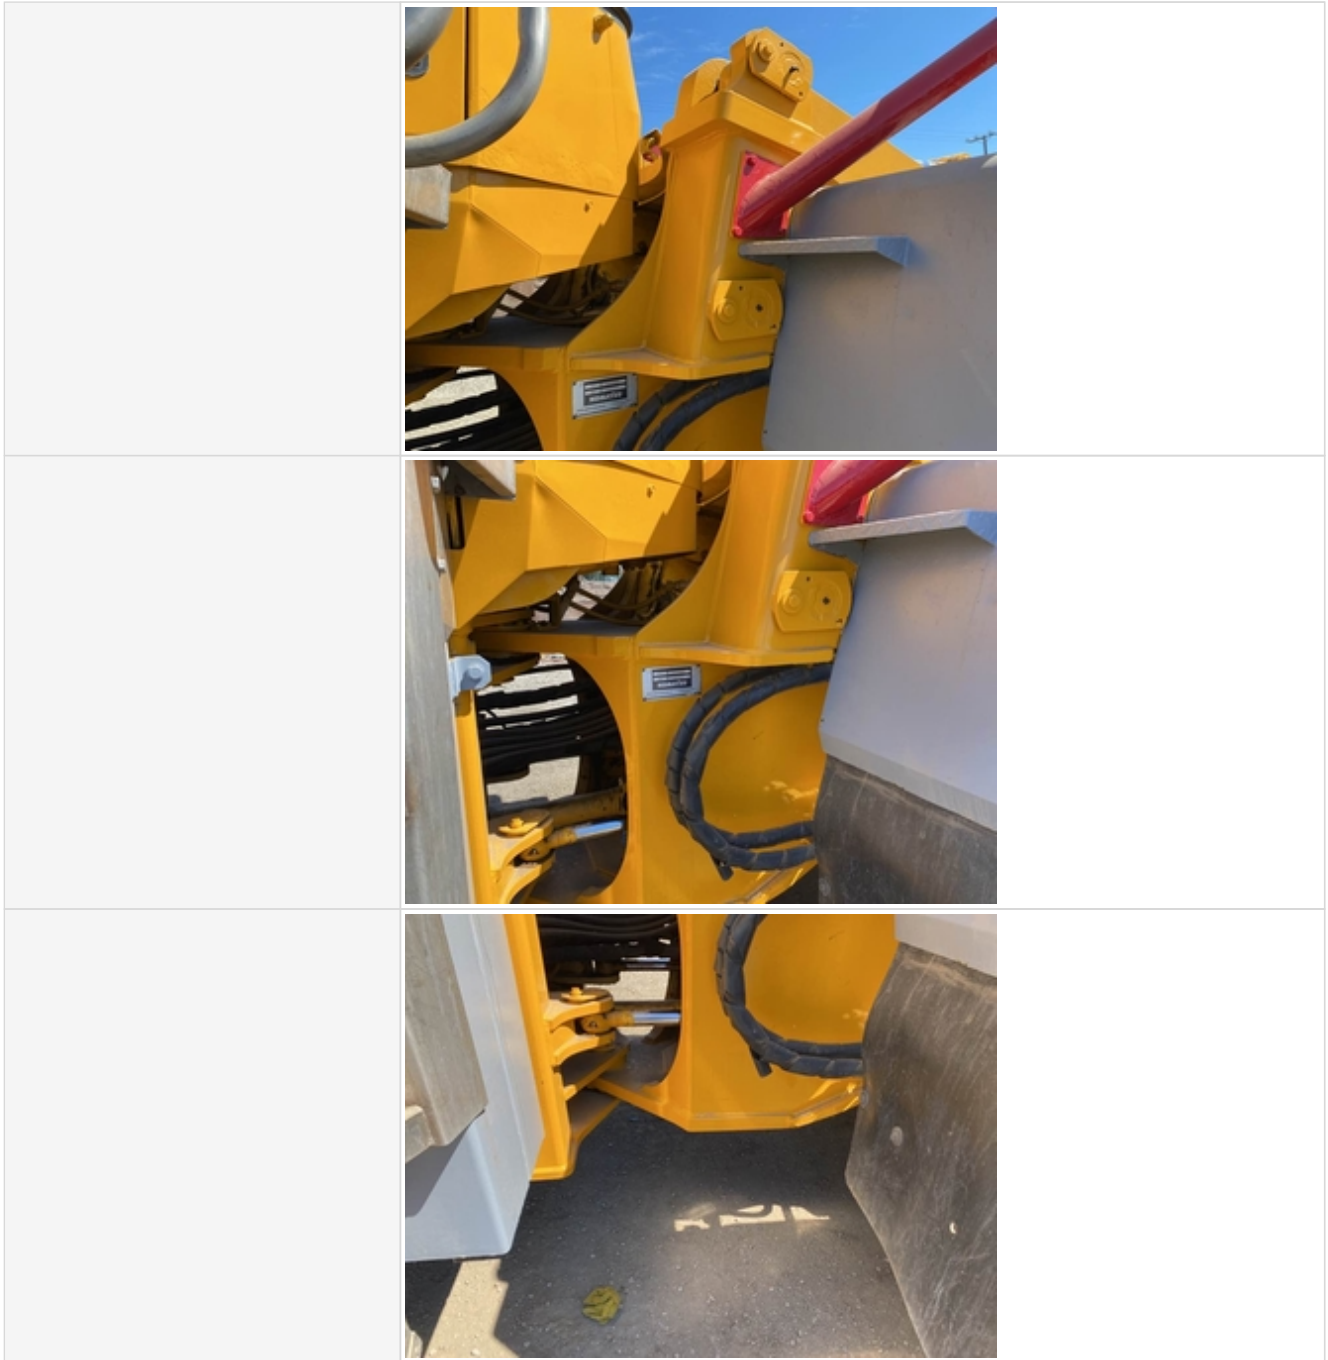
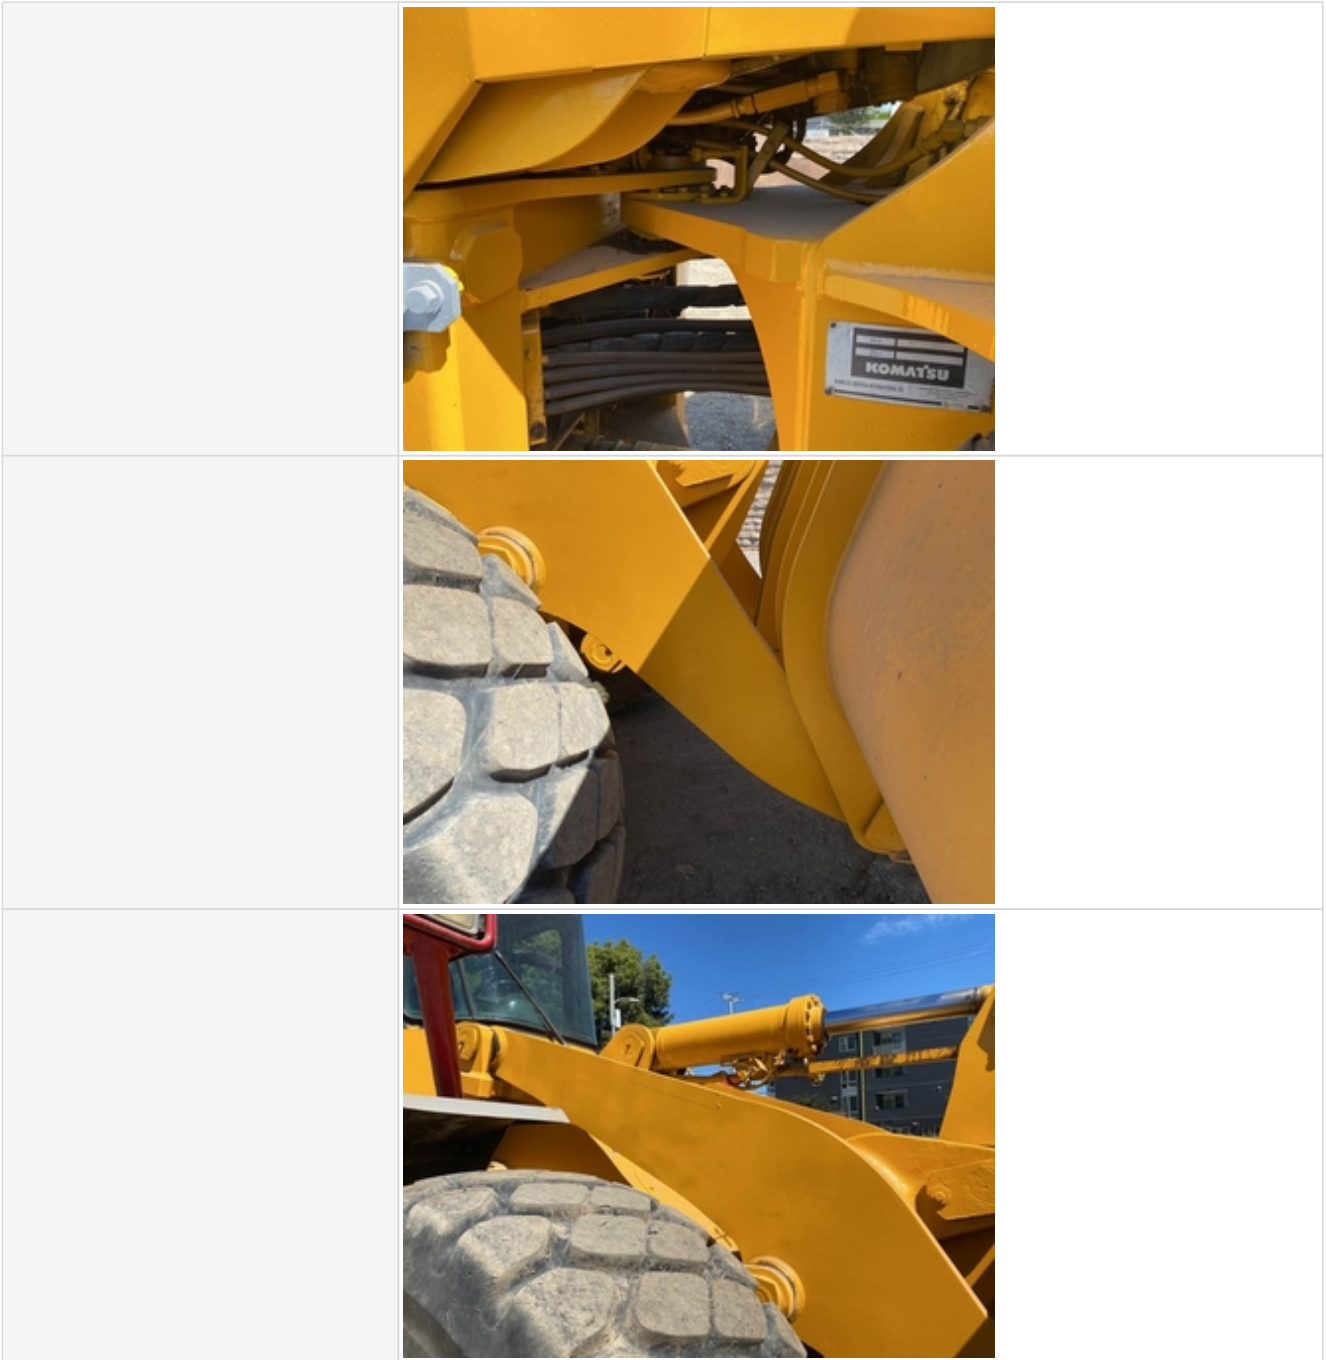
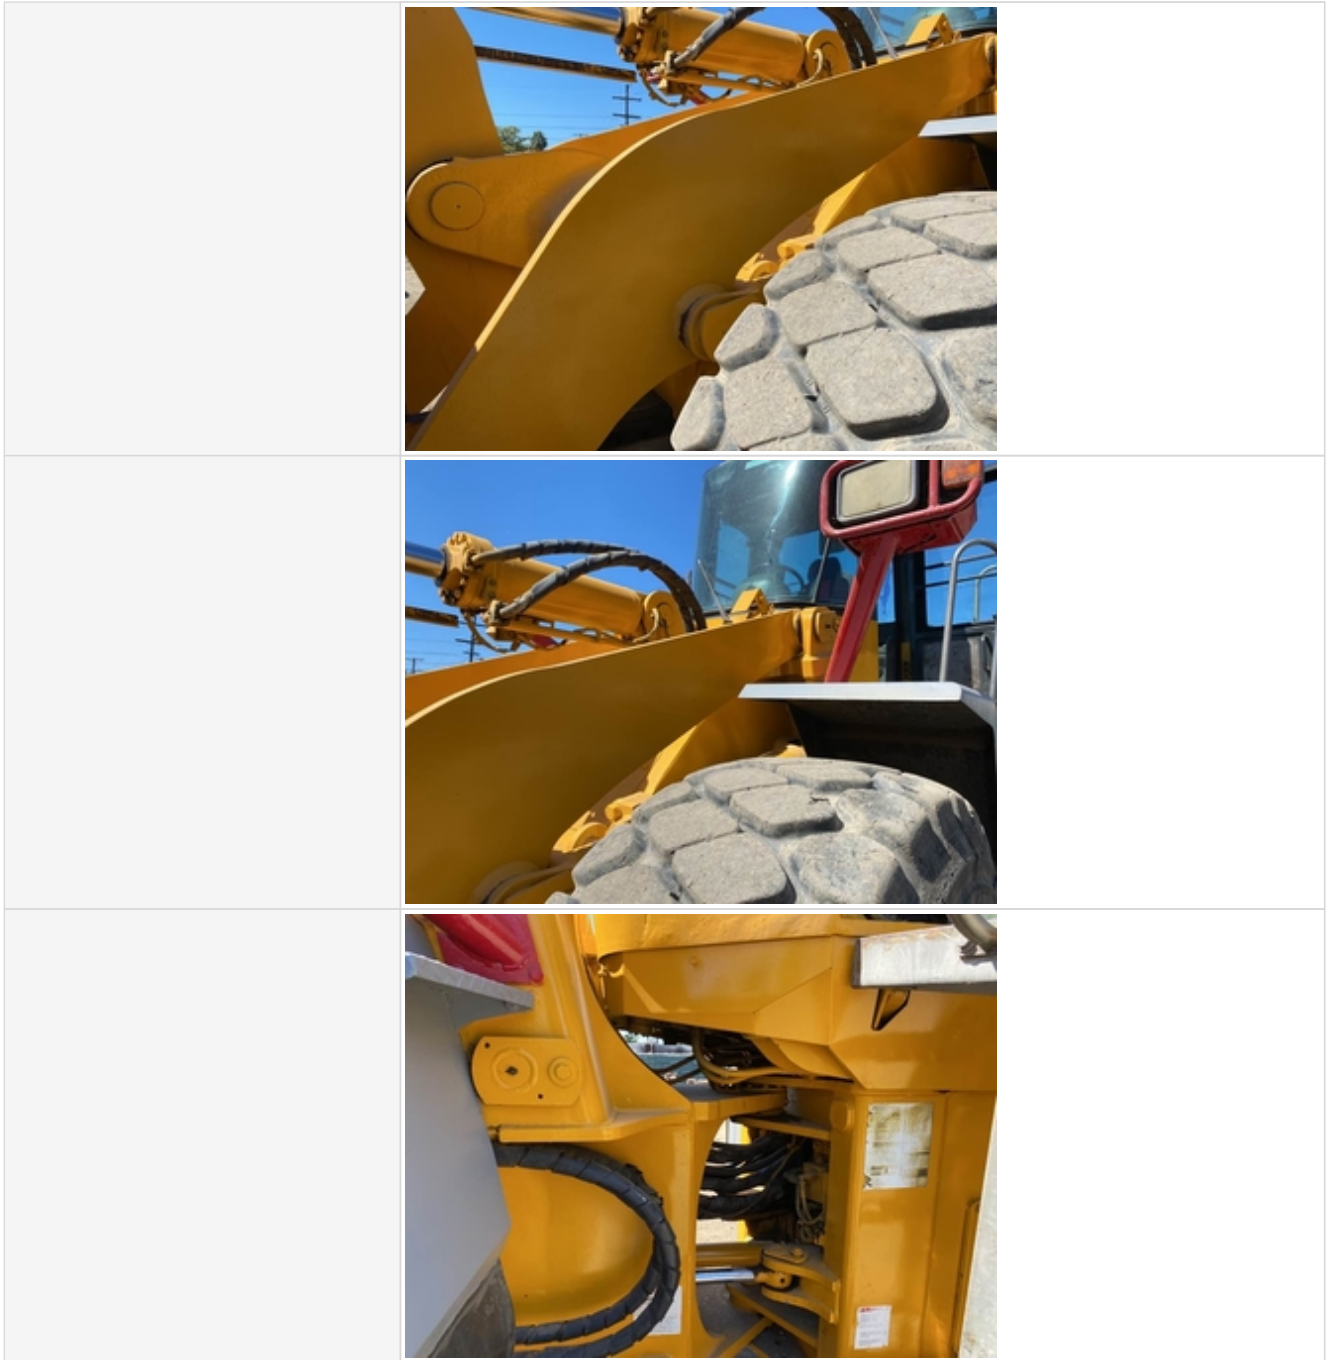
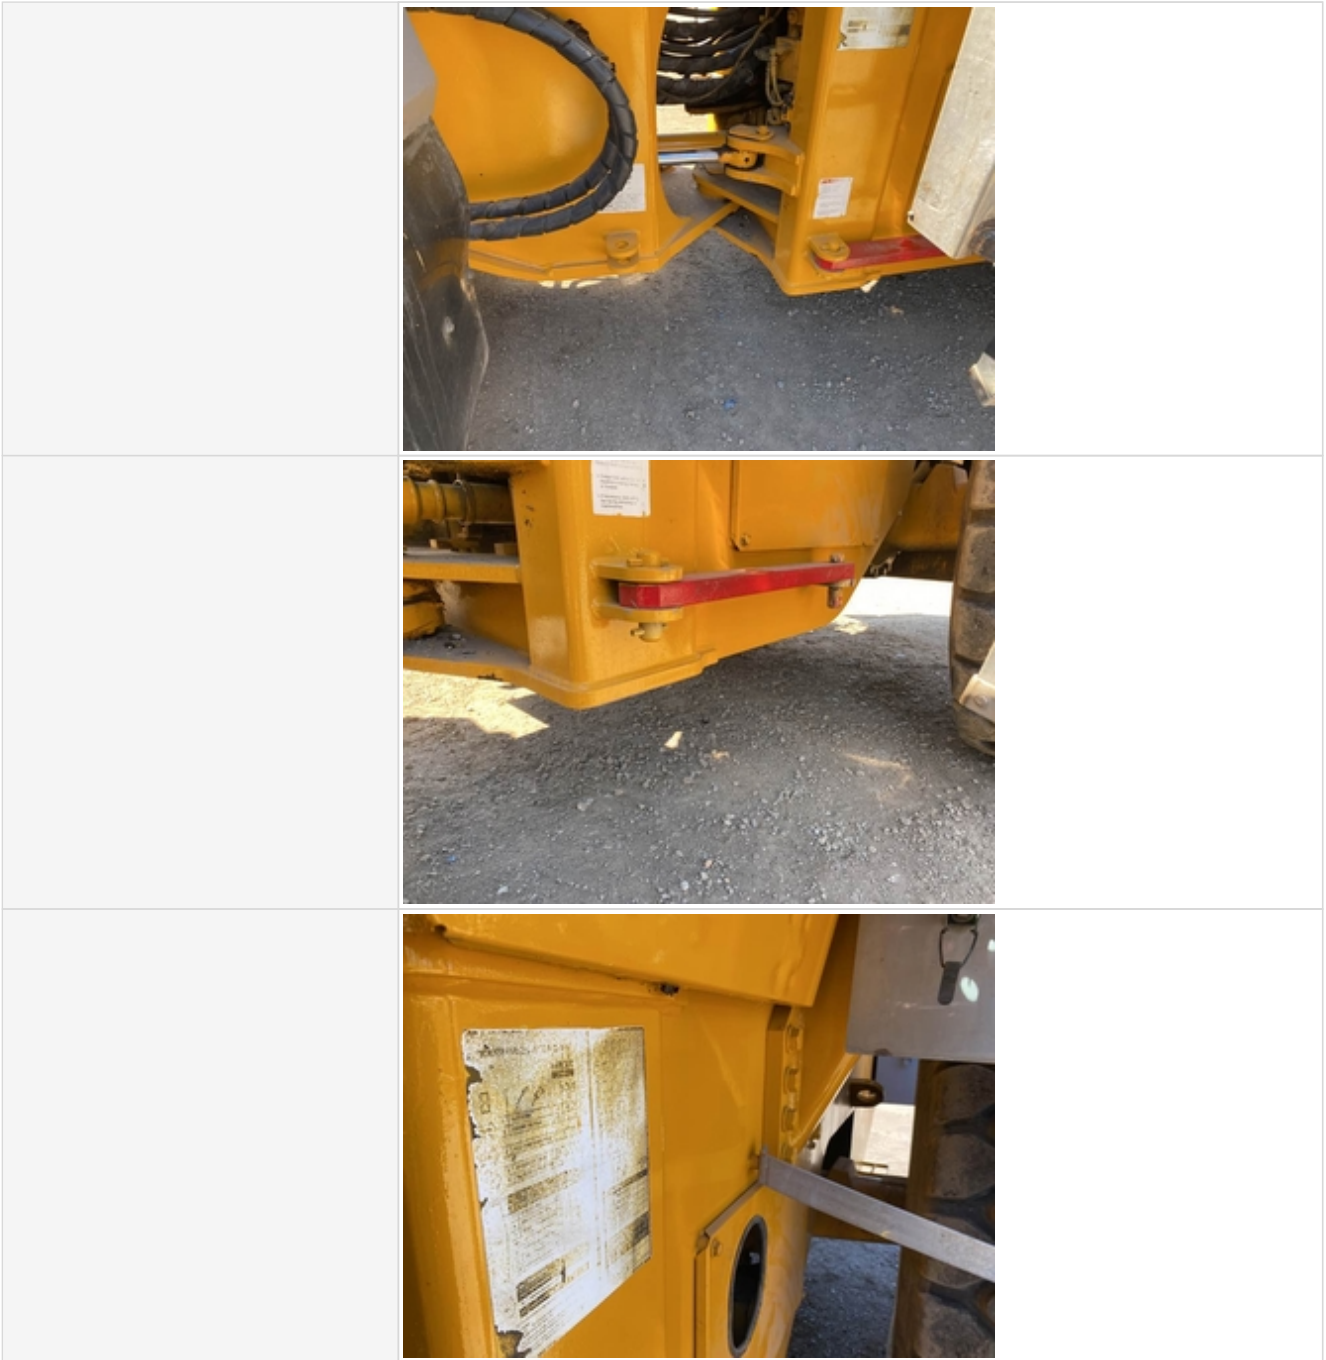
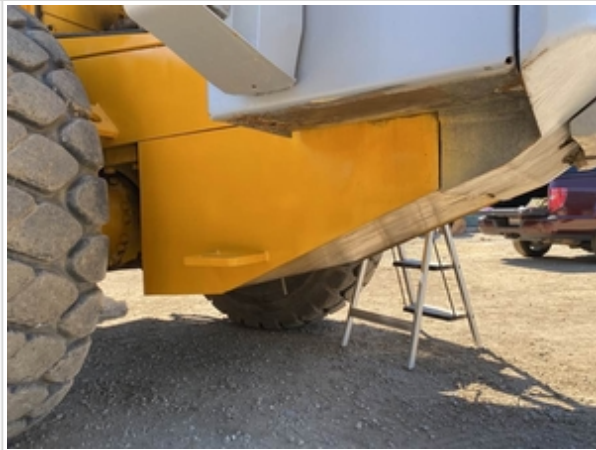
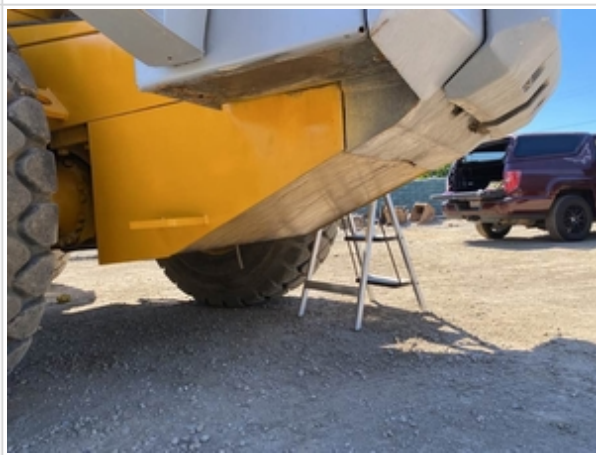
Instructions	<p>Evaluate the following on a 4 point scale (leave comments where an explanation is appropriate):</p> <p>4 = Like New, Recently Replaced 3 = Normal Wear & Tear 2 = Above Average Wear 1 = Service Required</p>
Frame	<p>3 - Normal Wear & Tear</p>
Frame Photos

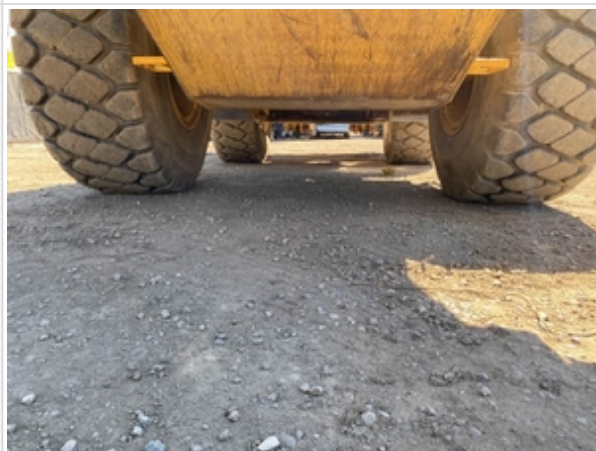
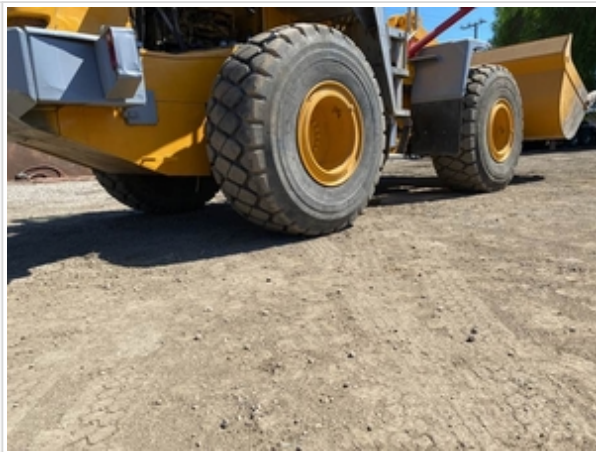
<p>Stance</p>	<p>3 - Normal Wear & Tear</p>	
<p>Stance Photos</p>

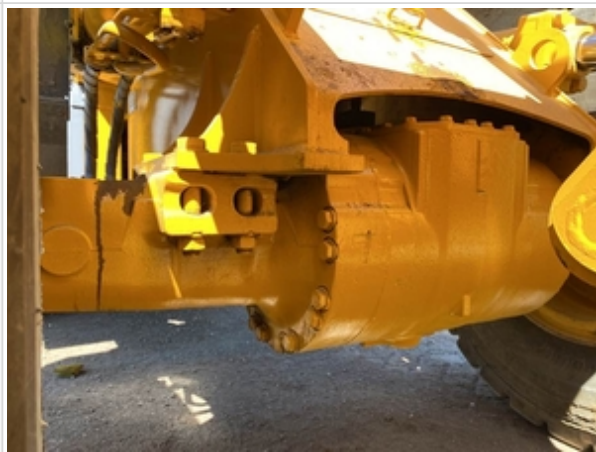
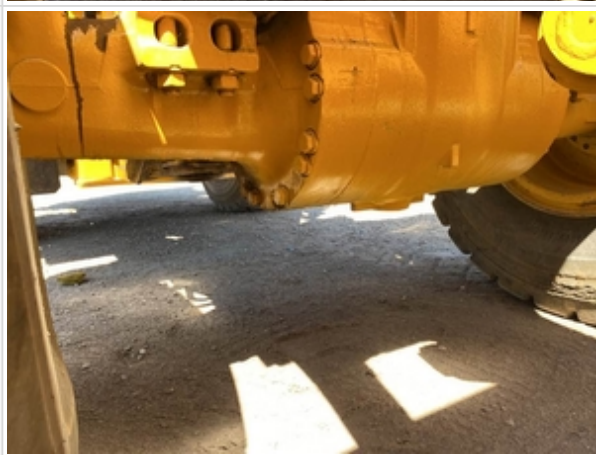
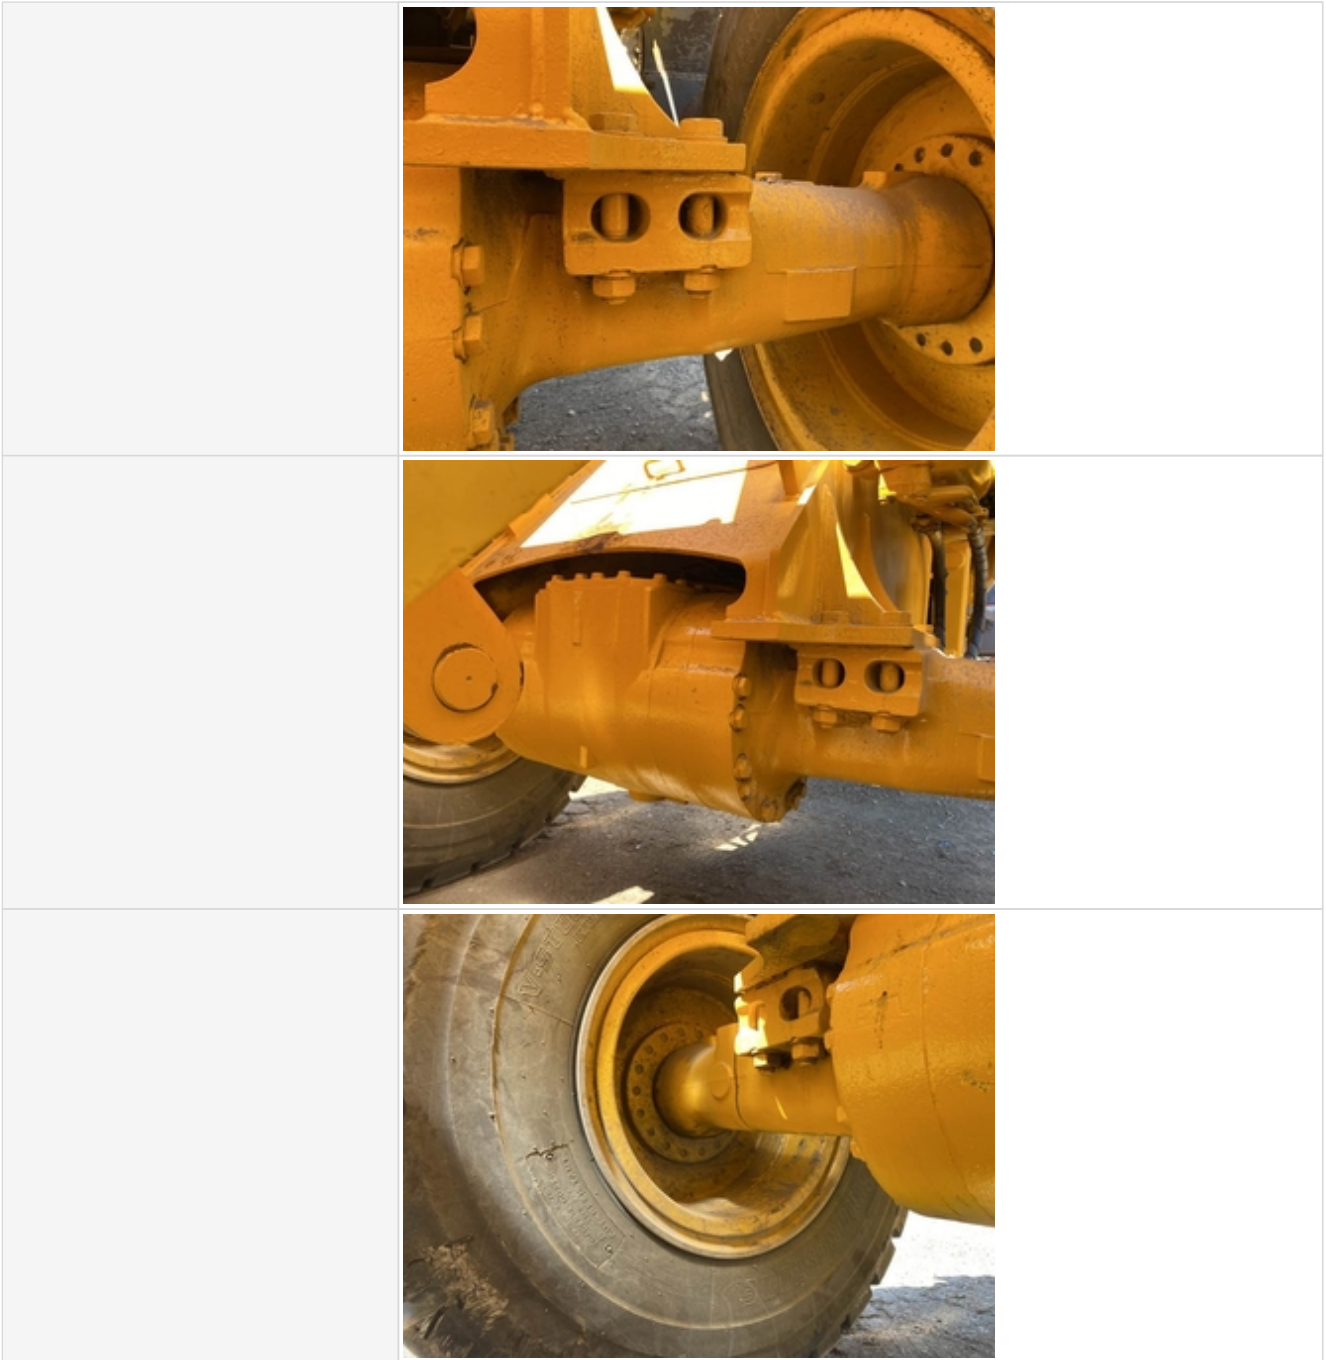
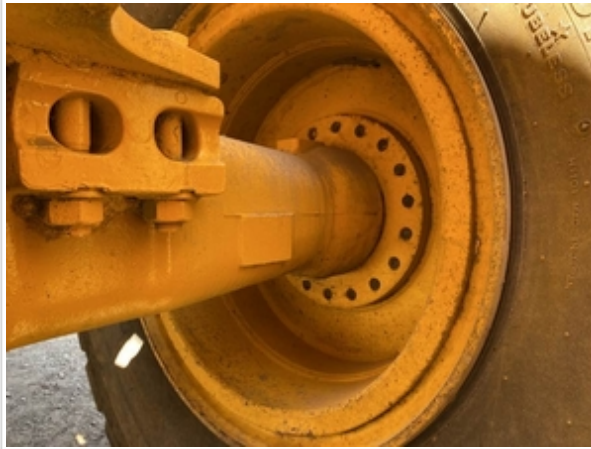
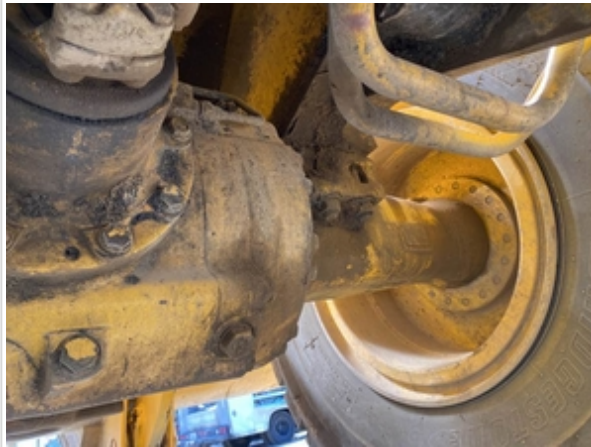
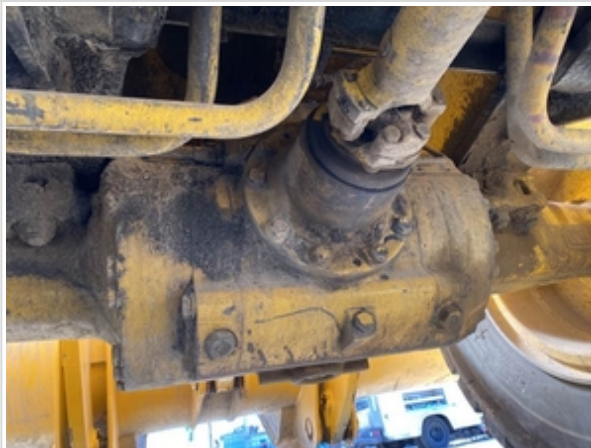
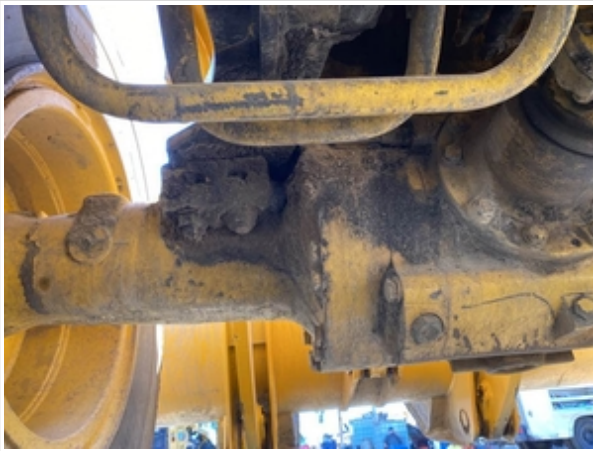
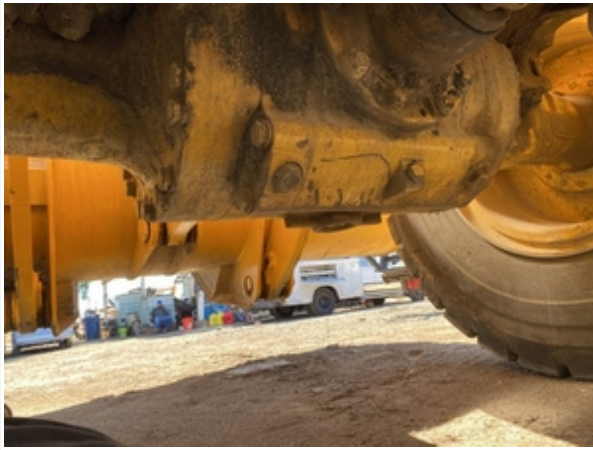
<p>Front Axle Appearance</p>	<p>3 - Normal Wear & Tear</p>	
<p>Front Axle Appearance Photos</p>

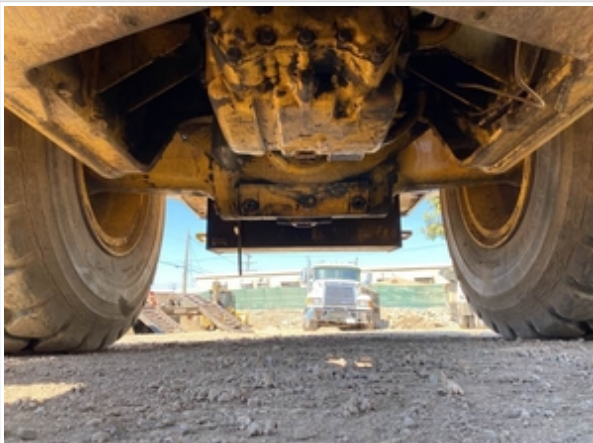
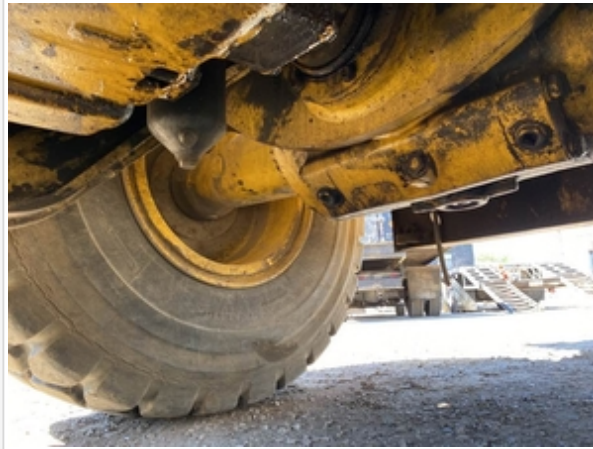
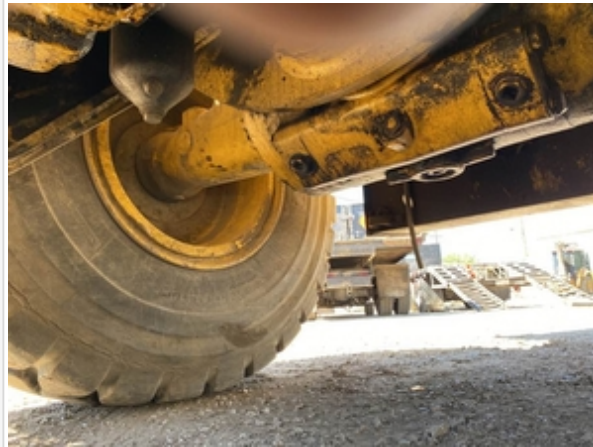
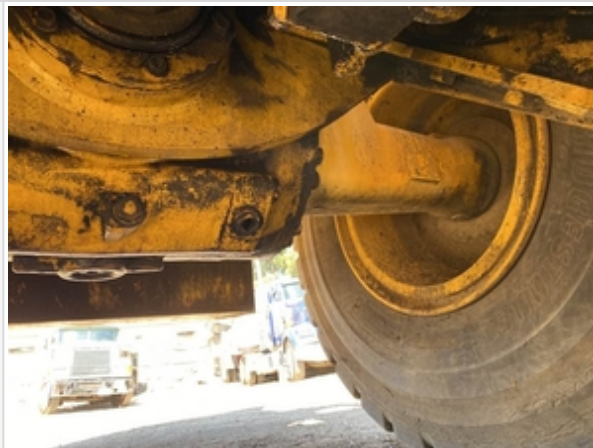
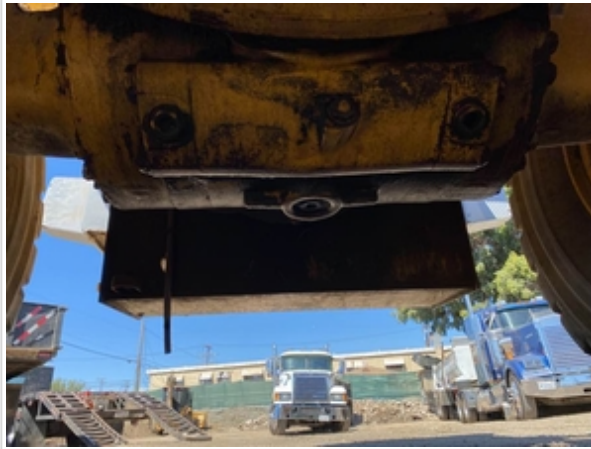
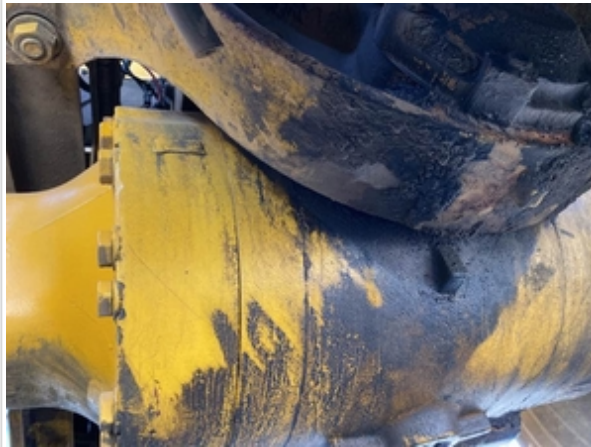
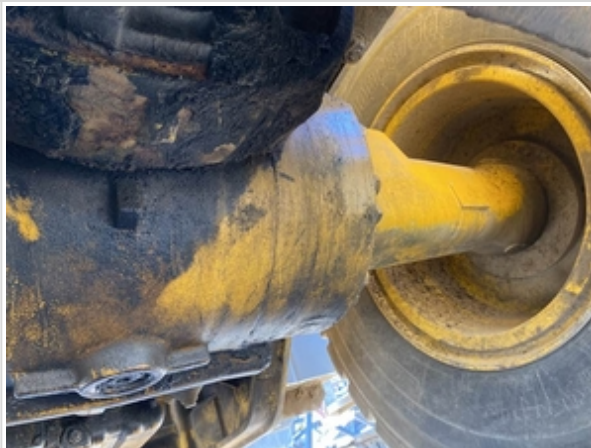
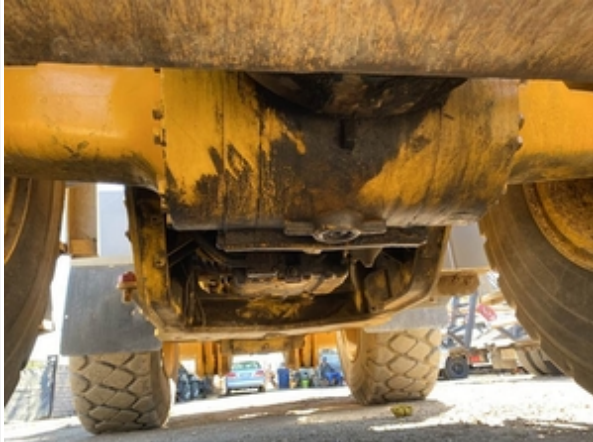
Rear Axle Appearance	3 - Normal Wear & Tear	
Comments	Rear axle has excessive mounting play (shifts forward and back)	
Rear Axle Appearance Photos

Quick Coupler	0	
Quick Coupler to Arms Pins	0	
Overall Chassis	3 - Normal Wear & Tear	
Overall Chassis Comments	When braking hard in either direction knocking noise heard and felt. Determined rear axle has excessive play and visibly moves front to back.

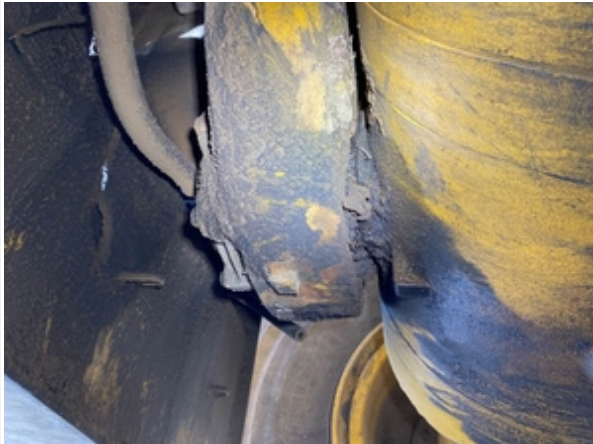
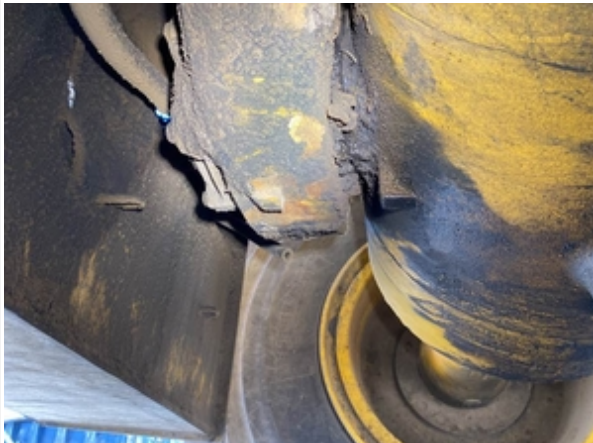
Articulating Center Pin Appearance	3 - Normal Wear & Tear	
Comments	Rear needs attention	
Articulating Center Pin Appearance Photos

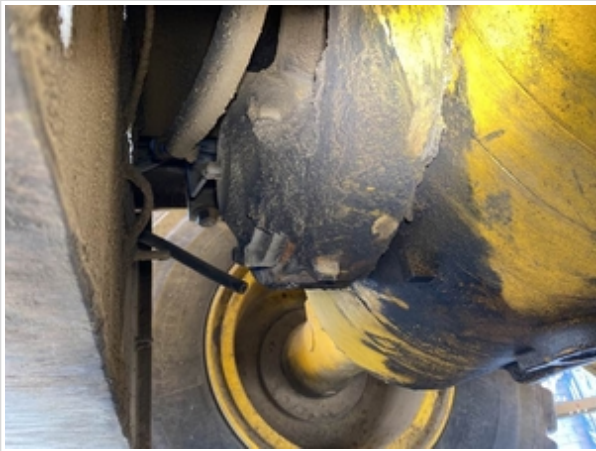
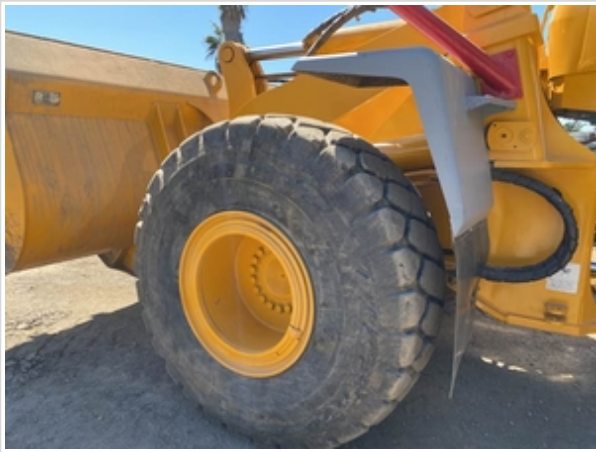
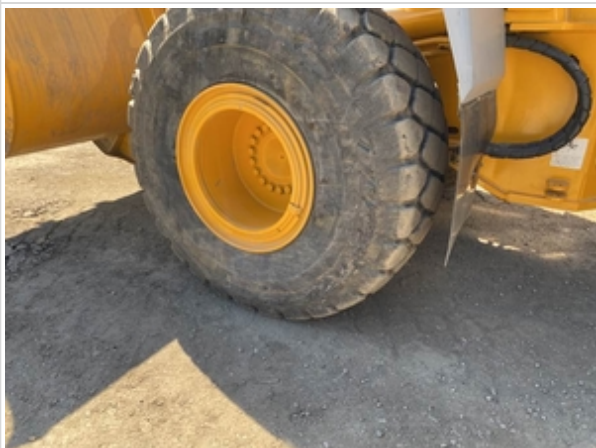
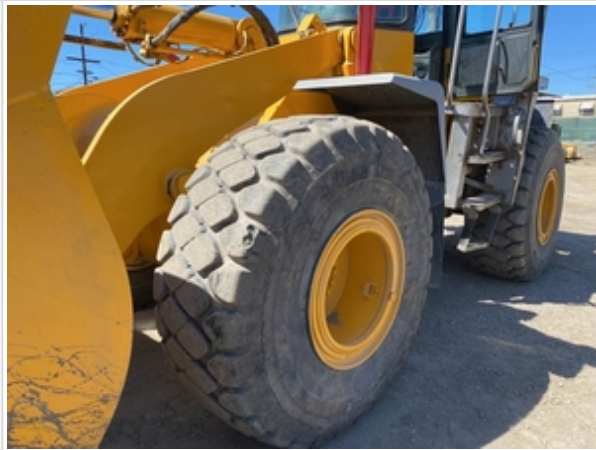
Tire Brand	Bridgestone (v steel M traction)	
Tire Size	23.5R 25	
Front Left Tire - Ratio Remaining	50%	
Front Left Tire Photos

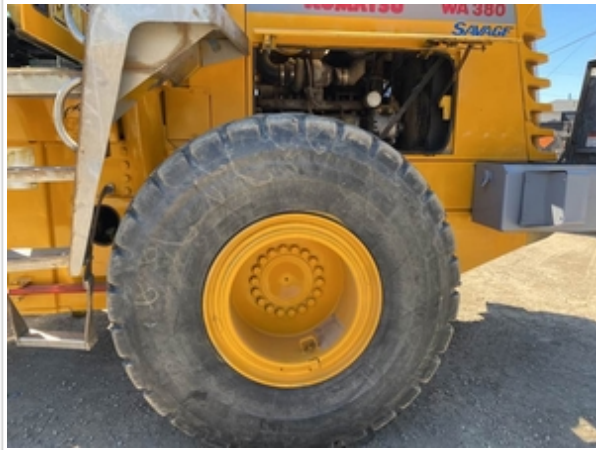
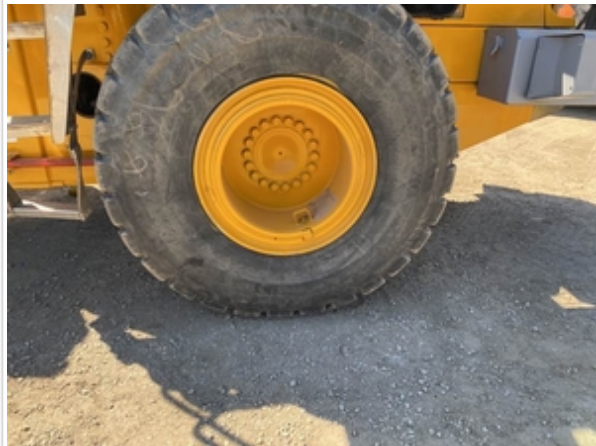
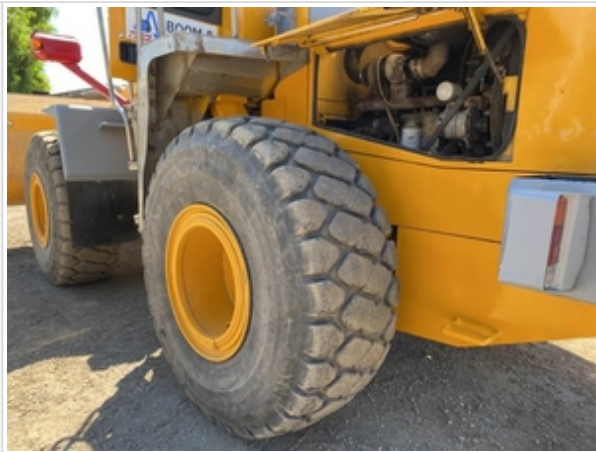
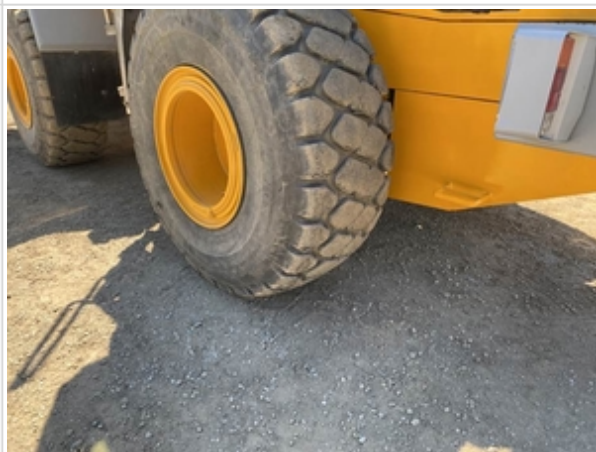
<p>Rear Left Tire - Ratio Remaining</p>	<p>70%</p>
<p>Rear Left Tire Photos</p>

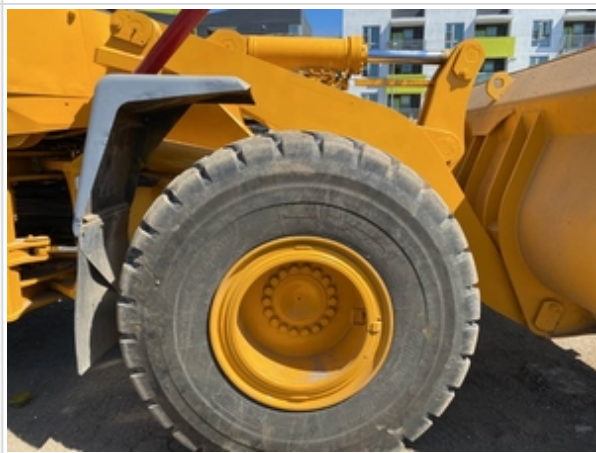
<p>Front Right Tire - Ratio Remaining</p>	<p>70%</p>	
<p>Front Right Tire Photos</p>

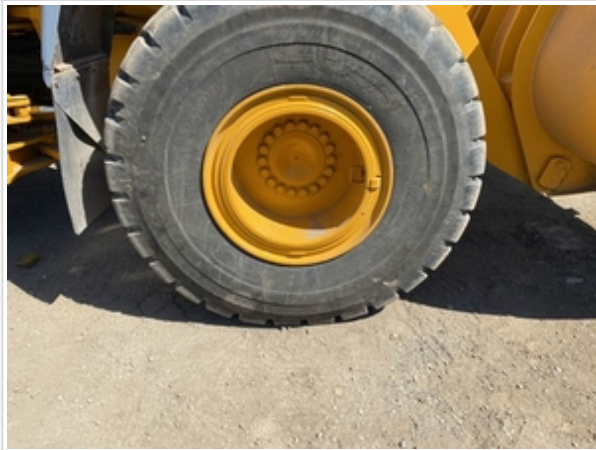
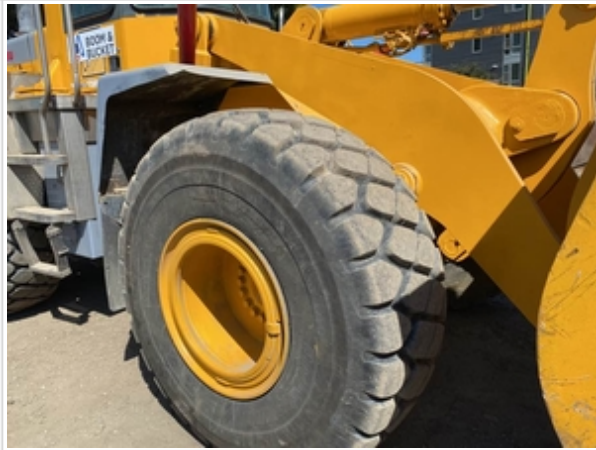
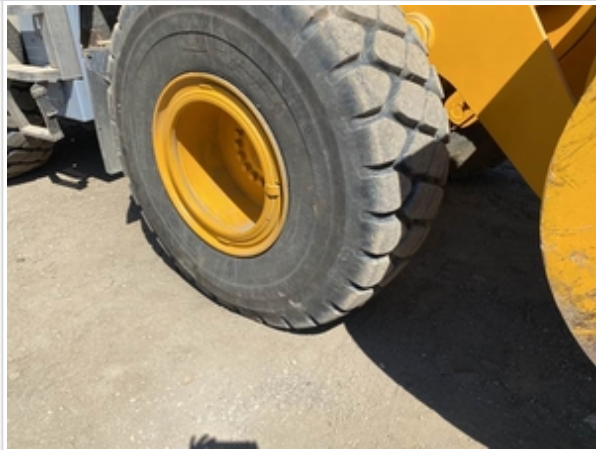
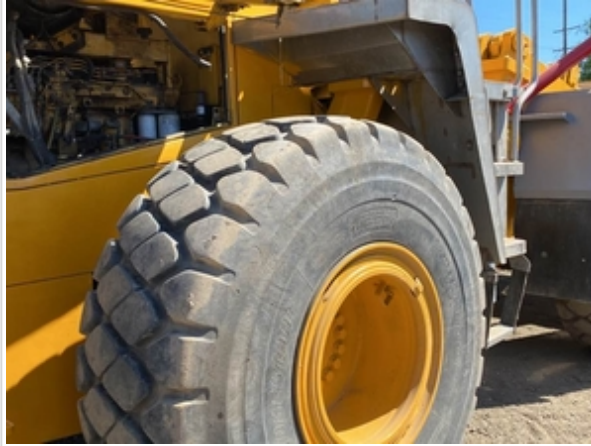
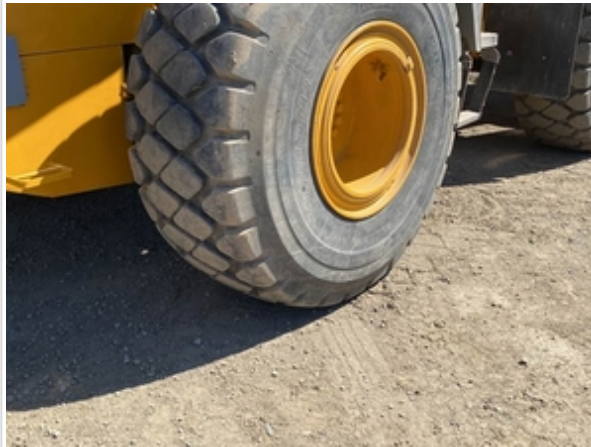
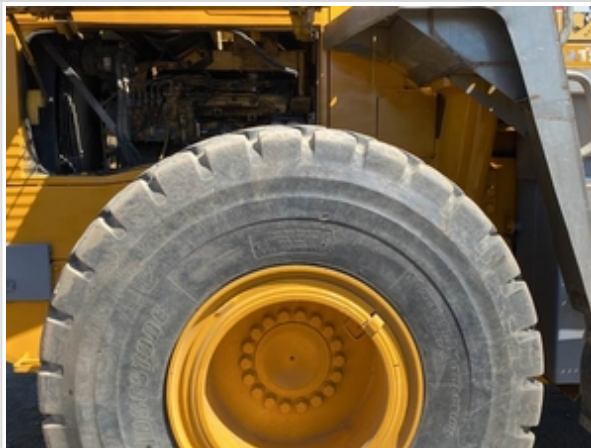
Rear Right Tire Photos

<p>Rear Right Tire - Ratio Remaining</p>	<p>70%</p>

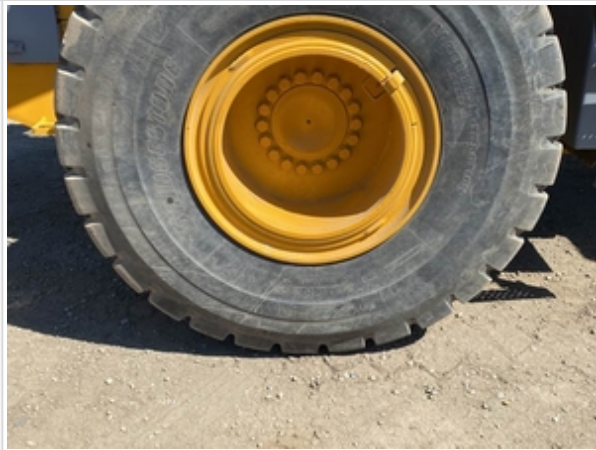
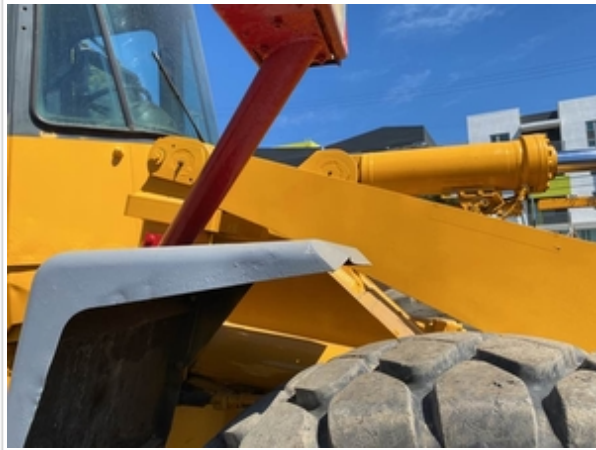
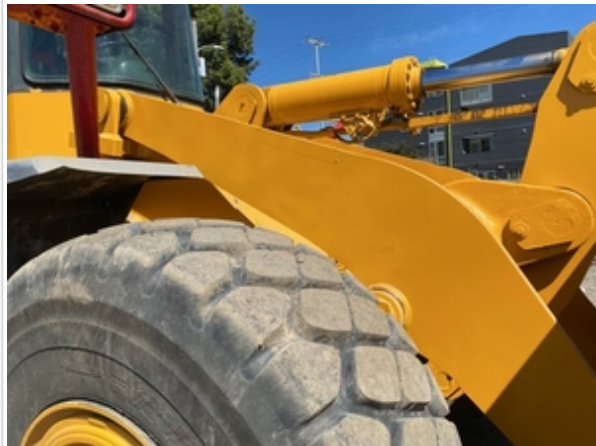
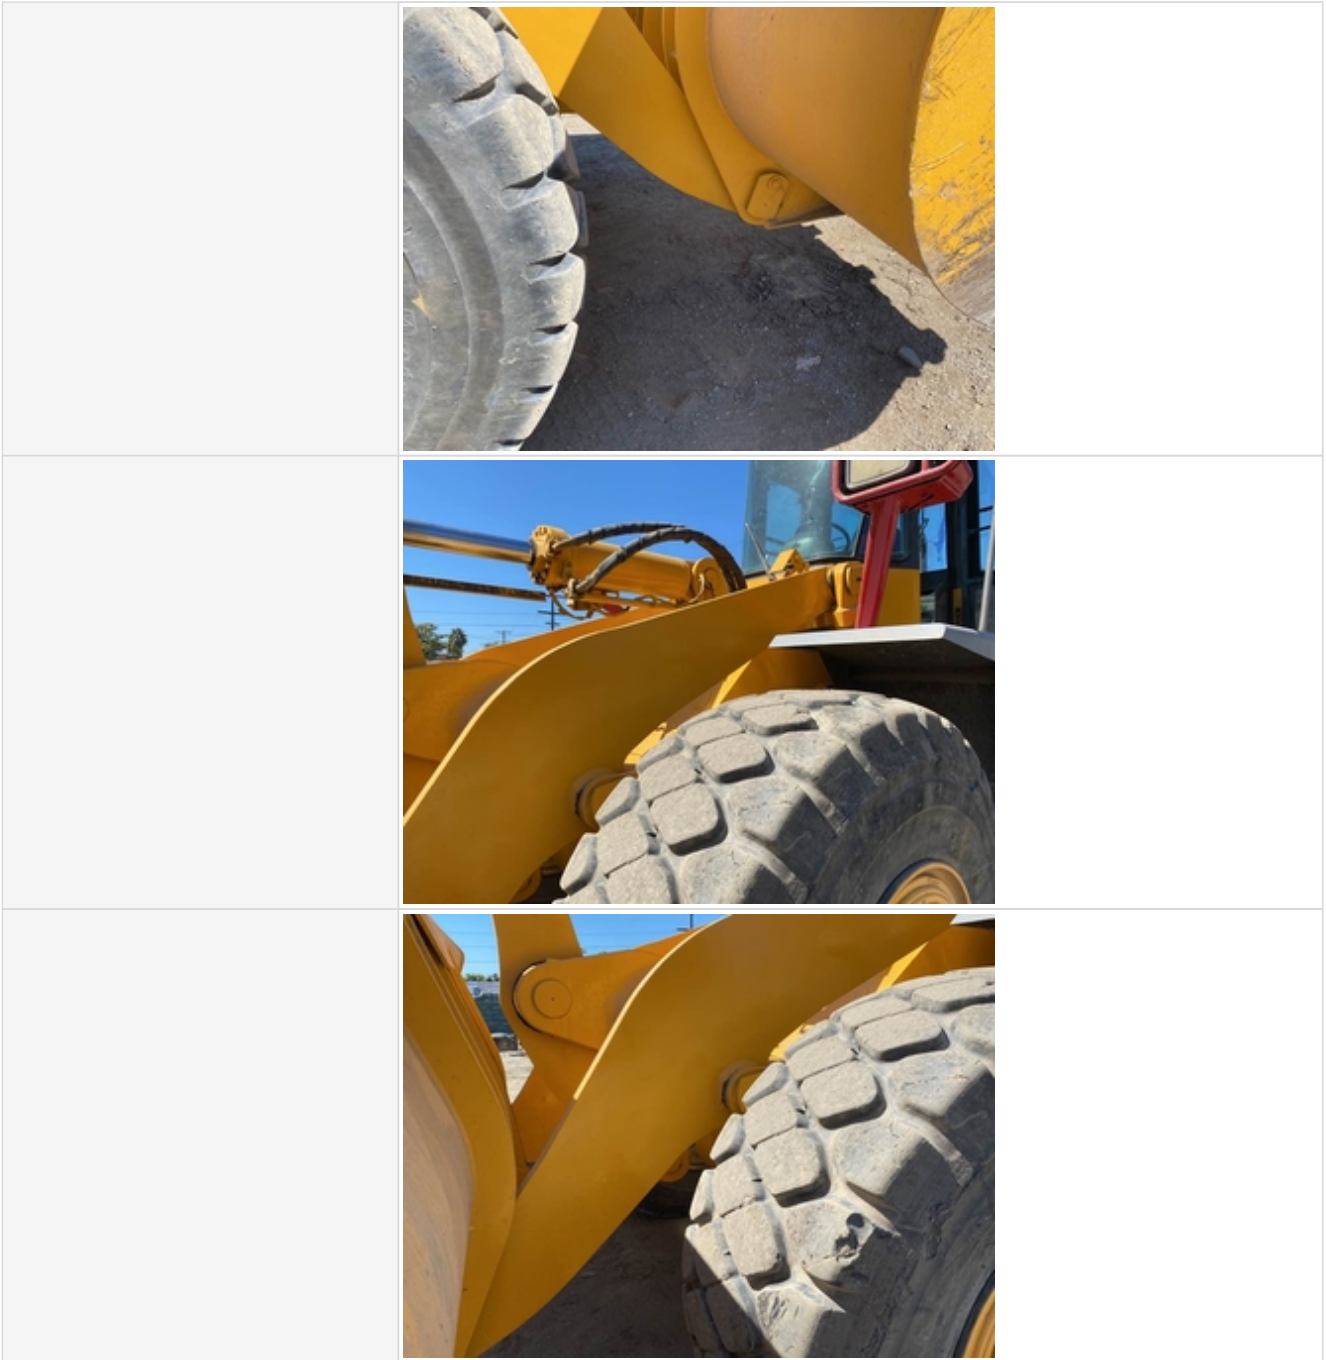
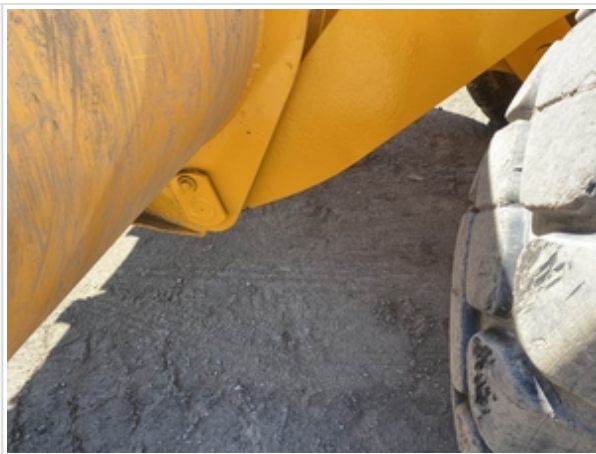
<p>Lift Arm</p>	<p>3 - Normal Wear & Tear</p>	
<p>Lift Arm Photos</p>
