Inspection Report (Wheel Loader)

Year	1998
Make	Komatsu
Model	WA380-3L
Serial Number	A50435
Hour Meter Reading	7,589
Previous Application (e.g., earth moving, mining, demolition, etc)	General Construction

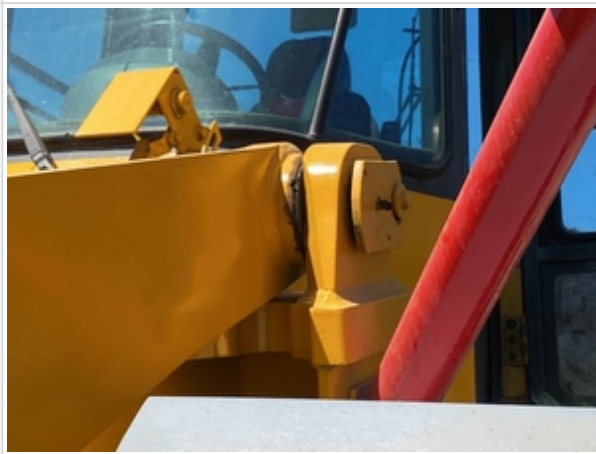
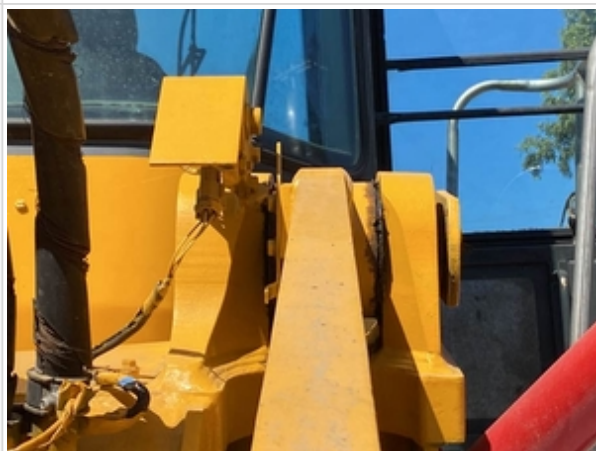
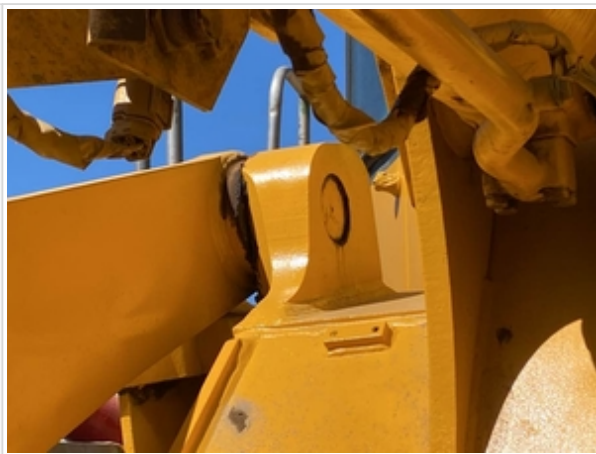
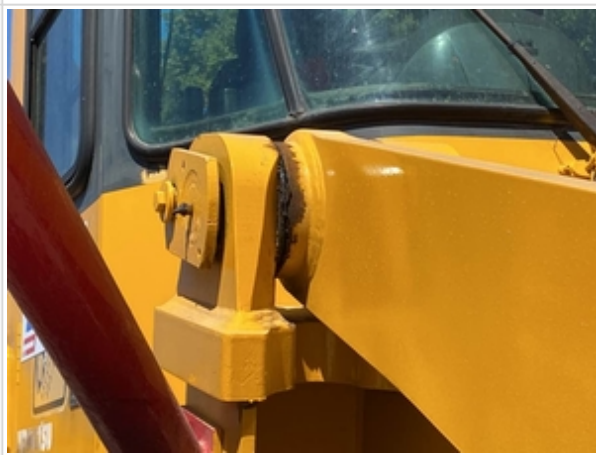
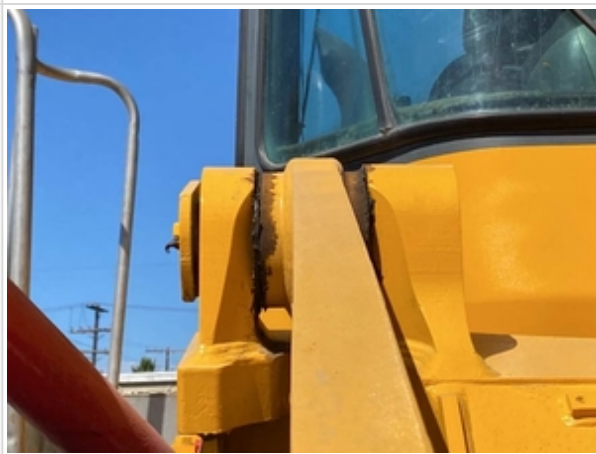
<p>Chassis to Arm Pins</p>	<p>3 - Normal Wear & Tear</p>	
<p>Chassis to Arm Pins Photos</p>

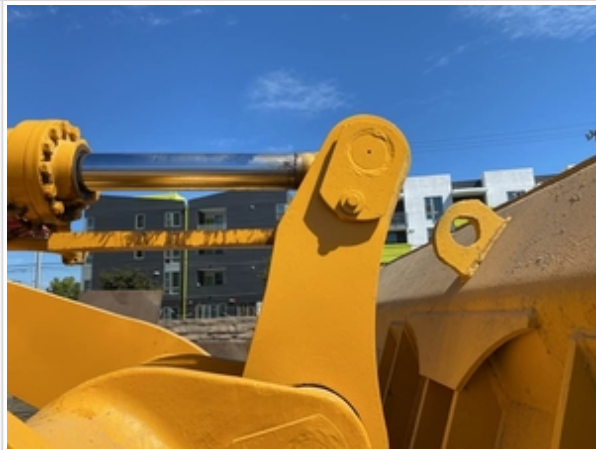
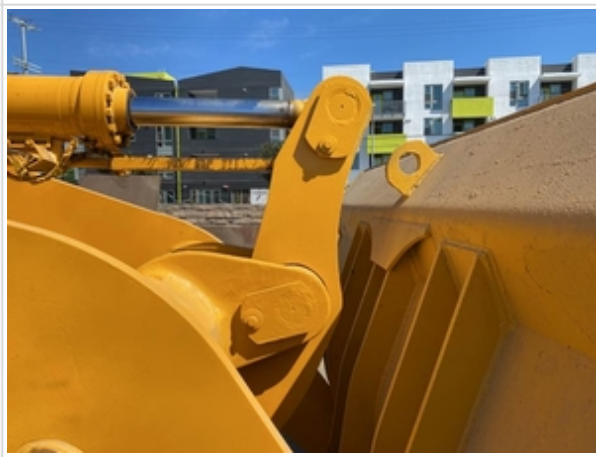
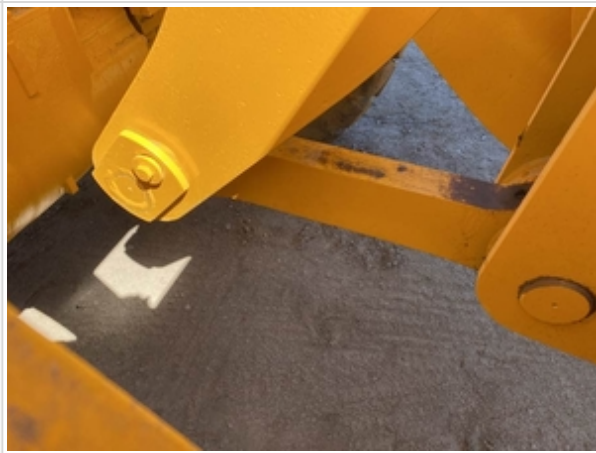
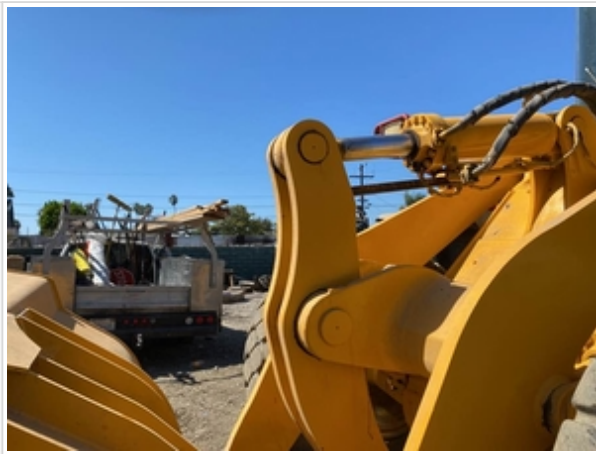
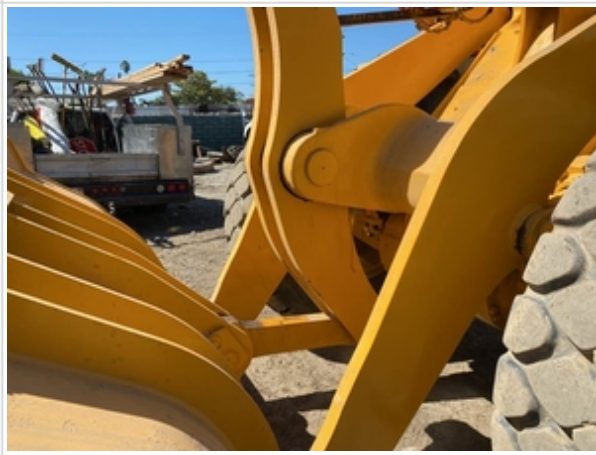
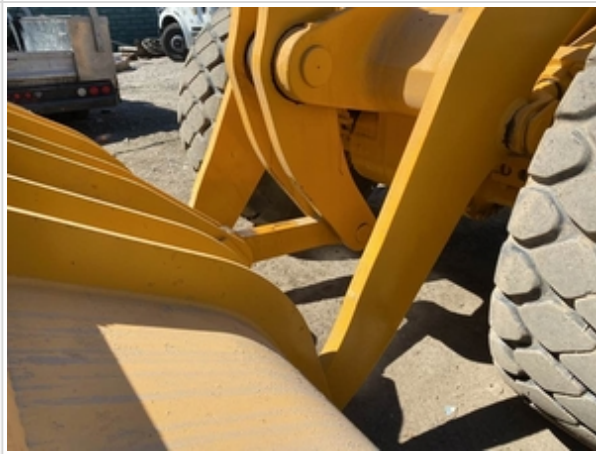
<p>Tilt Linkage Photos</p>

<p>Tilt Linkage</p>	<p>3 - Normal Wear & Tear</p>

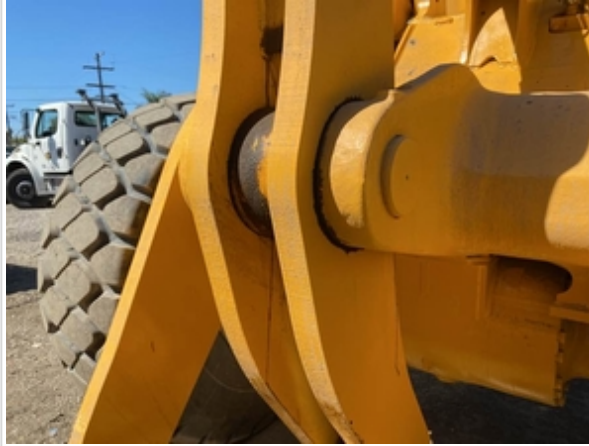
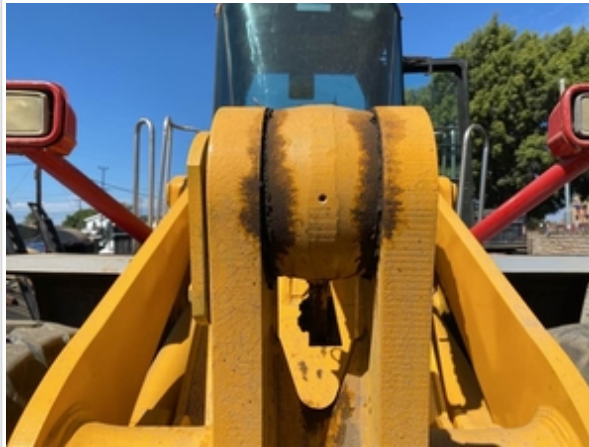
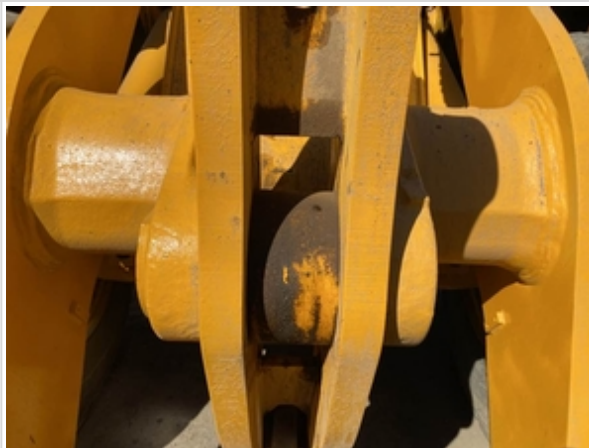
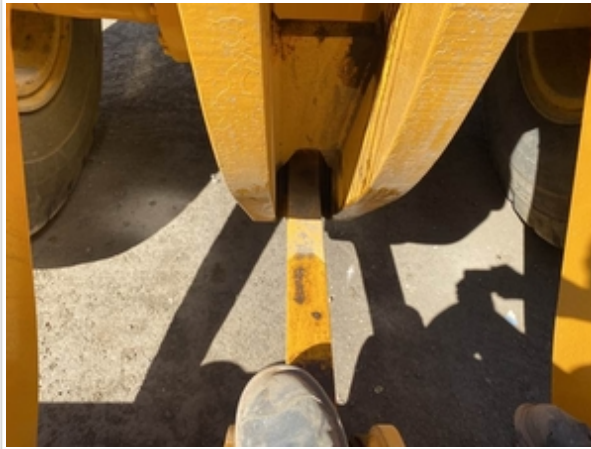
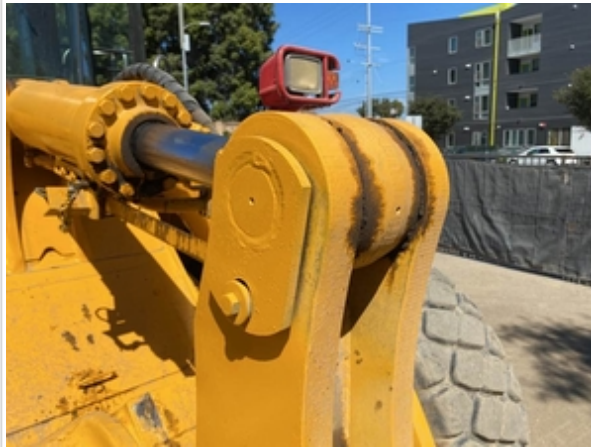
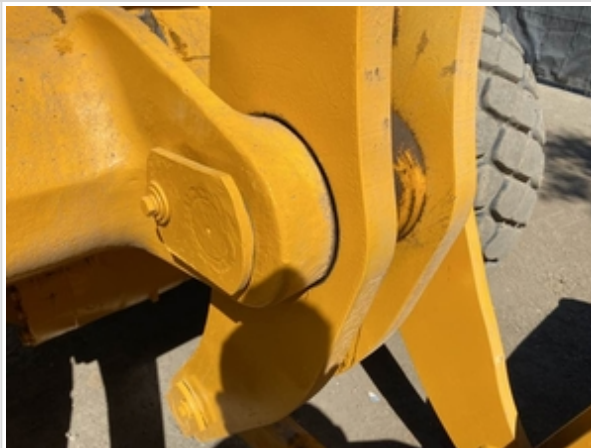
Tilt Linkage Pins and Bushings
Photos

<p>Tilt Linkage Pins and Bushings</p>	<p>3 - Normal Wear & Tear</p>

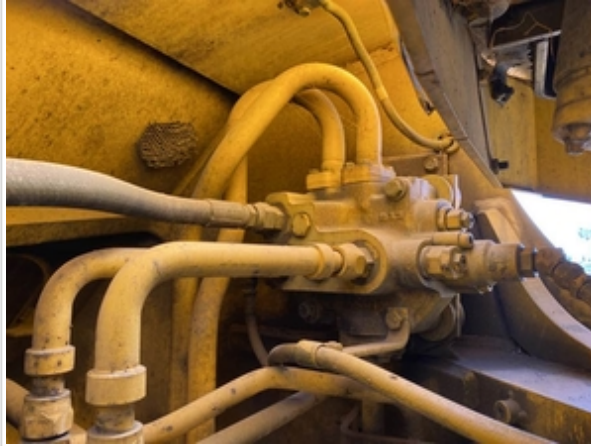
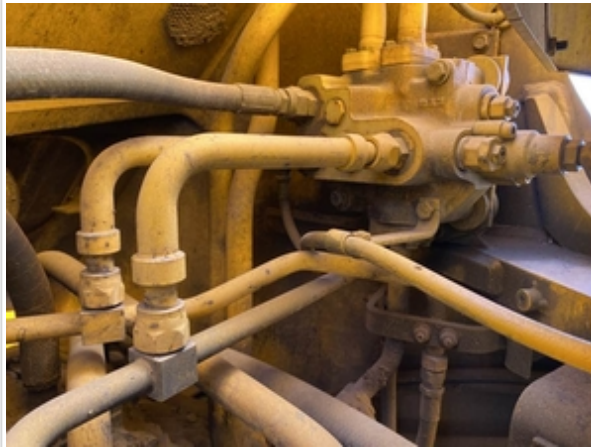
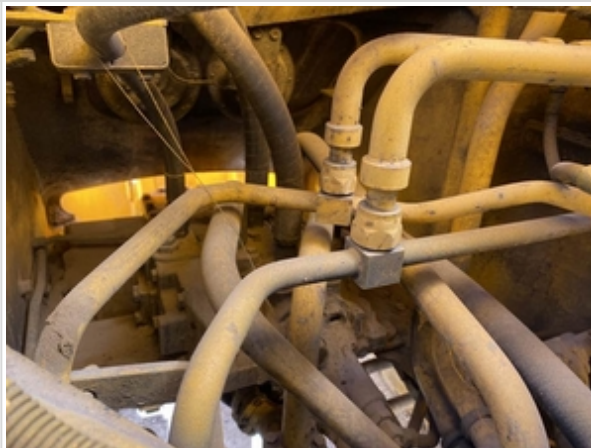
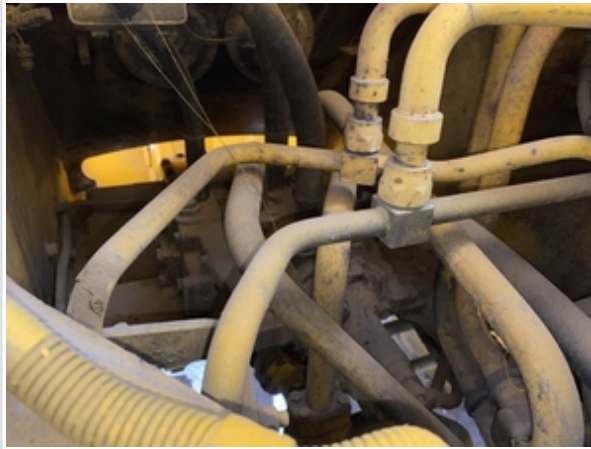
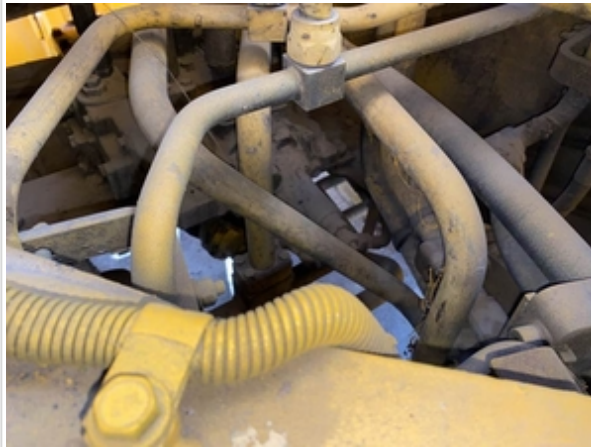
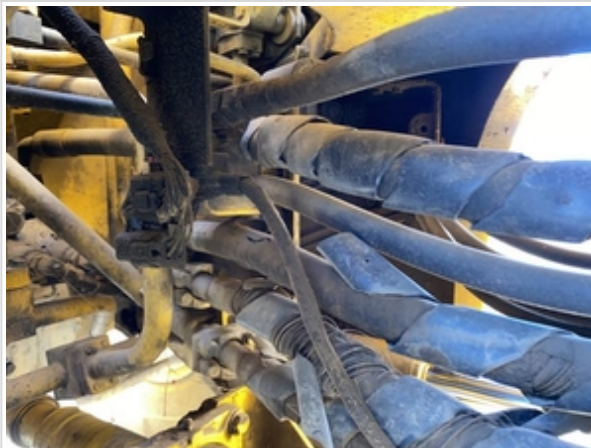
Appearance of Hydraulic Lines /
Fittings Photos

Wet or Damp Hydraulic Lines / Fittings	Yes	
Appearance of Hydraulic Lines / Fittings	2	
Hydraulic Lines / Fittings Condition	Dried seepages observed	
Comments	Many hoses need to be replaced soon

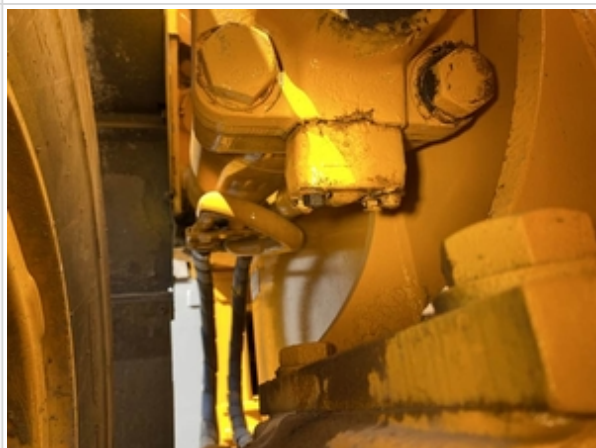
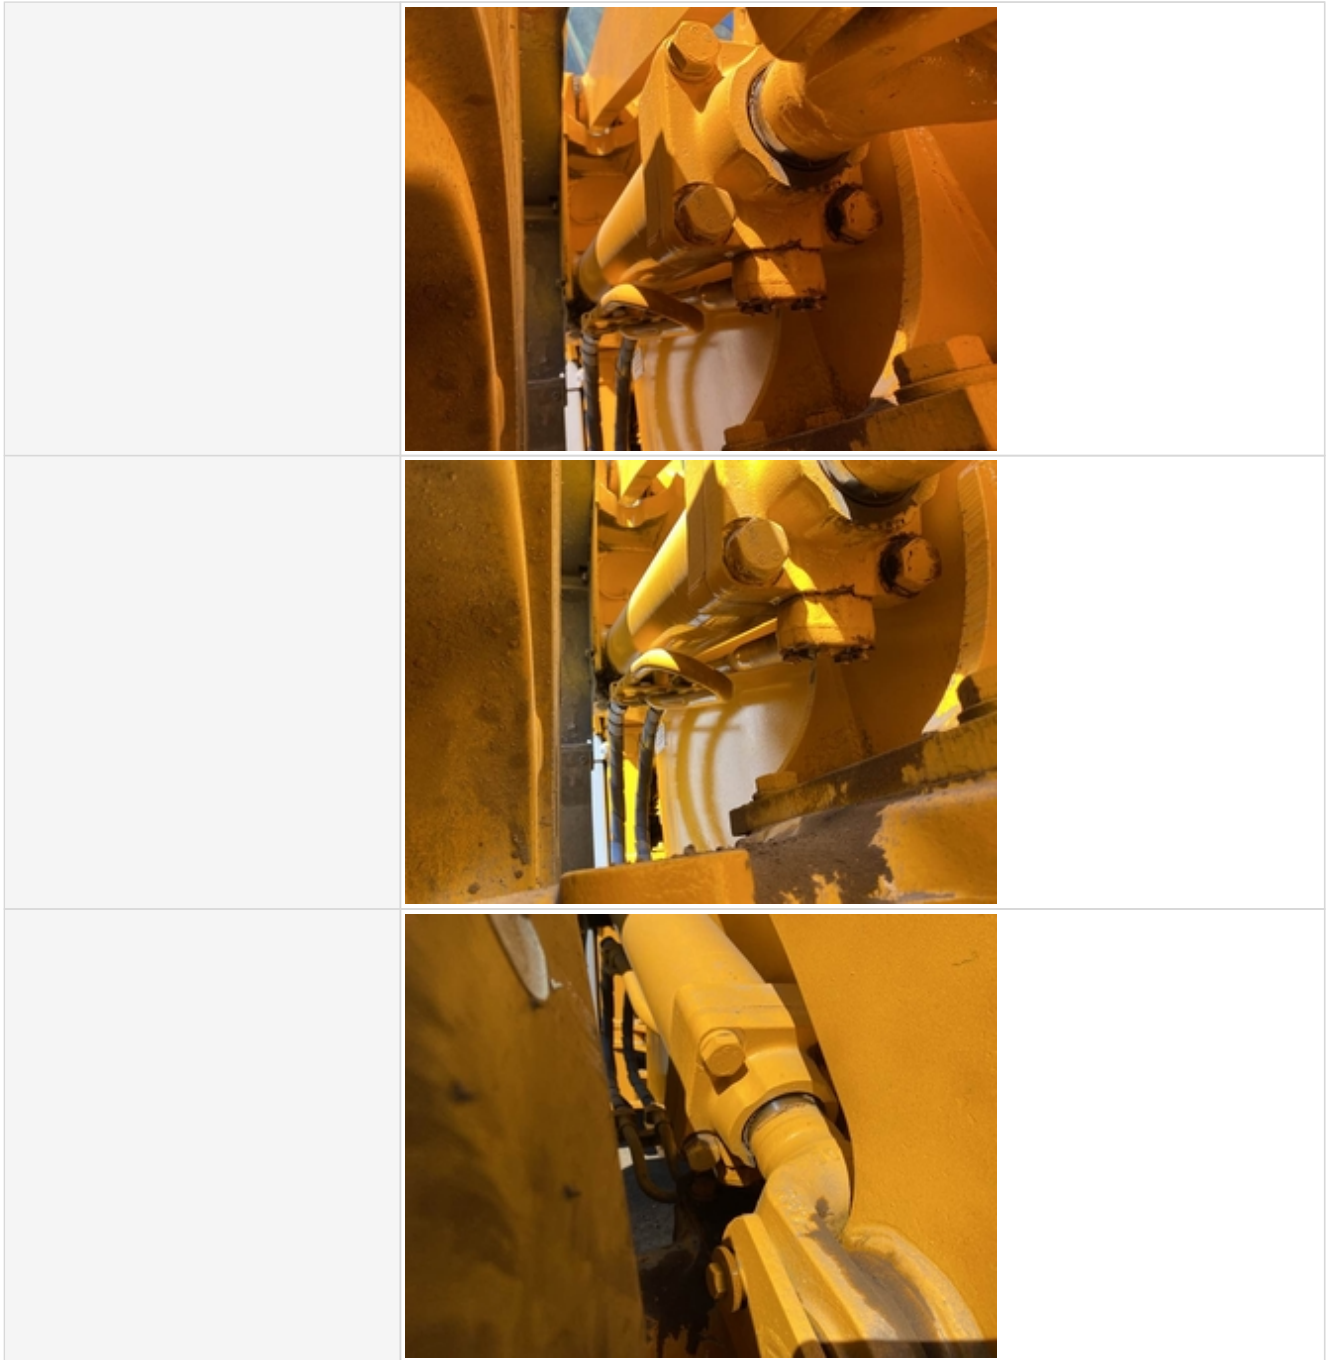
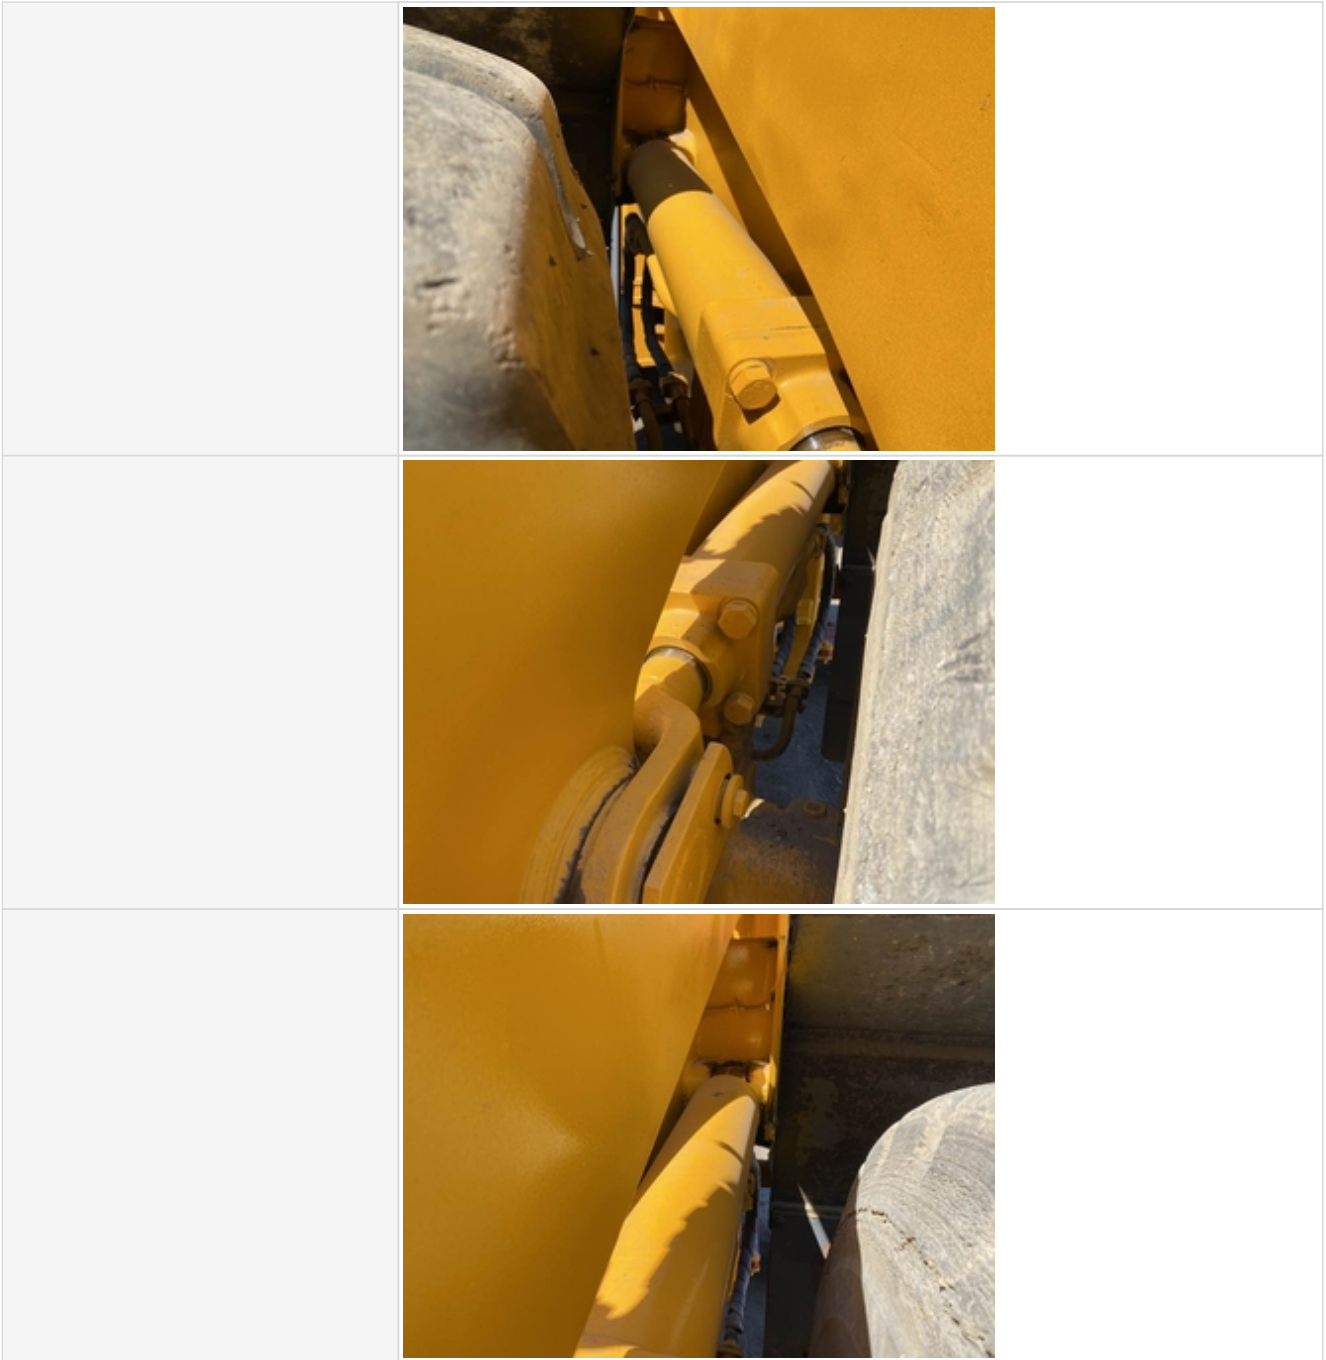
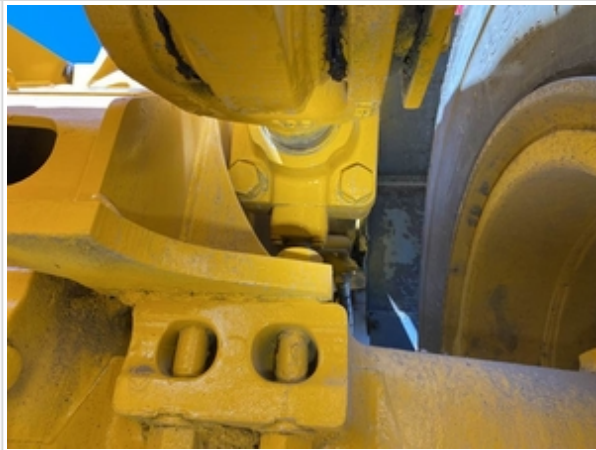
Lift Cylinder	Check the lift cylinder. Note any wear, pitting, discoloration, etc. Take photos.
Lift Cylinder: Mounting Pin	3
Lift Cylinder: Oil Leaks	Yes
Comments	Right side cylinder leak at hard line oring
Lift Cylinder Photos

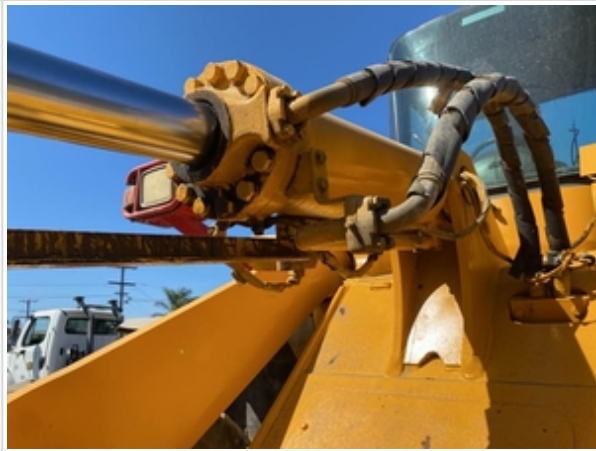
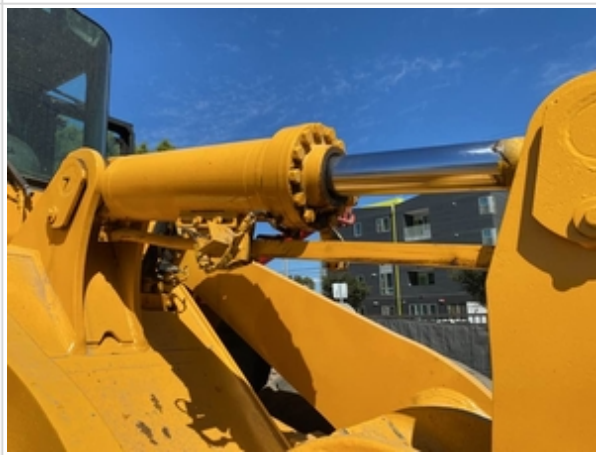
Bucket Cylinder	Check the bucket cylinder. Note any wear, pitting, discoloration, etc. Take photos.	
Bucket Cylinder: Mounting Pin	3	
Bucket Cylinder: Oil Leaks	Yes	
Comments	Oil at rod seal	
Bucket Cylinder Photos

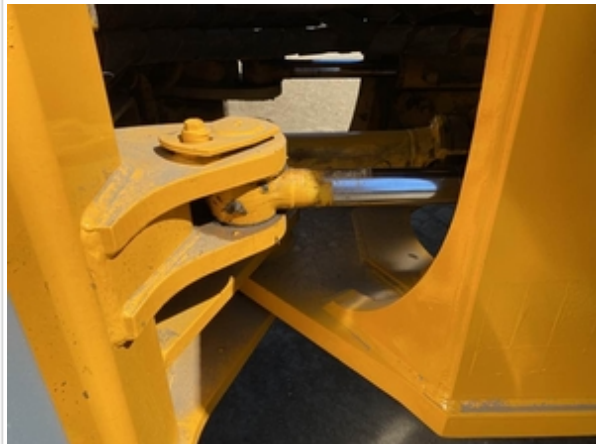
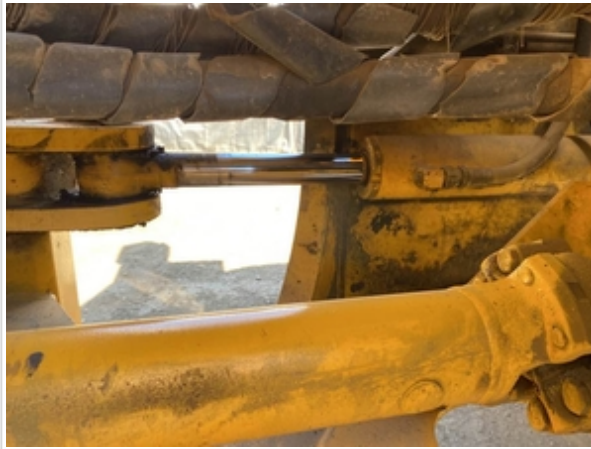
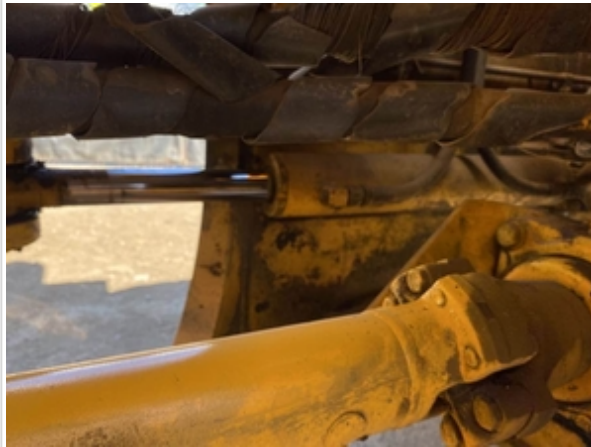
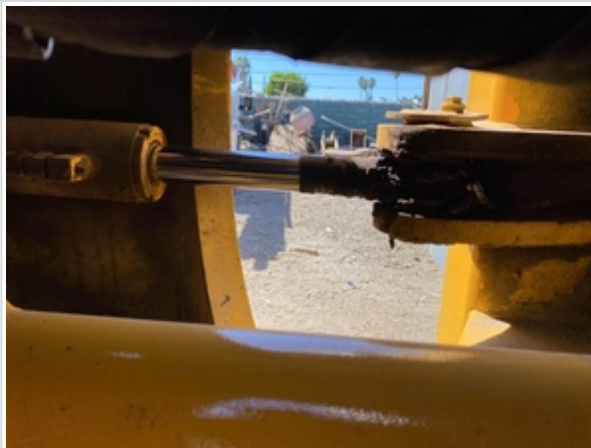
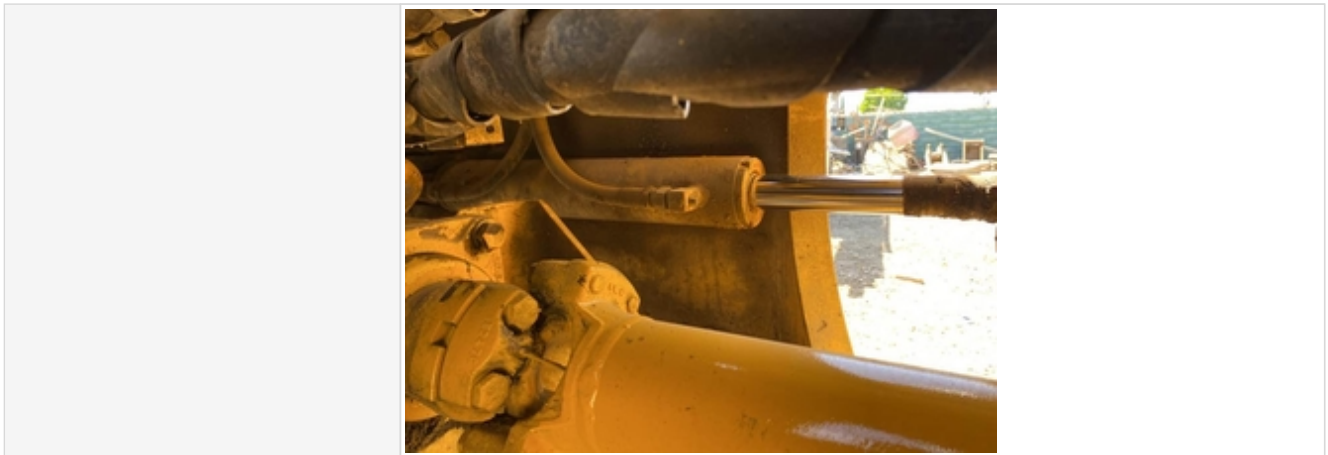
Steering Cylinder	Check the steering cylinder. Note any wear, pitting, discoloration, etc. Take photos.	
Steering Cylinder: Mounting Pin	3	
Steering Cylinder: Oil Leaks	No	
Steering Cylinder Photos

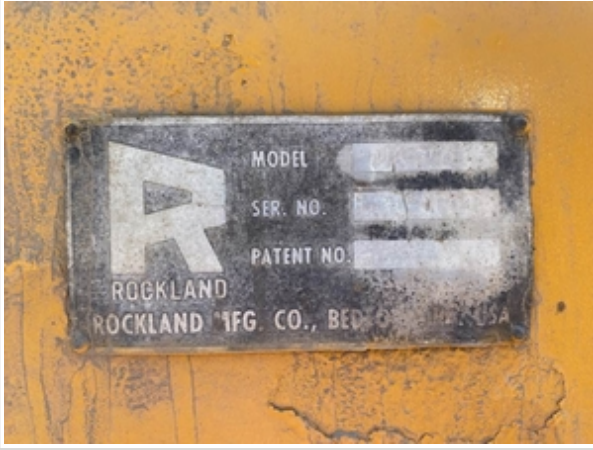
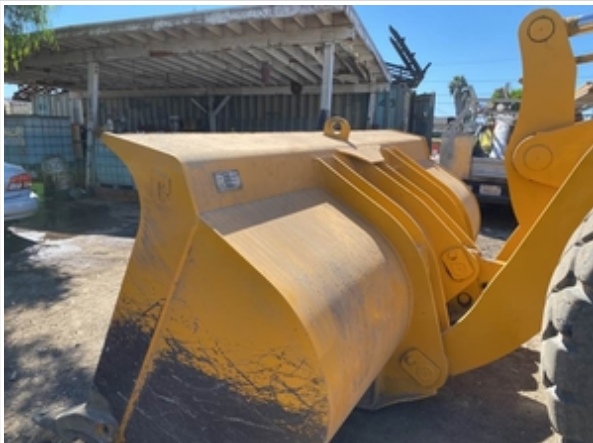
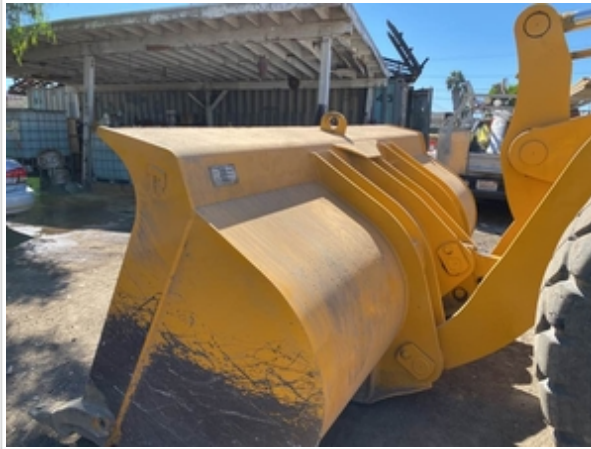
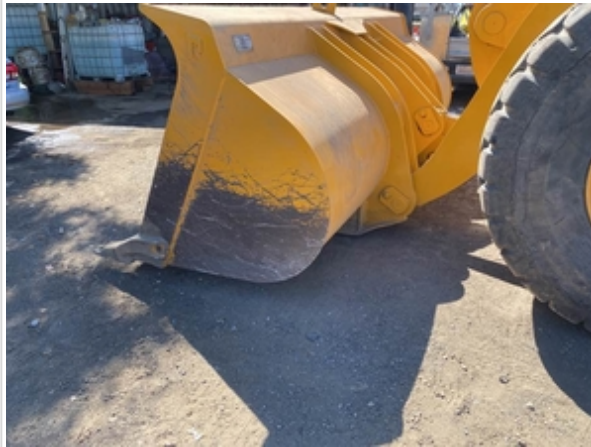
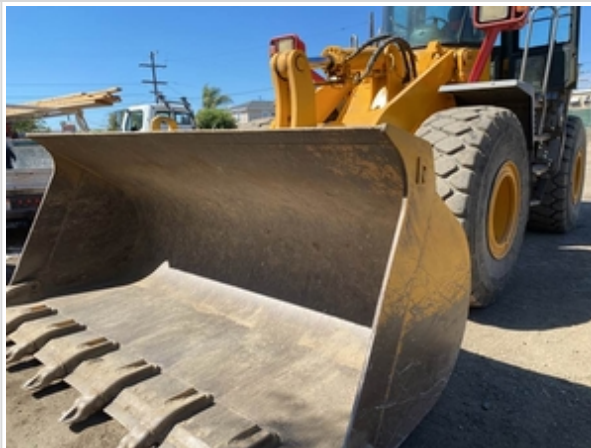
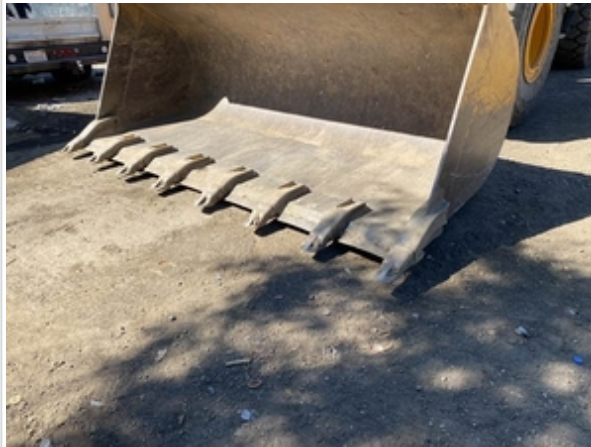
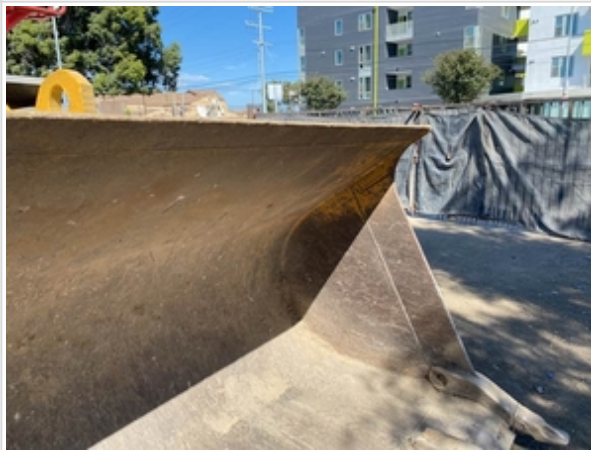
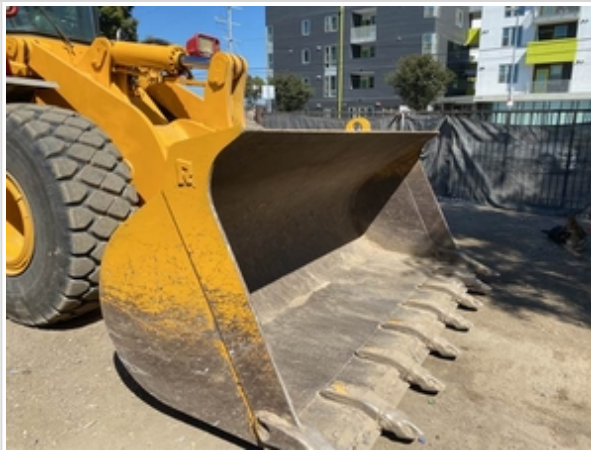
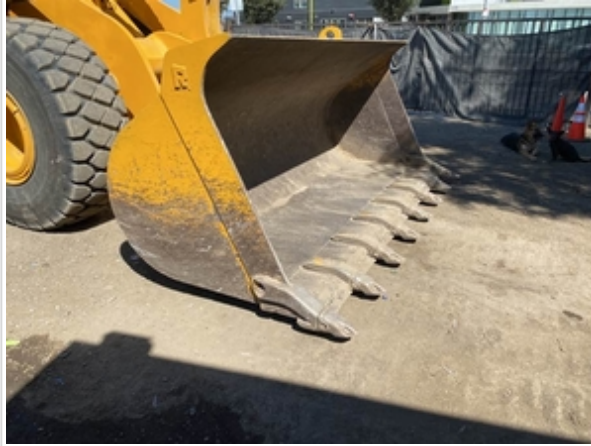
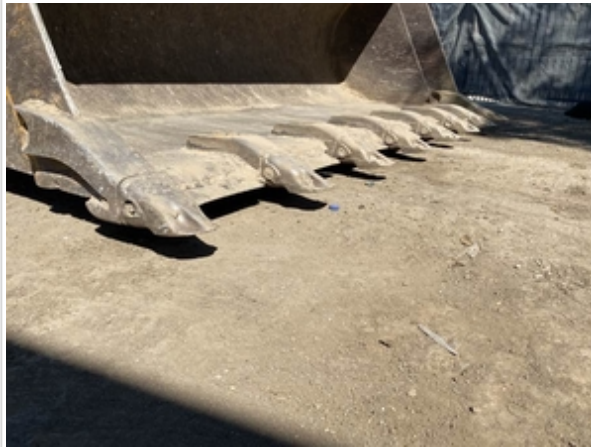
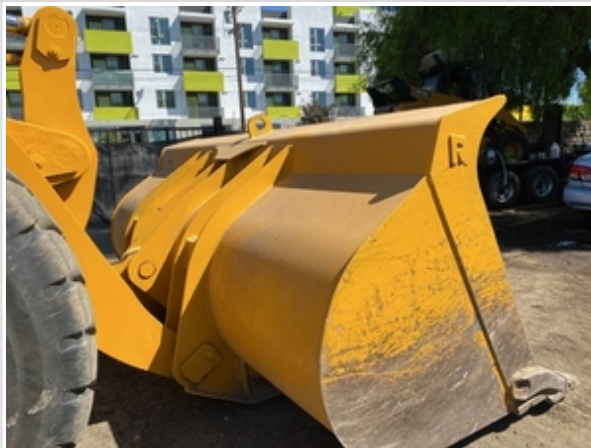
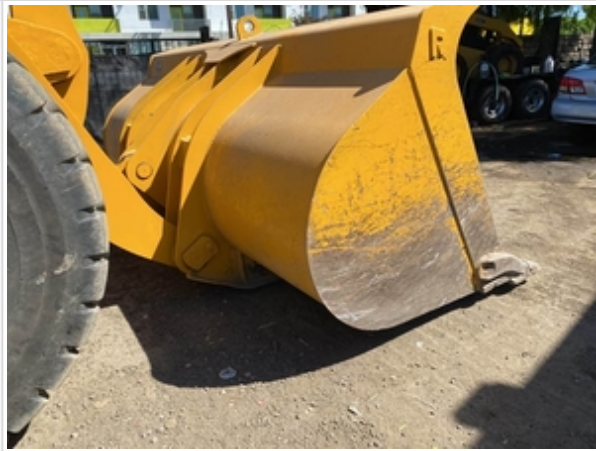
Instructions	<p>Evaluate the following on a 4 point scale (leave comments where an explanation is appropriate):</p> <p>4 = Like New, Recently Replaced 3 = Normal Wear & Tear 2 = Above Average Wear 1 = Service Required</p>
Bucket	3 - Normal Wear & Tear
Comments	11' wide
Bucket Photos

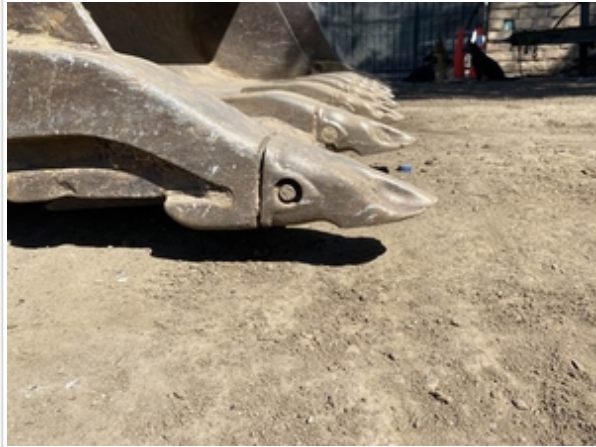
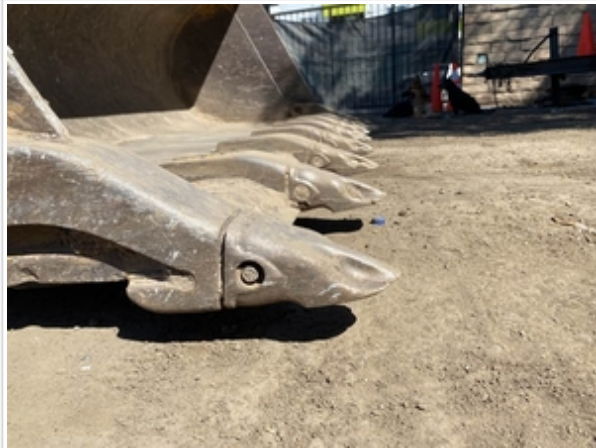
<p>Bucket Edge/Shanks/Teeth</p>	<p>2 - Above Average Wear</p>
<p>Comments</p>	<p>Worn need to be replaced soon</p>
<p>Bucket Edge/Shanks/Teeth Photos</p>
