## Inspection Report (Generator)

Year	2016
Make	Baldor
Model	TS80T
Serial Number	P0404290005
Hour Meter Reading	5,385
Previous Application (e.g., earth moving, mining, demolition, etc)	General Construction

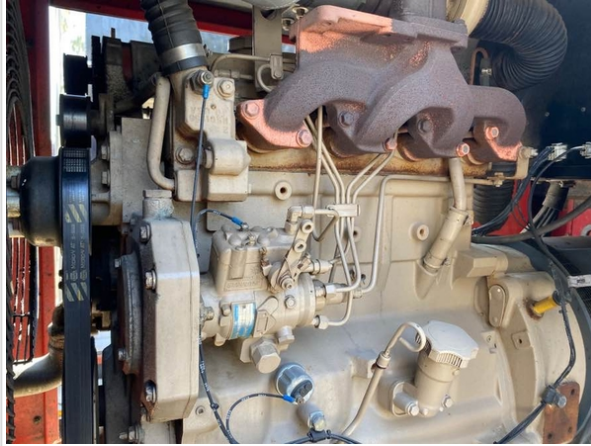
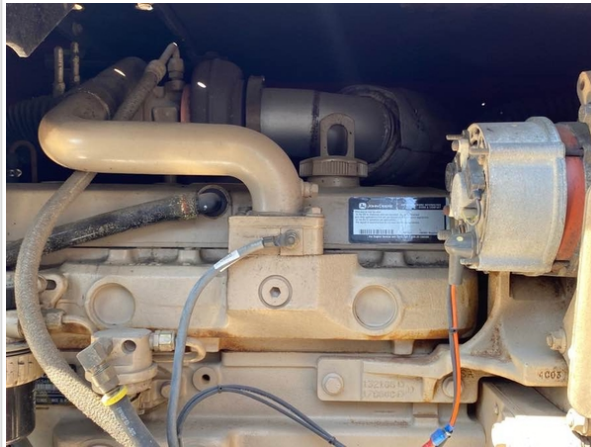
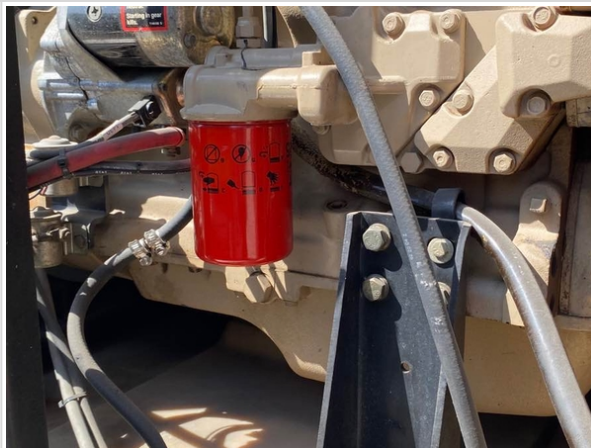
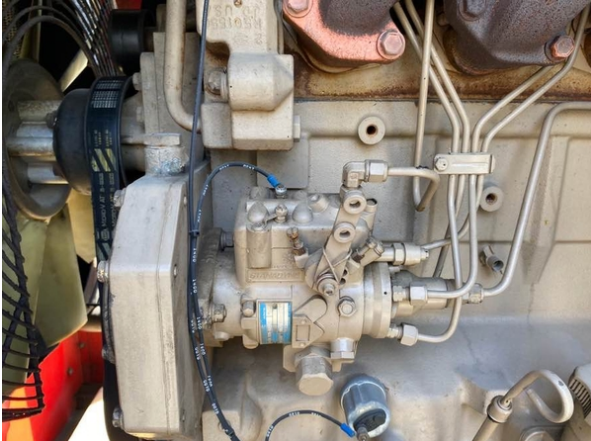
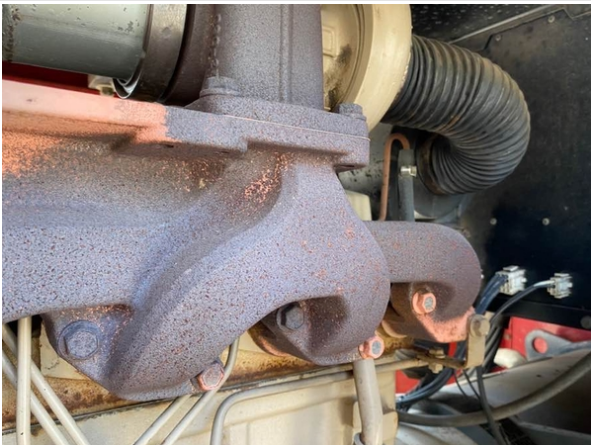
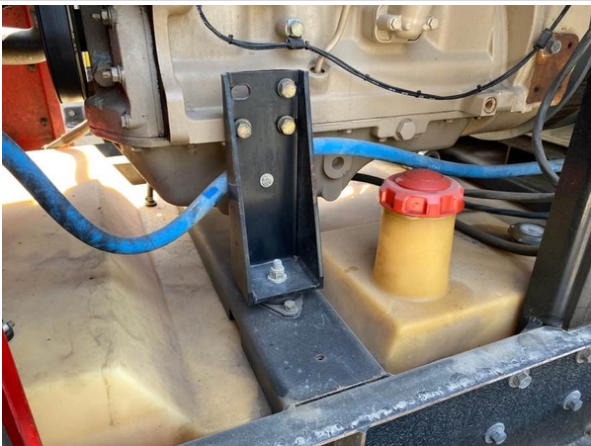
Engine Photos

<b>Hoses</b>	3 - Normal Wear & Tear
<b>Hose Condition</b>	Firm, pliant hoses with no signs of wear or leaks
<b>Water Pump</b>	3 - Normal Wear & Tear
<b>Water Pump Condition</b>	No unusual pump noises heard
<b>Cooling System Leaks</b>	No
<b>Coolant Color / Appearance</b>	3 - Normal Wear & Tear
<b>Coolant Color/Appearance Notes</b>	Normal Translucent appearance, no visual signs of contamination
<b>Fuel Leaks</b>	No
<b>Equipped with DPF (Diesel Particulate Filter)</b>	No
<b>Requires DEF (Diesel Exhaust Fluid)</b>	No
<b>Overall Engine Appearance</b>	Clean & dry
<b>Overall Engine Comments</b>	Overall engine in great condition and sounds healthy. No major obvious repairs needed.

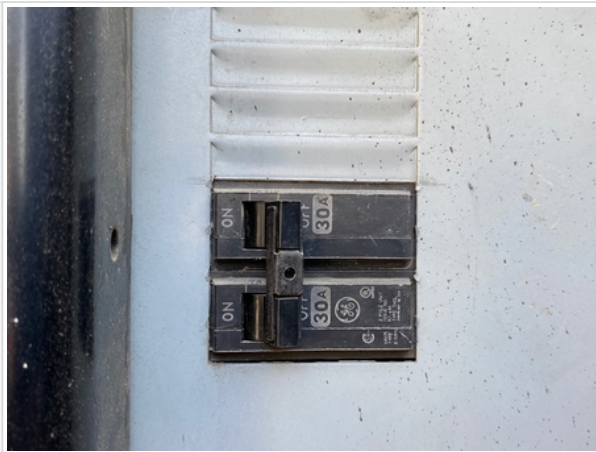
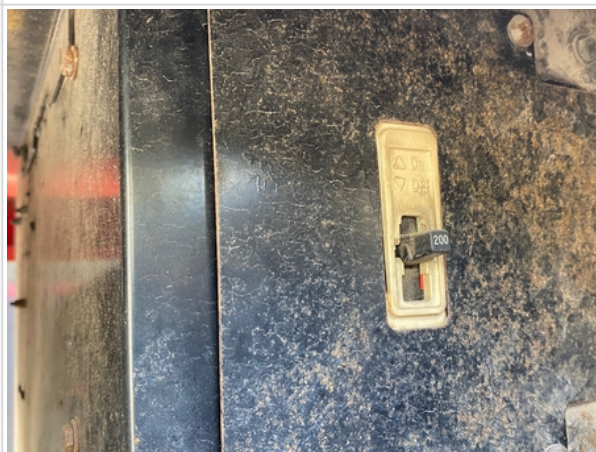
<b>Controls &amp; Switches Photos</b>

<b>Wire Harness</b>	3 - Normal Wear & Tear
<b>Cables &amp; Fittings</b>	3 - Normal Wear & Tear
<b>Electrical Connections</b>	3 - Normal Wear & Tear
<b>Controls &amp; Switches</b>	3 - Normal Wear & Tear

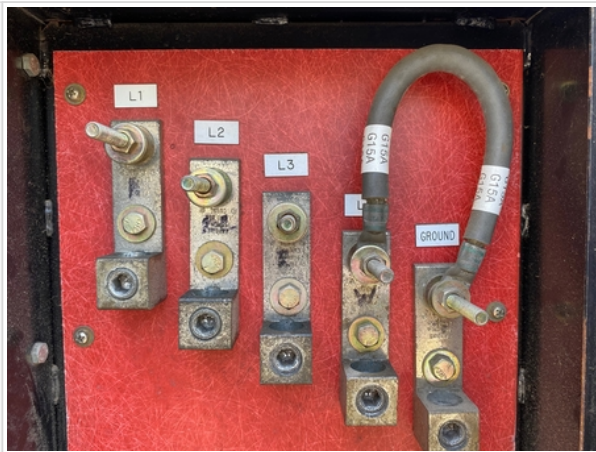
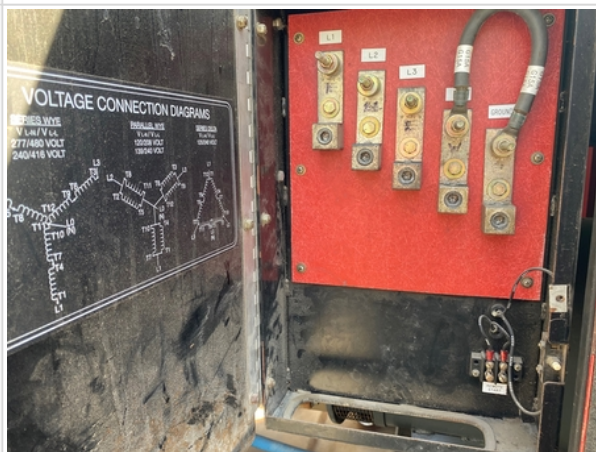
480V Outlet Photos

<b>110V</b>	Yes
<b>110V Outlet Condition</b>	3 - Normal Wear & Tear
<b>240V</b>	Yes
<b>240V Outlet Condition</b>	3 - Normal Wear & Tear
<b>480V</b>	Yes
<b>480V Outlet Condition</b>	3 - Normal Wear & Tear

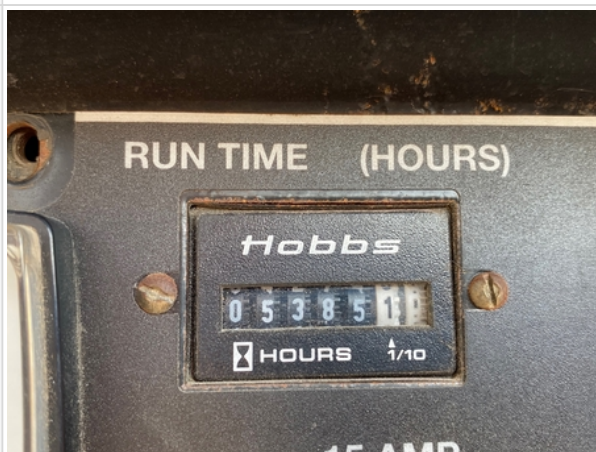
Hour Meter	3 - Normal Wear & Tear
Hour Meter Photos

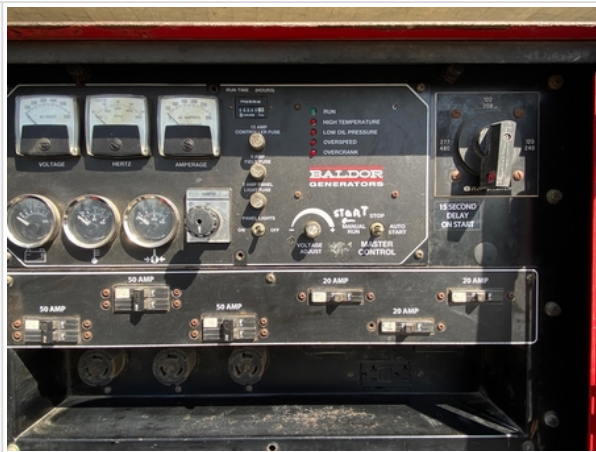
Volt Display Photos

RPM Display	0
Volt Display	3 - Normal Wear & Tear

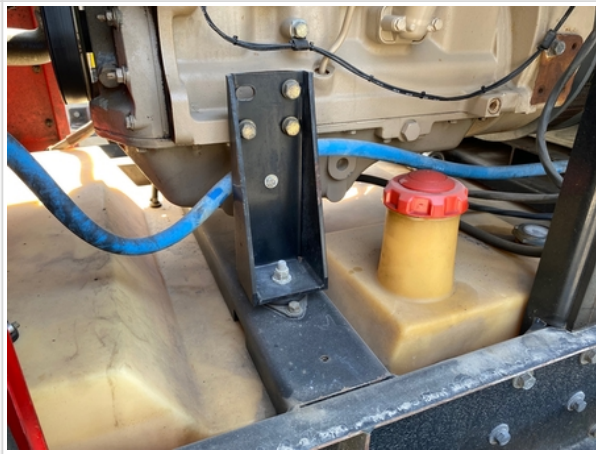
Pressure Display	3 - Normal Wear & Tear
Menu Display	0
Display Screen Appearance	0
<h3>Mounting Plate</h3>	
Overall Mounting Plate Appearance	3 - Normal Wear & Tear
Mounting Plate Photos

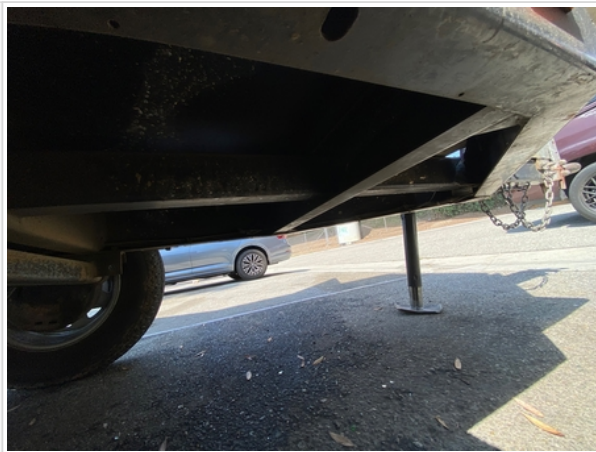
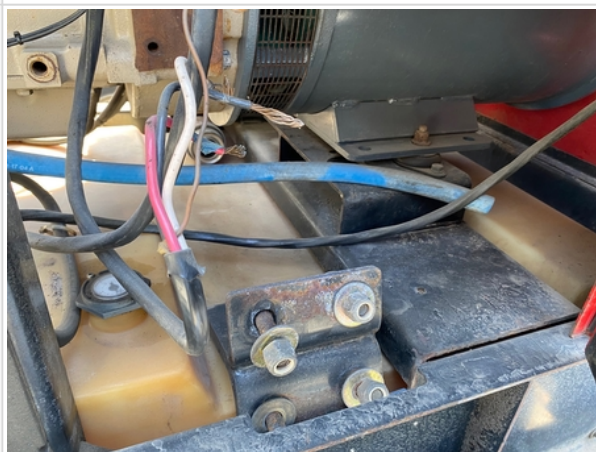
Bottom Surface Photos

Bottom Surface	3 - Normal Wear & Tear

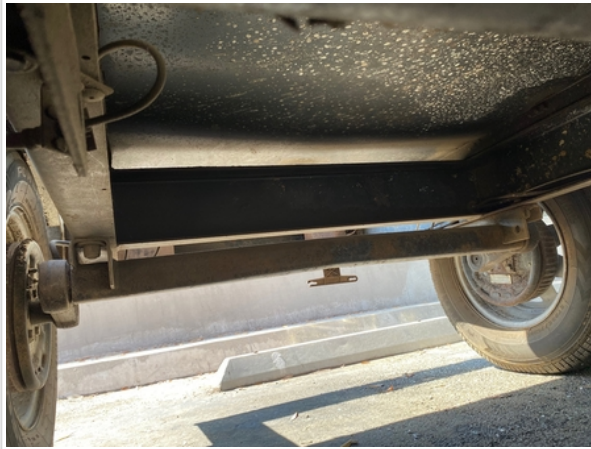
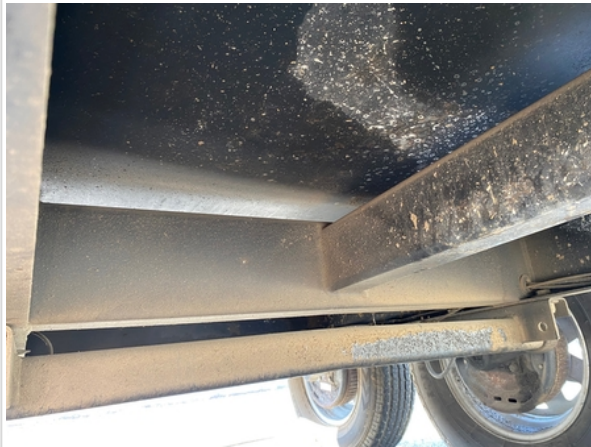
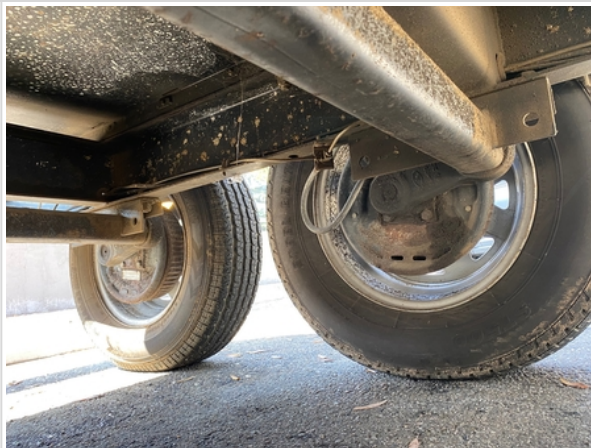
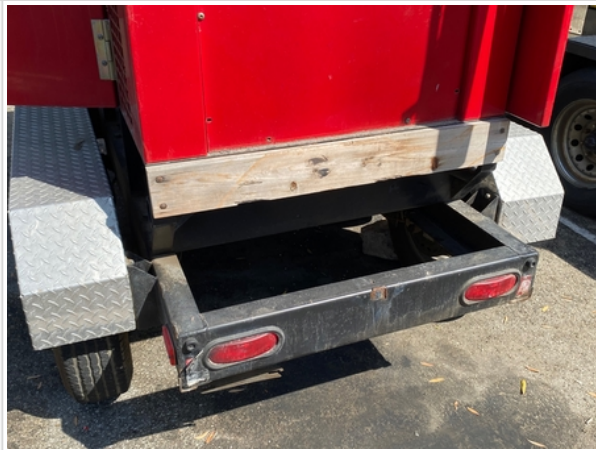
Frame Condition	3 - Normal Wear & Tear
Frame Photos

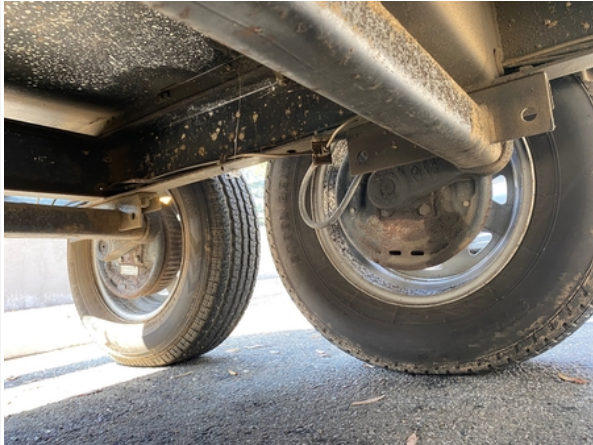
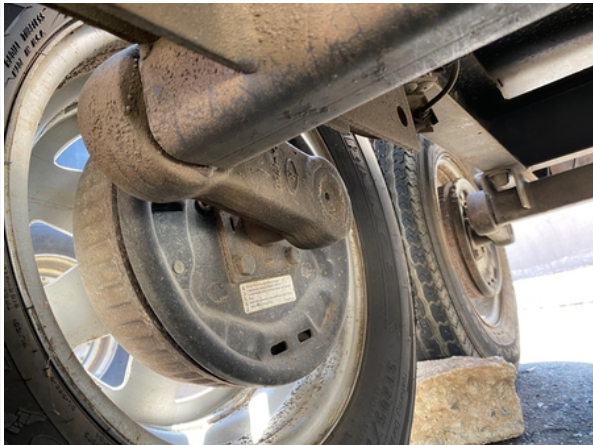
Springs	0	
U-Bolts	0	
Torque Arms	3	
Torque Arms Photos

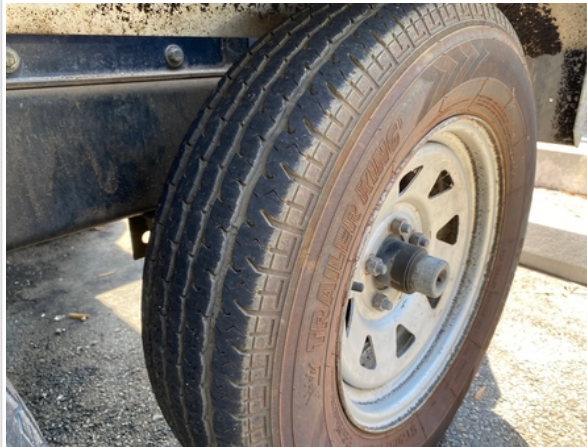
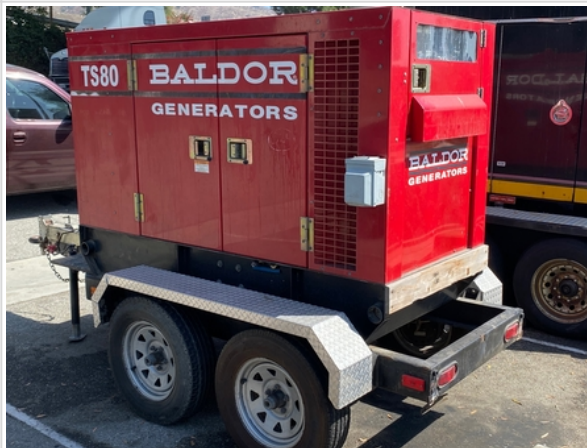
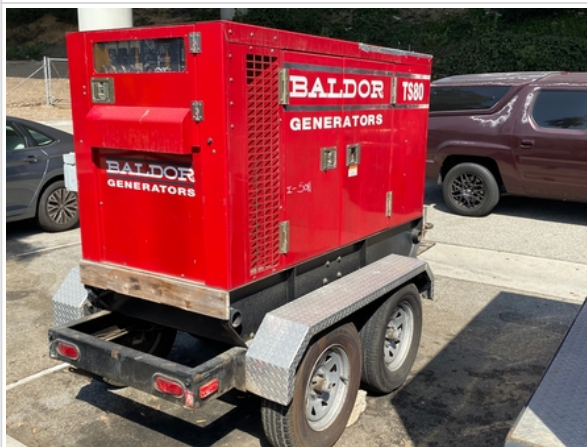
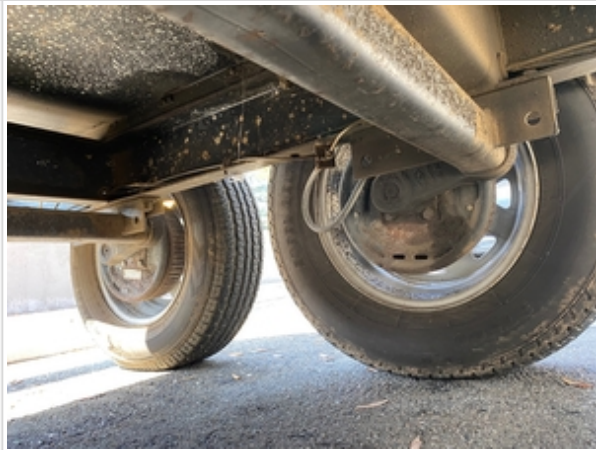
Wheels & Hub Condition	3 - Normal Wear & Tear	
Wheels & Hub Photos

Tire Brand	Primewell	
Tire Size	ST205/75r15	
Front Left Tire - Ratio Remaining	50%	
Front Right Tire - Ratio Remaining	50%	
Rear Right Tire - Ratio Remaining	50%	
Rear Left Tire - Ratio Remaining	50%

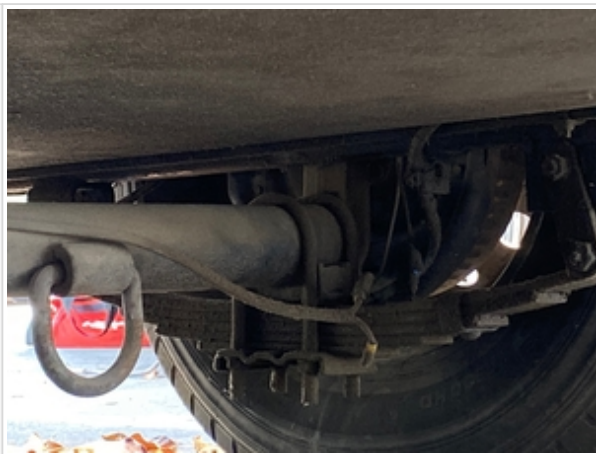
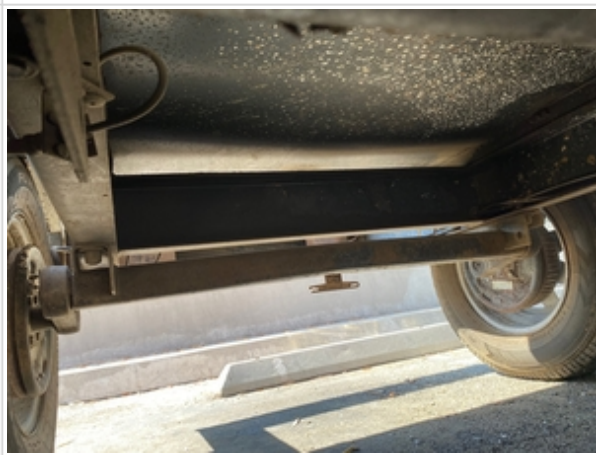
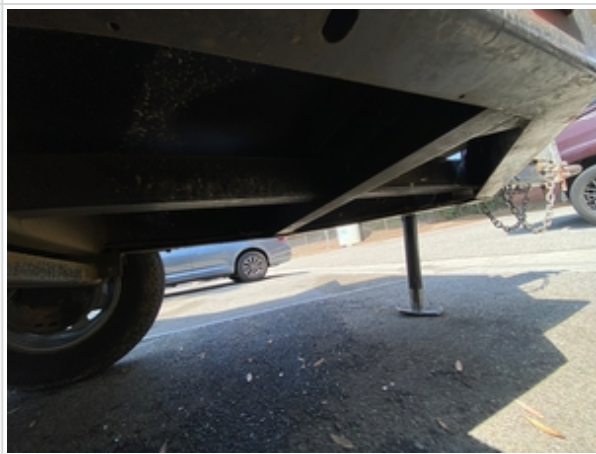
Overall Trailer	3 - Normal Wear & Tear	
Overall Trailer Comments	Overall trailers frame okay, Pintle ring and chains okay, brakes inoperable and unable to test lighting.	
Overall Trailer & Undercarriage Photos

<b>What Needs Work</b>	Trailer brake system needs to be repaired. No oil in reservoir and lighting system should be tested.
<b>Date/Time</b>	10-07-2022
