## Inspection Report (Excavator)

Year	2007
Make	CAT
Model	345CL
Serial Number	PJW02097
Hour Meter Reading	8,890 + 3,390 = 12,280
Previous Application (e.g., earth moving, mining, demolition, etc)	General Construction

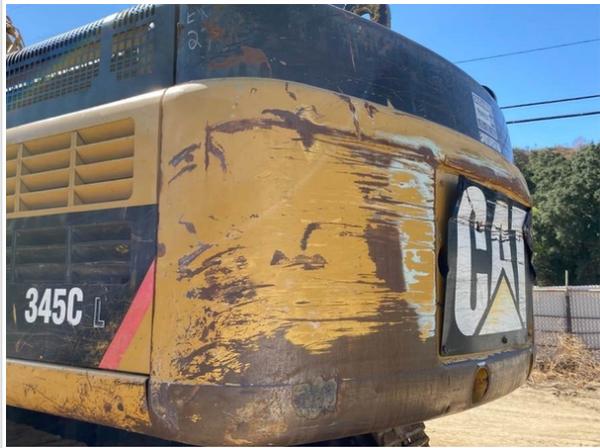
<b>Left</b>	3 - Normal Wear & Tear	
<b>Left Condition</b>	No visible damage	
<b>Left Photos</b>

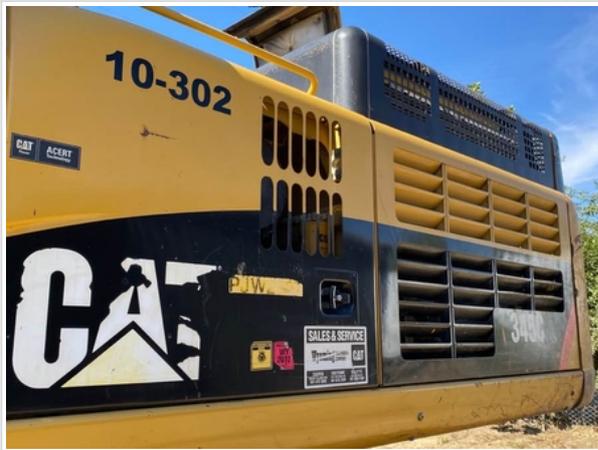
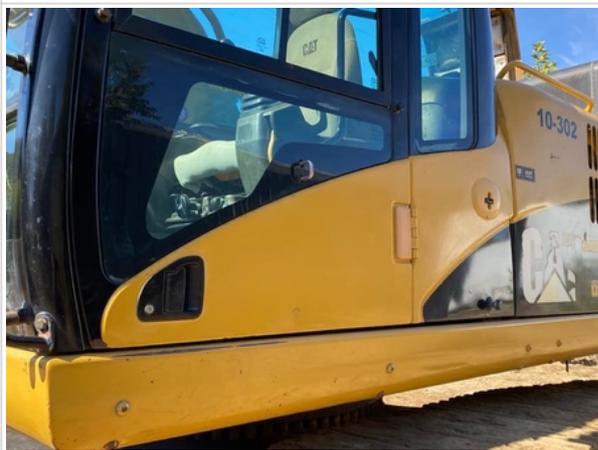
<p>Right</p>	<p>3 - Normal Wear &amp; Tear</p>	
<p>Right Condition</p>	<p>No visible damage</p>	
<p>Right Photos</p>

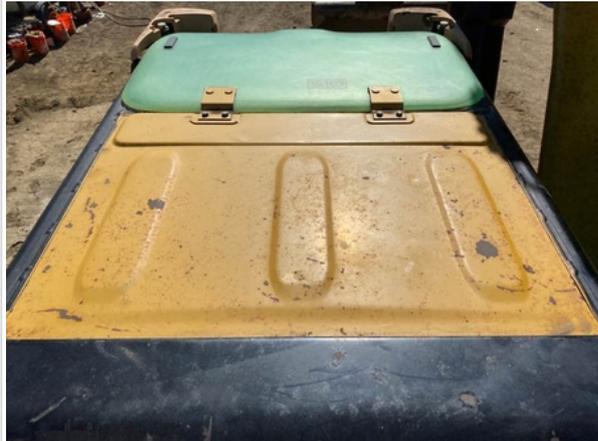
Upper	3 - Normal Wear & Tear	
Upper Condition	No visible damage	
Upper Photos

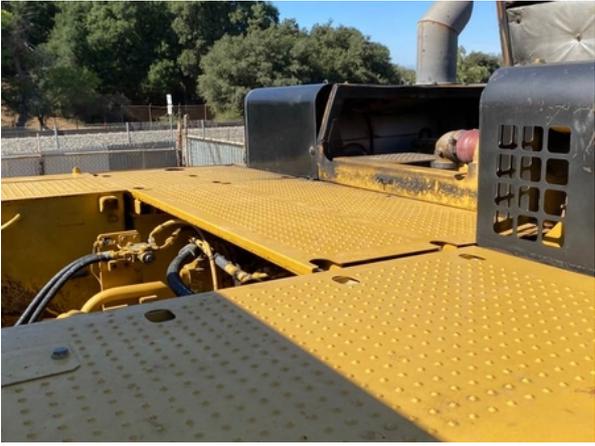
<b>Body Panels (Any Rust Damage?)</b>	3 - Normal Wear & Tear
<b>Body Panel Condition</b>	No visible damage, good paint condition and panel fitment
<b>Body Panels Photos</b>

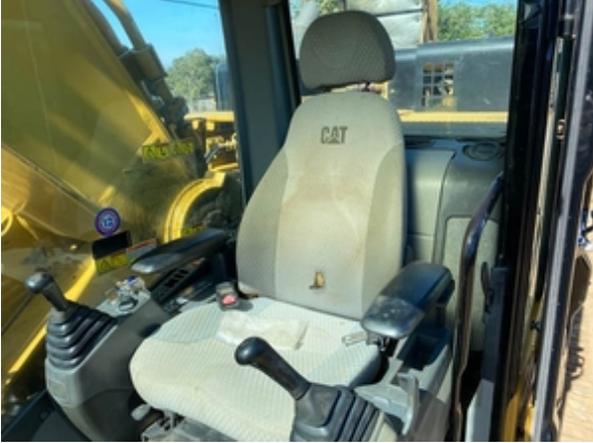
<p>Operator's Seat &amp; Arm Rests Photos</p>

<b>Operator's Seat &amp; Arm Rests</b>	3 - Normal Wear & Tear
<b>Operator's Seat &amp; Arm Rests Condition</b>	Seat(s) in good condition, no stains or tears in upholstery

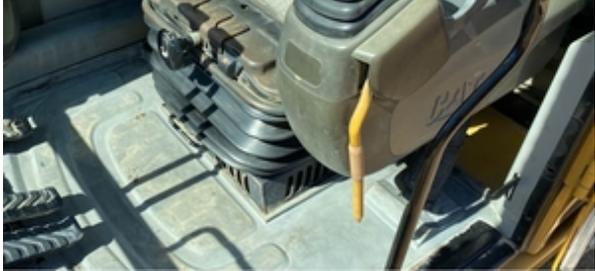
<p>Safety Lock Out / Stop Photos</p>

<p>Cabin Lights</p>	<p>3 - Normal Wear &amp; Tear</p>
<p>Cabin Lights Condition</p>	<p>Cabin lights are installed with all light covers in place, bulbs are installed and working properly</p>
<p>Safety Lock Out / Stop</p>	<p>3 - Normal Wear &amp; Tear</p>
<p>Safety Lock Out / Stop Condition</p>	<p>Safety lock out device is present, in good condition, and functional</p>

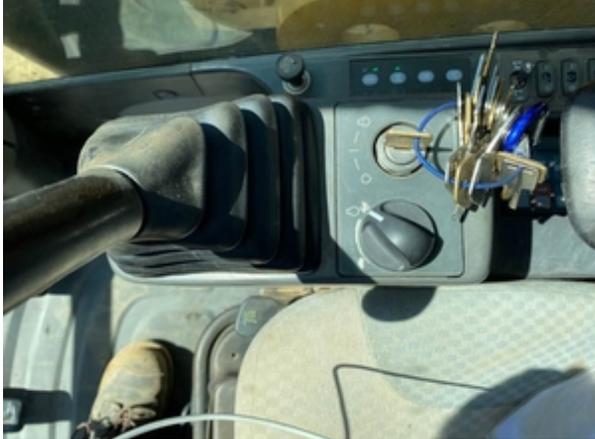
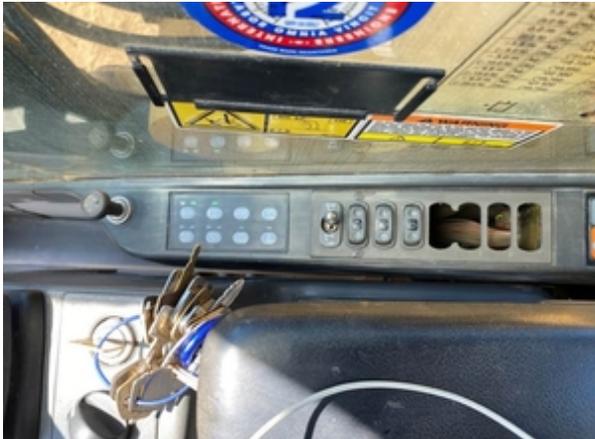
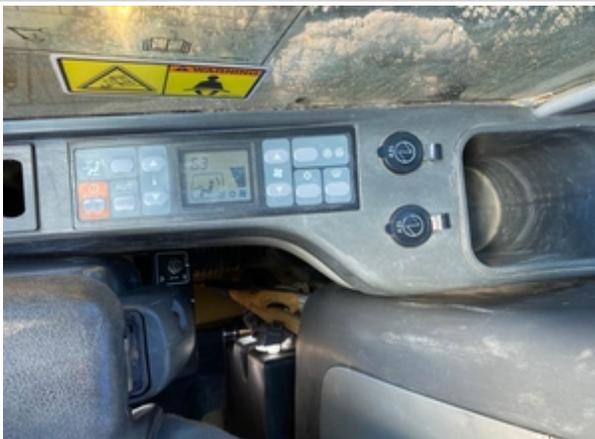
<p>Controls &amp; Switches</p>	<p>3 - Normal Wear &amp; Tear</p>
<p>Controls &amp; Switches Condition</p>	<p>All switches are installed and functional</p>
<p>Controls &amp; Switches Photos</p>

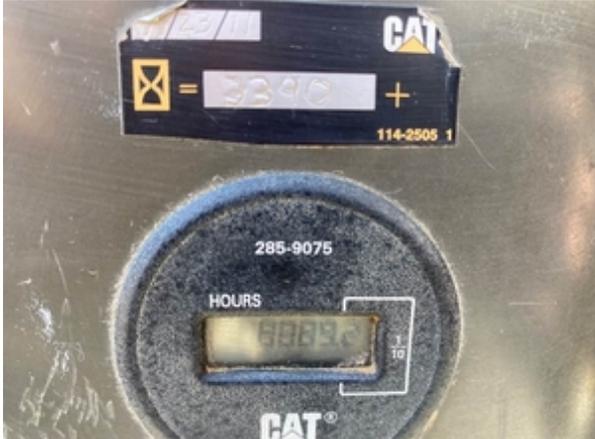
<b>Hour Meter Activity</b>	3 - Normal Wear & Tear
<b>Hour Meter Condition</b>	Hour meter is functional and in good condition, Hour meter is functional, with some minor wear and/or cosmetic damage, Other (see comments)
<b>Comments</b>	3,390 needs to be added to hour meter (hour meter was replaced )
<b>Hour Meter Activity Photos</b>

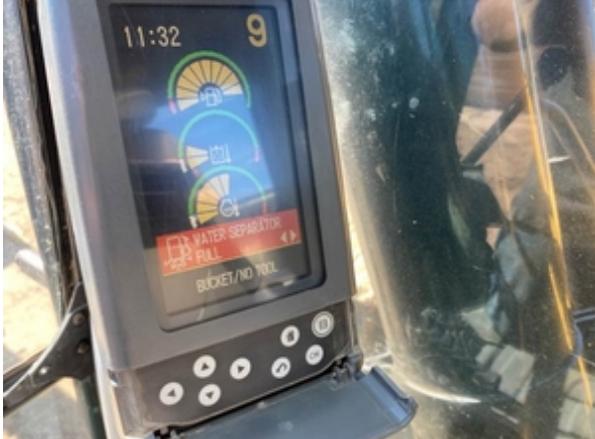
Other Gauge Activity Photos

<b>Other Gauge Activity</b>	3 - Normal Wear & Tear
<b>Other Gauge Condition</b>	All cockpit gauges are functional and in good condition

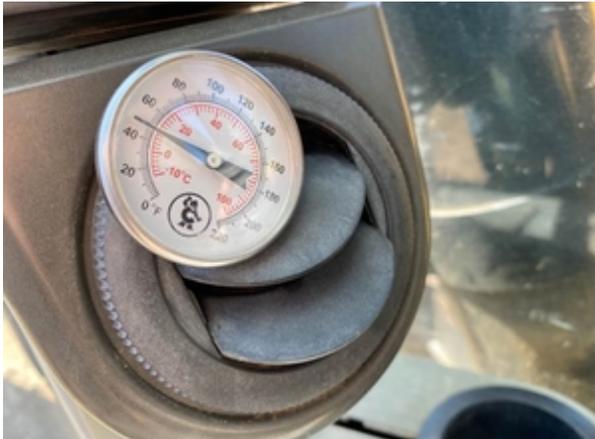
Heater & A/C	3 - Normal Wear & Tear
Heater & A/C Condition	Heater and A/C work and transition through full temperature range
Heater & A/C Photos

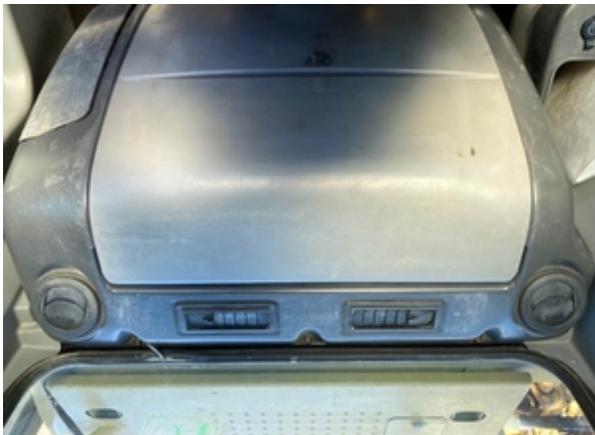
Fans / Vents	3 - Normal Wear & Tear
Fans / Vents Condition	Fan vents are functional, in good condition, and move through a full adjustable range of motion
Fans / Vents Photos

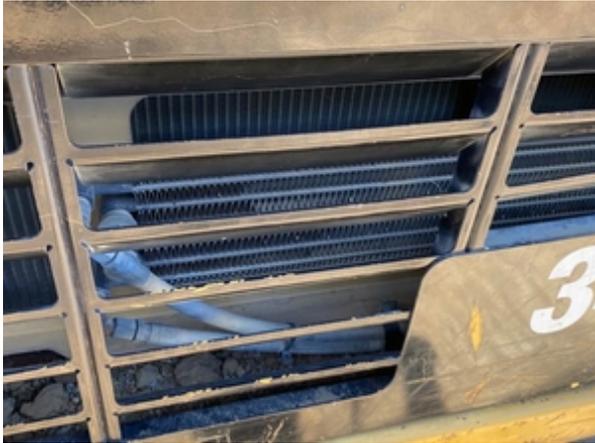
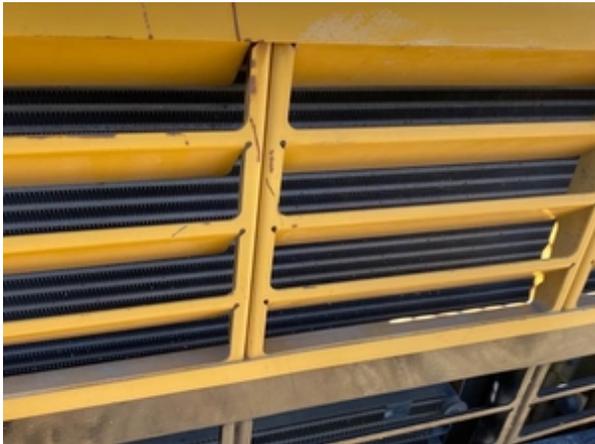
Blow-by (Visual Observation Check)	No
Unusual Noises (Upon Start-up, Idle, Shutdown)	No
Unusual Noise Notes	No unusual noises heard
Engine Smoke (Upon Start-up, Idle, Shutdown)	No
Engine Smoke Notes	No engine smoke issues observed
Engine Exhaust Color	Clear
Battery	3 - Normal Wear & Tear
Battery Condition	Clean & dry appearance, tight connections
Radiator	3 - Normal Wear & Tear
Radiator Condition	Radiator fins & components appear to be in good working order, no signs of damage or leaks
Radiator Photos

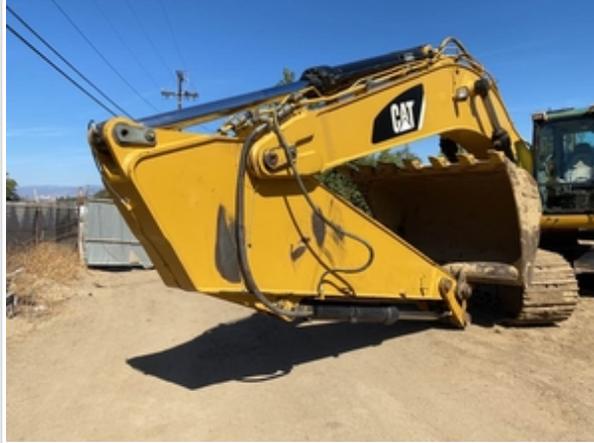
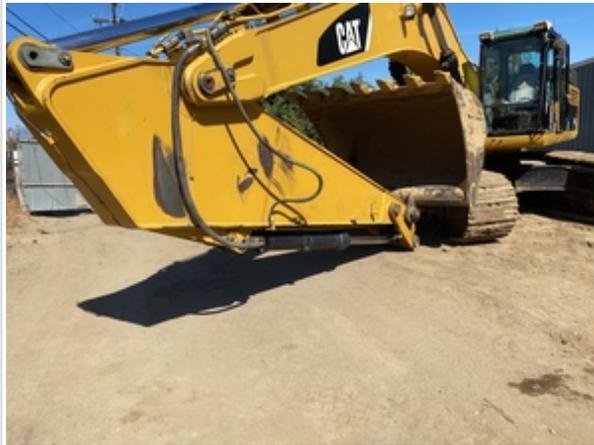
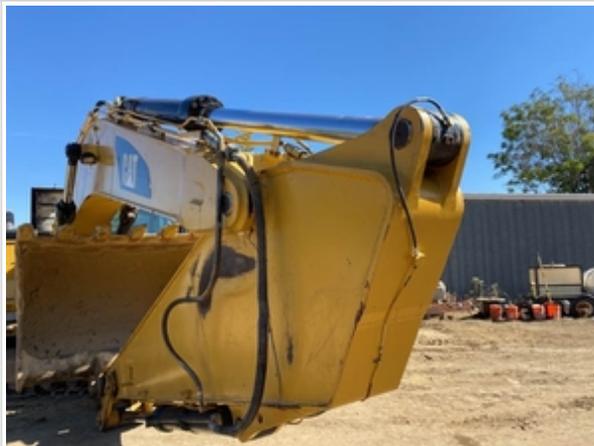
Stick Photos

<p>Stick Condition</p>	<p>3 - Normal Wear &amp; Tear</p>

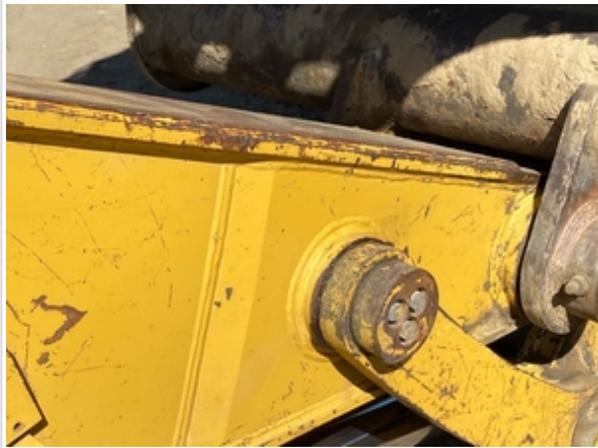
<p><b>Boom Base Pin &amp; Bushings</b></p>	<p>3 - Normal Wear &amp; Tear</p>	
<p><b>Boom Base Pin &amp; Bushings Photos</b></p>

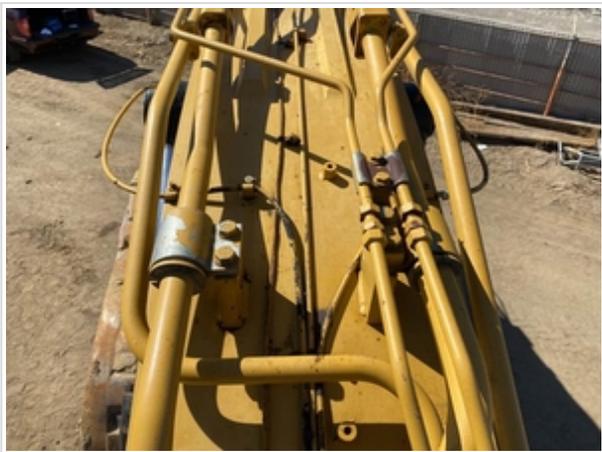
<p><b>Boom to Stick Pin &amp; Bushings</b></p>	<p>3 - Normal Wear &amp; Tear</p>	
<p><b>Boom to Stick Pin &amp; Bushings Photos</b></p>

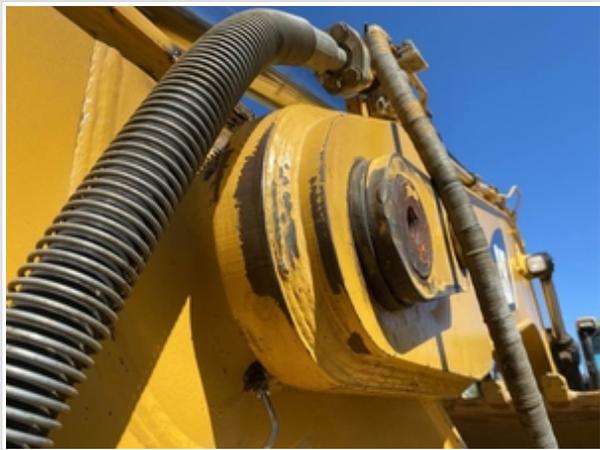
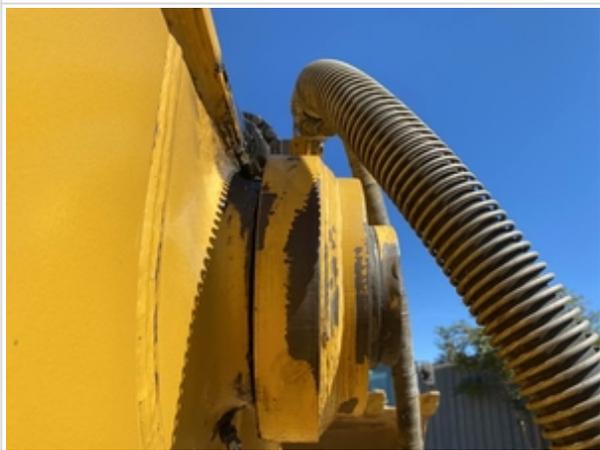
<p><b>Stick to Bucket Pin &amp; Bushings</b></p>	<p>3 - Normal Wear &amp; Tear</p>	
<p><b>Stick to Bucket Pin &amp; Bushings Photos</b></p>

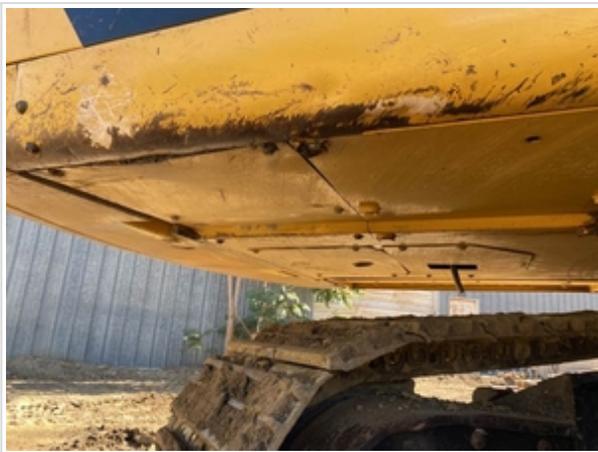
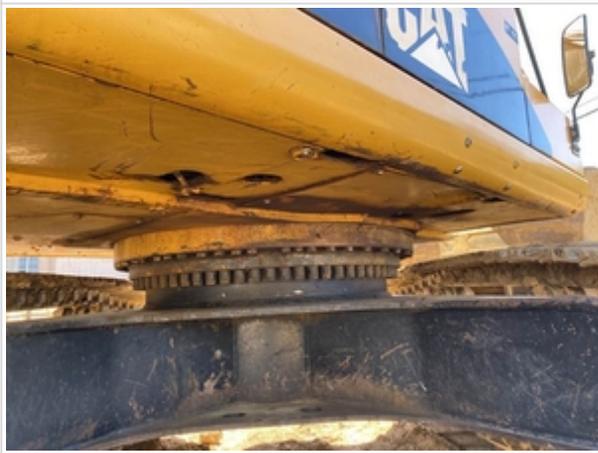
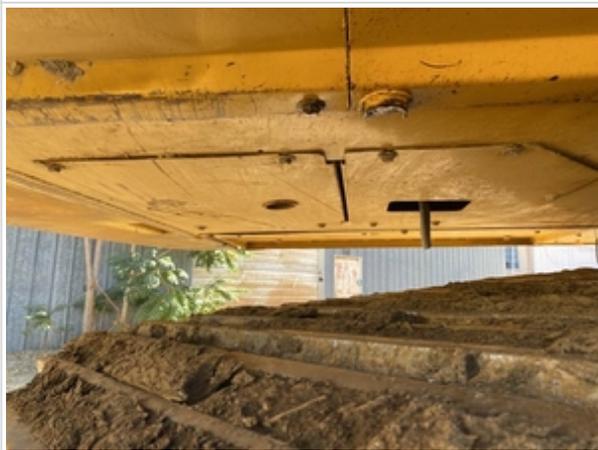
<p>Bottom Covers Photos</p>

<p>Bottom Covers</p>	<p>3 - Normal Wear &amp; Tear</p>

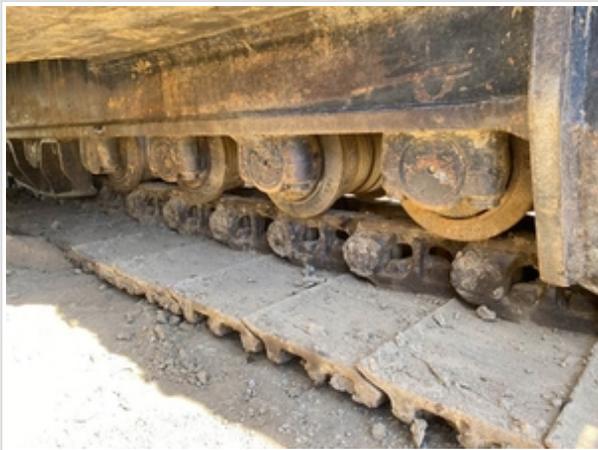
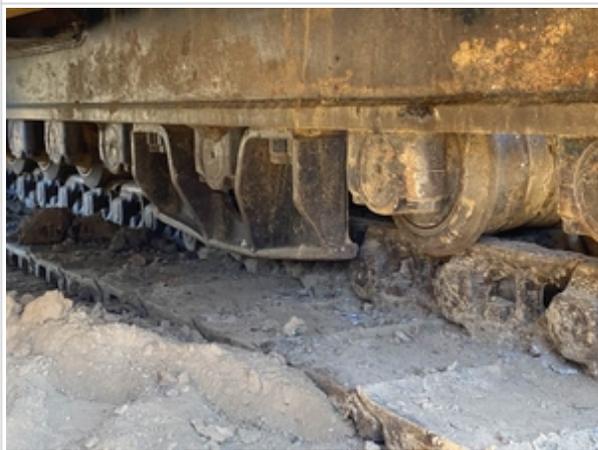
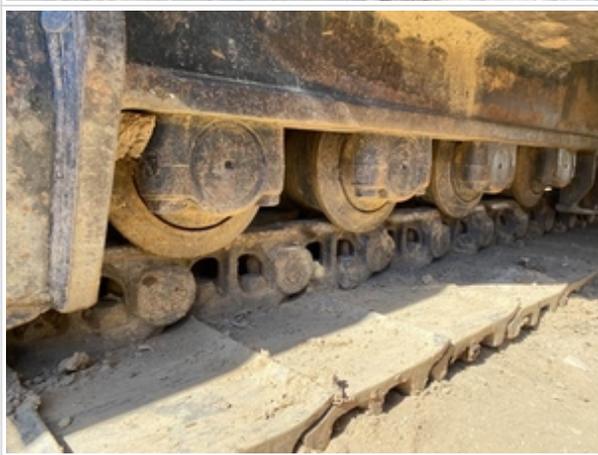
<p>Undercarriage Overall Photos</p>

<b>Undercarriage Overall Condition</b>	3 - Normal Wear & Tear
--	------------------------

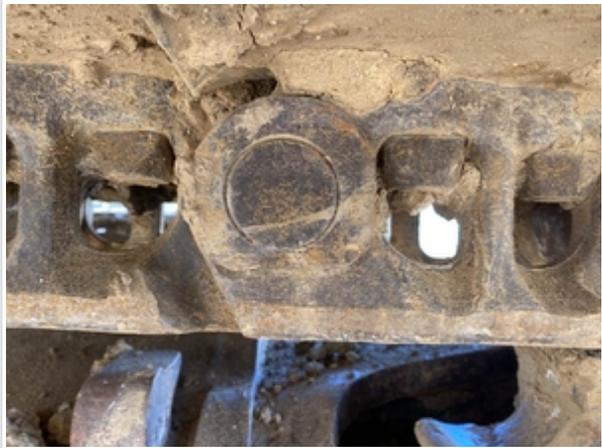
<p><b>Pin &amp; Bushings</b></p>	<p>3 - Normal Wear &amp; Tear</p>	
<p><b>Pin &amp; Bushings Photos</b></p>

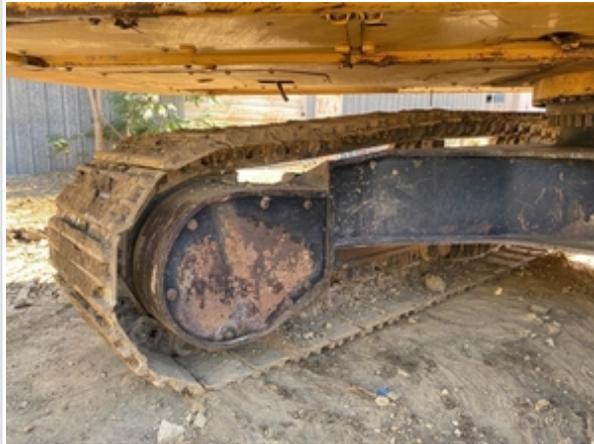
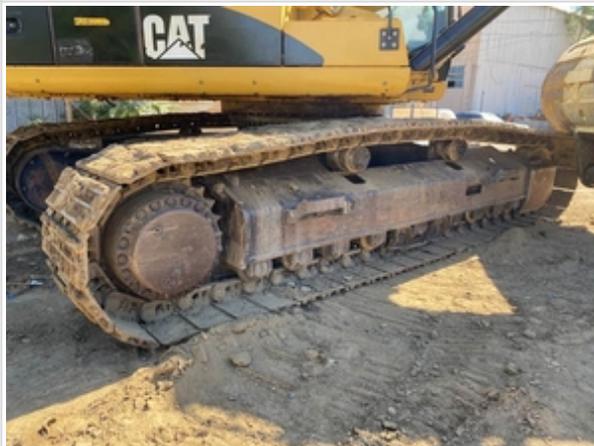
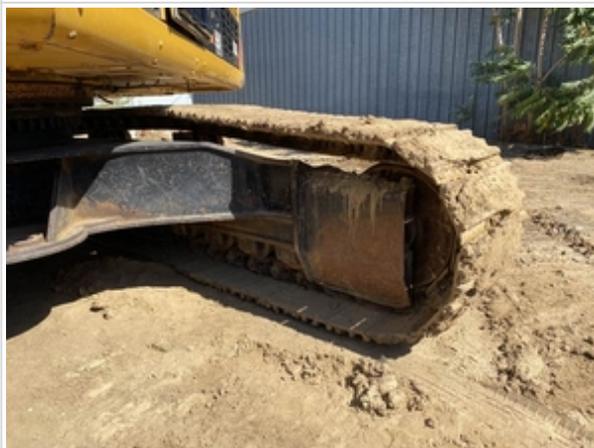
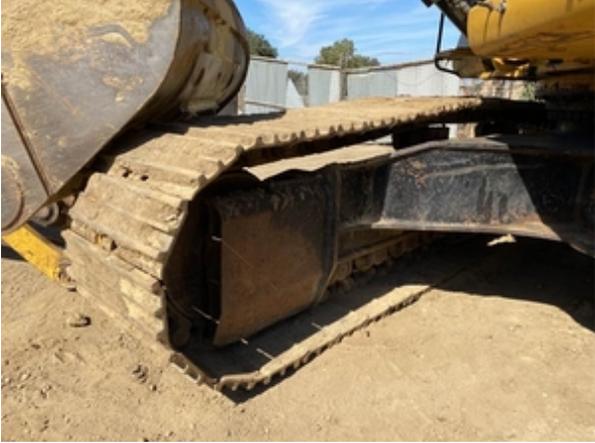
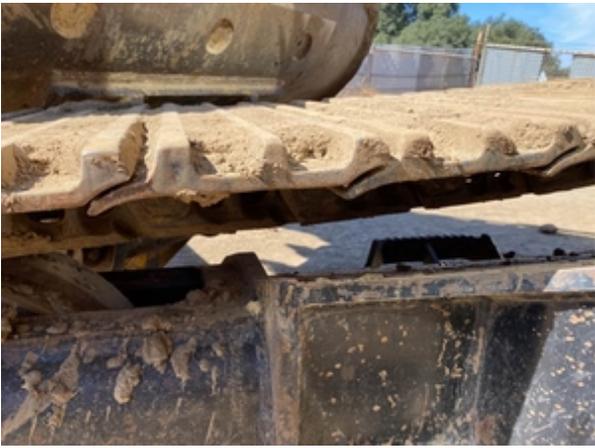
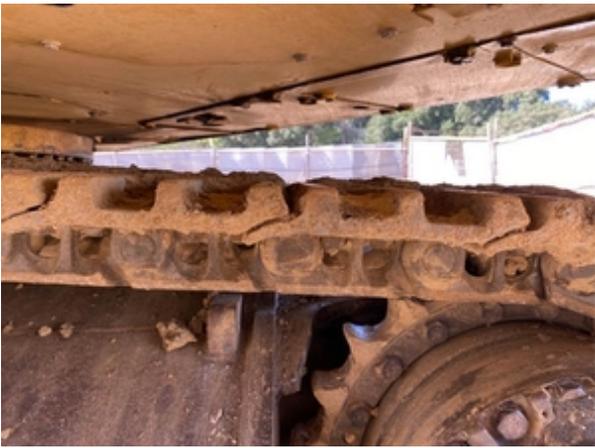
Tracks	3 - Normal Wear & Tear	
Tracks Photos

<b>Left Side: Link Bushings / Drive Sprocket / Shoe Condition</b>	3 - Normal Wear & Tear	
<b>Left Side: Upper &amp; Lower Roller / Front Idler Condition</b>	3 - Normal Wear & Tear	
<b>Track Condition: Left Front</b>	70%	
<b>Track Condition: Left Rear</b>	70%

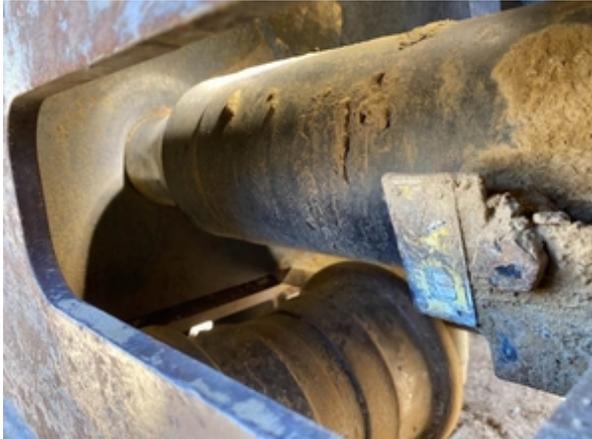
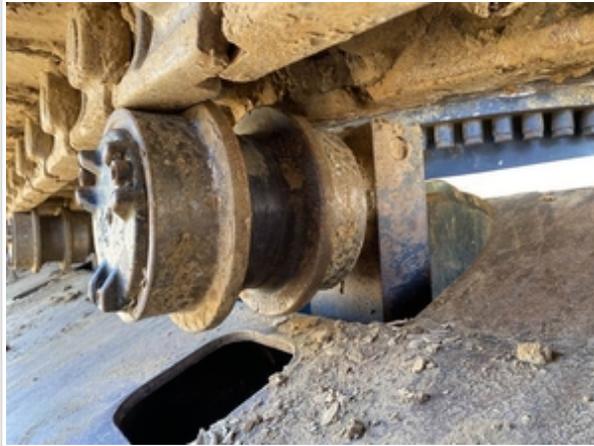
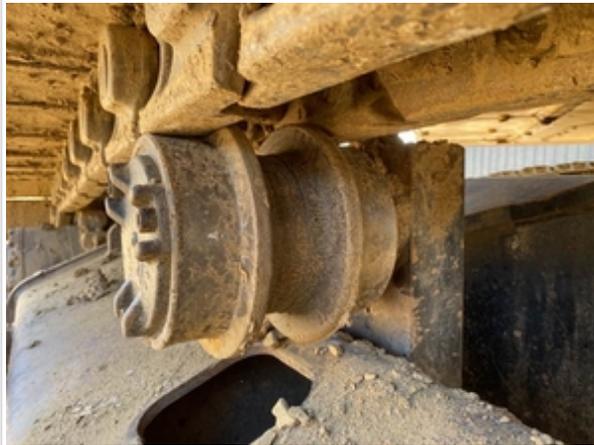
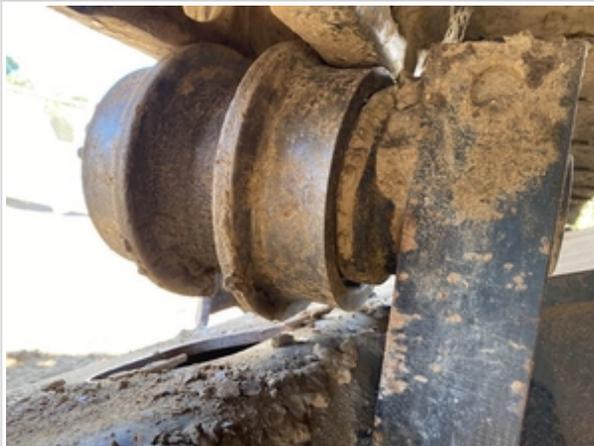
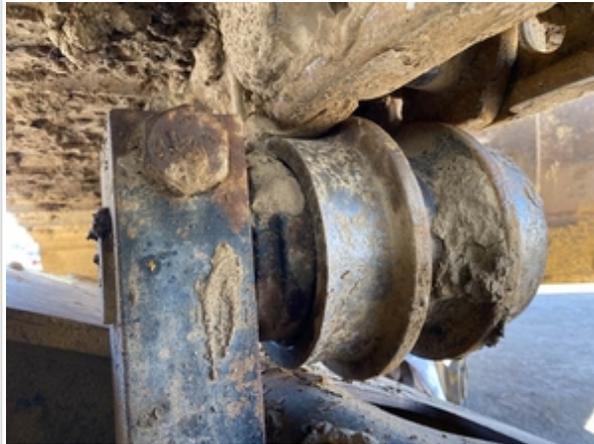
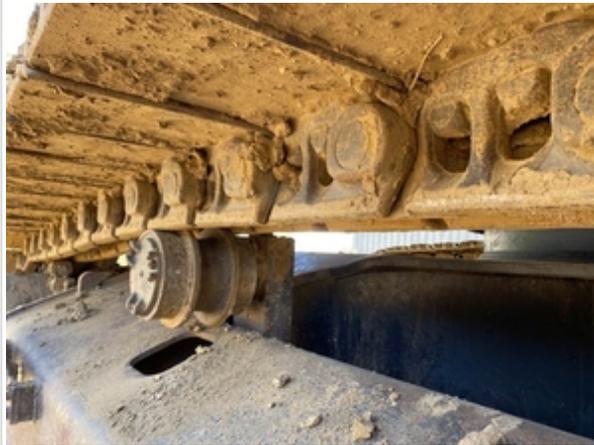
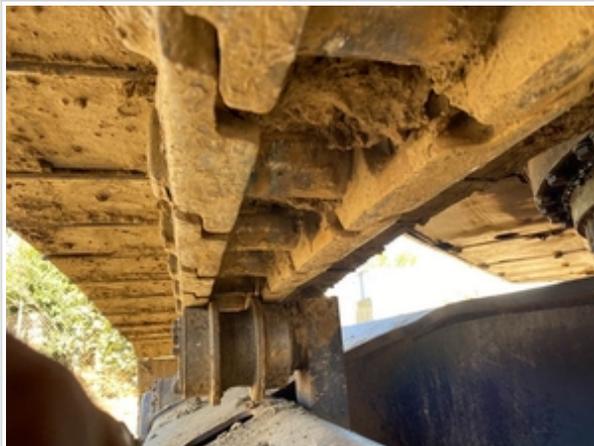
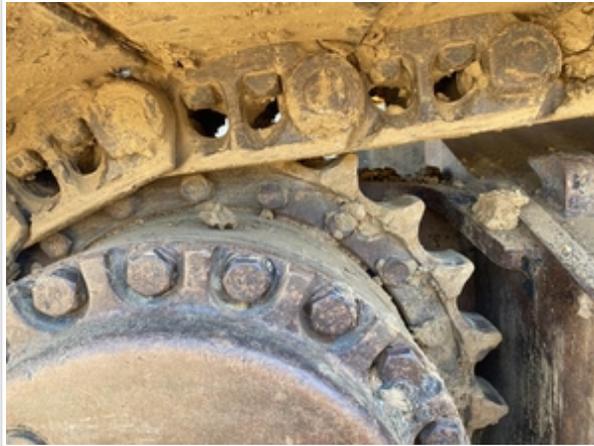
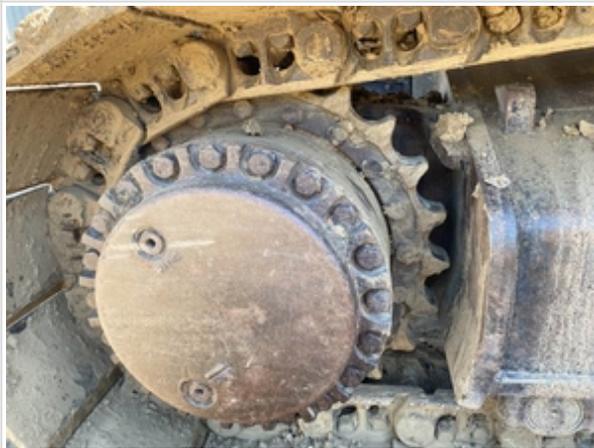
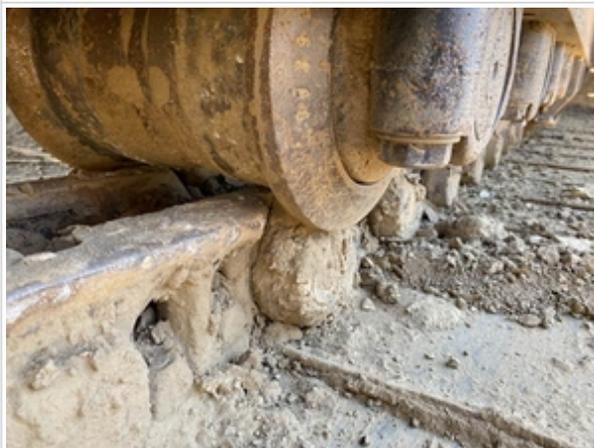
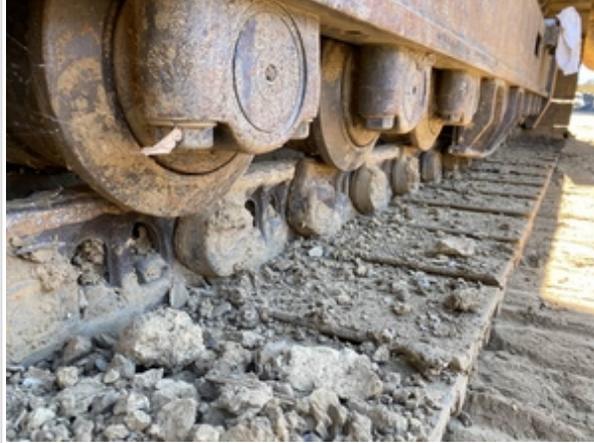
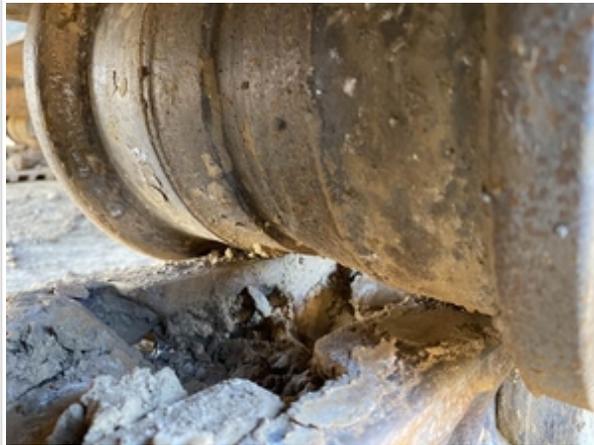
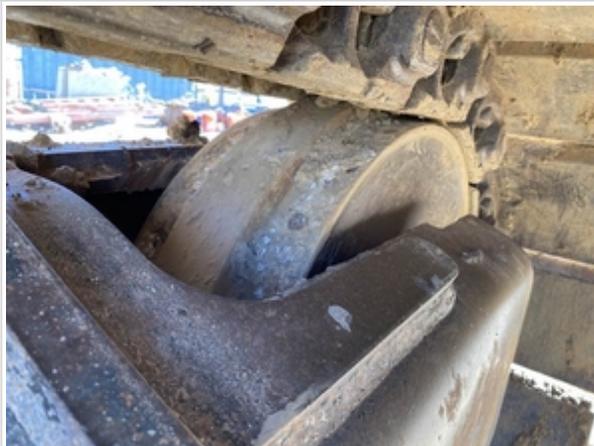
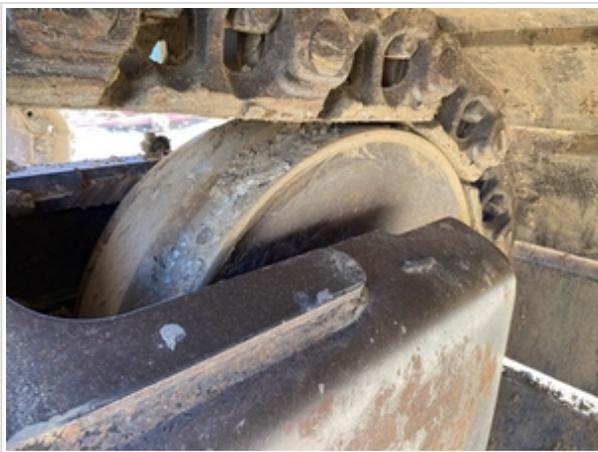
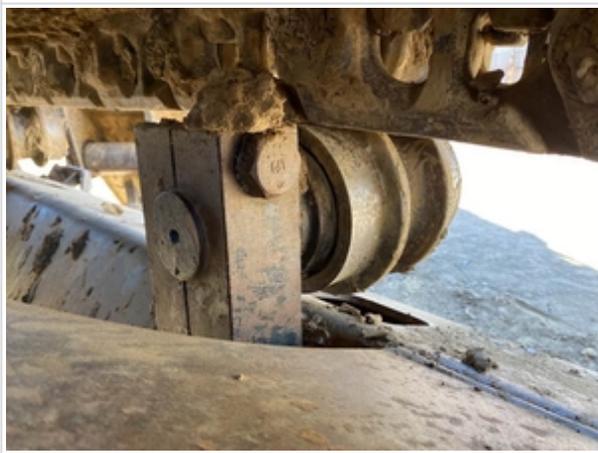
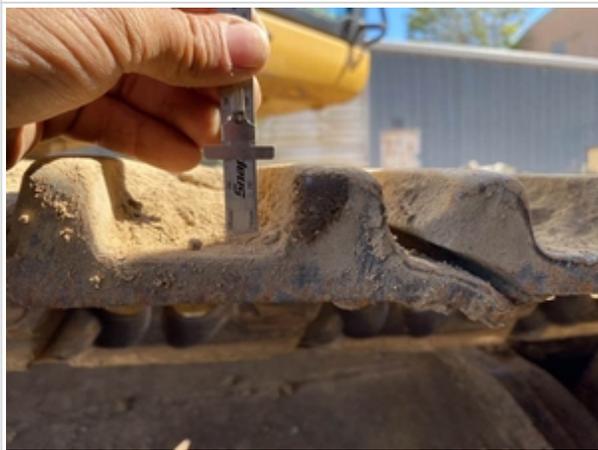
<b>Right Side: Link Bushings / Drive Sprocket / Shoe Condition</b>	3 - Normal Wear & Tear	
<b>Right Side: Upper &amp; Lower Roller / Front Idler Condition</b>	3 - Normal Wear & Tear	
<b>Track Condition: Right Front</b>	70%	
<b>Track Condition: Right Rear</b>	70%	
<b>Undercarriage Right Side Photo Instructions</b>	<p>Take photos of the undercarriage of this piece of equipment.</p> <p>Must have shots to capture:</p> <ul style="list-style-type: none"> <li>- Roller Frame (right)</li> <li>- Track Tensioner (right)</li> <li>- Track Pads (right)</li> <li>- Grouser Height (right)</li> <li>- Track Links (right)</li> <li>- Track Bushings (right)</li> <li>- Carrier Rollers (right)</li> <li>- Track Rollers (right)</li> <li>- Idler (right)</li> <li>- Sprocket (right)</li> </ul>	
<b>Undercarriage Right Side Photos</b>

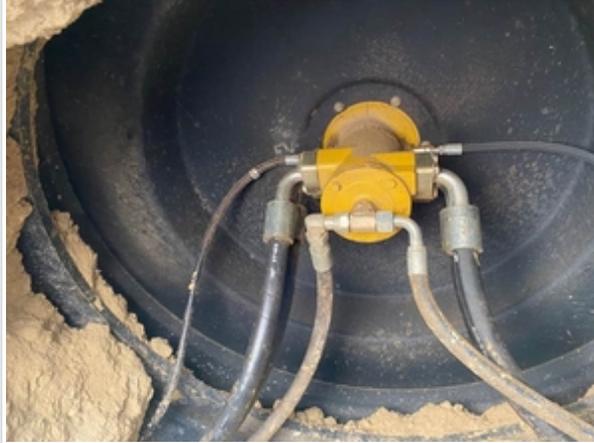
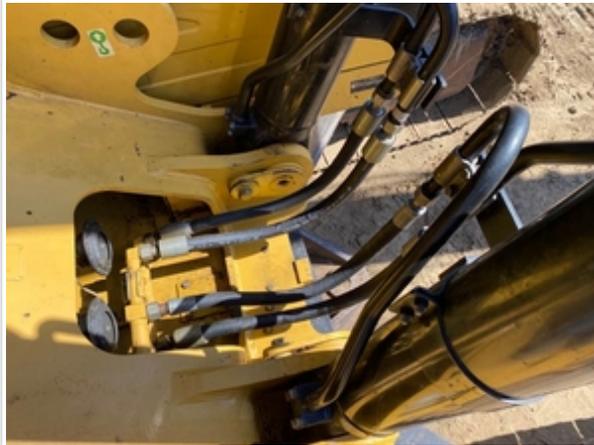
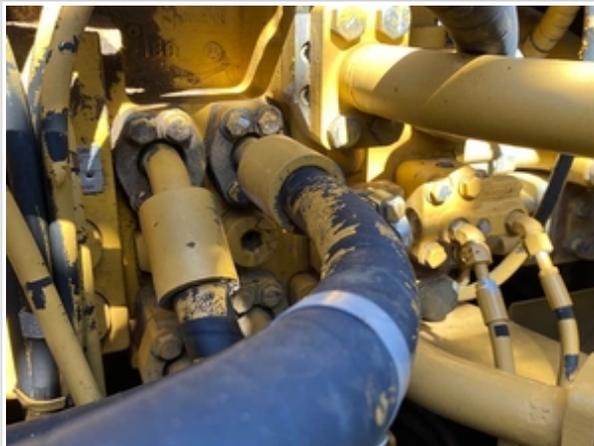
Appearance of Hydraulic Lines /  
Fittings Photos

Wet or Damp Hydraulic Lines / Fittings	No
Appearance of Hydraulic Lines / Fittings	3
Hydraulic Lines / Fittings Condition	Hydraulic lines & fittings are clean and in good condition

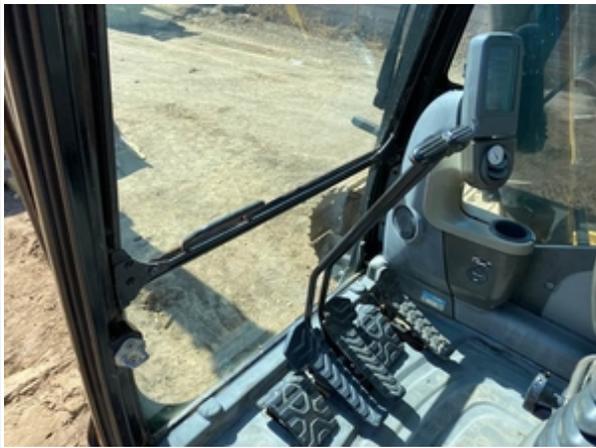
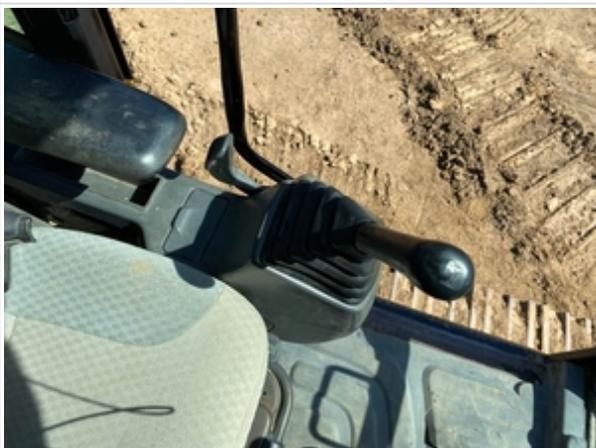
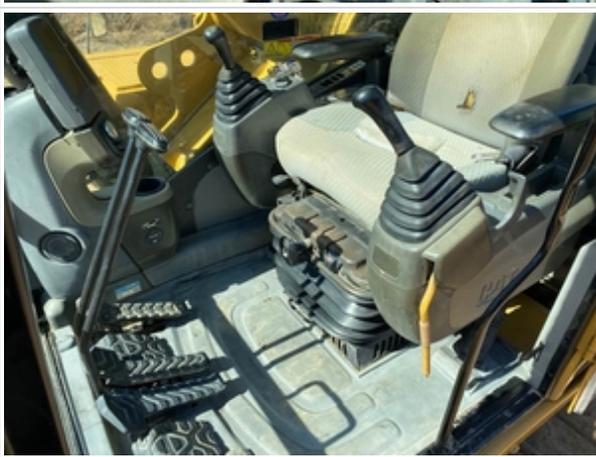
<p>External Controls / Levers Photos</p>

<b>Unusual Noises (Hydraulic Pump)</b>	No
<b>Hydraulic Pump Notes</b>	No unusual noises heard during operation
<b>External Controls / Levers</b>	3
<b>External Controls / Levers Condition</b>	Good function & condition of hydraulic controls

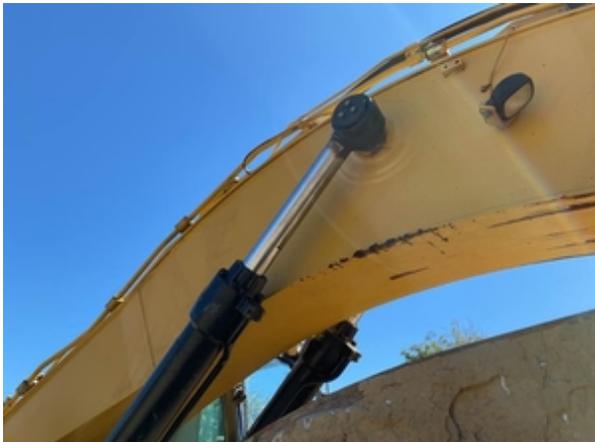
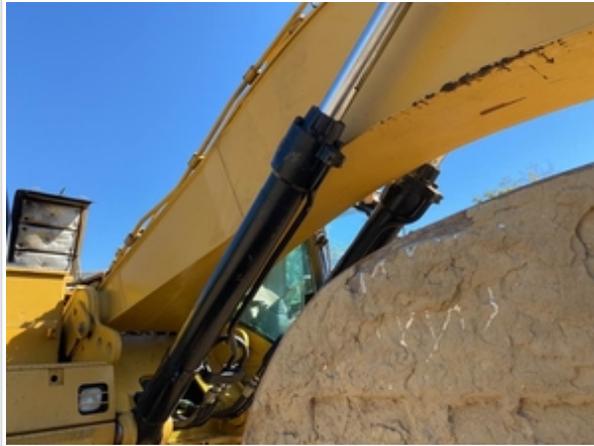
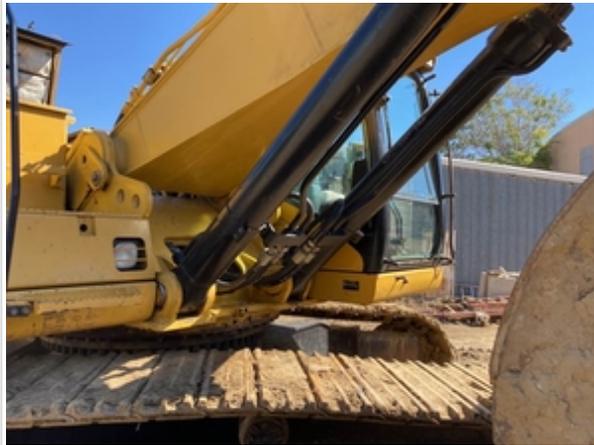
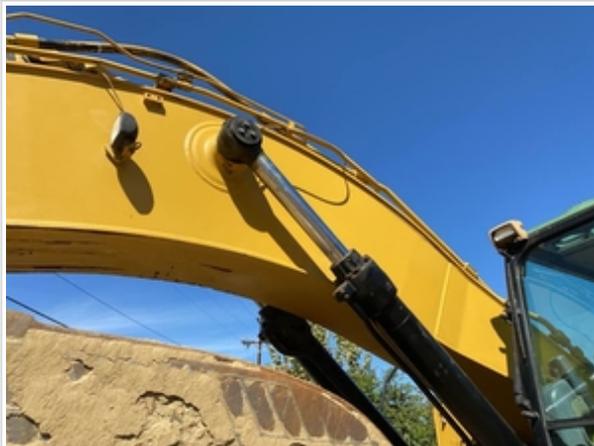
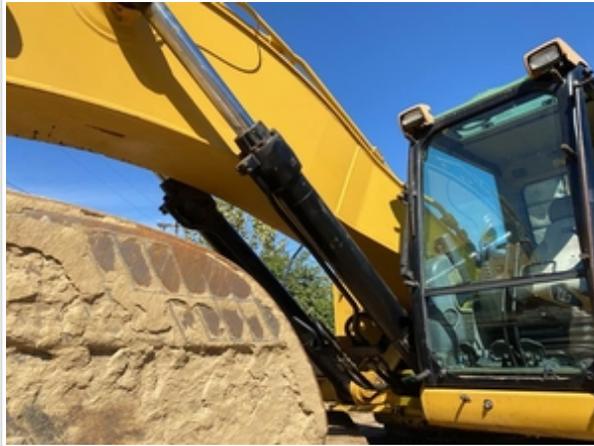
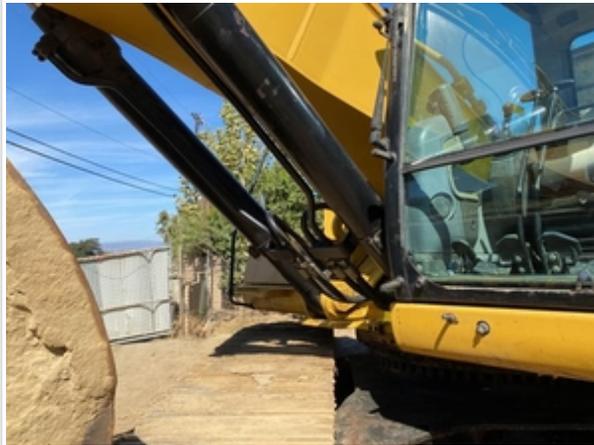
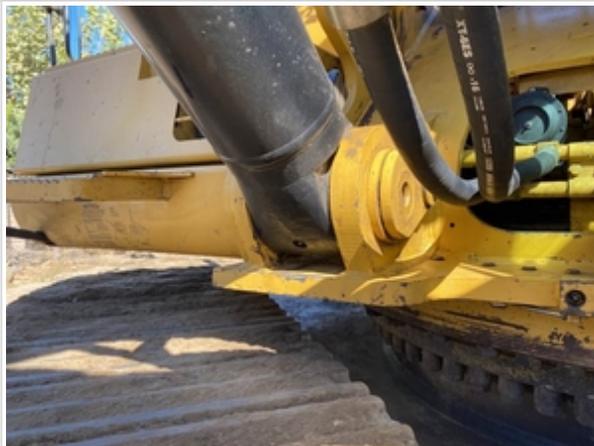
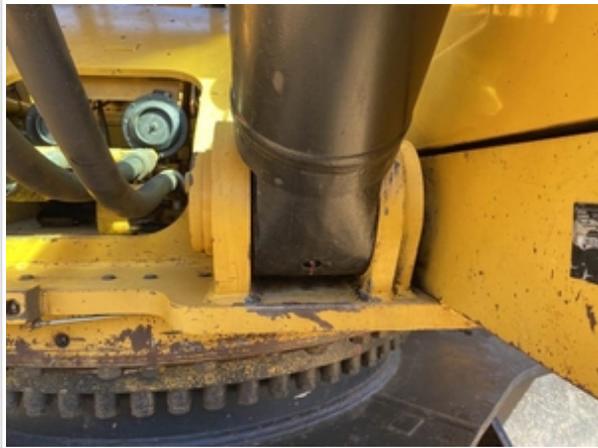
Boom Cylinder	Check the boom cylinder. Note any wear, pitting, discoloration, etc. Take photos.
Boom Cylinder: Mounting Pin	3
Boom Cylinder: Oil Leaks	No
Boom Cylinder Photos

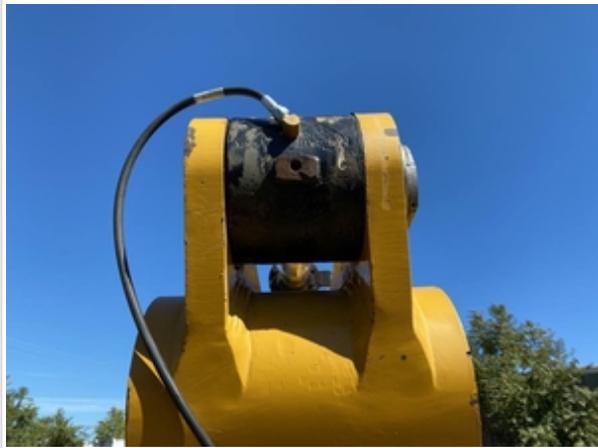
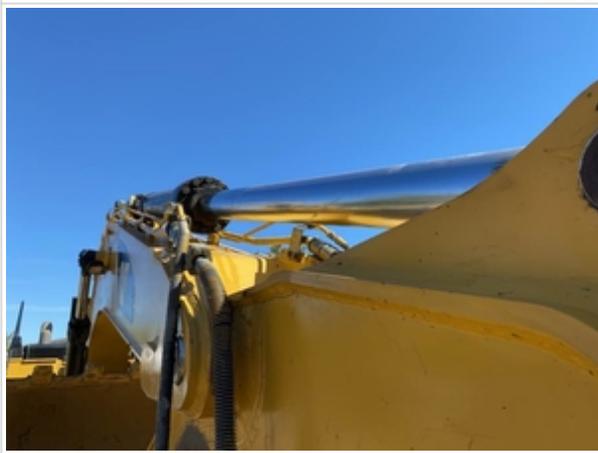
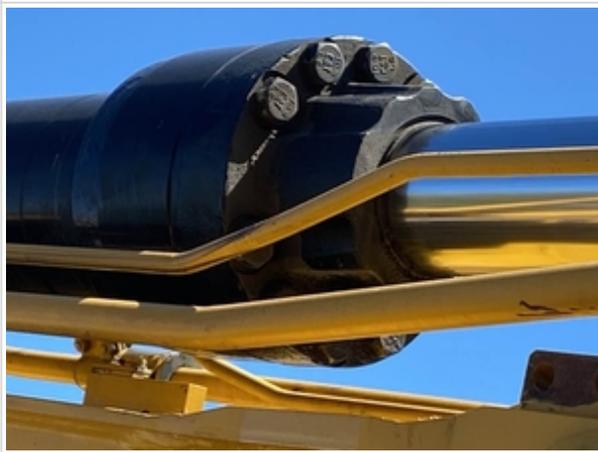
Stick Cylinder	Check the stick cylinder. Note any wear, pitting, discoloration, etc. Take photos.	
Stick Cylinder: Mounting Pin	3	
Stick Cylinder: Oil Leaks	Yes	
Comments	Seepage out of rod seal	
Stick Cylinder Photos

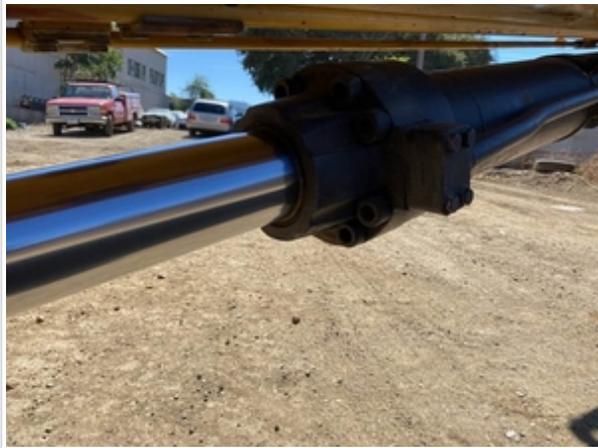
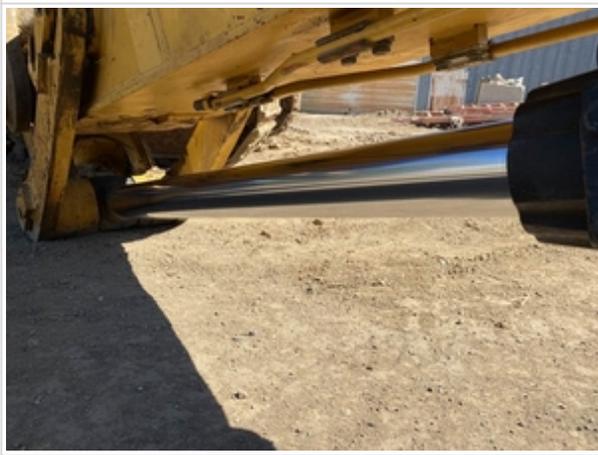
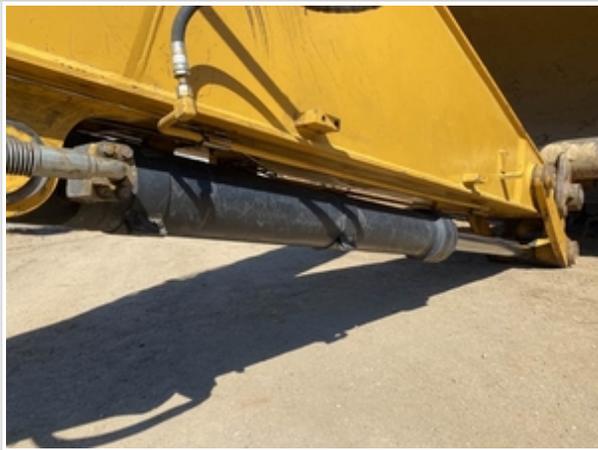
<p>Bucket Cylinder Photos</p>

<b>Bucket Cylinder</b>	Check the bucket cylinder. Note any wear, pitting, discoloration, etc. Take photos.	
<b>Bucket Cylinder: Mounting Pin</b>	3	
<b>Bucket Cylinder: Oil Leaks</b>	No
