Inspection Report (Wheel Loader)

Year	1980
Make	Cat
Model	920 unit 15-106
Serial Number	62K10833
Hour Meter Reading	2,514 (hours may be inaccurate)
Previous Application (e.g., earth moving, mining, demolition, etc)	General construction

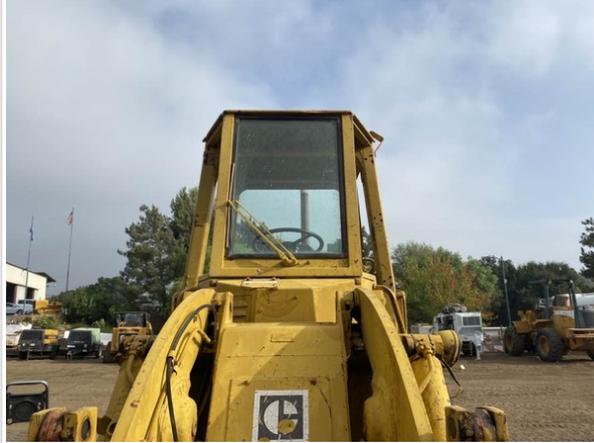
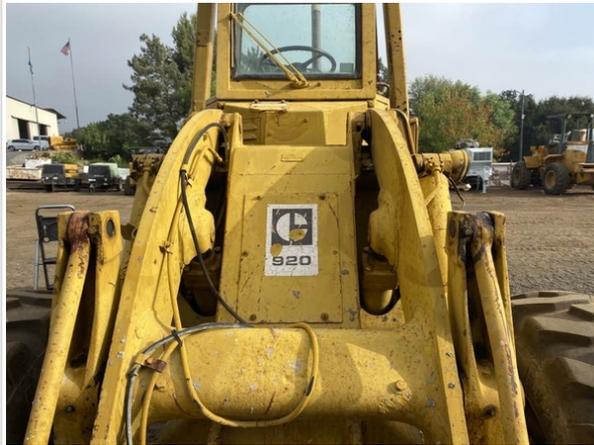
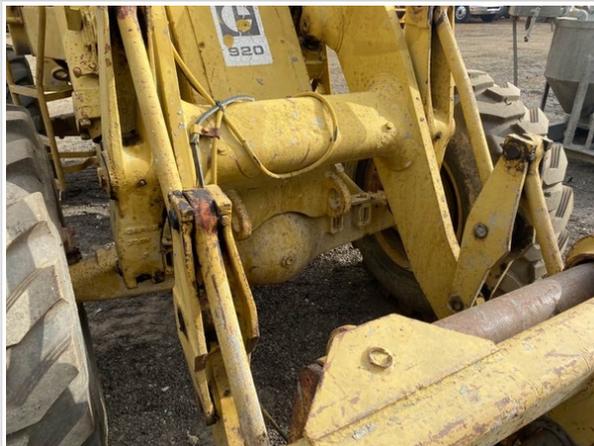
Front Photos

Front	3 - Normal Wear & Tear
Front Condition	No visible damage, Other (see comments)
Comments	Normal wear

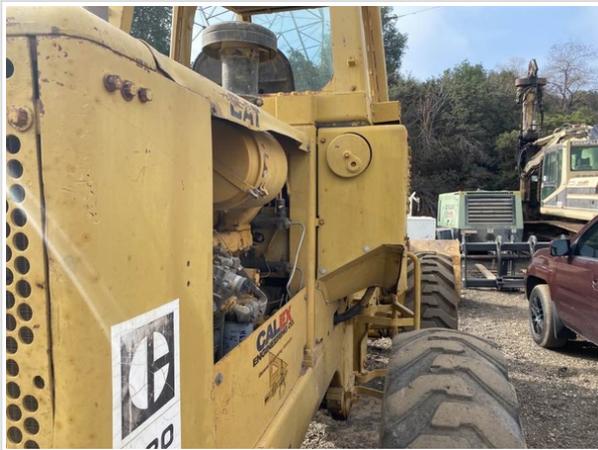
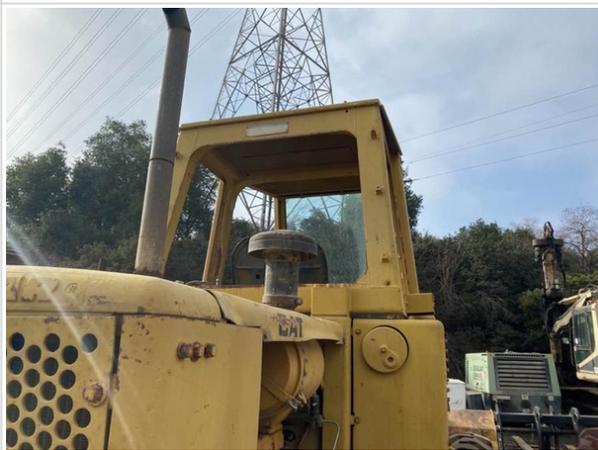
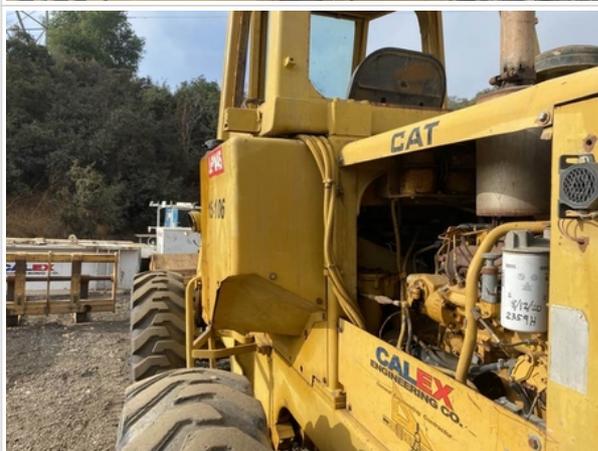
Rear	3 - Normal Wear & Tear	
Rear Condition	Large dents or cracks	
Comments	Rear bumper dented	
Rear Photos

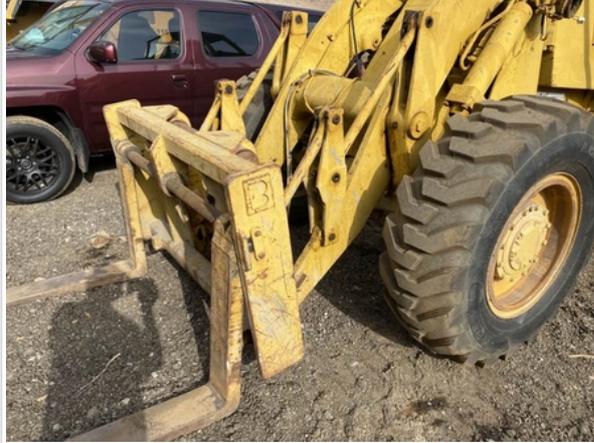
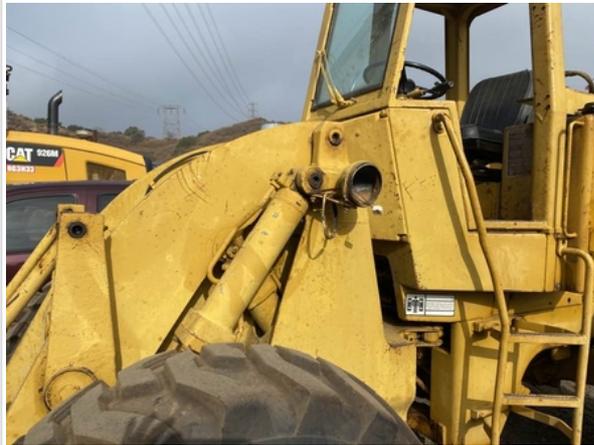
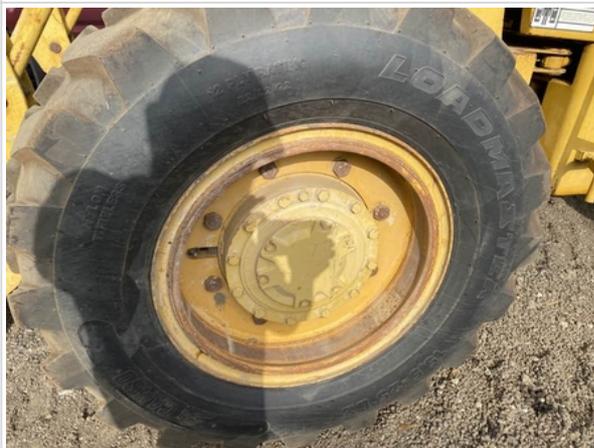
Left Photos

Left	3 - Normal Wear & Tear
Left Condition	No visible damage, Other (see comments)
Comments	Normal wear and tear

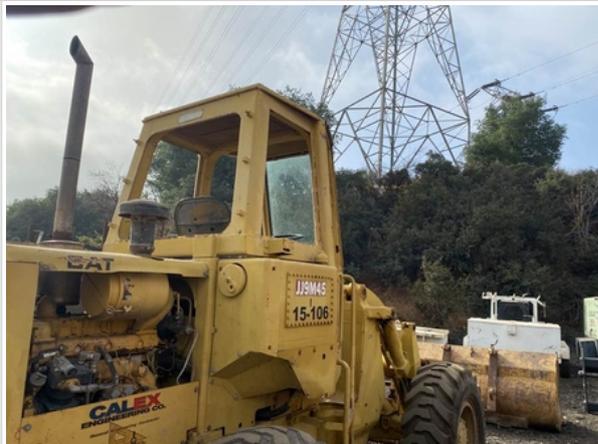
Right	3 - Normal Wear & Tear	
Right Condition	Other (see comments), Large dents or cracks	
Comments	Normal wear	
Right Photos

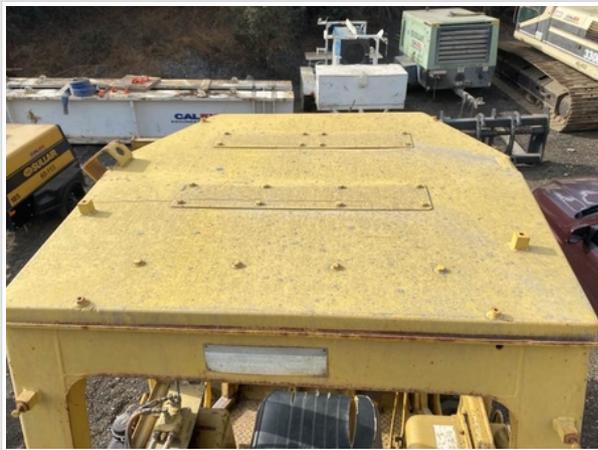
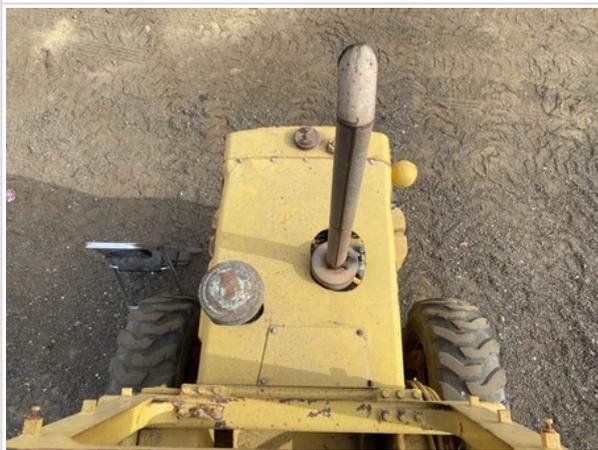
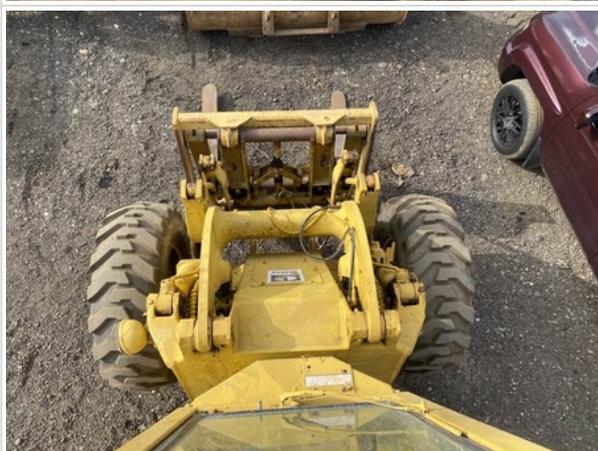
Upper Photos

<p>Upper</p>	<p>3 - Normal Wear & Tear</p>
<p>Upper Condition</p>	<p>No visible damage</p>

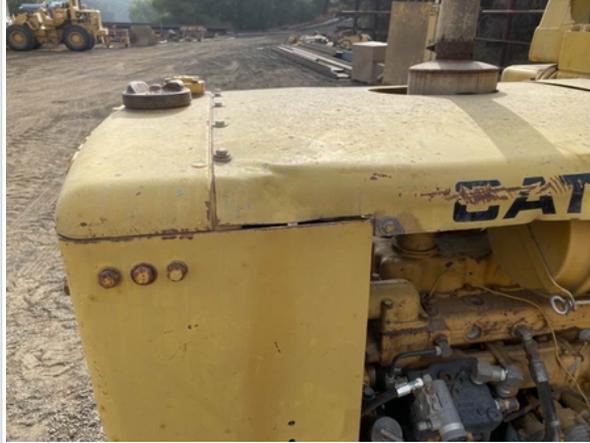
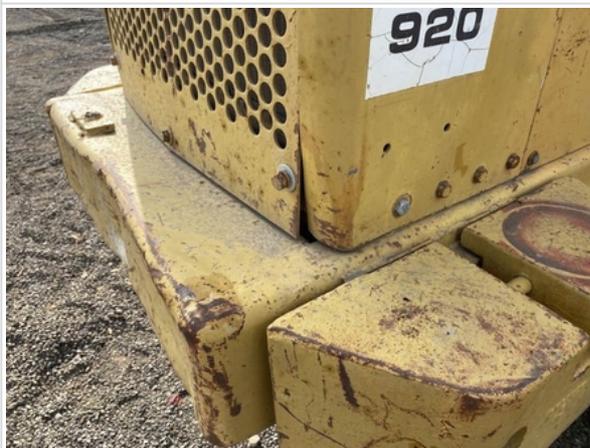
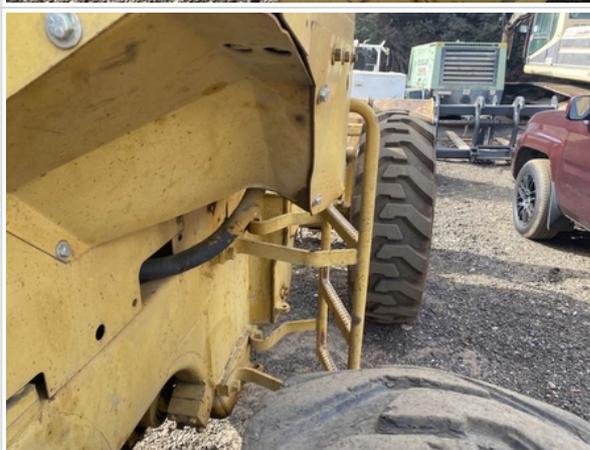
Body Panels Photos

Body Panels (Any Rust Damage?)	3 - Normal Wear & Tear
Body Panel Condition	Some panel misalignment observed

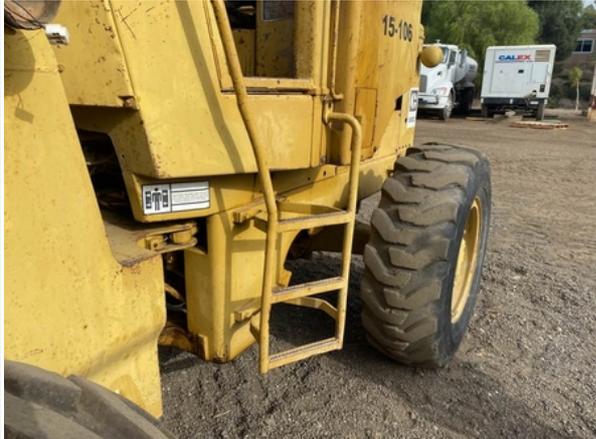
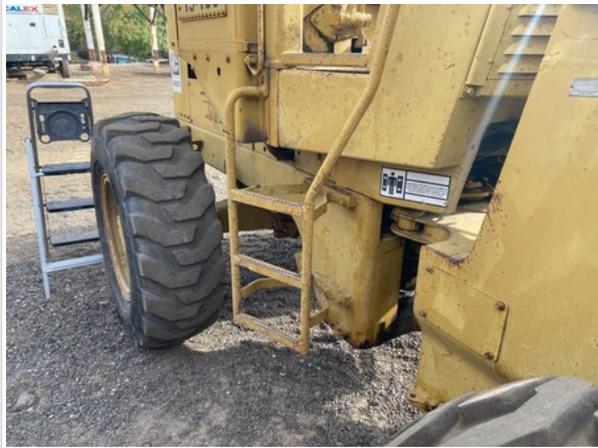
Steps / Ladders	3 - Normal Wear & Tear
Steps / Ladders Condition	Steps/ladders are fully intact and appear structurally sound
Steps / Ladders Photos

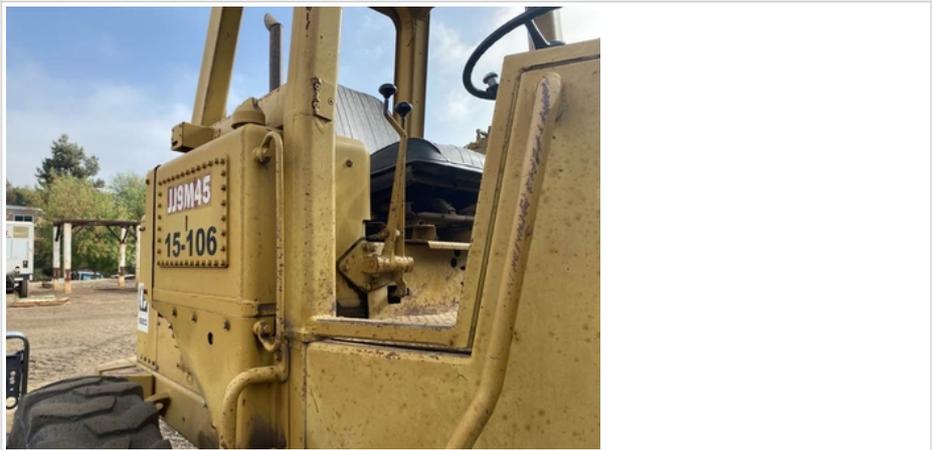
Handrails	3 - Normal Wear & Tear	
Handrails Condition	Handrails are fully intact and appear structurally sound	
Handrail Photos

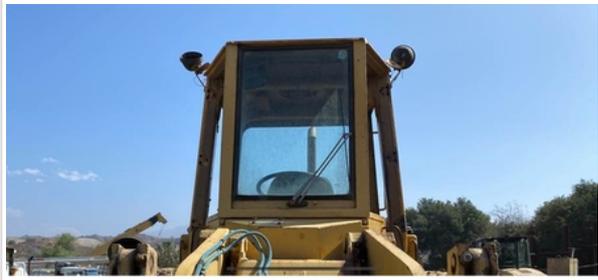
Glass Condition Photos

Glass Condition	3 - Normal Wear & Tear

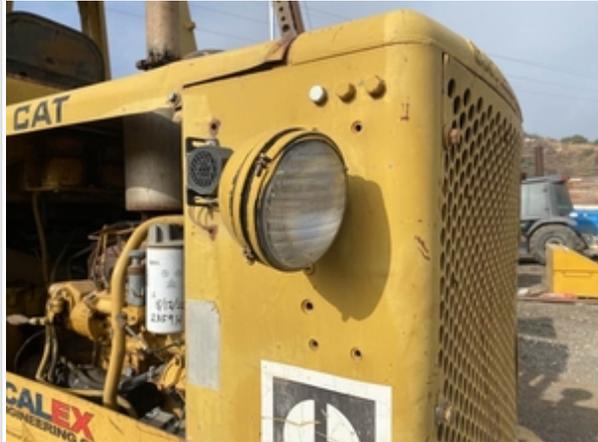
Mirrors	0
Lighting System	1 - Service Required
Lighting System Condition	Overall lighting system is non-operational
Lighting System Photos

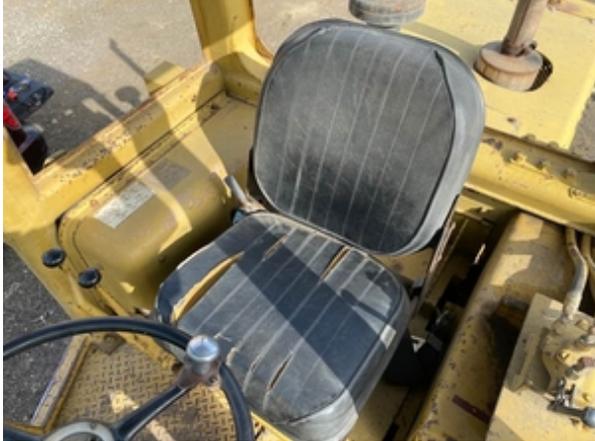
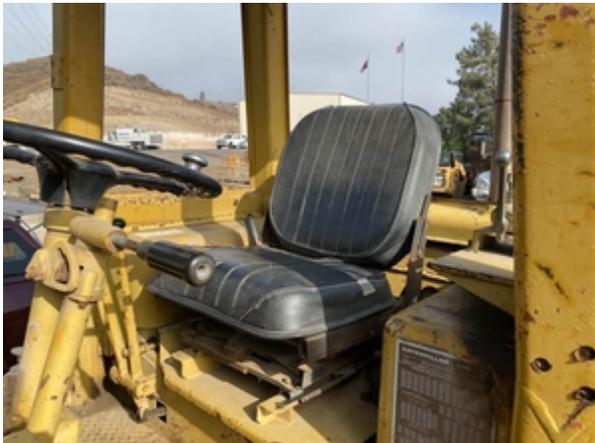
Operator's Seat & Arm Rests Photos

Operator's Seat & Arm Rests	2 - Above Average Wear
Operator's Seat & Arm Rests Condition	Seat(s) is damaged due to sun exposure; fading, cracking observed

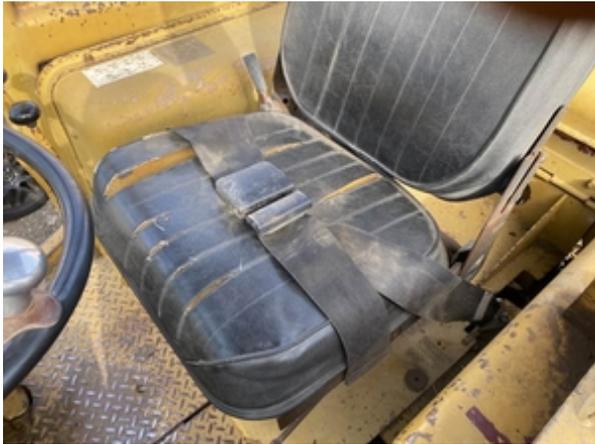
Seat Belt	3 - Normal Wear & Tear
Seat Belt Condition	Seat belt secures properly. Belt is intact and in good condition
Seat Belt Photos

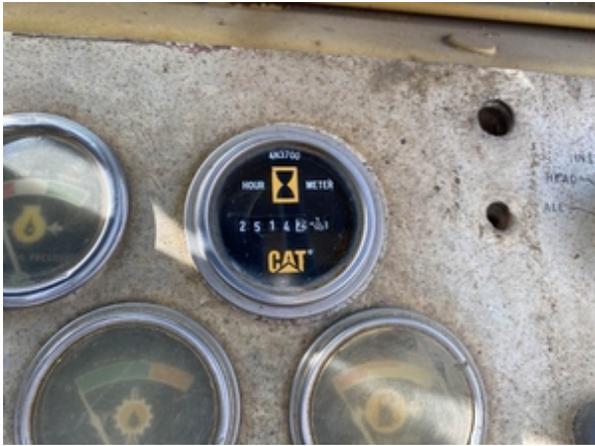
Hour Meter Activity Photos

<p>Hour Meter Activity</p>	<p>3 - Normal Wear & Tear</p>
<p>Hour Meter Condition</p>	<p>Hour meter is functional and in good condition</p>

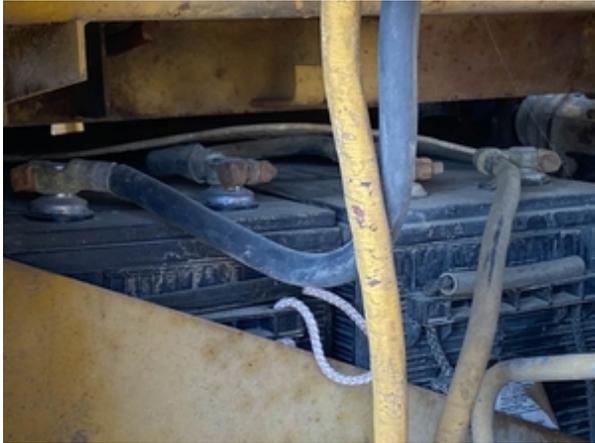
Comments	Normal black engine smoke under initial loads
Engine Exhaust Color	Black puffs observed under throttle, Other (see comments)
Comments	Minor black smoke observed from muffler intermittently
Battery	3 - Normal Wear & Tear
Battery Condition	Dusty & dirty appearance
Battery Condition Photos

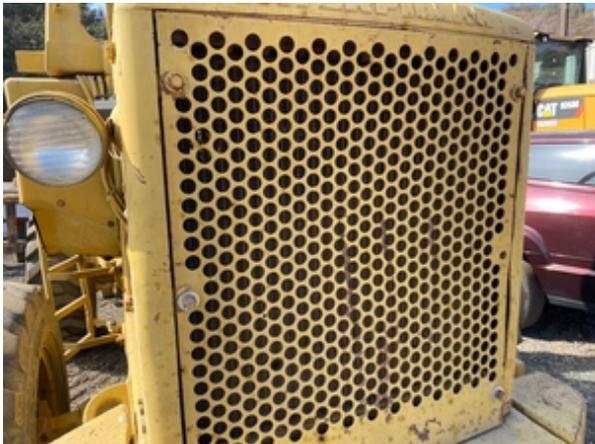
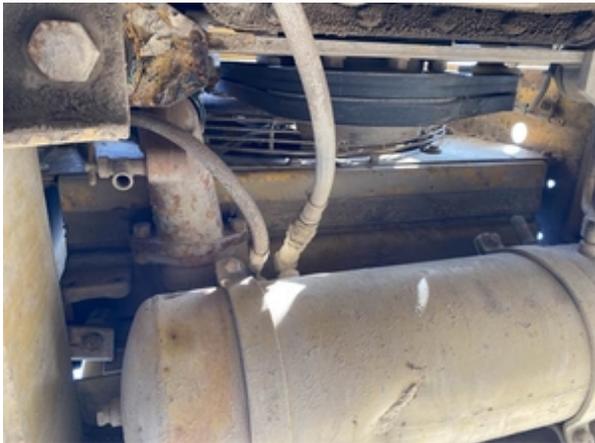
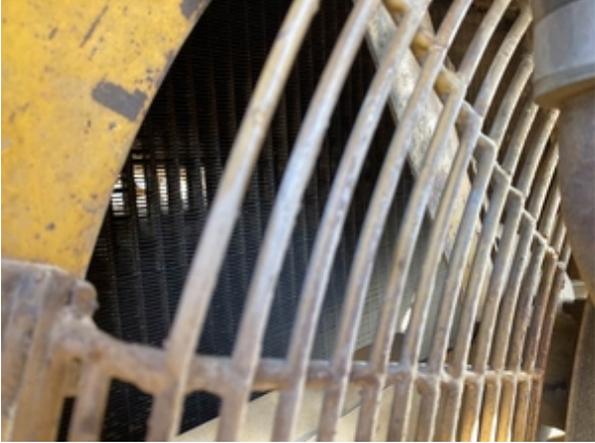
Radiator	3 - Normal Wear & Tear
Radiator Condition	Radiator fins & components appear to be in good working order, no signs of damage or leaks
Radiator Photos

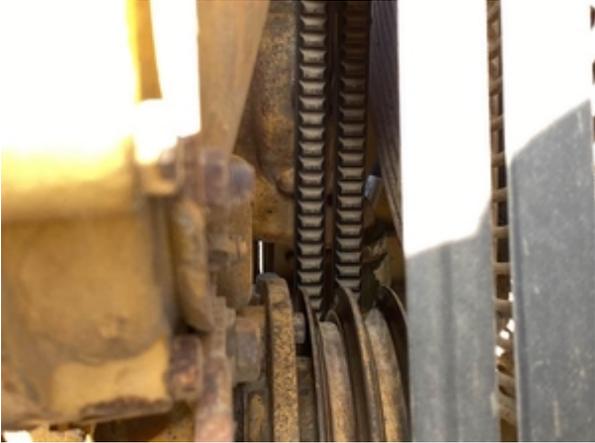
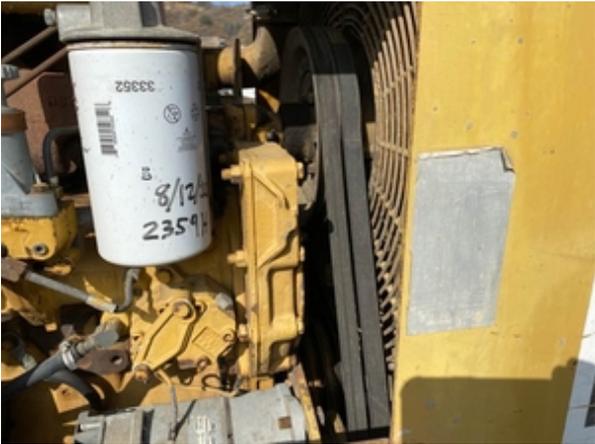
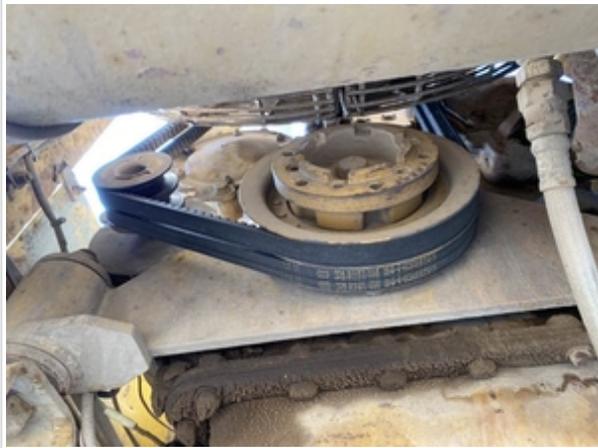
Belts	3 - Normal Wear & Tear	
Belt Condition	Belts appear in good condition & alignment with proper tension	
Belt Photos

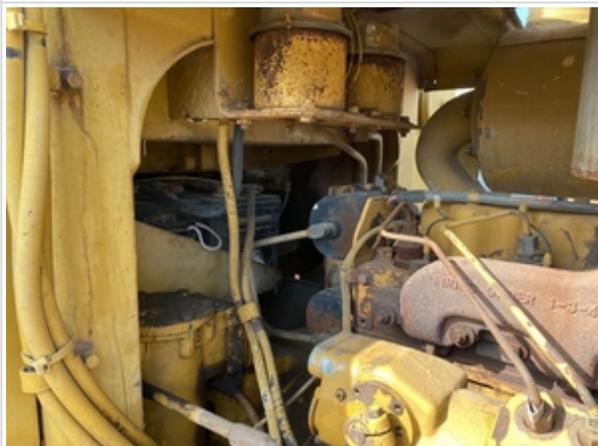
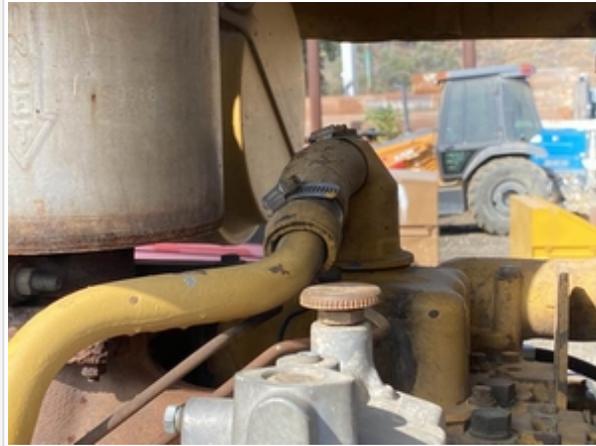
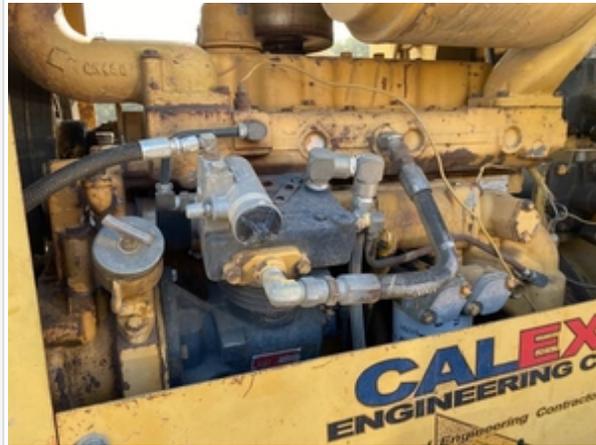
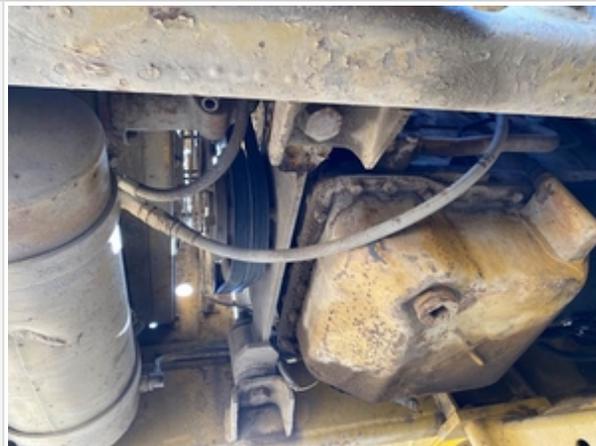
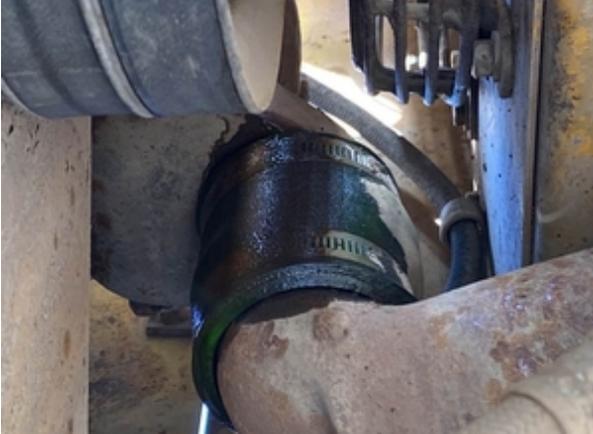
<p>Hoses</p>	<p>3 - Normal Wear & Tear</p>
<p>Hose Condition</p>	<p>Firm, pliant hoses with no signs of wear or leaks, Leaks in one or more hoses or fittings observed</p>
<p>Hose Photos</p>

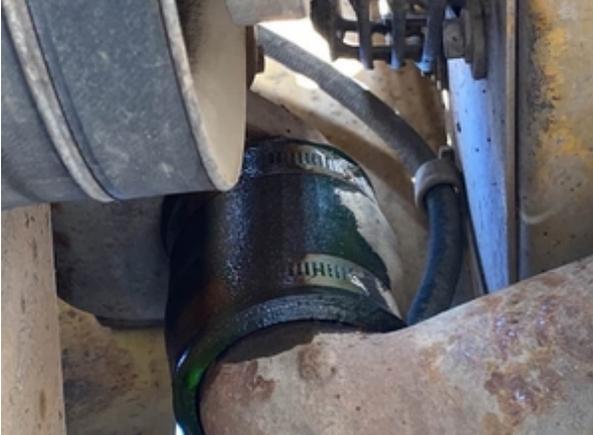
Water Pump	3 - Normal Wear & Tear
Water Pump Condition	No unusual pump noises heard
Cooling System Leaks	Yes
Cooling System Condition	Wetness observed on cooling system hoses
Cooling System Leaks Photos

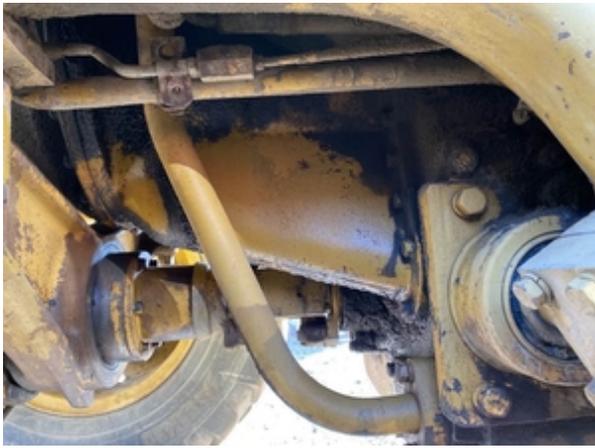
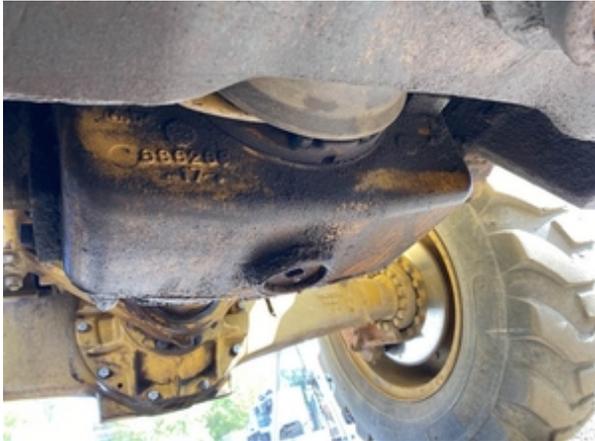
Hydrostatic Transmission?	No
Transmission Info (Make/Model/Speeds)	Powershift 4 speed
Transmission	3 - Normal Wear & Tear
Transmission Condition	No unusual noises or vibrations, Leaking transmission fluid observed, Other (see comments)
Comments	Active leaks see under trans
Transmission Photos

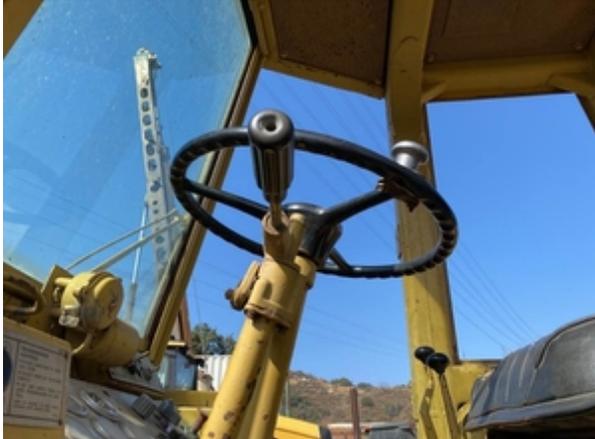
Shift Level Photos

Clutch	0
Shift Lever	3 - Normal Wear & Tear
Shift Lever Condition	Good forward and reverse function

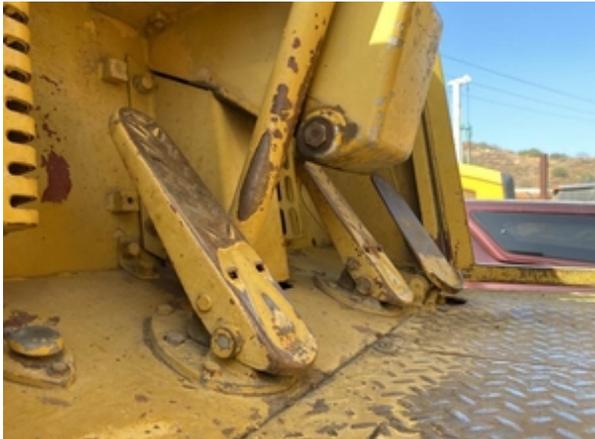
Foot Brake	3 - Normal Wear & Tear	
Foot Brake Condition	Good brake function	
Foot Brake Photos

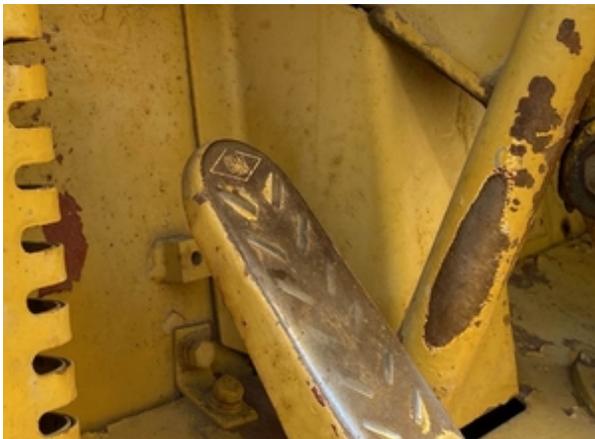
Inching Brake	3 - Normal Wear & Tear	
Inching Brake Condition	Good brake function	
Inching Brake Photos

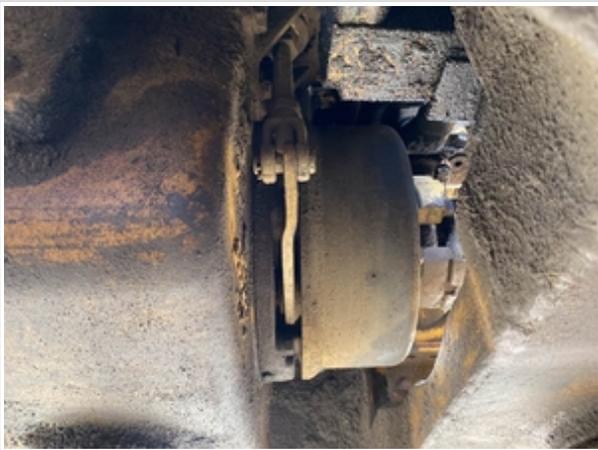
<p>Parking Brake Photos</p>

Parking Brake	3 - Normal Wear & Tear	
Parking Brake Condition	Good brake function

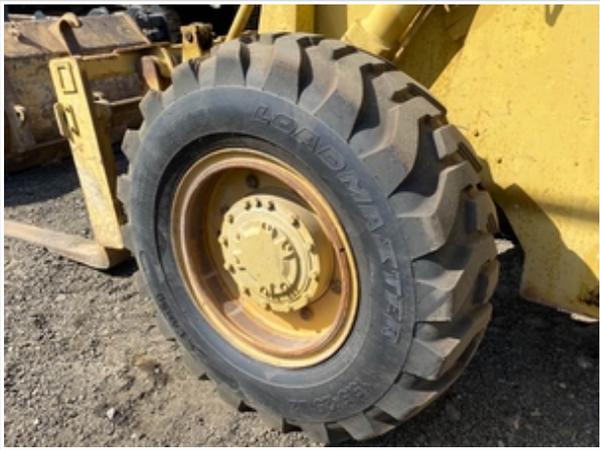
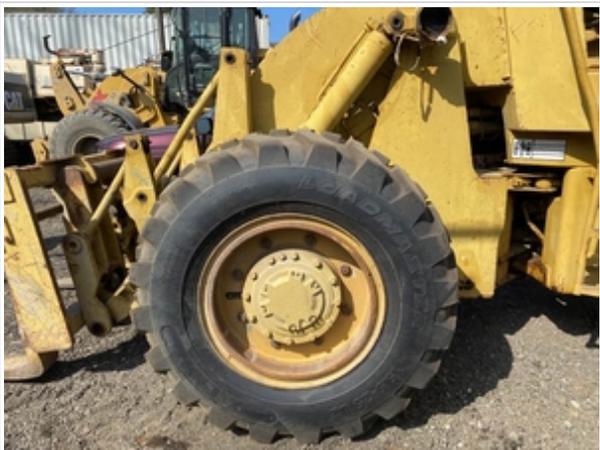
Tire Brand	Camso	
Tire Size	15.5 -25	
Front Left Tire - Ratio Remaining	90%	
Front Left Tire Photos

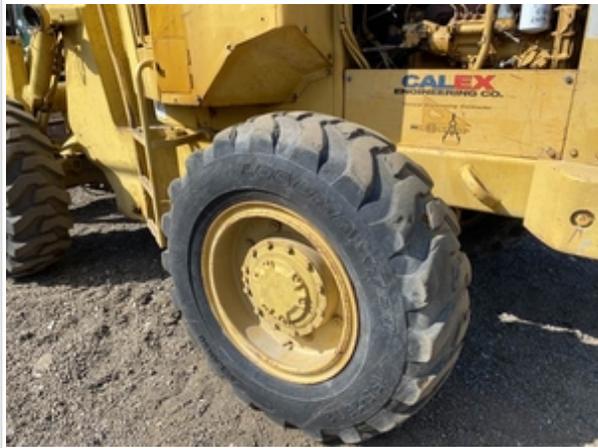
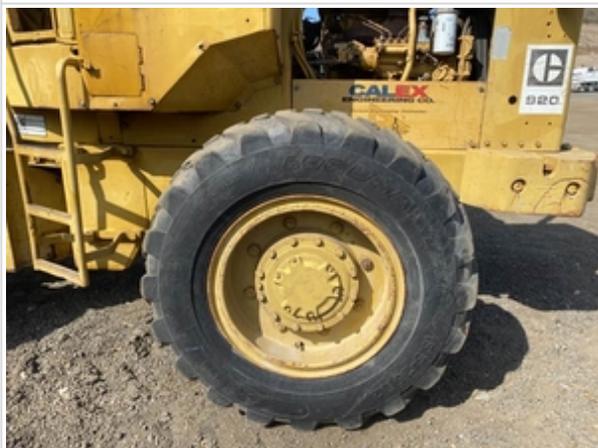
<p>Rear Left Tire Photos</p>

Rear Left Tire - Ratio Remaining	30%

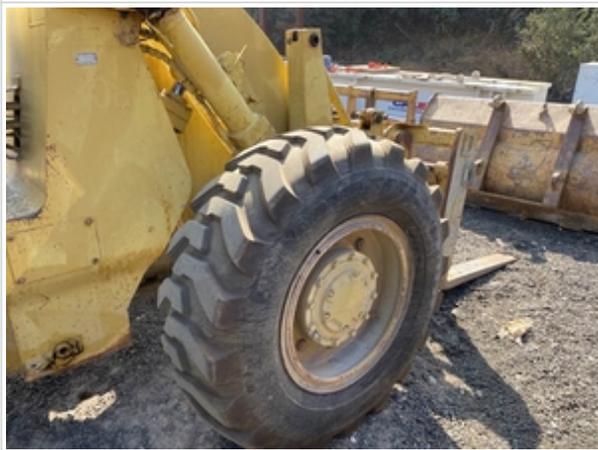
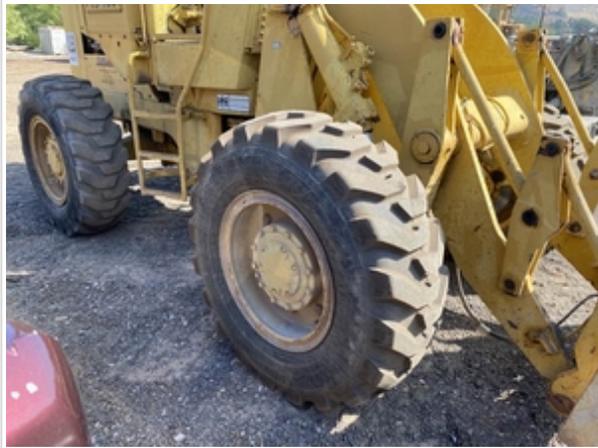
<p>Front Right Tire - Ratio Remaining</p>	<p>90%</p>
<p>Front Right Tire Photos</p>

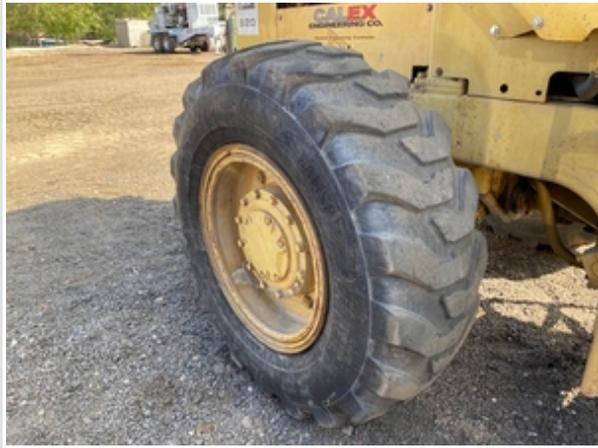
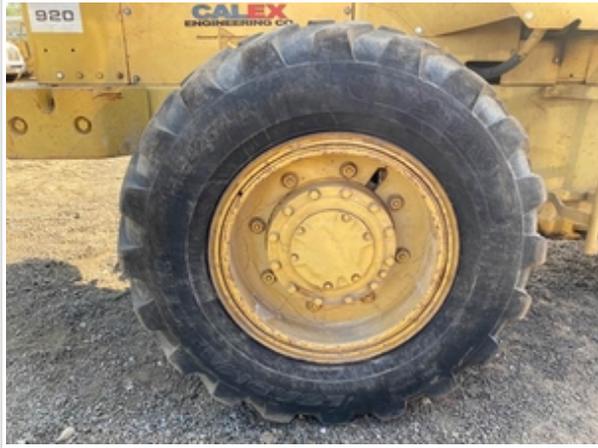
<p>Rear Right Tire - Ratio Remaining</p>	<p>30%</p>
<p>Rear Right Tire Photos</p>

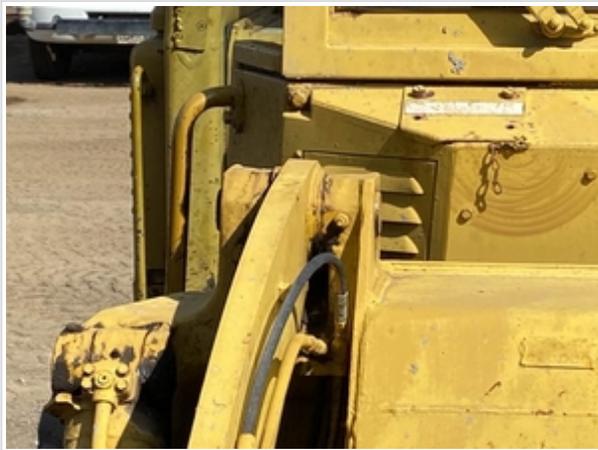
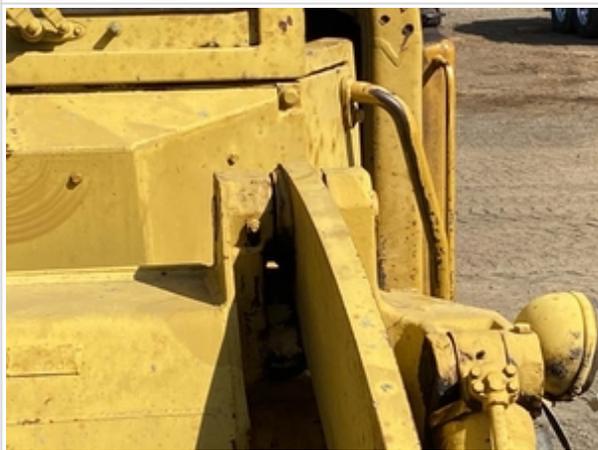
Chassis to Arm Pins Photos

Chassis to Arm Pins	3 - Normal Wear & Tear

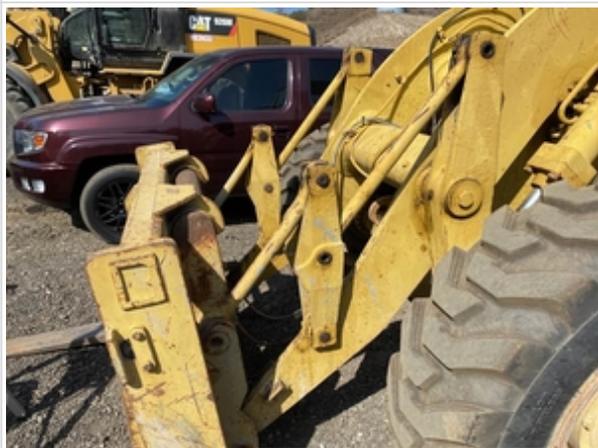
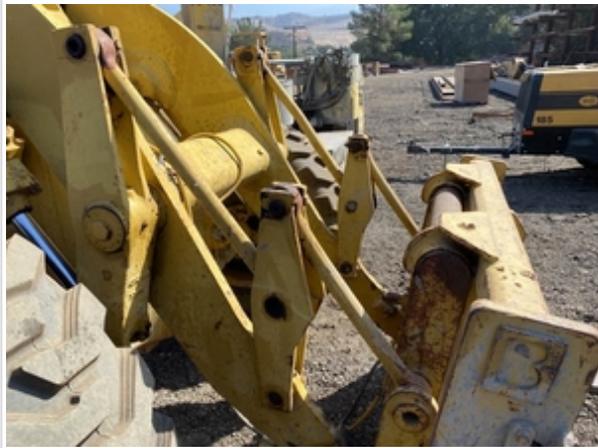
Tilt Linkage	3 - Normal Wear & Tear
Tilt Linkage Photos

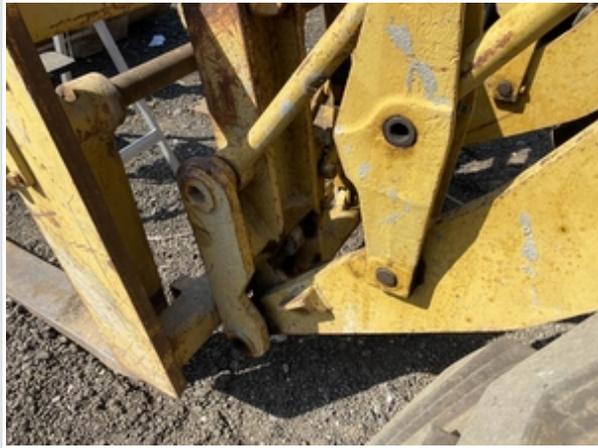
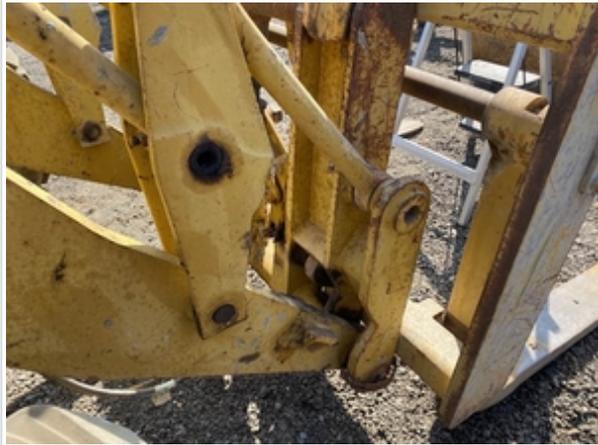
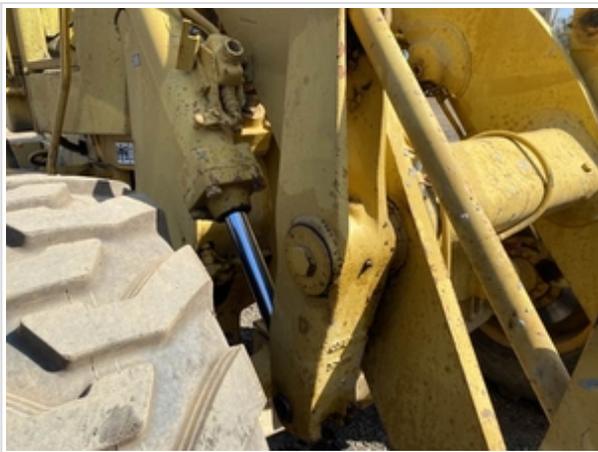
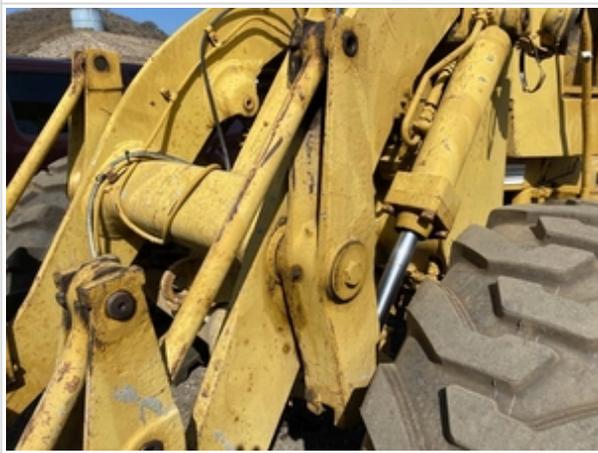
<p>Tilt Linkage Pins and Bushings</p>	<p>3 - Normal Wear & Tear</p>
<p>Tilt Linkage Pins and Bushings Photos</p>

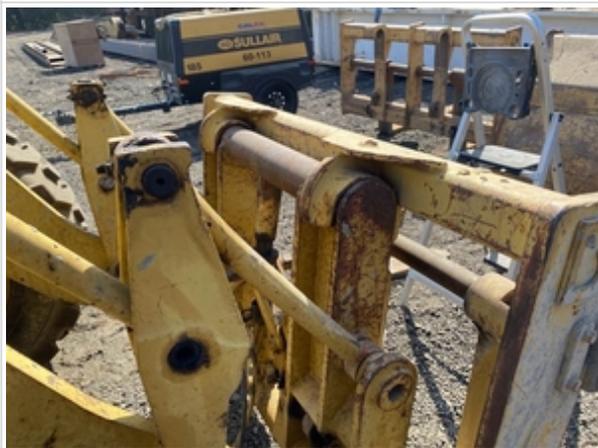
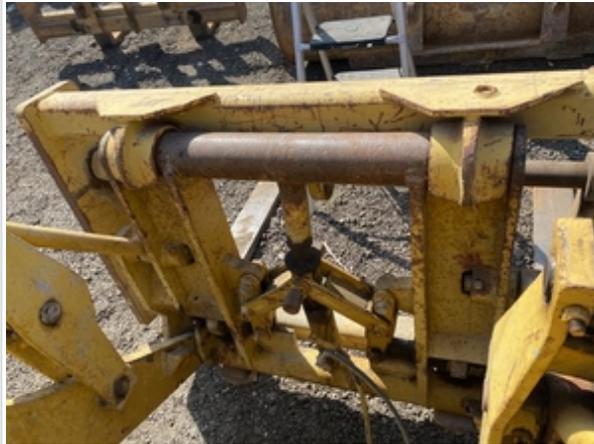
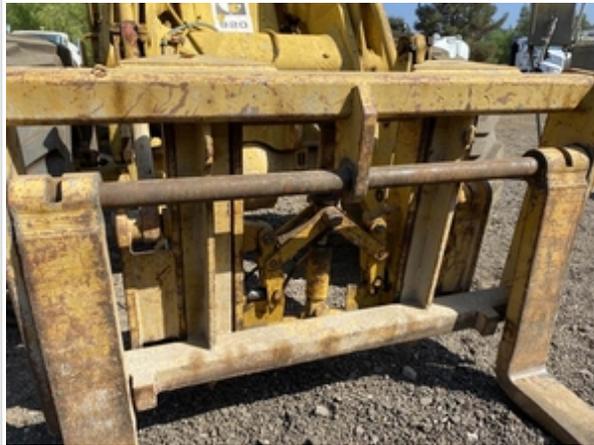
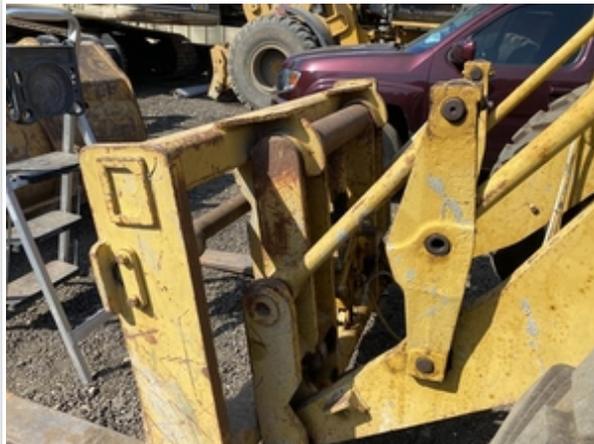
<p>Quick Coupler</p>	<p>3 - Normal Wear & Tear</p>	
<p>Quick Coupler Photos</p>

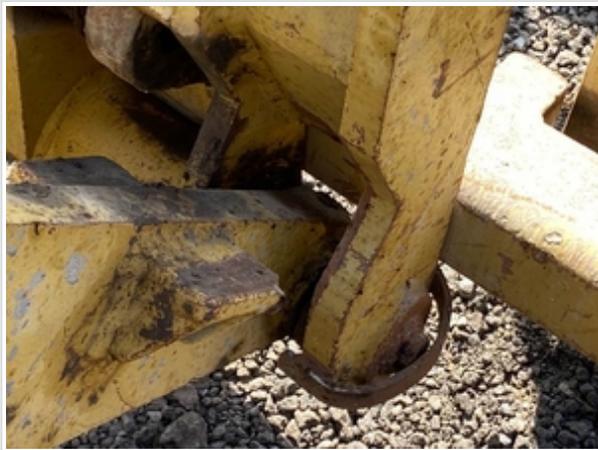
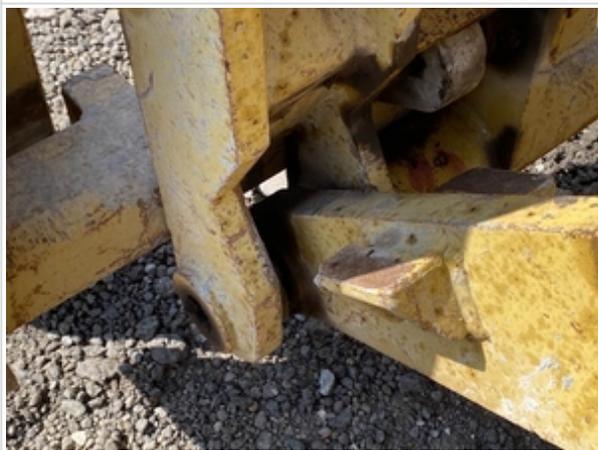
<p>Quick Coupler to Arms Pins Photos</p>

Quick Coupler to Arms Pins

3 - Normal Wear & Tear

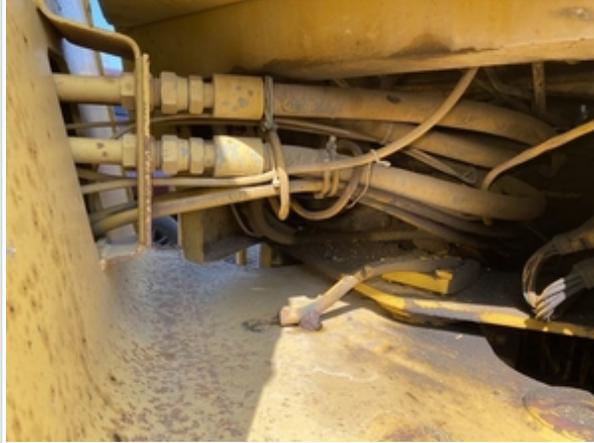
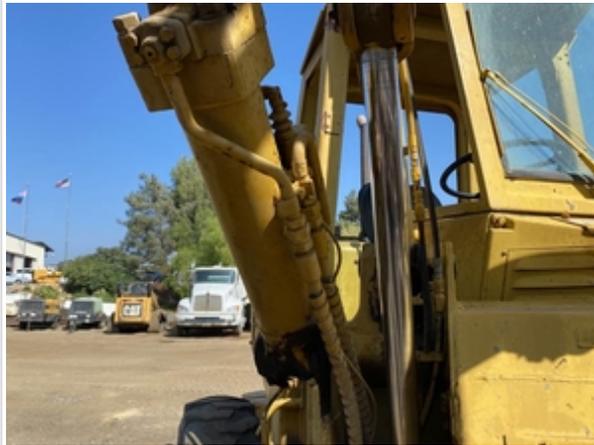
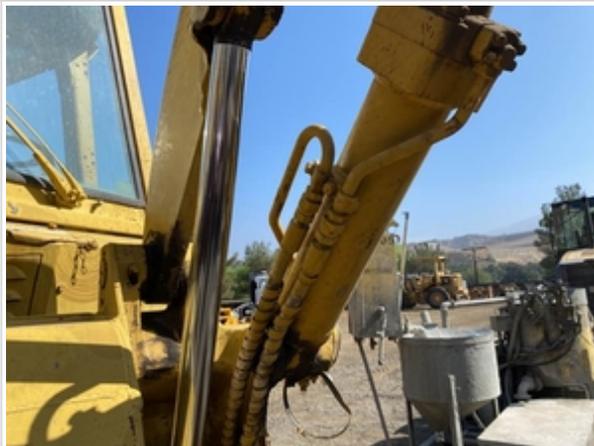
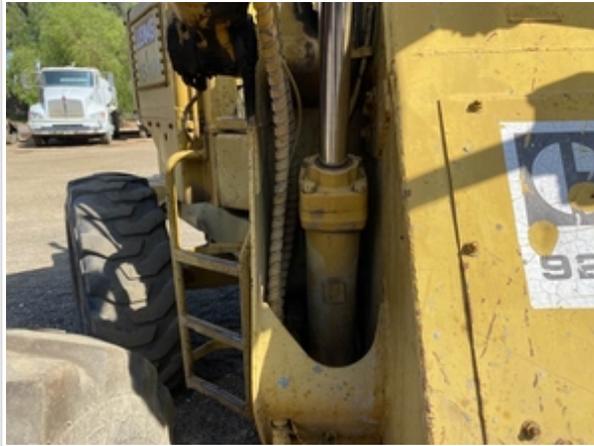
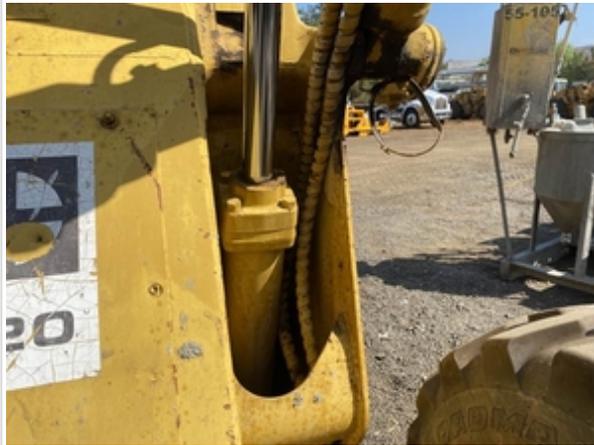
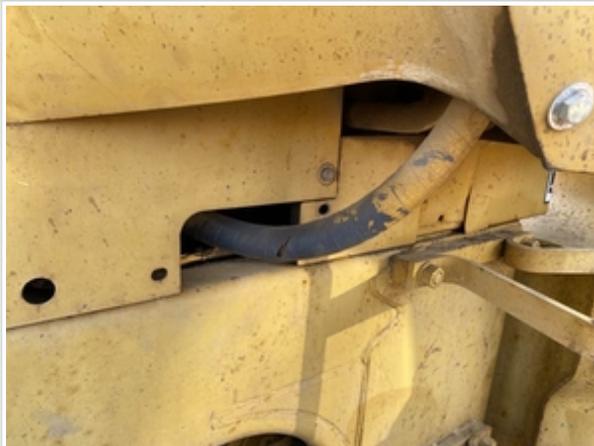
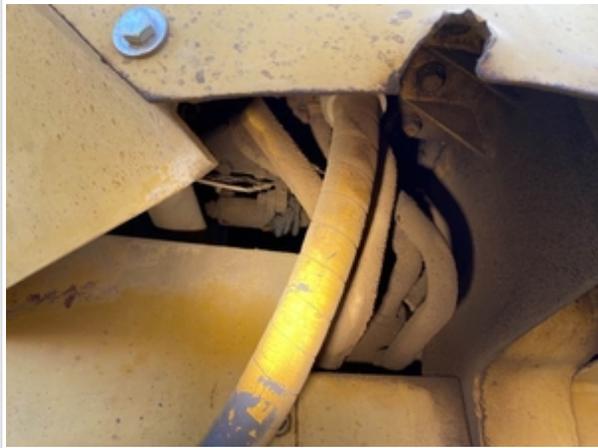
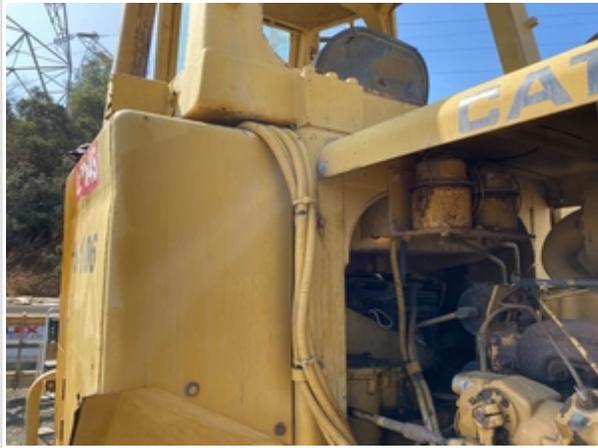
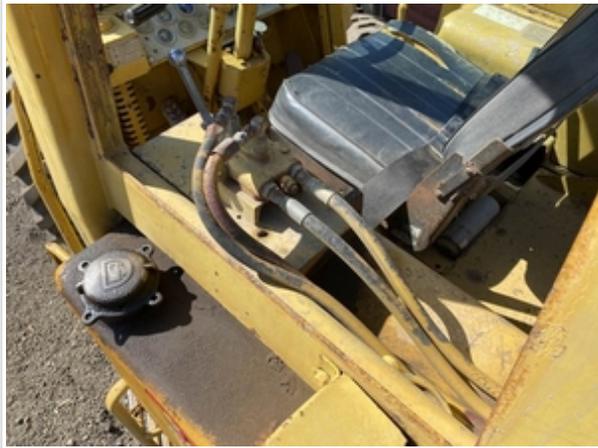
Appearance of Hydraulic Lines /
Fittings Photos

<h3>Hydraulics Overall</h3>	
<p>Wet or Damp Hydraulic Lines / Fittings</p>	<p>No</p>
<p>Appearance of Hydraulic Lines / Fittings</p>	<p>3</p>
<p>Hydraulic Lines / Fittings Condition</p>	<p>Hydraulic lines & fittings are clean and in good condition</p>

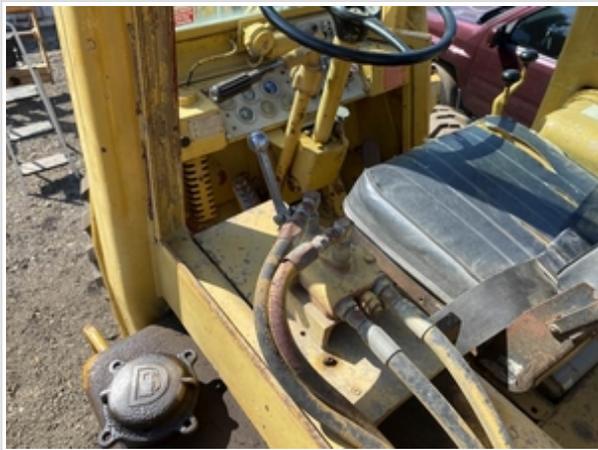
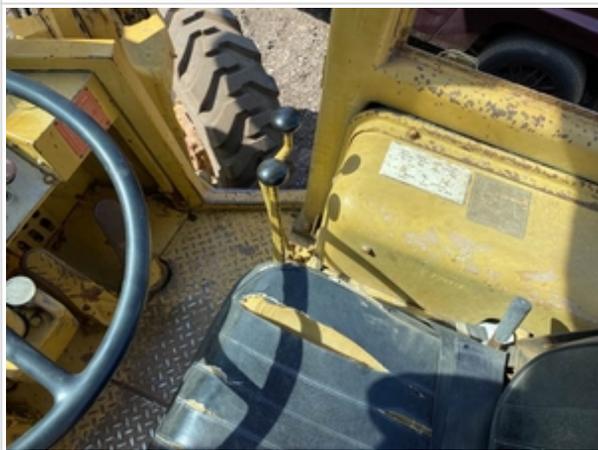
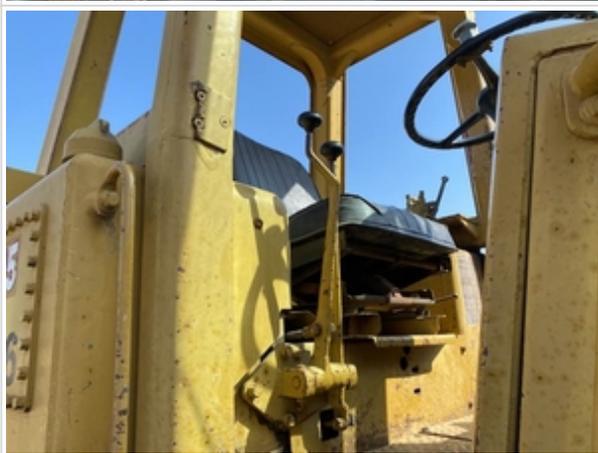
External Controls / Levers Photos

Unusual Noises (Hydraulic Pump)	No
Hydraulic Pump Notes	No unusual noises heard during operation
External Controls / Levers	3
External Controls / Levers Condition	Good function & condition of hydraulic controls
