Inspection Report (Wheel Loader)

Year	1980
Make	Cat
Model	920 unit 15-106
Serial Number	62K10833
Hour Meter Reading	2,514 (hours may be inaccurate)
Previous Application (e.g., earth moving, mining, demolition, etc)	General construction

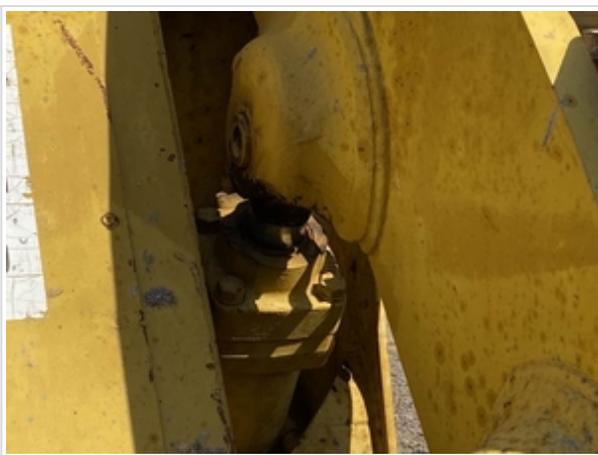
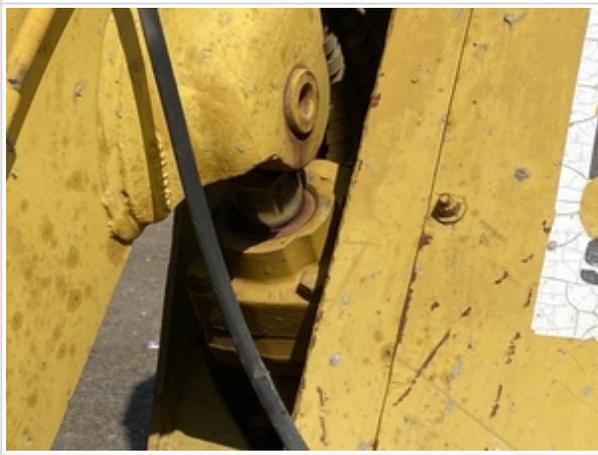
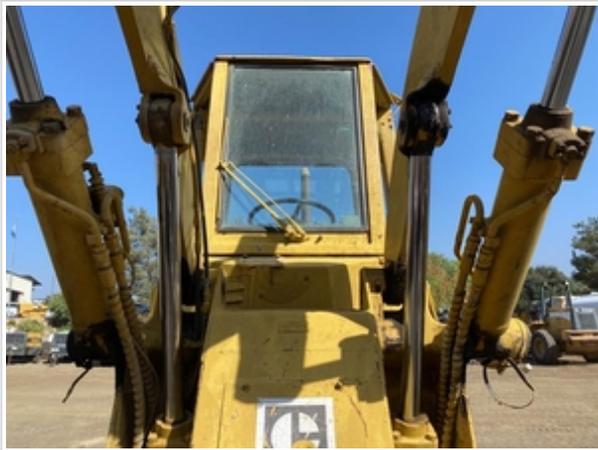
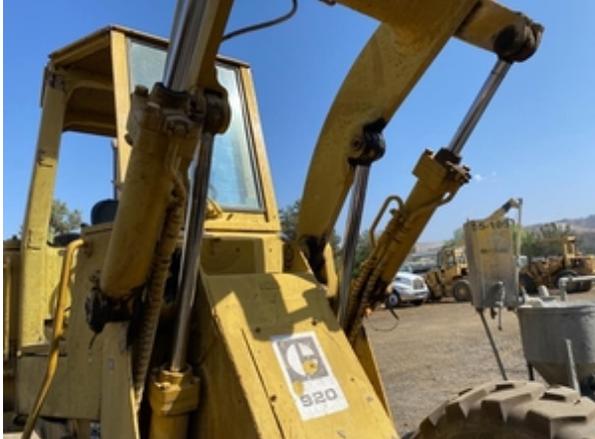
<p>Lift Cylinder Photos</p>

Lift Cylinder	Check the lift cylinder. Note any wear, pitting, discoloration, etc. Take photos.
Lift Cylinder: Mounting Pin	3
Lift Cylinder: Oil Leaks	No

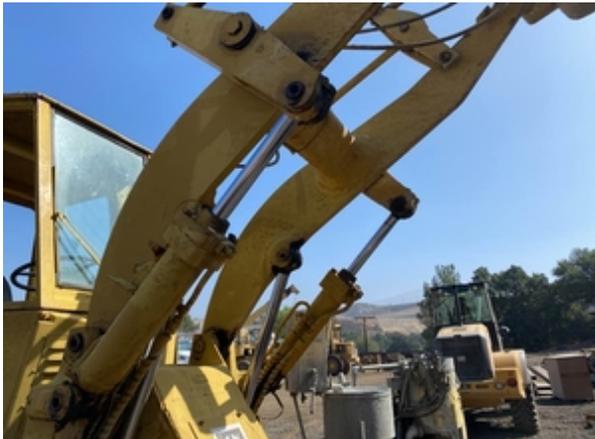
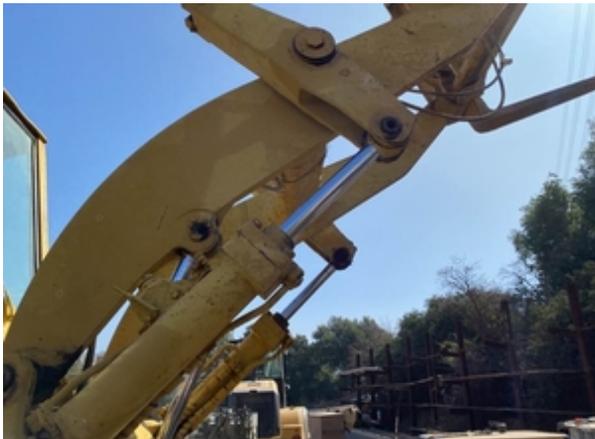
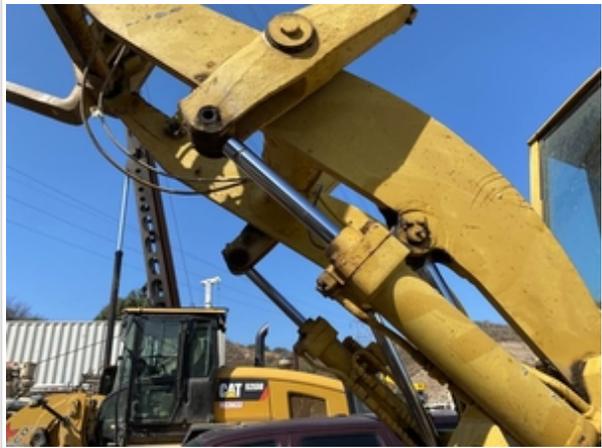
Bucket Cylinder	Check the bucket cylinder. Note any wear, pitting, discoloration, etc. Take photos.	
Bucket Cylinder: Mounting Pin	3	
Bucket Cylinder: Oil Leaks	No	
Bucket Cylinder Photos

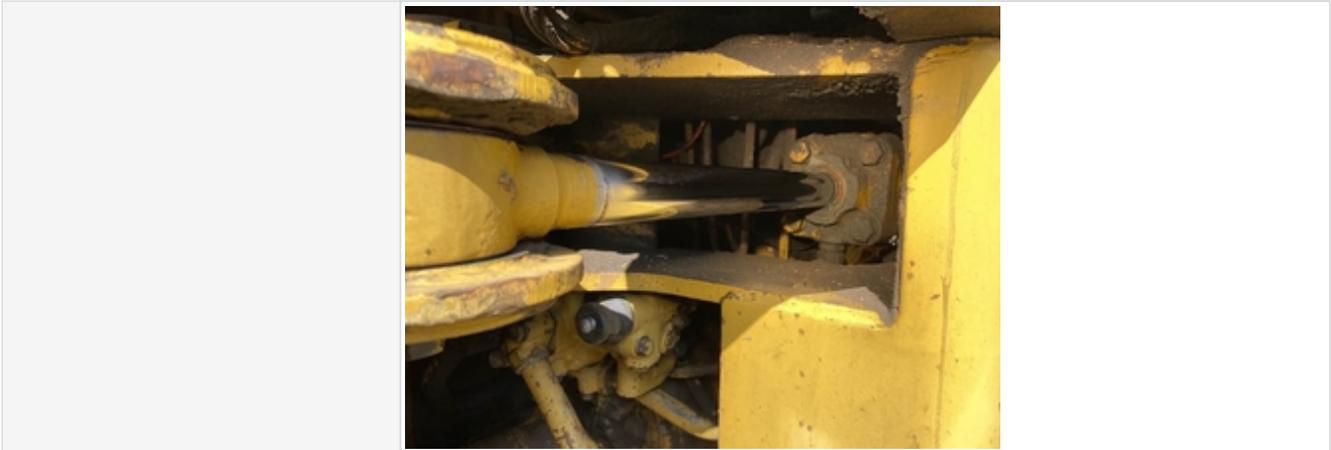
Steering Cylinder	Check the steering cylinder. Note any wear, pitting, discoloration, etc. Take photos.	
Steering Cylinder: Mounting Pin	3	
Steering Cylinder: Oil Leaks	Yes	
Comments	Minor seepage leaks from rod seals	
Steering Cylinder Photos

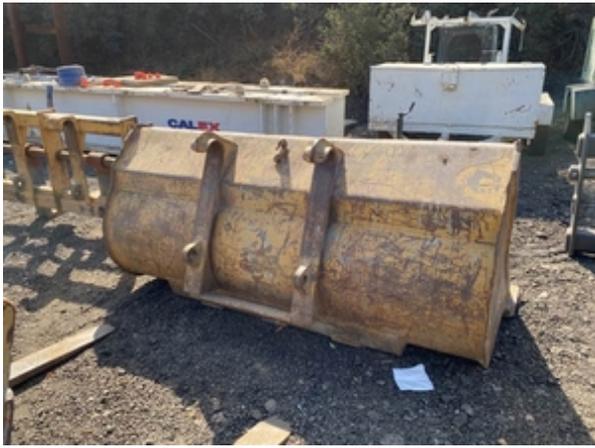
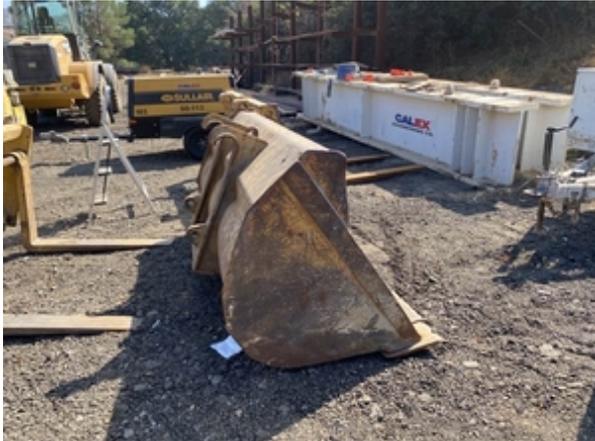
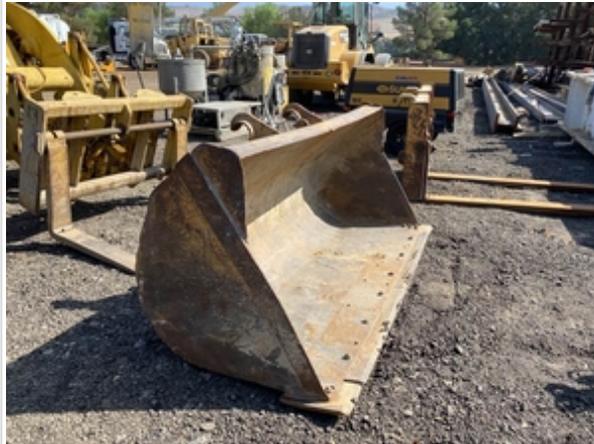
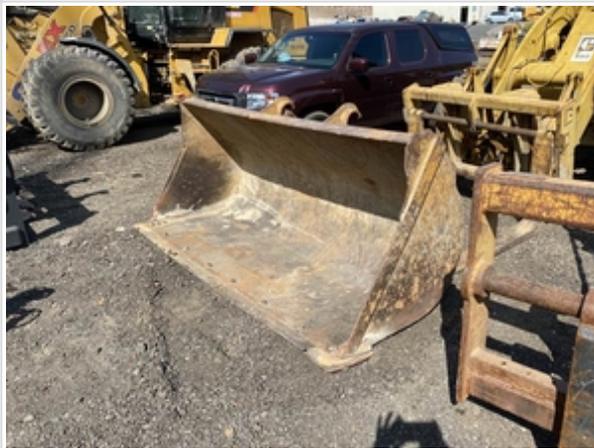
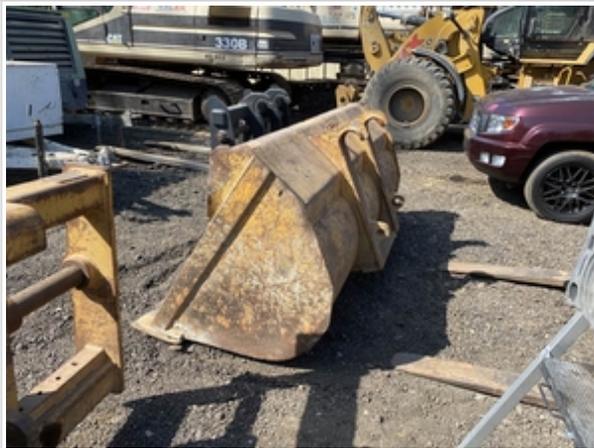
Bucket	3 - Normal Wear & Tear
Bucket Photos

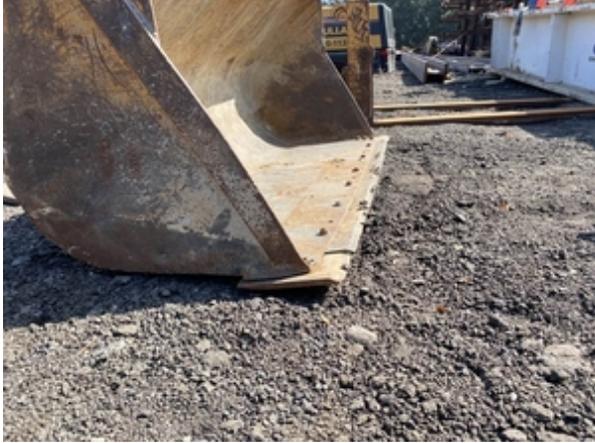
Bucket Edge/Shanks/Teeth Photos

Bucket Edge/Shanks/Teeth

3 - Normal Wear & Tear
