Inspection Report (Excavator)

Year	1997
Make	Komatsu
Model	PC 128UU
Serial Number	3267
Hour Meter Reading	10,607
Previous Application (e.g., earth moving, mining, demolition, etc)	General Construction

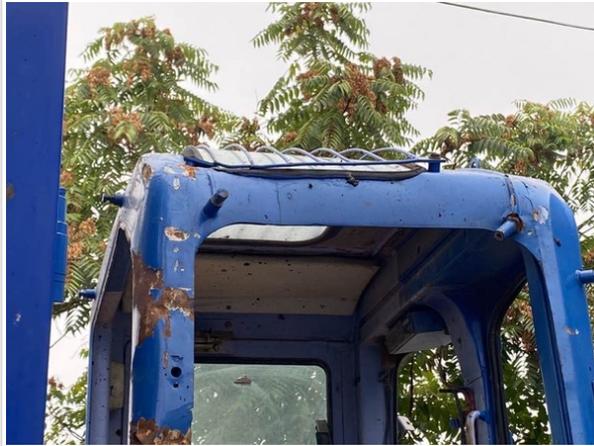
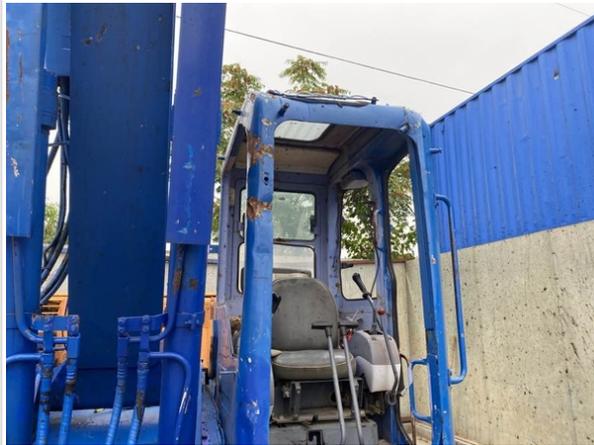
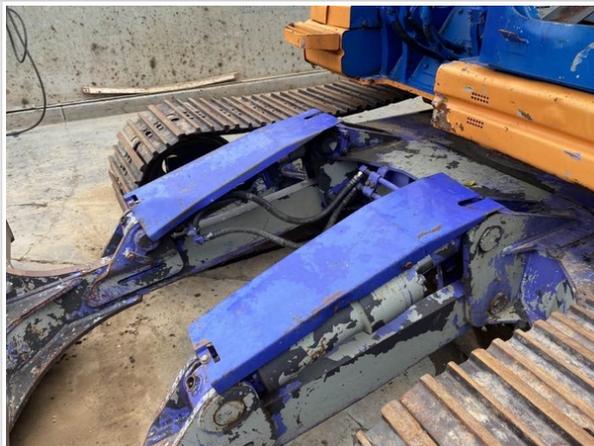
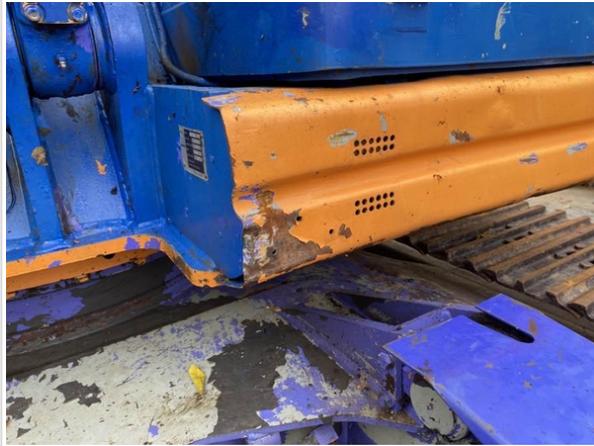
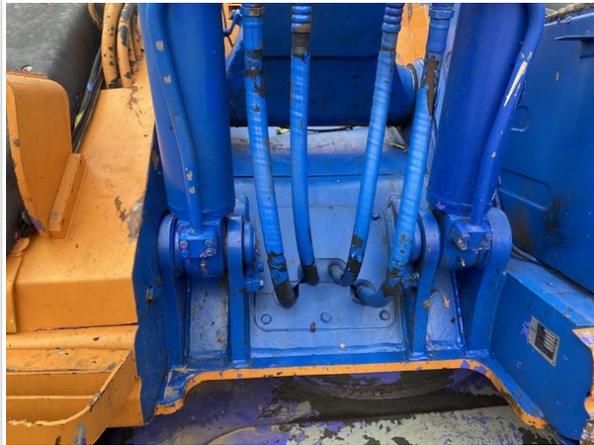
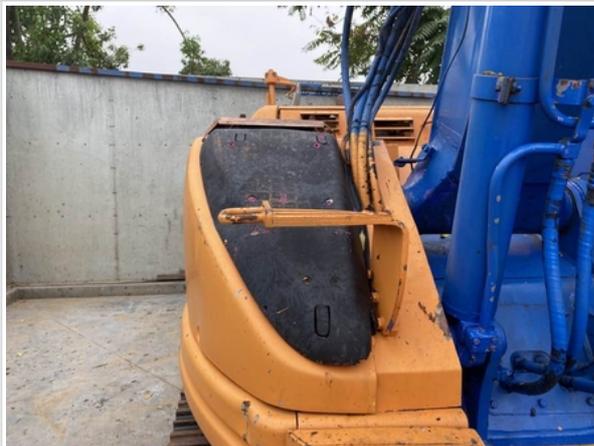
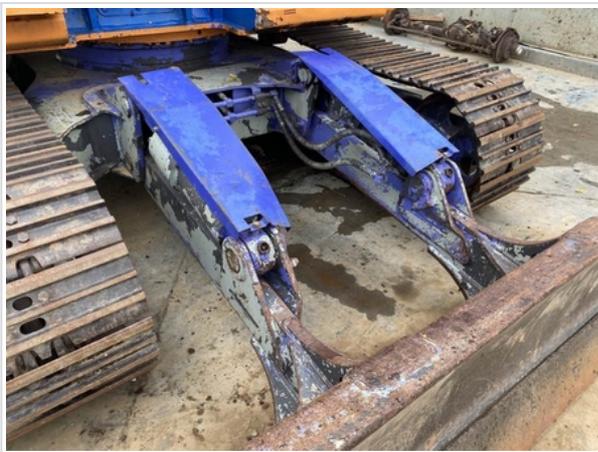
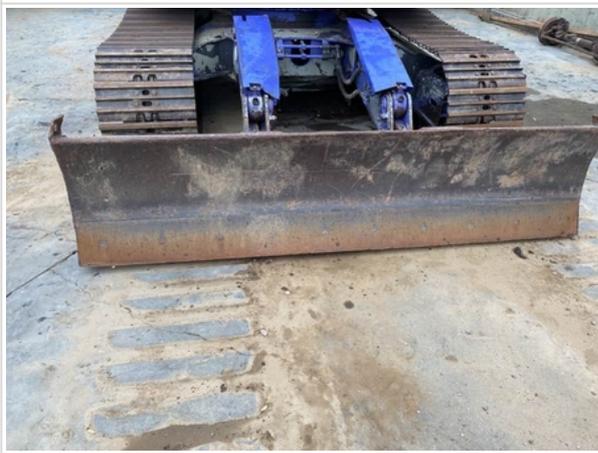
Front	3 - Normal Wear & Tear
Front Condition	Large dents or cracks, Other (see comments)
Comments	Front cab has dents, cylinder guards dented

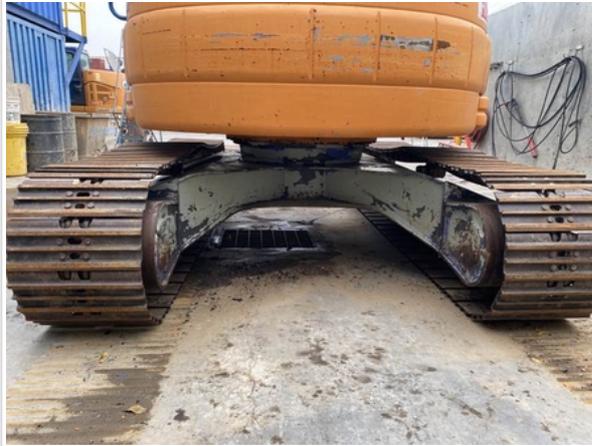
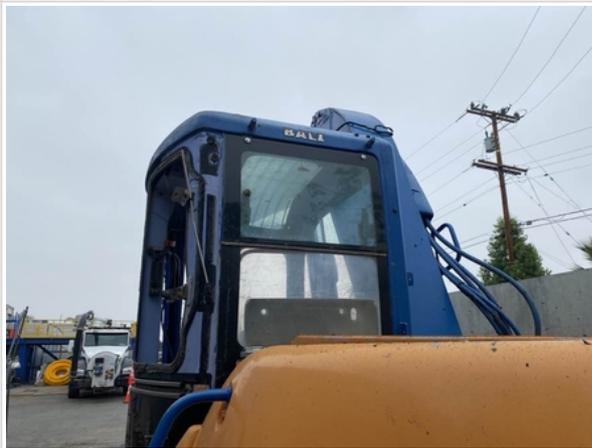
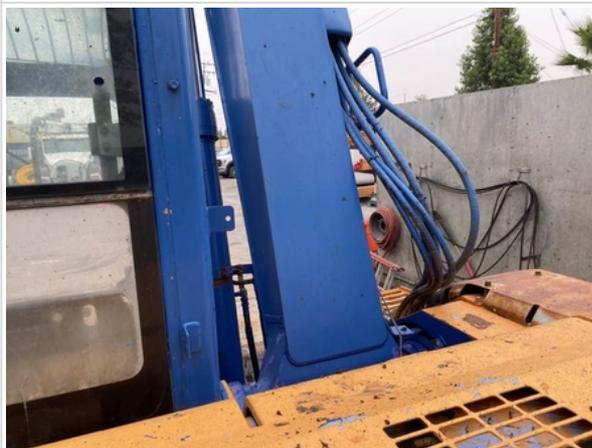
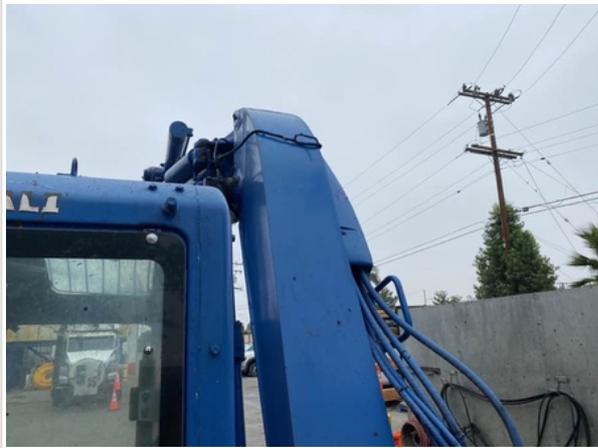
<p>Rear</p>	<p>3 - Normal Wear & Tear</p>	
<p>Rear Condition</p>	<p>Other (see comments)</p>	
<p>Comments</p>	<p>Normal wear and tear scuff marks</p>	
<p>Rear Photos</p>

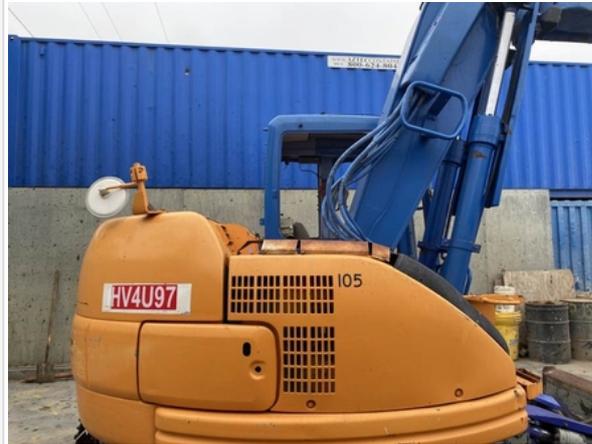
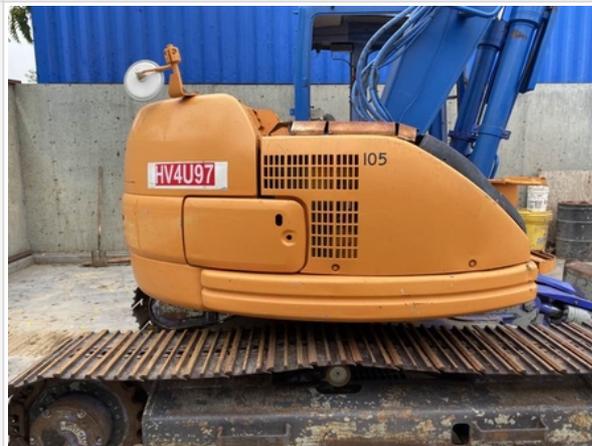
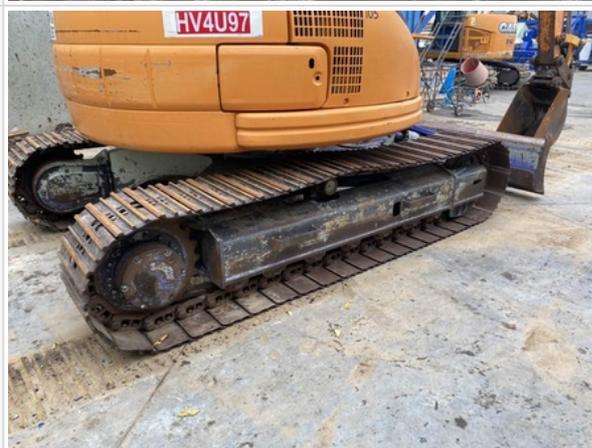
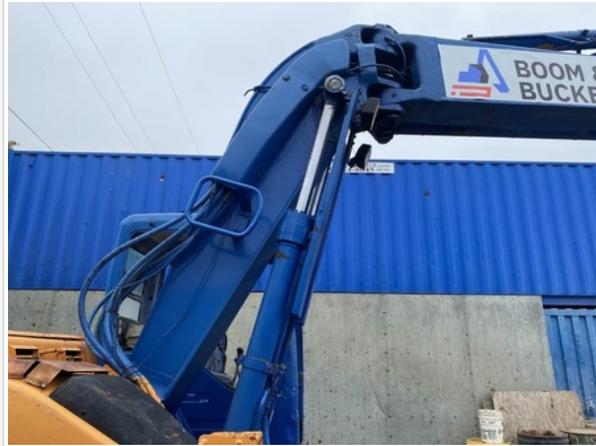
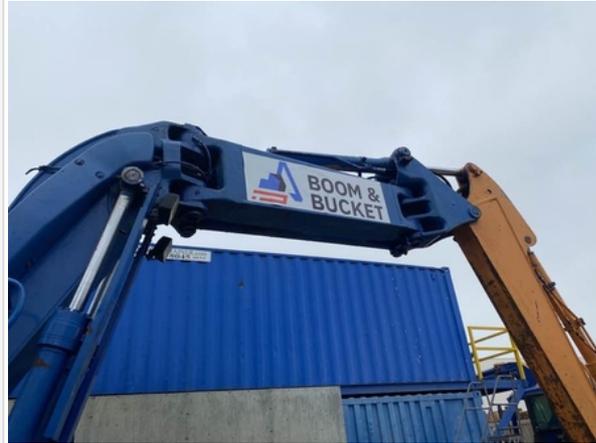
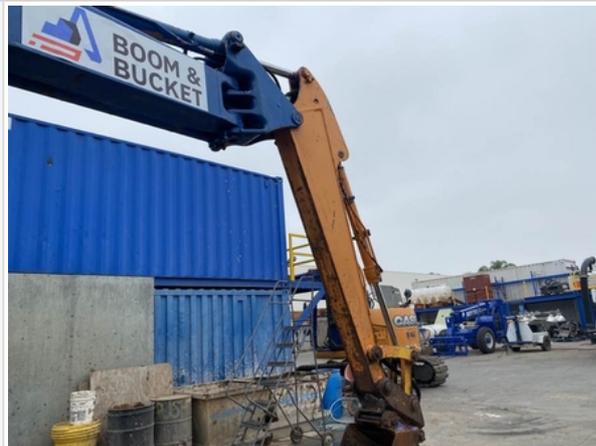
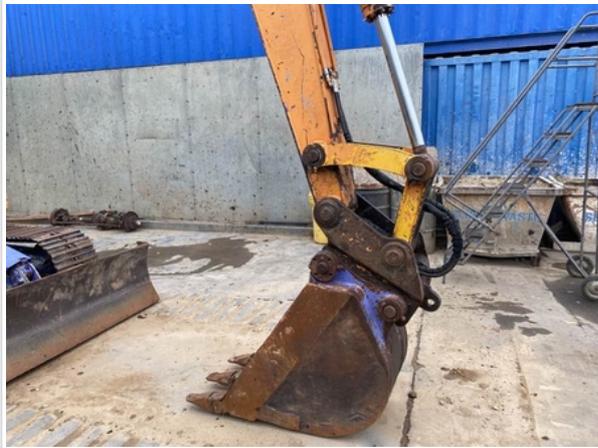
Right Photos

<p>Right</p>	<p>3 - Normal Wear & Tear</p>
<p>Right Condition</p>	<p>No visible damage, Other (see comments)</p>
<p>Comments</p>	<p>Normal wear and tear</p>

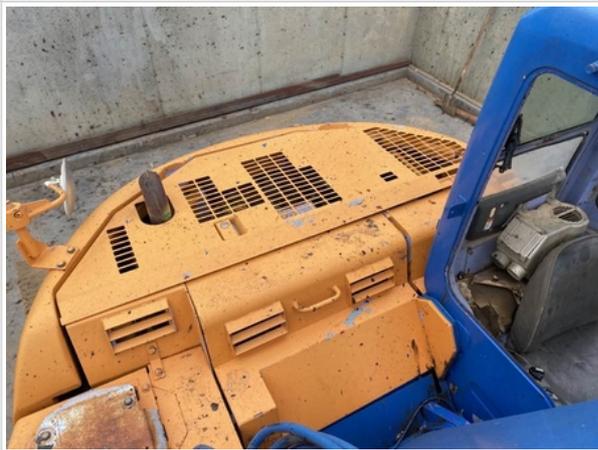
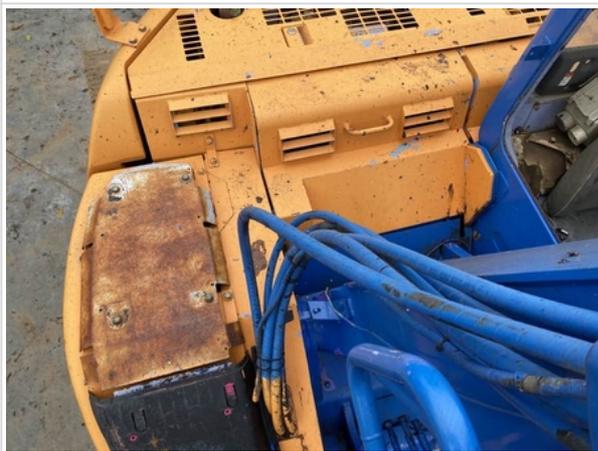
Upper	3 - Normal Wear & Tear	
Upper Condition	No visible damage, Other (see comments)	
Upper Photos

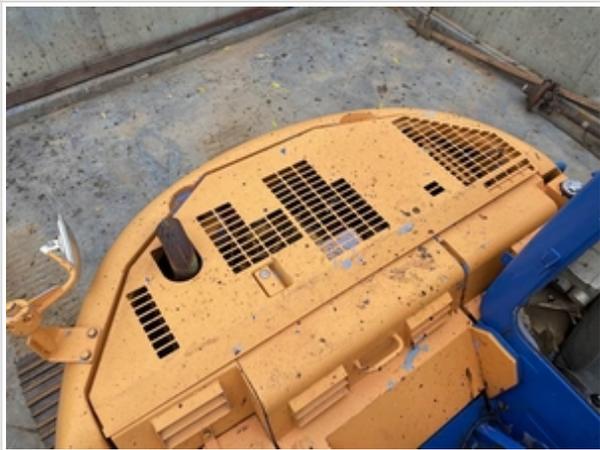
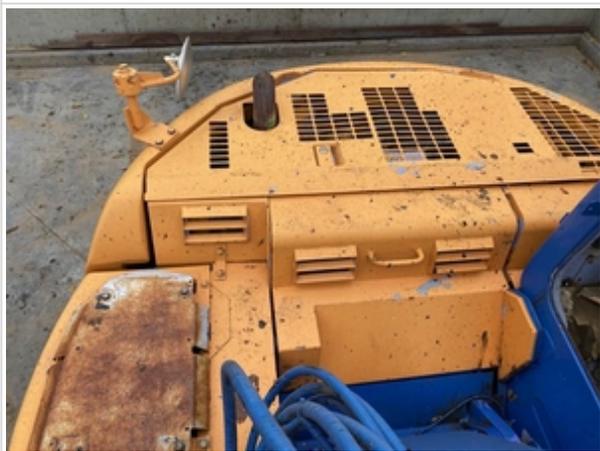
Body Panels (Any Rust Damage?)	3 - Normal Wear & Tear	
Body Panel Condition	No visible damage, good paint condition and panel fitment, Other (see comments)	
Body Panels Photos

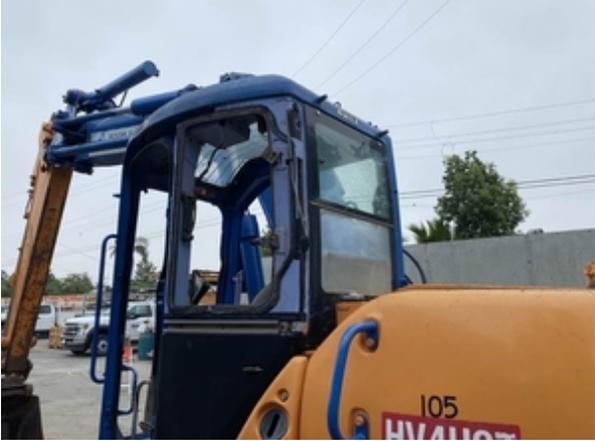
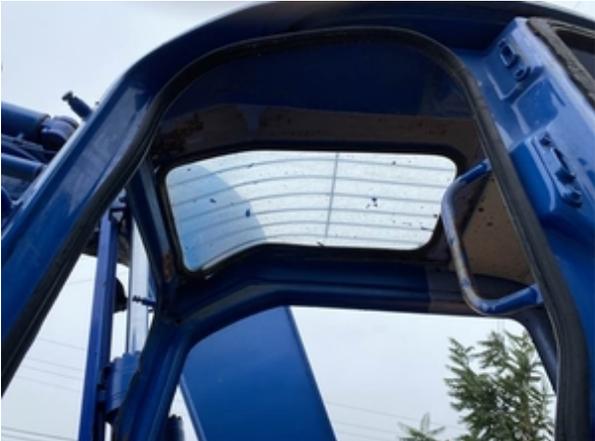
Glass Condition Photos

Glass Condition	2 - Above Average Wear	
Glass Condition Notes	Not applicable, no glass, Other (see comments)	
Comments	Rear window and sunroof window still intact and okay

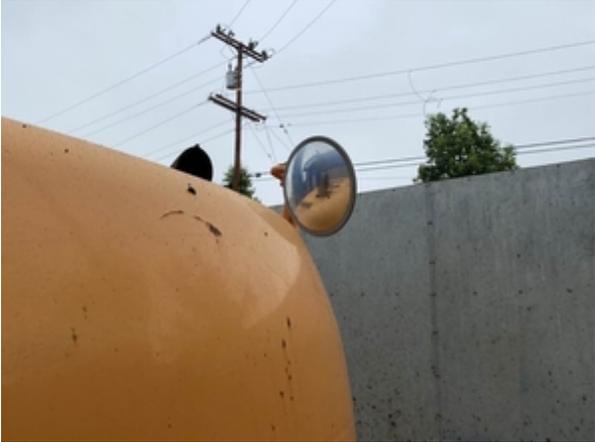
Mirrors	3 - Normal Wear & Tear
Mirror Condition Notes	Mirrors present and intact, no visible damage
Mirrors Photos

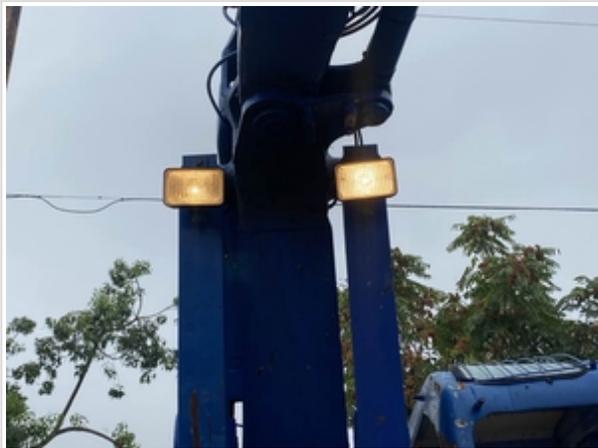
Lighting System Photos

Lighting System	3 - Normal Wear & Tear
Lighting System Condition	Other (see comments)
Comments	Light switch missing knob. Functions okay when switched to on position.

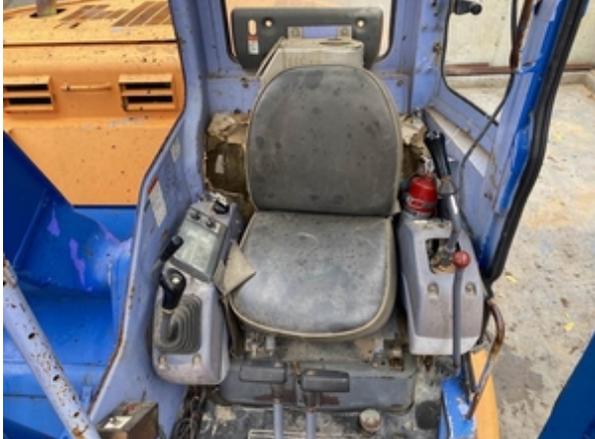
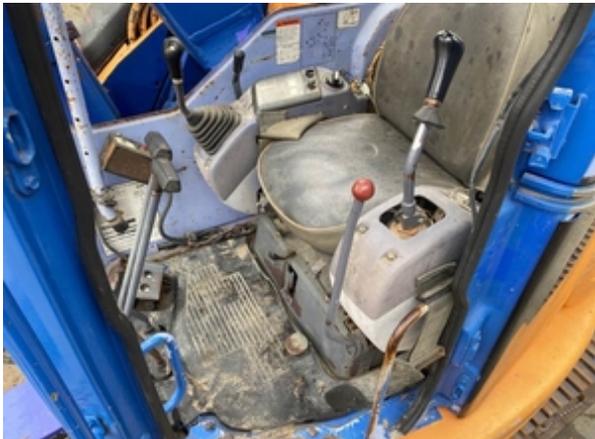
Operator Cabin Overall	2 - Above Average Wear
Operator Cabin Overall Condition	Significant wear and tear to cabin floor, panels, and ceiling
Operator Cabin Photos

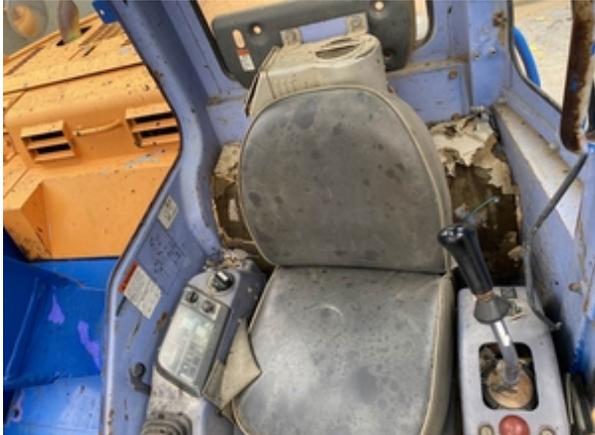
Operator's Seat & Arm Rests	2 - Above Average Wear
Operator's Seat & Arm Rests Condition	Seat(s) have minor surface staining or small tears
Comments	Seat sitting loose on frame (unbolted/unsecured)
Operator's Seat & Arm Rests Photos

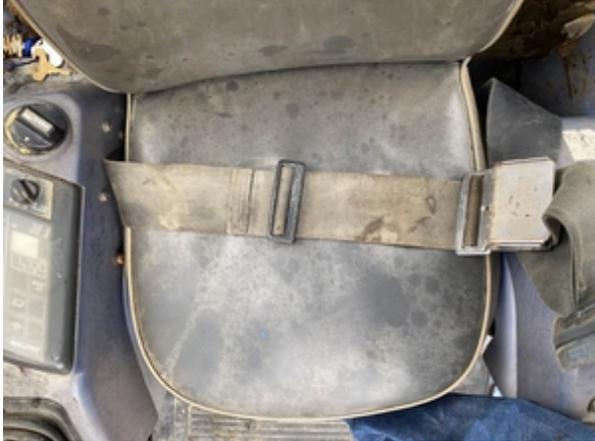
Seat Belt Photos

Seat Belt	3 - Normal Wear & Tear
Seat Belt Condition	Seat belt secures properly. Nicks, cuts, holes, or fraying observed on belt webbing

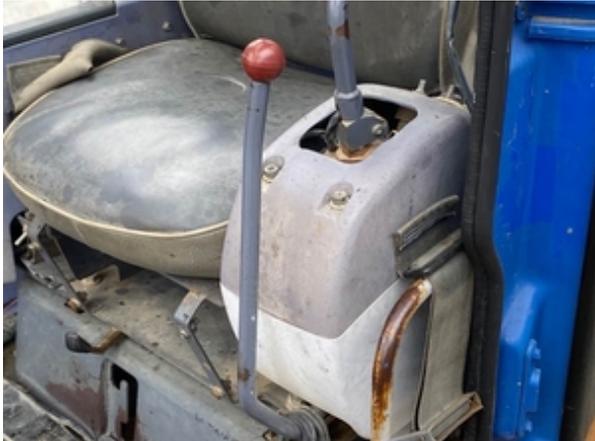
Cabin Lights	0
Safety Lock Out / Stop	3 - Normal Wear & Tear
Safety Lock Out / Stop Condition	Safety lock out device is present, in good condition, and functional
Safety Lock Out / Stop Photos

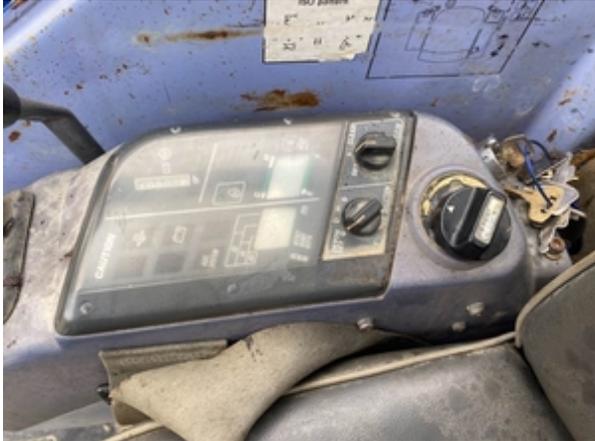
Controls & Switches	2 - Above Average Wear
Controls & Switches Condition	One or more switches are inoperative or missing, Other (see comments)
Comments	Light switch knob missing
Controls & Switches Photos

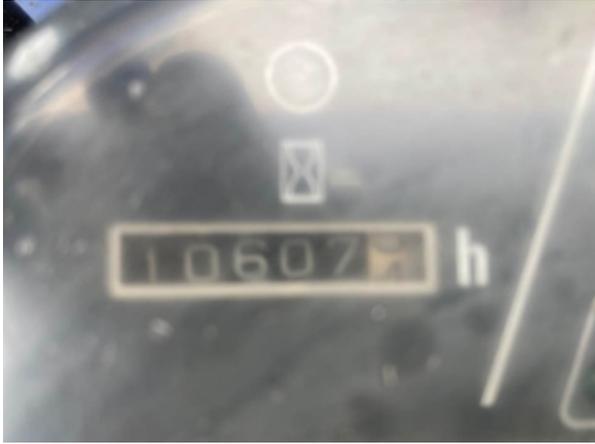
Hour Meter Activity	3 - Normal Wear & Tear
Hour Meter Condition	Hour meter is functional and in good condition
Hour Meter Activity Photos

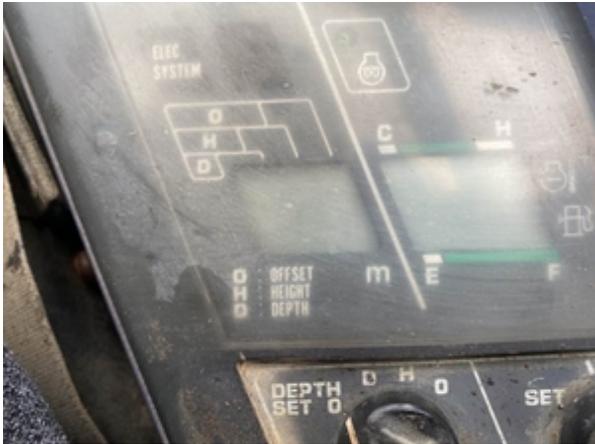
Other Gauge Activity	2 - Above Average Wear
Other Gauge Condition	One or more gauges are unreadable or not functioning (specify in comments), Other (see comments)
Comments	Fuel level gauge and coolant temperature gauge and boom indicator digital display in operable
Other Gauge Activity Photos

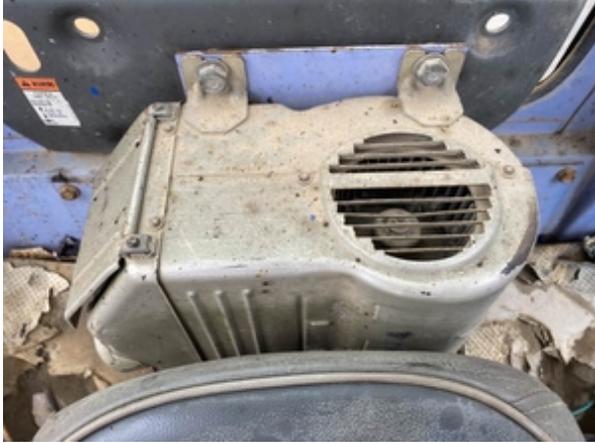
Fans / Vents Photos

Heater & A/C	0
Fans / Vents	1 - Service Required
Fans / Vents Condition	Other (see comments)
Comments	Fan motor turn on but making bad bearing sound

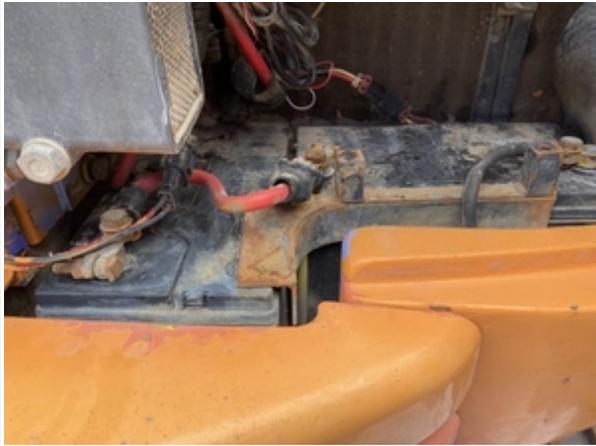
<p>Battery Condition Photos</p>

Blow-by (Visual Observation Check)	Yes
Comments	Excessive blowby observed at breather hose. Minor seepage leak at r/s engine block
Unusual Noises (Upon Start-up, Idle, Shutdown)	No
Unusual Noise Notes	No unusual noises heard
Engine Smoke (Upon Start-up, Idle, Shutdown)	No
Engine Smoke Notes	No engine smoke issues observed
Engine Exhaust Color	Clear, Other (see comments)
Comments	Normal black smoke at startup and very little under load
Battery	3 - Normal Wear & Tear
Battery Condition	Dusty & dirty appearance, Clean & dry appearance, tight connections

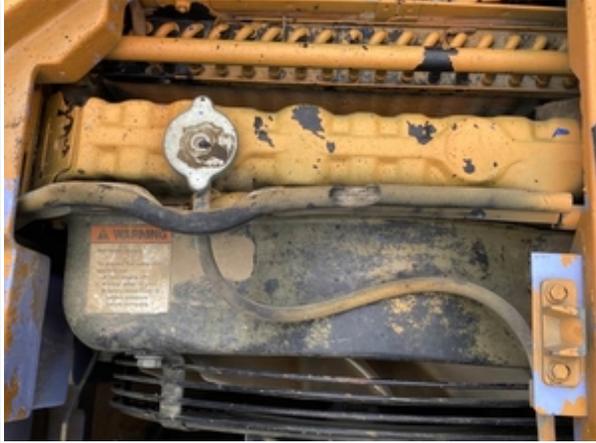
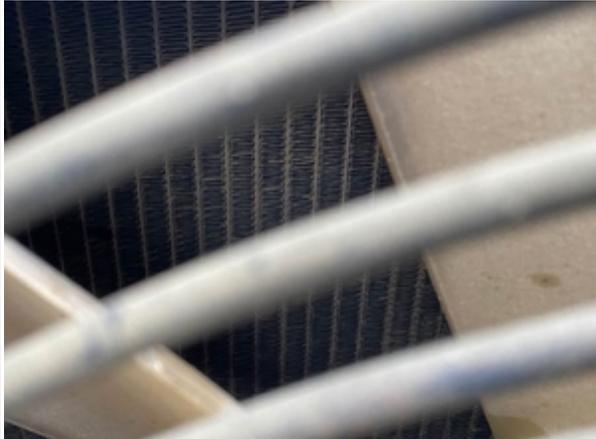
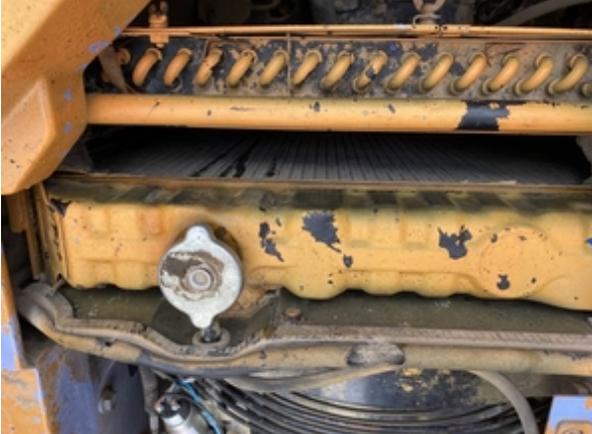
<p>Radiator</p>	<p>3 - Normal Wear & Tear</p>
<p>Radiator Condition</p>	<p>Radiator fins & components appear to be in good working order, no signs of damage or leaks</p>
<p>Radiator Photos</p>

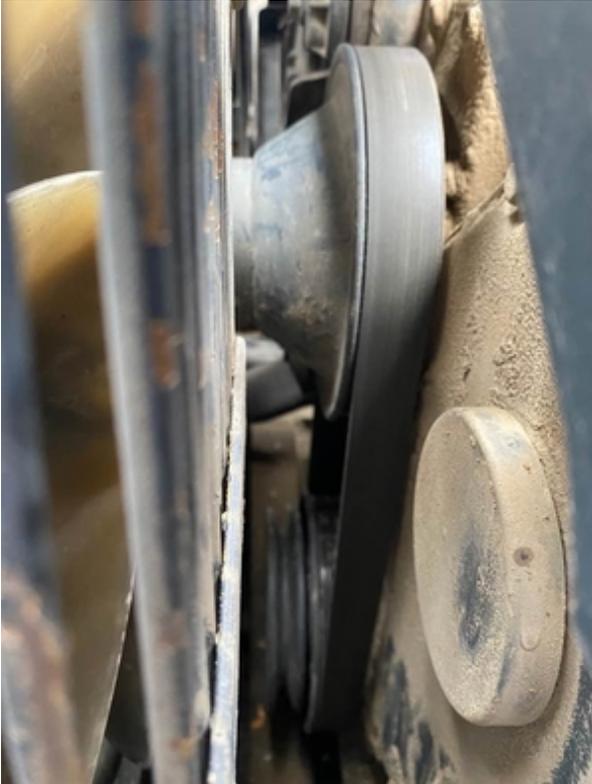
Belts	3 - Normal Wear & Tear	
Belt Condition	Belts appear in good condition & alignment with proper tension	
Belt Photos

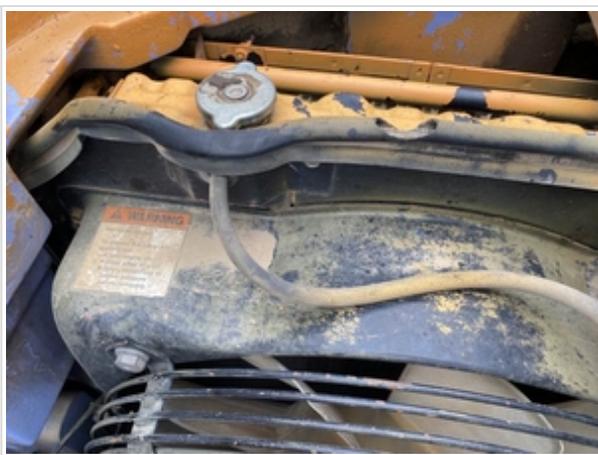
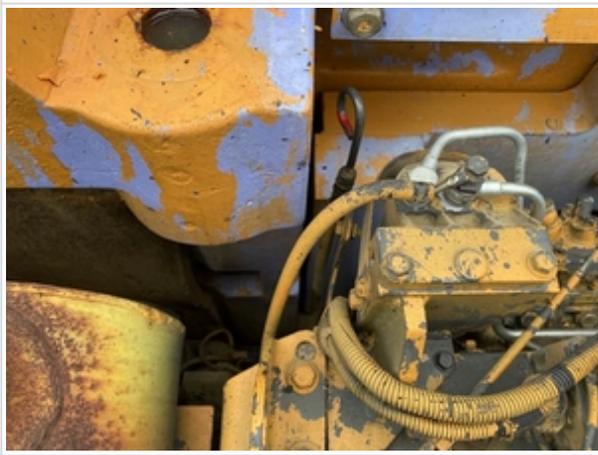
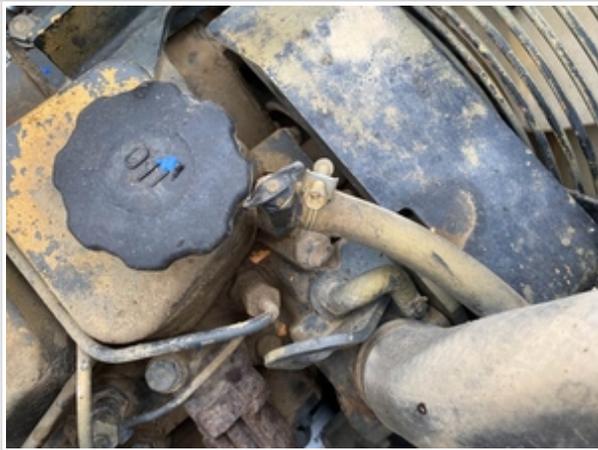
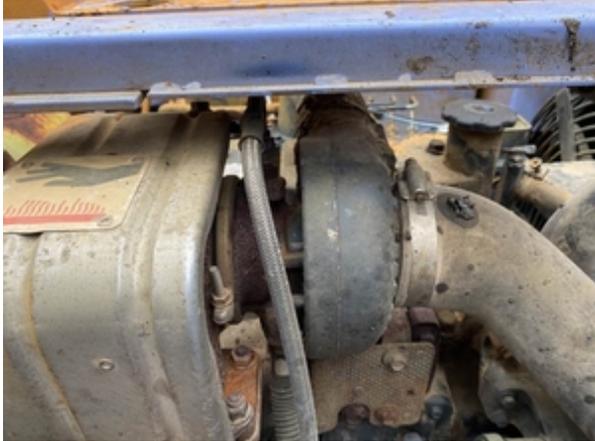
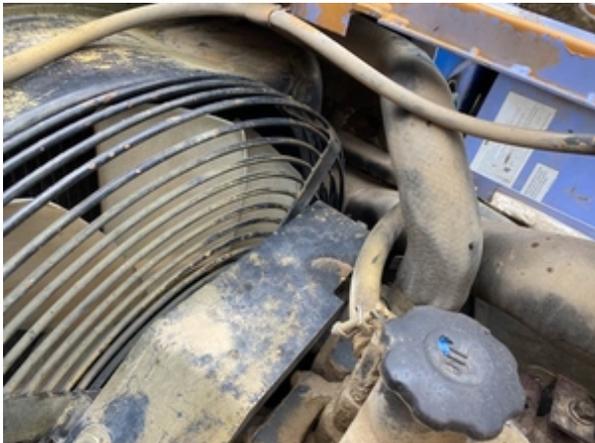
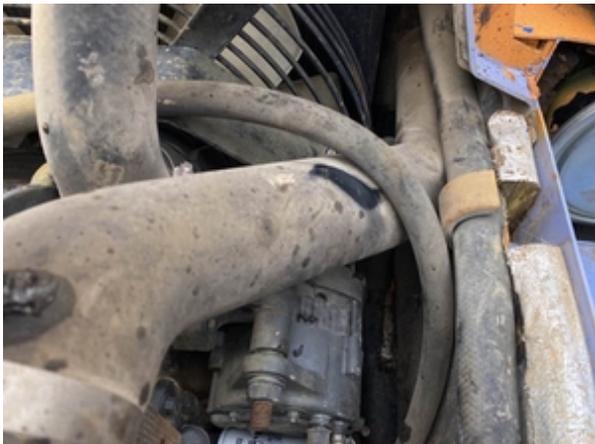
<p>Hose Photos</p>

Hoses	3 - Normal Wear & Tear	
Hose Condition	Firm, pliant hoses with no signs of wear or leaks, Worn, cut, or damaged outer covering on one or more hoses, Other (See comments)	
Comments	Worn intake hose from coolant hose rubbing it

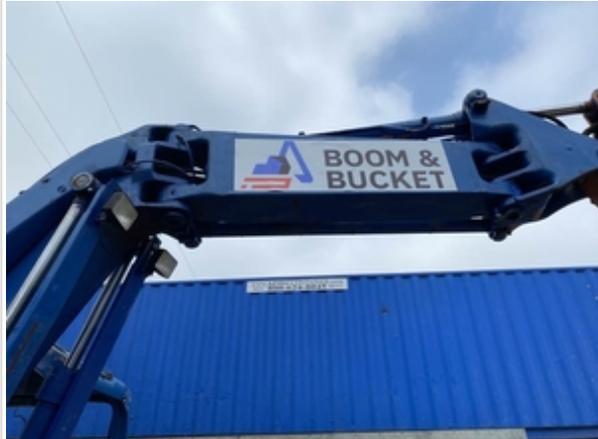
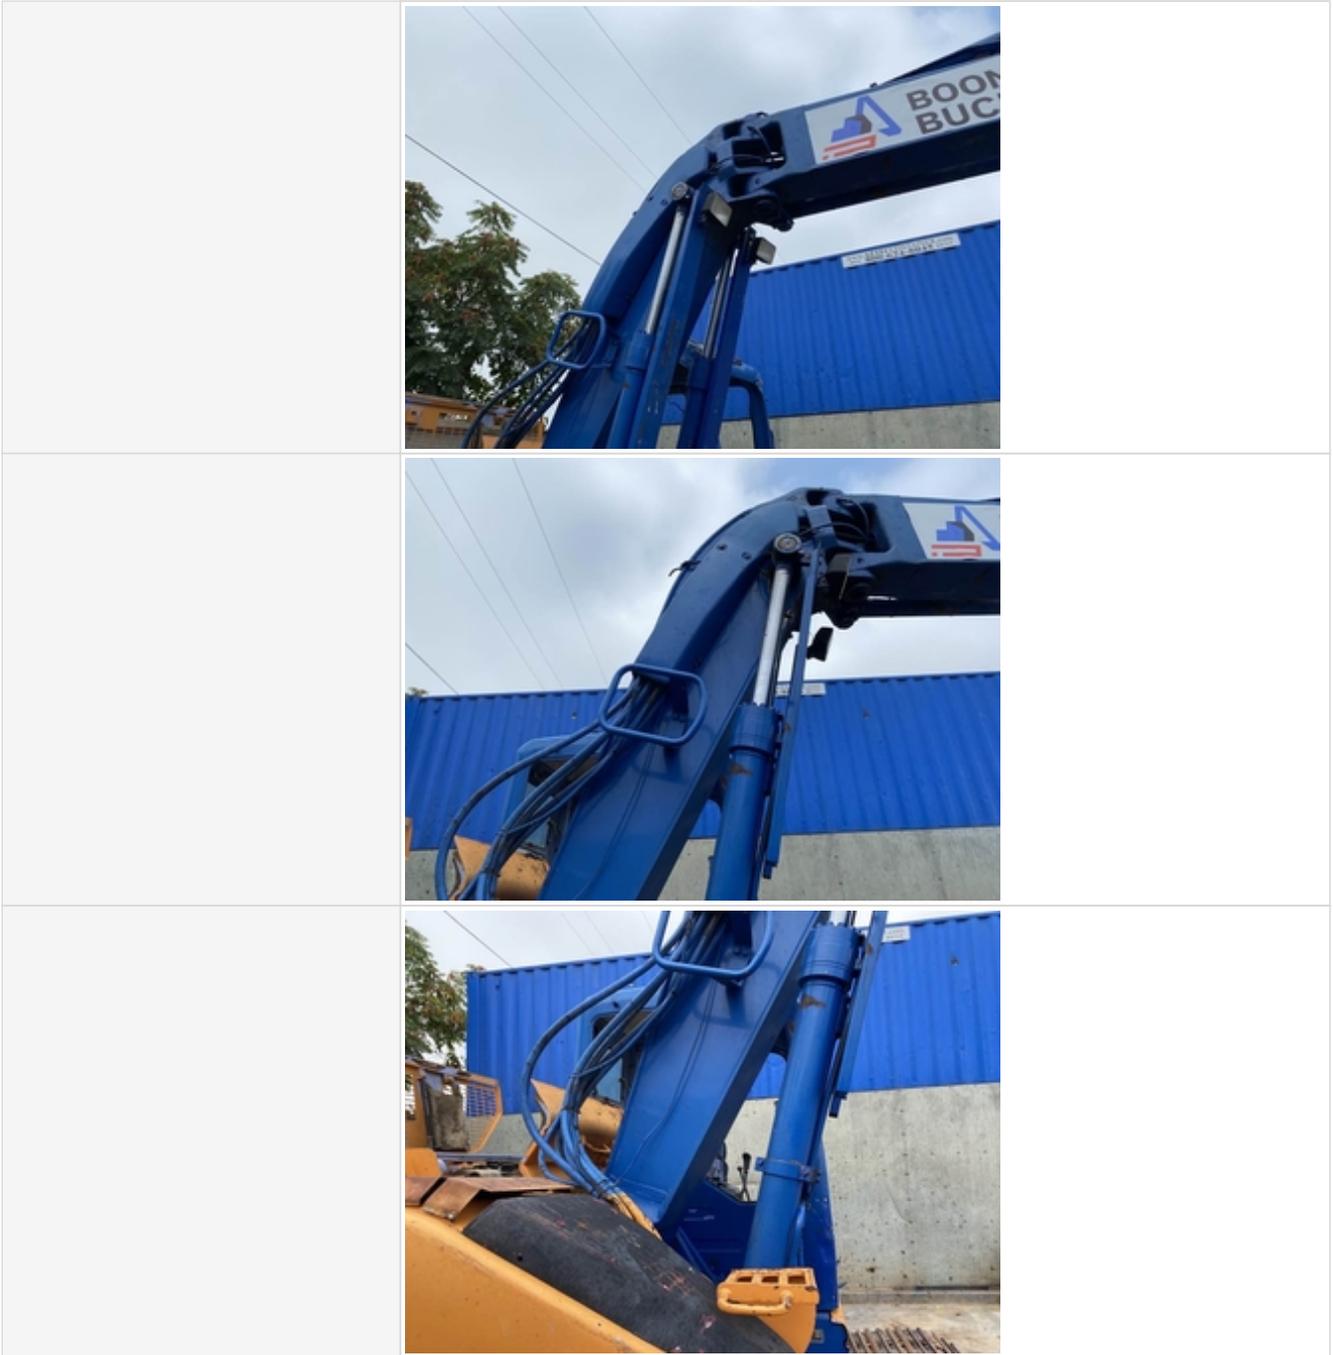
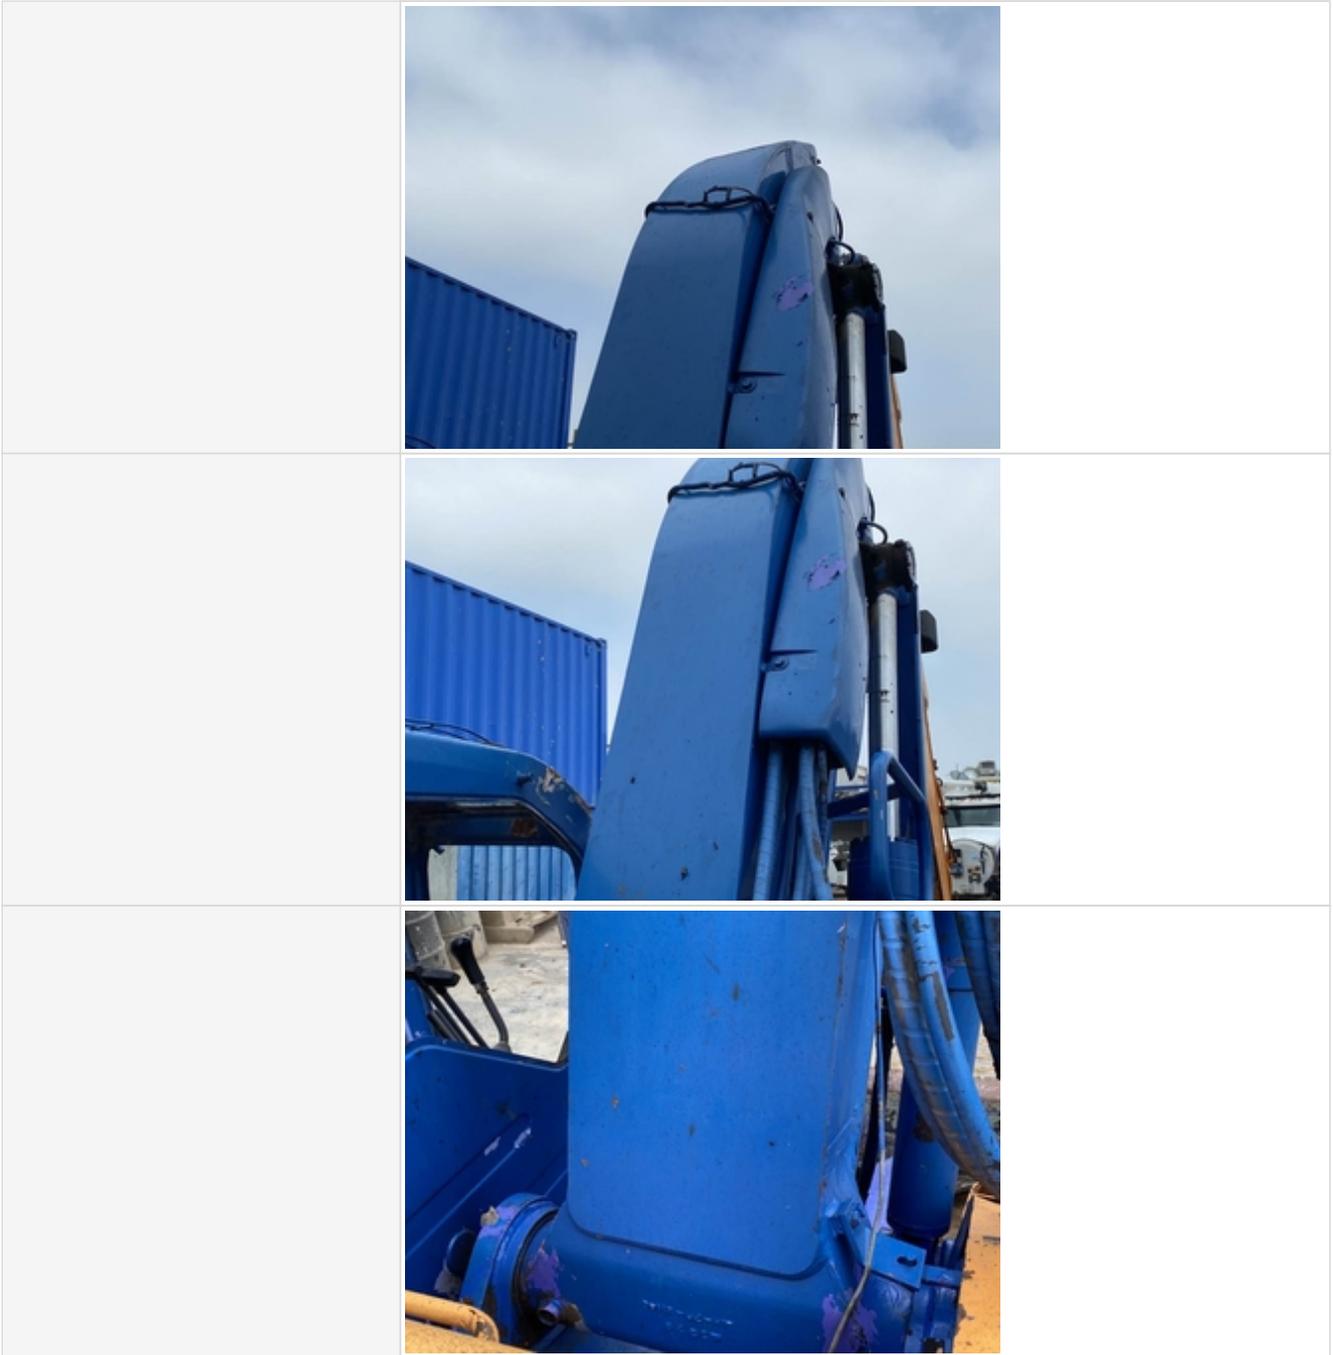
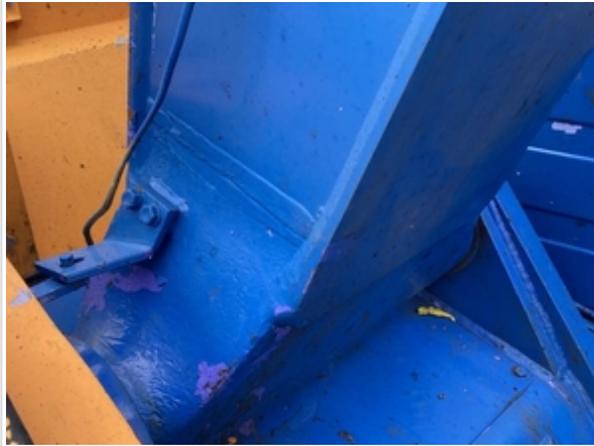
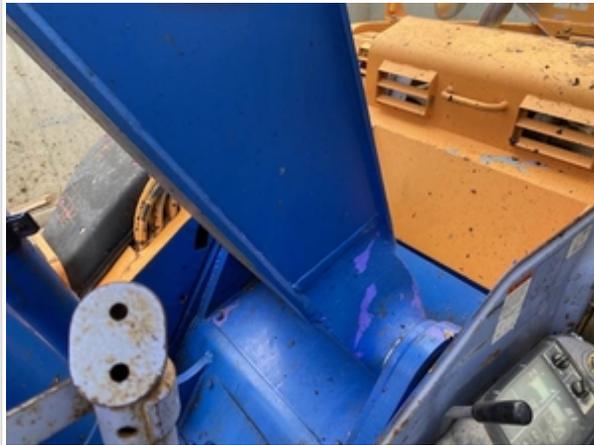
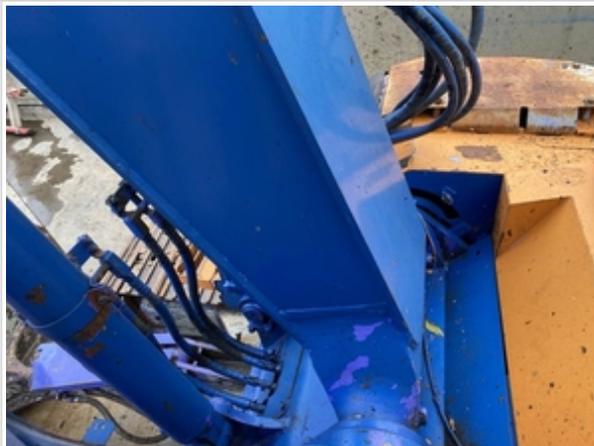
Boom Condition	3 - Normal Wear & Tear
Boom Photos

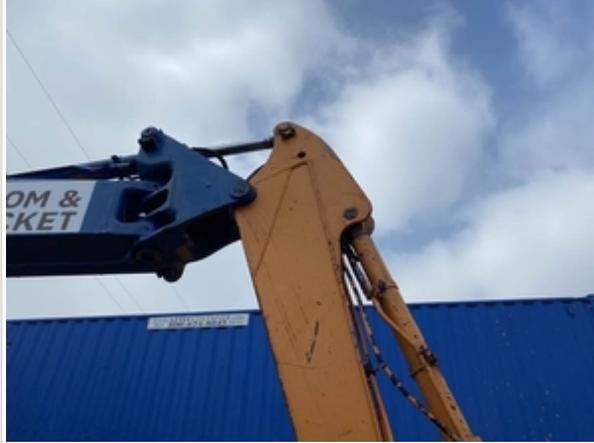
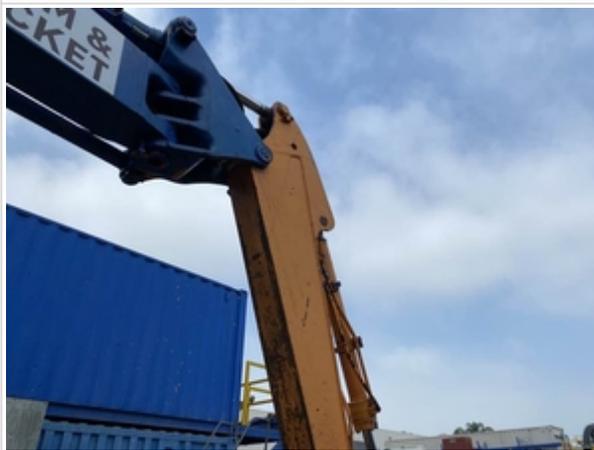
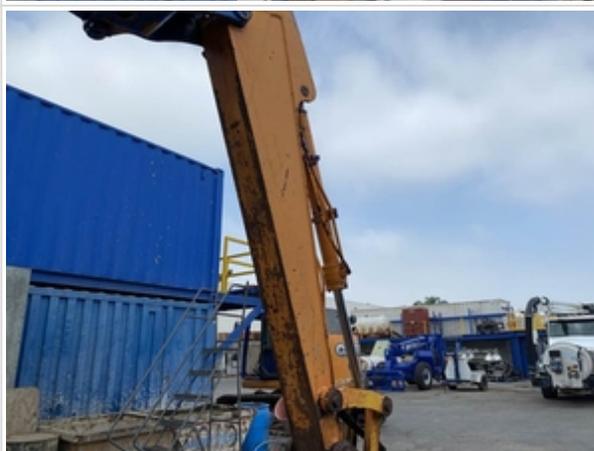
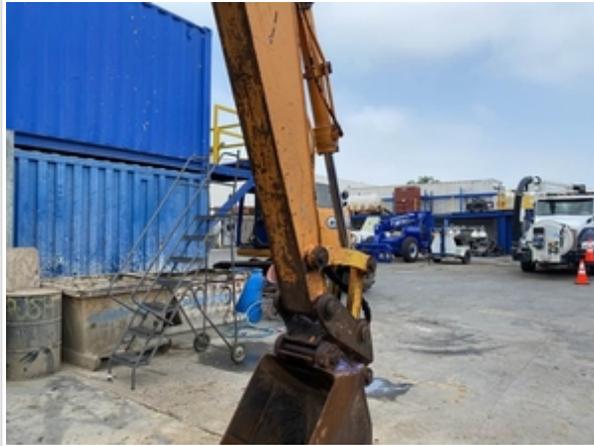
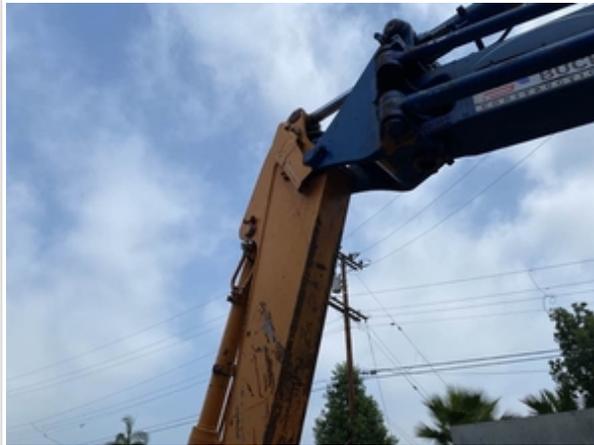
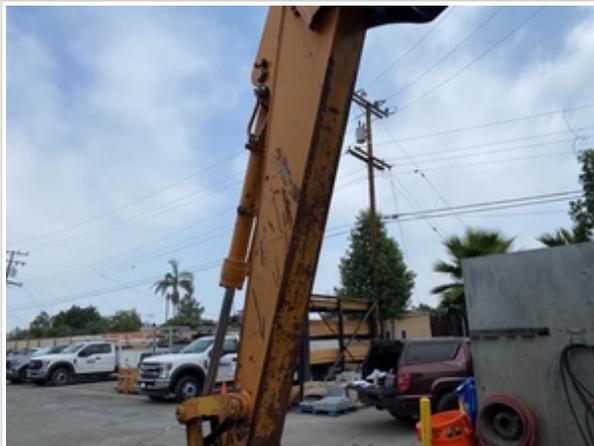
Stick Photos

<p>Stick Condition</p>	<p>3 - Normal Wear & Tear</p>

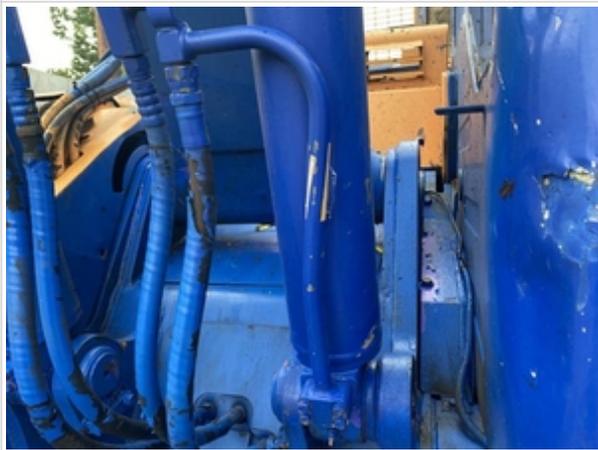
Boom Base Pin & Bushings	3 - Normal Wear & Tear
Boom Base Pin & Bushings Photos

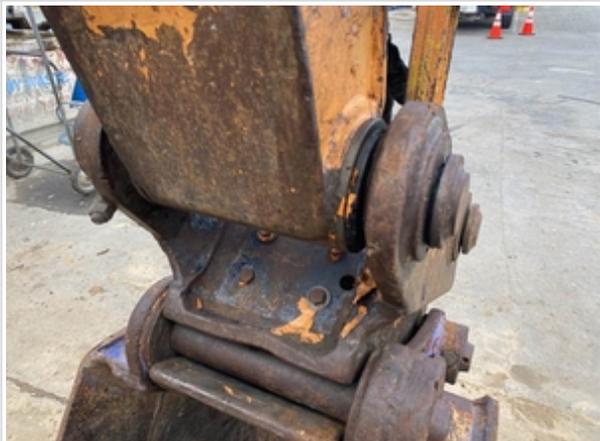
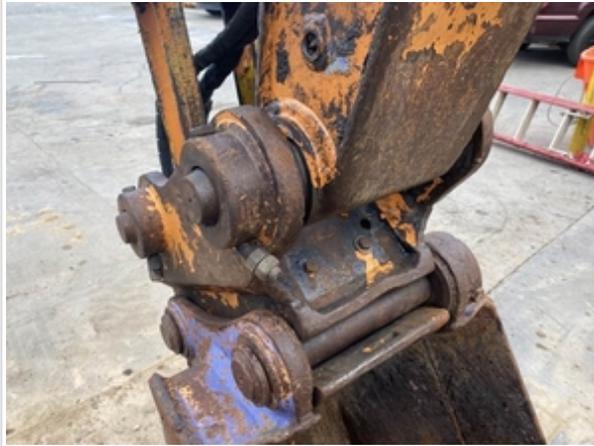
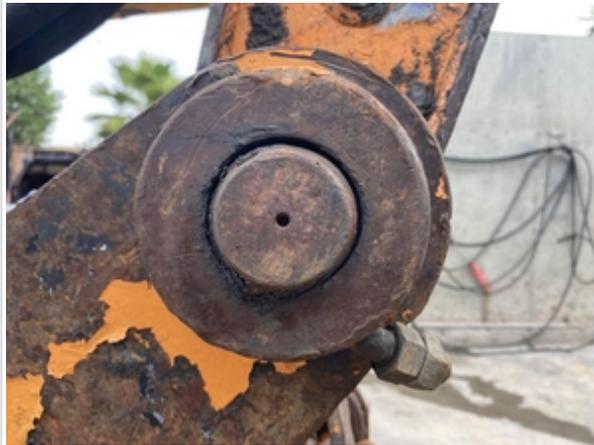
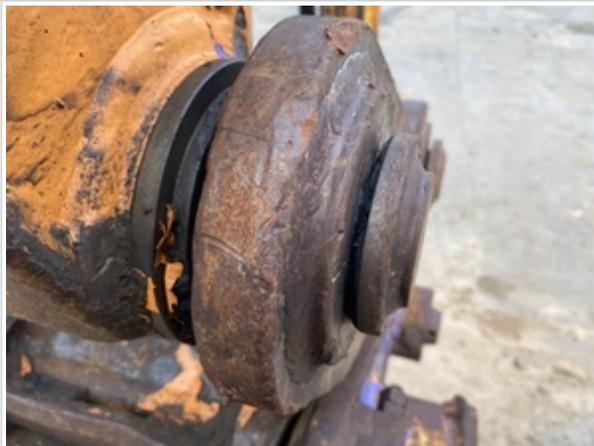
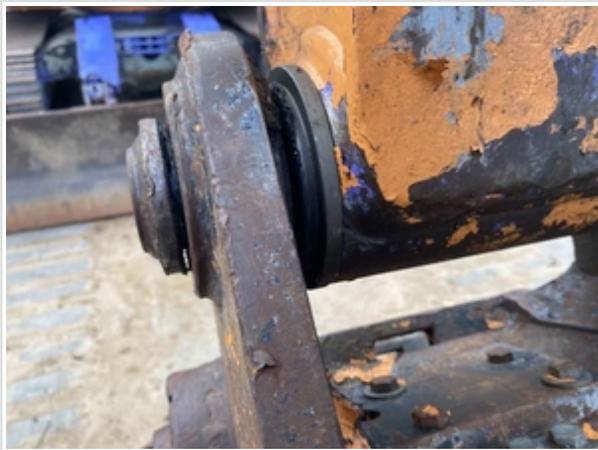
Boom to Stick Pin & Bushings	3 - Normal Wear & Tear
Stick to Bucket Pin & Bushings	3 - Normal Wear & Tear
Comments	Excessive play stick to Bucket coupler Pins connections
Stick to Bucket Pin & Bushings Photos

Overall Chassis	3 - Normal Wear & Tear	
Overall Chassis Comments	Stick to coupler and pins has excessive play. New bearings/bushings and or line boring may be needed

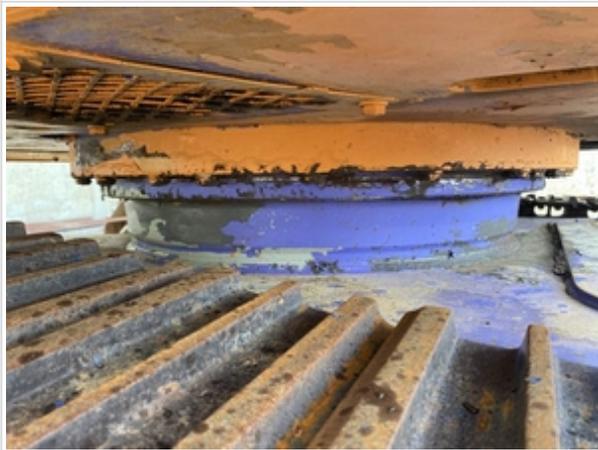
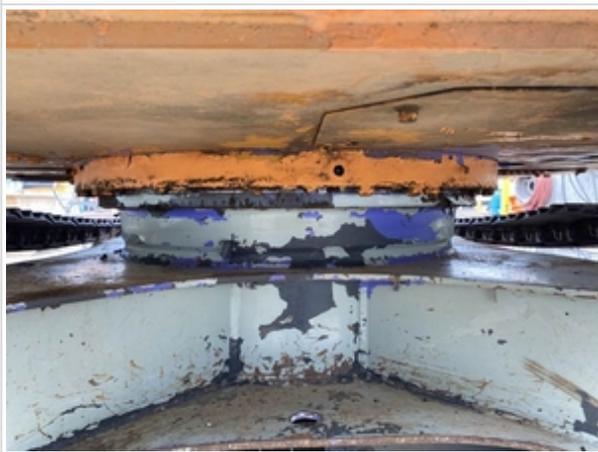
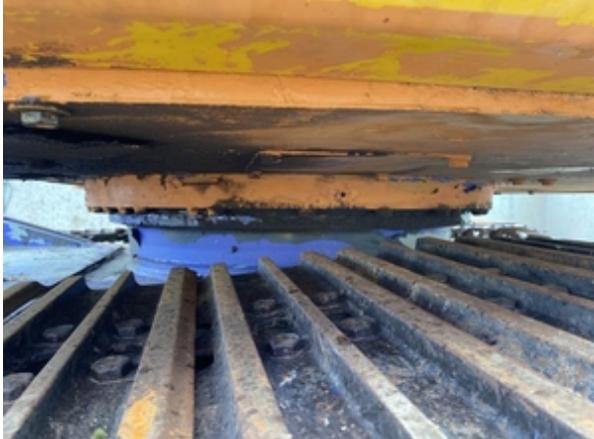
Turntable Bearing	3 - Normal Wear & Tear	
Turntable Bearing Photos
