Inspection Report (Excavator)

Year	1997
Make	Komatsu
Model	PC 128UU
Serial Number	3267
Hour Meter Reading	10,607
Previous Application (e.g., earth moving, mining, demolition, etc)	General Construction

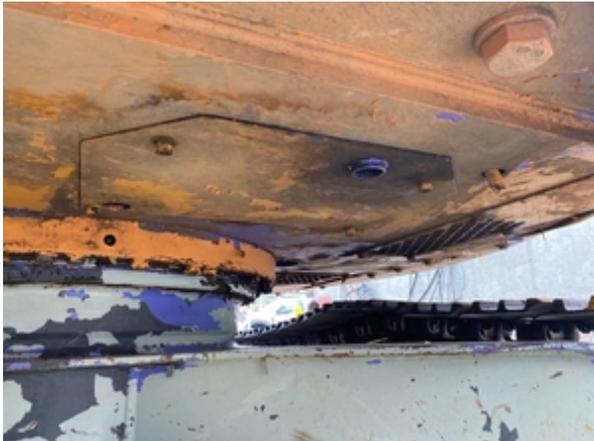
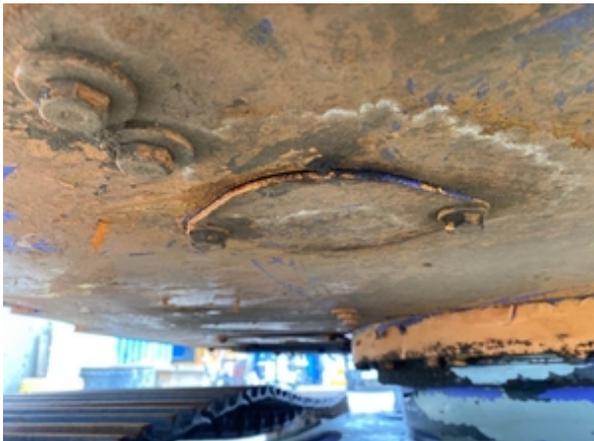
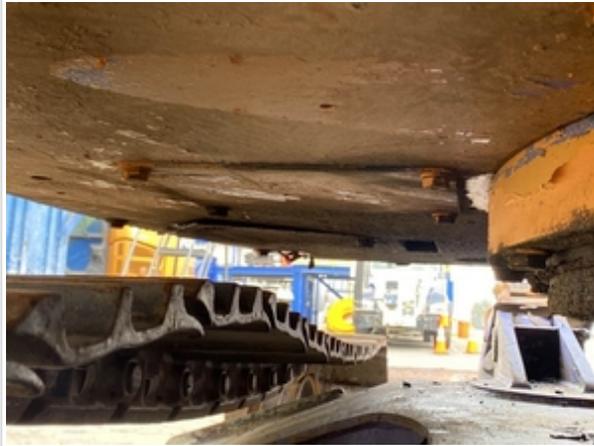
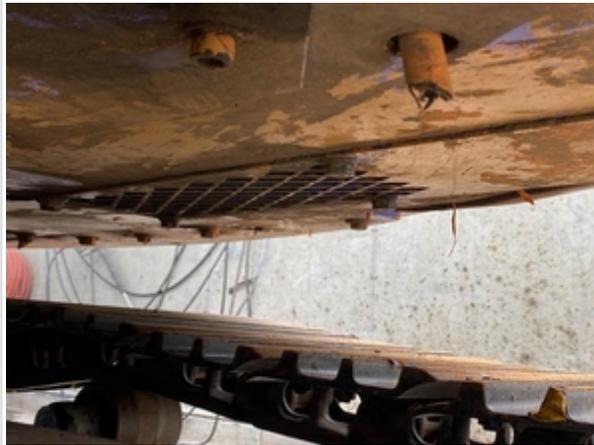
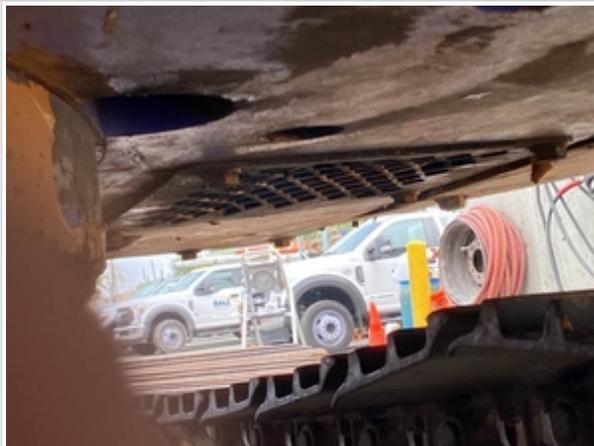
Bottom Covers	3 - Normal Wear & Tear	
Comments	Left side bottom cover slightly bent	
Bottom Covers Photos

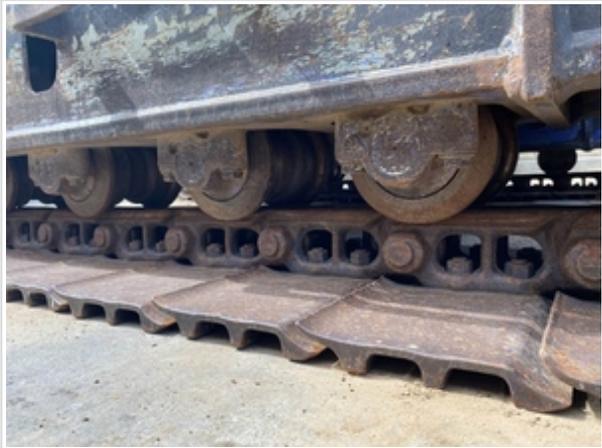
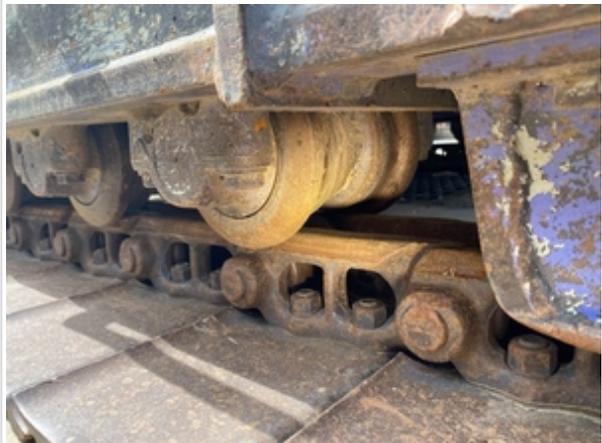
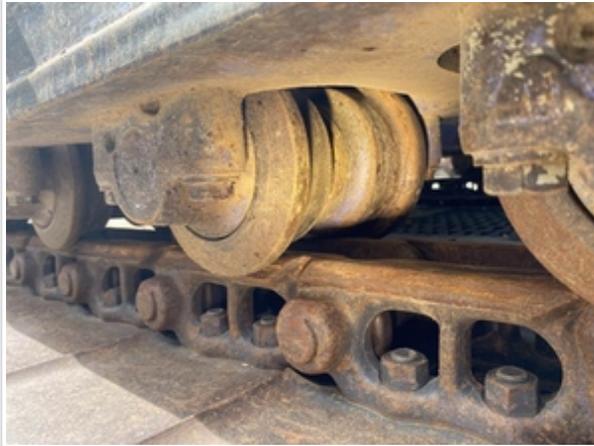
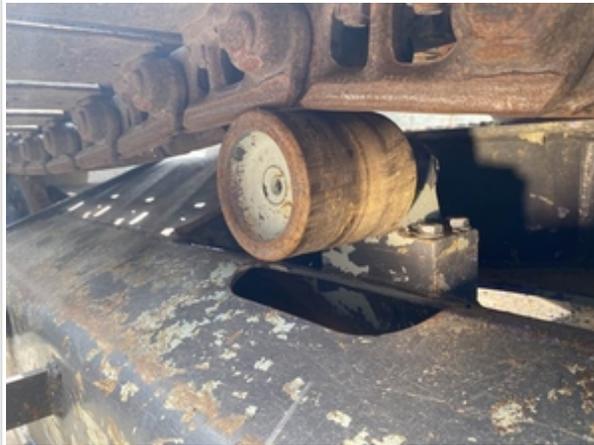
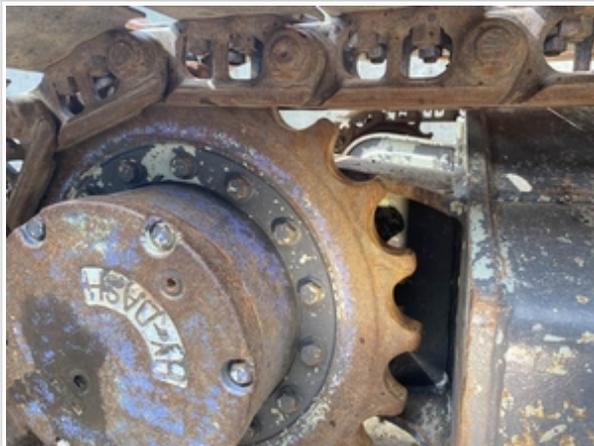
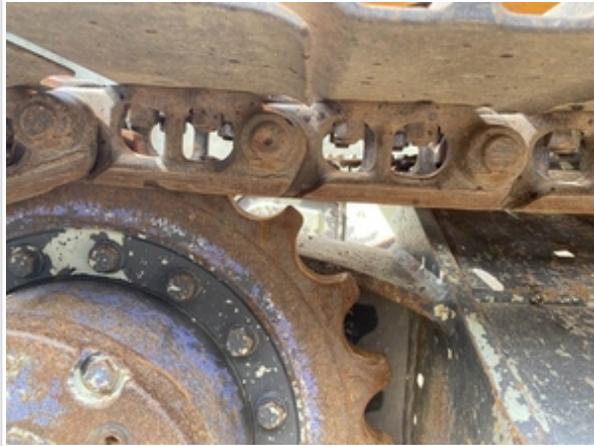
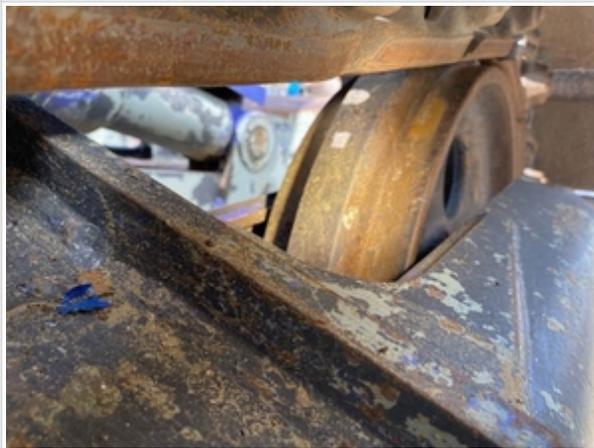
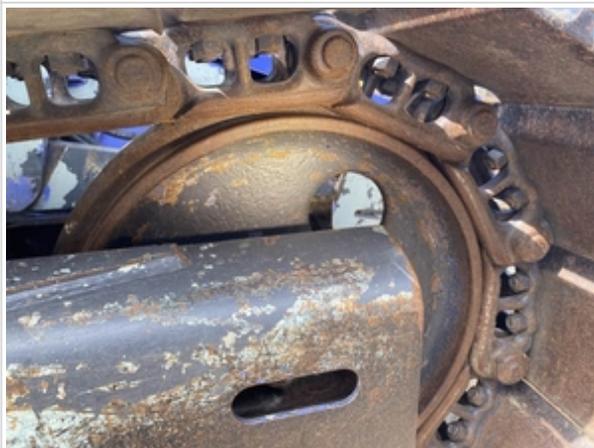
Undercarriage Overall Condition	3 - Normal Wear & Tear	
Undercarriage Overall Photos

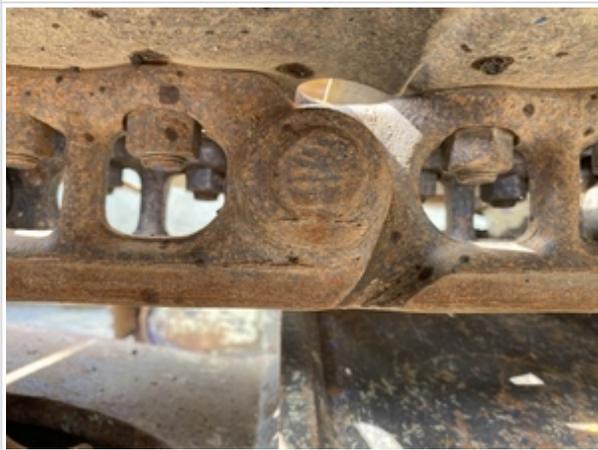
<p>Pin & Bushings</p>	<p>3 - Normal Wear & Tear</p>	
<p>Pin & Bushings Photos</p>

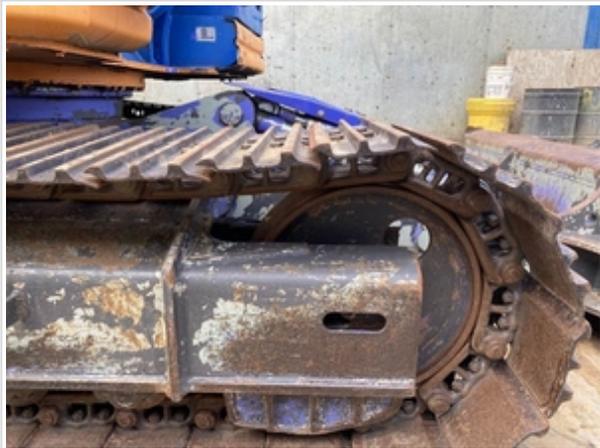
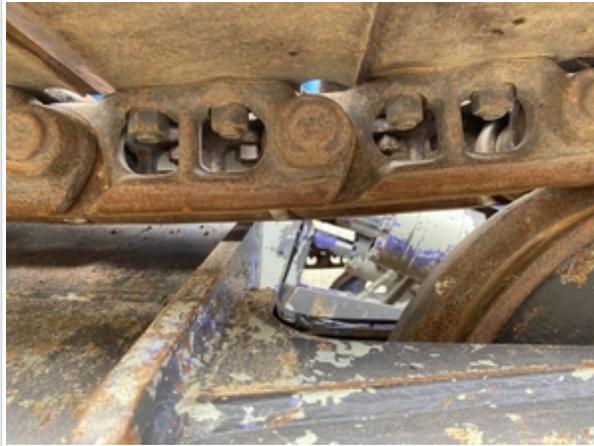
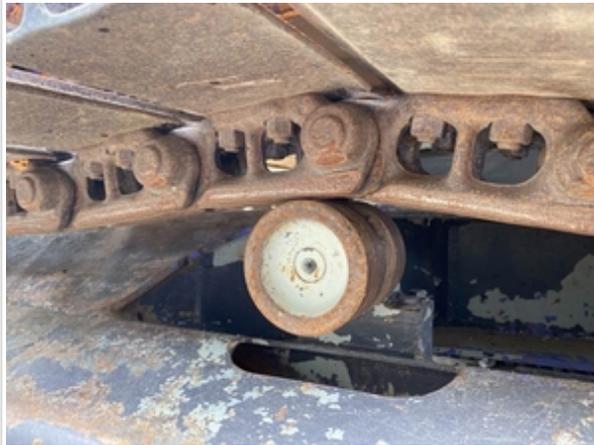
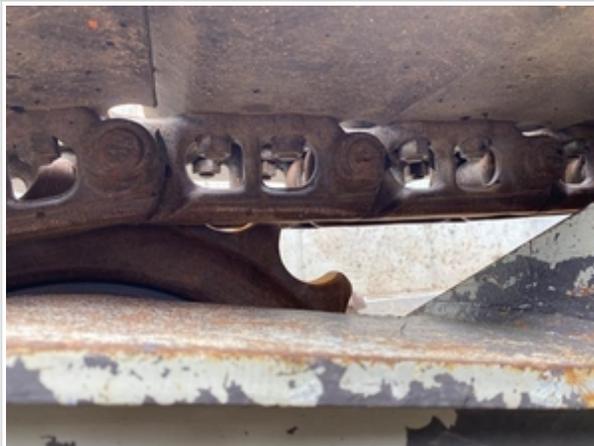
<p>Tracks</p>	<p>3 - Normal Wear & Tear</p>	
<p>Comments</p>	<p>20" wide 11' long</p>	
<p>Tracks Photos</p>

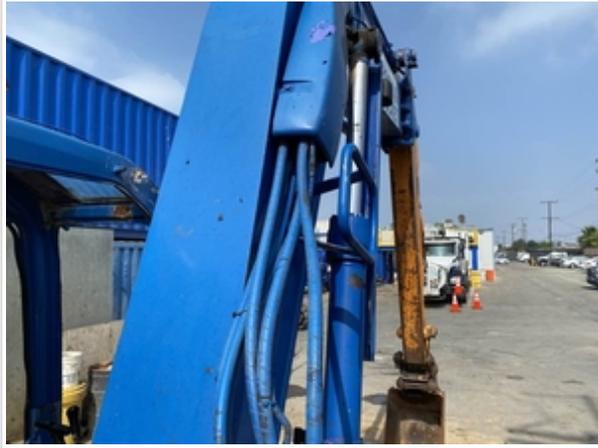
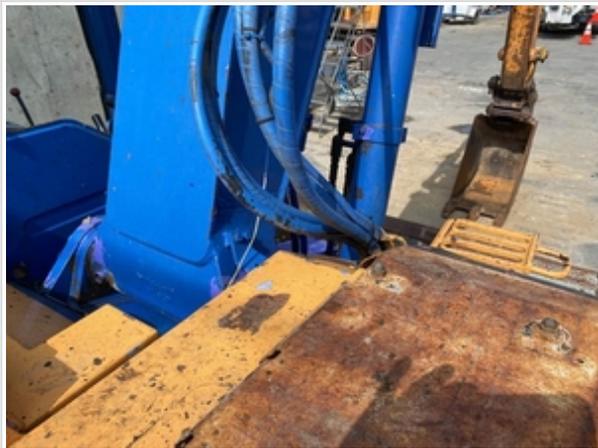
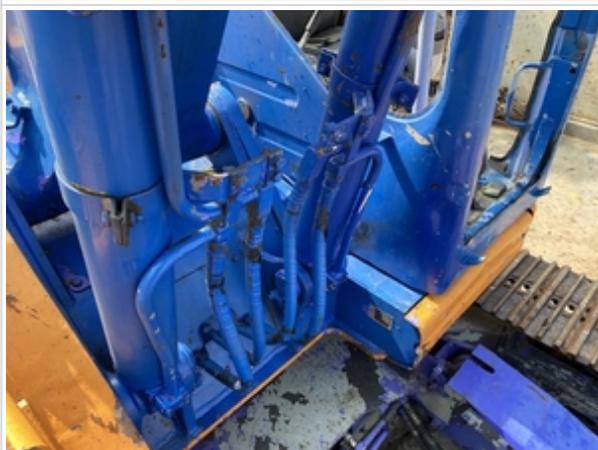
Wet or Damp Hydraulic Lines / Fittings	No
Appearance of Hydraulic Lines / Fittings	3
Hydraulic Lines / Fittings Condition	Hydraulic lines & fittings are clean and in good condition, Other (see comments)
Appearance of Hydraulic Lines / Fittings Photos

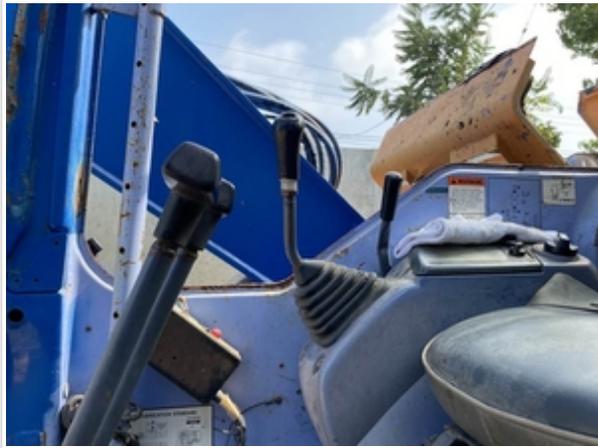
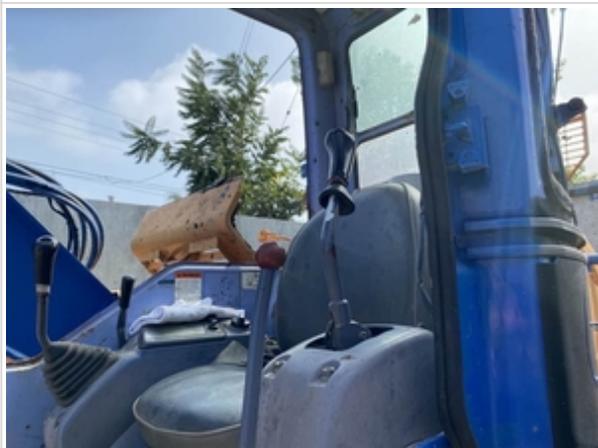
Unusual Noises (Hydraulic Pump)	No	
Hydraulic Pump Notes	No unusual noises heard during operation	
External Controls / Levers	3	
External Controls / Levers Condition	Good function & condition of hydraulic controls	
External Controls / Levers Photos

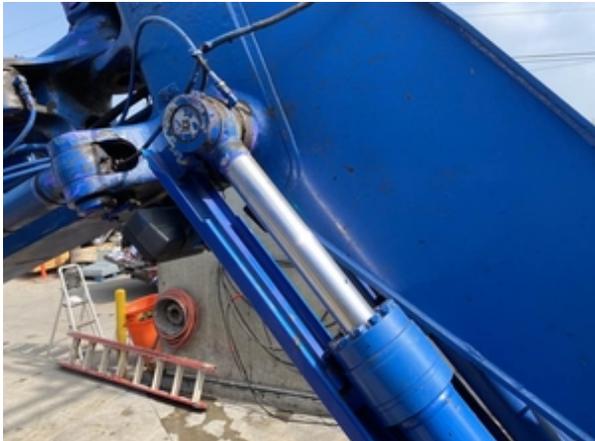
Boom Cylinder	Check the boom cylinder. Note any wear, pitting, discoloration, etc. Take photos.
Boom Cylinder: Mounting Pin	3
Boom Cylinder: Oil Leaks	Yes
Comments	R/S Boom Cylinder leaking oil out of rod seal
Boom Cylinder Photos

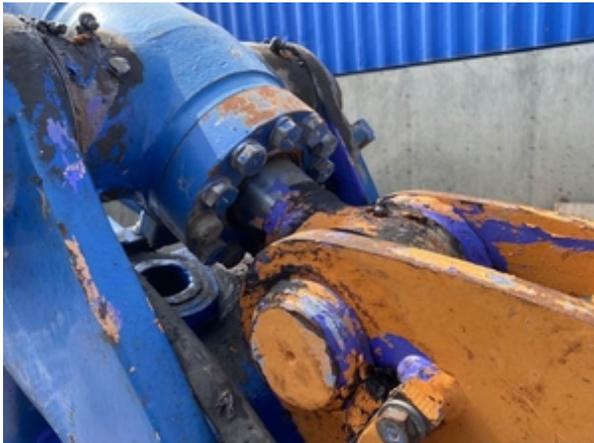
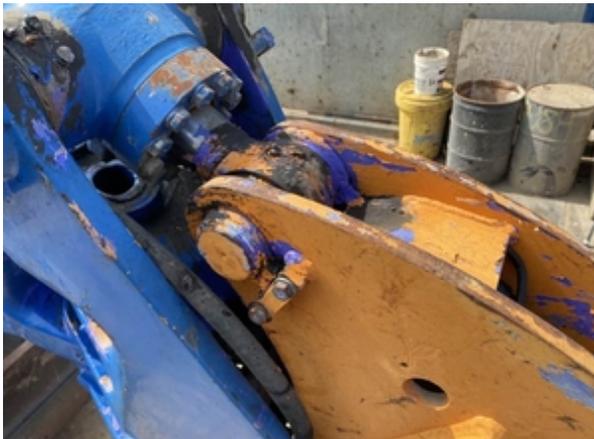
Stick Cylinder	Check the stick cylinder. Note any wear, pitting, discoloration, etc. Take photos.	
Stick Cylinder: Mounting Pin	3	
Stick Cylinder: Oil Leaks	No	
Stick Cylinder Photos

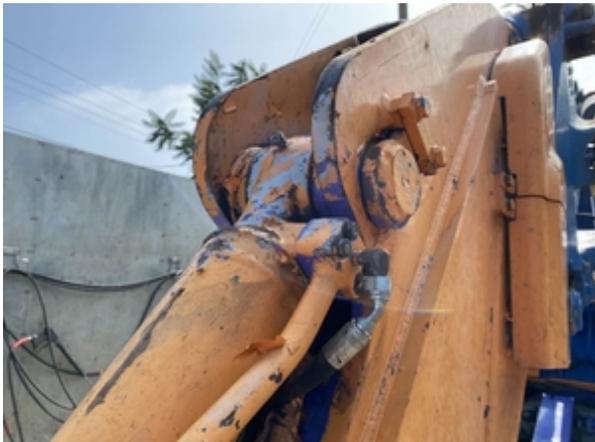
Bucket Cylinder	Check the bucket cylinder. Note any wear, pitting, discoloration, etc. Take photos.
Bucket Cylinder: Mounting Pin	3
Bucket Cylinder: Oil Leaks	No
Bucket Cylinder Photos

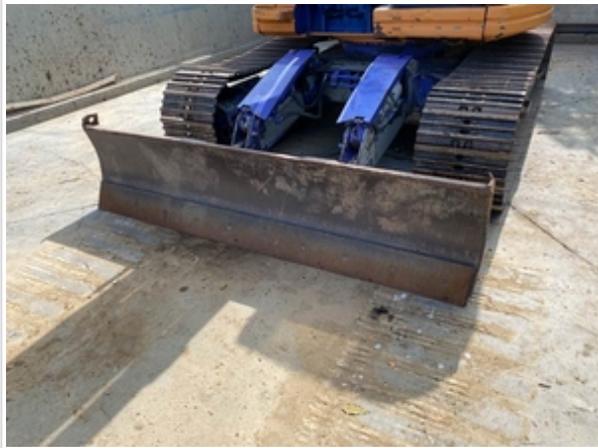
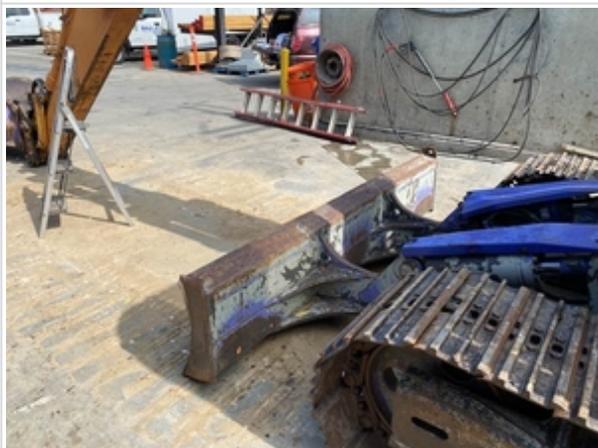
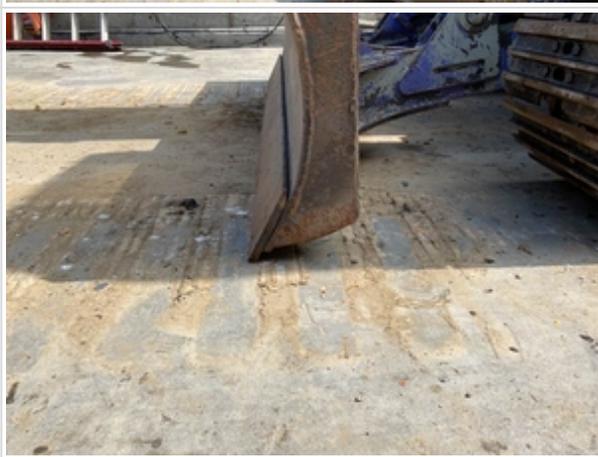
Blade Photos

<p>Blade</p>	<p>Check the blade. Note any wear, pitting, discoloration, etc. Take photos.</p>
<p>Blade</p>	<p>3</p>

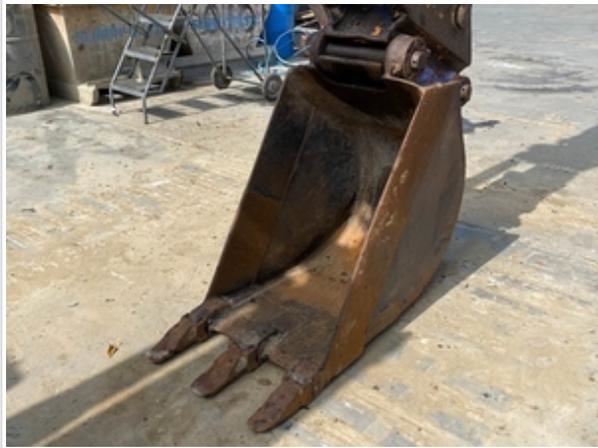
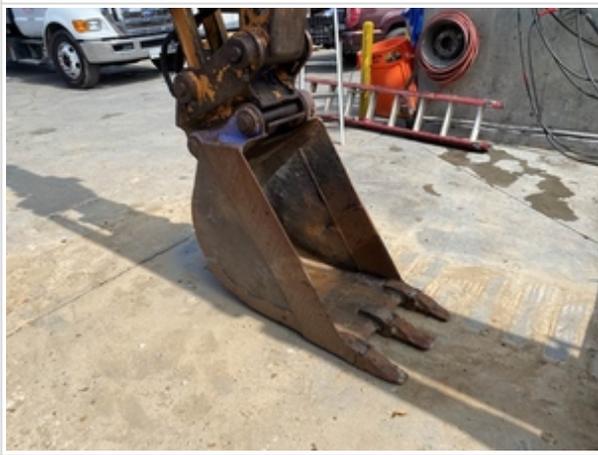
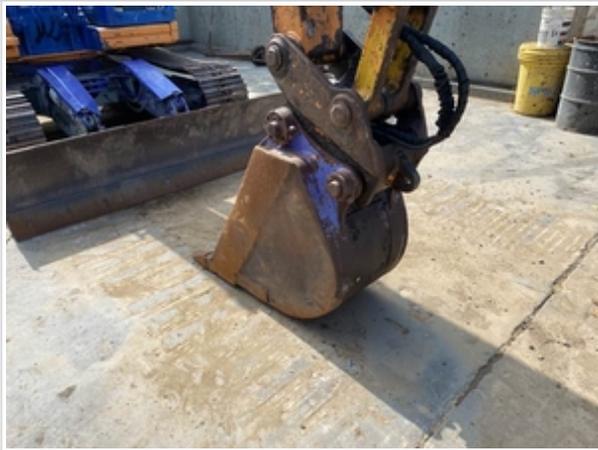
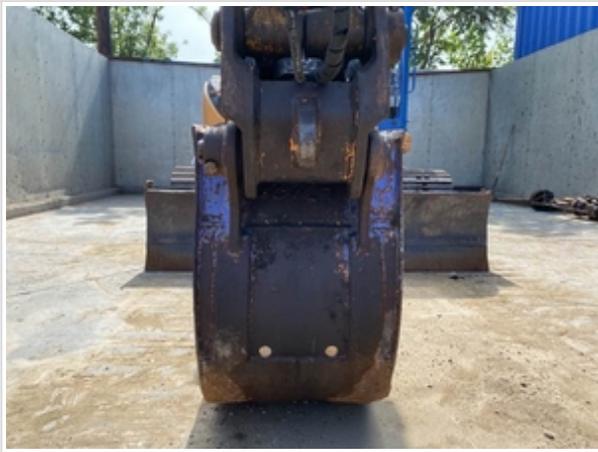
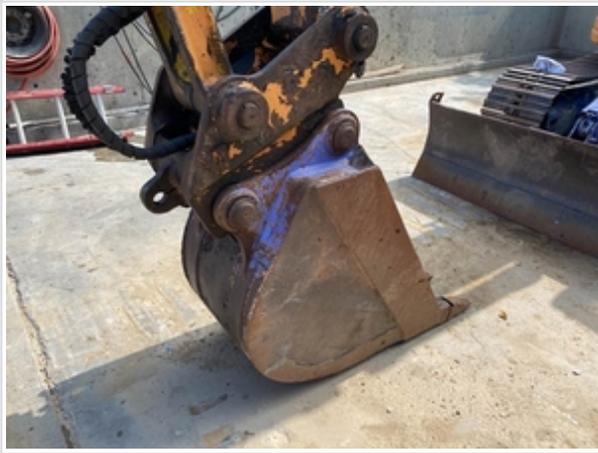
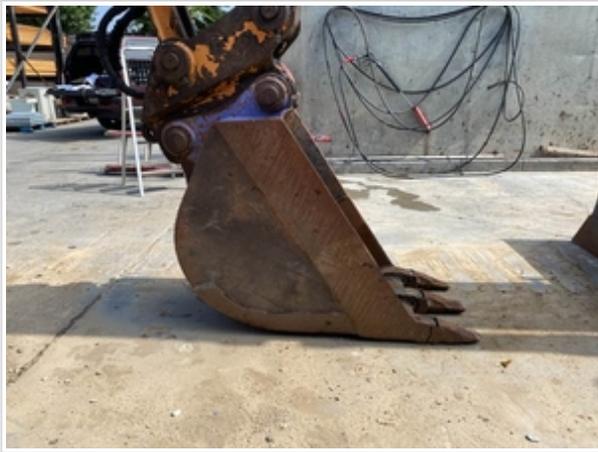
<p>Bucket Photos</p>

Bucket Condition	3 - Normal Wear & Tear
------------------	------------------------

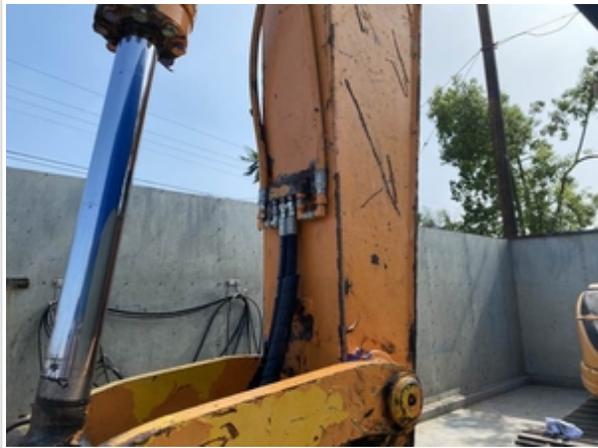
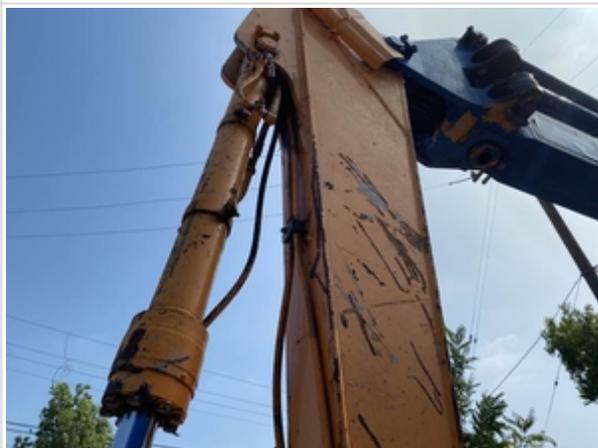
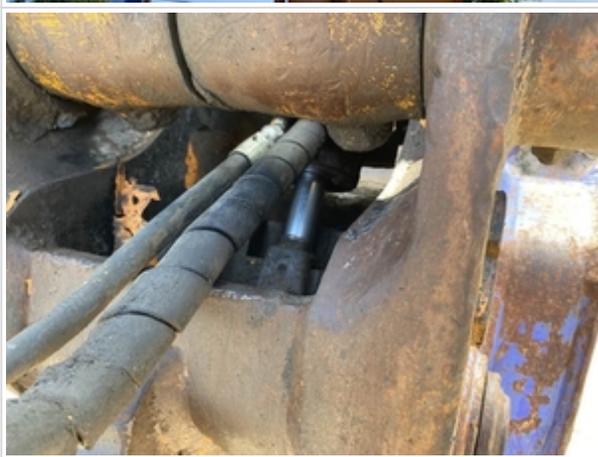
<p>Bucket Hose & Fittings Photos</p>

<p>Bucket Hose & Fittings</p>	<p>3 - Normal Wear & Tear</p>

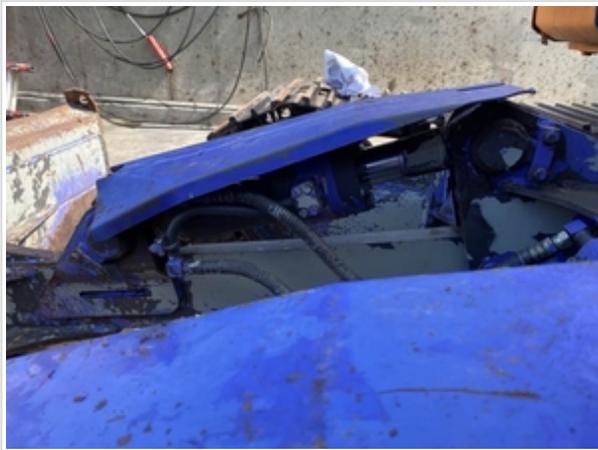
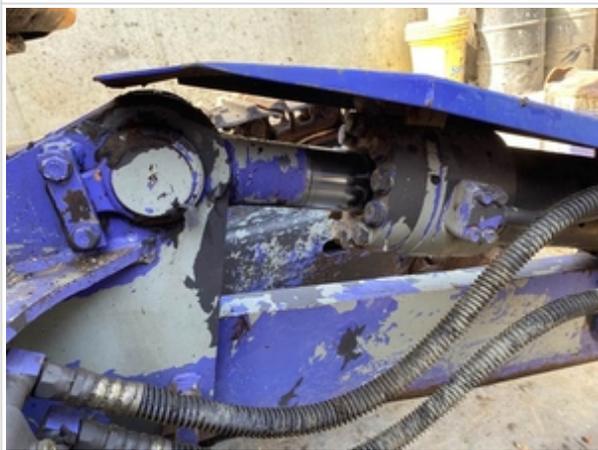
Blade Hose & Fittings Photos

<p>Blade Hose & Fittings</p>	<p>3 - Normal Wear & Tear</p>
----------------------------------	-----------------------------------

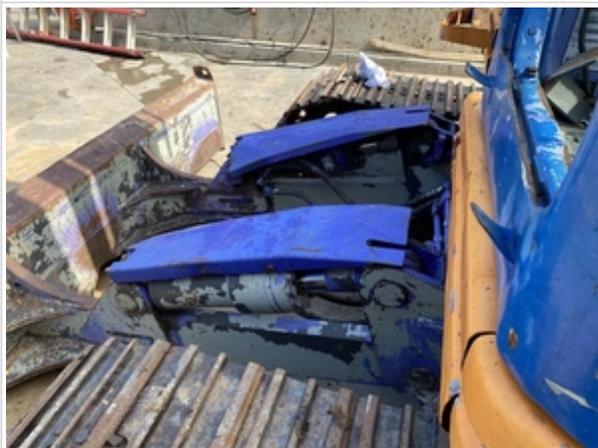
Blade Cylinder	3 - Normal Wear & Tear	
Blade Cylinder Photos
