Inspection Report (Mini Excavator)

Year	2013
Make	Takeuchi
Model	TB016
Serial Number	116116151
Hour Meter Reading	1,754 Hours
Previous Application (e.g., earth moving, mining, demolition, etc)	Pipeline/Electrical Construction

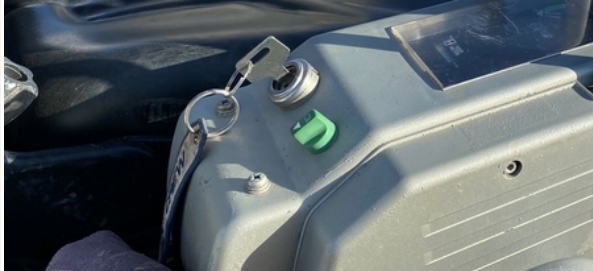
Controls & Switches	3 - Normal Wear & Tear
Controls & Switches Condition	All switches are installed and functional
Controls & Switches Photos

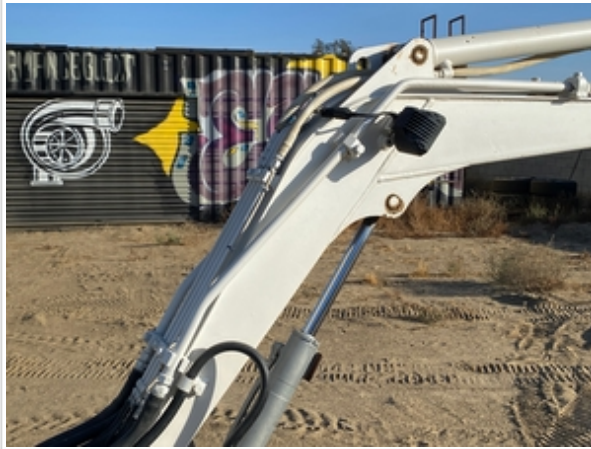
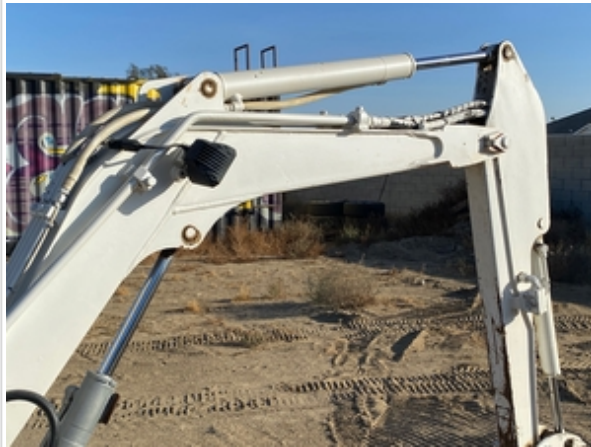
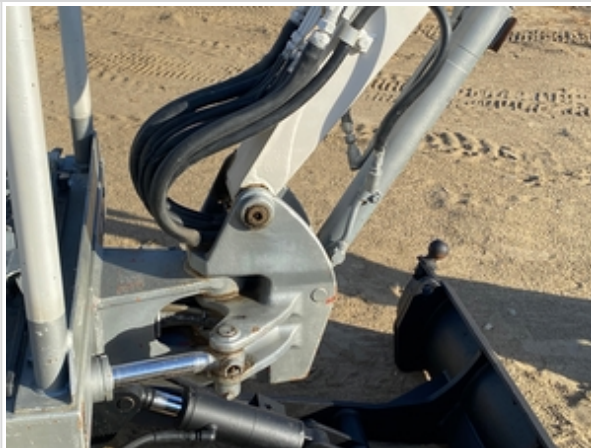
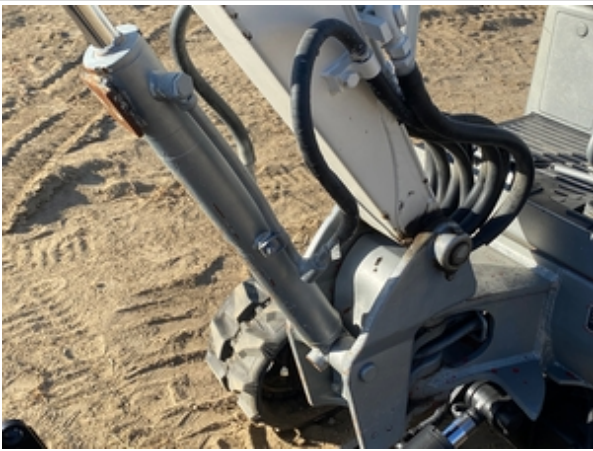
Boom Photos

Boom Condition	3 - Normal Wear & Tear
----------------	------------------------

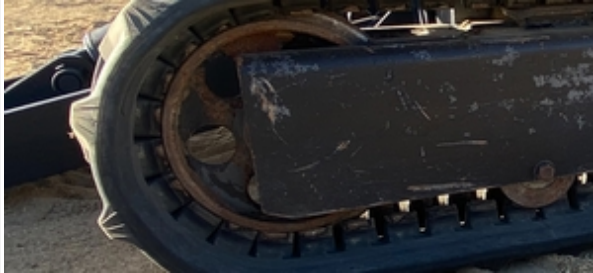
Front Idlers Photos

Rubber Belt Drive Lugs	3 - Normal Wear & Tear	
Track Tensioners	3 - Normal Wear & Tear	
Front Idlers	3 - Normal Wear & Tear

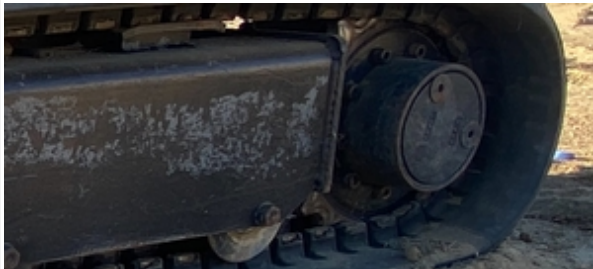
Rear Idlers	3 - Normal Wear & Tear
Track Rollers	3 - Normal Wear & Tear
Sprockets	3 - Normal Wear & Tear
Sprockets Photos

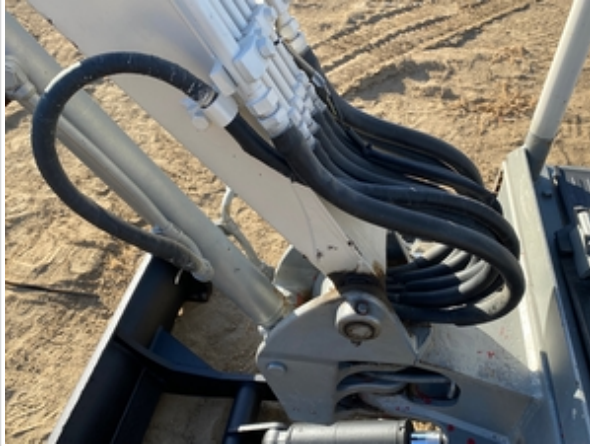
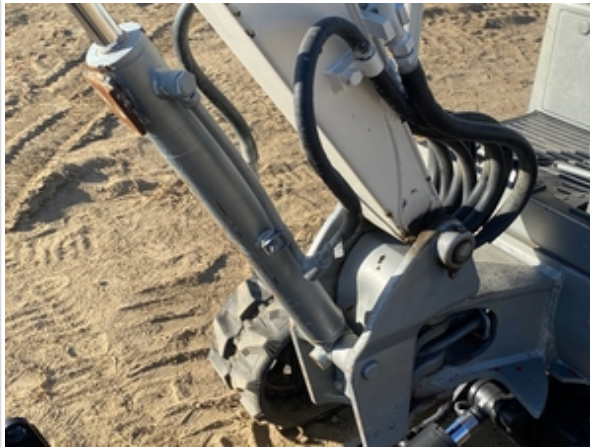
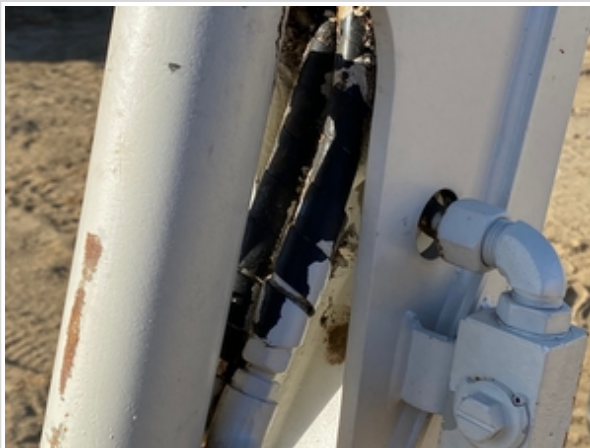
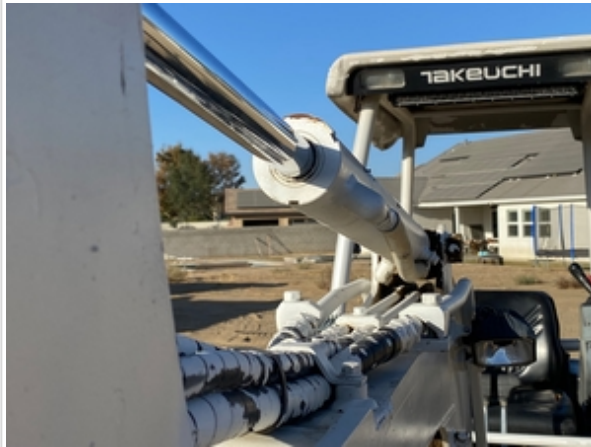
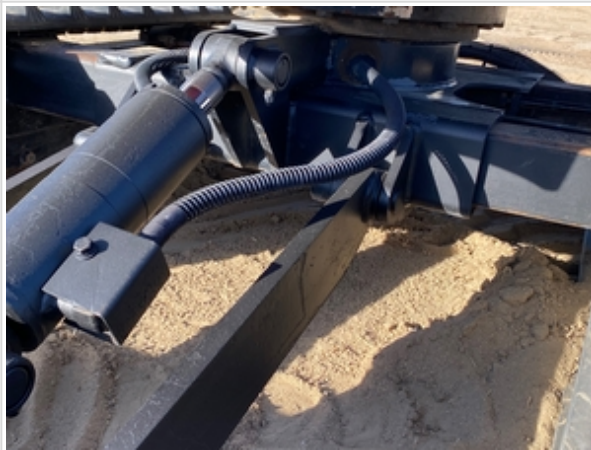
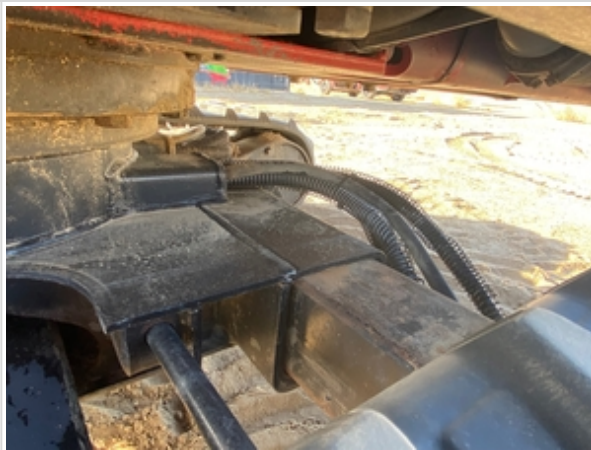
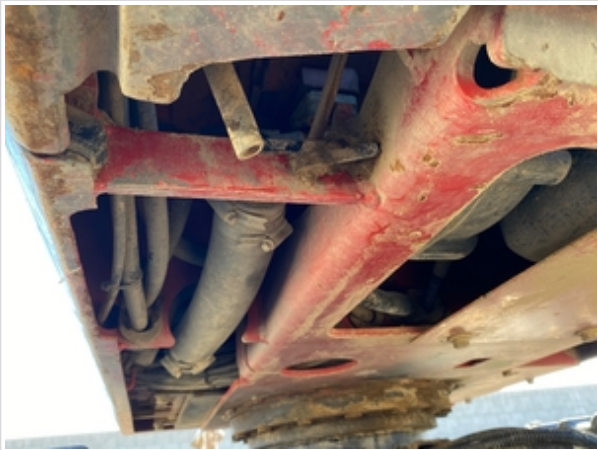
Appearance of Hydraulic Lines /
Fittings Photos

Wet or Damp Hydraulic Lines / Fittings	No
Appearance of Hydraulic Lines / Fittings	3
Hydraulic Lines / Fittings Condition	Hydraulic lines & fittings are clean and in good condition

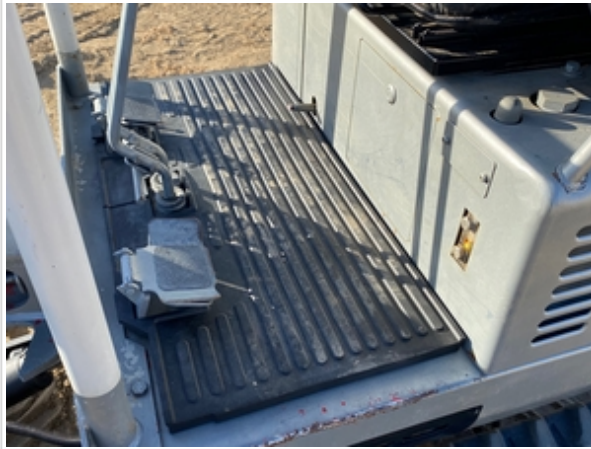
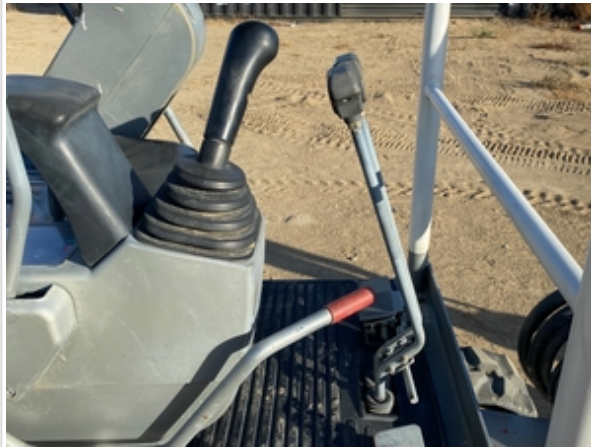
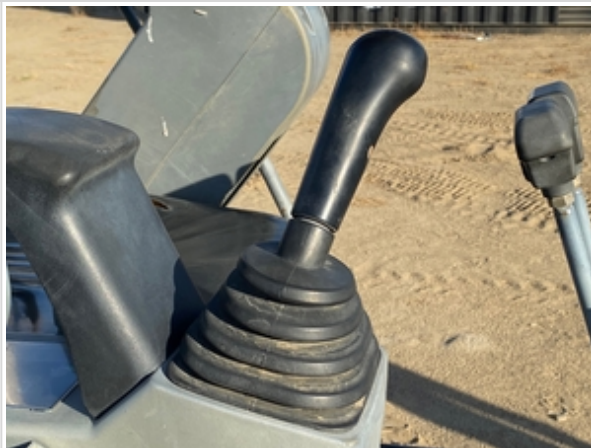
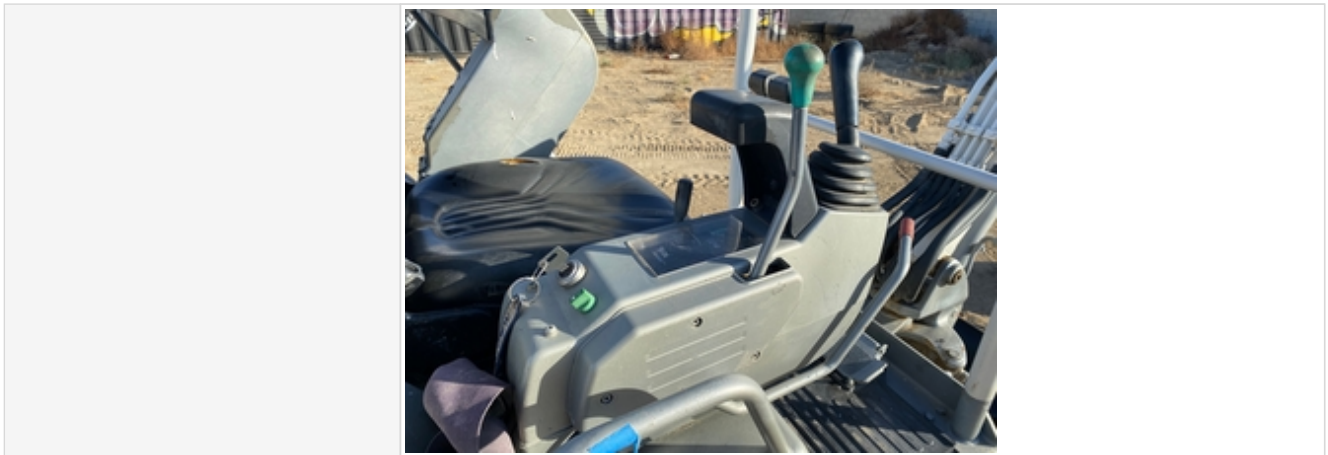
Unusual Noises (Hydraulic Pump)	No	
Hydraulic Pump Notes	No unusual noises heard during operation	
External Controls / Levers	3	
External Controls / Levers Condition	Good function & condition of hydraulic controls	
External Controls / Levers Photos
