Inspection Report (Compact Track Loader)

Year	2012
Make	CAT
Model	299D
Serial Number	NLC00387
Hour Meter Reading	5,567
Previous Application (e.g., earth moving, mining, demolition, etc)	Pipeline / Electrical Construction

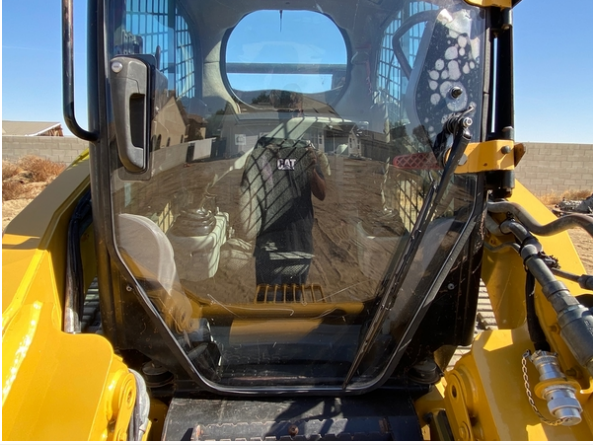
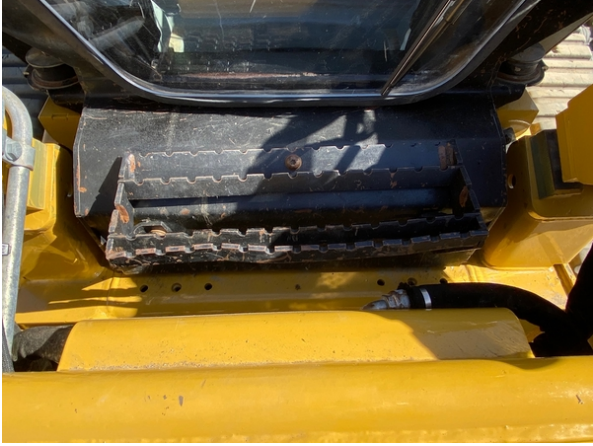
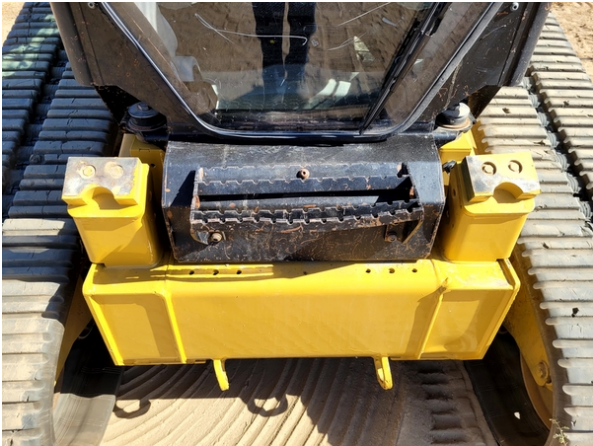
Front	3 - Normal Wear & Tear
Front Condition	No visible damage
Front Photos

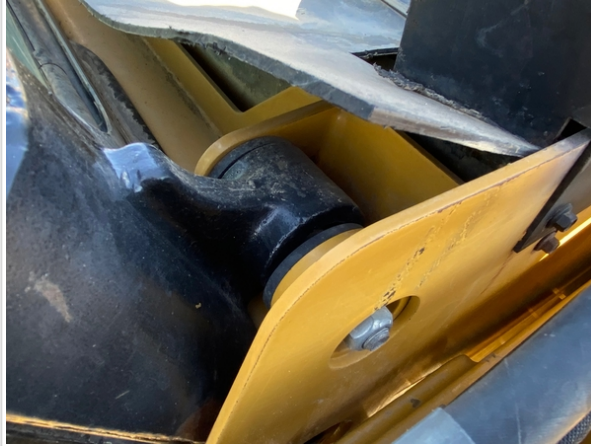
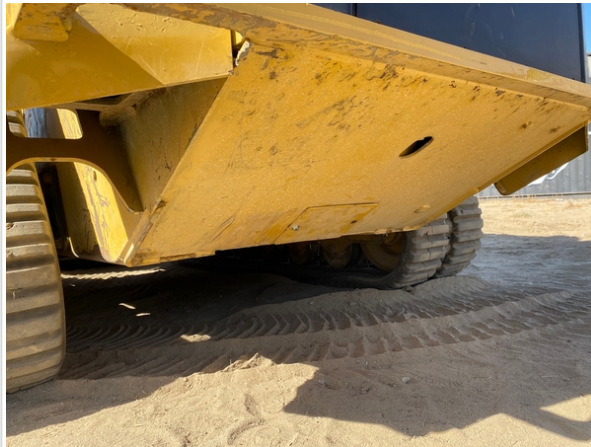
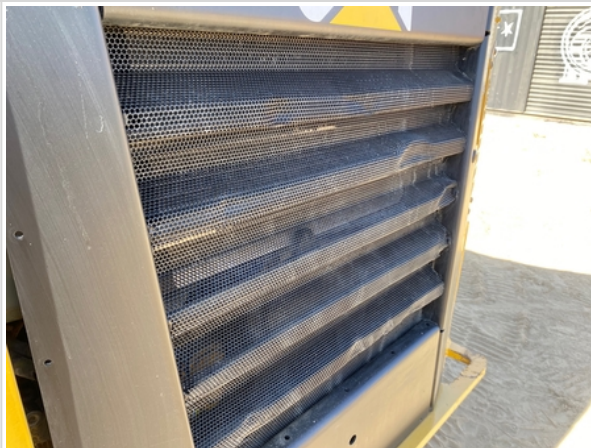
Rear Photos

Rear	3 - Normal Wear & Tear
Rear Condition	No visible damage

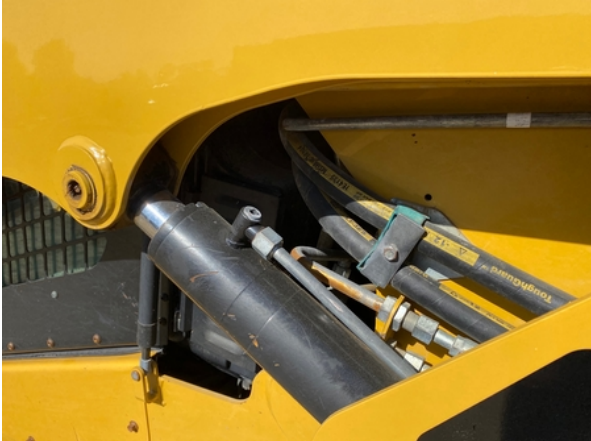
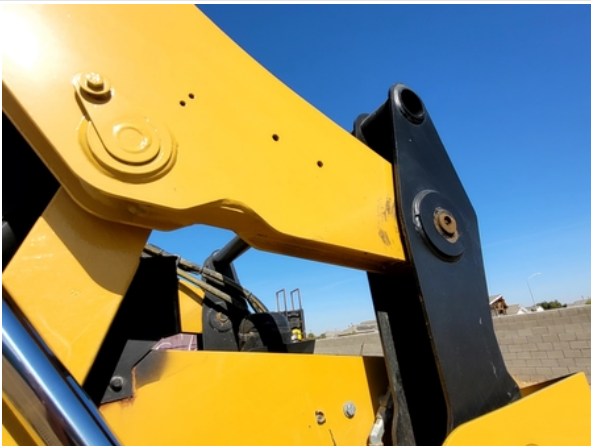
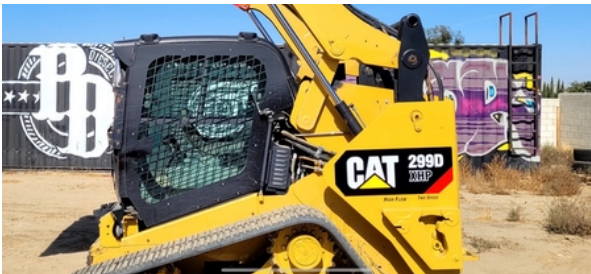
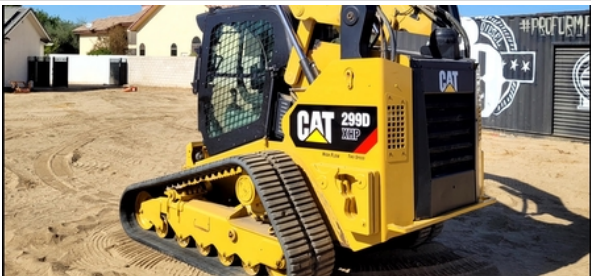
<p>Left</p>	<p>3 - Normal Wear & Tear</p>	
<p>Left Condition</p>	<p>No visible damage</p>	
<p>Left Photos</p>

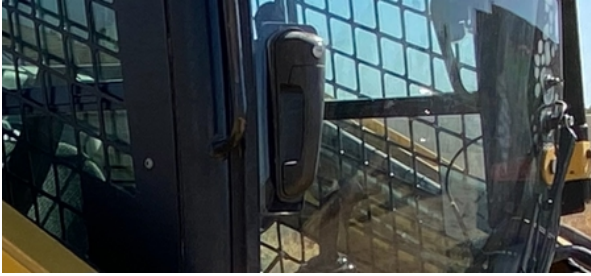
Doors / Canopy Latches Photos

Body Panels (Any Rust Damage?)	3 - Normal Wear & Tear
Body Panel Condition	No visible damage, good paint condition and panel fitment
Doors / Canopy Latches	3 - Normal Wear & Tear
Doors / Canopy Latches Condition	No visible damage

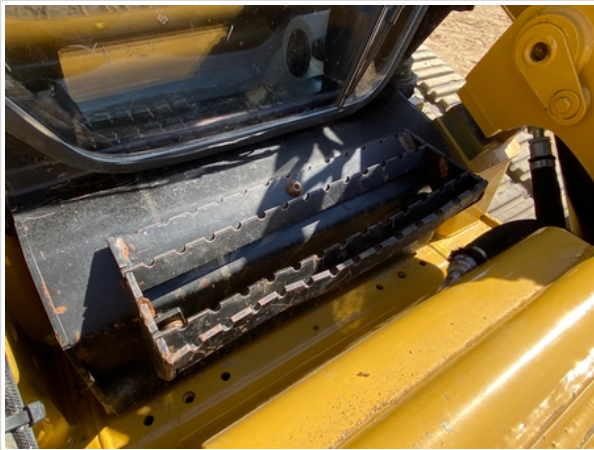
Steps / Ladders	3 - Normal Wear & Tear
Steps / Ladders Condition	Steps/ladders are fully intact and appear structurally sound, Other (see comments)
Comments	Front step slightly bent
Steps / Ladders Photos

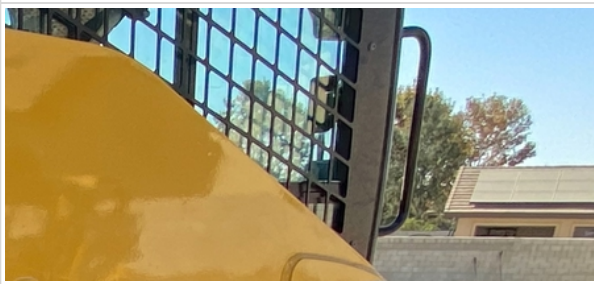
Handrails	3 - Normal Wear & Tear	
Handrails Condition	Handrails are fully intact and appear structurally sound	
Handrail Photos

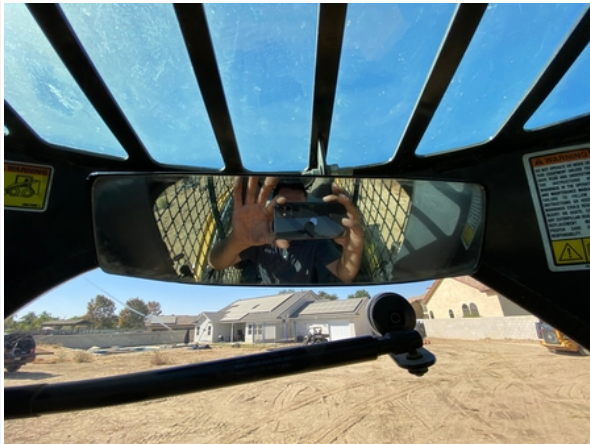
Mirrors	3 - Normal Wear & Tear	
Mirror Condition Notes	Mirrors present and intact, no visible damage	
Mirrors Photos

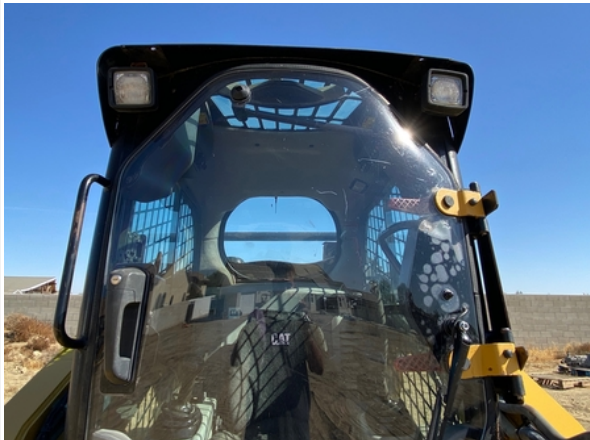
Lighting System	3 - Normal Wear & Tear	
Lighting System Condition	No visible damage, lighting system is operational	
Lighting System Photos

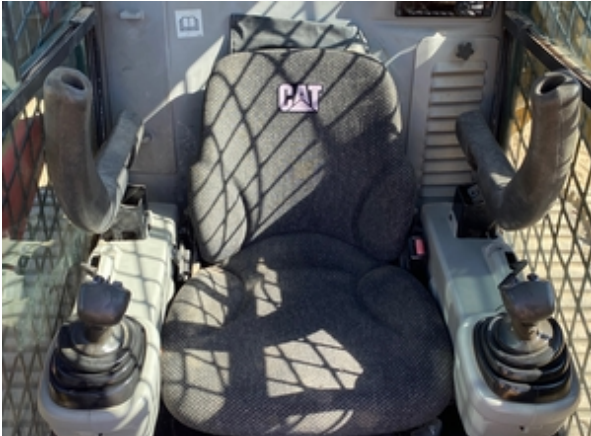
Operator's Seat & Arm Rests	3 - Normal Wear & Tear
Operator's Seat & Arm Rests Condition	Seat(s) in good condition, no stains or tears in upholstery
Operator's Seat & Arm Rests Photos

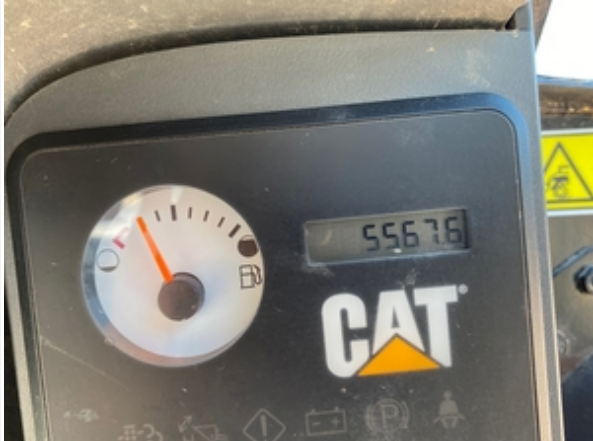
Hour Meter Activity Photos

Hour Meter Activity	3 - Normal Wear & Tear
Hour Meter Condition	Hour meter is functional and in good condition

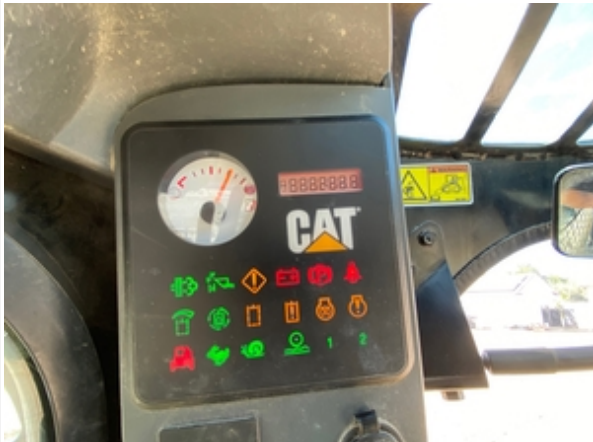
Other Gauge Activity	3 - Normal Wear & Tear
Other Gauge Condition	All cockpit gauges are functional and in good condition
Other Gauge Activity Photos

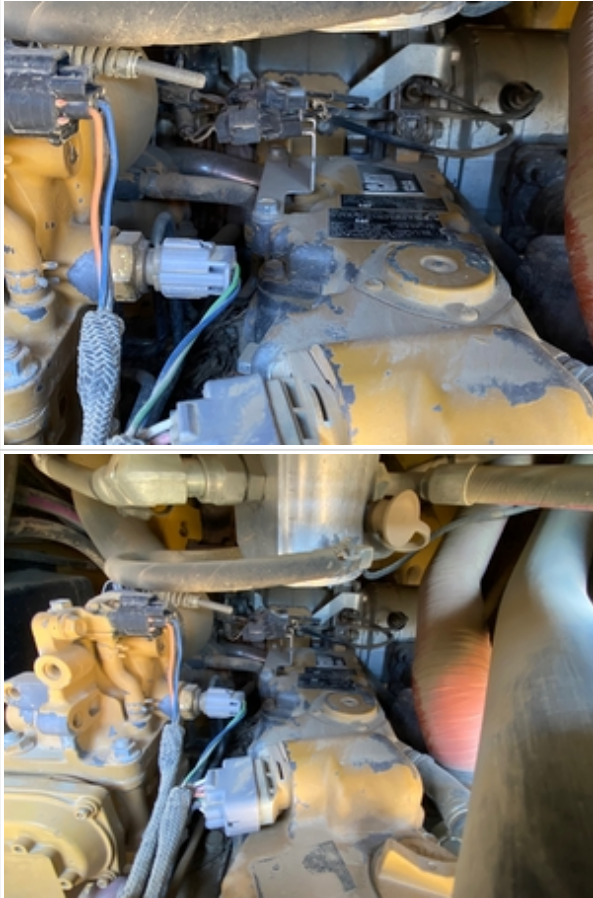
Engine	
Engine Type (Make, Model, Cylinders, Hp)	CAT - 3.8L - 4CYL. - 110HP -
Emissions Tier	Tier 4i
Engine Fuel Type	Diesel
Engine Photos

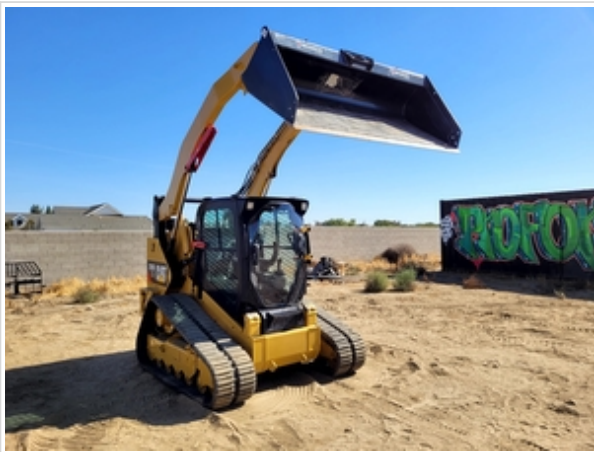
<p>Stance Photos</p>

<p>Stance</p>	<p>3 - Normal Wear & Tear</p>

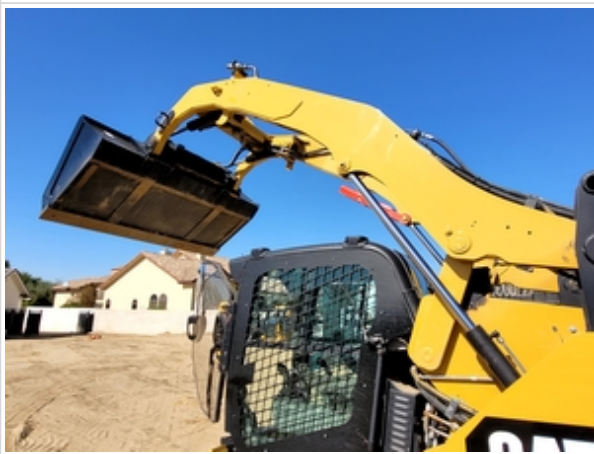
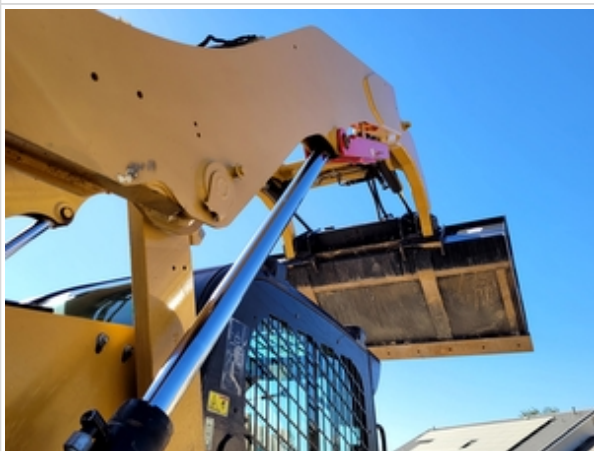
<p>Lift Arm</p>	<p>3 - Normal Wear & Tear</p>
<p>Lift Arm Photos</p>

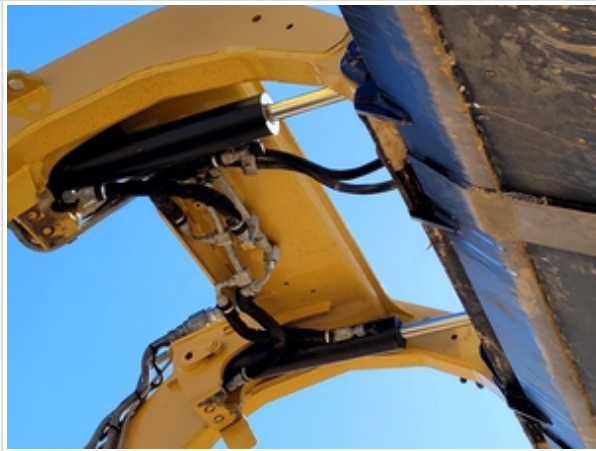
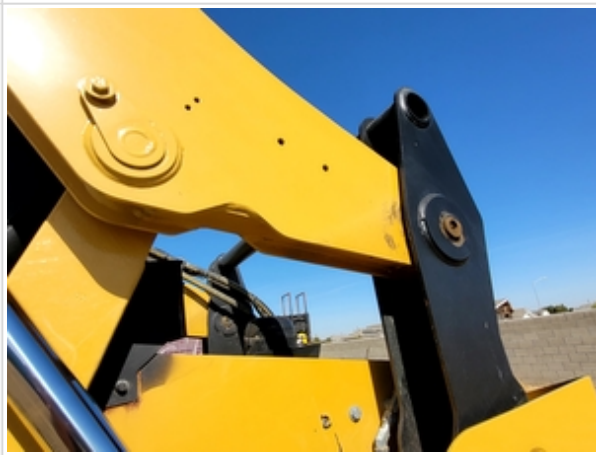
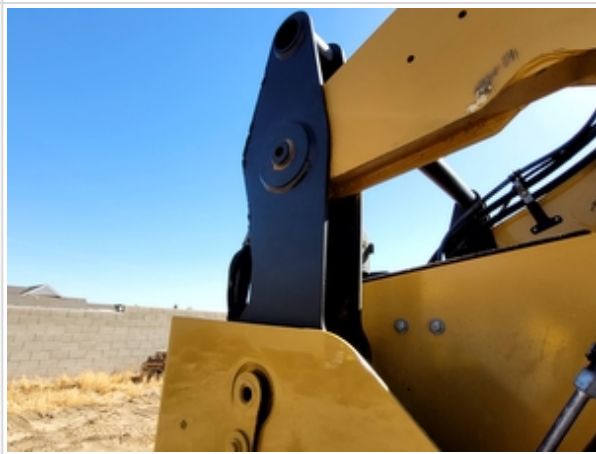
Chassis to Arm Pins	3 - Normal Wear & Tear	
Comments	Right side lift arm to center support bracket pin not locked in place

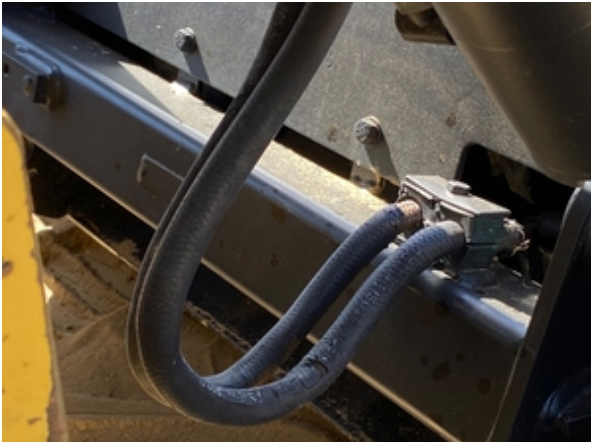
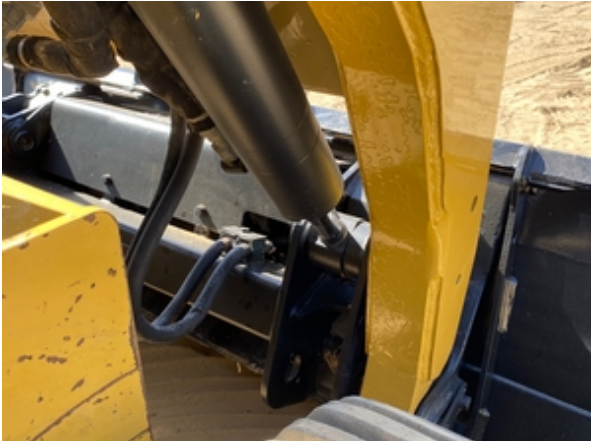
Quick Coupler	3 - Normal Wear & Tear
Quick Coupler Photos

Quick Coupler to Arms Pins	3 - Normal Wear & Tear
Overall Chassis	3 - Normal Wear & Tear
Overall Chassis Comments	Overall chassis in solid condition, well maintained with no issues found.

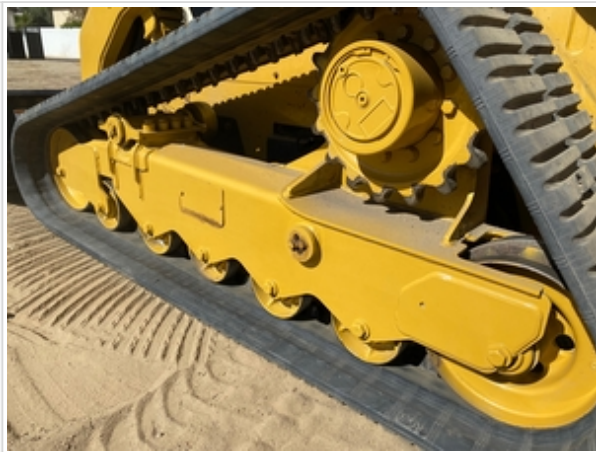
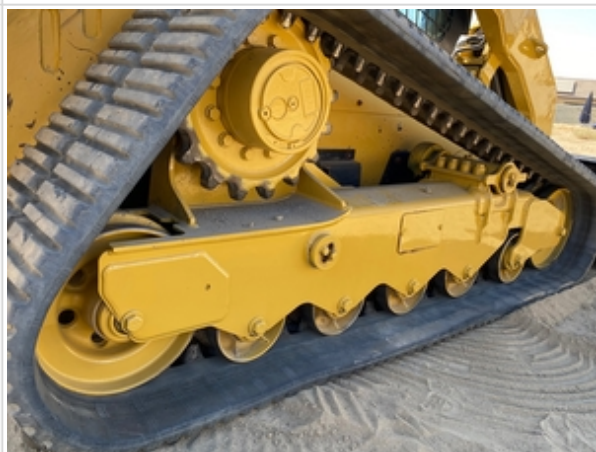
<p>Roller Frames Photos</p>

Roller Frames	3 - Normal Wear & Tear
---------------	------------------------

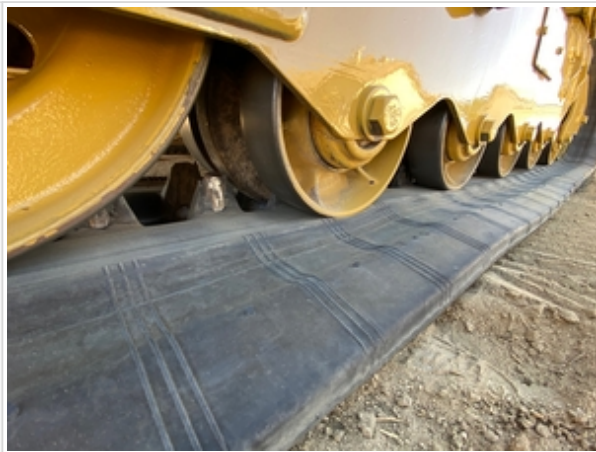
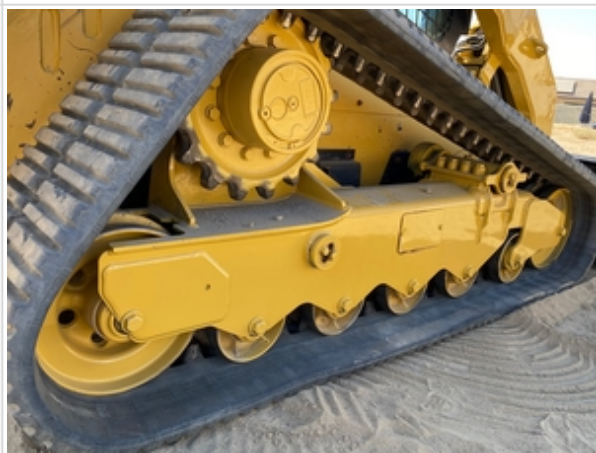
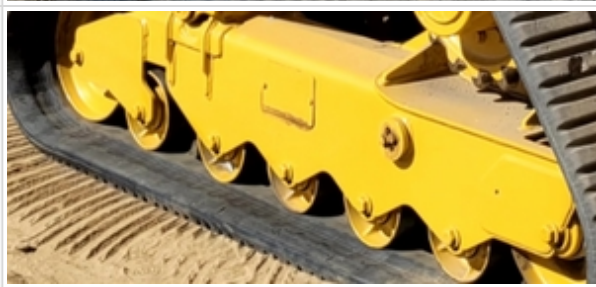
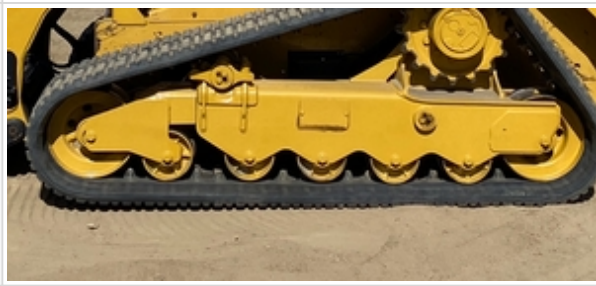
<p>Track Rollers Photos</p>

Rear Idlers	0	
Track Rollers	3 - Normal Wear & Tear

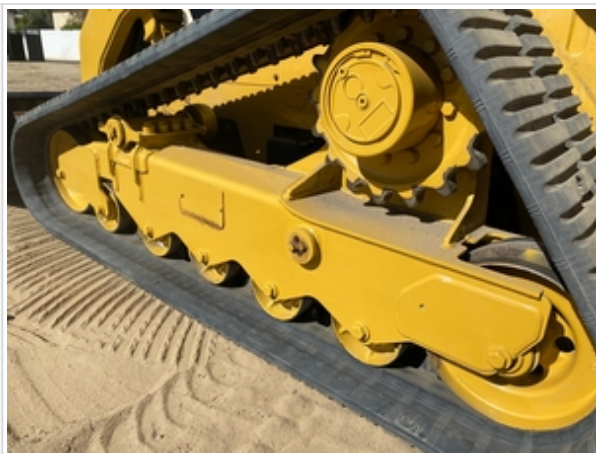
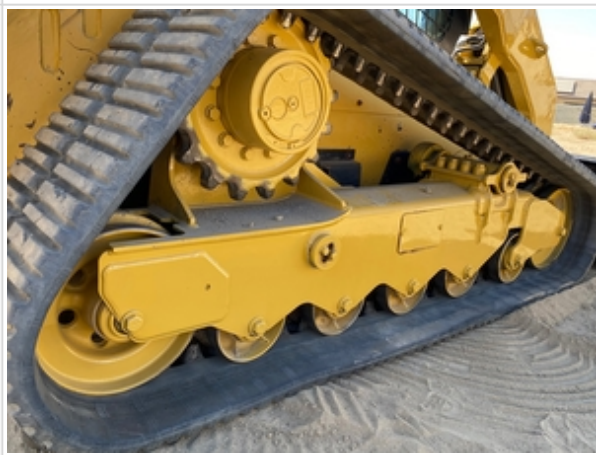
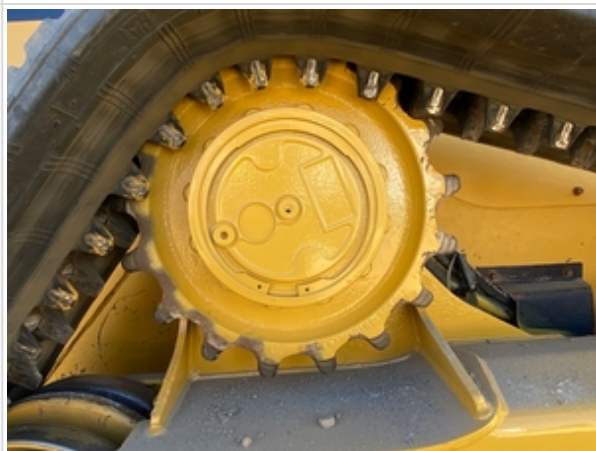
Sprockets Photos

<p>Sprockets</p>	<p>3 - Normal Wear & Tear</p>

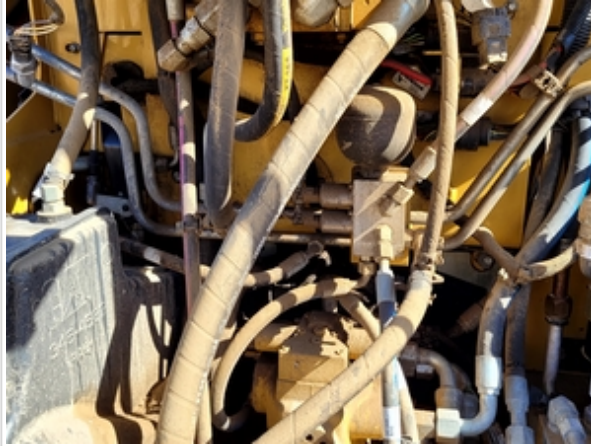
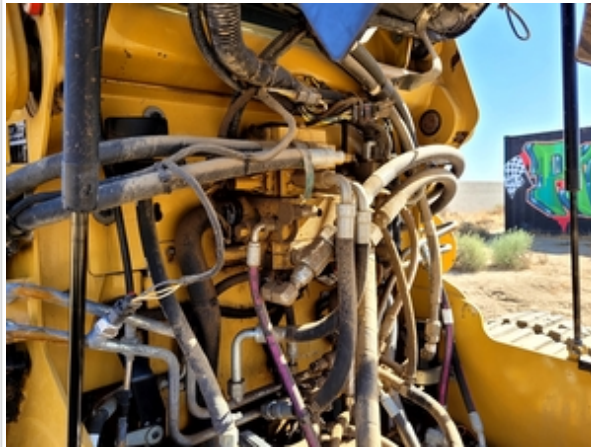
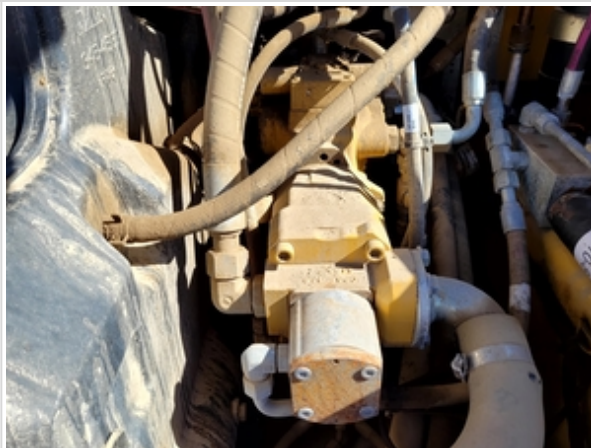
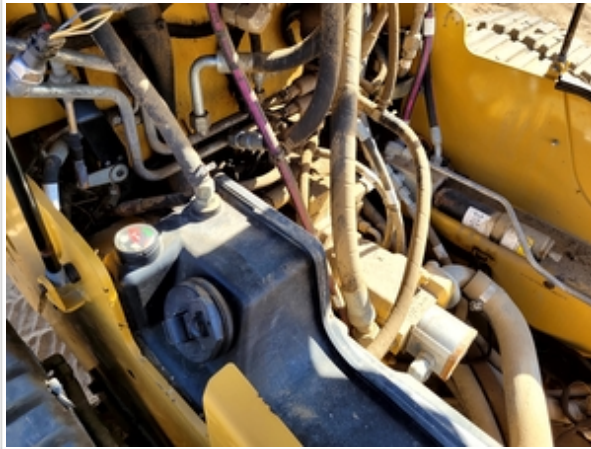
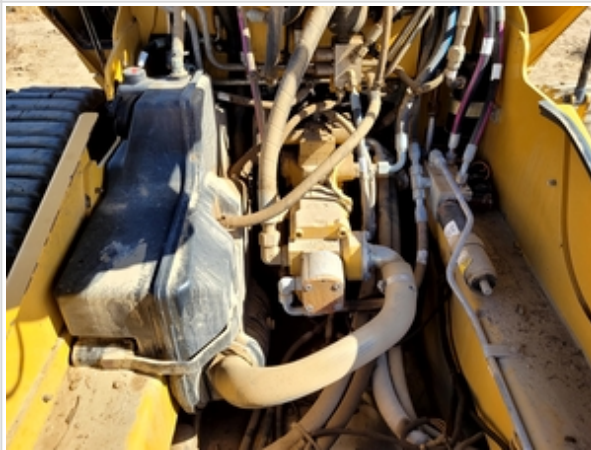
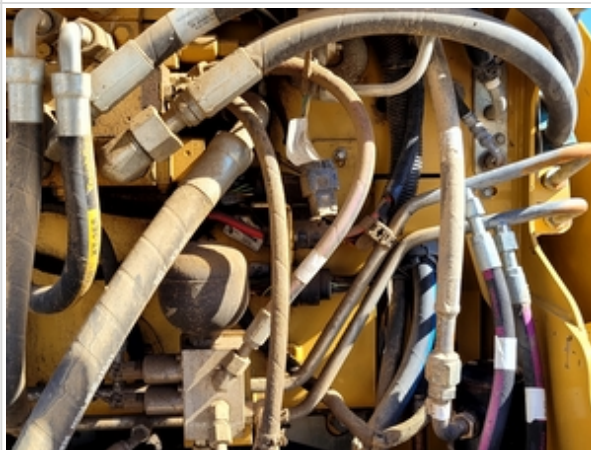
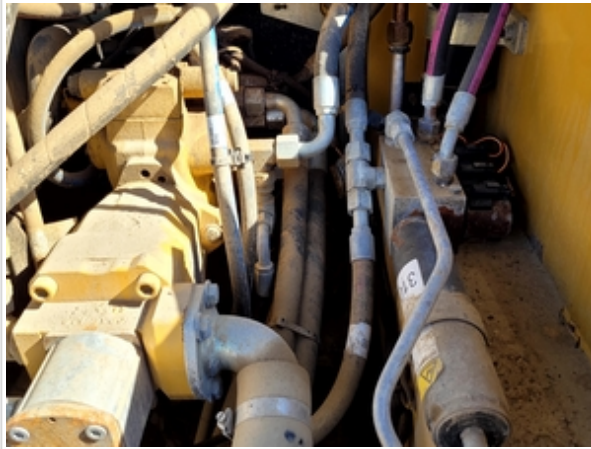
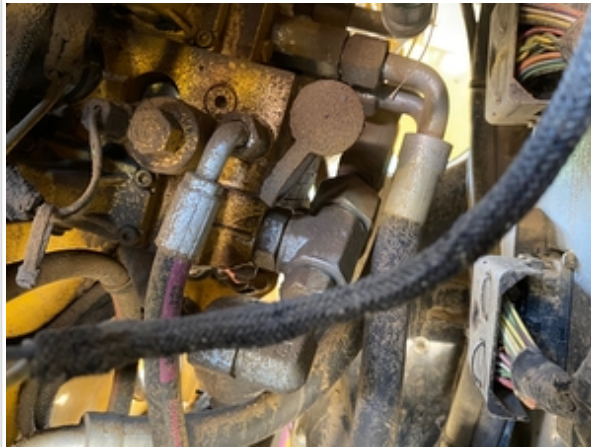
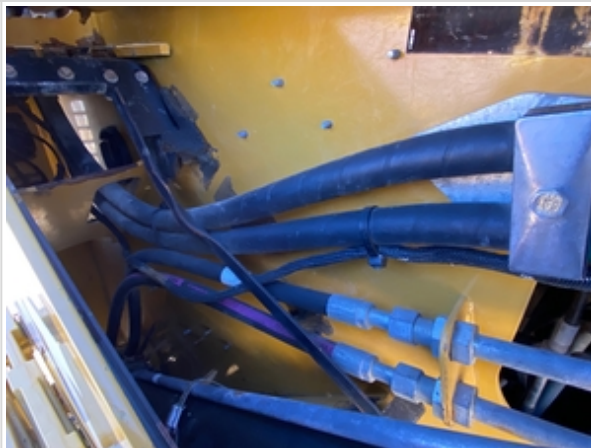
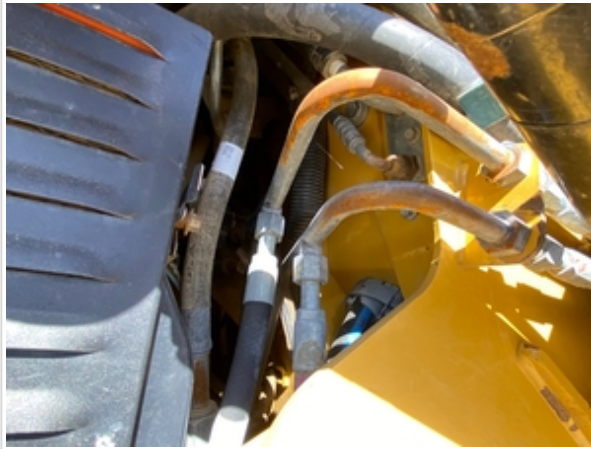
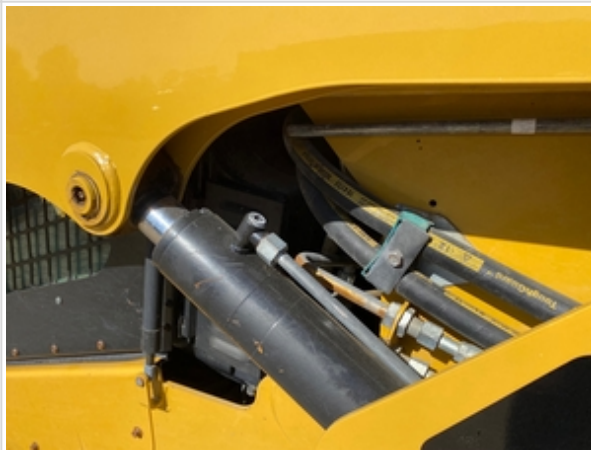
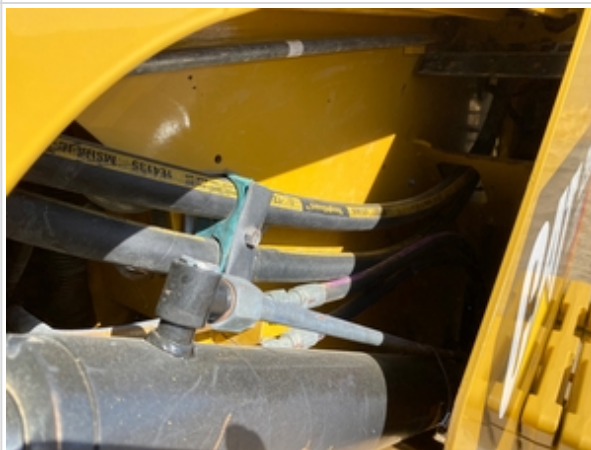
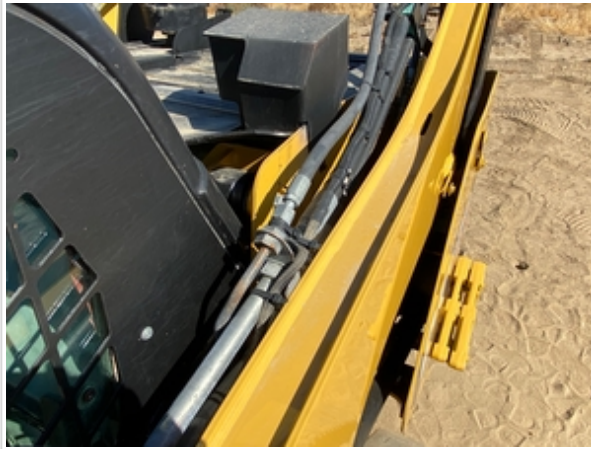
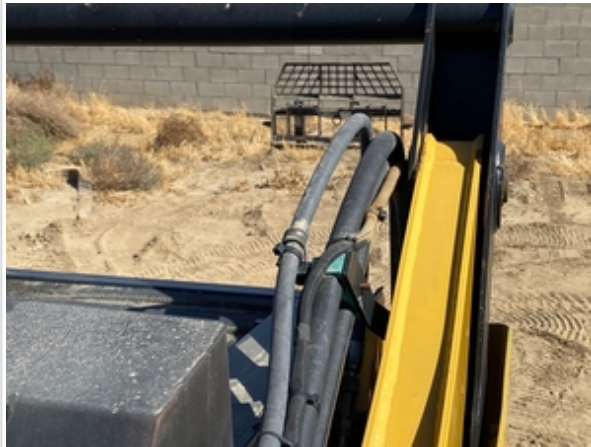
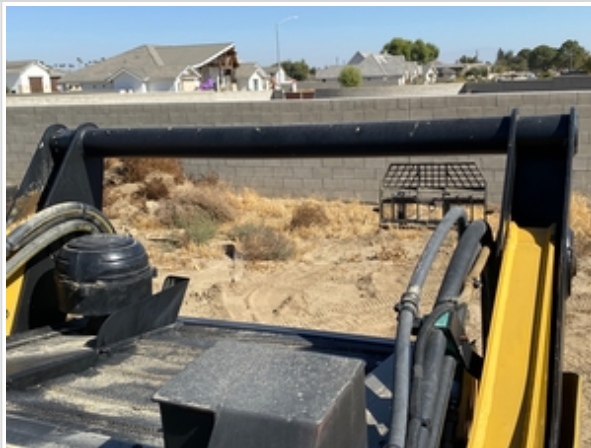
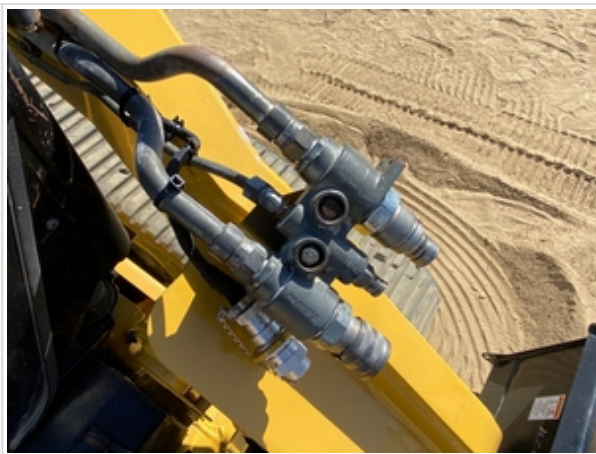
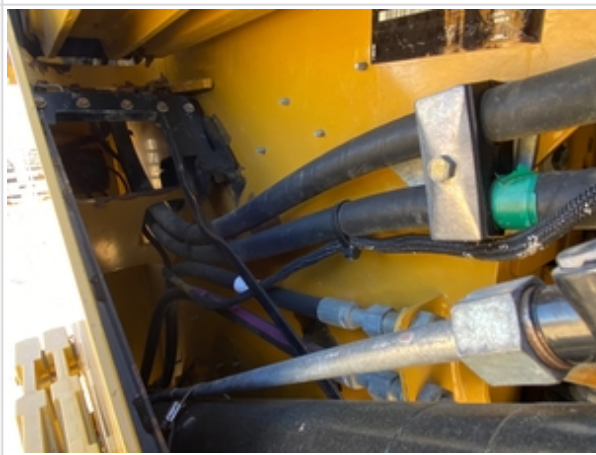
Appearance of Hydraulic Lines /
Fittings Photos

Wet or Damp Hydraulic Lines / Fittings	No
Appearance of Hydraulic Lines / Fittings	3
Hydraulic Lines / Fittings Condition	Hydraulic lines & fittings are clean and in good condition

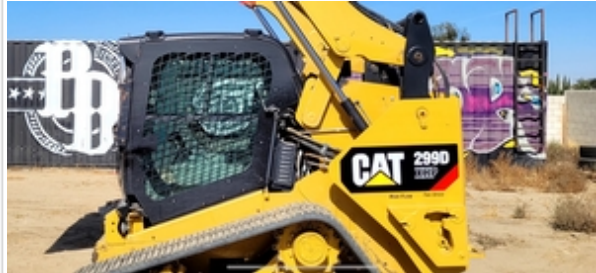
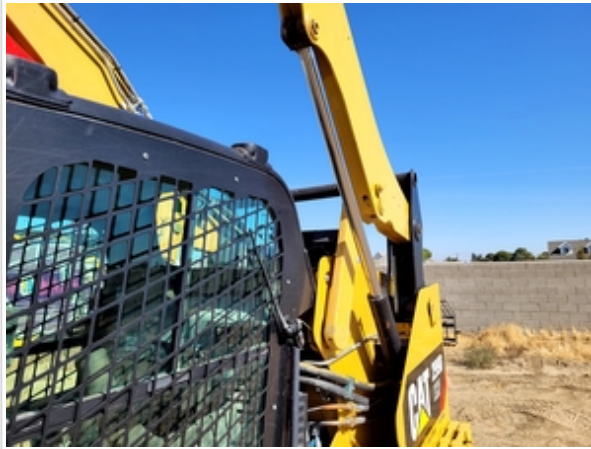
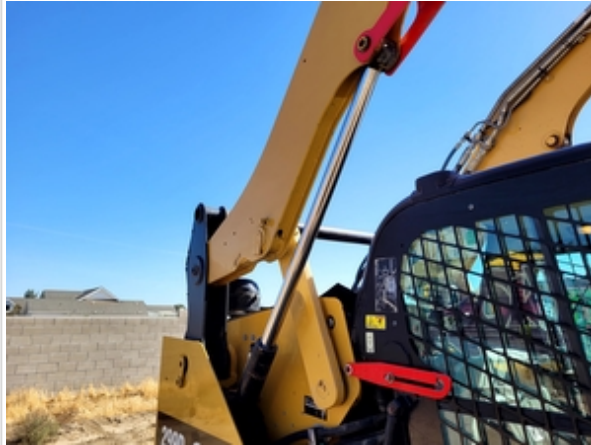
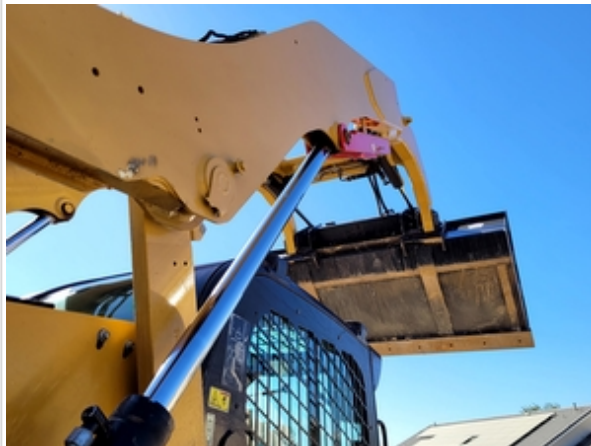
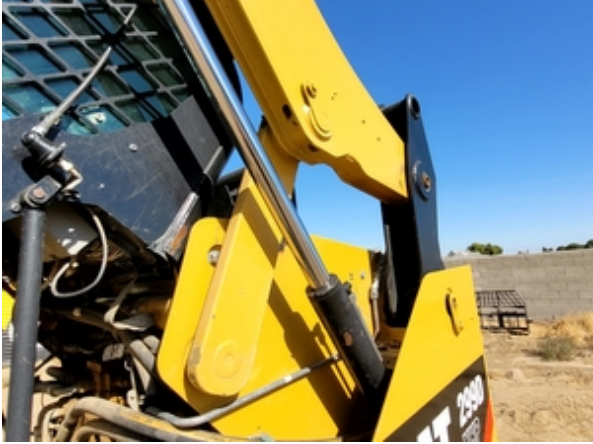
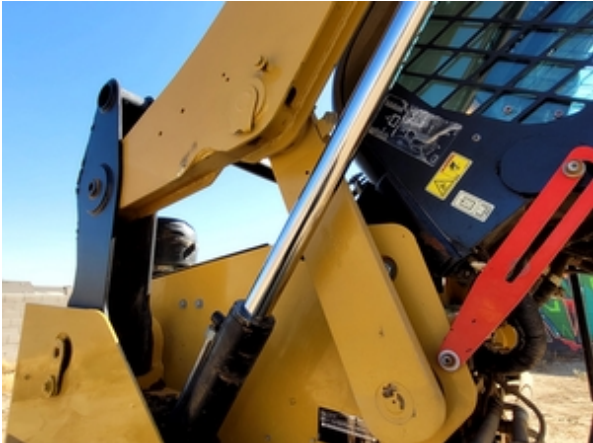
Lift Cylinder	Check the lift cylinder. Note any wear, pitting, discoloration, etc. Take photos.
Lift Cylinder: Mounting Pin	3
Lift Cylinder: Oil Leaks	No
Lift Cylinder Photos

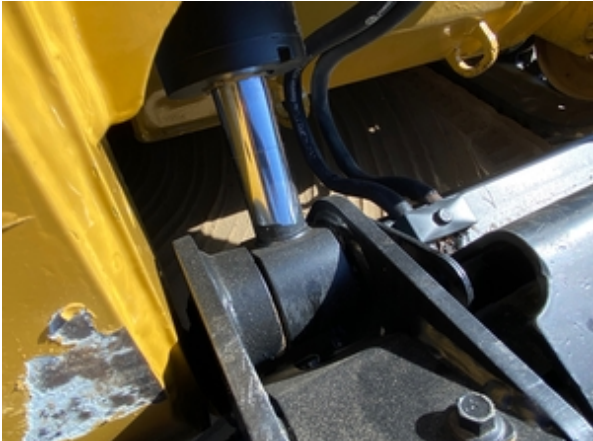
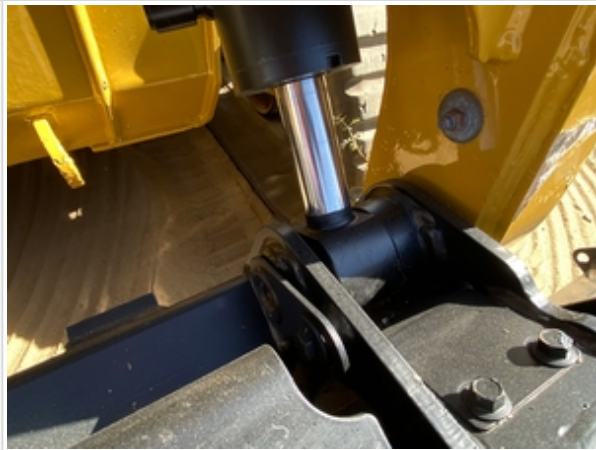
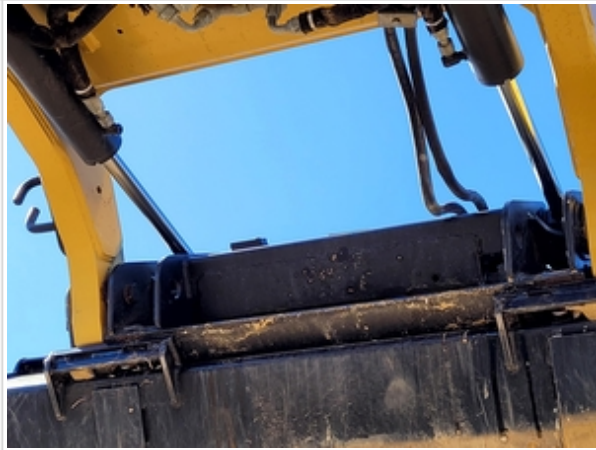
Bucket Cylinder	Check the bucket cylinder. Note any wear, pitting, discoloration, etc. Take photos.	
Bucket Cylinder: Mounting Pin	3	
Bucket Cylinder: Oil Leaks	No	
Bucket Cylinder Photos

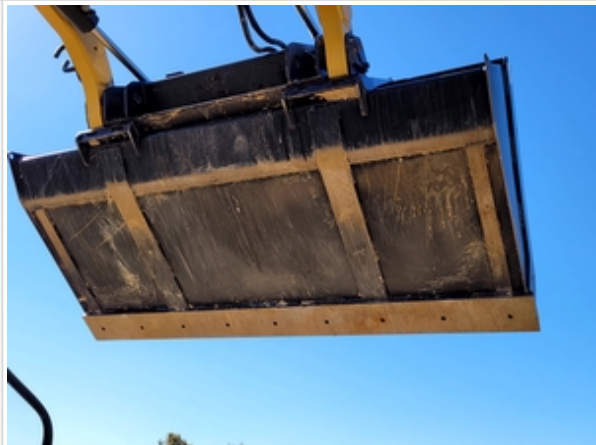
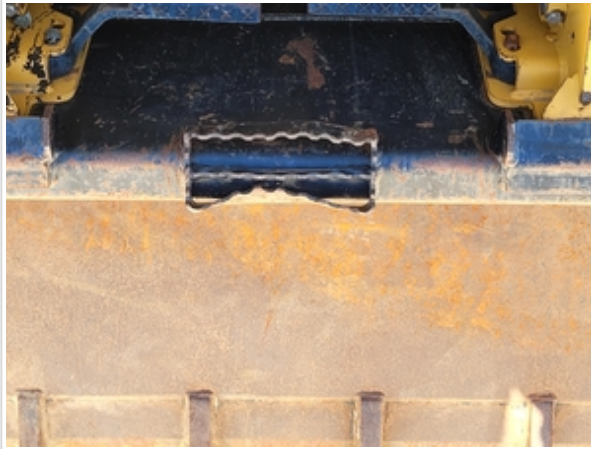
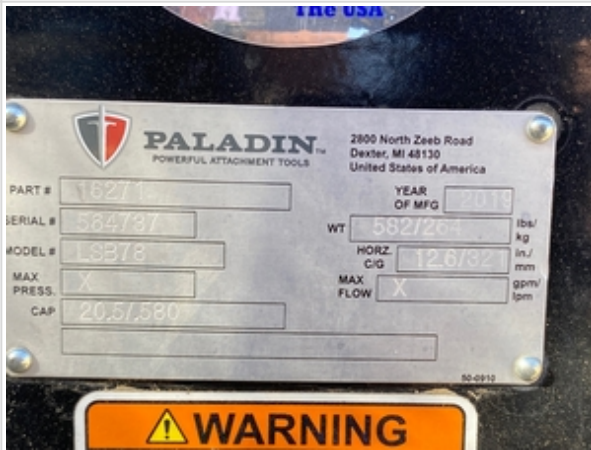
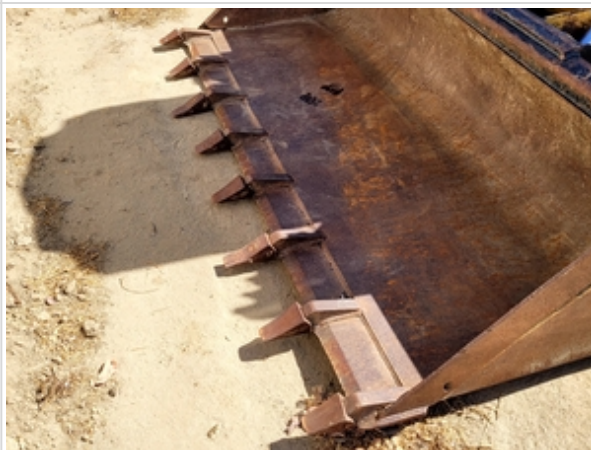
Bucket	3 - Normal Wear & Tear
Bucket Photos
