## Inspection Report (Compact Track Loader)

Year	2015
Make	John Deere
Model	333E
Serial Number	279331
Hour Meter Reading	1,704
Previous Application (e.g., earth moving, mining, demolition, etc)	Pipeline / Electrical Construction

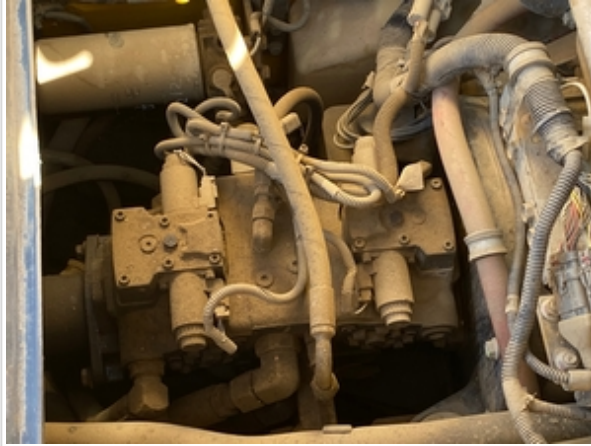
Appearance of Hydraulic Lines /  
Fittings Photos

Wet or Damp Hydraulic Lines / Fittings	No
Appearance of Hydraulic Lines / Fittings	3
Hydraulic Lines / Fittings Condition	Hydraulic lines & fittings are clean and in good condition
