Inspection Report (Excavator)

| Make | Komatsu |
| Model | PC128 UU |

| Date/Time | 11-01-2022 |

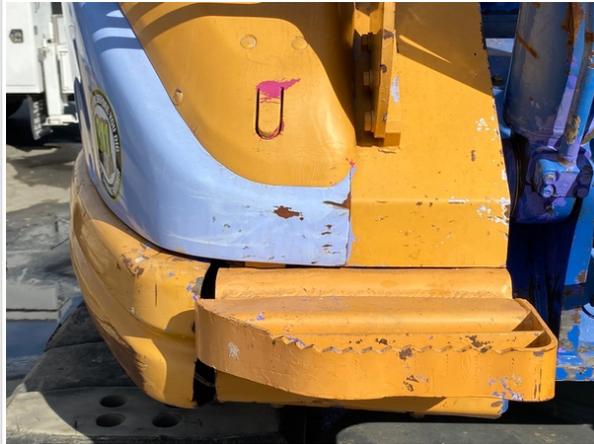
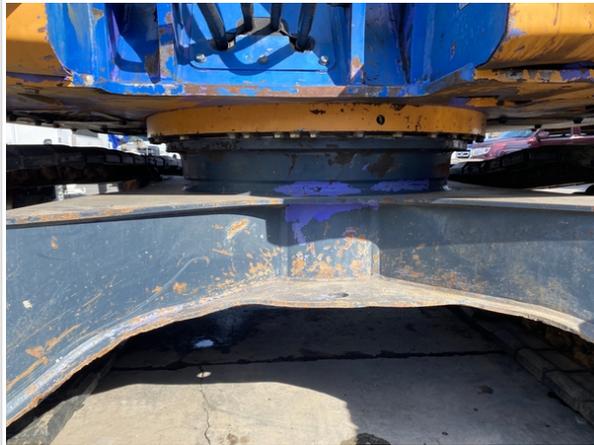
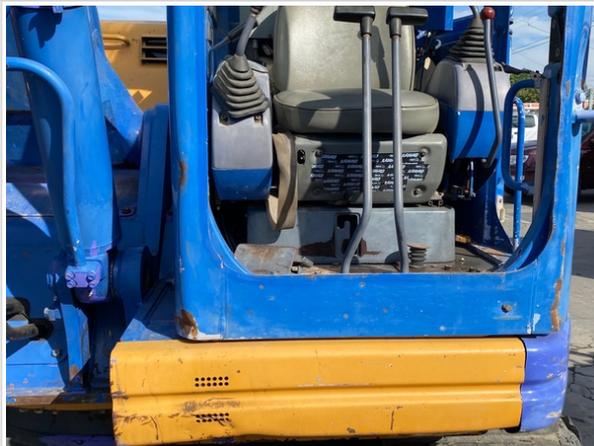
Front Photos

| Front | 3 - Normal Wear & Tear |
| Front Condition | No visible damage |

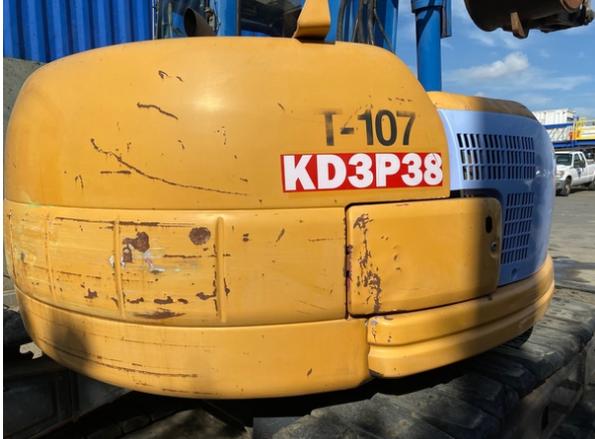
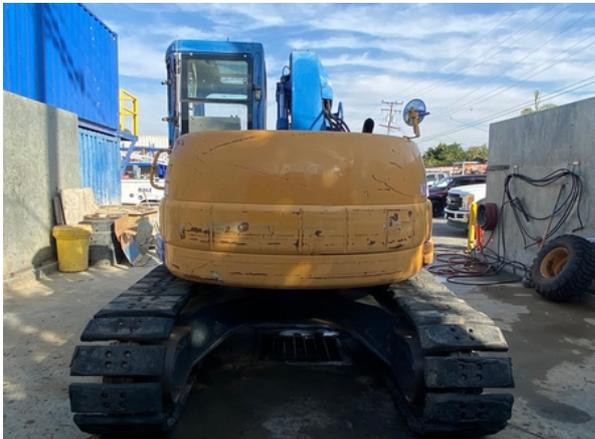
| Rear | 3 - Normal Wear & Tear | |
| Rear Condition | Other (see comments), No visible damage | |
| Comments | Normal wear and tear scuff marks | |

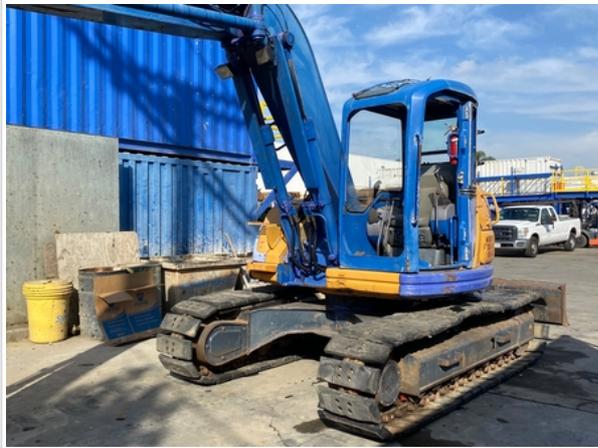
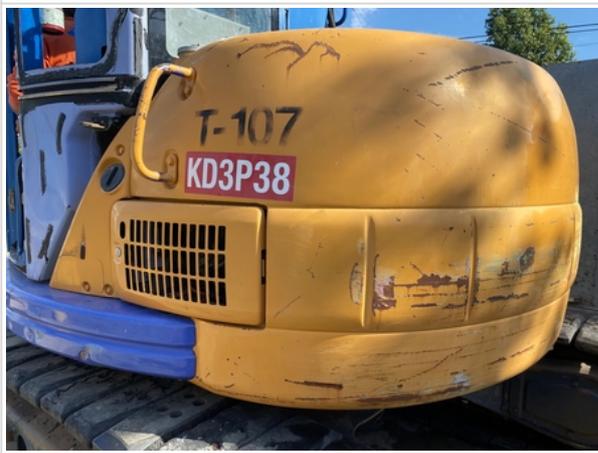
| Left | 3 - Normal Wear & Tear |
| Left Condition | No visible damage |

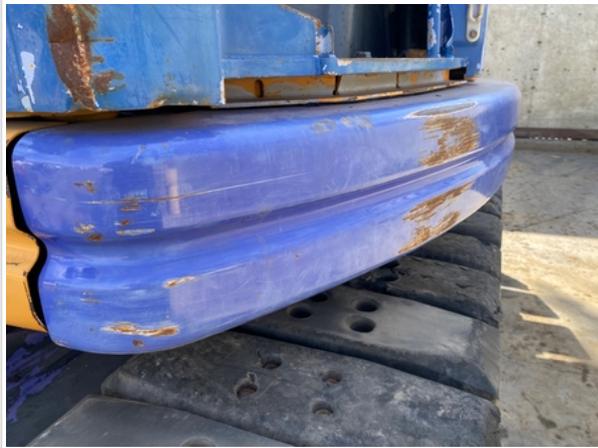
| <p>Right</p> | <p>3 - Normal Wear & Tear</p> | |
| <p>Right Condition</p> | <p>No visible damage</p> | |

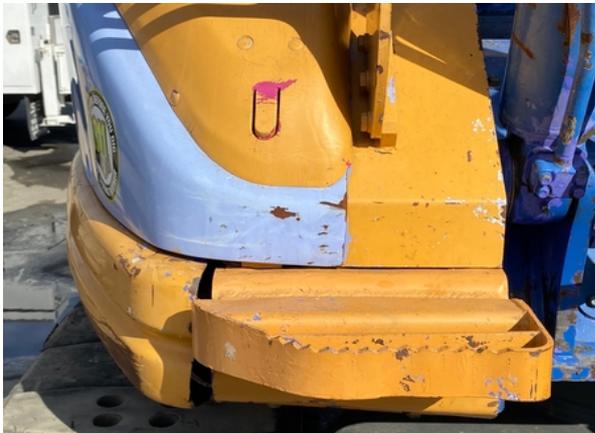
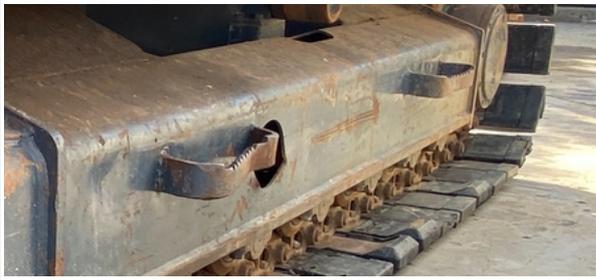
| Steps / Ladders | 3 - Normal Wear & Tear | |
| Steps / Ladders Condition | Bent or broken steps or rungs, Other (see comments) | |
| Comments | Left side track frame step bent | |

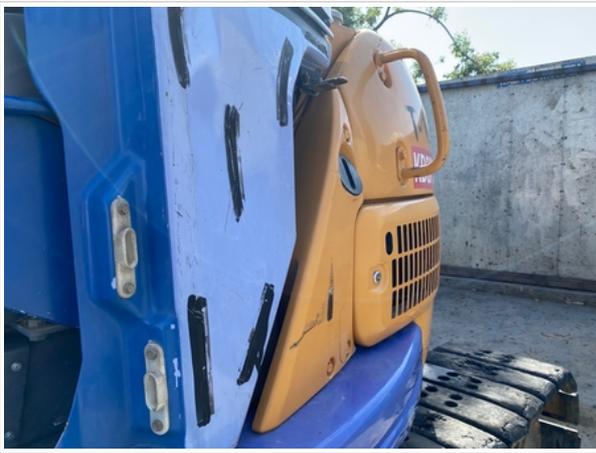
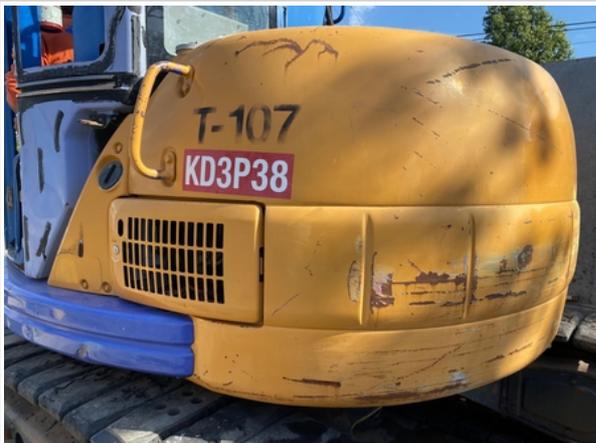
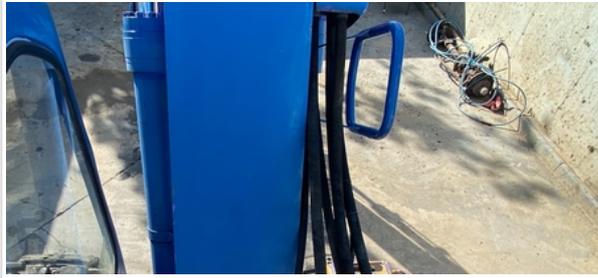
| Handrails | 3 - Normal Wear & Tear | |
| Handrails Condition | Handrails are fully intact and appear structurally sound | |

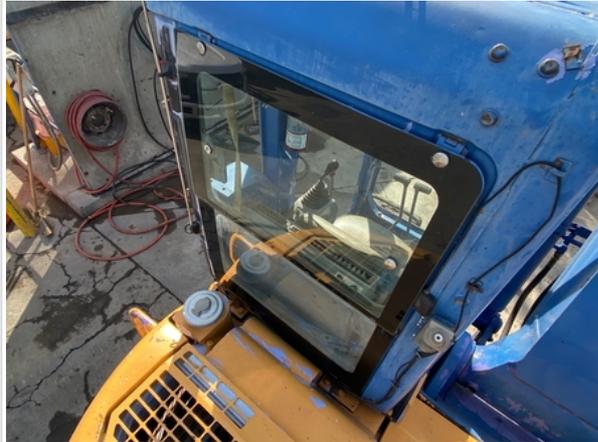
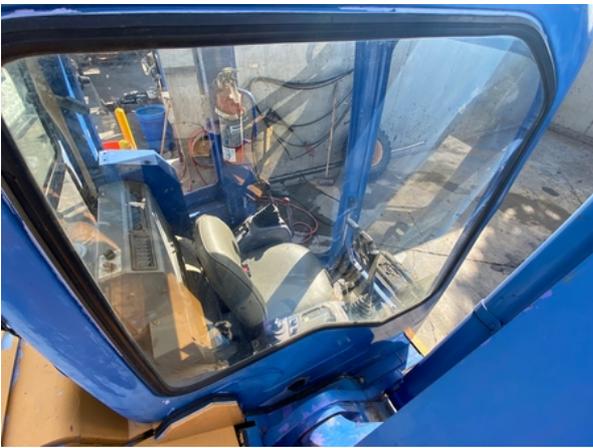
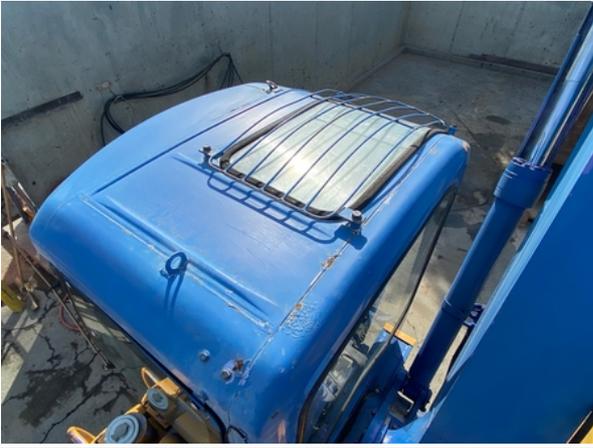
| Glass Condition | 2 - Above Average Wear |
| Glass Condition Notes | Other (see comments) |
| Comments | Front glass missing, door also removed |

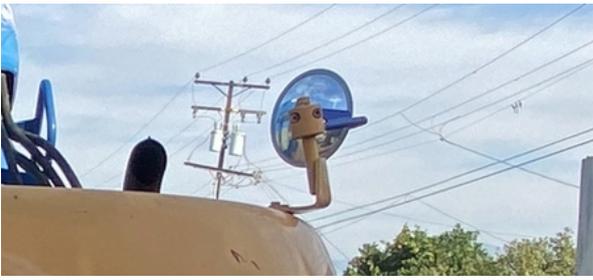
| Mirrors | 3 - Normal Wear & Tear | |
| Mirror Condition Notes | Mirrors present and intact, no visible damage | |

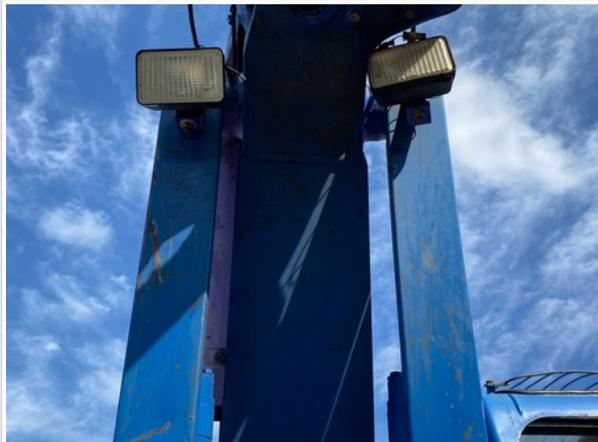
| Lighting System | 3 - Normal Wear & Tear | |
| Lighting System Condition | No visible damage, lighting system is operational | |

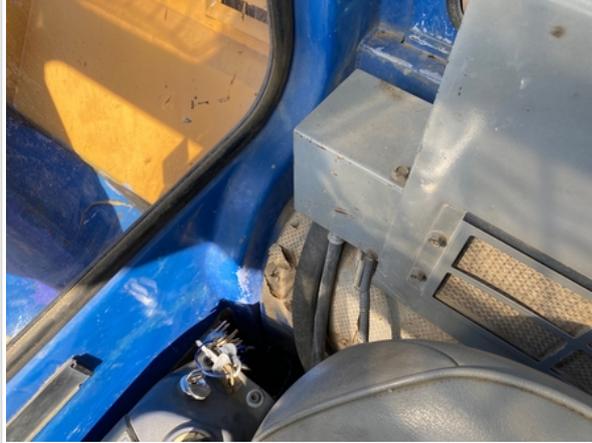
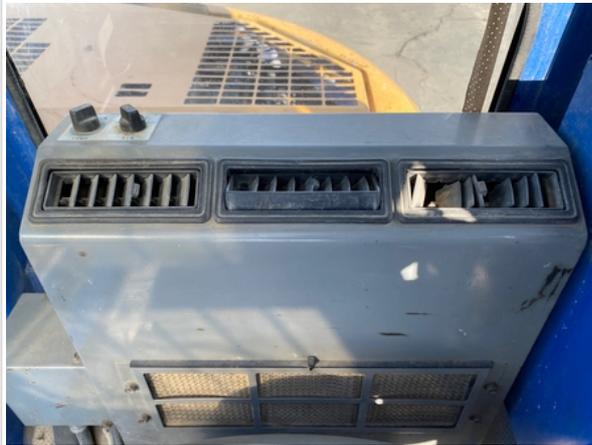
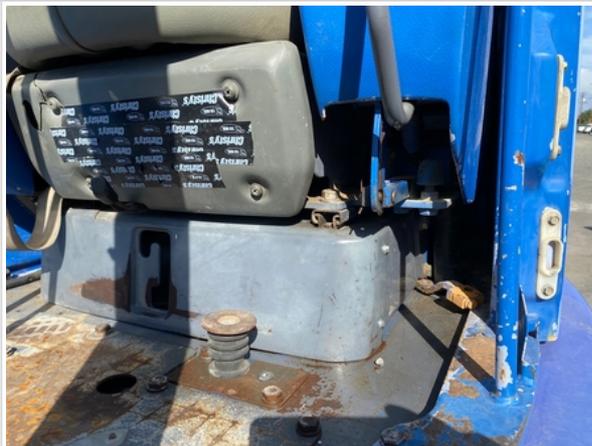
Operator Cabin Photos

| Operator Cabin Overall | 3 - Normal Wear & Tear |
| Operator Cabin Overall Condition | Good cabin appearance, solid floors, panels, and ceiling |

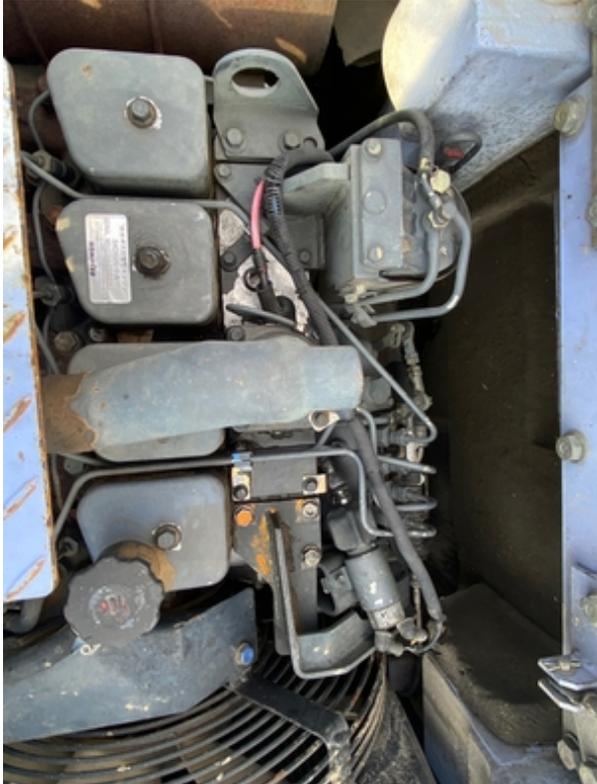
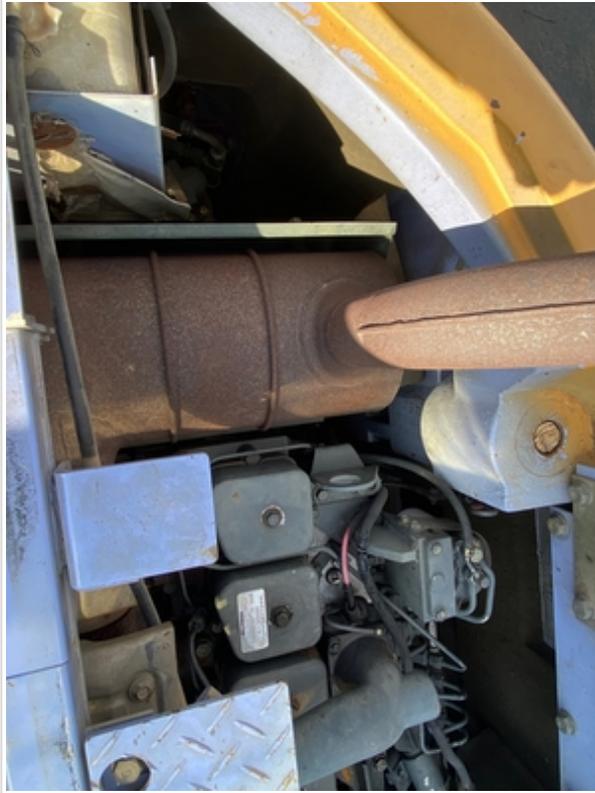
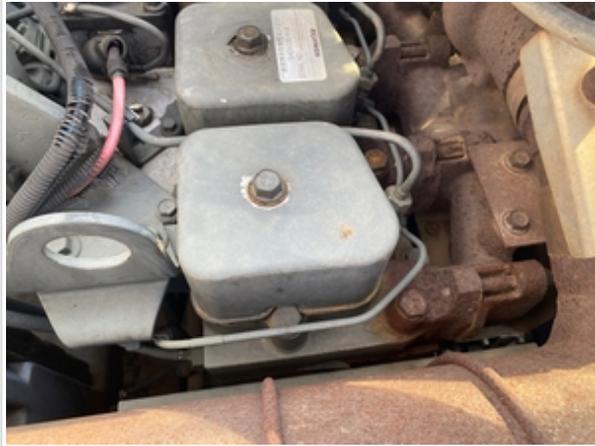
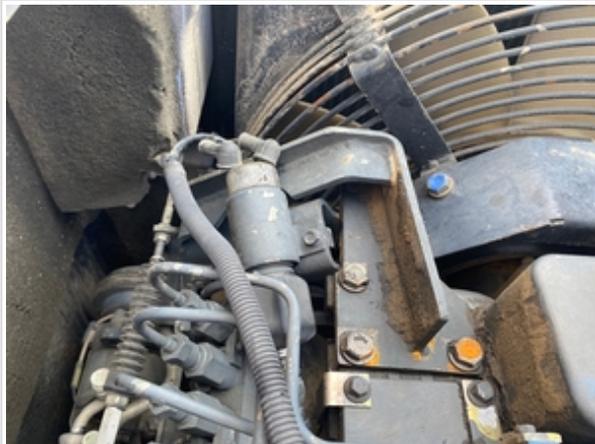
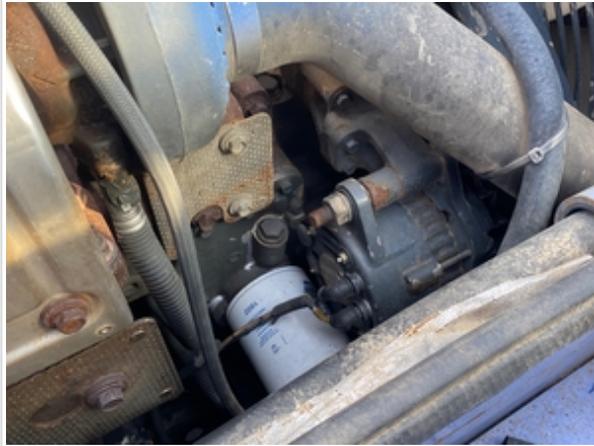
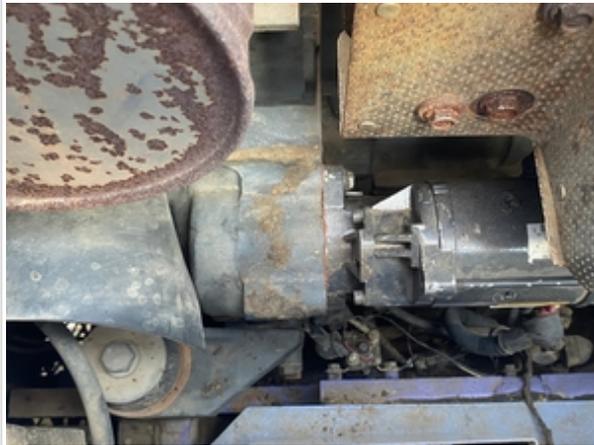
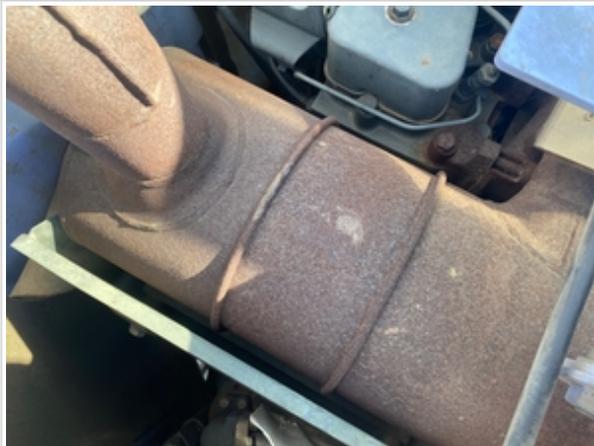
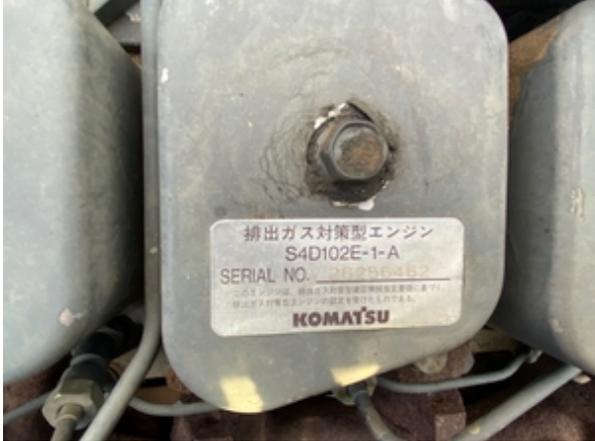
| Engine Photos | |

| Overall Engine Comments | Engine in good looking condition. Sounds healthy and no active leaks found. Clean and dry in regards to fluid leaks. |

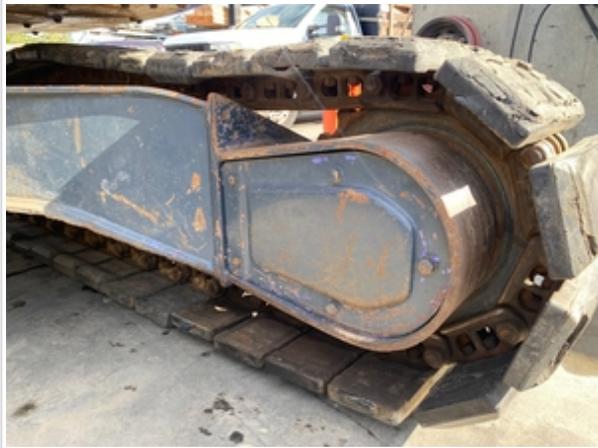
| Overall Drivetrain Comments | Overall drivetrain I'm good condition with no obvious abnormal issues found. Machine tracks good in both directions. | |

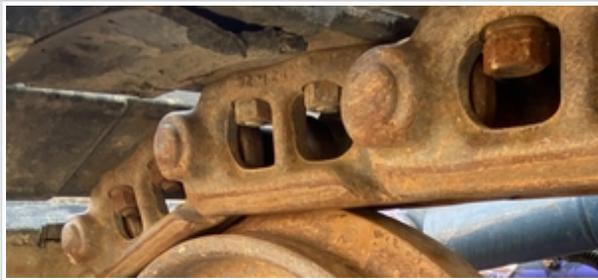
| Comments | Overall undercarriage in good condition. Some rubber pads chewed up and may need to be replaced soon. | |

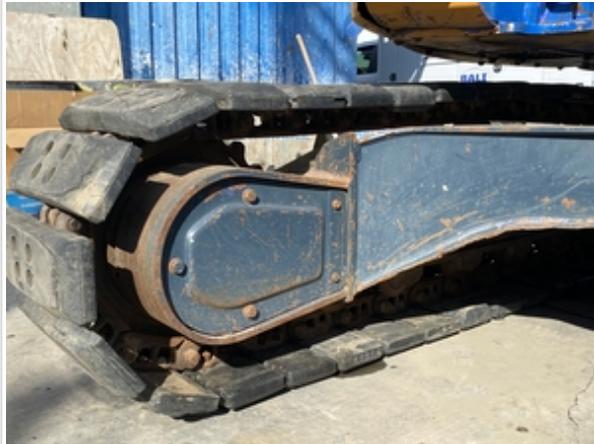
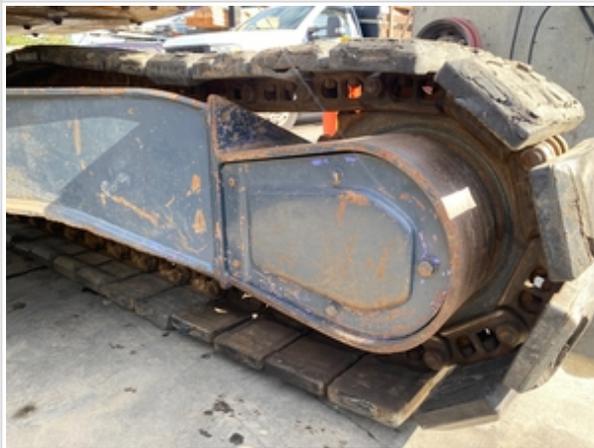
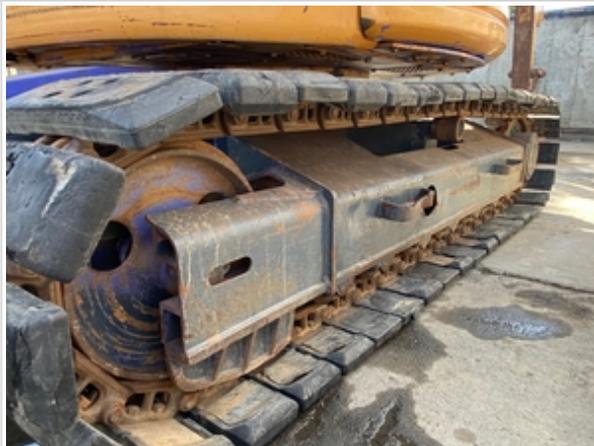
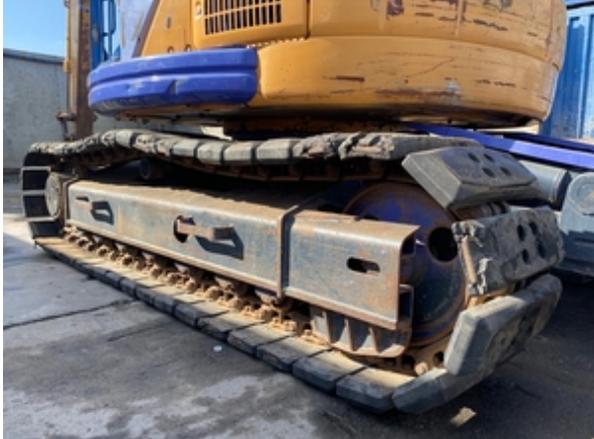
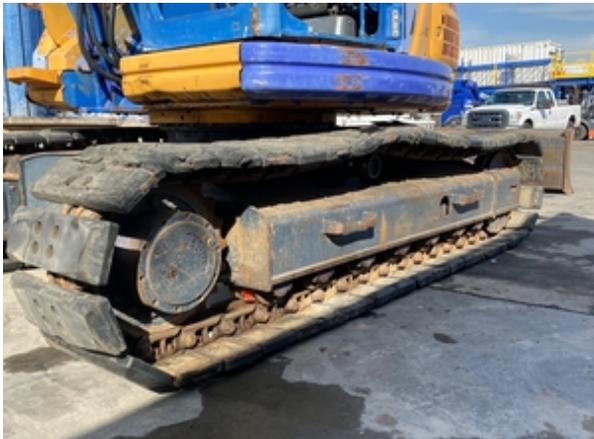
Tracks Photos

| Comments | Left side track loose (may just need adjustment) | |

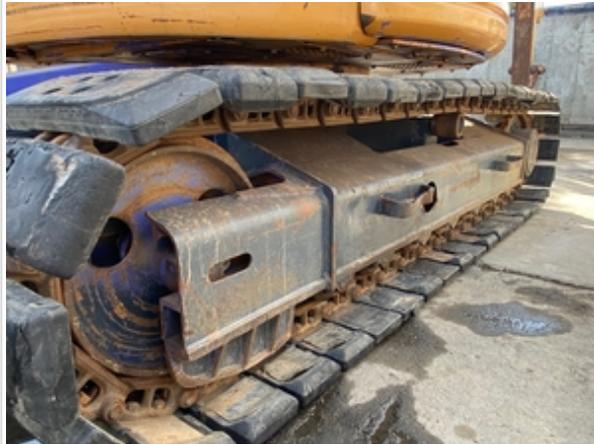
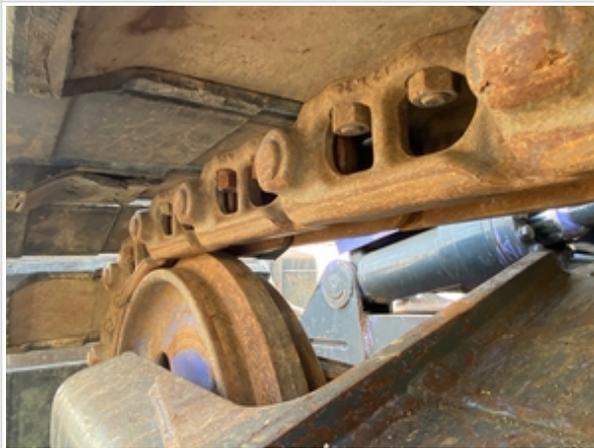
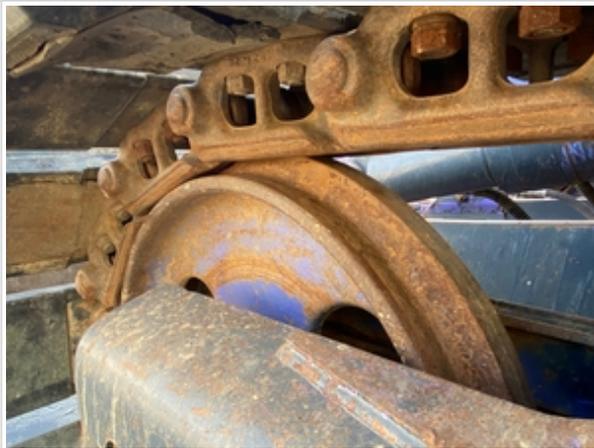
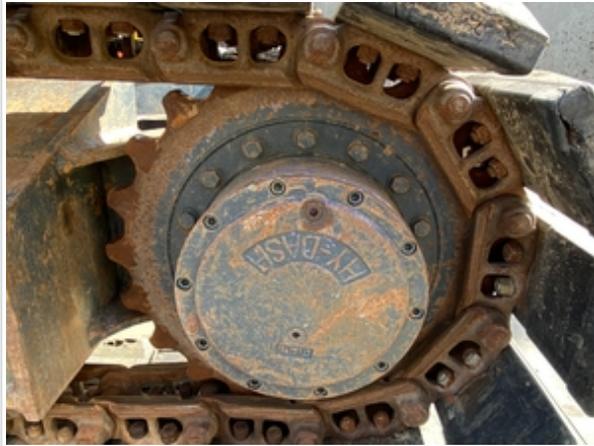
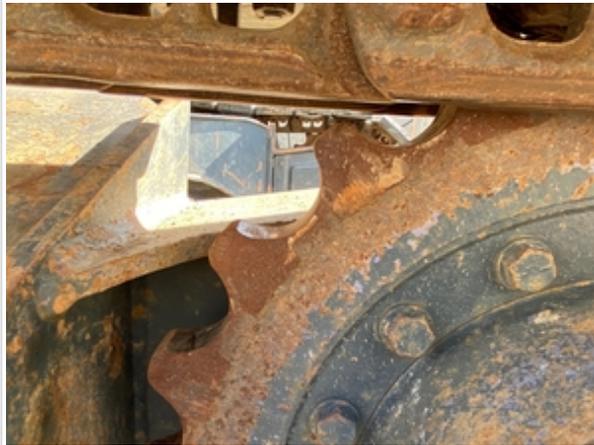
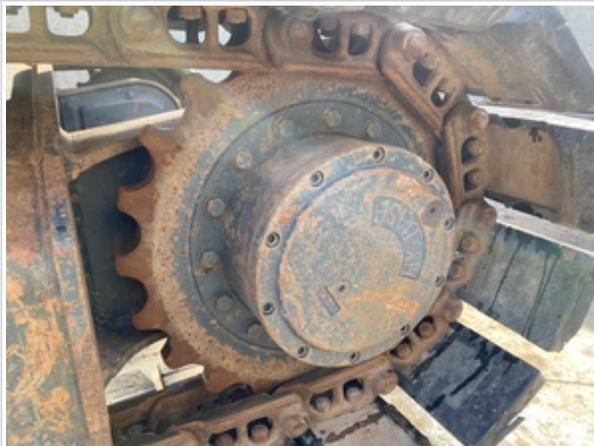
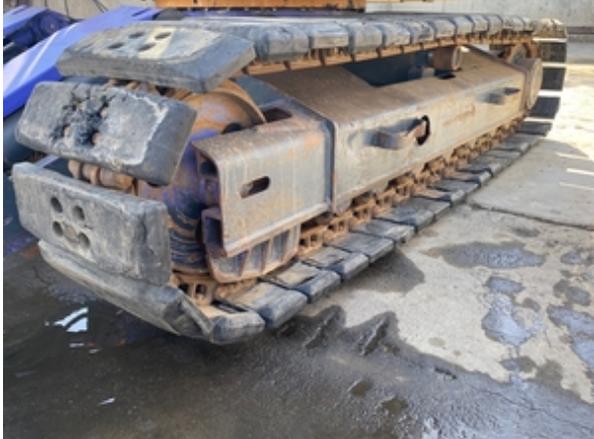
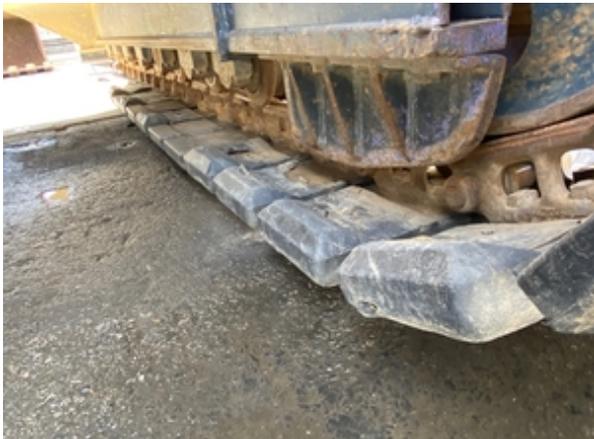
Undercarriage Left Side Photos

| Comments | Links, sprocket and rubber shoes about 50% worn | |
| Comments | Rollers and front idler in good shape 50% worn | |

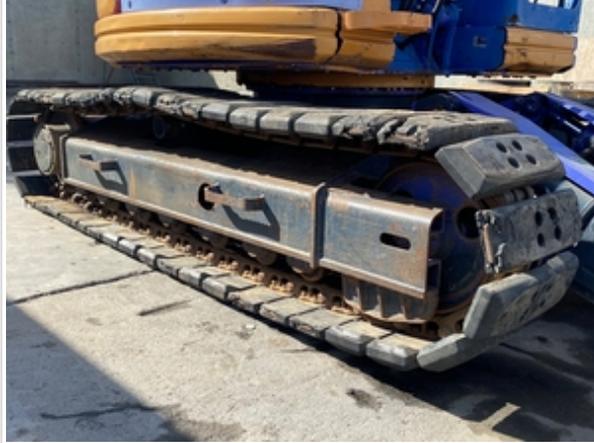
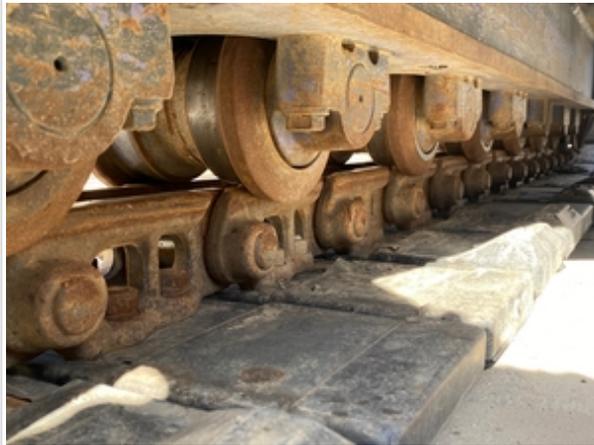
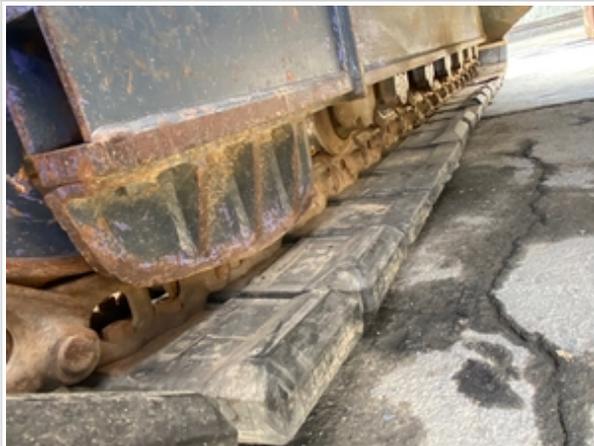
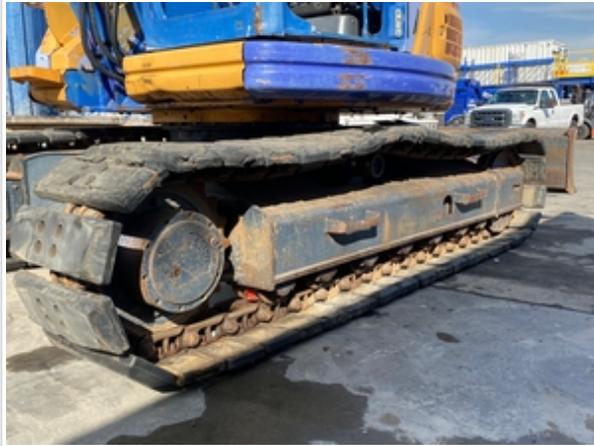
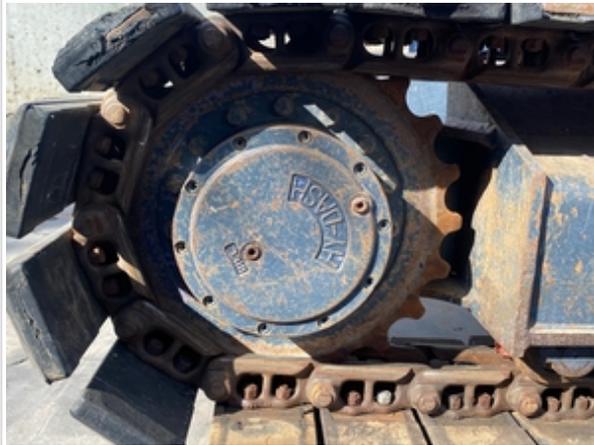
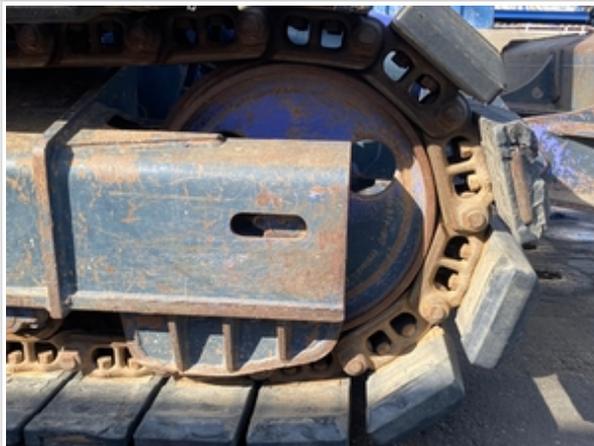
Undercarriage Right Side Photos

| Comments | Right side links and bushings 50% worn | |
| Comments | Right side idler and rollers in good shape 50% worn | |

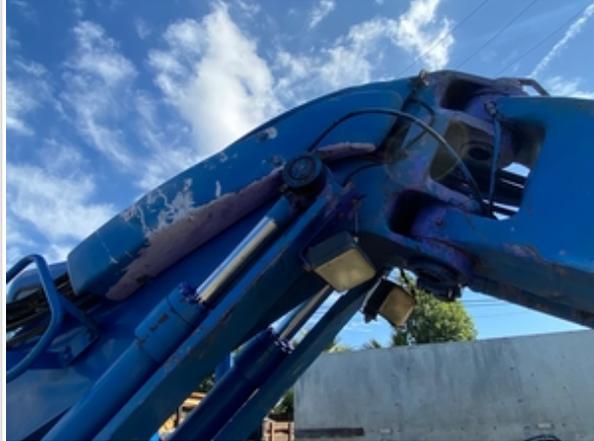
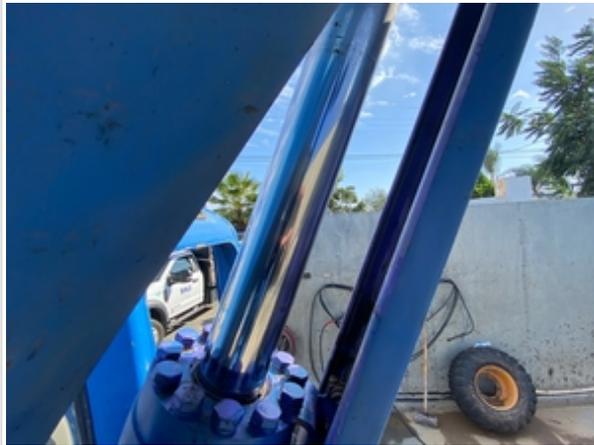
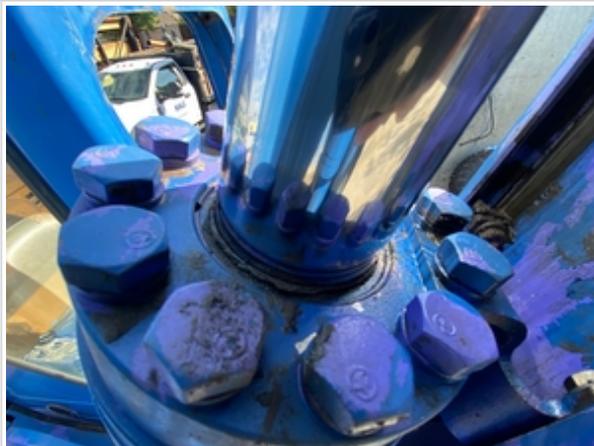
Boom Cylinder Photos

| Boom Cylinder: Oil Leaks | Yes |

| What Needs Work | Cosmetically this machine could use some repairs. Doors and some windows missing. Right side boom cylinder seeping out oil and bucket cylinder drifts when operating temperature reached. Right side track loose and track adjuster should be further inspected for possible issues. (may just need to be adjusted) |

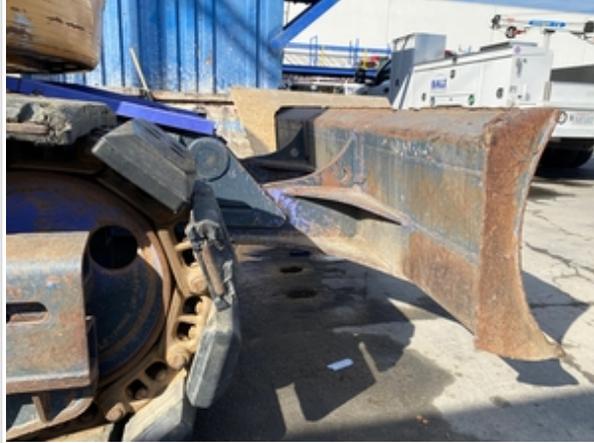
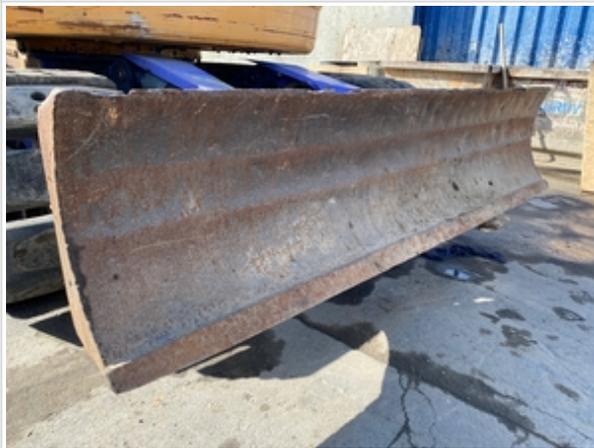
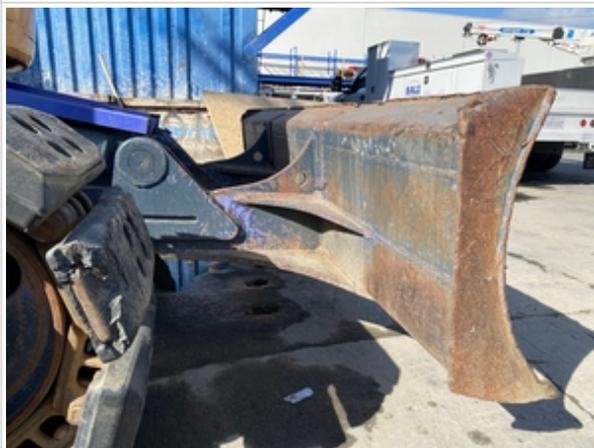
Blade Photos

| Blade | 3 |
