Inspection Report (Skid Steer)

Year	2017
Make	Bobcat
Model	T 450
Serial Number	AUVP13415
Hour Meter Reading	2,811
Previous Application (e.g., earth moving, mining, demolition, etc)	Demolition Work

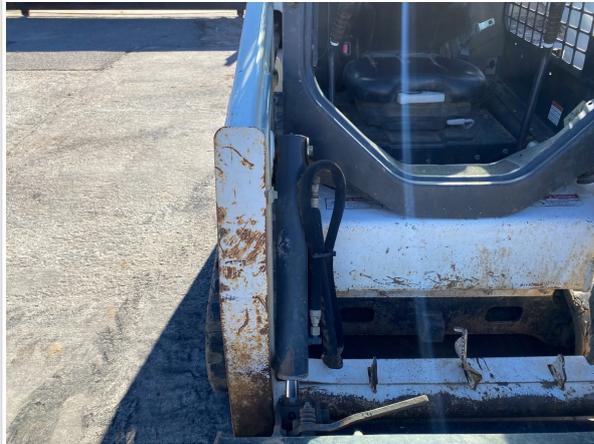
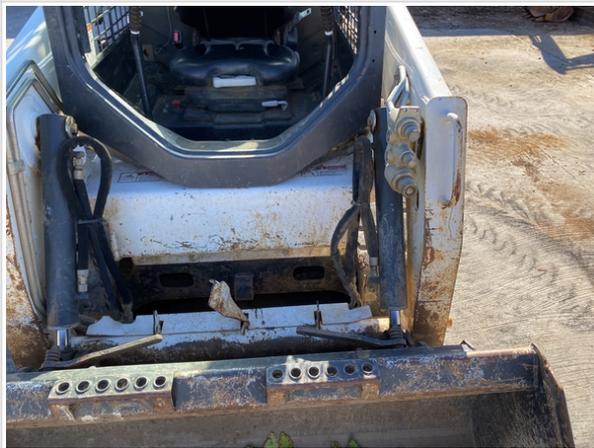
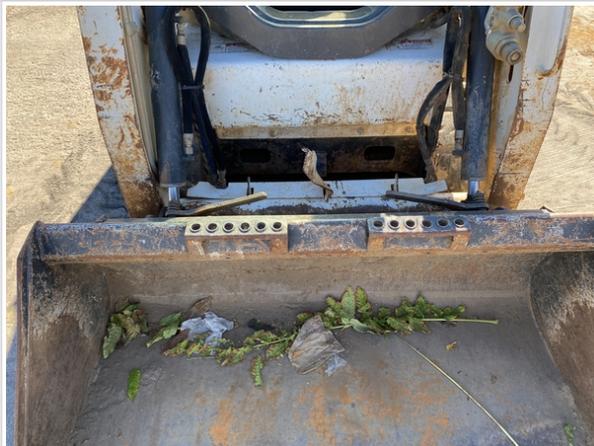
Front Photos

Front	3 - Normal Wear & Tear
Front Condition	No visible damage

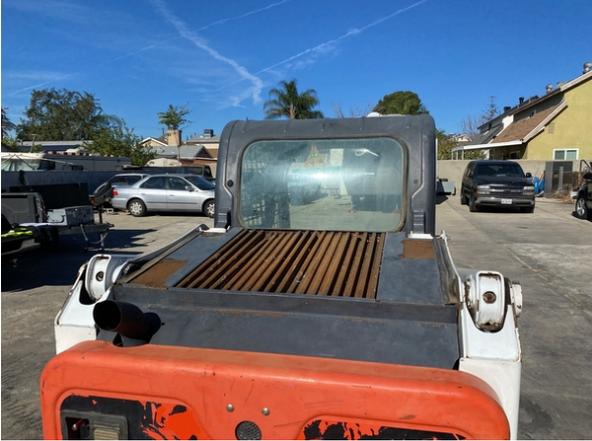
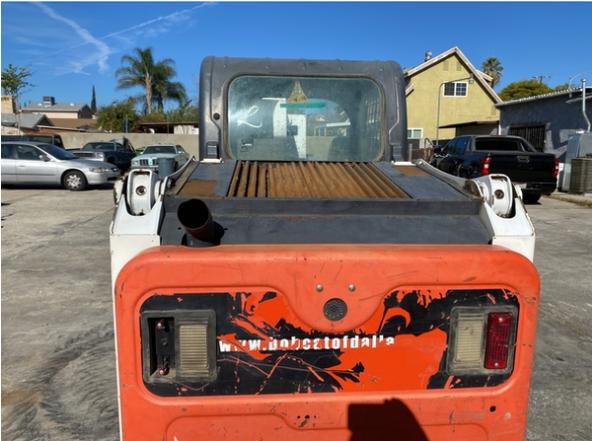
Rear	3 - Normal Wear & Tear	
Rear Condition	No visible damage, Other (see comments)	
Rear Photos

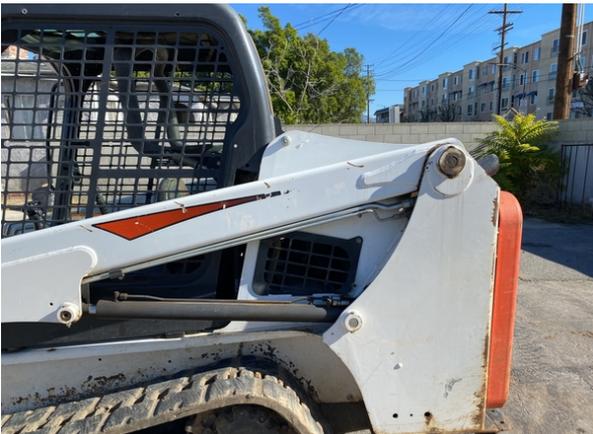
Left	3 - Normal Wear & Tear	
Left Condition	No visible damage, Other (see comments)	
Left Photos

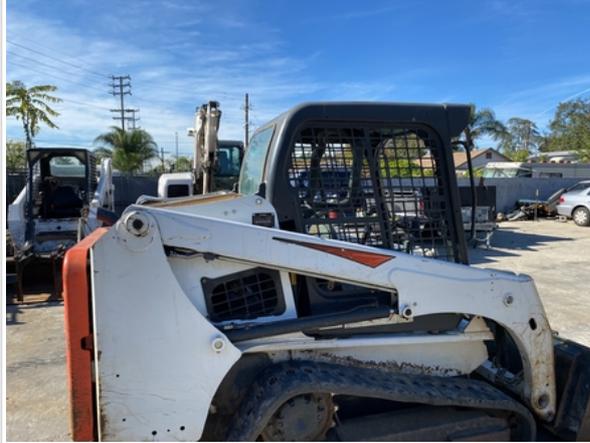
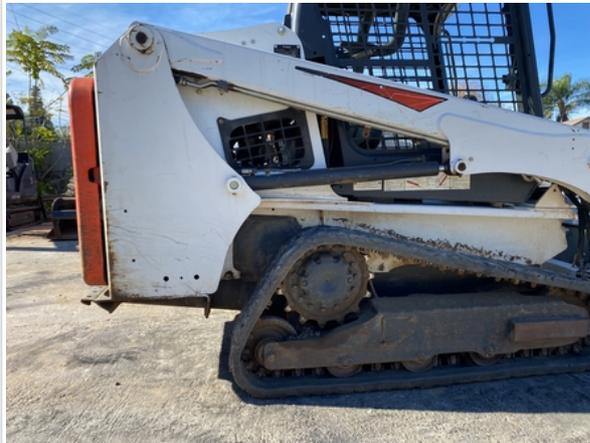
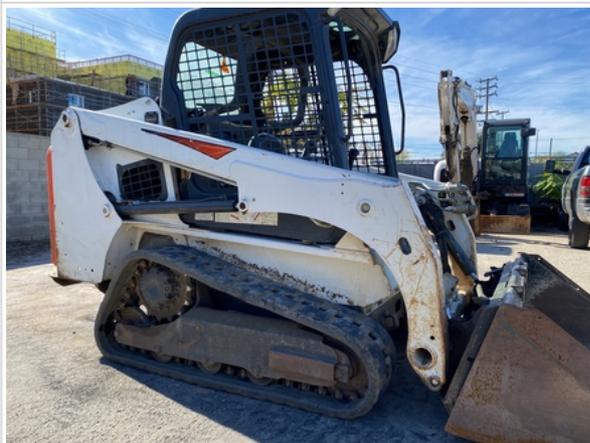
Right Photos

Right	3 - Normal Wear & Tear
Right Condition	No visible damage

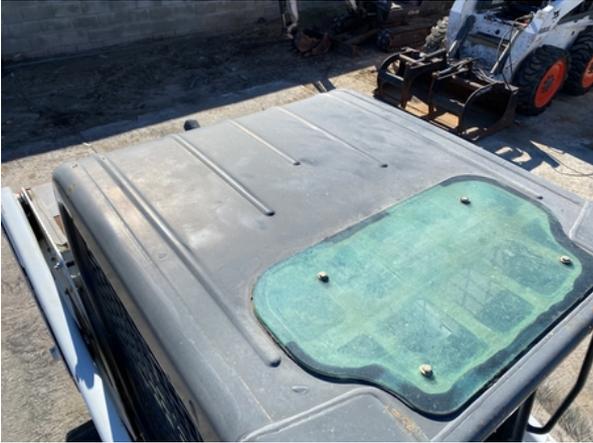
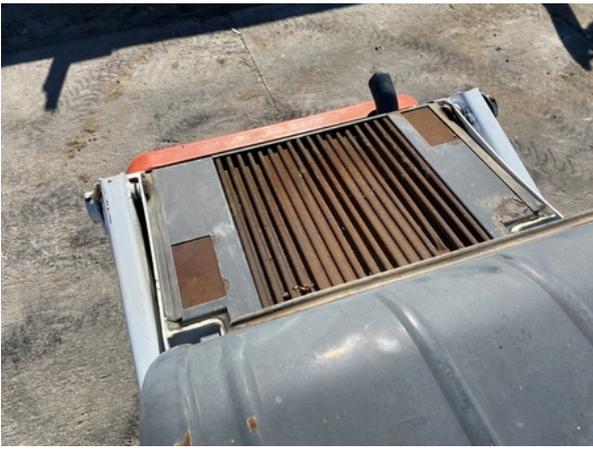
Upper	3 - Normal Wear & Tear
Upper Condition	No visible damage
Upper Photos

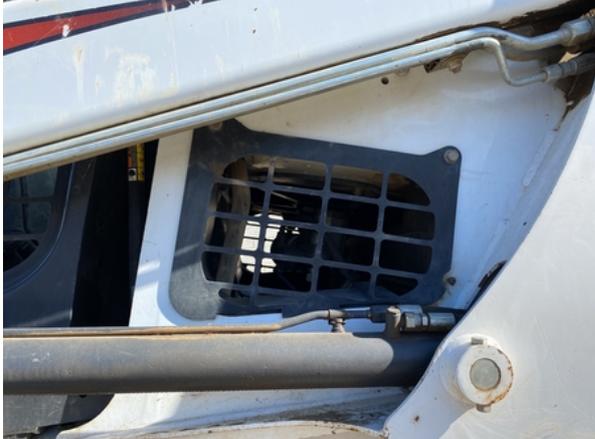
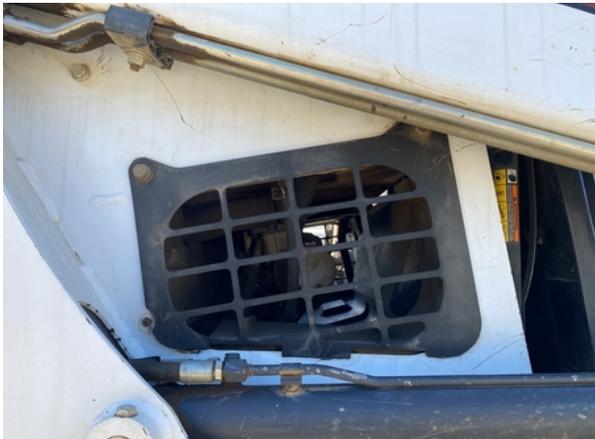
Body Panels Photos

Body Panels (Any Rust Damage?)	3 - Normal Wear & Tear
Body Panel Condition	No visible damage, good paint condition and panel fitment

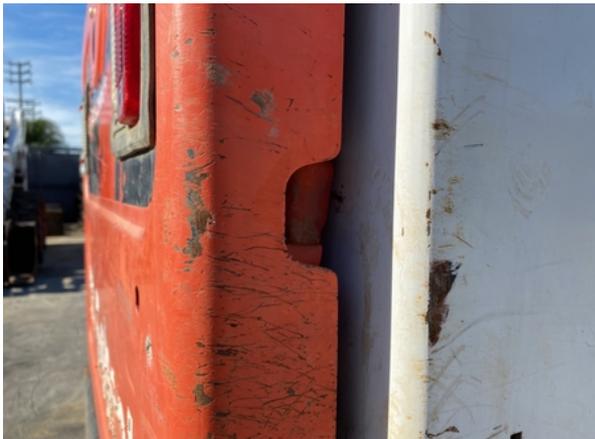
Doors / Canopy Latches	3 - Normal Wear & Tear
Doors / Canopy Latches Condition	No visible damage
Doors / Canopy Latches Photos

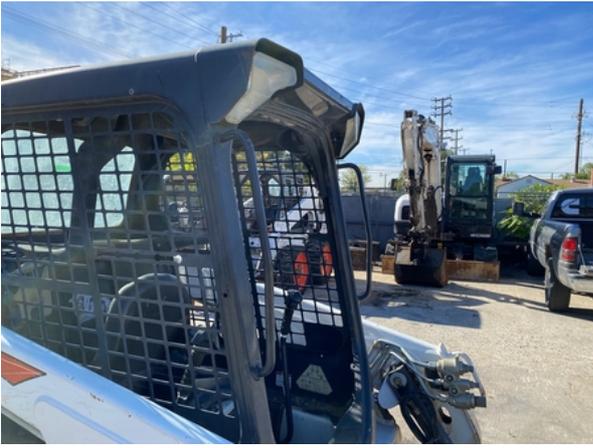
Handrails	3 - Normal Wear & Tear
Handrails Condition	Handrails are fully intact and appear structurally sound
Handrail Photos

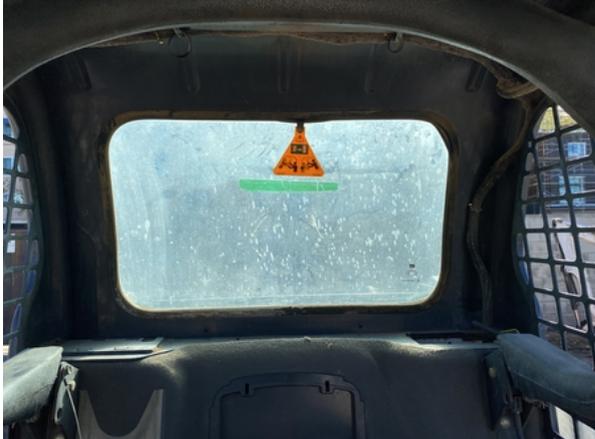
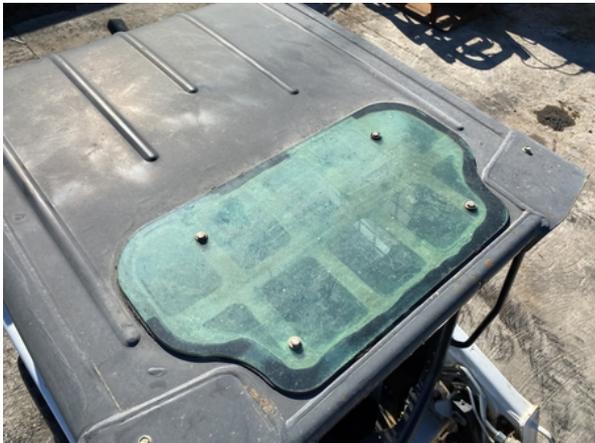
Glass Condition Photos

Glass Condition	3 - Normal Wear & Tear
Glass Condition Notes	Glass intact, no visible damage

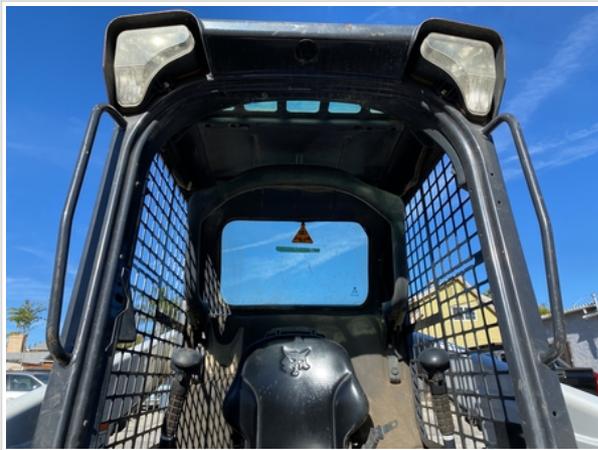
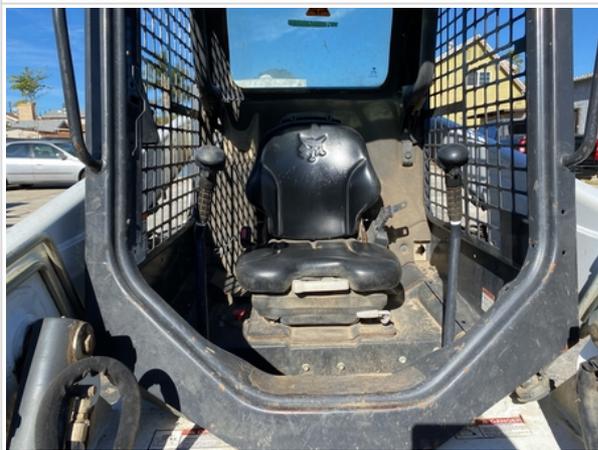
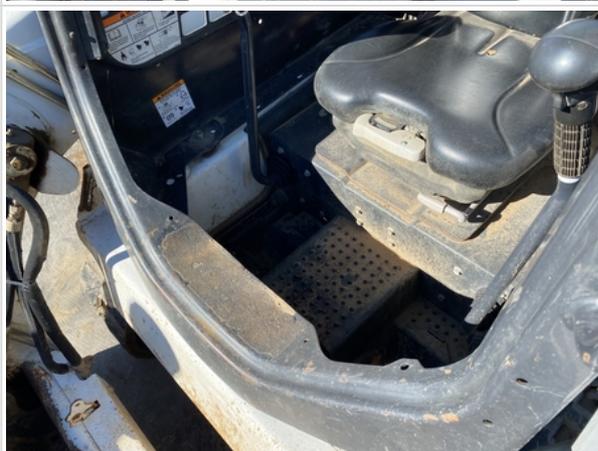
Operator Cabin Photos

Operator Cabin Overall	3 - Normal Wear & Tear
Operator Cabin Overall Condition	Good cabin appearance, solid floors, panels, and ceiling

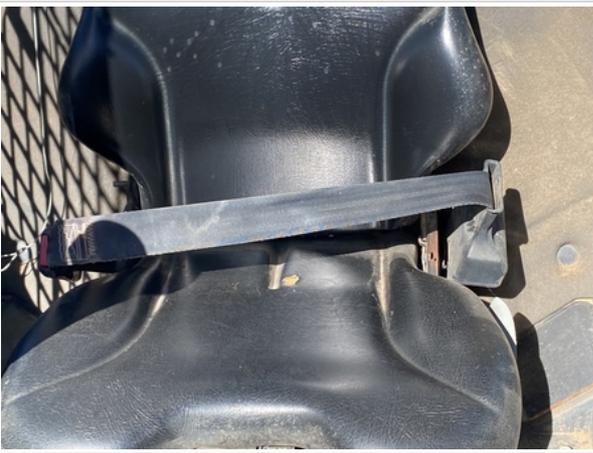
Seat Belt	3 - Normal Wear & Tear
Seat Belt Condition	Seat belt secures properly. Belt is intact and in good condition
Seat Belt Photos

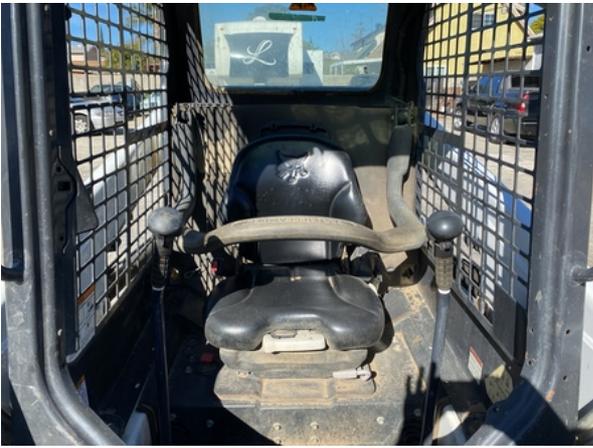
Cabin Lights	0
Safety Lock Out / Stop	3 - Normal Wear & Tear
Safety Lock Out / Stop Condition	Safety lock out device is present, in good condition, and functional
Safety Lock Out / Stop Photos

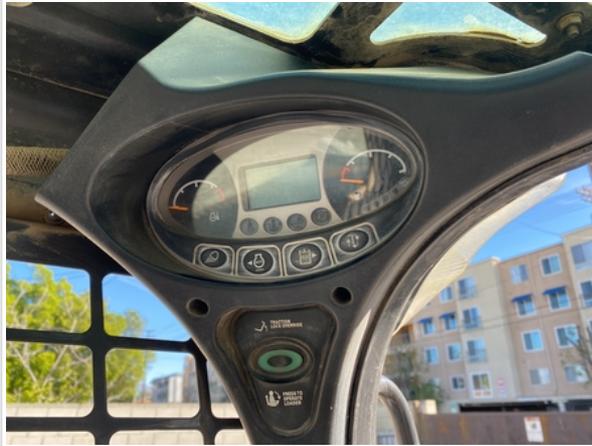
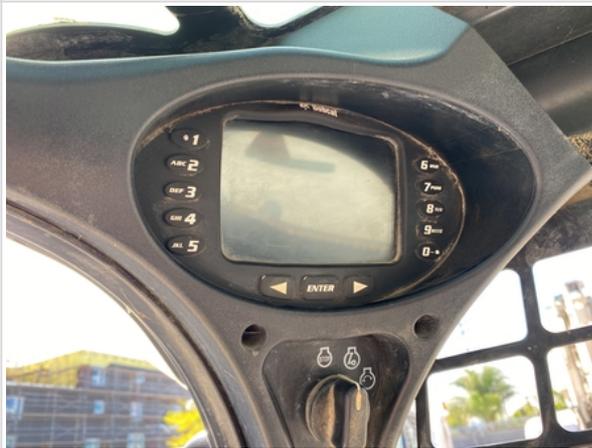
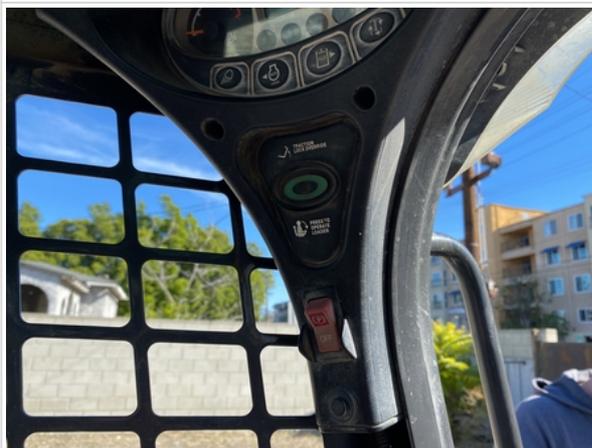
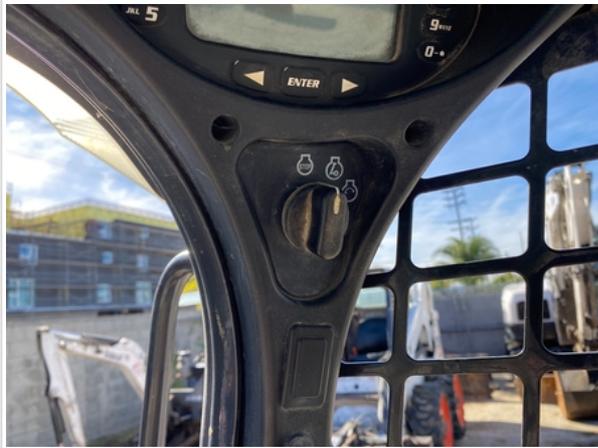
Controls & Switches Photos

Controls & Switches	3 - Normal Wear & Tear
Controls & Switches Condition	All switches are installed and functional

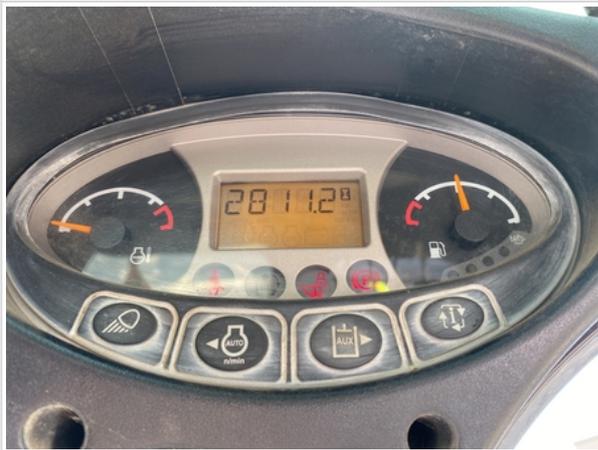
Hour Meter Activity	3 - Normal Wear & Tear	
Hour Meter Condition	Hour meter is functional and in good condition	
Hour Meter Activity Photos

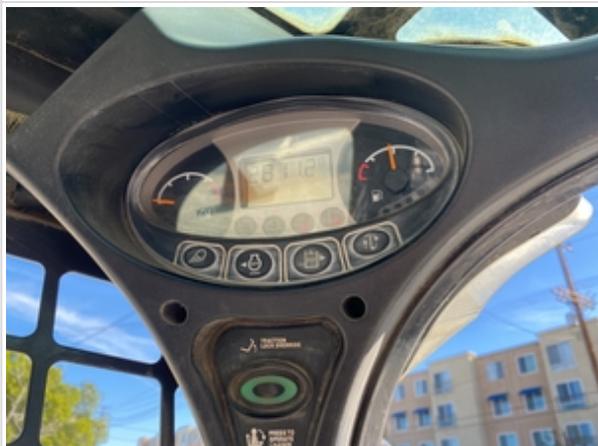
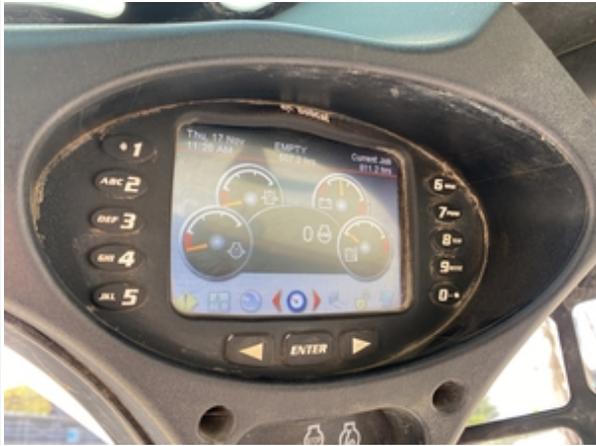
Other Gauge Activity	3 - Normal Wear & Tear	
Other Gauge Condition	All cockpit gauges are functional and in good condition	
Other Gauge Activity Photos

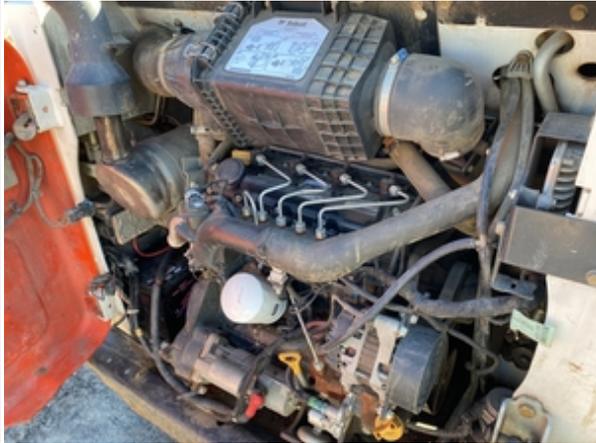
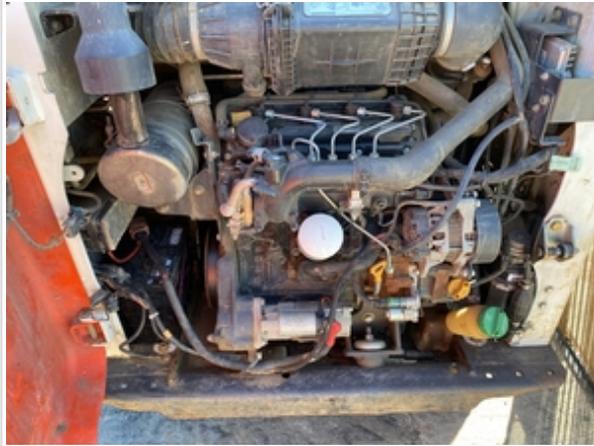
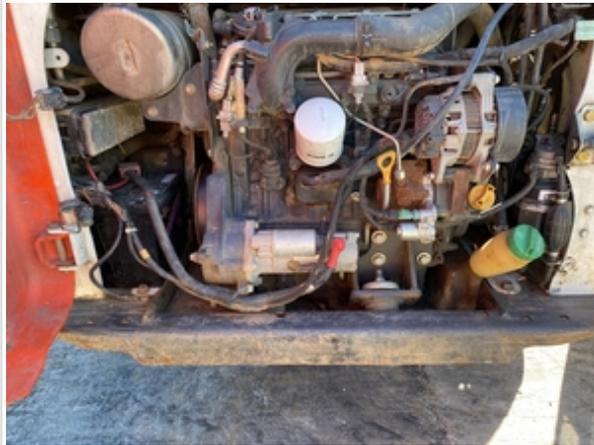
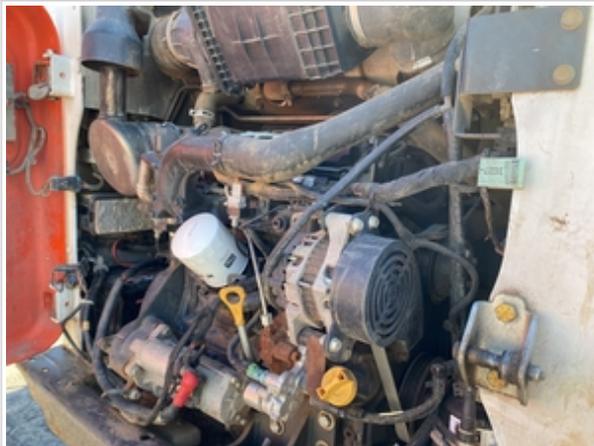
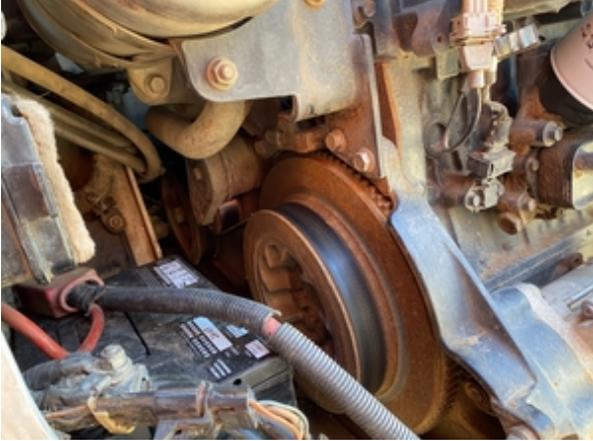
Engine Type (Make, Model, Cylinders, Hp)	Bobcat D24NAP - 4 Cyl - 61HP -
Emissions Tier	Tier 4F
Engine Serial Number	6076064
Engine Fuel Type	Diesel
Engine Photos

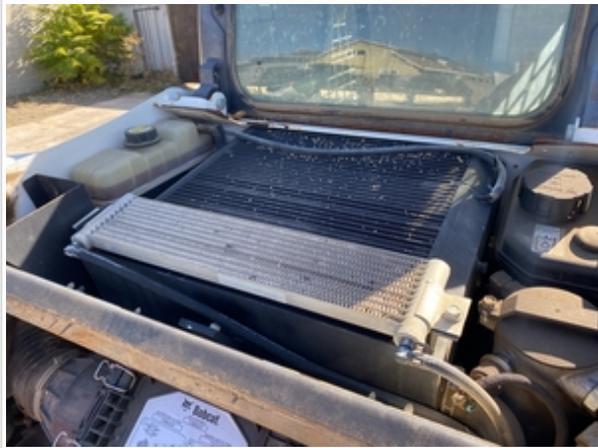
Radiator Photos

Radiator	3 - Normal Wear & Tear
Radiator Condition	Radiator fins & components appear to be in good working order, no signs of damage or leaks

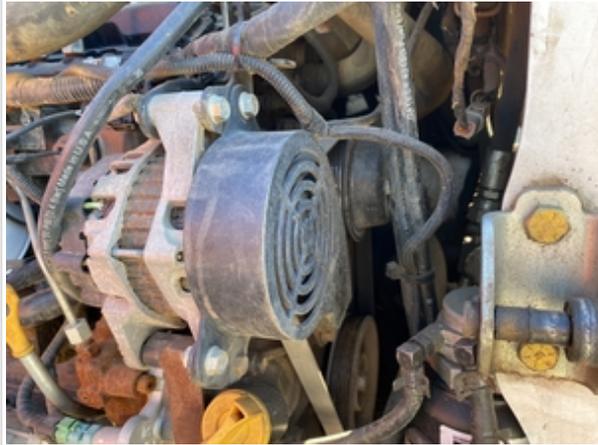
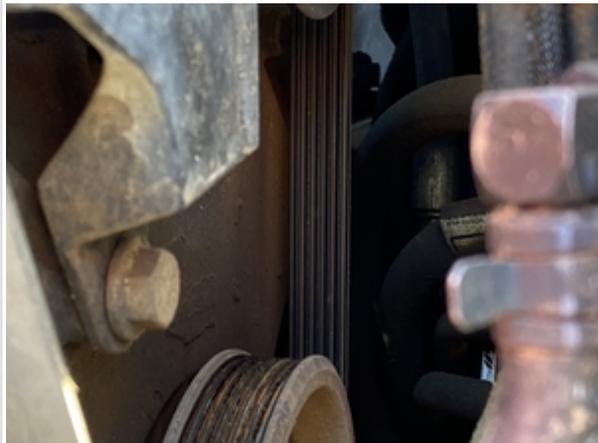
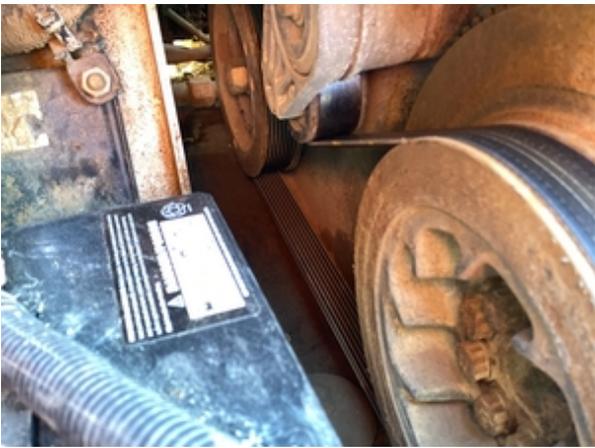
Belts	3 - Normal Wear & Tear
Belt Condition	Belts appear in good condition & alignment with proper tension
Belt Photos

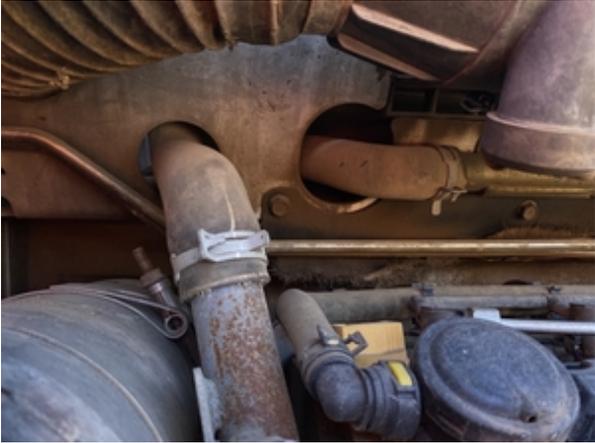
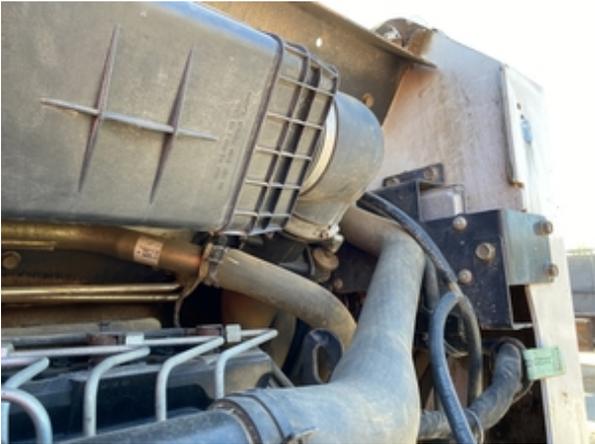
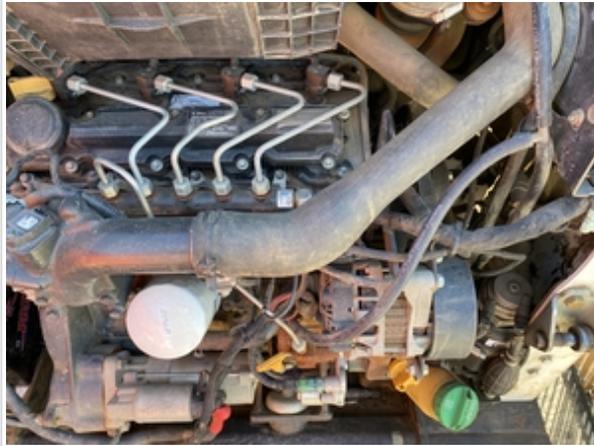
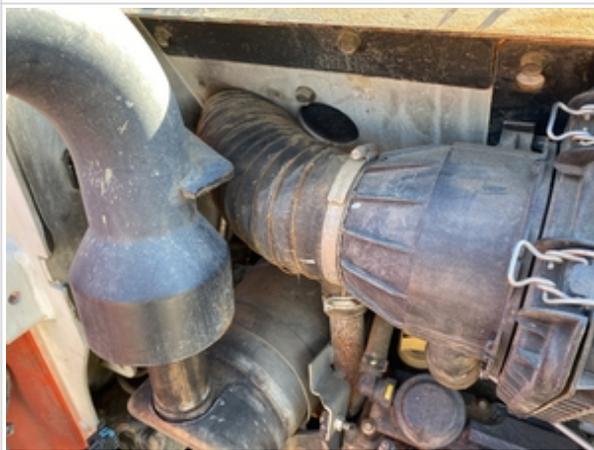
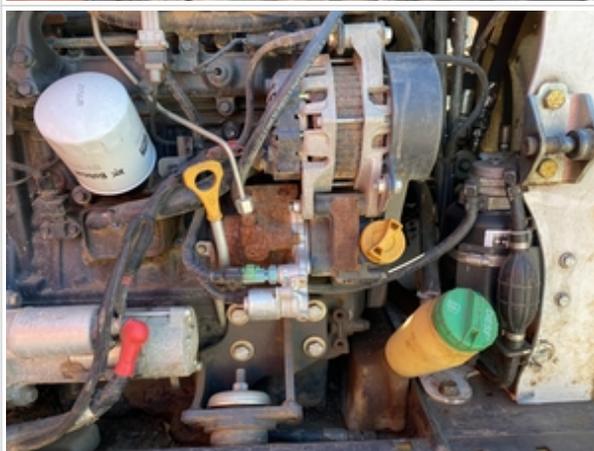
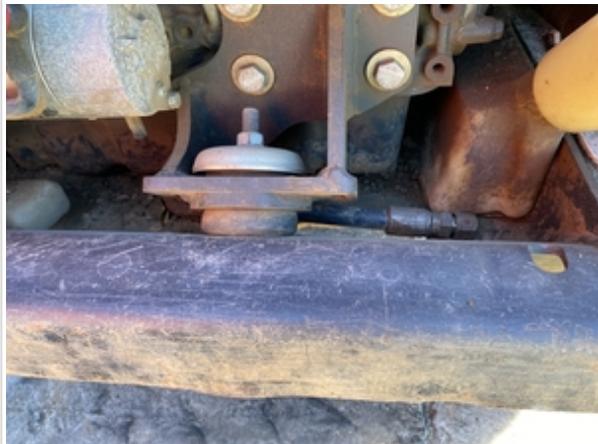
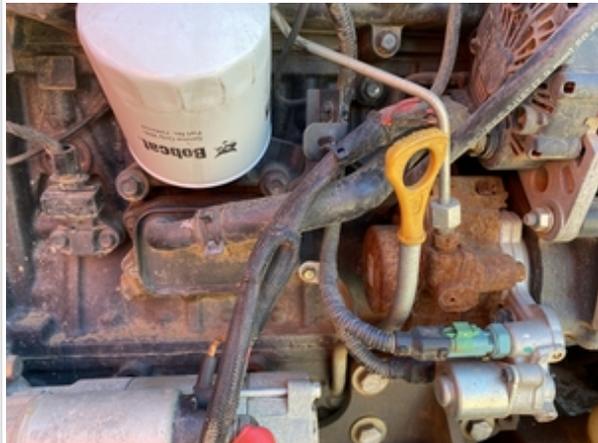
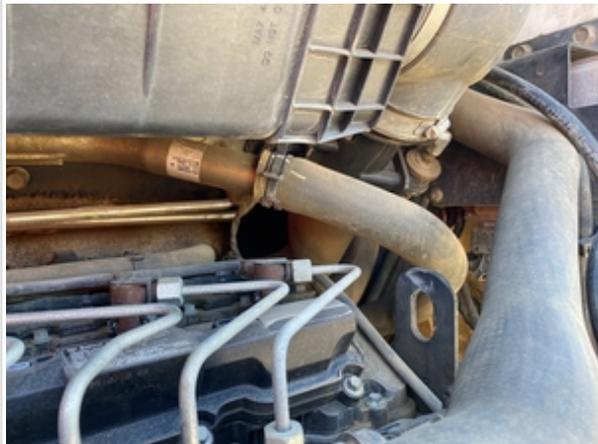
Hoses	3 - Normal Wear & Tear	
Hose Condition	Firm, pliant hoses with no signs of wear or leaks	
Hose Photos

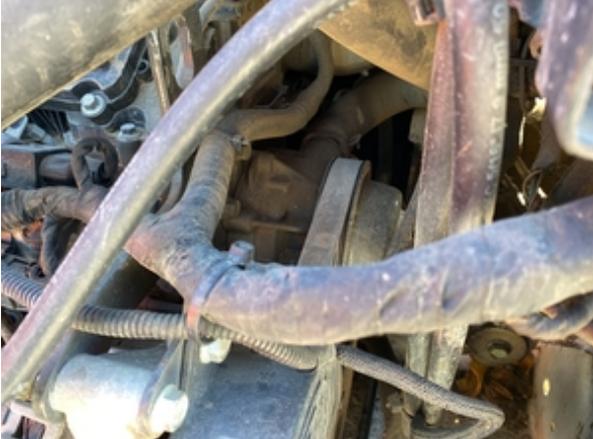
Water Pump Photos

Water Pump	3 - Normal Wear & Tear
Water Pump Condition	No unusual pump noises heard

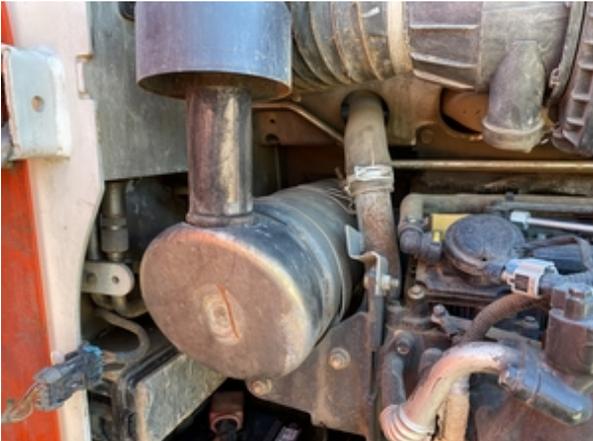
Cooling System Leaks	No
Coolant Color / Appearance	3 - Normal Wear & Tear
Coolant Color/Appearance Notes	Normal Translucent appearance, no visual signs of contamination
Oil Leaks	No
Oil Color / Appearance	3 - Normal Wear & Tear
Oil Color / Appearance Notes	Clean oil appearance, no signs of cross contamination, Appropriate oil level
Fuel Leaks	No
Equipped with DPF (Diesel Particulate Filter)	Yes
DPF Condition	3 - Normal Wear & Tear
DPF Condition Notes	Filter housing is intact with no signs of damage or malfunction, DPF indicator is not illuminated
DPF Photos

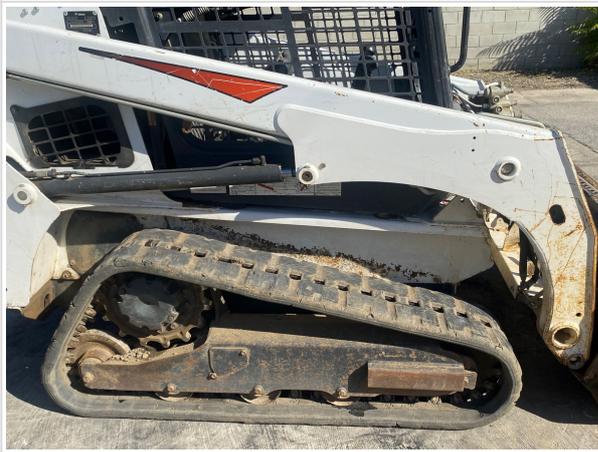
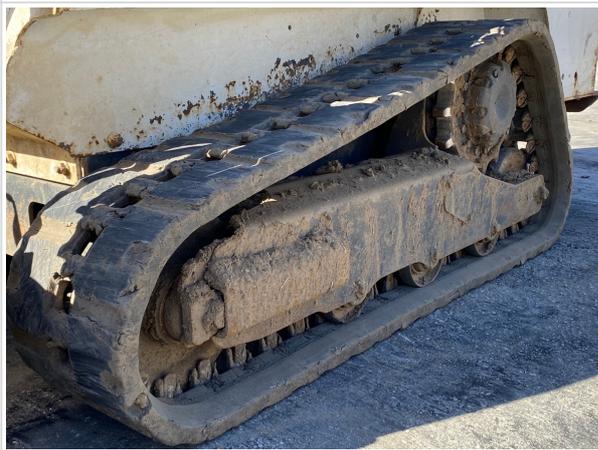
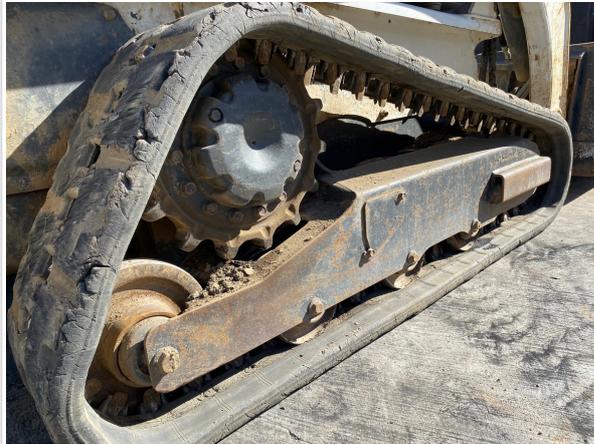
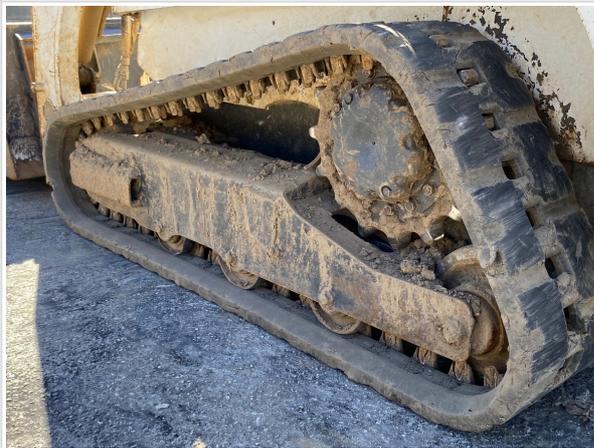
<p>Track Belt</p>	<p>3 - Normal Wear & Tear</p>
<p>Track Belt Photos</p>

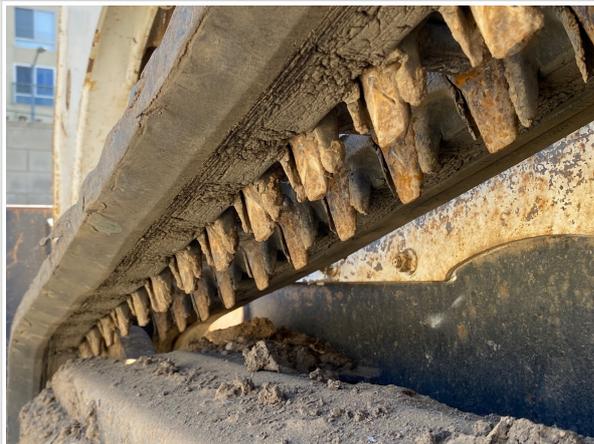
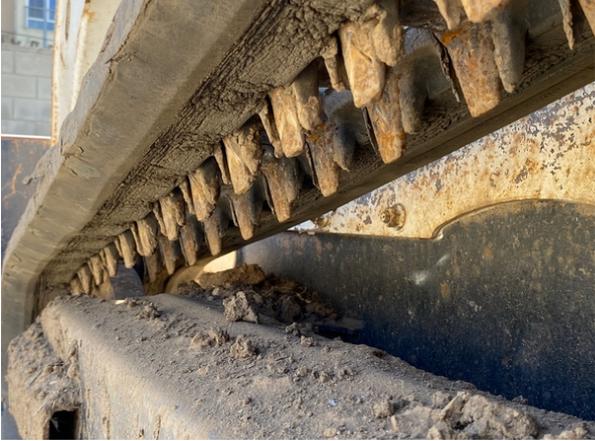
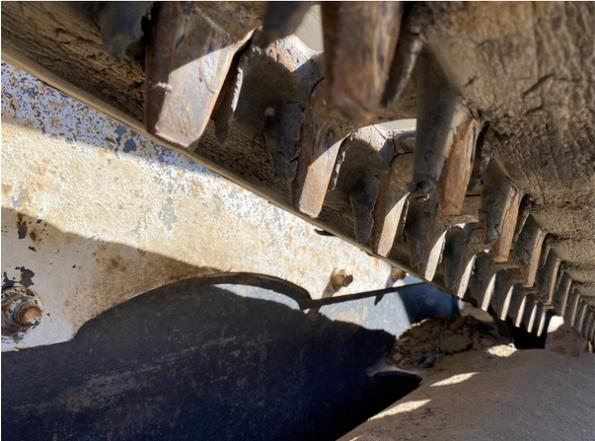
Rubber Belt Drive Lugs Photos

3 - Normal Wear & Tear

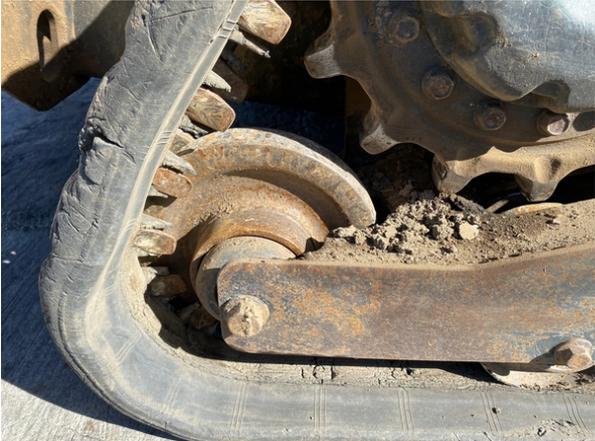
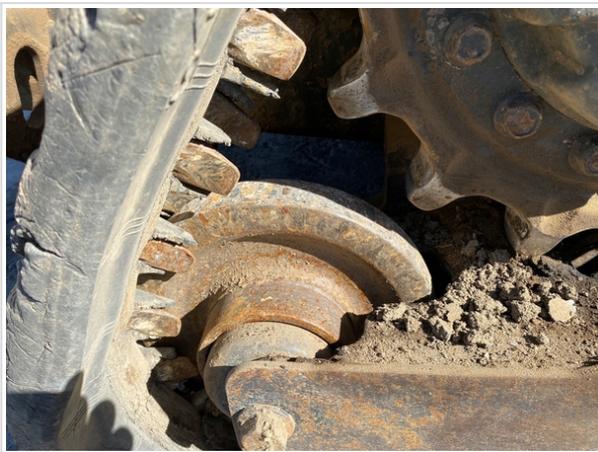
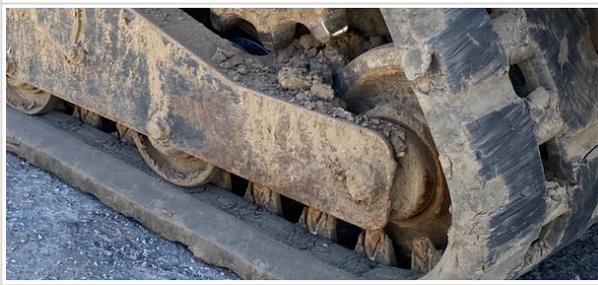
Track Tensioners	3 - Normal Wear & Tear	
Front Idlers	3 - Normal Wear & Tear	
Rear Idlers	3 - Normal Wear & Tear	
Rear Idlers Photos

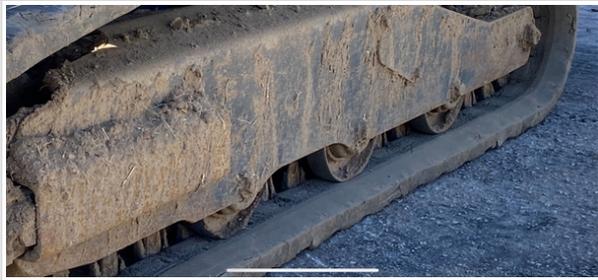
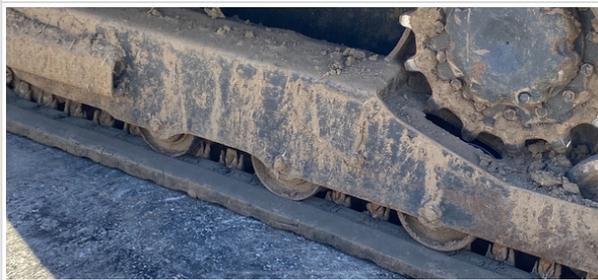
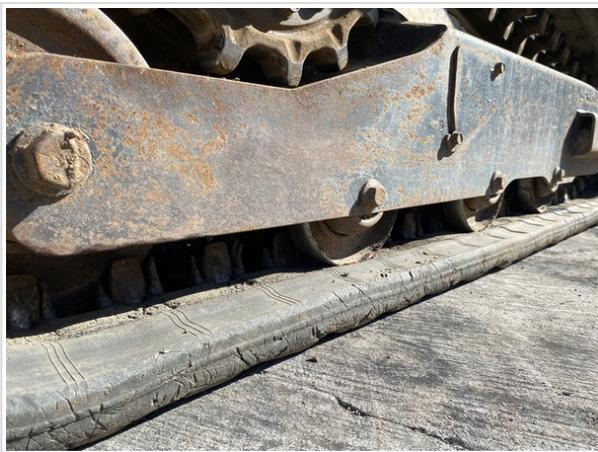
<p>Track Rollers</p>	<p>3 - Normal Wear & Tear</p>	
<p>Track Rollers Photos</p>

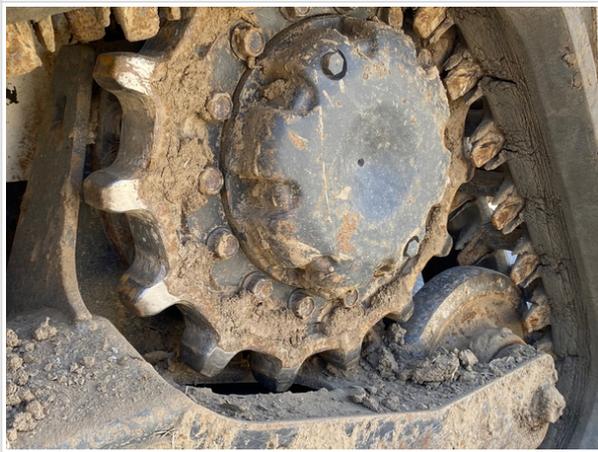
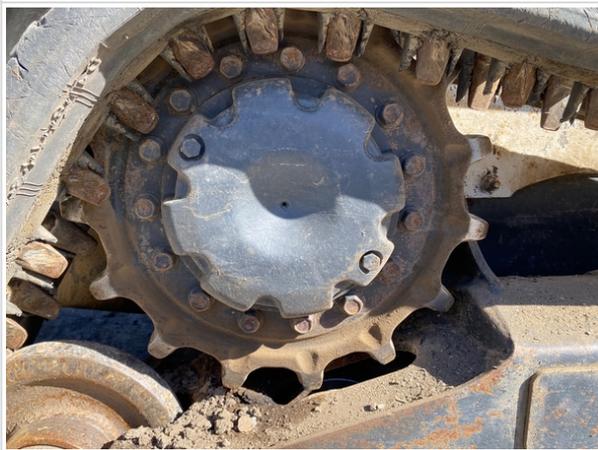
<p>Sprockets</p>	<p>3 - Normal Wear & Tear</p>	
<p>Sprockets Photos</p>

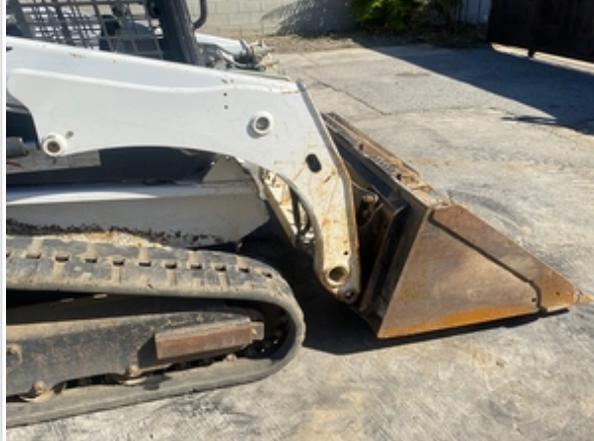
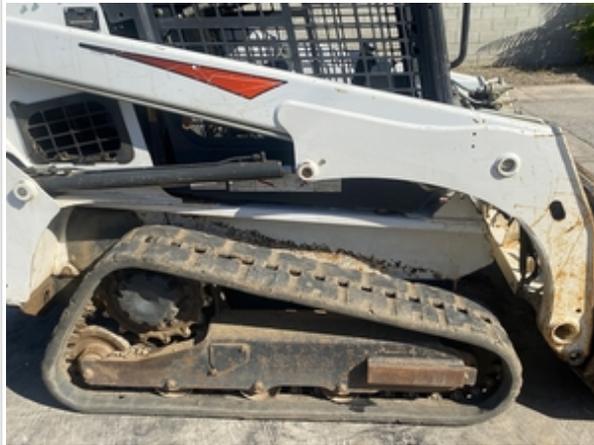
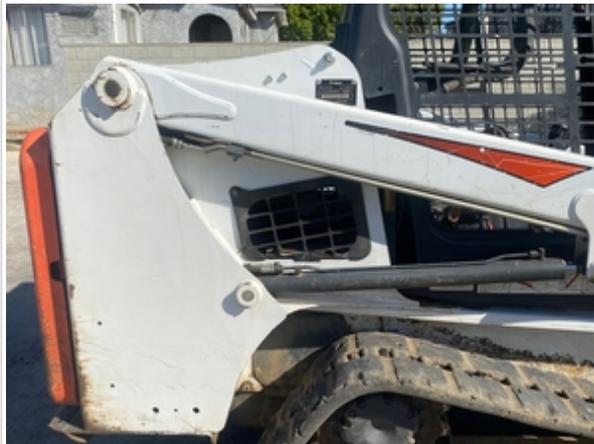
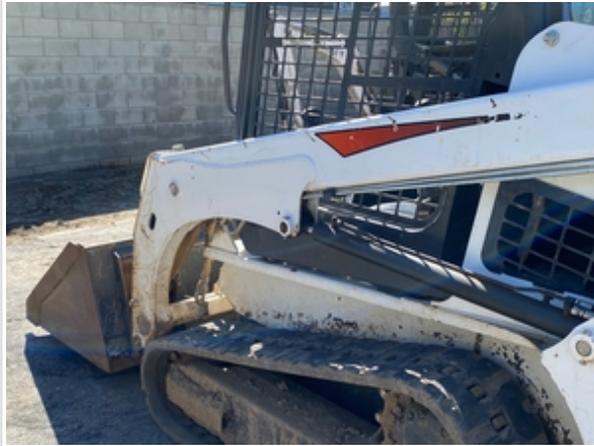
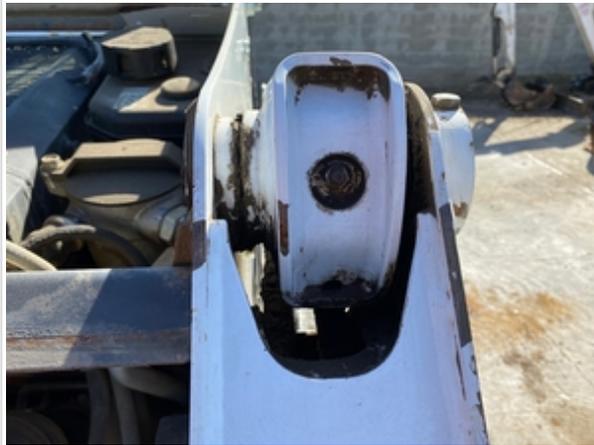
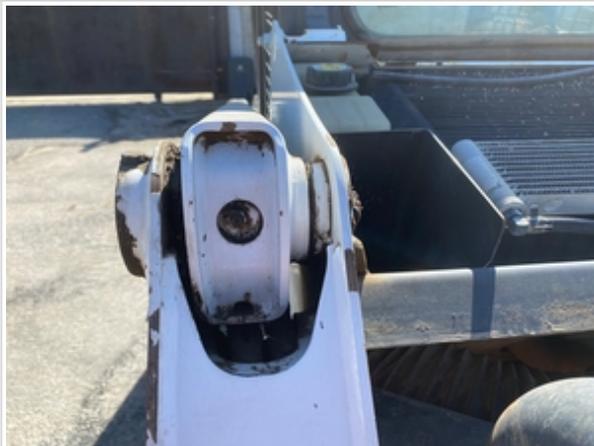
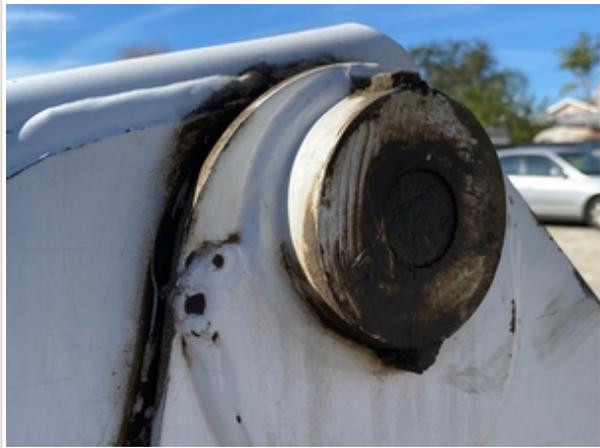
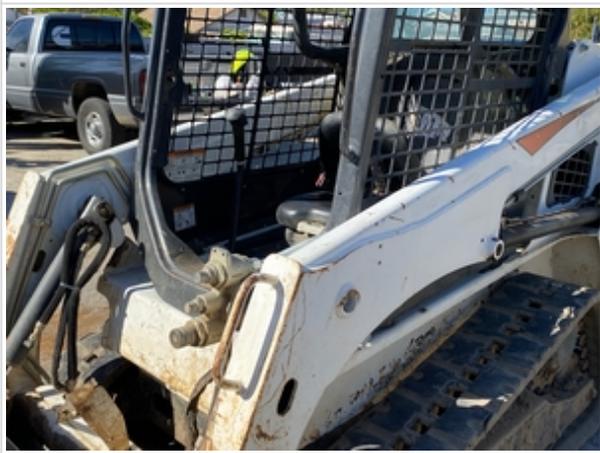
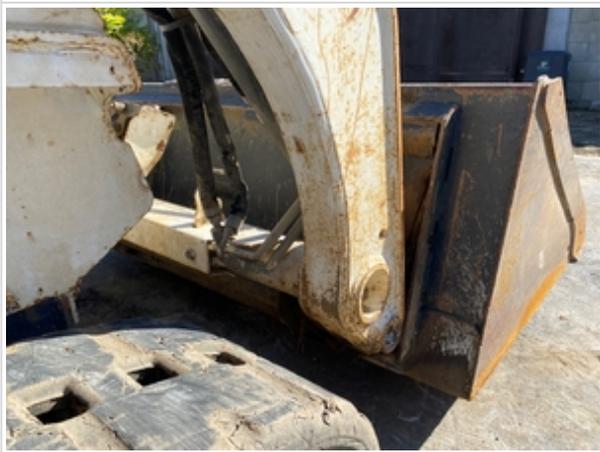
Lift Arm Photos

Frame	3 - Normal Wear & Tear
Stance	3 - Normal Wear & Tear
Wheels & Tires	3 - Normal Wear & Tear
Lift Arm	3 - Normal Wear & Tear

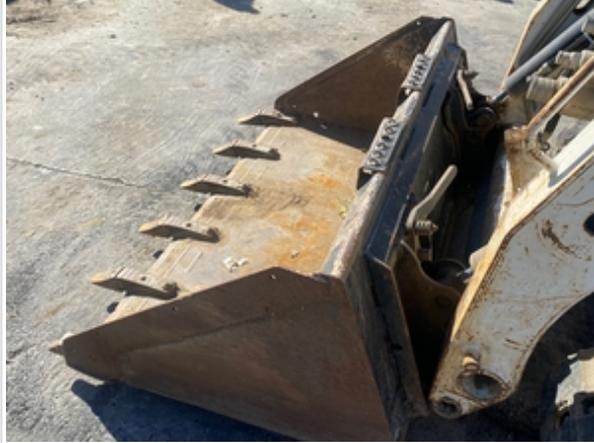
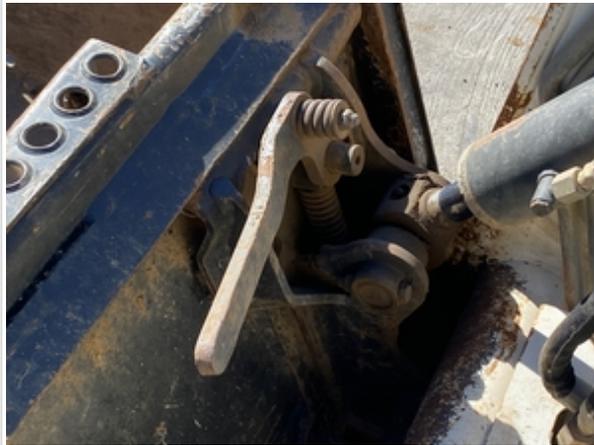
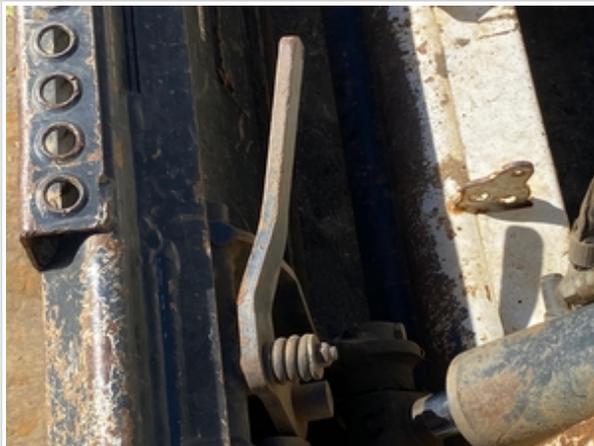
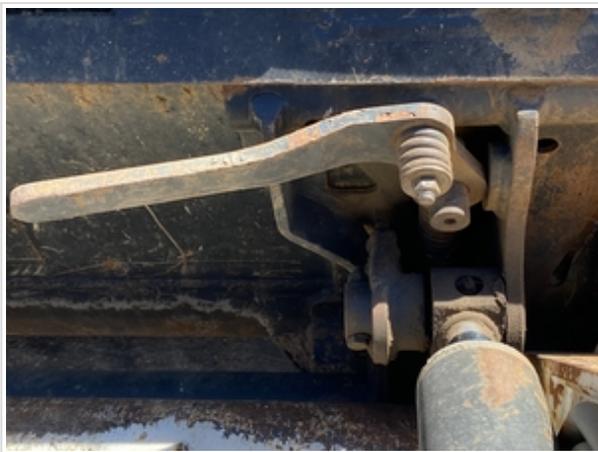
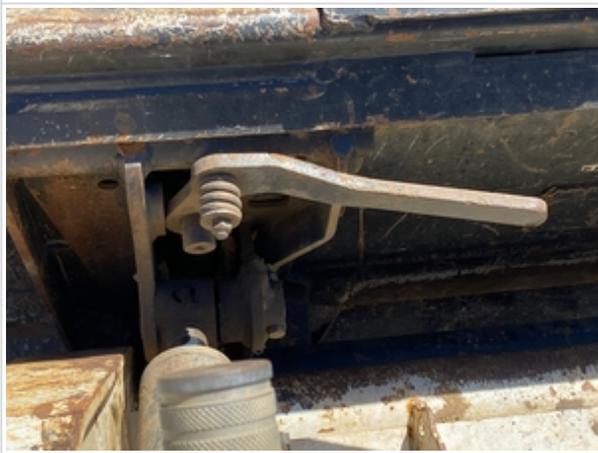
Quick Coupler Photos

Chassis to Arm Pins	3 - Normal Wear & Tear	
Quick Coupler	3 - Normal Wear & Tear
