Inspection Report (Skid Steer)

Year	2017
Make	Bobcat
Model	T 450
Serial Number	AUVP13415
Hour Meter Reading	2,811
Previous Application (e.g., earth moving, mining, demolition, etc)	Demolition Work

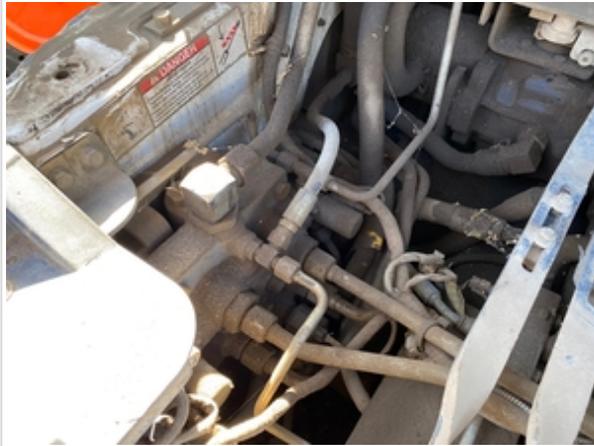
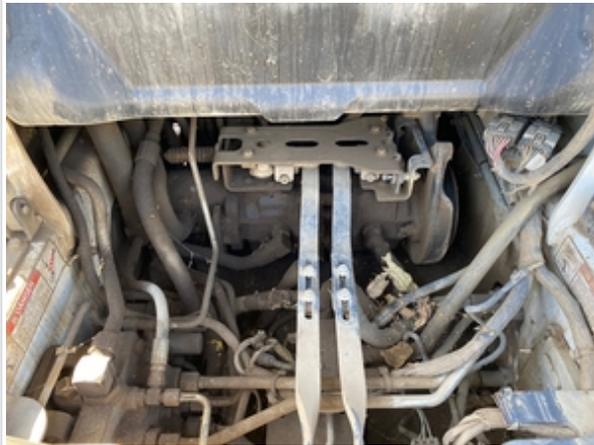
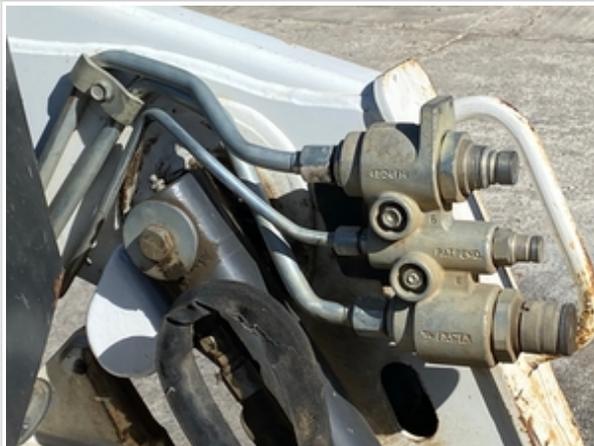
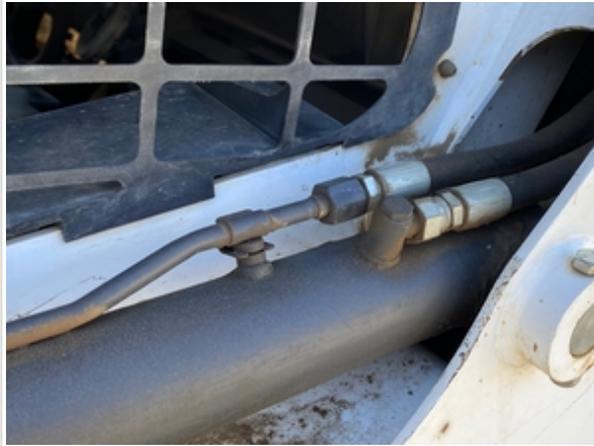
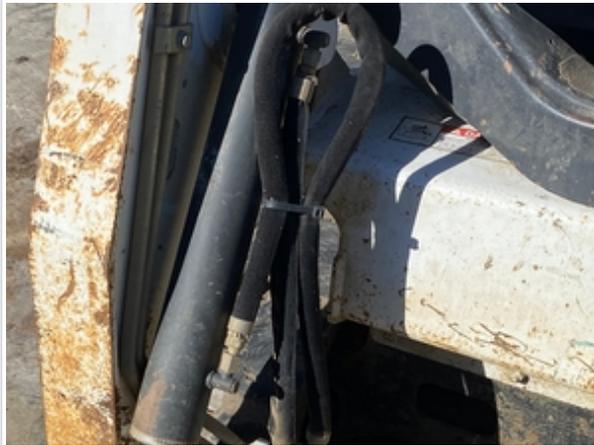
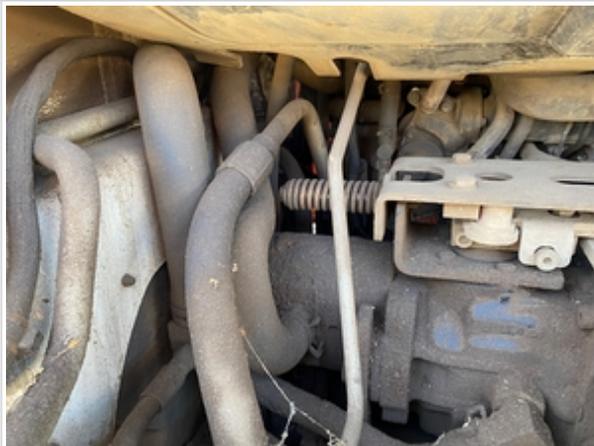
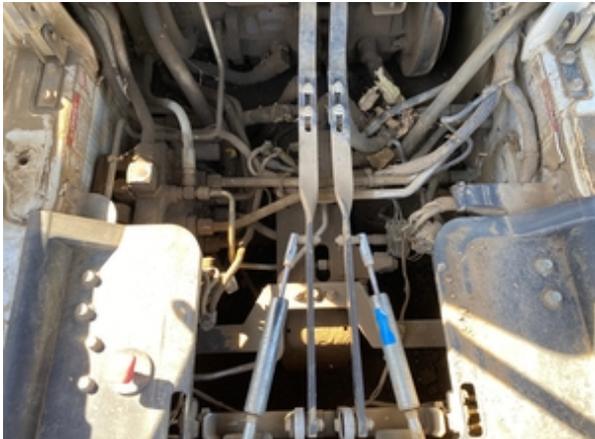
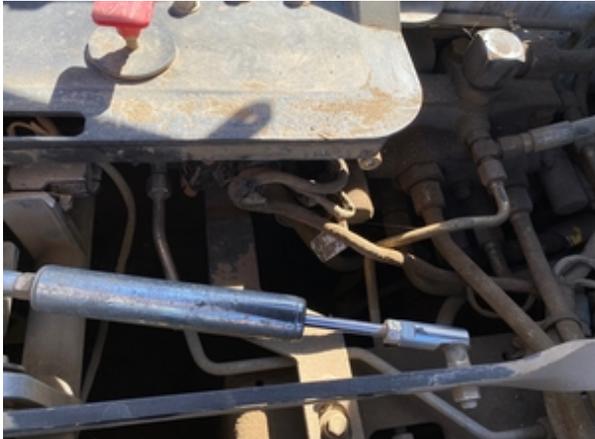
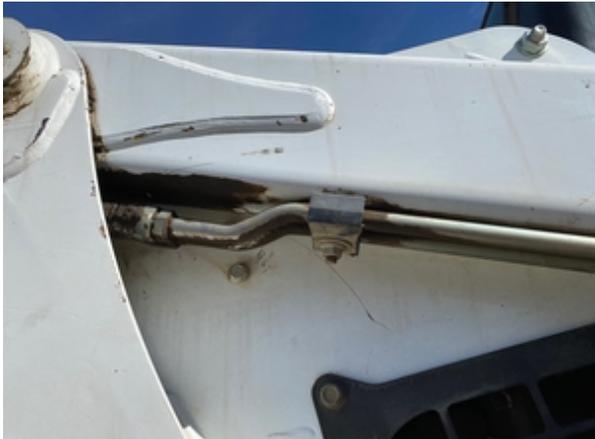
Appearance of Hydraulic Lines /
Fittings Photos

Wet or Damp Hydraulic Lines / Fittings	No
Appearance of Hydraulic Lines / Fittings	3
Hydraulic Lines / Fittings Condition	Hydraulic lines & fittings are clean and in good condition

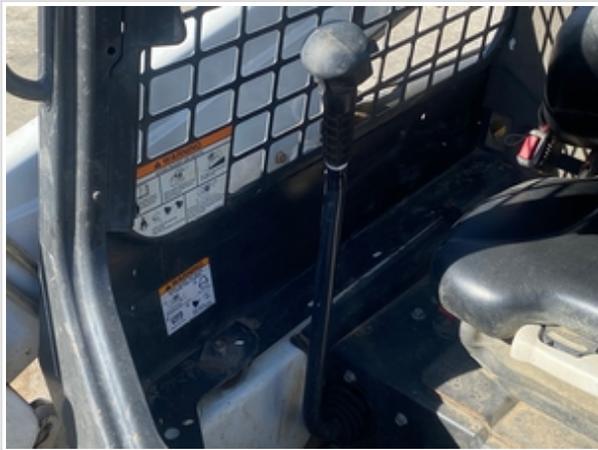
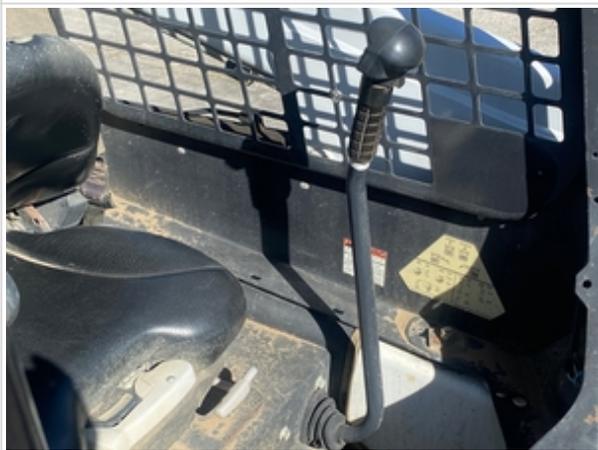
External Controls / Levers Photos

Unusual Noises (Hydraulic Pump)	No
Hydraulic Pump Notes	No unusual noises heard during operation
External Controls / Levers	3
External Controls / Levers Condition	Good function & condition of hydraulic controls

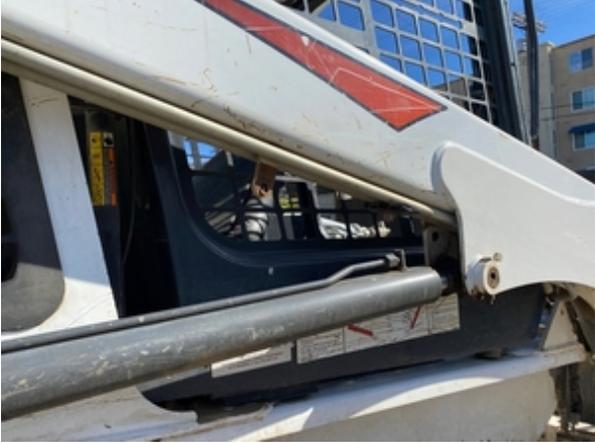
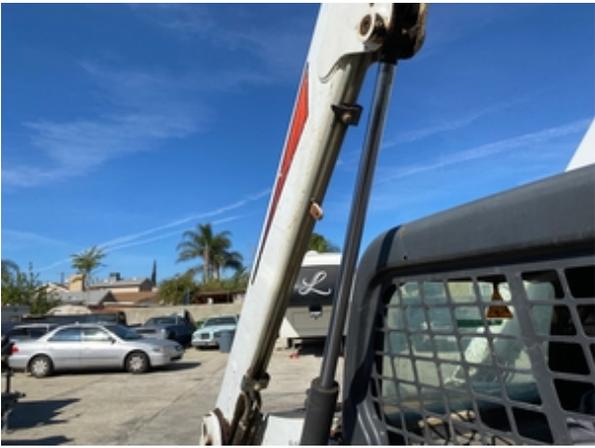
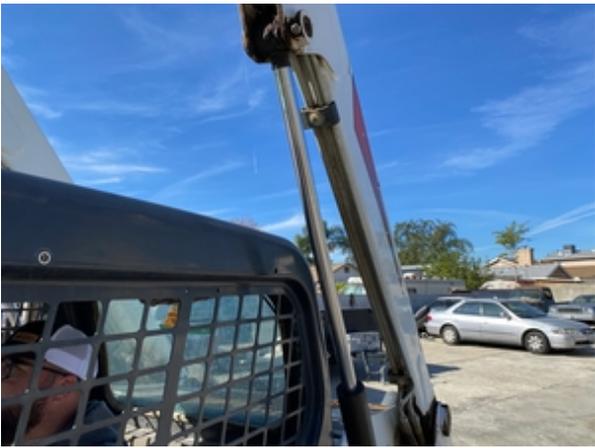
Lift Cylinder	Check the lift cylinder. Note any wear, pitting, discoloration, etc. Take photos.
Lift Cylinder: Mounting Pin	3
Lift Cylinder: Oil Leaks	No
Comments	Left side lift cylinder has residual oil buildup (possible cylinder reseal may be needed soon)
Lift Cylinder Photos

Exterior Rating	3
Interior Rating	3
Safety Rating	3
Quality Rating	3
Functionality Rating	3
Overall Rating	3
What's Great About the Machine	Machine is in good condition all the way around. All powertrain components healthy and no major active leaks observed. Engine compartment in good shape. Hydraulic compartment also in good shape.
What Needs Work	Minor seepage leaks may be coming from hydraulic lines underneath cab. Pressure wash recommended to find out if small leak present underneath cab. Tracks need to be replaced soon. Left side cylinder should be clean and tested to see if small leak exist.
Date/Time	11-17-2022

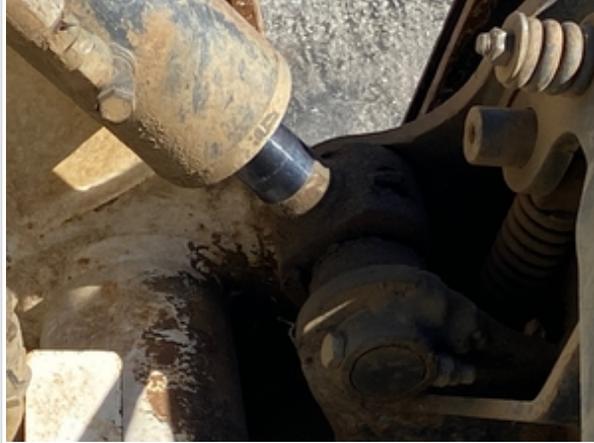
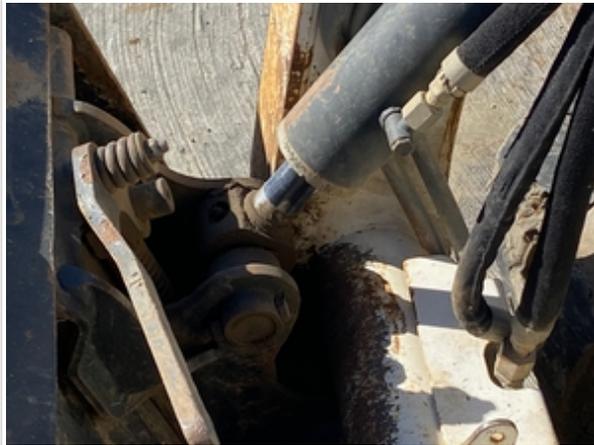
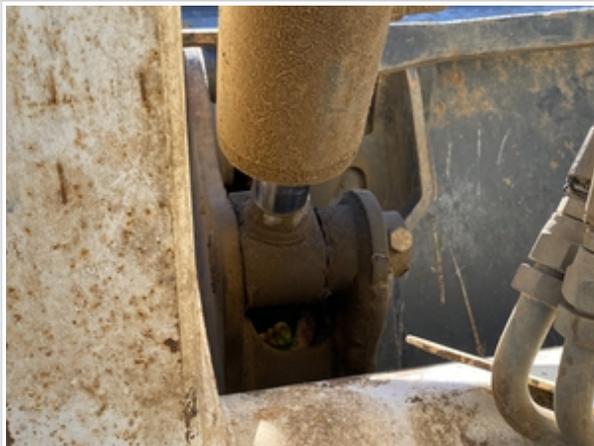
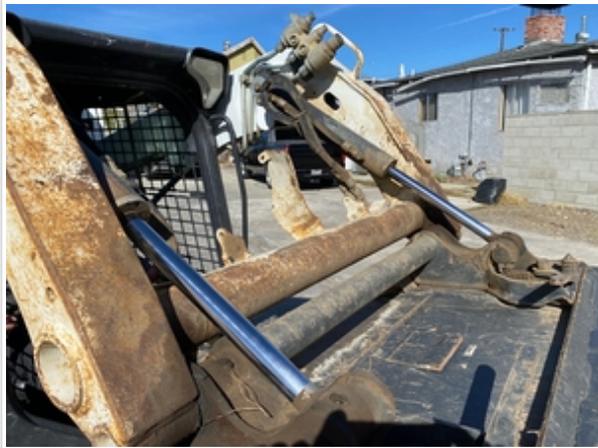
Bucket Cylinder Photos

Bucket Cylinder	Check the bucket cylinder. Note any wear, pitting, discoloration, etc. Take photos.	
Bucket Cylinder: Mounting Pin	3	
Bucket Cylinder: Oil Leaks	No

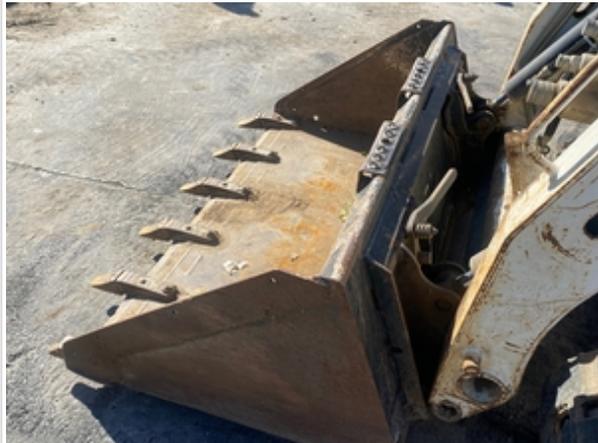
Bucket Condition	3 - Normal Wear & Tear
Bucket Photos
