Inspection Report (Mini Excavator)

Year	2015
Make	Kubota
Model	U25
Serial Number	50812
Hour Meter Reading	1,827
Previous Application (e.g., earth moving, mining, demolition, etc)	Equipment Rental

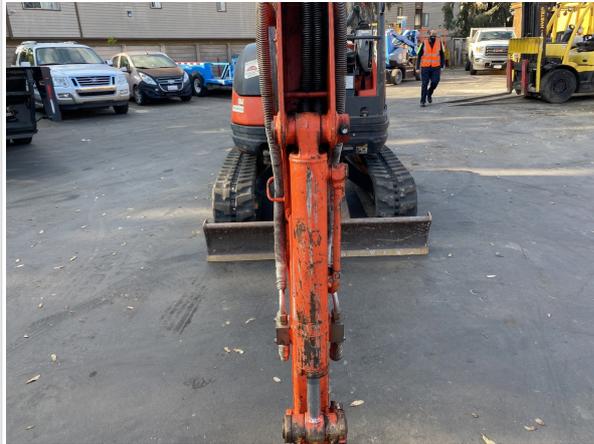
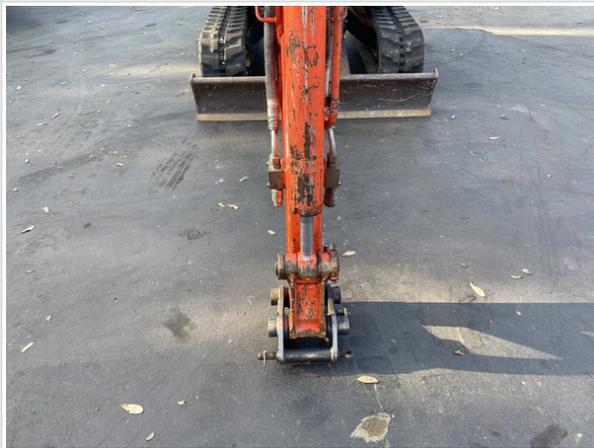
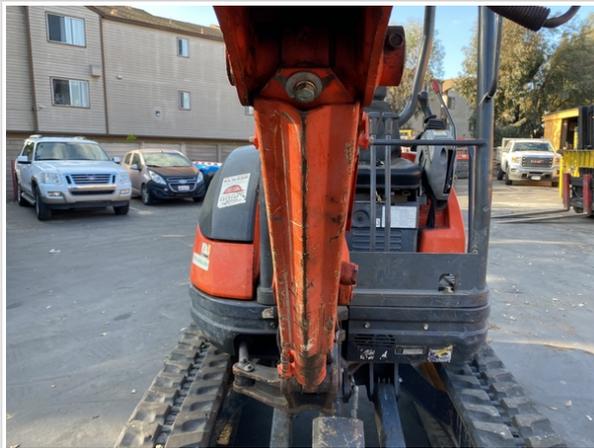
Front Photos

Front	3 - Normal Wear & Tear
Front Condition	No visible damage, Other (see comments)
Comments	Normal wear and tear scuff marks

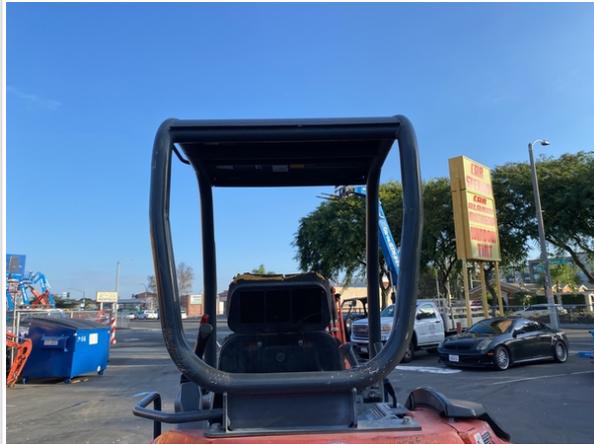
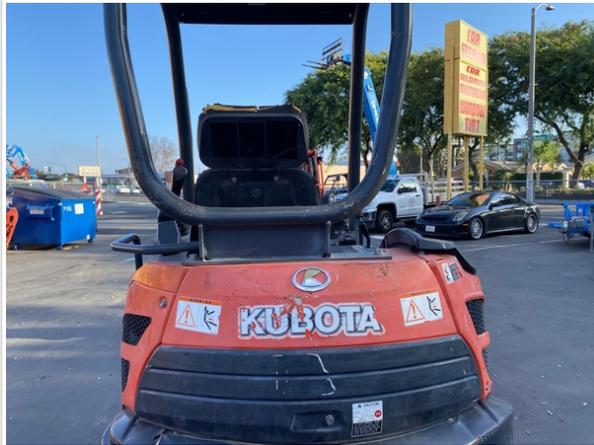
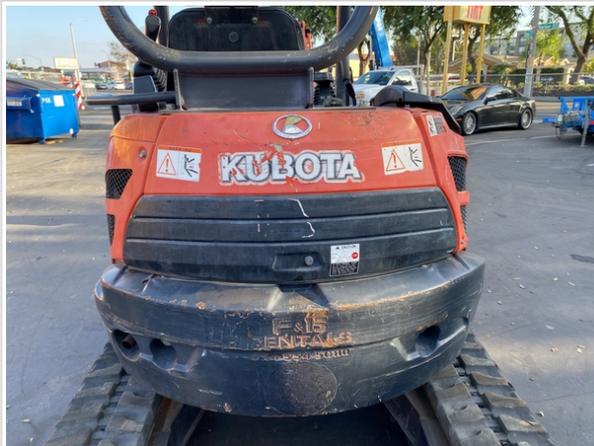
Rear Photos

Rear	2 - Above Average Wear
Rear Condition	No visible damage, Other (see comments)
Comments	Normal wear and tear scuff marks

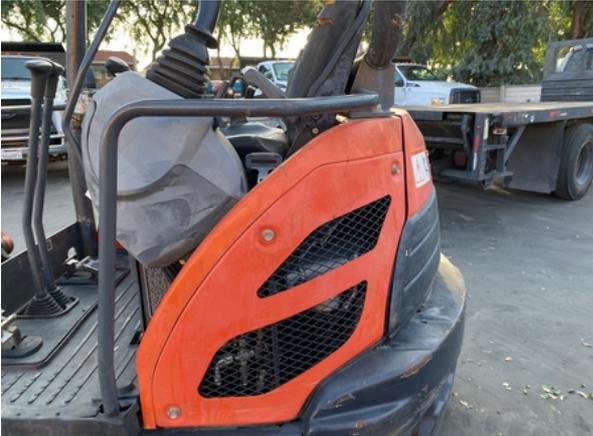
Left	3 - Normal Wear & Tear
Left Condition	No visible damage, Other (see comments)
Comments	Normal wear and tear scuff marks
Left Photos

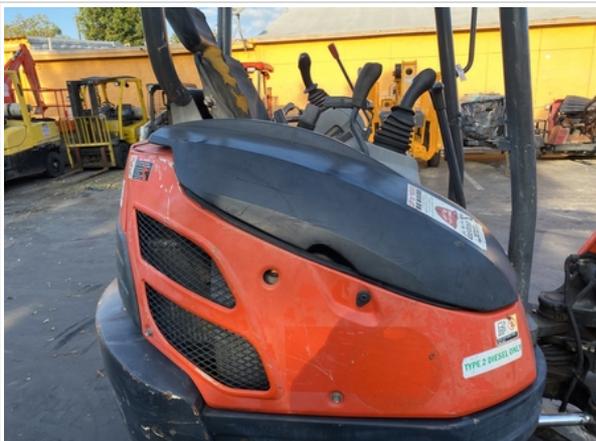
Right	3 - Normal Wear & Tear	
Right Condition	No visible damage, Other (see comments)	
Comments	Normal wear and tear scuff marks	
Right Photos

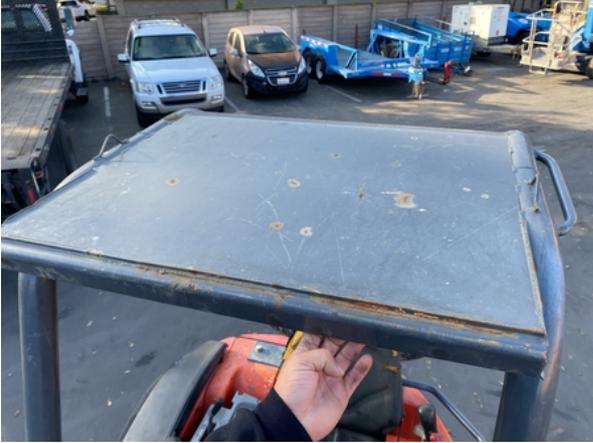
Upper Photos

Upper	3 - Normal Wear & Tear
Upper Condition	No visible damage

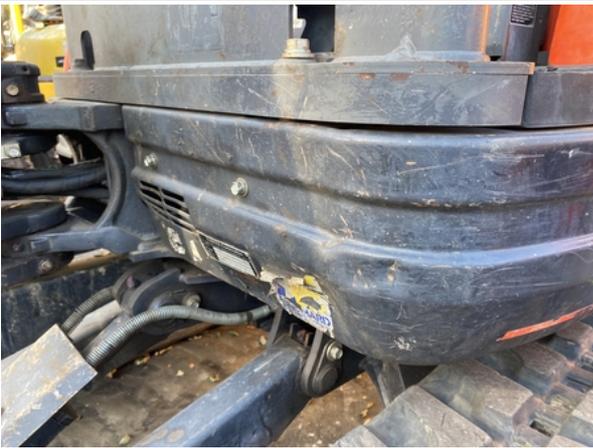
Body Panels (Any Rust Damage?)	3 - Normal Wear & Tear
Body Panel Condition	Other (see comments), Visible chipped paint or dents
Body Panels Photos

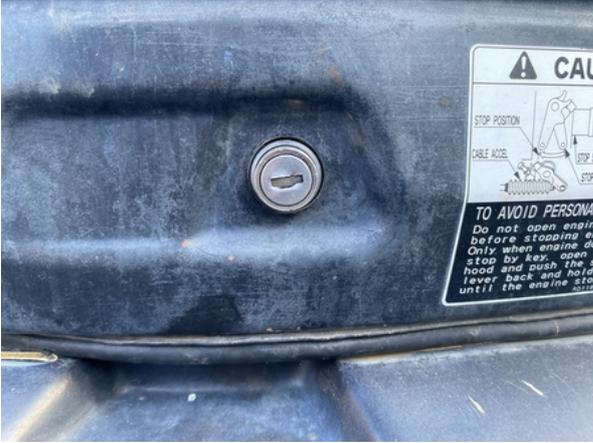
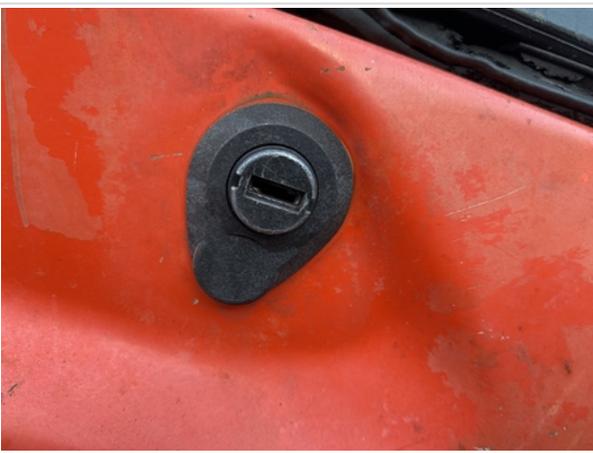
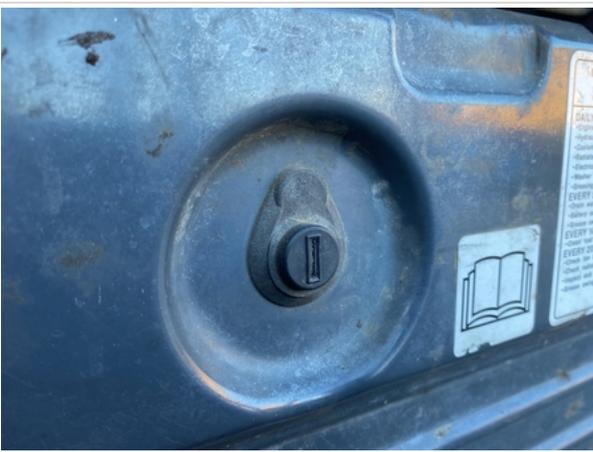
Doors / Canopy Latches Photos

Doors / Canopy Latches	3 - Normal Wear & Tear
Doors / Canopy Latches Condition	No visible damage

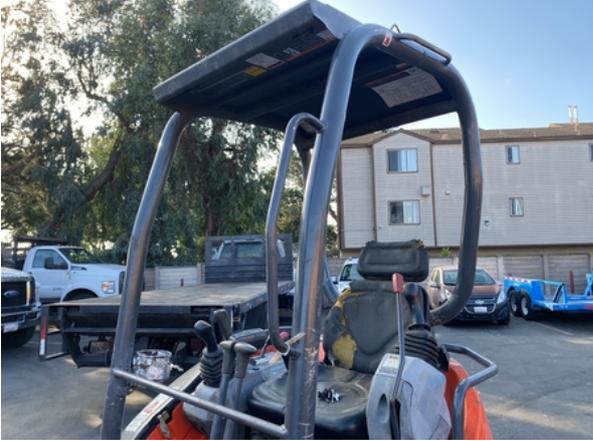
Handrail Photos

Steps / Ladders	0	
Handrails	3 - Normal Wear & Tear	
Handrails Condition	Handrails are fully intact and appear structurally sound

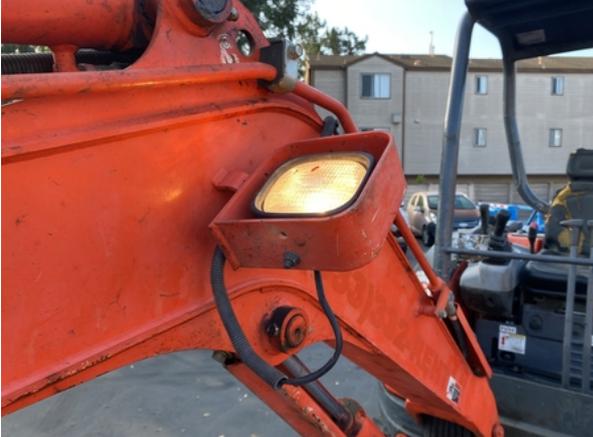
Glass Condition	0
Mirrors	0
Lighting System	3 - Normal Wear & Tear
Lighting System Condition	No visible damage, lighting system is operational
Lighting System Photos

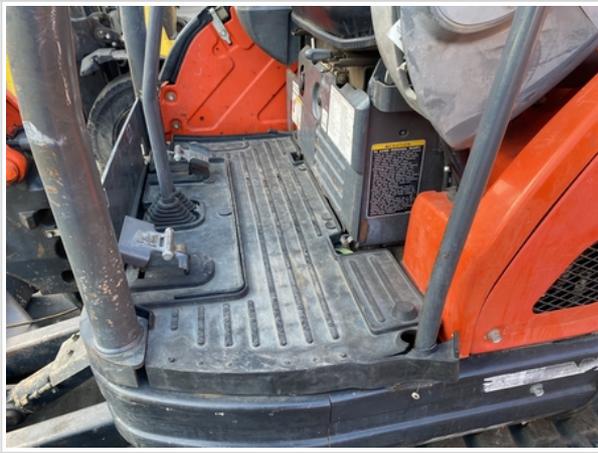
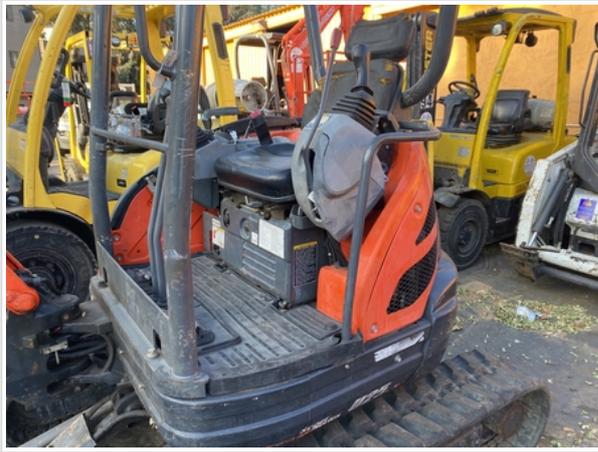
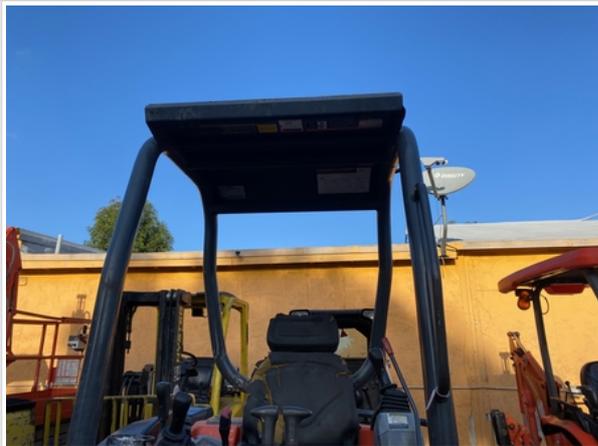
Operator Cabin Overall Condition	Good cabin appearance, solid floors, panels, and ceiling
Operator Cabin Photos

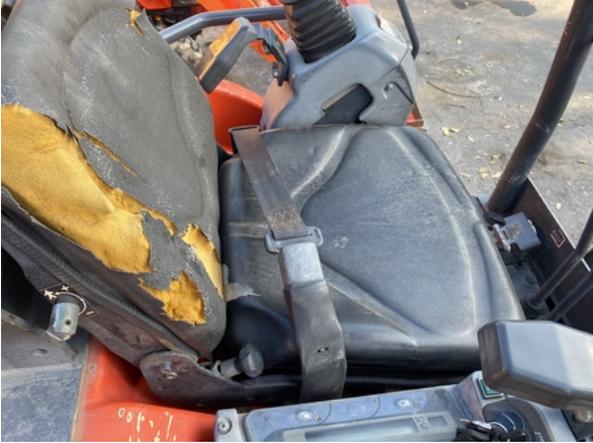
Seat Belt Photos

<p>Seat Belt</p>	<p>3 - Normal Wear & Tear</p>
<p>Seat Belt Condition</p>	<p>Seat belt secures properly. Belt is intact and in good condition</p>

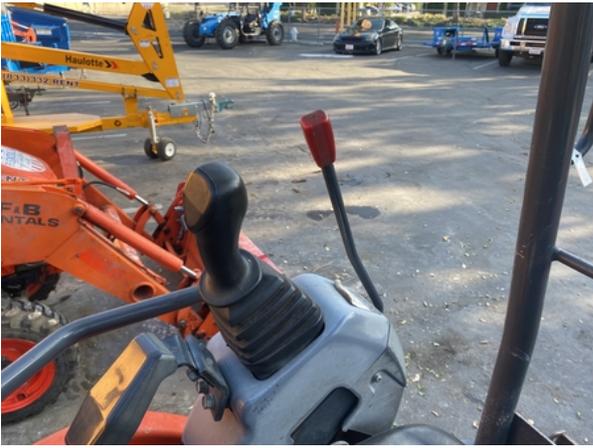
Cabin Lights	0	
Safety Lock Out / Stop	3 - Normal Wear & Tear	
Safety Lock Out / Stop Condition	Safety lock out device is present, in good condition, and functional	
Safety Lock Out / Stop Photos

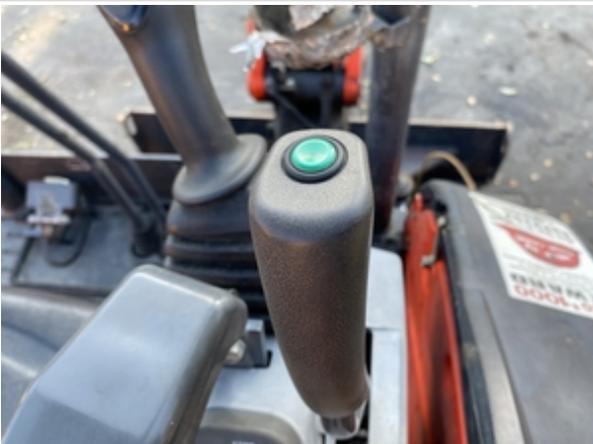
Controls & Switches	3 - Normal Wear & Tear	
Controls & Switches Condition	All switches are installed and functional	
Controls & Switches Photos

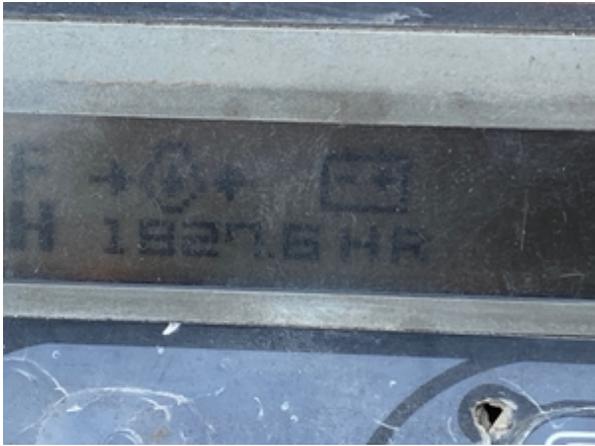
Hour Meter Activity Photos

Hour Meter Activity	3 - Normal Wear & Tear
Hour Meter Condition	Hour meter is functional and in good condition

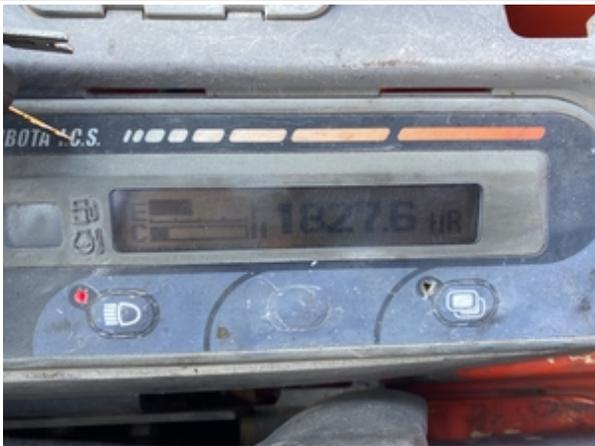
Other Gauge Activity	3 - Normal Wear & Tear
Other Gauge Condition	All cockpit gauges are functional and in good condition
Other Gauge Activity Photos

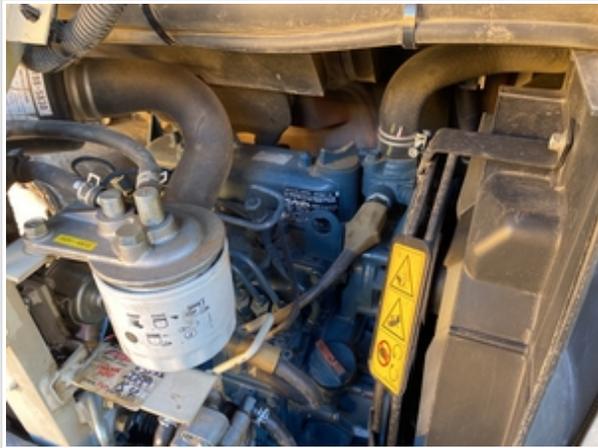
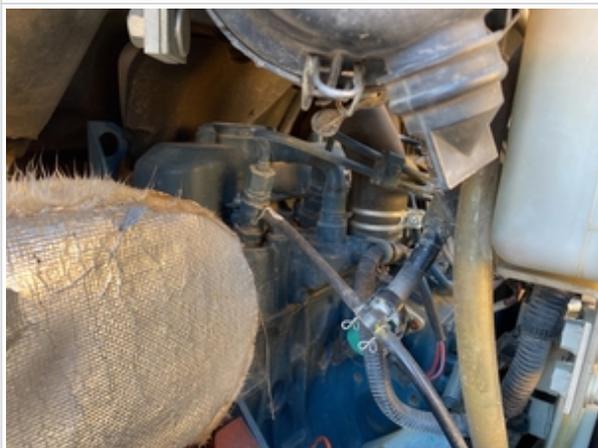
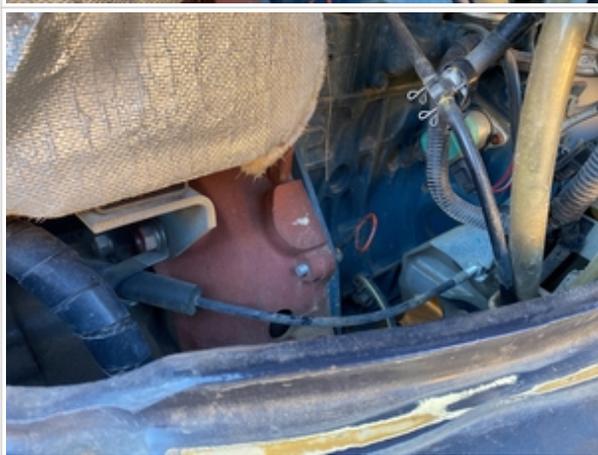
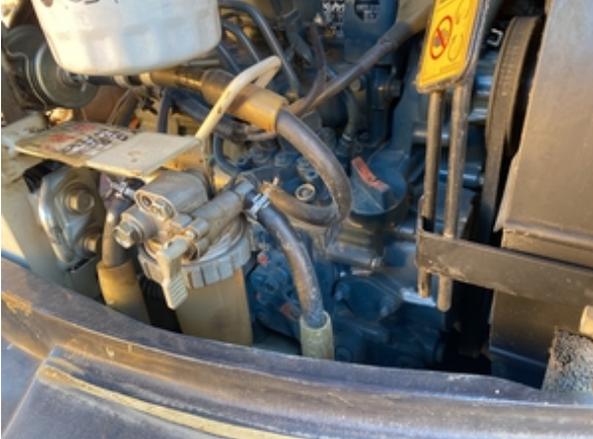
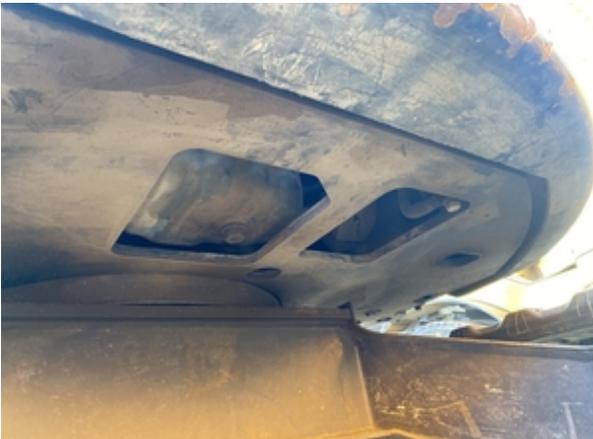
Engine Serial Number	N/A
Engine Fuel Type	Diesel
Engine Photos

Oil Color / Appearance Notes	Clean oil appearance, no signs of cross contamination, Appropriate oil level
Fuel Leaks	No
Equipped with DPF (Diesel Particulate Filter)	No
Requires DEF (Diesel Exhaust Fluid)	No
Overall Engine Appearance	Clean & dry
Overall Engine Comments	Overall engine well maintained and no active leaks seen.

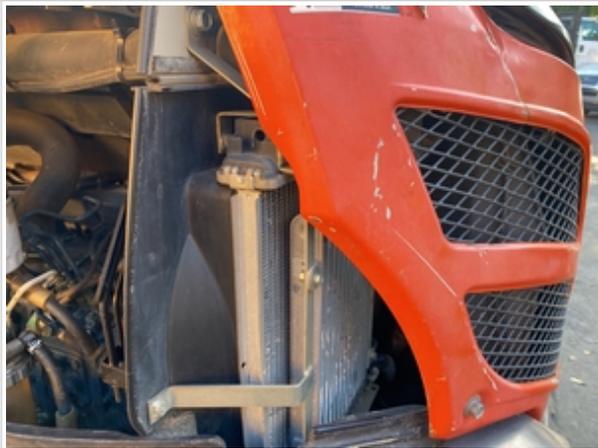
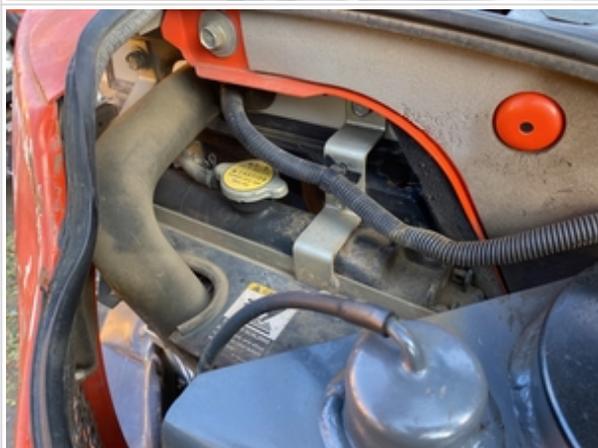
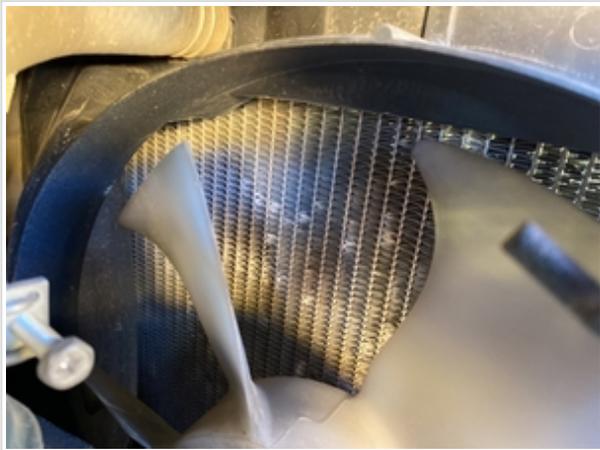
Radiator	3 - Normal Wear & Tear	
Radiator Condition	Radiator fins & components appear to be in good working order, no signs of damage or leaks	
Radiator Photos

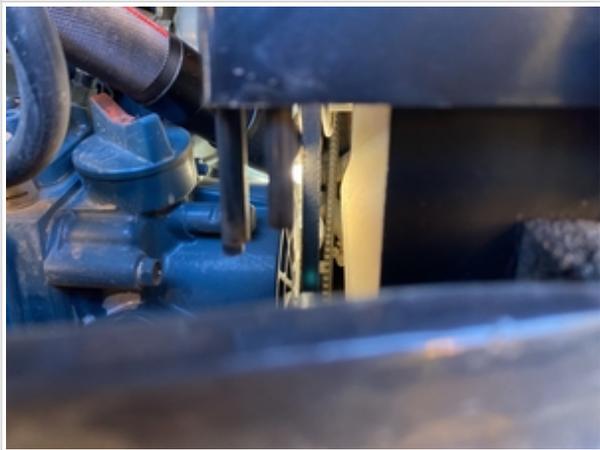
Belts	3 - Normal Wear & Tear	
Belt Condition	Belts appear in good condition & alignment with proper tension	
Belt Photos

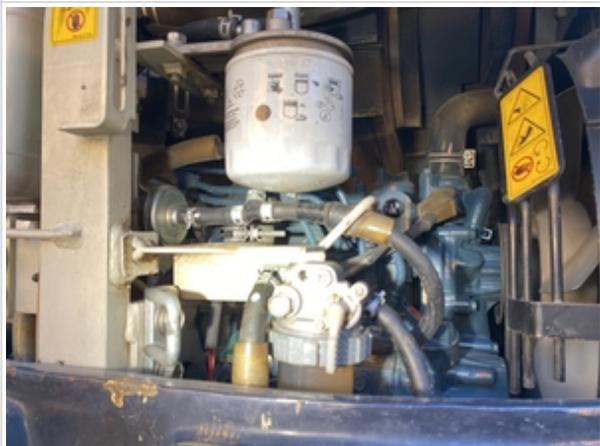
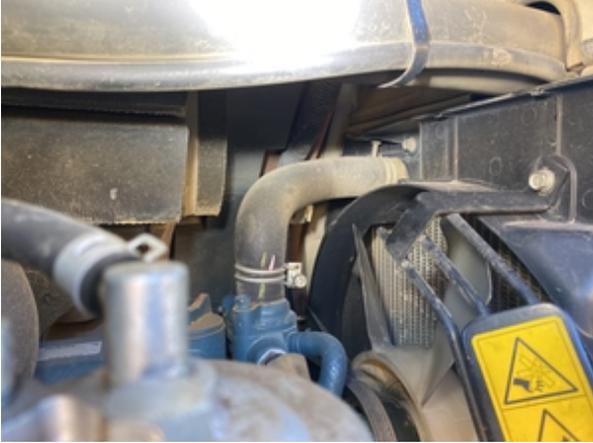
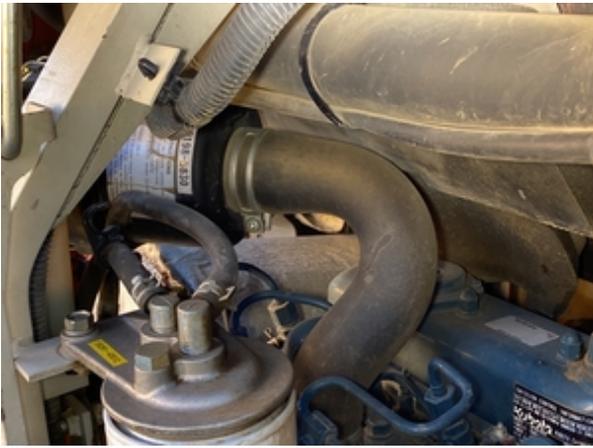
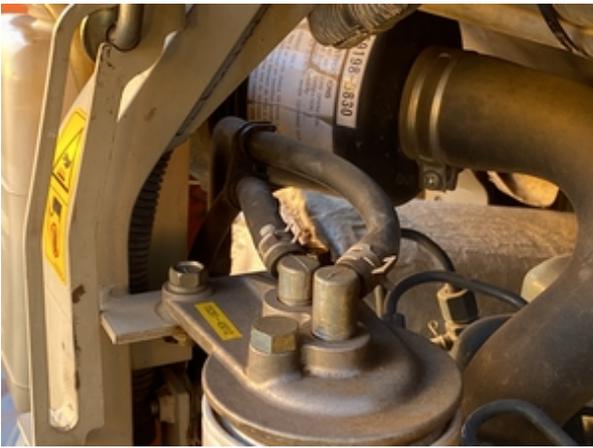
Hoses	3 - Normal Wear & Tear	
Hose Condition	Firm, pliant hoses with no signs of wear or leaks	
Hose Photos

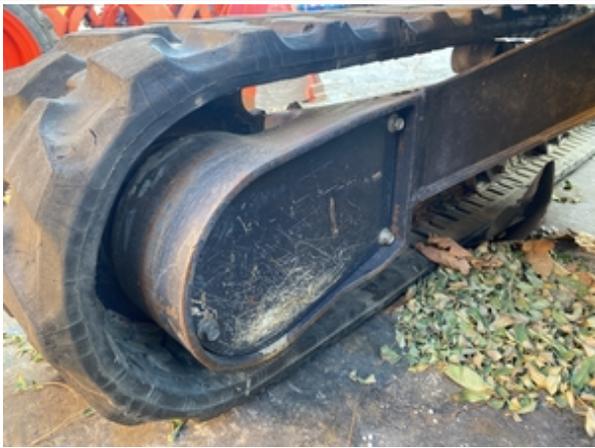
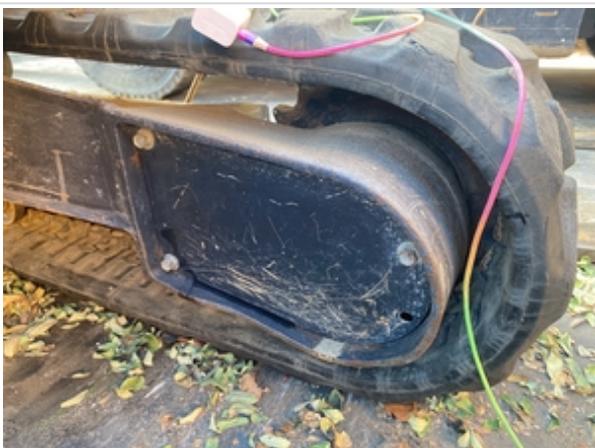
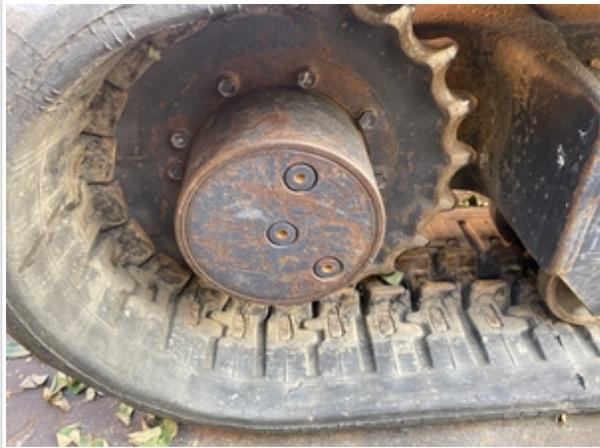
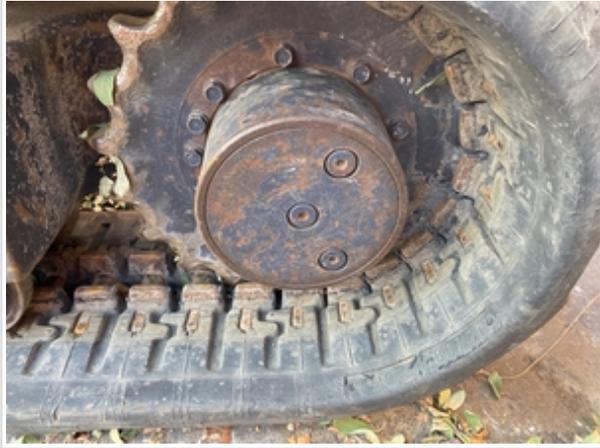
Hydrostatic Transmission?	Yes
2 Speed?	Yes
Hydrostatic Drive Configuration	Split Transmission
Drive Motors	2 - Above Average Wear
Drive Motor Photos

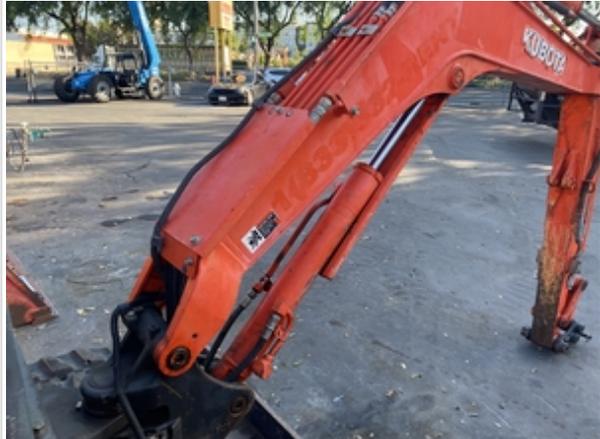
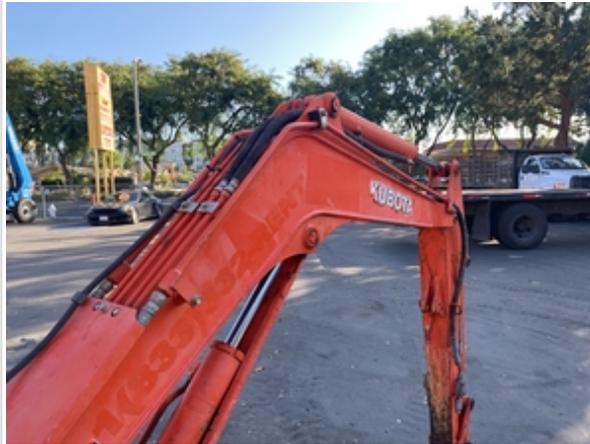
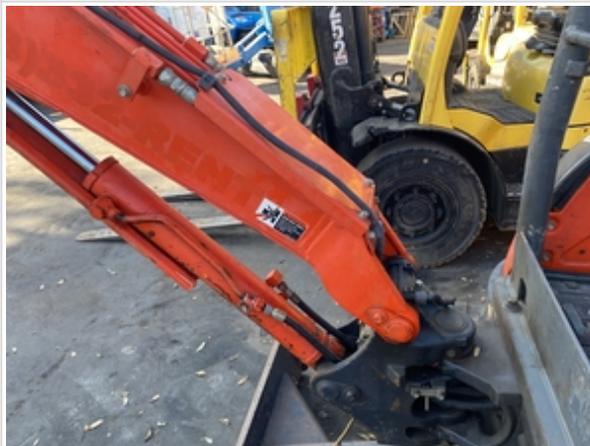
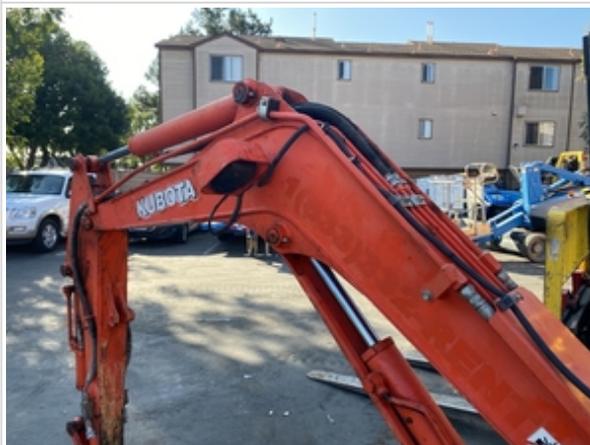
Boom Condition	3 - Normal Wear & Tear	
Boom Photos

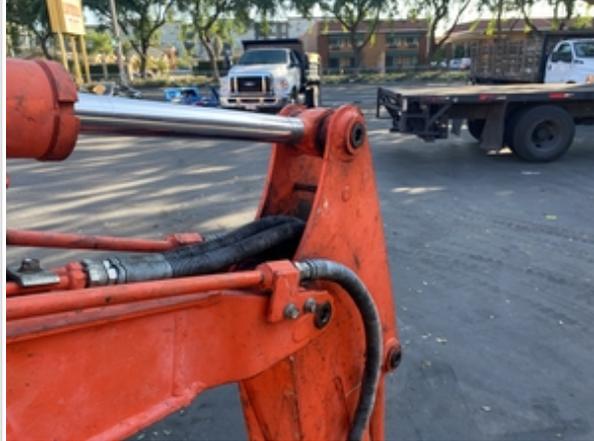
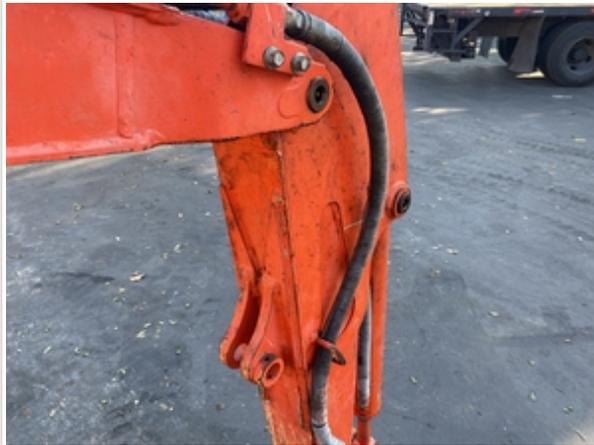
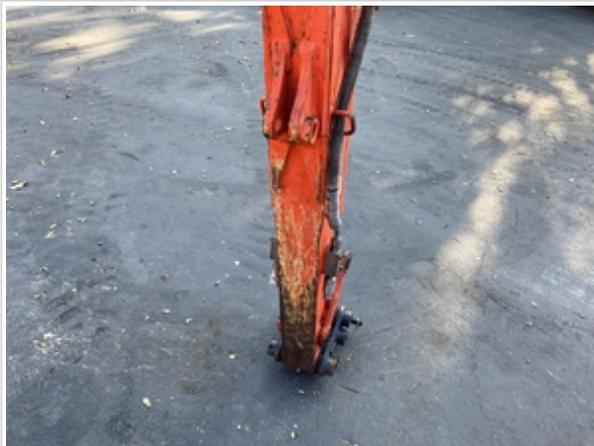
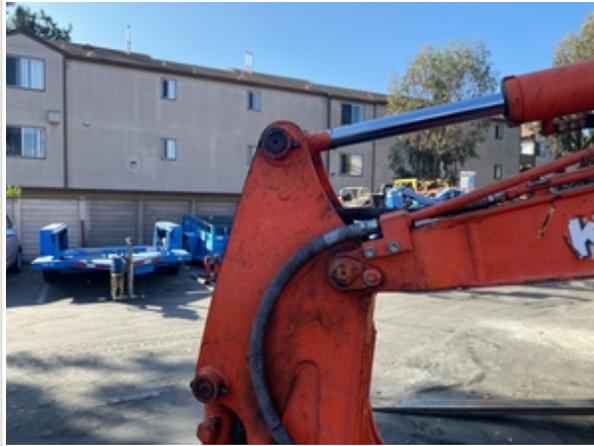
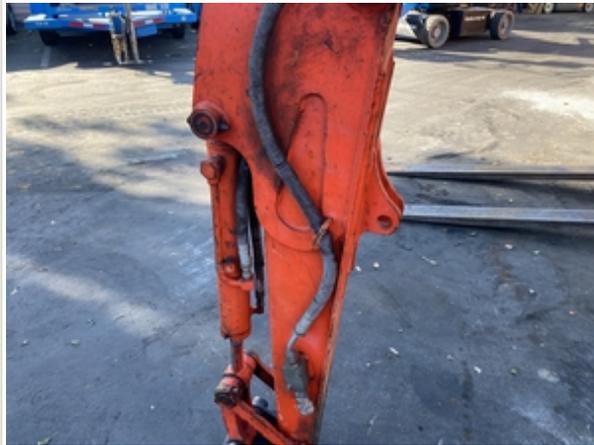
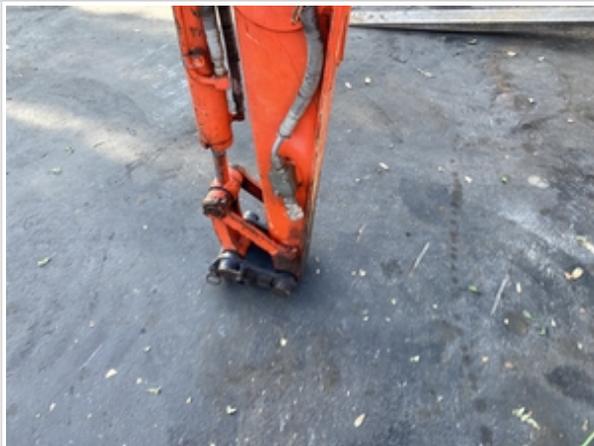
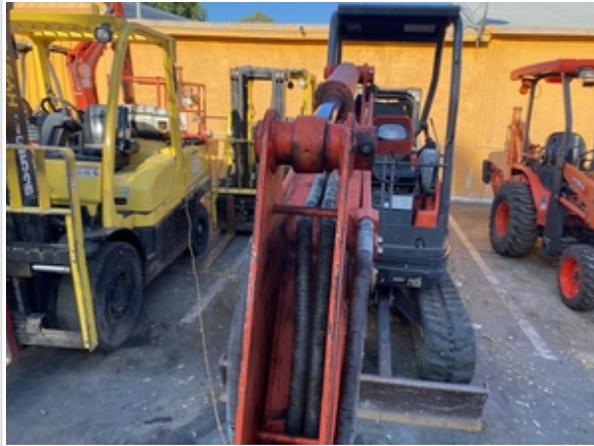
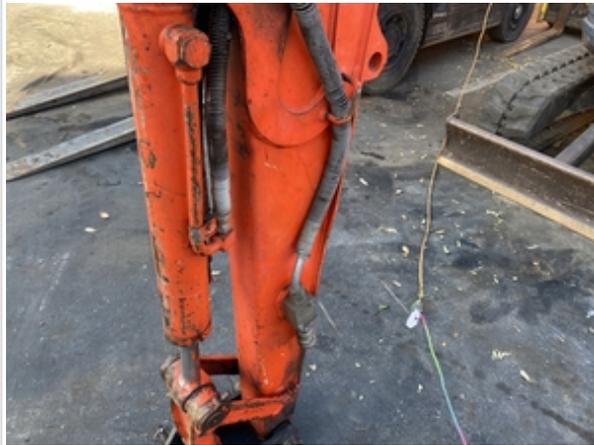
Stick Photos

Stick Condition

3 - Normal Wear & Tear

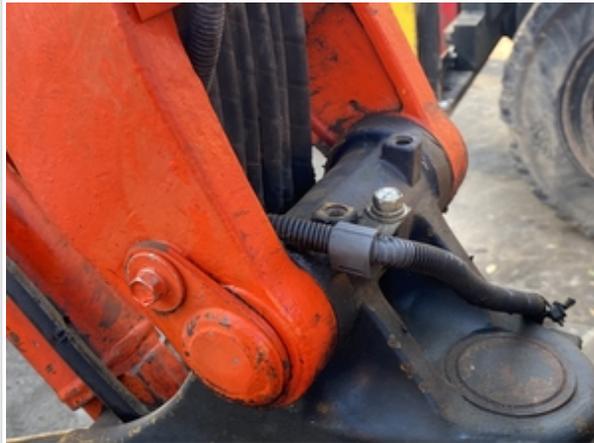
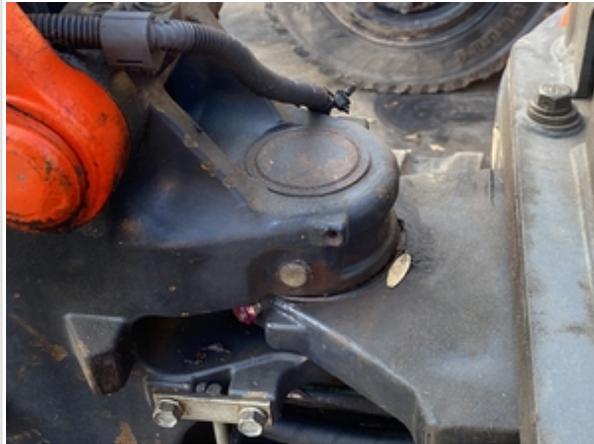
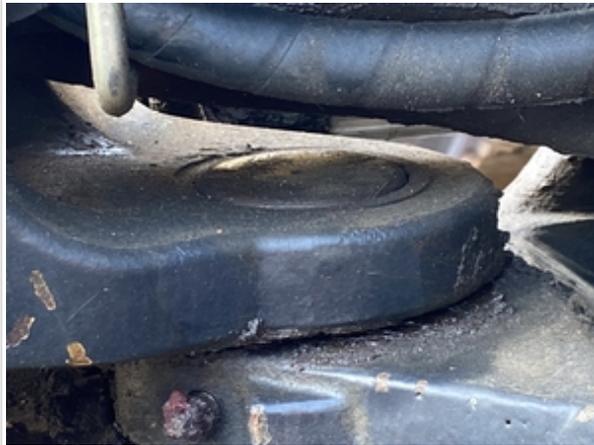
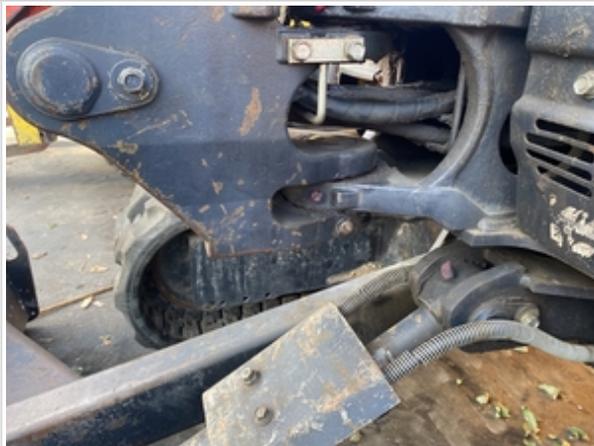
**Boom Base Pin & Bushings
Photos**

Boom Base Pin & Bushings

3 - Normal Wear & Tear

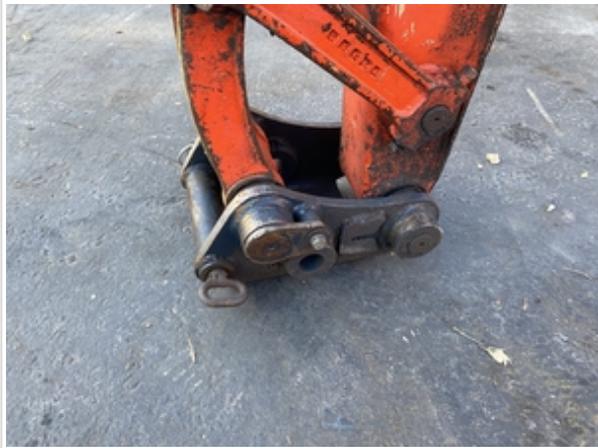
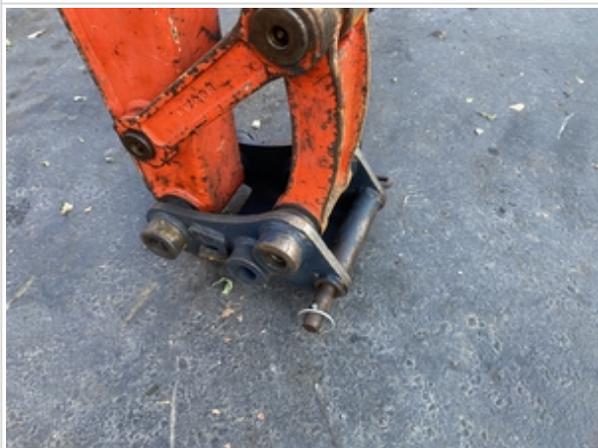
<p>Stick to Bucket Pin & Bushings Photos</p>

<p>Stick to Bucket Pin & Bushings</p>	<p>3 - Normal Wear & Tear</p>

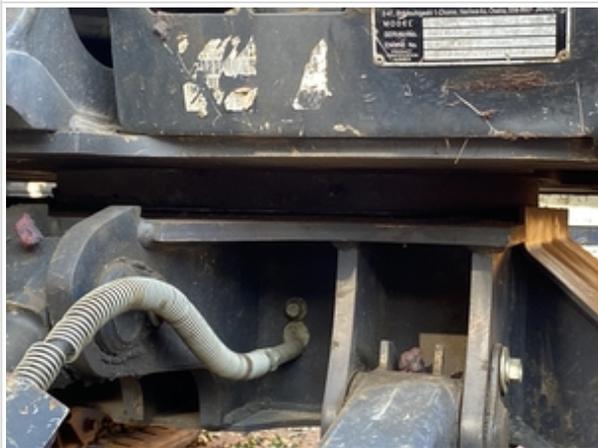
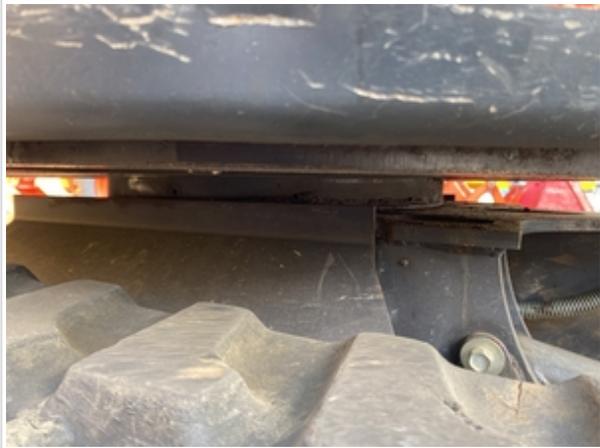
<p>Turntable Bearing</p>	<p>3 - Normal Wear & Tear</p>
<p>Turntable Bearing Photos</p>

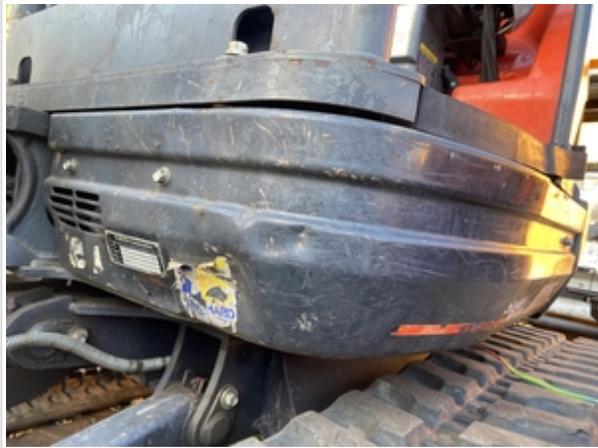
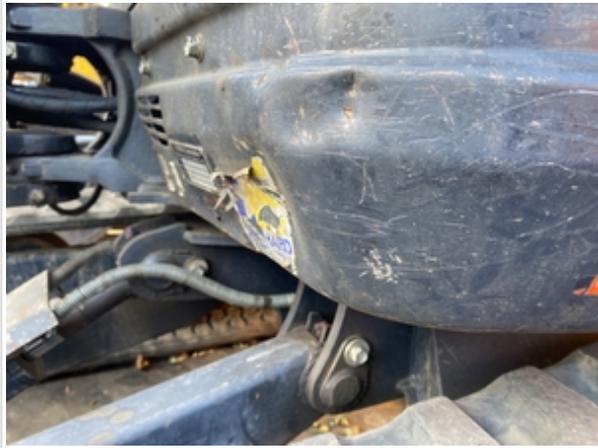
<p>Bottom Covers</p>	<p>3 - Normal Wear & Tear</p>	
<p>Comments</p>	<p>Small dent front lower panel</p>	
<p>Bottom Covers Photos</p>

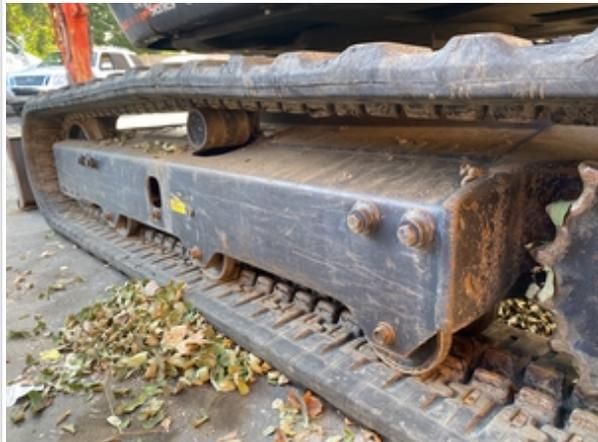
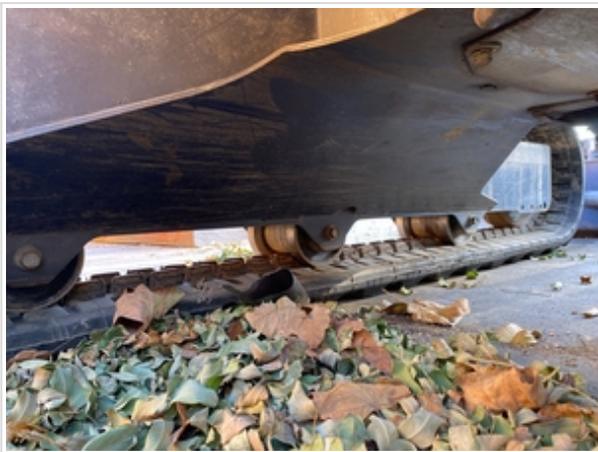
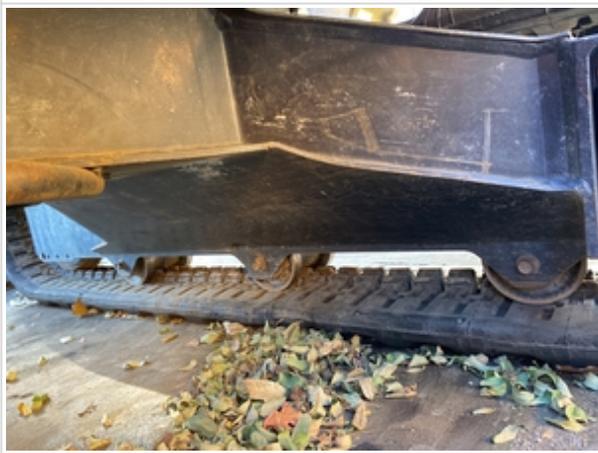
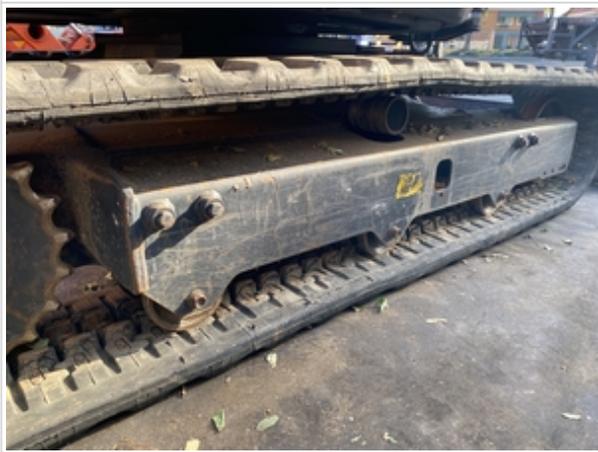
Roller Frames	3 - Normal Wear & Tear
Roller Frames Photos

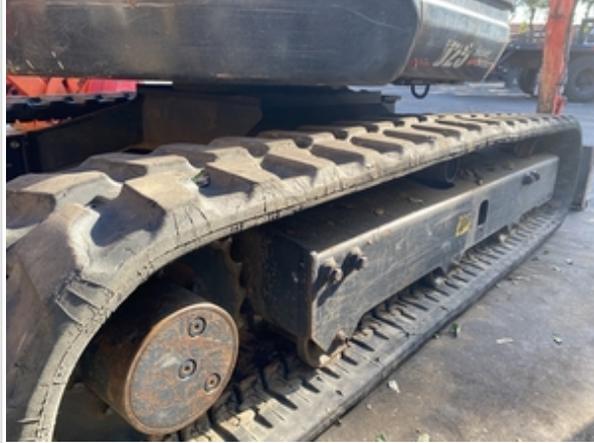
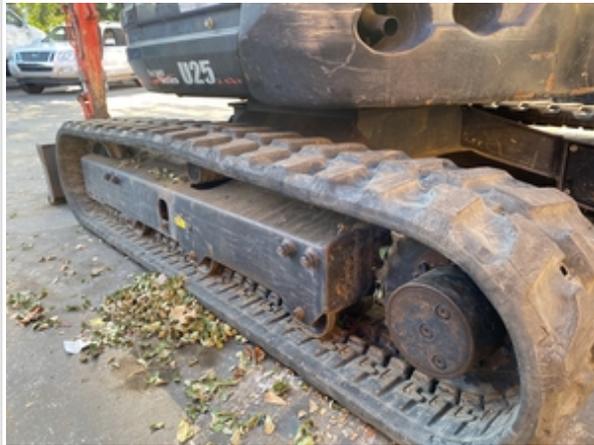
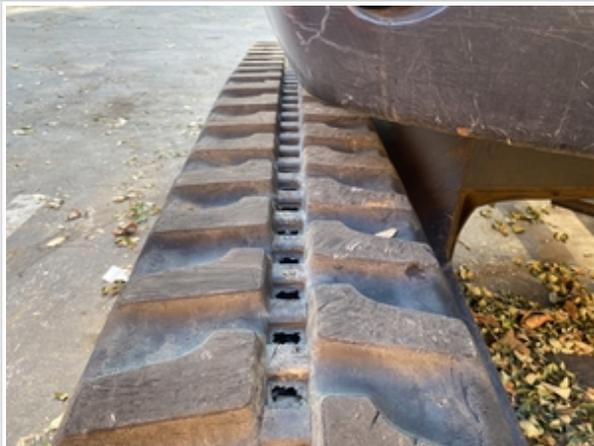
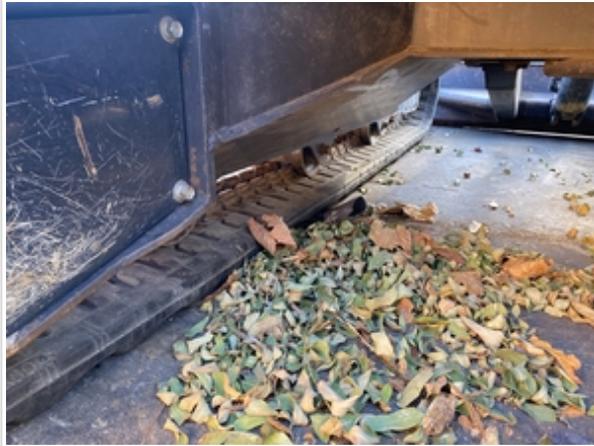
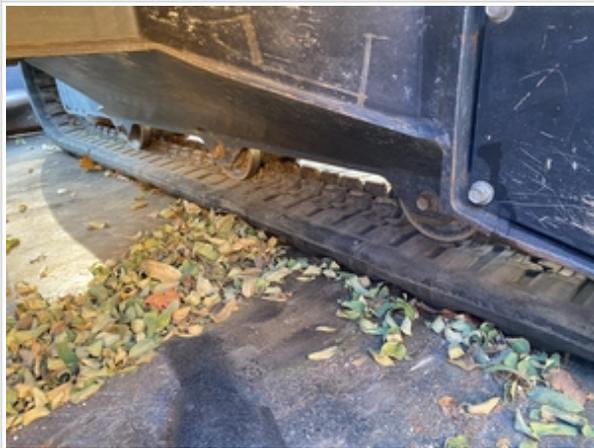
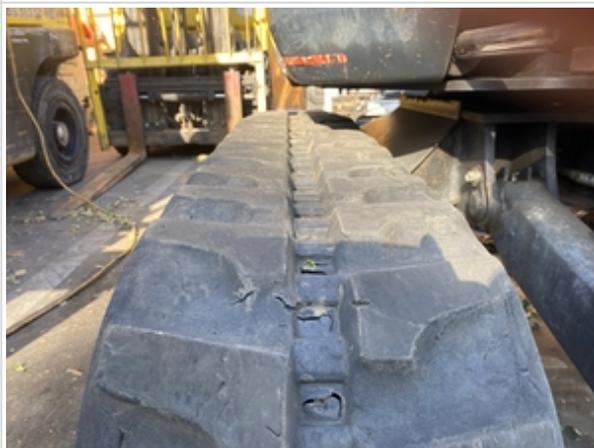
Track Belt Photos

<p>Track Belt</p>	<p>3 - Normal Wear & Tear</p>

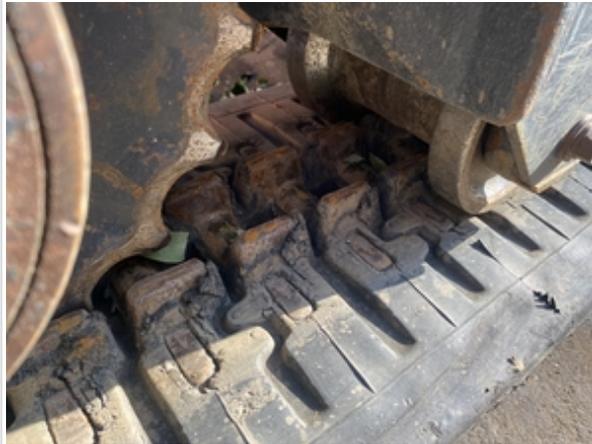
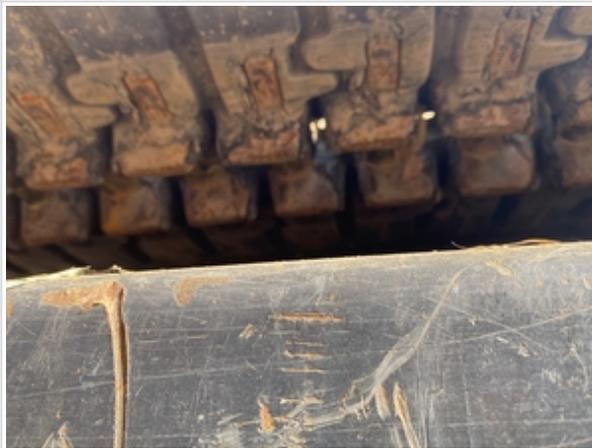
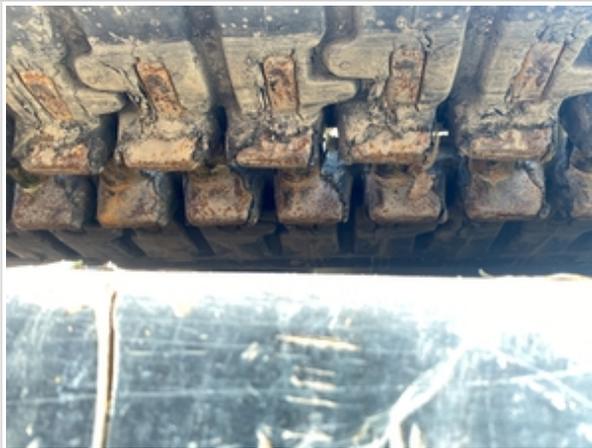
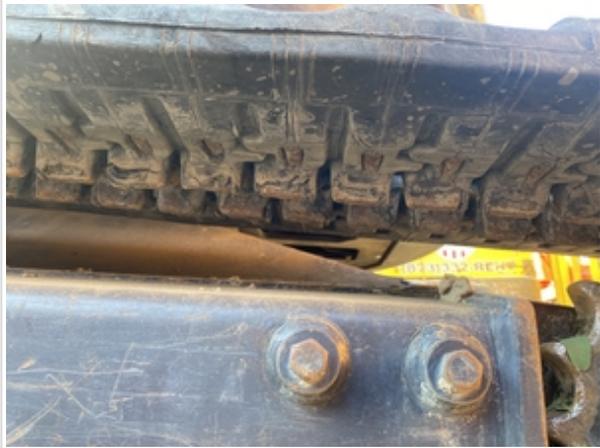
Rubber Belt Drive Lugs Photos

Rubber Belt Drive Lugs

3 - Normal Wear & Tear

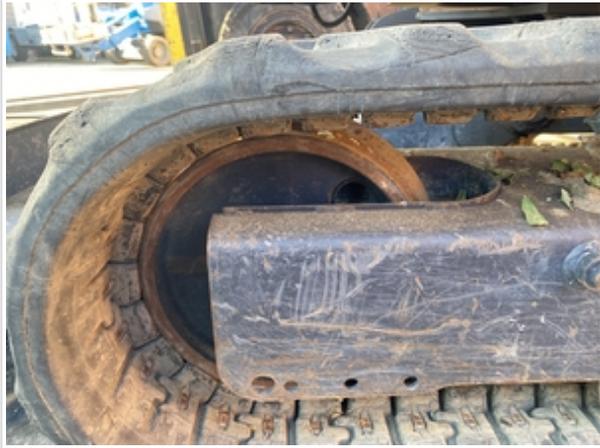
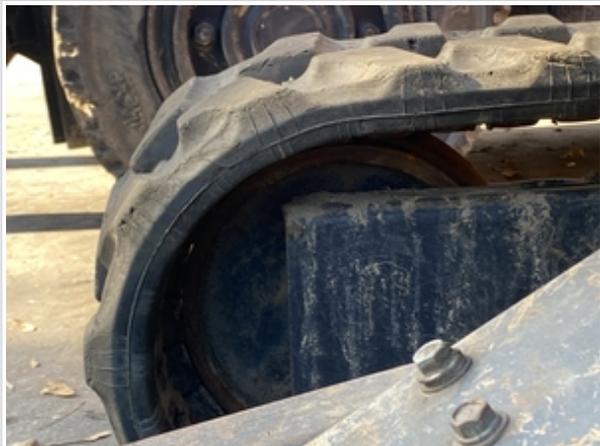
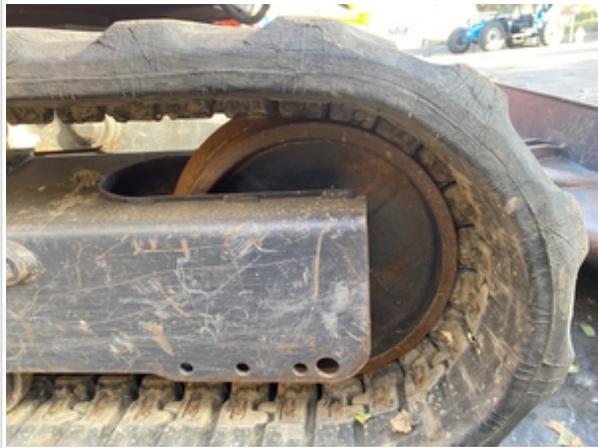
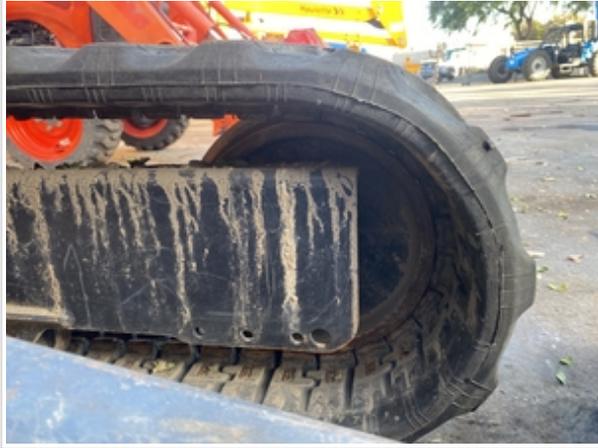
Track Tensioners	3 - Normal Wear & Tear	
Comments	Tracks holding tension	
Front Idlers	3 - Normal Wear & Tear	
Front Idlers Photos
