Inspection Report (Mini Excavator)

Year	2015
Make	Kubota
Model	U25
Serial Number	50812
Hour Meter Reading	1,827
Previous Application (e.g., earth moving, mining, demolition, etc)	Equipment Rental

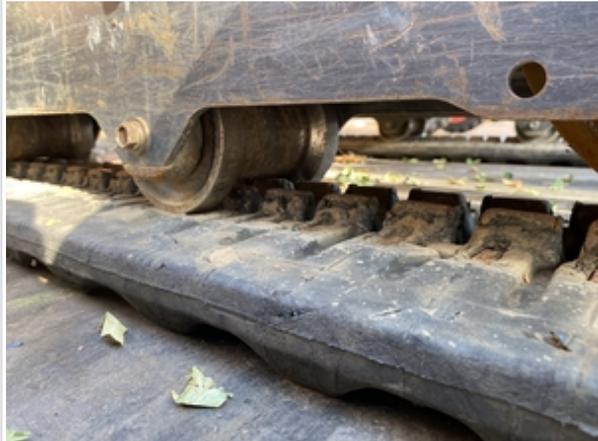
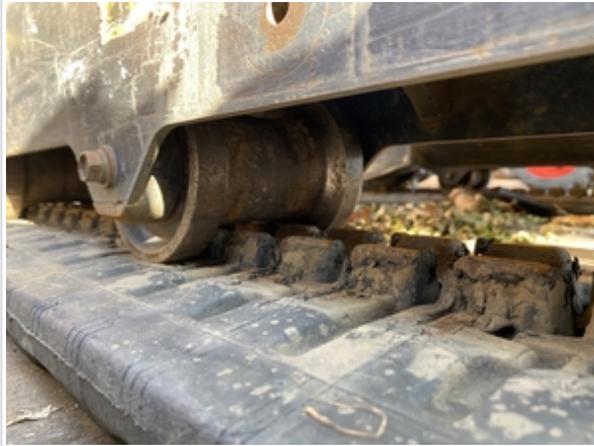
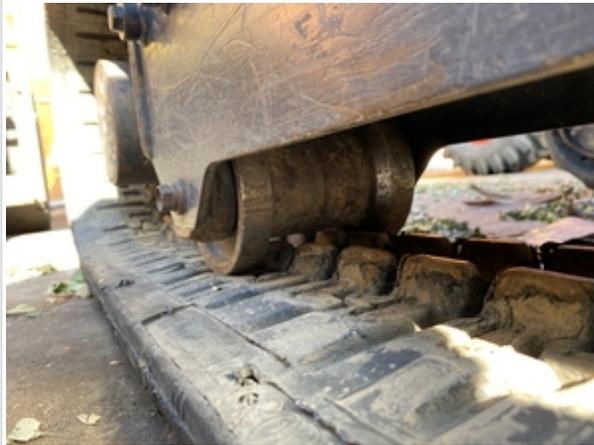
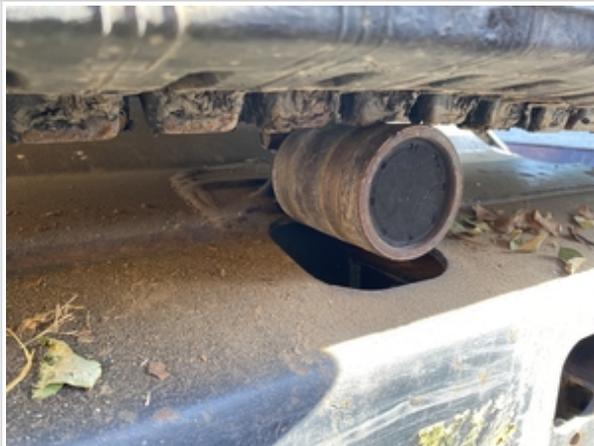
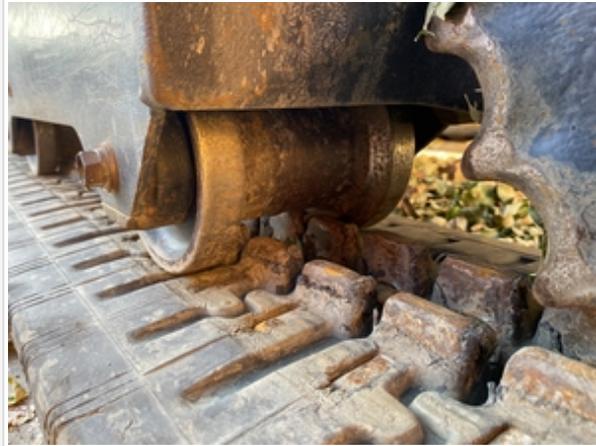
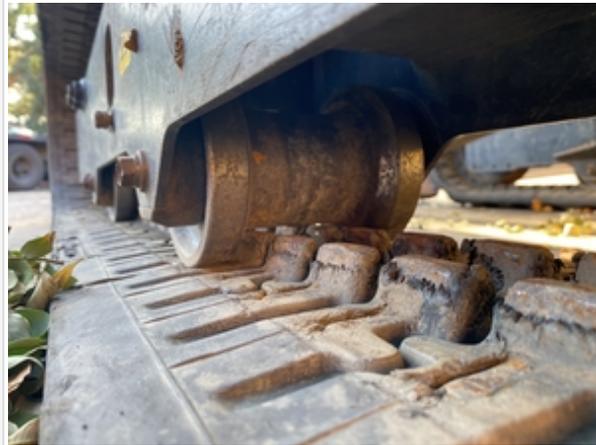
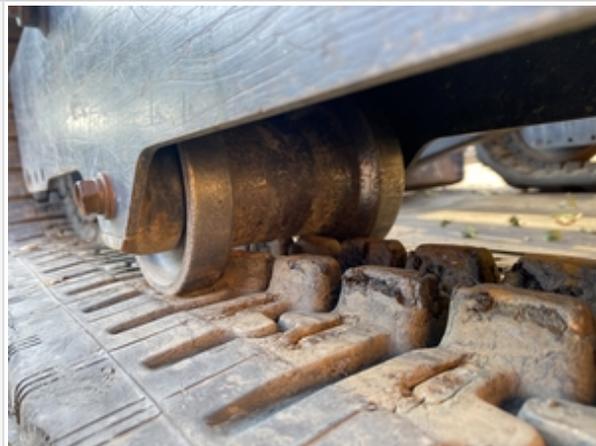
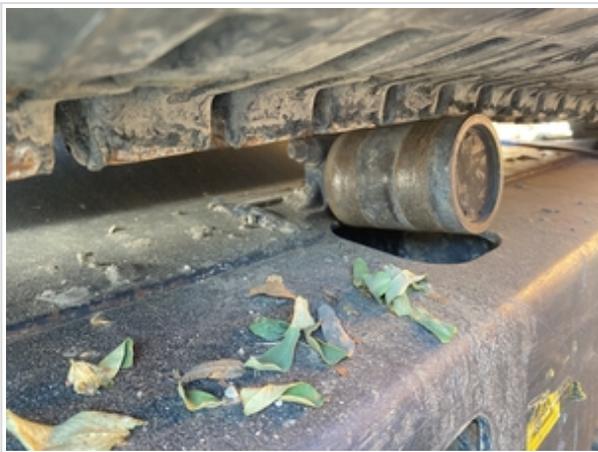
Rear Idlers	0
Track Rollers	3 - Normal Wear & Tear
Track Rollers Photos

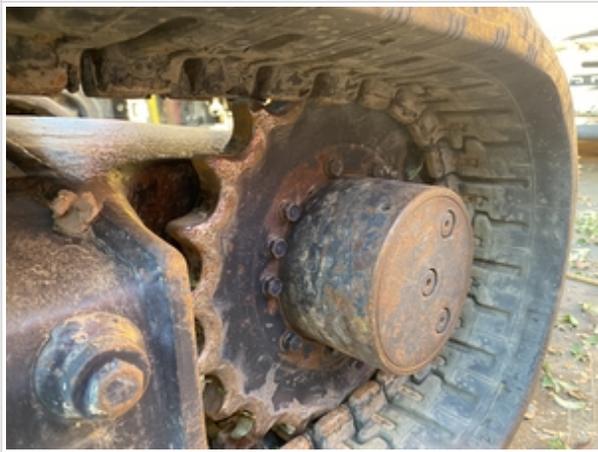
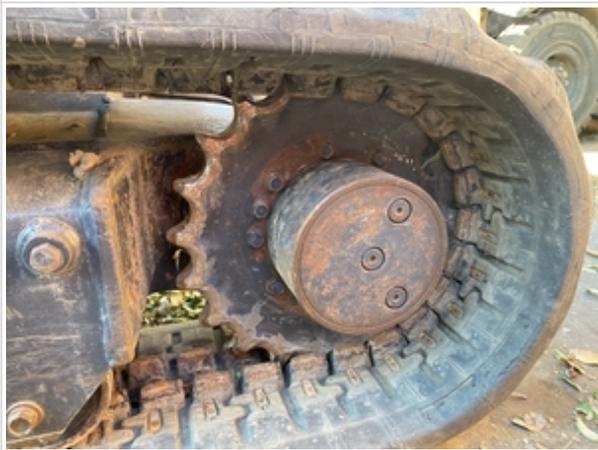
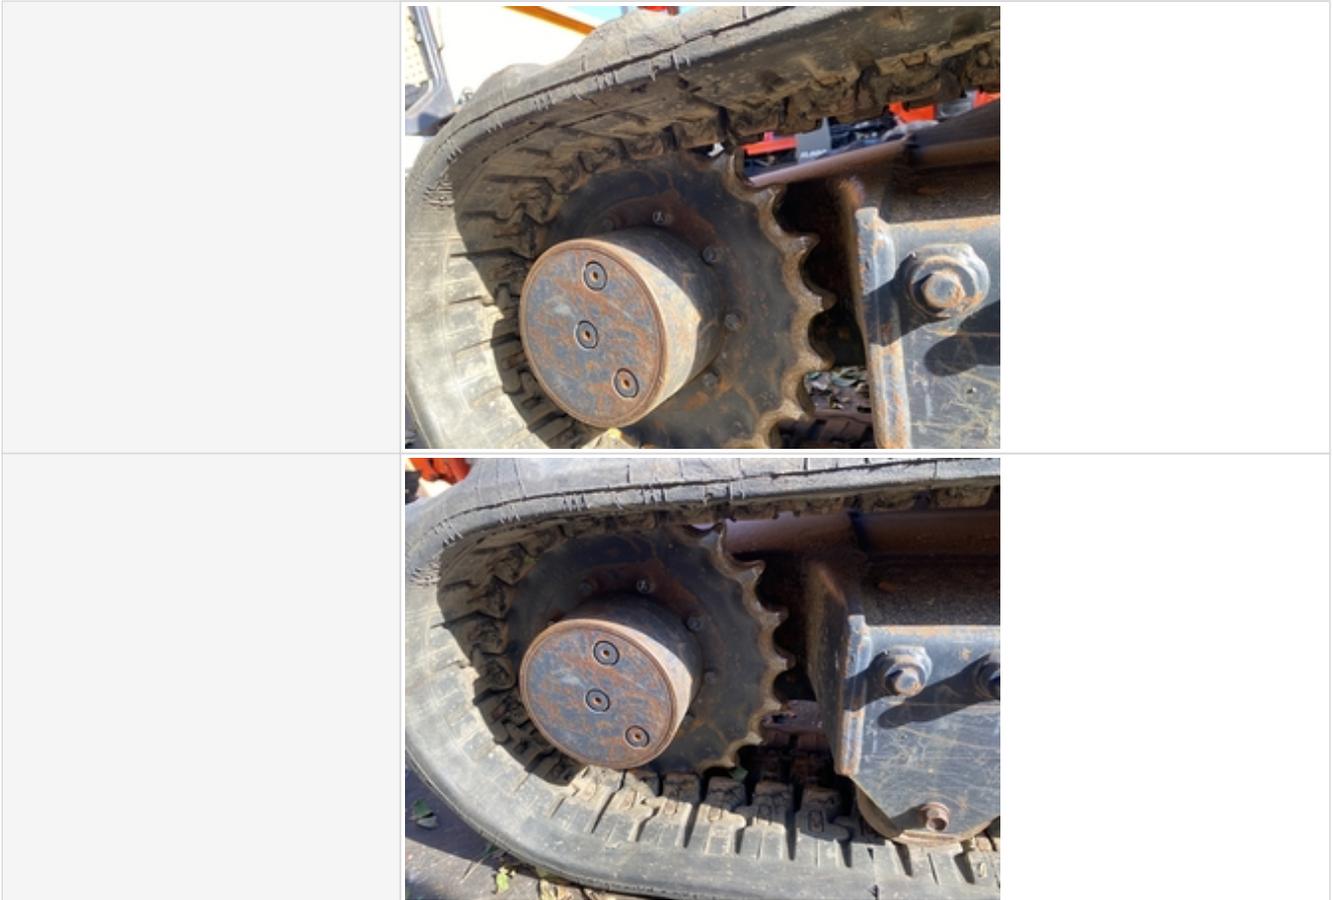
<p>Sprockets</p>	<p>3 - Normal Wear & Tear</p>	
<p>Sprockets Photos</p>

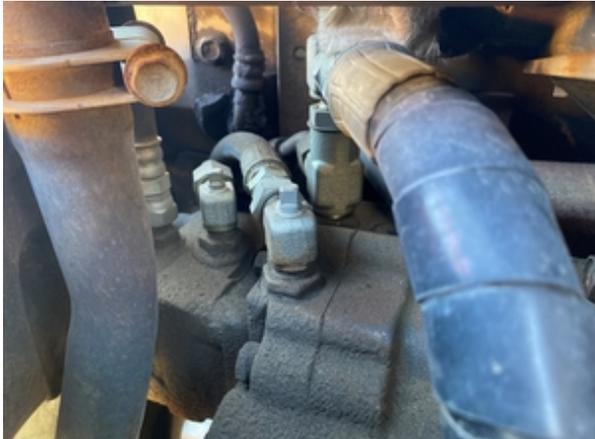
Hydraulics Overall	
Wet or Damp Hydraulic Lines / Fittings	Yes
Appearance of Hydraulic Lines / Fittings	3
Hydraulic Lines / Fittings Condition	Hydraulic lines & fittings are clean and in good condition
Appearance of Hydraulic Lines / Fittings Photos

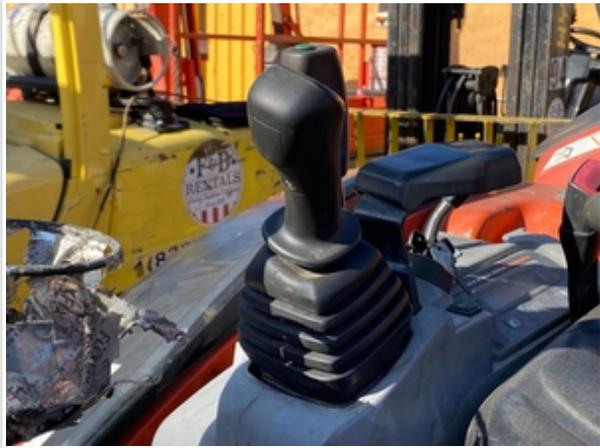
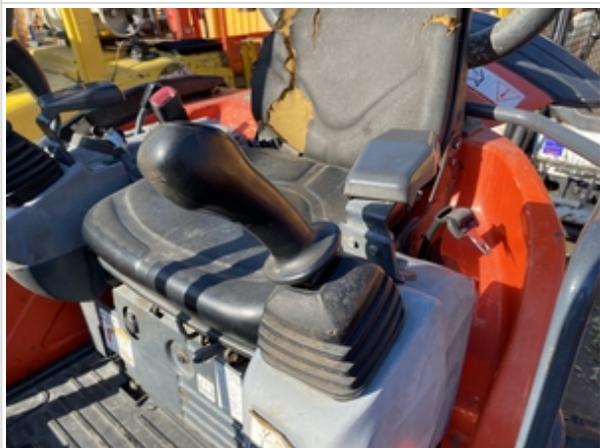
Unusual Noises (Hydraulic Pump)	No	
Hydraulic Pump Notes	No unusual noises heard during operation	
External Controls / Levers	3	
External Controls / Levers Condition	Good function & condition of hydraulic controls	
External Controls / Levers Photos

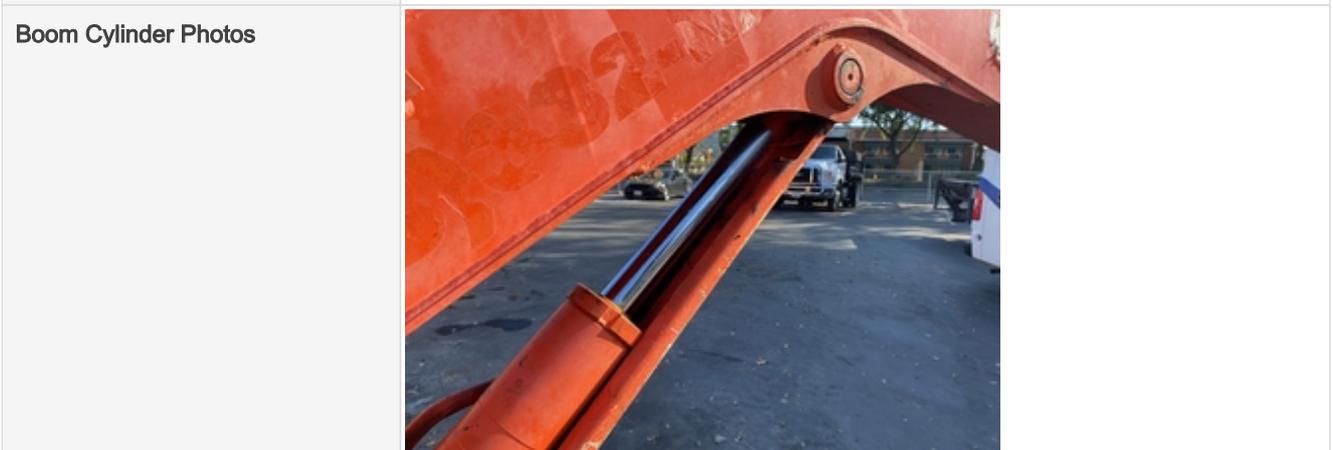
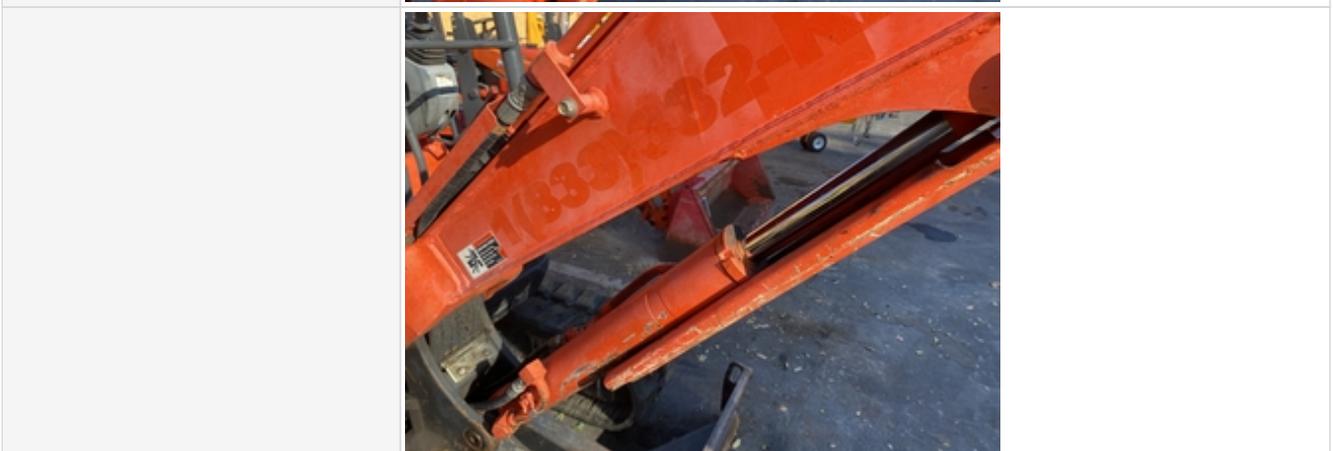
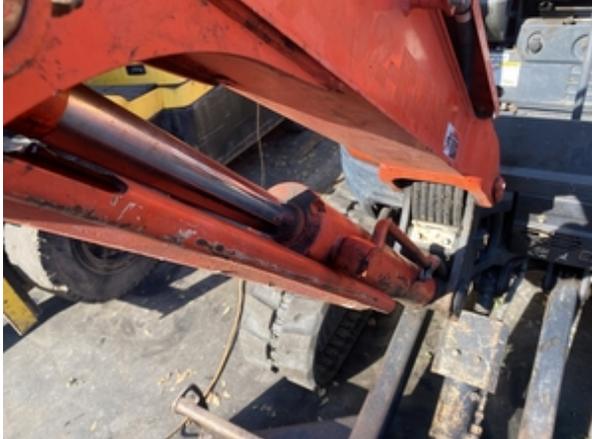
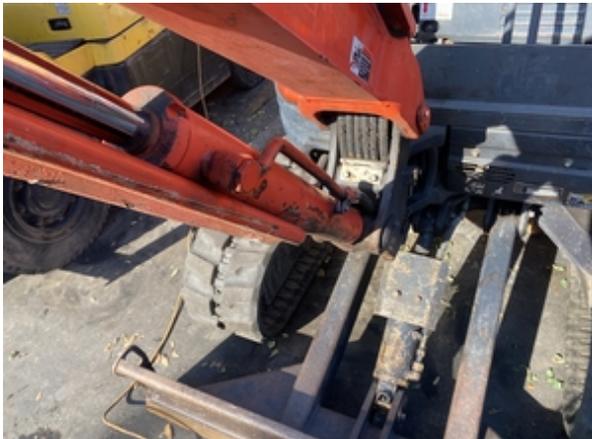
Boom Cylinder	Check the boom cylinder. Note any wear, pitting, discoloration, etc. Take photos.
Boom Cylinder: Mounting Pin	3
Boom Cylinder: Oil Leaks	No

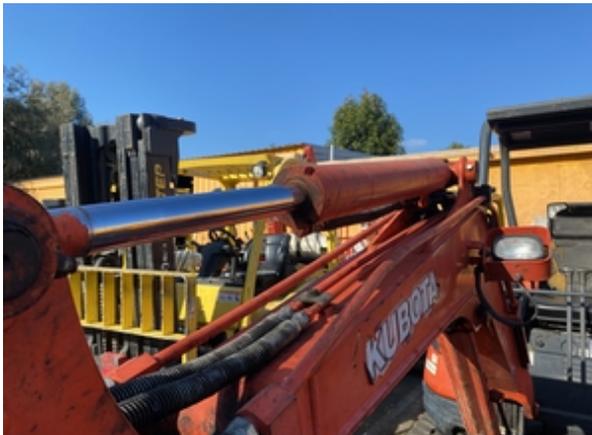
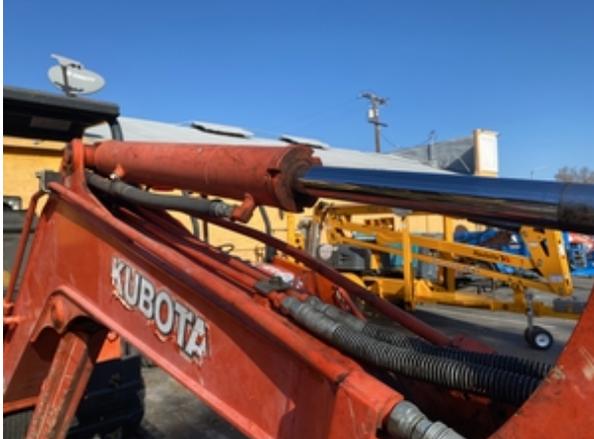
Stick Cylinder	Check the stick cylinder. Note any wear, pitting, discoloration, etc. Take photos.	
Stick Cylinder: Mounting Pin	3	
Stick Cylinder: Oil Leaks	No	
Stick Cylinder Photos

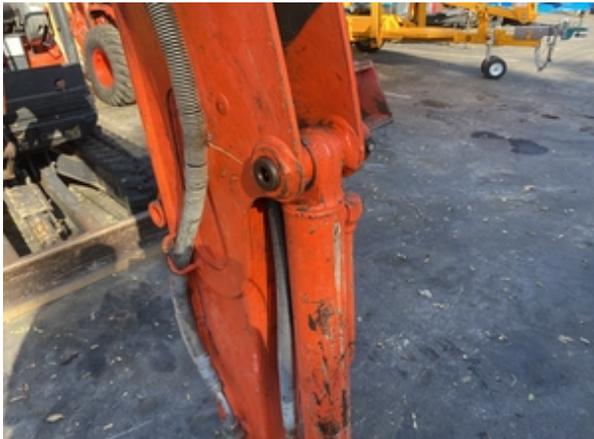
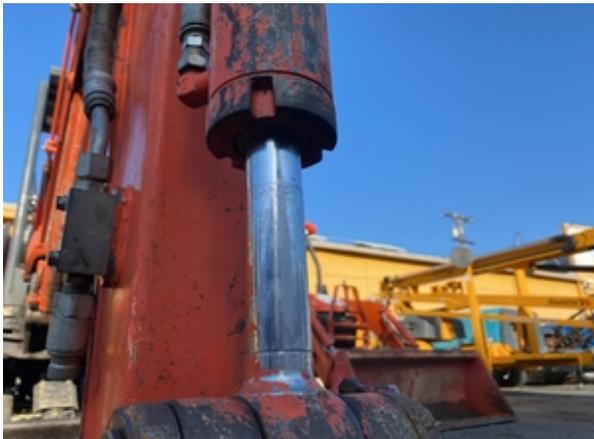
Bucket Cylinder	Check the bucket cylinder. Note any wear, pitting, discoloration, etc. Take photos.	
Bucket Cylinder: Mounting Pin	3	
Bucket Cylinder: Oil Leaks	No	
Bucket Cylinder Photos

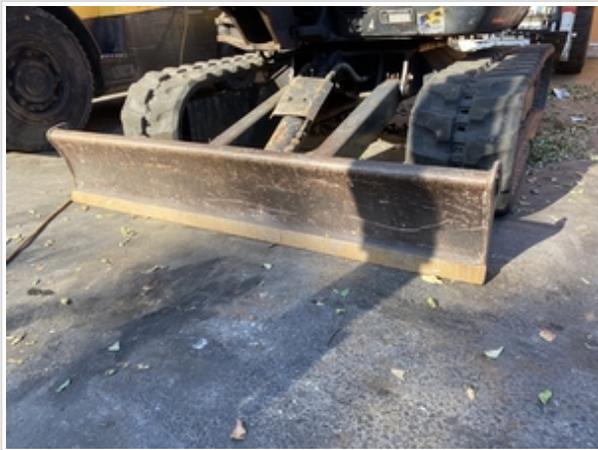
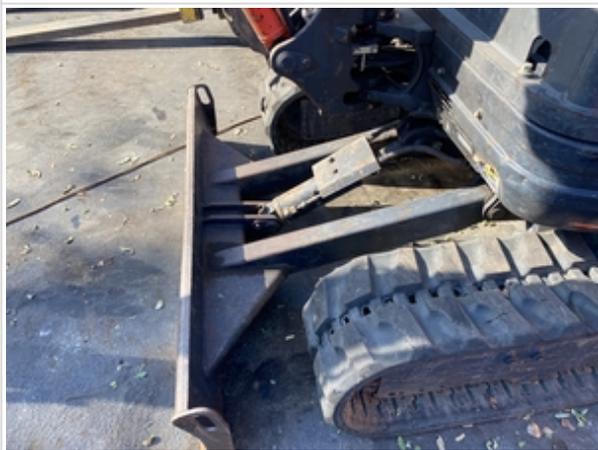
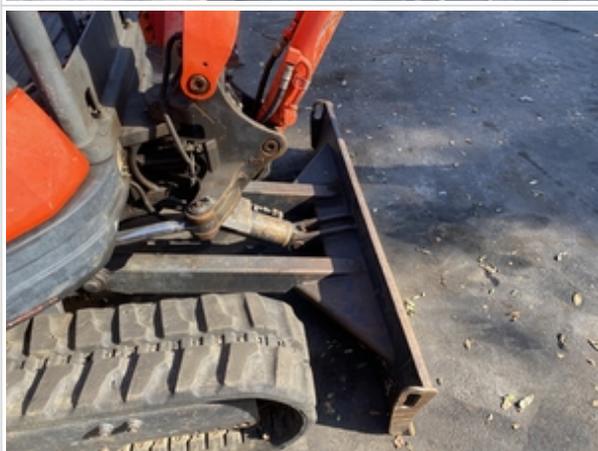
Blade Photos

Blade	Check the blade. Note any wear, pitting, discoloration, etc. Take photos.
Blade	3

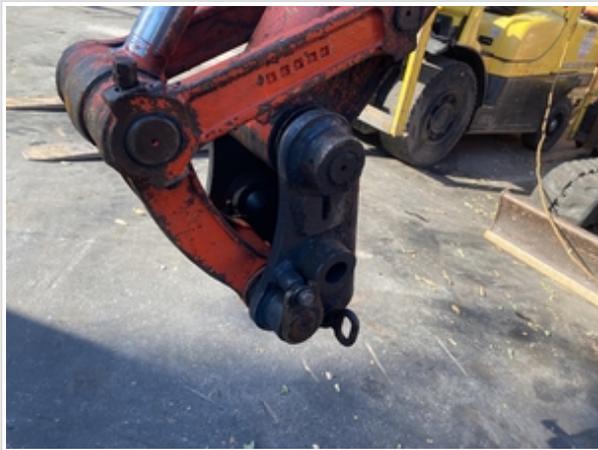
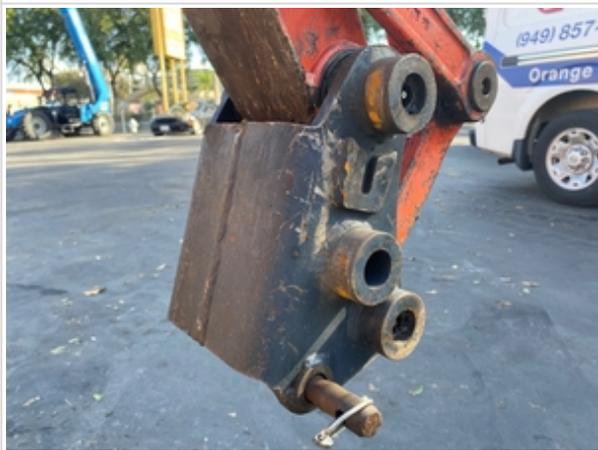
Attachment Photos

Attachment Type	Bucket quick coupler
Attachment Condition	3 - Normal Wear & Tear
